Geotechnical Extreme Events Reconnaissance

July 22, 2014

The 22 March 2014 Oso Landslide, Snohomish County, Washington

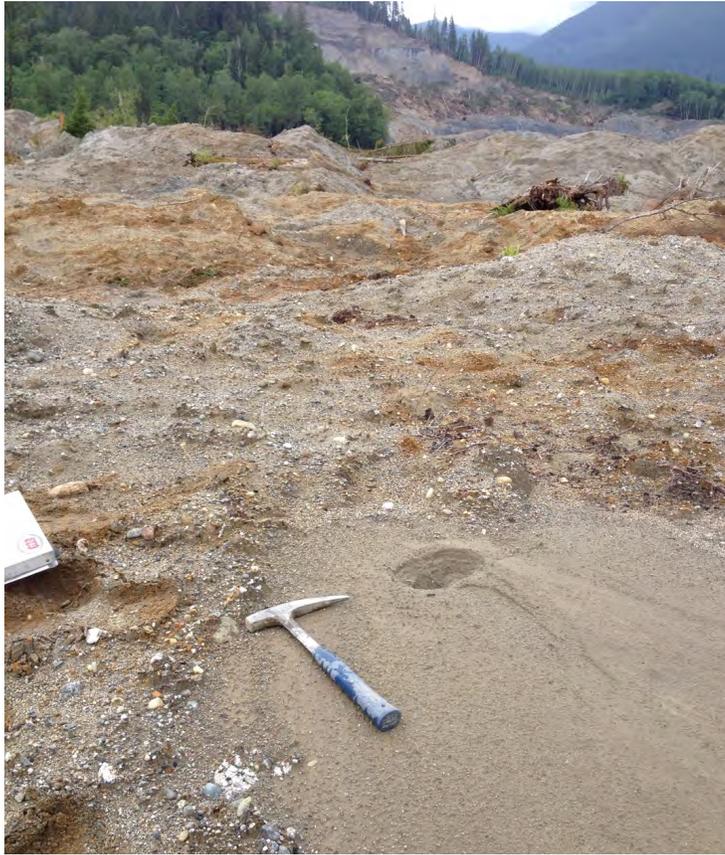
Figure 5.2.27 Typical sand boil. Location: 48.27616, -121.84686.

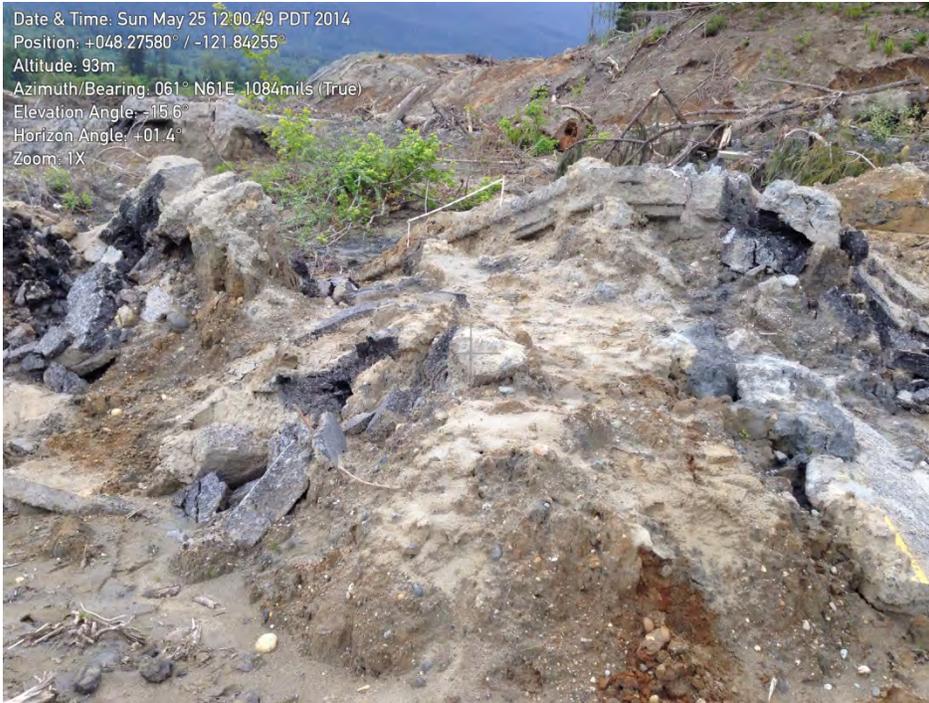
Figure 5.2.32 Asphalt with intact base course from SR 530 road bed plucked and transported by the debris flow. Note piece of asphalt in lower right with yellow paint stripe. Camera position: 48.27580°N, 121.84255°W, view to the northeast.

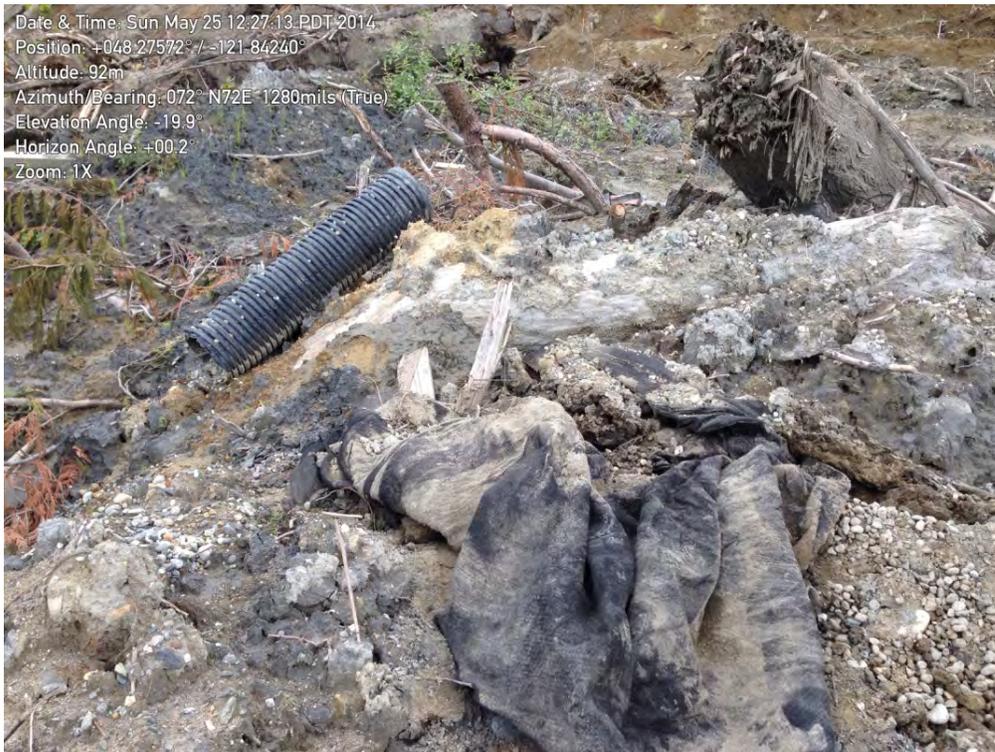
Figure 5.2.33 Drainage pipe and filter fabric from SR 530 transported to the southwest by initial debris flow. Camera position: 48.27572°N, 121.84240°W, view looking east-southeast.

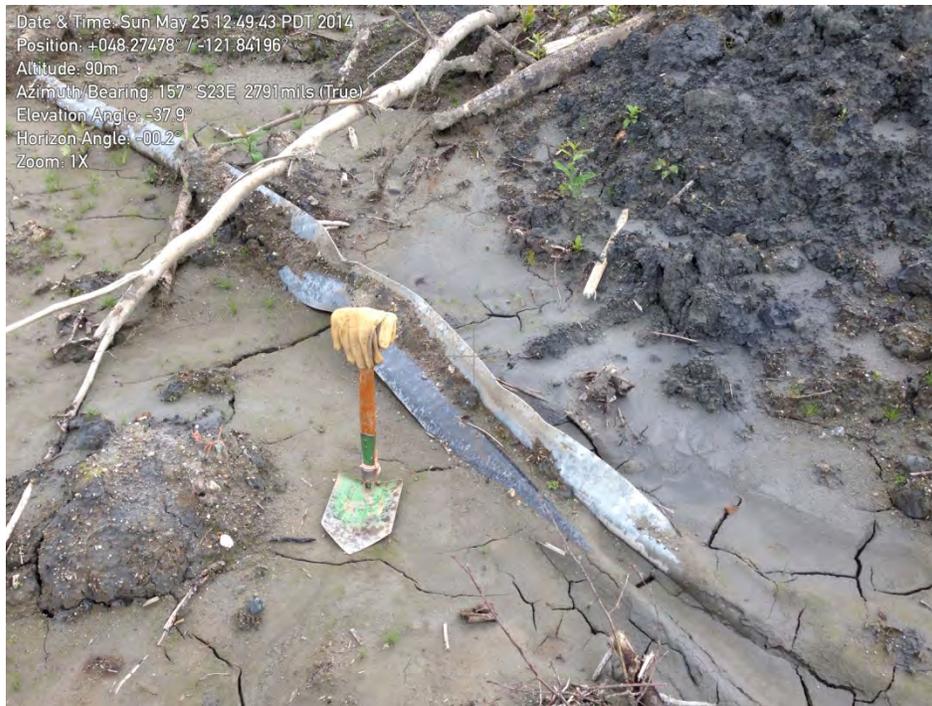
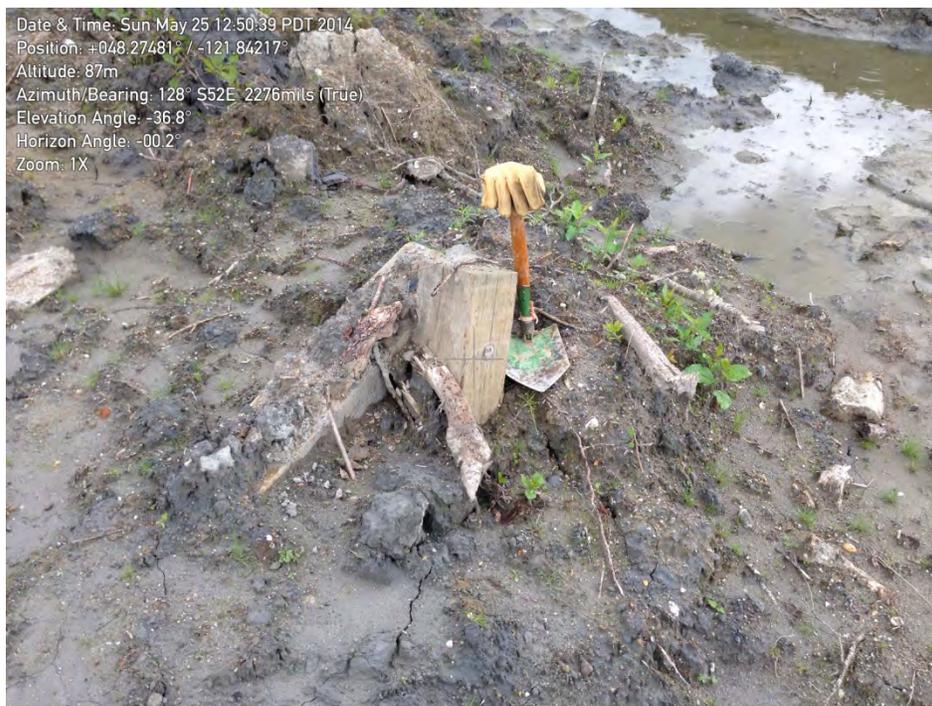
Figure 5.2.34. Section of guard rail (top) and timber support (bottom) transported from SR 530 by initial debris flow. Camera positions: 48.27478°N, 121.84196°W, view toward southeast (top); 48.27481°N, 121.84217°W, view toward southeast (bottom).

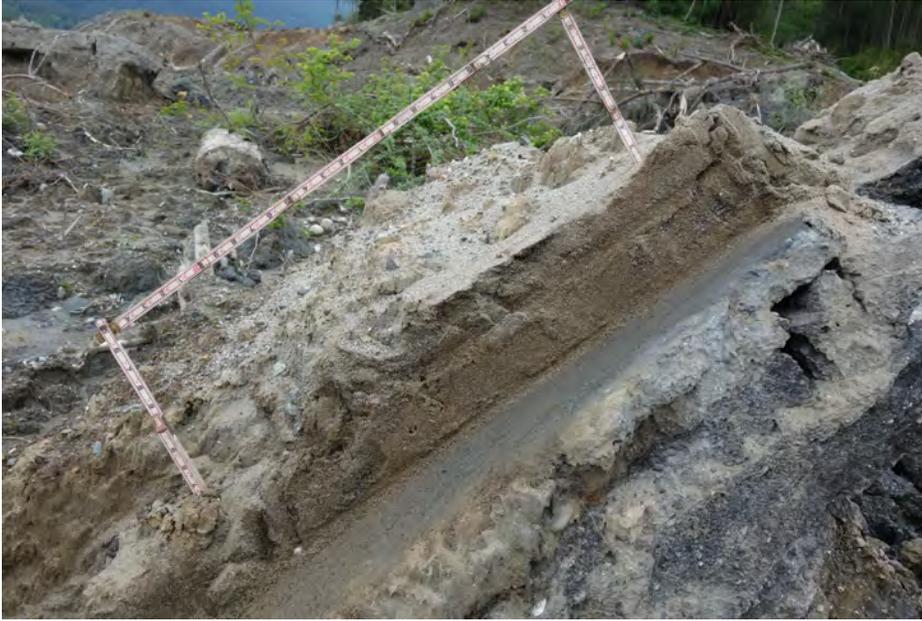
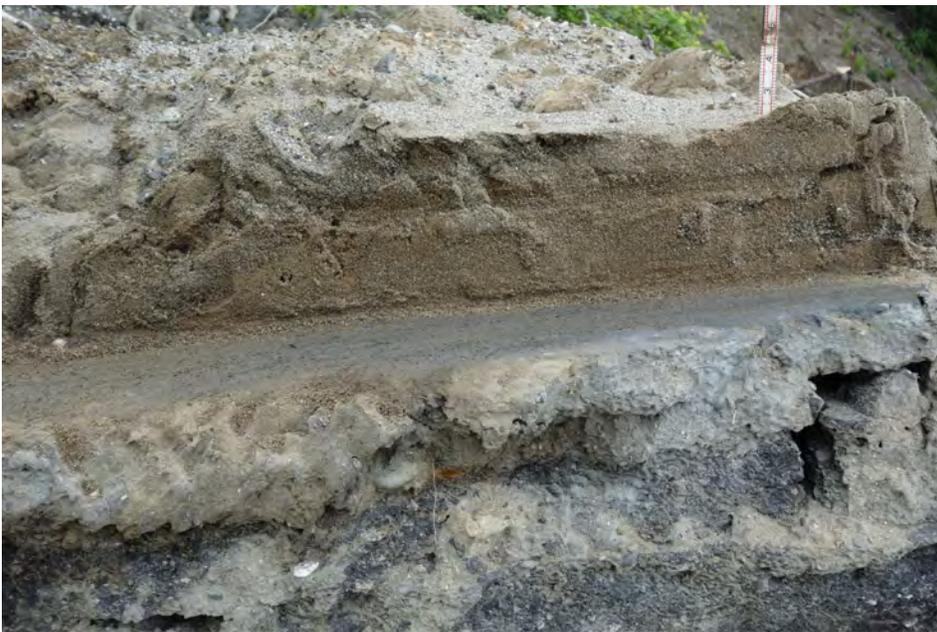
Figure 5.2.35. (upper) Example of one of several Highway 530 pavement sections that were uplifted and transported by the landslide. The pavement section (which is inclined down to the left) shows an intact segment of what is believed to be the first material to have crossed the highway prior to its subsequent uplifting and transport. The scale shown is in feet (location: -121.842560, 48.275860). (lower) Close view of the deposit above the pavement section. The photograph shows a coarse-grained tan sand over a thin (several mm) film of grey silt and clay over the asphalt. The pavement is underlain by a gravelly pavement base course material that was emplaced during construction of the road. The structure of the tan sand deposit suggests initial arrival of a hyper-concentrated flow rather than a debris flow.

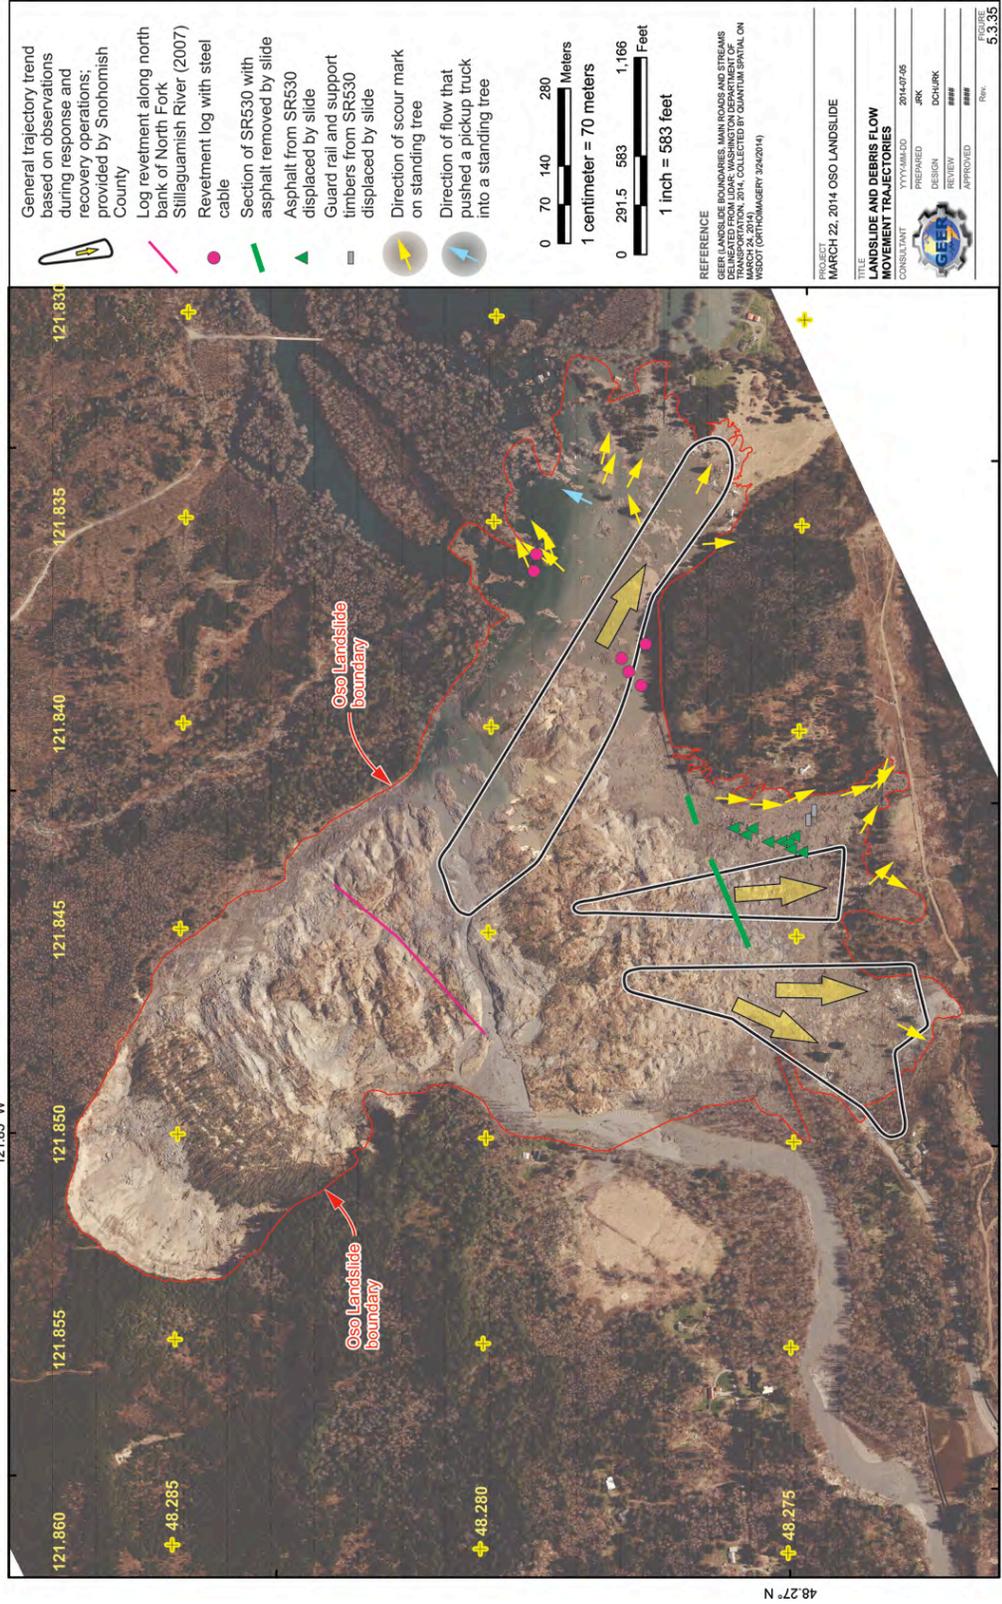
Figure 5.2.36 The travel vectors (vector from point of origin to depositional location) of identifiable materials.

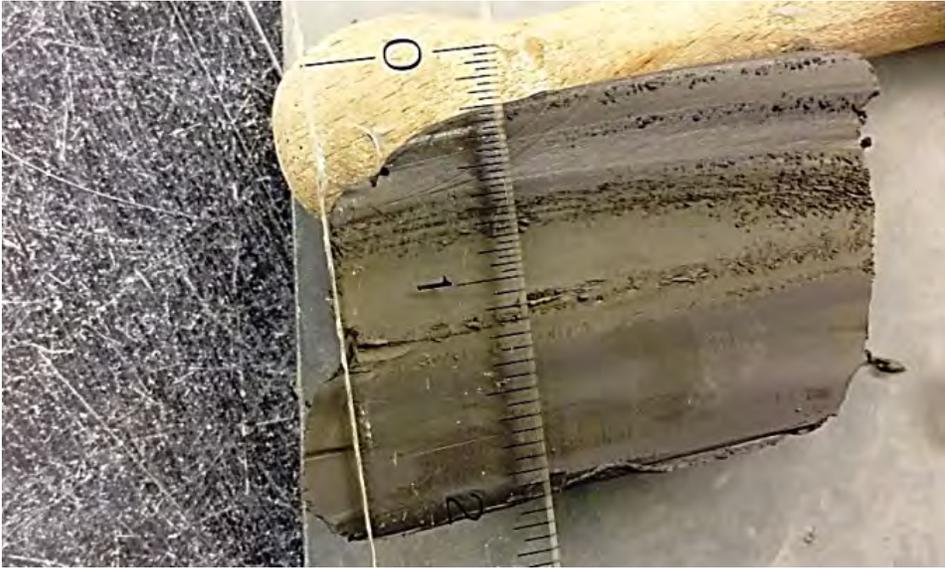
Figure 5.3.7: Varved clay test specimen.

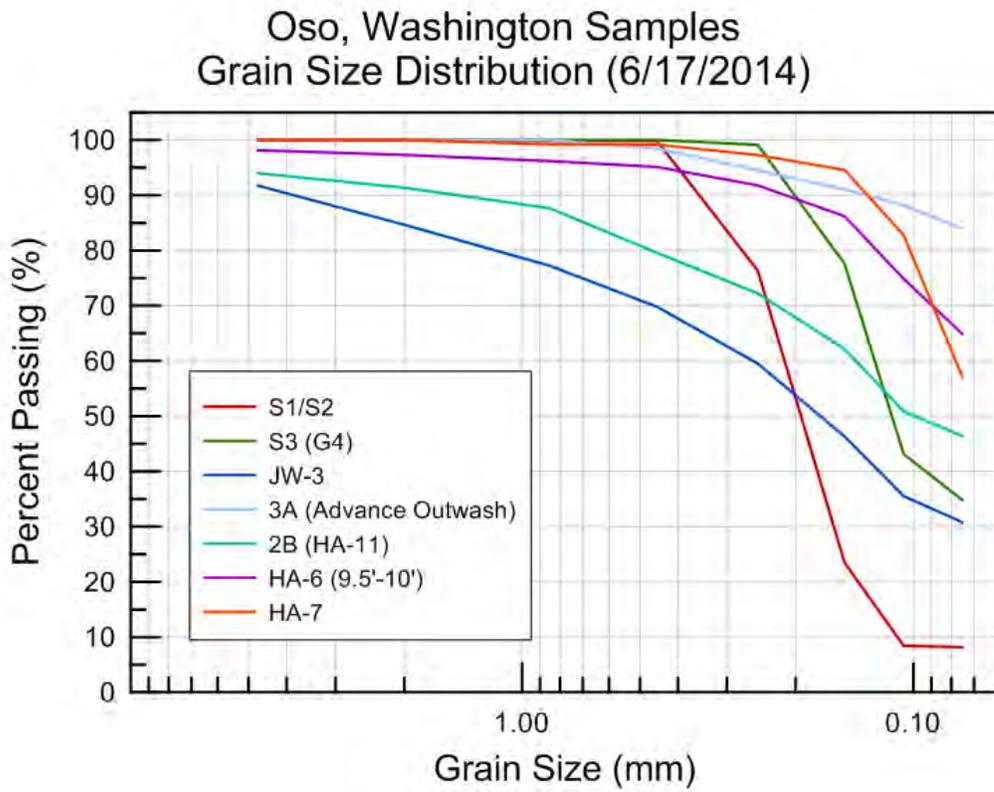
Figure 5.3.8 Grain size distribution plot for data in Table 5.4.2.

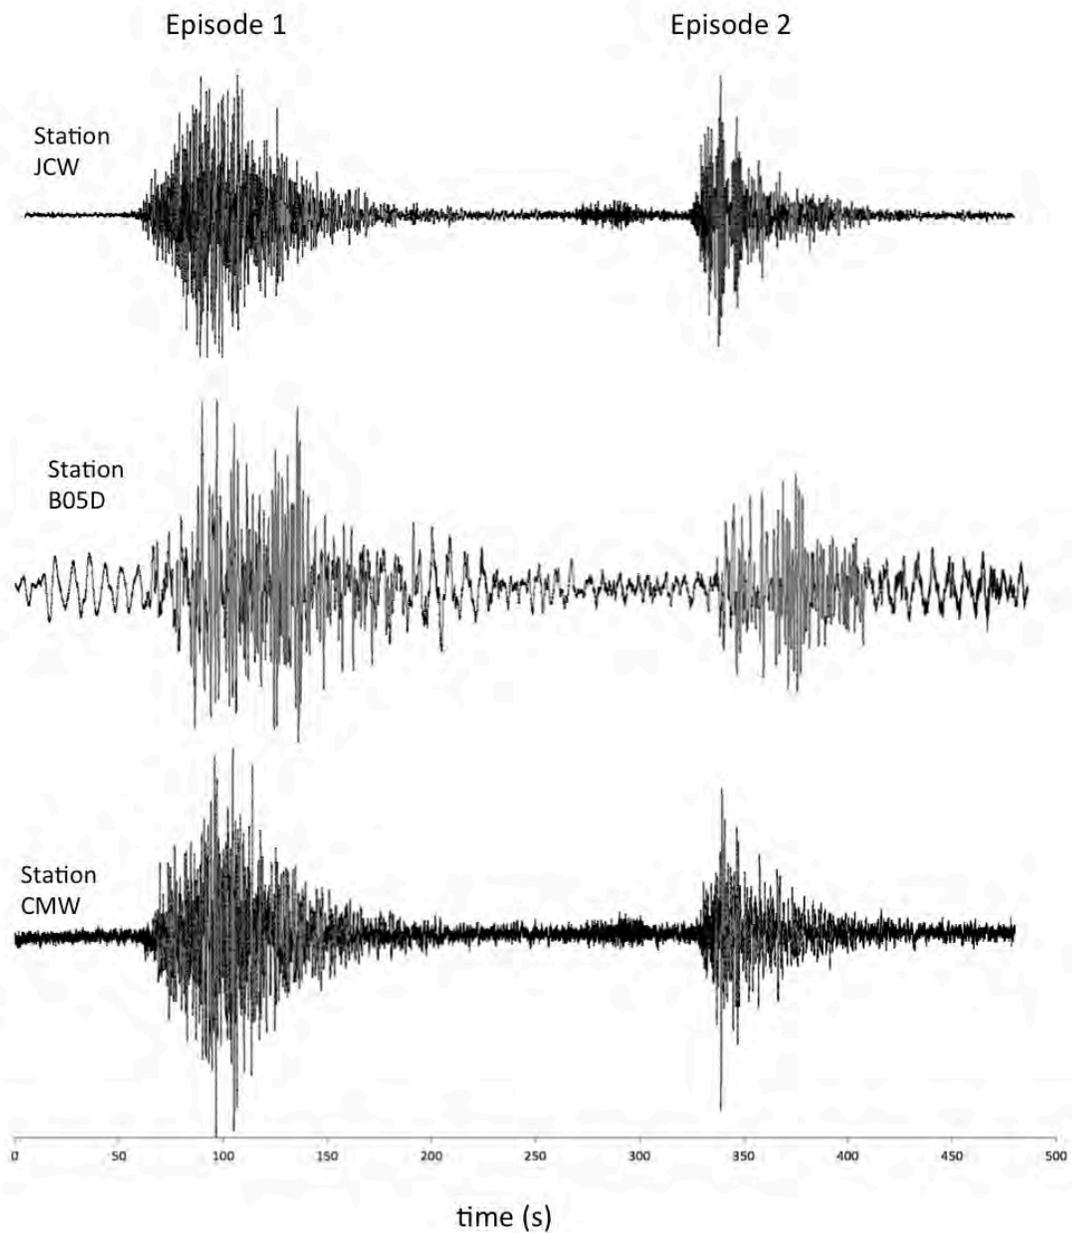
Figure 5.4.1 Velocity-time histories generated by the Oso Landslide. The signals were recorded at seismic stations located within approximately 22 km of the landslide site. A minor baseline correction was made to the signals, which are otherwise unmodified. Velocity values (vertical axis) have been normalized to facilitate a general comparison of the three signals; they are thus relative rather than absolute.

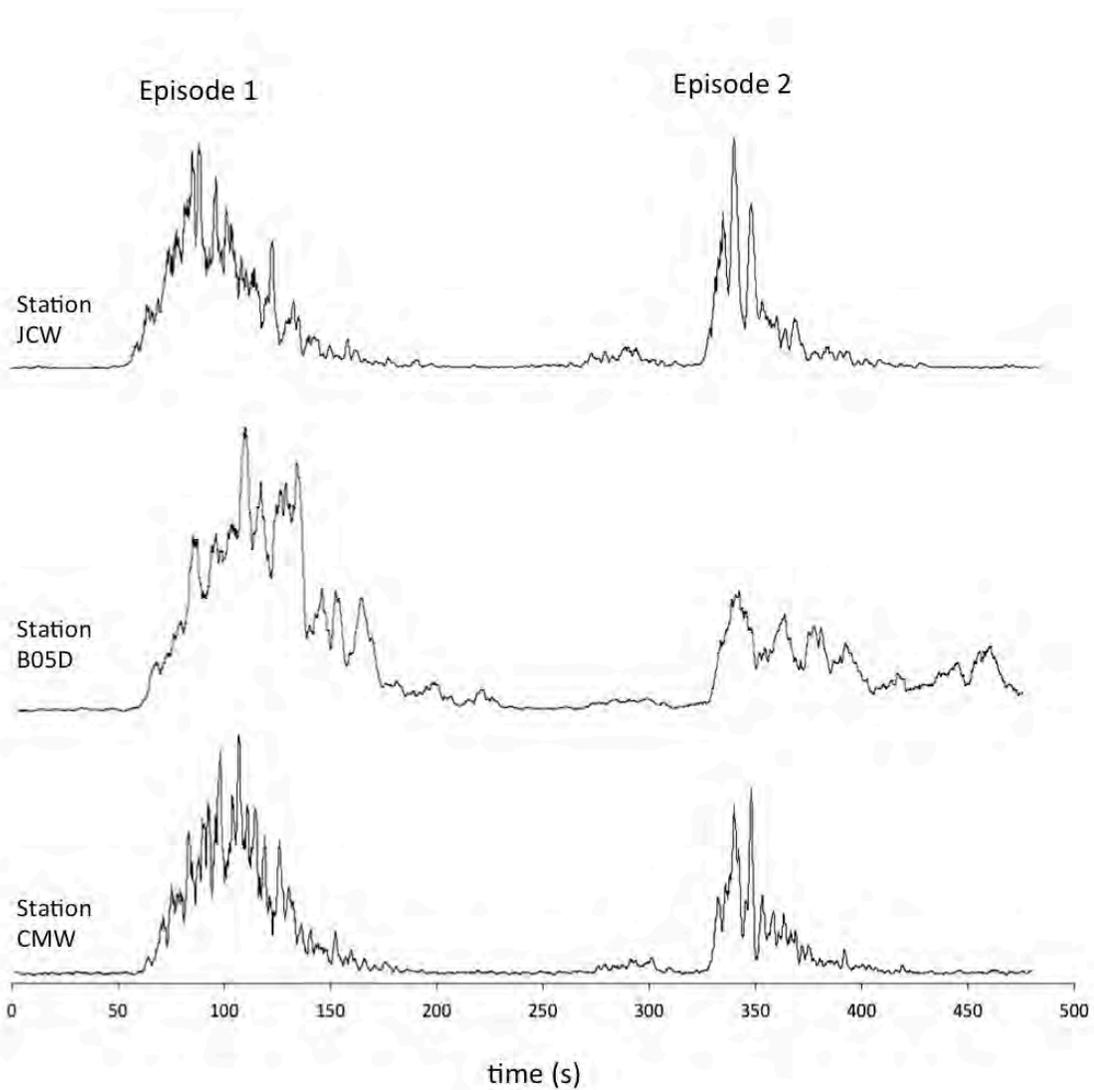
Figure 5.4.2: Landslide-generated velocity-time histories presented plotted as smoothed, high-pass filtered (<1 Hz), smoothed envelopes. Owing to the smoothing function, the velocity amplitude data (vertical axis) is relative rather than absolute.

Seismic records show that several discernable events also occurred within an hour of the Stage 1 failure and these are all considered to be part of Stage 2 in that they happened after the Stage 1 collapse, remained north of the river, and, therefore, did not contribute to the damage south of the river. Some of these are likely smaller failures of the main scarp, for example, Zone A4, which is clearly visible (Figure 6.1.3). Some of these likely had other origins because, despite the continued raveling of soil for over two months (at the time of our visit the scarp was continuously and audibly raveling and a few approximately 10 cubic meter collapses occurred each day during our field reconnaissance), the scarp and slump block still are clearly defined and look fresh. In fact, that fresh appearance helps to make Zone A4 stand out as an exception. Other possible sources for these small seismic signals include debris flows in Zone C and the back-rotation of slump blocks in Zones A3 and B, as they came to equilibrium after their rapid emplacement.

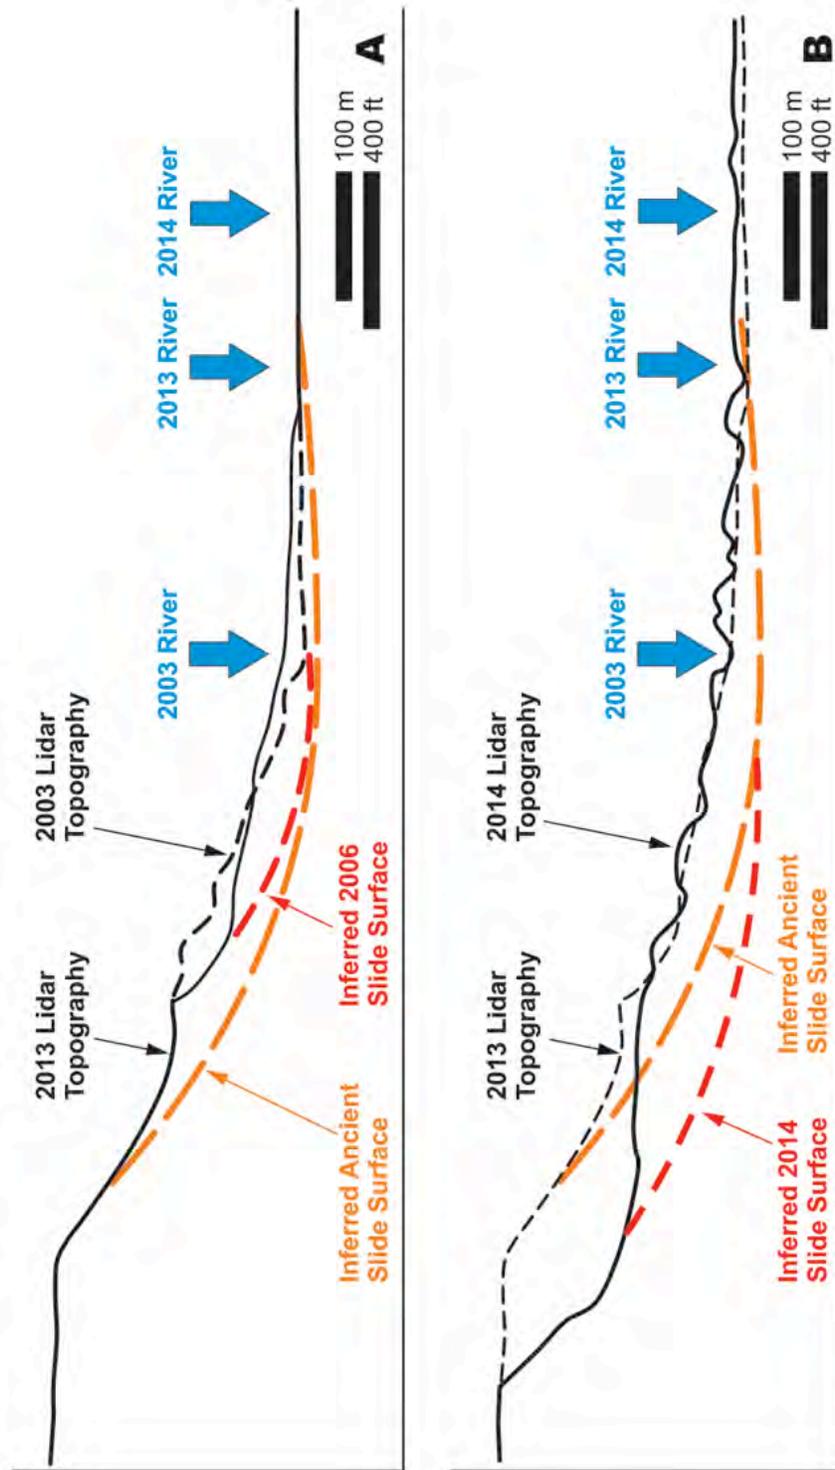
Figure 6.1.1: Schematic cross section (modified from A-A' from Figure 4.1.8) showing conceptualized 2006 and ancient slide surfaces (upper diagram). Also shown is a conceptualized 2014 slide surface (lower diagram).

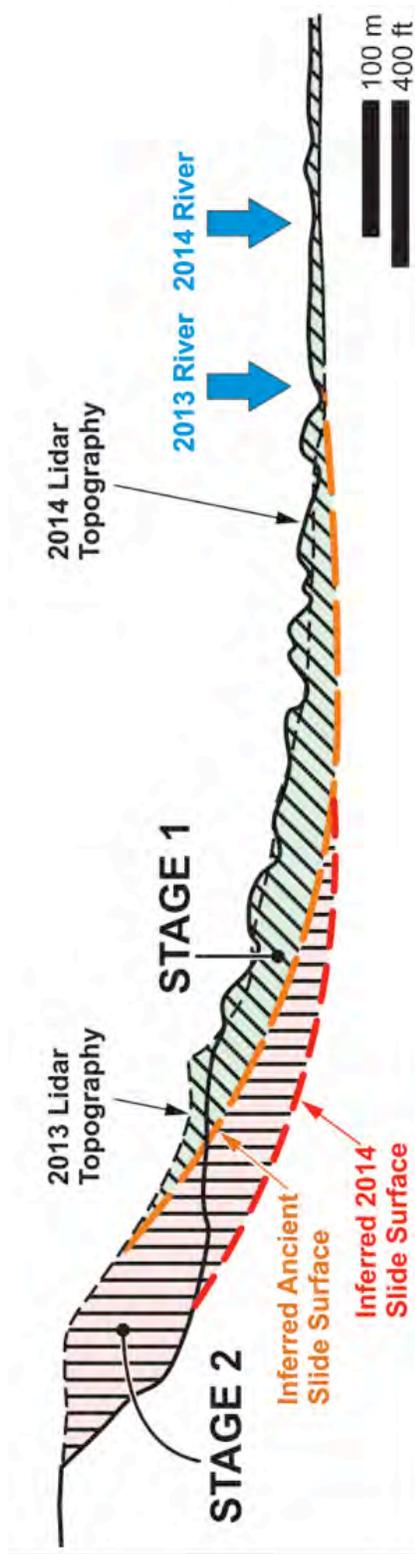
The first major stage of movement (Stage 1) is interpreted to be a remobilization of the 2006 slide mass and a headward extension that included part of the forested slope of the pre-historic slide. As such, Stage 1 was comprised largely or entirely of previous landslide deposits, some as recent as 2006, and others ancient. It is believed that Stage 1 initiated partly on a shear surface that is essentially the lower portion of the ancient slide surface, as is shown schematically in Figure 6.1.1, and mobilized as a debris flow, traveling across the valley and causing most or all of the damage and destruction south of the river.

The second stage (Stage 2) occurred subsequently in response to the unloading (i.e., loss of "buttressing") and the redirection of principal stresses and possibly, to groundwater seepage forces. Stage 2 was a retrogression into the Whitman Bench of up to nearly 90 m (300 feet) horizontally from the ancient slide scarp. The Stage 2 slip surface probably joined the slip surface of Stage 1 (and that of the 2006 and ancient slides) at depth, but also included up to 300 m (1000 feet) or more of previously deeper in-place outwash, till and lacustrine deposits (Figure 6.1.1). The Stage 2 landslide moved rapidly on the existing Stage 1 slip surface until it essentially collided with the more intact blocks at the trailing edge of the Stage 1 slide mass, and came to rest. The seismic signals show several much smaller events in the time following Stage 1 and these are included as part of Stage 2 in the discussion that follows. Stages 1 and 2 are shown schematically in section in Figure 6.1.2, and in plan view in Figure 6.1.3.

Figure 6.1.2 Schematic cross section (modified from A-A' from Figure 4.1.8) with conceptualized boundaries of Stage 1 and Stage 2 shown by hatch marks. Stage 1 evolved to be essentially a remobilization to the prehistoric slide surface. Stage 2 mobilized the material between the prehistoric slide surface and the 2014 slide surface.

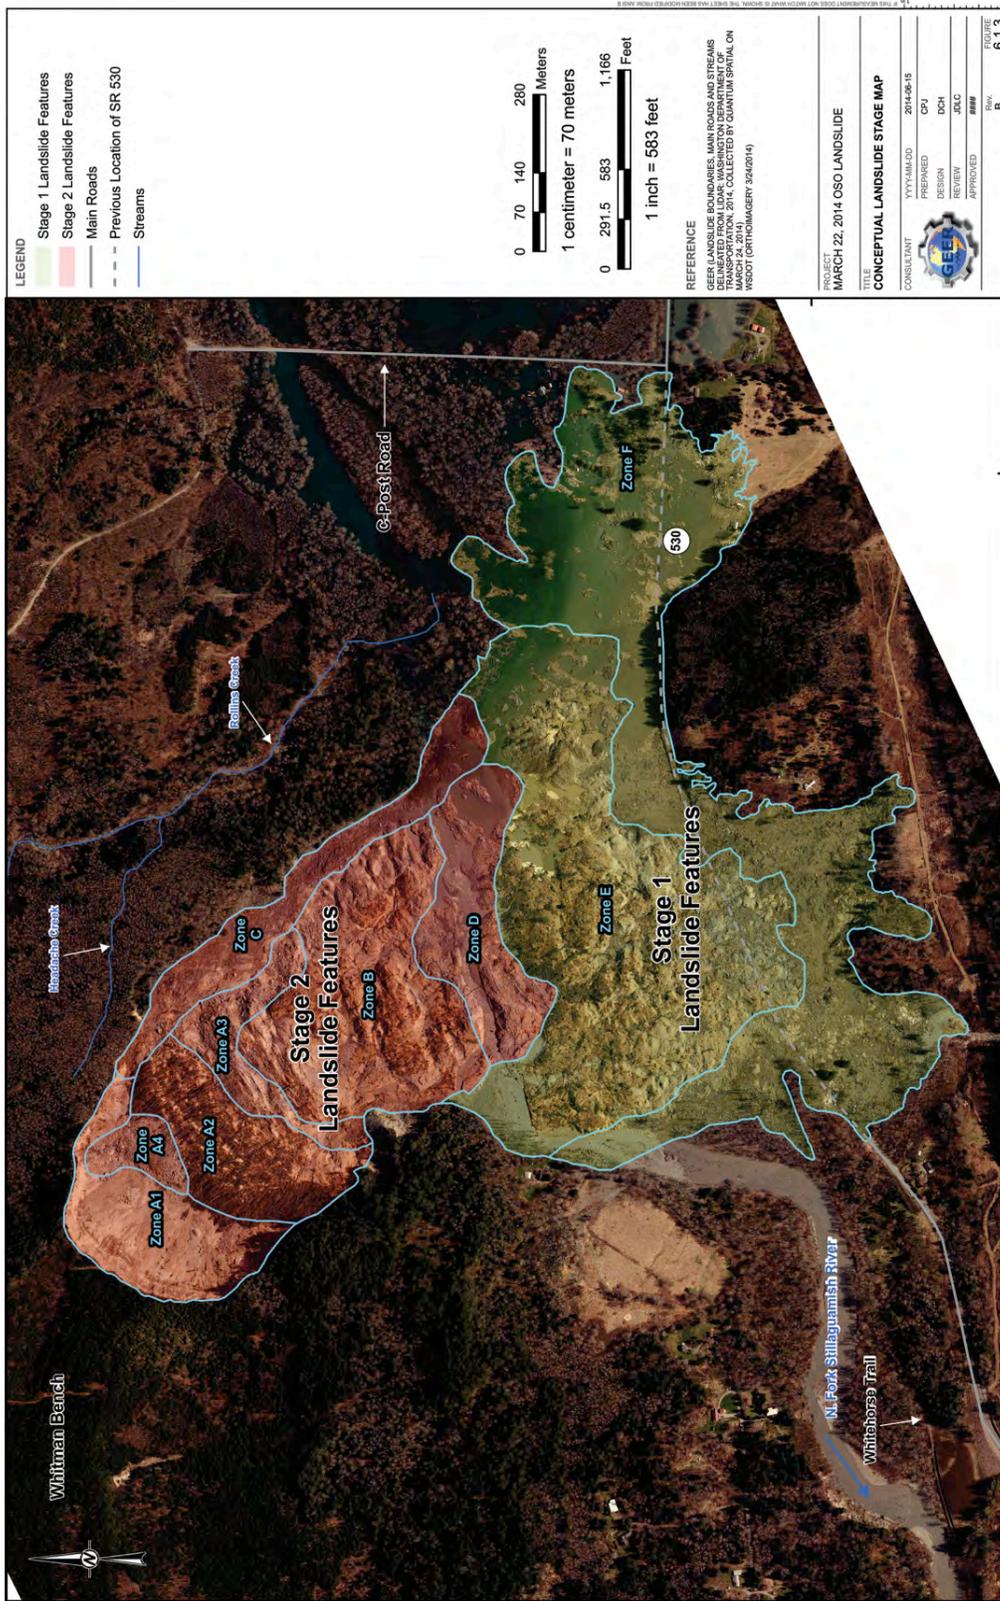
Figure 6.1.3. Conceptual landslide stage map.

With respect to the mechanism of movement, Stage 2 can be subdivided into four types and areas. The upper part of Stage 2 underwent no more than 700 feet (210 m) of lateral movement and rotated backward as a slump block so that the ground surface is largely intact and all trees have fallen and been laid flat by the downward acceleration or the back rotation and stopping of the block. This area has a classic slump-block morphology and the stratigraphy of recessional outwash over till appears largely intact (Zone A2 and A3 in Figure 5.3.1; Figure 6.1.3). Note that the till appears to have been a little more mobile and to have travelled farther downslope near the east margin, as can be seen in Figure 5.3.1 (Figure 6.1.3).

The upper middle part has an extensional morphology with back rotation evident by ground surface slopes, exposure of repeating stratigraphy, slickensides, and, in one location shown in Figure 5.3.8b, the skid marks left by fallen trees are clearly inscribed upon a slope. The lower middle part of the Stage 2 slide mass shows more signs of extension, including thinning of the outwash cover, and less back rotation of slump blocks. The area of extension is the lower part of Zone B as shown in Figure 5.3.1 (Figure 6.1.3).

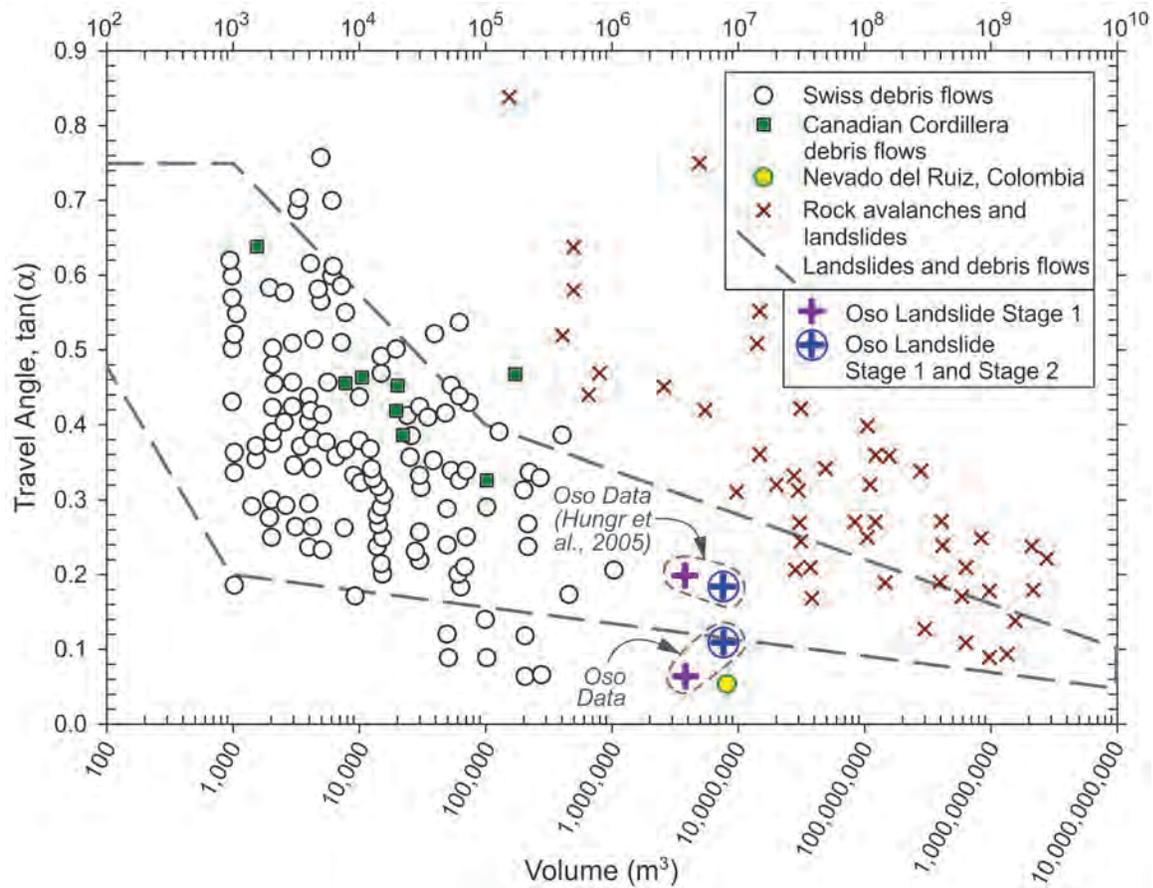
Figure 7.2.2 Travel Angle versus Volume of Mass Movement (adapted from Jakob and Hungr 2005). The data represented in this figure is from various case histories including debris flows, debris avalanches, rock falls and landslides. The travel angle for the Oso Landslide was estimated using the empirical relationship of Hungr et al. (2005) for debris flows using the total volume of the Oso slide and using 50% of the total volume. The lower data points are the travel angles based on the landslide height, H and the horizontal distance from the headscarp to the distal edge, L measured at Oso for the total volume and for 50% of the total volume of the slide.

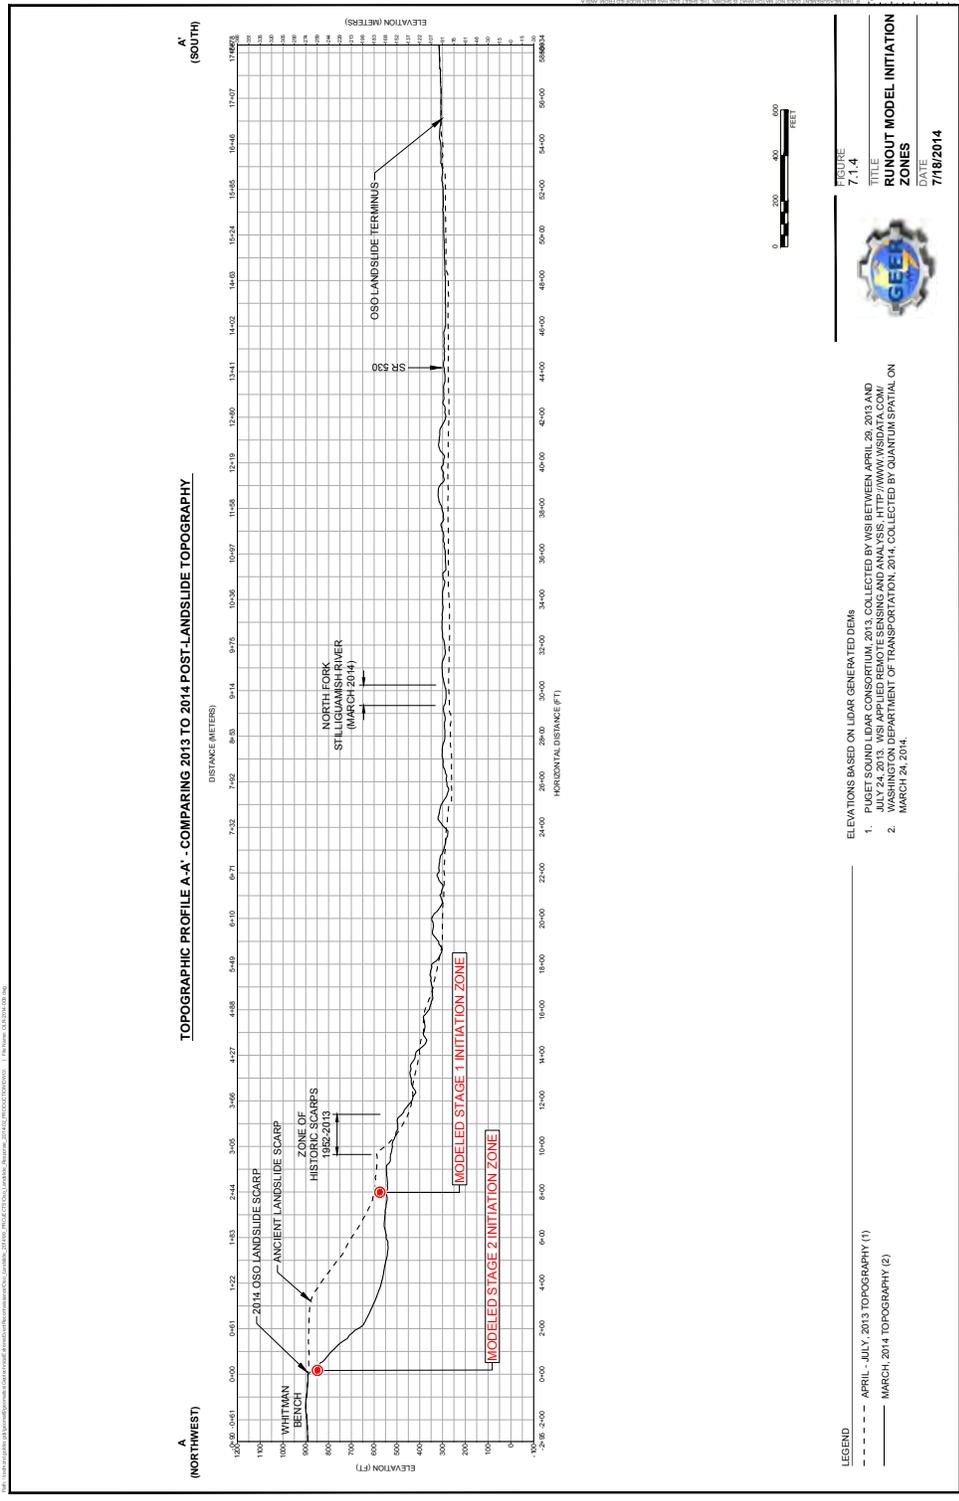
Figure 7.2.4 Profile showing starting locations for Stage 1 and Stage 2 events at Oso.

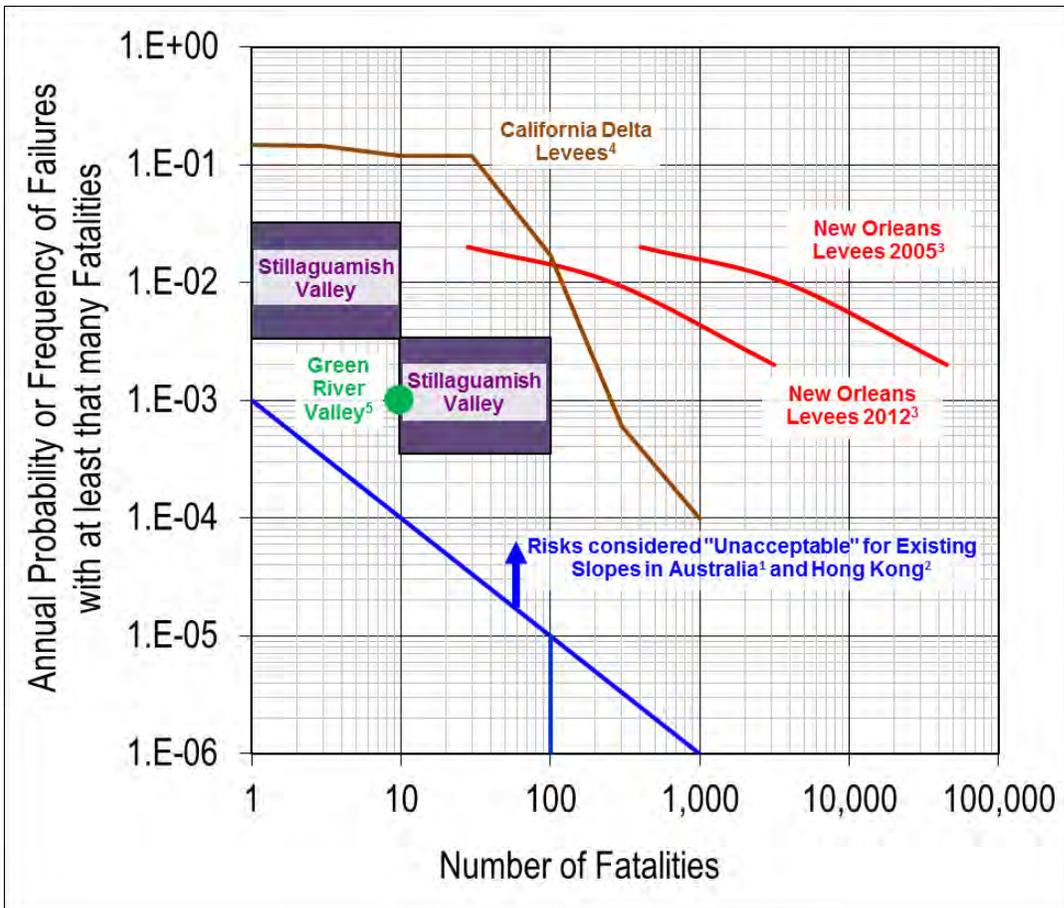
The rough assessments of failure probabilities for different human safety consequences are plotted in Figure 7.5.1 for this 5-km stretch of the valley. This plot shows the annual probabilities for different events versus the consequences of those events; both probabilities and consequences are expressed as order-of-magnitude ranges due to the limited information used to assess them.

No national or state guidelines exist in the United States for levels of risk due to natural landslides that warrant action. However, several benchmarks exist for the risk to human safety that provide informational context for the risk in this 5-km stretch of valley; these benchmarks are included in Figure 7.5.1 for comparison.

One benchmark is for natural slopes in other developed countries. For example, Hong Kong (GEO 1998) and Australia (AGS 2000) have recommended guidelines for risk levels that warrant action to reduce the risk. If this valley were located in one of these countries, then action to reduce the risk would be considered warranted (Figure 7.5.1). However, neither of these countries have the same legal system or regulatory system as the United States.

A second benchmark is the level of risk associated with major flood-protection systems in the United States (IPET 2009 and DWR 2008). This information provides context for what we are achieving in this country for a related natural hazard that is more regulated than natural landslides. The risk to human safety due to natural landslides in this valley is smaller than what exists for two major levee systems, one in California and one in New Orleans (Figure 7.5.1), primarily because the population at risk in the North Fork Stillaguamish River Valley is smaller.

A fourth benchmark is for major dams in the United States. The United States Bureau of Reclamation has established guidelines for risk levels that warrant action to reduce the risk in order to prioritize resources for remediating existing dams (USBR 2003). While the USBR (2003) risk thresholds are expressed in a way that cannot be plotted directly on Figure 7.5.1, they are similar to those shown on the figure for existing slopes in Australia and Hong Kong. If the risk in

this valley were due to a major dam rather than natural landslides, then “justification to take expedited action to reduce the risk” would be warranted (USBR 2003). However, this natural slope is not an engineered facility like a dam. In addition, the risk from a dam is to some extent imposed by society on the people living downstream from the dam in contrast to a risk that is accepted voluntarily.

Figure 7.5.1 Rough approximation of risk from landslides in 5-km stretch of North Fork Stillaguamish River Valley in vicinity of Oso compared with related benchmarks for human safety risk (¹AGS 2000; ²GEO 1998; ³IPET 2009; ⁴DWR 2008; ⁵Gilbert 2013).
