# **Reconnaissance of the New Orleans Hurricane and Storm Damage Risk Reduction System after Hurricane Gustav**

R. Lee Wooten, P.E., Robert B. Gilbert, Ph.D., P.E., William F. Marcuson, III, Ph.D., P.E.,  
Leslie F. Harder, Jr., Ph.D., P.E., G.E., and Peter G. Nicholson, Ph.D., P.E.

Geoengineering Extreme Events Reconnaissance (GEER) Association.

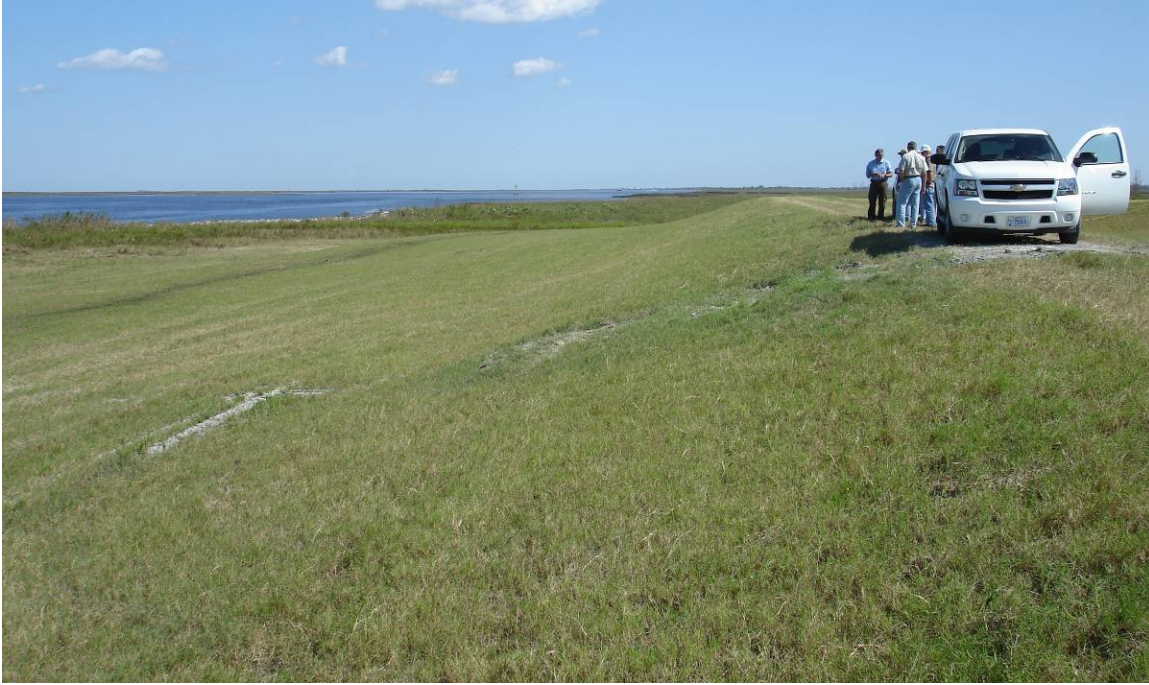
Fig. 1.2.2-2. Southeast corner of the MRGO levee, flood side (L.Wooten)

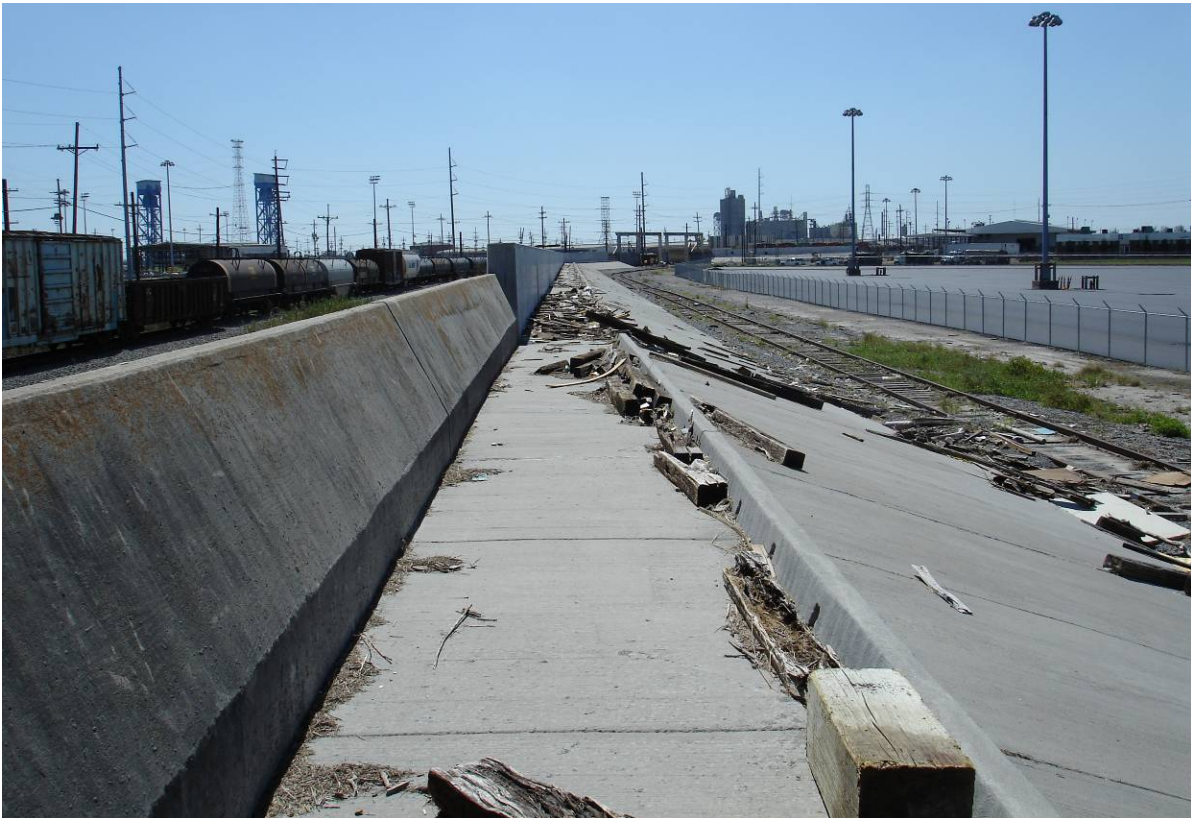
Fig. 1.2.3-3. I-wall and splash apron, IHNC west along France Road; New L-wall and splash apron in background (L.Wooten)

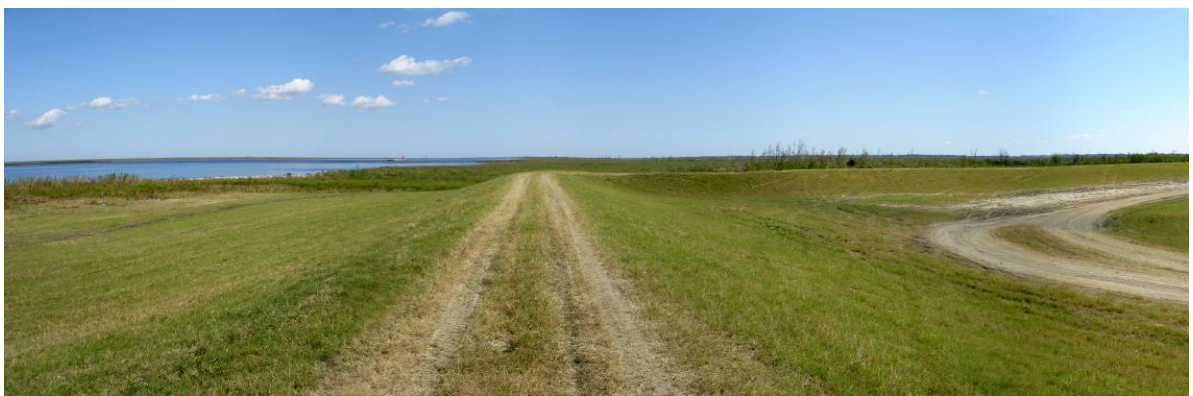
We observed no signs of either erosion or overtopping of the MRGO frontage levee during our visit. Based on the limited debris lines along the levee, the high water levels during Gustav were well below the crest of these rebuilt and elevated earthen embankments. The wave and current actions of Gustav also appeared to have caused no erosion on the earth embankments. Figures 2.2.1-2 and 2.2.1-3 show two typical views of the MRGO frontage levee embankment.

Fig. 2.2.1-3 Southeast Corner of MRGO Frontage Levee, looking southeast (L. Wooten)

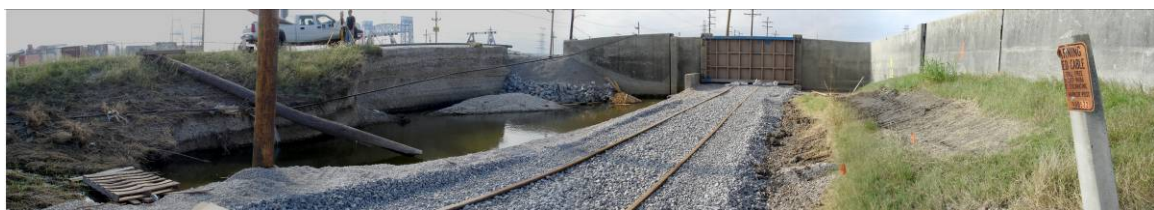
Fig. 2.4.1-4 IHNC West Katrina breach at railroad gate transition, October 2005 (L. Wooten)

Repairs and improvements of these failed and distressed sections included raising and buttressing embankment sections, armoring of embankment-concrete floodwall transitions, replacement of I walls with L-walls (due to space constraints), and buttressing of pre-existing I-wall sections to reduce the stick-up height (the height of wall above finished grade). Figures 2.4.1-2 and 3 show the post-Katrina (October 2005) and post-Gustav (October 2008) conditions at the location of the earth levee breach. Figures 2.4.1-4 and 5 show the post-Katrina and post-Gustav conditions at the railroad gate transition breach location. Figures 2.4.1-6 and 7 show the post-Katrina and post-Gustav conditions at the I-wall breach location.

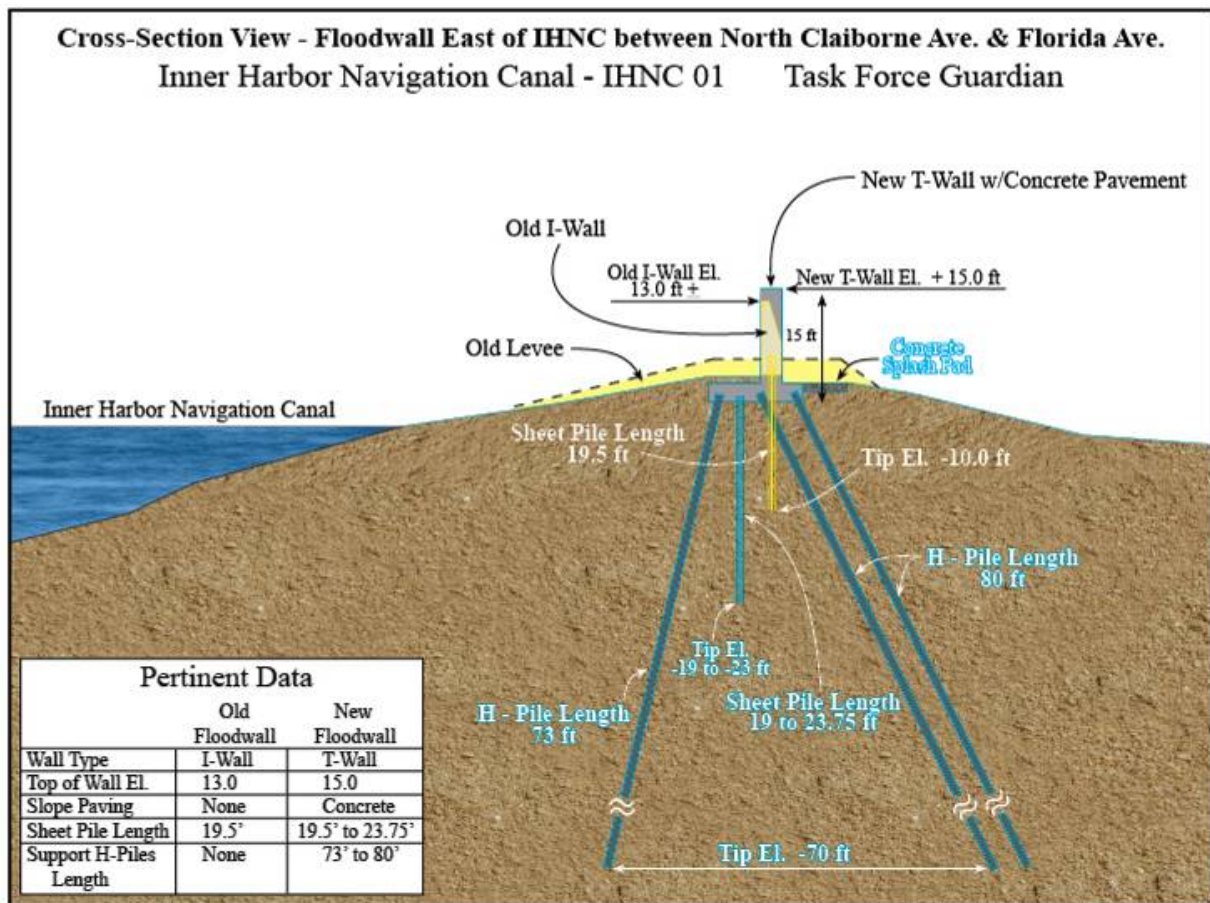
Fig. 2.4.3-6 Cross-section showing the new T-wall constructed to replace the I-wall that failed during Katrina between Claiborne and Florida Avenues. (USACE)

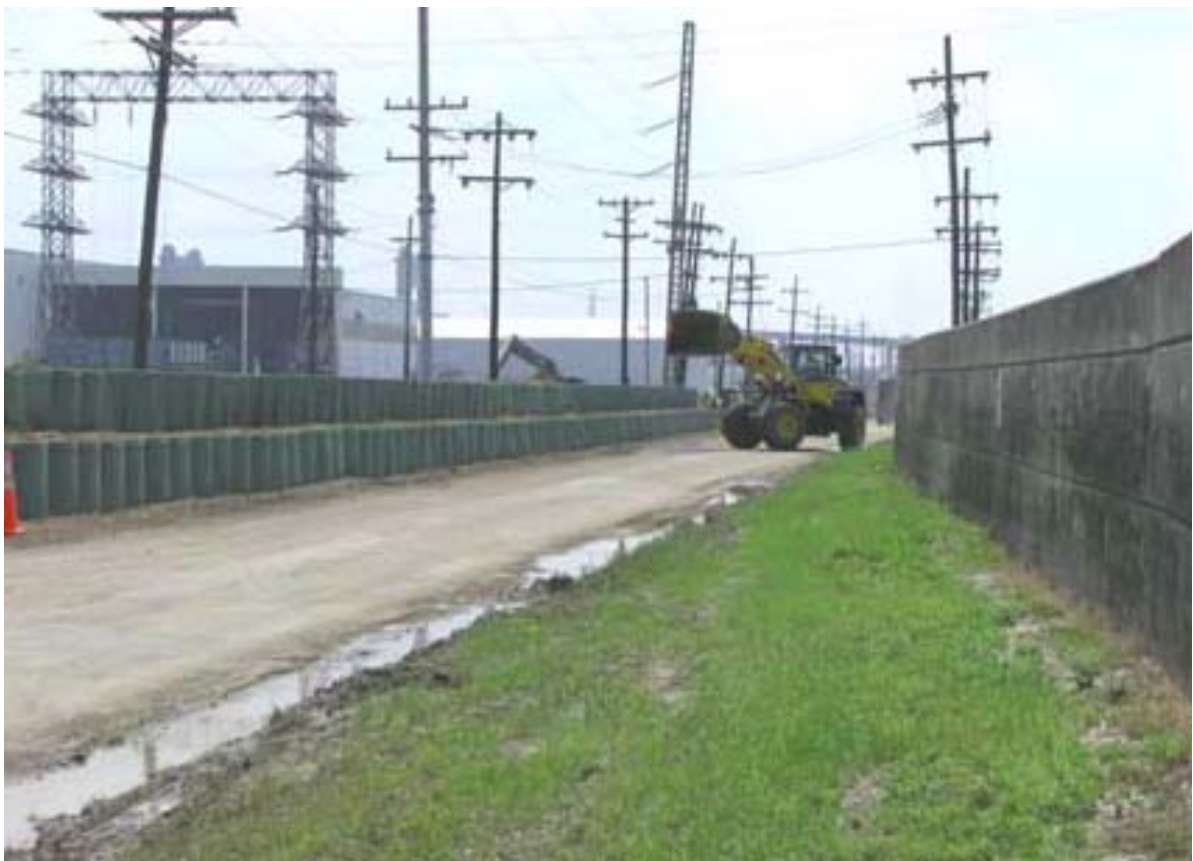
Immediately prior to Gustav, the USACE constructed an 1800-foot-long temporary bin wall using HESCO baskets to protect one length of I-wall along the northwest side of the IHNC that did not meet required stability criteria. Figure 2.4.5-1 shows the temporary bin wall under construction by the USACE, and Figure 2.4.5-2 shows the bin wall immediately after Gustav.

Fig. 2.4.5-1. Temporary Bin Wall under construction, IHNC northwest along France Road ([http://www.mvn.usace.army.mil/HPS/Status%20Report%20Newsletters/Sept\\_9\\_2008.pdf](http://www.mvn.usace.army.mil/HPS/Status%20Report%20Newsletters/Sept_9_2008.pdf))

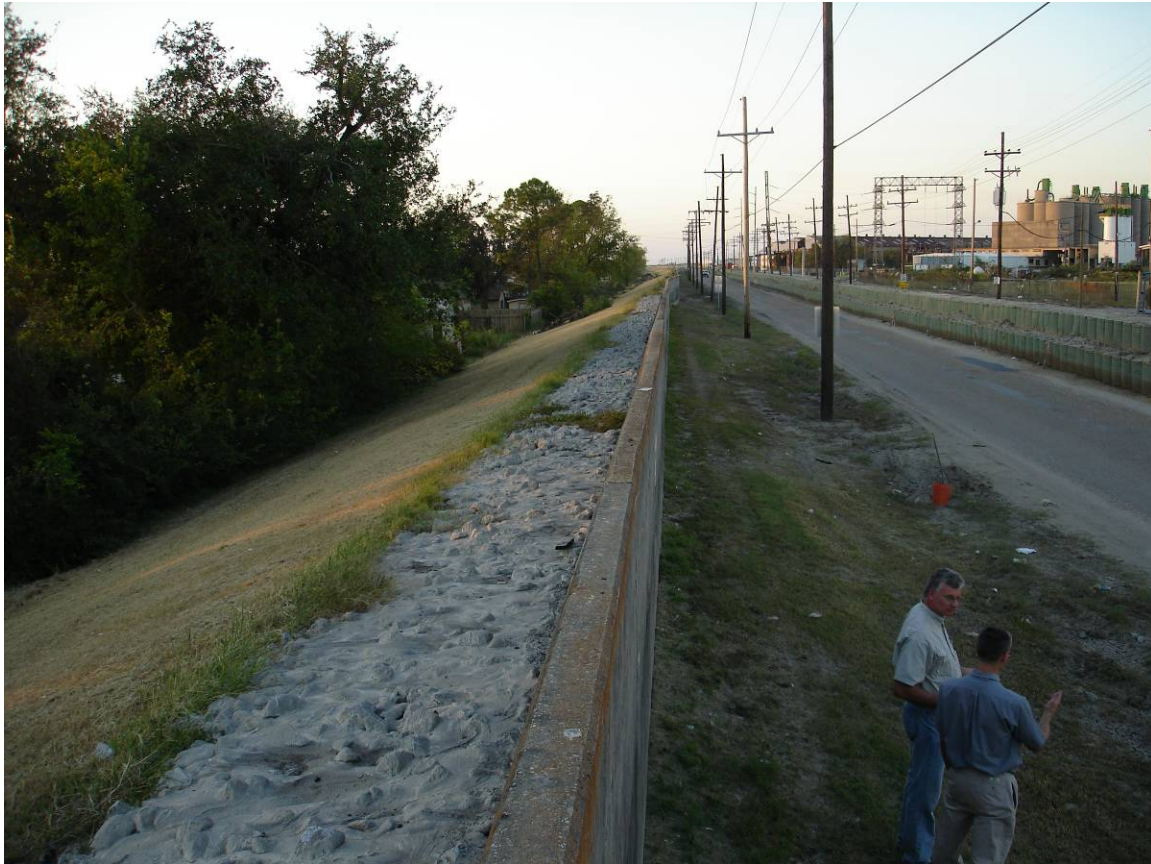
The majority of the bin wall was constructed about 50 feet outboard of and parallel to the I-wall, with two tiers of baskets. The lower tier was four baskets wide and the upper tier was two baskets wide. The top of the bin wall was about 2 to 3 feet lower than the top of the adjacent flood wall. Surge and waves from Gustav left debris on the first tier (3-foot-height) of the bin wall but not on the top of the second tier. The bin wall appears to have protected this section of floodwall from any loading during Gustav. If Gustav had generated a storm surge higher than the bin wall, the existing I-wall would have been loaded, but to a lesser degree because of the bin wall. Specifically, the bin wall would have (1) reduced the period of loading, (2) mitigated wave loading, and (3) lengthened the seepage path during pre-overtopping periods. The permanent configuration of this section of the IHNC floodwall has not been determined. Figure 2.4.5-3 shows an overhead view of the I-wall and the post-Katrina installed grouted riprap splash apron on the protected side of the wall.

Fig. 2.4.5-3. IHNC I-wall and grouted riprap splash apron (L. Wooten)

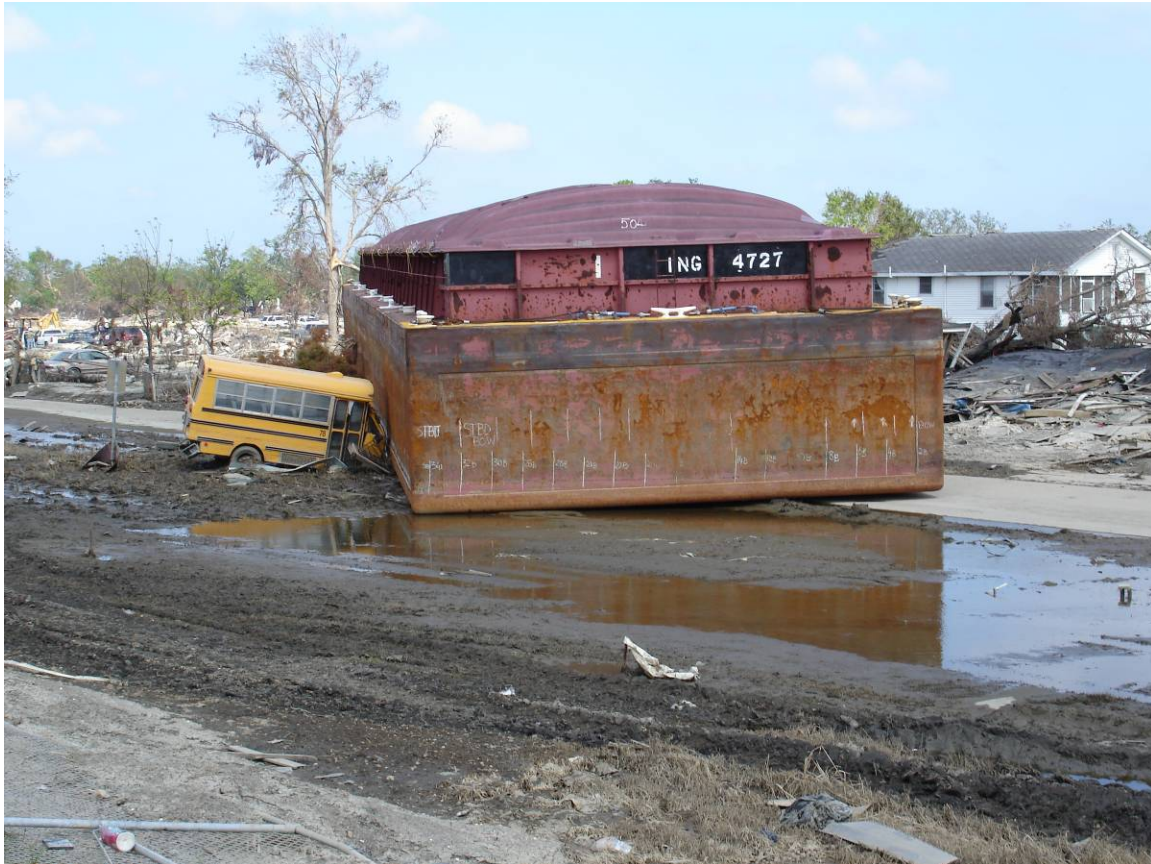
Fig. 2.4.6-1. Barge in the Lower 9<sup>th</sup> Ward, October 2005 (L. Wooten)

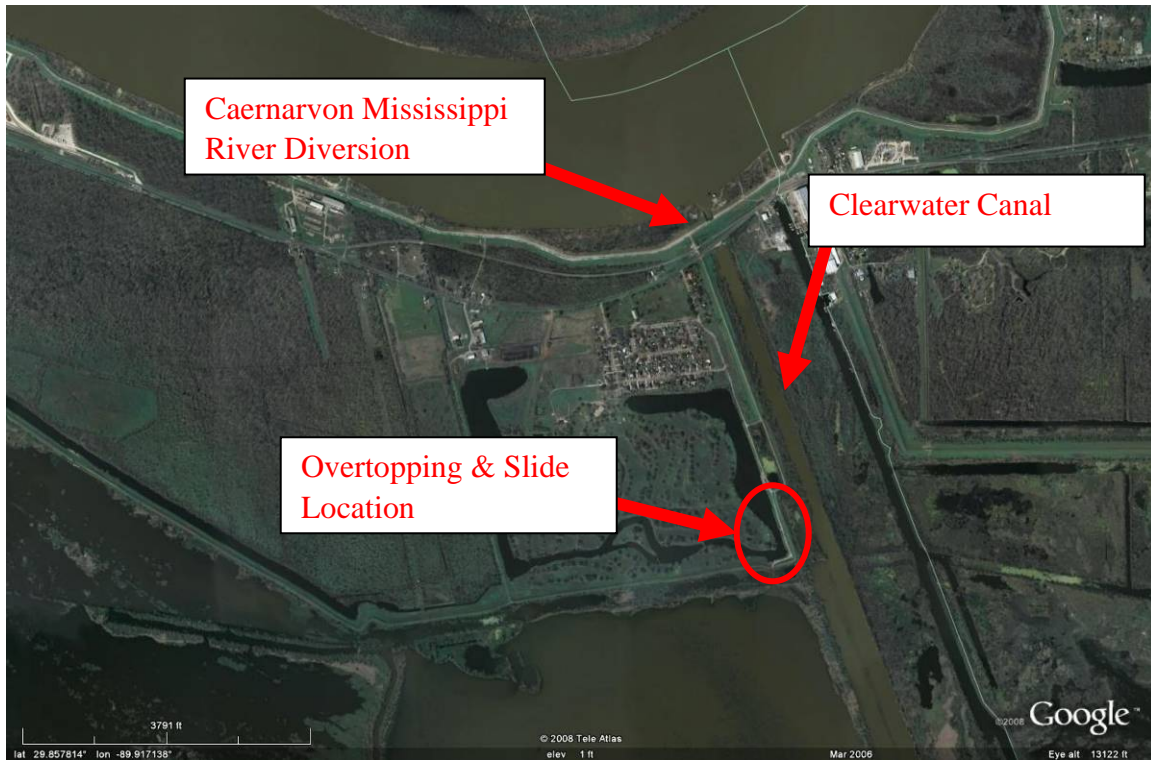
Plaquemines Parish workers and emergency workers from St. Bernard and Orleans Parishes and the USACE were reported to have responded during Gustav to help prevent a breach of the levee. The Caernarvon Mississippi River Diversion gates were also reported to have been opened in an effort to drain high flood waters in the Clearwater Canal, which abuts the northeastern edge of the back levee, to the lower level of the Mississippi River (see Figure 2.6-2) (Vanacore, Andrew (2008)).

Fig. 2.6-2. Plaquemines Parish Back Levee (Google Earth / USGS Imagery)

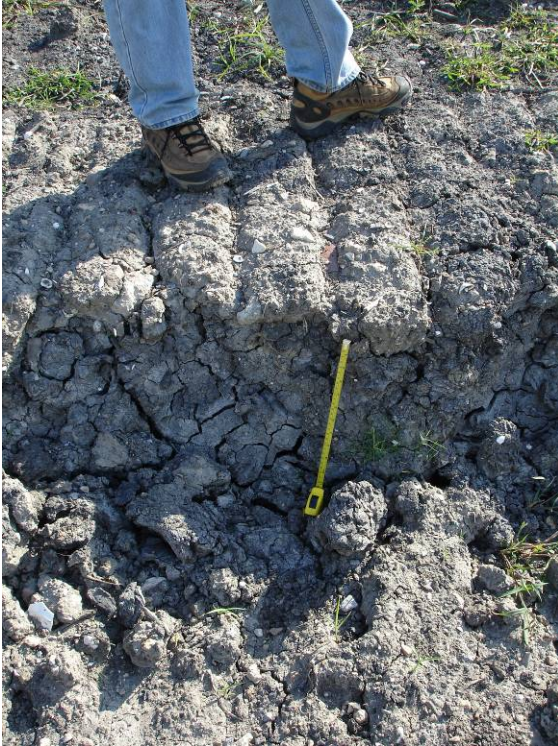
Fig. 2.6-5. Scarp above slide on Plaquemines back levee (L. Wooten)

Plaquemines Parish Back Non-Federal Local Levee Performance – The non-federal local back levee in Plaquemines Parish was overtopped by Gustav flood levels and was in danger of failure at the location of the slope slide. Desiccation cracks on the levee may have contributed to the slide by allowing overtopping water pressures into embankment zones

critical to slope stability. The placement water content, compaction, and organic content of the back levee soils were not known and may be factors in the susceptibility of the levee soils to desiccation cracks and erosion.

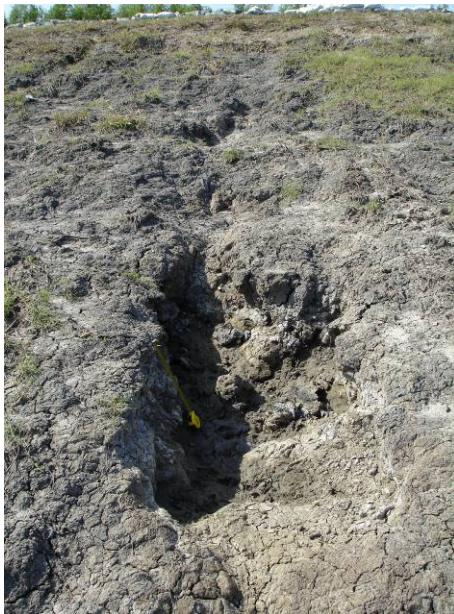
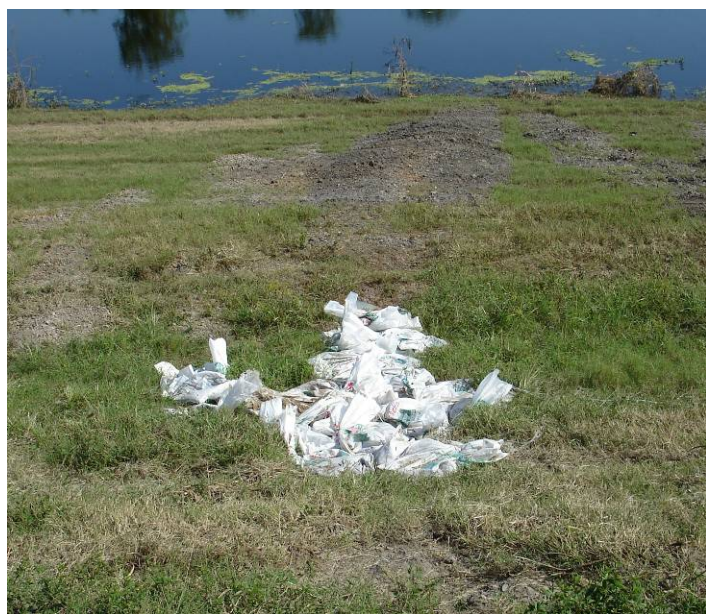
Along more southerly sections of the levee, we observed signs of overtopping with less dramatic effects. Debris and erosion gullies, often covered with sand bags, were prevalent along sections of the levee (Figures 2.6-8, 2.6-9, and 2.6-10). We did not visit other sections of the various Plaquemines Parish back levees south of the locations shown on Figure 2.6-1.

Figs. 2.6-9 and 2.6-10. Overtopping erosion gullies on Plaquemines Parish back levee, protected side (L. Wooten)

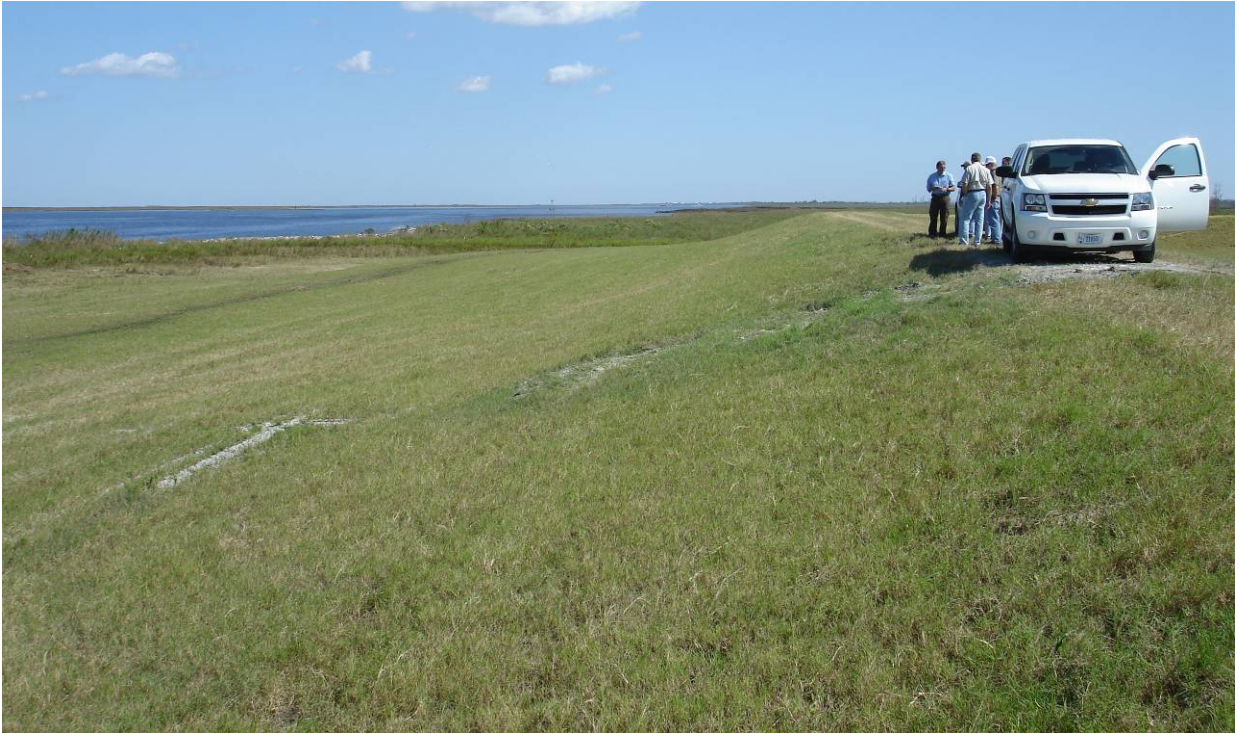
Figures A.2-2 and A.2-3 shows the earth levee at the southeast corner of the HSDRRS along the MRGO. The current reconstructed levee features include:

- Compacted clay fill construction for erosion resistance – The MRGO levees have been raised using compacted clay fill to create higher, broader levees which have increased resistance to erosion because of the use of the clay on the upper layers of the embankment crown and slopes.
- Grass cover, also for erosion resistance – Establishing and maintaining the grass cover has required a significant effort during periods of dry weather because of the lack of fresh water in the immediate vicinity of the MRGO levee.
- 3H:1V and 4H:1V slopes with stability berms - The geometry of the rebuilt MRGO levee is dictated by USACE stability criteria and typically includes slopes of between 4H:1V and 3H:1V, 100-foot wide stability berms on both flood and protected sides, and crest widths of about 10 feet or more.

Fig. A.2-2. Southeast corner of the MRGO levee, flood side (L.Wooten)

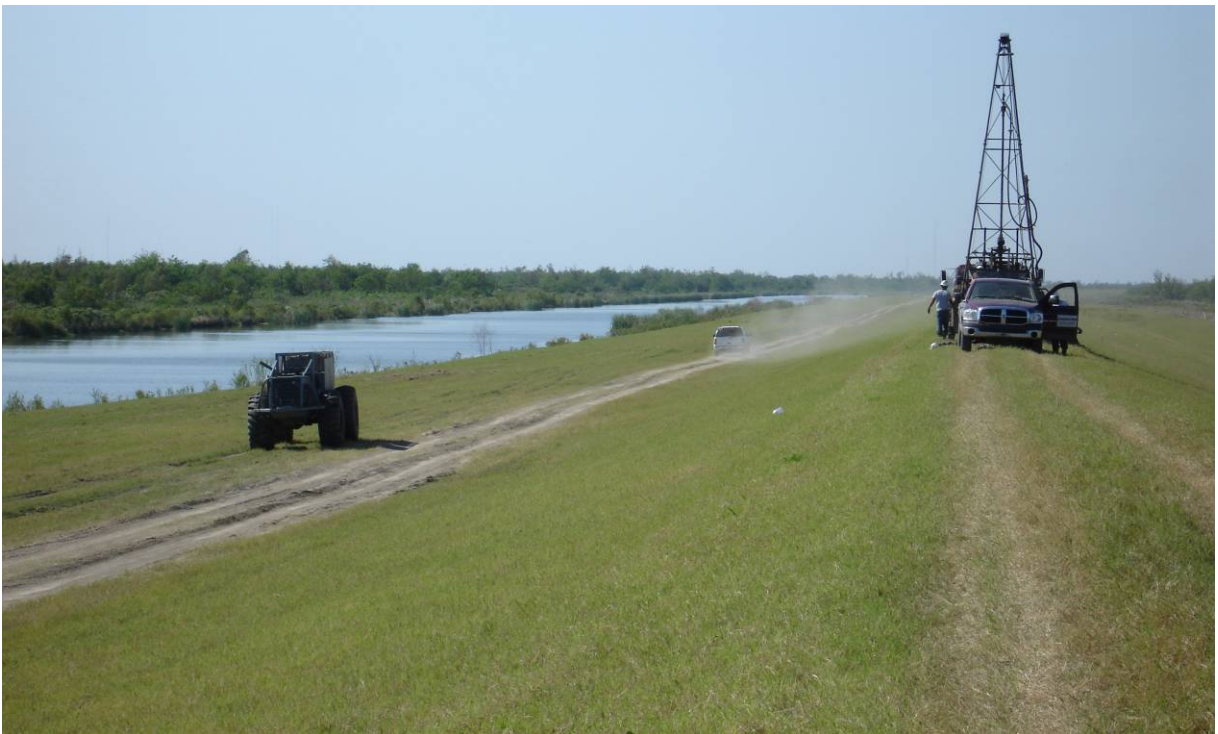
Fig. A.2-3. MRGO levee crest and protected side slope (L.Wooten)

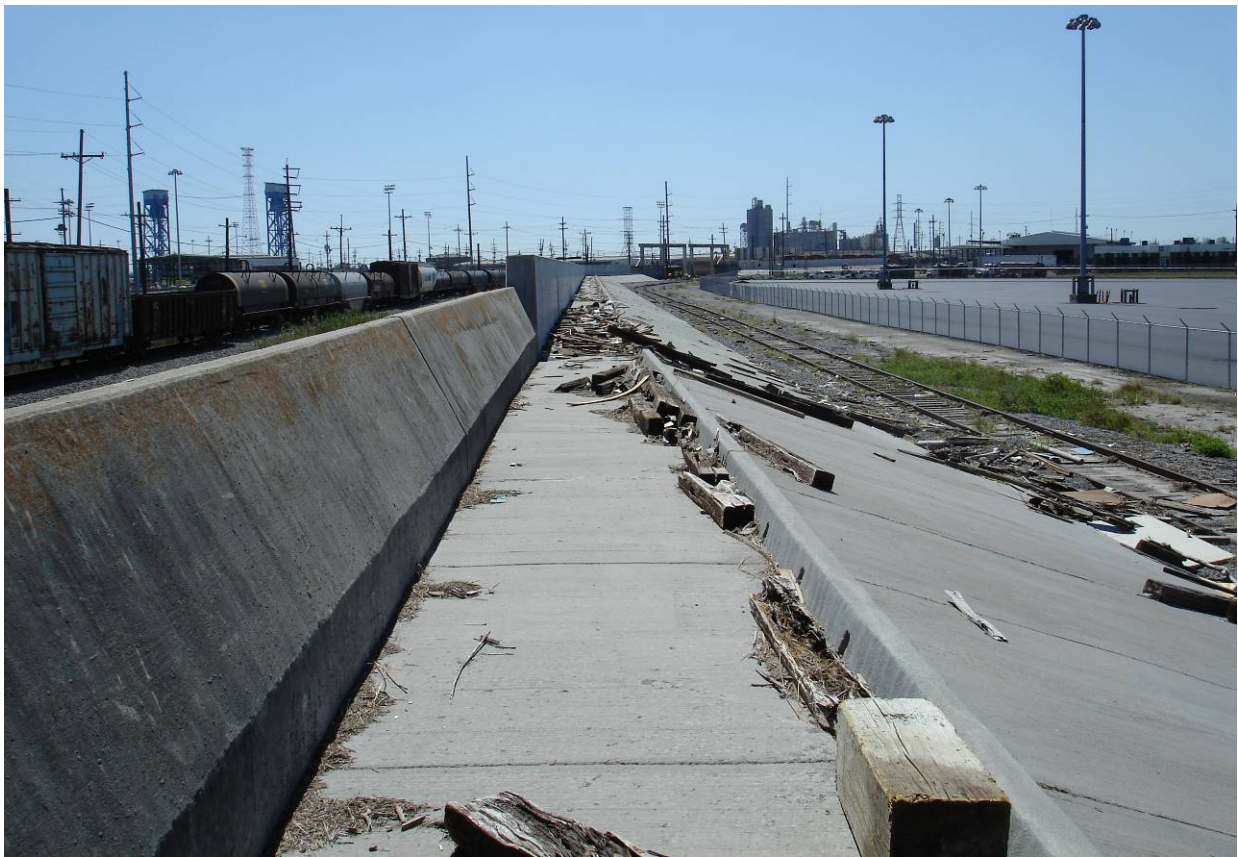
I-Walls Repairs and Upgrades - The HSDRRS currently depends on many of the I-walls that were in place before Katrina. These I-walls have been repaired, where necessary, by filling scour trenches on the protected side, and enhanced with splash aprons. The USACE has established criteria for retaining I-walls calling for a maximum protected side stick-up height of 4-foot, and a maximum flood-side:protected-side stick-up differential height of 2-feet. Allowable stick-up heights for new T-walls and L-walls are significantly higher. Splash aprons, typically extending at least 7 feet from the I-wall, have been constructed for all I-walls using either reinforced concrete or grouted riprap. Figure A.3-3 shows a reinforced concrete splash apron on the protected side of the I-wall and T-wall on the west side of the IHNC along France Road adjacent to the former container terminal.

Fig. A.3-3. I-wall and splash apron, IHNC west along France Road; new T-wall and splash apron in background (L.Wooten)

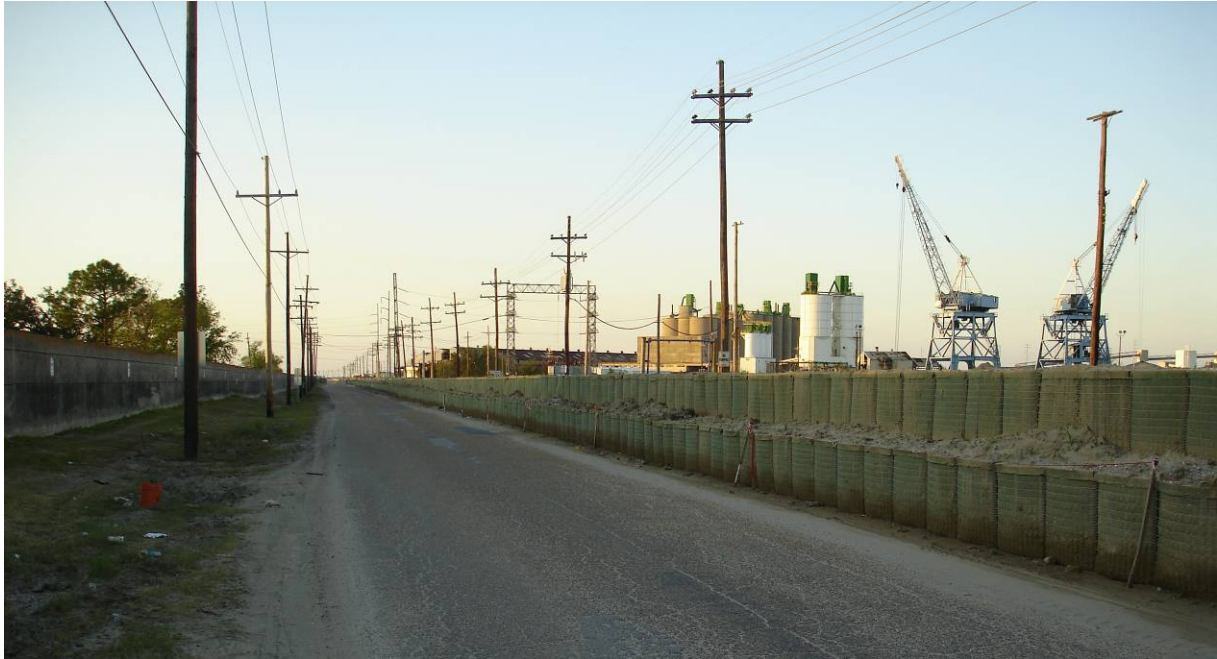
Temporary Bin Wall - The USACE determined that one 1800-foot length of I-wall along the northwest side of the IHNC did not meet the required stability criteria. To protect this length of I-wall, two weeks prior to Gustav, the USACE constructed a temporary 6-foot-high cage and geotextile bin (HESCO baskets) fill wall on the flood side. The temporary bin wall was constructed with two levels of 3-foot baskets configured with a four- and two-basket width on the first and second levels respectively. Figure A.3-4 is a photograph of the bin wall.

Fig. A.3-4. Temporary Bin Wall, IHNC northwest along France Road (L. Wooten)

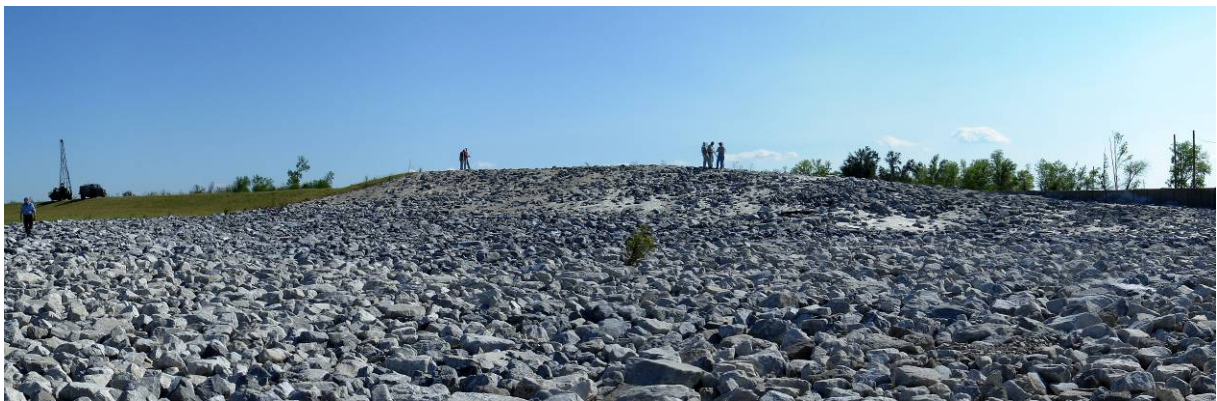
Transition Hardening - Katrina overtopping caused significant erosion at transitions between many of the numerous earth levees and floodwalls in the hurricane protection system. The USACE has modified these transitions by placing erosion protection, typically grouted riprap, and, in some cases, by modifying the transition profiles. Figure A.3-5 shows the transition between the Bayou Dupree floodwall and the MRGO earth levee. At this transition, the USACE has elevated the earth levee at the transition and covered it with grouted riprap.

Fig. A.3-5. Transition Protection and Modification, Flood Side of Bayou Dupree Flood Wall (L. Wooten)

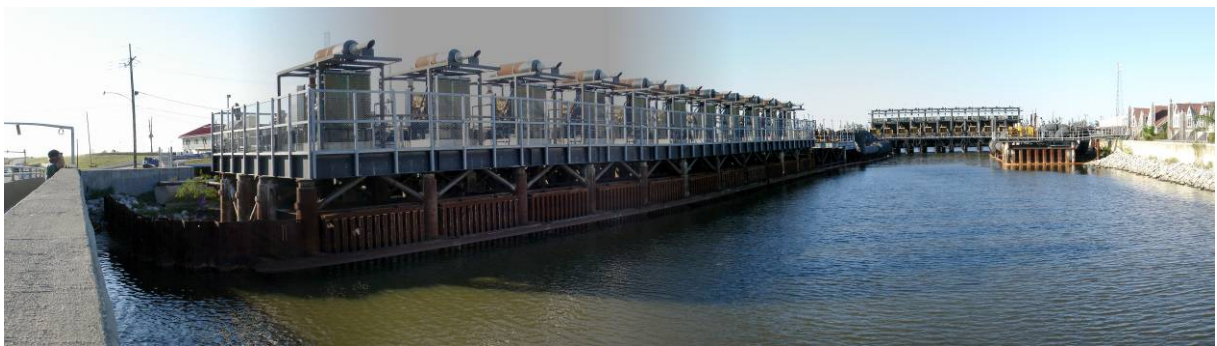
Fig. A.4-2. 17<sup>th</sup> Street Canal Outfall Closure Structure & Pumps, Protected Side  
(L. Wooten)

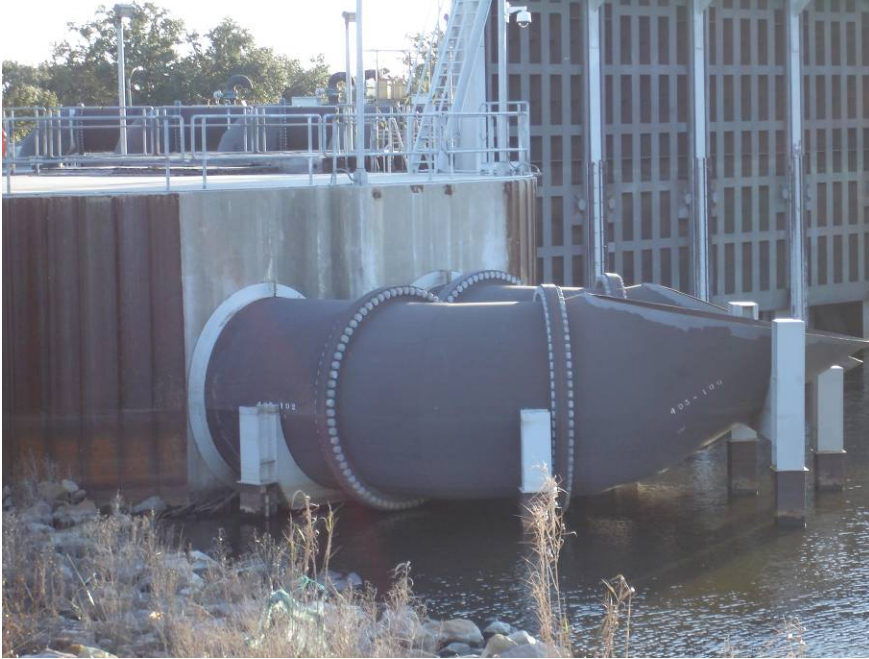
Fig. A.4-3. Orleans Avenue East Closure Structure East Side Discharge and Gates (L. Wooten)

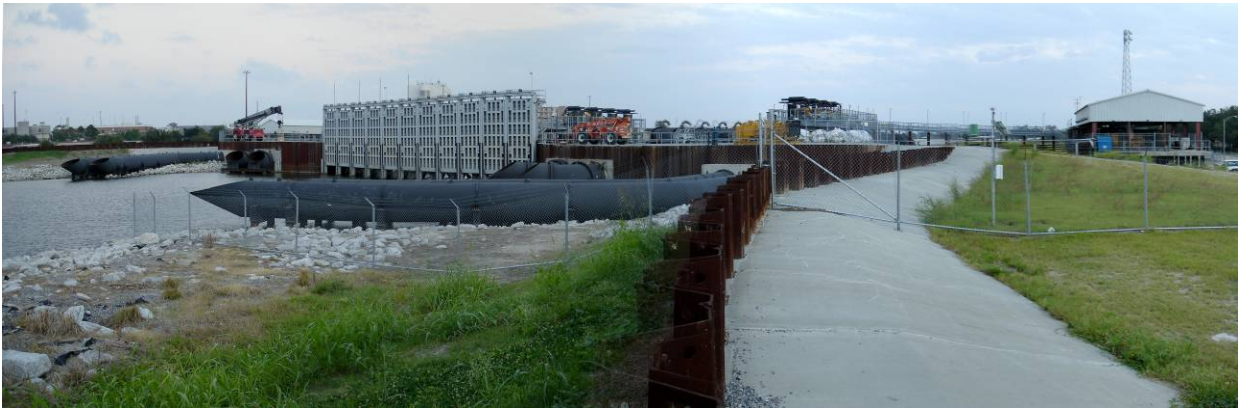
Fig. A.4-4. London Avenue Canal Closure Structure, Flood Side (L. Wooten)
