**GEOTECHNICAL EFFECTS OF  
INTENSE PRECIPITATION ON AUGUST 9, 2013, ON  
SLOPES ABOVE MANITOU SPRINGS, COLORADO,  
THAT WERE BURNED IN THE  
2012 WALDO CANYON FIRE**

Geotechnical Extreme Events Reconnaissance (GEER) Association  
Reconnaissance Dates: August 16 to 18, 2013

Jeffrey Keaton, AMEC Americas (Team Leader)  
Scott Anderson, Federal Highway Administration  
Paul Santi, Colorado School of Mines  
Shideh Dashti, University of Colorado, Boulder

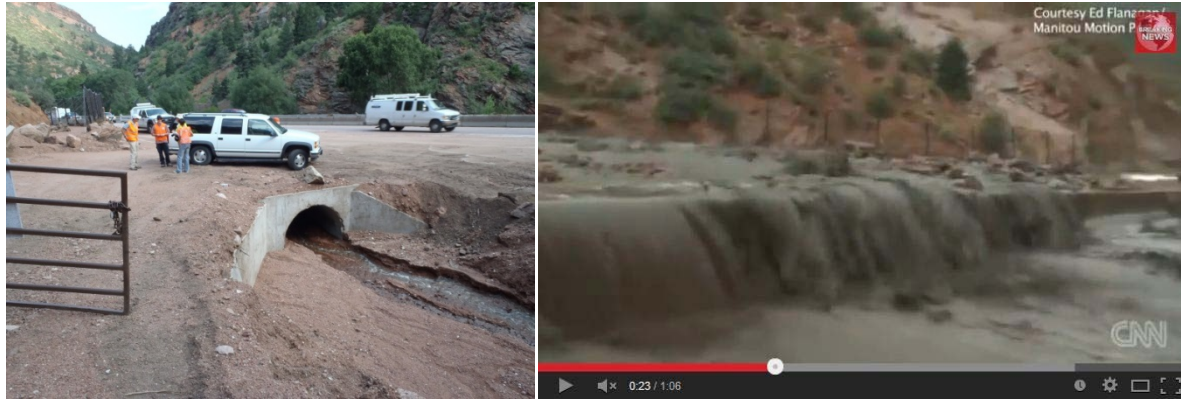
Figure 3.2.1. Mouth of Waldo Canyon at US Highway 24; Waldo Canyon culvert inlet on August 16, 2013, half full of sediment at inlet (left); screenshot of YouTube video by Ed Flanagan taken on August 9, 2013 (right). Left: View toward southeast from  $+38.887^{\circ}\text{N}$ ,  $-104.932^{\circ}\text{W}$ , approximate elevation 6767 feet. Right: View from eastbound lanes showing the center K-rail barrier on US 24 being overtopped by water and sediment discharge from Waldo Canyon apparently after filling the westbound lanes ([http://www.youtube.com/watch?v=Q\\_iMDHqRV4U](http://www.youtube.com/watch?v=Q_iMDHqRV4U)); rock fall fence adjacent to east side of Waldo Canyon is visible.

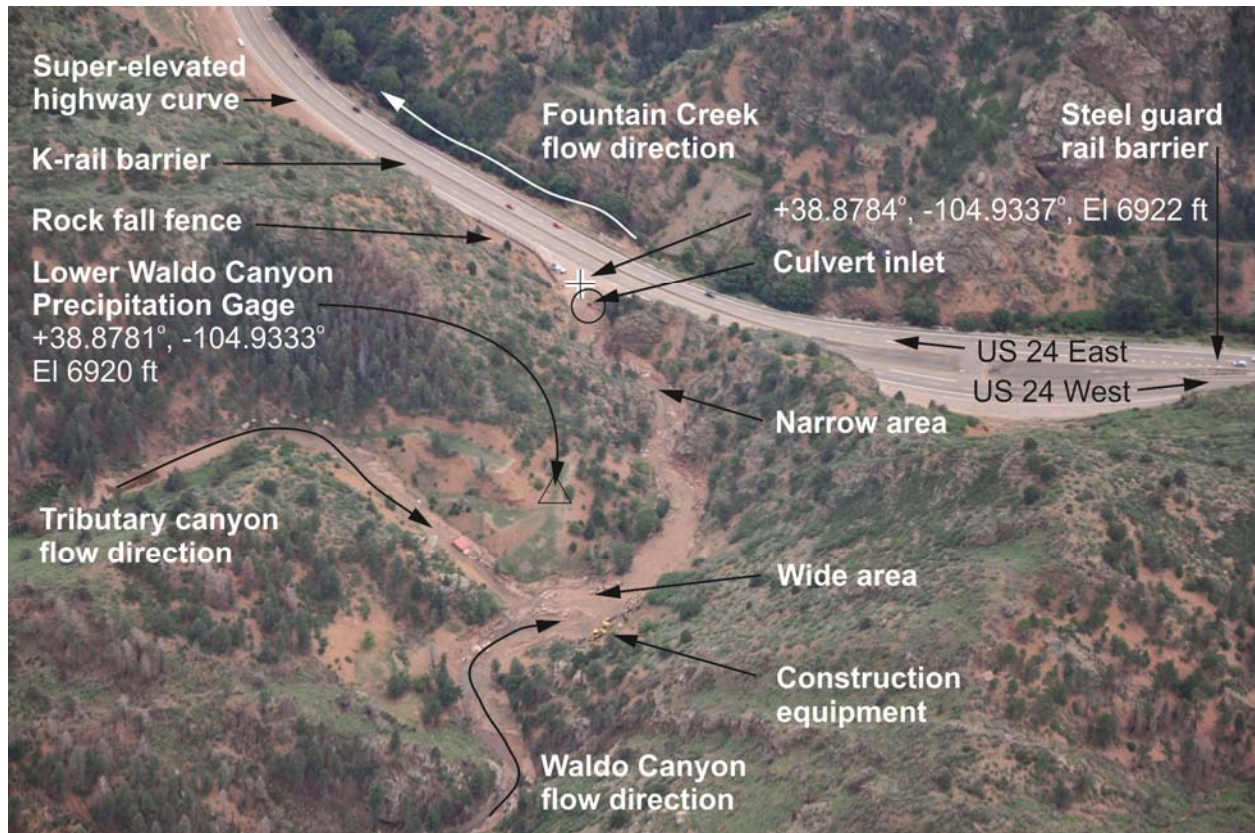
Figure 3.2.2. Aerial oblique photograph showing the lower part of Waldo Canyon and US Highway 24. Photo taken August 17, 2013, as part of the GEER reconnaissance. Location of Lower Waldo Canyon Precipitation Gage (marked by open black triangle) is 38.8781°N, -104.9333°W, elevation 6920 ft. Photo view is toward the south-southeast.

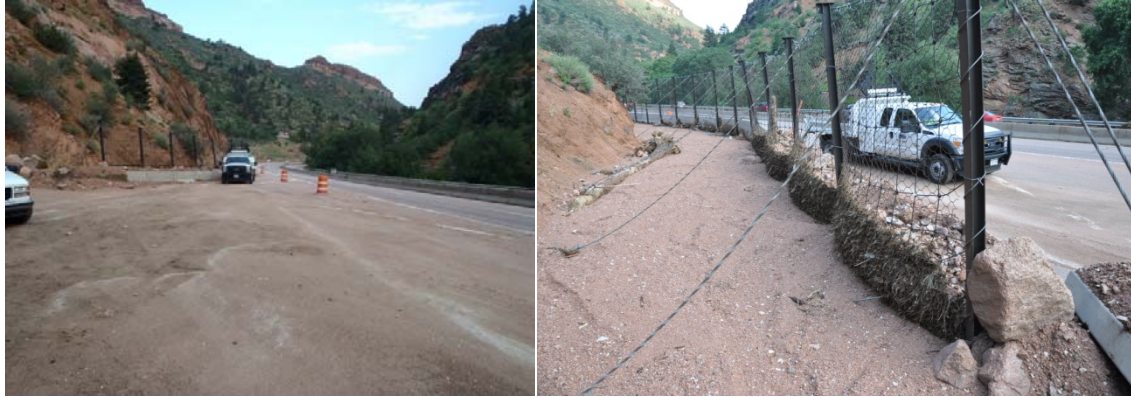
Figure 3.2.5. The rockfall fence adjacent to the mouth of Waldo Canyon. Left: the K-rail barrier and the super-elevation of the highway east of where Waldo Canyon meets US 24 also are visible. View is east-southeast from  $+38.877^{\circ}$  N,  $-104.932^{\circ}$  W, approximate elevation 6765 feet. Right: view of August 9, 2013, storm debris trapped by rockfall fence on the highway side of the fence.

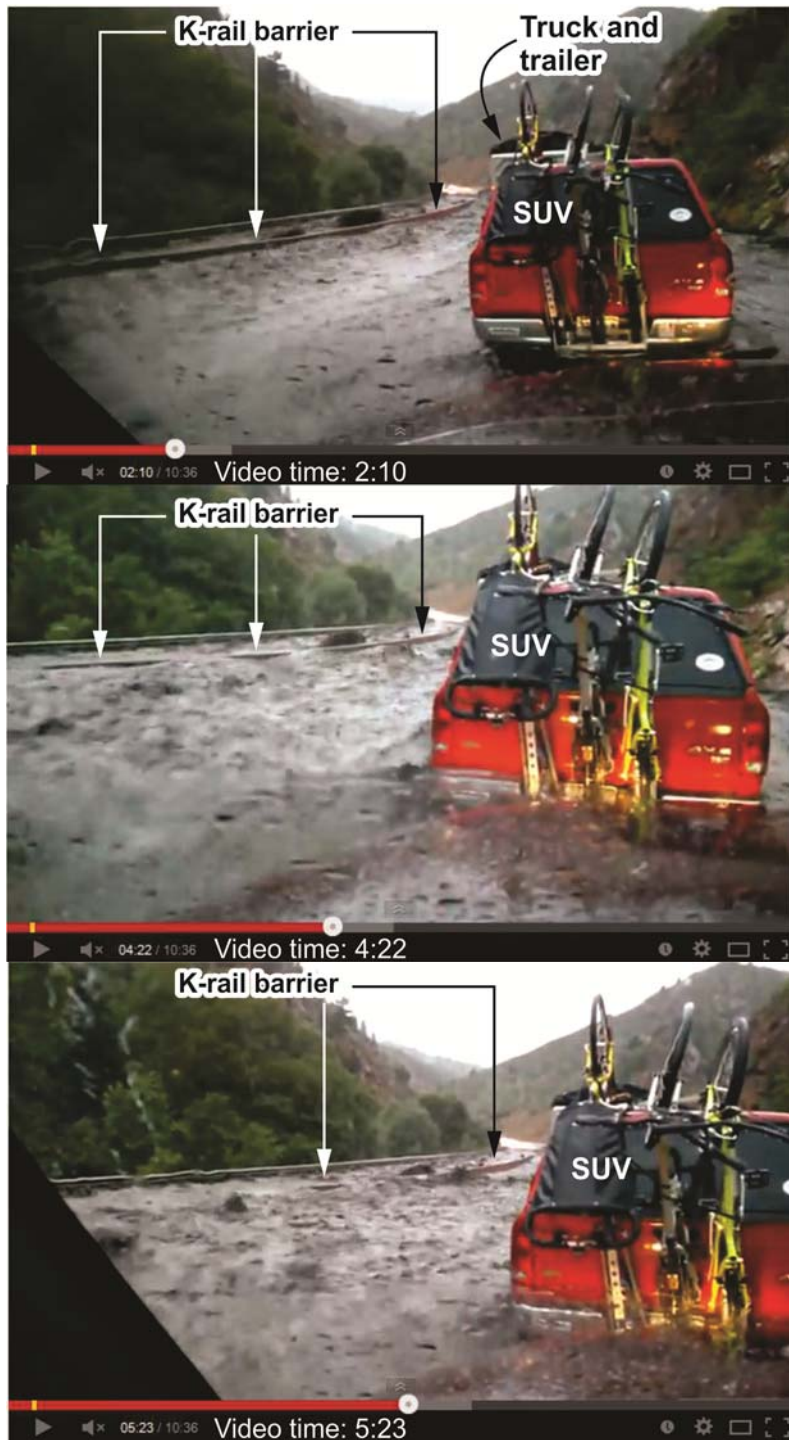
Figure 3.2.7. Screenshots from YouTube video by Tj Omara at three times during its 10:36 duration. The vehicle from which the video was taken was located in the westbound lanes of US 24 about 0.1 mi (0.18 km) east of Waldo Canyon at about 38.8761° N, -104.9303° W.

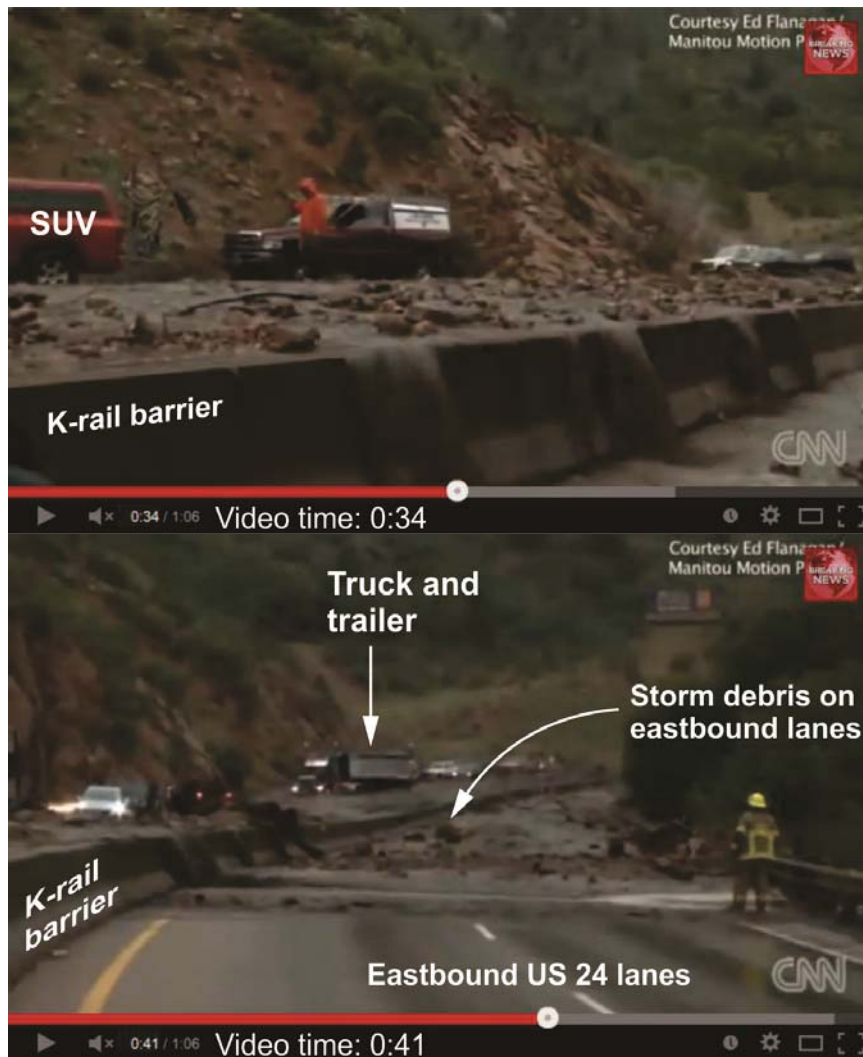
Figure 3.2.8. Screenshots from YouTube video by Breaking News attributed to Ed Flanagan, Manitou Motion Pictures, at two times during its 1:06 duration. Upper (video time 0:34): the vehicle from which the video by Tj Omara was taken is in the center of this screenshot; the red SUV in Figure 3.2.7 is labeled; view toward the east over K-rail barrier from eastbound lanes of US 24 showing that the westbound lanes are choked with sediment up to the top of the K-rail barrier. Lower (video time 0:41): the truck and trailer ahead of the red SUV in Figure 3.2.7 are labeled; storm debris on eastbound lanes is visible; Fountain Creek is just off the right edge of the photo.

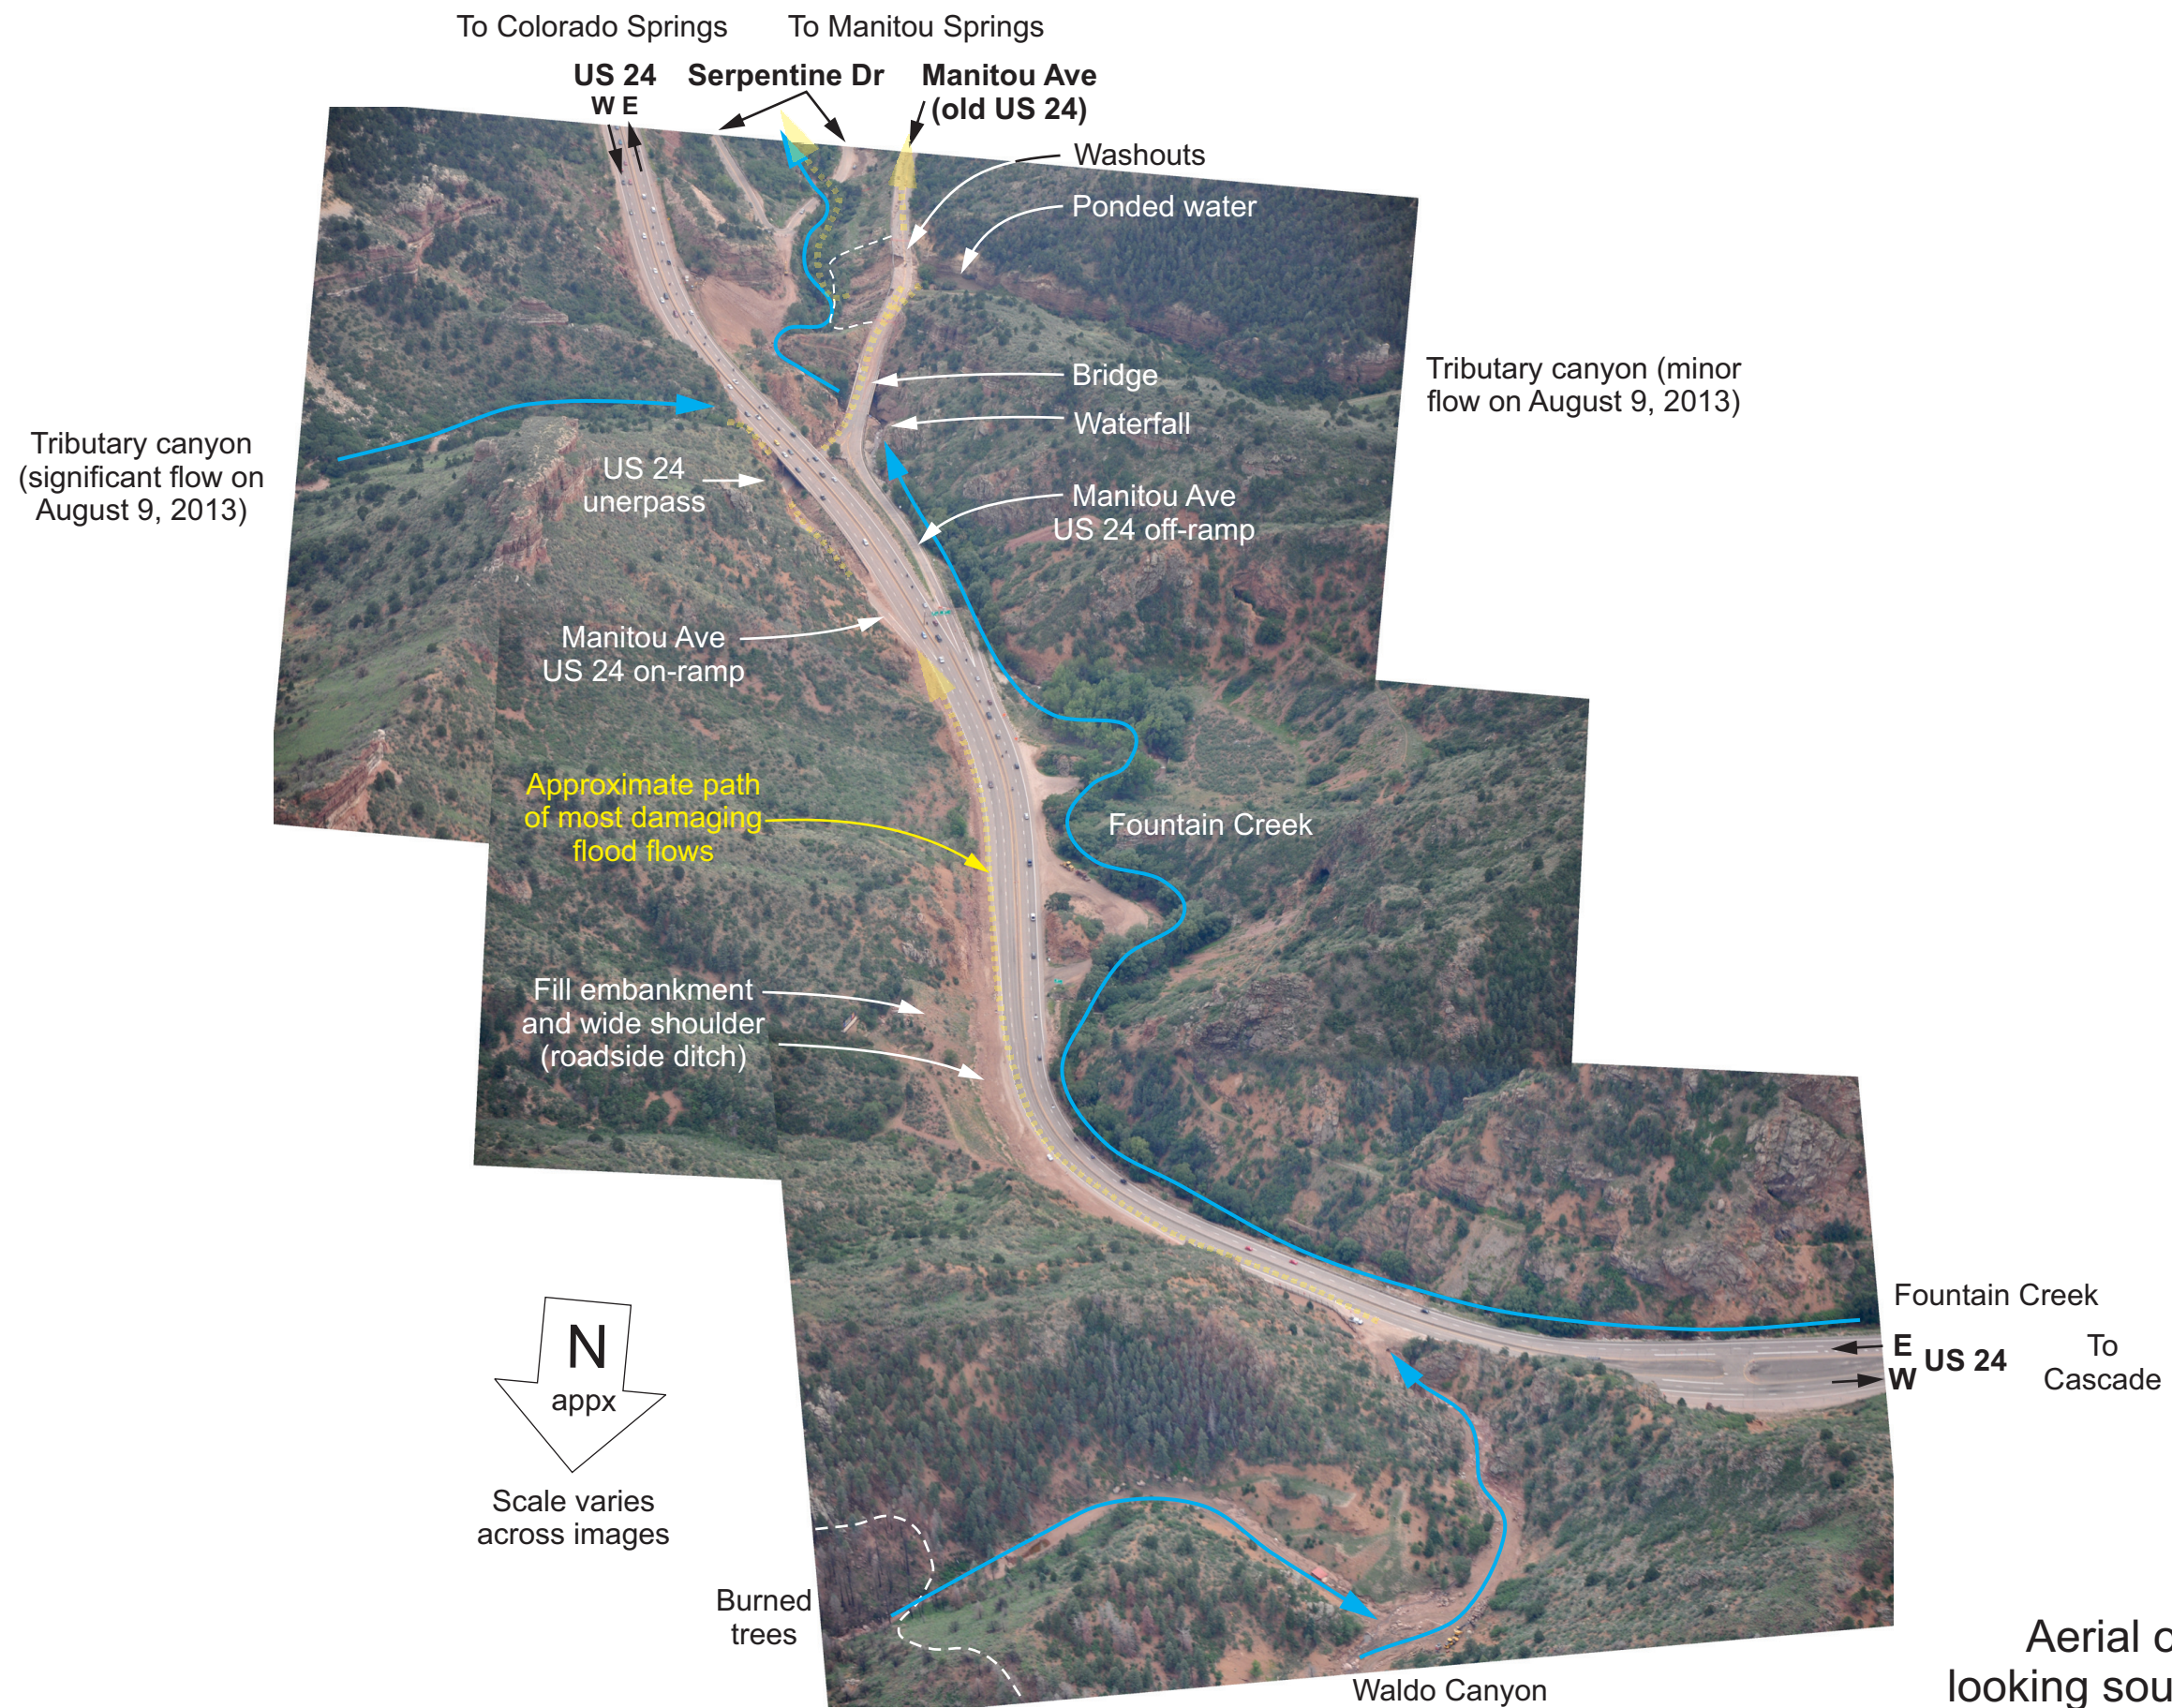
Figure 3.2.9  
Aerial oblique photo mosaic  
looking south at US 24 from west of  
Manitou Springs to Waldo Canyon

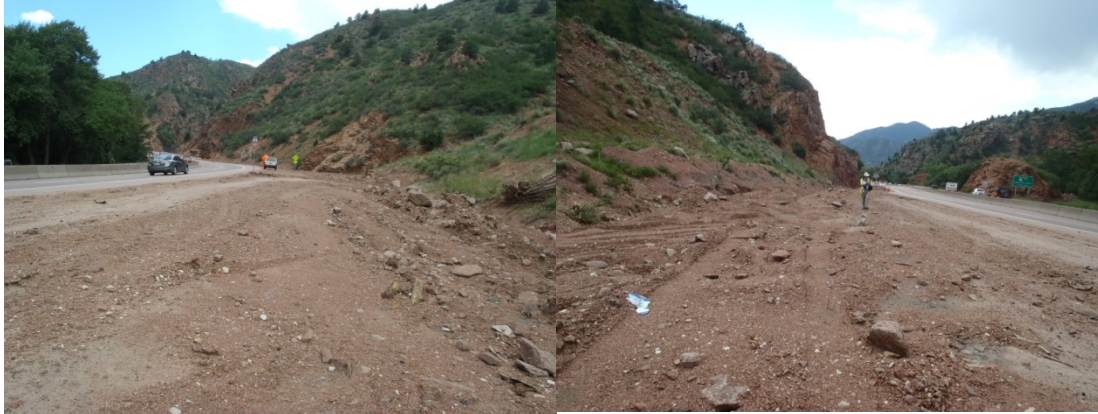
Figure 3.2.10. Looking northwest (left) and southeast (right) from relative high ground along shoulder of westbound US 24. US 24 super-elevation is visible to the left in the left image. Wide shoulder is visible in both images. Camera location:  $+38.8757^{\circ}$  N,  $-104.9295^{\circ}$  W, approximate elevation 6686 feet. Waldo Canyon is in the distance above car on highway in left image. The earth embankment toe visible in the foreground on the right side of the left image is a placed earth fill of uncertain purpose (see Figure 3.2.9 for aerial oblique view); it could be a stockpile in a material site and may indicate wider DOT Right of Way. Right image shows flattening of highway grade, wide shoulder, and the earth fill embankment toe. The westbound on-ramp is at steeper grade and just beyond the person. The eastbound off-ramp is near the cars and highway sign on the right side of right image.

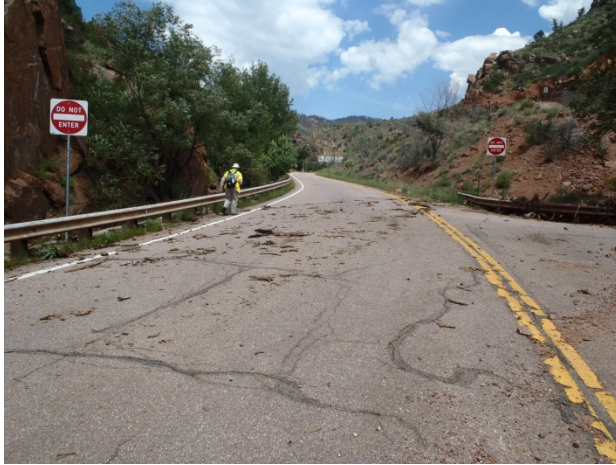
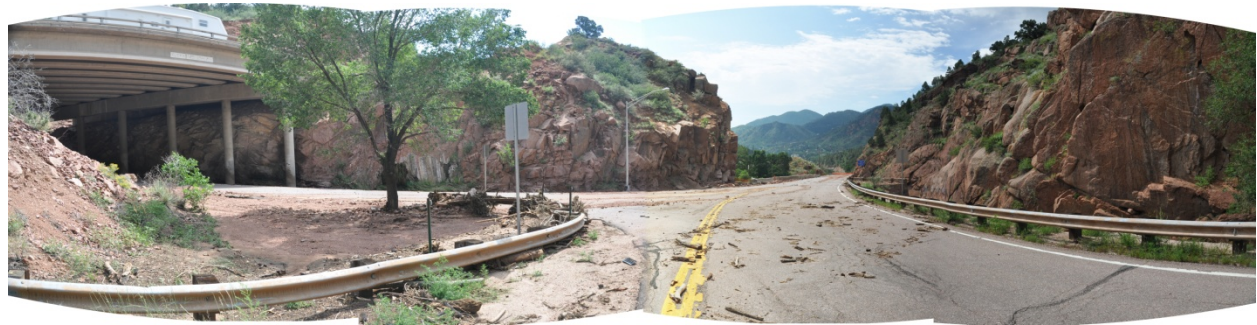
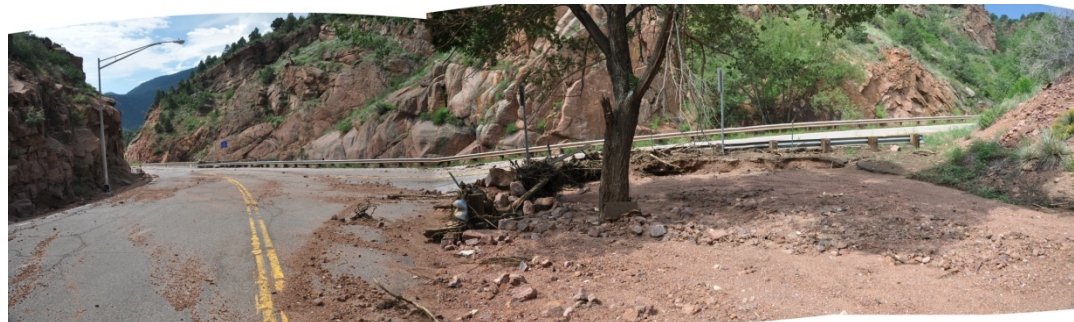
Figure 3.2.11. View of the US 24 eastbound off-ramp. Top: view northwest up the off-ramp; the US 24 underpass to the on-ramp is to the left of the camera position; Fountain Creek is located to the right of the guardrail. Middle: panorama view to the east and southeast from a point part way down the off-ramp; underpass is visible on the left; Fountain Creek is located to the right of the guardrail. Bottom: view southwest of base of off-ramp; camera position is on access road connecting Manitou Avenue to US 24 westbound on-ramp; tree in middle of view is the same tree that is visible left of center in the middle photo. Note that only woody debris is present on

the off-ramp visible and that it extends only to where the person is walking (top photo); the remainder of the ramp is clear of debris and it appears that the woody debris may have been deposited by water flowing under the guardrail on the left side of the bottom photo. Camera position for the top photo is +38.8708° N, -104.9261° W, approximate elevation 6592 feet.

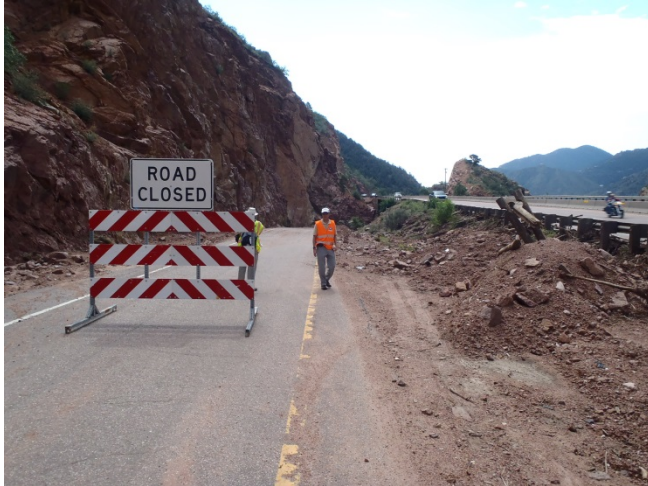
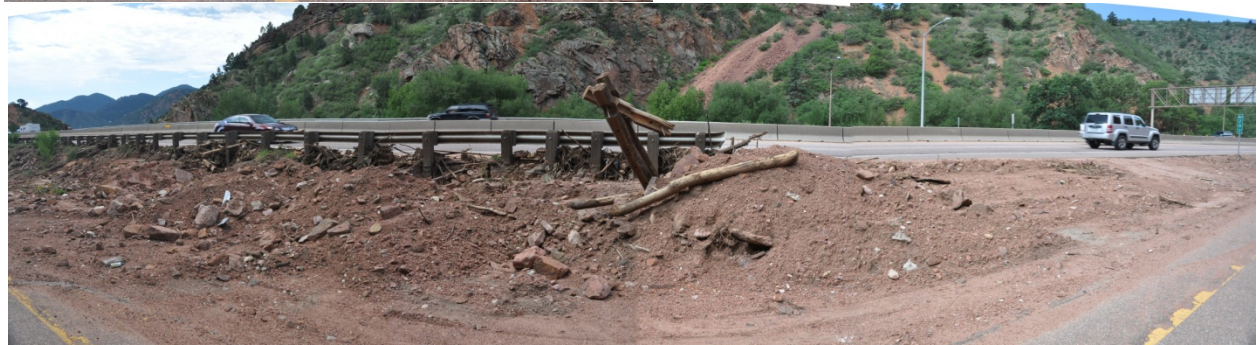
Figure 3.2.12. View of the US 24 westbound on-ramp. Top: view southeast down the westbound on-ramp; some of the sediment cleared from on-ramp is visible on the shoulder between westbound US 24 and the on-ramp. Bottom: panoramic view toward southwest (left) and northwest (right); woody debris around the wood posts of the guardrail may be a suggestion of the flood level in the westbound lanes. Camera position for top photo is  $+38.8719^{\circ}$  N,  $-104.9265^{\circ}$  W, approximate elevation 6670 feet.

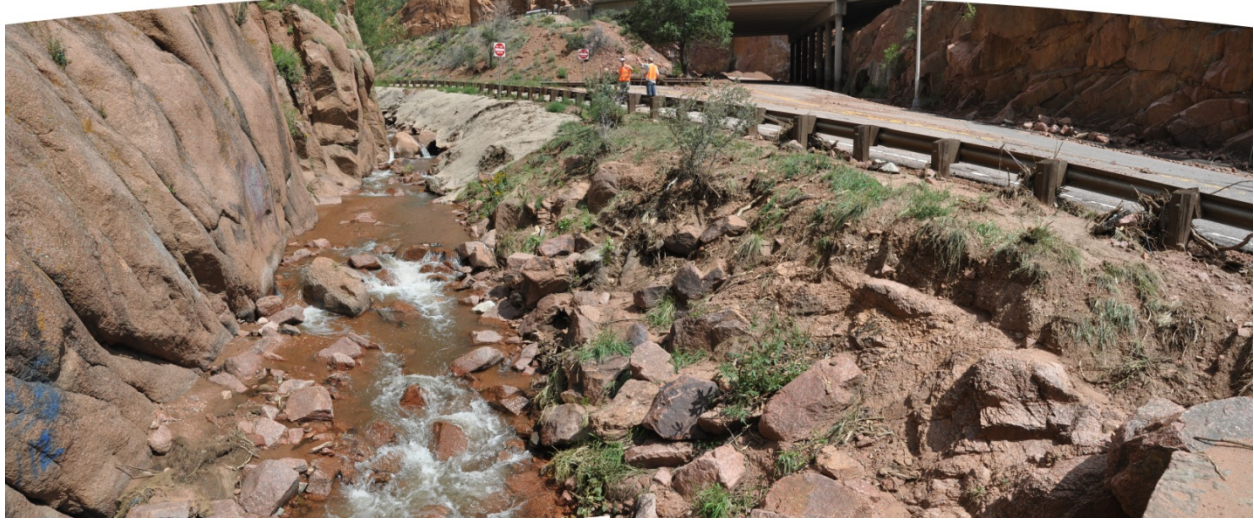
Figure 3.2.16. Fountain Creek adjacent to the junction of the eastbound off-ramp and Manitou Avenue where some of the Waldo Canyon flood water entered it. This part of the channel appears to have had little sediment or woody debris in it from the August 9,2013, storm. View north from +38.8702° N, -104.9259° W, approximate elevation 6598.

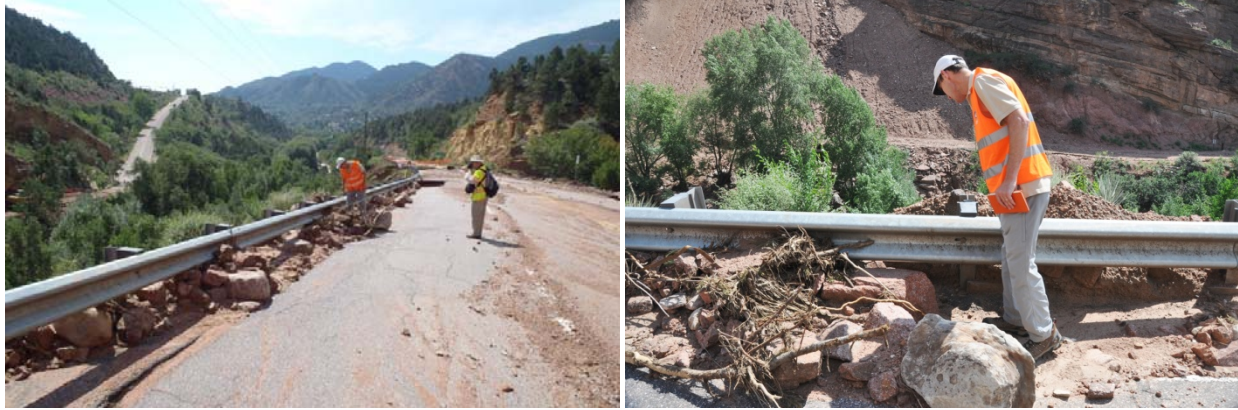
The Manitou Avenue embankment was partially washed out at two locations by flow from the August 9, 2013, flood (Figures 3.2.18 and 3.2.21). Contributing factors to these washouts included the combination of conditions that routed the Waldo Canyon flood flows down the westbound lanes of US 24 to the Manitou Avenue on-ramp, around the curve to Manitou Avenue, and across the Fountain Creek bridge, as well as the drainage details on the shoulder of the westbound lane that allowed discharge over the crest of the fill embankment. A tributary canyon to Fountain Creek located to the west of the embankment section (Figure 3.2.18) had water ponded against the road fill at the time of the reconnaissance. This ponded water also is visible in the bottom photo of Figure 3.2.20 and photos A, B, and C in Figure 3.2.21. The details of the flood event on Manitou Avenue are not known completely. However, it appears that storm water flowed down Manitou Avenue and into the tributary canyon at the position of photo C in Figure 3.2.21. Observations made in the lower part of the tributary canyon above the pond indicate that little runoff occurred in this canyon. The NEXRAD Doppler radar (Figure 3.1.1) scenes are consistent with an interpretation that this canyon was mostly outside the area of major precipitation. Water marks on the north-facing wall of this canyon indicate that water flowed

onto Manitou Avenue. A cross culvert was not observed at this location; the amount of ponded water remaining behind the road embankment would have concealed a culvert that is expected to have been in place.

The influence of water from the pond on the large and small washouts is unknown. Seepage through the embankment, as well as flow through the culvert discharging onto the embankment slope, certainly would have contributed to the washouts. Seepage may have been an historical phenomenon that needed to be managed at the small washout because a perforated corrugated steel pipe was observed on the embankment slope (Figure 3.2.21D). It is clear that this pipe was partly buried at one time because of the brown color at one end and bright galvanized steel at the other. The pipe diameter was not measured, but it appears to be too large for a normal sub-drain.

Figure 3.2.18. Aerial oblique photo of Manitou Avenue showing selected features, including two washout areas. Aerial oblique photograph taken August 17, 2013, as part of the GEER reconnaissance.

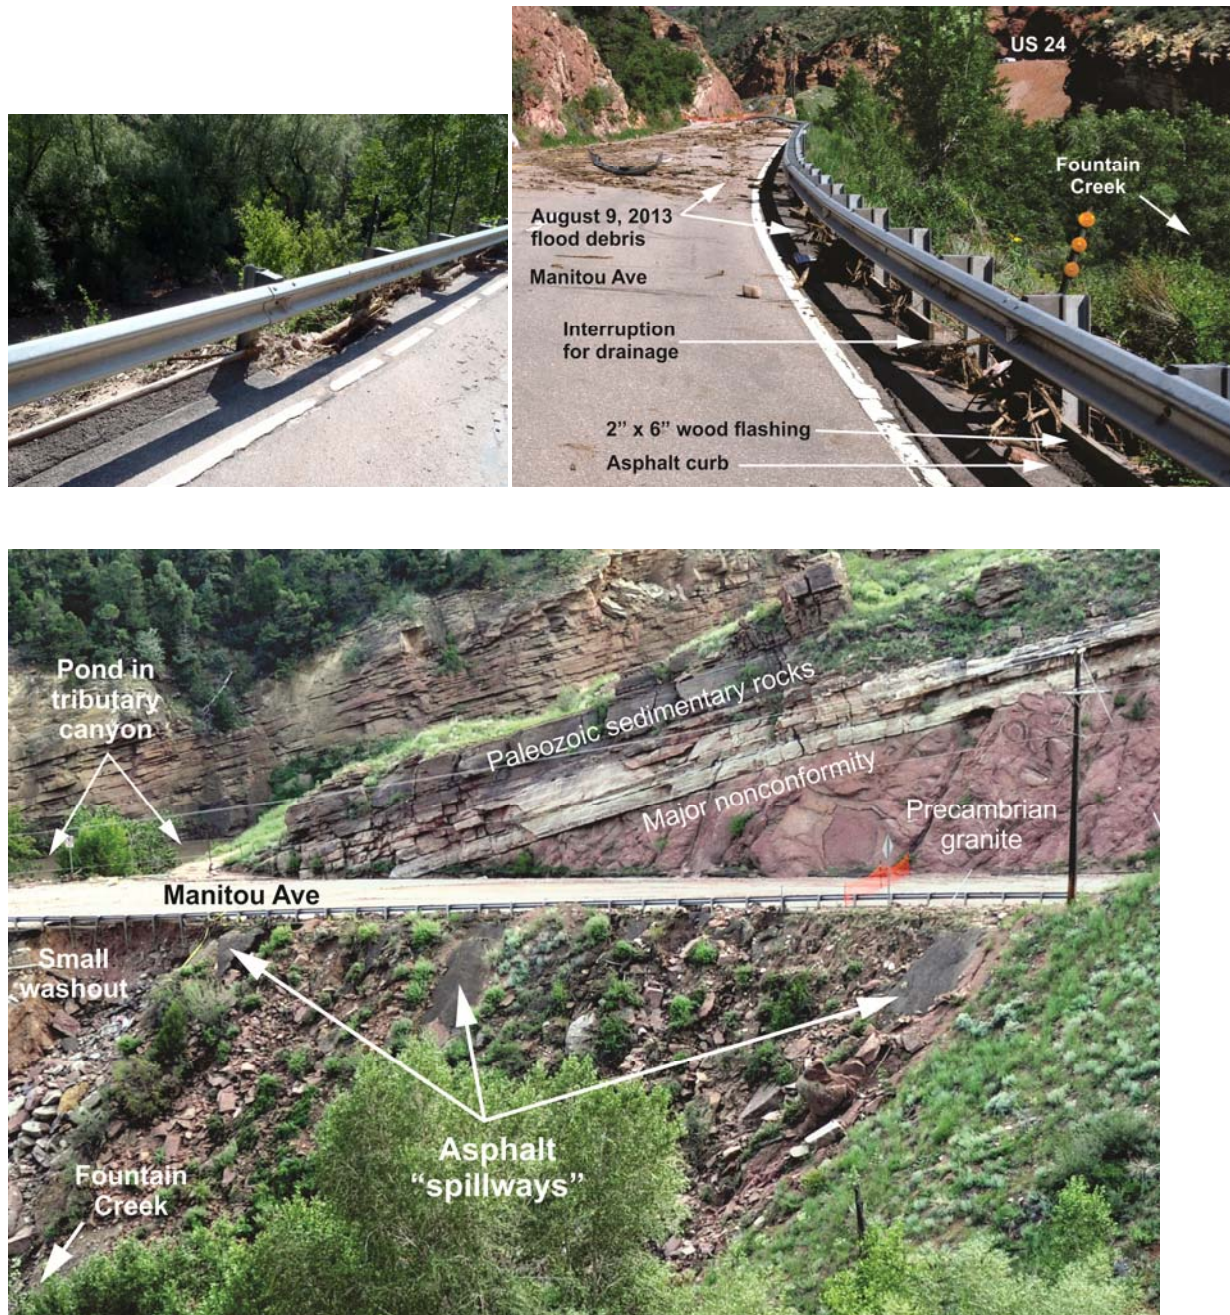
Figure 3.2.19. Debris-clogged guardrail on Manitou Avenue (old US 24). View south from +38.8691° N, -104.9255° W, approximate elevation 6573.

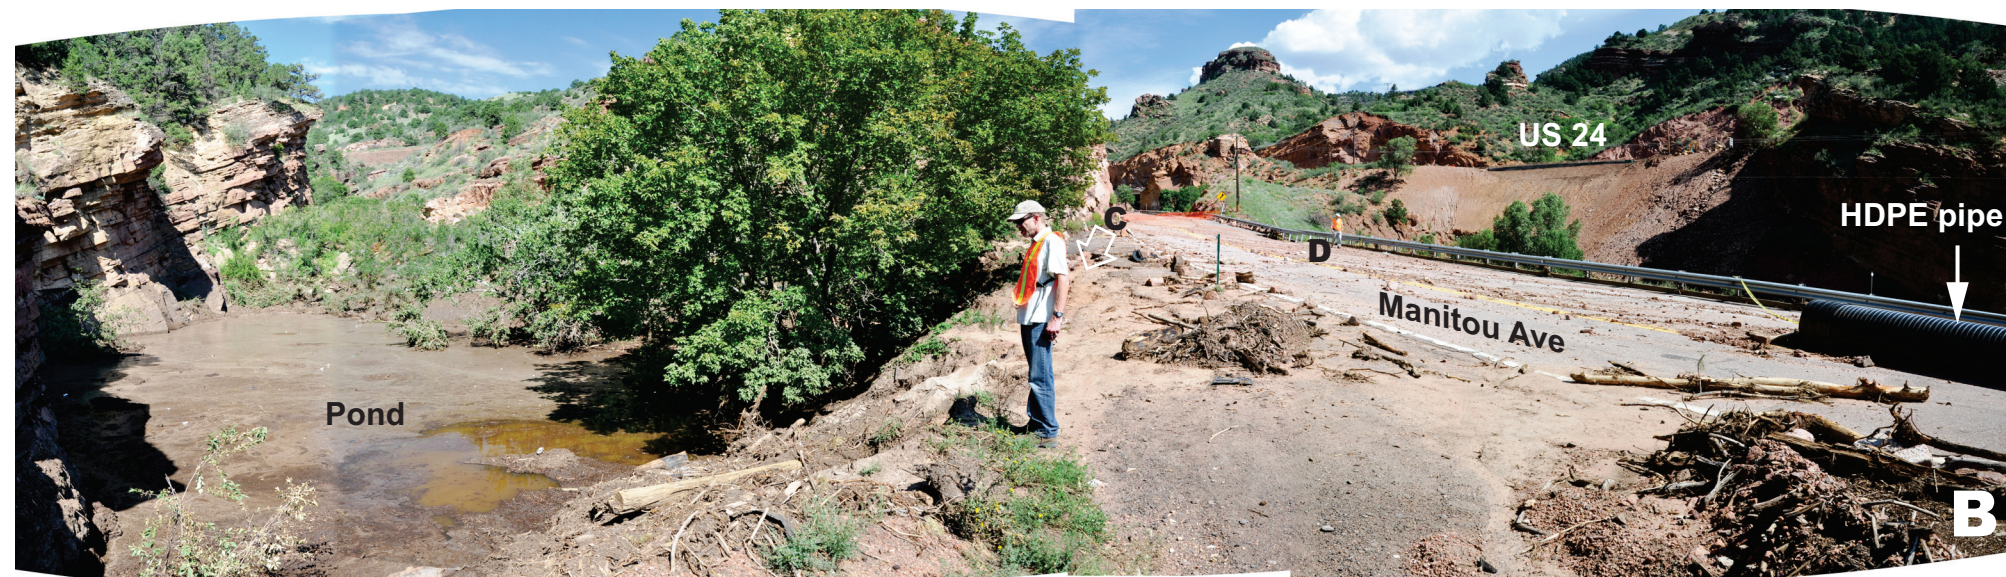
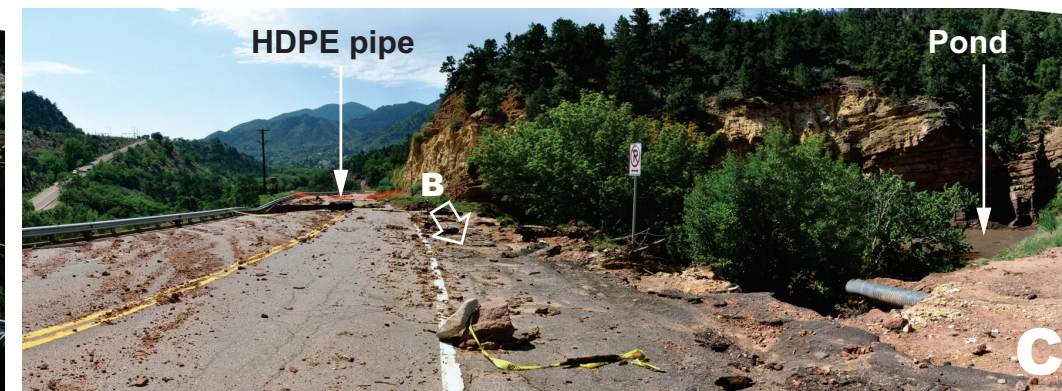
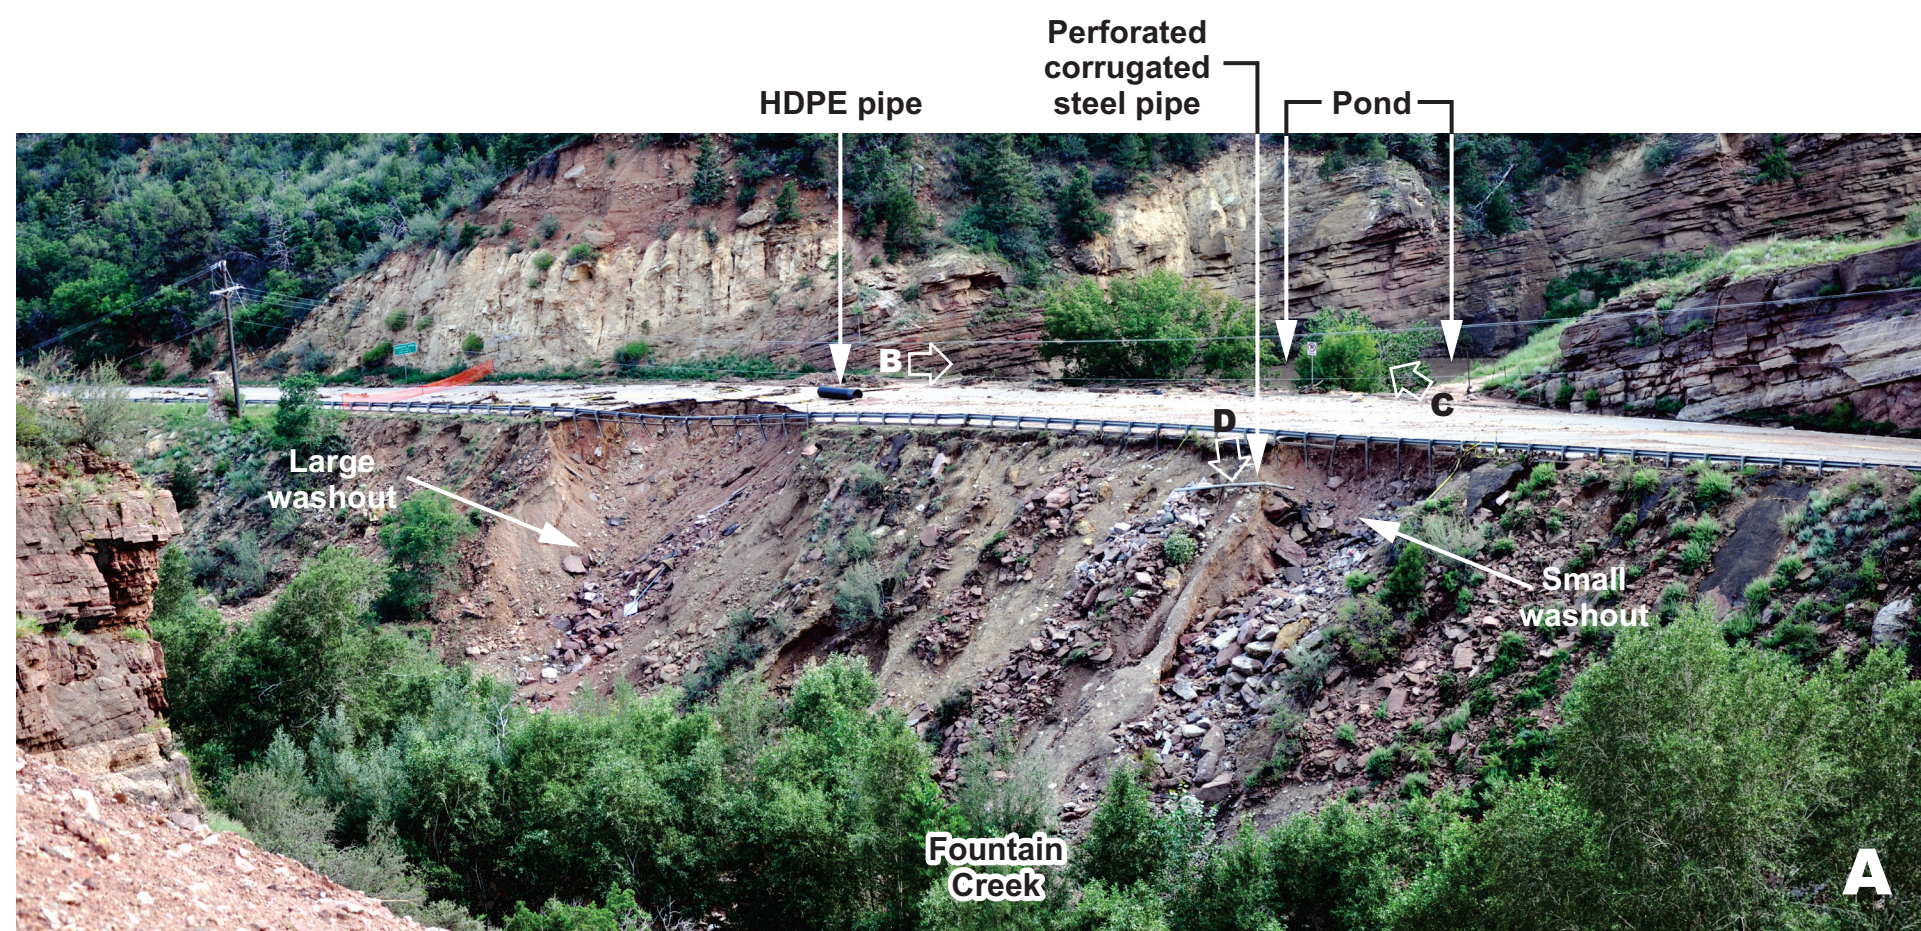
Figure 3.2.20. Designed interruptions in asphalt curb and asphalt “spillways” located along Manitou Avenue embankment crest above Fountain Creek. Camera positions: top left, looking south from  $+38.8652^{\circ}$  N,  $-104.9234^{\circ}$  W, approximate elevation 6431 ft; top right, looking northwest ( $336^{\circ}$  azm) from  $+38.8662^{\circ}$  N,  $-104.9243^{\circ}$  W, approximate elevation 6481 ft; bottom, looking southwest ( $238^{\circ}$  azm) from  $+38.8695^{\circ}$  N,  $-104.9244^{\circ}$  W, approximate elevation 6565 ft.

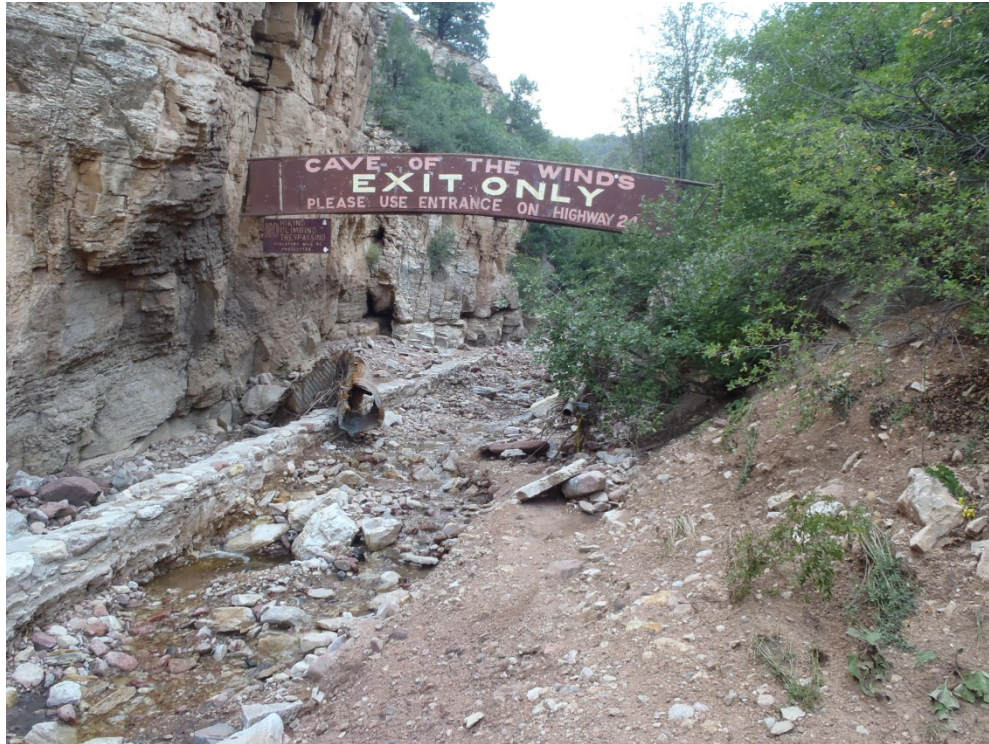
Figure 3.3.2. View looking north (upstream) from the bottom of Williams Canyon at the end of Cañon Avenue at Geneva Trail. The pre-flood channel appears to be the narrow space between the rock cliff and the stone-and-mortar wall; the wider eroded strip appears to be the exit road from Cave of the Winds. Camera location: +38.8655° N, -104.9178° W, elevation 6522 ft.

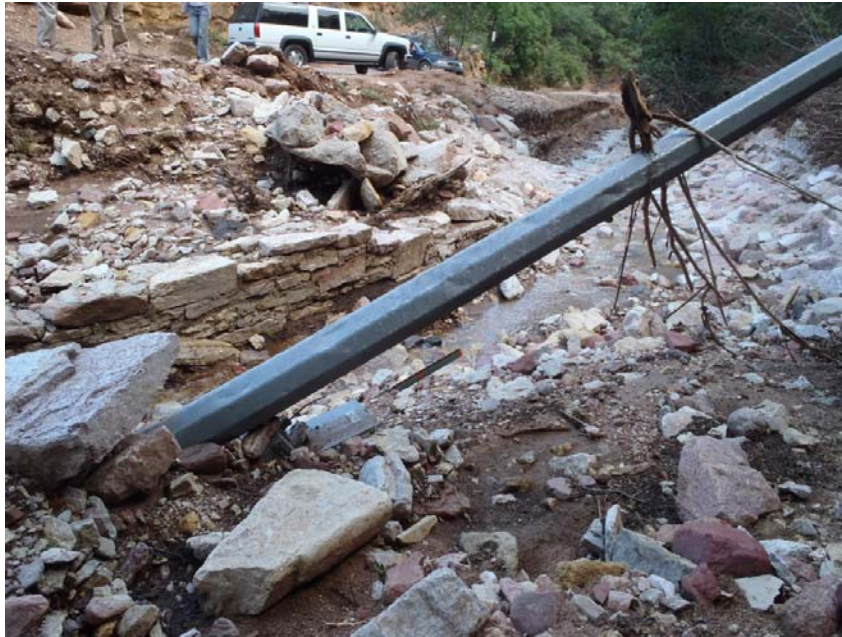
Figure 3.3.3. View looking south (downstream) from the bottom of Williams Canyon near the end of Cañon Avenue at Geneva Trail. Vehicles are parked on Cañon Avenue. Leaning metal feature is a light pole that has a tree branch hanging on it; above the tree branch is smooth steel, whereas dents are present in the pole below the tree branch providing an indication of maximum flood depth. Grouted riprap is visible in the middle-right part of the photo, and gabion baskets are visible at the end of the grouted riprap to the right of the vehicles. Camera location: +38.8655° N, -104.9178° W, elevation 6522 ft.

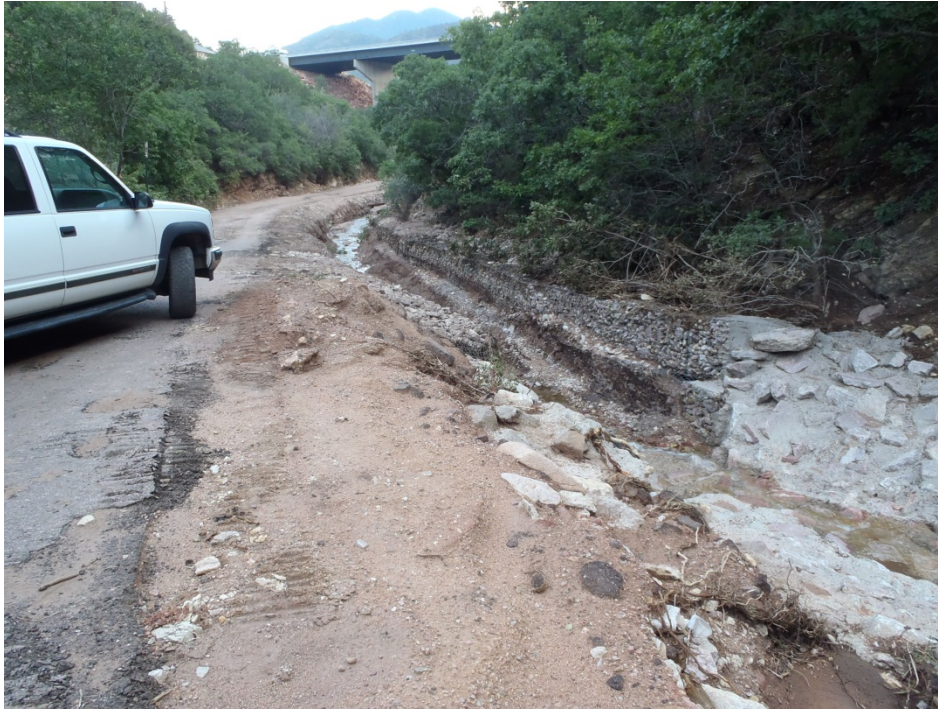
Figure 3.3.4. View looking south along Cañon Avenue at the transition from grouted riprap to gabion baskets lining the channel of Williams Canyon. The US 24 bridge over Williams Canyon is visible in the top center of the photo. Camera location: +38.9320° N, -104.9178° W, elevation 6515 ft.

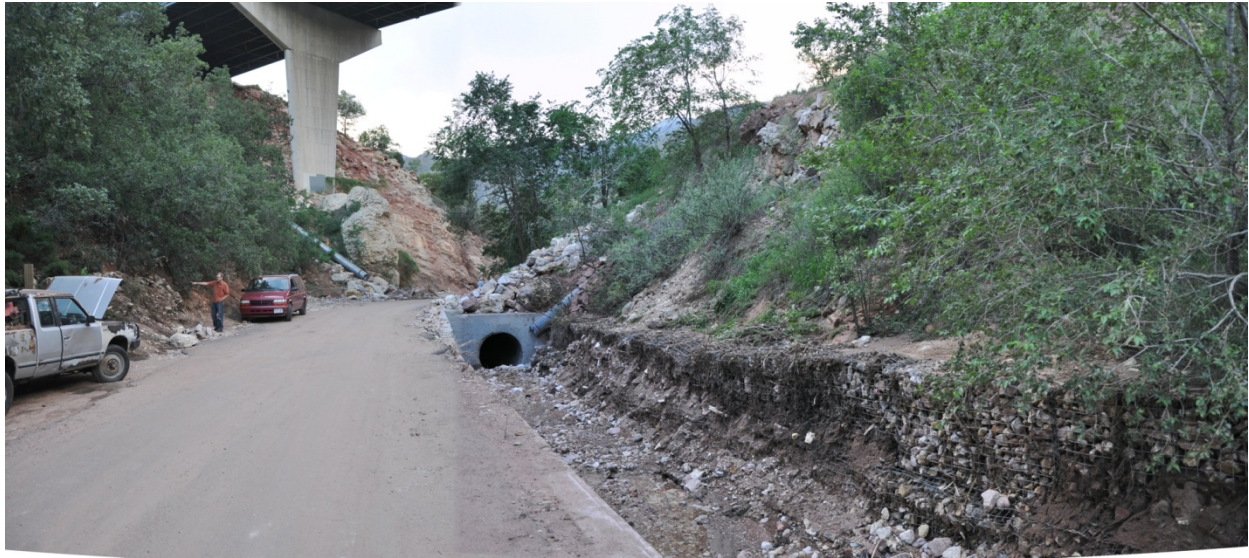
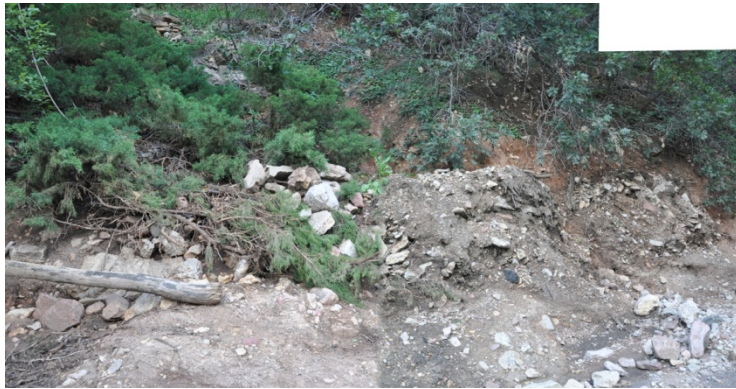
Figure 3.3.5. View looking south along Cañon Avenue at the transition from gabion-lined open channel to a culvert estimated to be 54 inches in diameter. US 24 bridge over Williams Canyon is visible. Steel pipe next to bridge pier discharges into an inlet to the culvert. The narrow bottom of Williams Canyon is evident in this photo. Northernmost residence in Williams Canyon is adjacent to the left side of this photo; see Figure 3.3.6. Inset photo is a view of debris on east side of canyon between the two vehicles where the man is pointing. Camera location: +38.8641° N, -104.9173° W, elevation 6472 ft.
