**GEOTECHNICAL EFFECTS OF  
INTENSE PRECIPITATION ON AUGUST 9, 2013, ON  
SLOPES ABOVE MANITOU SPRINGS, COLORADO,  
THAT WERE BURNED IN THE  
2012 WALDO CANYON FIRE**

Geotechnical Extreme Events Reconnaissance (GEER) Association  
Reconnaissance Dates: August 16 to 18, 2013

Jeffrey Keaton, AMEC Americas (Team Leader)  
Scott Anderson, Federal Highway Administration  
Paul Santi, Colorado School of Mines  
Shideh Dashti, University of Colorado, Boulder

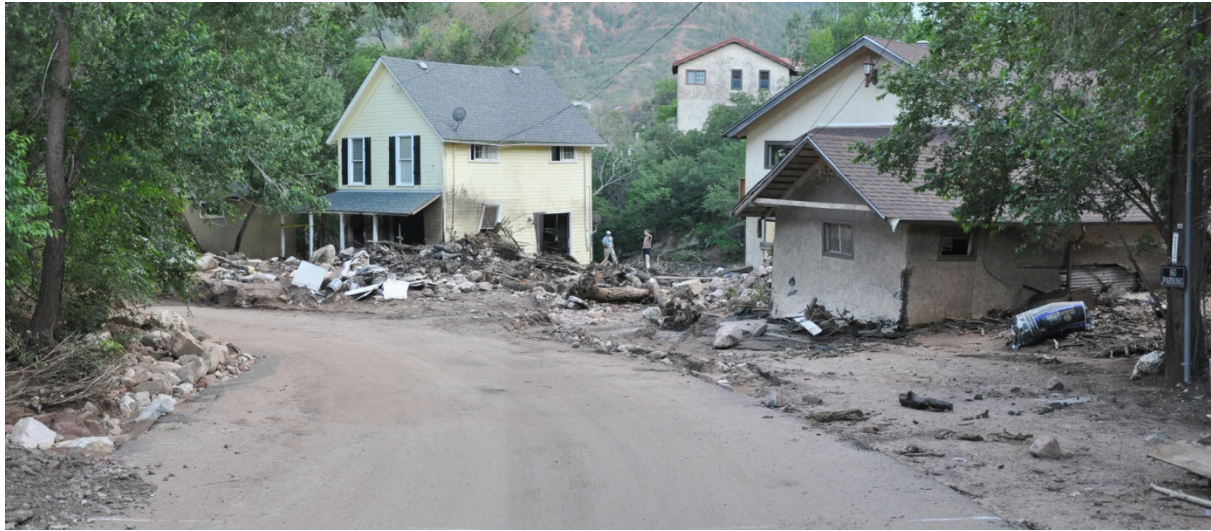
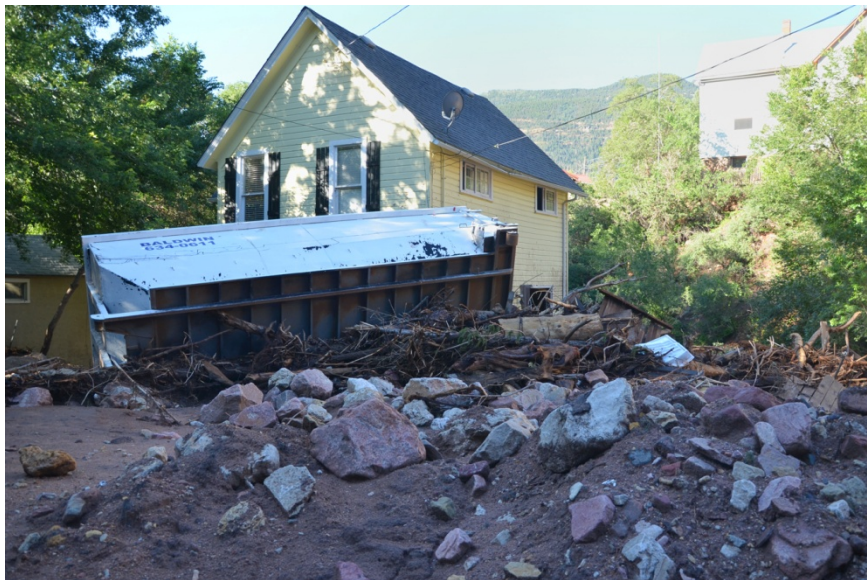
Figure 3.3.7. View looking south along Cañon Avenue and the buried culvert for Williams Canyon drainage. Most of the flood flow passed to the right of the two-story yellow house, but substantial flow also went to the left down Cañon Avenue. Top: photo by GEER team members taken on August 16, 2013. Bottom: photo by Jason Kean, US Geological Survey, taken on August 13, 2013. Camera location:  $+38.8633^{\circ}$  N,  $-104.9173^{\circ}$  W, elevation 6453 ft.

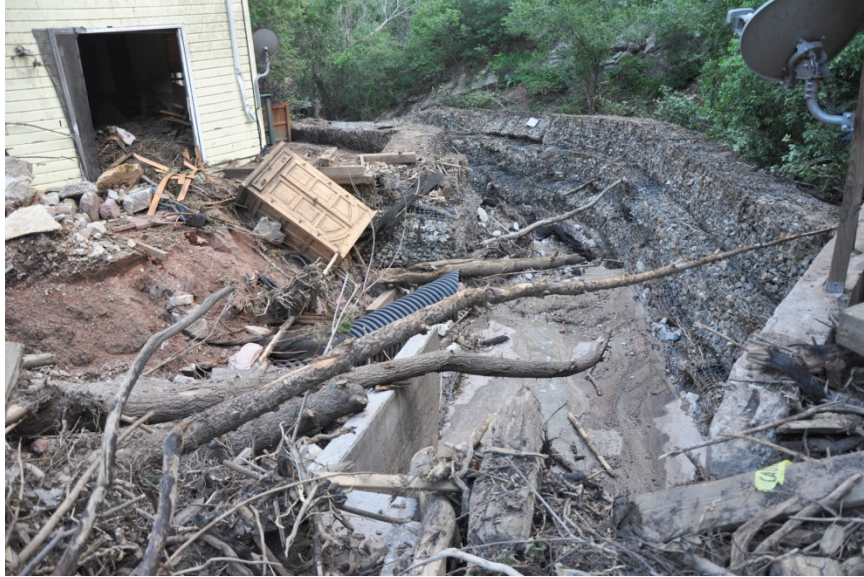
Figure 3.3.8. View looking south from the culvert outlet at the gabion-lined channel in the northern part of Manitou Springs residential area south of US 24. The concrete wall visible in the lower center of the photo is the culvert outlet. The main part of the flood passed through the area shown in this photograph. Substantial flood flows also went around the left side of the yellow house. Camera location: +38.8630° N, -104.9174° W, elevation 6432 ft.

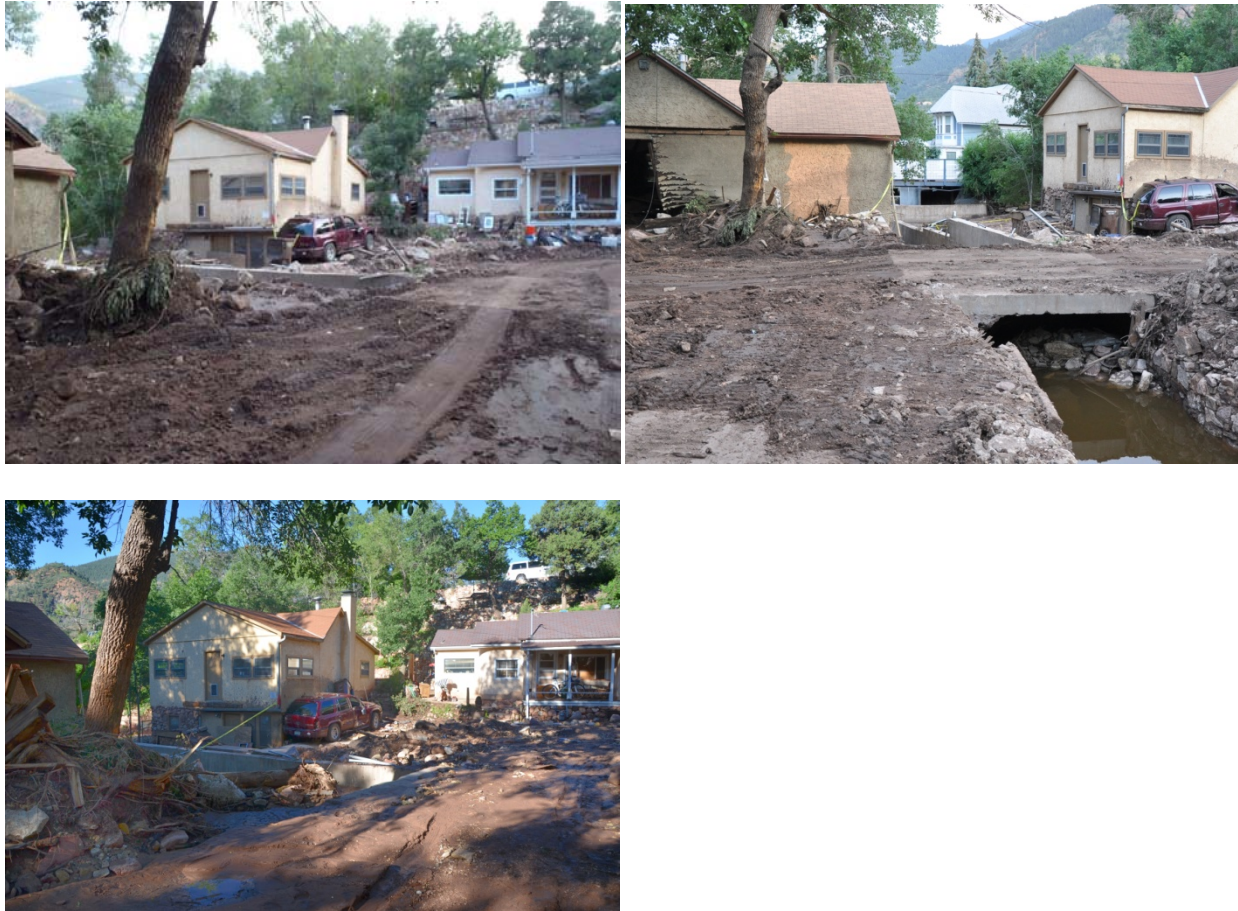
The gabion-lined open channel extends southward from the area shown in Figure 3.3.8 to a concrete box culvert beneath Narrows Road west of Canon Avenue (Figure 3.3.9), at some point making a transition to a rock- or slab-lined open channel. Narrows Road is covered by earth material presumably from flood-damage cleanup. Figure 3.3.9 shows two photos of essentially the same view; the top photo was taken by the GEER team on August 16, 2013, whereas the bottom photo was taken by Jason Kean, US Geological Survey, on August 13.

Figure 3.3.9. Views west along Narrows Road at concrete-lined open-channel section of Williams Canyon drainage and south at box culvert under Narrows Road. Top: photos by GEER team on August 16, 2013. Bottom: photo by Jason Kean, US Geological Survey, taken on August 13, 2013. Camera location: +38.8620° N, -104.9170° W, elevation 6401 ft.

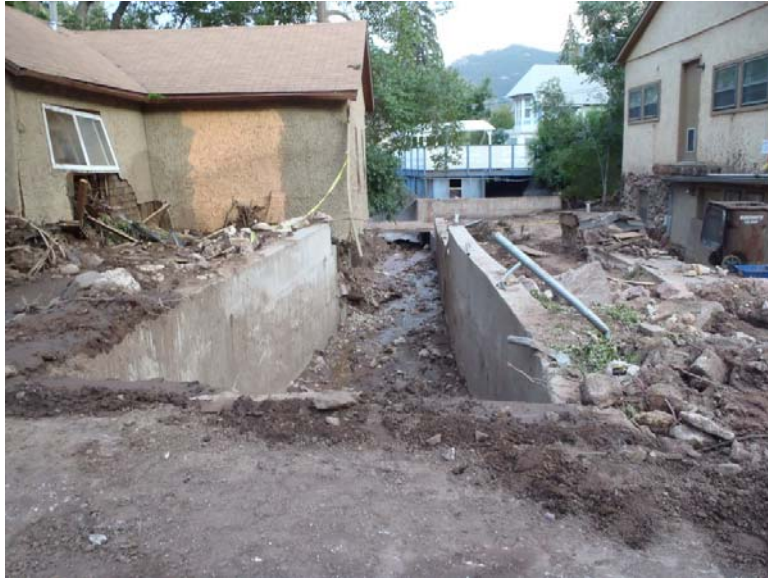
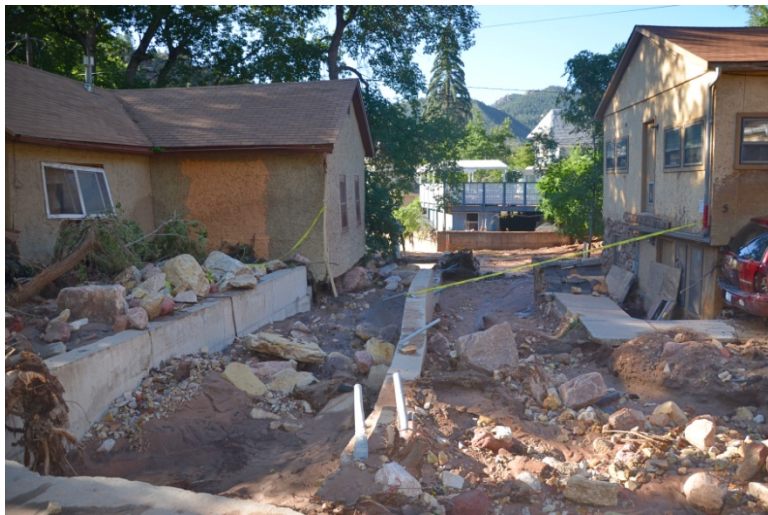
Figure 3.3.10. View south from Narrows Road along concrete-lined open-channel section of Williams Canyon drainage. Top: photo by GEER team on August 16, 2013. Bottom: photo by Jason Kean, US Geological Survey, taken on August 13, 2013. Camera location: +38.8620° N, - 104.9171° W, elevation 6407 ft.

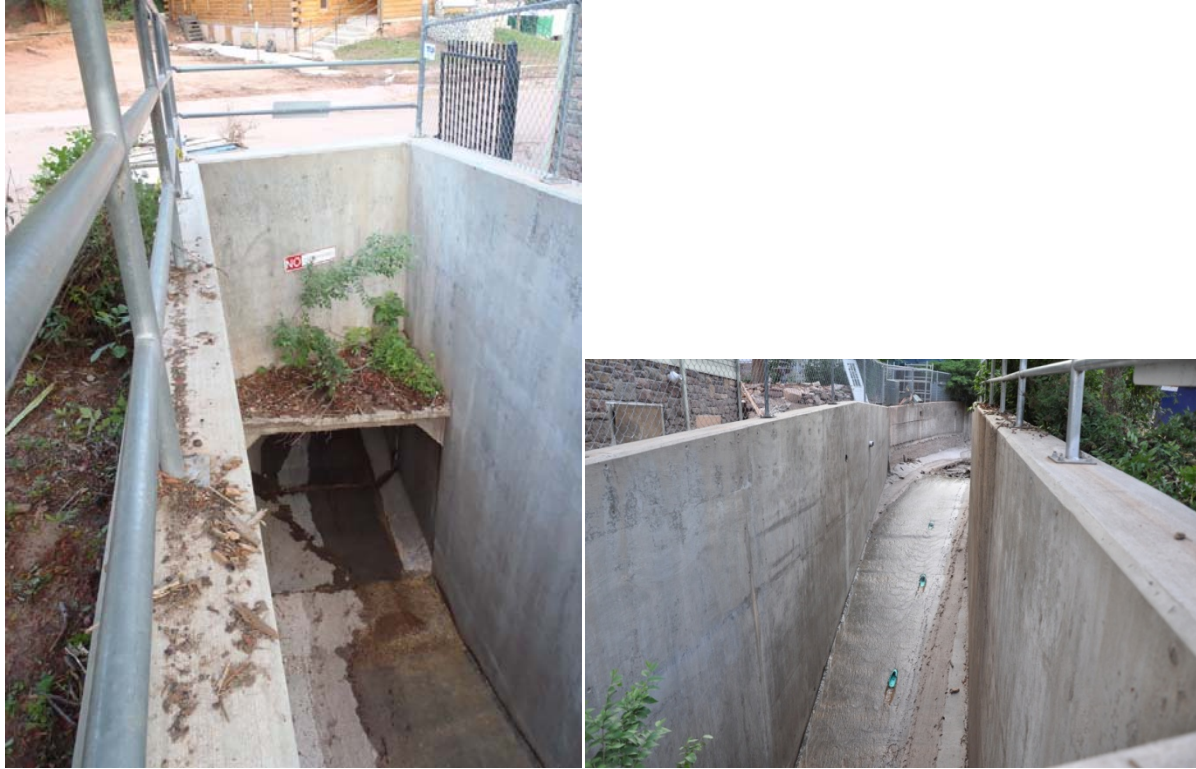
Figure 3.3.11. Views of deep rectangular channel and inlet to box culvert at Cañon Avenue. Left: view to southeast; Cañon Avenue and church at top of photo. Right: view northwest at grade transition from open-channel section to box culvert section. It is difficult to appreciate from these photos that a major flood event occurred one week prior to the date they were taken. Camera location:  $+38.8616^{\circ}$  N,  $-104.9169^{\circ}$  W, elevation 6405 ft.

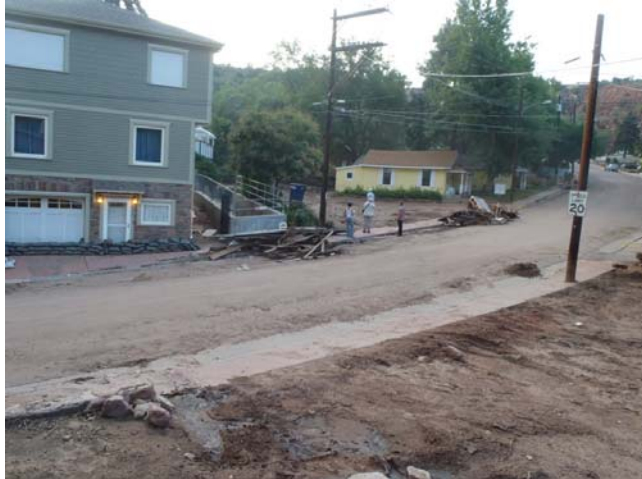
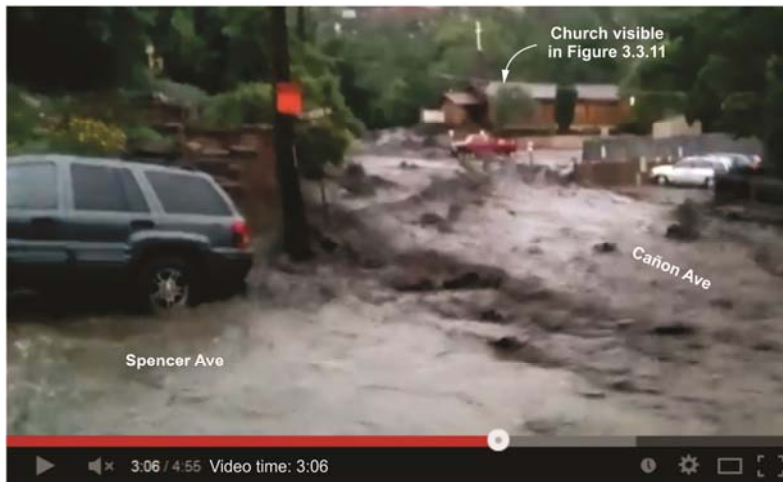
Figure 3.3.12. Views of Cañon Avenue near the culvert inlet that carries Williams Canyon drainage to Fountain Creek. Top: view to the northwest from the church visible in Figure 3.3.11 across Cañon Avenue to the culvert inlet that carries Williams Canyon drainage to Fountain Creek. Bottom: screenshot of YouTube video by Dave McCrary taken on August 9, 2013, looking north up Cañon Avenue at flood flow; Video 2 in Figure 3.3.1. Camera location: +38.8613° N, -104.9167° W, elevation 6391 ft.

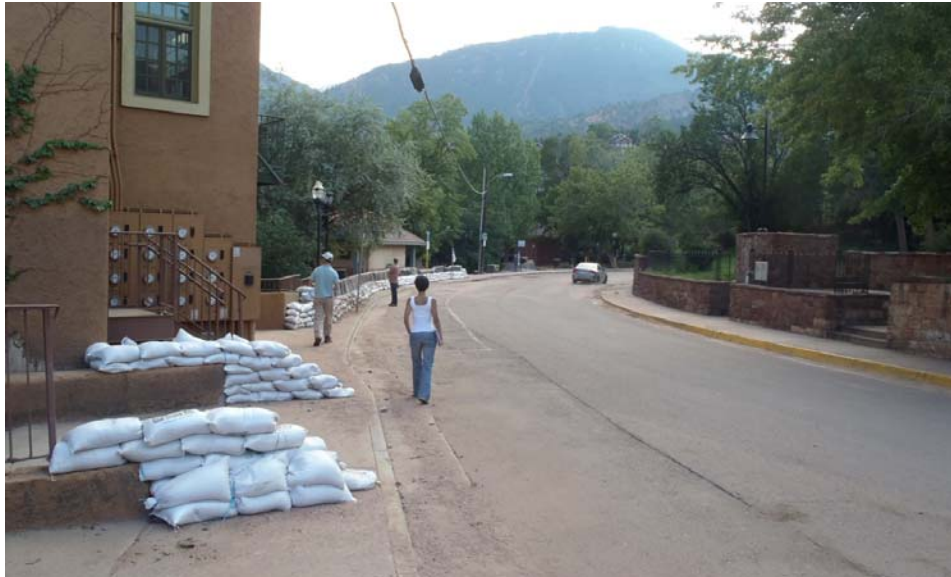
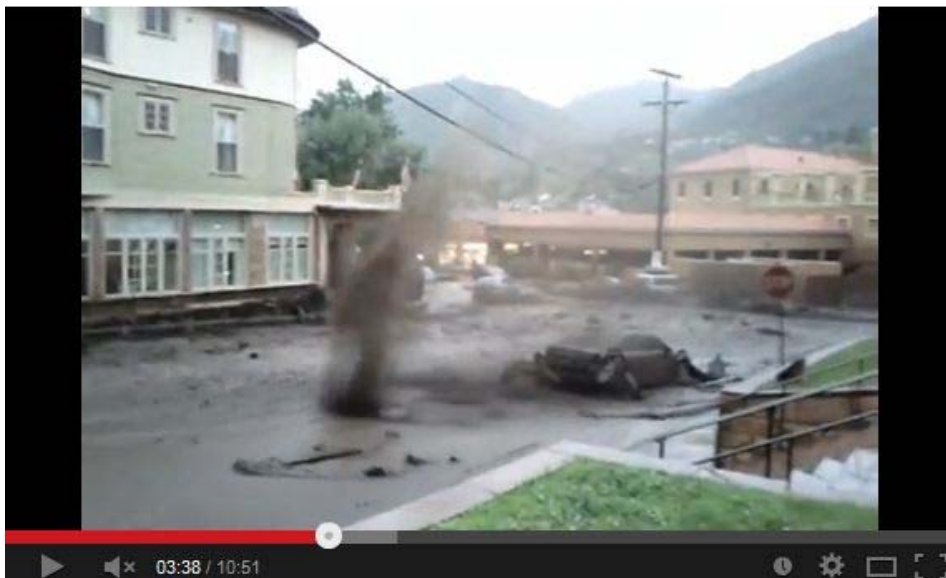
Figure 3.3.13. Views near intersection of Park Avenue and Canon Avenue. Top: view west along Park Avenue after cleanup. Bottom: screenshot of YouTube video by JS4VI taken on August 9, 2013, looking southeast down Cañon Avenue from Post Office building at flood flow with pressure discharge from service hole on Williams Canyon drainage culvert; Video 3 in Figure 3.3.1. Intersection of Cañon Avenue and Park Avenue is just to the right of the stop sign. Camera location: +38.8596° N, -104.9178° W, elevation 6354 ft.

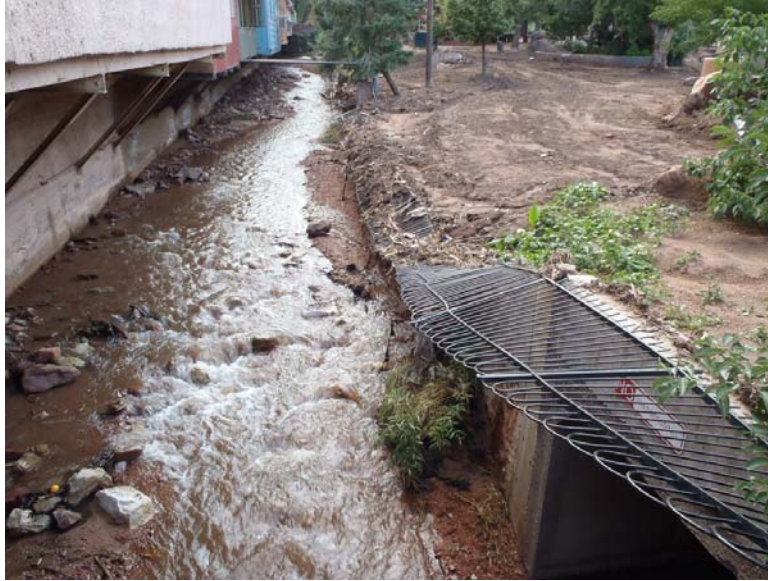
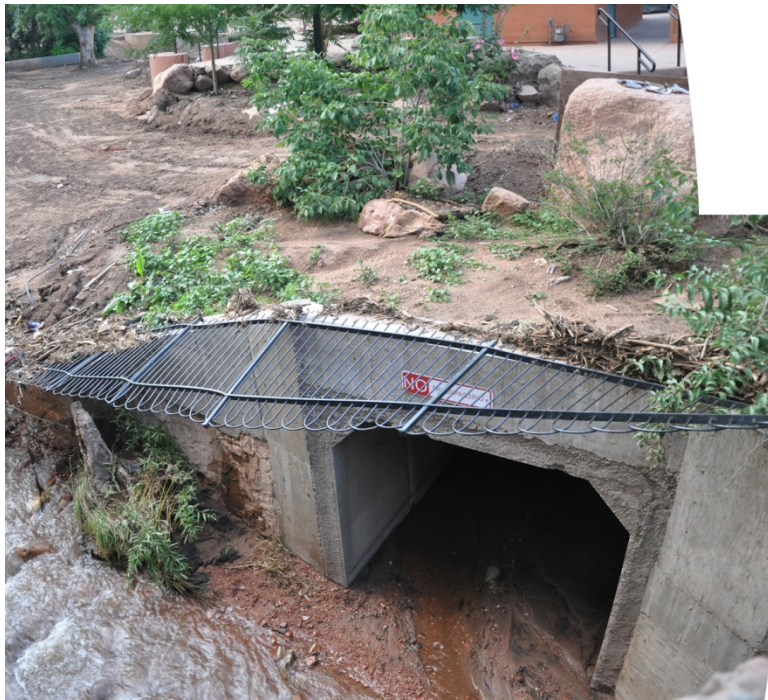
Figure 3.3.14. Outlet of the Williams Canyon drainage culvert at Fountain Creek. Top: view to the west (upstream) along Fountain Creek showing backs of retail stores to the left of the creek and flood damage to the right; culvert outlet is in the lower right of photo. Bottom: view to the north of Williams Canyon drainage culvert outlet. Camera location: +38.8592° N, -104.9184° W, elevation 6344 ft.

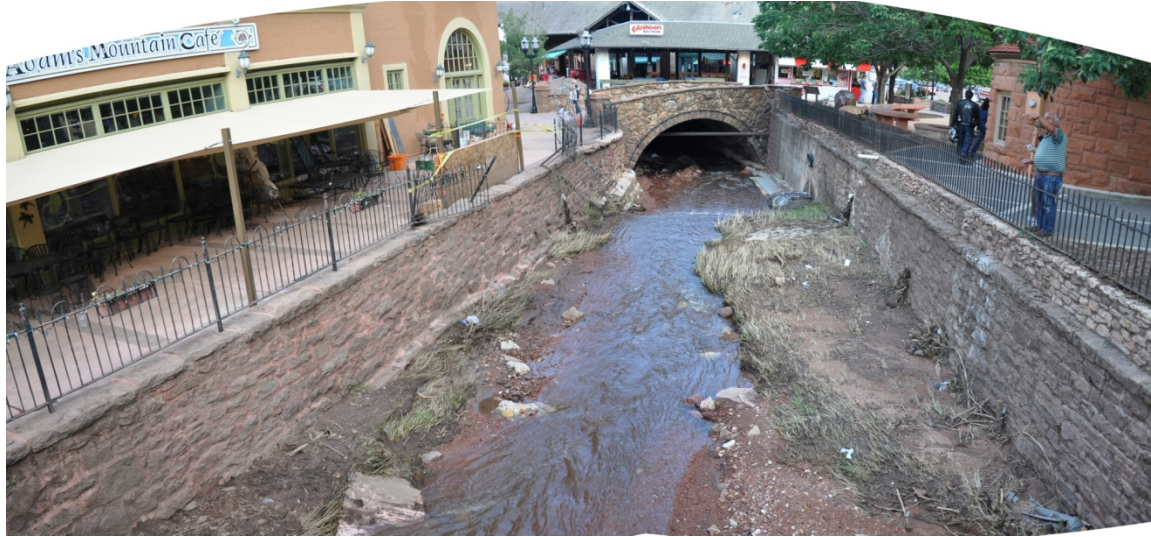
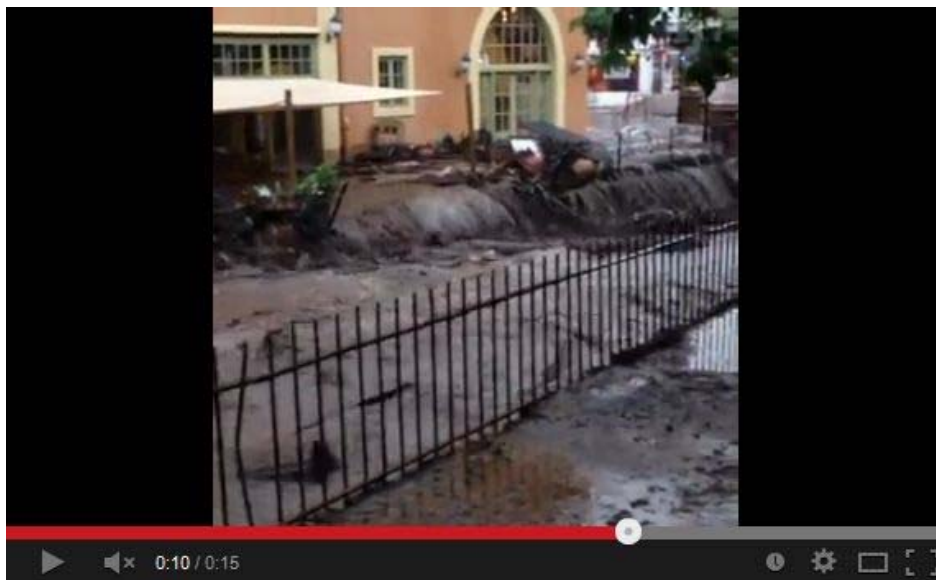
The building in Figure 3.3.13 borders on Fountain Creek. The south side of the building is a café with creek-side patio seating (Figure 3.3.15). The top photo in Figure 3.3.15 was taken by the GEER team on August 16, 2013, whereas the bottom photo is a screenshot from a YouTube video by Thom Vincent taken on August 9 (<http://www.youtube.com/watch?v=ZBs-7siS86c>) (labeled Video 4 in Figure 3.3.1). The damaged fence is the primary indication of the flood remaining on the patio after the week of cleanup activities. Views of Fountain Creek looking upstream from the footbridge visible in Figure 3.3.15 are shown in Figure 3.3.16. The water level in the video by Apeakrunner taken on August 9 (labeled Video 5 in Figure 3.3.1) (<http://www.youtube.com/watch?v=DWu5lizAPKY>) appears to be lower, hence later in the flood, than the water level in the video by Thom Vincent.

Figure 3.3.15. View looking downstream of Fountain Creek downstream from the Williams Canyon drainage culvert inlet. Top: view looking east from footbridge visible in Figure 3.3.16 taken by GEER team on August 16, 2013; note fence damage on left near end of the awning. Bottom: screenshot of YouTube video by Thom Vincent taken on August 9, 2013; Video 4 in Figure 3.3.1. Camera location:  $+38.8592^{\circ}$  N,  $-104.9184^{\circ}$  W, elevation 6344 ft.

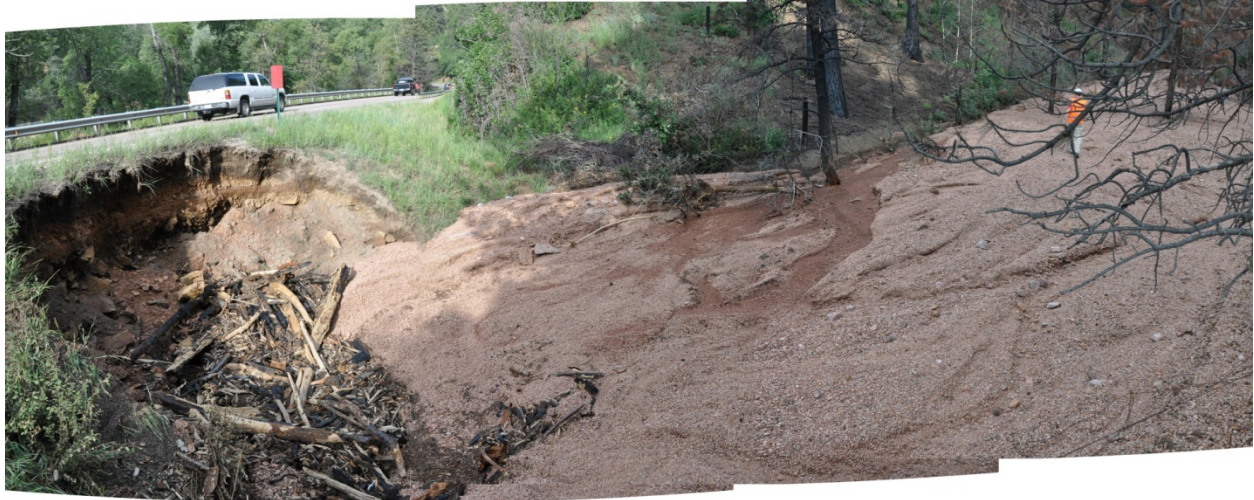
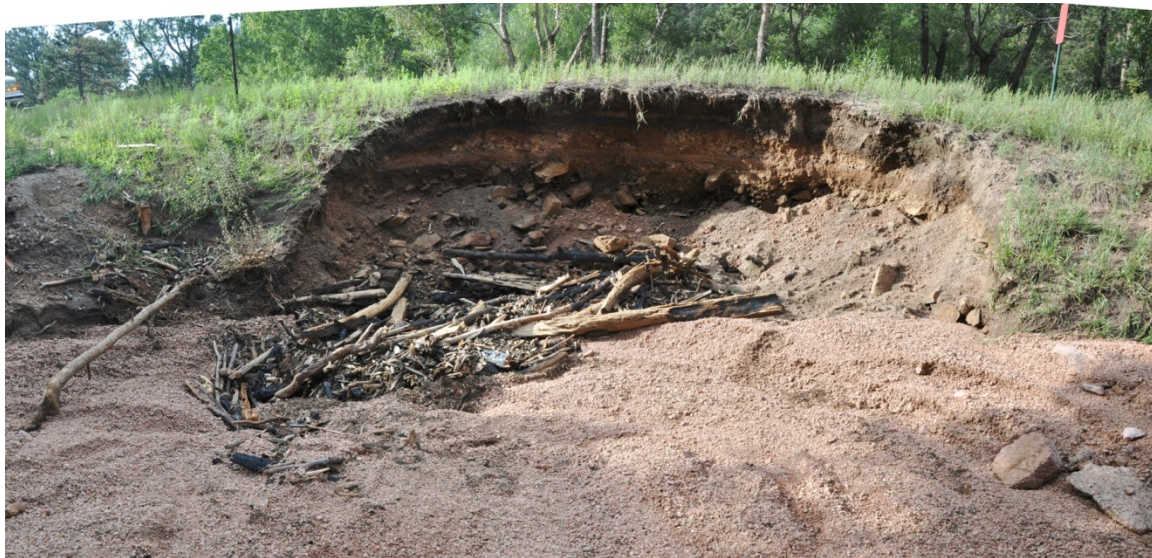
Figure 3.4.2. Unnamed Creek 1 where it enters a culvert under US 24 that was buried by sediment in the August 9, 2013, storm. Top: view looking west across the mouth of Unnamed Creek 1 at US 24. Bottom: view looking south at embankment of US 24 where the culvert inlet has been buried. Location of culvert inlet at westbound US 24: 38.8900° N, -104.9586° W, approximate elevation 7195 ft.

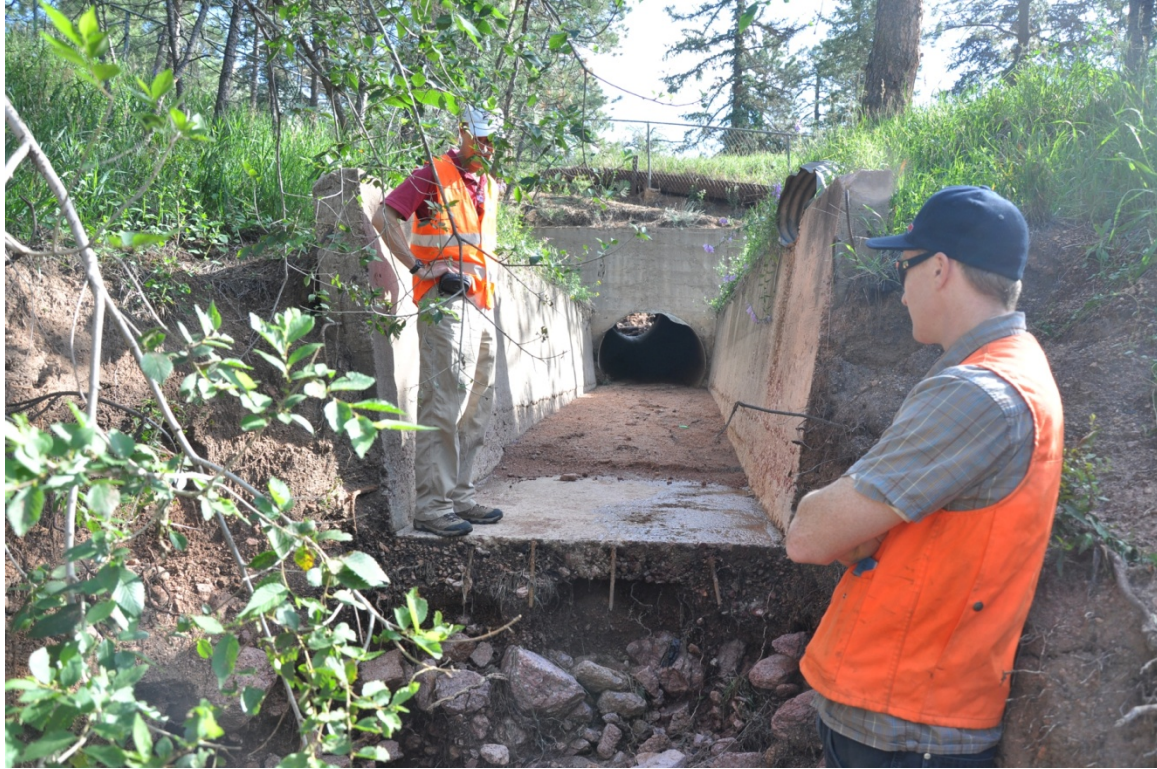
Figure 3.4.6. Concrete open-channel section and metal pipe culvert outlet on west side of Hagerman Road, Town of Cascade. Concrete channel appears to have been constructed after the culvert, probably because of erosion at the culvert outfall similar to the erosion at the end of the concrete channel section. Bare concrete at end of concrete section probably is related to discharge from the 12-inch-diameter corrugated metal pipe at shoulder height across from man standing on the concrete. View looking northeast from 38.8972° N, -104.9695° W, approximate elevation 7421 ft.

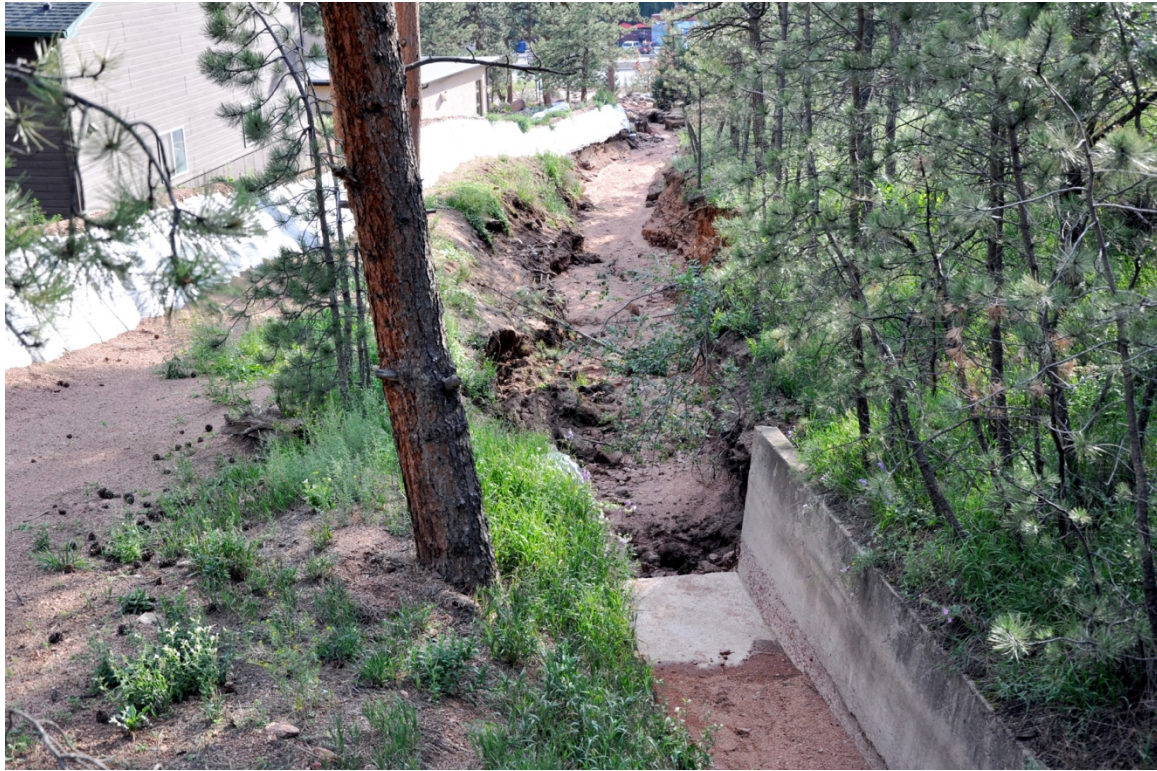
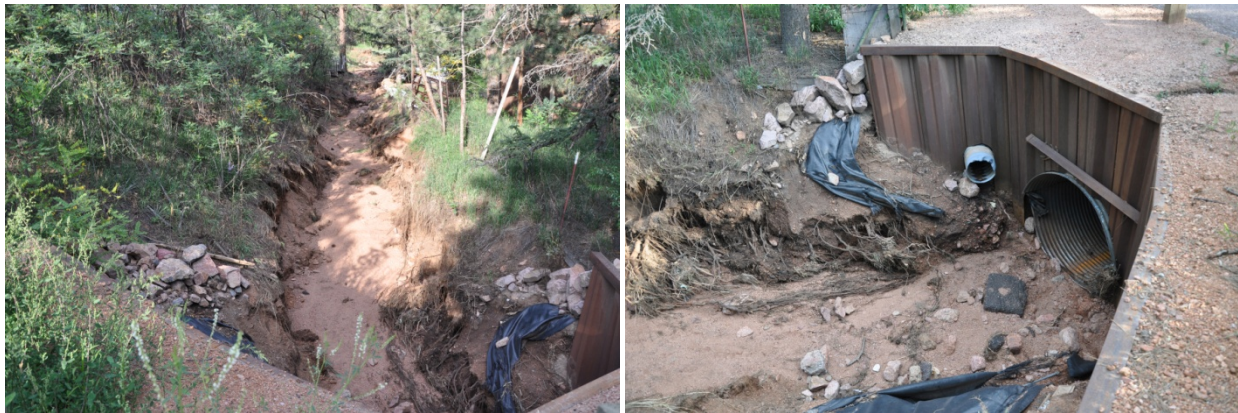
Figure 3.4.7. Unnamed Creek 3 downstream and upstream from Hagerman Road. Top: view looking downstream (southwest) at the concrete channel. Bottom left: view looking upstream (northeast) at the unlined channel. Bottom right: view looking south at the inlet to the metal pipe culvert under Hagerman Road. All views from approximately 38.8971° N, -104.9695° W, approximate elevation 7426 ft.

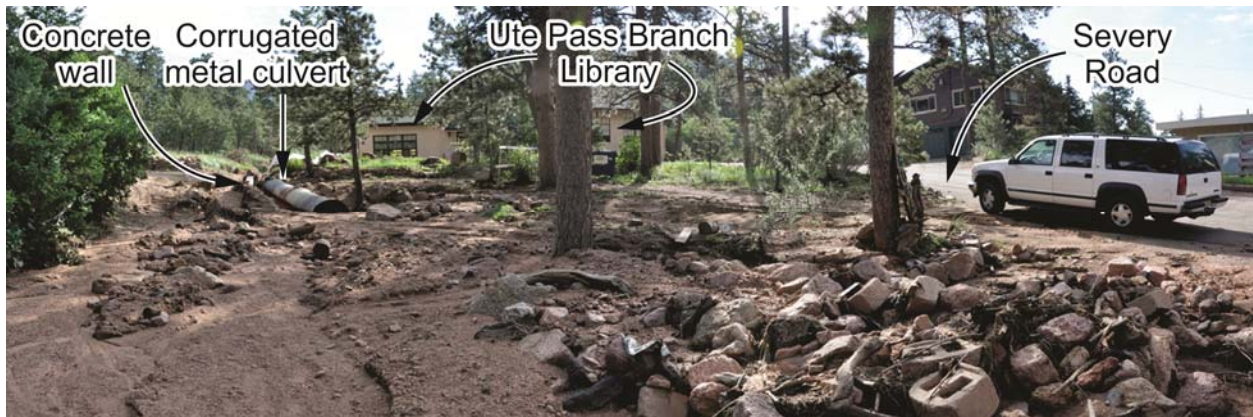
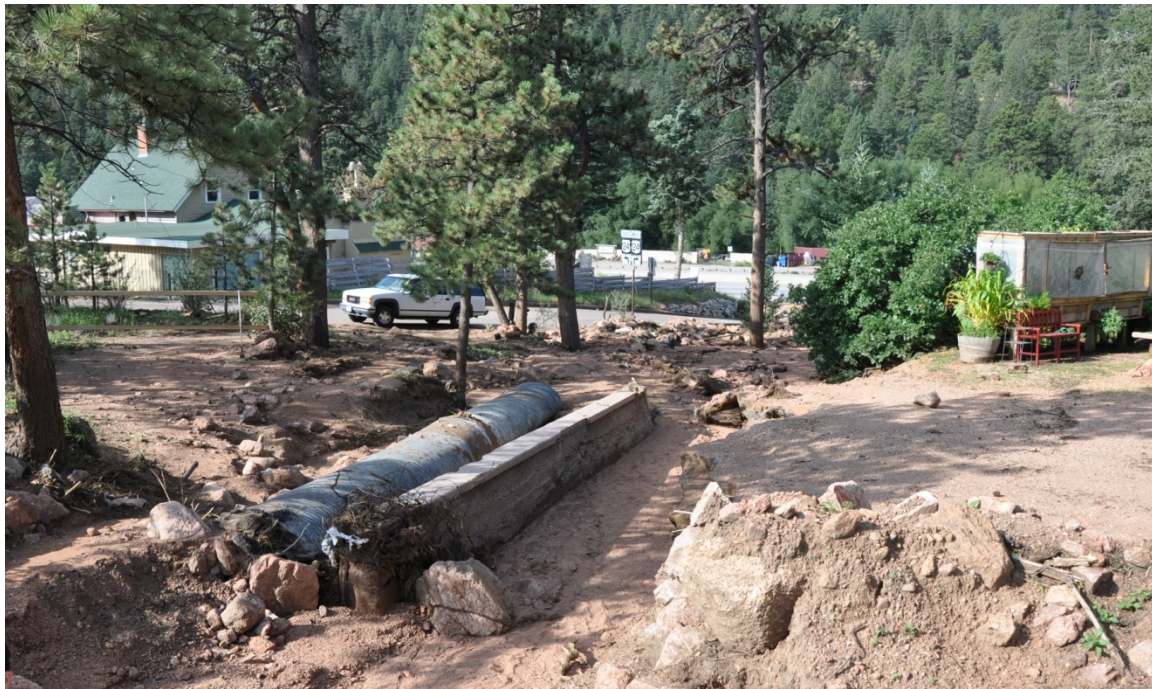
The August 9, 2013, storms caused erosion of the channel and deposition at and below the intersection point near the distal end of the alluvial fan (Figure 3.4.8). Boulders visible in the lower right part of the top photo in Figure 3.4.8 appear to be anomalous based on the channel conditions documented in Figure 3.4.7. The corrugated metal pipe and low concrete wall visible in both photos in Figure 3.4.8 mark the position of a driveway from Severy Road to a private residential garage.

Figure 3.4.8. Unnamed Creek 3 at its intersection point in the lower part of the alluvial fan in the Town of Cascade. Top: panorama view looking northeast (left side) to southeast (right side) from a point near Ute Pass Avenue and Severy Road. Bottom: view looking southwest at exposed concrete wall and oval corrugated metal pipe culvert at a driveway from Severy Road (white truck) to the right side of photo. Camera location for top view  $38.8965^{\circ}$  N,  $-104.9705^{\circ}$  W, approximate elevation 7367 ft; camera location for bottom view  $38.8968^{\circ}$  N,  $-104.9702^{\circ}$  W, approximate elevation 7405 ft.

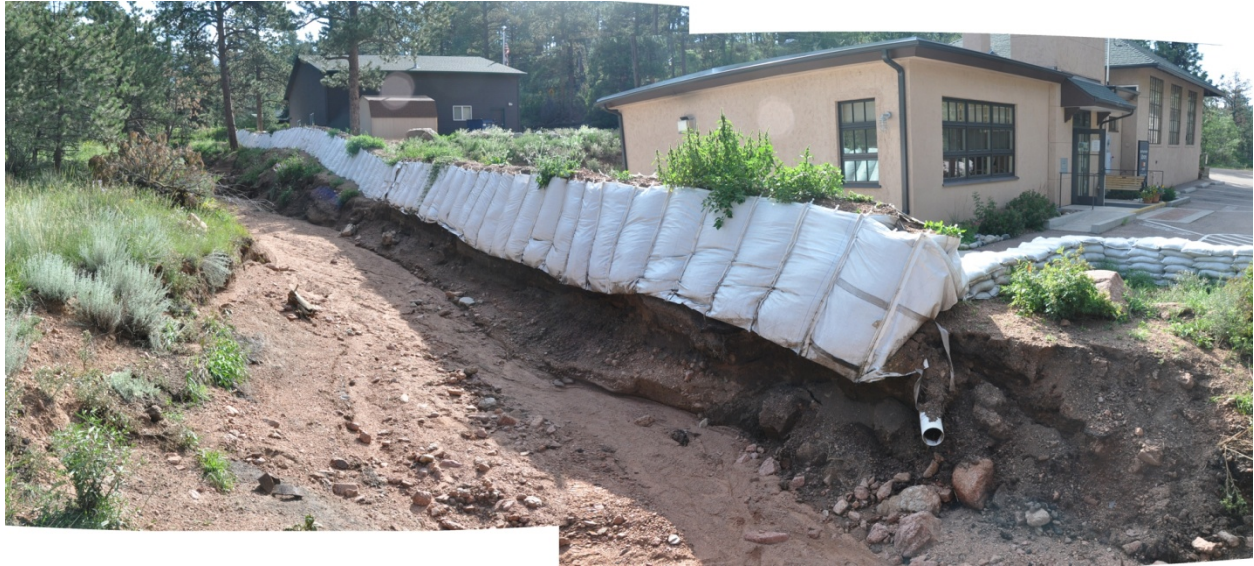
Figure 3.4.9. Unnamed Creek 3 in the lower part of the alluvial fan adjacent to the Ute Pass Branch Library in the Town of Cascade. Panorama view looking northeast; white objects lining the channel are fabric bulk handling bags that are somewhat similar to saddle bags that are able to straddle a ridge or cable. Vegetation growing on soil filling the bags indicates that these bags were in place at the time of the August 9, 2013, flood. This location is just above the intersection point on the Cascade alluvial fan. View from  $38.8968^{\circ}$  N,  $-104.9702^{\circ}$  W, approximate elevation 7405 ft

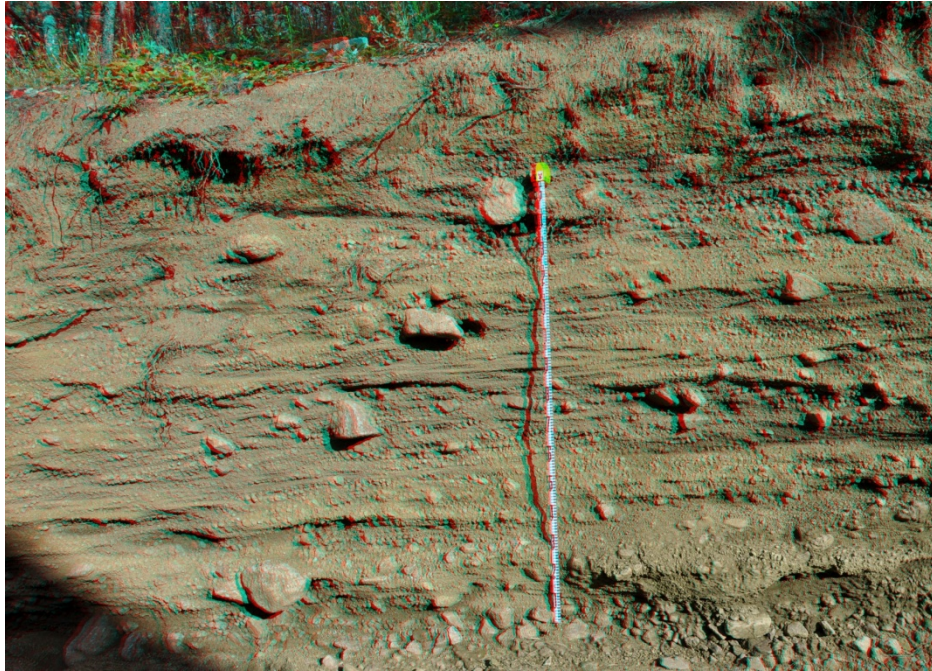
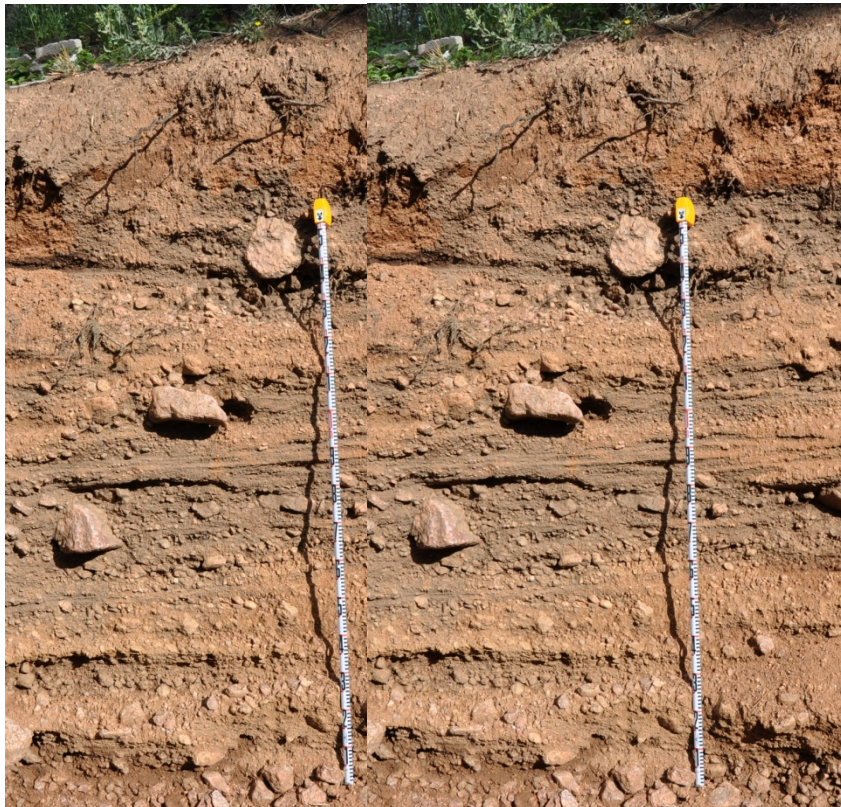
Figure 3.4.10. Exposure of Cascade alluvial fan stratigraphy. Top: view looking northwest; red-cyan anaglyph made with StereoPhotoMaker v. 4.41. Bottom: pair of photos arranged for

stereoscopic viewing. Ruler is 1.57 m long. Note brighter red-brown color above the top of the ruler (Bw soil horizon). View from 38.8971° N, -104.9699° W, approximate elevation 7405 ft.

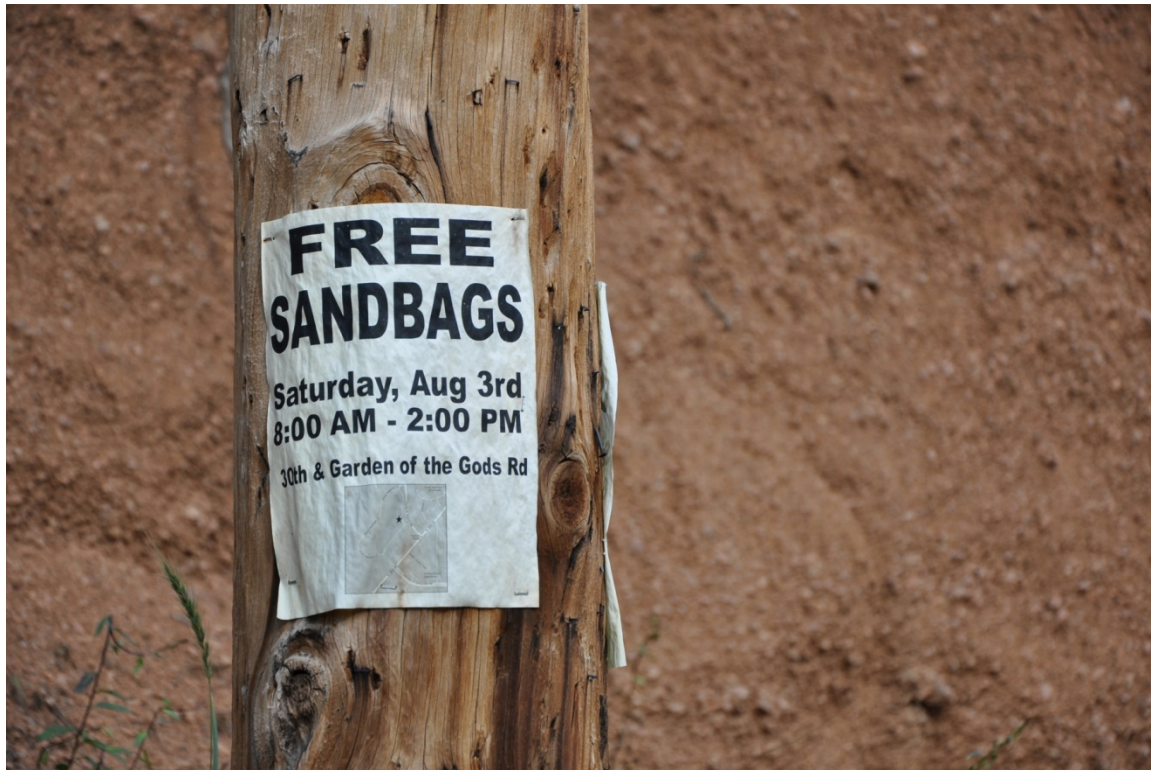
Figure 3.4.12. “Free sandbags” poster stapled to a utility pole on Pyramid Mountain Road near US 24. Granite sand exposed behind utility pole is in a road cut in alluvial and colluvial deposits. View looking south from 38.9053° N, -104.9694° W, approximate elevation 7505 ft.

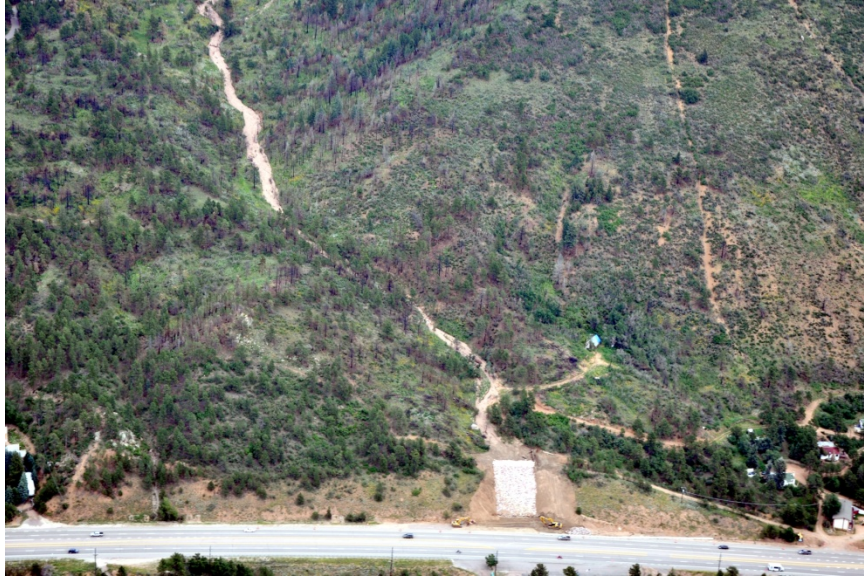
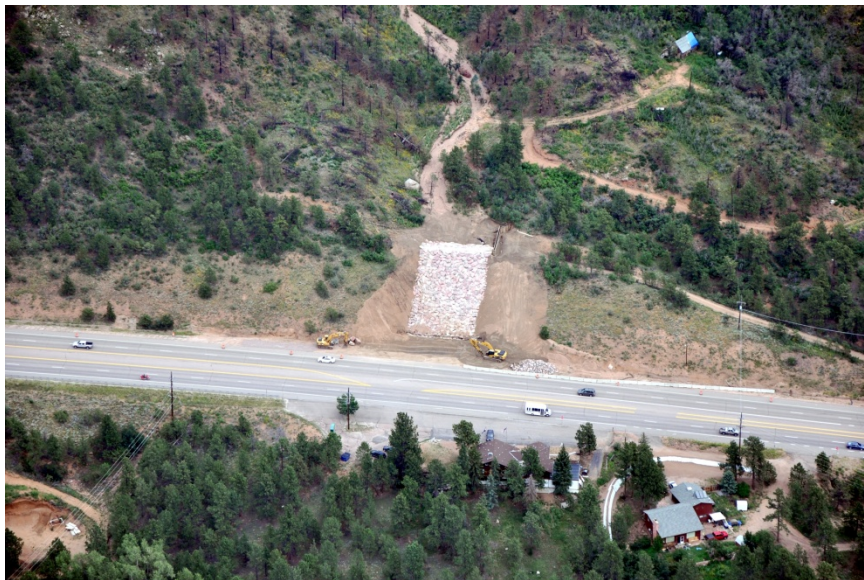
Figure 3.4.13. Aerial oblique views of the mouth of Unnamed Creek 6 located about 1.5 miles northwest of Cascade. Inclined rectangle is a partially grouted riprap panel that was under construction at the time of the GEER reconnaissance (August 17, 2013). The toe of the riprap is located at 38.9123° N, -104.9769° W, approximate elevation 7552 ft.

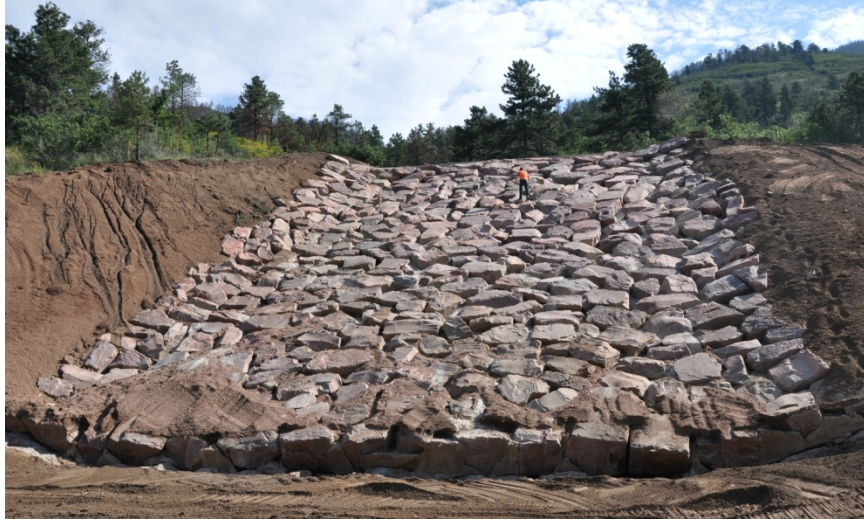
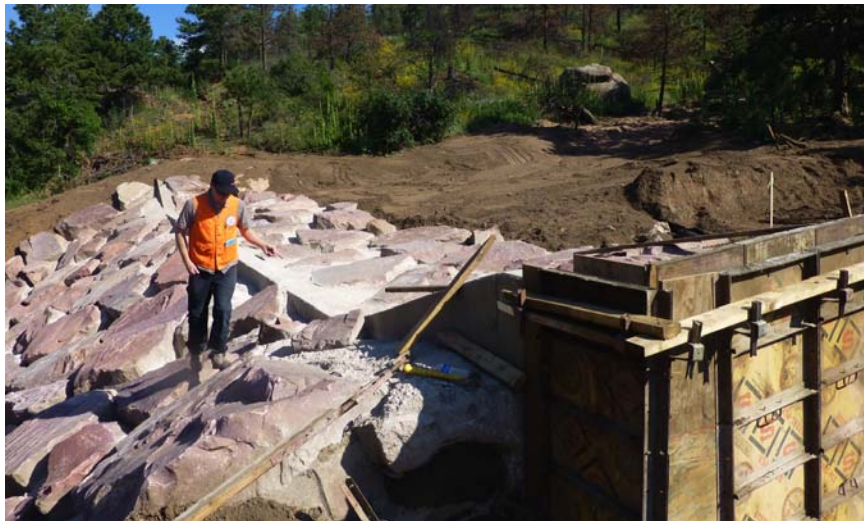
At the time of the GEER reconnaissance visit, two pieces of construction equipment were parked at the toe of the slope and a partially grouted riprap spillway was nearly completed (Figure 3.4.14). The riprap slope serves as a spillway for local drainage from Unnamed Creek 6. The riprap was grouted in a manner that holds the rock blocks together while allowing free drainage; geofabric was used to prevent migration of soil particles from the foundation into the large voids within the riprap (Figure 3.4.15). This structure is intended to pass water flow while controlling the grade line of the channel. Since the road cut created an over-steepened section, aggressive erosion must have been a persistent problem.

Figure 3.4.14. Partially grouted riprap spillway west of Cascade on US 24. Top: view looking northeast from the shoulder of US 24; camera position was 38.9123° N, -104.9769° W, approximate elevation 7552 ft. Bottom: view looking north from the crest of the riprap spillway; camera position was 38.9125° N, -104.9766° W, approximate elevation 7592 ft. Individual rock blocks are approximately 1 m across; note minimal freeboard between the top of the spillway in the center of the photograph and the natural drainage channel to the right.

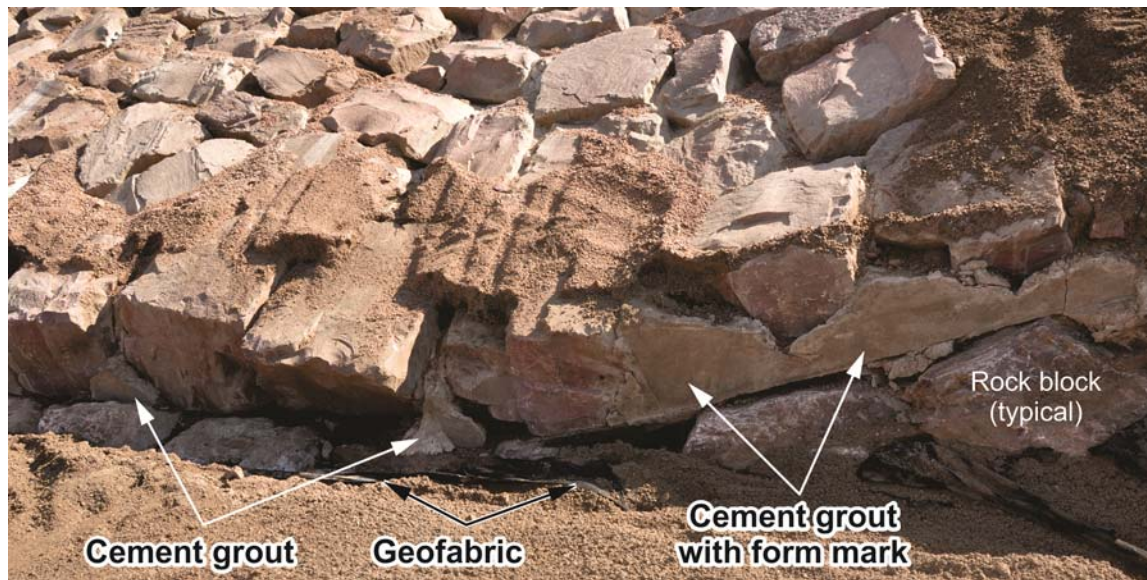
Figure 3.4.15. Detailed view of partially grouted riprap. View looking northeast from the toe of the riprap spillway; geofabric and cement grout are indicated with annotations. The purpose of partial grouting is to hold the durable rock blocks together while allowing unrestricted drainage of subsurface water. Camera position was approximately 38.9123° N, -104.9769° W, elevation 7552 ft.

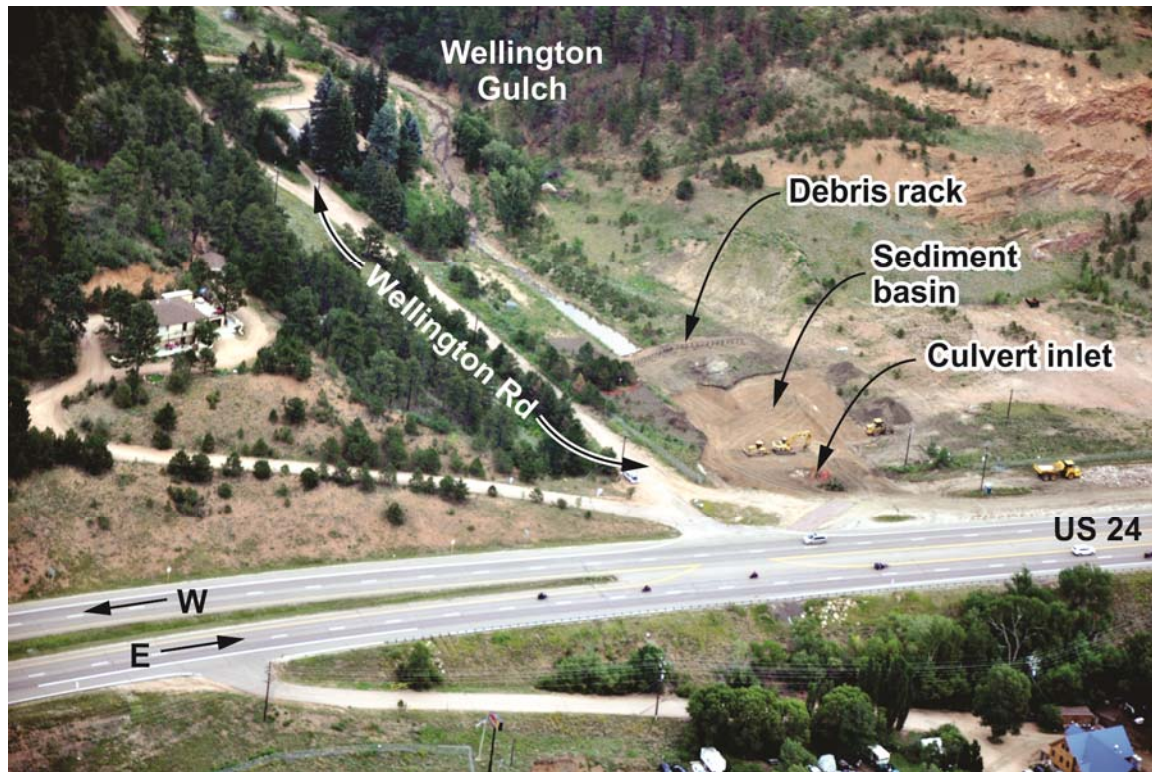
Figure 3.4.16. Oblique aerial view of the mouth of Wellington Gulch showing position of a sediment basin and a debris rack. View to the east; location of intersection of Wellington Road and westbound US 24: 38.9185° N, -104.9843° W, approximate elevation 7590 ft.
