**GEOTECHNICAL EFFECTS OF  
INTENSE PRECIPITATION ON AUGUST 9, 2013, ON  
SLOPES ABOVE MANITOU SPRINGS, COLORADO,  
THAT WERE BURNED IN THE  
2012 WALDO CANYON FIRE**

Geotechnical Extreme Events Reconnaissance (GEER) Association  
Reconnaissance Dates: August 16 to 18, 2013

Jeffrey Keaton, AMEC Americas (Team Leader)  
Scott Anderson, Federal Highway Administration  
Paul Santi, Colorado School of Mines  
Shideh Dashti, University of Colorado, Boulder

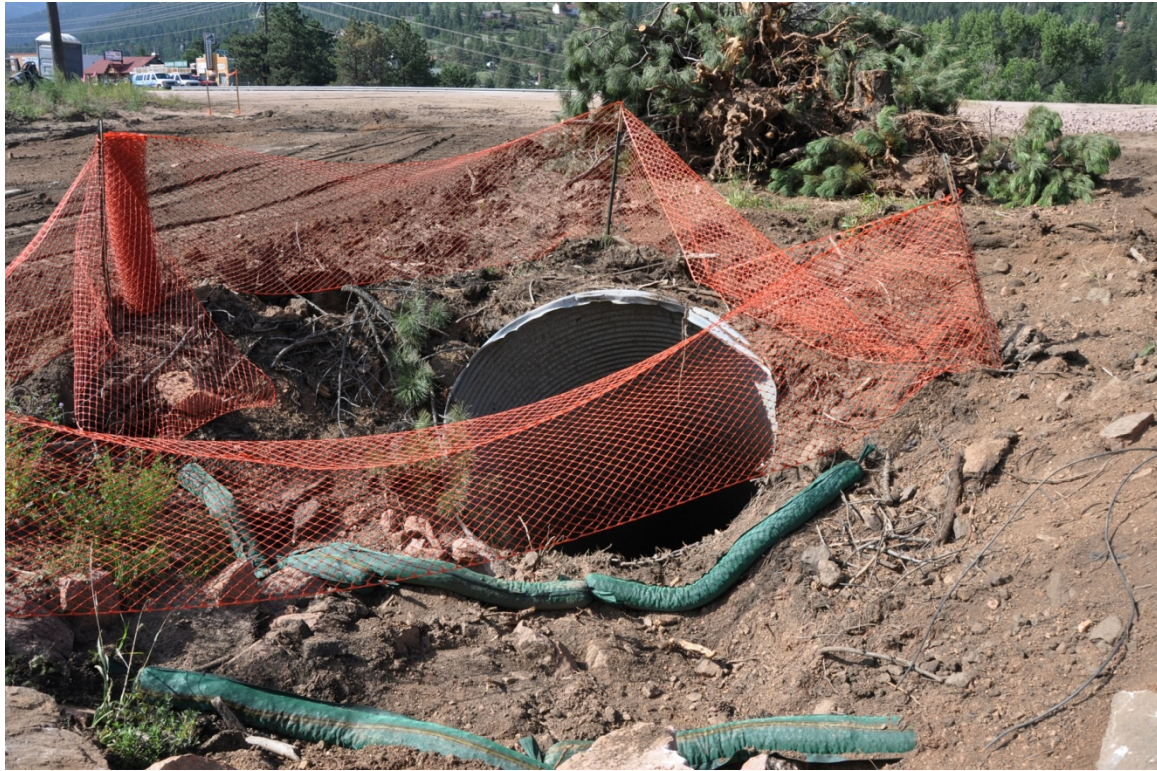
Figure 3.4.19. Inlet to existing corrugated metal pipe culvert at Wellington Gulch. View toward the southwest at US 24 from 38.9185° N, -104.9838° W, approximate elevation 7597 ft.

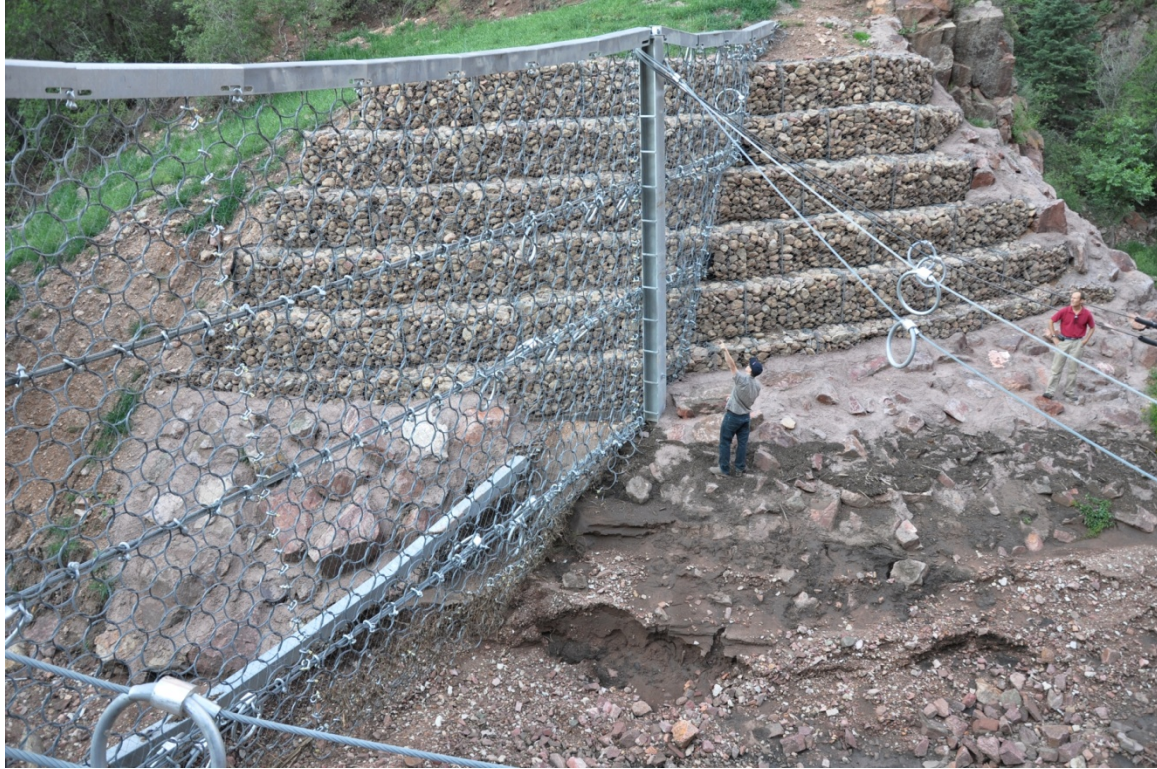
Figure 3.4.21. Ring-net debris fence in Queens Canyon above Glen Eyrie conference center.

View to the south from  $38.8938^{\circ}$  N,  $-104.8873^{\circ}$  W, approximate elevation 6569 ft.
