Preliminary Report on Engineering and Geological Effects of the July 2019 Ridgecrest Earthquake Sequence

A report of the NSF-Sponsored Geotechnical Extreme Event Reconnaissance Association

Report GEER-064

July 19 2019

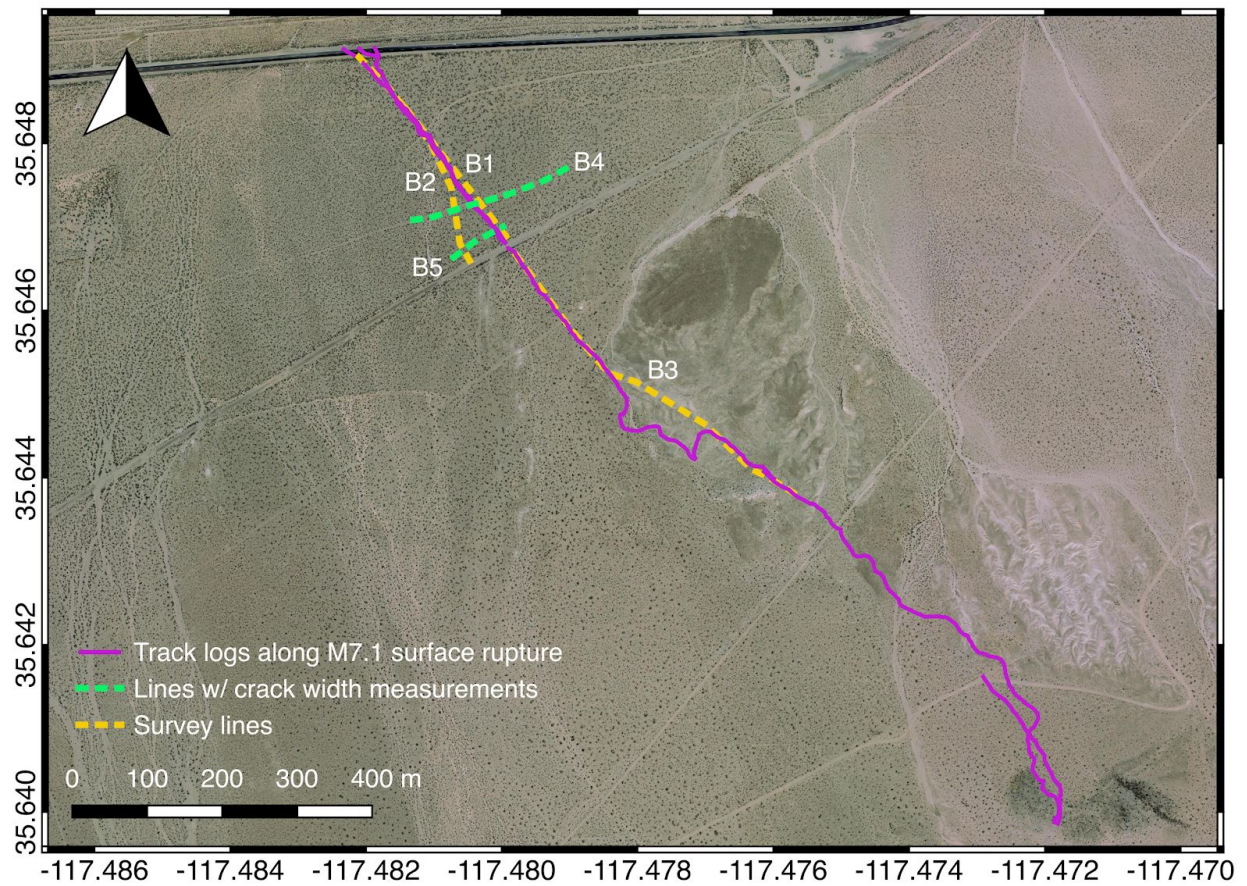
For the fault trace from the **M7.1** event, one team focused on documenting the two main strands of the fault from Highway 178 to the first dirt service road (B1 to the East and B2 to the West, Figure 19). At the north end near Highway 178, the strands mostly coincide. In between, they gradually converge. Figure 20 shows where the zone is 3 m wide, about a third of the way south of Highway 178 towards the service road. The strands diverge towards the service road, creating a localized extensional graben that is 60 m wide along line B5. The ground in the extension zone is about 40 cm lower relative to the zones outside of the fault strands. Line B1 followed the main eastern strand starting at Highway 178 and extending in a SW-direction for 1150 ft (350 m). Generally, longitudinal cracks appeared in the stiff upper crust of the arid alluvial soil, with openings ranging from a few mm to 50 cm right at the surface. Lateral offsets in that area are marginal and vertical offsets were observed up to 16 in (40 cm) in some locations (Figure 21). At one particular location where the rupture crossed a dirt road south of Highway 178, a graben-like feature of distributed shear was encountered, having a zone of cracking nearly 16 ft (4.9 m) in width. In addition, transects B4 and B5 were followed to capture the full fault zone width. We bound the transect end-points by walking several meters past the point shown on Figure 22 to make sure no cracks were visible beyond those points. On these transects, we took continuous and overlapping pictures of the fault zone following a measuring tape on the ground. The crack location and width data is to be quantified in the lab.

Figure 19. Fault trace mapping at location of the surface rupture from the **M7.1** event just south of Highway 178.

The GEER team also recorded track logs along surface fault rupture traces using the “GPS Tracks” app. The track logs are shown in purple in Figure 19. These tracks generally follow the fault rupture zone, but they do not delineate individual ground cracks. The ground cracks were generally observed to be parallel to the track logs over much of the fault trace, though ground cracks transitioned to lie at approximately 45° angles from the fault strike toward the southeastern limit of the track.

Line B1 and the purple tracks shown on Figure 19 were mapped on July 6. Lines B2 and B5 were captured on July 7. Line B3 and B4 were documented on July 11. Line B4 outside of the main strands was not damaged by trampling and its intersection with features documented in lines B1 and B2 allows us to anchor the fault zone location.

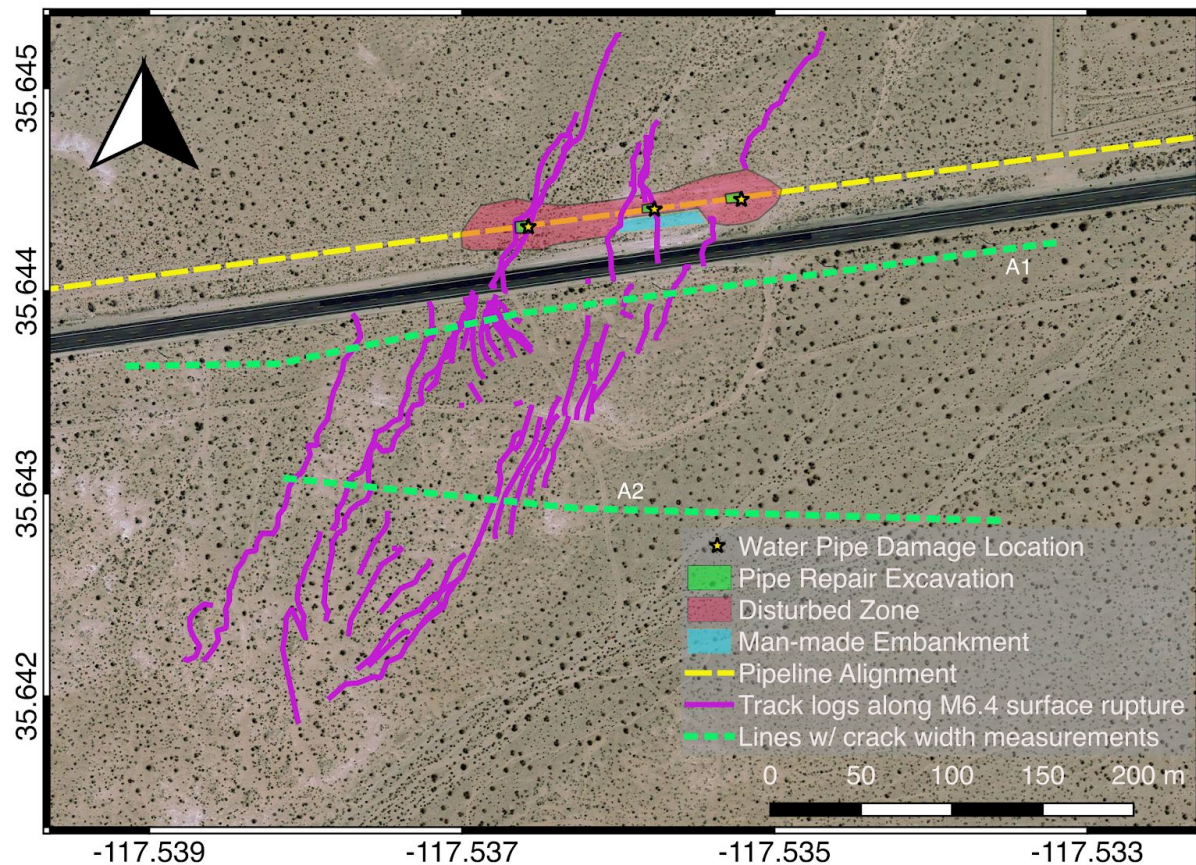
The process for performing detailed mapping along the **M6.4** fault was similar to that described for the **M7.1** trace. The study area extended from Highway 178 to approximately 300 m to the south. In that area, the fault zone appeared more diffuse than for the **M7.1** fault, so detailed

crack measurements along continuous longitudinal lines were not performed. Transects A1 and A2 were documented in detail so as to constrain the fault zone width, using continuous and overlapping pictures of the cracks along the extended measuring tape. As for the **M7.1** fault, the limits of the transects were defined by the teams walking further SE and NW until no more deformations were visible. Two teams measured crack widths and documented their locations along transects A1 and A2 just south of Highway 178. Another team tracked continuous cracks using the “GPS Tracks” app as described above (purple lines on Figure 23). A separate track log was recorded for each surface rupture splay by starting the track log, walking along the surface rupture a distance of a few hundred meters on either side of Highway 178, then terminating the track log. This process was repeated for surface rupture splays over a width of a few hundred meters. We walked in a direction perpendicular to the fault strike about a hundred meters further in both the NW and SE directions, and did not encounter additional ground cracks. The surface rupture extended further toward the northeast and toward the southwest as this mapping effort focused on the region near Highway 178, and was conducted in parallel with an effort by other GEER team members to map the crack widths along transects perpendicular to the fault strike. The followed tracks are shown in purple in Figure 19. The purple lines do not represent all of the ground cracks, but the most obvious continuous ones. Additional cracks were observed along A1 and A2, which were documented on July 7.

Figure 23. Fault trace mapping at location where surface rupture for **M6.4** event crosses Highway 178. Map traces available in DesignSafe at Community Data / Main / Recon Portal / 2019 Ridgecrest, CA Earthquake / GEER Resources.

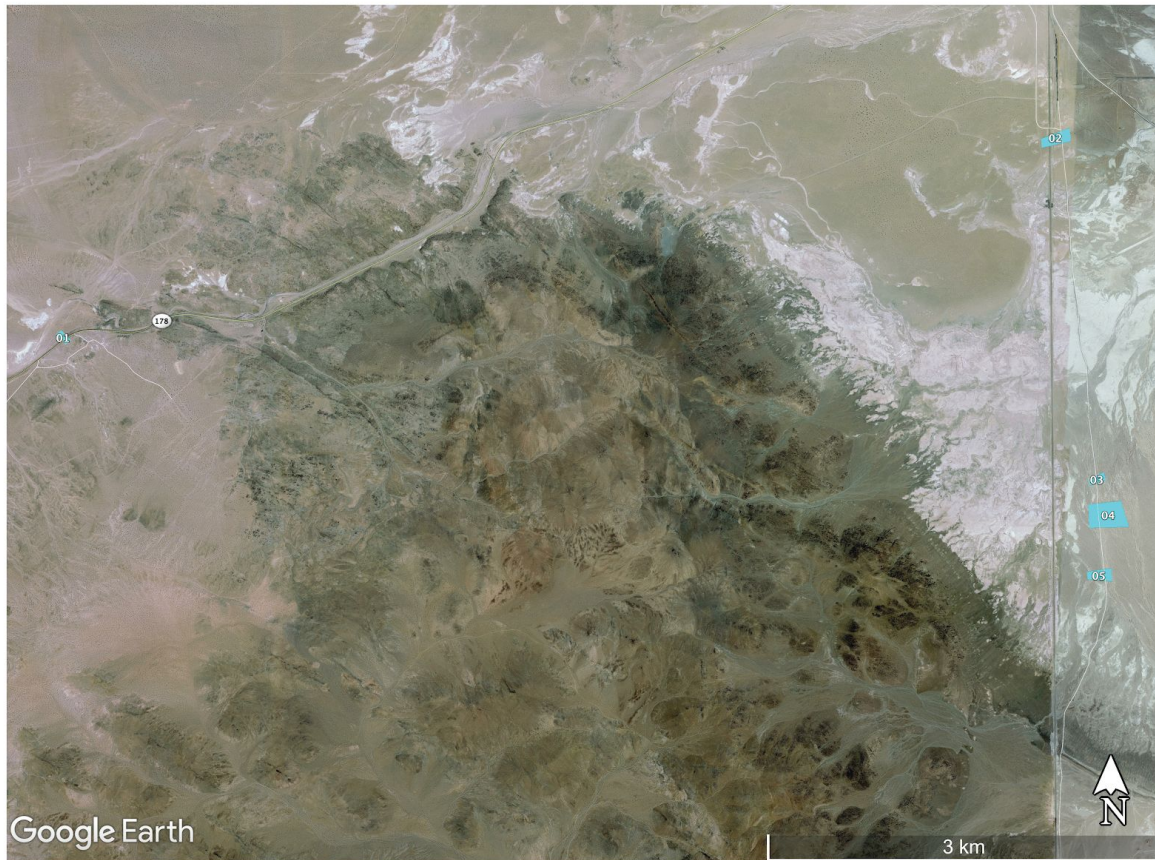
We have documented additional ground deformations that appear to be fault strands located away from the main ruptures from the **M6.4** and **M7.1** events. These areas are shown on Figure 24. We have shared the location of those features with several groups, including the USGS and SCEC, so that future reconnaissance and remote sensing teams can add them to their investigation region.

The first displacement area (01 in Figure 24) was observed East of the **M7.1** rupture and contained cracks parallel to the main rupture. The cracks appeared on Highway 178 following the **M7.1** (they were not observed right after the **M6.4** event), crossing it perpendicularly. The cracks were not continuous and we were only able to observe them up to roughly 50 m away from the road, on the north and south side. The observed cracks were fairly narrow and concentrated in a narrow area as well. The site was visited on July 7 and 11.

The other three zones of cracks were found crossing the Pinnacles Road, the dirt road leading to the Trona Pinnacles National Natural Landmark. These observations were made on July 12. The four areas showed persistent cracks generally trending from E to ENE to NE and were interspersed with variably trending set of secondary cracks (example on Figure 25). It is possible that some of the observed ground failure be due to lateral spreading, however, we have not observed any sand boil or moisture in the cracked areas. The cracks were followed on the east and west sides of the road for about 60 m to 120 m on each side.

Figure 24. Map showing the different zones exhibiting cracks (numbered cyan polygons).

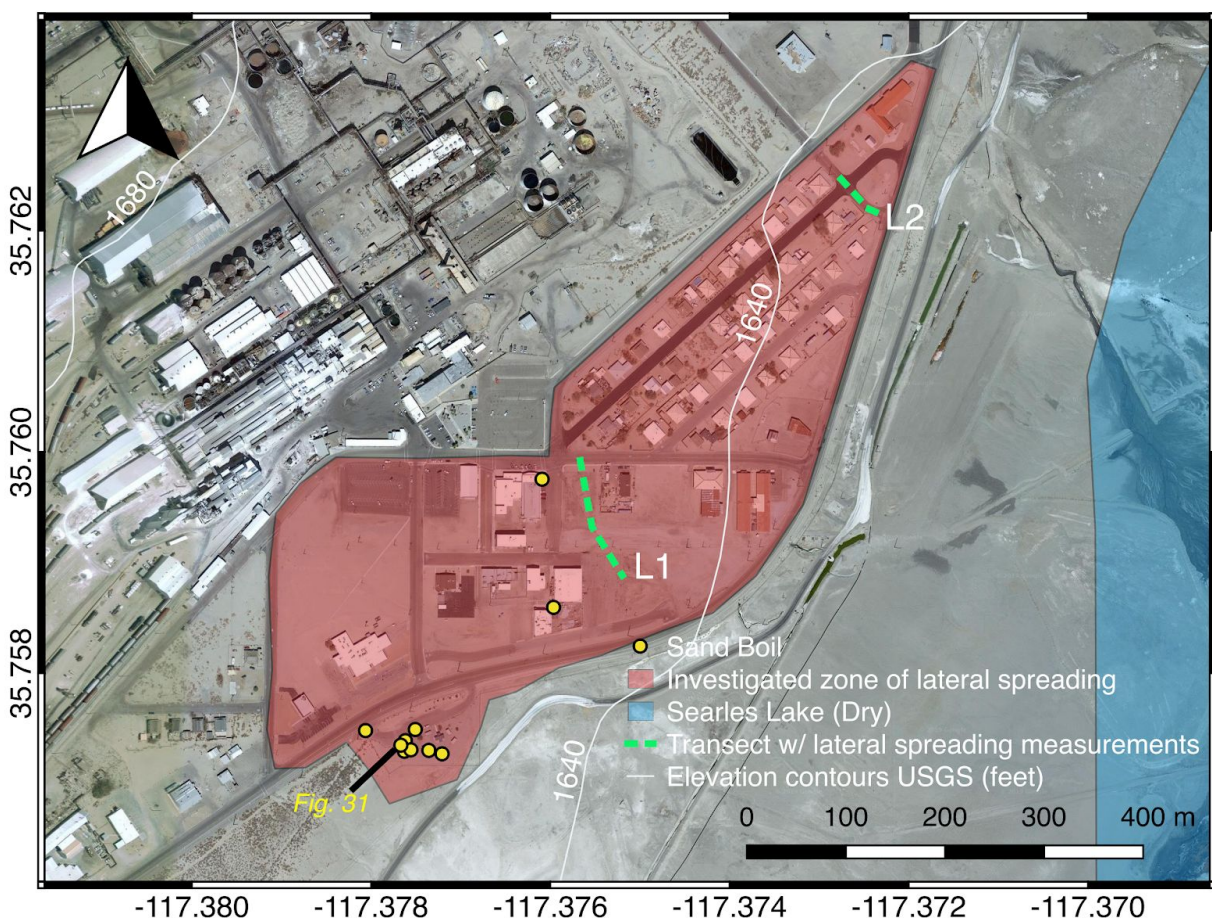
Figure 30 highlights the region of Trona investigated by the GEER team. Liquefaction features were apparent throughout this region. Yellow markers indicate regions where the team photographed sand boils (e.g., Figure 31). The team did not perform an exhaustive survey of all sand boils in Trona, and it is therefore possible that sand boils existed in additional areas. Sand boils were encountered along the southern margin of Trona near the northern margin of Searles Lake. The GEER team could not access Searles Lake near Trona because it was protected by a chain link fence with barbed wire at the top. Ground cracks caused by extensional strain due to lateral spreading were apparent near the sand boils, and throughout the region investigated by the GEER team. The orientation of the extensional cracks was highly variable. Many cracks trended toward the northeast, parallel to the lake perimeter, but many other cracks were at different angles. We interpret this to indicate that the lateral spreading was predominantly toward the lakebed, but spreading occurred in many other directions as well,

possibly due to the influence of structures on ground displacements, or due to ground lurch. In addition to the extensional ground cracks (Fig. 32), compressional features were also observed in various regions (Fig. 33), as evidenced by buckled concrete curbs, and regions where the asphalt pavement cracked and rode up over adjacent pavement. Structures appear to have been affected by the lateral spreading, including the restaurant shown in Fig. 34, which experiences wall cracks in the **M6.4** event that were widened in the **M7.1** event. It is possible that many cracks pre-dated the earthquake sequence, and were subsequently widened by the earthquake. Considering the complicated deformation patterns and possibility of pre-earthquake cracks, we suggest that future remote sensing surveys may be valuable at this site.

Figure 30. Map of Trona showing region investigated by the GEER team, along with selected sand boils that were photographed by the team. Lateral spreading features, including tensile cracks and compressional features, were observed throughout the investigated zone.

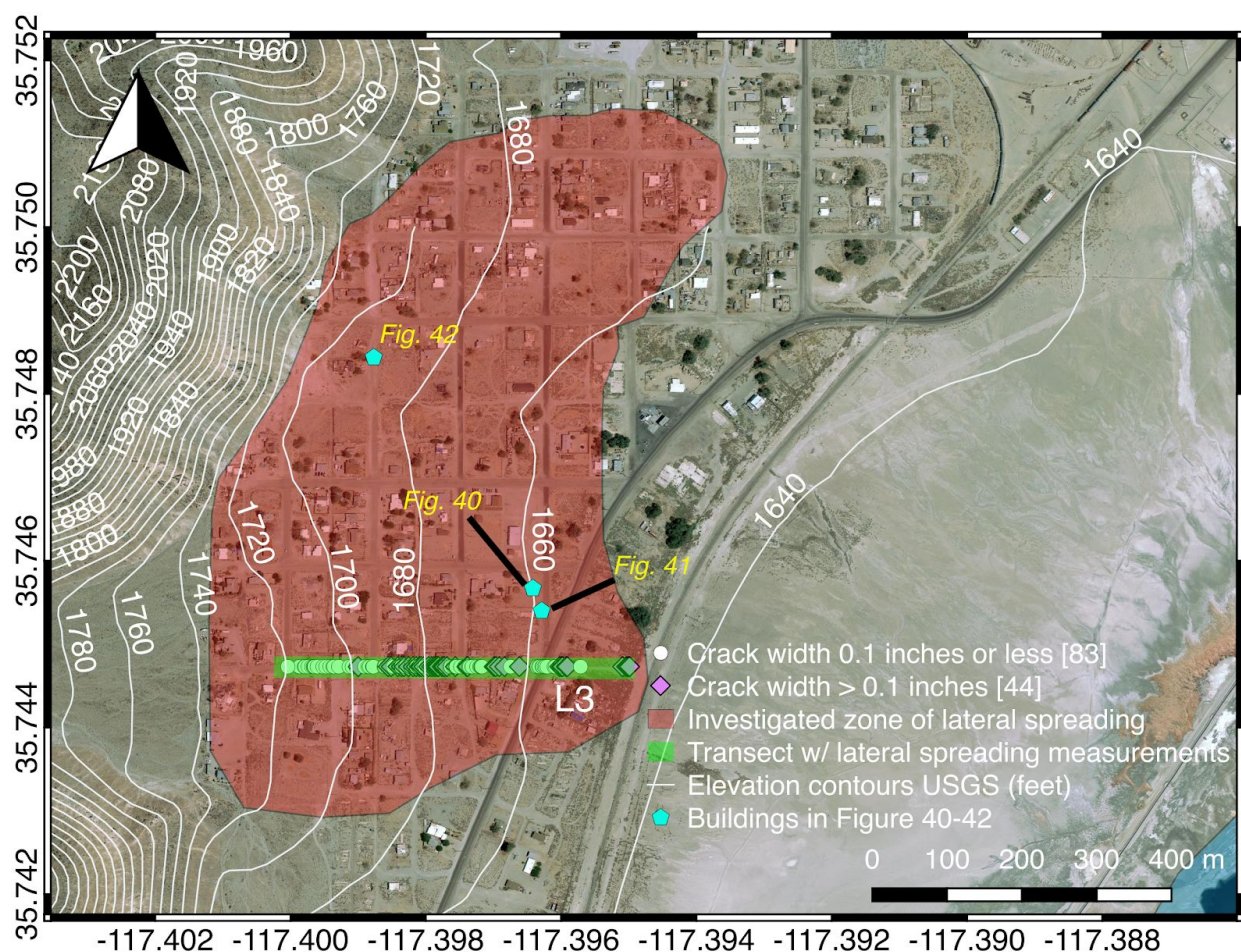
Figure 35 displays the areas of Argus surveyed by the GEER team. Similarly to Trona, many liquefaction related features were observed throughout Argus. The ground surface in the area shown as experiencing liquefaction has a gentle slope. The ground surface exhibited

extensional cracks ranging from less than a millimeter to approximately 10 cm in width. The lateral spreading features became less frequent with proximity to the hills to the west of Argus. The lateral spreading features were more pervasive along the axis of a large alluvial fan coming from the ridge to the west. A photo survey was performed along a transect on A Street, approximately along the axis of the alluvial fan as shown in Figure 35. The transect was 1,500 feet long, and the elevation difference (from USGS Topographic Map) ranged from 1640 to 1720 MSL (east to west), indicating an average ground surface slope along the transect of approximately 5%. The extensional features were measured along the transect and the cumulative displacement is shown in Figure 36. The sum of ground cracks measured across the 1500-foot long photo survey was approximately 22 inches.

Figure 35. Map of Argus showing region investigated by the GEER team. Lateral spreading features, including tensile cracks and compressional features, were observed throughout the investigated zone. Lateral spread cracks were measured along a transect on A Street.

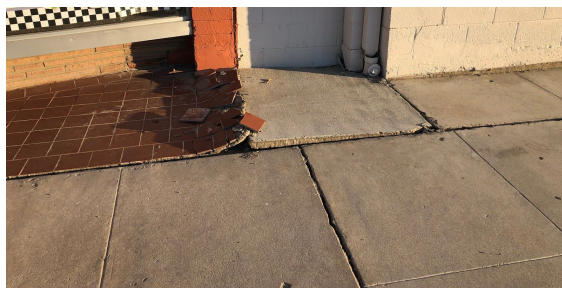
Horizontal and vertical cracks were induced and widened in masonry walls during the **M6.4** and **M7.1** events in Trona (See Figure 48a). These damages were related to possible liquefaction-induced lateral spreading, which also caused damages to pavements (See Figure 48c). Yard walls were displaced in Trona and Ridgecrest resulting in fall over of walls (see Figure 48d). There have been reports of chimney failure in Trona after the **M7.1** event (Figure 48b).

Figure 48. Damages to Masonry components after the M7.1 event (a: 35.7595, -117.7357, b: 35.7592, -117.3766, c: 35.7595, -117.7357, d: 35.6444, -117.6720) Photo credit: Christine Goulet and Jawad Fayaz

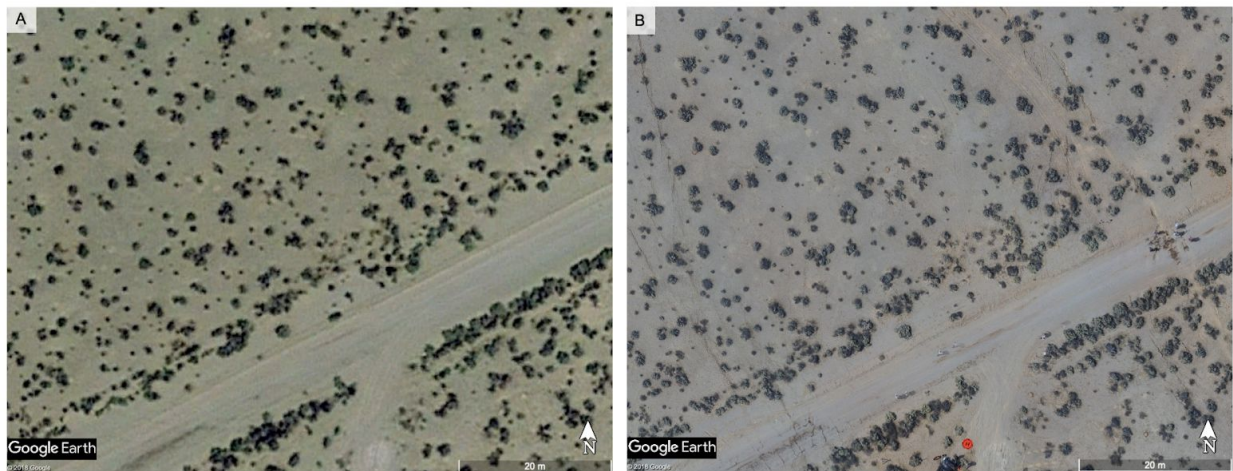
Figure 52. Images showing the detailed mapping area of the **M7.1** rupture near line B5 as shown on Figure 19. A. Basemap image from Google Earth dated 2017/07. B. JPL SfM initial image created on July 10 following their first UAV flight showing the main fault strands as well as the distributed cracks in the rupture zone.

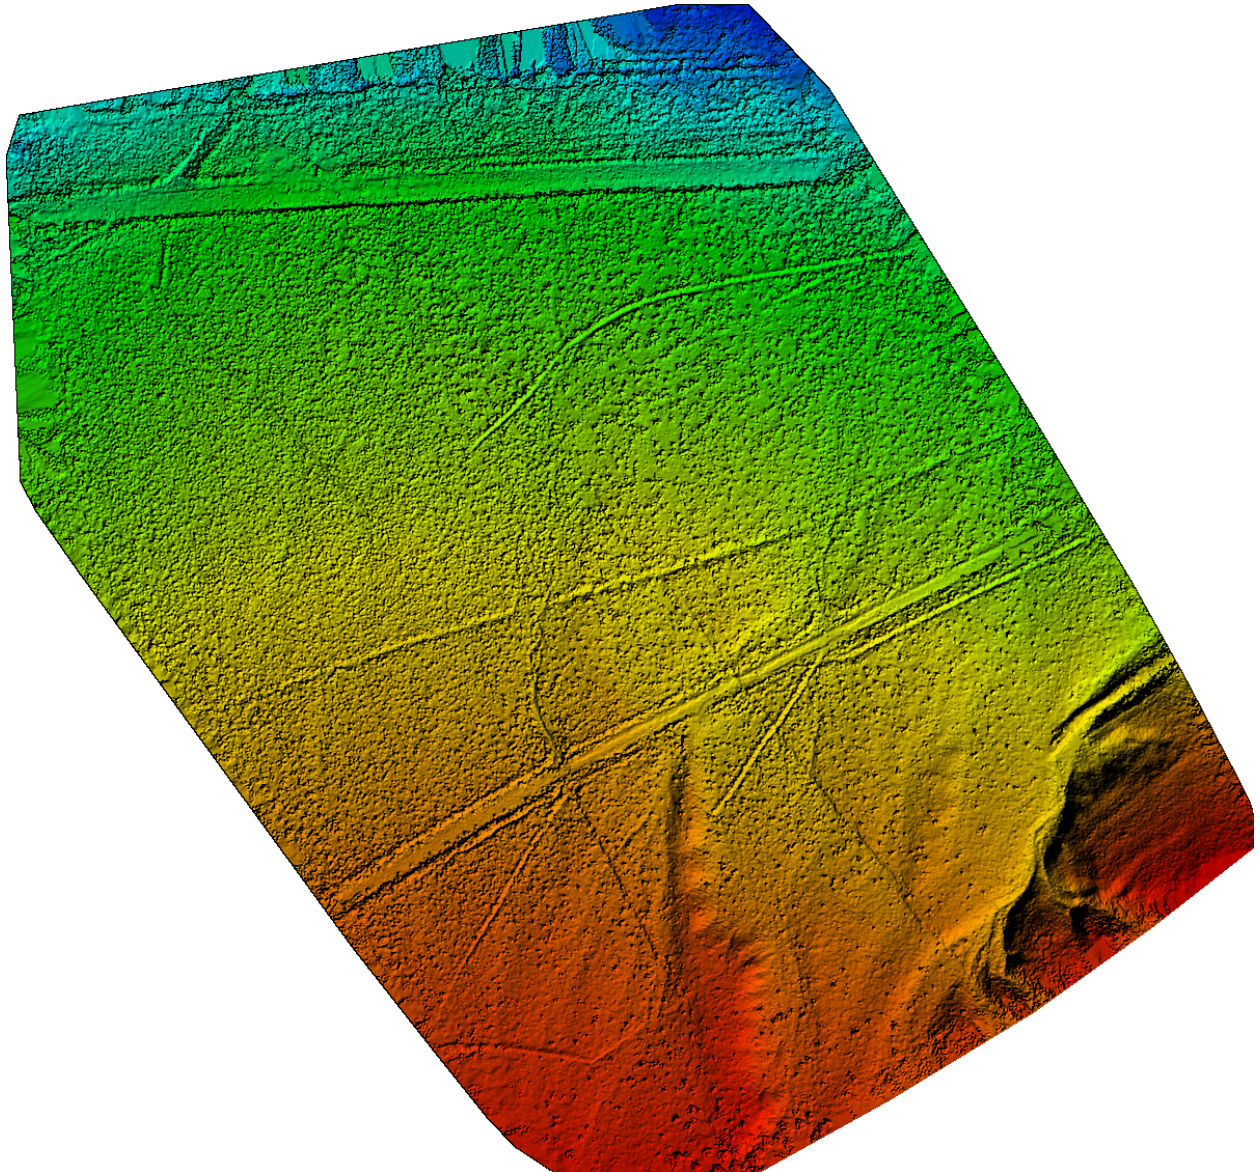
Figure 53. Initial DEM produced by the JPL team for the **M7.1** rupture. The fault scarp is identifiable where it crosses the service road shown on Figure 48B and is more pronounced to the south.

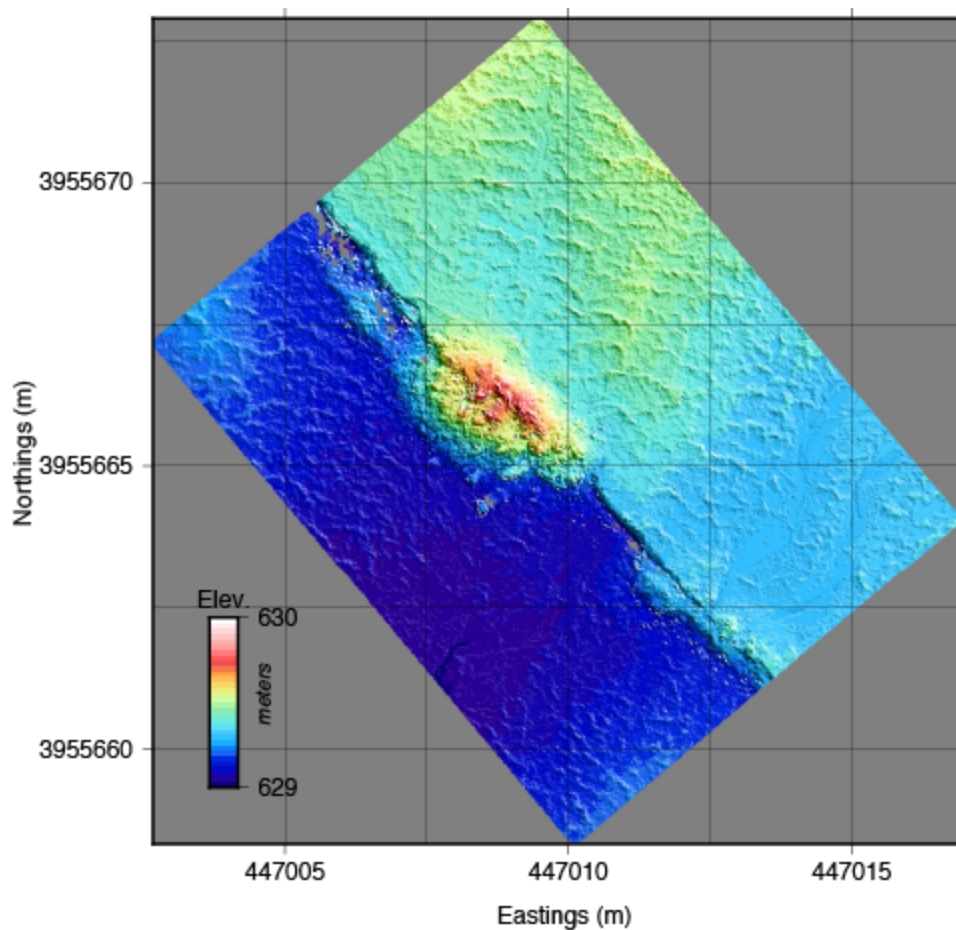
Figure 55. Example of USGS mobile LiDAR digital elevation model (DEM). DEM grid size is 2.5cm. The example shows the principal rupture on China Lake offsetting right-laterally a preexisting sand dune. Additionally the DEM shows vertical relief on the fault scarp on the order of ~25cms.
