GEOTECHNICAL ENGINEERING RECONNAISSANCE OF THE 19 SEPTEMBER 2017 Mw 7.1 PUEBLA-MEXICO CITY EARTHQUAKE

Report No. GEER-055A

16 October, 2017

Geotechnical Engineering Reconnaissance of the 19 September 2017 M_w 7.1 Puebla-Mexico City Earthquake: Version 1.0

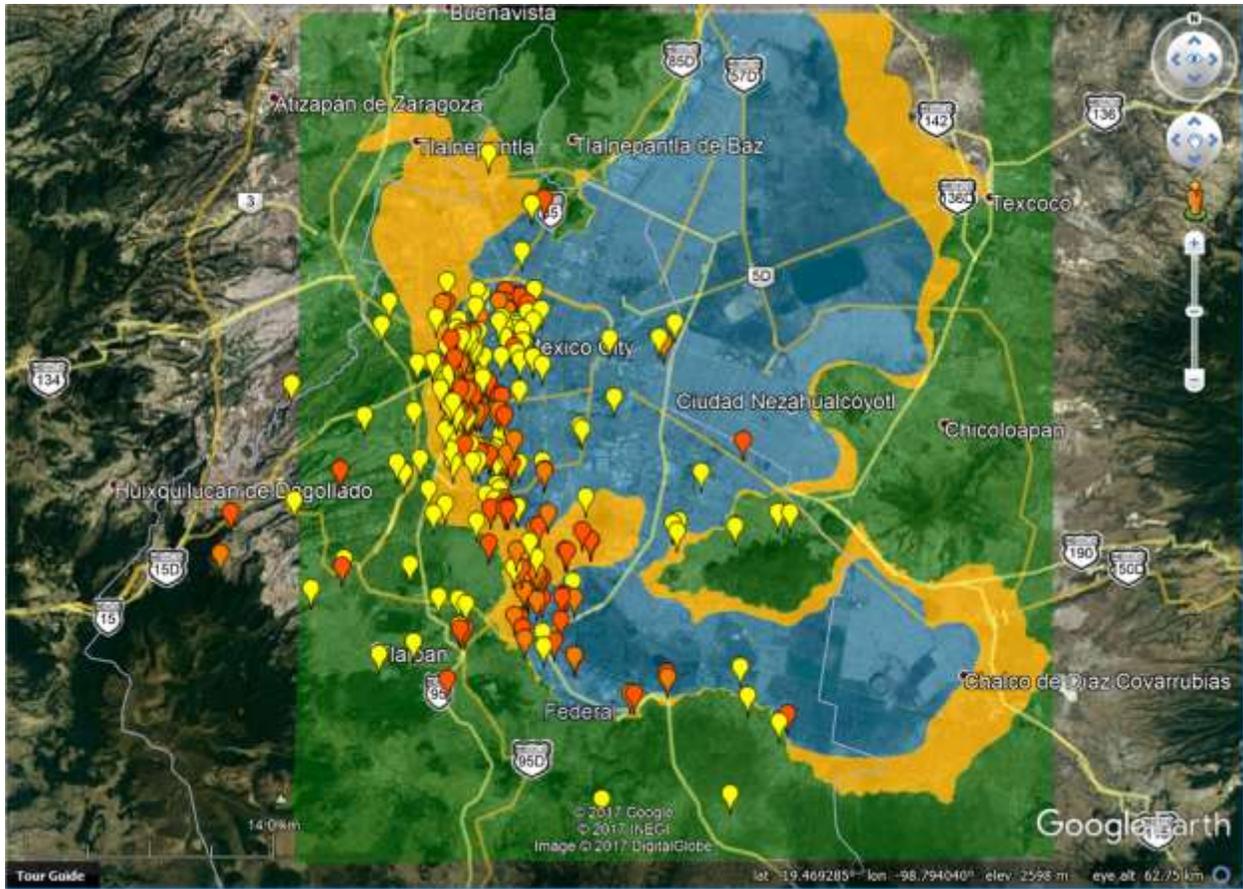
During the September 19th 2017 earthquake, most of the major structural damage in Mexico City was located in the west and southwest Transition (Zone II) and Lake zones, IIIa, and IIIb, as depicted in Figure 16. These zones exhibit 1D predominant periods ranging from 0.8 to 1.5 s according to the map by Arroyo et al. (2013), which accounts for the changes in predominant periods due to regional subsidence effects (Figure 17). This map is slightly different from that included in the Mexico City Seismic Design Code, NTCs. The UNAM-GEER team conducted H/V test at selected locations in the City. These 1D site response periods are expected to be slightly smaller than those reported in 2013, due to its continuous evolution over time. Figure 16 demonstrates that a majority of the notable structural damage is located within a 7 km by 20 km area adjacent to the boundary between Lake Zone (Zone III) sediments (in blue) and stiffer Transition Zone (Zone II) sediments (in yellow) on the western side of the city. The green boundaries in Figure 16 represent stiff/dense Hill Zone (Zone III) sediments and volcanic rocks. Based on the mapped damages and the field observations from the UNAM-GEER team, the neighborhoods of Mexico City that were most severely impacted by site response and structural damage/collapse from the September 19th event appeared to be Cuauhtemoc, Juarez, La Condesa, Roma, Hipodromo, Hipodromo Condesa, Roma Sur, Roma, Col del Valle NTE, Narvarte Poniente, and Col del Valle Centro.

Figure 16. Mapped structural damage and collapse (Google Maps, 2017) combined with mapped soil zones for Mexico City. Green is stiff Zone I (Hill Zone), yellow is Zone II (Transition Zone), and blue is soft Zone III (Lake Zone). Red points indicate structural collapse, yellow and orange points indicate moderate and minor structural damage, respectively.

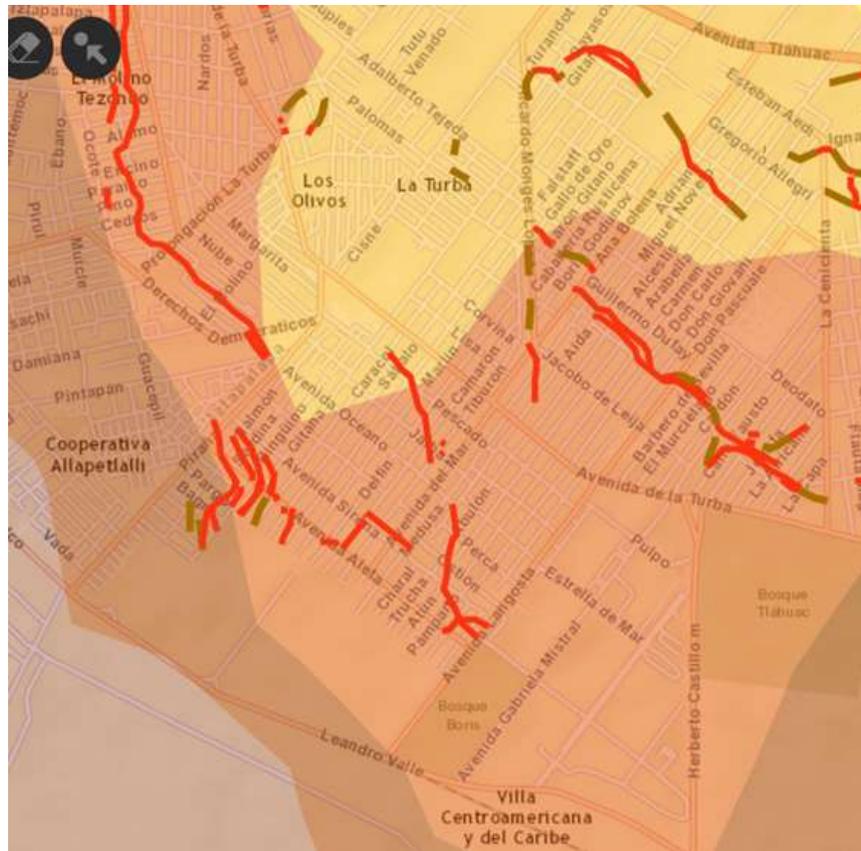
beneath residences, causing many of the structures to tilt. The UNAM-GEER team originally postulated that these bands of settlement may have been caused by buried alluvial stream deposits with varying thickness that may have settled or moved laterally during the earthquake. However, subsequent investigation by team members revealed that numerous cracks from settlement-induced subsidence had been previously mapped throughout that portion of the city (CENEPRED, 2017). The mapped location of the cracks (Figure 26) corresponded well with our observed cracks in Colonia del Mar. While it is clear that the earthquake likely initiated additional settlement and lateral displacement along existing cracks, preliminary assessment suggests that new cracks may have developed. This assessment is currently being refined, and new findings will be reported in Version 2 of this report.

Figure 26. Mapped groundwater subsidence cracks in the Colonia del Mar neighborhood in Tlahuac (after CENAPRED, 2017)

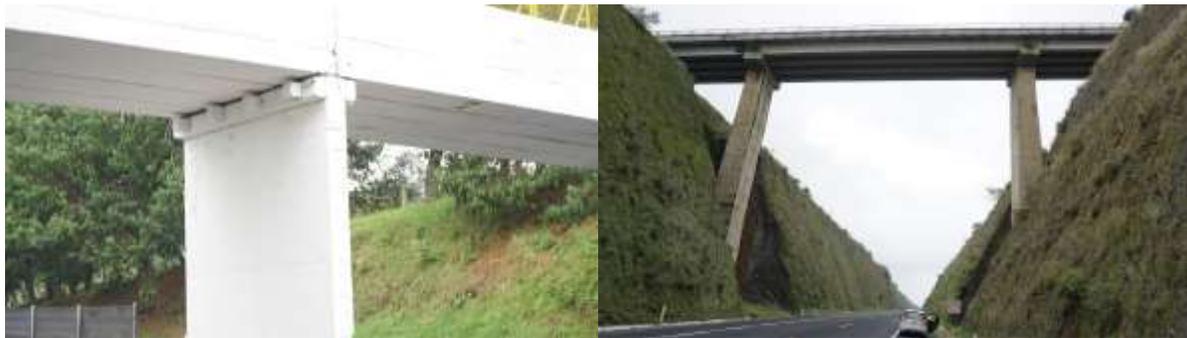
Figure 27. Left: Two span Pedestrian OC across 95D in Coajomulco (19.0323, -99.2057), Right: 3 Span OC across 438D in Santiago Atzitz Huacan (18.8268, -98.6038).

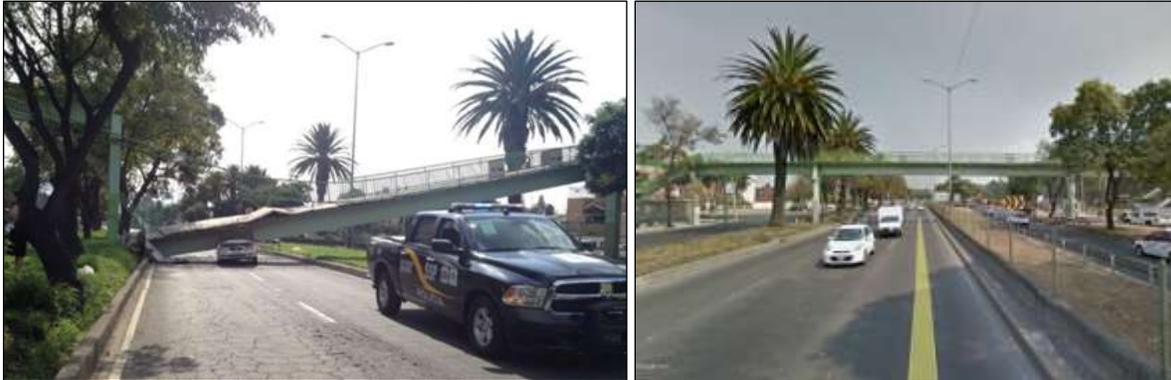
Despite the overall good bridge performance that was observed, some bridge damage and even bridge collapse did occur. A pedestrian overcrossing in Mexico City collapsed during the earthquake, unfortunately falling onto a taxi (Figure 29). In the town of Puente de Ixtla the GEER team drove past a collapsed bridge (18.6122, 99.3182), but were unable to stop. The main UNAM-GEER team was able to collect more information regarding this bridge, which will be presented in the Version 2 report.

Figure 29. Left: Collapsed POC across Blvd. Adolfo Ruiz Cortines (19.2913, -99.1105), Right: POC (taken from Google Earth) shown before the earthquake (19.2913, -99.1105).

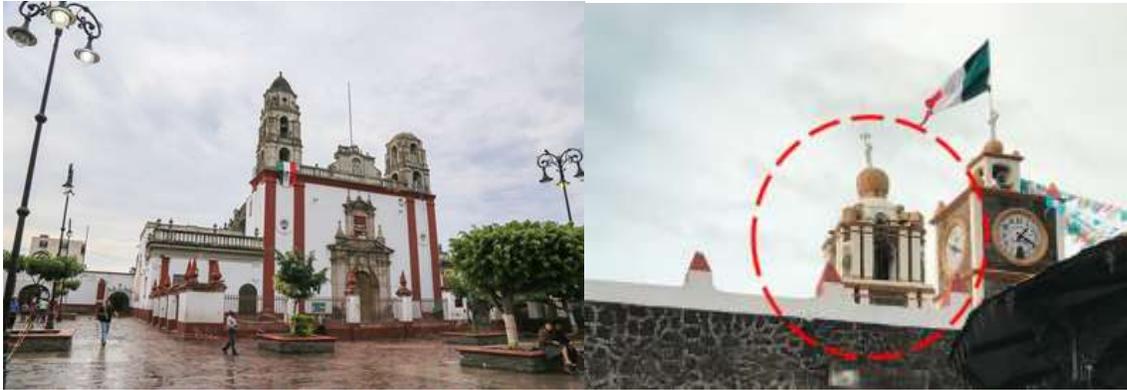
Significant damage was observed in historic church buildings throughout the entire regions visited by the UNAM-GEER team. Many churches lost bell towers, showed cracked facades, severe interior damage, roof (and/or dome) collapse and were closed for further inspection. World Heritage buildings, such as the Cuernavaca Cathedral in the state of Morelos, suffered moderate structural damage, while other churches in the southern region of Morelos suffered significant damage and will require significant repair or demolition. Municipal buildings with similar architectural features (e.g. free-standing facades with towers, etc.) showed similar damage patterns. Many historical buildings were adobe construction, with limited to no reinforcing elements. Figures 35 through 38 show several examples of damage to churches and municipal buildings observed by the team.

Figure 37. Left: Collapsed Church tower in Cuautla (18.8125, -98.9542), right: Crack on bell tower of church in Juitepec (19.0285, -99.2675)

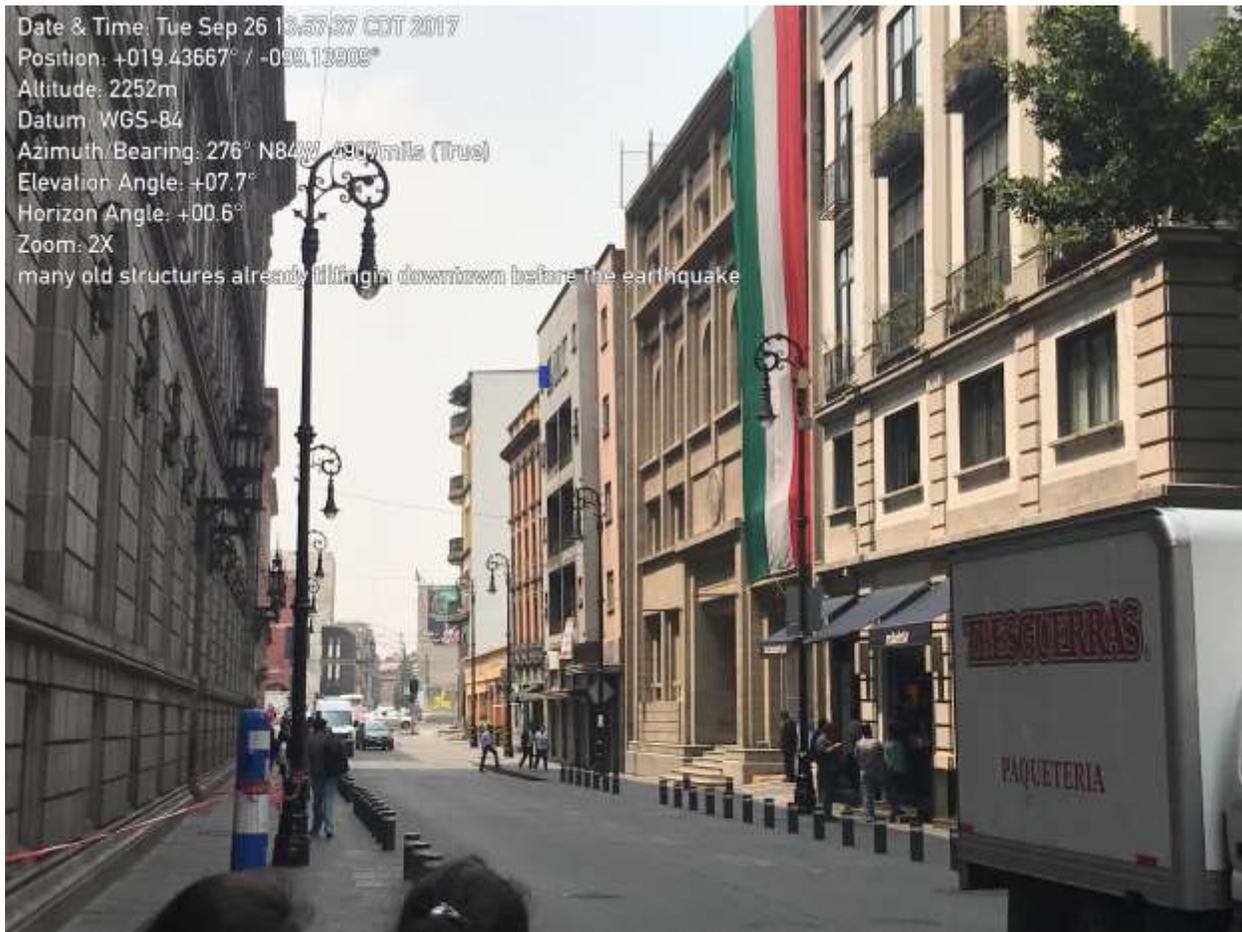
Figure 40. Common example of the type of structural tilting that is prevalent in the historic district in Mexico City; local residents confirm that these structures were already tilting prior to the 2017 event

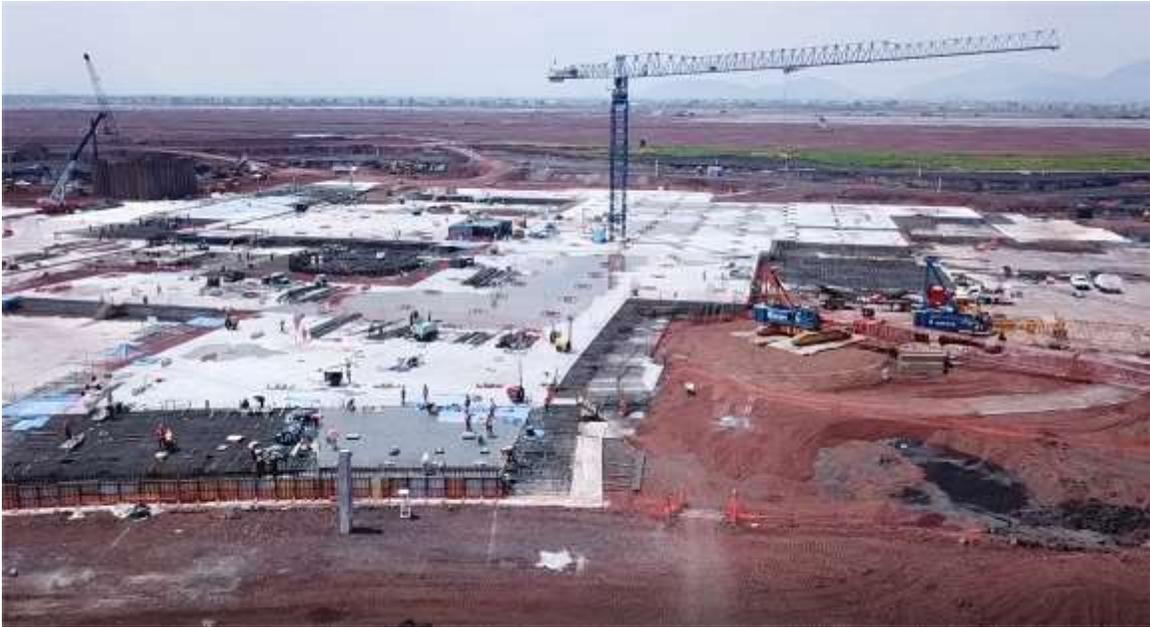
At the time of the UNAM-GEER team site visit at NAICM, the reinforced concrete slab for the main terminal was being constructed (Figure 42). This area is only illustrative, the actual size of the NAICM site is much larger than the one shown in Figure 42. The slab consists of 1.6 meter thick concrete heavily reinforced with #12 high strength steel rebar. The slab had already settled 8 cm at its center, causing it to pond water from the rain the night before the team visit (see the visible water on the slab in Figure 42). According to the designer ARUP, the terminal building raft is built in 20x20m segments. Each of the segments suffers an undrained settlement of about 60 to 80mm at its center and 30-40mm at the edges. The first segment of the raft was built where the crane is, which is actually a bit higher than the areas where water is ponded. According to current surveys there is a maximum differential elevation of about 100mm between the highest and the lowest point of the 30,000m² of raft already built. Full area of the terminal building raft is about 320,000m². We observed that many of the piles located around the perimeter of the site were bent out of plum, as shown in Figure 43. The site foreman informed us that these piles were out already tilted before the earthquake, but the earthquake made them worse.

Figure 42. UAV image of the NAICM terminal construction site at the time of the UNAM-GEER team site visit (19.5052, -98.9967)

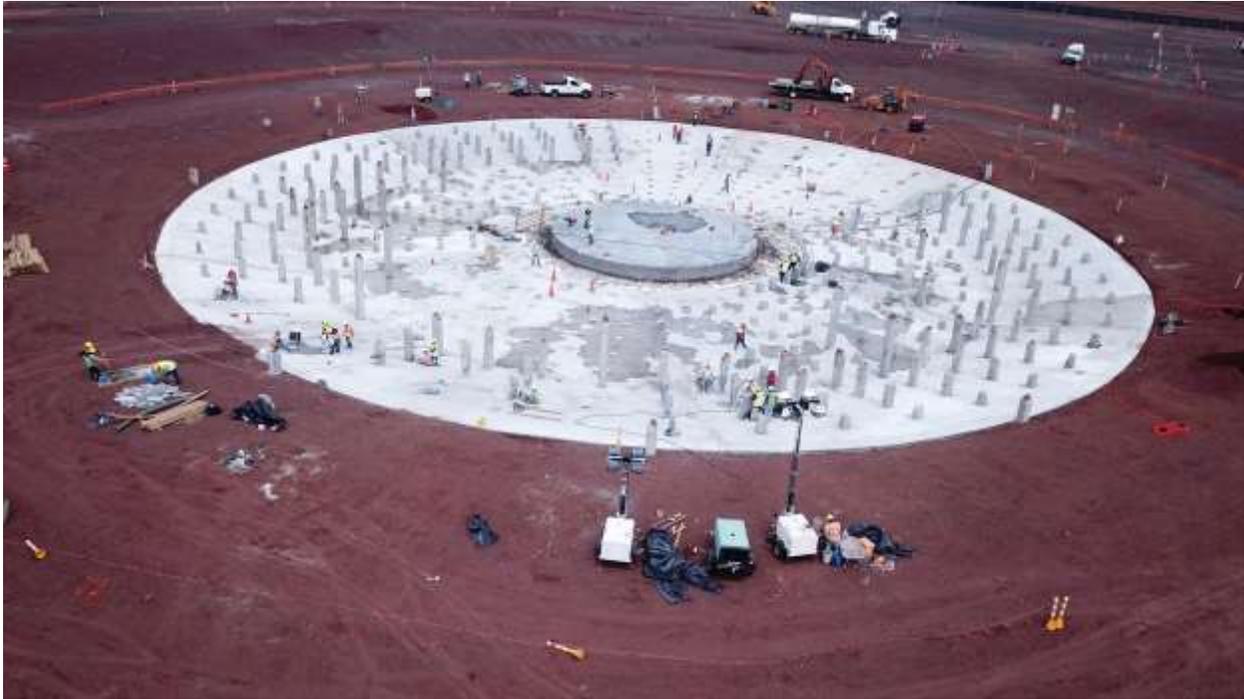
The final part of the NAICM construction project that was visited by the UNAM-GEER advance team was the construction site for the new control tower. At the time of the team visit, the foundation was under construction, and no superstructure was yet in place. The foundation design consisted of 480 friction piles connected to 1m thick circular raft foundation. The system will eventually support the base-isolated control tower for the NAICM. An aerial image of the control foundation tower being constructed is presented in Figure 45.

Figure 45. UAV image of the construction of the new control tower foundation at NAICM (19.5223, -98.9971)

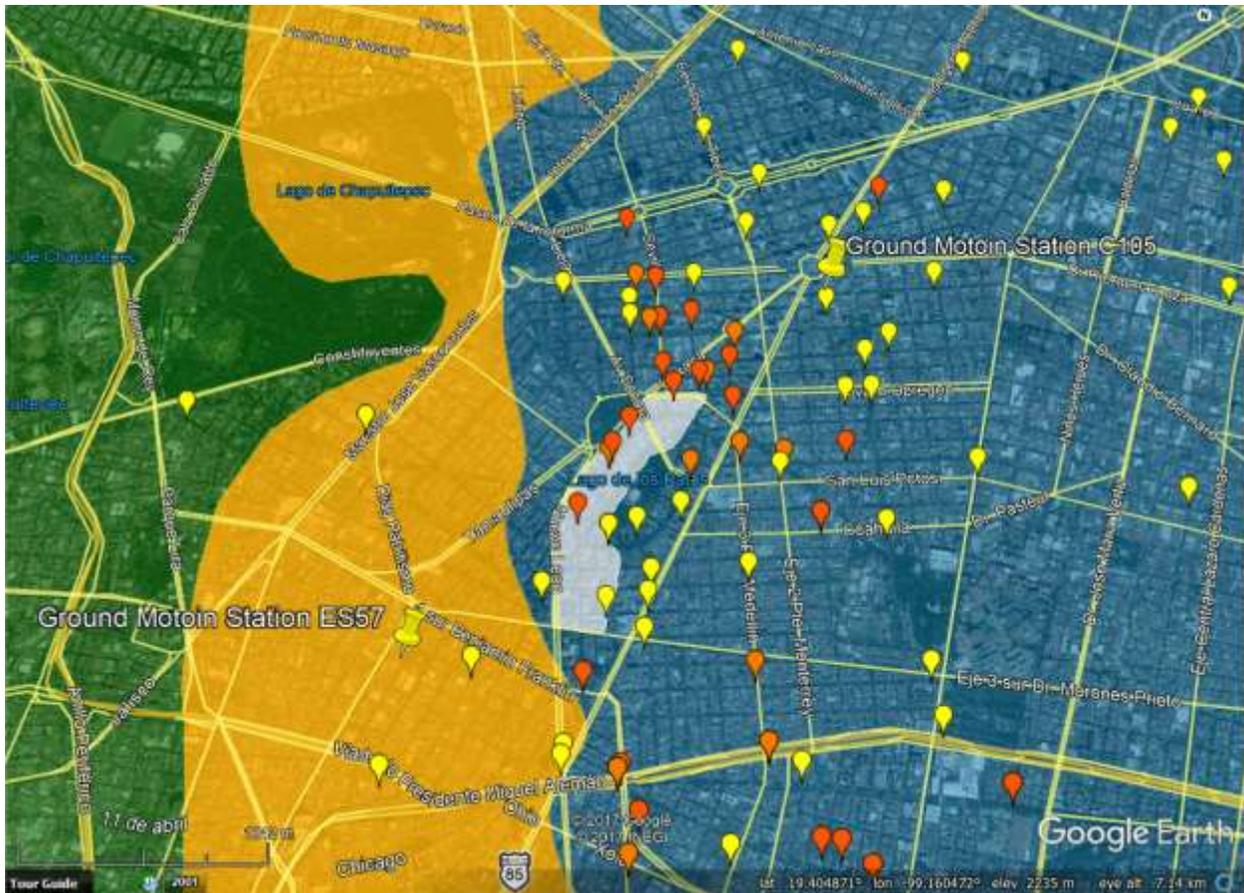
Description of Damage: Damage ranged from minor cracking in the exterior masonry to total collapse. Several multi-story buildings were tilting between one to three degrees, and numerous buildings were observed to be resting on the adjacent building. Several gas line breaks were reported in the area, but the gas supply had apparently been shut off to the affected area prior to our team's arrival.

Figure A2. Delineated zone of preliminary UAV flight in La Condesa and Hipódromo; note the relatively high number of collapsed and damaged structures from Google Maps (2017) to the north of the preliminary UAV flight area, as well as the CIRES ground motion station C105

Follow up/Interest: This area in many ways comprises the heart of the structural damage from this earthquake. More structures were damaged in these neighborhoods than in any other neighborhood in Mexico City. Additionally, two CIRES ground motion stations are located very near this area (see Figure A2). The team could not access these ground motion stations because they are located inside schools, and were under military guard at the time of advance reconnaissance. However, it is known that significant structural damage occurred in the vicinity of both of these ground motions stations. It would be interesting for future researchers to carefully classify the structural and foundation performance in this area of the city, and compare that performance against the CIRES recorded ground motions once they become available. It would also be interesting to perform north-south and east-west lines of Vs and site period measurements across this area, and use that information to see if our current site response analysis methods can match the observed ground motion response in this area. In particular, the city blocks to the north of the UAV flight zone, just west of the ground motion station C105, would be very interesting to study further. Note that Google Maps (2017) currently shows few of the damaged structures that were observed by the UNAM-GEER team in this area. However, the map continues to include more damaged and collapsed buildings each day.

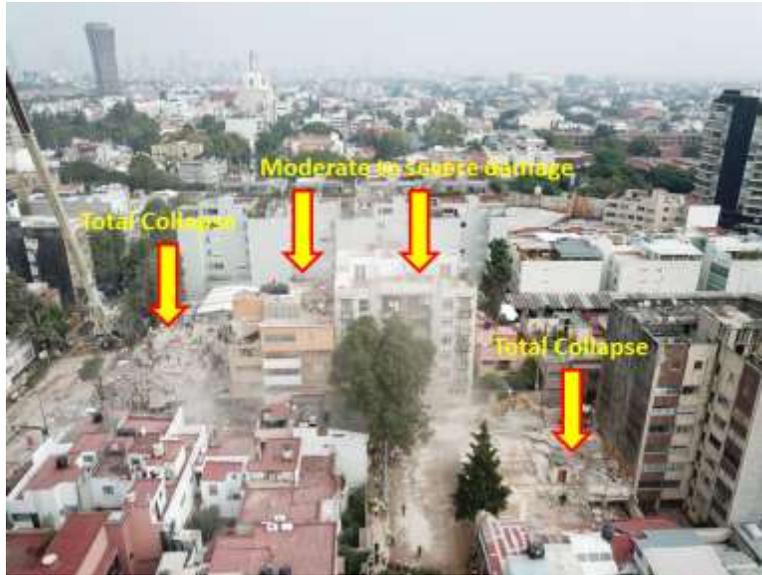
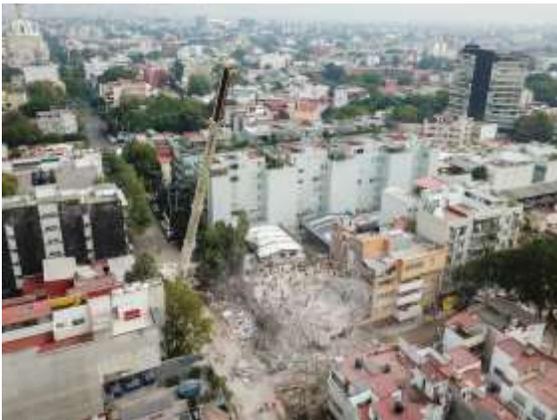
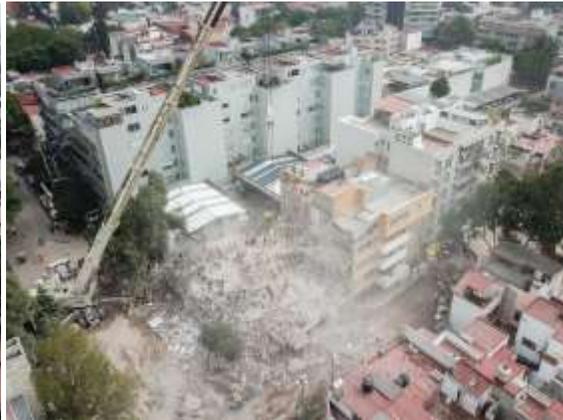
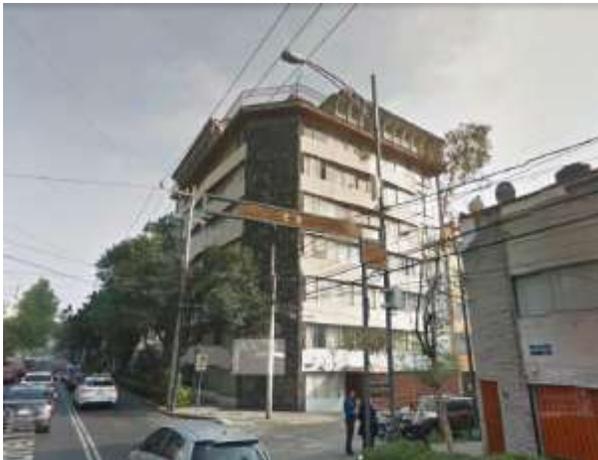
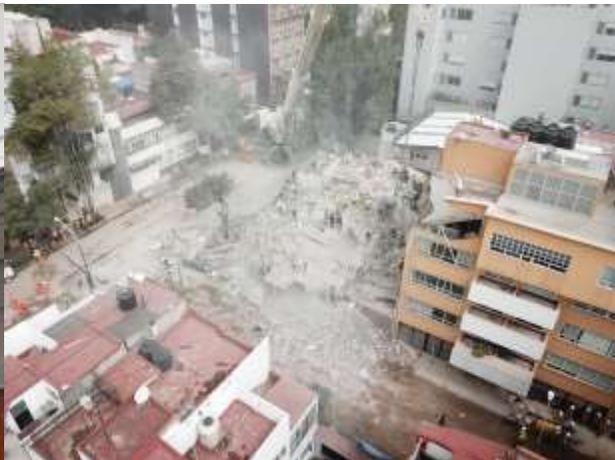
Description of Damage: Total Collapse

Follow up/Interest: Immediately adjacent to the collapsed building were 2 structures that experienced severe damage, but no collapse. Buildings were evacuated but area was not accessible at the time for further investigation. Of interest are the different site conditions, foundation types, structural lateral force resisting system.

Figure A4. Before (left) and after (right) shots of the Escocia 4 Building (19.3877, -99.1637)

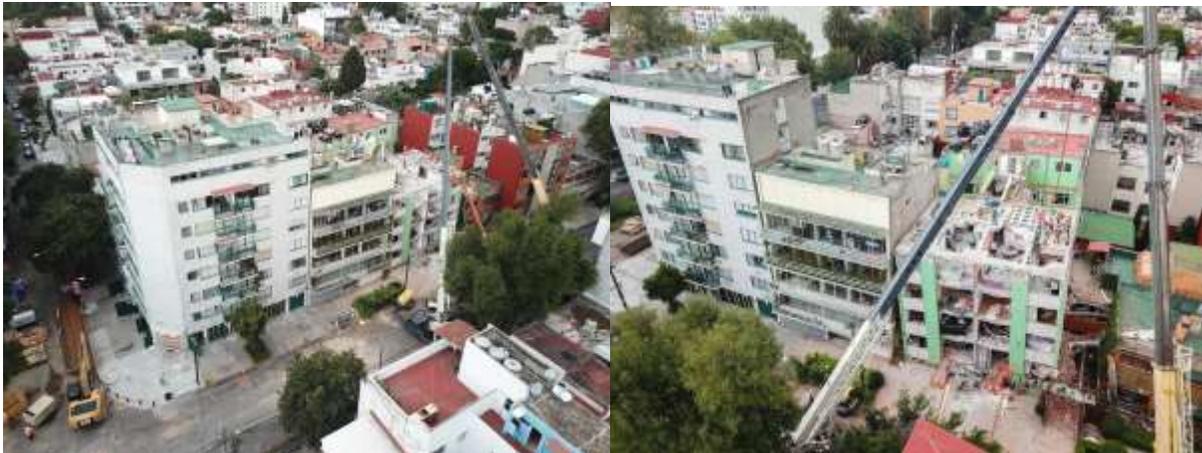
This site also consisted of a group of buildings that showed significantly different behavior. One building experienced severe damage (corner building), one building showed only sign of small damage, and one building experienced total collapse. The response of each individual structure might be related to the foundation type (unknown), age and structural system. A smaller structure adjacent to the green (collapsed) building was also majorly damaged and demolished. Overview Photos:

Figure A6. UAV photographs of the Escocia/La Morena intersection with 4 buildings of interest (19.3984, -99.1587)

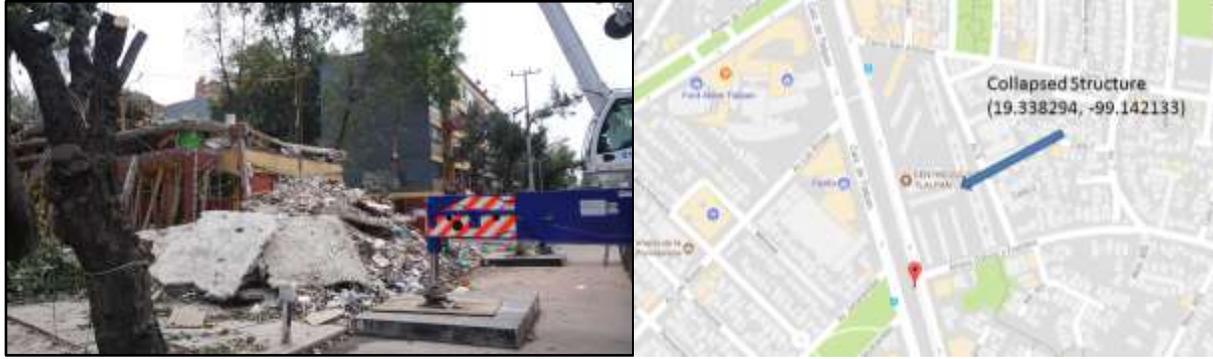
Figure A12. Photograph (left) and Location (right) of collapsed residential structure in Multifamilia Tlaplan (19.3383, -99.1421)

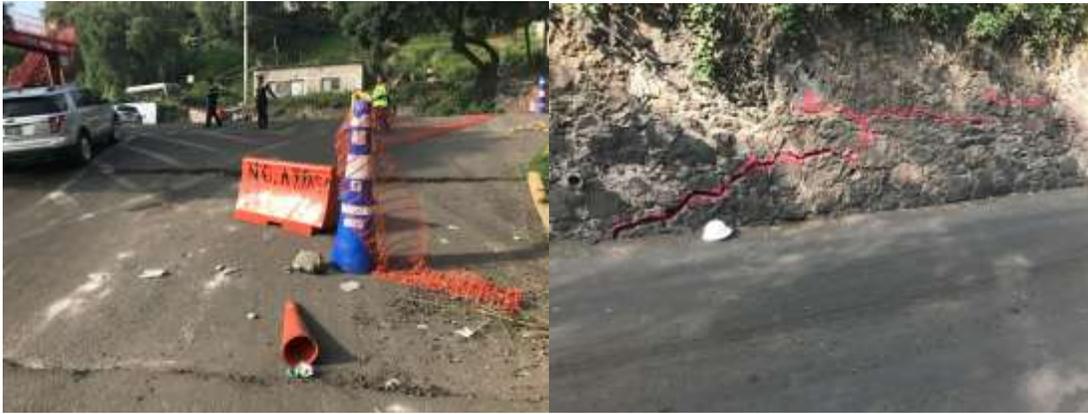
Figure A16. Crack along the street (left) and cracks on retaining wall holding upper step (right), (19.2470, -99.0875)

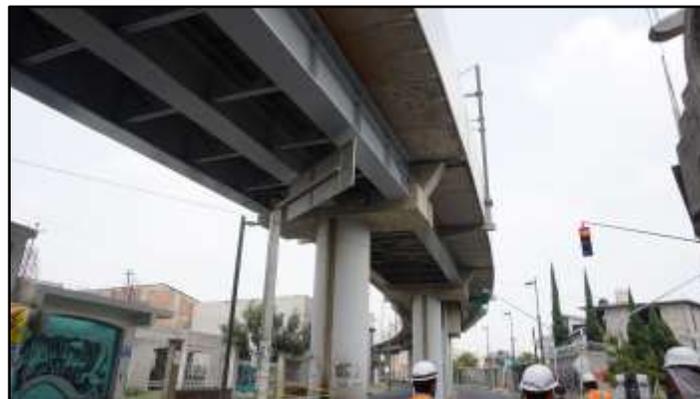
Figure A20. Photo showing 'S' shaped viaduct (19.2982, -99.0339)

Follow-Up: Given the unique foundation system of the bridge pier (Floating foundations), it would be of interest to gather information of potential foundation damage. Furthermore, the available amount of bridge seat the ends of the girders would be of interest to assess if the girders have any restraint (or enough seat) left to prevent them from falling.

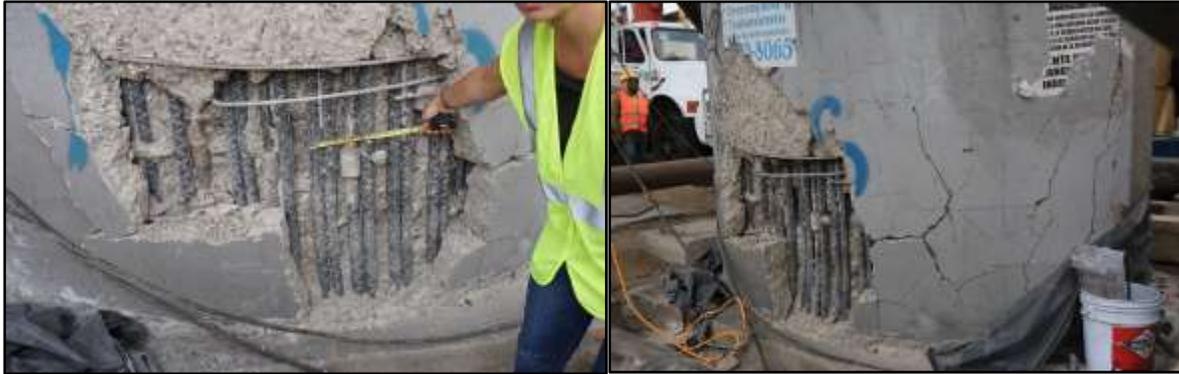
columns of the bridge segment. X-ray measurements are anticipated to ensure this column is an anomaly and not typical along the viaduct.

Figure A23. Cracks extending into the column core (shown on top) and superstructure shoring with tubular steel frame sections (shown on bottom). (19.3017, -99.0520).

Follow-Up: X-Ray results are of interest and whether this is a localized construction issue or a repeated construction error along the metro line.

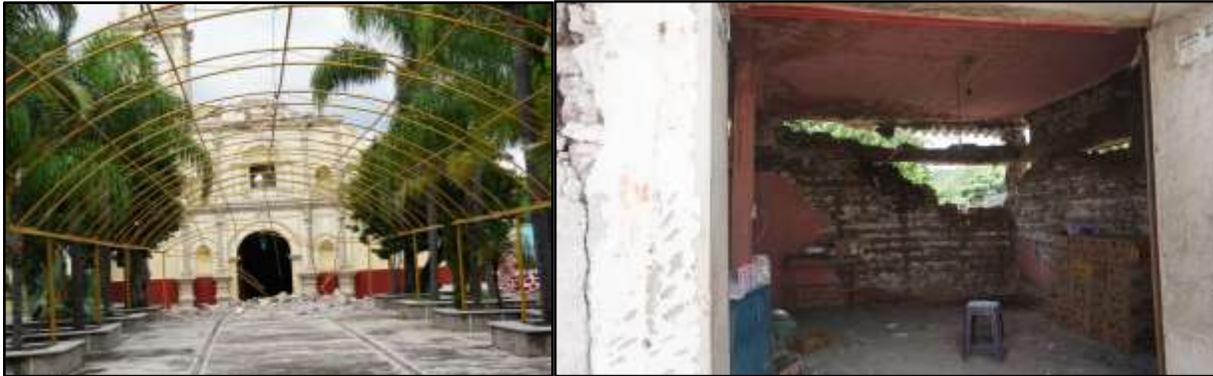
Figure A27. Damaged church (left) (18.2330, -98.7050), and typical adobe damage from earthquake (right) (18.2334, -98.7055).

Follow-Up: Was the extensive damage simply due to adobe construction or were there site effects that contributed to the damage?

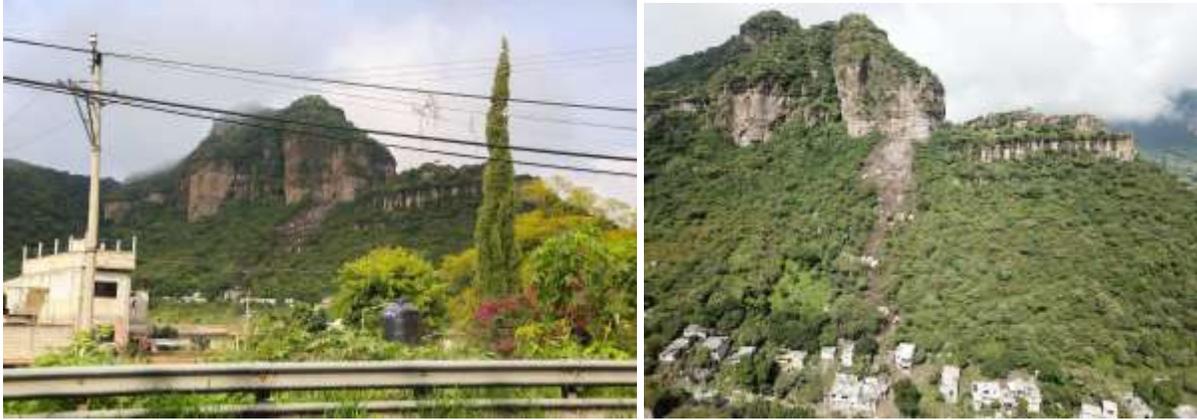
Figure A31. Photographs from main highway (left) and UAV (right) (18.9486, -98.9837)

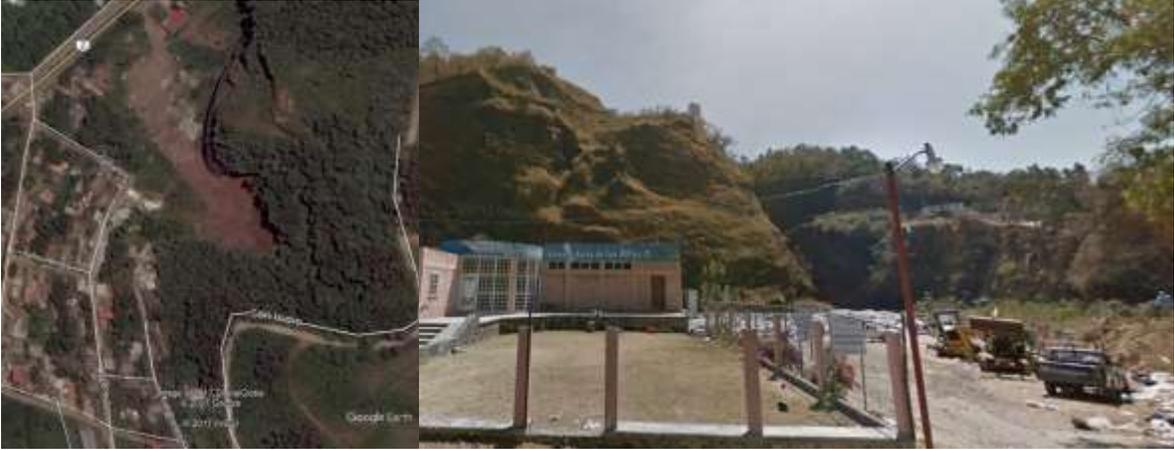
This site is an old lava rock (Tezontle) quarry which is currently being used as landfill. The cuts of the quarry are overly steep and possibly undercut. Aerial imagery shows an existing cut area where previous landslides might have occurred (on the left - Source: Google Earth). Given the quarry geometry, the new landslide (triggered by the earthquake) was somewhat anticipated. New material covered about half of the landfill (i.e., waste) area and left nearby houses unstable. The instability of the slope is clearly observed by extension cracks meters north of the houses and a medium size failure during the reconnaissance team

visit to the site. Short duration rain storms can potentially produce more failures in the site, substantial cracking was identified via aerial photographs. Soil type: clay and lava material.

Figure A33. Google earth before shots of Totolapan Landslide (18.9816, -98.9246)

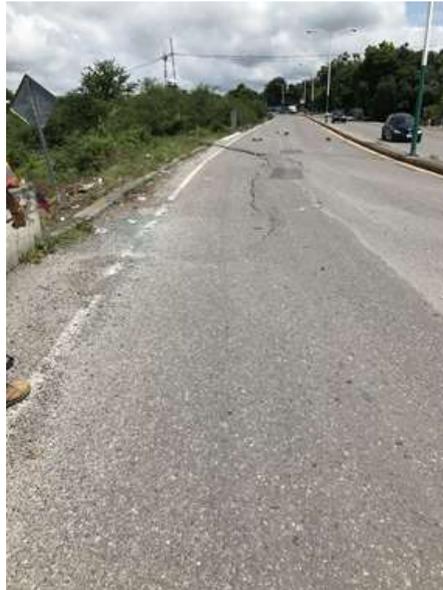
Description of Damage: A portion of an embankment partially supported on a retaining wall suffered significant damage manifested as medium to large cracks on the pavement for a length of 70 ft. The failure occurred on the section of the embankment that was not supported by the retaining wall, indicating a failure due to suboptimal design.

Figure A38. Significant deformations along pavement due to embankment deformation (18.7146, -99.1835).

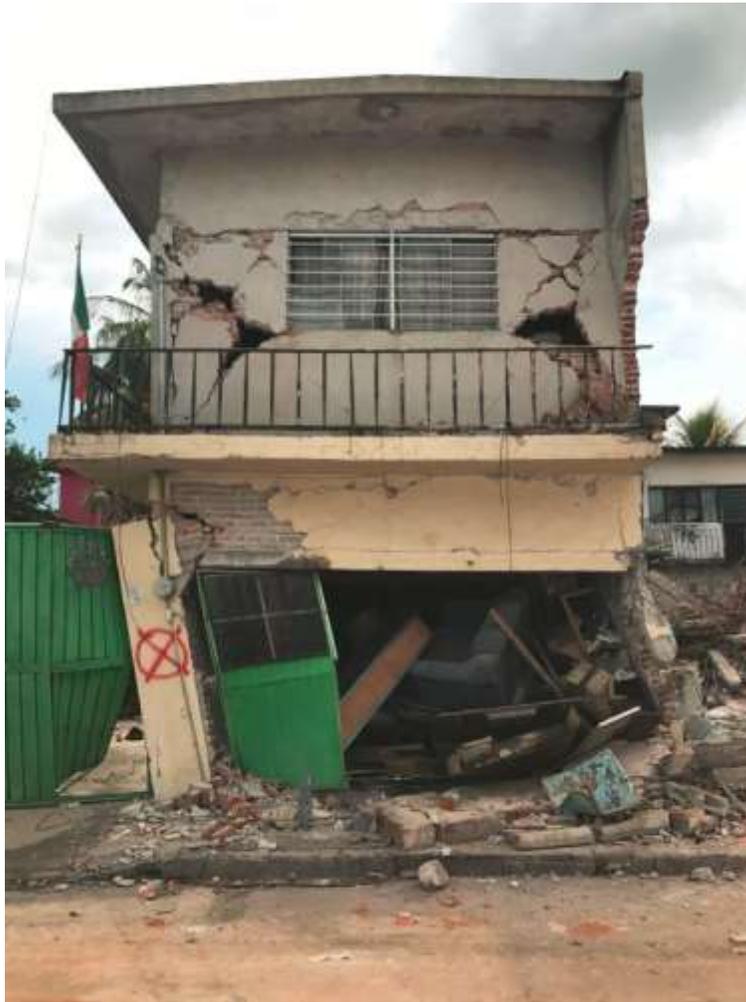
Figure A41. Partially collapsed building (18.6176; -99.1775)

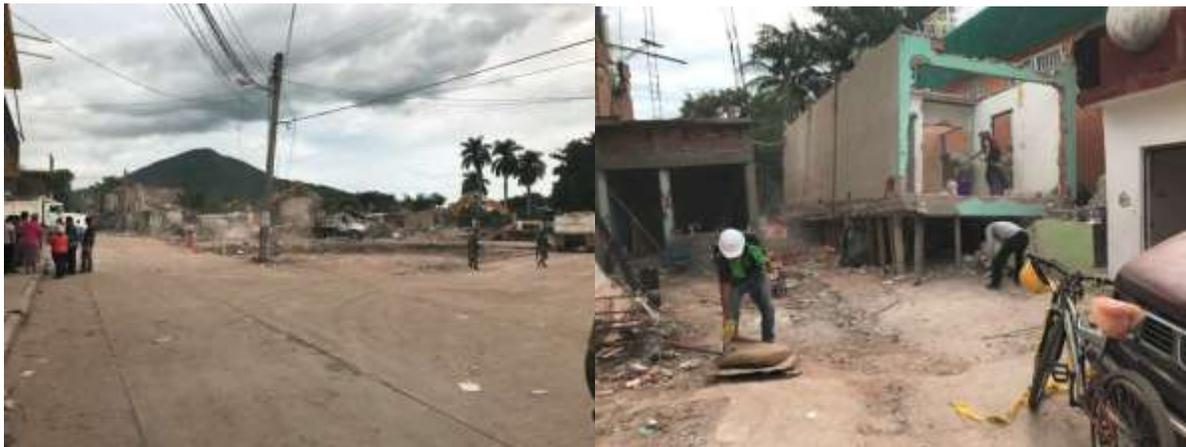
- Jojutla: Widespread damage to 1 to 2 story structures. In some blocks most of the buildings collapsed or partially collapsed. No drone flights were made at this location to take aerial photographs and map the extent of the damage; however, from ground observations it appeared that the damage was widespread and a relatively large portion of buildings were significantly damaged (about 5 buildings collapsed or partially collapsed per block in the most affected area). Most of the collapsed or partially collapsed structures were either constructed out of masonry with reinforced concrete columns or out of older adobe bricks. It appears that many of the affected structures were originally designed as 1 story structures, and some time later a second story was added. The structural failures indicated shear wall failures and collapse of first story due to buckling

Figure A42. Block with several collapsed buildings (rubble already removed) (18.6153; -99.1744), and collapsed building with second story on ground after first story collapsed (18.6154, -99.1746)
