Preliminary Report on the Principal Seismological and Engineering Aspects of the $M_w=6.5$ Achaia-Ilia (Greece) Earthquake on 8 June 2008

Report for Web Dissemination
Geotechnical Earthquake Engineering Reconnaissance
http://research.eerc.berkeley.edu/projects/GEER/Post_EQ_Reports.html

GEER Association Report No. GEER-013

June 2008

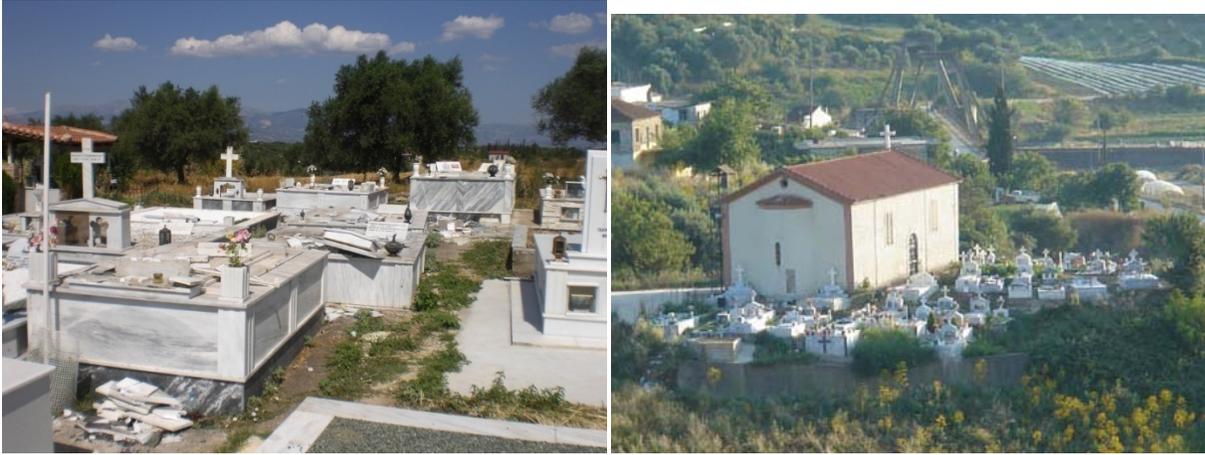
The first observation concerns the performance of cemetery monuments located along the fault strike. Traditional Greek cemeteries feature above-ground tombs adorned with crosses, photograph frames, and similar grave markings. At cemeteries along approximately the north half of the fault, many of these objects were toppled from the tombs, as shown in Figure 3.7 (left). At a cemetery near Pinios Lake at the south end of the rupture, no such toppling was observed, as shown in Figure 3.7 (right). This suggests that the characteristics of ground motion that control the toppling of such objects were likely stronger to the north end of the fault rupture than to the south.

Figure 3.7. View of toppled cemetery relics at Ano Achaia (left) and lack of toppling at Kentro (right).

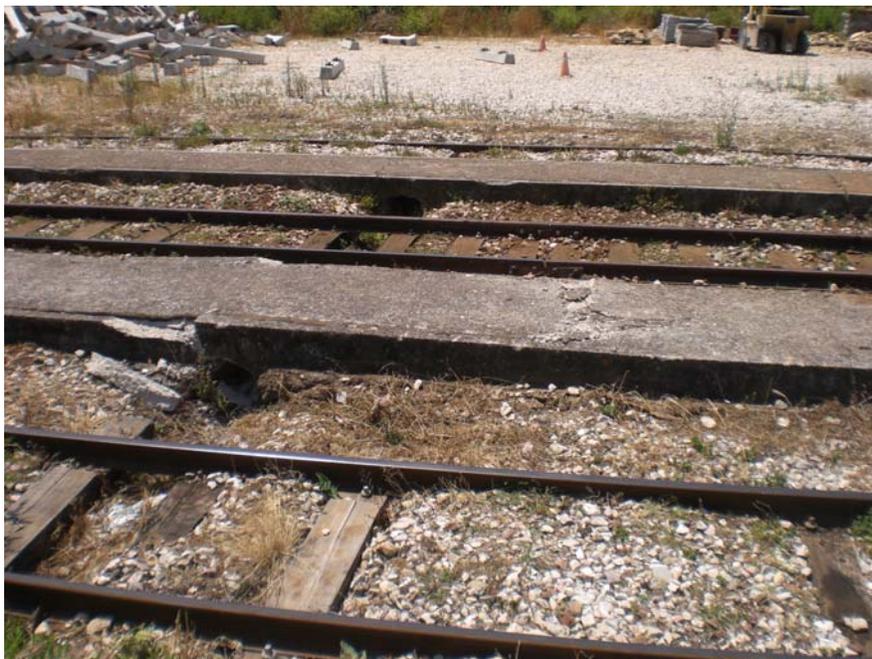
At the time of inspection, unrepaired damage remained on the south track, as shown in Figure 4.2 and 4.3. Damage to the two north tracks had been repaired immediately after the main shock, to keep train service open, but the removed sections of rail were available onsite for inspection. The damage to the south track consists of a buckling-type failure of the rail due to compression of the ground in the direction of the rail (Figure 4.3). No strike-slip displacement of sections of rail on opposite sides of the damaged section was apparent from visual inspection (Figure 4.3). Immediately north of the buckled rail, both compression and extension features were apparent in the concrete platforms, as shown in Figure 4.2. Note that the widths of extensional ground cracks were noted in the field, but it was not possible to measure displacements across compression features. Photographs of the distress in this area are shown in Figure 4.3-4.4.

Figure 4.4. Photograph of compression features in concrete platforms. Marked as Photo b in Figure 4.2.

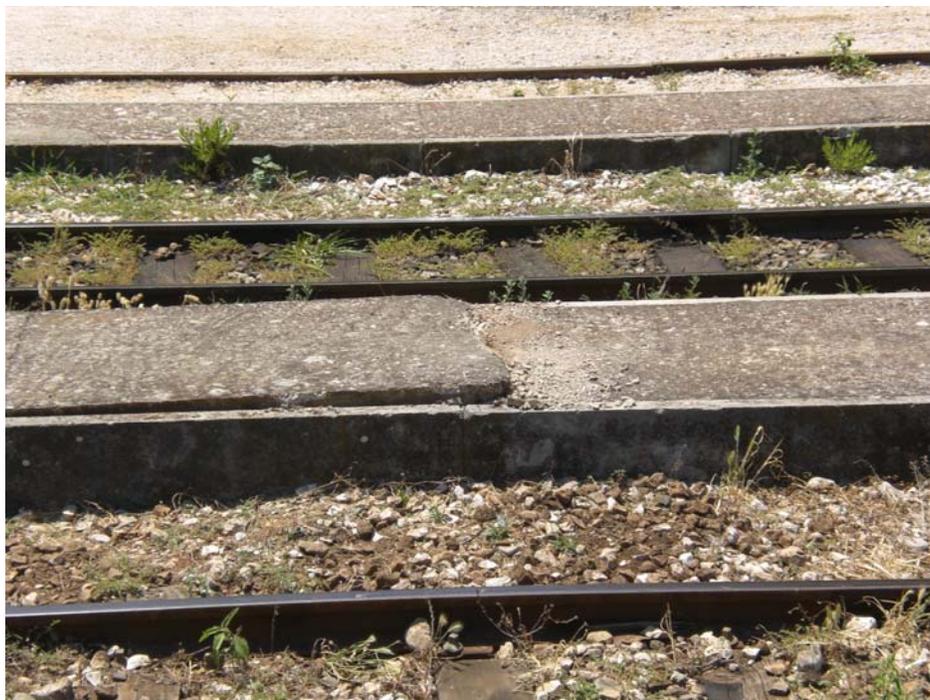
Figure 4.5. Photograph of compression features in concrete platform near west end of station. Marked as Photo c in Figure 4.2.

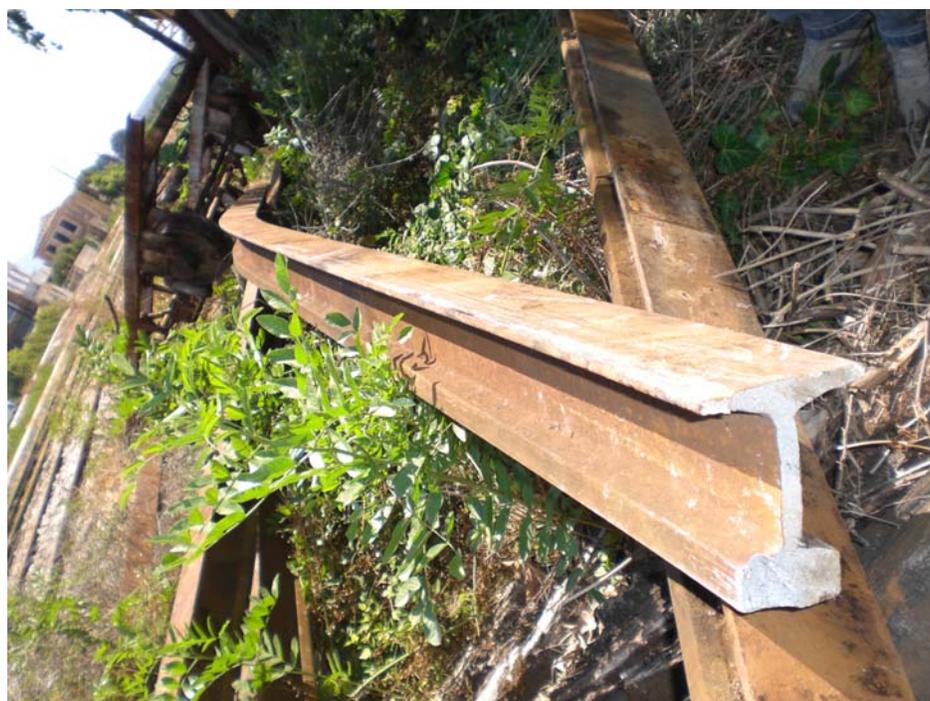
The damaged sections of rail were available for inspection onsite. According to the station operator, those sections were removed the day of the earthquake so that train service could continue. As shown in Figure 4.6, significant lateral displacements of the rail sections was observed in the removed segments. Those displacements are likely due to buckling failures similar to that observed on the south rail.

Figure 4.6. Photograph of deformed rail sections removed from service following earthquake.

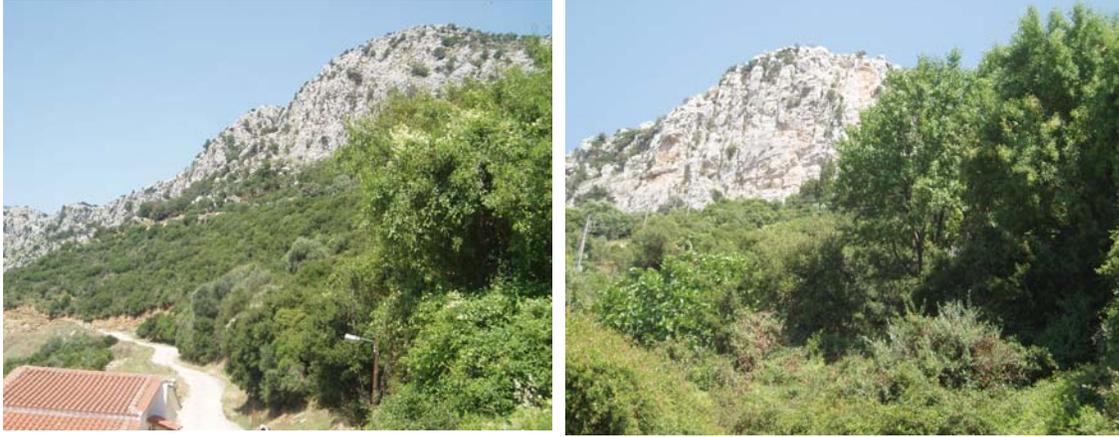
Figure 5.2 Santomeri village: general view of the limestones hanging over flysh

In both cases, rock toppling failures of limestones occurred during the earthquake as a result of the unfavorable combination of very steep slopes with the sub-vertical fractures and the inclined bedding. The volume of the rock blocks that toppled is crudely estimated between 1 and 7m³. In Figure 5.3, the location where a rock block was detached is shown on the left, whereas on the right is shown a detached rock block that rolled downslope and caused serious structural damage at a house in Santomeri village (fortunately with no casualties). The same features were observed in a less pronounced way at Portes village, as shown in Figure 5.4. Both villages have been declared by the Hellenic state, as “hazardous areas” due to rock detachment and toppling and therefore evacuation of the inhabitants was ordered.

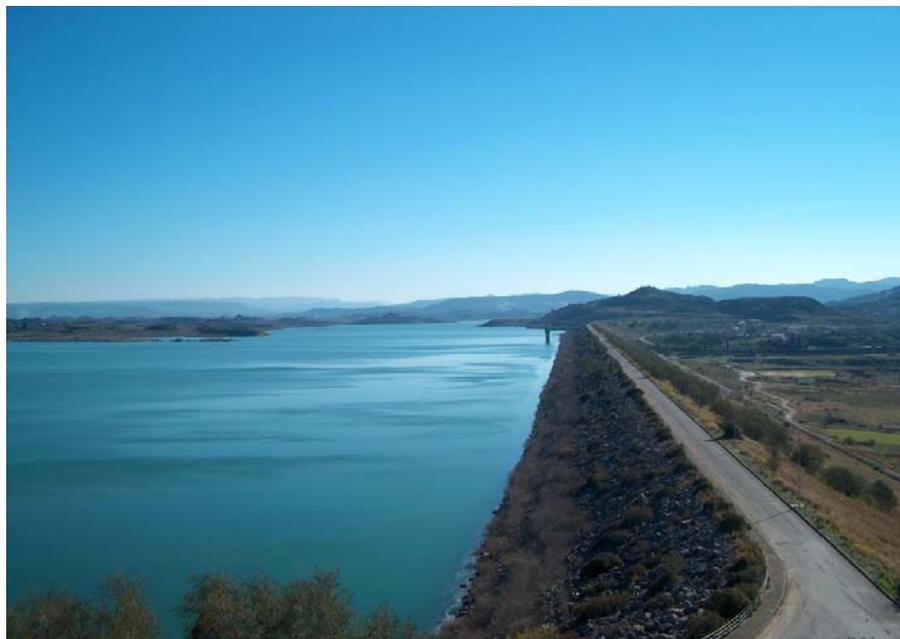
Figure 6.3. View of Pinios dam from the north abutment.

At the time of the earthquake the water depth behind the dam was about 25m. No earthquake damages were observed in the dam (crest, slopes, spillway, outlet tower, abutments). Figures 6.3-6.5 show the main embankment, outlet tower, and spillway, all of which were found to have no visible damage from the earthquake. However, the occurrence of soil liquefaction with sand ejecta has been reported in several locations in the area surrounding the reservoir (http://users.auth.gr/~ac/Files/AUTh_quick_report.pdf).

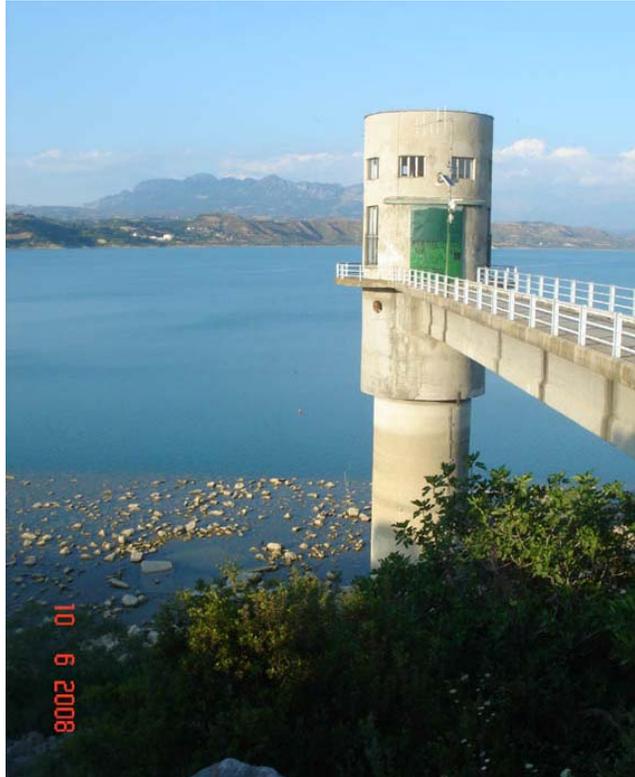
Figure 6.4. View of the outlet tower of Pinios dam.

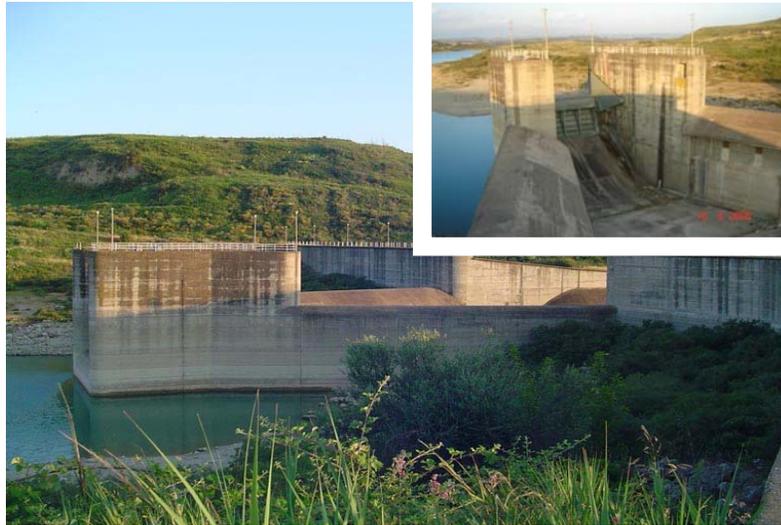
Figure 6.5. View of the spillway of Pinios dam.

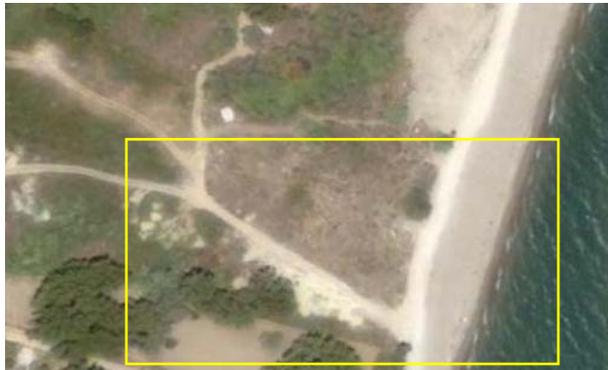
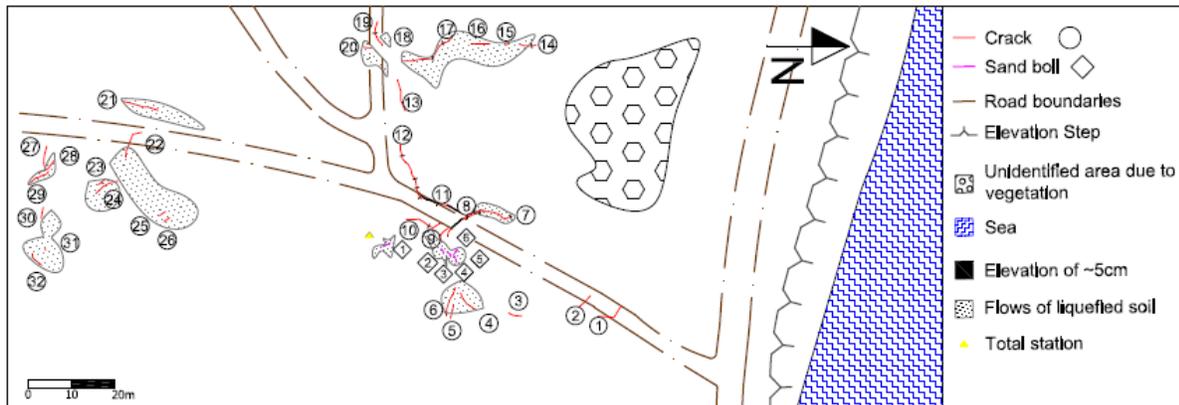
as “eastern site” (GPS coordinates, 38.15179°,21.56338°) is approximately a 150m x 90m lot ending about 30m from water, as shown in Figure 7.2. Contrary to the surrounding areas which are covered by vegetation, the specific lot was practically empty. The site was first visited on 11 June 2008 and was subsequently surveyed using GPS total station equipment on 14 June 2008. According to the owner, who was present during the second visit, the site was rich in gravelly material, which was excavated approximately 10 years ago by a construction company up to a depth of 5-6 m and was replaced by filling material, which seems to have included sandy silt and silty sand. Accordingly, the site contained different material than the surrounding locations, which did not liquefy.

Figure 7.2. Vicinity map, surveyed site plan, and crack inventory for lateral spread referred as eastern site

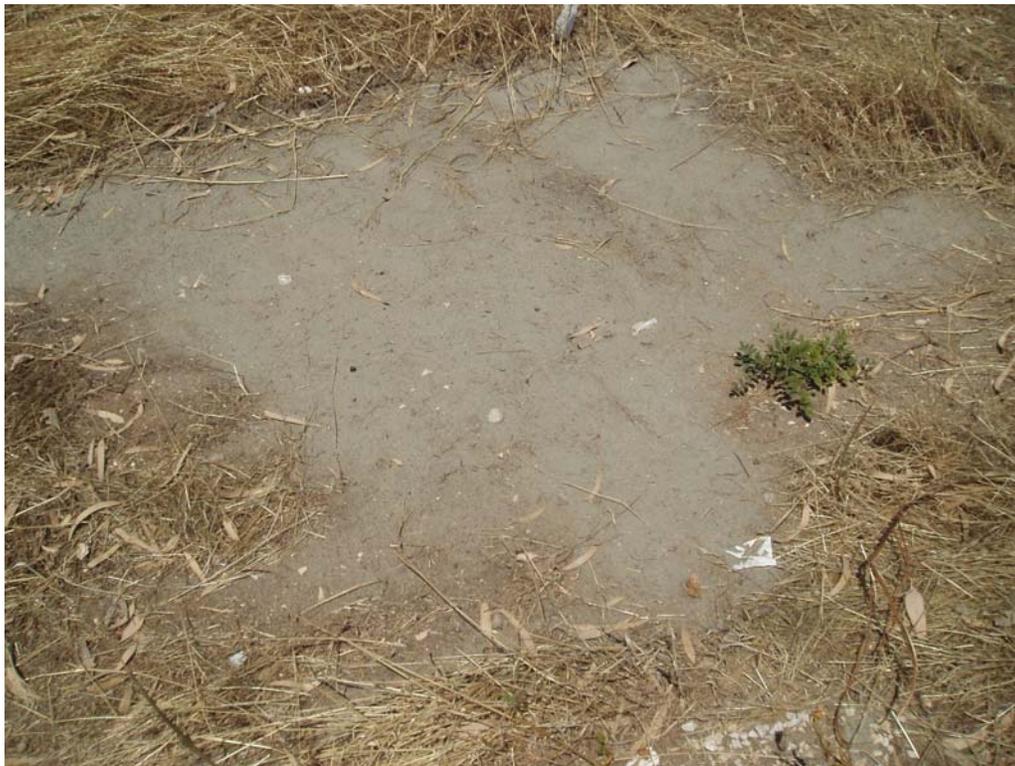
Figure 7.9. Detail of liquefied material at the west part of Kato Achaia beach

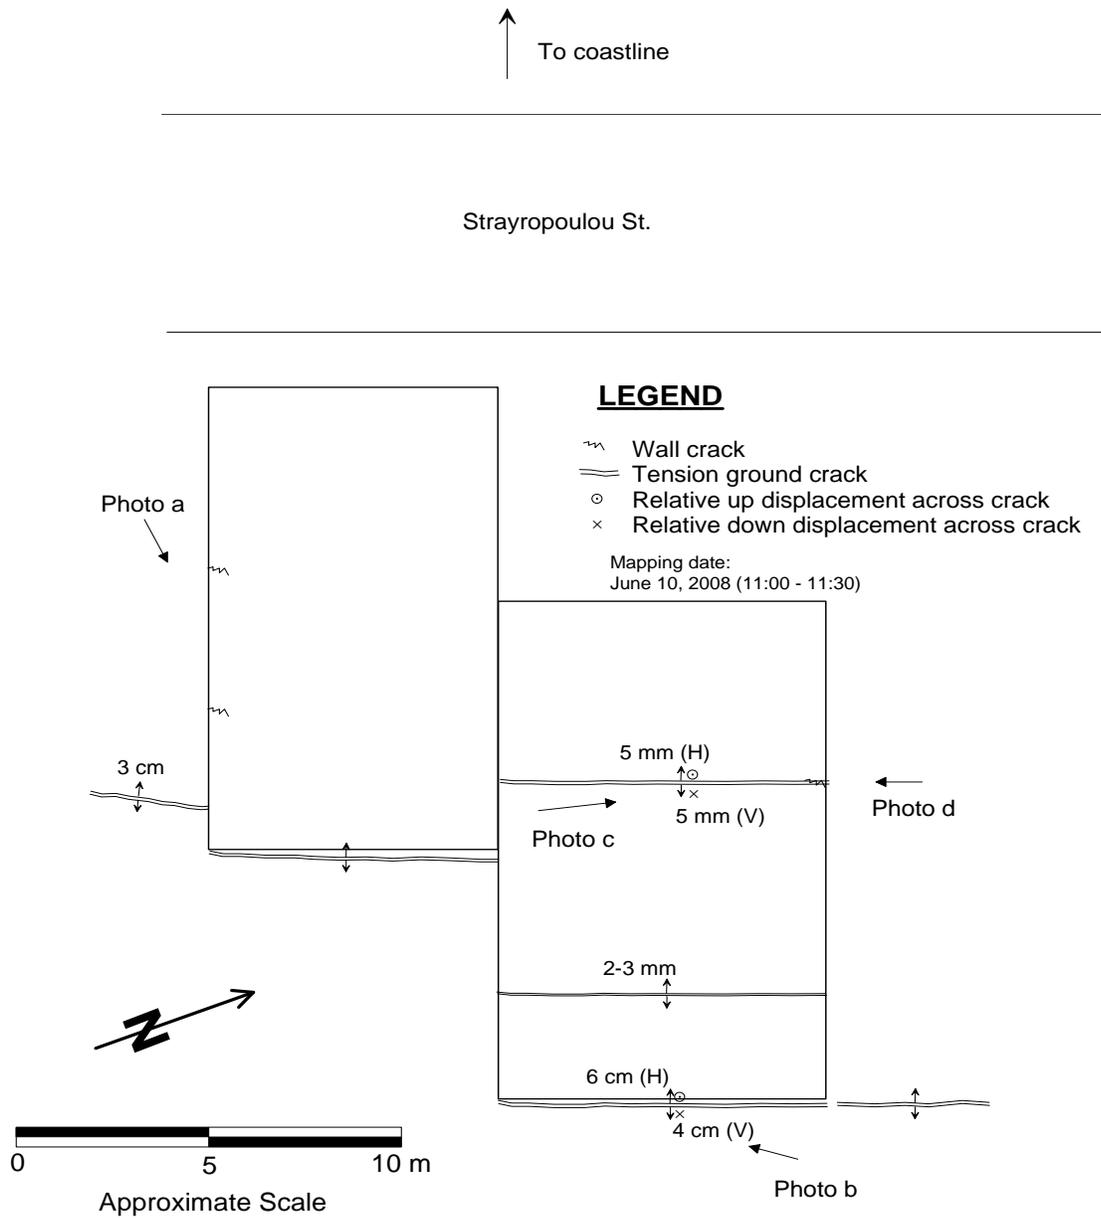
Ground cracking was typically oriented sub-parallel to the coast and manifest approximately 15 m from the coastline in the street. Typical crack widths were approximately 3-6 cm. No soil ejecta was observed at the ground surface in the vicinity of these cracks. It is unknown at present if the affected soil is fill or natural ground.

This structure is located on the south (landward) side of the street, approximately 20 m from the coast. Mapping was performed of the ground deformations relative to the structure and associated structural distress. The mapping of distress at this structure is shown in Figure 7.10. Figure 7.11 shows photographs of distress at locations shown in Figure 7.10. The major features shown in Figure 7.10 are an extensional ground crack of approximately 3-6 cm in width that passes along the back of the pair of structures (only the interior of the east structure was inspected). Interestingly, the ground crack moves southward when it encounters the building foundations. Although the structures were damaged, crack widths within the floor slabs and walls are much narrower than the ground cracks, as shown in Figure 7.10. The 4 cm vertical uplift of the foundation relative to surrounding ground at the rear of the structure suggestive of possible rotation and differential settlement of the building structure towards the sea. This could be confirmed by floor level surveys, but such data is not available at present.

Figure 7.10. Map of ground cracking from coastal subsidence at two-story reinforced concrete structures in Vrachneika. Cracks without marked vertical offsets had zero observed vertical offset. Location: 38° 10.375' N; 21°40.543'

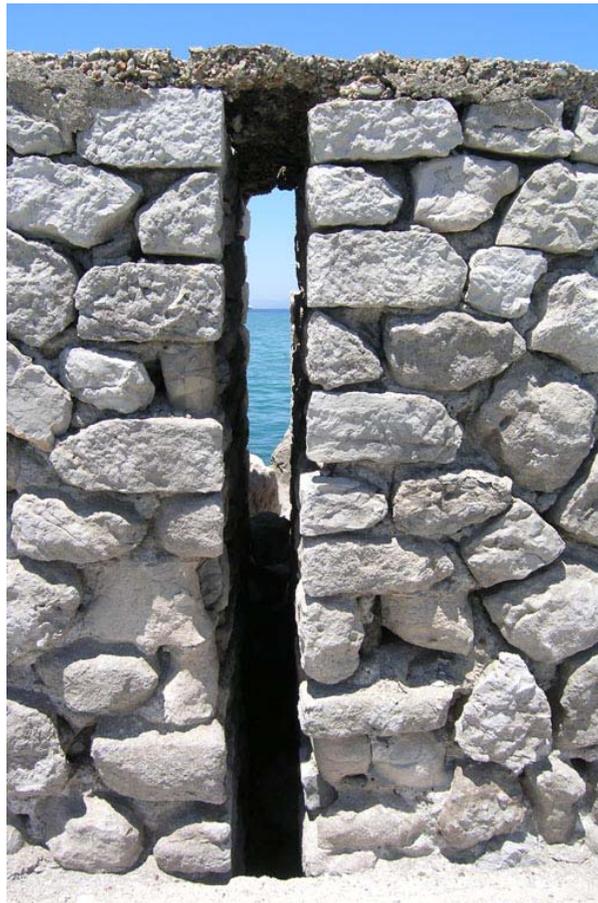
Figure 8.4. Separation (0.20m) between two consecutive segments of the breakwater. The concrete slab at the top bridges the gap between the consecutive segments.

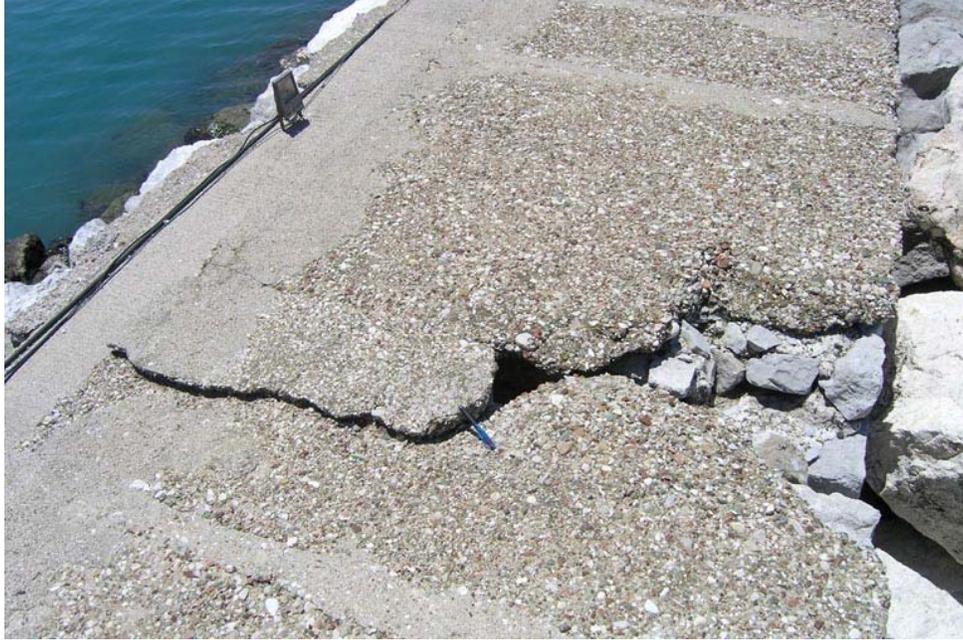
- (a) signs of minor longitudinal compression in the concrete slab bridging the open space between consecutive segments, as shown in Figure 8.5, and
- (b) detachment of a few stones from the landward face of one segment of the breakwater, as shown in Figure 8.6.

It is not certain that the above observations are related to earthquake effects.

Figure 8.5. Signs of compression in the concrete slab overlying the masonry segments of the breakwater.

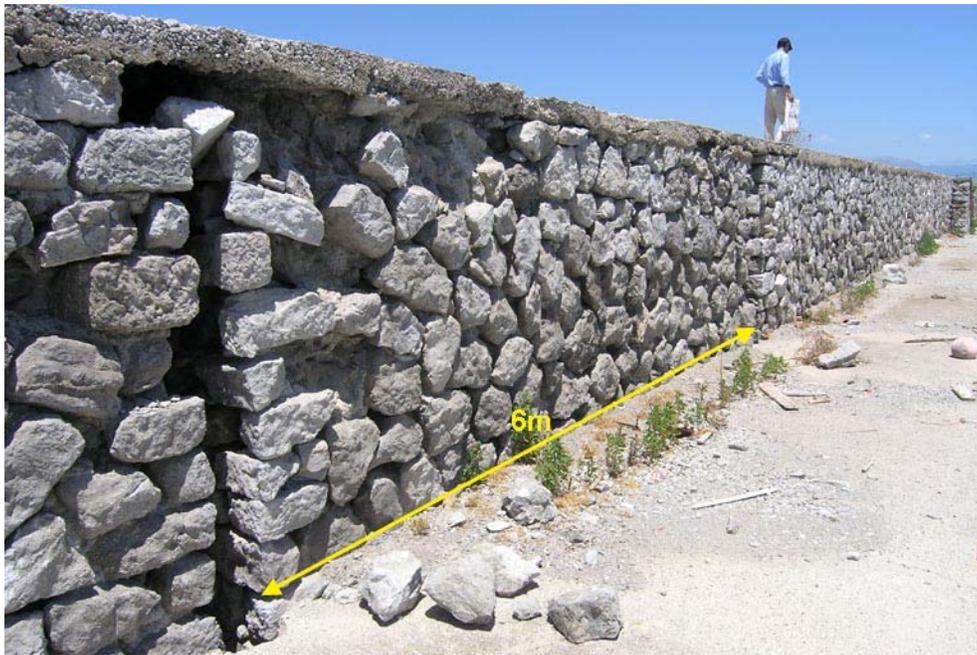
Figure 8.6. Detachment of stones from the landward face of one segment of the breakwater.

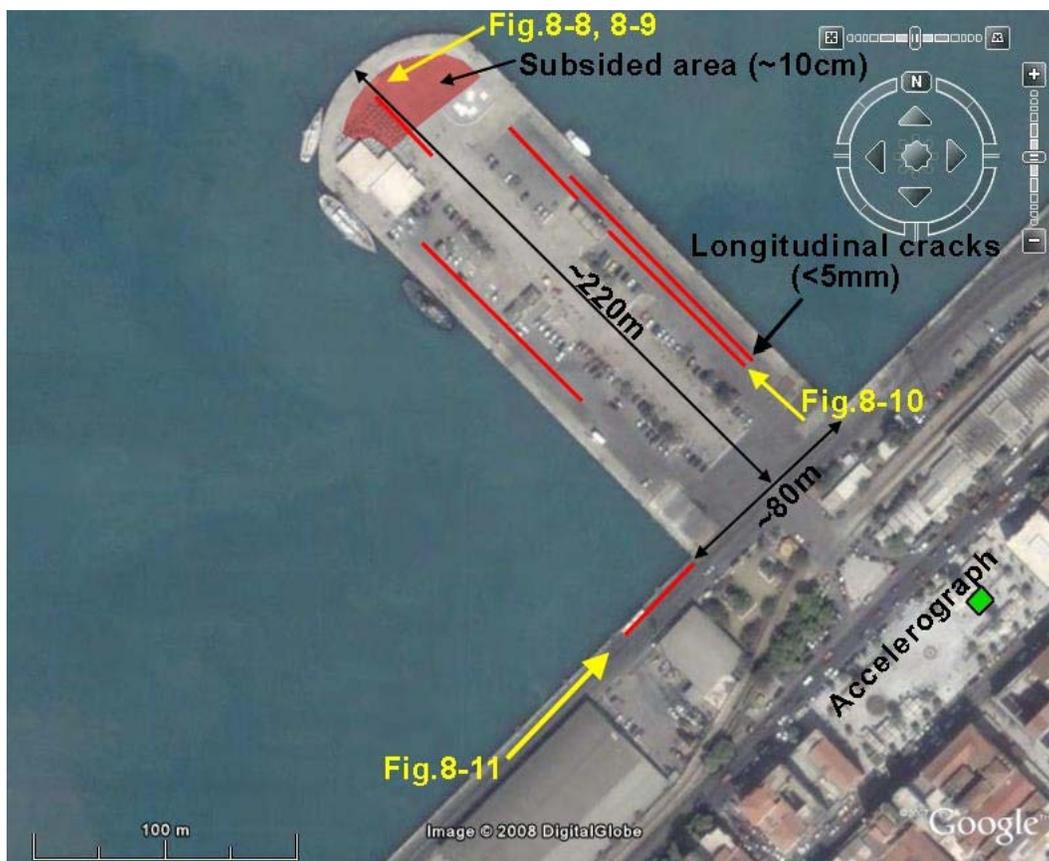
Surface subsidence of about 0.10m occurred as a result of the earthquake near the edge of the mole, as shown in Figure 8.7. Longitudinal cracks were also developed along the two sides of the mole, with a maximum width of about 5mm. Similar cracking was also developed on the pavement of the quay wall close to the entrance of the mole. It is known however, that the above features have repeatedly appeared in the past (due to consolidation of soft sediments beneath the mole) and are being constantly repaired.

Figure 8.7. Plan view of the St. Nicolas mole with the locations of subsided area and cracks, with arrows indicating location and direction of shots shown in subsequent figures. The location of the University of Patras accelerograph at the Trion Symahon square is also depicted.

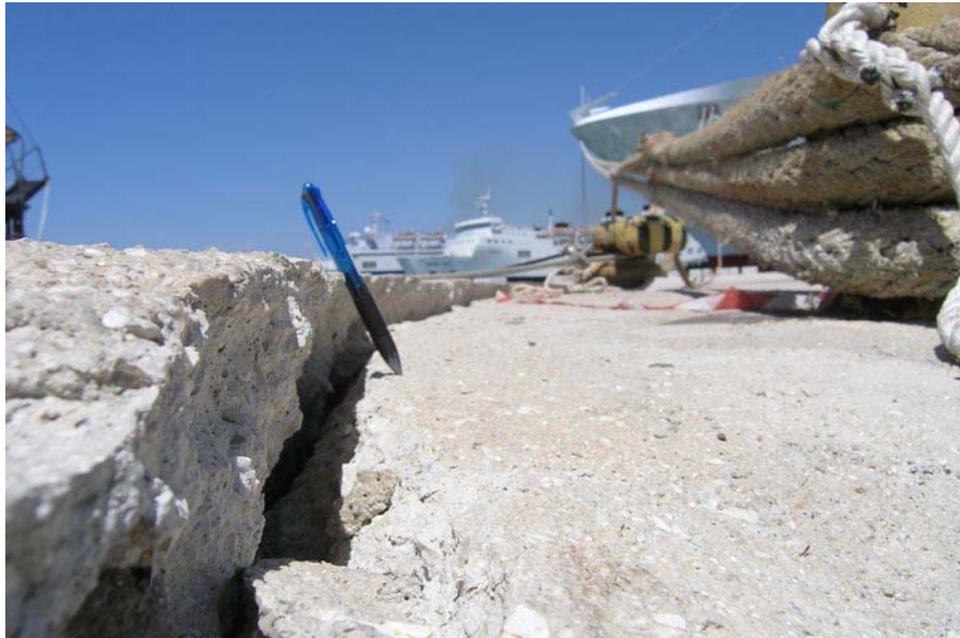
Figure 8.9. Detail of the subsided part of the mole, showing a vertical offset of about 0.10m.

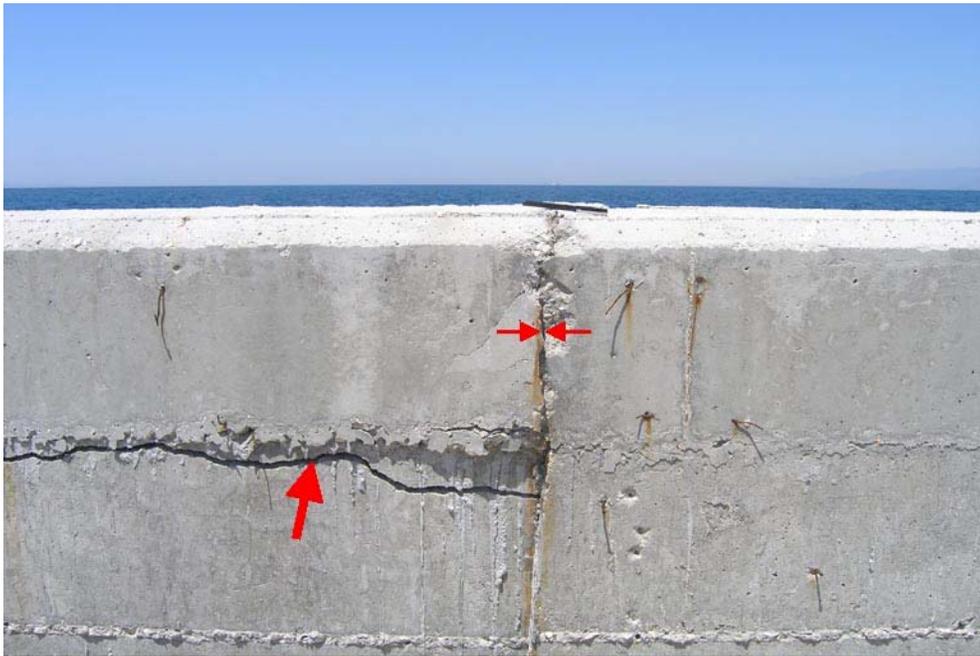
The performance of the breakwater was quite satisfactory with only minor signs of distress (joint compression, joint opening and differential settlement, less than 30mm) at 3 or 4 joints, as shown in Figures 8.14 to 8.16. A geodetic survey performed following the June 8, 2008 earthquake, has indicated a settlement of the entire breakwater of about 0.35m, with reference to the latest available measurement taken at the end of 2005. At the time of writing, it is not known which portion of this settlement was caused by the main shock (an initial assessment is 0.20m).

Figure 8.14. Signs of compression at a face wall joint of the breakwater.

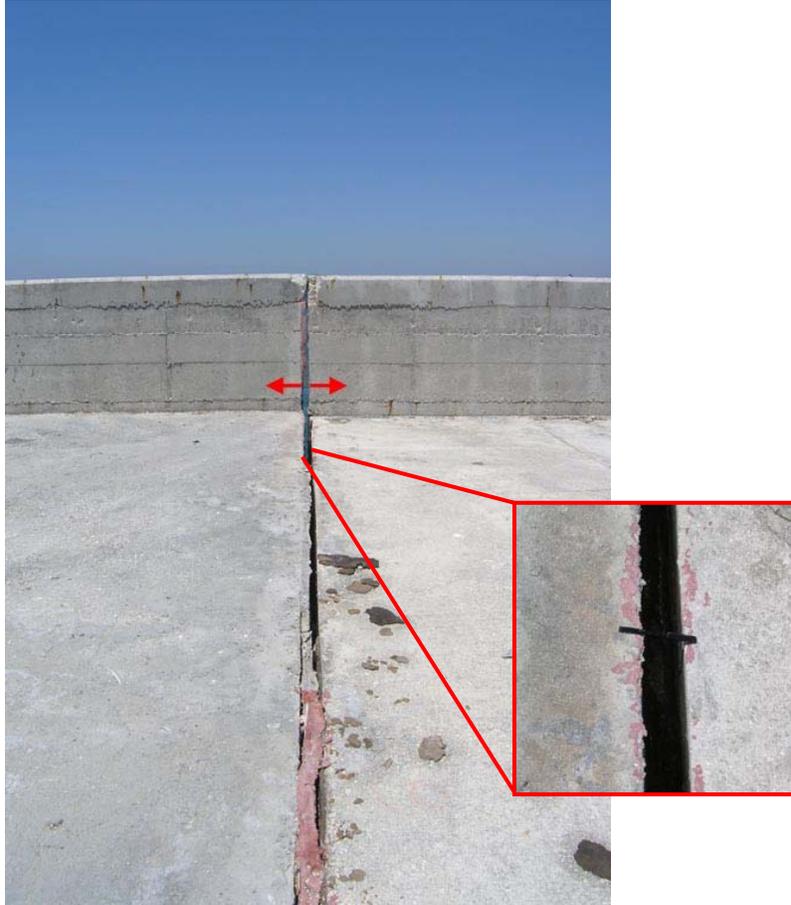
Figure 8.15. Joint opening between adjacent caissons of the breakwater.

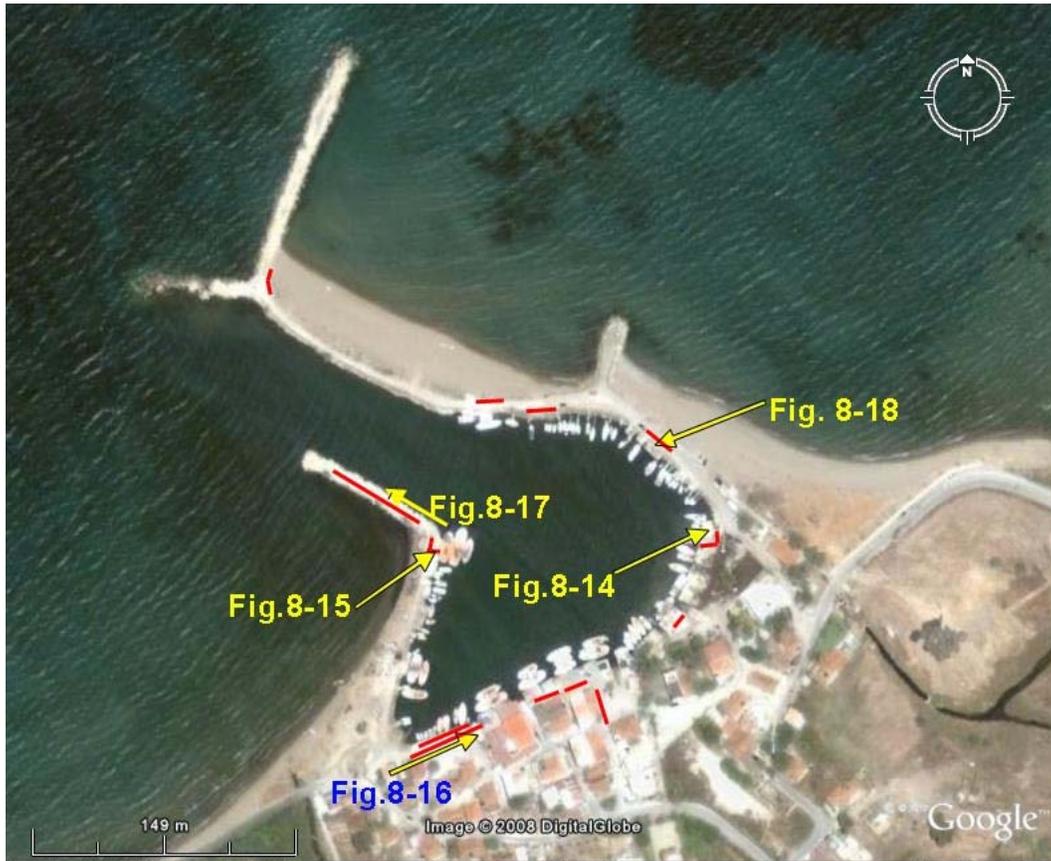
Figure 8.19. Plan view of Alykes (Kato Achaia) fishing harbor with arrows indicating location and direction of shots shown in subsequent figures.

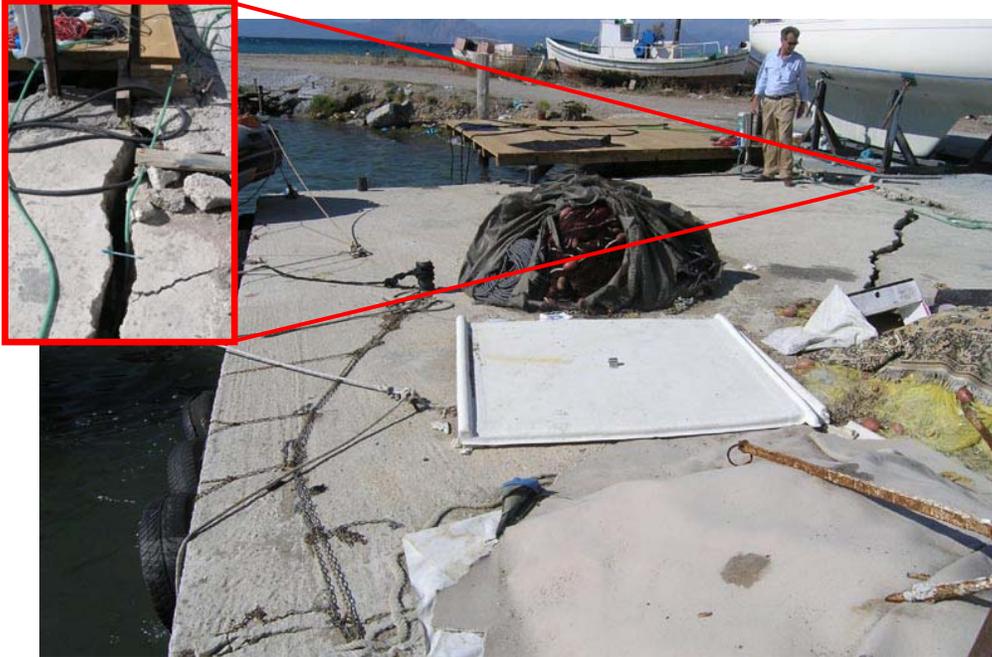
- (a) Subsidence, rotation and seaward inclination of small concrete quay walls, as shown in Figures 8.20 and 8.21. The above movements resulted in crack opening (sub-parallel to the coast) near the landward end of the concrete blocks. In one case a separation crack appeared between the foundation of a house and the surrounding ground, about 15m from the quay wall, as shown in Figure 8-22.
- (b) Development of longitudinal cracks (width ranging from 1cm-4cm) in the jetties, in a direction mainly sub-parallel the axis of jetty, as shown in Figure 8.23. In the case shown in Fig. 8.24, development of surface cracking and related soil movement, caused the breakage and horizontal displacement of the upper part of a small earth retaining brick wall.

Figure 8.20. Typical example of subsidence, rotation and seaward inclination of a quay wall in Alykes harbor.

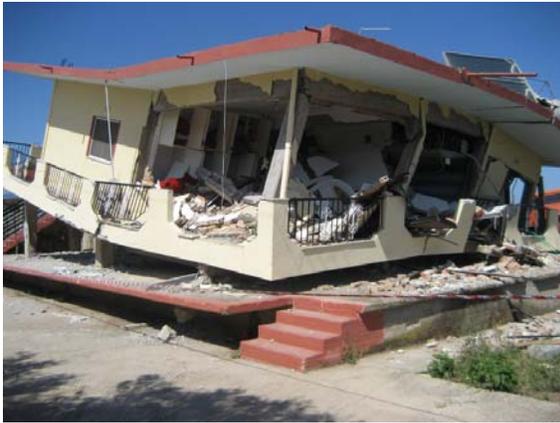
Figure 9.4 . Didacheika village. Collapse of a two-storey r/c building.

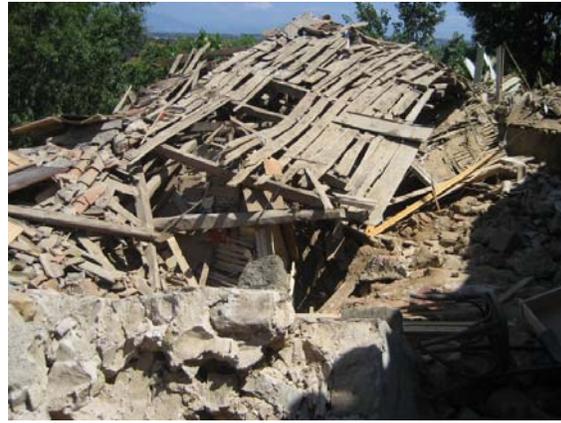
Figure 9.5. Fostaina village. Total collapse of a single-storey masonry building.

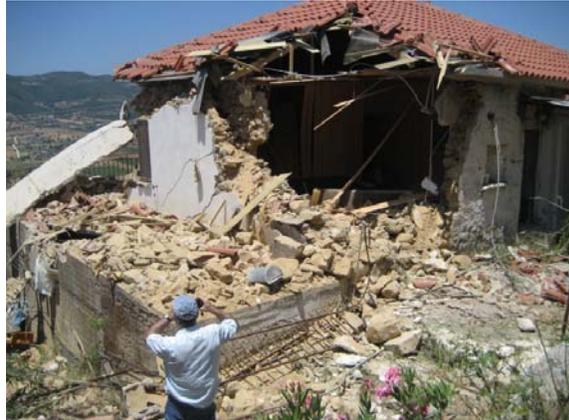
Masonry residential buildings have usually one to two storeys; they constitute a considerable percentage of the building stock in the stricken area, and are typically found in the villages. A special subcategory are residential brick masonry buildings of cultural importance, which are described in more detail in paragraph c (Monuments and other buildings of cultural heritage). Damage (cracking and collapse of stone/brick/mudbrick walls) in the rest, common buildings can be attributed mainly to insufficient or nonexistent seismic resistance measures (almost all of them were not built according to any seismic code), as well as to their already poor condition (old age, inadequate maintenance) even before the earthquake. Partial or total collapse of such buildings was observed mainly in the villages of Fostaina (Figure 9.5), Santomeri, Valmi, Kato Achaia (Figure 9.18, 9.19) and Vrachnaiika. Especially in the village Valmi, more than 80% of the buildings were severely damaged (Figure 9.8, 9.9). In contrast, recently renovated / strengthened masonry buildings in the village of Santomeri did not suffer major damage. In the same village a corner of a masonry building was destroyed by a huge boulder that detached (along with others that fell on the road) from the steep hill side overhanging the village (see Figure 9.7 and Chapter 5).

Figure 9.7. Santomeri village. Partial collapse of masonry walls due to boulder fall.

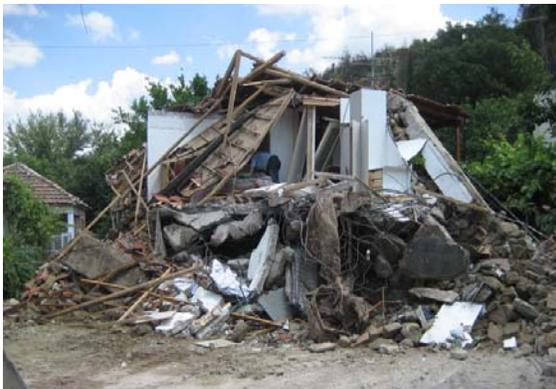
Figure 9.8. Valmi village. Total collapse of masonry building.

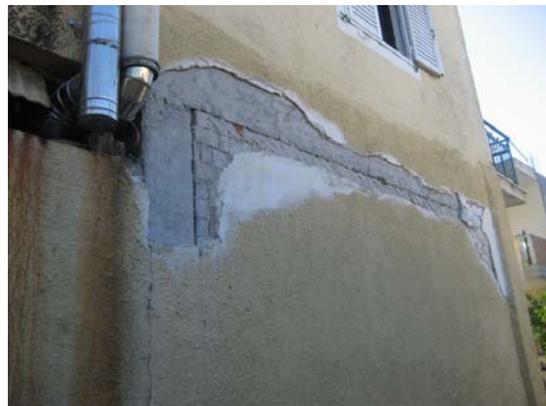
In most cases damage was concentrated in non-load bearing components, mainly brick infill walls. Diagonal cracks (Figure 9.11, 9.16) or detachment of the walls from the surrounding R/C frame (Figure 9.13, 9.15) was the most usual failure. In some cases damage to R/C elements was observed. In the village of Didachaiika a two-storey R/C building collapsed (built in 1984, with a soft ground storey) (Figure 9.4). In the village of Valmi, a two-storey R/C building suffered severe cracking at the top of the load-bearing elements (columns and shear walls) of the ground floor. At the port of the city of Patras, limited cracks were observed at shear walls of the Customs building (which also houses other public authorities). In the same building (which was put out of service), extensive damage to infill walls was observed (Figure 9.21). The Agios Andreas hospital also at Patras was evacuated, until further assessment of its actual structural condition is performed. In the town of Lehaina, several short R/C columns at the ground floor of the two-storey Fire department building were severely cracked.

Figure 9.15. Vartholomio village. Detachment of infill masonry walls from r/c frame.

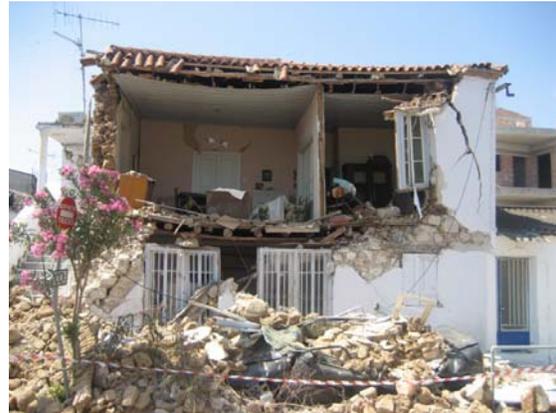
Figure 9.19. Kato-Achaia village. Partial collapse of masonry building.
