GEOTECHNICAL RECONNAISSANCE AND INVESTIGATION OF IMPACTS FROM HURRICANE IAN

Geotechnical Extreme Events Reconnaissance
GEER Report - 080

Report Date: 9/21/2023

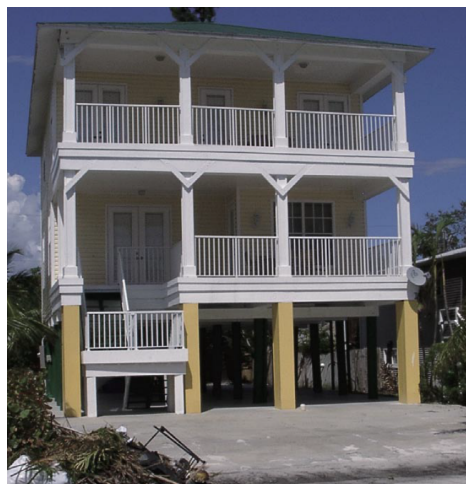
It can be shown that the Fort Myers Beach area suffered only minor geotechnical damage during both hurricanes Charley and Ian when comparing the same surveyed regions. Homes that were initially impacted by the hurricanes' course fell away at the connection of piers, however the pier footings were unharmed. Additionally, it was noted that houses elevated higher on piles were not impacted by the storm surge and only experienced mild scouring around their piles. (figure 2.7). This shows that major instances of storm damage were observed as structural damage rather than geotechnical damage in both hurricanes.

Figure 2.7: No storm surge damage was done to a newly built house perched on piles in Fort Myers Beach. Coordinates: 26.97066, -82.08998. (Ingargiola *et al.*, 2005)

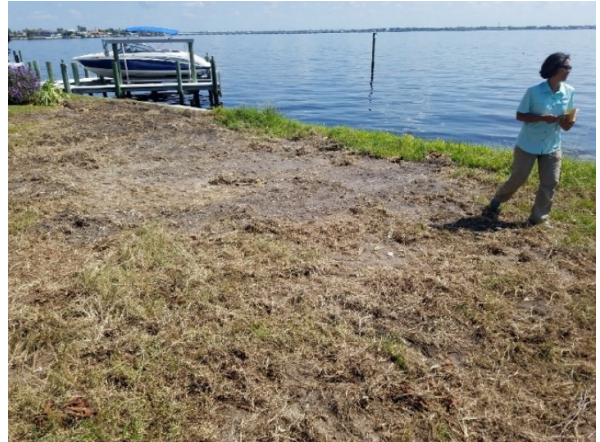
These are some highlights of storm Irma-related failures that occurred quite nearby to the regions that the crew assessed for hurricane Ian. The GEER team (figure 2.13) discovered that one property's seawall was in poor condition. The failures are defined in detail. The barrier rotated with areas that were noticeably out of line in the longitudinal direction because the seawall's foundation appeared to be eroding. The wall was partially immersed in the canal in some places. Cape Coral Beach, which is located in the southern part of the city, was also surveyed by the GEER team (figure 2.14). The beach's surface and the areas

Figure 2.14: Surface erosion in Cape Coral. Coordinates: 26.596114, -81.926528 (Stark & Hudyma, 2017)

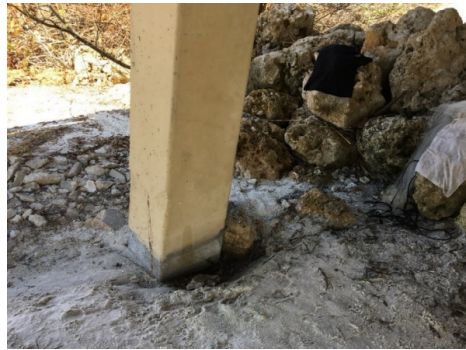
Figure 2.16: Bridge scour at the base of the piers, Big Carlos Pass Bridge. Coordinates: 26.404081, -81.878197 (Stark & Hudyma, 2017)

near the ocean were undermined by the storm surge. The storm surge eroded the beach's surface and the places around the water. The side of state road 865 in Fort Myers, which runs parallel to the shoreline, shows signs of beach erosion and deposition as well (figure 2.15). The team also inspected the Big Carlos Pass drawbridge (figure 2.16) and found that the southernmost bridge pile had around 9 inches (23 cm) of scour. Riprap stopped the abutment from being destroyed. GEER did not find any significant structural damage to the bridge while they were there (Stark & Hudyma, 2017).

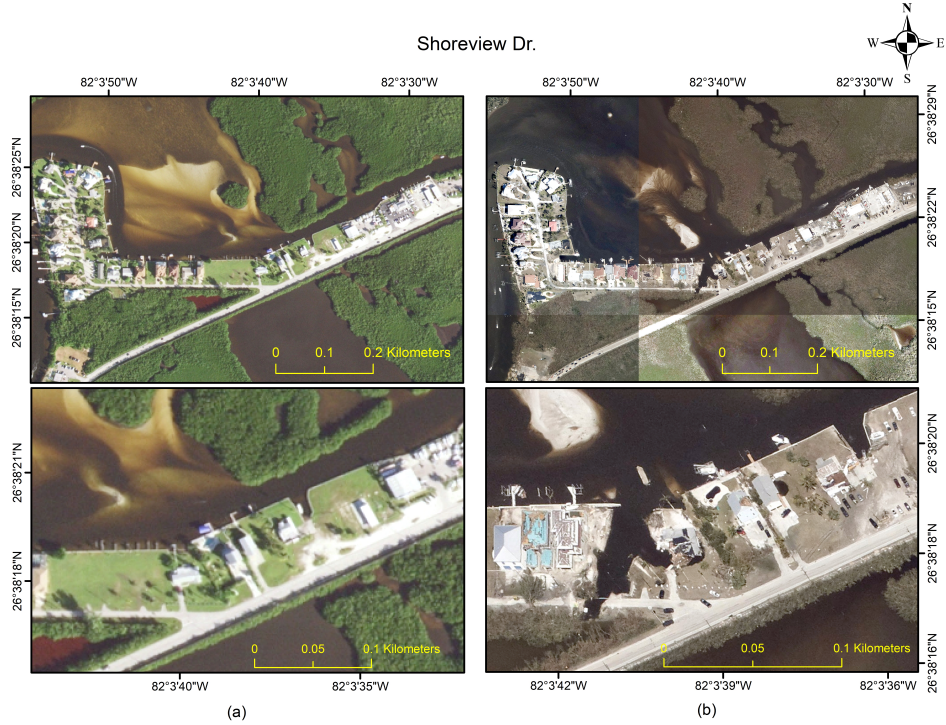
Shoreview Drive, technically in Matlacha Isles-Matlacha Shores, is a road that forks off Pine Island Road (the main road leading to Pine Island) with a small residential community. As illustrated in pre-and post-event satellite imagery in figure 4.2, a section of the sea wall and Shoreview Drive were destroyed, making the road impassable immediately following the event. Notably, there was no damage observed to Pine Island Road near Shoreview Drive or nearby drainage infrastructure (e.g. culvert), though the damaged section of road does intersect with a small contained body of water (swamp) within this land bridge and eroded regions behind the failed sea wall. This suggests that the failure of the sea wall likely initiated erosion that retrogressed from the failed seawall towards Shoreview Drive, though it remains unclear how the presence of the swamp, configuration of homes, or potentially localized storm surge effects in this relatively unprotected section of Matlacha Isles-Matlacha Shores (e.g. fewer mangroves and open bodies of water on both sides) contributed to the failure of the sea wall and damage to the road on Shoreview Drive.

Figure 4.2: Satellite photos of Shoreview Drive in Matlacha Isles-Matlacha Shores at different scales (top vs. bottom) a.)before and b.)after Hurricane Ian, where it can be seen that a section of the sea wall and Shoreview Drive were eroded away and made impassable immediately after the storm. Note that the home shown immediately west of the eroded region was under construction and is not shown pre-event satellite imagery.

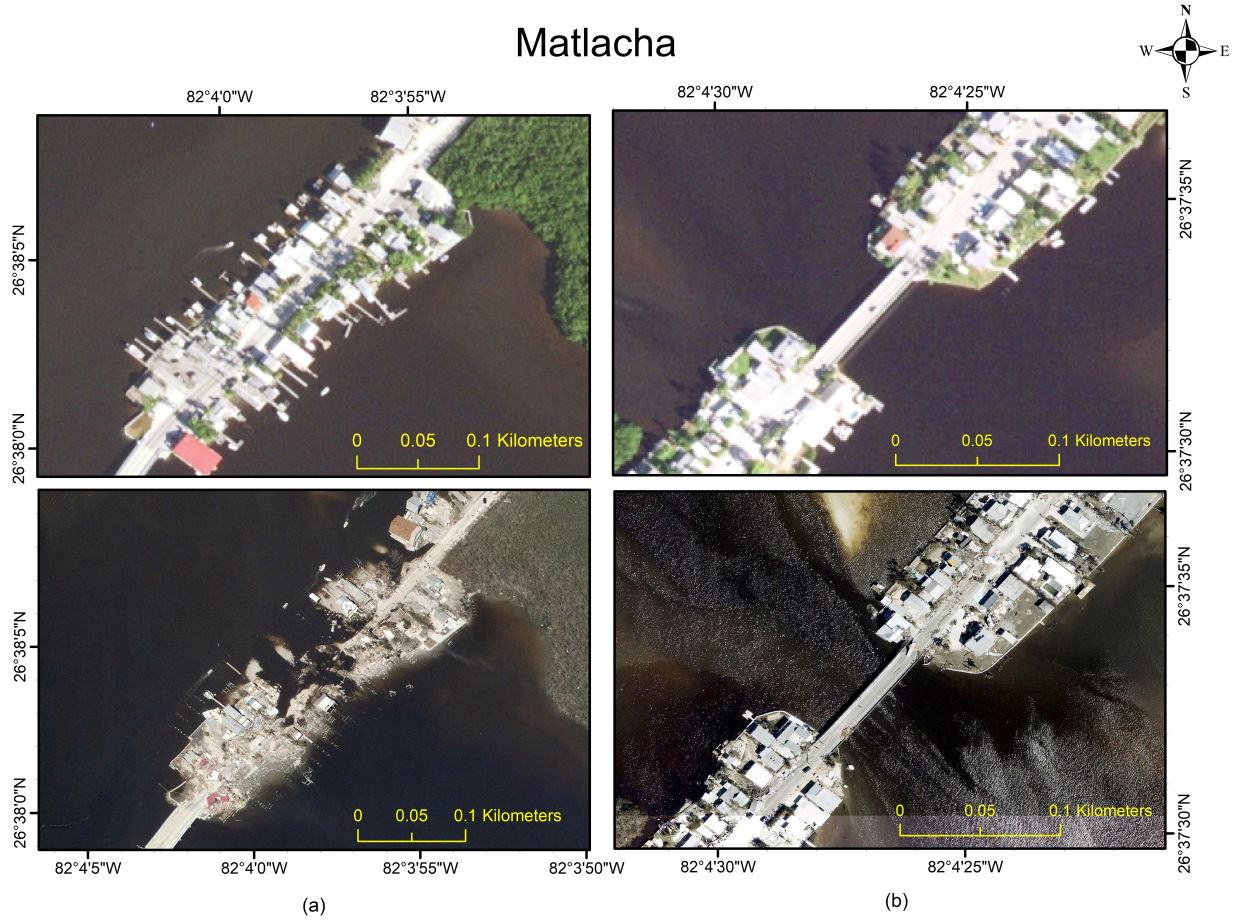
Figure 4.6 depicts an overview of the Matlacha region in the province of Pine Island. 4.6a. refers to the substantial damage the Island's east-facing entrance has sustained as a result of the storm surge's intensification. When the GEER team was investigating the area, the Matlacha entrance bridge on the east side had already been built. The construction of a temporary bridge began on October 3rd, 2022. The FDOT sent out more than 130 vehicles and laborers to work around-the-clock to help Lee County with the repairs. A temporary road linking Matlacha and Pine Island was built on October 4th, 2022, and was primarily used by the electrical and infrastructure trucks. Access to the Matlacha-Pine Island area was restricted and checkpoints were being manned by law enforcement. The bridge's construction was finished on October 8th, 2022, and the island was then accessible to all locals, business owners, emergency responders, and surveying teams.

Figure 4.6: Pre- and post-event (top vs. bottom) satellite images of a.) the east entrance onto Matlacha and b.) west entrance onto Matlacha.

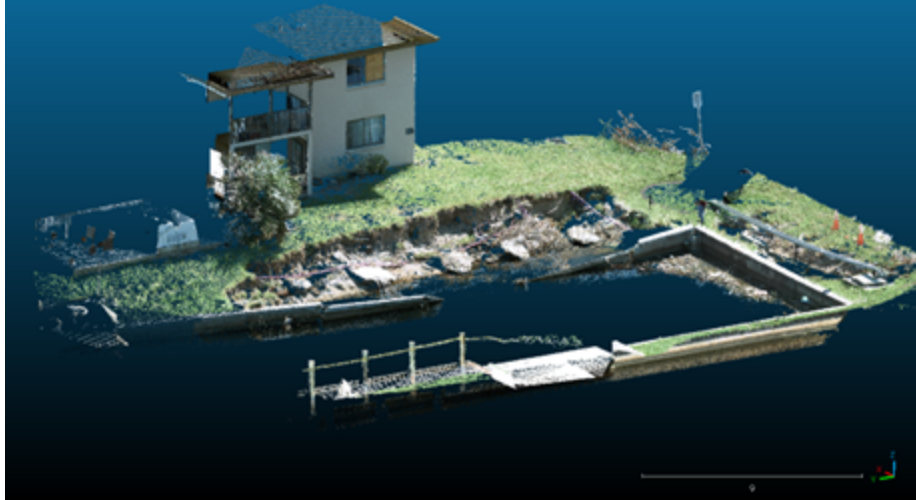
Figure 4.18 shows a terrestrial LiDAR image taken at the site where the magnitude of this event is more visible.

Figure 4.18: Cape Coral: Terrestrial LiDAR scan of a canal retaining wall in a residential neighborhood. Coordinates 26.564127, -81.963464

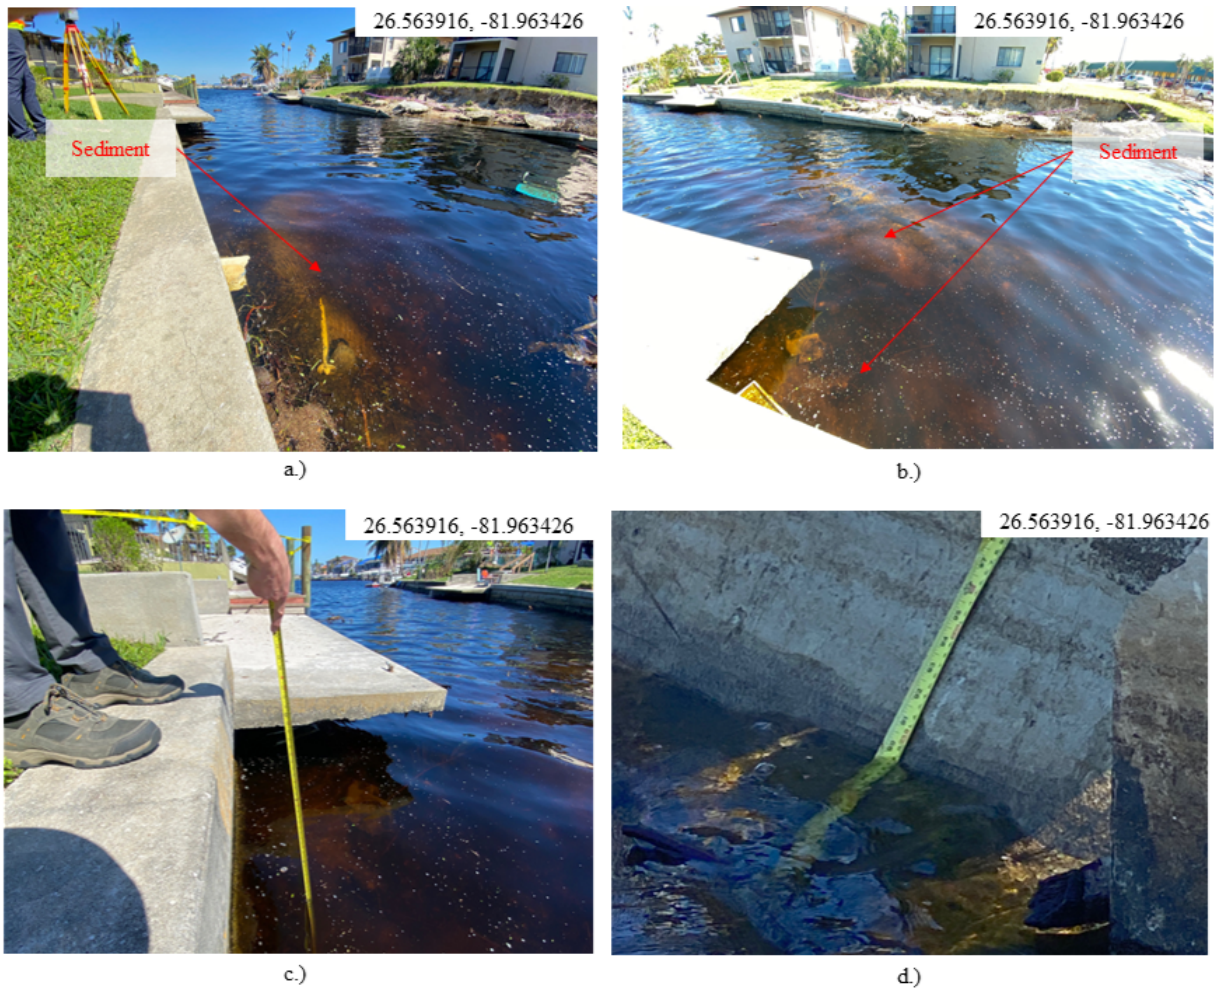
GEER team also observed massive sediment transportation in the canal which is depicted in figure 4.19. In the case of the retaining wall failure, the sediment transport analysis showed that the path of the storm was directly in the canal. The water flow and associated sediment transport were intensified in this particular location, which could have contributed to the erosion and failure of the retaining wall. The depth of sediment to the water surface was measured as shown in figure 4.19c-d.

Figure 4.19: Post-hurricane sediment transport analysis of a canal in Cape Coral showing significant accumulation of sediment, indicating the path of the storm

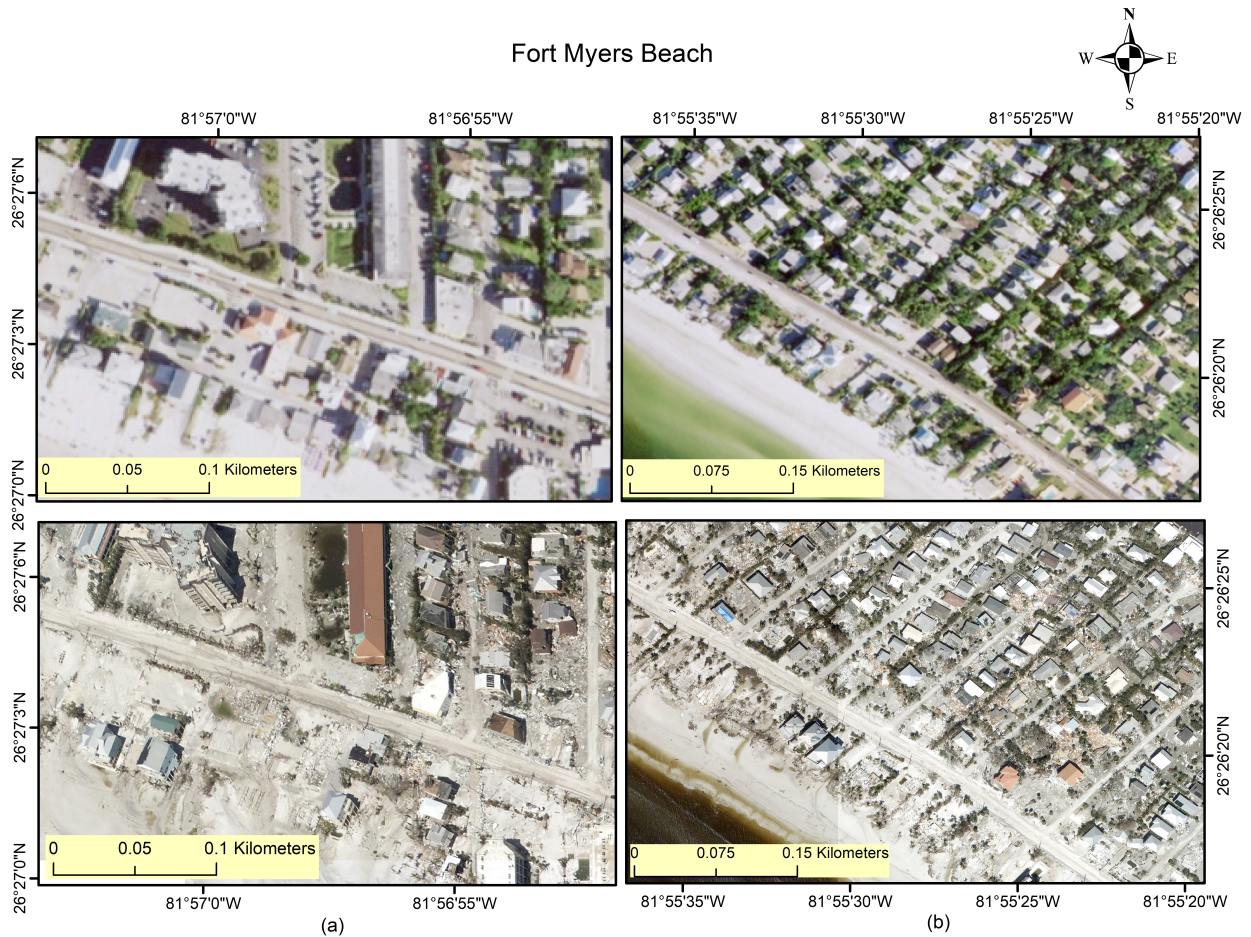
The impact of Hurricane Ian on Fort Myers Beach is illustrated in Figure 4.25, which shows a before-and-after comparison. Notably, the figure highlights the location of an erosion-induced sinkhole, as shown in Figure 4.25a. However, the majority of the damage observed on the beach was related to structural damage caused by the hurricane.

Figure 4.25: Overview of Fort Myers Beach

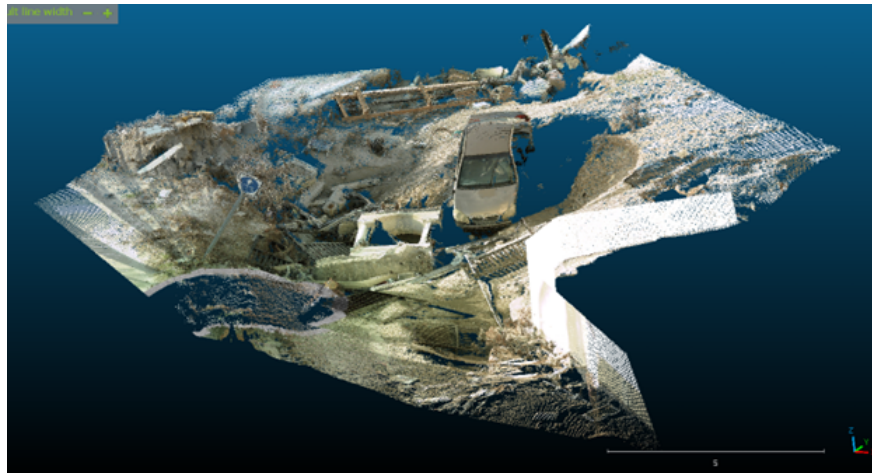
Figure 4.29: Terrestrial LiDAR scan of depression feature adjacent to road and apartment building. Coordinates 26.446486, -81.937939

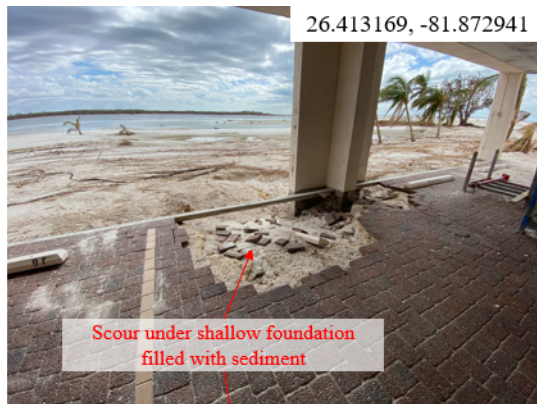
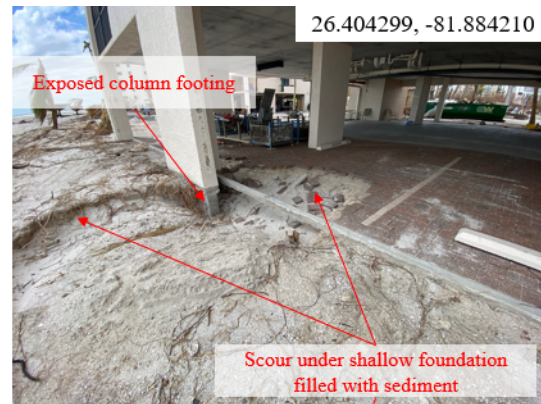
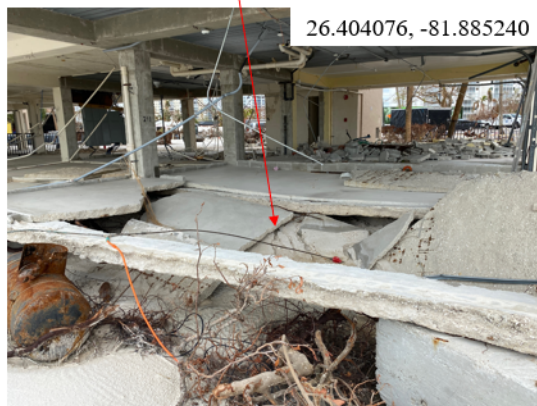
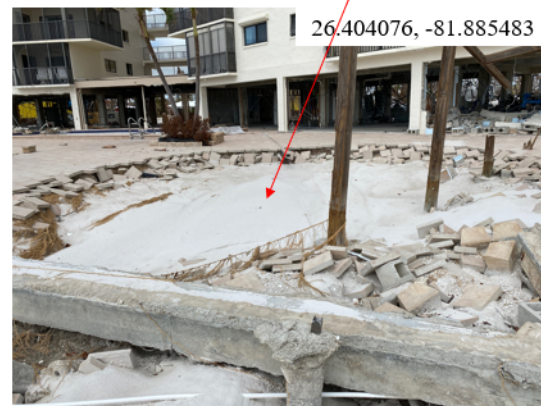
The influx of sediment can lead to the formation of empty cavities below the foundation. These cavities as shown in figures 4.32b-d, 4.34, 4.35 and figure 4.33b, when unsupported, further reduce the load-bearing capacity of the soil and increase the risk of foundation failure.

Figure 4.34: Ground photos of failures observed in south east end of the Fort Myers Beach island, at Carlos Point Condominium Associates: (a) erosion below the foundation of the condominium caused land subsidies which were filled with sediment transported by the storm surge: (b) exposed footings of a column and more scour underneath the shallow foundation causing cavities filled with sediment; (c) scour below the shallow foundation resulting in a cavity leading to a loss of support, cracks, and breakage; (d) scour underneath the foundation of the building causing the same breakage and cracking issues as cavities emerge and creates a ground depression resembling a sinkhole.

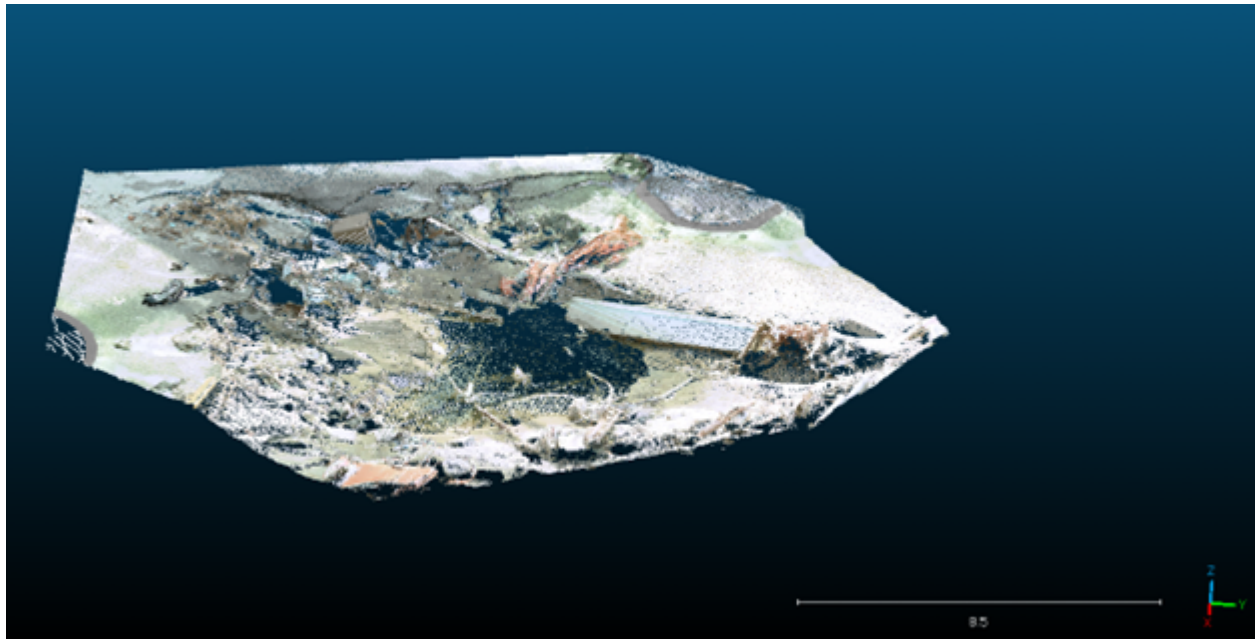
Figure 4.39: Terrestrial LiDAR scan of depression feature adjacent to road. Coordinates 26.450556, -81.949677

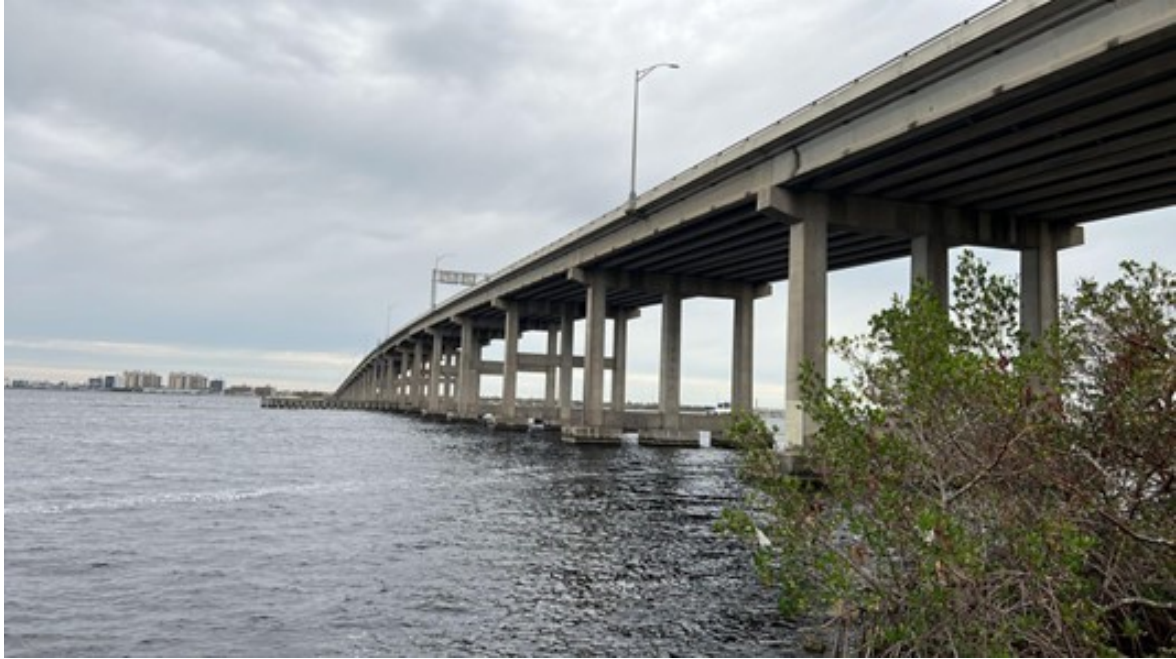
Figure 4.46: Caloosahatchee Bridge showing no sign of damage. Coordinates: 26.64413, -81.87405

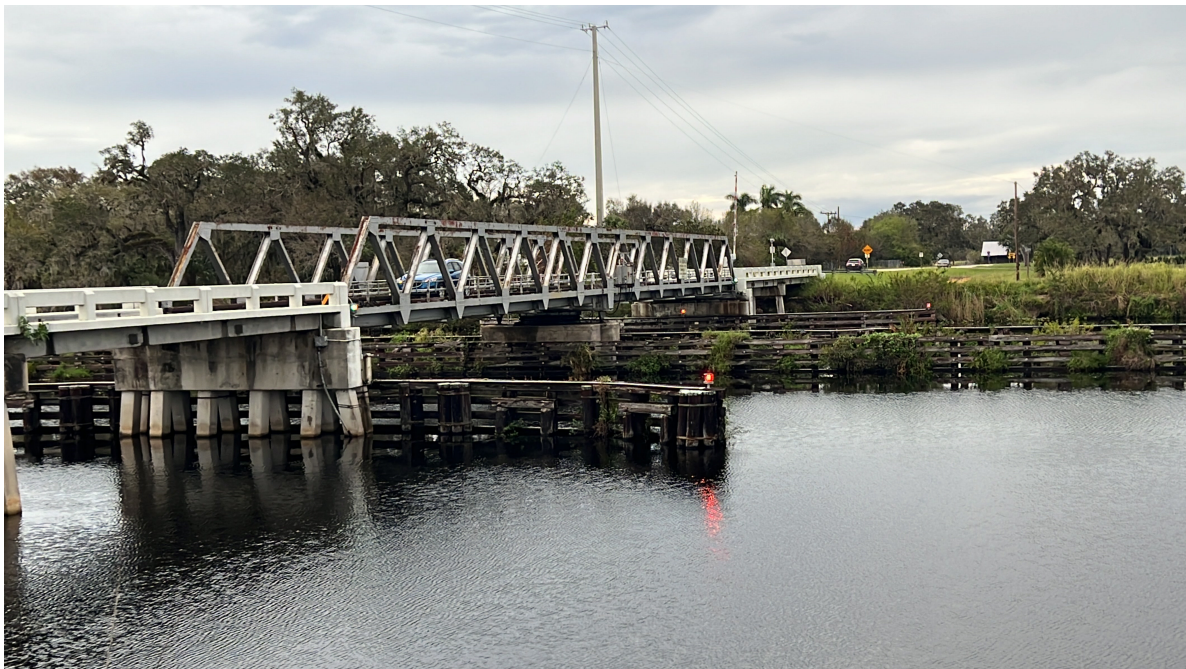
Figure 4.47: Fort Denaud Swing Bridge showing no sign of damage. Coordinates: 26.74411, -81.51015

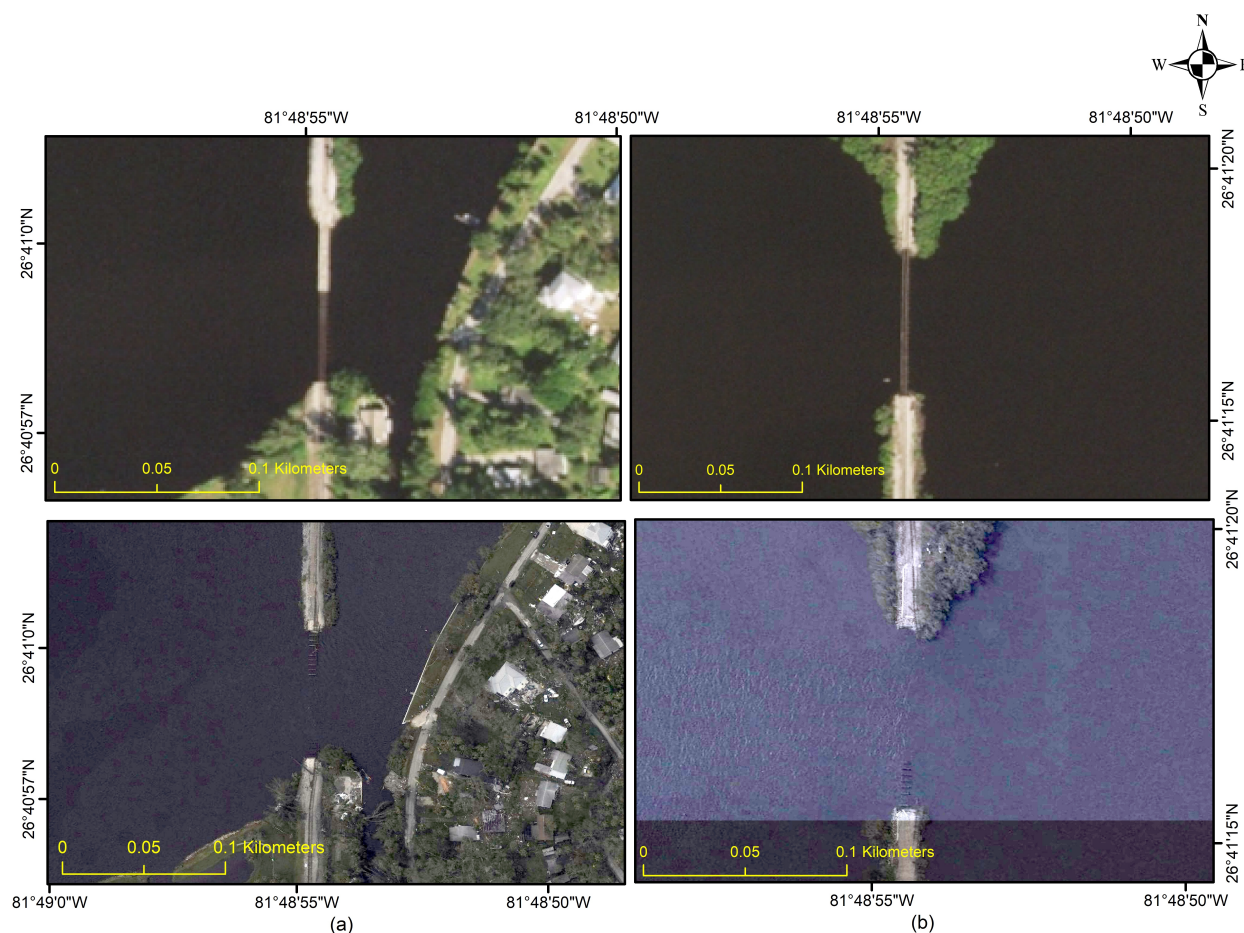
Figure 4.48, a satellite image depicting the Caloosahatchee railway system crossing Beautiful Island reveals the conditions before and after the hurricane's impact, highlighting the damage caused to the railway. As shown in figure 4.51, the storm pulled the tracks off of the piles and into the Caloosahatchee. Figure 4.50, shows the photogrammetry model of the damages transversing over Beautiful Island taken by the GEER team.

Figure 4.48: Satellite Images of Beautiful Island Rail Bridge before and after Hurricane Ian

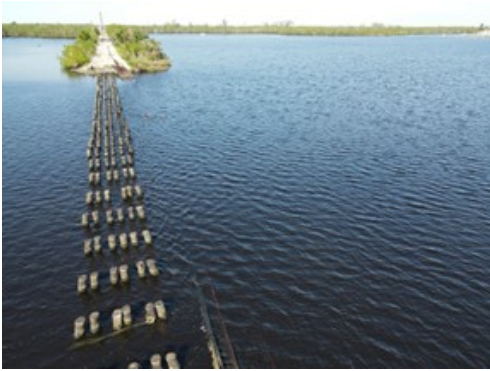
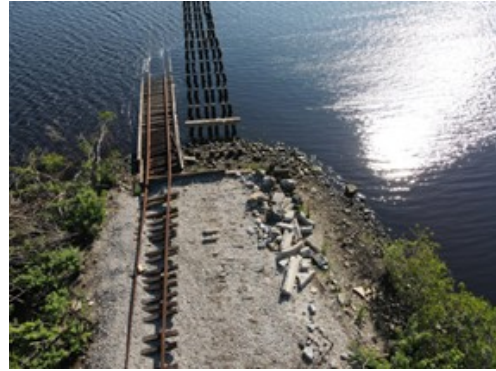
Robert Fay, who owns and operates the railway, expected bridge reparations to take a month and a half once funding is secured. However, by November 29, bridge repairs had not yet begun.

Figure 4.49: Beautiful Island Rail Bridge on November 29. Coordinates: 26.6928137, -81.8124748

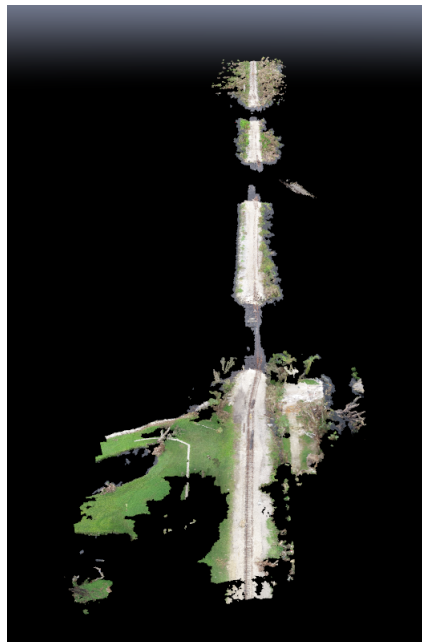
Figure 4.50: Structure from Motion photogrammetry model of rail bridge failure across the Caloosahatchee River. Coordinates: 26.6922922, -81.8123293

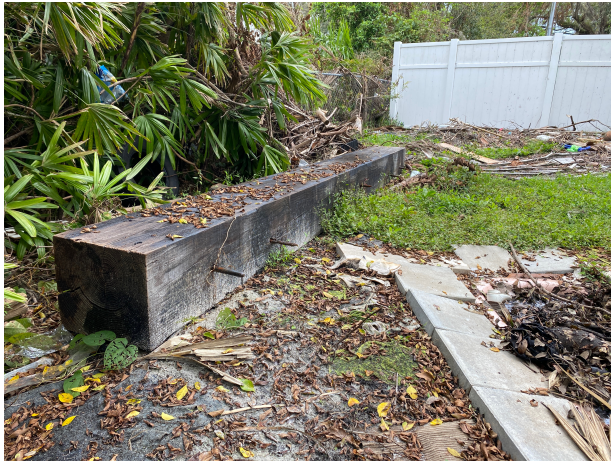
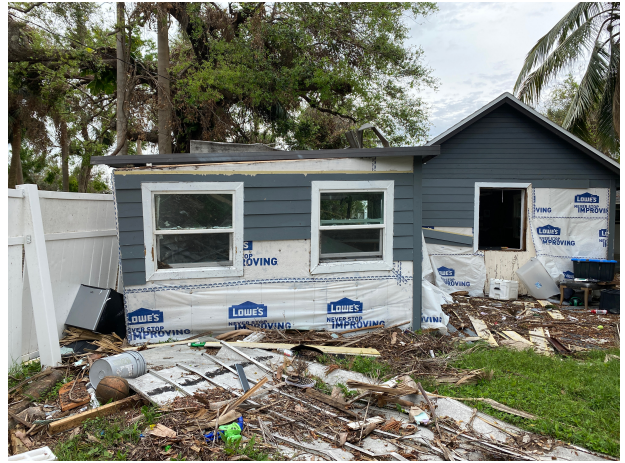
Figure 4.51: Beautiful Island residential area: (a) Railroad cross beam carried by waves through a house garage. Coordinates: 26.682601, -81.814131; (b) Destroyed garage due to wave power and impact of railroad cross beam debris. Coordinates: 26.682601, -81.814131

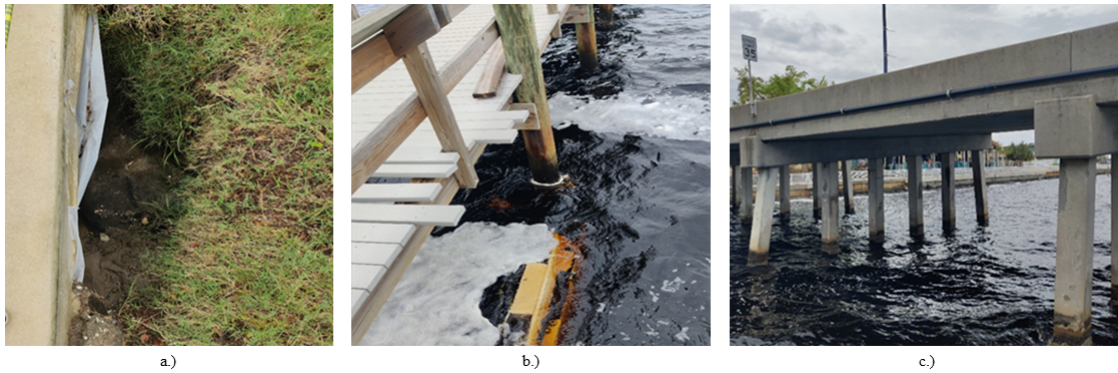
The bridges and piers along Peace River are investigated, starting from Punta Gorda and ending at Arcadia. Figure 4.53 shows the disaster reconnaissance route along Peace River. The GEER team observed surface erosion by the riverside of Peace River at Punta Gorda. Around the same location, damaged fishing pier was found, however, no scour or sinkhole were observed. No geotechnical or structural damages were found when driving towards the inland area. Figure 4.52 shows some of the observations in this area.

Figure 4.52: Observations along Peace River: (a) Surface erosion along the riverside of Punta Gorda, Coordinates: 26.93235, -82.05837; (b) Broken pier along the riverside of Punta Gorda, Coordinates: 26.93351, -82.05694; (c) No damage observed at Barron Collier Bridge, Punta Gorda, Coordinates: 26.93689, -82.05460

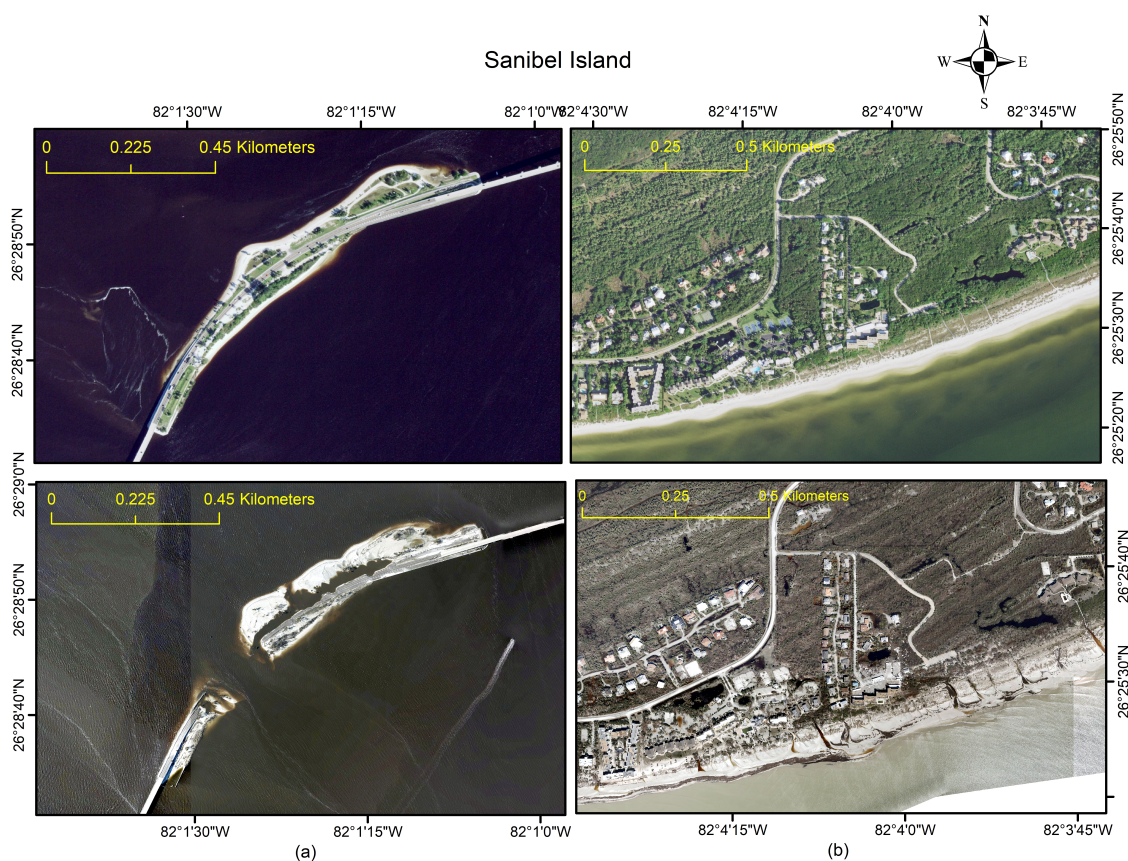
Figure 4.54: Satellite photos of some damages in Sanibel Island (top vs. bottom) a.) Sanibel Causeway and b.) Shoreline of Sanibel Island

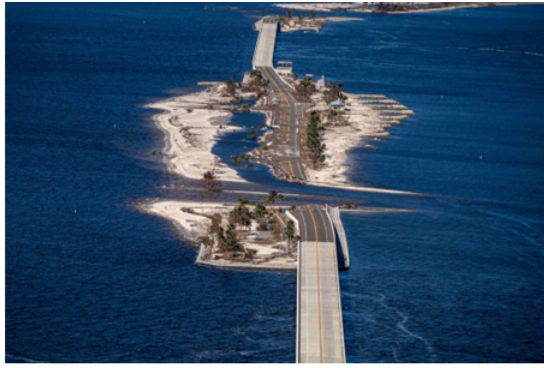
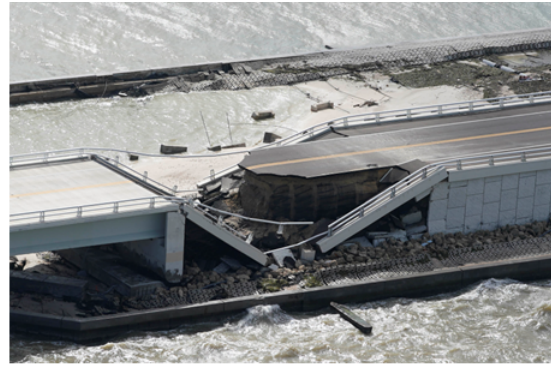
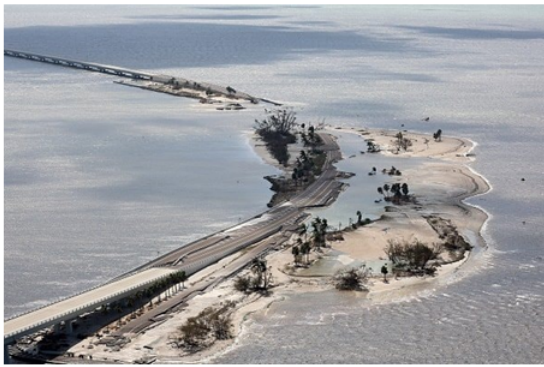
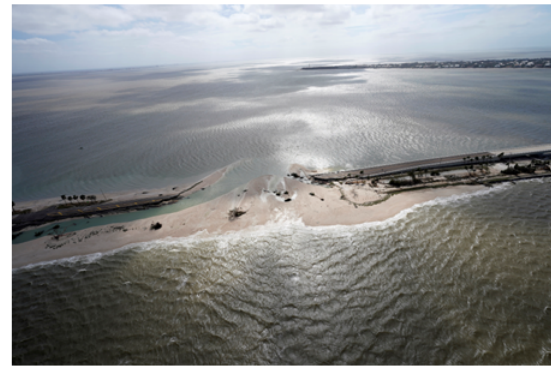
Figure 4.55: Drone photos of Sanibel Causeway: (a) picture taken on Friday, Sept. 30, 2022, by Ricardo Arduengo from Agence France-Presse; (b) picture taken on Thursday, Sept. 29, 2022, by Wilfredo Lee, distributed by the Associated Press; (c) picture taken on Thursday, Sept. 29, 2022, by Wilfredo Lee, distributed by the Associated Press; (d) picture taken on Thursday, Sept. 29, 2022, by Joe Raedle. Coordinates: 26.48339, -82.01301

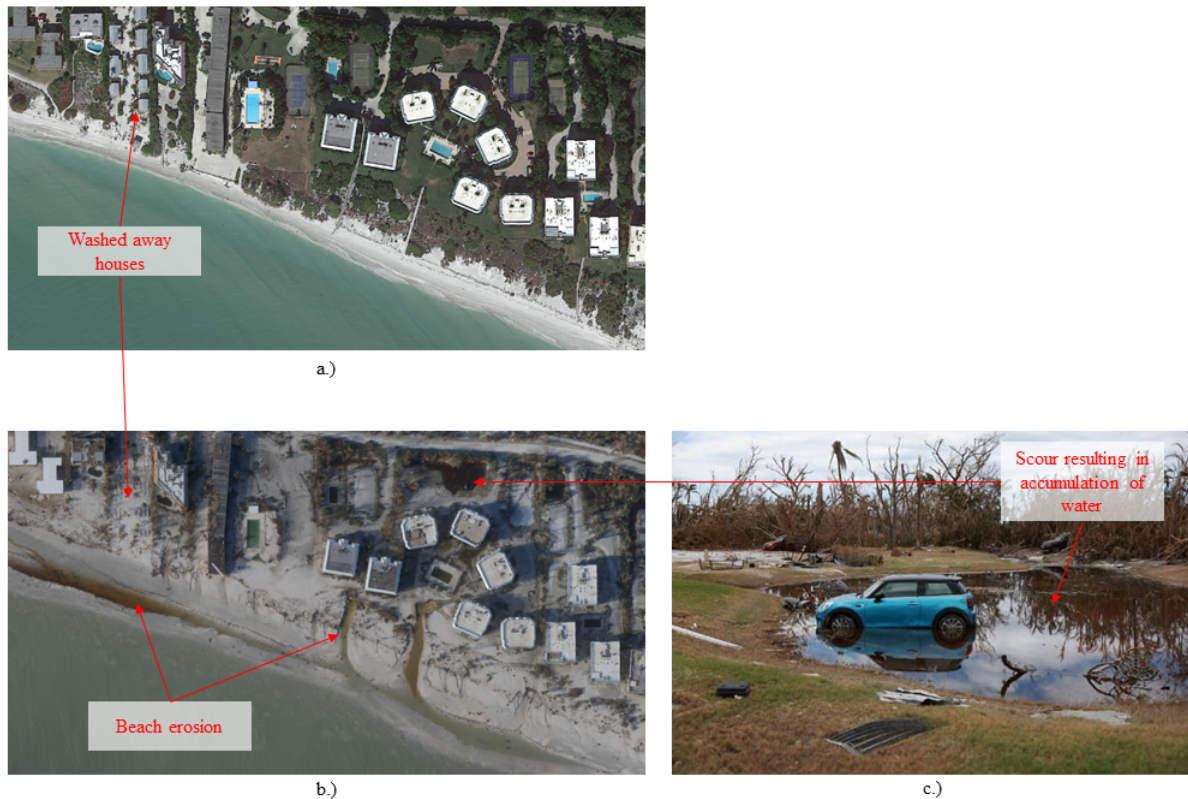
Hurricane Ian also caused the structural collapse, and Sanibel Island experienced several instances of structural collapse. The damage caused by the hurricane was so severe that many buildings on the island were leveled to the ground. The collapse of these structures required extensive repairs or rebuilding efforts, further adding to the economic toll of the hurricane on the island. In addition to the structural damages observed on Sanibel Island, it was apparent that beach erosion had occurred across the shoreline. This erosion was particularly pronounced along the walkway paths of houses, where the waves and storm surge had eroded the sand as shown in figure 4.56.

Figure 4.56: Effects of Hurricane Ian on Sanibel Island's shoreline: (a) pre-hurricane satellite photo; (b) post-hurricane satellite photo showing extreme beach erosion more pronounced on the path of the walkways; (c) ground depression and accumulation of water. Coordinates: 26.42657, -82.10010
