Initial Geotechnical Observations of the August 17, 1999, Kocaeli Earthquake

**A report of the Turkey-US geotechnical earthquake engineering
reconnaissance team**

September 3, 1999

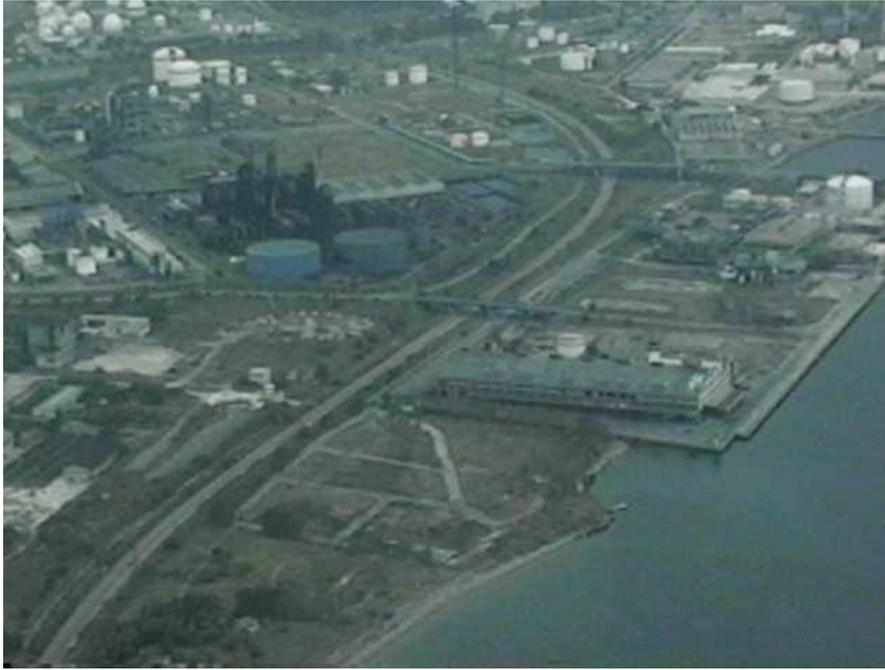
Overview of the TUPRAS refinery along the Izmit Bay after the fire that started right after the earthquake on August 17, 1999 (N40°45.938', E29°33.684', 8/24/99, 15:23:17).

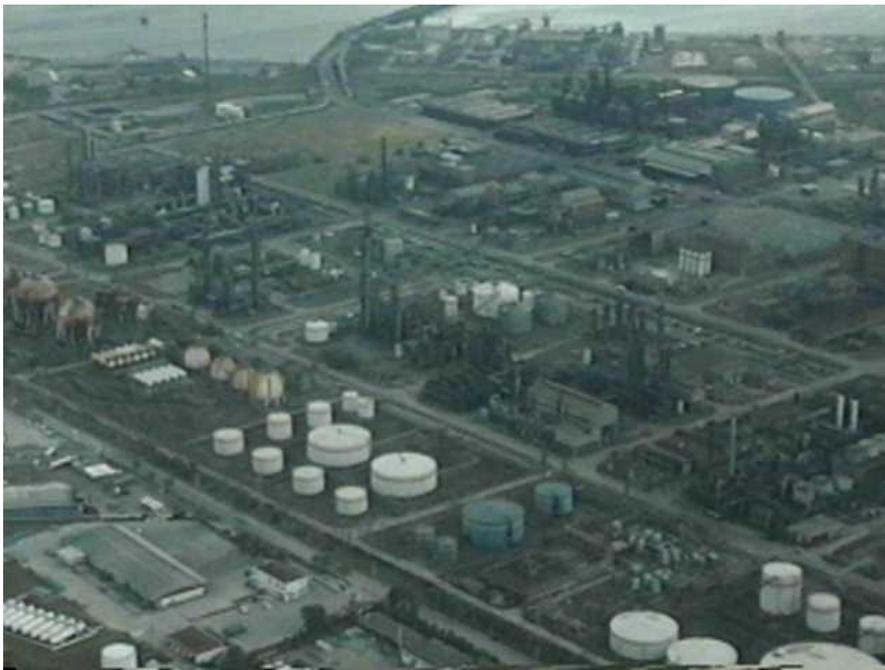
View of the TUPRAS refinery along the Izmit Bay after the fire that started right after the earthquake on August 17, 1999 (N40°45.938', E29°33.684', 8/24/99, 15:23:17).

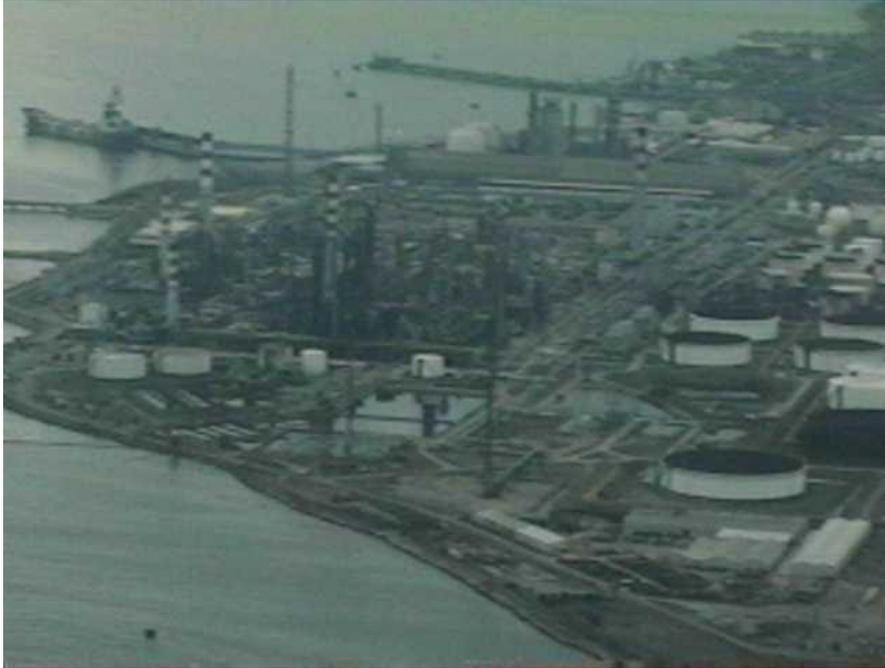
View of the TUPRAS refinery along the Izmit Bay after the fire that started right after the earthquake on August 17, 1999 (N40°43.07', E29°42.118', 8/24/99, 16:49:11).

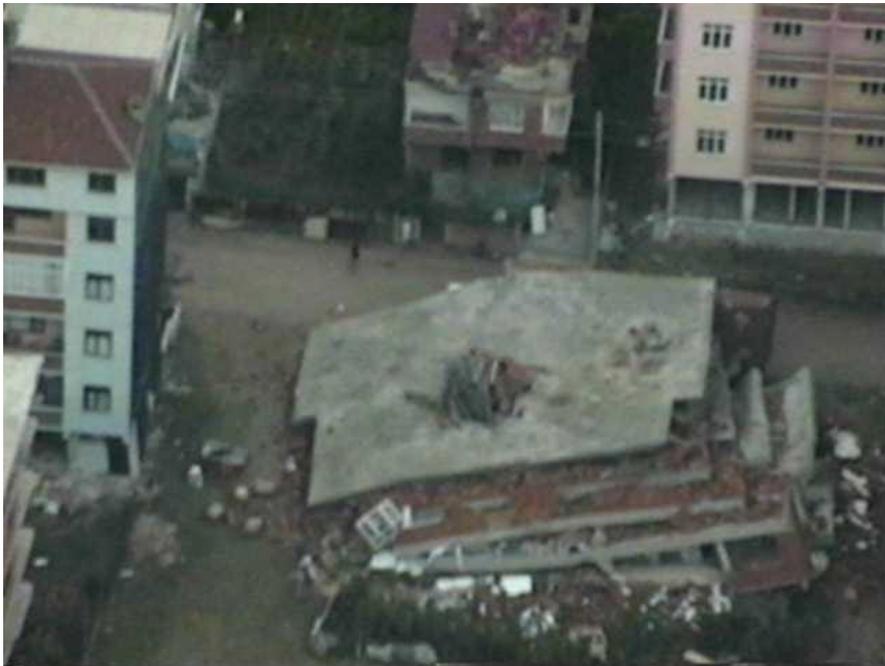
Collapse of a reinforced concrete apartment in the Izmit area. This type of failure was commonly observed after the earthquake, and caused many casualties (N40°45.759', E29°51.987', 8/24/99, 15:27:36).

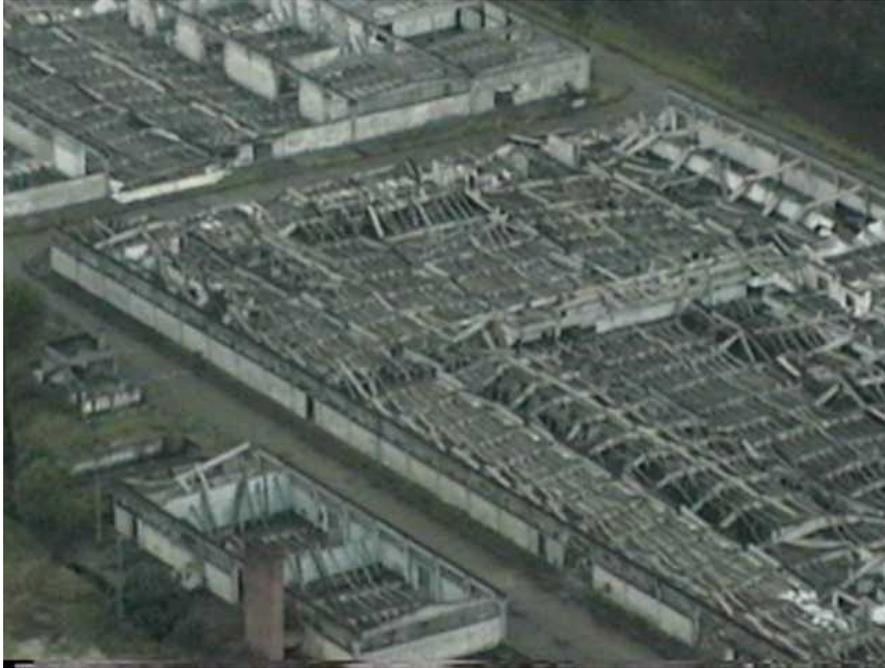
The roof of this warehouse in the Izmit area caved in due to the earthquake shaking. The Izmit bay area is the heart of Turkey's industry (N40°45.406', E29°58.063', 8/24/99, 15:31:05).

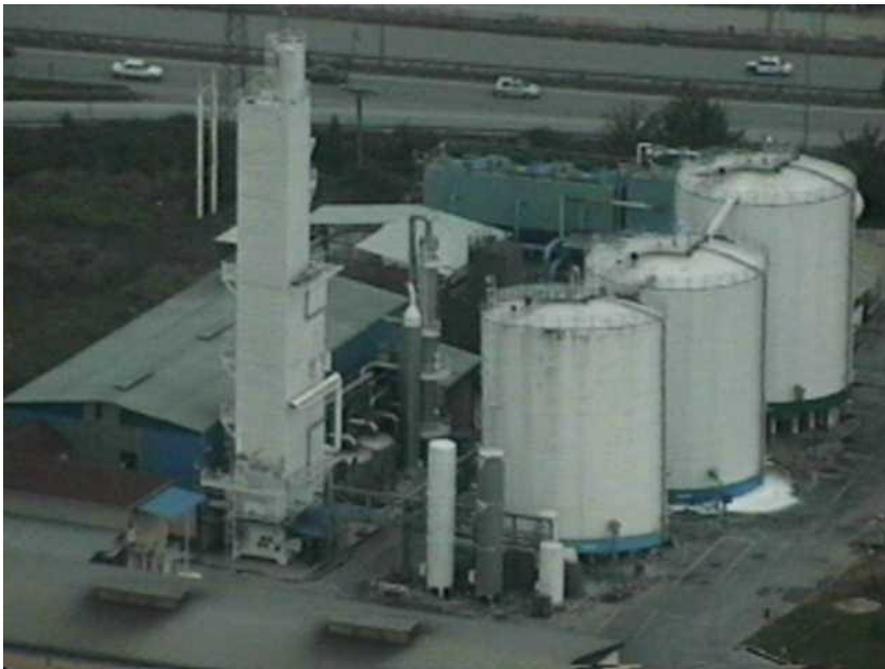
Damage to the middle tank of this chemical plant in the Kosekoy area. The short-column support of the middle tank collapsed and the tank leaned slightly and leaked (N40°45.549', E30°02.344', 8/24/99, 15:33:25).

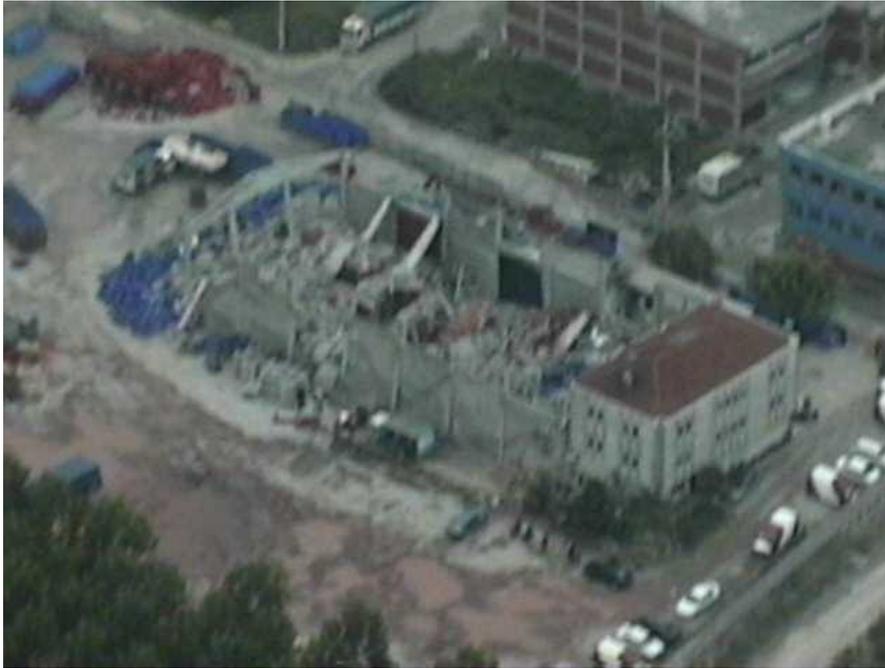
Collapse of the roof of a small factory to the west of the Sapanca Lake close to Arifiye (N40°44.223', E30°23.811', 8/24/99, 15:45:35).

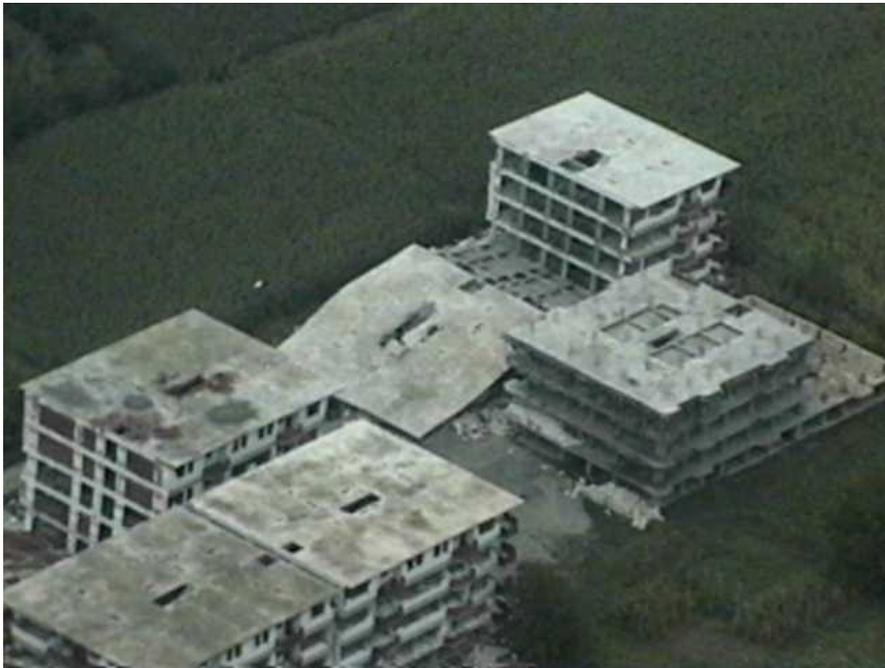
One of these apartment buildings collapsed laterally while the others withstood the earthquake forces (Arifiye area, N40°46.329', E30°24.328', 8/24/99, 15:47:42).

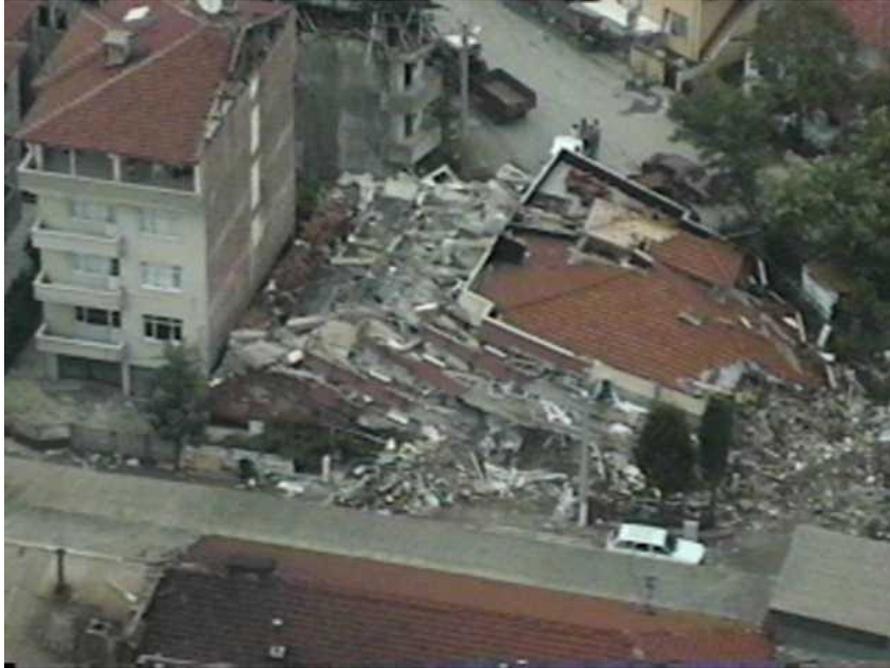
Lateral collapse of an apartment building next to an intact building in Adapazari (N40°47.811', E30°22.625', 8/24/99, 15:54:29).

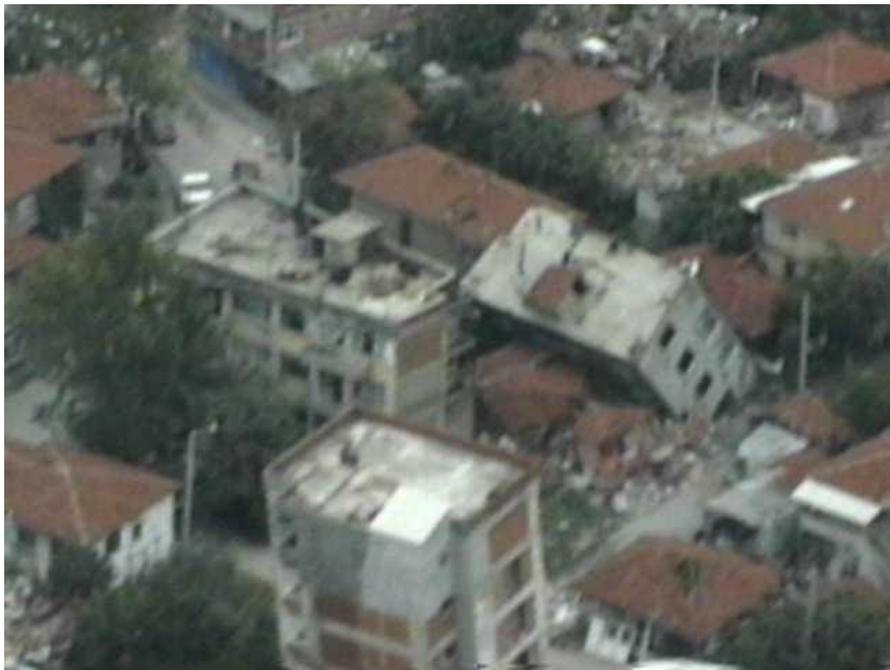
An apartment building leaned sideways against another building in Adapazari (N40°47.811', E30°22.625', 8/24/99, 15:54:29).

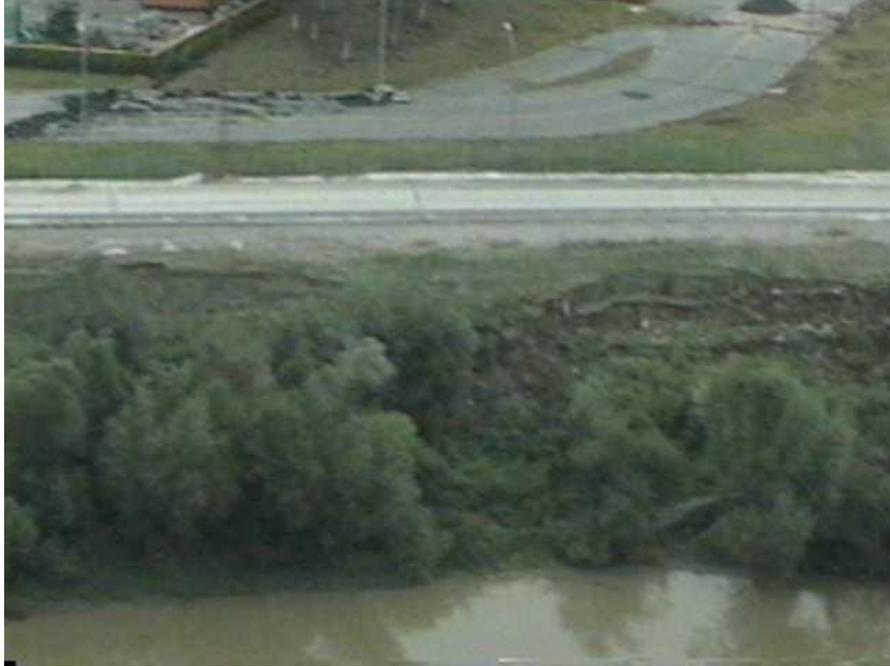
Lateral spread of the bank of the Sakarya river in the Arifiye area (N40°42.41', E30°22.808', 8/24/99, 16:26:18).

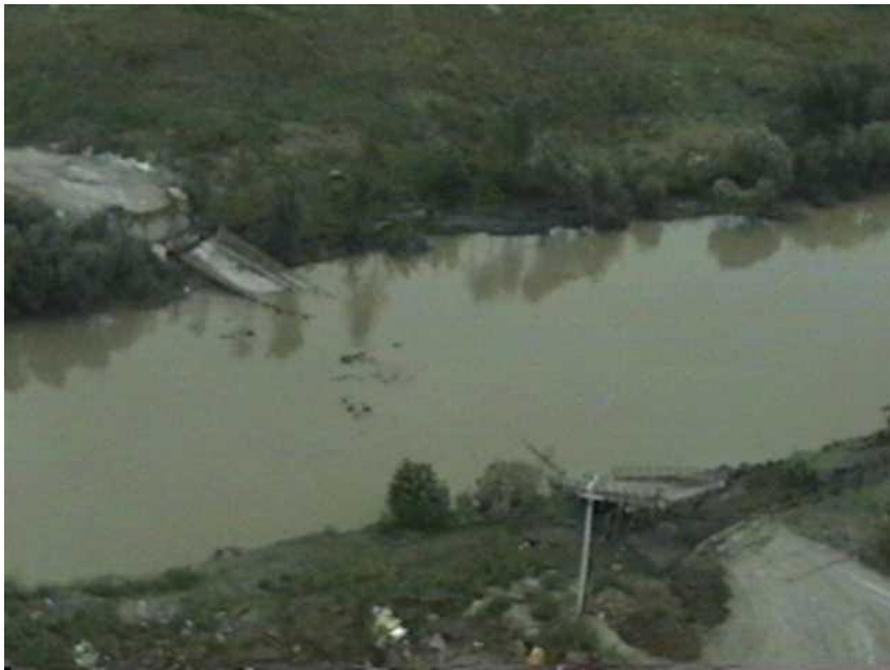
Collapse of the bridge on the Sakarya river in the Arifiye area (N40°42.41', E30°22.808', 8/24/99, 16:26:18).

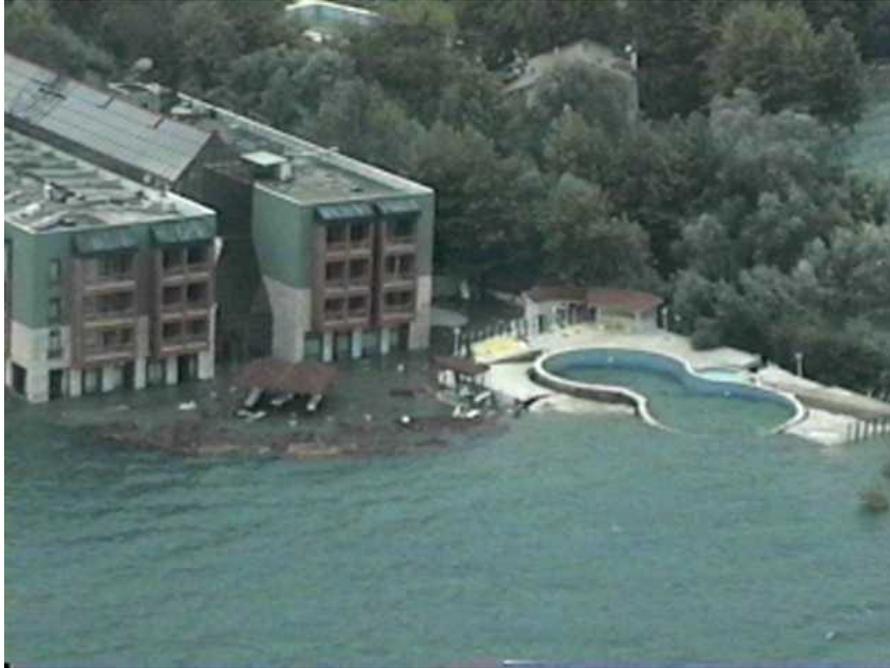
Subsidence of hotel Sapanca on the shore of the Sapanca lake (N40°41.448', E30°16.733', 8/24/99, 16:31:54).

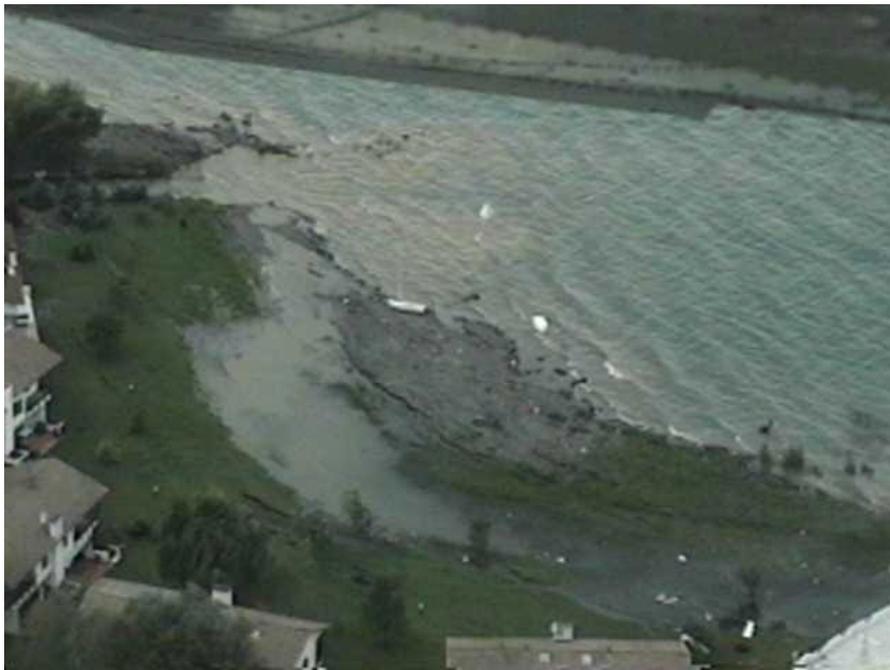
Lateral spread on the southern shore of Lake Sapanca (N40°41.448', E30°16.733', 8/24/99, 16:31:54).

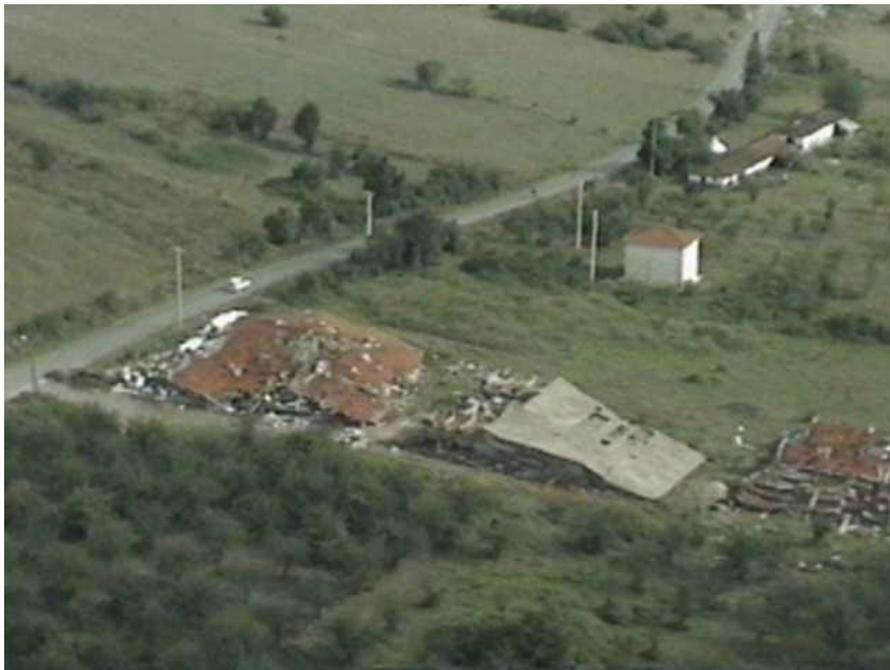
Three apartment buildings collapsed in the Arifye area (N40°42.829', E29°23.768', 8/24/99, 16:59:06).

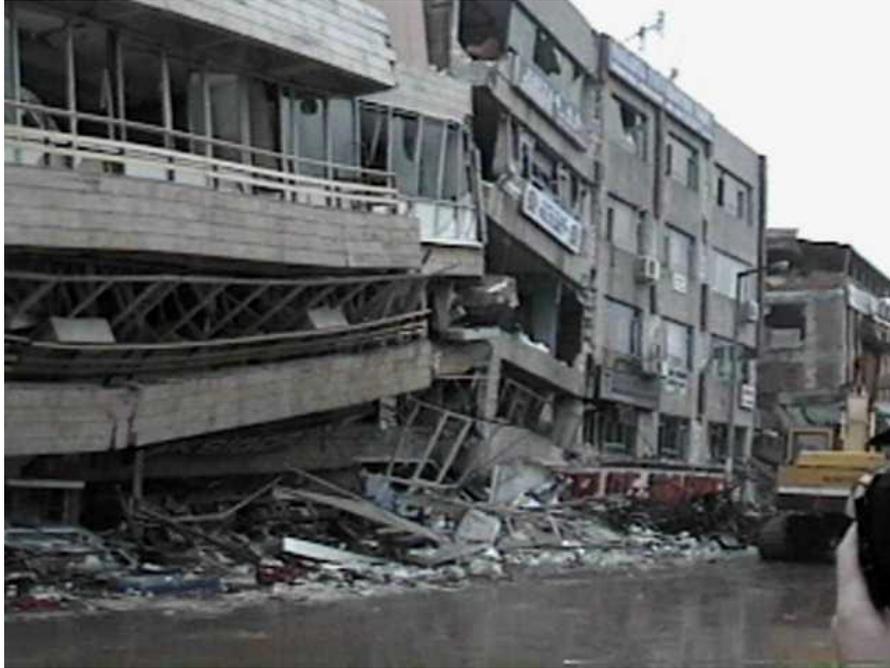
The bottom floors of the reinforced concrete office buildings collapsed in the city of Adapazari (N40°42.527', E30°21.62', 8/25/99, 10:43:17).

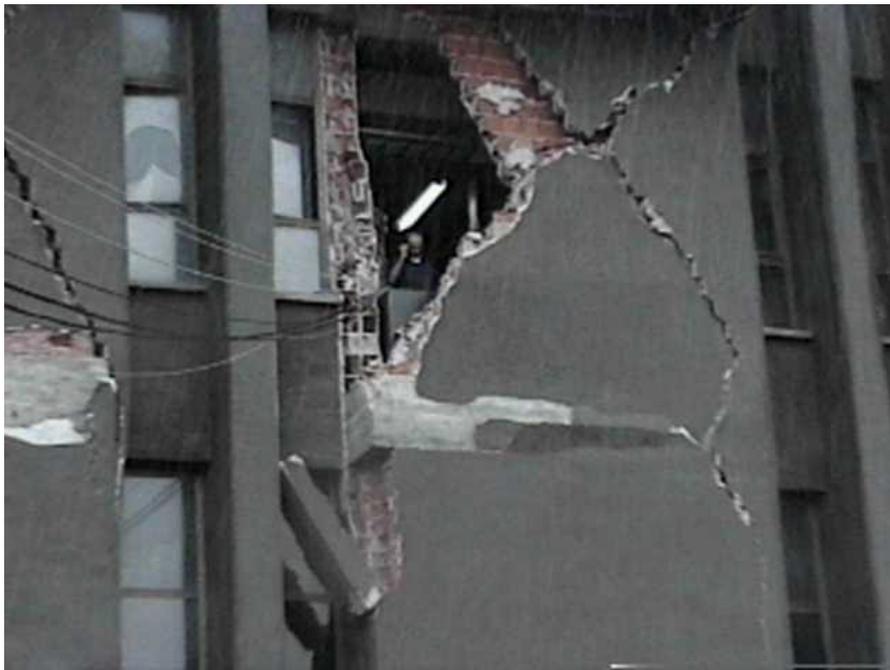
Electricity and telephone lines were operational on August 25, 1999 in some office buildings despite the extensive damage in Adapazari (N40°55.302', E29°21.011', 8/25/99, 11:25:55, poor GPS coverage).

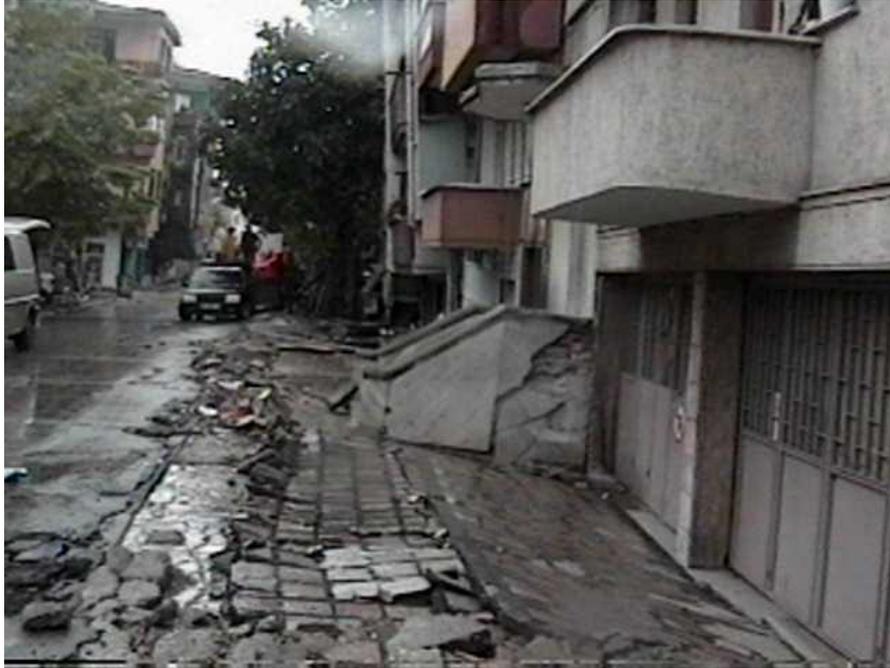
Settlement of building in downtown Adapazari. The staircase was sheared due to settlement (N40°55.202', E29°21.011', 8/25/99, 11:50:23). (The GPS has some problem).

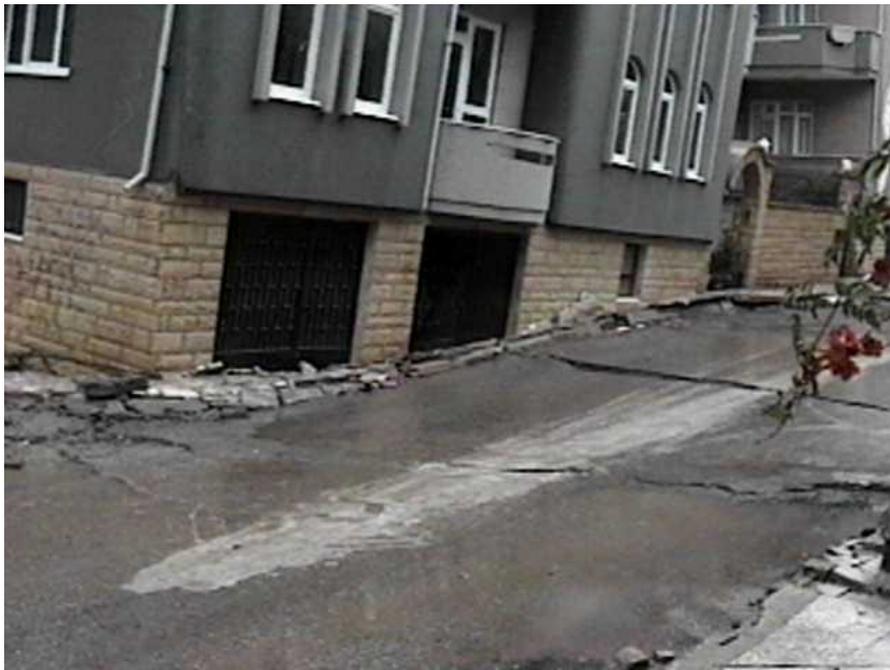
An apartment building in downtown Adapazari that has tilted due to differential settlement (N40°46.485', E30°23.807', 8/25/99, 11:53:51).

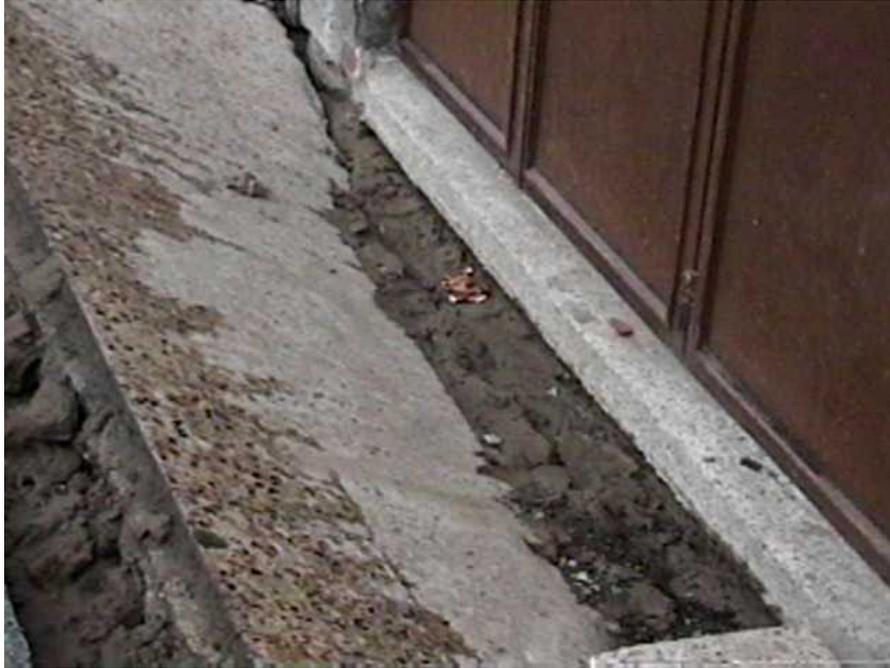
At the entrance of the garage door of an apartment building that has settled close to 1 foot, there were traces of silty soil which had been ejected during the earthquake. The sidewalk has caved in towards the building (N40°46.689', E30°23.762', 8/25/99, 12:01:29).

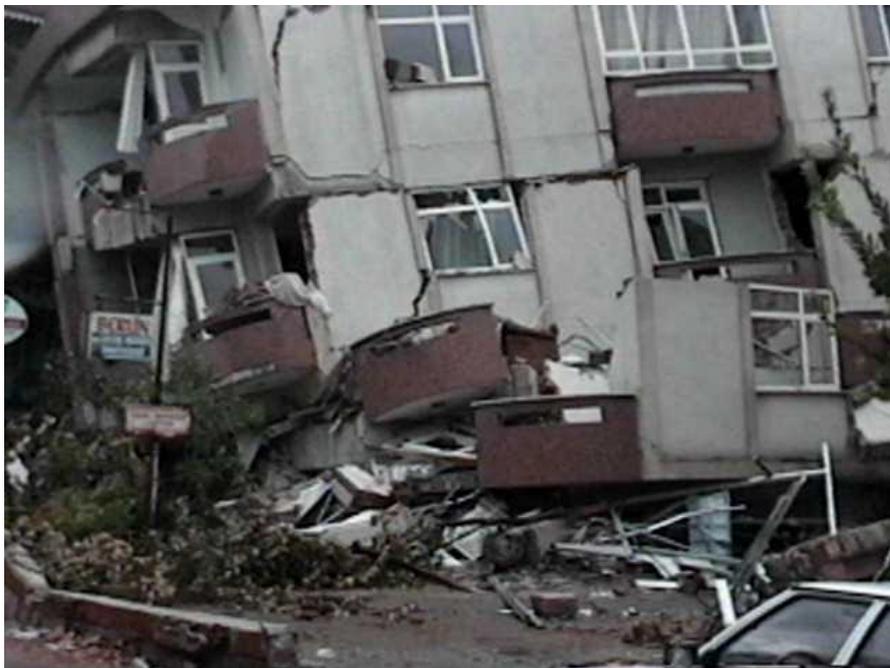
The collapse of the lower floors of an apartment building in Adapazari crushed a car (N40°46.716', E30°23.821', 8/25/99, 12:15:17).

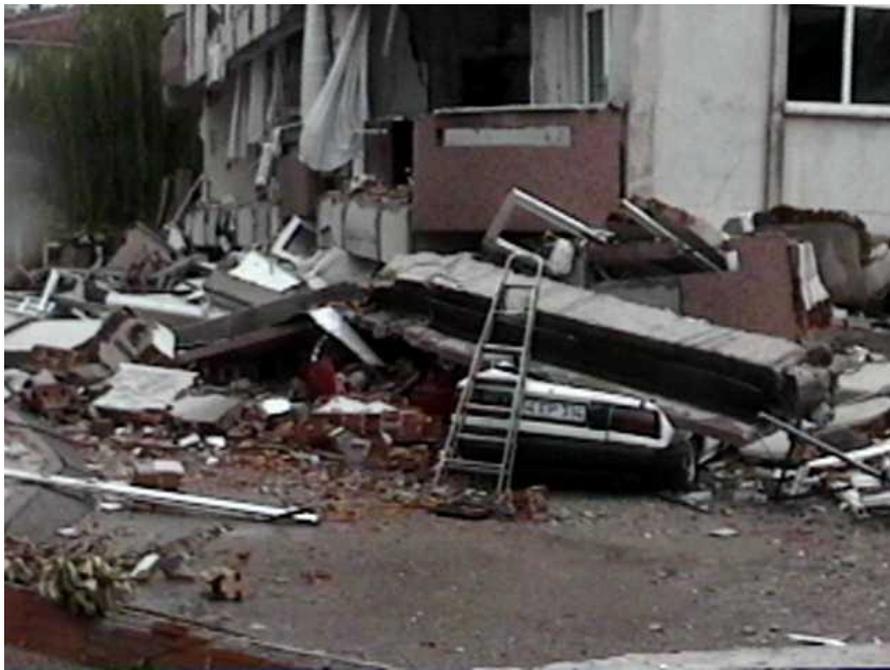
Many cars were crushed due to the collapse of buildings in Adapazari (N40°46.70', E30°23.778', 8/25/99, 12:19:03).

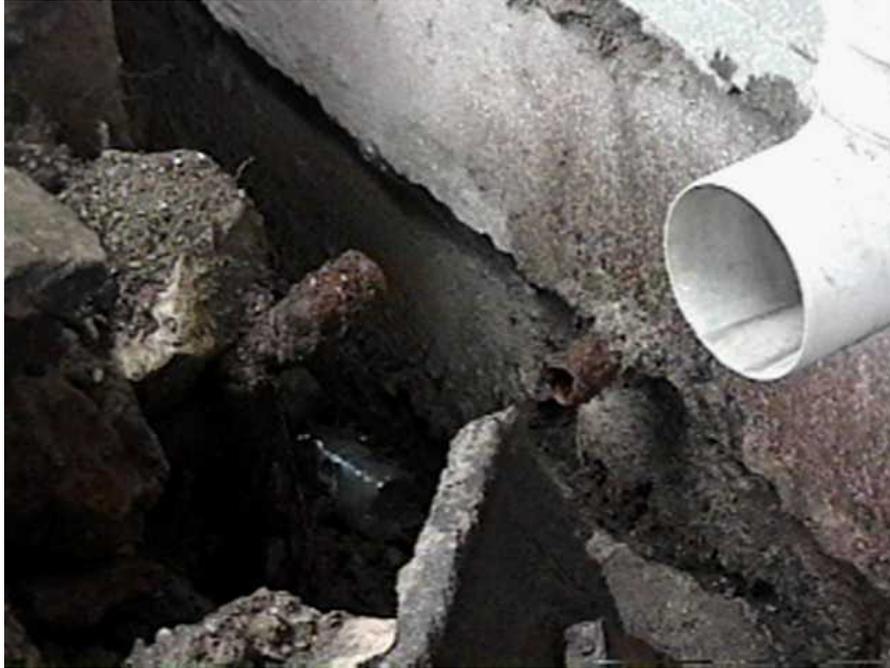
The buried metal pipe broke down at the interface between soil and building due to the building settlement and lateral movement (Adapazari, N40°47.038', E30°24.033', 8/25/99, 12:51:04).

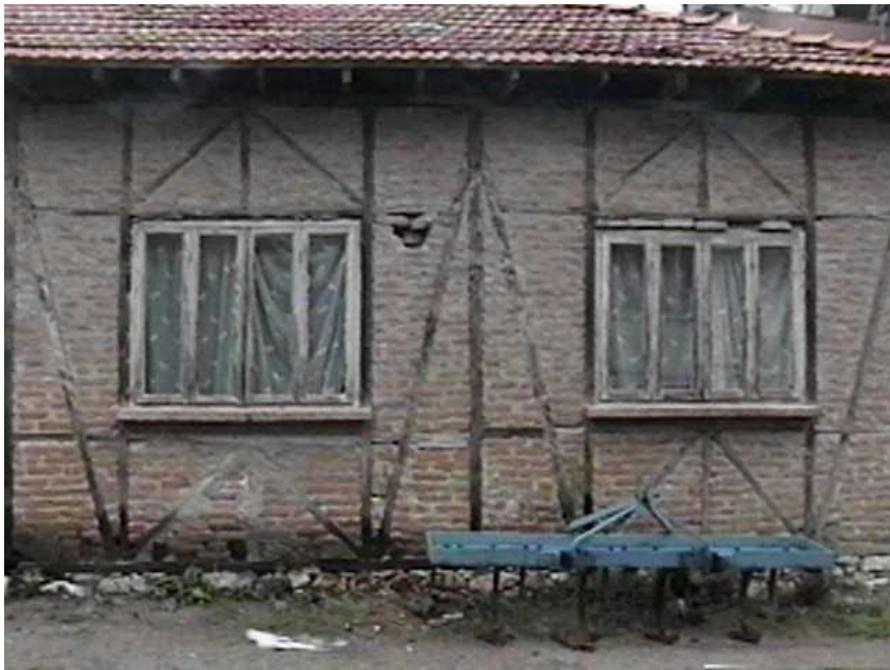
Some old wood structures with masonry brick infills performed remarkably well during the earthquake, whereas nearby more modern reinforced concrete buildings collapsed (Adapazari, N40°47.027', E30°24.085', 8/25/99, 13:18:20).

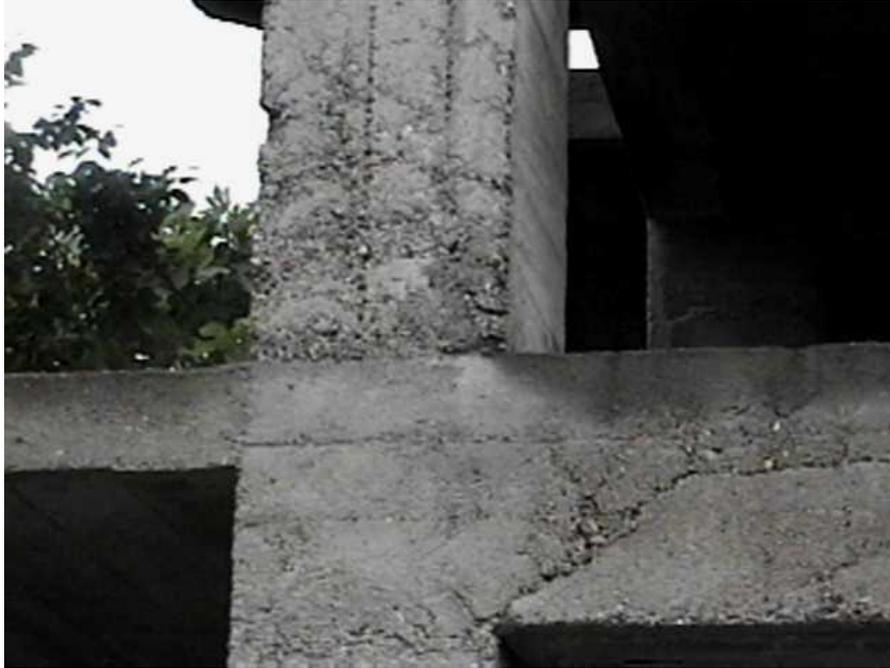
In some of the buildings under construction in Adapazari, building codes may not have been consistently enforced as demonstrated by the separation of aggregates and concrete at the column-beam junction (N40°47.027', E30°24.085', 8/25/99, 13:18:20).

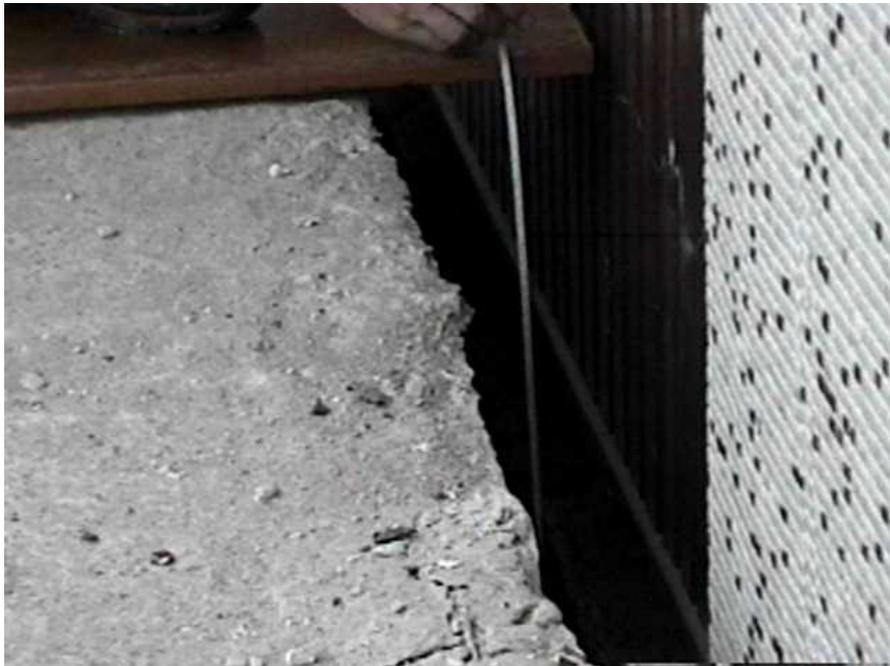
The building settled one foot and shifted laterally, blocking the entrance of the car garage (Adapazari, N40°47.027', E30°24.085', 8/25/99, 13:18:20).

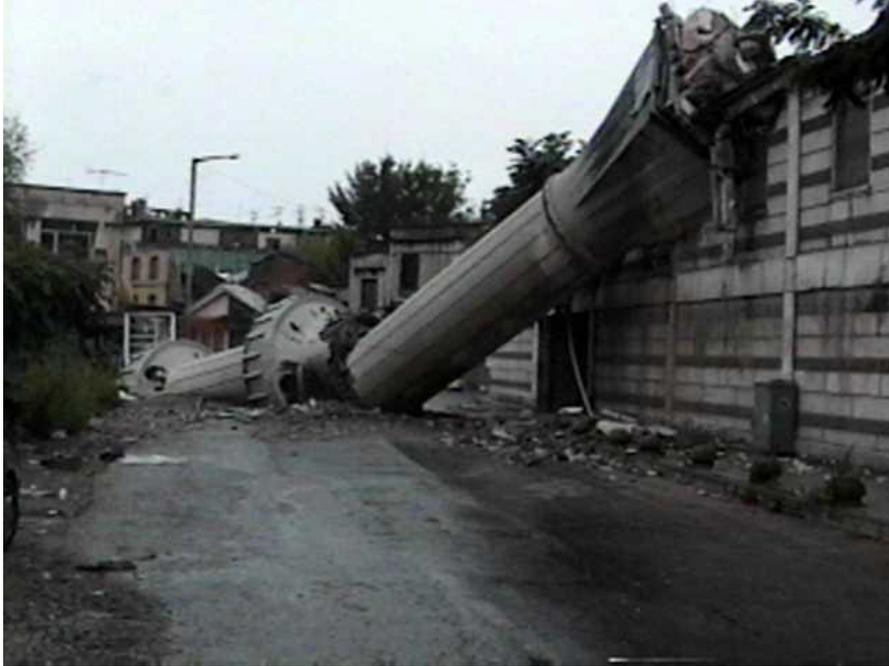
The minaret of the mosque tipped over and broke (Adapazari, N40°46.822', E30°24.128', 8/25/99, 13:53:21).

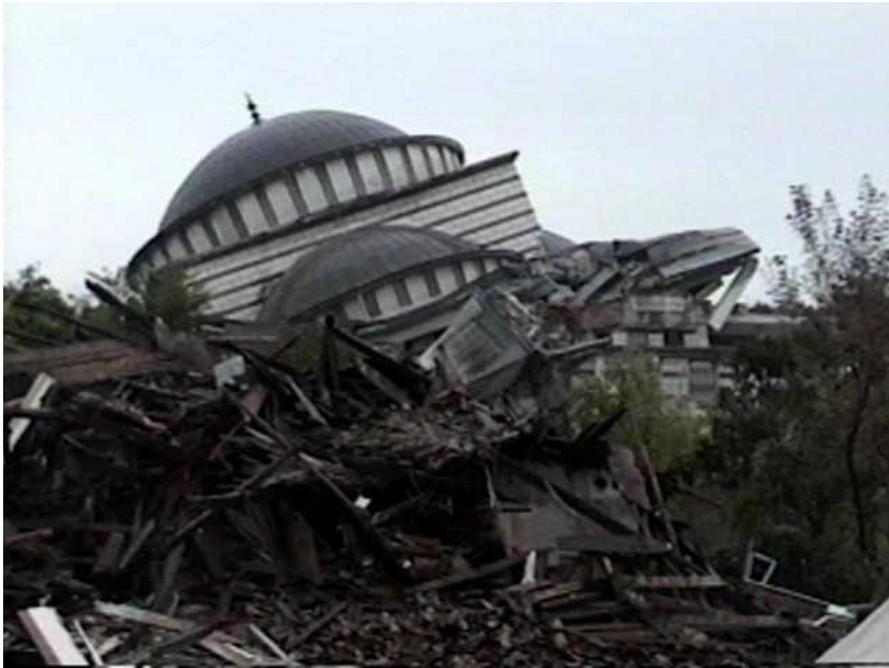
The mosque failed and leaned sideways (Adapazari) (N40°46.822', E30°24.128', 8/25/99, 13:53:21).

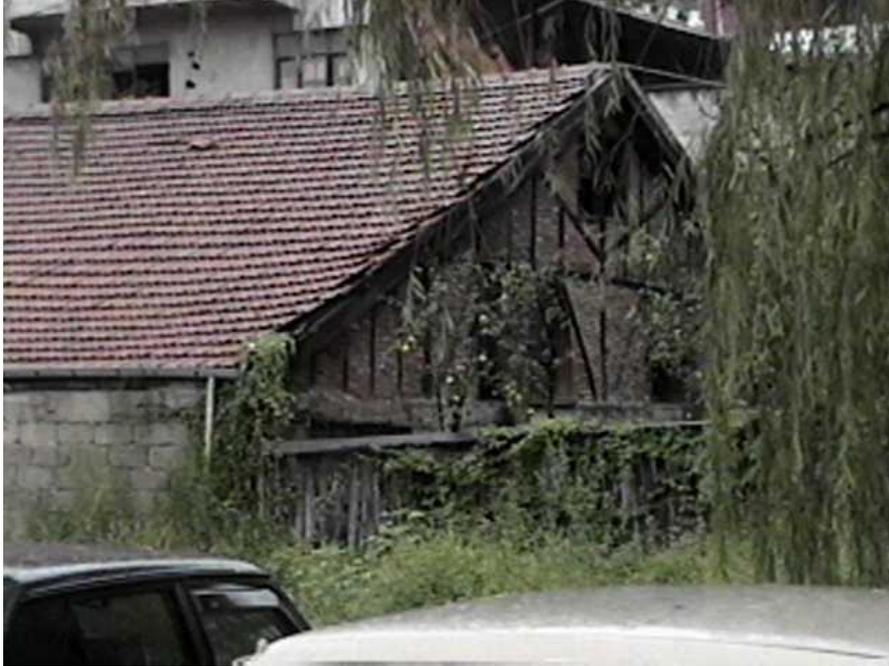
The unreinforced building with wood-frame and masonry infill performed well during the earthquake. (Adapazari, N40°46.822', E30°24.128', 8/25/99, 13:53:21).

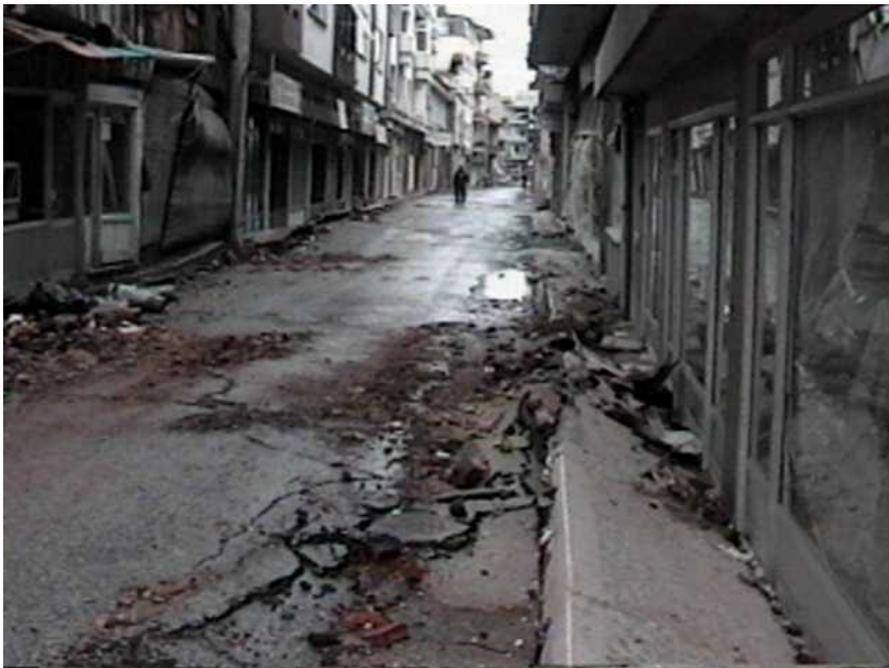
All the buildings in this street in Adapazari settled at least one foot (N40°46.779', E30°24.266', 8/25/99, 14:04:14).

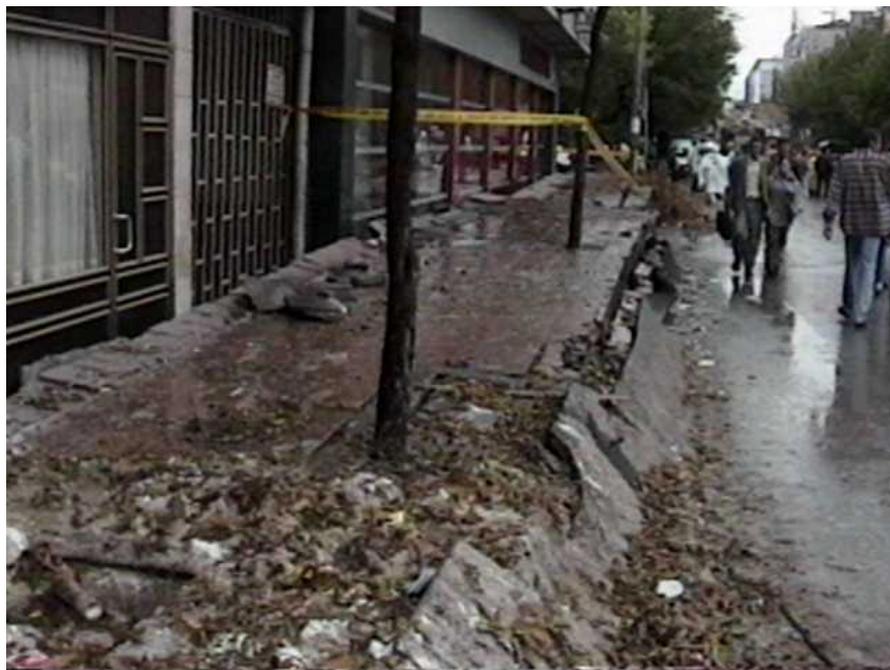
The buildings settled. The sidewalk heaved and lifted up part of the asphalt pavement (Adapazari, N40°46.742', E30°24.185', 8/25/99, 14:12:59).

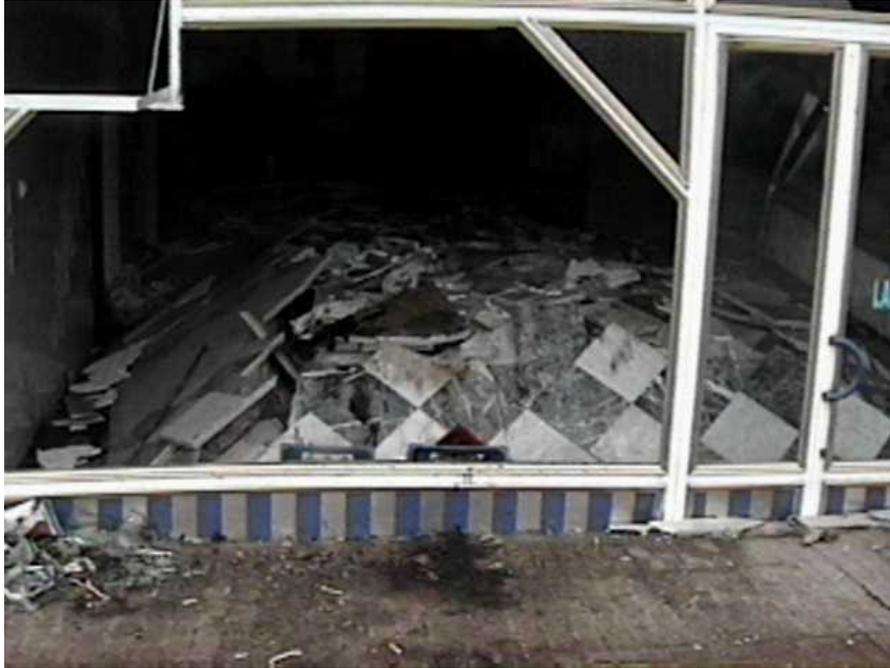
The marble tile floor of the shop bulged as the building settled into the ground (Adapazari, $N40^{\circ}46.662'$, $E30^{\circ}24.163'$, 8/25/99, 14:17:45).

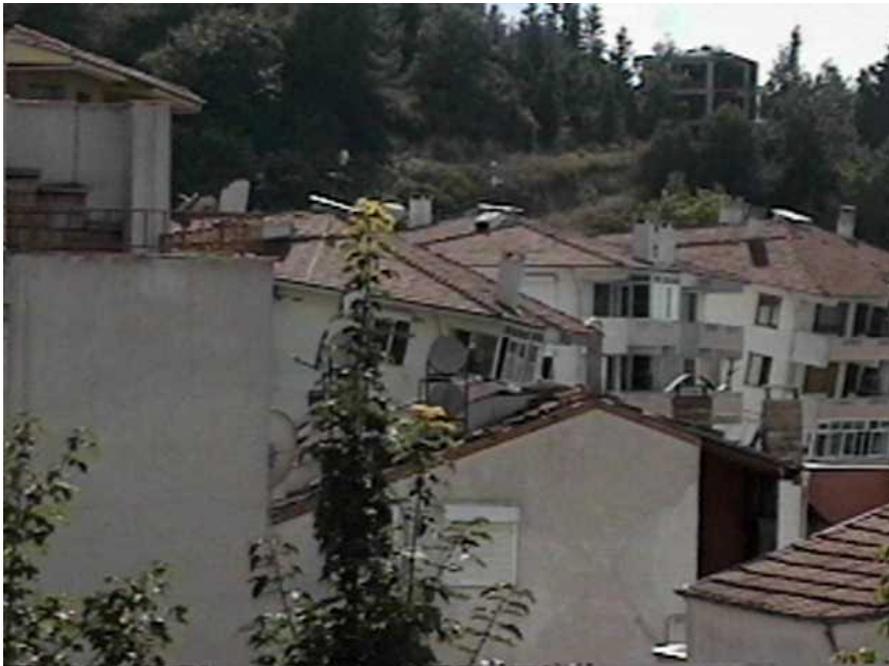
The first floors of the apartment buildings on the hillside east of Yalova were damaged or collapsed. There was no evidence of slope stability problems or ground failure (N40°41.274', E29°35.257', 8/26/99, 16:23:52).

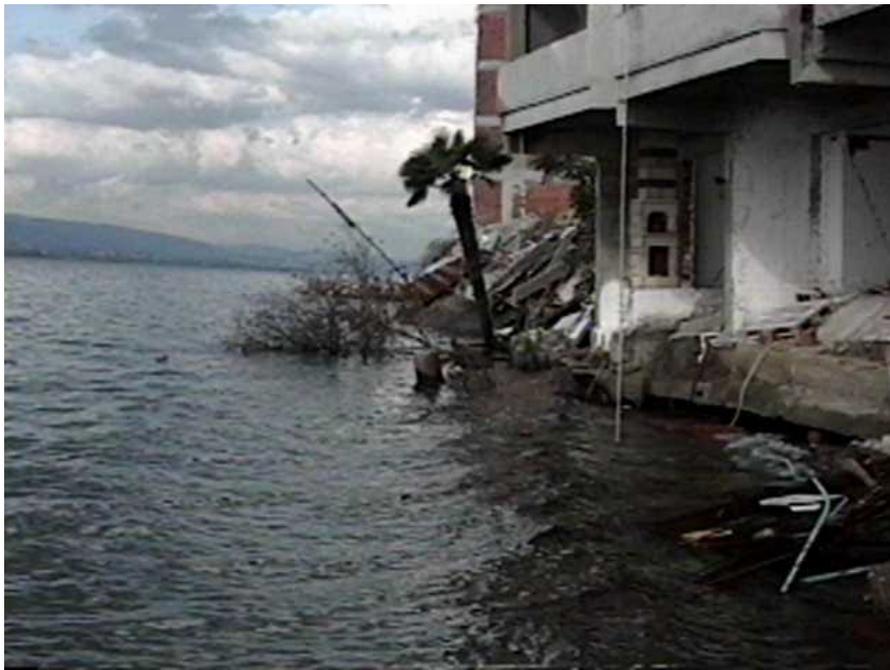
In Halidere, an apartment building collapsed., and the waterfront spread laterally toward the Marmara Sea (N40°42.961', E29°44.805', 8/26/99, 17:33:58).

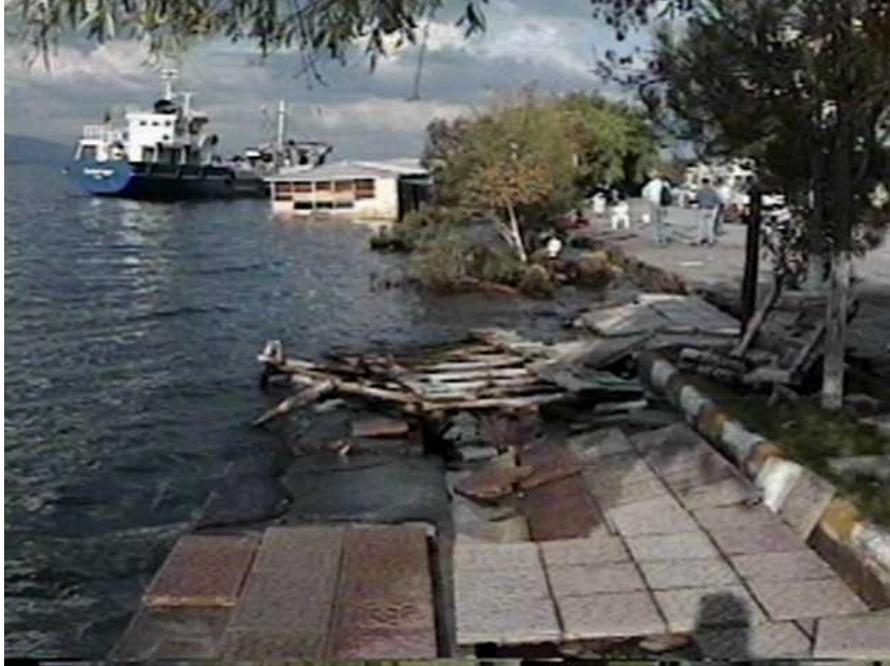
Along the shoreline in Halidere, the road and the waterfront disappeared into the Marmara sea. Some trees were left standing in the water (N40°42.961', E29°44.805', 8/26/99, 17:33:58).

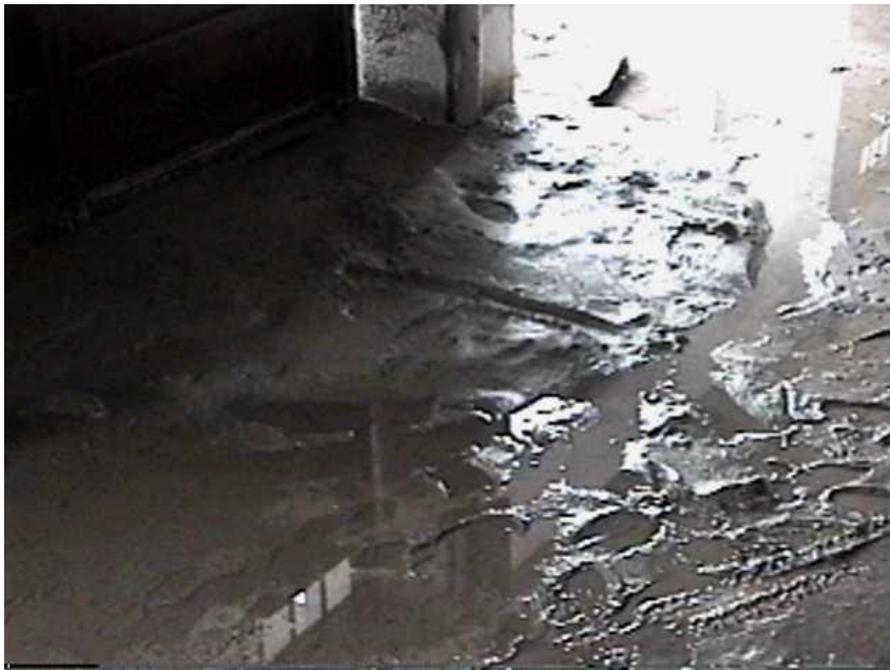
The column punched through the floor of the building which settled (Adapazari, N40°46.614', E30°24.287', 8/27/99, 13:02:07).
