Initial Geotechnical Observations of the August 17, 1999, Kocaeli Earthquake

**A report of the Turkey-US geotechnical earthquake engineering
reconnaissance team**

September 3, 1999

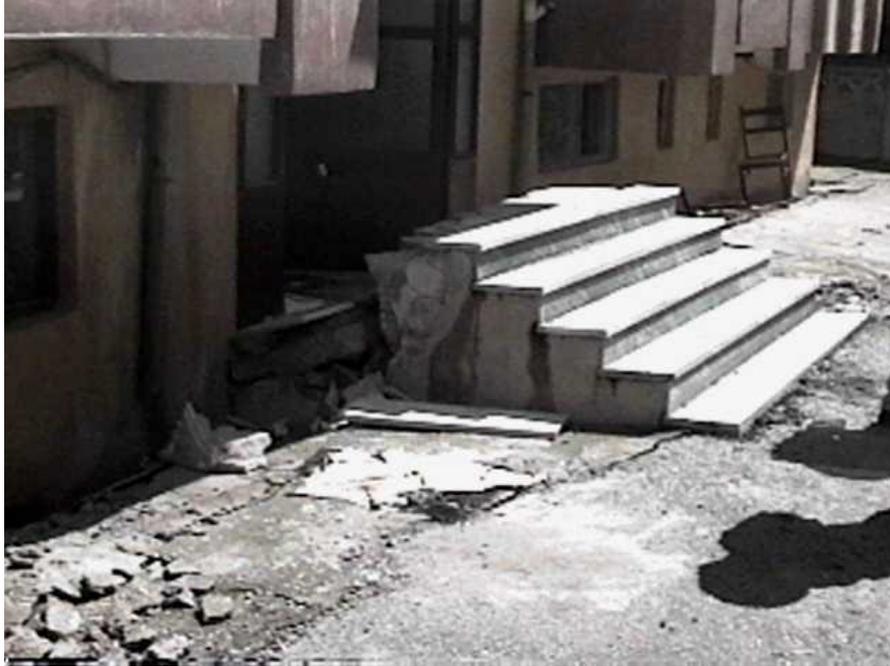
In the garage at the first floor of an apartment building, silty sand had littered the concrete slab. Water was reported to have flooded the garage after the earthquake (N40°46.651', E30°24.598', 8/27/99, 13:09:48).

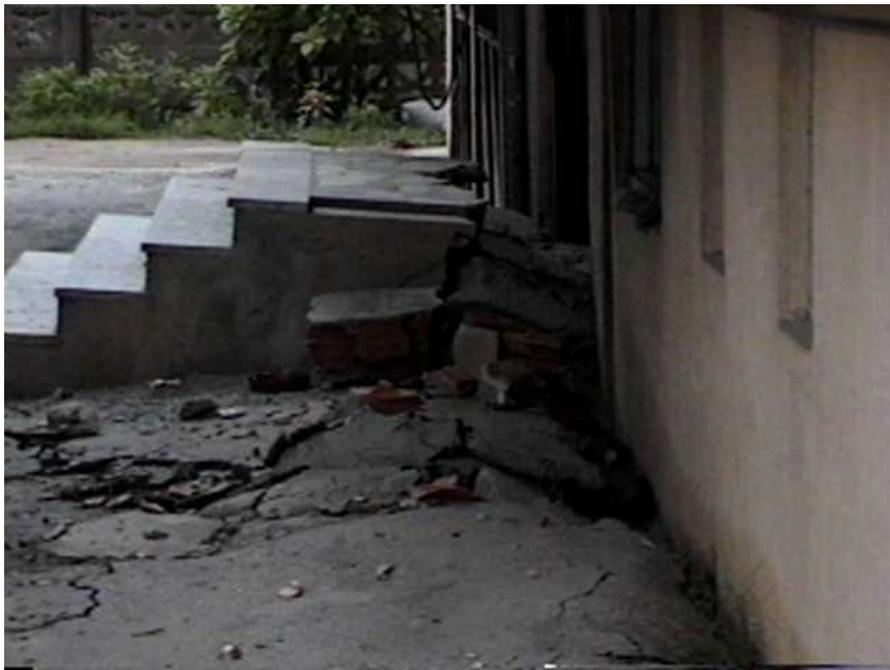
The building settled due to liquefaction, and the connection to the staircase was sheared (Adapazari, N40°46.499', E30°24.646', 8/27/99, 13:47:19).

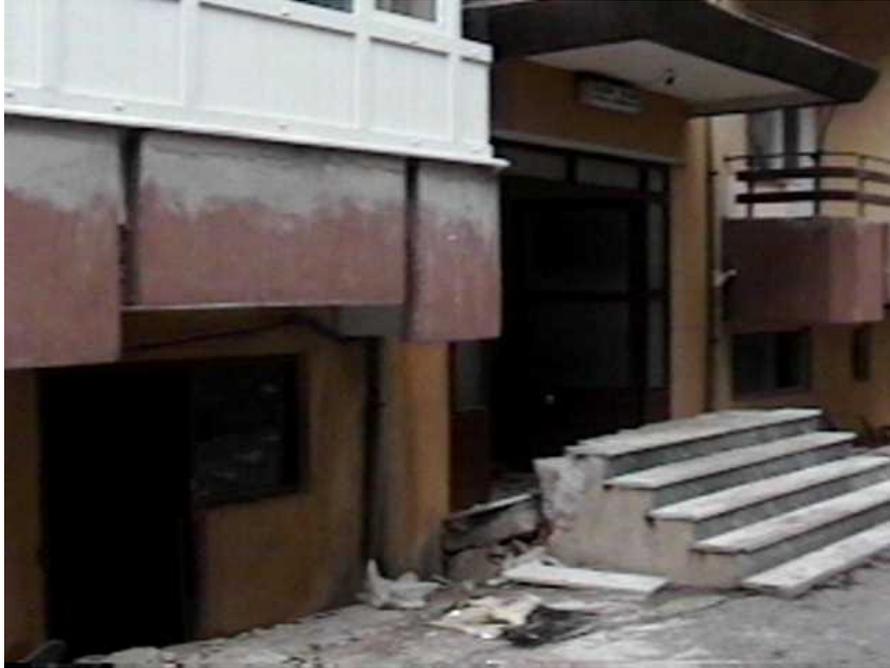
The building settled due to liquefaction, and the connection to the staircase was sheared (Adapazari, N40°46.561', E30°24.626', 8/27/99, 14:19:57).

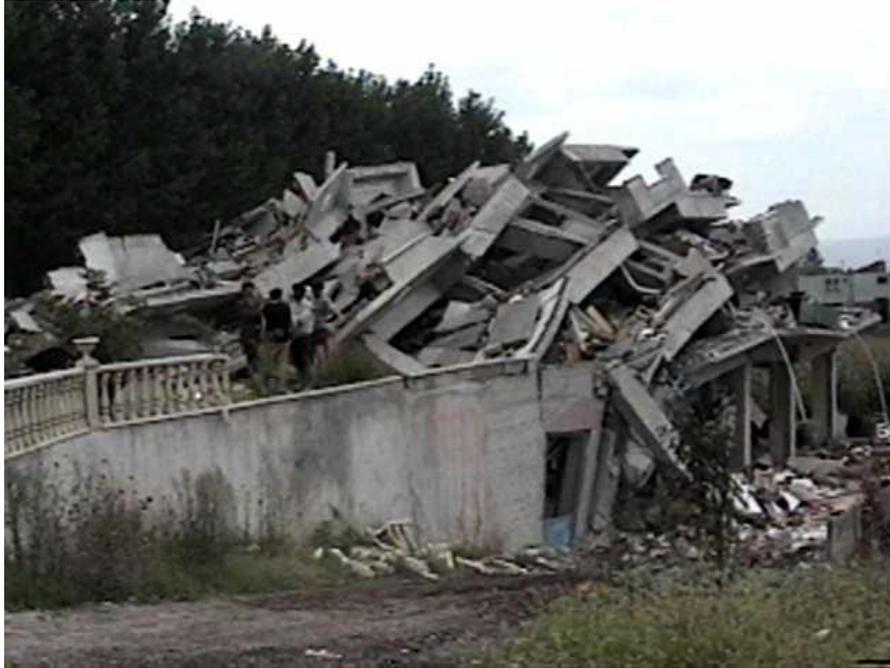
In Golcuk, the crane and steel frame of a construction site were standing apparently undamaged while many reinforced concrete buildings in the foreground had been destroyed by the earthquake (N40°42.385', E29°52.456', 8/28/99, 12:20:10).

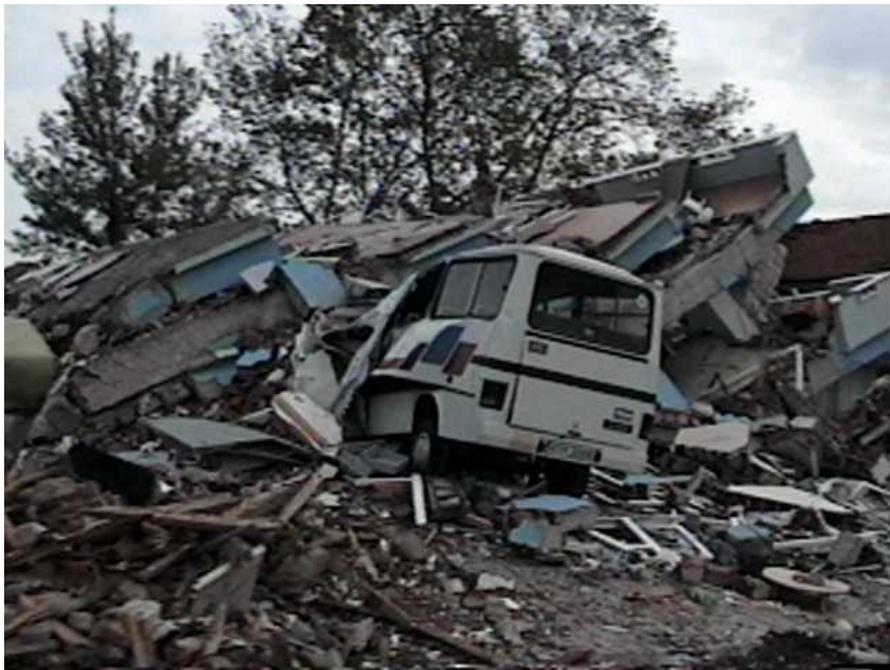
The town of Golcuk was severely impacted by the earthquake. Many lost their lives due to the collapse of apartment buildings (N40°42.374', E29°52.259', 8/28/99, 12:22:44).

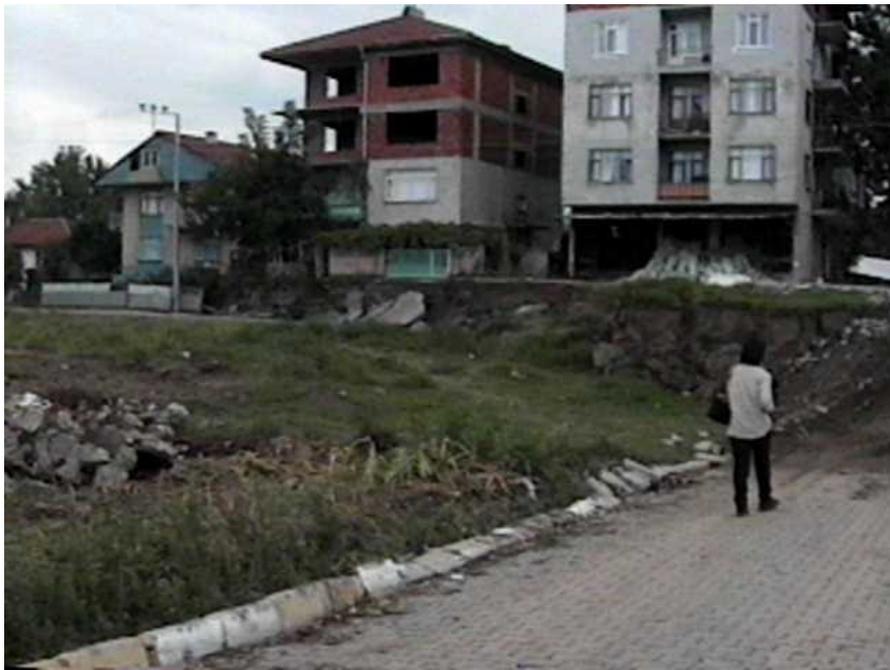
In Golcuk, the ground rupture passed close to a wall, intersected it, and sheared it. Most of the wall remained intact (N40°43.245', E29°50.477', 8/28/99, 16:01:42).

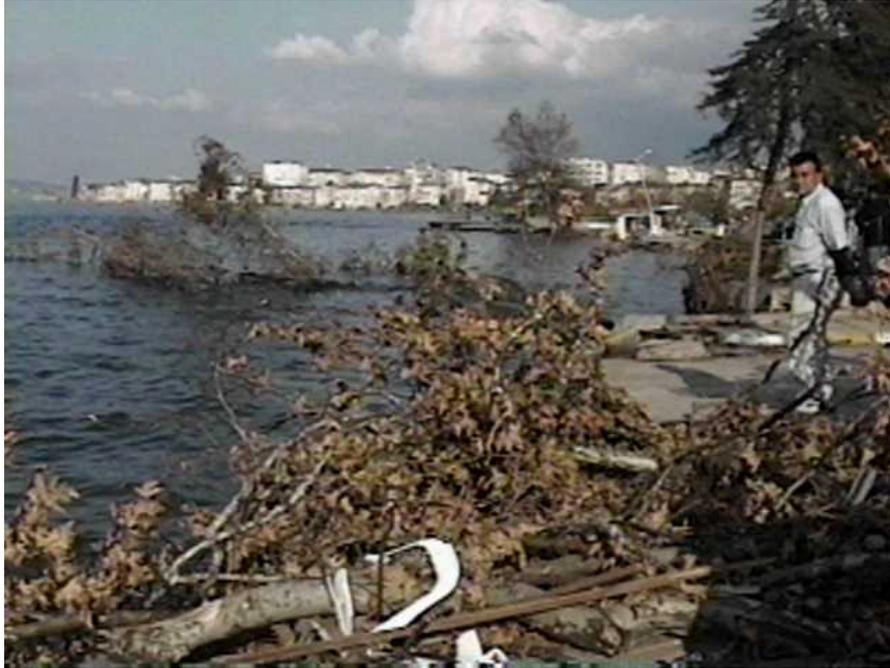
To the west of Golcuk, a piece of land disappeared into the Marmara Sea (N40°43.328', E29°46.994', 8/28/99, 17:26:22).

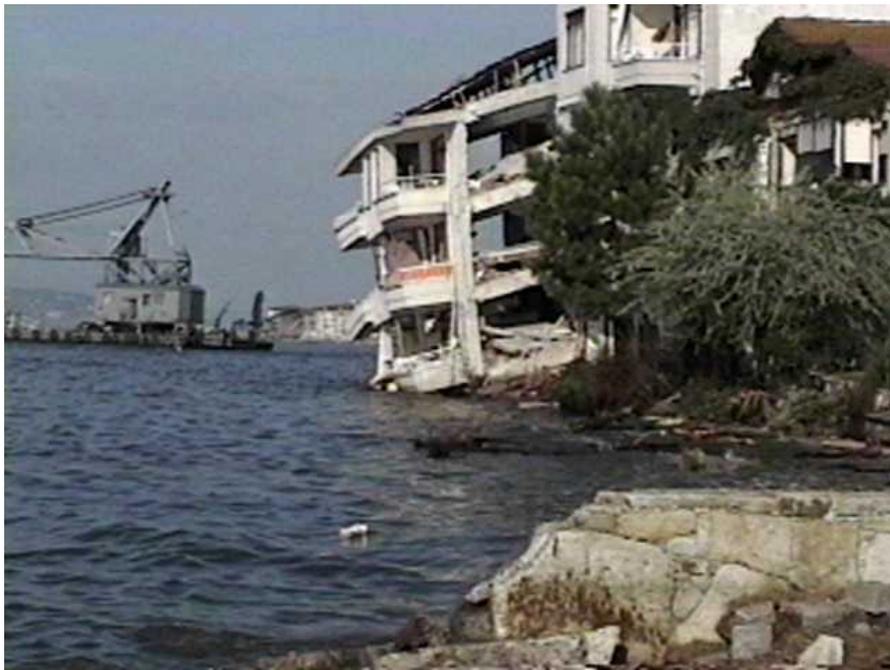
To the west of Golcuk, the waterfront disappeared into the Marmara Sea (N40°43.326', E29°46.823', 8/28/99, 17:41:54).

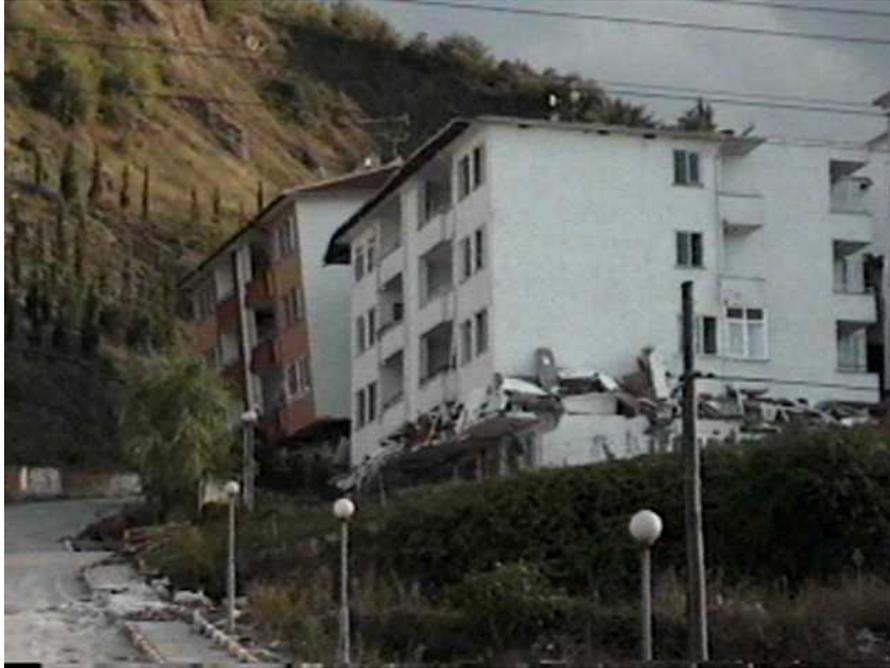
To the west of Golcuk, the road and waterfront disappeared into the sea, and took with it part of the apartment building (N40°43.326', E29°46.823', 8/28/99, 17:41:54).

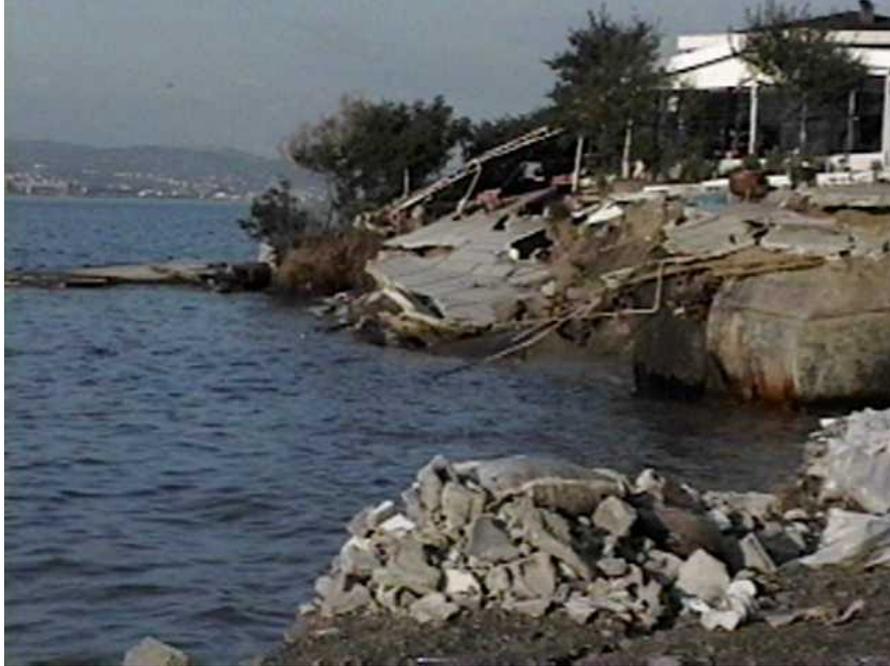
To the west of Golcuk, a piece of land slid into the sea. There were ground cracks parallel to the new shoreline (N40°43.074', E29°46.083', 8/28/99, 16:20:48).

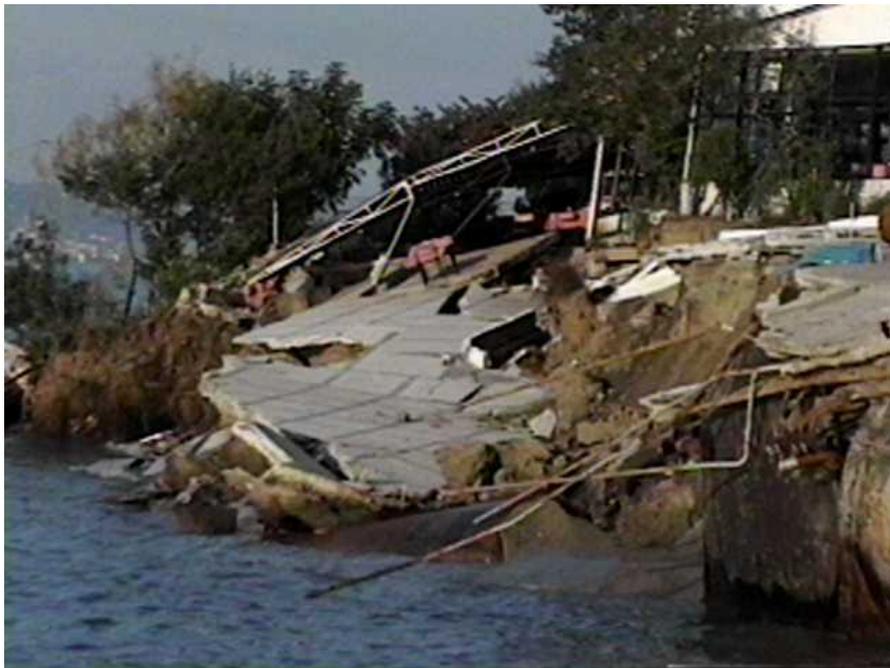
To the west of Golcuk, the waterfront slid into the sea, and exposed two tanks of a gas station (N40°43.074', E29°46.083', 8/28/99, 16:20:48).
