REPORT NO.
UCB/EERC-90/05
APRIL 1990

EARTHQUAKE ENGINEERING RESEARCH CENTER

PRELIMINARY REPORT ON THE PRINCIPAL GEOTECHNICAL ASPECTS OF THE OCTOBER 17, 1989 LOMA PRIETA EARTHQUAKE

R. B. Seed, S. E. Dickenson, M. F. Riemer, J. D. Bray,
N. Sitar, J. K. Mitchell, I. M. Idriss, R. E. Kayen
A. Kropp, L. F. Harder, Jr. and M. S. Power

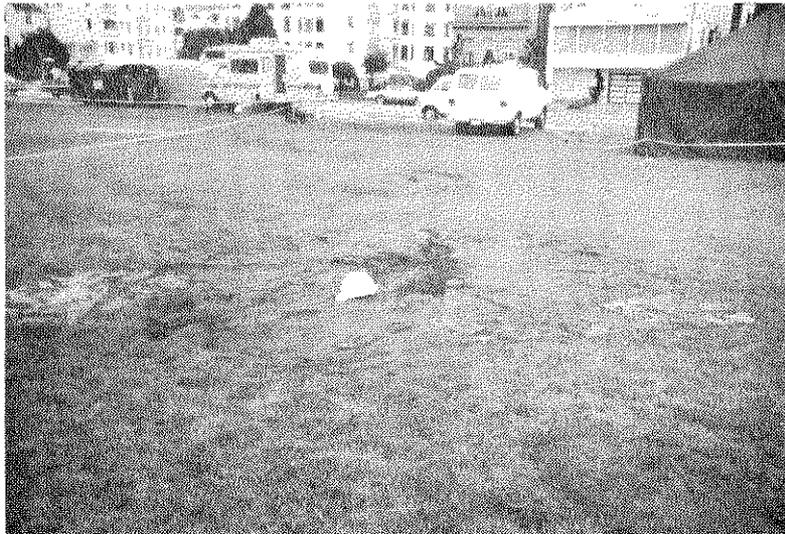
Soil liquefaction during the Loma Prieta Earthquake of October 17, 1989 occurred in both the hydraulically placed fill and the earlier, uncompacted fills around the perimeter of the District. Figure 3.4 shows a typical sand boil on the Marina Green at the northern edge of the Marina District. Numerous sand boils occurred throughout the District, both on open ground and along cracks and joints in pavements, gutters, and around the edges of structures. Sand intrusions also occurred in basements and ground floors of buildings. Changes in both color and gradation of the extruded boil materials were readily apparent at various locations across the District, and these could be readily correlated with the origins of the fill materials and their placement history.

Fig. 3.4: Sand Boil on Marina Green, San Francisco

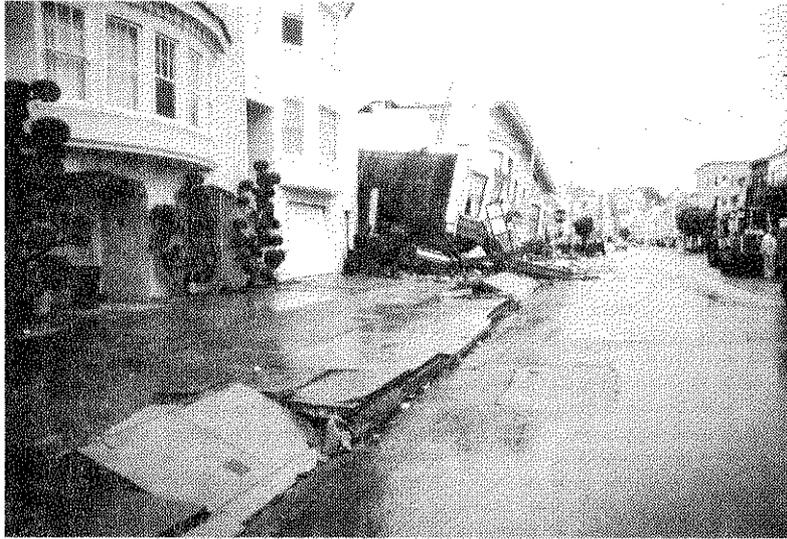
Figure 3.5 shows damage to the sea wall at the edge of the small yacht harbor at the north end of the District. This damage was the result of lateral spreading associated with liquefaction of the fill materials. Figure 3.6 illustrates conditions near the center of the Marina District (farther inland) immediately after the earthquake. In addition to the collapsed structure, this figure clearly shows buckling of the sidewalk at two locations. This buckling is not the result of settlement, but rather of lateral compression of the pavement due to lateral spreading associated with liquefaction of the underlying fill in this area. Similar evidence of lateral spreading, including extension and/or compression of pavements, occurred throughout much of the District.

Fig. 3.6: Pavement Buckling Indicative of Lateral Compression; Marina District, San Francisco

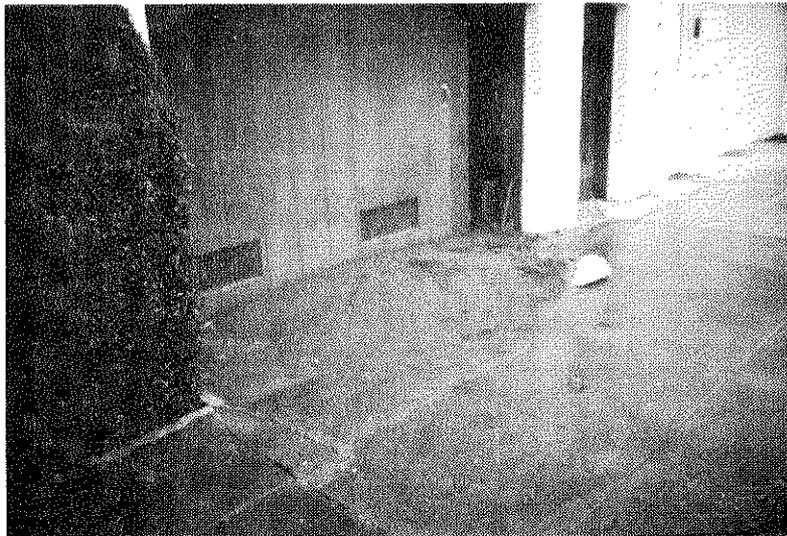
Figure 3.7 shows an example of a building which suffered a partial bearing failure as a result of liquefaction-induced loss of strength of its foundation soils. The right-hand side of this building settled several inches into the fill. Figure 3.8 shows sand extruded under the garage door of a building in the Marina District, and Figure 3.9 presents an example of differential settlement of interior footings in another structure near the center of the Marina District. This settlement, resulting from softening of the underlying sandy fill, resulted in wracking and damage to the structure. These and other examples of liquefaction-related damages occurred throughout much of the Marina District.

Fig. 3.8: Sand Extruded Beneath A Garage Door; Marina District, San Francisco

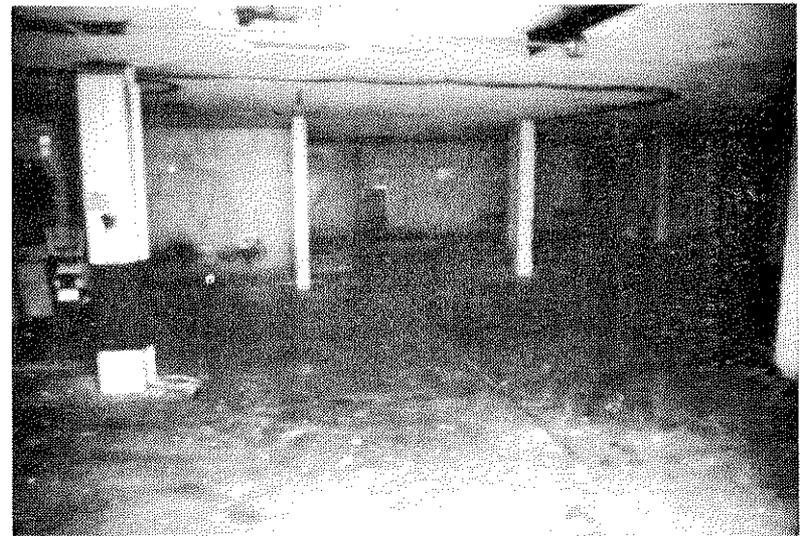
Fig. 3.9: Differential Settlement of Interior Footings; Marina District, San Francisco

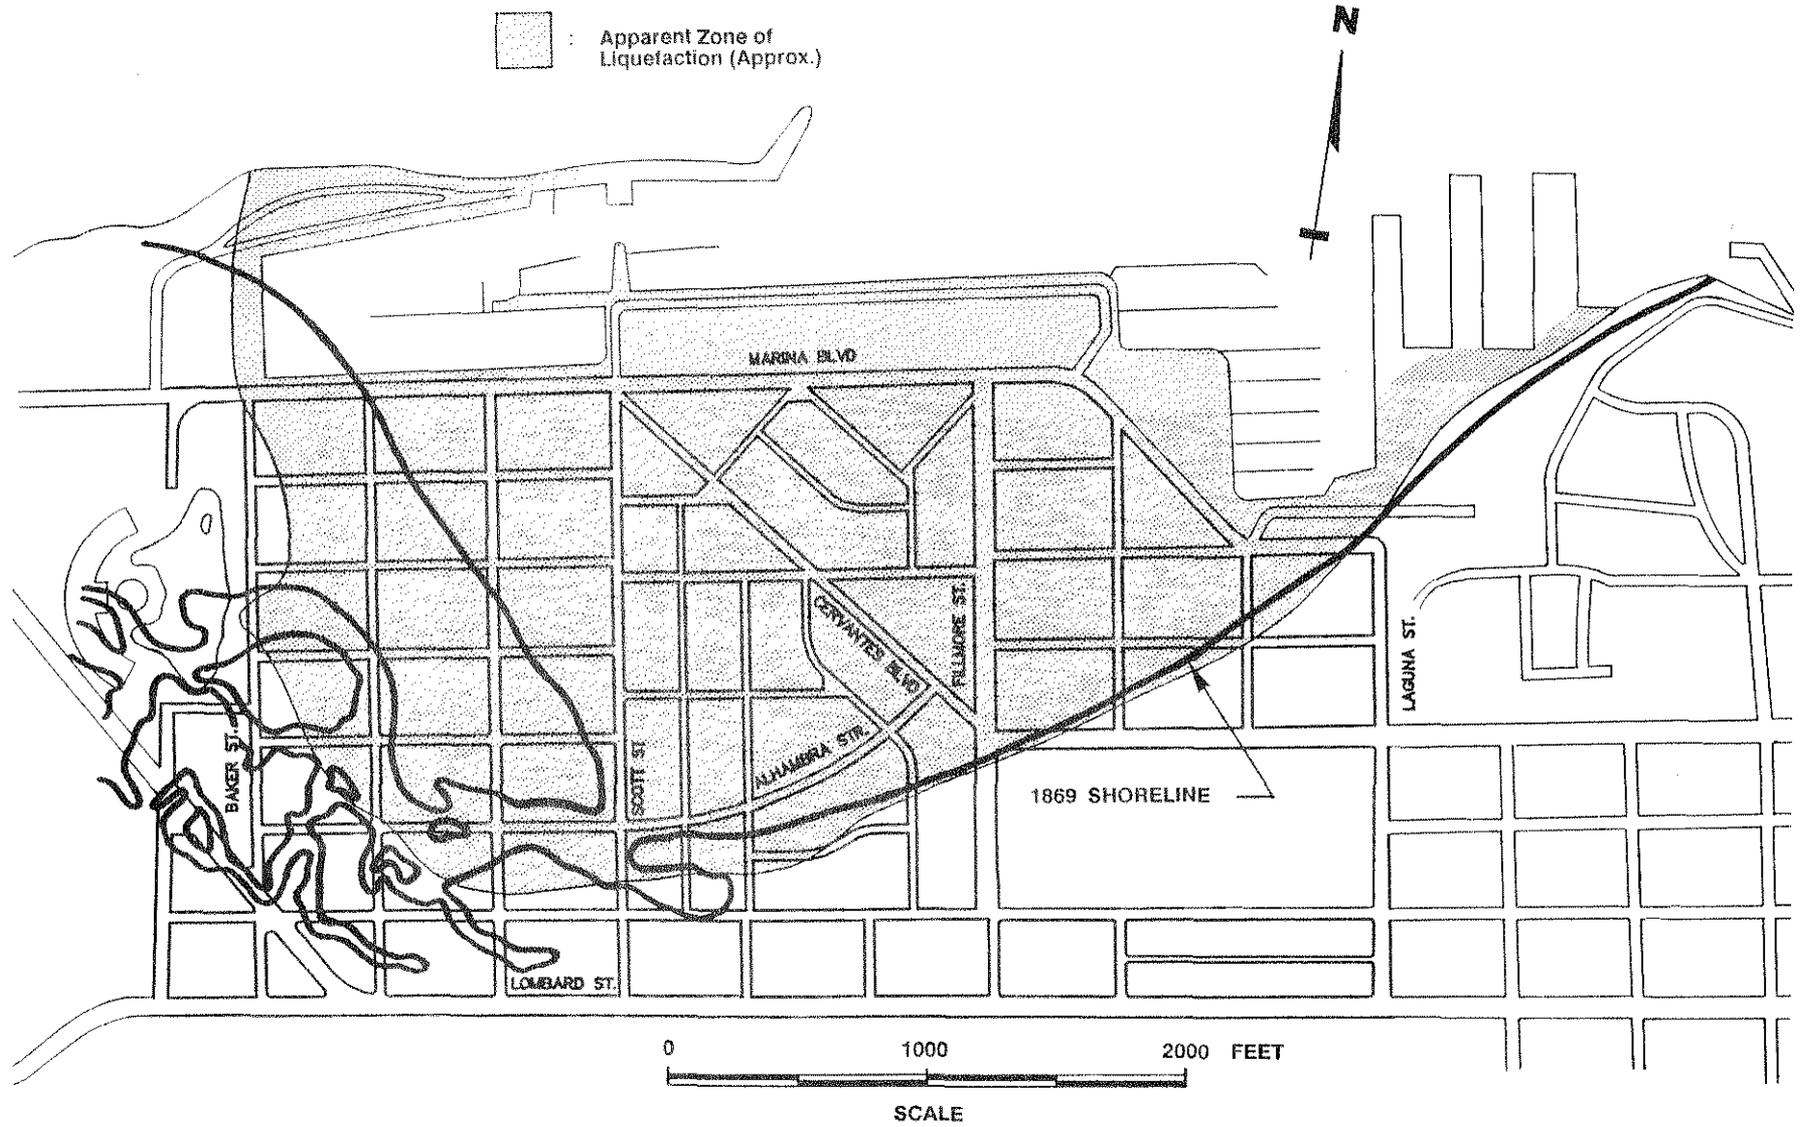
Figure 3.10 shows the approximate zone of apparent soil liquefaction during the Loma Prieta Earthquake of October 17, 1989, as evidenced by sand boils, settlement, lateral spreading or compression, pavement damage, and/or foundation displacements. A comparison with Figure 3.1 shows that the zone of apparent liquefaction encompasses essentially the entire hydraulically filled central region, as well as portions of the earlier fill around the perimeter of the District and overlying the coastal marshes at the western end of the District.

Fig. 3.10: Apparent Zone of Soil Liquefaction in the San Francisco Marina District on October 17, 1989

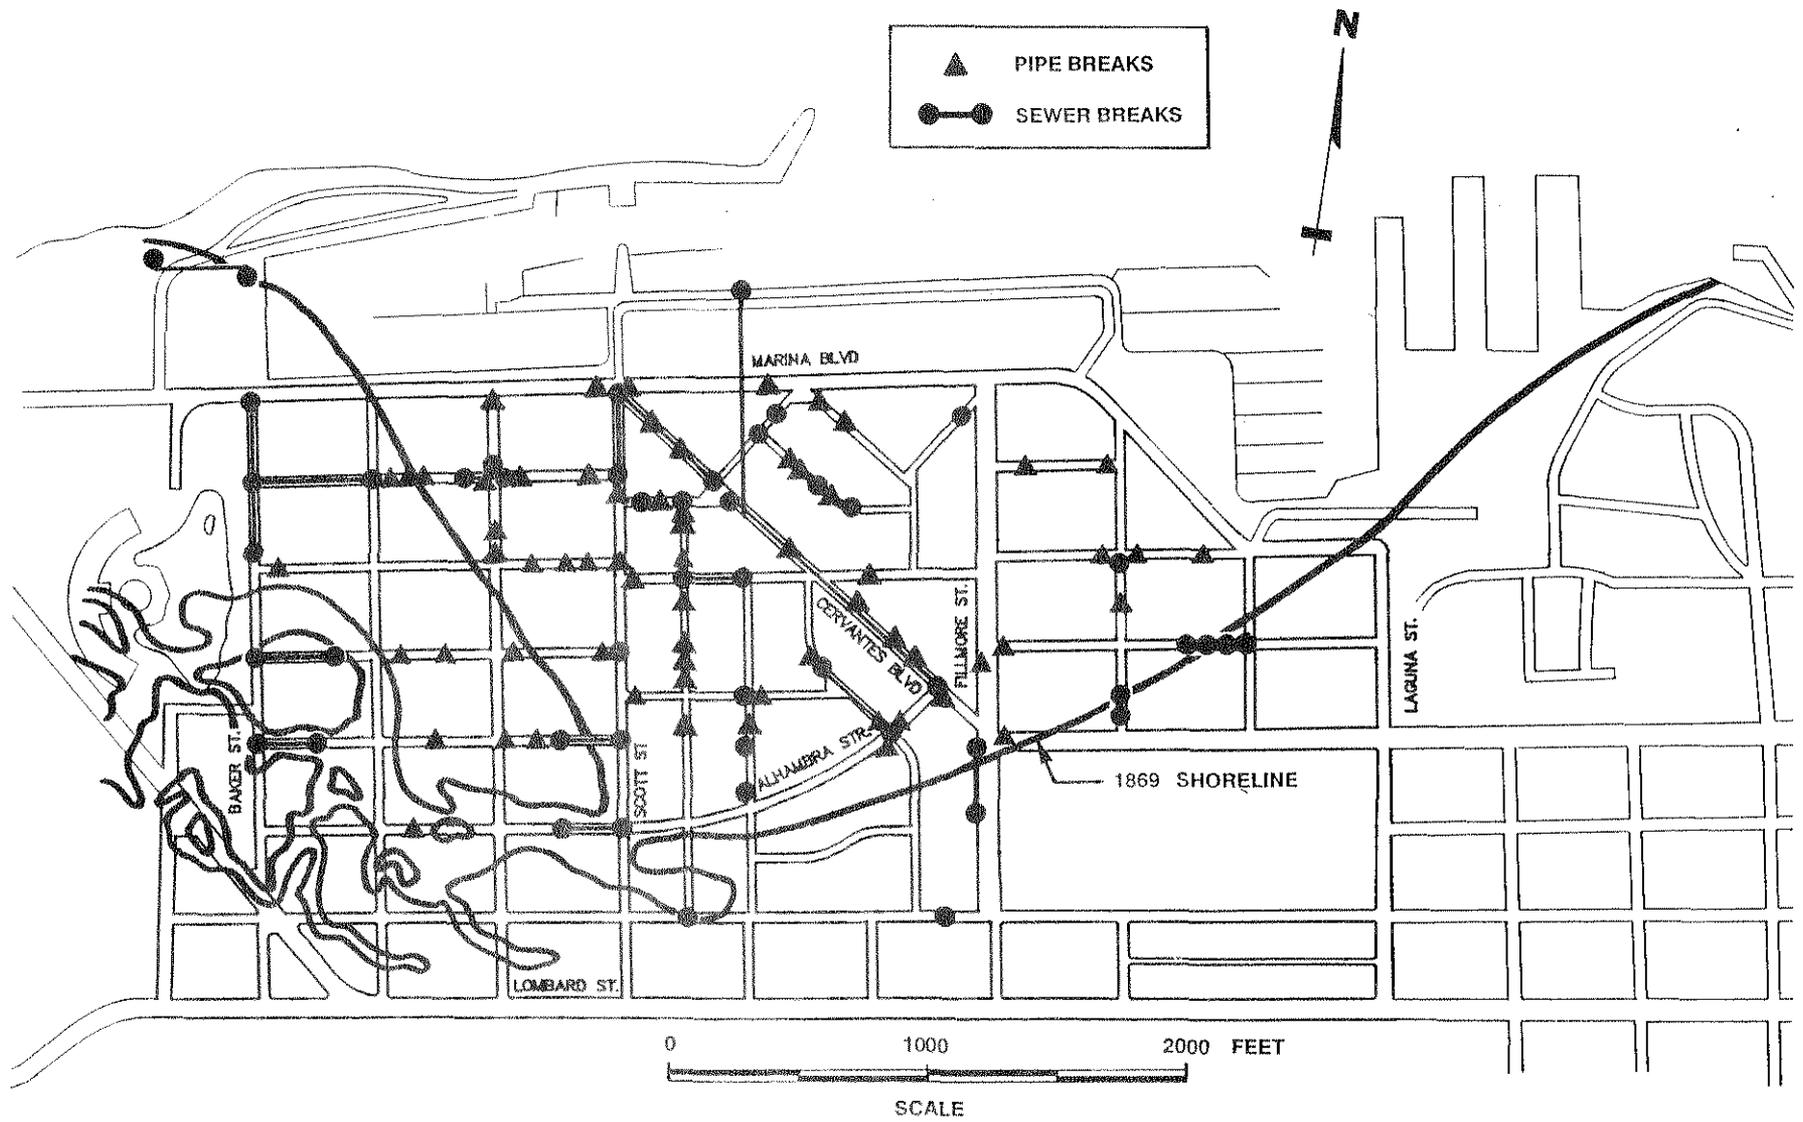
Figure 3.11 shows the locations of breaks in water pipes greater than 4-inches in diameter, as well as breaks in main sewer lines. Considerable damage to buried utilities occurred as a result of soil liquefaction in the Marina District during the earthquake. In addition to water and sewer breaks, numerous breaks in natural gas pipelines also occurred. It was, however, the water main outages which were most nearly catastrophic.

Fig. 3.11 Locations of Major Water Pipe and Sewer Breaks; Marina District, San Francisco

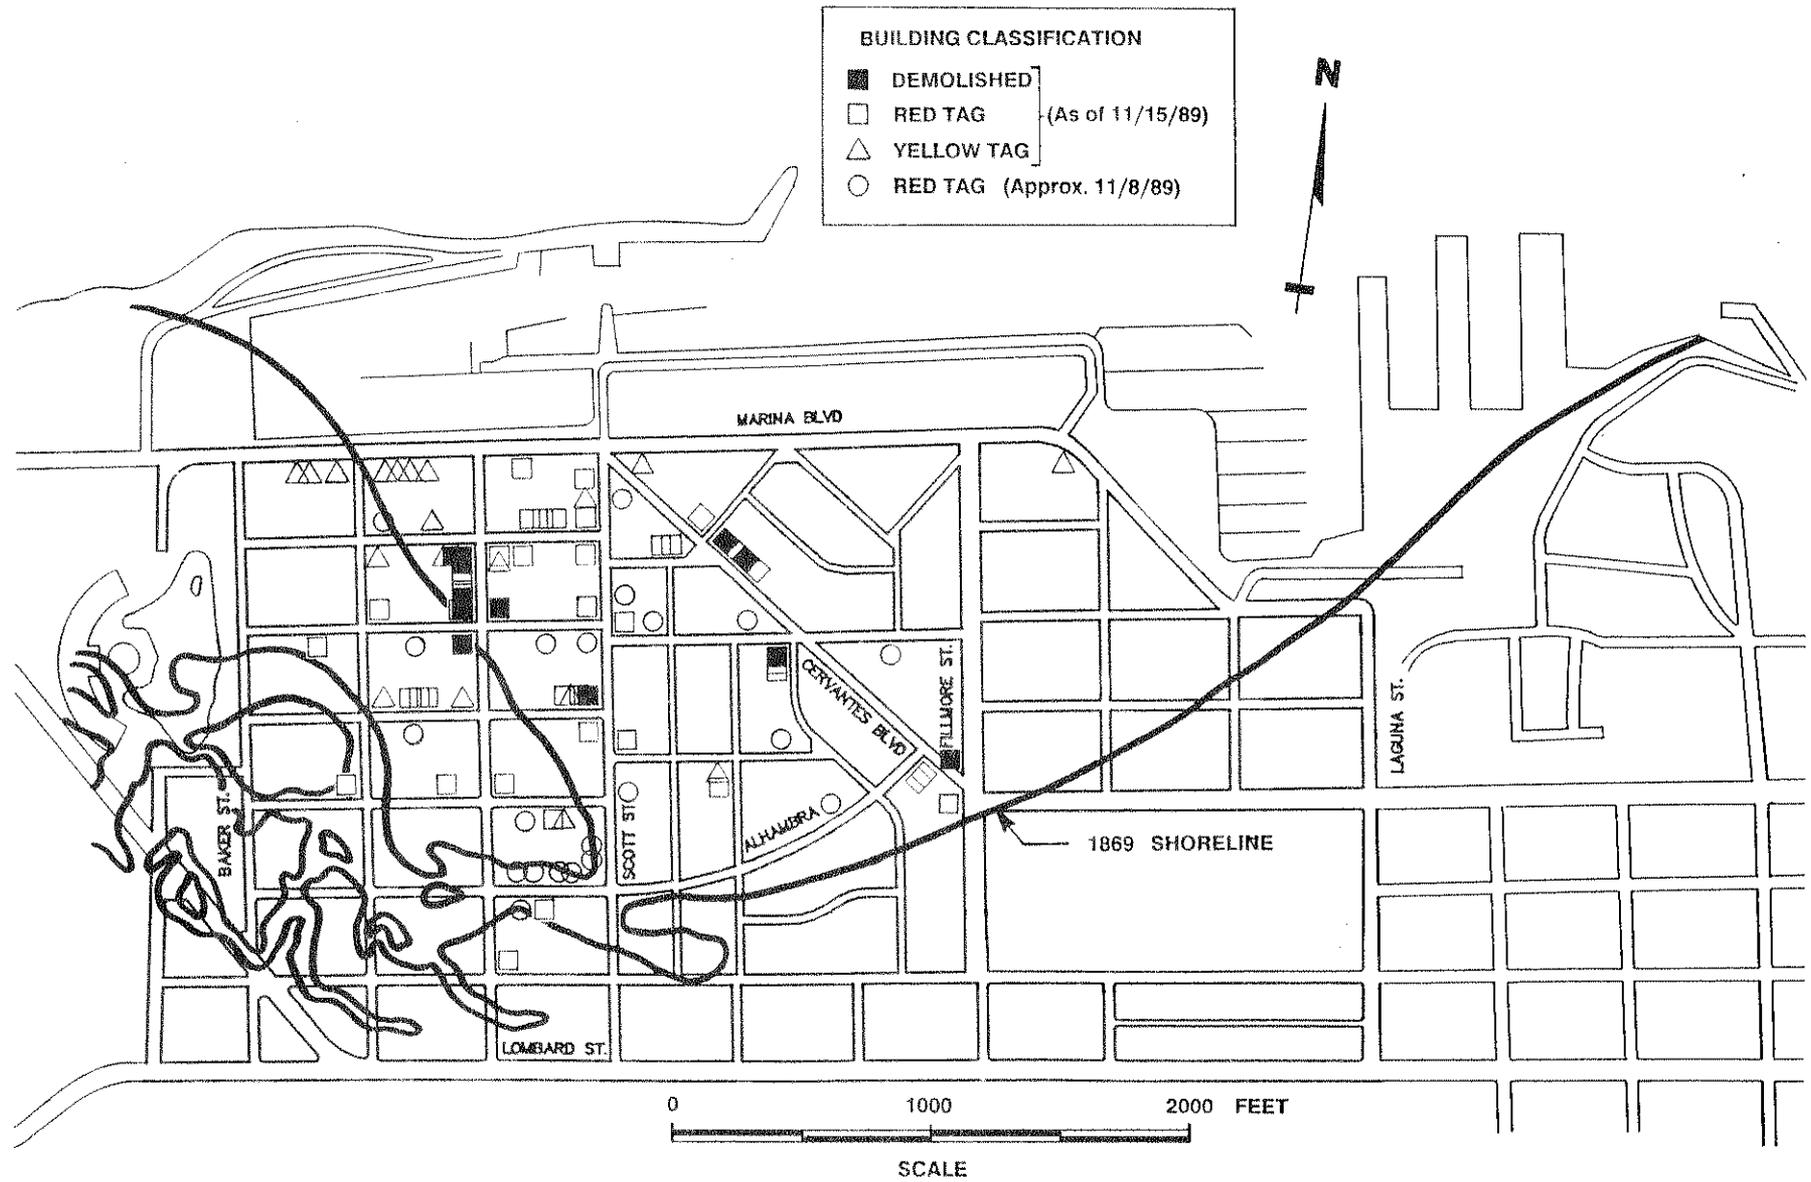
Figure 3.12 shows the locations of heavily damaged structures, as indicated by post-earthquake inspection "tags", roughly one month after the earthquake. City inspectors placed tags of different colors on buildings; these tags indicated their perceived level of safety and controlled access to these buildings in the wake of the earthquake. Structures with red tags were considered unsafe for occupancy, while yellow tags indicated structures to which limited access might be allowed. Damaged structures were periodically re-inspected, and tags were changed or removed as these inspections progressed. As illustrated in Figure 3.12, a majority of the structural damage occurred near the heart of the Marina District. Much of this ground is underlain by the loose hydraulic fill placed in 1910-1912, and much of the rest is underlain either by fill placed to reclaim the perimeter marshes or by naturally deposited loose to medium dense beach and dune sands which occur at the edges of the region.

This does not mean, however, that this concentration of structural damages is due primarily to soil liquefaction. Instead, a majority of the damage to structures in the Marina District on October 17, 1989 was caused by strong shaking. The fill in much of the region of heaviest structural damage is underlain by relatively soft and compressible recent clayey estuarine deposits. These are underlain, in turn, by deeper, and much stiffer pleistocene units, also consisting primarily of clayey soils. These cohesive soils strongly amplified the relatively modest levels of shaking produced in the bedrock underlying the Marina District by the fault rupture near Santa Cruz (more than 40 miles to the south), and resulted in considerably stronger (amplified) levels of shaking at the ground surface. These local soil conditions also altered the frequency characteristics of the accelerations propagating from the rock to the ground surface. This amplification of accelerations, and the especially pronounced amplification of long period motions, appears to have been the primary cause of structural damage in this region. It is also interesting to note that much of the structural damage was associated with the collapse of "weak" ground floors consisting primarily of garages with few walls and thus little structural capacity for carrying lateral shear forces at the ground-floor levels of two to four-story apartment structures.

Fig. 3.12: Locations of Demolished Structures, and Structures Marked with Red and Yellow Post-Earthquake Inspection Tags as of Mid-November, 1989: Marina District, San Francisco

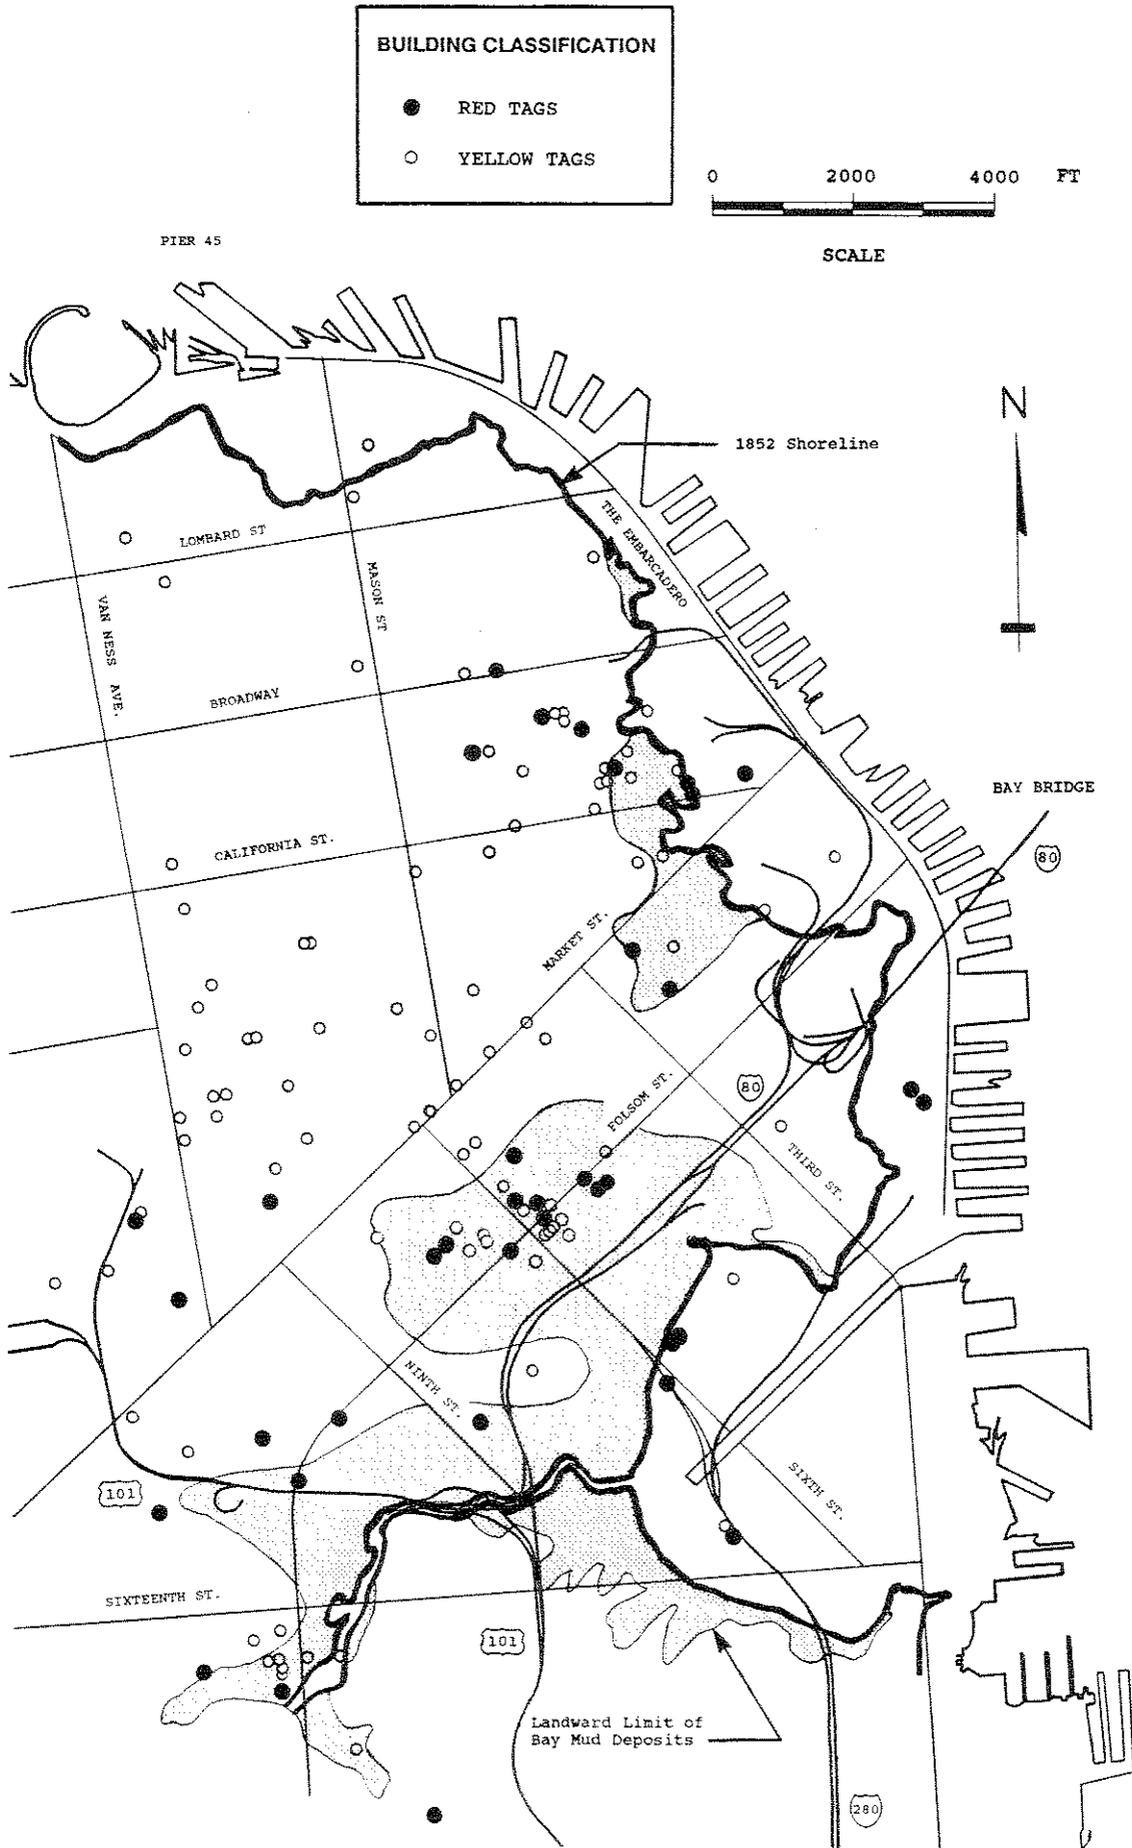
Figure 3.14 shows the locations of heavily damaged structures as indicated by red and yellow post-earthquake inspection tags as of mid-November, 1989. It is interesting to note that there is again some evidence of concentration of damage in the regions indicated in the previous figure as having suffered most heavily in 1906.

Fig. 3.14: Locations of Demolished and/or Heavily Damaged Structures in East San Francisco Based on Post-Earthquake Inspection Tags as of Mid-November, 1989

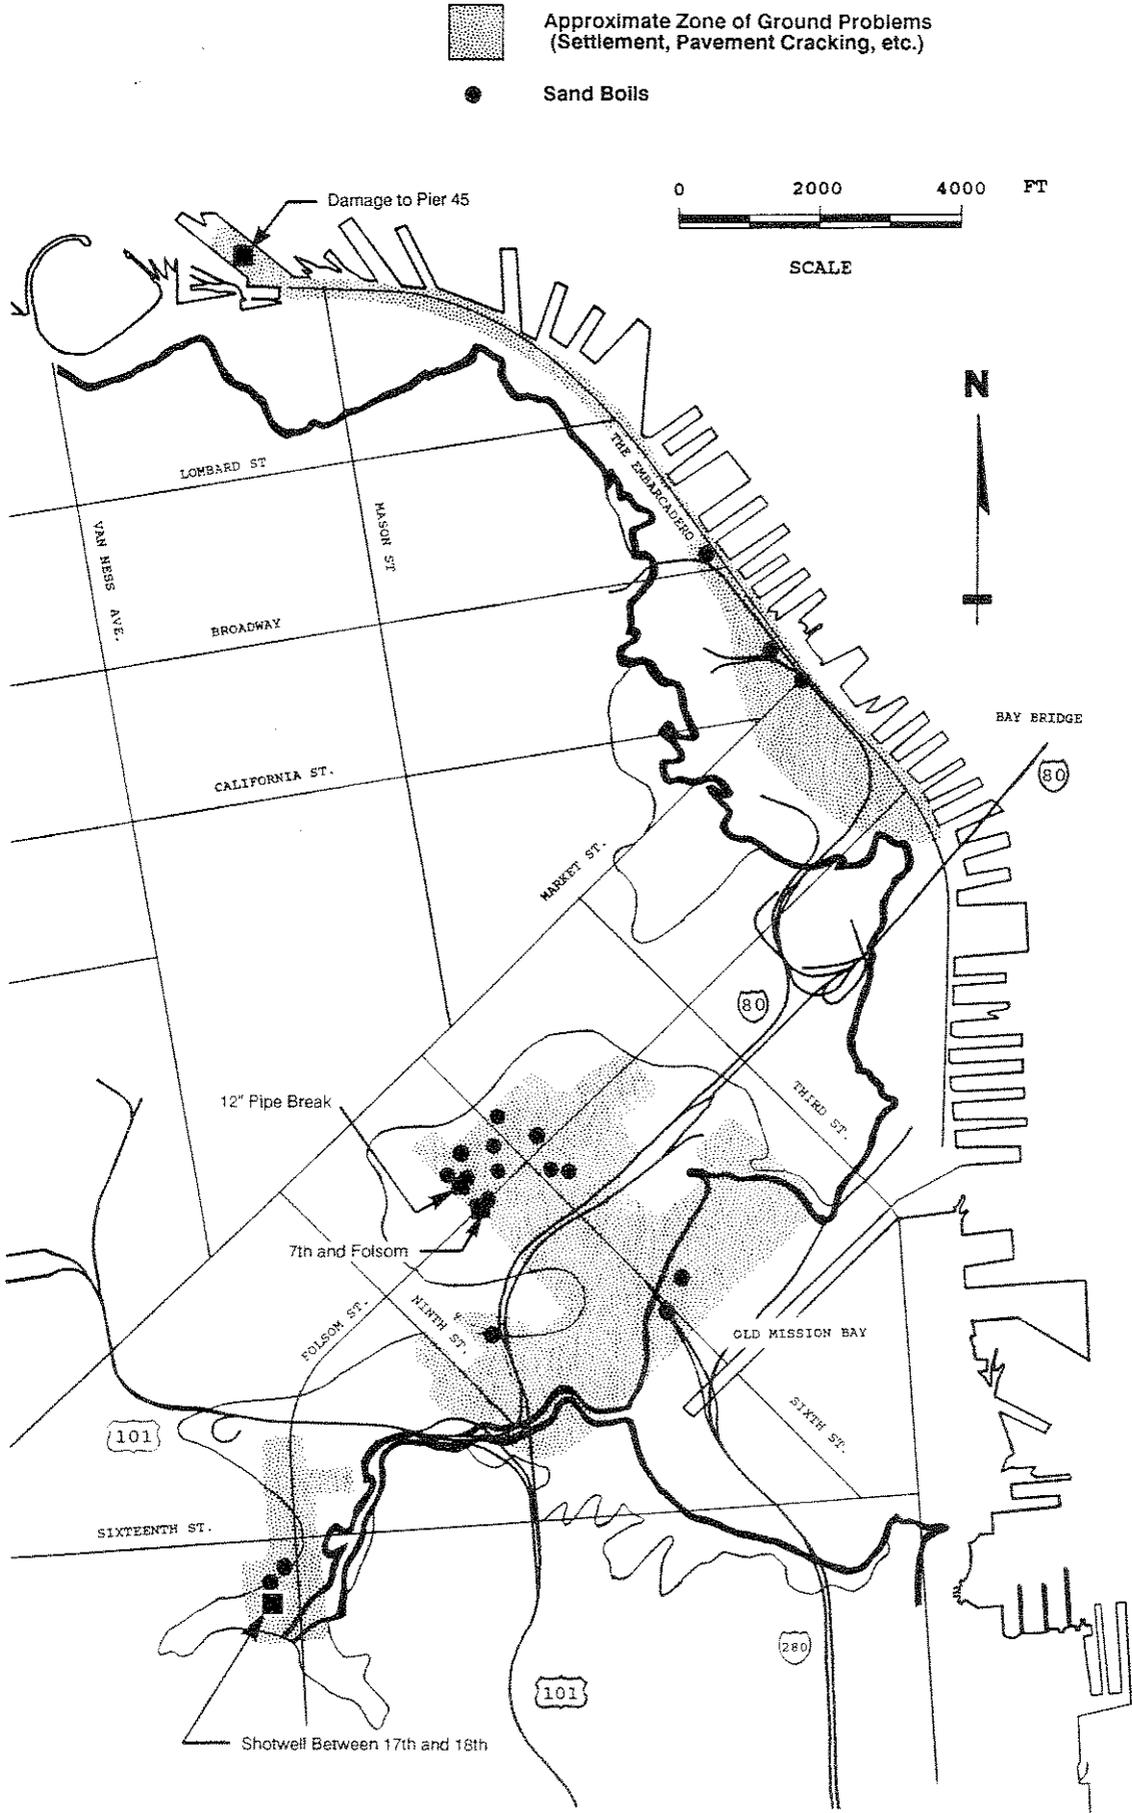
It should also be noted that much of the extensive damage which occurred in these regions in 1906 appears to have been directly attributable to massive and widespread liquefaction of the sandy fills in these regions. Figure 3.15 shows regions in which evidence of soil liquefaction was observed following the Loma Prieta earthquake of October 17, 1989. Once again, the regions south of Market Street showing evidence of liquefaction in the recent earthquake are largely coincident with the regions which suffered heavy damage in 1906.

Fig. 3.15: Apparent Extent of Soil Liquefaction in San Francisco's Embarcadero and Old Mission Bay Regions on October 17, 1989

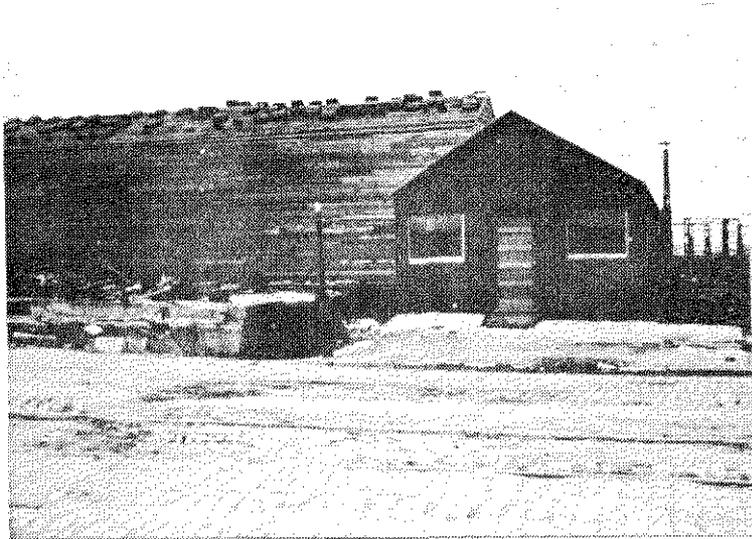
Figure 3.16 illustrates conditions near the corner of what are now 6th and Howard Streets immediately after the great earthquake of 1906. The structure shown

Fig. 3.16: Conditions Near 6th and Howard Streets After the 1906 San Francisco Earthquake [Lawson et al., 1908]

is supported on piles, and the surrounding ground has settled nearly 3 feet as a result of liquefaction. Figure 3.17 shows demolition of a 5-story apartment building at virtually this same location in November of 1989. This building sustained extensive structural damage due to liquefaction and differential settlement of the foundation soils during the Loma Prieta earthquake of October 17, 1989.

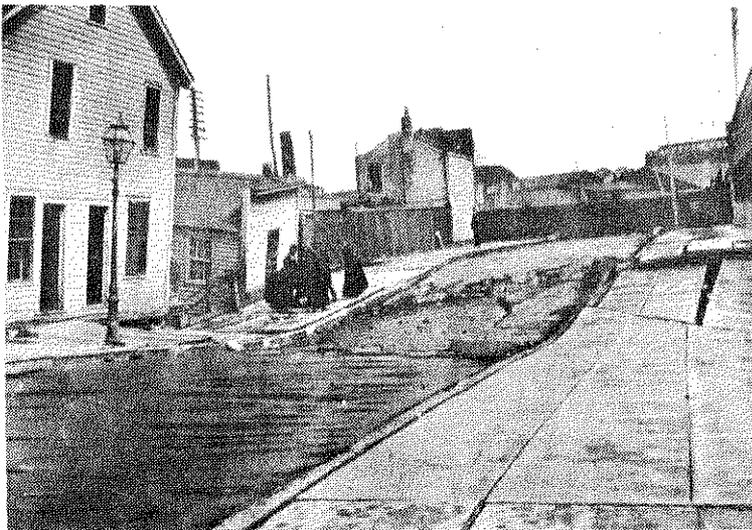
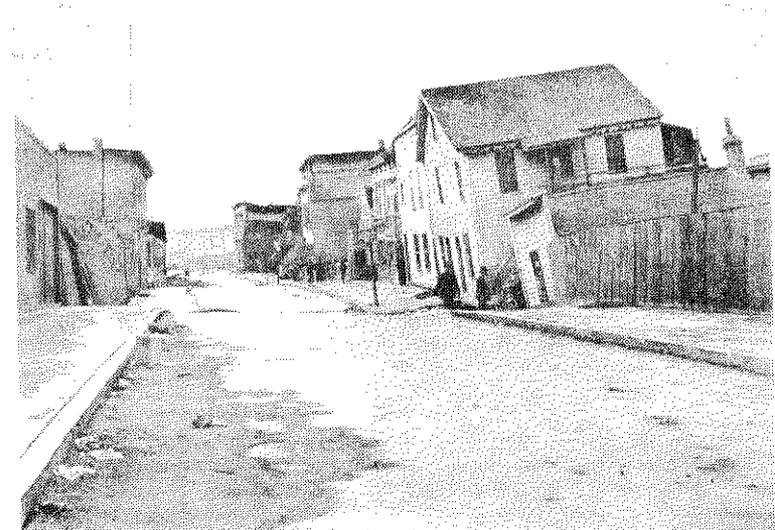
Fig. 3.18: Conditions on Dore Street Near Brannan After the 1906 San Francisco Earthquake [Lawson et al., 1908]

Fig. 3.19: Conditions on Dore Street Between Brannan and Bryant After the 1906 San Francisco Earthquake [Lawson et al., 1908]

Figures 3.18 and 3.19 illustrate the considerable ground deformations which resulted from liquefaction in 1906 in the vicinity of what are now Dore and Brannan Streets in the heart of the old Mission Bay region. The ground shown in Figure 3.18 had been level prior to the earthquake; liquefaction and resulting ground deformations produced permanent undulations or "waves" with amplitudes of up to 5 feet in this area. Figure 3.19 illustrates the effects of lateral spreading and bearing failures in this region during the 1906 earthquake. The building at the center of the photograph displaced more than 8 feet to the left as a result of lateral spreading associated with loss of strength of the underlying foundation soils. Figure 3.20 shows sand boils, differential settlement and resulting damages to a structure on 6th Street south of Howard Street (in the vicinity of Figs. 3.18 and 3.19) after the 1989 Loma Prieta earthquake. The basement of the building was filled with intruded sand, and sufficient structural damage occurred as a result of differential settlements that the building was condemned. Figure 3.21 shows a building one block farther to the North. The basement of this structure also experienced considerable sand intrusions during the Loma Prieta Earthquake, and foundation settlements resulted in sufficient damage that this structure was condemned as well.

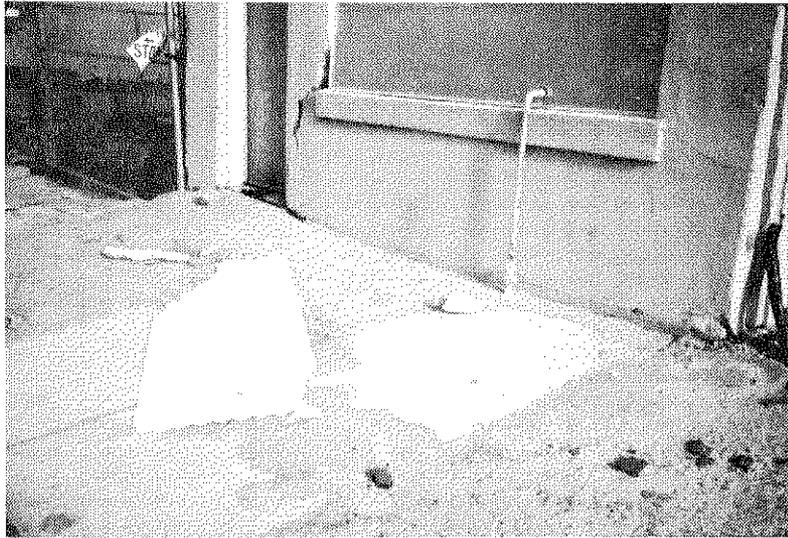
Fig. 3.20: Sand Boils, Foundation Movement and Structural Damage on 6th Street South of Howard After the Loma Prieta Earthquake [Courtesy of Dr. Marshall Lew]

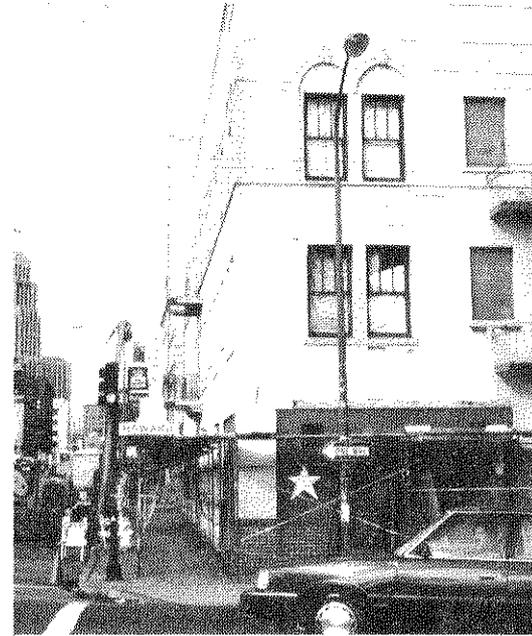
Fig. 3.21: Structure Heavily Damaged by Liquefaction-Induced Foundation Movements at 7th and Howard Streets in the Loma Prieta Earthquake

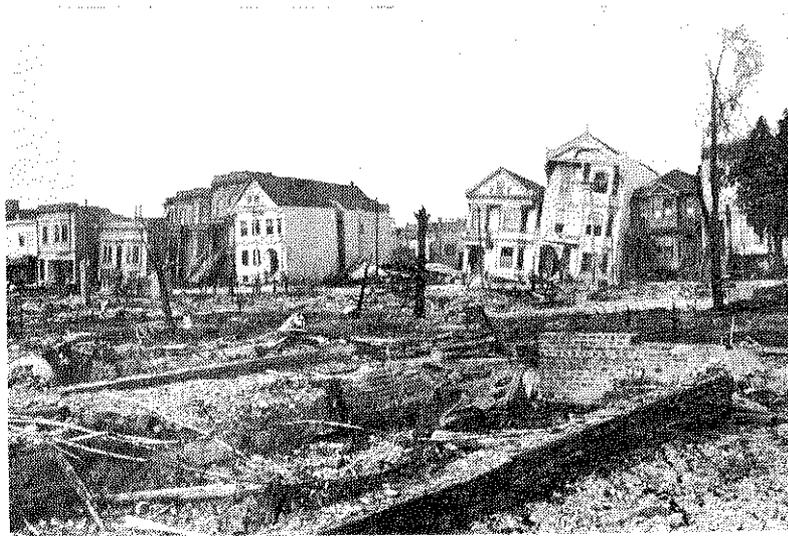
Figure 3.22 shows conditions in the vicinity of 19th Street and Shotwell in the wake of the 1906 San Francisco earthquake. Note the foundation bearing failures and differential settlements, the tilted structures and the uneven ground (which had been essentially level prior to the earthquake). Figures 3.23 and 3.24 show damage to several structures also at Shotwell at 18th Street in the wake of the 1989 Loma Prieta earthquake. Four of these buildings suffered differential settlements and/or partial bearing failures, and significant sand intrusions occurred in the basements of three of the buildings. All four buildings were heavily damaged by differential foundation displacements.

Fig. 3.22: Conditions at 18th and Shotwell Streets After the 1906 San Francisco Earthquake [Lawson et al., 1908]

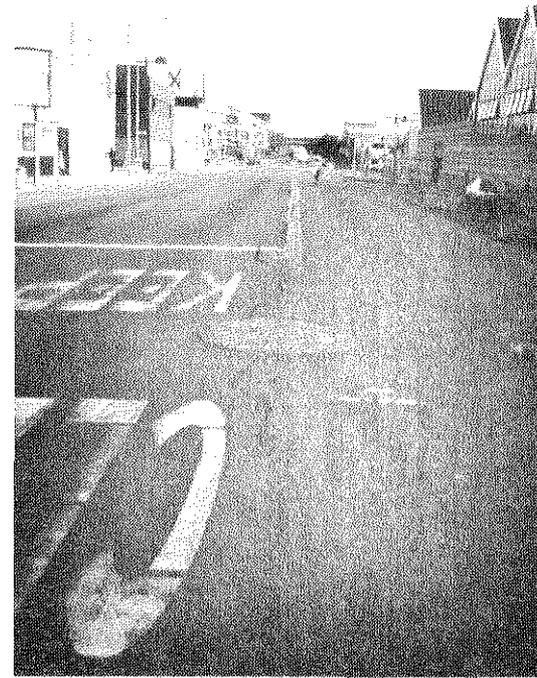
Fig. 3.25: Example of Centerline Cracking of a Roadway Pavement in the Old Mission Bay Region: 6th Street at Tehama [Courtesy of Dr. Marshall Lew]

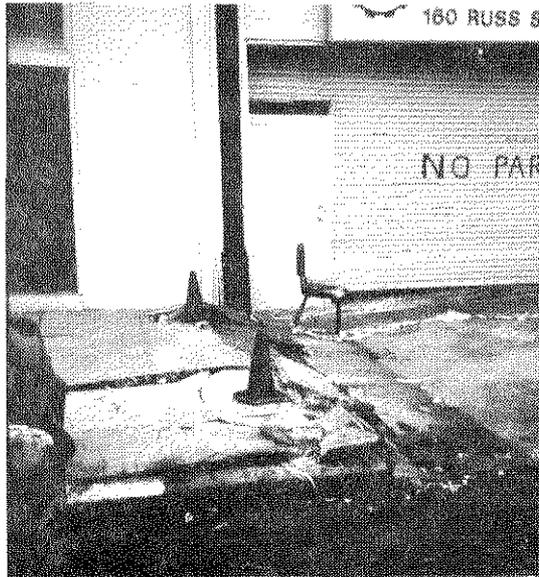
Fig. 3.26: Pavement Damage and Differential Settlement on Russ Street Near Howard Street [Courtesy of Dr. Marshall Lew]

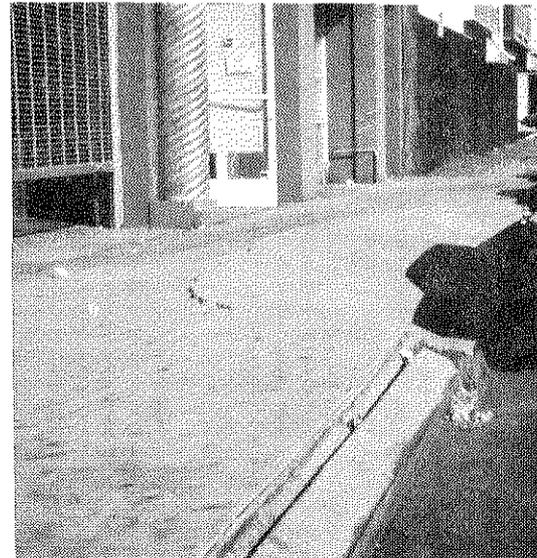
Fig. 3.27: Settlement Adjacent to Storm Sewer Alignment on Bryant Street at Dore Street

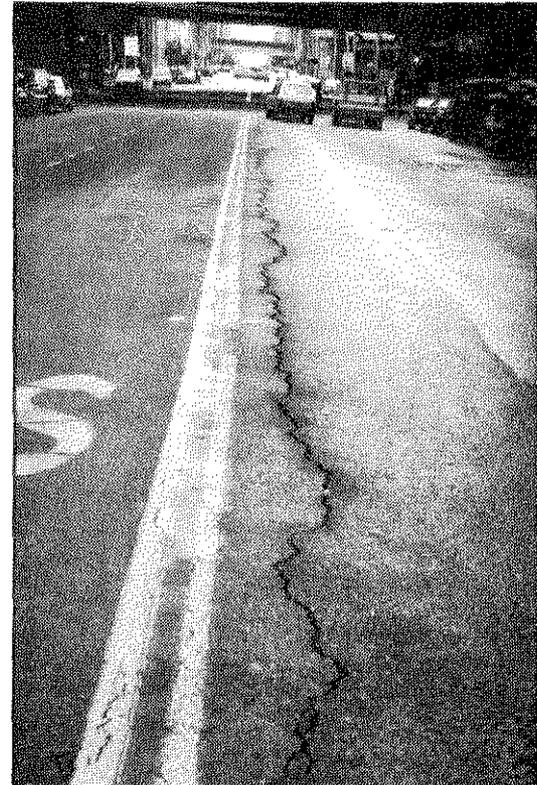
Fig. 3.30: "Centerline" Cracking of Pavement on Mission Street Near Beale Street After the Loma Prieta Earthquake

As described previously for the old Mission Bay district, numerous streets exhibited cracked pavements along their center-lines, overlying the centrally located major sewer conduits typical of this coastal area of the city. Figure 3.30 shows a typical example of centerline pavement cracking in this region. Figure 3.31 presents an example of pavement cracking associated with liquefaction-induced settlements near the foot of Market Street, and Figure 3.32 illustrates settlement of the curb and pavement adjacent to a pile-supported pier carrying a portion of the elevated Embarcadero freeway.

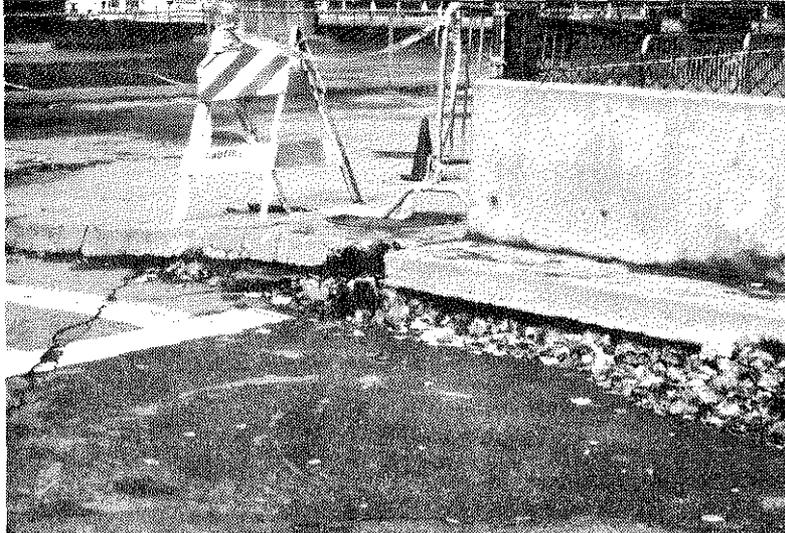
Settlements throughout much of the district could be relatively easily observed by comparison between settled pavement surfaces and marks left by the original pavement at the bases of the walls of pile-supported structures in this area. Settlements of the extreme edge of the coastal fill at the ends of the pile-supported piers along the waterfront varied between a minimum of approximately 1 inch at several piers to a maximum of approximately 5 to 6 inches near Piers 15 and 17.

Fig. 3.31: Settlement and Pavement Damage on the West Side of Embarcadero near Market Street [Courtesy of Dr. Marshall Lew]

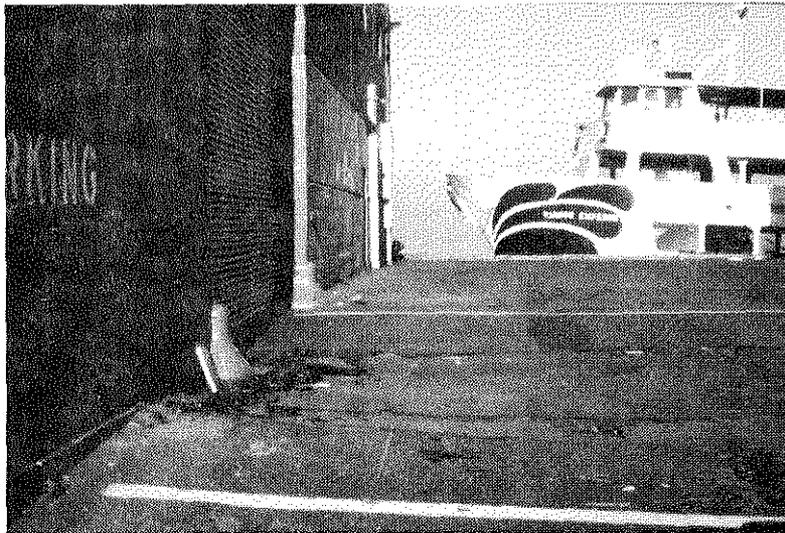
A single notable exception to the general observation that liquefaction caused little serious damage in this region during the Loma Prieta Earthquake was the damage which occurred at Pier 45. Figure 3.33 shows liquefaction-induced settlement and cracking of the pavement at the entrance to this pier, and Figure 3.34 shows a crack running along the pier inside one of the four large warehouses on this pier. Liquefaction-induced damages to Pier 45 and its warehouse structures caused closure and/or partial closure of several of the warehouses and temporary relocation

Fig. 3.33: Settlement at the South End of Pier 45, San Francisco

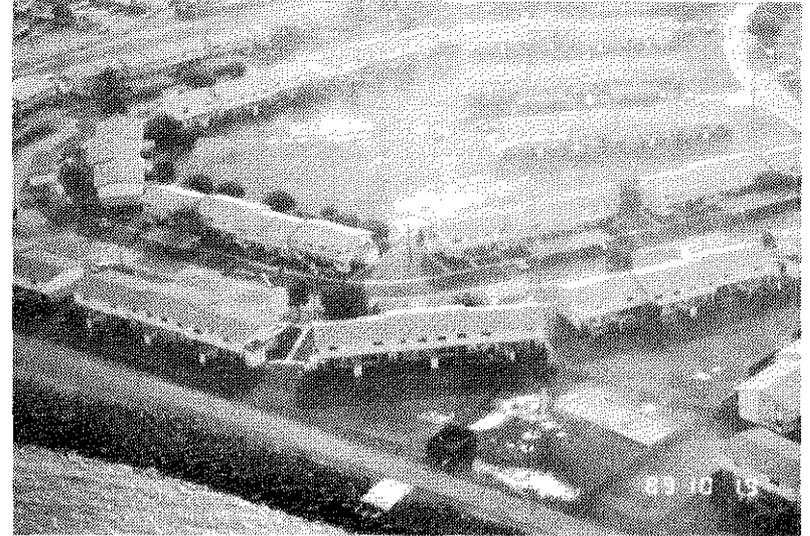
Figure 3.38 is an aerial view of the northern end of the Island, taken on the day after the Loma Prieta Earthquake. Numerous light spots in this photograph (many of which are reflecting sunlight) are sand boils which occurred during the Loma Prieta Earthquake. Sand boils and settlements occurred over most of the Island, with the few exceptions being localized zones in which ground improvement techniques had been applied. Many of the sand boils were quite large. Figures 3.39 and 3.40 show examples of large boils near the central western edge and southwest corners of the island, respectively. Sand boils of up to 20 feet in diameter occurred in numerous locations, and some of these exuded "clay balls" as well as sandy and silty boil material. Figures 3.41 and 3.42 present examples of two areas in which sand boils, settlements and associated expulsion of water created ponds of fair size. Figure 3.41 shows boil material and ponded water at the schoolyard on 12th Street, near the center of the island, and Figure 3.42 shows similar conditions on 9th Street several blocks farther south.

Fig. 3.38: Oblique Aerial View of the Northern End of Treasure Island on October 18, 1989

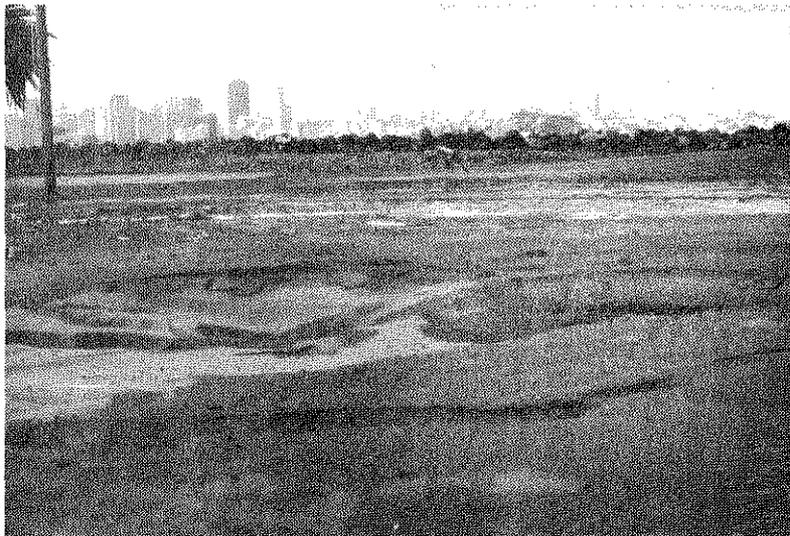
Fig. 3.39: Large Sand Boils near the Western Edge of Treasure Island [Photo courtesy of David T. Schrier]

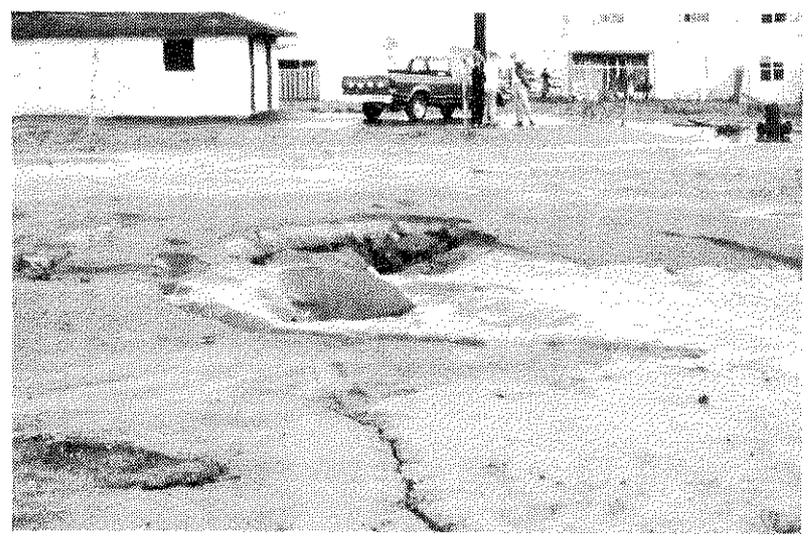
Fig. 3.40: Large Sand Boils Near the Southwest Corner of Treasure Island [Photo Courtesy of David T. Schrier]

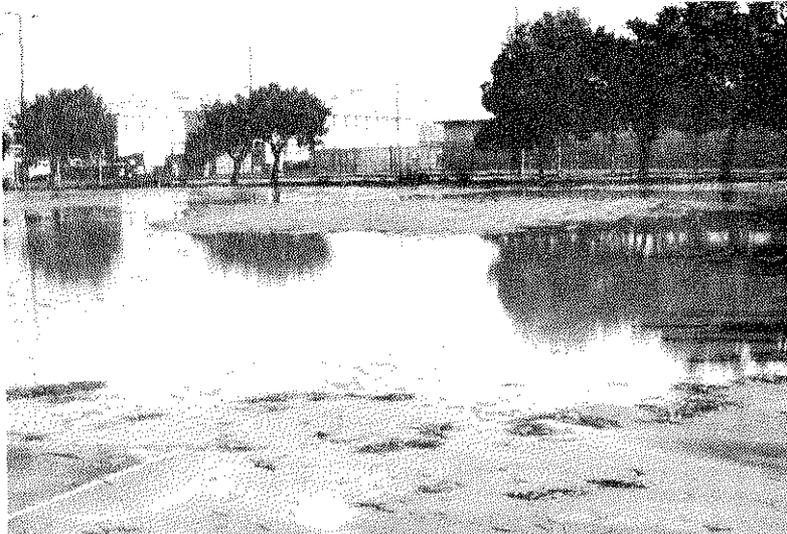
Fig. 3.41: Sand Boils and Ponded Water at Schoolyard on 12th Street, Treasure Island, on October 18, 1989. [Photo courtesy of David T. Schrier]
