REPORT NO.
UCB/EERC-90/05
APRIL 1990

EARTHQUAKE ENGINEERING RESEARCH CENTER

PRELIMINARY REPORT ON THE PRINCIPAL GEOTECHNICAL ASPECTS OF THE OCTOBER 17, 1989 LOMA PRIETA EARTHQUAKE

R. B. Seed, S. E. Dickenson, M. F. Riemer, J. D. Bray,
N. Sitar, J. K. Mitchell, I. M. Idriss, R. E. Kayen
A. Kropp, L. F. Harder, Jr. and M. S. Power

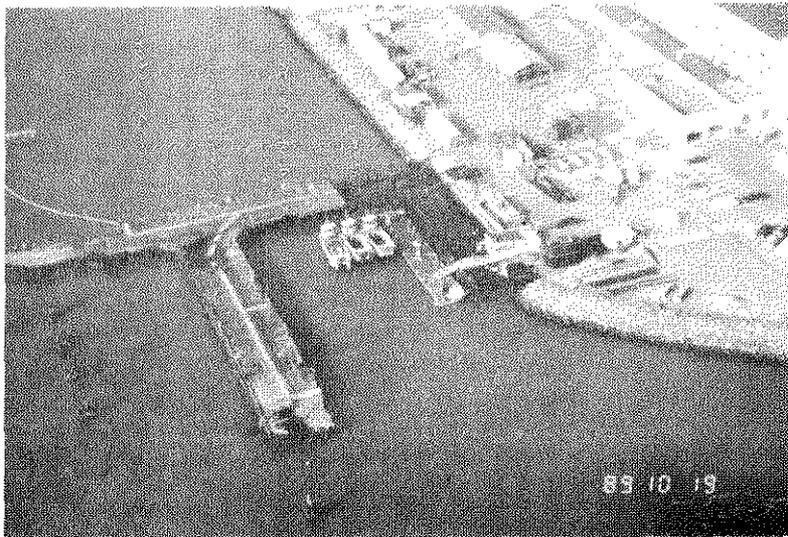
Figure 3.43 shows the area at the head of a wharf at the south-eastern corner of the Island. Soils adjacent to the area immediately inboard of the wharf (at the heads of a nearby group of wharfs) had been densified by vibro-flotation and showed no signs of liquefaction, settlement, or lateral spreading. Adjacent to the improved zone, however, major sand boils occurred in the fill. These can be seen in the upper right-hand corner of Figure 3.43, and a closer view of one of these boils, as well as work to repair ruptured buried utilities, is presented in Figure 3.44.

Fig. 3.43: Aerial View of Southeast Corner of Treasure Island on October 19, 1989

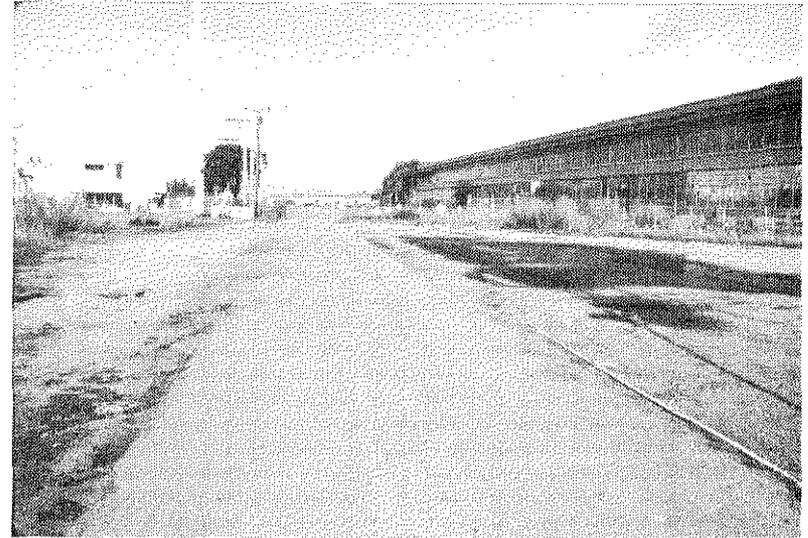
Figures 3.46 and 3.47 show sand boils near the middle of the area in which liquefaction occurred. Figure 3.48 shows the small dock and the adjacent structure which was lightly damaged by the liquefaction-induced ground displacements. Figure 3.49 shows a warehouse adjacent to the area in which liquefaction occurred. This structure suffered considerable damage during the earthquake, but this damage does not appear to have been caused by liquefaction of the foundation soils. Instead, this building appears to have suffered damage as a result of strong shaking. The absence of damage to a number of similar masonry warehouse structures at other sites in the Richmond Inner Harbor provides support for the hypothesis that the unusually deep clays at the extreme western edge of the Inner Harbor, overlying the old channel, amplified the levels of ground shaking produced in this area.

Fig. 3.47: Sand Boils on Undeveloped Land at Richmond Inner Harbor

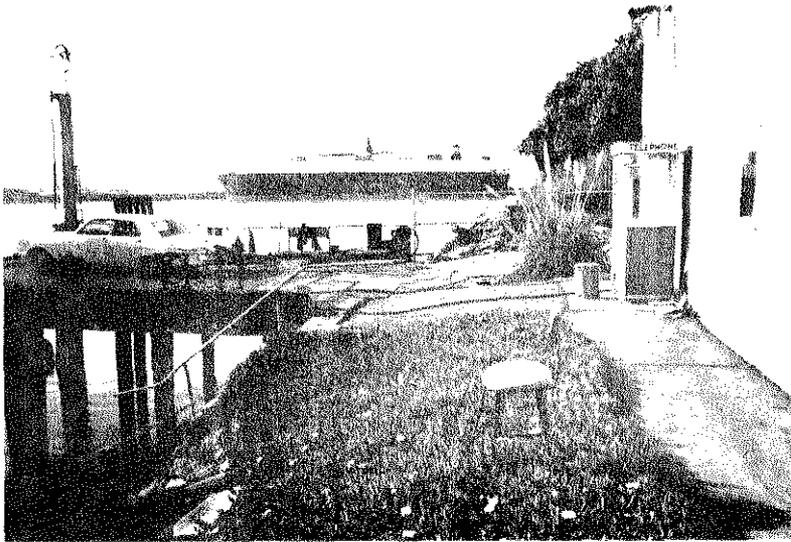
Fig. 3.48: Small Dock and Adjacent Structure at Edge of Apparent Zone of Liquefaction at Richmond Inner Harbor

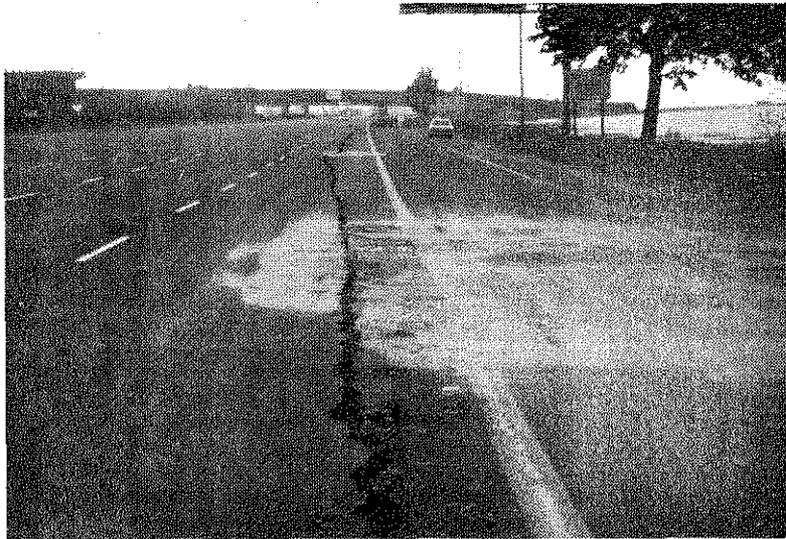
Fig. 3.50: Example of Fissure in Bayshore Highway in Southern Emeryville caused by Lateral Spreading Due to Liquefaction

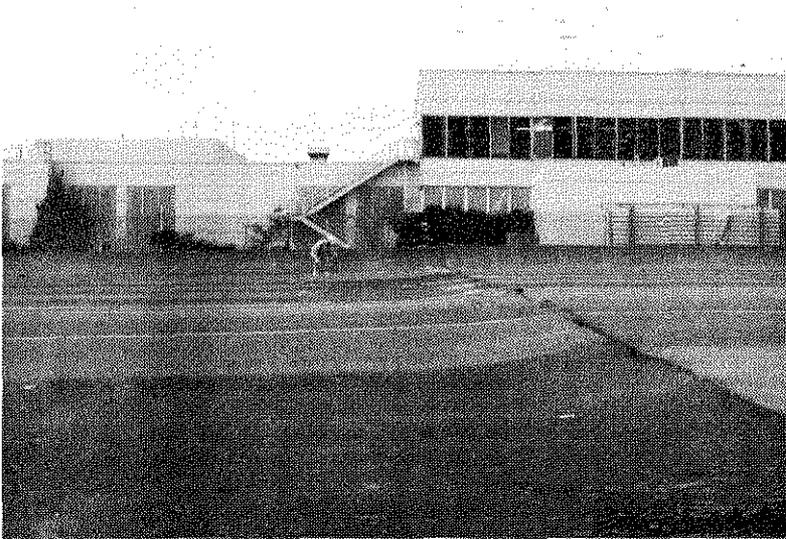
Fig. 3.52: Pavement Settlement Adjacent to the Operations Building on the Bay Bridge Approach Fill

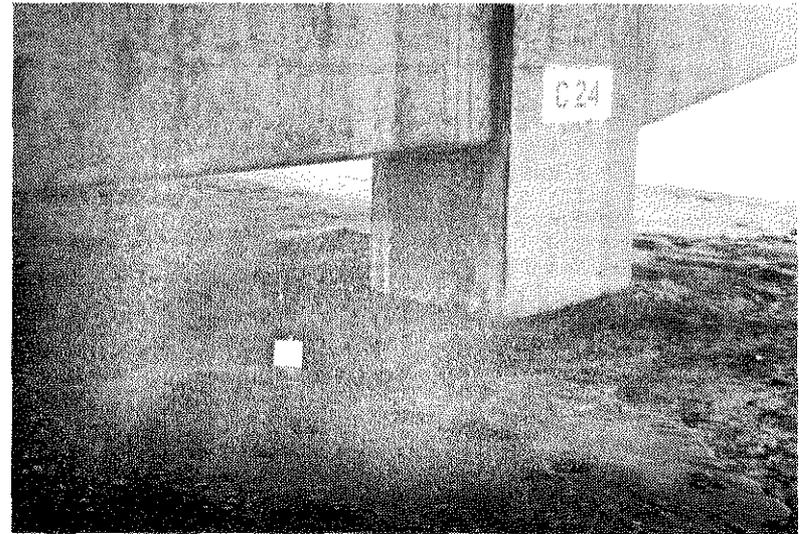
Fig. 3.53: Example of Sand Boils Beneath the Elevated Distribution Structure Inland of the Bay Bridge Approach Fill in Oakland

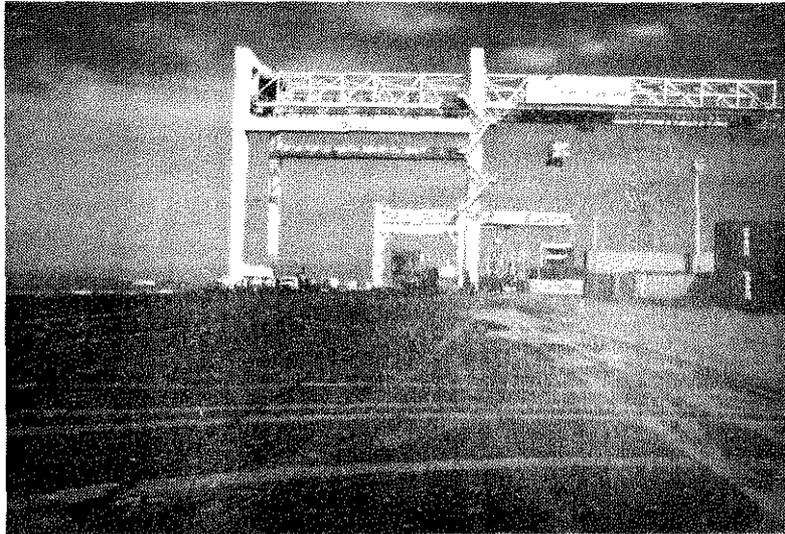
Figure 3.54 shows two of the large cranes operating along the northern side of the west end of the 7th Street Terminal, and Figure 3.55 shows a closeup view of damage to the pavement beneath the crane nearest to the camera in Figure 3.54. Similar cracks and fissures occurred along much of the terminal. Figure 3.56 shows a typical sand boil in the paved container yards in this area.

Fig. 3.54: View Looking East Along the 7th Street Terminal Showing Two of the Large Cranes at this Terminal and Pavement Damage

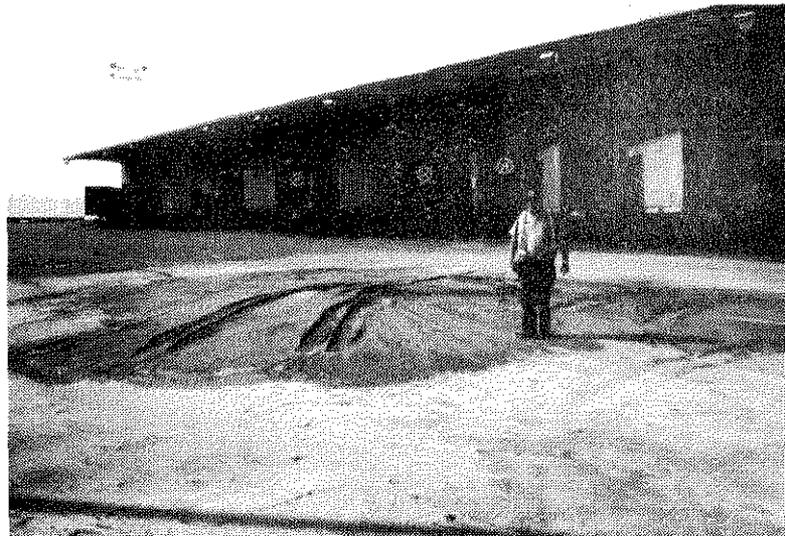
Fig. 3.56: Sand Boil at the 7th Street Terminal

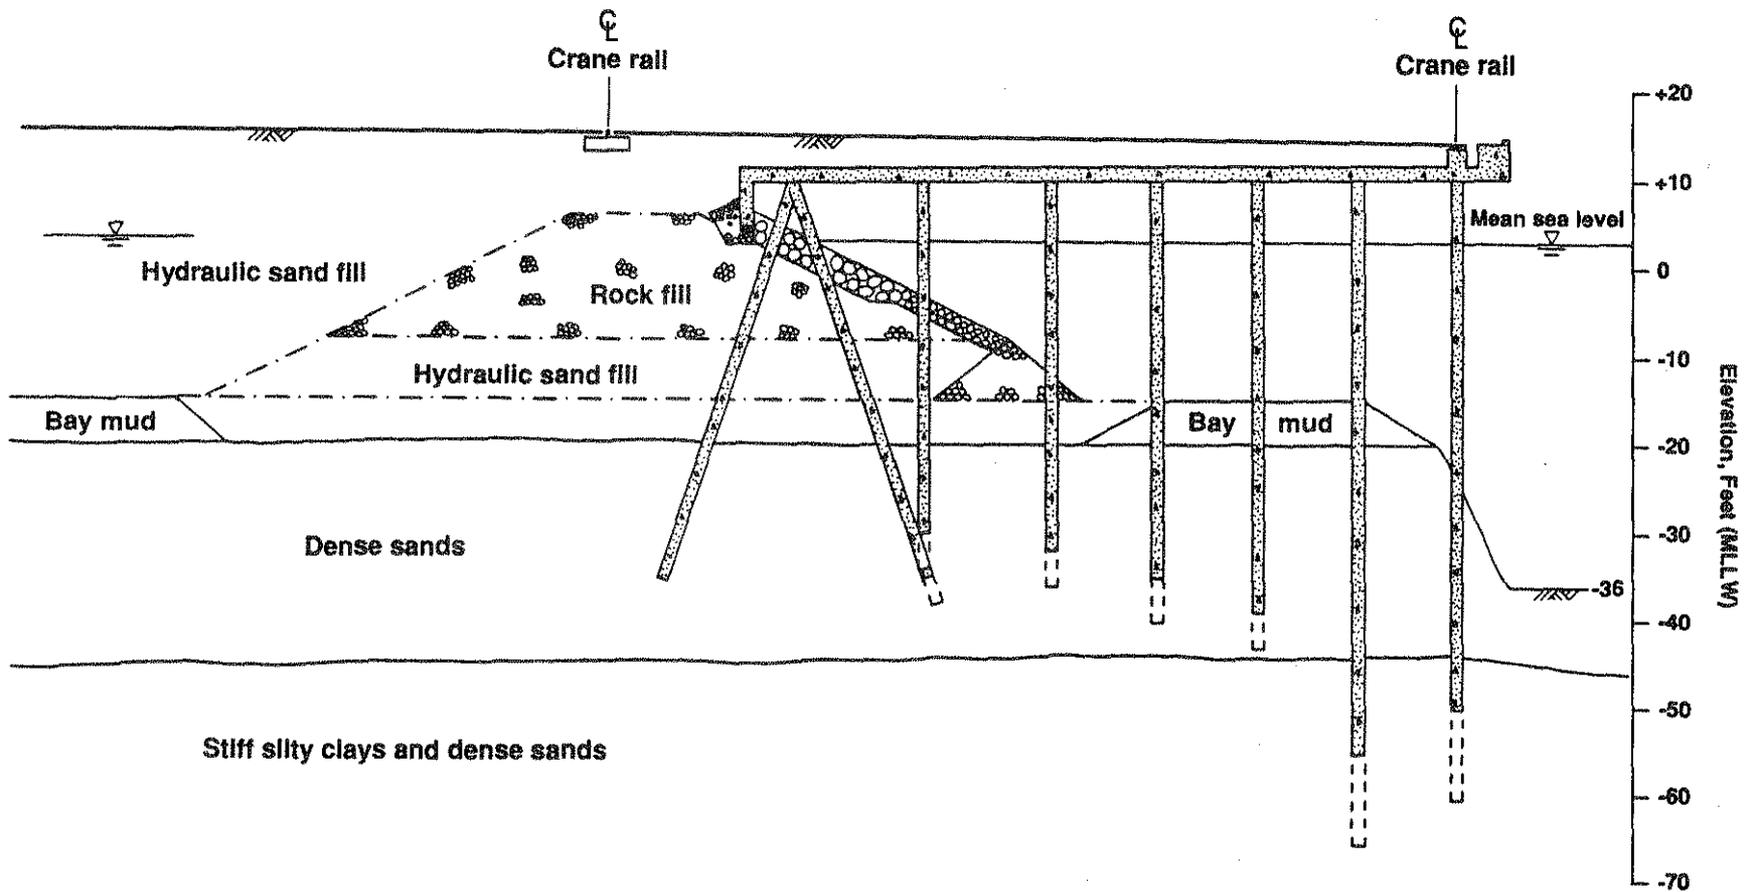
In addition to settlement and lateral spreading, and associated pavement damage and related mobility problems for the large terminal cranes, damage occurred at the tops of a number of piles supporting the wharves in this area. Figure 3.58 is a cross-section through the northern edge of the 7th Street Terminal showing the rock dike, the pile-supported concrete wharf, and the hydraulic fill. Damage to piles occurred at the tops of the inboard, battered piles and consisted primarily of tensile failures, though some piles also appeared to have been damaged in shear and compression. Figure 3.57 shows typical damage to the top of one of the concrete piles at this location. The vertical piles farther outboard were largely undamaged (a few isolated piles sustained minor damage). It has not yet been conclusively established whether this pile damage was caused by (a) liquefaction of the hydraulic fill and associated increased lateral thrust, spreading and settlement, or (b) by oscillatory ground movements associated with strong ground shaking during the earthquake. This pile damage appears to represent an example of the damage that can occur as a result of employment of battered piles to resist lateral movements in relatively soft, compliant soil foundations. These piles represent a "stiff" inclusion in an otherwise relatively flexible surrounding foundation and structural system. The result is large stress concentrations, alternately tensile and compressive, during earthquake shaking. The mode of failure observed, however, was predominantly tensile failure driven by outboard thrust of the fill, suggesting that liquefaction and associated lateral spreading were important factors.

Fig. 3.58: Cross-Section Through the Edge of the Fill, Dike and Wharf at the North Side of the 7th Street Terminal, Port of Oakland
 [Courtesy of EERI Post-Earthquake Investigation Report, in progress]

As a result of widespread damage to the battered piles, the Port of Oakland is replacing the battered piles with vertical piles designed to resist lateral forces, but providing limited lateral flexibility during earthquake loading that will be more compatible with the surrounding foundation soils and structural systems. In addition, the pile-supported wharf deck will be extended inboard, with additional piles, to provide improved support for the inboard crane rails in this area.

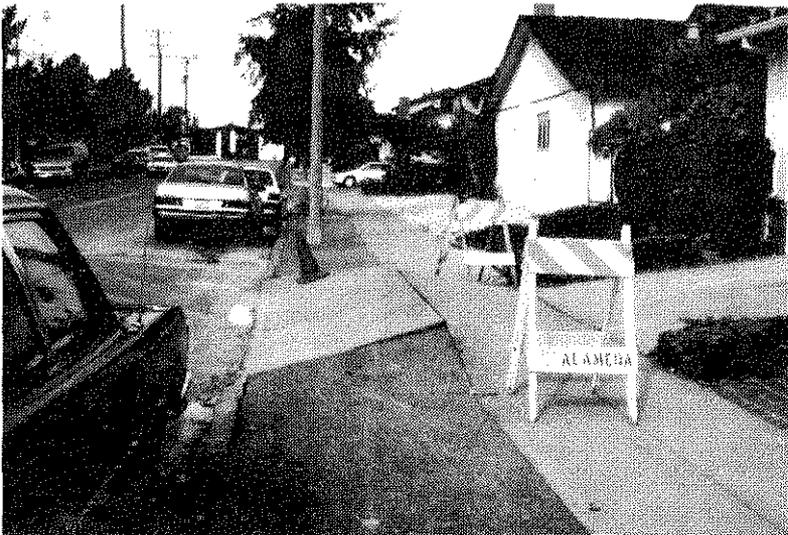
Fig. 3.61: Minor Settlement and Buckling of Pavement at the Southwest Edge of Alameda

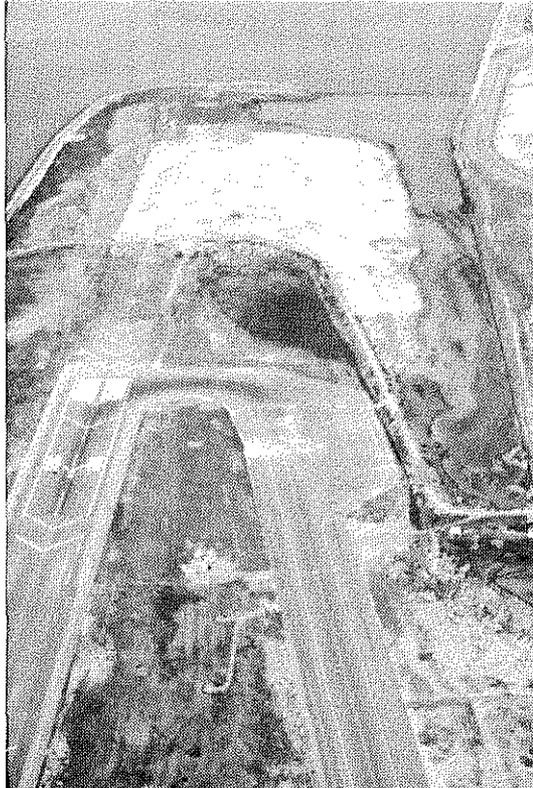
Fig. 3.63: Aerial View of the Western End of the Main Runway and Adjacent Taxiway at the Oakland International Airport on October 18, 1989

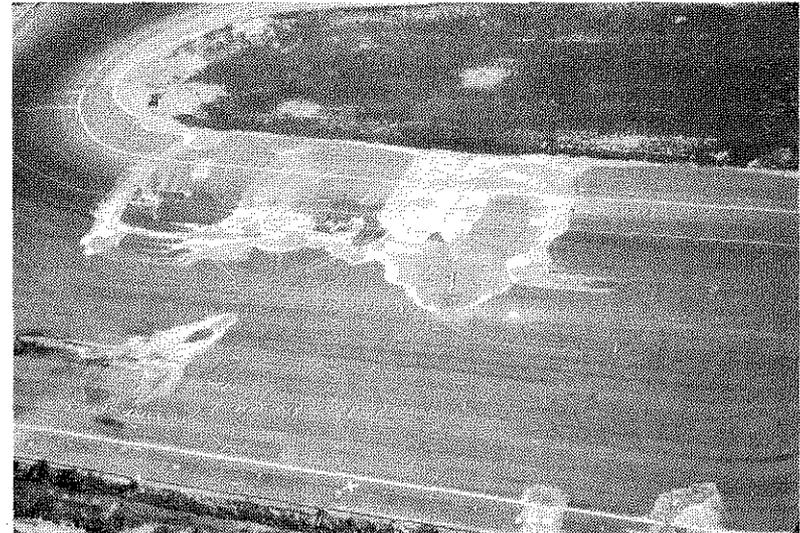
Fig. 3.64: Aerial View of the Main Taxiway Adjacent to the West End of the Main Runway, Oakland International Airport

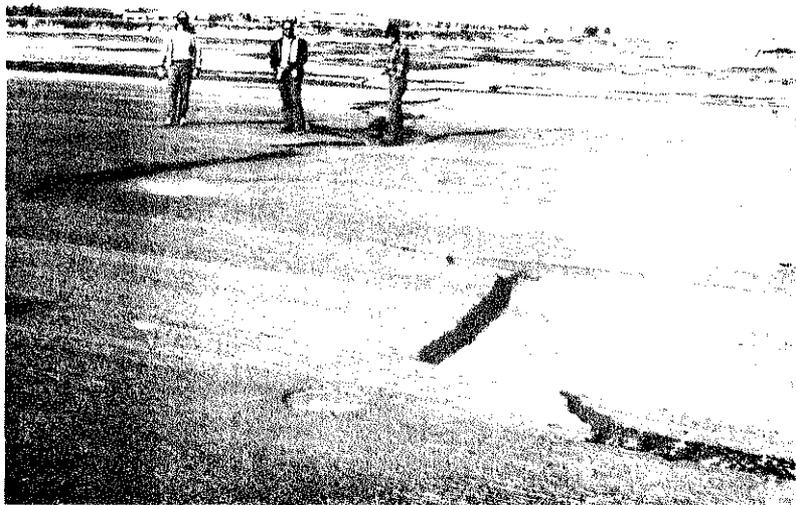
Figure 3.67 shows a crack in the pavement of the taxiway adjacent to the main runway, and Figure 3.68 shows cracking of the main runway. Cracks in the main runway and the adjacent taxiway had maximum widths of up to approximately 12 inches, and vertical offsets of up to 8 inches were observed. The fill in the area of the western end of the main runway underwent settlements of on the order of 6 to 12 inches, and evidence of lateral spreading also occurred over large parts of this fill zone.

Fig. 3.68: Cracking of the Pavement of the Main Runway, Oakland International Airport [Photo courtesy of B. A. Vallerga]

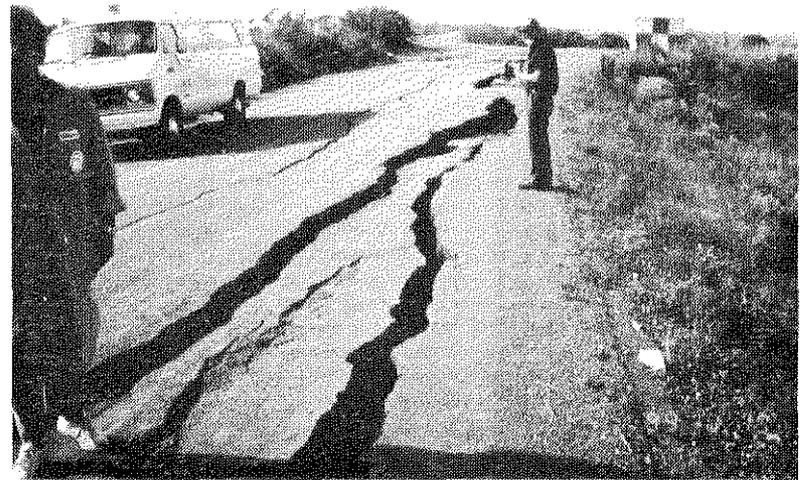
In addition to liquefaction, settlement, and lateral spreading of the main fill in and around the west end of the main runway, the surrounding perimeter dikes at this end of the runway fill also suffered from settlement and lateral spreading in several places. Figure 3.69 shows cracking along the crest of a levee section near the northwest corner of the runway fill which suffered as a result of both settlement and lateral spreading. The maximum observed levee settlement in this area was on the order of 2 to 3 feet, and lateral deformations associated with spreading were generally similar in magnitude. Extensive liquefaction also damaged the fill to the north and west of the main runway. Figure 3.70 shows sand boils and major fissures caused by lateral spreading in this area. There are no pavements or structures in this area.

Fig. 3.69: Cracking and Settlement of Perimeter Levee Near the Northwest Corner of the Oakland International Airport Runway Fill

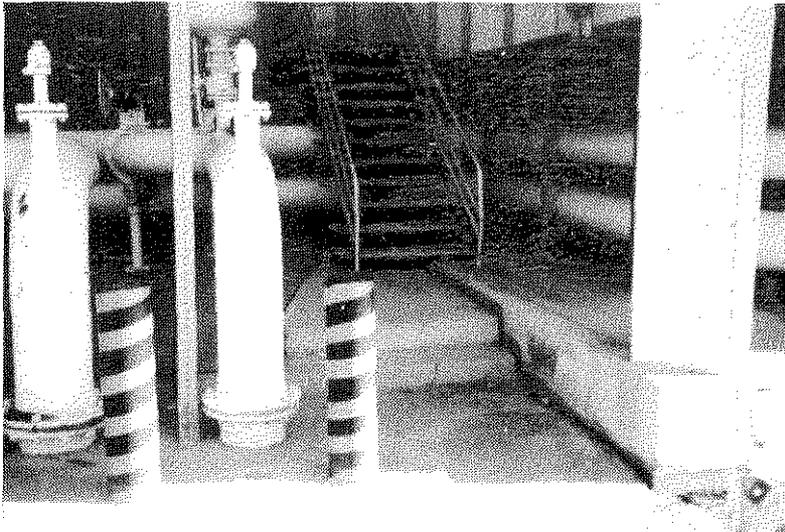
Fig. 3.71: Settlement Adjacent to Main Terminal Building, Oakland International Airport [Photo courtesy of B. A. Vallerga]

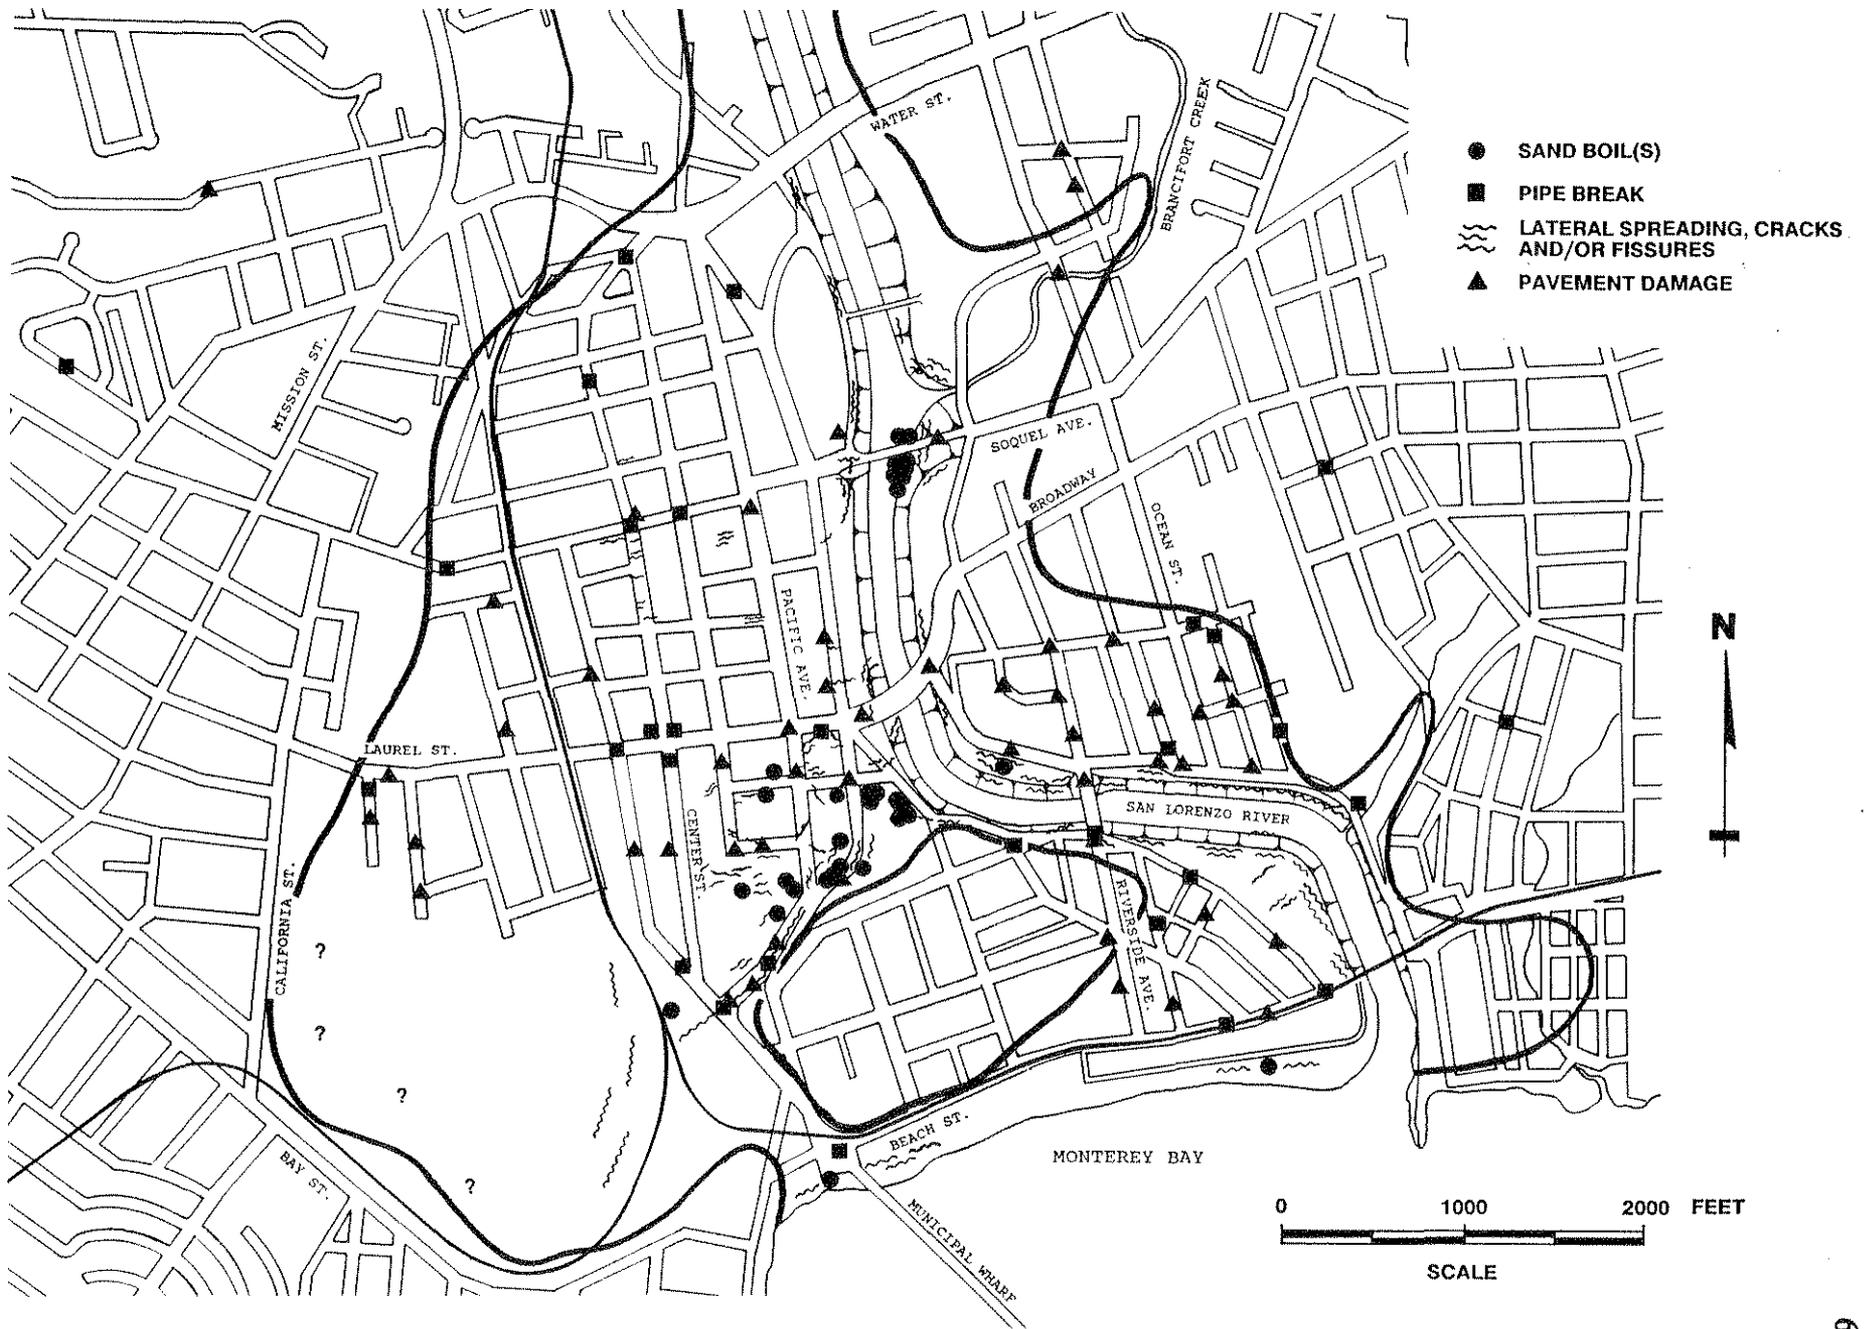
The shaded zone delineating potential liquefaction hazard shown in Figure 3.73 was established using SPT-based techniques for evaluation of the in situ liquefaction resistance of sandy soils, as proposed by Seed and Idriss (1971). Figure 3.74 presents a mapping of features clearly associated with soil liquefaction during the Loma Prieta Earthquake of October 17, 1989, including sand boils, pipe breaks, significant lateral spreading, cracking, fissures and significant pavement damage. Additional minor pavement damages, as well as zones of minor ground settlement and/or lateral spreading are not mapped. Also included on this figure is the outline of the shaded region of predicted potential liquefaction hazard from Figure 3.73. As shown in Figure 3.74, clear evidence of liquefaction was observed throughout much of the previously identified zone of potential liquefaction, but little evidence of liquefaction was observed beyond the boundaries of the identified zone of potential liquefaction. (It should be noted that the undeveloped land in the southwest corner of the zone of potential liquefaction, marked with question marks in Figure 3.74, was not investigated prior to the rains which occurred several days after the earthquake. As a result, no evaluation of the occurrence or non-occurrence of liquefaction in this area could be made.) In general, the 1976 hazard studies appear to have correctly defined the areas of principal liquefaction risk, and thus provide a strong endorsement for the use of in situ testing-based methods (e.g. SPT) as a basis for evaluation of liquefaction potential.

Fig. 3.74: Map of Central Santa Cruz Showing Major Liquefaction-Related Features After the Loma Prieta Earthquake of October 17, 1989

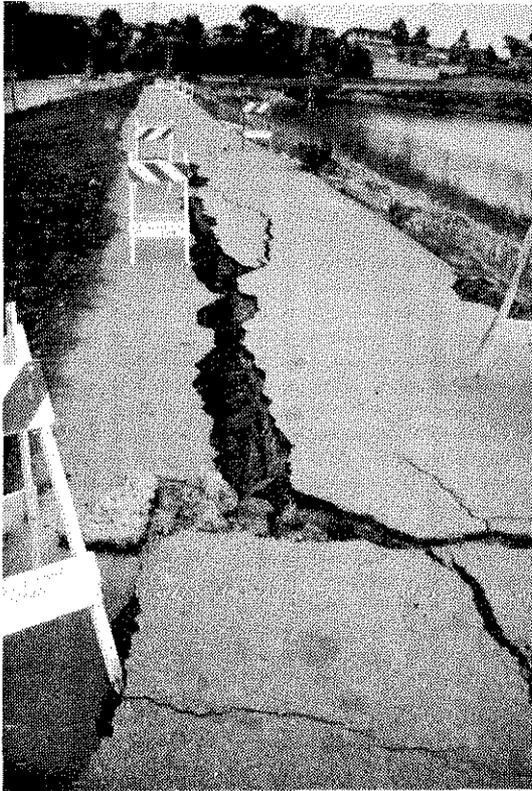
Soil liquefaction and associated settlement and lateral spreading produced boils and fissures at several points along the main beach, but these were fairly quickly erased by rainfall and tidal action. Liquefaction also caused settlement and lateral spreading which resulted in considerable damage to the levees lining the San Lorenzo River throughout much of this area, as shown in Figure 3.74. Figure 3.75 shows a fairly typical example of damage to one of these levee sections. Fissures, with widths of up to 6 inches and depths of more than 5 feet, were relatively common along several thousand feet of levees in this area.

Fig. 3.75: Settlement and Lateral Spreading of Levee Adjacent to the San Lorenzo River; Central Santa Cruz

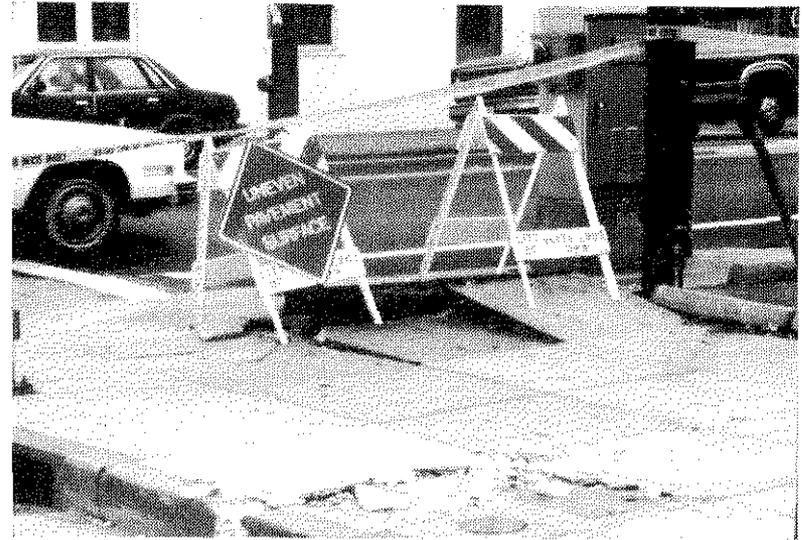
Fig. 3.76: Compression-Induced Pavement Buckling in Central Santa Cruz

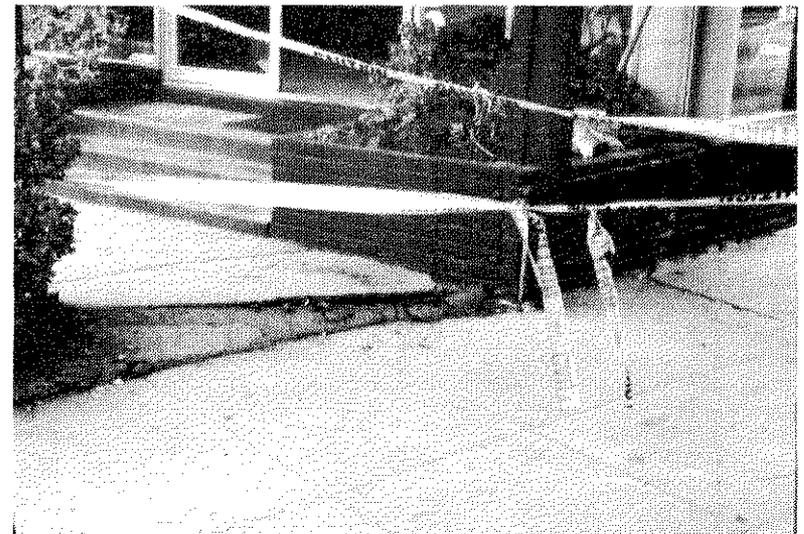
Fig. 3.77: Settlement and Lateral Displacement of the Corner of a Building in Central Santa Cruz

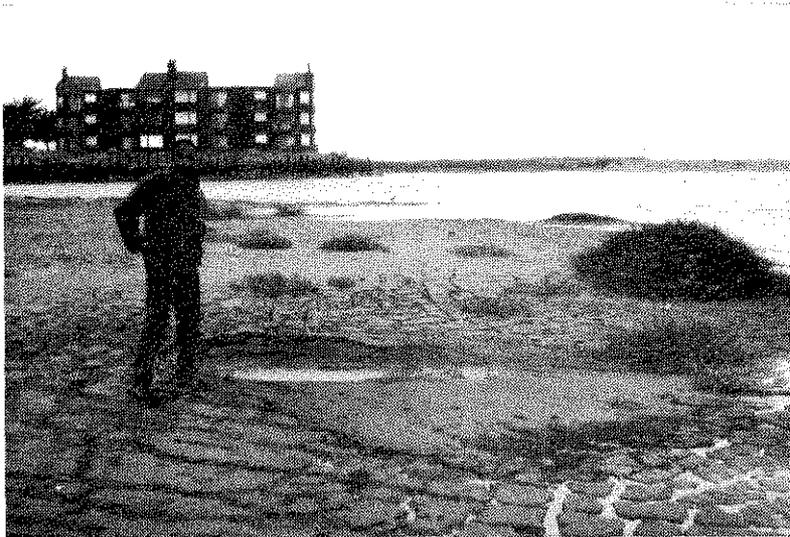
Figure 3.79 shows one of hundreds of sand boils which occurred on the beach at the mouth of the Pajaro River, and Figure 3.80 shows fissures caused by lateral spreading adjacent to the river at this location. Liquefaction caused only minor damage to a number of structures at this location, including wracking of stairwells and decks, and the rupture of a water main. An eyewitness provides an interesting view of the sequence and timing of events at this site. The eyewitness, terrified by the strong shaking at this site, raced out of her wood-frame residence (clutching her young nephew under one arm) and ran to the "safety" of the open beach. Arriving at the beach some seconds after the shaking had subsided, she was initially relieved. She was then frightened anew when, after some additional brief interval of time elapsed, sand boils began to erupt from the beach and fissures appeared "more or less all at once" over an area of several acres as the beach softened and "spread" towards the ocean. [She ran back into her residence at this point.]

Fig. 3.79: Sand Boil and Lateral Spreading on the Beach at the Mouth of the Pajaro River

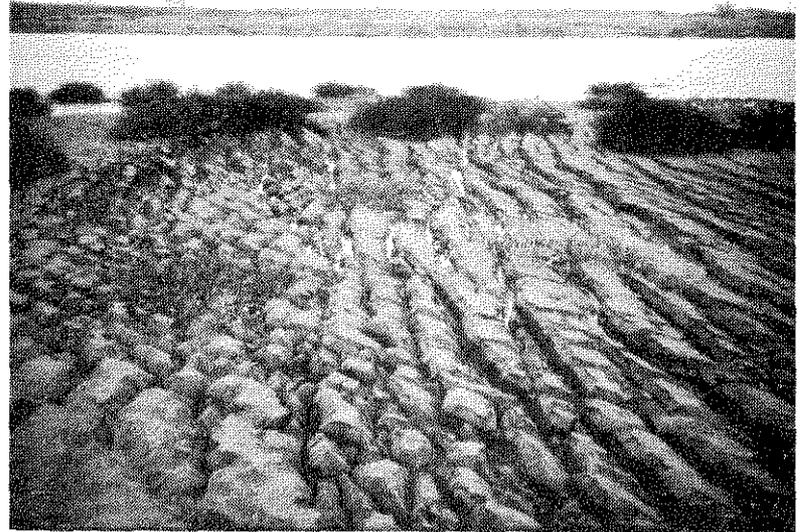
Fig. 3.80: Lateral Spreading at the Mouth of the Pajaro River
[Photo courtesy of James R. Martin, II]

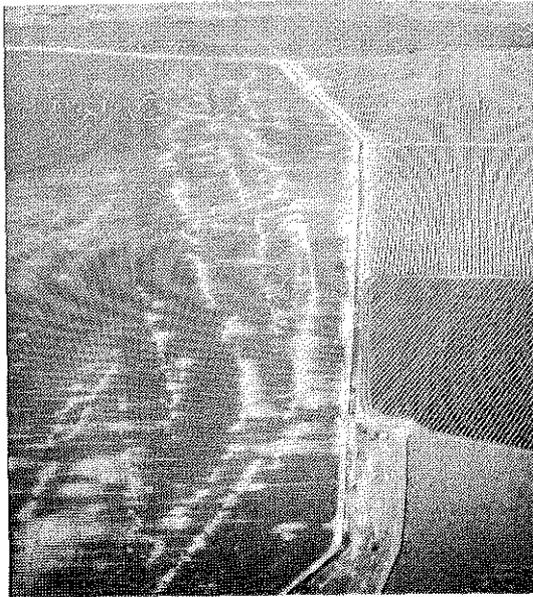
Fig. 3.81: Aerial View of Sand Boils in Cultivated Fields South of Moss Landing, Along the Old Salinas River Channel

shows numerous boils in open fields just south of Moss Landing along what had once been a northern leg of the Salinas River Channel, and Figure 3.82 shows similar boils in an open field farther to the east. These boils tended to form largely linear features across the open fields, and appeared to correlate with the locations of historic stream channel deposits.

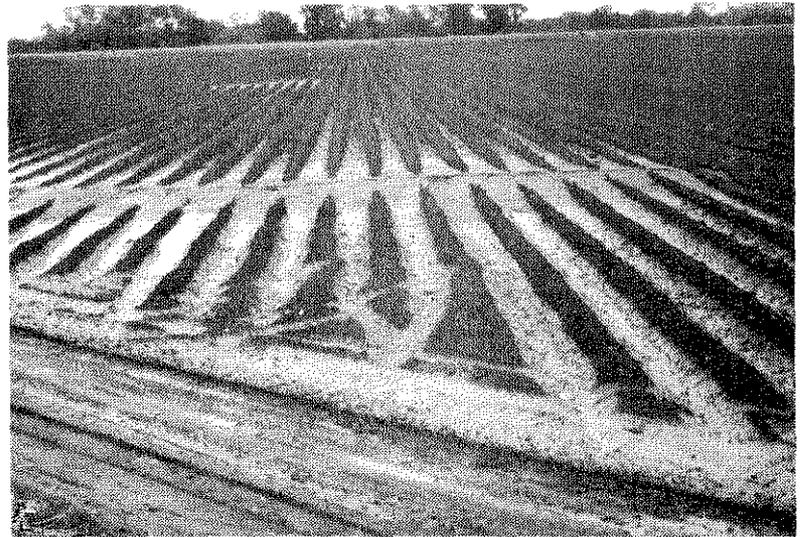
Fig. 3.82: Ground View of Sand Boils in a Cultivated Field East of Moss Landing

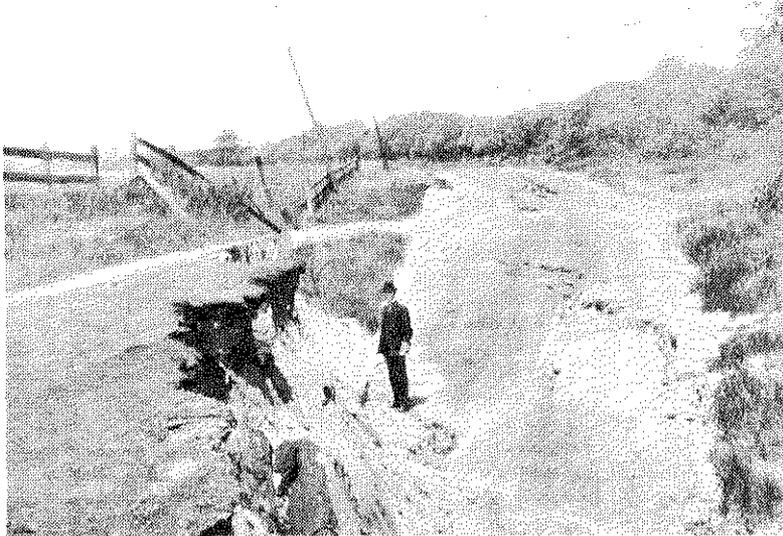
It should also be noted that the widespread liquefaction of alluvial channel deposits in the east Monterey Bay region is not without historic precedent. As an example, Figure 3.83 shows damage to a roadway caused by massive lateral spreading and settlement adjacent to the Salinas River, approximately five miles inland from the coast, which occurred during the 1906 San Francisco Earthquake. There is considerable, well-documented evidence of widespread liquefaction of channel deposits throughout this general region during the 1906 earthquake.

Fig. 3.83: Apparent Massive Lateral Spreading and Settlement at the Edge of the Salinas River, Near Spreckels, After the 1906 San Francisco Earthquake [Lawson et al., 1908]

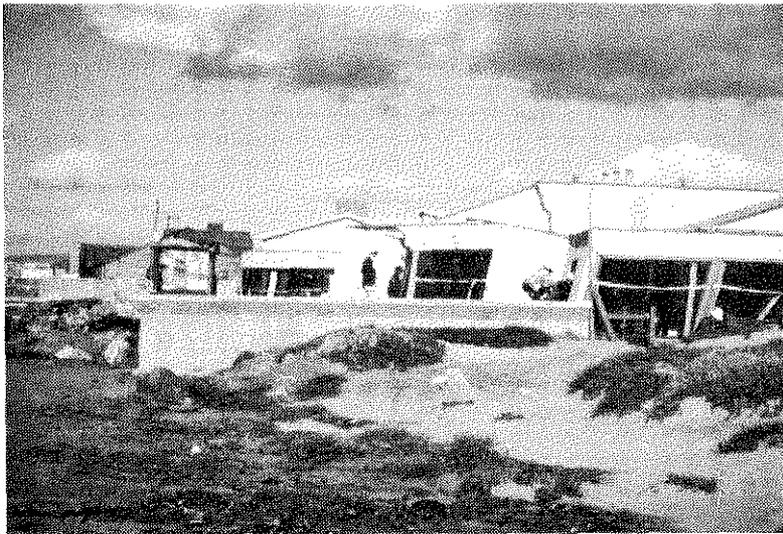
One of the clearest examples of the structural damage that can result from soil liquefaction was the destruction of the Marine Research Facility at Moss Landing. As shown in Figures 3.85 through 3.87, this facility was a group of low, modern 1 and 2-story structures founded on concrete slabs. The structures were grouped together to provide a series of classrooms and laboratories surrounding a central courtyard. The buildings do not appear to have been significantly damaged by shaking during the Loma Prieta Earthquake. This facility was, however, destroyed beyond repair by foundation displacements (settlement and lateral spreading) as a result of liquefaction of the foundation soils. The inboard roadway adjacent to this structure settled several feet, and lateral spreading deformations of the foundation soils stretched the facility by 6 feet, literally pulling it apart. Figures 3.85 and 3.86 present exterior views of this facility, clearly showing the massive damage caused by these foundation movements. Figure 3.87 presents an interior view, showing a section of the main foundation slab pulled apart by these movements.

Fig. 3.85: Damage to the Moss Landing Marine Research Facility as a Result of Settlement and Lateral Spreading

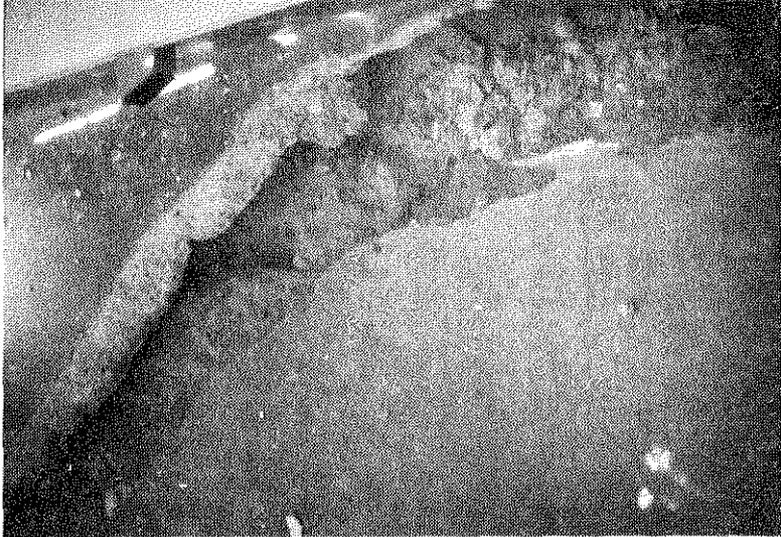
Fig. 3.87: Damage to the Moss Landing Marine Research Facility as a Result of Settlement and Lateral Spreading

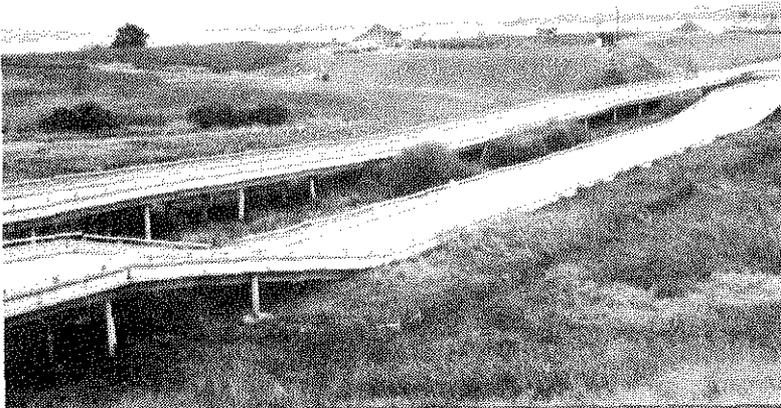
Fig. 3.89: Collapse of the Elevated Highway 1 Crossing over the Struve Slough Near Watsonville

In addition to damaging levees, roads, and the relatively few structures described above, soil liquefaction has also been cited by a number of investigators as possibly having contributed to the damage to a pair of parallel major highway bridges carrying Highway 1 across Struve Slough near Watsonville. Figure 3.89 shows the collapsed section of this elevated highway across Struve Slough. The south-bound section collapsed completely, and several of the piles supporting this structure were thrust through the collapsed roadway, as shown in Figure 3.90. The parallel north-bound section was also damaged, but did not collapse. The mode of failure appears to have been excessive lateral deflections of the vertical, reinforced concrete piles supporting the structure. This, in turn, resulted in failures of the connections of the tops of the piles to the bases of the support bents under the combination of flexural and shear forces produced by these movements. Figures 3.91 and 3.92 show examples of typical damage at the pile/bent connections.

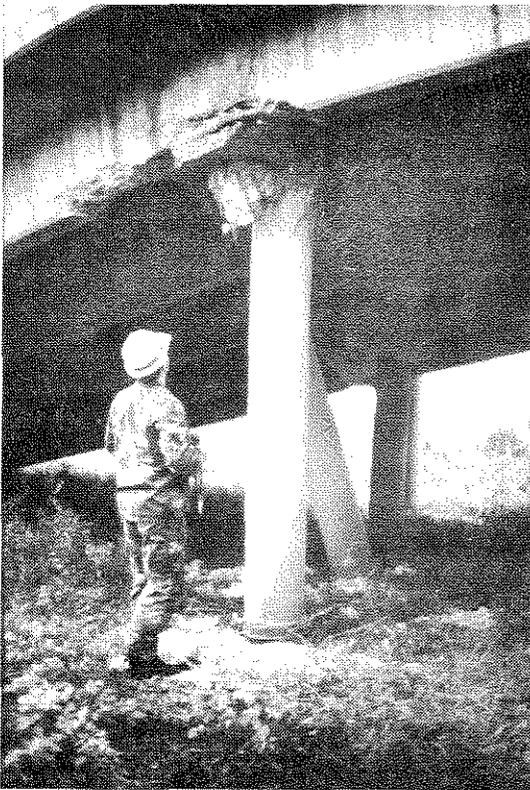
Fig. 3.91: Damage to Pile/Bridge Connection;
Struve Slough Crossing

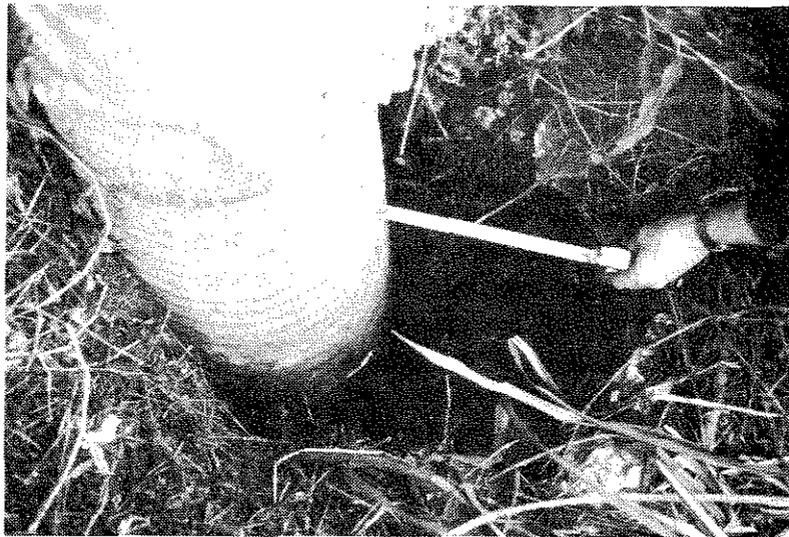
Fig. 3.93: Typical Gap Adjacent to One of the Piles Supporting the
Collapsed Struve Slough Crossing

The excessive lateral pile deflections may have been the result of inadequate lateral support provided by the soils surrounding the upper portions of the piles. All of the piles beneath the collapsed section showed "gaps" between the piles and the surrounding soil indicating that significant movements had occurred. A typical example of one such gap is shown in Figure 3.93. The poor lateral support of the foundation soils appears to have been due primarily to the soft, weak saturated clays and organics which comprise much of the upper foundation. Alluvial sands are also present in these foundation soils, and sand boils were noted at several locations indicating that some liquefaction occurred at this site. These boils were not extensive, however, and it does not appear that ground softening as a result of liquefaction was a major factor in the lack of lateral support provided by the upper foundation soils. In addition, most of the piles showed no signs of vertical settlement, so that partial bearing failures as a result of liquefaction do not appear to have been a significant factor in this failure.

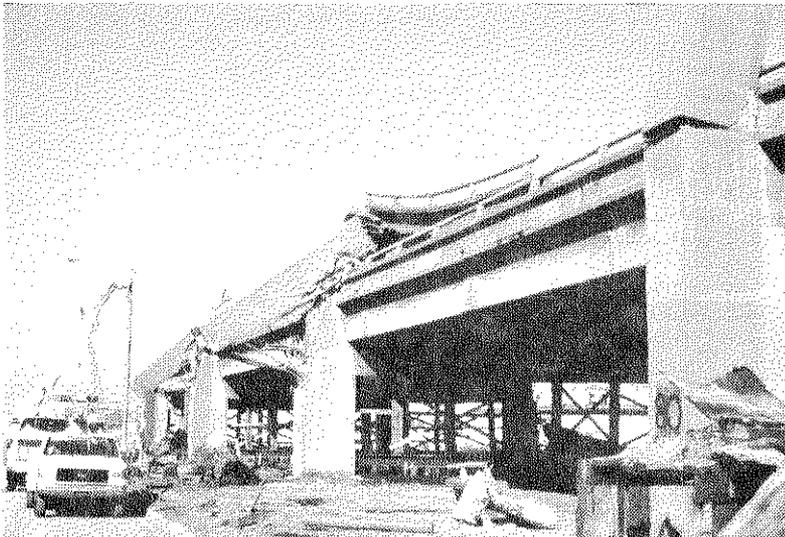
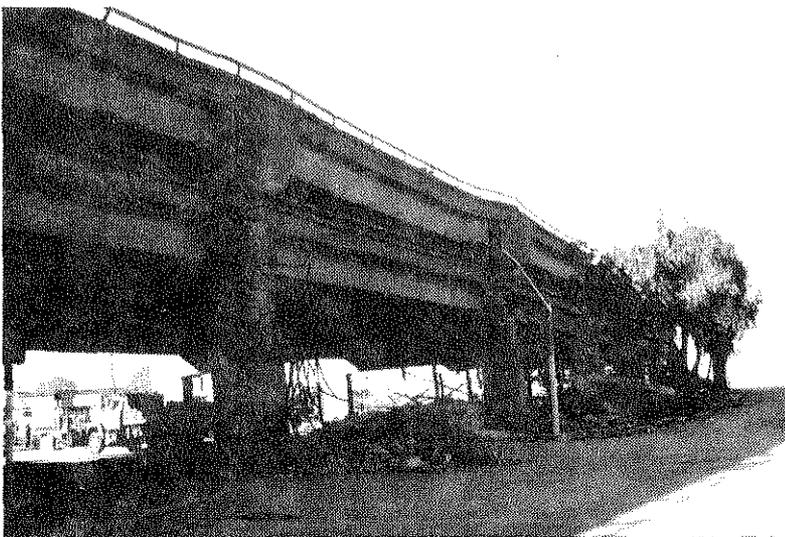
A good example of this was the catastrophic collapse of an elevated viaduct carrying Interstate 880 through west Oakland. The elevated I-880 Cypress viaduct is a double-decked highway structure, approximately 1.5 miles long, running from north to south through west Oakland, just south of the Bay Bridge approach and distribution structure. The catastrophic collapse of the northern end of the Cypress viaduct (Figures 4.8 through 4.10) was the single most devastating failure during the Loma Prieta Earthquake, resulting in the loss of 38 lives, as well as massive and indefinite disruption of eastern Bay Area transportation networks.

Fig. 4.8: The Collapsed Interstate 880 Cypress Viaduct

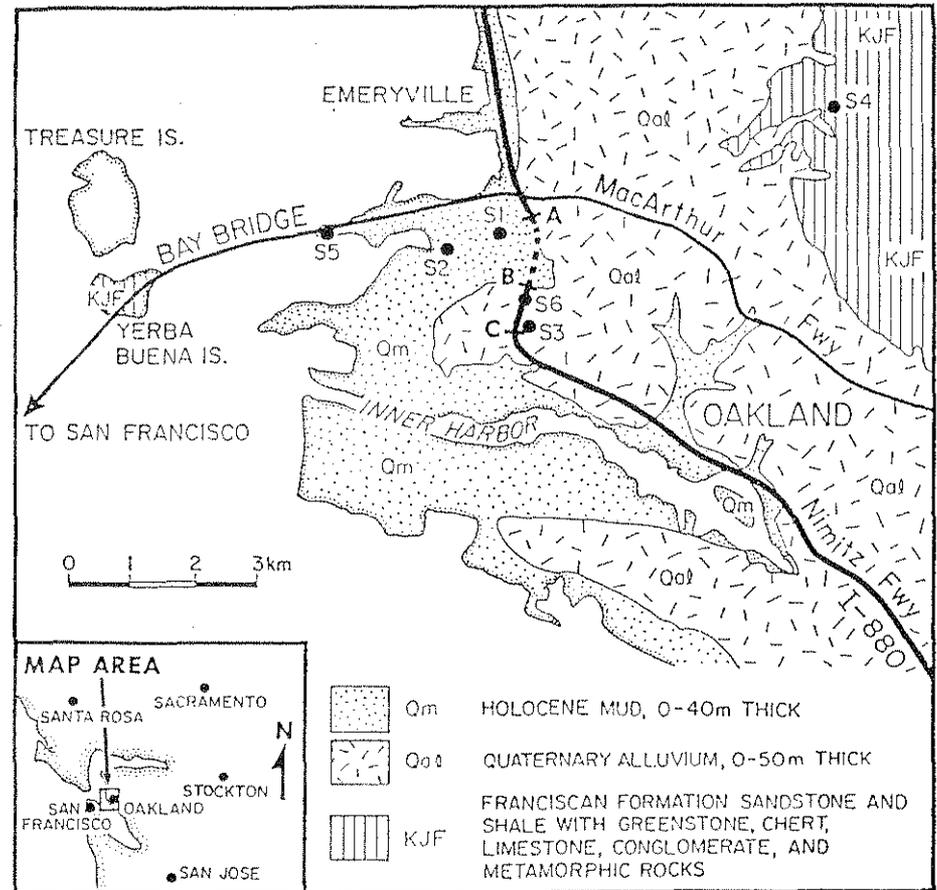
As shown in the simplified geologic map presented in Figure 4.11 (after Hough et al., 1989), the northern end of this viaduct, which collapsed catastrophically, overlies somewhat different soil conditions than the southern end, which was also damaged but which did not collapse. Much of the collapsed northern end of the structure was underlain by an engineered surface fill (compacted, primarily cohesive soils), approximately 15 to 25 feet in depth, underlain along much of this section by soft to medium stiff recent estuarine deposits of silty marine clay known locally as Bay Mud. These Bay Mud deposits, ranging in thickness from 0 to approximately 25 feet, are in turn underlain by very deep deposits of older (Quaternary), and much stiffer (primarily cohesive) sediments. These deeper sediments are primarily stiff, overconsolidated clays and sandy clays, but also include layers and lenses of both sandy and gravelly soils. The upper portion of these deep Quaternary deposits are referred to as the Temescal Formation, and are underlain by deeper, stiffer units referred to locally as the Alameda Formation. These deep deposits are overconsolidated as a result of extended periods of glacial drawdown of sea levels, as well as by ageing effects, and represent strong, competent foundation materials. Most major structures in this area (including the Cypress viaduct) are founded on piles supported in these stiff, deep alluvial soils. As a result, the depth to bedrock is poorly defined throughout this region as few borings have been drilled down to bedrock. A single deep boring, performed by CALTRANS in December and January of 1989-90 along the alignment of the collapsed northern end of the Cypress viaduct, encountered bedrock of the Franciscan Formation at a depth of 570 feet.

Fig. 4.10: Simplified Geologic Map Showing Alignment of the I-880 Cypress Elevated Viaduct (Viaduct collapsed from A to B, and was damaged from B to C). [After Hough, et al., 1989]

recordings, surface geophysical measurements and preliminary site response analyses, it appears that peak horizontal ground surface accelerations at the collapsed northern end of the Cypress viaduct were on the order of 0.25 g to 0.33 g. Equally importantly, the predominant site periods along much of this section, for these levels of shaking, appear to be on the order of 1.2 to 2 seconds. The Cypress viaduct was a complex structure, and the predominant period of the structure under these levels of shaking has not yet been conclusively determined, but it appears likely that the structure would have responded strongly to these long-period motions, especially as damage began to "soften" the structure's response stiffness. Similar preliminary analyses, aftershock recordings and surface geophysical measurements suggest that the southern portion of the Cypress viaduct alignment, with its somewhat stiffer near-surface alluvial soils, may have experienced similar to slightly lower levels of peak ground surface acceleration, and with similar to slightly lower predominant periods.
