REPORT NO.
UCB/EERC-90/05
APRIL 1990

EARTHQUAKE ENGINEERING RESEARCH CENTER

PRELIMINARY REPORT ON THE PRINCIPAL GEOTECHNICAL ASPECTS OF THE OCTOBER 17, 1989 LOMA PRIETA EARTHQUAKE

R. B. Seed, S. E. Dickenson, M. F. Riemer, J. D. Bray,
N. Sitar, J. K. Mitchell, I. M. Idriss, R. E. Kayen
A. Kropp, L. F. Harder, Jr. and M. S. Power

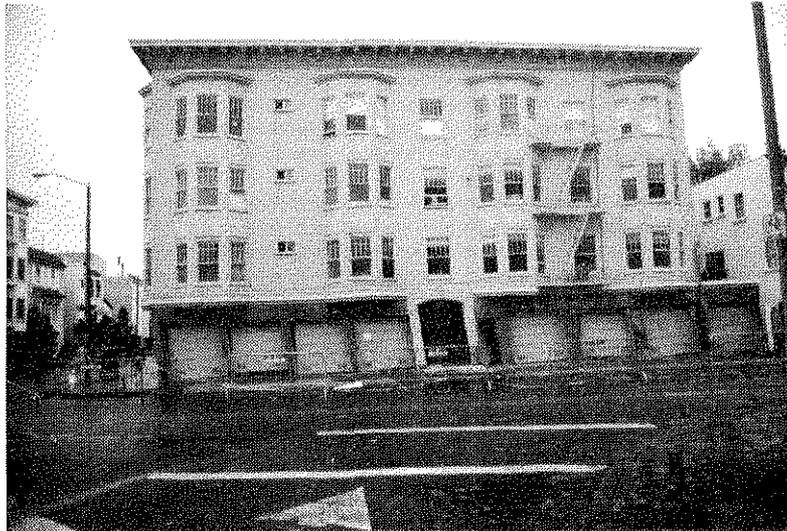
This does not mean, however, that this concentration of structural damages was due primarily to liquefaction of these saturated sandy soils. Instead, a majority of the damage to structures in the Marina District on October 17, 1989 was caused by strong shaking, as the cohesive soils underlying the fill strongly amplified the relatively modest levels of shaking produced in the bedrock underlying the Marina District. These local soil conditions also altered the frequency characteristics of the accelerations propagating from the rock to the ground surface. This amplification of accelerations, and the especially pronounced amplification of long period motions, appears to have been the primary cause of the observed heavy concentration of structural damage in this region. It is also interesting to note that much of the structural damage was associated with the collapse of "weak" ground floors consisting primarily of garages with few walls and thus little structural capacity for carrying lateral shear forces. Two examples of this are shown in Figures 4.11 and 4.12.

Fig. 4.12: Partial Collapse of a Structure in San Francisco's Marina District With a "Soft" Ground Floor

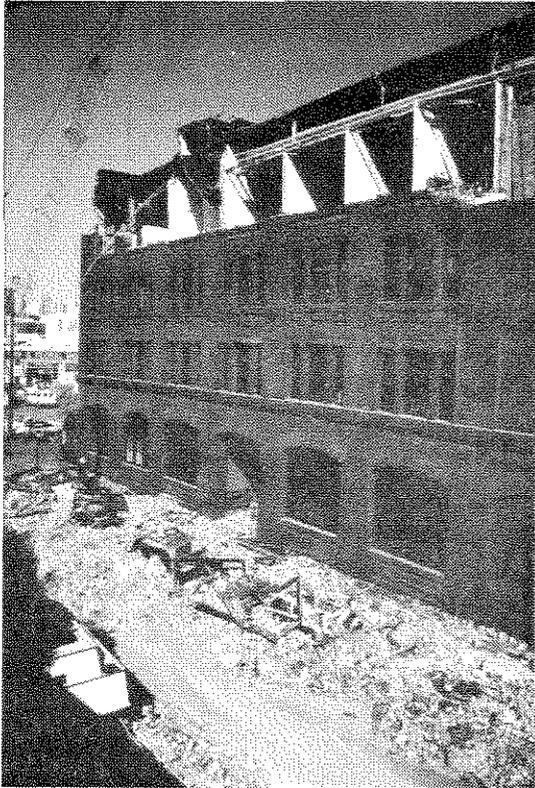
- In the historic old Mission Bay marsh region in San Francisco. The region surrounding Sixth and Folsom in San Francisco was an area of particularly concentrated structural damages, as shown in Figure 3.14, including the catastrophic failure of the unreinforced masonry structure near 6th and Townsend shown in Figure 4.14. A major portion of one of the exterior walls of this building fell onto the sidewalk, killing 5 people. A smaller, similar pocket of both concentrated structural damage and liquefaction occurred on similar marsh deposits near Shotwell at Folsom and 17th Streets. Another elevated highway viaduct, the Interstate 280 viaduct, was also damaged and remains out of service in the Old Mission Bay region.

Fig. 4.14: Collapse of Exterior Wall of Unreinforced Masonry Structure Near 6th & Townsend, San Francisco

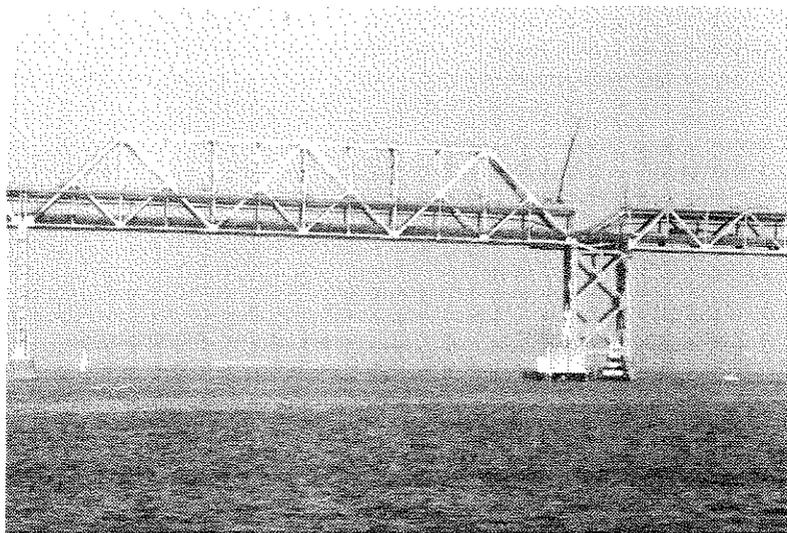
- In the central San Francisco Bay and at Treasure Island. As described previously in Section 3.4, amplification of shaking levels by the underlying alluvial soils is suspected to have been a significant factor in the widespread liquefaction which occurred at Treasure Island. The soft Bay Mud, and underlying deeper, stiffer alluvium also appear to have been important factors in the collapse of a section of the Bay Bridge between Yerba Buena Island and Oakland (see Figure 4.16). The two deck sections (upper and lower decks) at the collapse point were simply supported on 5-inch long support brackets, and appear to have slipped off of these supports as a result of more than 5 inches of (transient) differential seismic displacement of adjoining bridge sections during shaking (A. Astaneh, 1989). The depth of the alluvial deposits at and near the collapsed section

Fig. 4.16: Collapsed Section of San Francisco-Oakland Bay Bridge Prior to Removal of Fallen Deck Sections

is not known, but is known to be in excess of 350 feet. These deep alluvial deposits, with a fairly thick surficial layer of soft to medium stiff Bay Mud, appear likely to have produced amplified long period strong shaking, resulting in large transient displacements of both the bridge foundation elements and the towers and deck sections. Additional, less dramatic damage to this bridge also appears likely to have been influenced by the amplified long-period motions at this site.

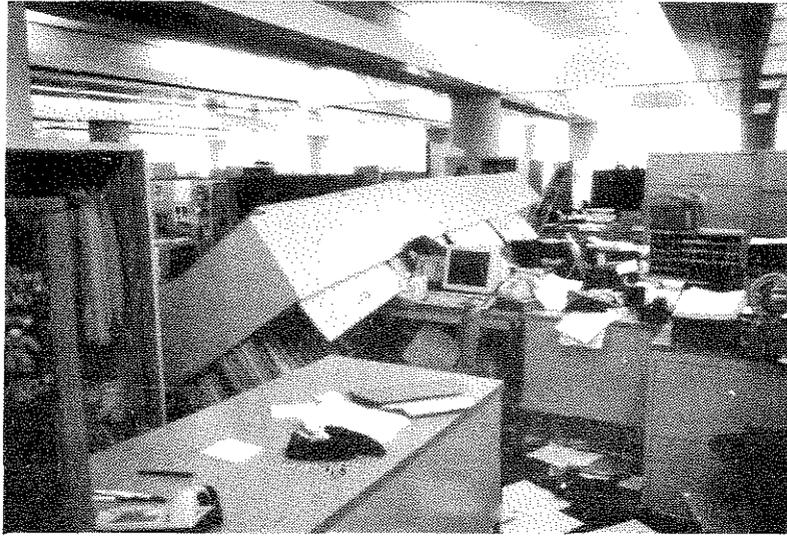
Fig. 4.17: Displaced Office Furniture in Upper Floor of a High-Rise Building in Emeryville/West Oakland Area

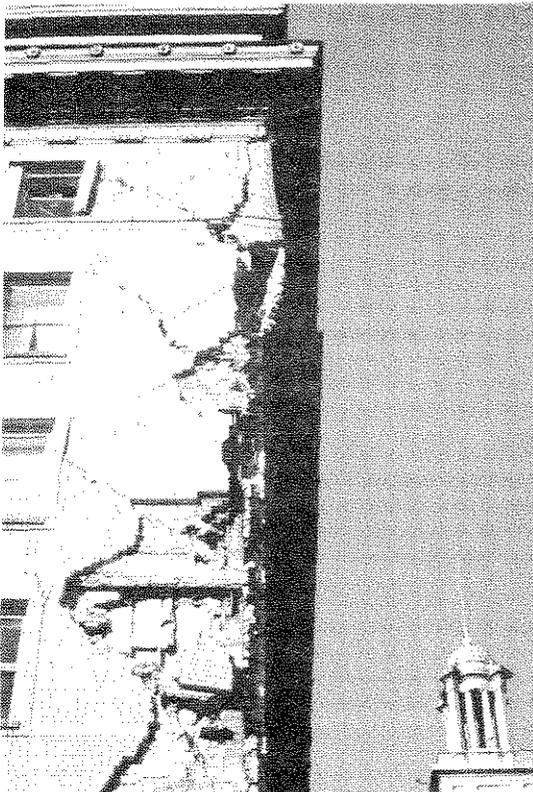
Fig. 4.18: Damage to an Upper Corner of the Oakland Hotel [Photo courtesy of Prof. S. A. Mahin]

local soil conditions. Many of the heavily damaged multi-story and high rise office buildings, retail operations, hotels and apartment complexes in this area appear to have been either masonry or reinforced concrete structures built between 1930 and 1970 (e.g. the Oakland Hotel, Figure 4.18), during which time site effects and resonant soil/structure interaction were poorly understood. Most of the damage appears to have been the result of strong shaking (strong structural response to the amplified, long period ground surface motions), but a number of cases of "pounding" between adjacent multi-story and/or high rise structures (e.g. Figure 4.19) were also noted. In addition to large economic losses and disruption of business, another very serious consequence of the damage to tall structures in this area was the forced closure of the damaged City Hall, which disrupted city operations at a particularly unfortunate time. (City Hall remains closed, pending analysis and retrofit.) Although most of the major structures damaged in this area were built prior to 1970, damage to tall structures also included at least one prominent building built during the 1970's. The seismic codes of this era, though providing some general improvement in resistance, thus appear to have underestimated site amplification and spectral amplification (or resonant site/structure interaction) effects, as this relatively distant $M_S = 7.1$ event (of unusually short duration) represents a considerably less severe level of seismic shaking than that more typically associated with a "design level" event in this area.

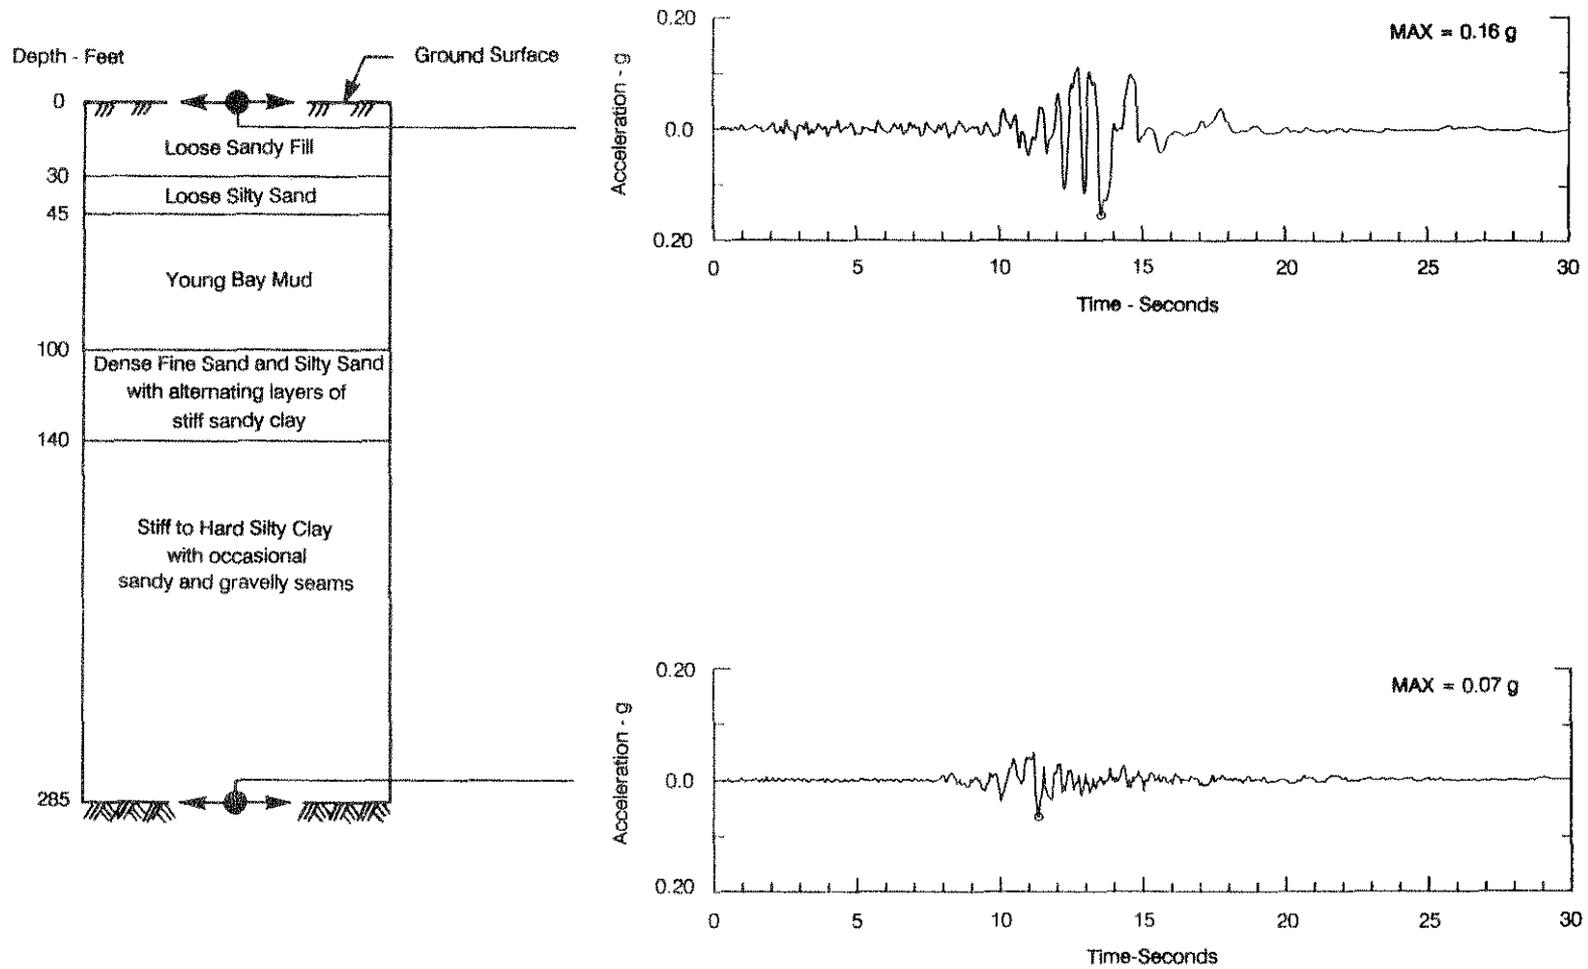
Figure 4.20 presents a schematic illustration of the soil column underlying the Treasure Island recording station. The upper 30 feet of soil consists of loose, dredged hydraulic fill, primarily sand and silty sand. This is underlain at the recording station by approximately 15 feet of loose silty sand which may represent either additional hydraulic fill or part of the sand bar upon which parts of the island fill were placed. This is underlain by approximately 55 feet of soft to medium stiff, normally consolidated silty clay (Bay Mud). The Bay Mud is underlain by approximately 40 feet of alternating layers of dense, fine sand and silty sand, and layers of stiff, overconsolidated sandy clay. Beneath this, stiff to hard, overconsolidated silty clays and clays, with occasional seams and lenses of sandy and gravelly soils, extend down to bedrock, which occurs at a depth of approximately 285 feet.

Also shown in Figure 4.20 are the N-S component strong motion records from the Yerba Buena "rock" site (shown at the base of the profile) and from the Treasure Island station (shown at the ground surface). It is clear from inspection that the Treasure Island ground surface record has a significantly higher (amplified) peak ground surface acceleration, and a longer predominant period.

Fig. 4.20: Schematic Soil Profile and Site Response at the Treasure Island Station

The soil profile shown in Figure 4.20 was modelled, using the program SHAKE90 (Schnabel, et al., 1990), in a one-dimensional dynamic site response analysis based on vertical propagation of shear waves. The E-W Yerba Buena Island record was taken as a basis for development of the "bedrock" input motion applied at the base of the soil column, and the resulting ground surface motions calculated were compared with the E-W component of the motions recorded at the Treasure Island station. It should be noted that the Yerba Buena Island record was an "outcrop" motion, and so was slightly modified (accelerations were decreased by almost 10% and the predominant period was slightly increased, as described by Schnabel et al., 1972) to generate a more representative "bedrock" motion at a depth of 285 feet.

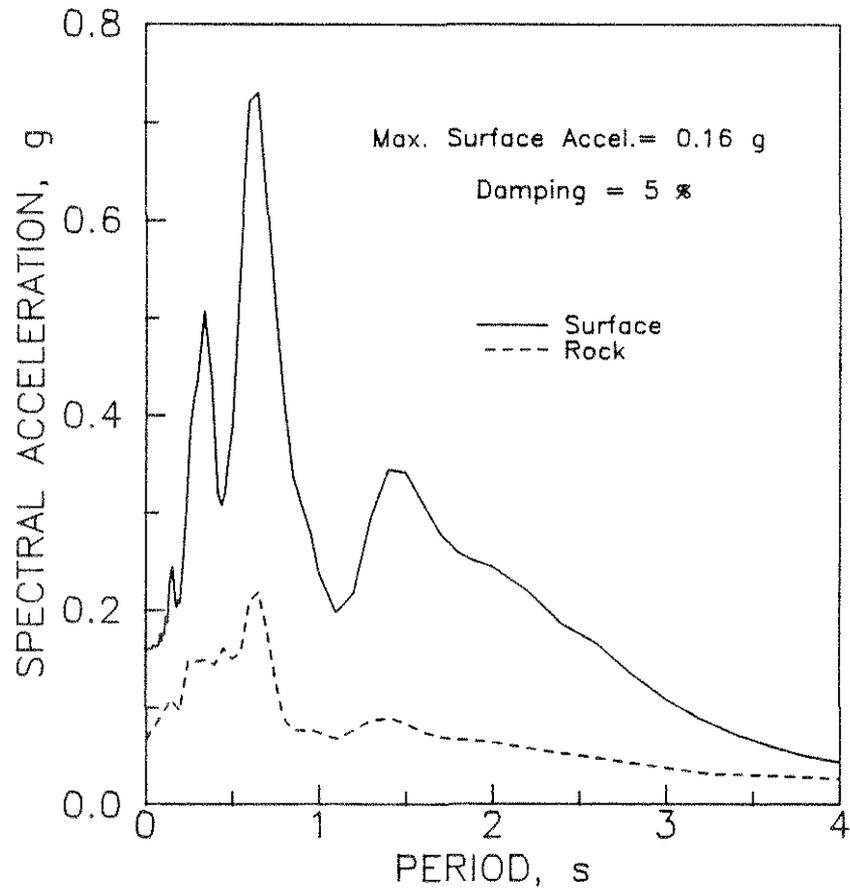
Figures 4.21 and 4.22 show the response spectra (5% damping) for the E-W and N-S component records, respectively, at these two stations. In addition to amplification of the peak ground surface accelerations, it can be seen in this figure that the deep, soft cohesive soil profile at the Treasure Island station also caused especially pronounced amplification of the long-period components of motion.

Fig. 4.21: Response Spectra for Treasure Island and Yerba Buena Island Station Records (90 degree components)

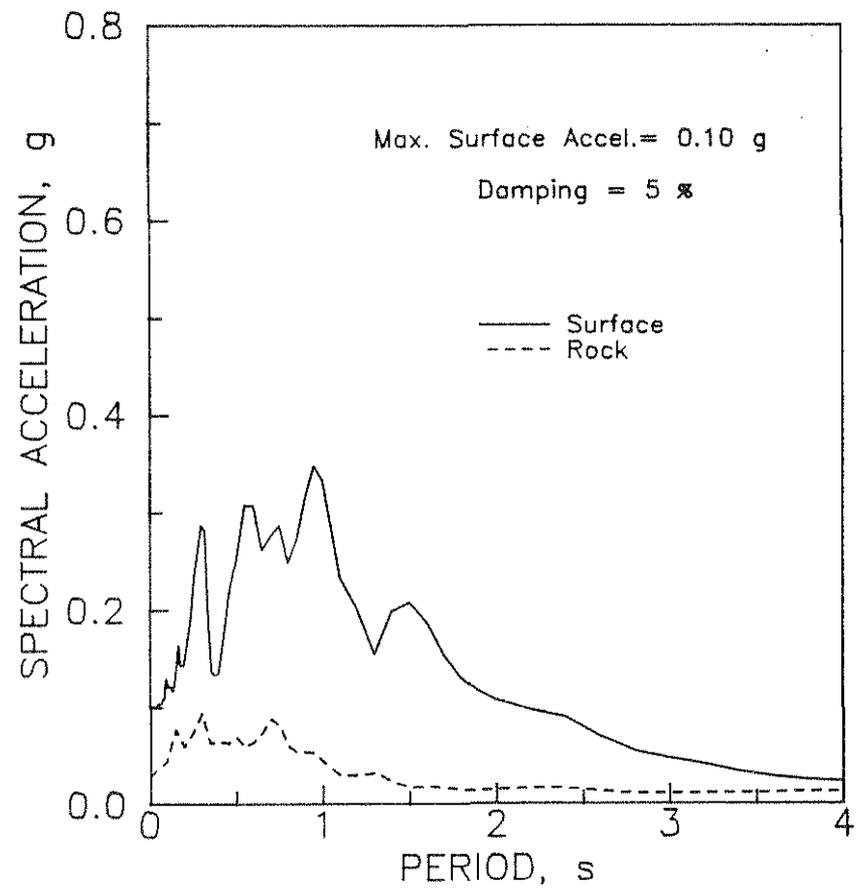
Fig. 4.22: Response Spectra for Treasure Island and Yerba Buena Island Station Records (0 degree components)

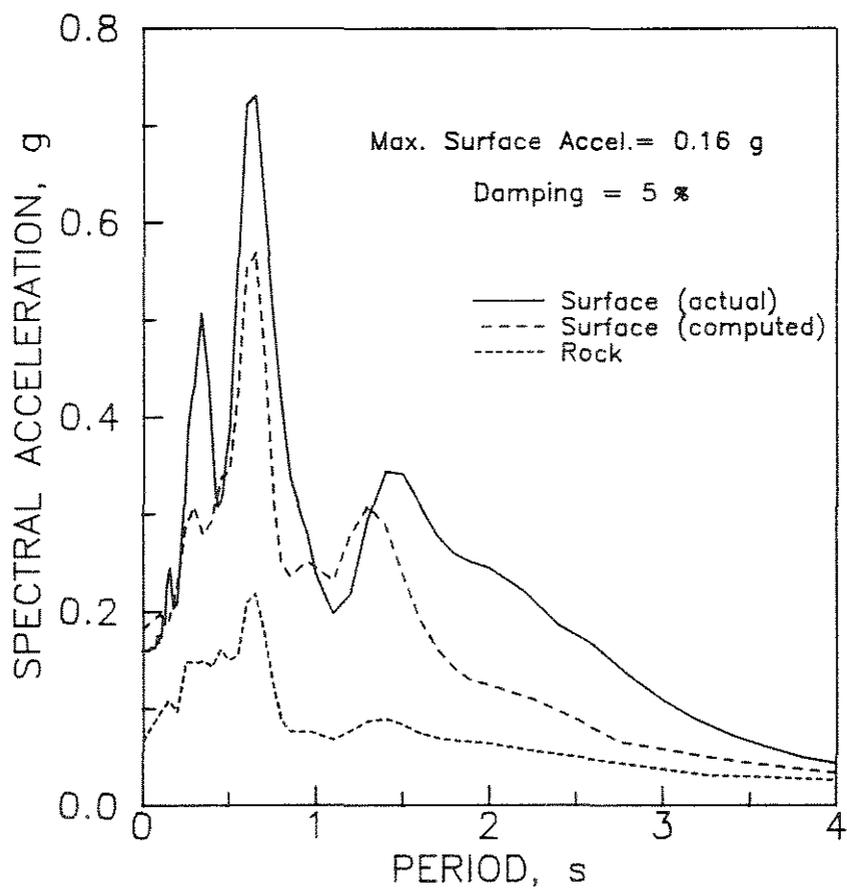
As shown in this figure, these relatively simple, one-dimensional response analyses performed using the "equivalent linear" method to model nonlinear soil behavior provide good agreement with the observed surface response. The calculated maximum horizontal ground surface acceleration of $a_{\max} = 0.18$ g agrees well with the recorded value of $a_{\max} = 0.16$ g. The calculated motion also provides a reasonably good "fit" for the recorded motion's response spectrum, with a strong spectral peak at a period of $T_s \approx 0.6$ seconds, and a secondary peak at $T_s \approx 1.3$ seconds.

Finally, although these simple dynamic response analyses do a good job of predicting the recorded Treasure Island ground surface motions, the agreement between the calculated and the recorded motions is not perfect. The failure of the calculated motions to pick up the full spectral content (or spectral peak) of the recorded motions at $T_s \approx 0.35$ seconds (see Figure 4.24) is probably due in large part

Fig. 4.24: Comparison Between Calculated and Recorded Response Spectra - Treasure Island Fire Station (90 degree comp.)

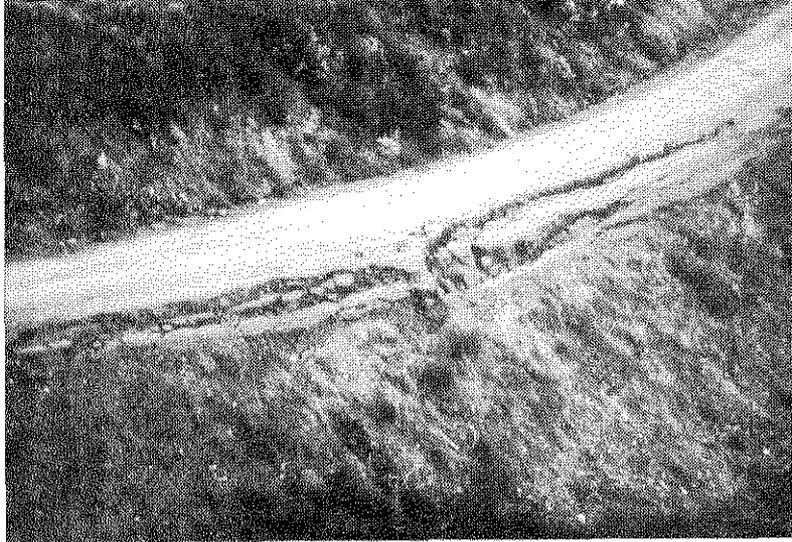
Fig. 5.2: Slumping of Fill Along Summit Road in the Santa Cruz Mountains [Photo courtesy of the U.S. Army Corps of Engineers Waterways Experiment Station.]

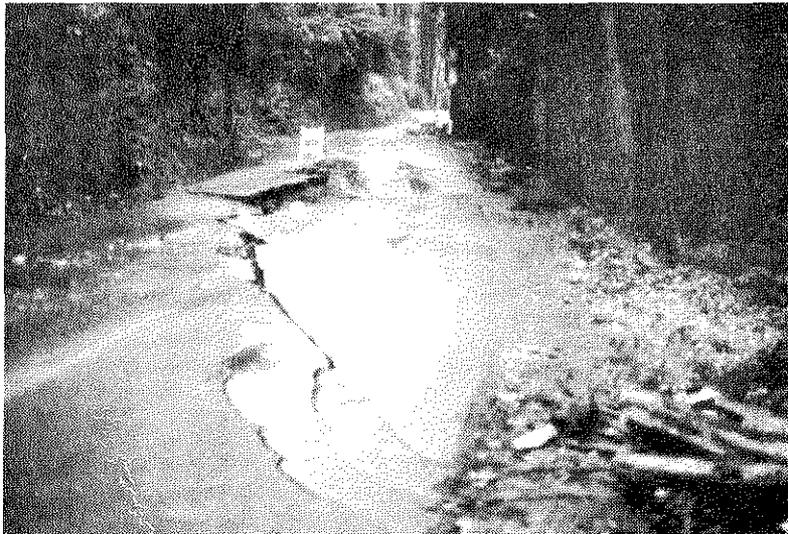
Fig. 5.4: Head Scarp of Partially Developed Slide on Summit Road in the Santa Cruz Mountains

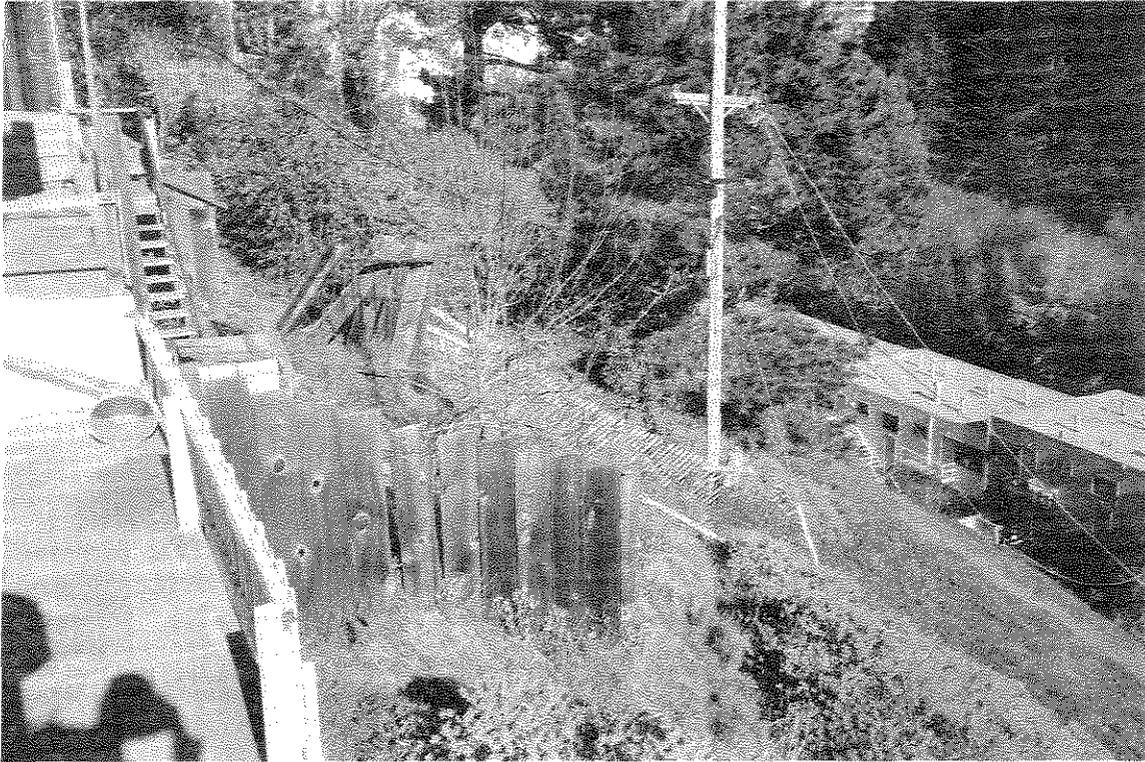
The first of these problems was the 8th Avenue landslide, which occurred near the center of the City of San Francisco, as shown in Figure 5.1. Eighth Avenue in San Francisco runs in a north to south direction along the top of a very steep east-facing slope, with a face slope that varies from 1:1 to 2:1 (horizontal:vertical). Figure 5.9 shows an oblique view down this steep slope from the rear porch of a home on the crest of the slope. The slope height increases from about 70 ft near the intersection of Eighth Avenue and Moraga Street to about 110 ft near the intersection of Eighth Avenue and Ortega Street. Eighth Avenue is aligned with the eastern crest of a large sand dune, and the slope which underlies the roads and houses in this area is

Fig. 5.9: View Downslope Showing the Steepness of the Slope Face at Eighth Avenue near Noriega Street, San Francisco

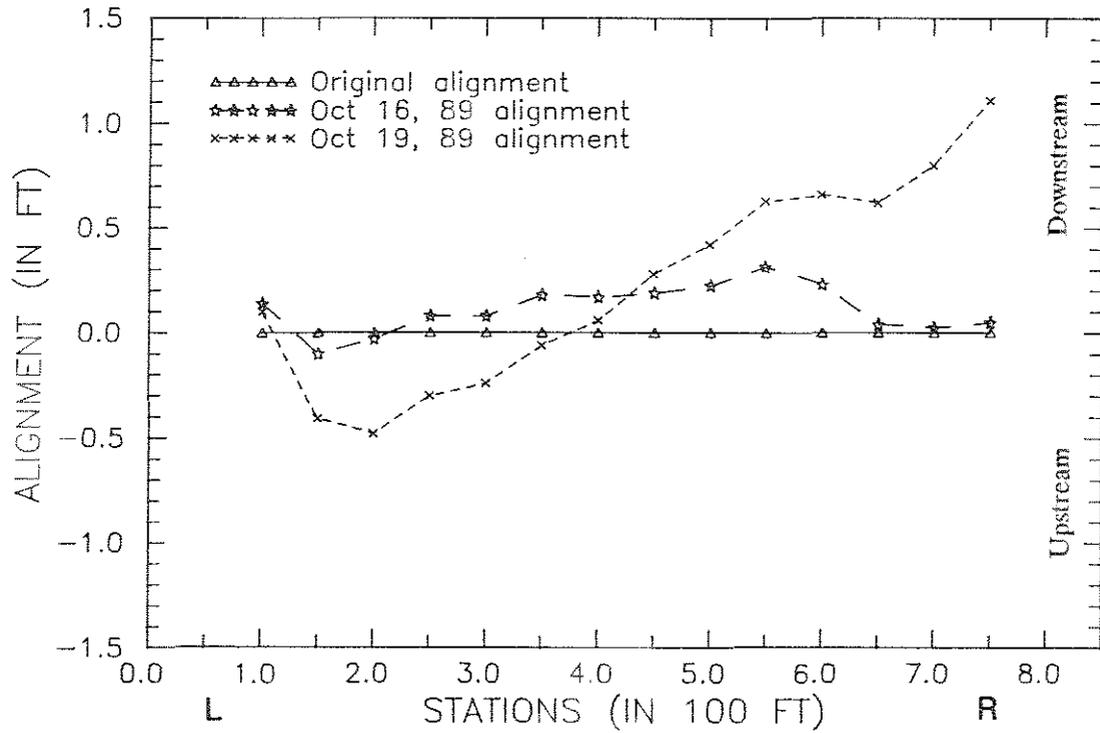
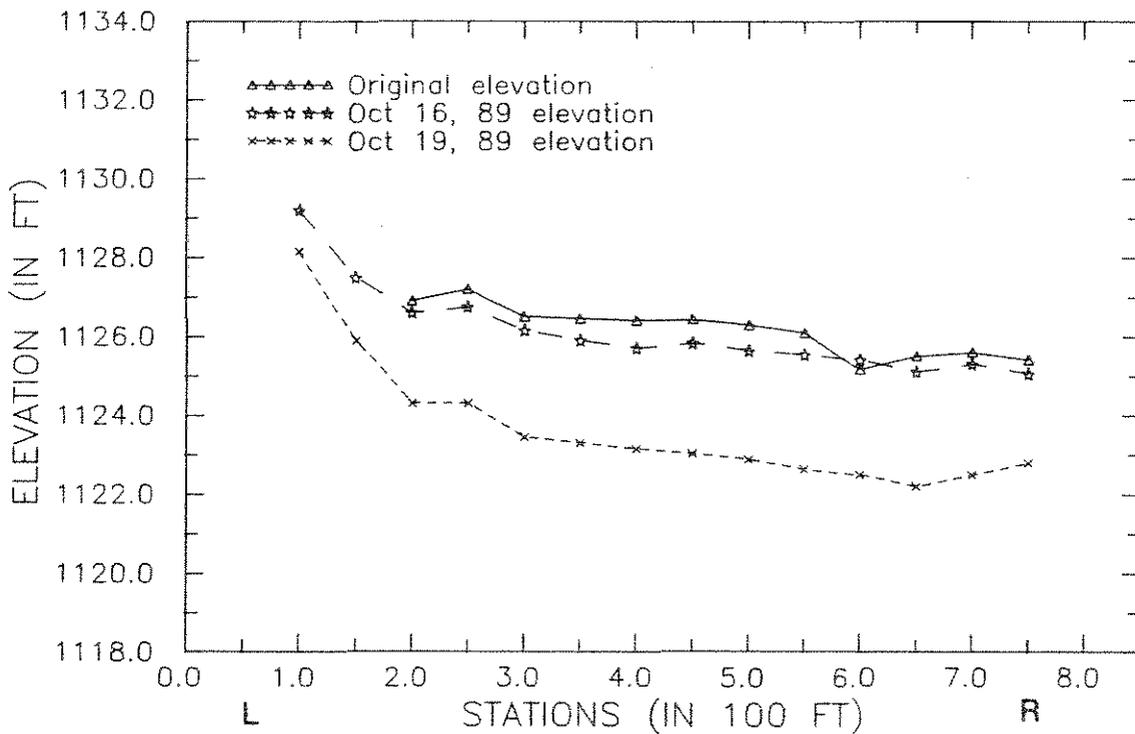
Strong motion attenuation relationships and strong motion recordings at nearby rock sites suggest that peak horizontal ground accelerations of rock at the Austrian Dam site were probably on the order of 0.5 g. The survey monuments along the 700 foot long crest of the dam were surveyed the day before the earthquake, and a resurvey of these crest monuments just two days after the main shock revealed that relatively significant deformation of the dam's crest occurred (See Figure 6.5). The right crest section appeared to move downstream horizontally 1.5 feet relative to the left crest section. Maximum vertical settlements along the crest occurred near the right abutment and were measured to be on the order of 2.5 to 3 feet.

Fig. 6.5: Crest Movement at Austrian Dam

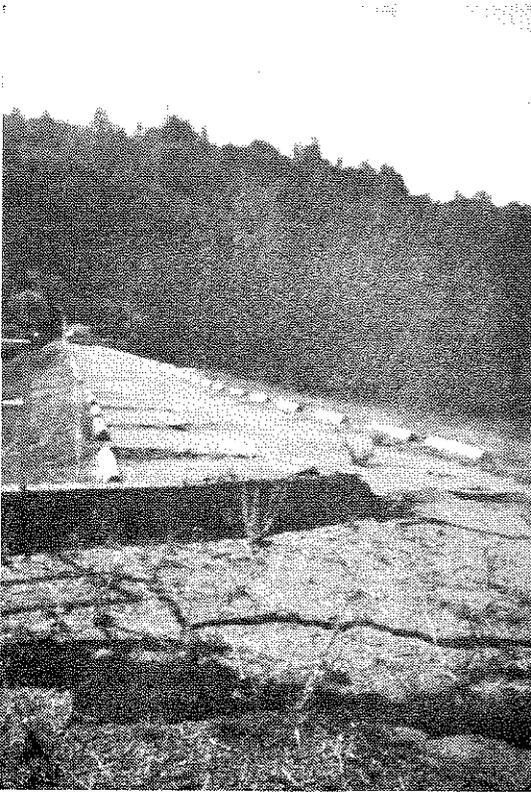
The strong shaking and ground movements produced extensive longitudinal and transverse cracking along the crest, especially near the spillway section at the right abutment (See Figure 6.6). The transverse earth fissures near the spillway were up to 1 foot wide and up to 10 to 25 feet deep. Considerable fissuring also occurred near the left abutment (See Figure 6.7). This abutment fissuring generally followed an access road which connected the left abutment to the intake structure, which was

Fig. 6.6: Fissures and Damage Along the Crest of Austrian Dam

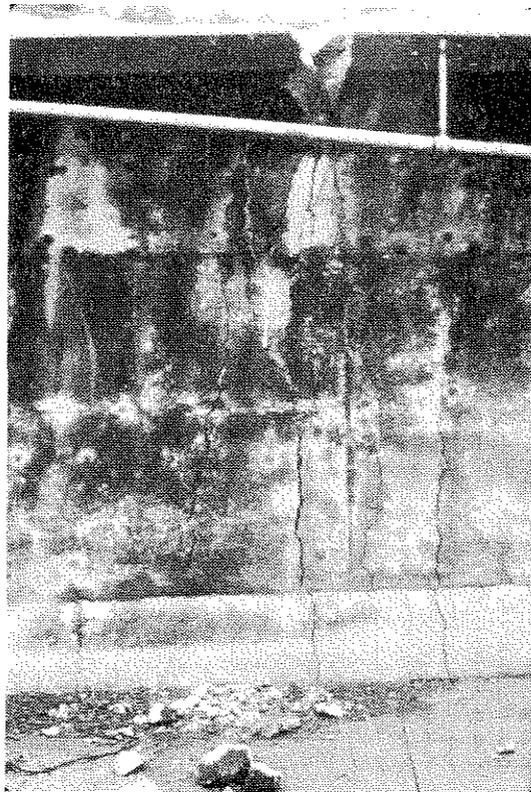
Fig. 6.8: Cracking in Concrete Spillway at Austrian Dam

The majority of the localized ground failure and cracking occurred near the spillway section, and these earth movements produced extensive cracking of the upper quarter of the concrete spillway channel, as shown in Figure 6.8. The cracks were oriented primarily perpendicular to the centerline of the spillway section. The cracks were typically 0.25 to 0.5 inches in width, with a fairly regular spacing of 2 to 4 feet. The earth material in front of the mouth of the spillway settled 6 to 12 inches relative to the spillway's inlet elevation, and large ground fissures were observed along the contact between the concrete spillway section and the ground surrounding it. In addition, differential movements between the concrete spillway walls and the surrounding soil caused several of the concrete cutoff walls (positioned to prevent seepage along the exterior walls of the concrete spillway along the plane of concrete/soil contact) to be sheared off.
