M 6.5 Earthquake Offshore Northern California January 9, 2010

Field Reconnaissance Summary

February 12, 2010

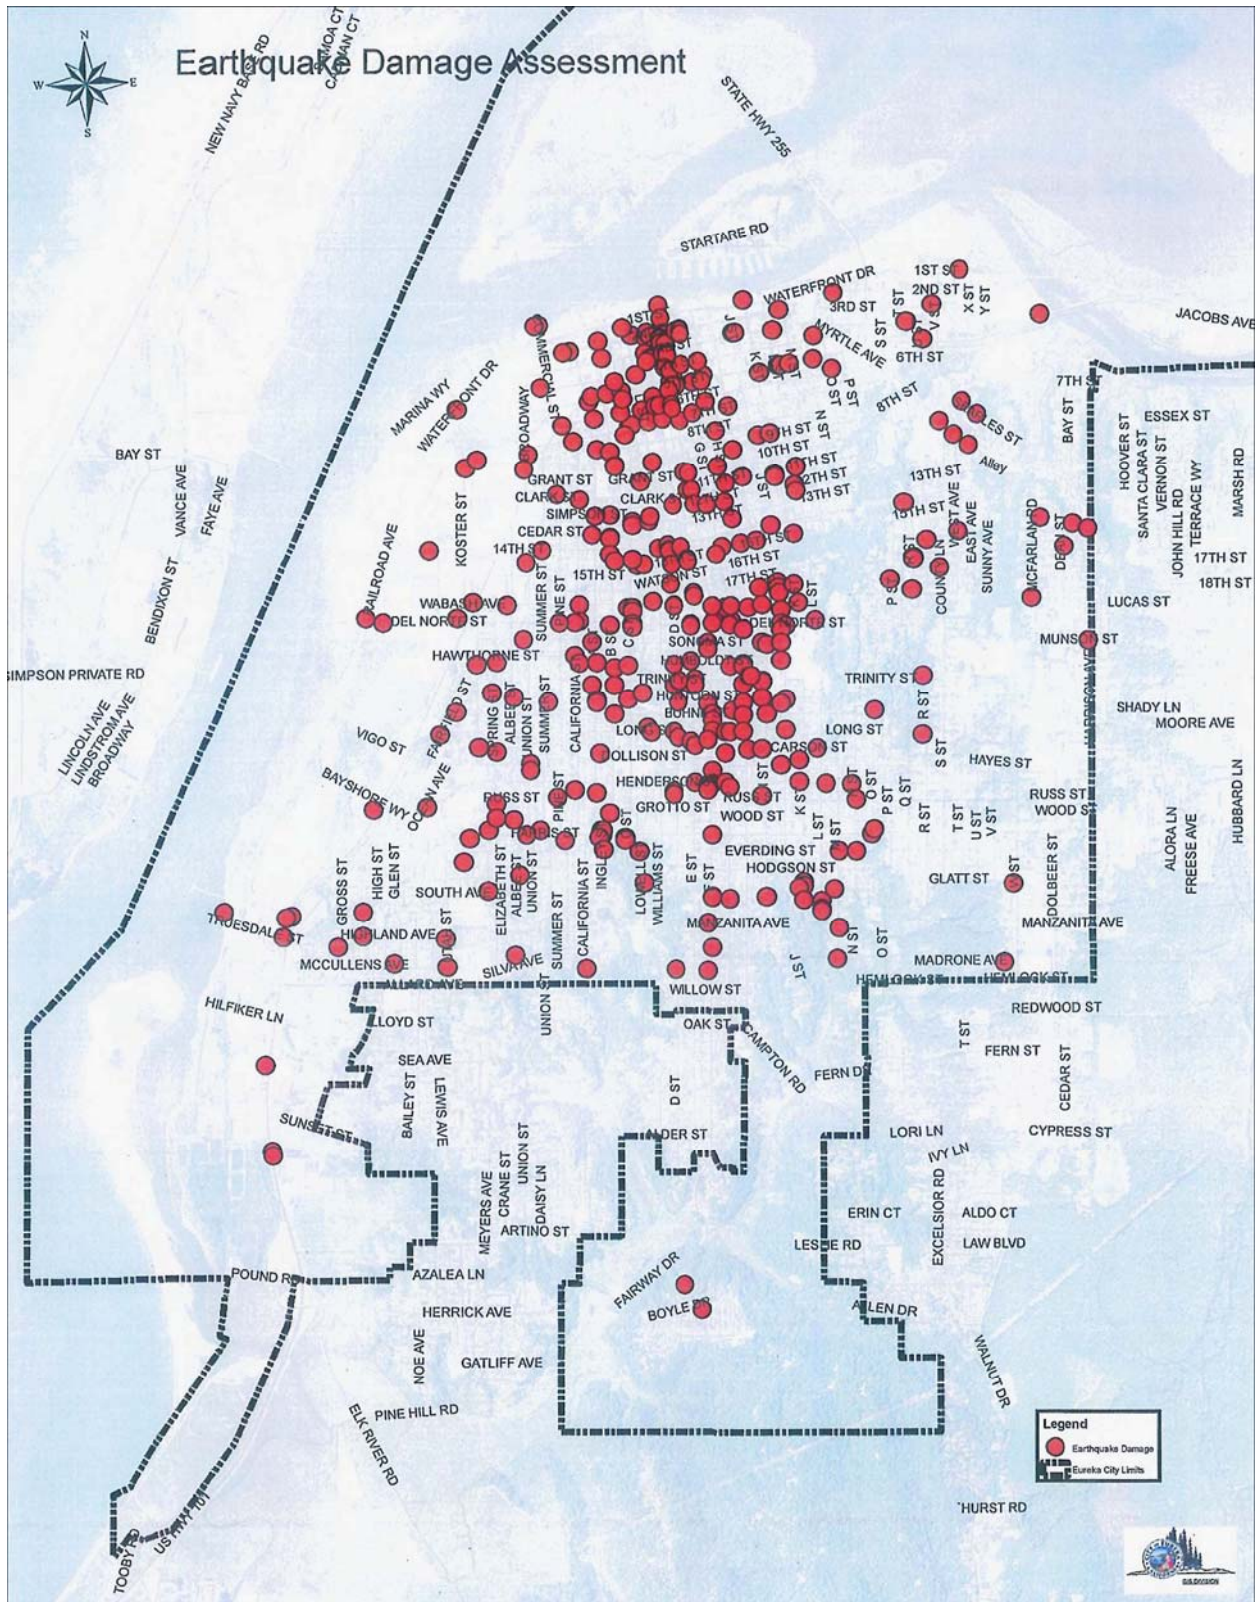
Damage was concentrated along the coast from Ferndale to Eureka and appears to be the result of both distance to the hypocenter and guided energy along the strike of the fault. Eureka, the most heavily impacted city by the earthquake, reported over 600 structures affected and nine with major damage (Figure 35). The majority of damaged structures were single-family homes, and several dozen chimneys were severely damaged or knocked down. Eureka's Bayshore Mall, completed in 1987 and the largest commercial property in Humboldt County, had damage to the suspended ceiling and was closed for four days. Earthquake losses for the county (as of Jan. 14, 2010) were estimated at over \$40 million. None of the unreinforced masonry buildings retrofitted after Eureka's 1989 URM ordinance suffered anything more than cosmetic damage.

Figure 35 Preliminary map of damaged structures in the city of Eureka, compiled by Eureka Fire Department.
