# M7.7 Myanmar Earthquake

March 28, 2025

## JOINT PRELIMINARY VIRTUAL RECONNAISSANCE REPORT (J-PVRR)

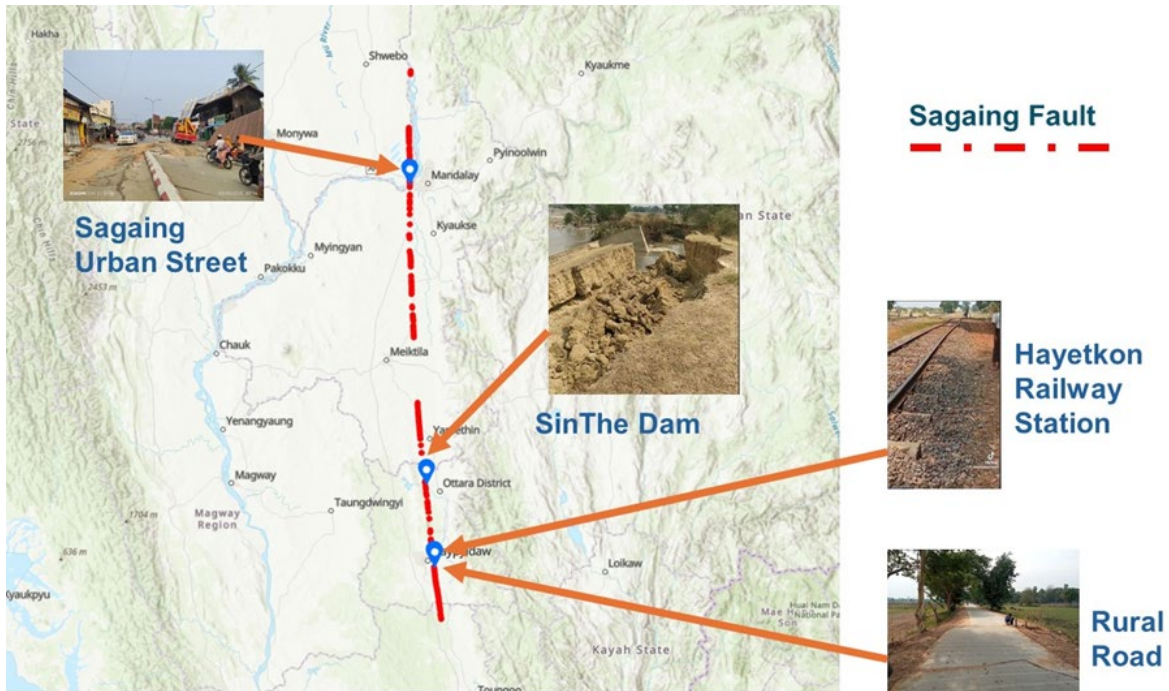
**Figure 2.16.** Map showing observed offsets of various structures along the Sagaing Fault.

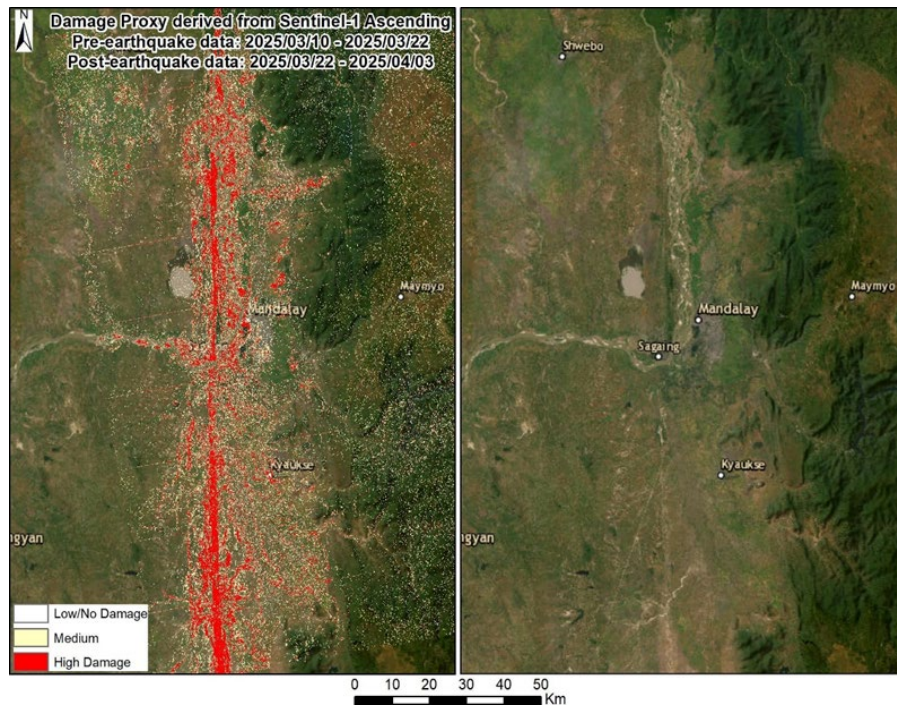
Figure 4.1.1. Damage Proxy Map derived from InSAR coherence using [Appendix B](#) (Credit: BGC).

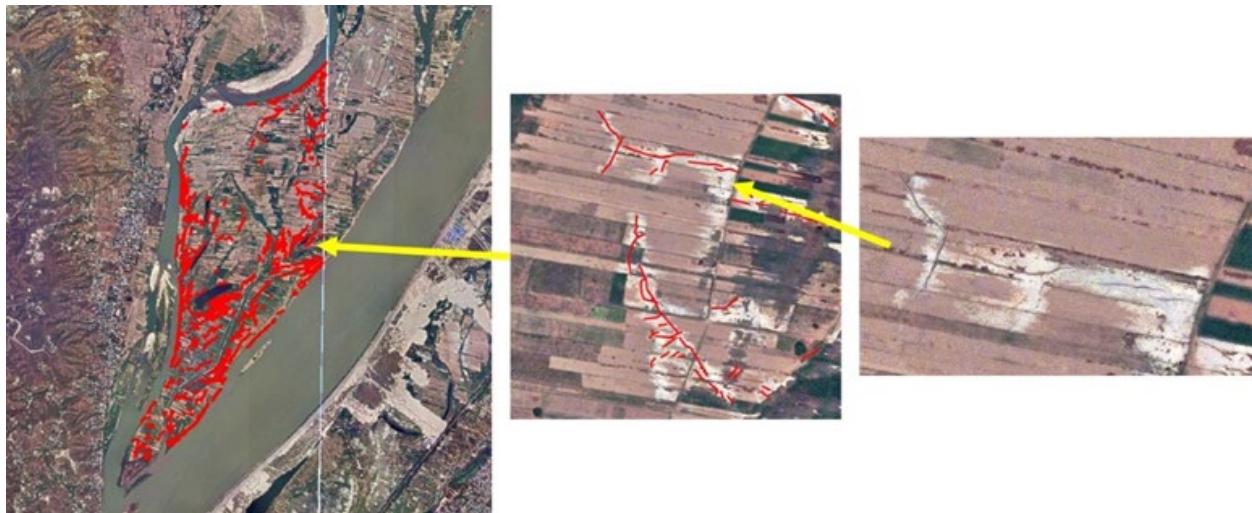
Maxar satellite images as well as photos taken locally in Areas 2 and 3 (although it is prevalent throughout the entire impacted area) show evidence of ejecta resulting from liquefaction, e.g., see example in Area 2 in Figure 4.2.1. The lowest magnification image to the left maps (in red) the locations of lateral spread fissures throughout the entire area. The pattern is consistent with the location of this sand bar between two river channels. The middle image shows a magnified view of a smaller portion of the area, also with the location of fissures indicated in red. Finally, the image on the right at the highest magnification shows that significant amounts of ejecta were expelled from the fissures.

**Figure 4.2.1.** Mapping of lateral spread features in Area 2. Insets show increasing magnification of targeted subarea showing ejecta. Lateral spread fissures marked in red.

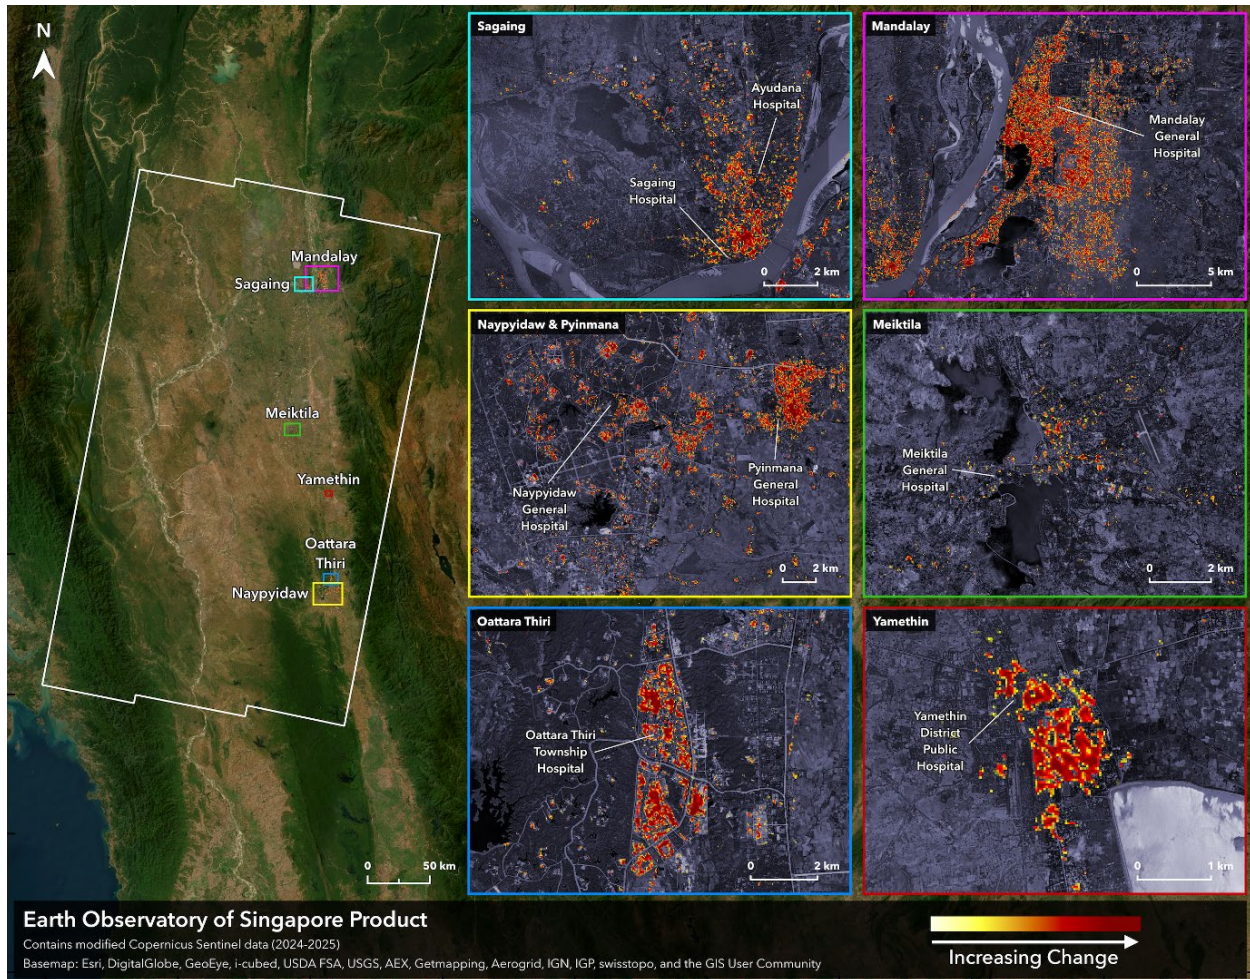
**Figure 5.1.** Damage Proxy Map for Myanmar (EOS 2025a). The red pixels indicate significant potential damage, based on the detection of ground surface change. Credits: Earth Observatory of Singapore Remote Sensing Lab (EOS-RS), contains modified Copernicus Sentinel data (2024-2025).

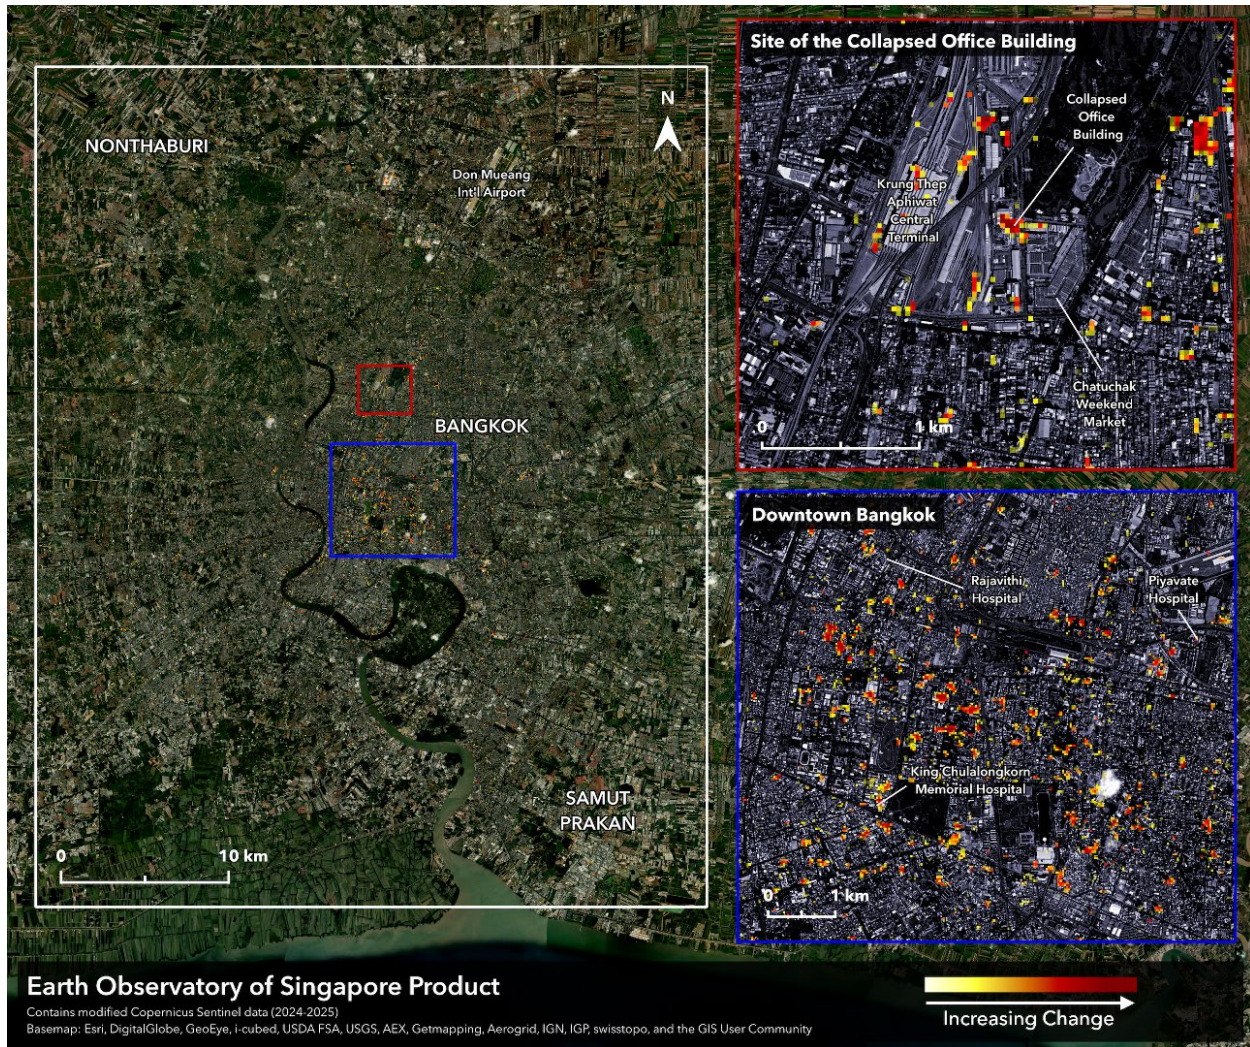
**Figure 5.2.** Damage Proxy Map for Bangkok, Thailand (EOS 2025b). The red pixels indicate significant potential damage, based on the detection of ground surface change. Credits: Earth Observatory of Singapore Remote Sensing Lab (EOS-RS), Contains modified Copernicus Sentinel data (2024-2025).

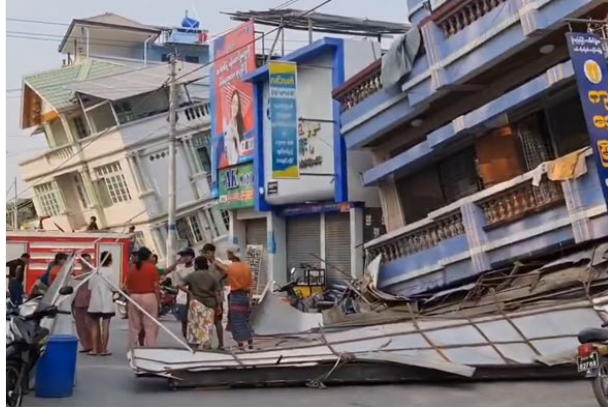
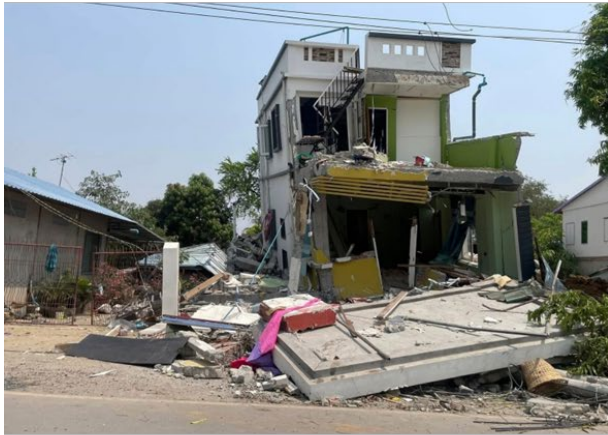
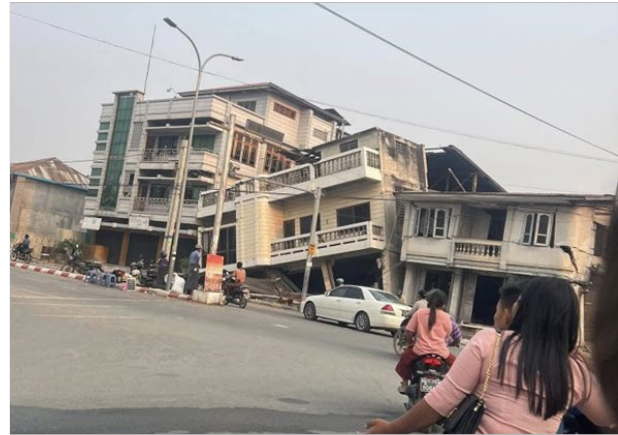
Figure 5.1.2 overviews low-rise buildings with soft-story mechanisms at the ground floor. These primarily reinforced concrete frame structures with unreinforced brick infill walls are characterized by a relatively open ground story to accommodate parking, shops and large entrances, which creates a story weaker and more flexible than those above. Observed failures were not necessarily symmetrical, as shown in Figure 5.1.2 where one of the sides of the first story failed and caused collapse.

**Figure 5.1.2.** Low-rise buildings with soft-story mechanisms at the first floor (Sources: (a) [@heungburma on X](#), (b) and (c) [@TostevinM on X](#)).

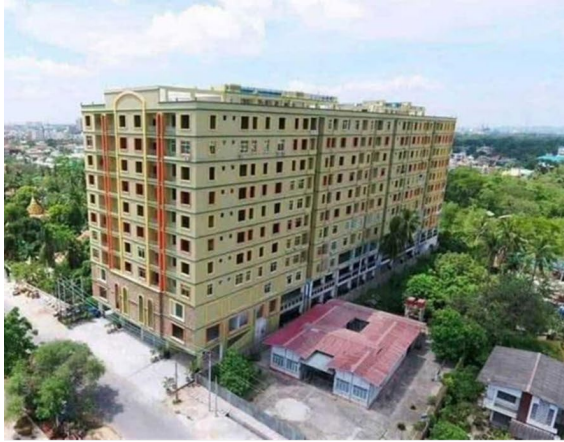
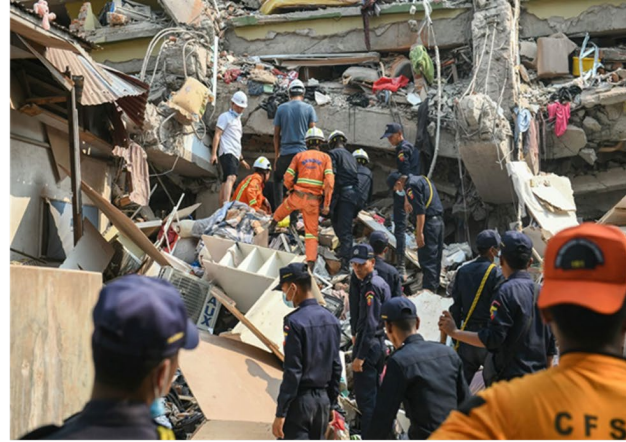
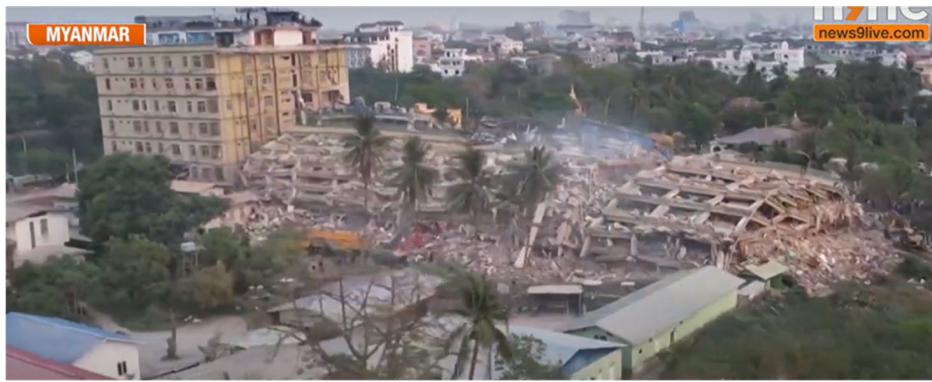
Figure 5.1.3 documents the collapse of the Sky Villa Condominiums. This complex appears to consist of three independent, but similar buildings immediately adjacent to each other. The front building in Figure 5.1.3a suffered collapse of the lower floors, while the middle and rear buildings suffered complete collapse. The buildings consisted of reinforced concrete frames with infill masonry walls in the upper stories. The first story, as seen in Figure 5.1.3a, had fewer structural elements and lacked infill and structural walls, which weakened the first story that collapsed (see Figure 5.1.3b). Video evidence (Fig. 5.1.3c) indicates that at least one building collapse did not occur immediately, but some minutes later.

**Figure 5.1.3.** Sky Villa Condominium (a) before and (b-c) after the earthquake. (Sources: (a) screengrab from [Eleven Broadcasting on YouTube](#), (b) [@Myanmar38187592 on X](#) (c) screengrab from [NEWS9 Live on YouTube](#)).

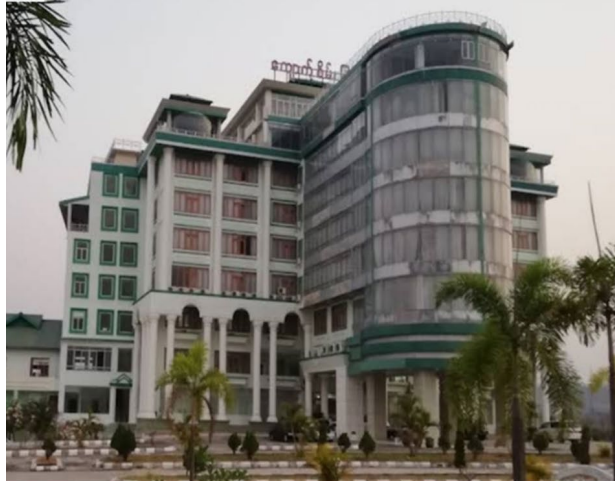
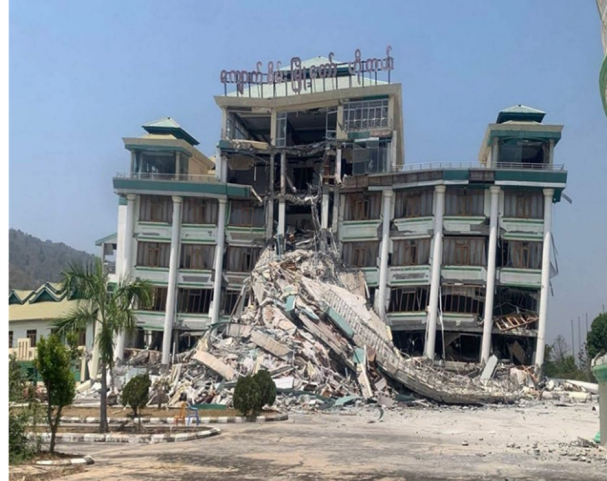
Figure 5.1.5 shows the collapsed Jade City Hotel, Nay Pyi Taw, Myanmar. The pre-earthquake view (Fig. 5.1.5a) shows both vertical and plan irregularities. The earthquake possibly affected the building more in the longitudinal direction. The irregular front part of the building above the main entrance (Fig. 5.1.5a) has long columns, possibly just two in the short direction at the ground floor. Open space for the entry and lobby reduced lateral stiffness and strength, and potential torsional effects from the plan irregularity resulted in complete collapse of the front part of the building, as well as collapse of the lower three (apparently softer/weaker) stories of the building.

**Figure 5.1.5.** Jade City Hotel, Nay Pyi Taw, Myanmar [Coordinates: 19.88025,96.15184] (a) before and (b) after the earthquake (Sources: (a) [Google Maps](#); (b) [SiThu Maung on Facebook](#)).

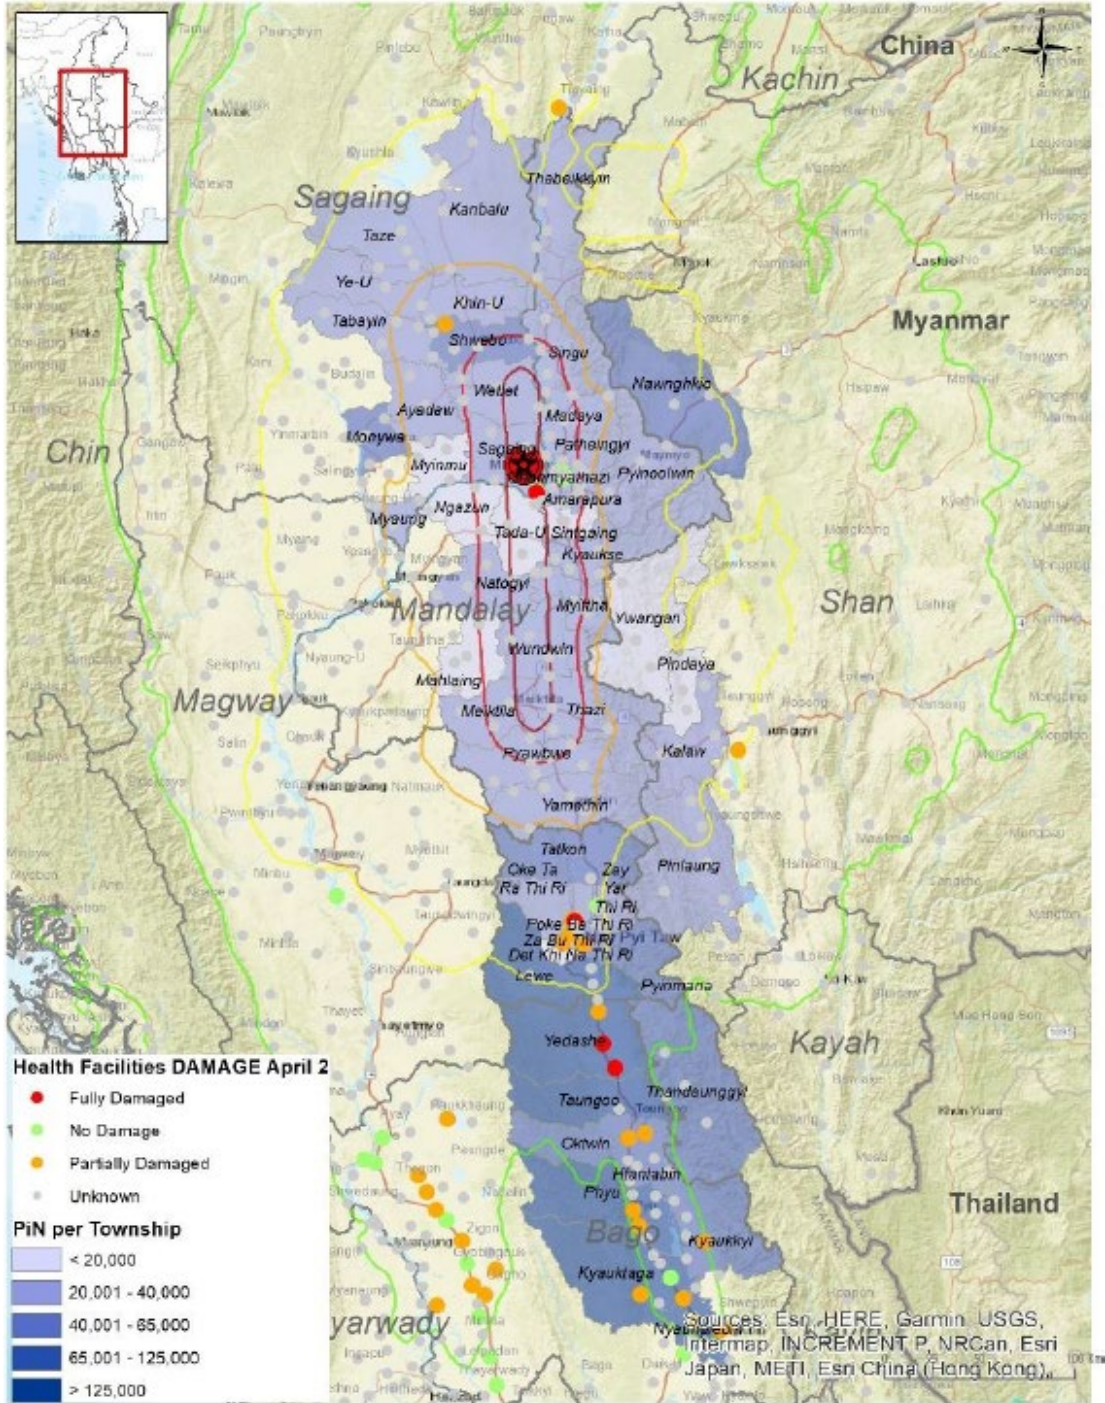
Figure 5.2.1. Location of damaged health facilities verified by health cluster partners as of April 2 (Health Cluster 2025).

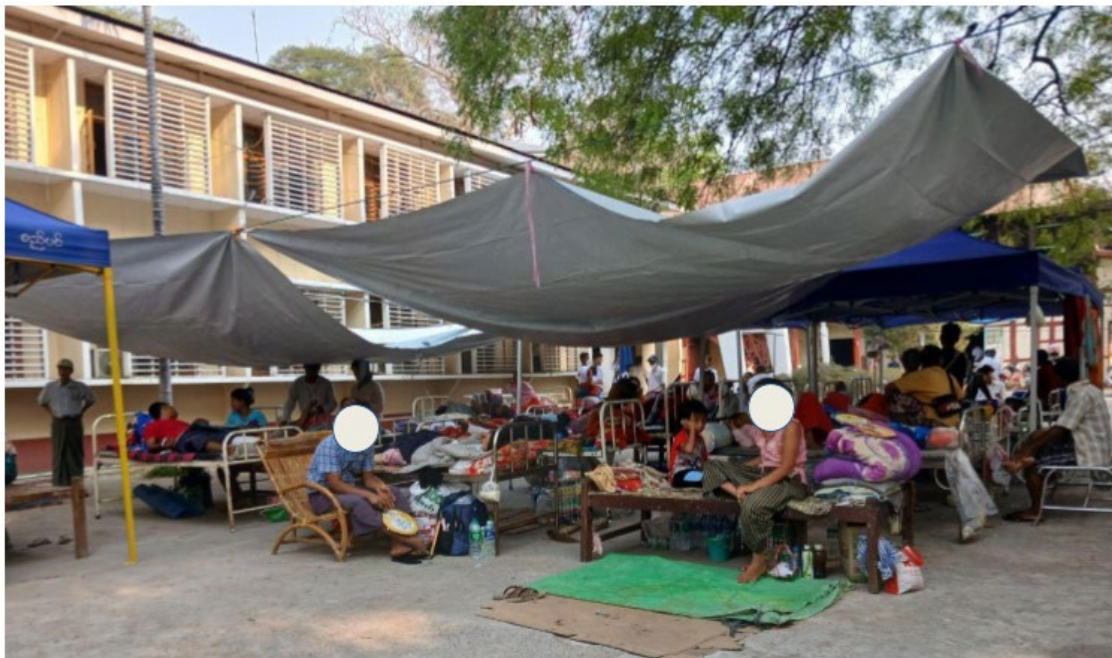
**Figure 5.2.6.** Patients treated outdoors at Sagaing General Hospital; note no visible damage to the outside of the building shown. Identifiable faces are masked. (Source: [DVB](#)).

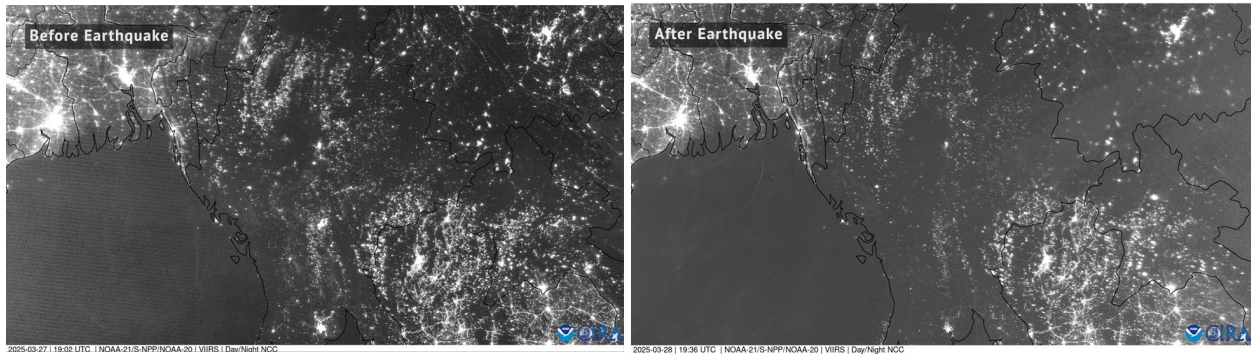
Historically, hydropower has been the dominant source of electricity in Myanmar, with the distribution of power sources in recent years baselined in the Outage and Restoration database curated with this report in DesignSafe. However, Myanmar’s power sector has been severely affected by the ongoing political turmoil since 2021, with prolonged electricity blackouts throughout the country (Aliyev, Seong, and Myint 2023). The earthquake only compounded these vulnerabilities. Electricity outages were widespread as illustrated by the nighttime lights imagery shown in Figure 6.1.1, with light intensity analyses in Table 6.2 suggesting significant power

losses in Mandalay, Mogoke, Wundwin, Yamethin, and Nay Pyi Taw (IRDR 2025). Media reports suggest that the most affected areas, such as Nay Pyi Taw and Mandalay, experienced complete power loss (Myanmar Now 2025b). Outages cascaded to affect other utilities, such as water, in locations like Pathein (DVB 2025d). Even relatively less affected areas like Yangon were experiencing significant power outages; even once power was restored, rolling blackouts for 2-4 hours per day persisted for days (Cho 2025). There was no information on the status of restoration efforts at the time this report was issued.

**Figure 6.1.1.** Nighttime lights over Myanmar before and after the earthquake; reduced illumination post-event (28 Mar 2025) indicates potential power or infrastructure impacts (Source: [CIRA](#)).

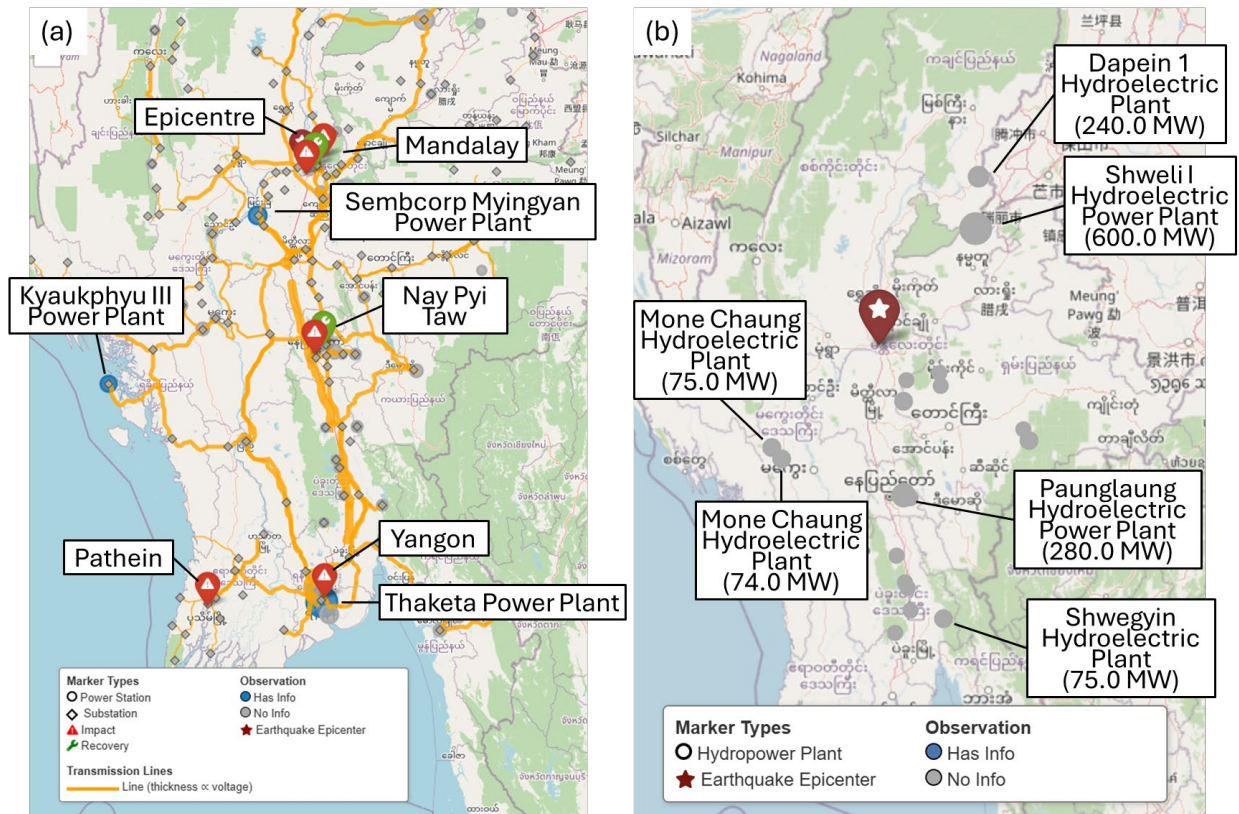
Impacted power infrastructure contributing to these outages are reported in Figure 6.1.2a, alongside locations of high-capacity hydroelectric power plants, which comprise the largest portion of Myanmar’s power generation (Fig. 6.1.2b). The Thaketa Gas Engine Power Plant experienced a complete power outage due to national grid collapse, but was restored after 16 hours. As of April 2nd, 2025, this plant carried 30% of Yangon’s emergency power load (PowerChina 2025). The Sembcorp Myingyan Power Plant was automatically shut down during grid failure but sustained no physical damage. As of April 6th, 2025, there was no confirmation that the plant had resumed operations (Lin 2025). The condition of other power plants, substations or transmission systems could not be confirmed.

**Figure 6.1.2.** (a) Geospatial distribution of impacts to power systems, and (b) location of hydroelectric power plants with capacity greater than 70.0 MW (Data Source: OpenStreetMap).

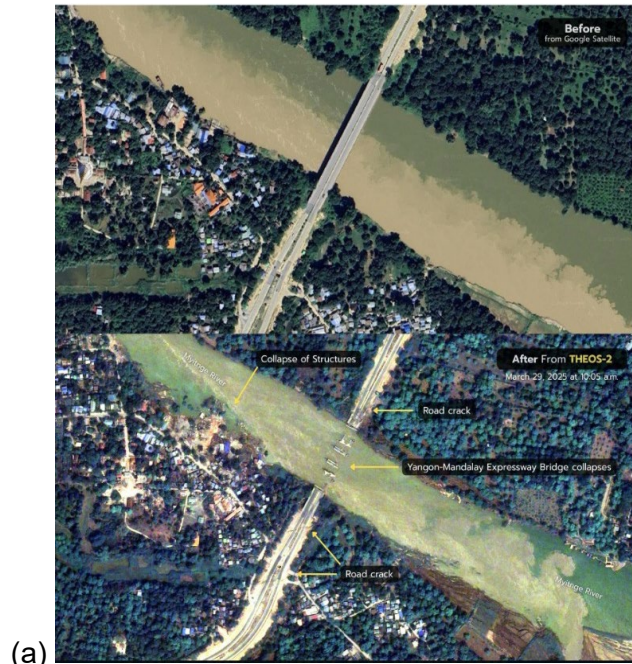
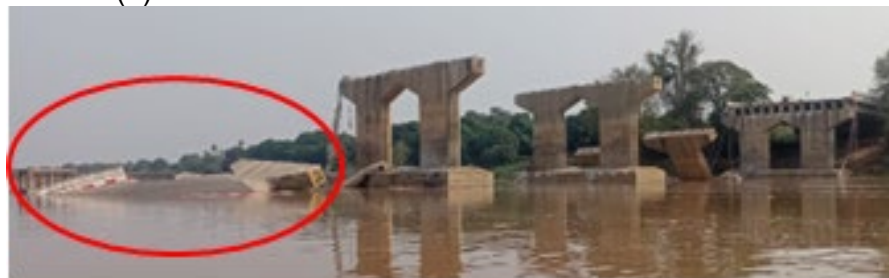
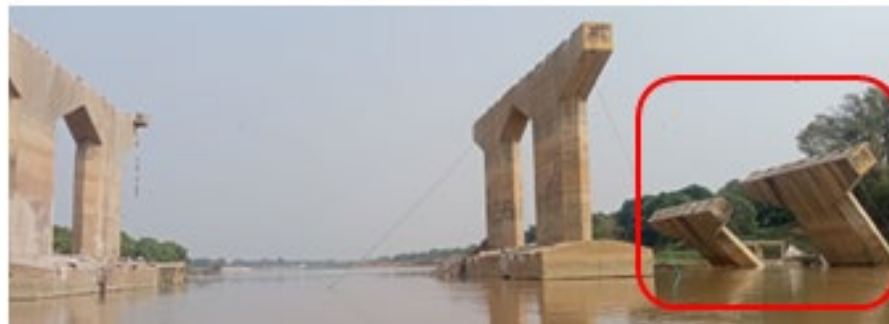
Located on the AH-1 (Yangon-Mandalay Expressway), the Duthawaddy (U Man Lay) Bridge crossing the Myittha River, served as a vital link along a major transportation corridor. As part of AH-1, the primary north-south transportation artery, this bridge was essential for mobility, emergency response, and logistics. Its collapse due to unseating of the bridge decks on all its spans (Fig. 6.2.3a) caused major transportation disruptions, delaying relief operations, and increasing travel times. Several of its piers also lifted off their foundations and overturned (Fig. 6.2.3b), with heavy damage to its abutment and ground failure at the approach and shoulder (Fig. 6.2.4).

**Figure 6.2.3.** Dutthawaddy (U Man Lay) Bridge crossing Myitnge River: (a) satellite images before (top) and after (bottom) the earthquake (Credit: Gansu Data and Application Center for High-Resolution Earth Observation System); (b) unseated bridge decks and overturned piers (Source: [Khit Thit Media on Facebook](#)).

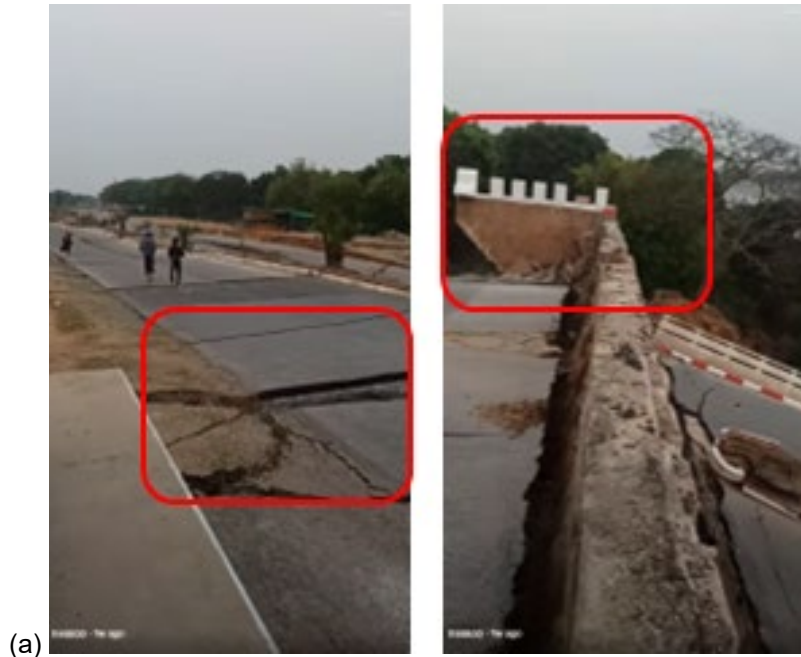
**Figure 6.2.4.** Dutthawaddy (U Man Lay) Bridge crossing Myitnge River: (a) roadway and abutment damage (Source: Extracted from video from [@fri4800 on TikTok](#)); (b) approach and shoulder road failure with wide separation (Source: Extracted from video from [@aungsl1 on TikTok](#)).

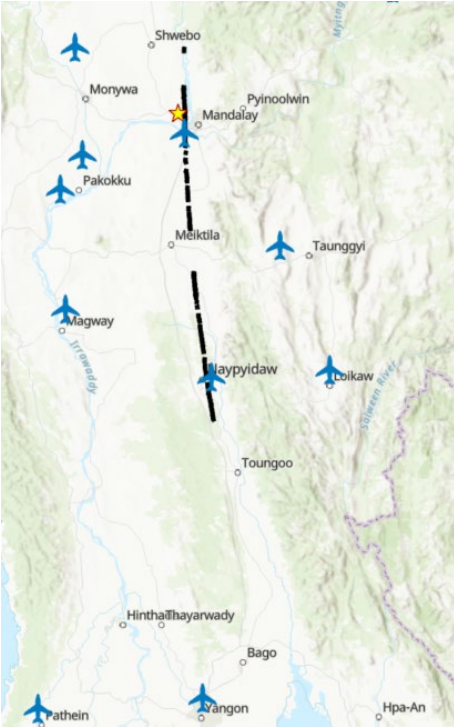
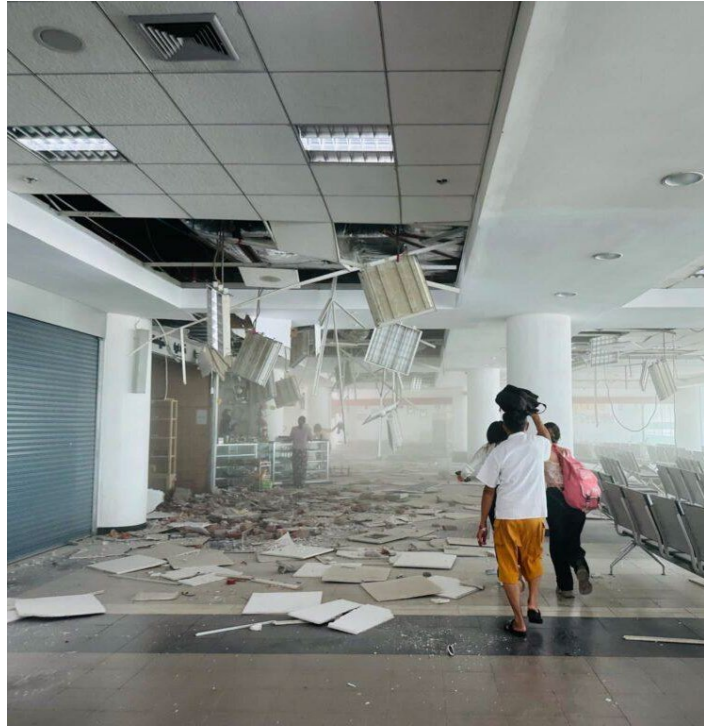
Figure 6.2.6 maps locations of airports relative to the 460 km surface fault rupture from USGS (USGS 2025c), with Mandalay Airport near the epicenter and Nay Pyi Taw Airport along the fault rupture to the south. Immediately after the earthquake, the radar systems at both airports were not operating, halting flights. During this time, Yangon Airport was the only operational airport in Myanmar handling international aid (Myanmar Now 2025a). Despite nonstructural damage, including suspended ceiling failure (Fig. 6.2.6), experienced in the Mandalay Airport, the airport reopened for domestic flights on April 4. The airport was fully reopened on April 6 (Xinhua 2025).

**Figure 6.2.6.** (left) Locations of major airports in Myanmar relevant to earthquake epicenter and the surface fault rupture trace from USGS (USGS 2025c); (right) suspended ceiling damage in a terminal building at the Mandalay Airport (Source: (Myanmar Now 2025a)).
