# 11.0 DAMS, LEVEES, AND MINE TAILINGS DAMS

#### 11. 1 Water Storage Dams

## 11.1.1 Coiheuco Dam (S36.637166°, W71.797530°)

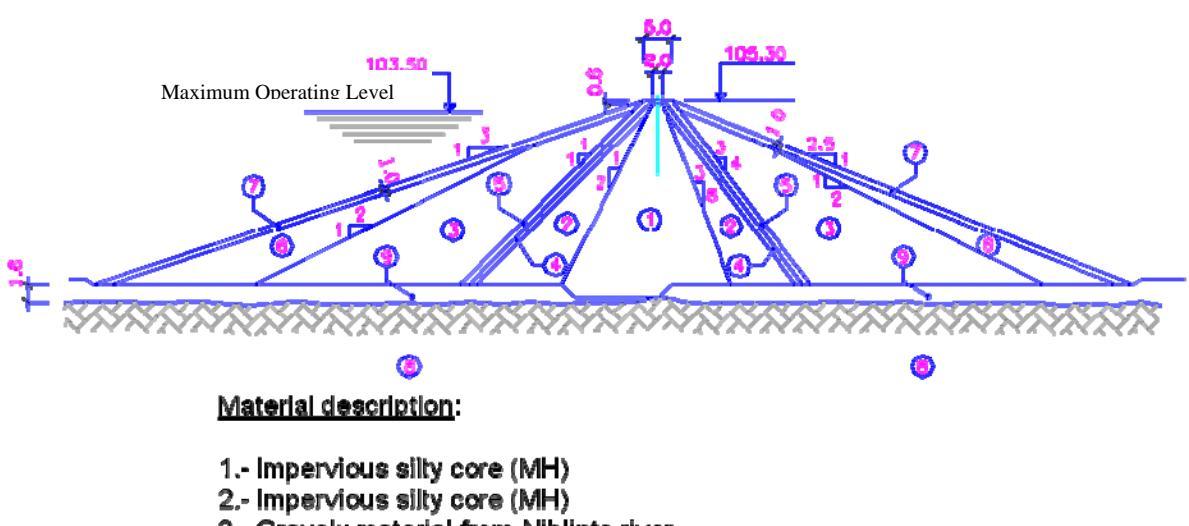
Figure 11.1b Typical Cross Section of Coihueco Dam

- 3.- Gravely material from Niblinto river
- 4.- Contact core
- 5.- Filter
- 6.- Oversize rounded rocks
- 7.- Rounded rocks placed by hand
- 8.- Impervious glacial material
- 9.-Fines (MH)

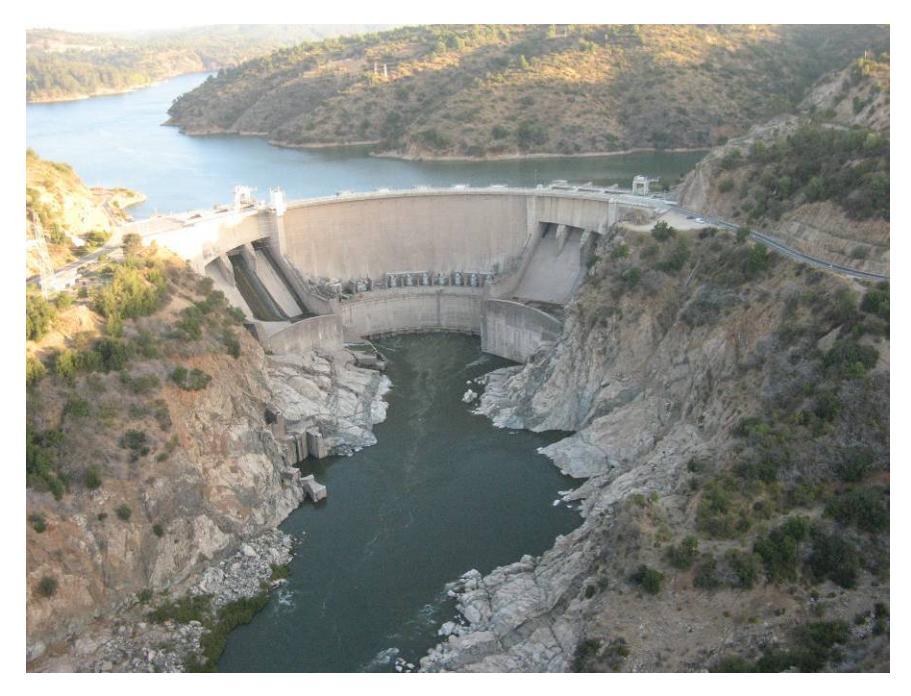
Observations of the Rapel Concrete Dam were made from helicopter on March 10, 2010. The dam was functioning and no signs of damage were observed. A leak upstream of one of the gates is reported to pre-date the February 27, 2010 earthquake.

Figure 11.6. March 10, 2010. Rapel Concrete Dam Downstream Face (S34.038754°, W71.590223°)

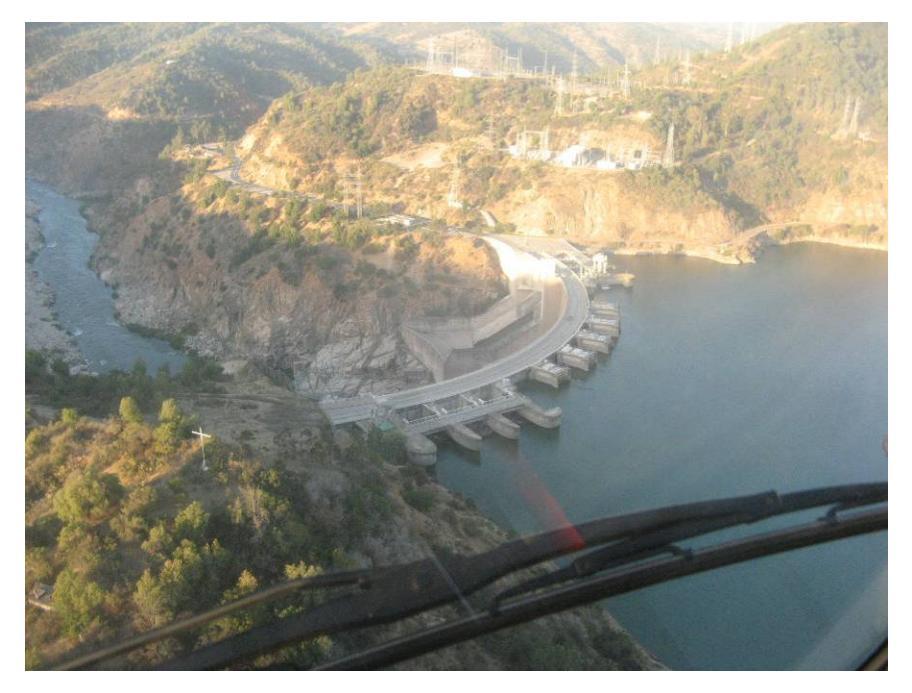
Figure 11.7. March 10, 2010 – View of Upstream of Rapel Concrete Dam (S34.043786°, W71.592053°)

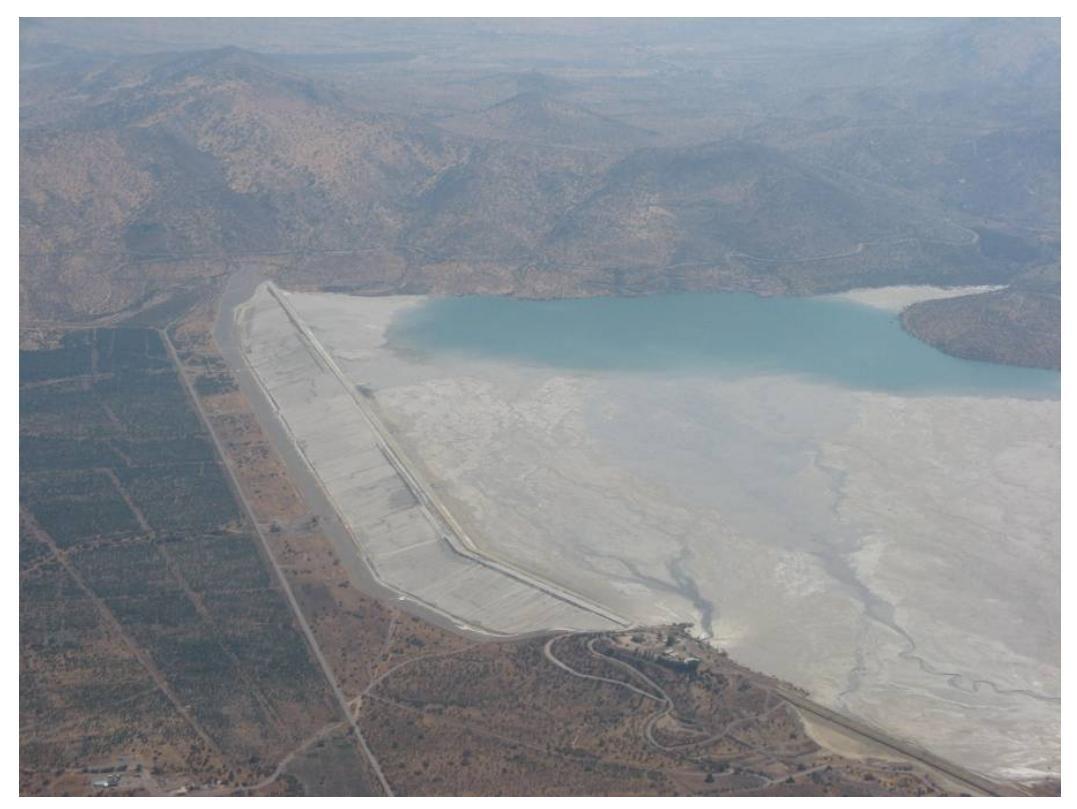
Both the on-ground inspection and the helicopter reconnaissance identified no problems with the tailings sand dam. There were many expressions of high pore pressure (sand boils) in the tailings upstream of the dam and the maximum settlement of the tailings near the dam was about 0.5 m, representing a strain of about 1%. The liner on the upstream showed no signs of dam. Several large valves rest directly on the liner, and there was not stretching or tearing of the liner at these valves. No cracks were observed on the crest or on the downstream face.

Figure 11.8. March 10, 2010 View of Ovejeria Tailings Dam from Helicopter (\$33.054182°, W70.768953°)

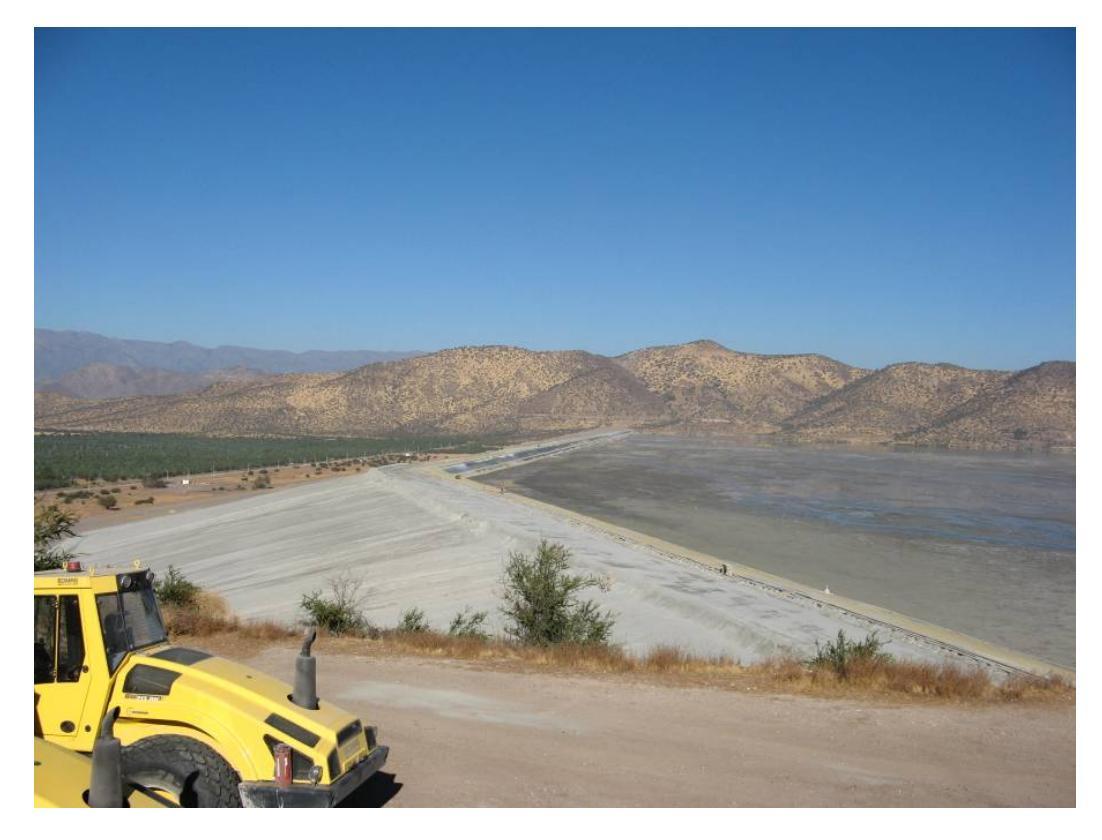
Figure 11.9. March 9, 2010 View from the Left Abutment Along the Ovejeria Tailings Dam (S33.049364°, W70.785354°)

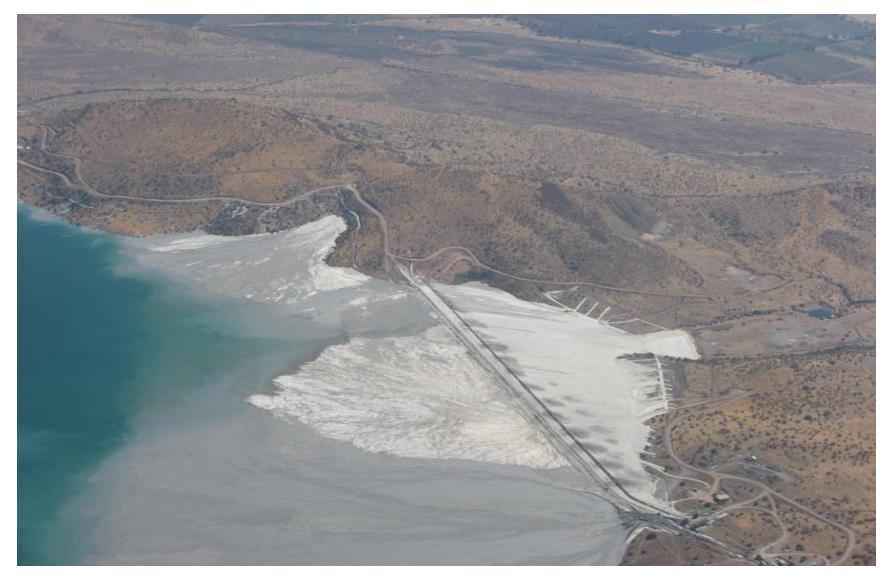
An overflight by helicopter was made of this tailings impoundment. The impoundment was operating and dam construction was ongoing. No damage was observed.

Figure 11.13. March 10, 2010 View of Tortolas Tailings Dam from Helicopter (\$33.115406°. W70.733297°)

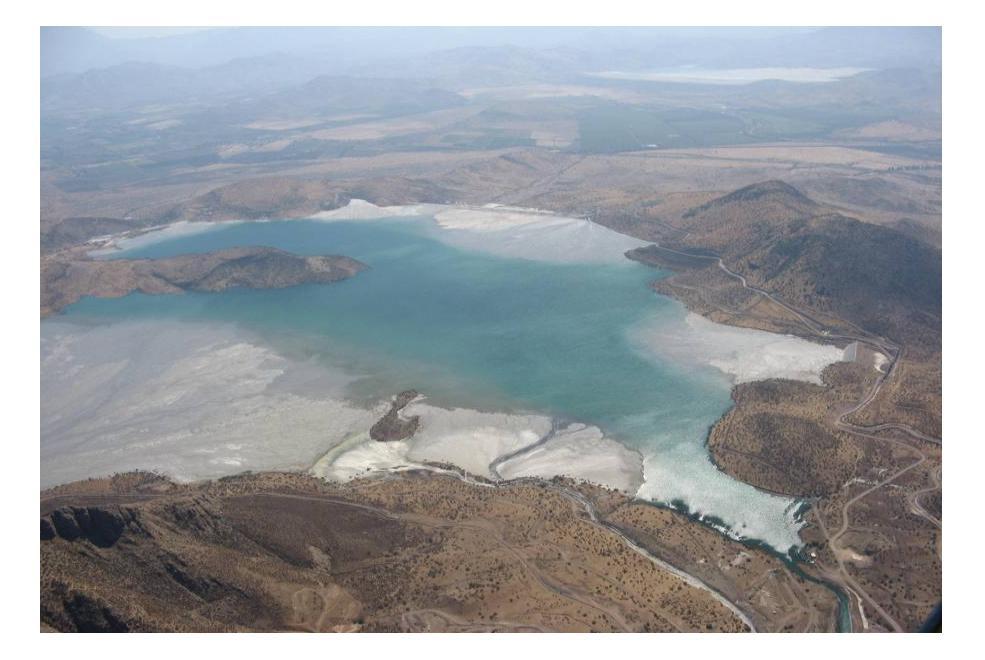
Figure 11.14. March 10, 2010 View of Tortolas Tailings Impoundment from Helicopter (S33.144658°, W70.710449°)

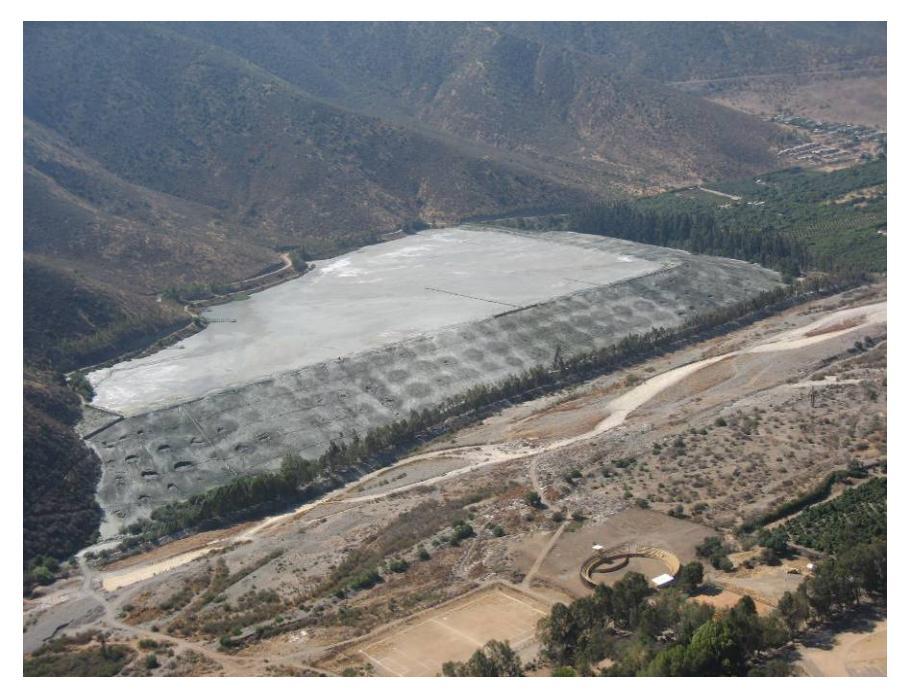
The Calbildo tailings dam was visited by helicopter on March 10, 2010. The helicopter landed and a ground based inspection was made of the dam. No issues were observed with this dam due to the February 27, 2010 earthquake. The tailings facility was not being operated. There was a minimal amount of water in the pond against the natural topography and long dry beaches adjacent to the dam. The downstream face of the dam is being rehabilitated by planting trees and an irrigation system has been installed.

Figure 11.15. March 10, 2010 View of Cabildo Tailings Dam from Helicopter (S32.427724°, W71.077282°)

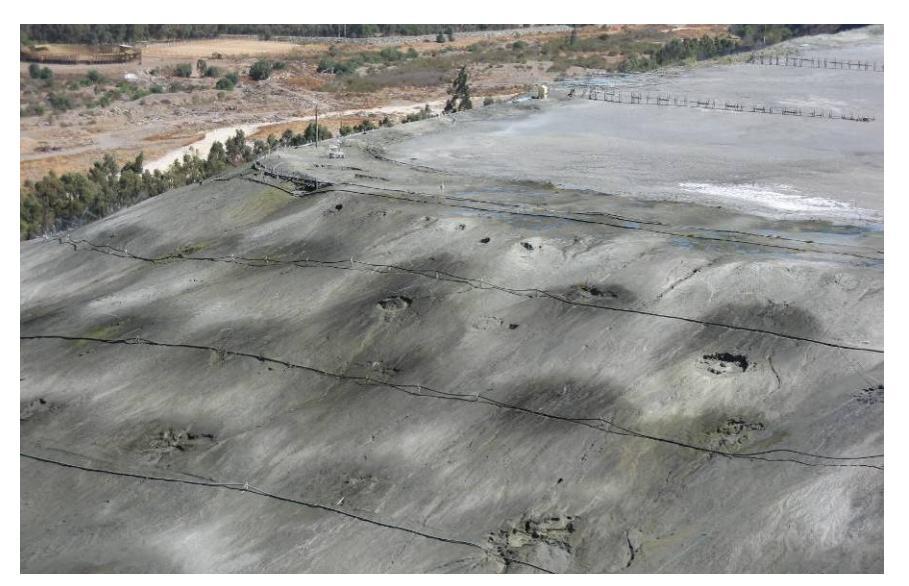
Figure 11.16. March 10, 2010 View of Cabildo Tailings Dam from Helicopter Showing Sprinkler System on Downstream Face (S32.422414°, W71.077165°)

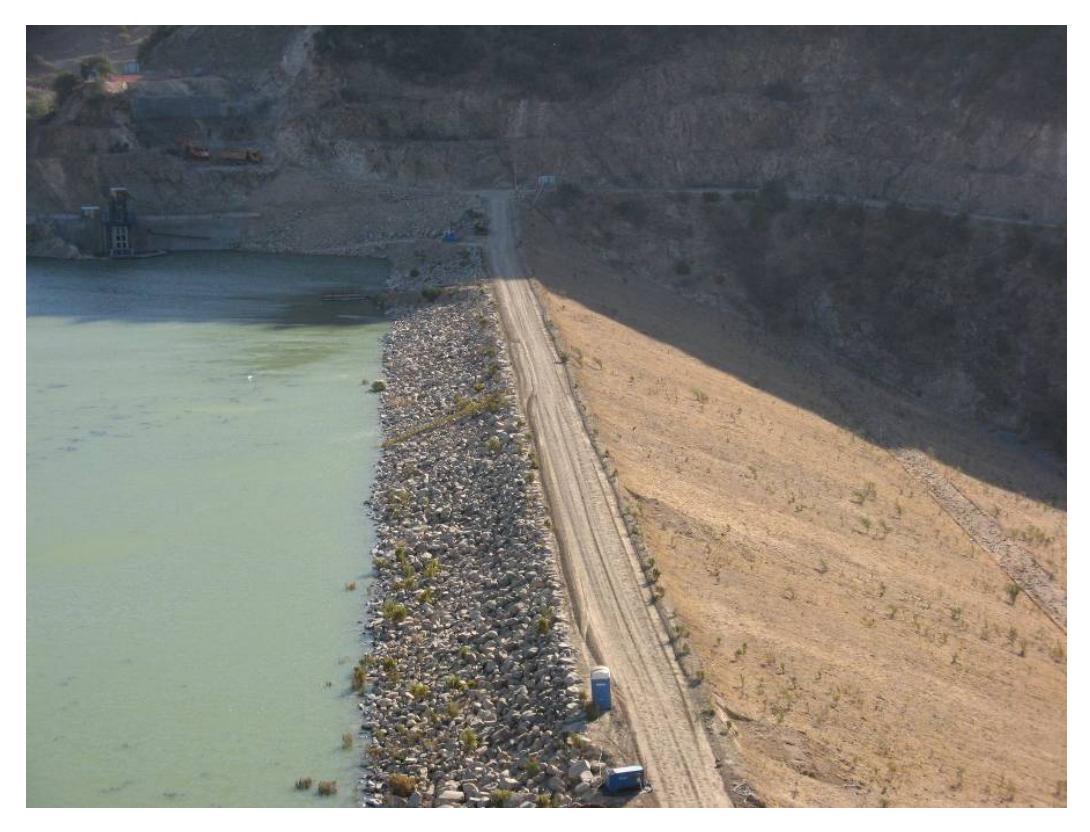
Figure 11.18. March 10, 2010 View from Helicopter Towards the Left Abutment of the Caren Tailings Dam (S34.093959°, W71.175046°)

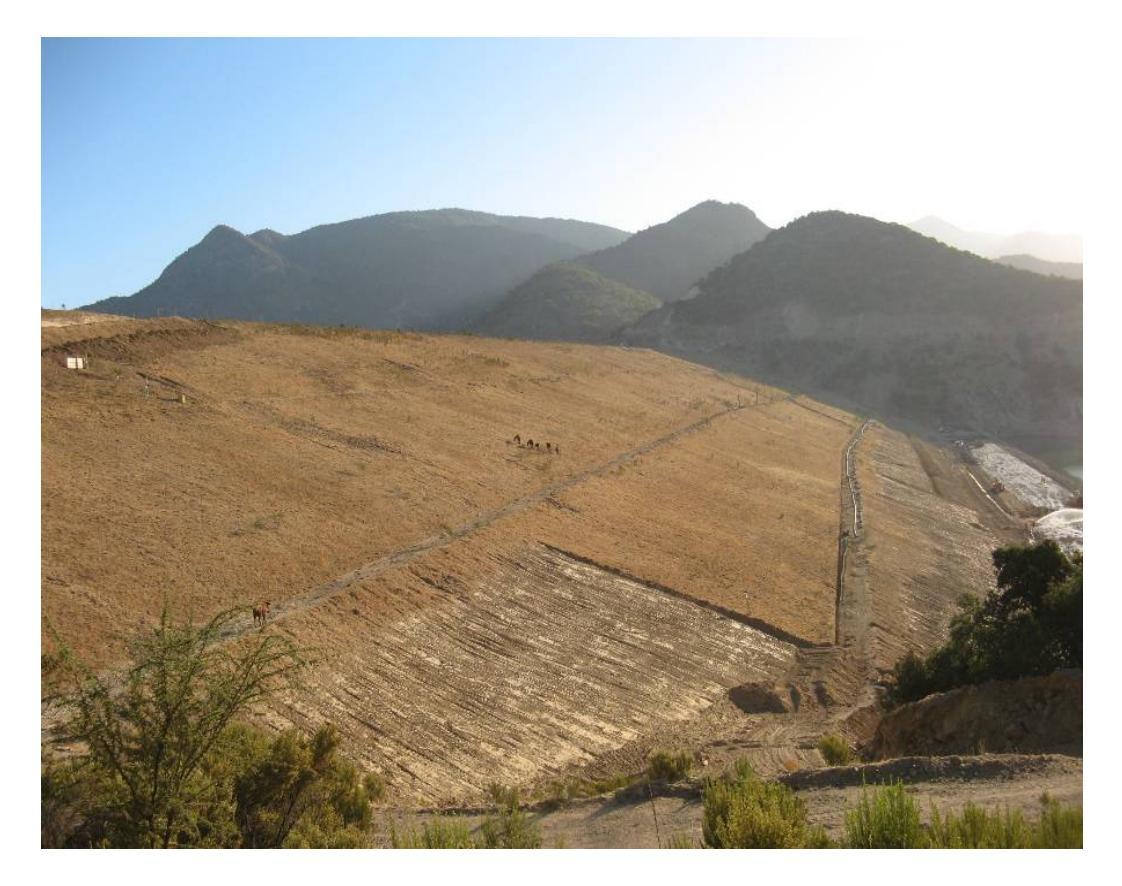
Figure 11.20. March 10, 2010 View of the Downstream Face of the Caren Tailings Dam Showing Progress of Dam Raise Construction (S34.092422°, W71.173250°)

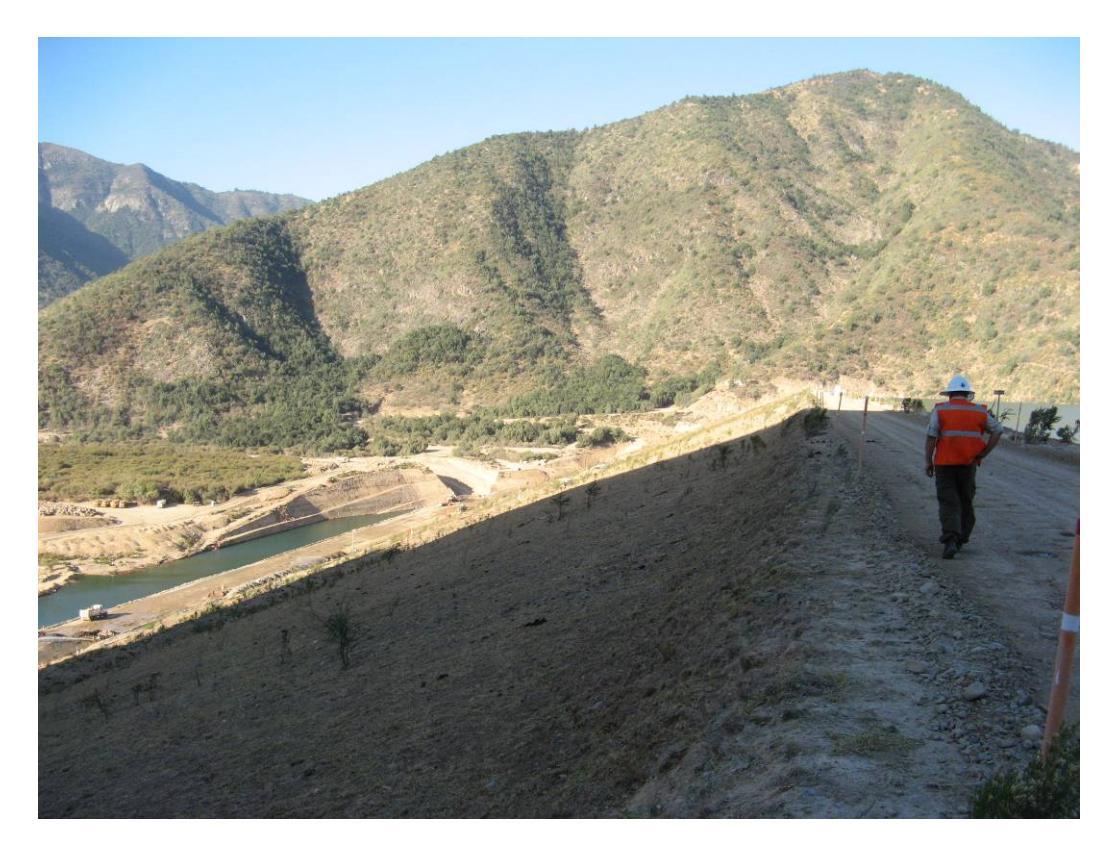
Figure 11.21. March 10, 2010 Crest and Downstream Face of Caren Dam from Left Abutment (S34.095570°, W71.179076°)

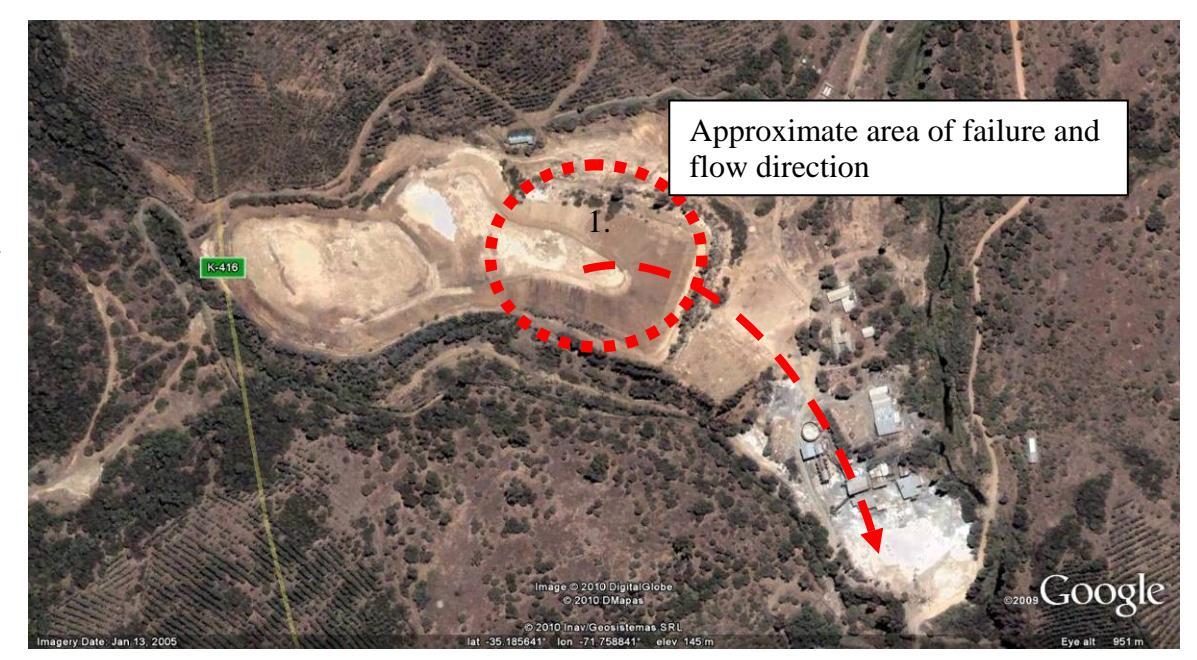
Figure 11.22. Google Earth Image Tailings Impoundment Pre-Failure  $(35.184679^{\circ} \text{ S}, 71.759410^{\circ} \text{ W})$

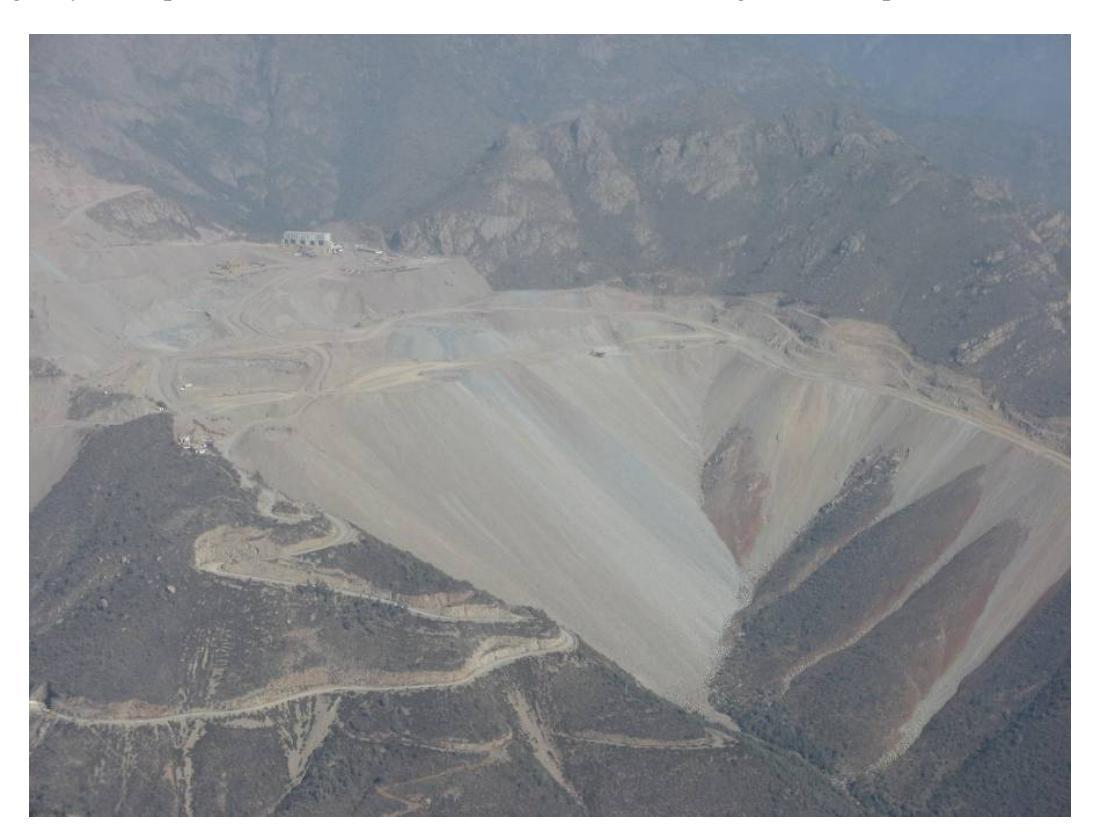
Overflight by helicopter made. No evidence of movement of these high rock dumps.

Figure 11.38. March 10, 2010. Soldado Waste Dump (S32.654695°, W71.121352°)
