13.0 TSUNAMI EFFECTS

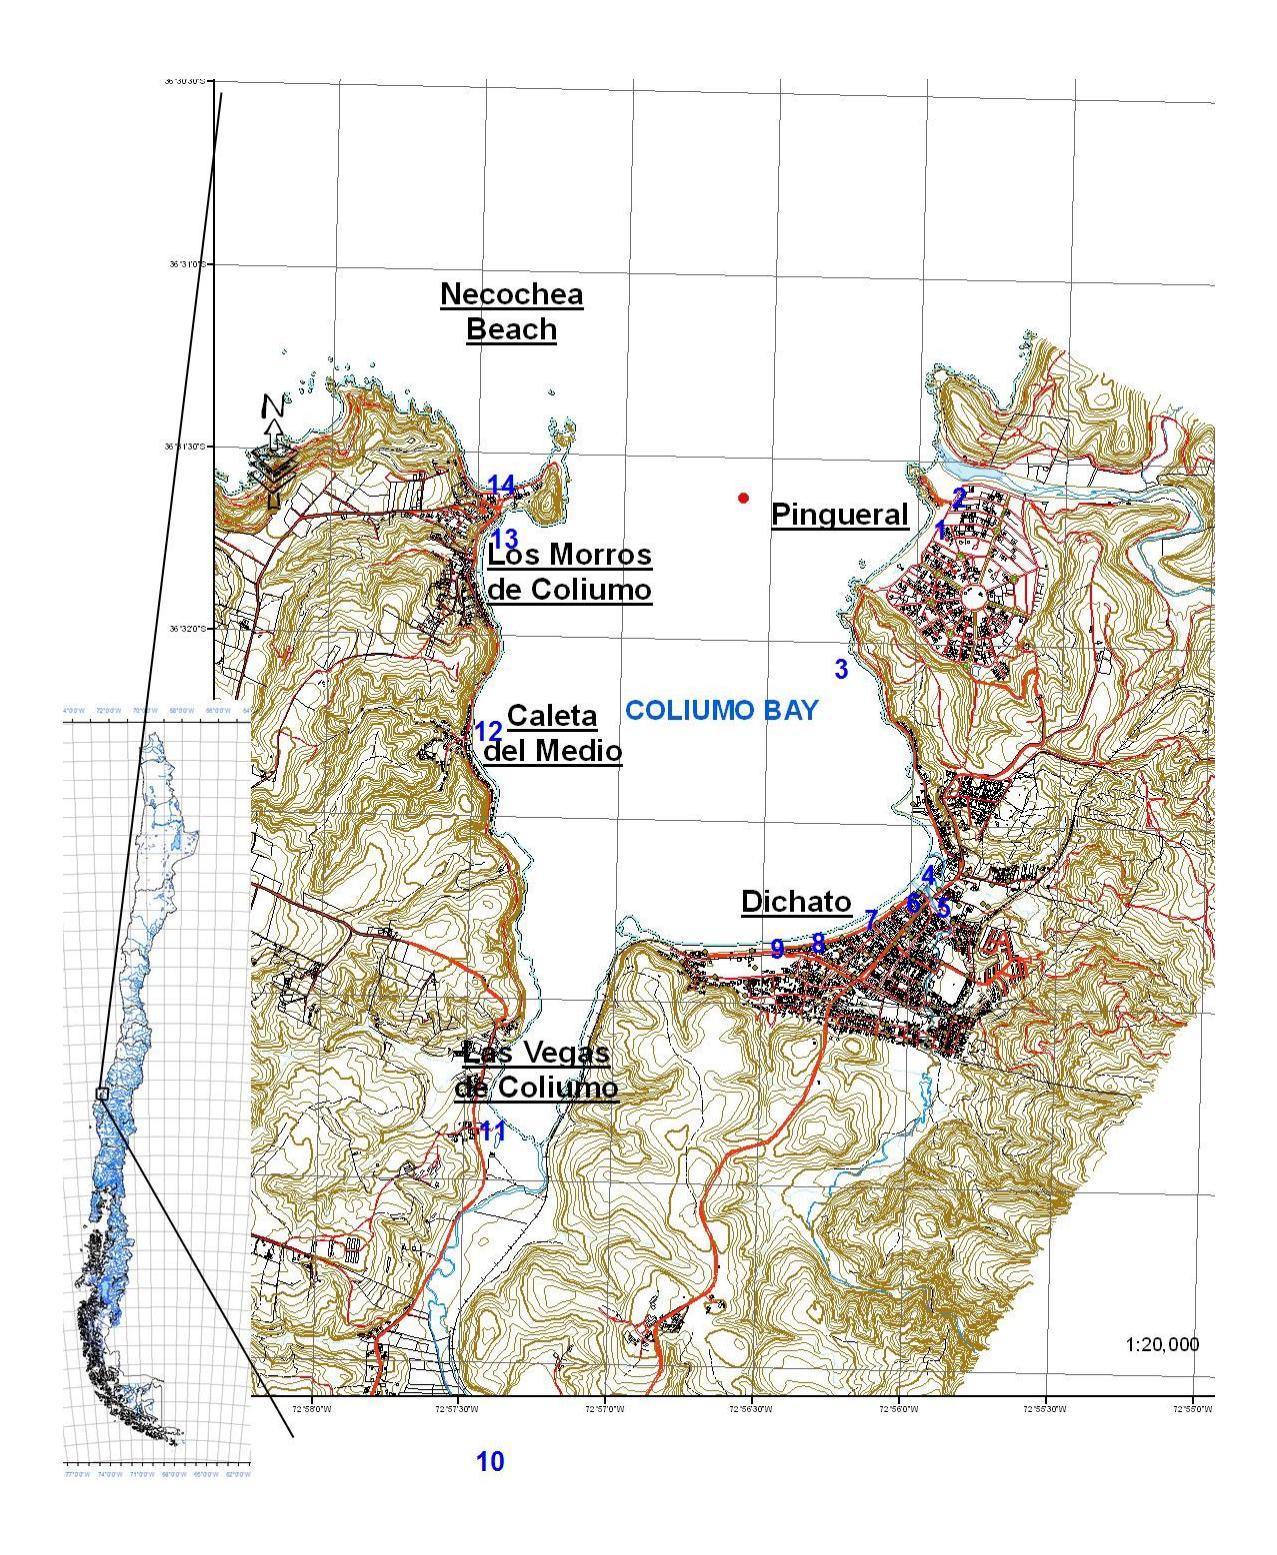
Figure 13.7 Location of population centers around Coliumo Bay (after Zoa et al.).

The largest town in Coliumo Bay is Dichato, located at the South end of the bay that measures approximately 2 km West to East and 2.5 km South to North. Many of the homes in Dichato are built on the floodplain of a small river called the Rio Dichato. Pingueral is a gated residential community, about 2 kilometers north of Dichato, on the east side of the bay. Pingueral has a wide swimming beach that faces northwest towards the Pacific Ocean. There are three small fishing communities built on the steep hillsides of the west side of the bay. From south to north, they are Las Vegas de Coliumo, Caleta de Medio and Los Morros de Coliumo. On the northwest corner of the bay is Nocochea Beach, where there are about 25 vacation homes built along a beach facing north towards the Pacific Ocean. The location of the various population centers are shown in Figure 13.7.

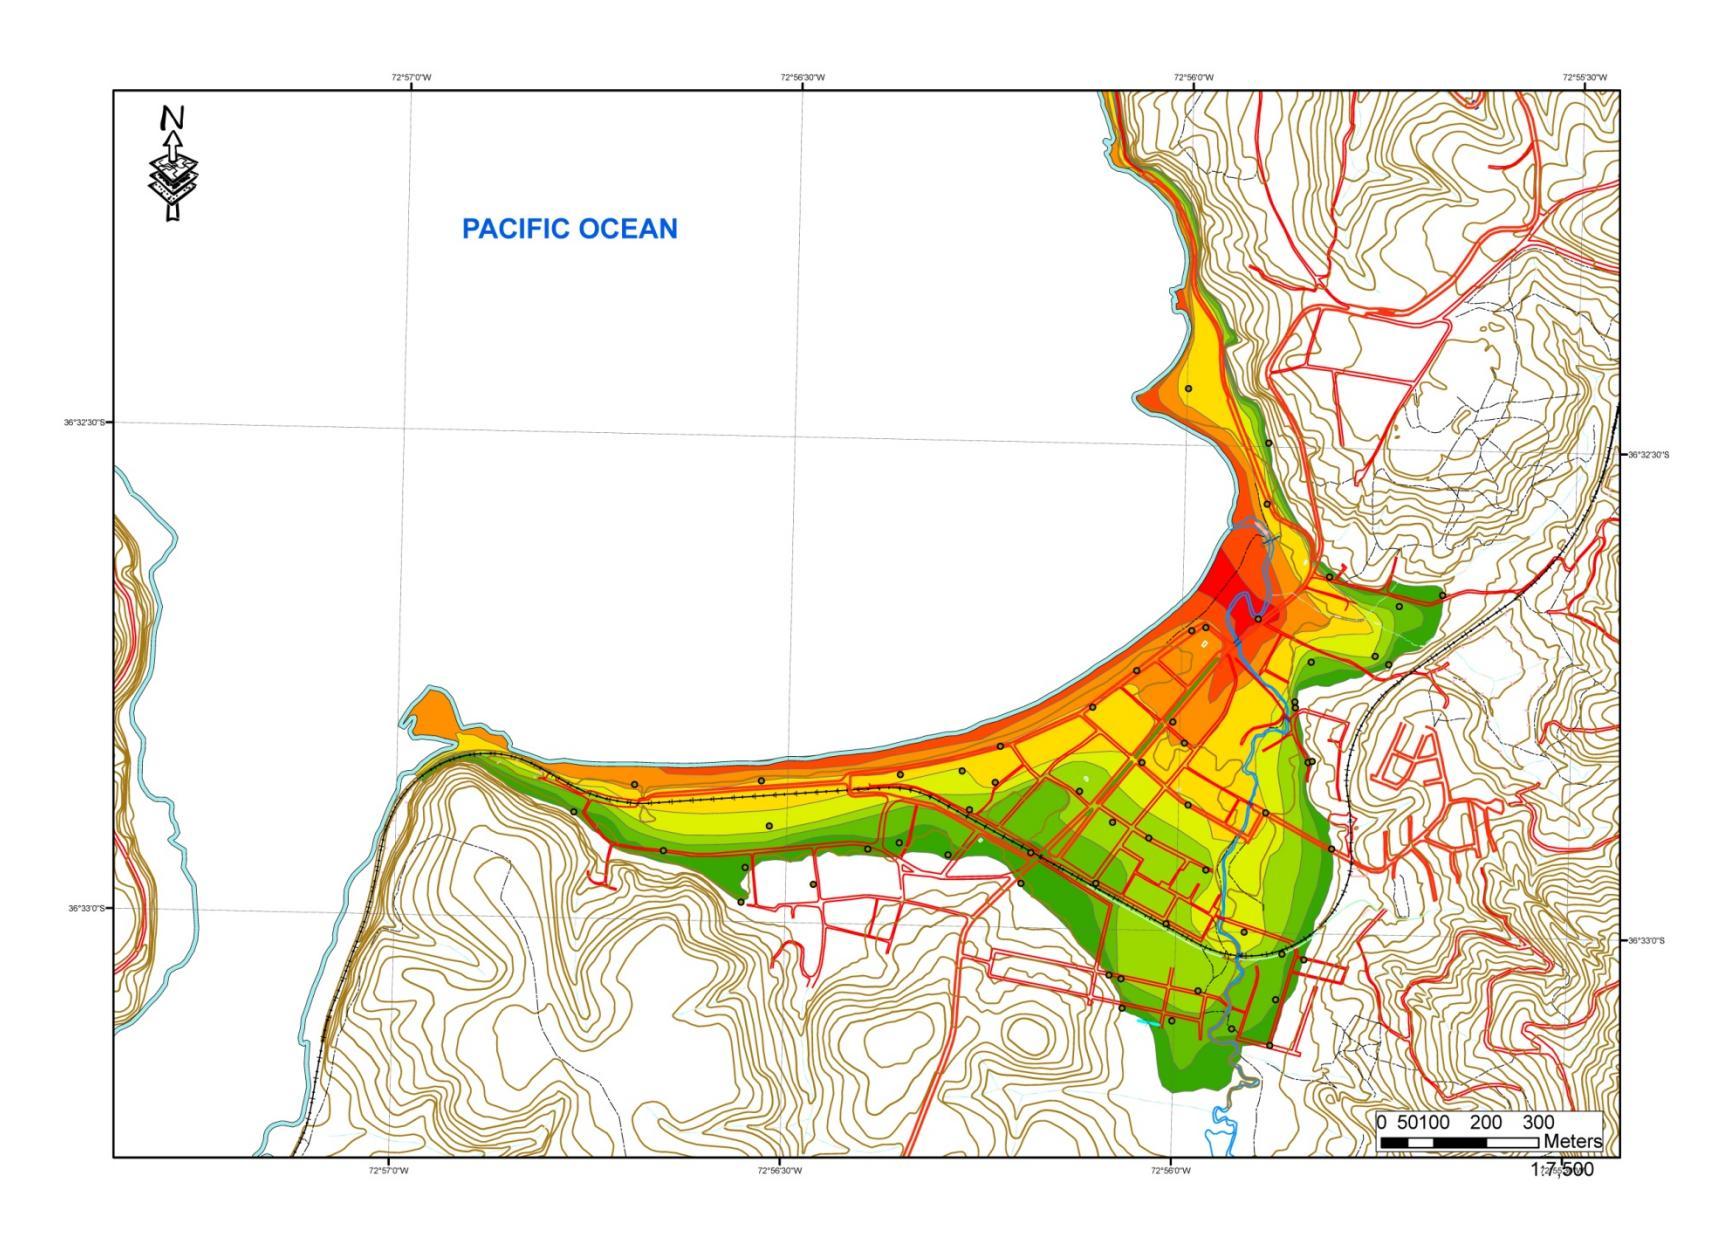
Figure 13.10 Inundation extent and contours of inundation depth in Dichato by Zoa et al.

The maximum inland incursion of the tsunami in the Dichato area was about 2.2 kilometers. Based on ground measurements, it is estimated that the maximum depth of the water in the town of Dichato was about 6 m, and about 6.5 m in the agricultural valley that extends to the South of Coliumo Bay west of Dichato as shown in Figure 13.8. A photograph of a large portion of the town of Dichato taken during an aerial reconnaissance flight is shown in Figure 13.9. An expanded view of the inundation extent and depth based on ground observations at the location of the black open dots is shown in Figure 13.10. Structure locations are overlaid in Figure 13.11. Most residents of the Dichato area agree that the first wave arrived within an hour after the earthquake. A second set of waves entered Coliumo Bay between 6:30 and 7:00 am. A third surge of water entered the bay at about 10:00 a.m. Depending on location, the largest and most destructive waves were either the second or third set of waves. Eyewitness accounts stated that the waves did not generally advance as cresting breakers, but moved into the bay and onto the land as surges, first causing flooding and then creating an outwash that carried structures and debris back into the ocean.
