5.0 SITE EFFECTS AND DAMAGE PATTERNS

5.1 The City of Santiago

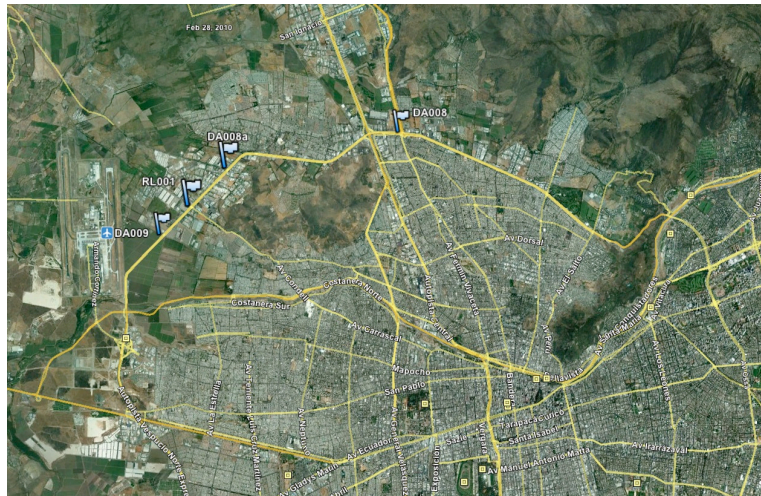
Figure 5.2. Four Americo Vesputio Ring Road bridges visited during the reconnaissance.

During the reconnaissance, four bridge sites were inspected along the road Americo Vesputio Norte, the Northern section of Santiago's ring road. Their locations are depicted in Figure 5.2. The damage intensity was highly variable, with two bridges fully collapsed (DA008a, DA009) and two showing minor structural damage such as shear key cracking (DA008, RL001).

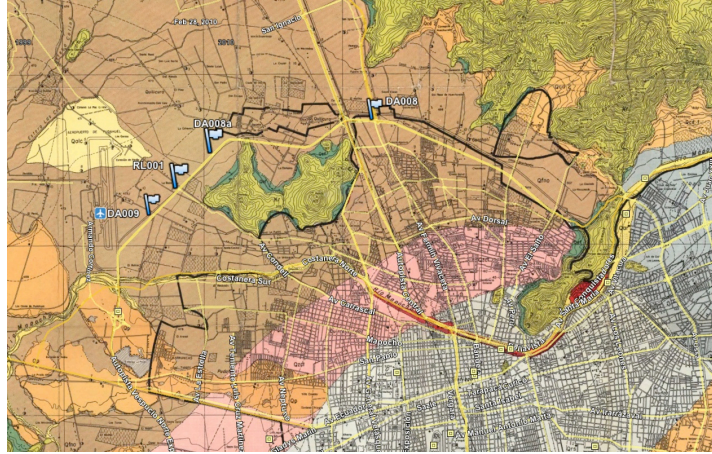
Figure 5.3. Location of the four bridge sites on the geology map of Santiago Metropolitan Area (Dr. Christian Ledezma, personal communication; approximate map overlay on Google Earth)

Investigating potential correlation between the bridge damage patterns and the underlying soil conditions, the locations of the four inspected bridges are depicted on a geology map of the Santiago Metropolitan Area in Figure 5.3. The soil conditions at the four bridge sites appear to be similar, characterized as Finos del Noroeste which are silts and clays of high plasticity horizontally stratified as thin interchangeable layers. The site conditions at the locations of the four bridge sites are characteristic of Class C/D sites according to the NEHRP soil classification system.

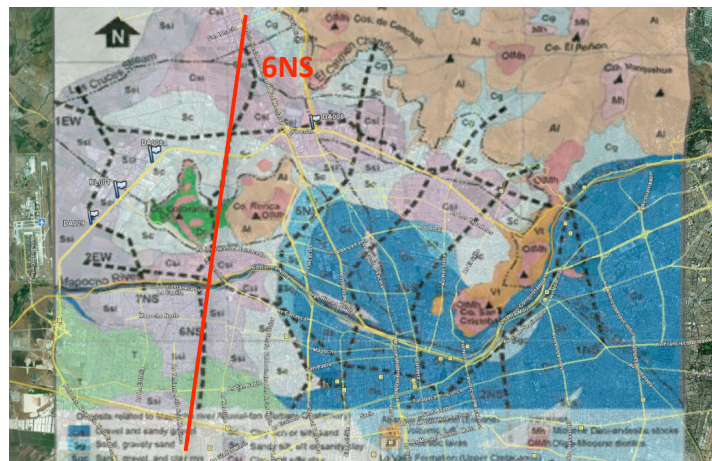
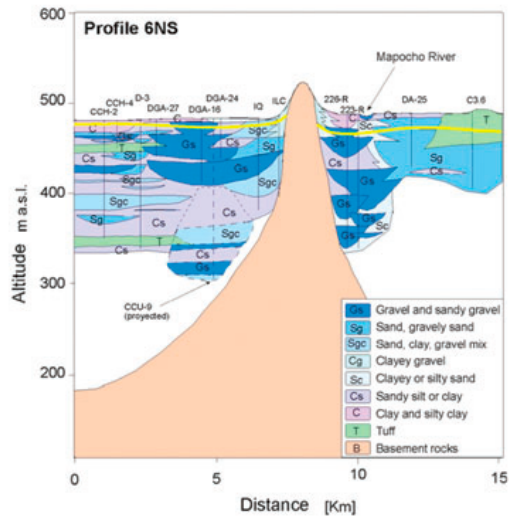
Figure 5.4 depicts the locations of the bridge sites on the geological map by Iriarte-Diaz (2003), along with typical N-S cross section of the valley geology. The depth to bedrock-basement at the bridge sites as approximately interpreted from the cross-section does not show clear correlation with the damage states.

Figure 5.4. Location of the four bridge sites on the map of geological cross-sections in the North-Western part of Santiago de Chile; and Geological cross-section along profile 6NS (Iriarte-Diaz, 2003). Site DA008 (minor damage) is located on clay/silty clay, DA008a (collapsed) on clay/silty sand, and sites RL001 (minor damage) and DA009 (damaged) on sandy silt or silt.

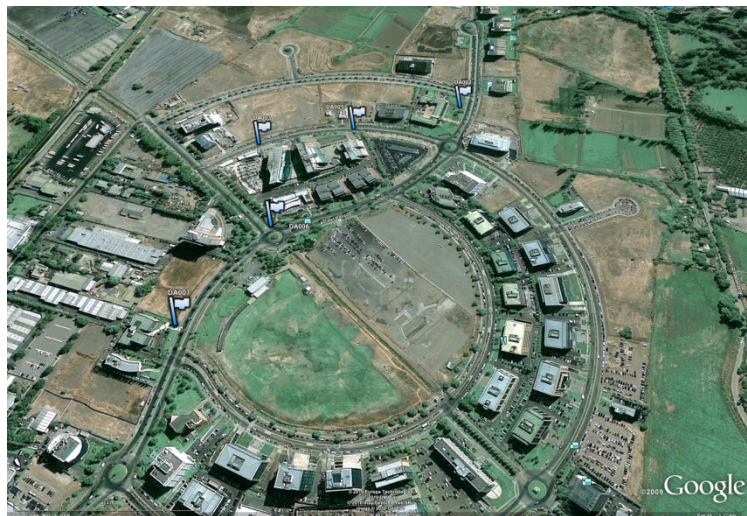
Figure 5.9. Aerial view of Ciudad Empresarial, depicting the structures that were inspected during reconnaissance.

Overall, the business park was severely damaged, with 7 buildings that failed and were closed to the public. No total collapse was documented and no casualties were reported at the site, while the only evidence of soil deformation is shown in Figure 11e. The damaged structures ranged from a 5- to 12-stories, which to first approximation corresponds to 0.5-1.2 sec resonant periods (0.8-2 Hz).

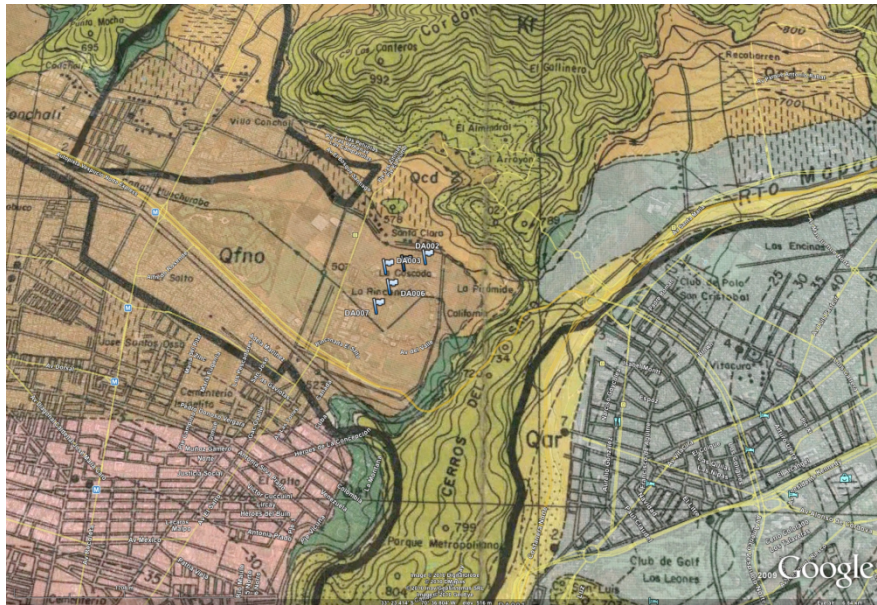
Figure 5.10. Geologic map of Santiago, zoom in Ciudad Empresarial business park. The geologic material at the site is Finos del Noroeste (Qfno), horizontally stratified thin interchangeable layers of silts and clays of high plasticity.

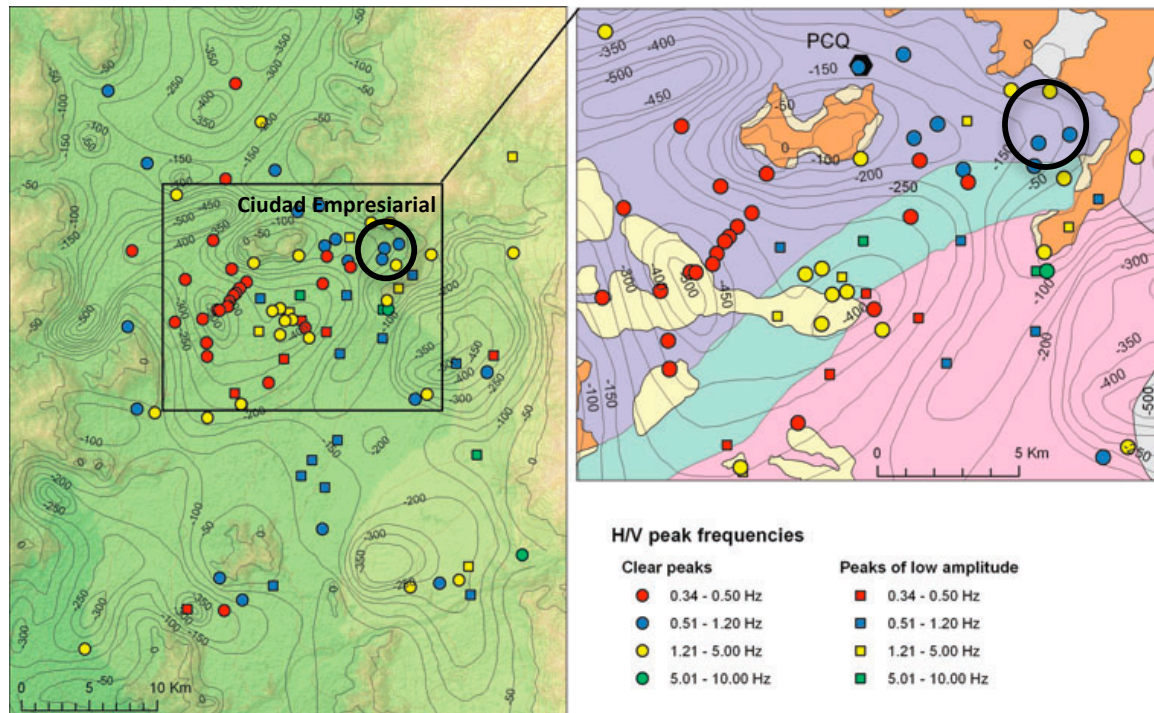
Bonnefoy et al (2008) conducted extensive ambient vibration measurements in the basin of Santiago de Chile (Chile), evaluating the reliability of the horizontal-to-vertical amplitude spectra ratio method (H/V) as a tool to provide qualitative and quantitative information of site conditions in complex geological media. Results from this study showing the spatial distribution of the H/V peaks according to their frequencies are depicted in Figure 5.17: (red) 0.3–0.5, (blue) 0.51–1.2, (yellow) 1.21–5 and (green) 5.1–10 Hz. Circles display frequencies for clear peaked H/V curves, whereas squares depict frequencies for peaks of low amplitude. The surface geology is shown in background, while the green circle corresponds to the location of Ciudad Empresarial. As can be readily seen, the resonant frequencies at the site of the business park as identified by means of H/V ratios range from 0.5-5Hz, consistent with the structural resonant periods of the damaged structures. This is an indication that site effects may have contributed to the concentrated structural damage at the site.

Figure 5.17. Spatial distribution of H/V peaks from ambient noise measurements in NE Santiago, denoted according to their frequencies: (red) 0.3–0.5, (blue) 0.51–1.2, (yellow) 1.21–5 and (green) 5.1–10 Hz (after Bonnefoy et al, 2008). Green circle corresponds to Ciudad Empresarial.

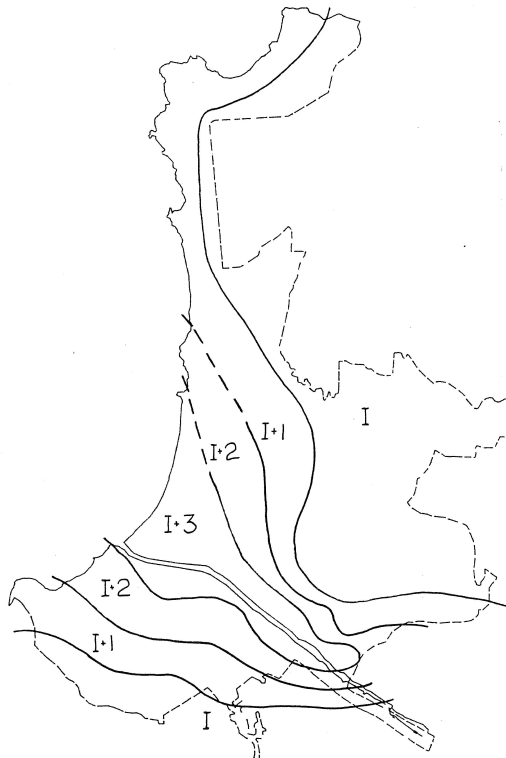
Immediately following the 1985 Earthquake, a microzonation study was conducted by the municipality of Viña del Mar, leading to the development of maps that identified the location of all existing buildings during the 1985 event, the damage distribution, and the location of demolished structures. Results from this study showed that, if an earthquake causes an intensity I in the surrounding marine terraces, the intensity is likely to be I+1 and I+2 on the slopes leading down to the city and I+3 in the alluvial, fluvial, and colluvial deposits along the Marga-Marga River (Figure 5.20).

Figure 5.20. Anticipated Modified Mercalli Intensity in the town of Viña Del Mar (Moehle et al, 1986).

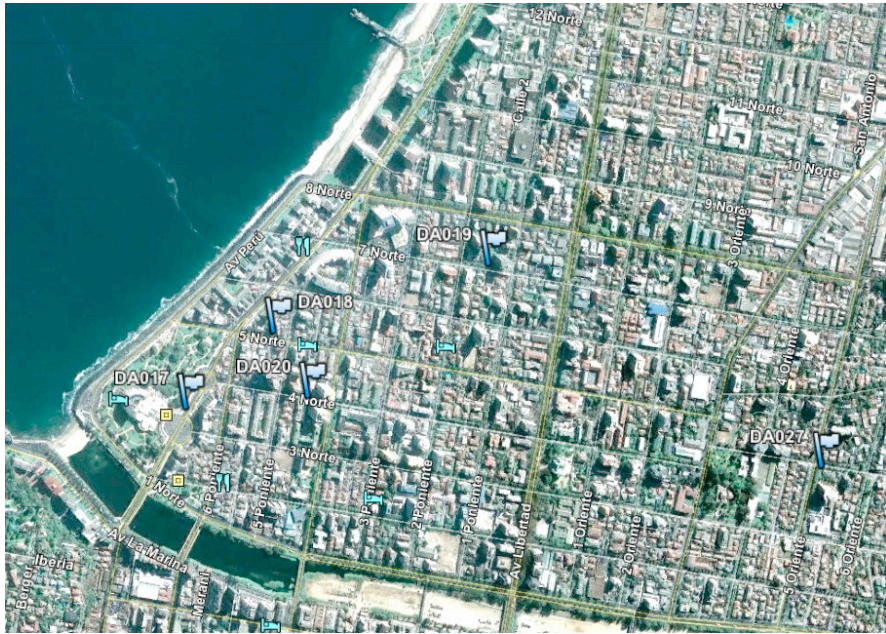
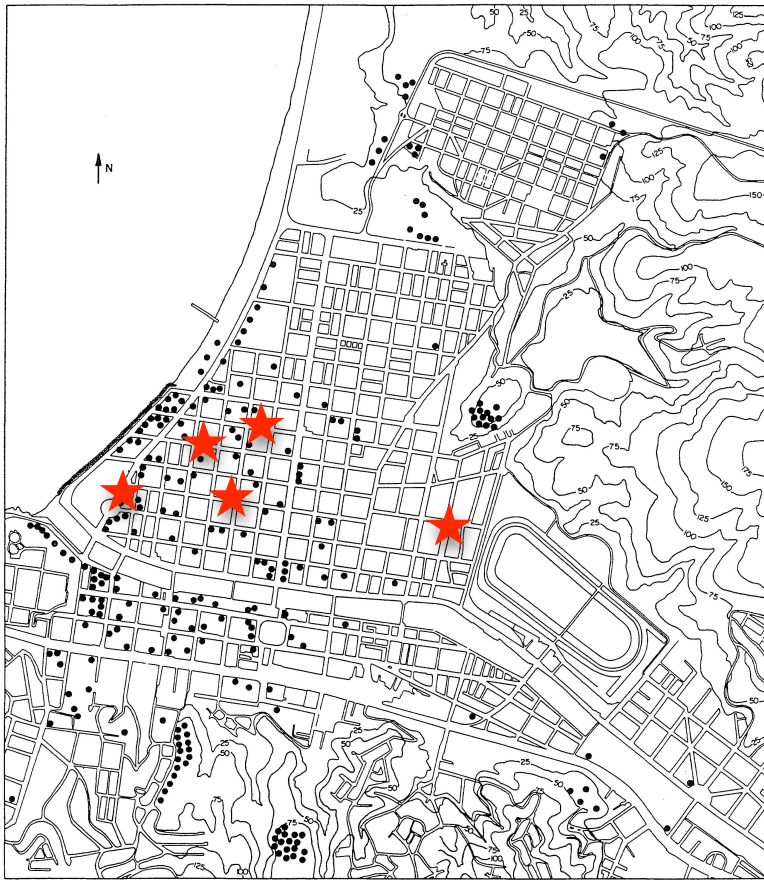
Indeed, the same damage pattern was observed during reconnaissance of the 2010 event. Five severely damaged buildings were inspected, all located in the vicinity of the Marga-Marga river mouth and thus founded on soft soil conditions. Note that during the microzonation study following the 1985 Earthquake, the Municipality of Viña del Mar mapped the location of buildings with 5 or more stories (Figure 5.21). The buildings inspected during reconnaissance after the 2010 Earthquake are also shown on this map (also depicted on the aerial view of Google Earth), and are clearly located in the immediate vicinity of the river. Figures 5.22-5.26 depict the structural damage observations of the reconnaissance team.

Figure 5.21. Buildings inspected during reconnaissance in Viña del Mar. Bottom figure depicts the location of buildings of 5-stories or higher, as mapped during microzonation study that followed the 1985 Valparaiso Earthquake (from Moehle et al, 1986).

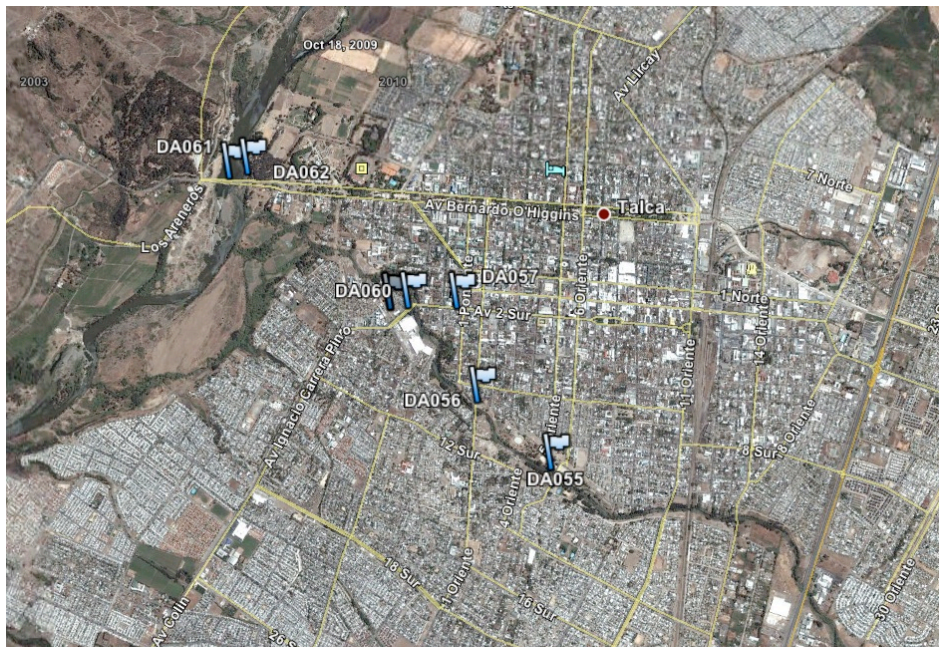
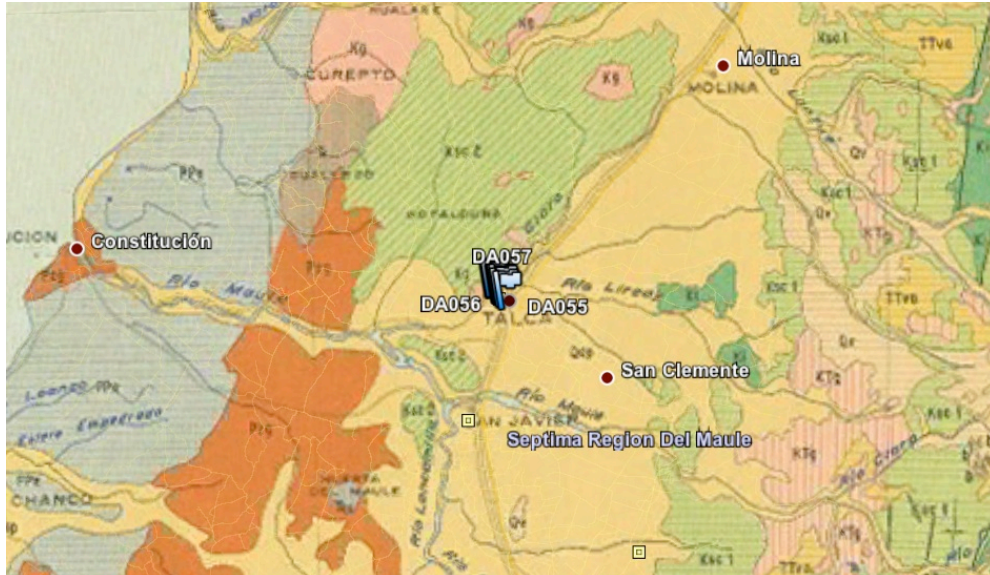
Figure 5.27. Aerial Google earth view and regional geology for the city of Talca.

The aerial view and geology of downtown Talca are shown in Figure 5.27. Alluvial and marine deposits prevail in the region. Structures with major damage or collapsed structures were primarily located near and around the downtown region while the modern (including the tallest, 20-story residential) buildings in the same region suffered minor damage (http://mceer.buffalo.edu/research/Reconnaissance/Chile227-10/City_Talca/default.asp). Four overpasses were inspected along the Maule river with no or minor structural damage. The uneven distribution of damaged adobe structures in the area is potentially indicative of site effects. Figure 5.28 depicts a few pictures from damaged structures located within a few building blocks from the river, and Figure 5.29 depicts modern structures within the same distance from the river with minor damage.

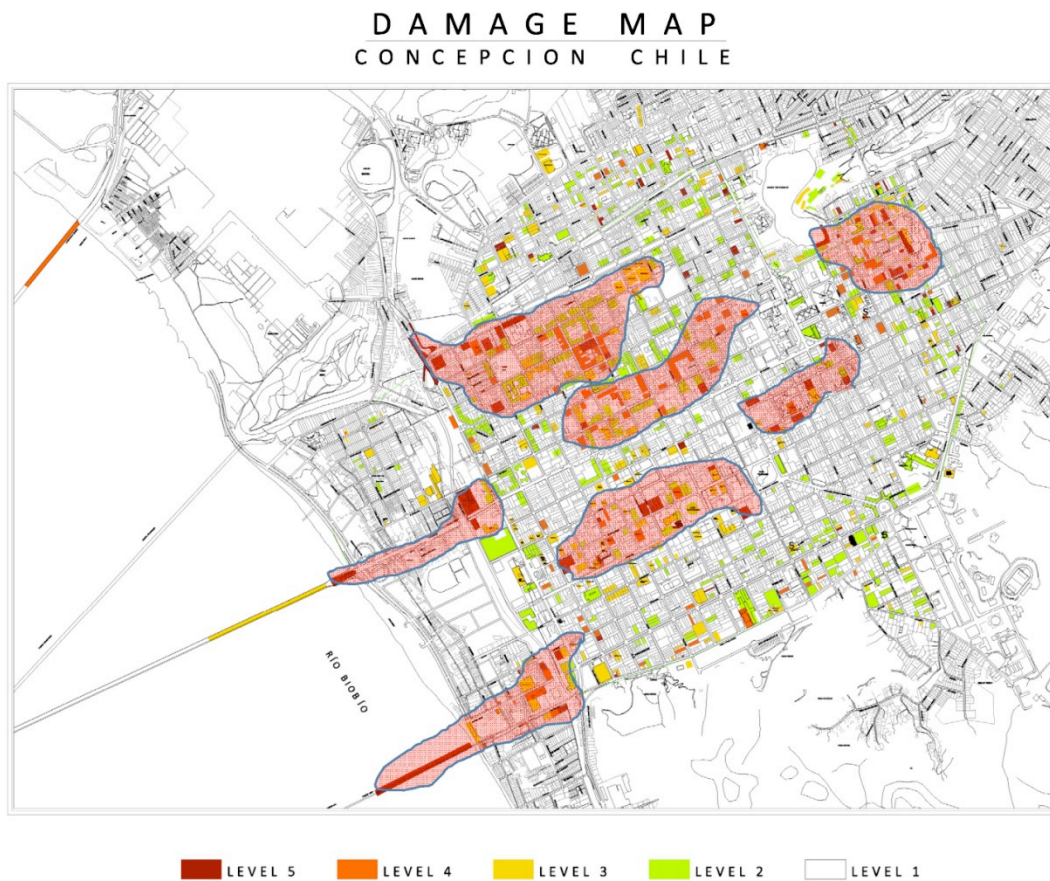
Figure 5.31. Damaged sections in downtown Concepción; 6 out of 7 are parallel to La Polvora fault.

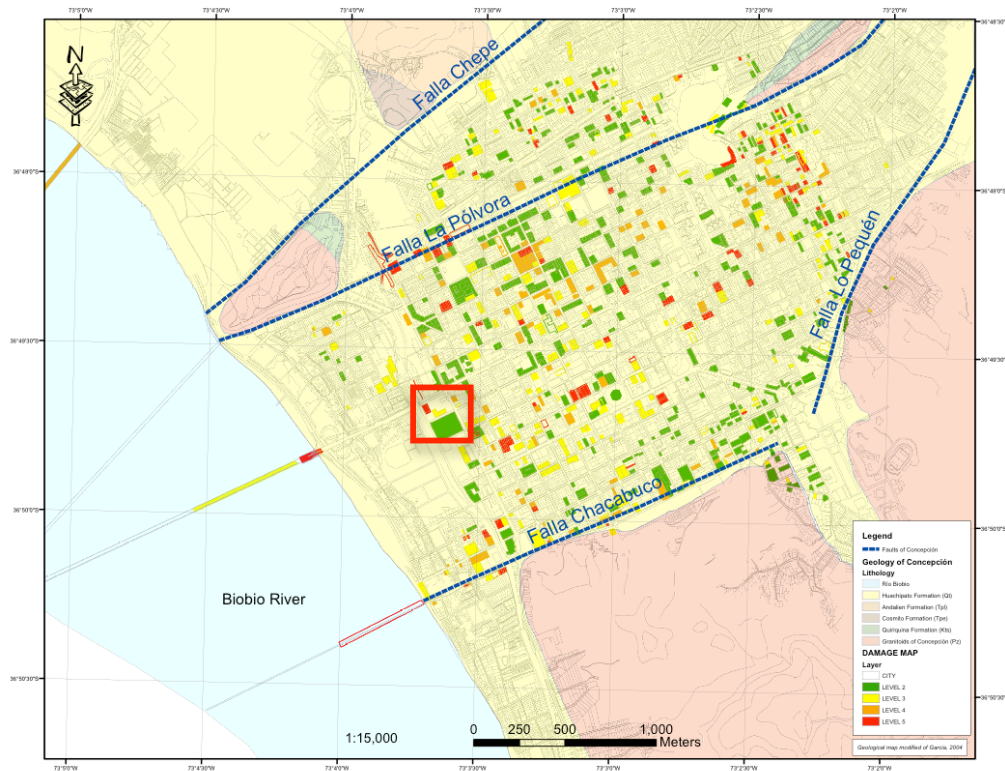
Figure 5.32. Inspected buildings and damage level in downtown Concepción, superimposed on geology map of the region.

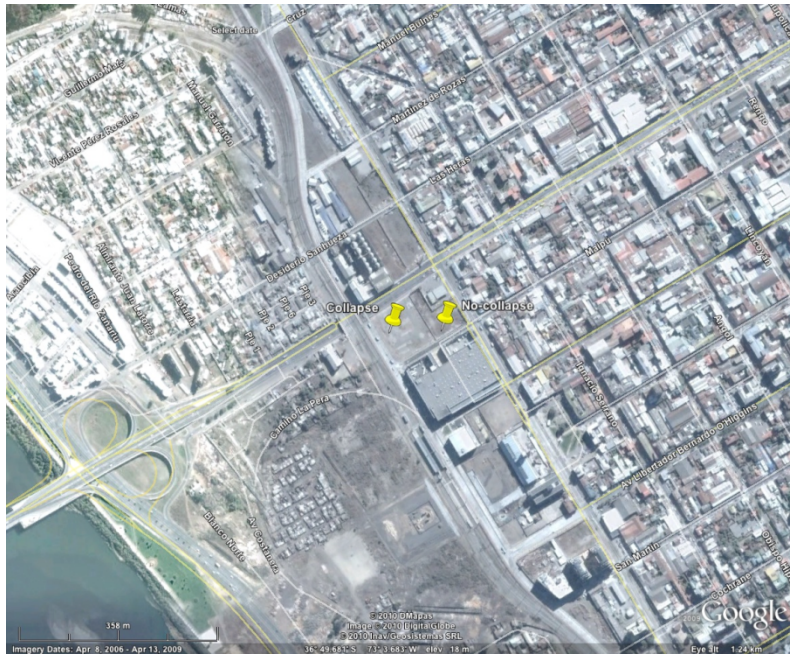
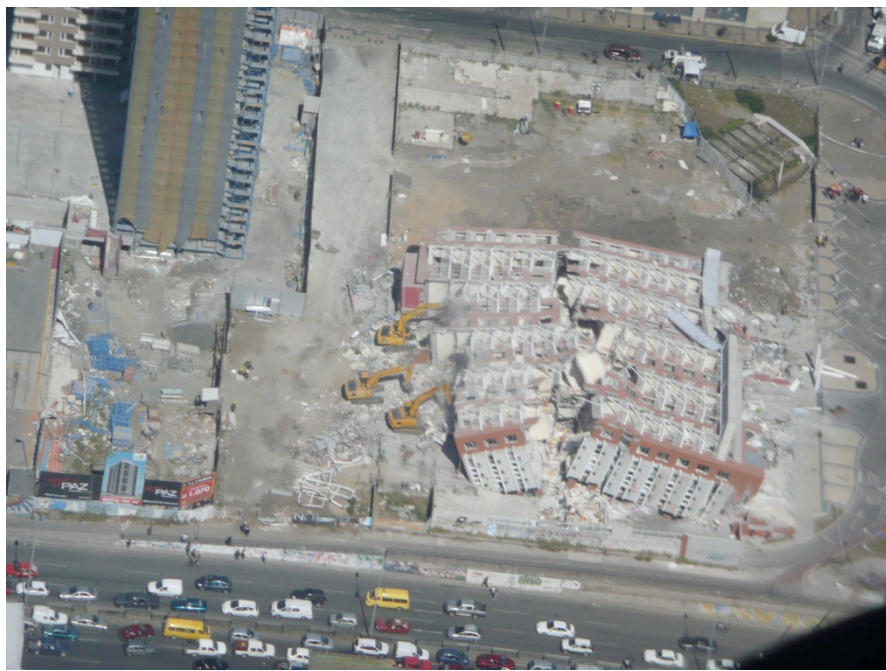
Two adjacent 20-story structures were inspected during reconnaissance close to the Llacolen bridge in downtown Concepción (see location in Figure 5.32), one fully collapsed during the 2010 event and the other suffered minor damage and is currently being repaired. The collapsed building was designed using Site Type II (Chilean design code) and the one that did not collapse using Site Type III, which implies different design spectra. While there is no evidence that the soil conditions are indeed different at the locations of the two structures (distance between approximately 20m), the difference in design spectra likely played an important role in the failure of the building. The locations of the two buildings are depicted in Figure 5.33 below.

Figure 5.33. Locations of two adjacent buildings designed with using different site conditions in Conception (map and aerial view).
