7.0 EFFECTS OF GROUND FAILURE ON BUILDINGS

7.1 General

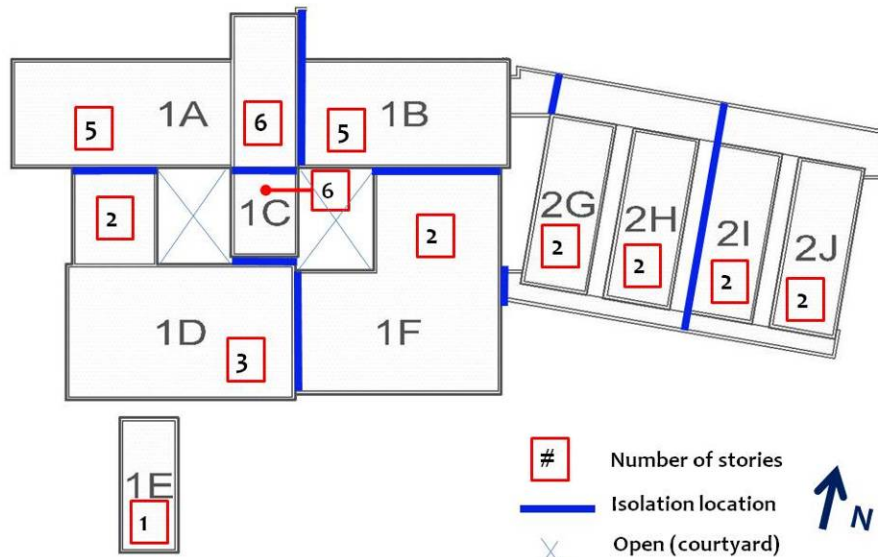
Figure 7.4. Hospital wing locator map (left) and typical seismic isolation detail (right; image taken from S37.47370°, W73.34848°; 03/16/10).

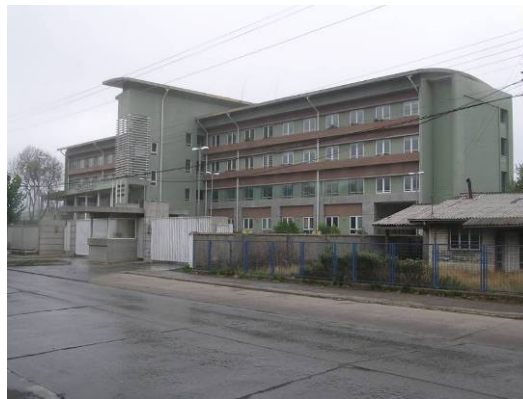
Figure 7.5. View of front of Wings 1A and 1B looking south (S37.47355° W73.34799°; 1900 hrs on 03/16/10)

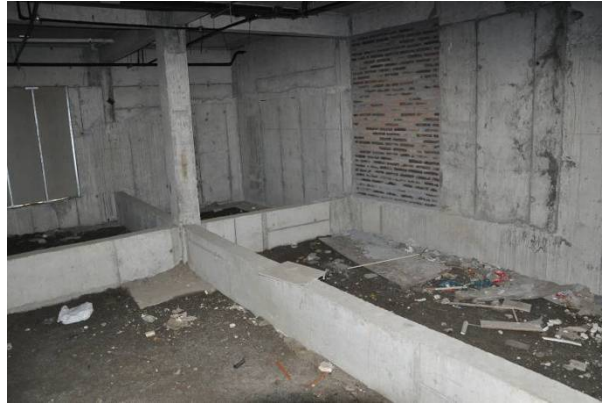
The ten wings of the hospital are of common concrete construction. Lateral loading is predominantly resisted by structural concrete pier shear walls linked via deep spandrel beams. For the taller structures (wings 1A, 1B, 1C) where one axis of the building is much shorter than the other, structural shear walls are used in isolation along the (sparser window) transverse axis. Interior concrete columns are used to carry gravity loads with a slab-girder style diaphragm. The diaphragm appeared to be conventional cast-in-place construction. Infill masonry walls are used at ground floor locations at select lower floors and the foundation is a likely common to that observed in the two-story wings, namely shallow spread and strip-type construction with interconnecting grade-beams (Figure 7.6).

Figure 7.6. General configuration of the foundation, perimeter structural shear walls and interior gravity columns (view at ground floor of wing 2I looking east) (S37.47366°, W73.34761°; 1625 hrs on 3/16/2010)

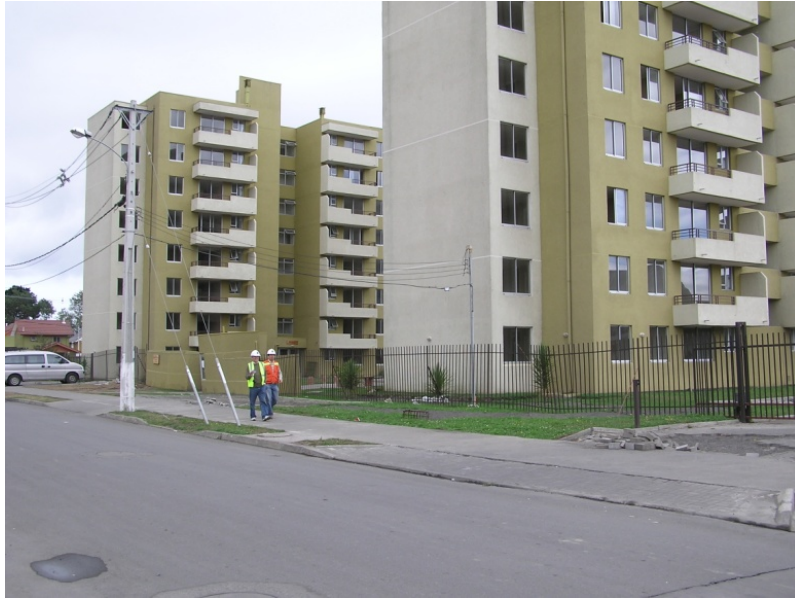
Figure 7.16. Southern most buildings at the four 8-story condominium building site (S36.791026°; W73.081235°; 1300 hrs on 03/17/10).

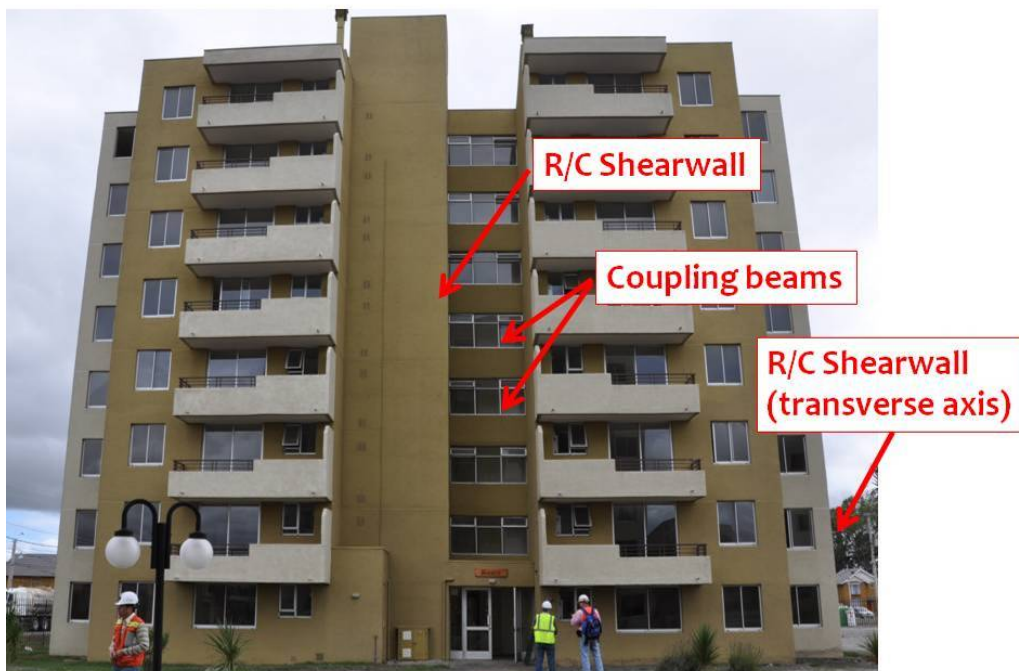
Individual buildings have a footprint of 11.43 m by 25.65 m, with two apartment units on each of the north and south wings of the buildings (Figure 7.17). The estimated height of the buildings was 18.7 m, with the first floor measuring 2.3 m. The apartment unit pairs are separated by a full height elevator and stairwell approximately centered along the core of the building. Seismic load resistance in the longitudinal direction of shaking is provided by a full height structural shear wall at the elevator shaft of length 345 cm, with some redundancy and gravity load support provided by short wall segments within the apartment units' walls on either side of windows. The transverse axis of the buildings is absent openings, therefore, the full transverse length of the building comprises a structural shear wall for gravity and seismic load resistance. The perimeter wall thickness was measured as 15 cm, while interior partition walls were full height and measured as 7 cm thick. Along the longitudinal axis of the buildings, a 270 cm long by 78 cm deep coupling beam provides continuity in load transfer (Figure 7.18).

Figure 7.18. Elevation of the Riesco building depicting the general components of the structural system of the building (image taken at S36.790929°, W73.081296°; 1400 hrs on 3/17/2010).

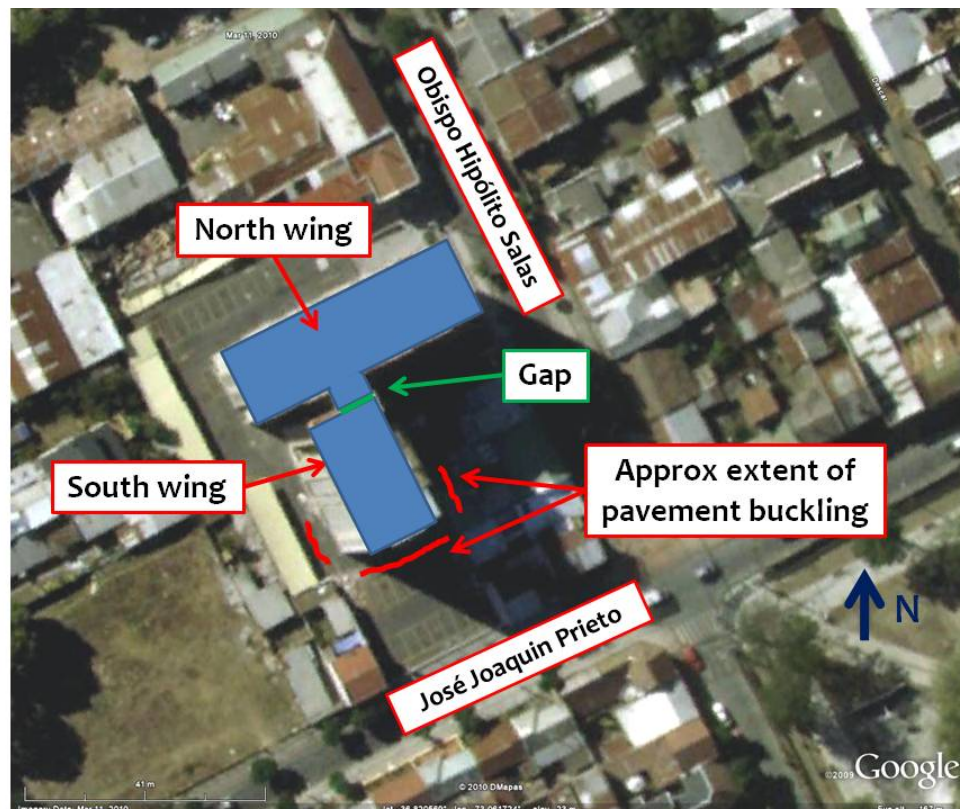
The EERI Reconnaissance Team observed damage of the south wing of a 13-story building located at 1343 Salas (S36.82044, W73.06164). The apartment building consisted of 2 rectangular wings in an offset T-shape (denoted as north and south wing in Figure 7.35). The north wings longitudinal axis runs approximately east-west, while the south wings longitudinal axis runs approximately north-south. The response of the two wings was extremely different. The north wing suffered only moderate damage, while the damage to the south wing was significant, including a residual tilt to the east of the entire wing. Residual tilt is believed to largely be attributed to cumulative structural damage. Failure was observed in the walls of the south wing, manifested as local shear as well as horizontal cracking (Figure 7.36).

Although minor settlement was observed around both wings, pavement buckling was observed on the west, south, and east sides of the south wing (Figure 7.37), leading the EERI team to suspect that the south end foundation of the south wing underwent rocking during the shaking (Figures 7.37 and 7.38). The foundation below the north end (east-west running walls) of the south wing did not manifest pavement buckling. This may be due to restraint provided at the north end of the south wing foundation from the north wing. Minor pounding between the north and south wings was evident in the upper stories of the east side (Figure 7.39). It should be noted that the cracking pattern observed at the south end of the south wing was not pure shear as would be observed in well designed Chilean construction practice, but rather tension-type failure manifesting nearly horizontal crack patterns (Figure 7.37). For more information on the structural performance, refer to the EERI Reconnaissance Report.

Figure 7.35. Annotated GoogleEarth image of 1343 Salas two wing apartment complex (S36.8205°, W73.0619°) (Image taken on March 11, 2010).
