9.0 EFFECTS OF GROUND FAILURE ON BRIDGES, ROADS, RAILROADS, AND LIFELINE SYSTEMS

9.1 Introduction

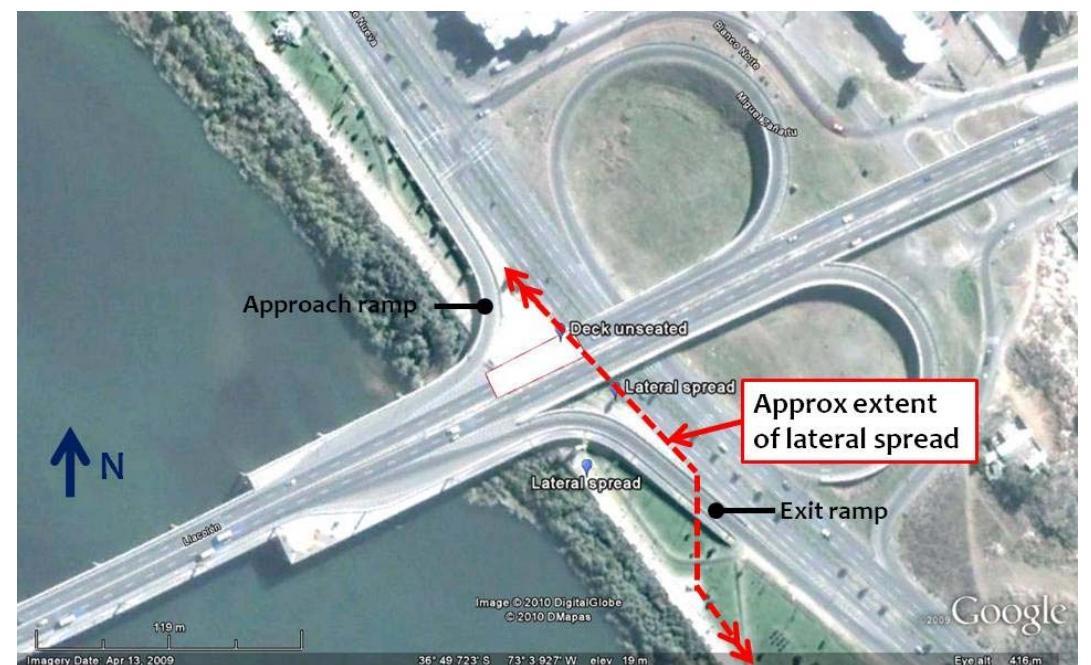
The Llacolén Bridge in Concepción was constructed in 2000 and spans 2,160 m across the Bio Bio river supporting four lanes of vehicular as well as pedestrian access to downtown Concepción (Figure 9.1). During the earthquake the north approach (S36.830108°; W73.067991°) suffered deck unseating and lateral spreading shore (Figure 9.2). Ground damage at this approach was observed to extend inland into the southbound traffic lane of Calle Nueva road and south below the bridge's exit ramp continuing along a pedestrian walkway (Figure 9.4). Calle Nueva parallels the coastline and runs under the approach to the bridge. The lateral spreading ground resulted in unseating of the west and east bound traffic support deck (Figure 9.5). Flexural cracks on the river-side face of the 1.5 m diameter support columns were observed near the ground surface typically tightly spaced at approximately 0.10-0.20 m on center (Figure 9.6). The distribution of flexural cracking was more severe for those columns supporting the unseated deck, however, all columns at the north shoreline support observed flexural cracking at their construction joint (between 2-2.5m above ground surface). Ground settlement of 0.25-0.30 m was also noted to surround each of the exit ramp bents (Figure 9.7).

Figure 9.4. Plan view of the North approach to the damaged Llacolén bridge in Concepción (S36.830108°, W73.067991°).

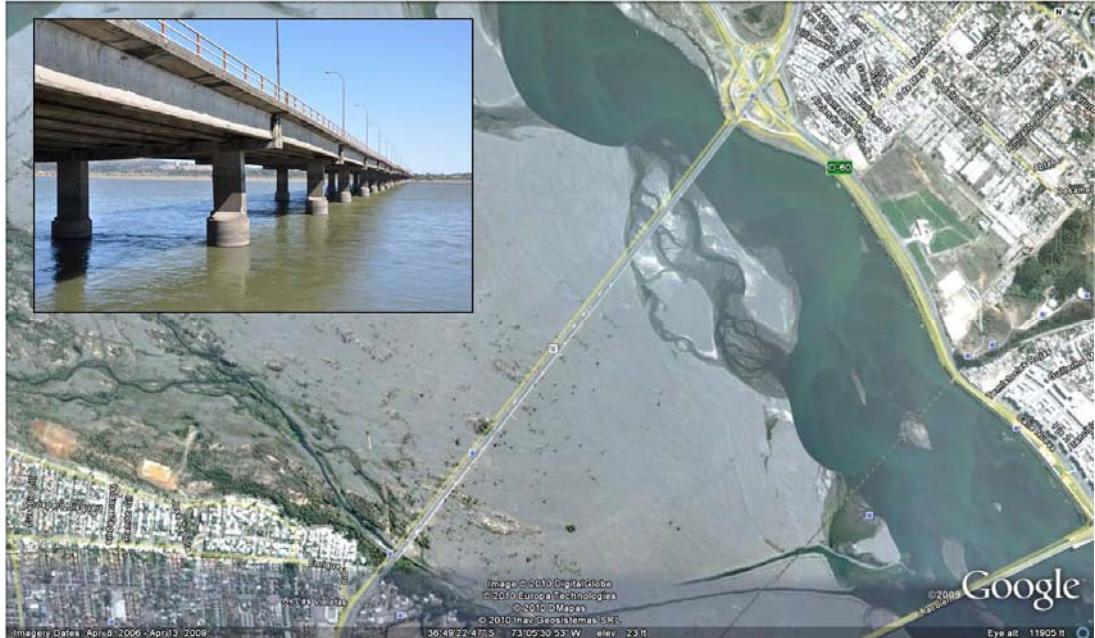
Figure 9.8. Juan Pablo II bridge connecting the cities of Concepción and San Pedro de la Paz across the Bio Bio River (S36.815122° W73.084369°; 1453 hrs on 3/15/2010)

During the 2010 Chile earthquake, the bridge suffered severe damage and was closed to the public. Evidence of liquefaction and lateral spreading was observed in the north-east approach with significant effects on the bridge. A Google Earth view of in Figure 9.9a and Figure 9.9b. As shown in the northeast approach with schematics of the observed ground failure and structural effects is shown Figure 9.11, liquefaction of the soil and lateral spreading in the embankment contributed to settlements and lateral displacement of the bridge deck. Visual inspection of the surrounding soils indicated the presence of fine loose sands. Several sand ejecta features were observed near the structure on the south and north sides of the embankment as shown in Figure 9.12. Several samples of the ejected soil were taken at this site, and grain size analysis and Atterberg limit testing are being performed. The results of this testing will be included in later versions of this report.

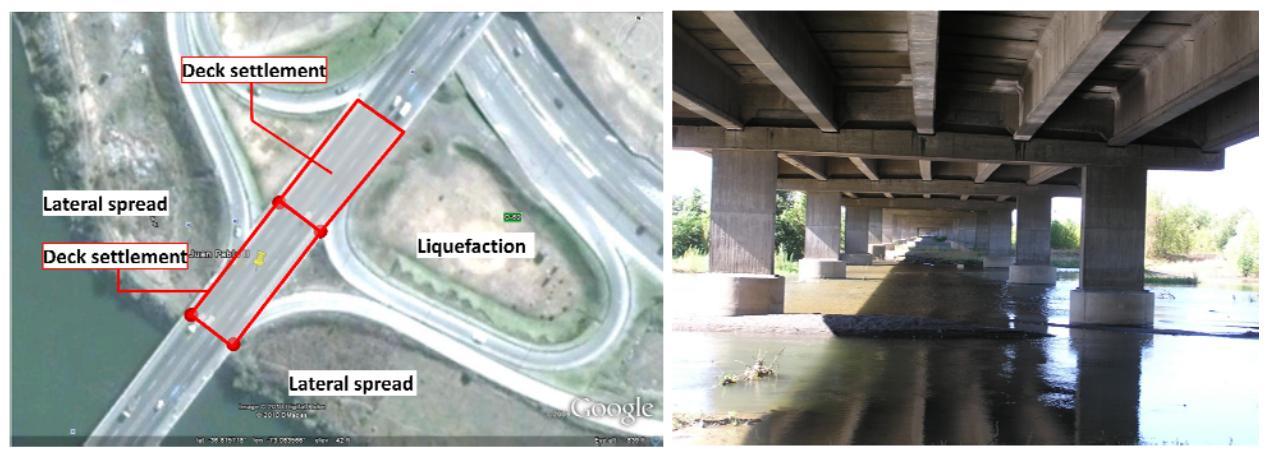
Figure 9.9. Juan Pablo II Bridge (a) Google Earth view of northeast Approach with schematics of observed damage (S36.815864° W73.083674°) (b) Typical bridge bent configuration (S36.828181° W73.095850°; 1636 hrs on 3/15/2010).

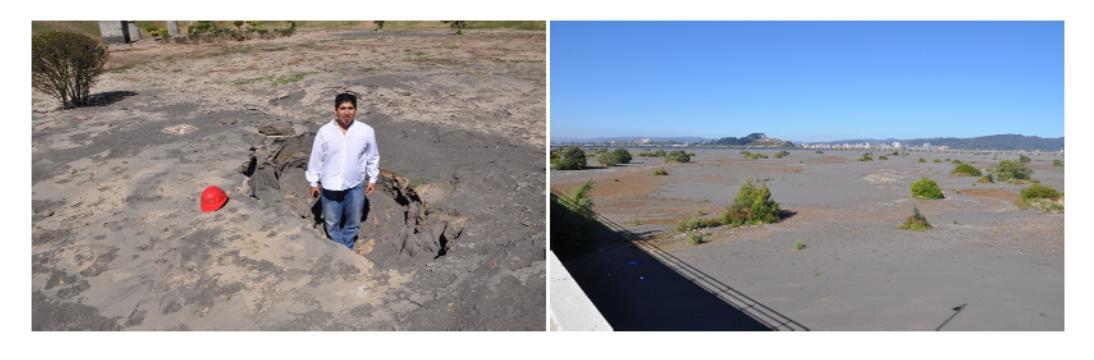
Noticeable pier settlements were observed at several locations along the length of the bridge. Vertical settlements appeared to be due to liquefaction of the soil near the pier foundations. Visual inspection of the surrounding soils indicated the presence of loose sands near the surface. Although the Bio Bio River was once navigable by ship up to the City of Nacimiento over-logging during the twentieth century has led to heavy erosion that has choked the river with silt and rendered it impossible to ship traffic. Near Concepción the river behaves as a meandering river with fine-grained material deposited on the floodplains. The GEER team identified several sand boils near the approaches (e.g. Figure 9.12a) and

along the bridge spans (in sections not covered by water). The presence of fine material is clearly shown in Figure 9.12(b).

Figure 9.12. Juan Pablo II bridge: (a) Sand ejecta near northeast approach and (S36.815619° W73.083311°; 1522 hrs on 3/15/2010) (b) Fine-grained material in the floodplains (S36.825592° W73.093264° on 3/15/2010).

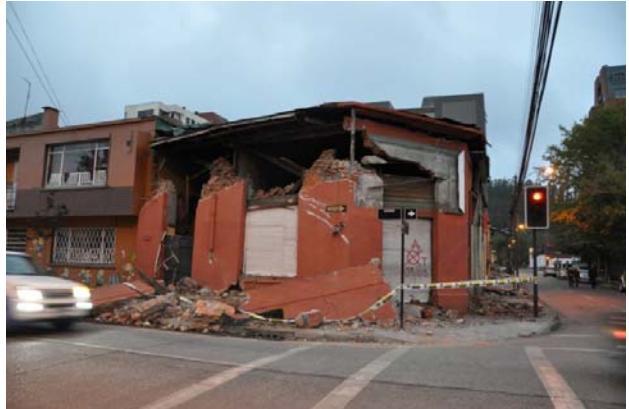
The City of Talca suffered significant damage due to earthquake shaking. The damage was predominantly associated with low-rise adobe and unreinforced masonry construction (Figure 9.28). Taller, well-designed structures performed relatively well, with the exception of damage to exterior cladding and contents in the upper floors (RMS, 2010). The GEER team did not conduct an extensive survey of building damage within the city; rather the team focused on regions near the Rio Claro, which runs along the west edge of the city, extending north-south parallel with Route 5 (Figure 9.29). In addition, the team inspected areas along a branch of the river running east-west towards the southern edge of the city.

Figure 9.28. Typical construction type and observed damage within the city of Talca (\$36.832375, \$W73.055439; 2016 hrs on 3/17/2010).

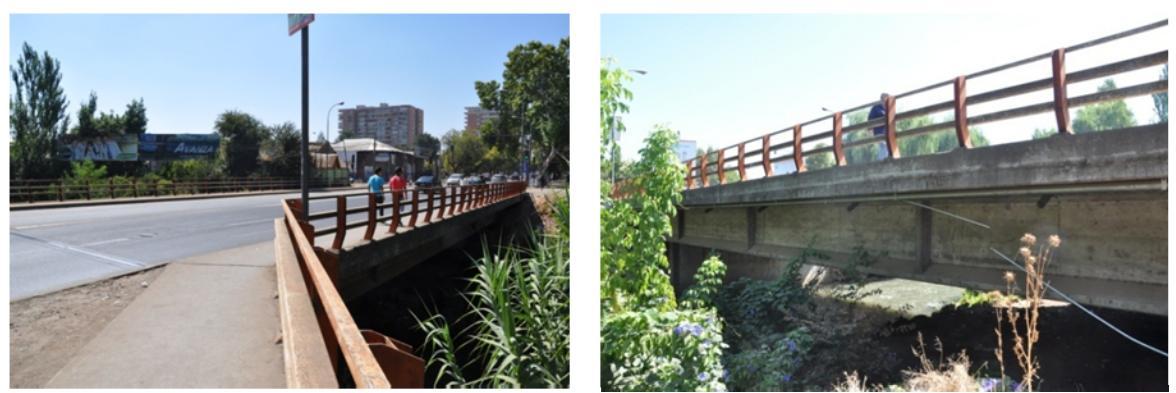
Bridges crossing the east-west branch of the river were primarily short span (less than 50 m long) slab bridges (Figure 9.31). Of the bridges inspected along the branch of the Rio Claro, no visible damage to the structure or surrounding ground was observed. Two long span bridges that cross the Rio Claro), one a vehicular bridge, the other a pedestrian bridge (Puente Rio Claro Nuevo and Puente Rio Claro Viejo) (Figure 9.31) were of interest. Both structures are constructed of reinforced concrete, and of a girder-slab type configuration with the vehicular bridge bents supported on pier walls and the pedestrian bridge bents supported on angled multi-column subassemblies integral with a pier cap at both base and column head.

Figure 9.30. (a) Typical short span bridge construction on the branch of the Rio Claro, city of Talca (S35.428011° W71.670269°; 1302 hrs on 3/18/2010). (b) Bridges were observed to remain undamaged (S35.428086° W71.669894°; 1303 hrs on 3/18/2010).

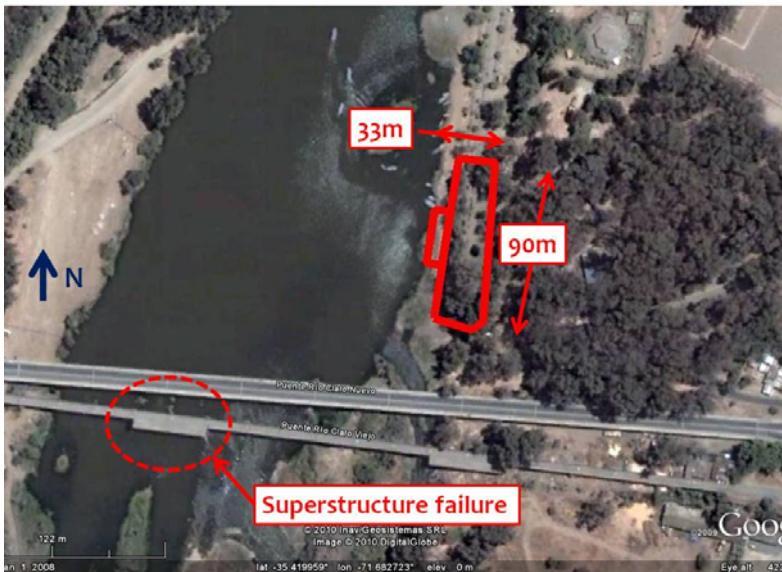
Local ground failure was observed approximately 50 m north of the Puente Rio Claro Nuevo (vehicular bridge) (Figure 9.32 and Figure 9.33). Two distinct regions were observed, a smaller lateral spread near shore (Figure 9.33), and a larger ground failure more characteristic of a soft clay failure confined within a park area (Figure 9.32). Soils near the shore area were predominantly gravely materials, likely with pockets of sand (one sand boil was observed at the near shore failure), whereas the park area indicated the presence of a soft clayey material. The ground failure extended approximately 90 m by 33 m north-south, however, it had no impact on the vehicular bridge, as it was open to traffic with no visible distress noted from the team's inspection on the east shore area. In contrast, the Puente Rio Claro Viejo (pedestrian bridge) suffered unseating of the longitudinally spanning girders and subsequent shear failure of the

Figure 9.31. Plan view of the Puente Rio Claro Nuevo and Puente Rio Claro Viejo, locating the observed ground failure area to the north (S35.420772° W71.682932°).

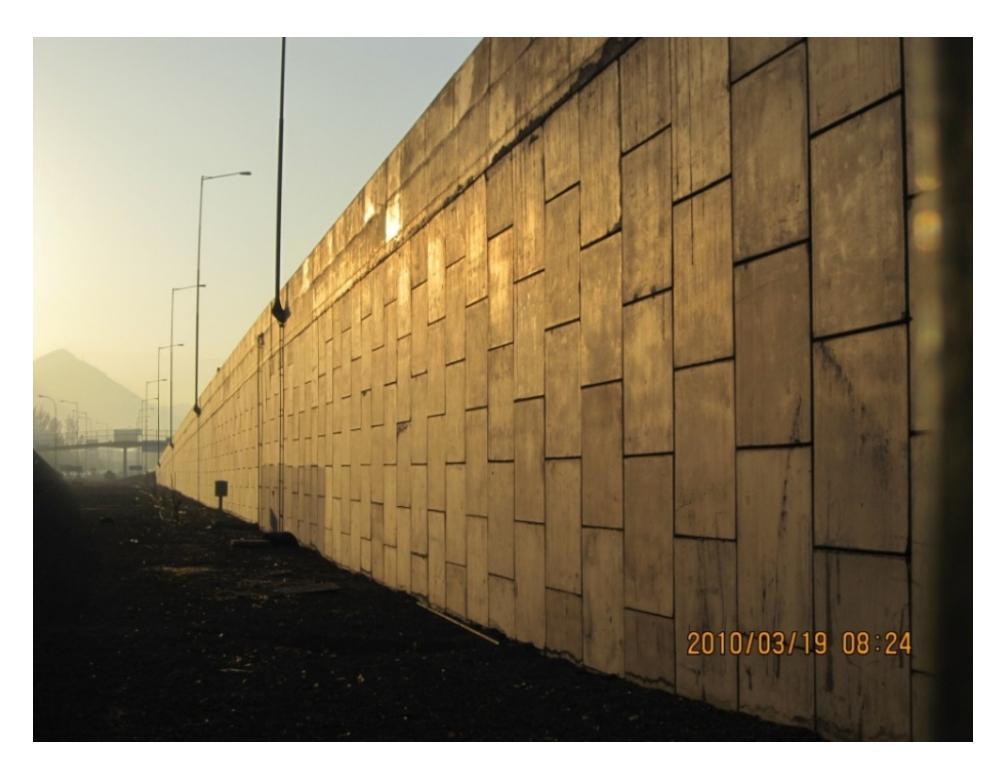
Figure 9.37. Retaining walls and mechanically-stabilized-embankment (MSE) walls appeared to perform well in the Quilicura area of Santiago (S33.366137, W70.688913; 824 hrs on 3/19/2010)

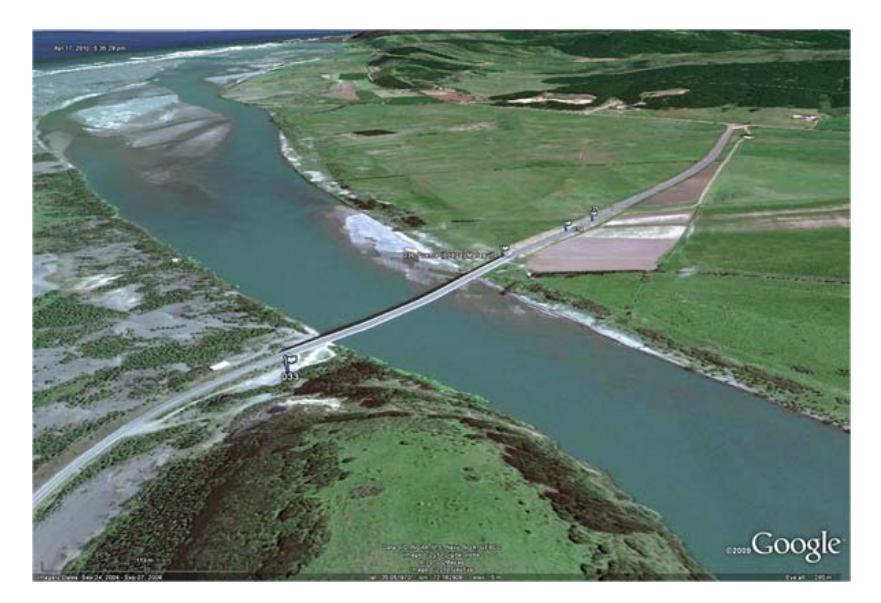
This bridge crosses the Mataquito river close to the Pacific Ocean. During the 2007 Maule earthquake extensive liquefaction and lateral spreading occurred at the north and south abutments and in the adjacent fields. Figure 9.39 through Figure 9.43 show photos of the bridge and the damage. The lateral spreading on the south abutment appeared to be more confined due to the topography of the area. In contrast, on the north side, and due to the large extent of the fields that are around the bridge, extensive lateral spreading was observed going back almost 270 m from the river edge. The lateral spreading from the edge of the abutment wall to the first row of piers was about 54 cm and the total lateral spreading from the edge of the abutment wall to the river's edge was about 180 cm (over a distance of about 65 m). The approach embankment is about 7.6 m high, and settled about 70 cm relative to the bridge deck. The approach embankment experienced outward transverse movement of about 60 cm from the center line as manifested by cracking of the asphalt along a distance of about 200m. This appears due to liquefaction and failure of the underlying soil and is evidenced by compression ridged in the field at the toe of the embankments. Despite evidence of liquefaction at both abutments of this bridge, its overall seismic performance was good.

Figure 9.38 Puente Mataquito, looking north, S35.050712°,W72.162258°, April 16, 2010

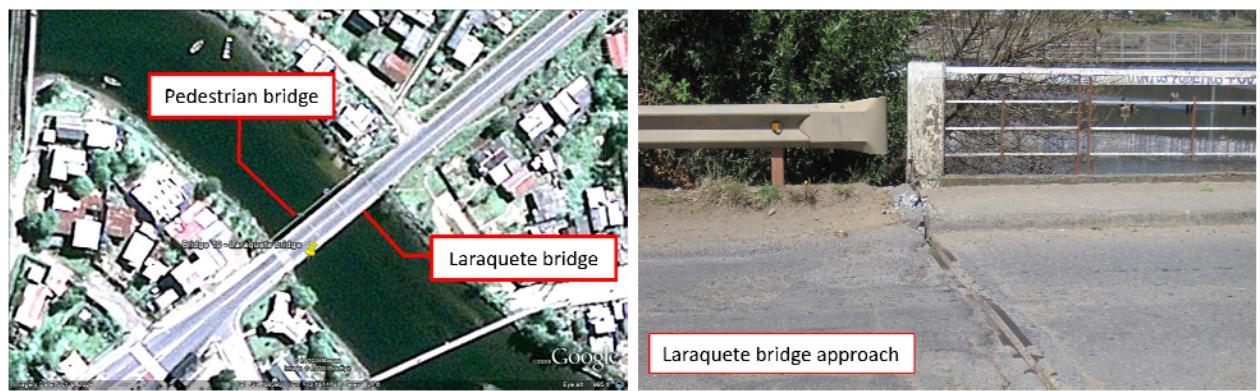
Two bridges were inspected in the Town of Laraquete, which is 50 km south of Concepción: A pedestrian two span bridge and an adjacent vehicular three span reinforced concrete bridge. The pedestrian bridge experienced damage due to foundation settlement of the middle bent with an estimated 0.50 m vertical deformation. Figure 9.47 shows the deformed bridge with noticeable inclination of the bridge deck. The adjacent reinforced concrete bridge, shown in Figure 9.46, suffered minor damage near the approaches due to pounding with the concrete structure and settlement due to poorly compacted fill. This bridge did not show evidence of foundation settlement.

Figure 9.46. Laraquete bridge (a) Aerial view (S37.166788° W73.184486°), (b)Bridge approach (S37.166804° W73.184760°; 1430 hrs on 3/10/2010)

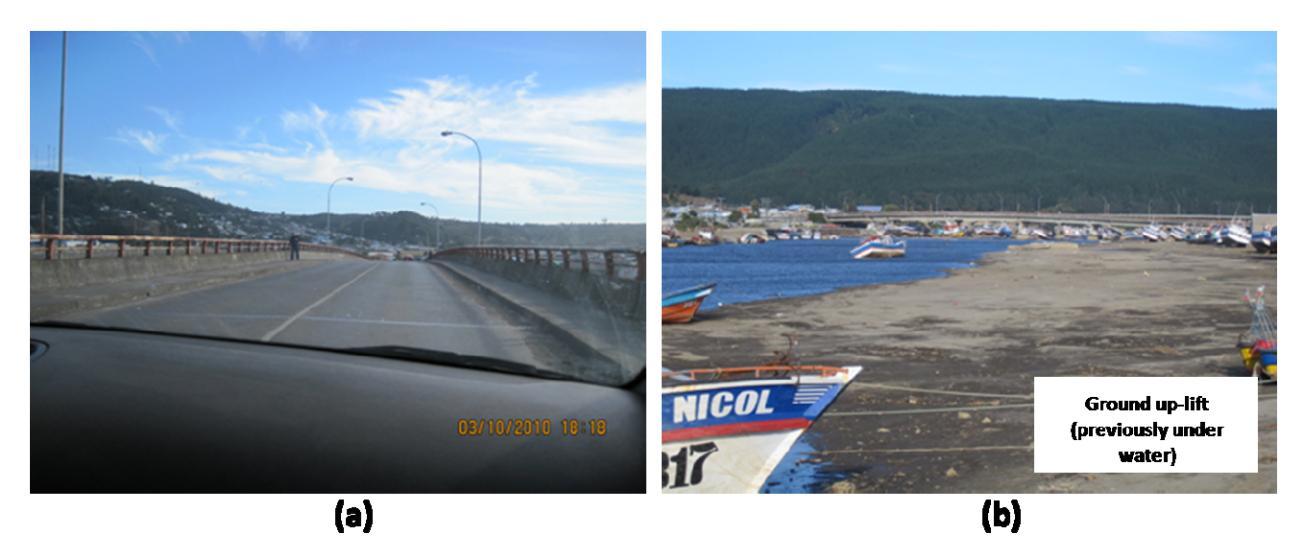
This bridge was operational by the time the GEER team got to Lebu. No major approach fill settlement could be observed. Good overall performance of the bridge in an area where evidence of ground uplift of 1.8 m to 2 m was found.

Figure 9.48. Lebu bridge: (a) Crossing Lebu bridge fully functional, and (b) Lebu bridge from the distance (S37.606344, W73.649496, 1818 hrs on 3/10/2010)

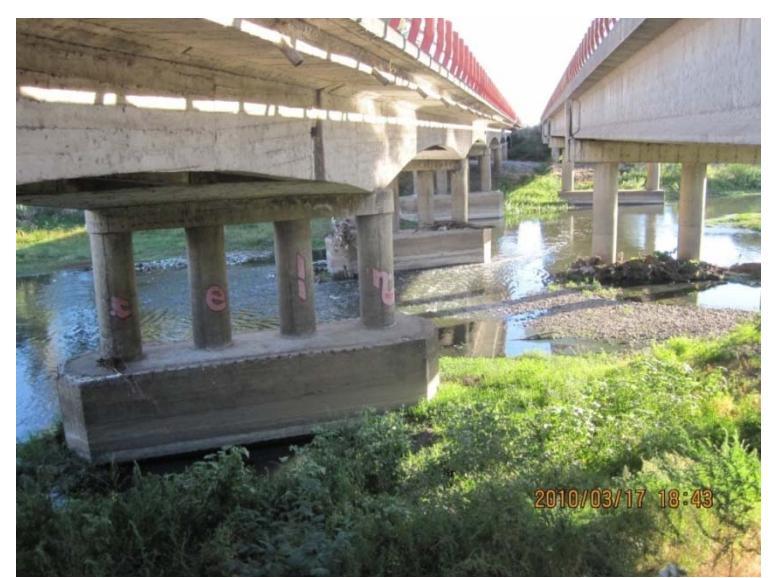
The EERI LFE Bridge Team observed this pair of bridges crossing the Rio Nebuco just South of Chillan along Route 5. The northbound bridge had a single dropped span, which had already been removed. The newer southbound bridge suffered only minor damage and was still in service handling both northbound and southbound traffic. The collapse was apparently a result of strong shaking. No apparent signs of liquefaction or lateral spreading and slope movement were observed.

Figure 9.49. This pair of bridges crosses the Rio Nebuco along Route 5 (S36.641846° W72.211264°; 1843 hrs on 3/17/2010).

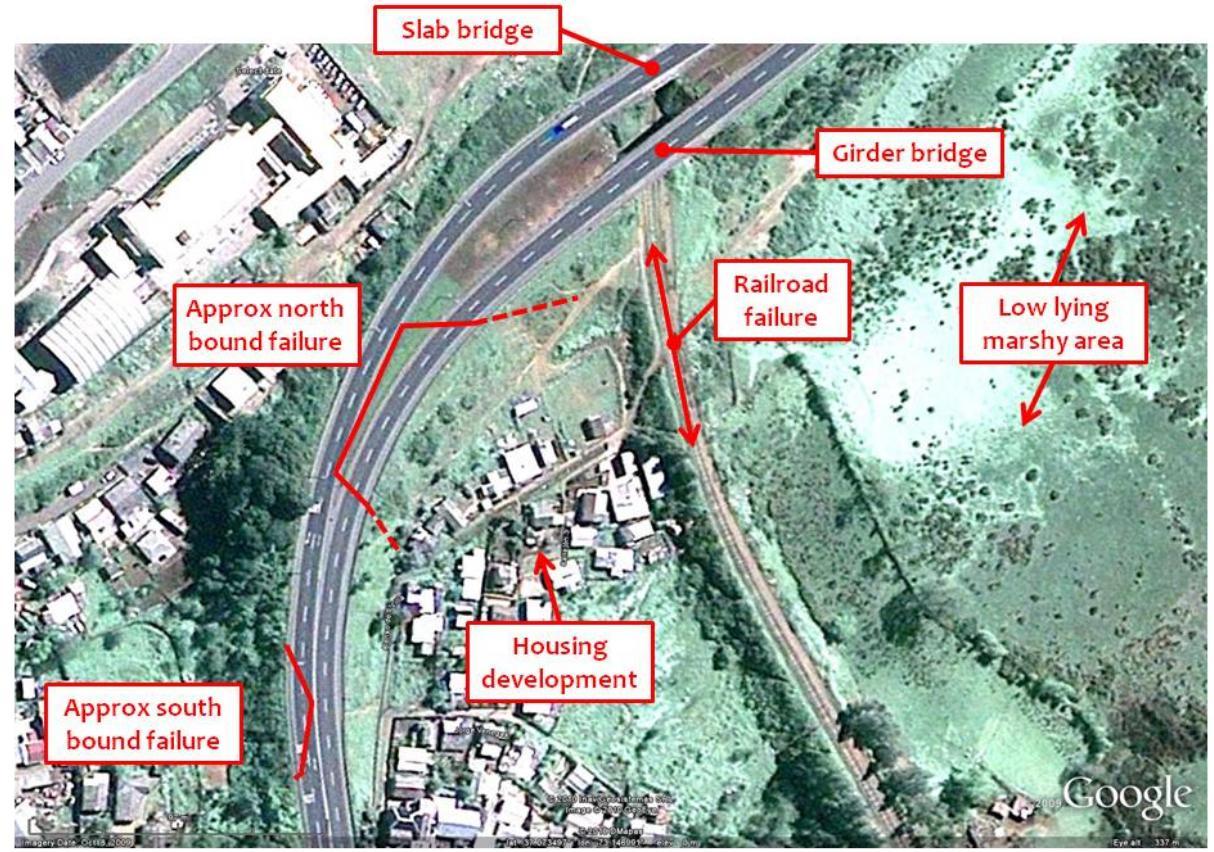
Several large ground failure areas were observed north of Lota along Route 160. Two failures resulted in damage to a roadway embankment section (denoted herein as the "south bound failure" and "north bound failure"; Figure 9.55, 9.56 and 9.57), while a third failure resulted in damage to an elevated railroad section (denoted as "railroad failure"; Figure 9.53 and Figure 9.56). Minor side road spreading-like failures were also noted near the approach abutments to two short span overpass bridges, north of the embankment failures, as well as just north of the short span bridges. The area east of Route 160 is largely marshy with low lying organic material (Figure 9.53). South of the north bound failure and east of the south bound failure of the elevated roadway sections is a small housing development.

Figure 9.53. Plan view of approximate affected area (Google Earth image at S37.0734°, W73.1469°).

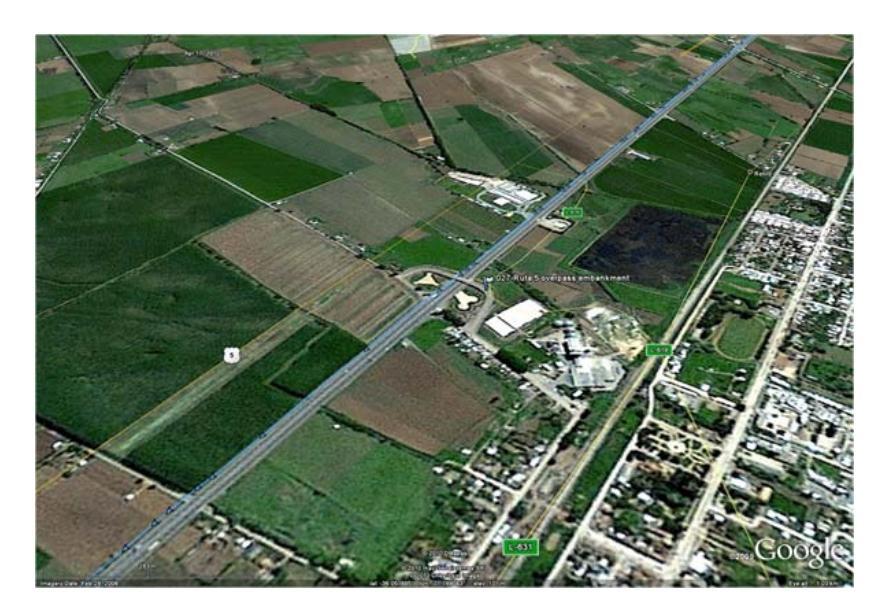
Team D performed SASW measurement s on a damaged overpass embankment on the right side of the north bound lane of Route 5 Sur. The damage of the embankment appears to be due to shaking and bulging of the embankment material. The underlying soils appear to be intact with no evidence of loss of loss of strength. The embankment bulged laterally and settled. The overpass embankment to the left of the north bound lane does not show signs of damage.

Figure 9.61 Ruta 5 Sur overpass embankment, looking north, to Retiro at Tucapel Mill (\$36.051209°, W71.768005°).
