The September 18-20 2020 Medicane Ianos Impact on Greece

Phase I Reconnaissance Report

Geotechnical Extreme Events Reconnaissance Association

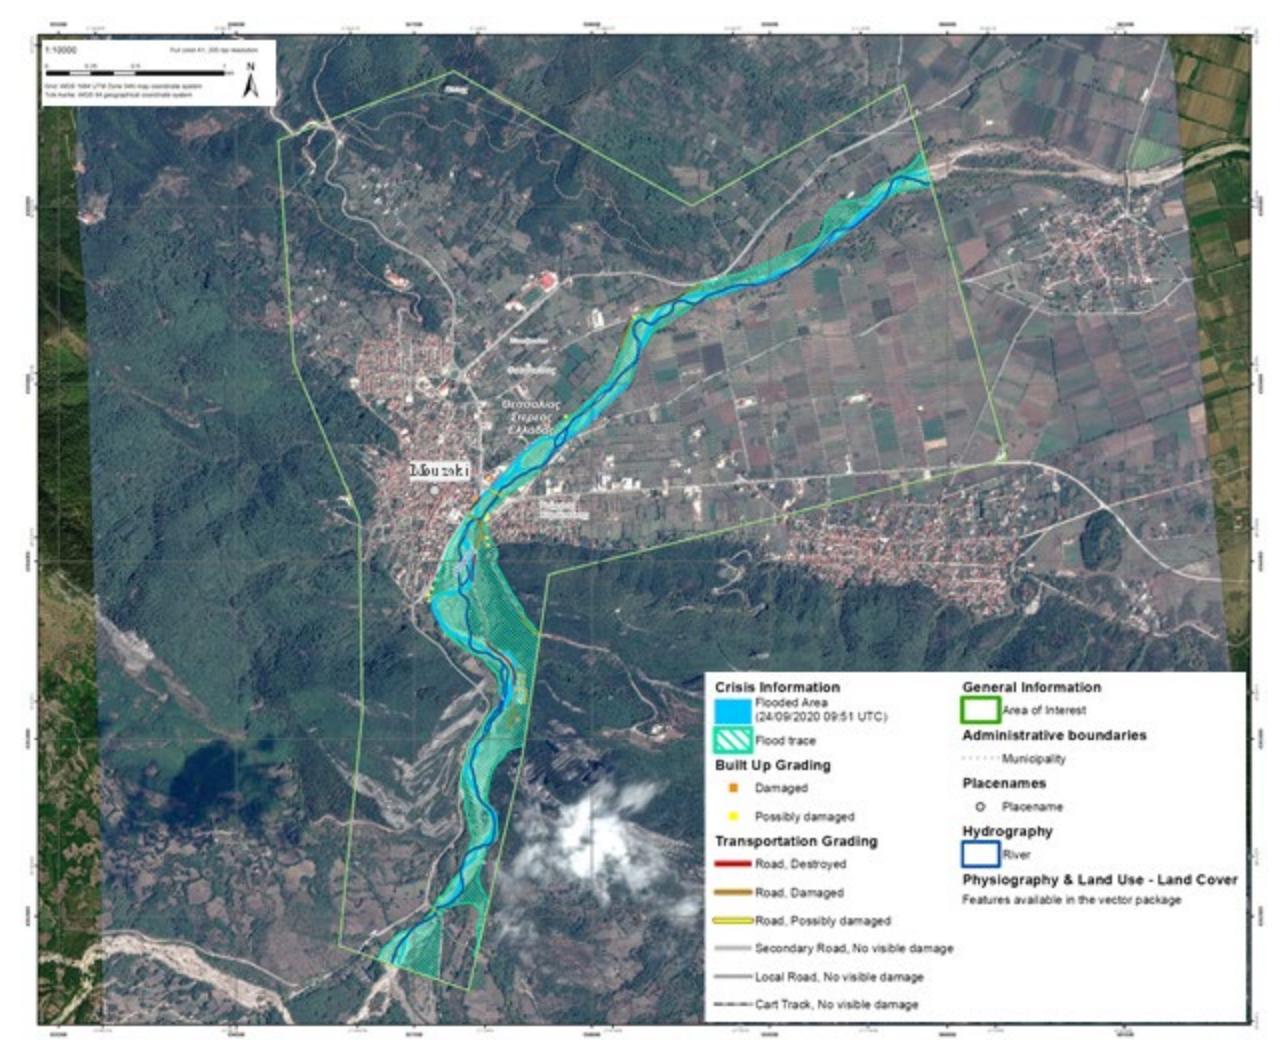
Figure 4.2. <u>E.U. Copernicus Emergency Management Service - Mapping damage grade</u> assessment product in the area of Mouzaki (EMSR465), situation as of September 24 2020 (product provided by the General Secretariat for Civil Protection - Directorate for Emergency Planning and Response)

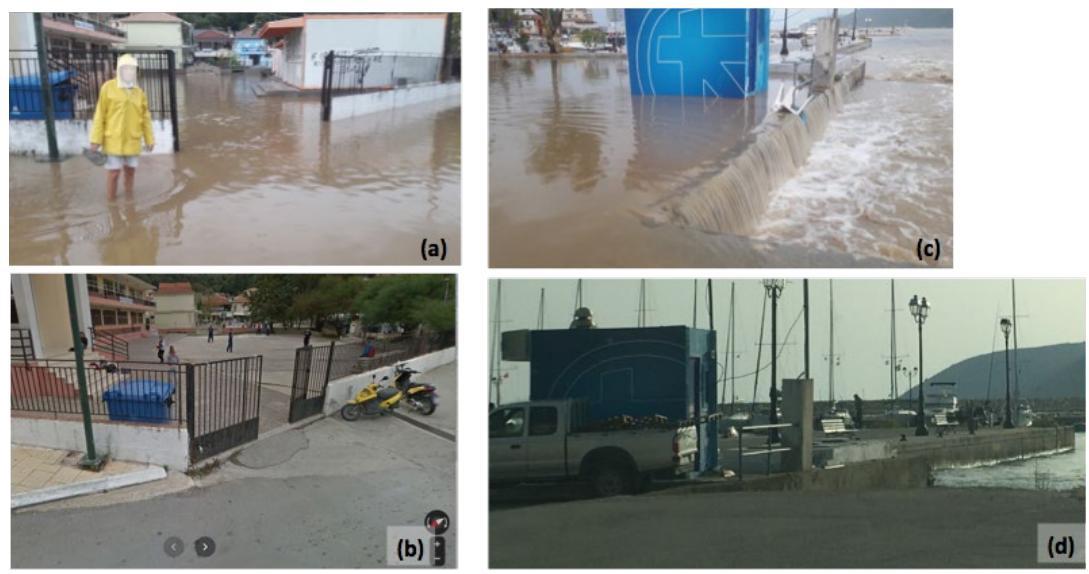
flooding occurred (Figure 4.7), while minor erosional features and road embankment failures were observed along the river bank of the Vassiliki valley (Figure 4.8). Sediment movement and landslide activity was also observed along the western coastline of Lefkada where significant landsliding occurred during the 2015 Lefkada earthquake.

Figure 4.7. a) Flooding along the seaside at Vasiliki village, Lefkada, as photographed by an eye witness on the day vs. b) reference photo from GoogleMaps (38.627504°N, 20.607268°E). c) flooding at the same spot on the day vs. d) reference photo (38.627504°N, 20.607268°E).

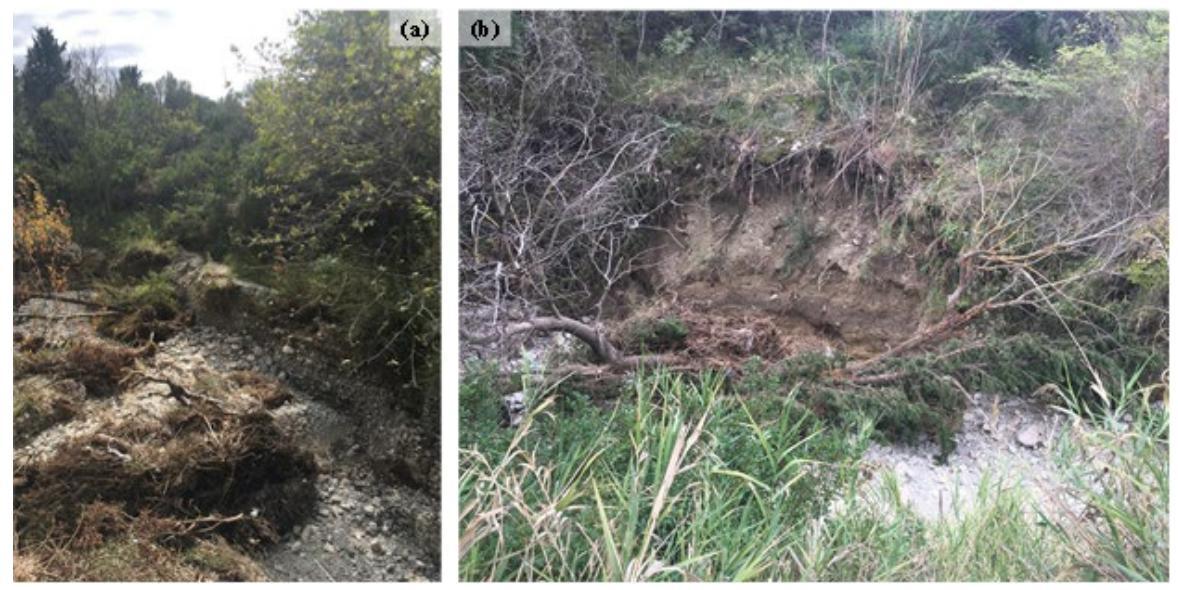
Figure 4.8. Riverbank erosion features in Vassiliki valley, Lefkada: a) 38.6658694°N, 20.6202861°E; b) 38.6638861°N, 20.624483°E

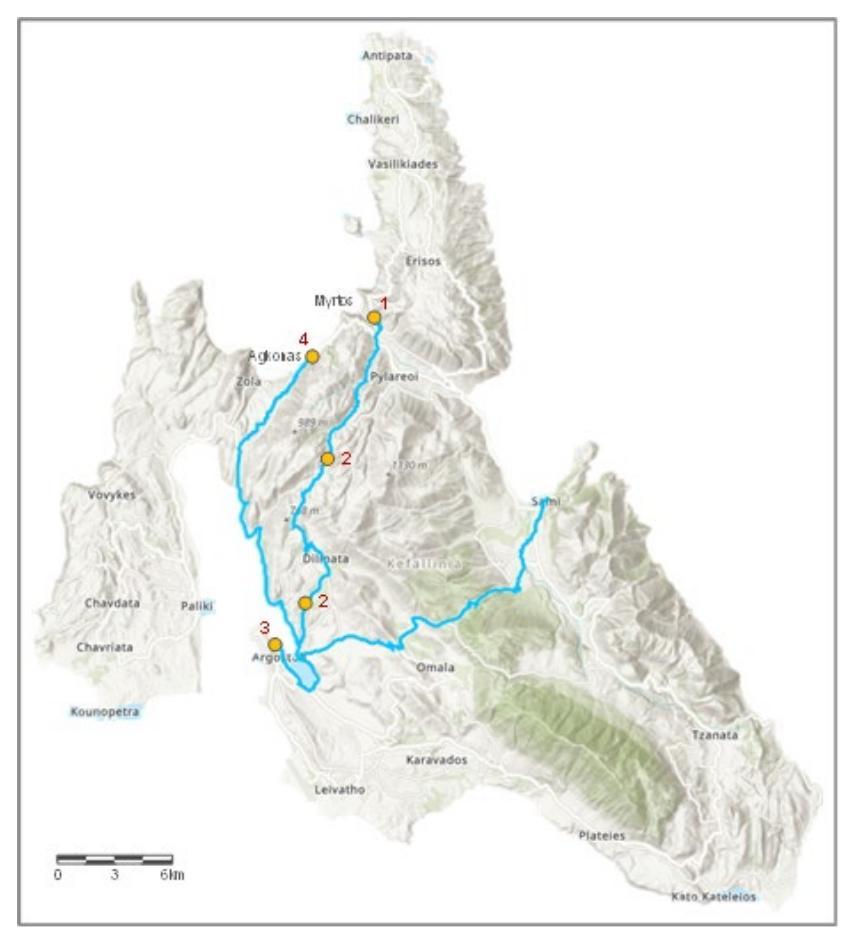
Figure 4.11. Area covered during day 3 of reconnaissance mission to Cephalonia

- 1. UAV-enabled mapping of the landslide at Myrtos beach;
- 2. Reconnaissance along E.O. Faraklaton-Ag. Efimias;
- 3. Documentation of damages along the cruise-ship-deck promenade of the town of Argostoli;
- 4. Detailed UAV-enabled mapping of the collapsed bridge on E.O. Argostoliou-Fiskardou.

Bridges in Cephalonia island performed generally adequately during Medicane Ianos. Nonetheless, a critical, simple-supported, multi-span, reinforced concrete bridge founded on steep topography and connecting the village of Agkonas with Myrtos beach and Erissos peninsula (point 4 in Figure 4.11), collapsed, impacting the transportation network of the island (Figure 5.1). The structure, better known to the islanders as the "Chimoniko" bridge, was characterized by a width of ~9 m and a length of ~30 m, and was simply supported on two piers with a height of approximately 10 m (east pier) and 13 m (west pier), respectively. The span length was ~10 m, and the piers were founded on shallow footings on a limestone formation.

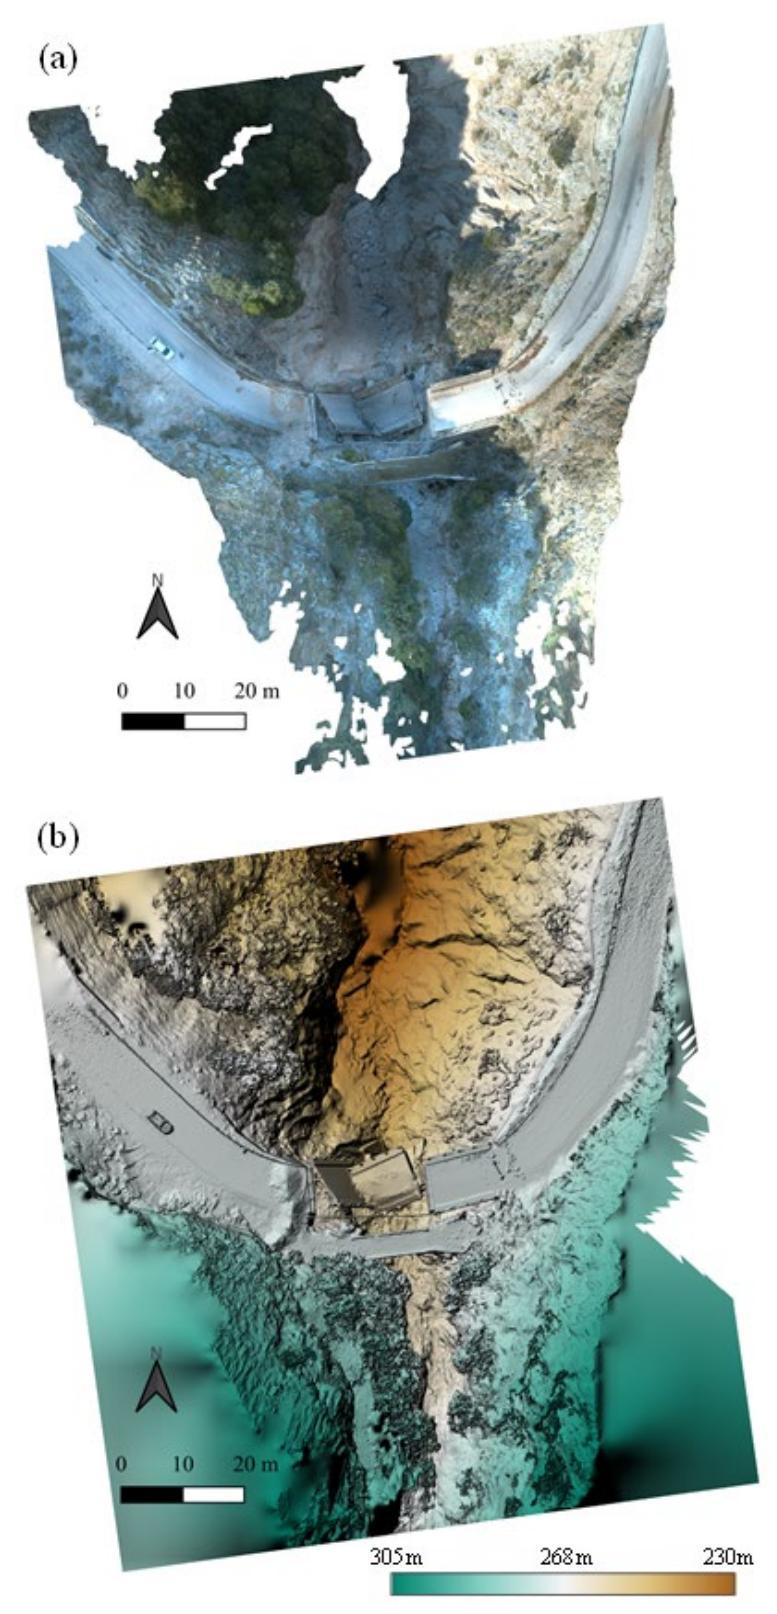
Figure 5.2. UAV-enabled mapping of collapsed bridge on E.O. Argostoliou-Fiskardou (38.319506°N, 20.508197°E): a) top-view Orthophoto, and b) top-view DSM (view 3D model at: <u>https://skfb.ly/6WyYT</u>)

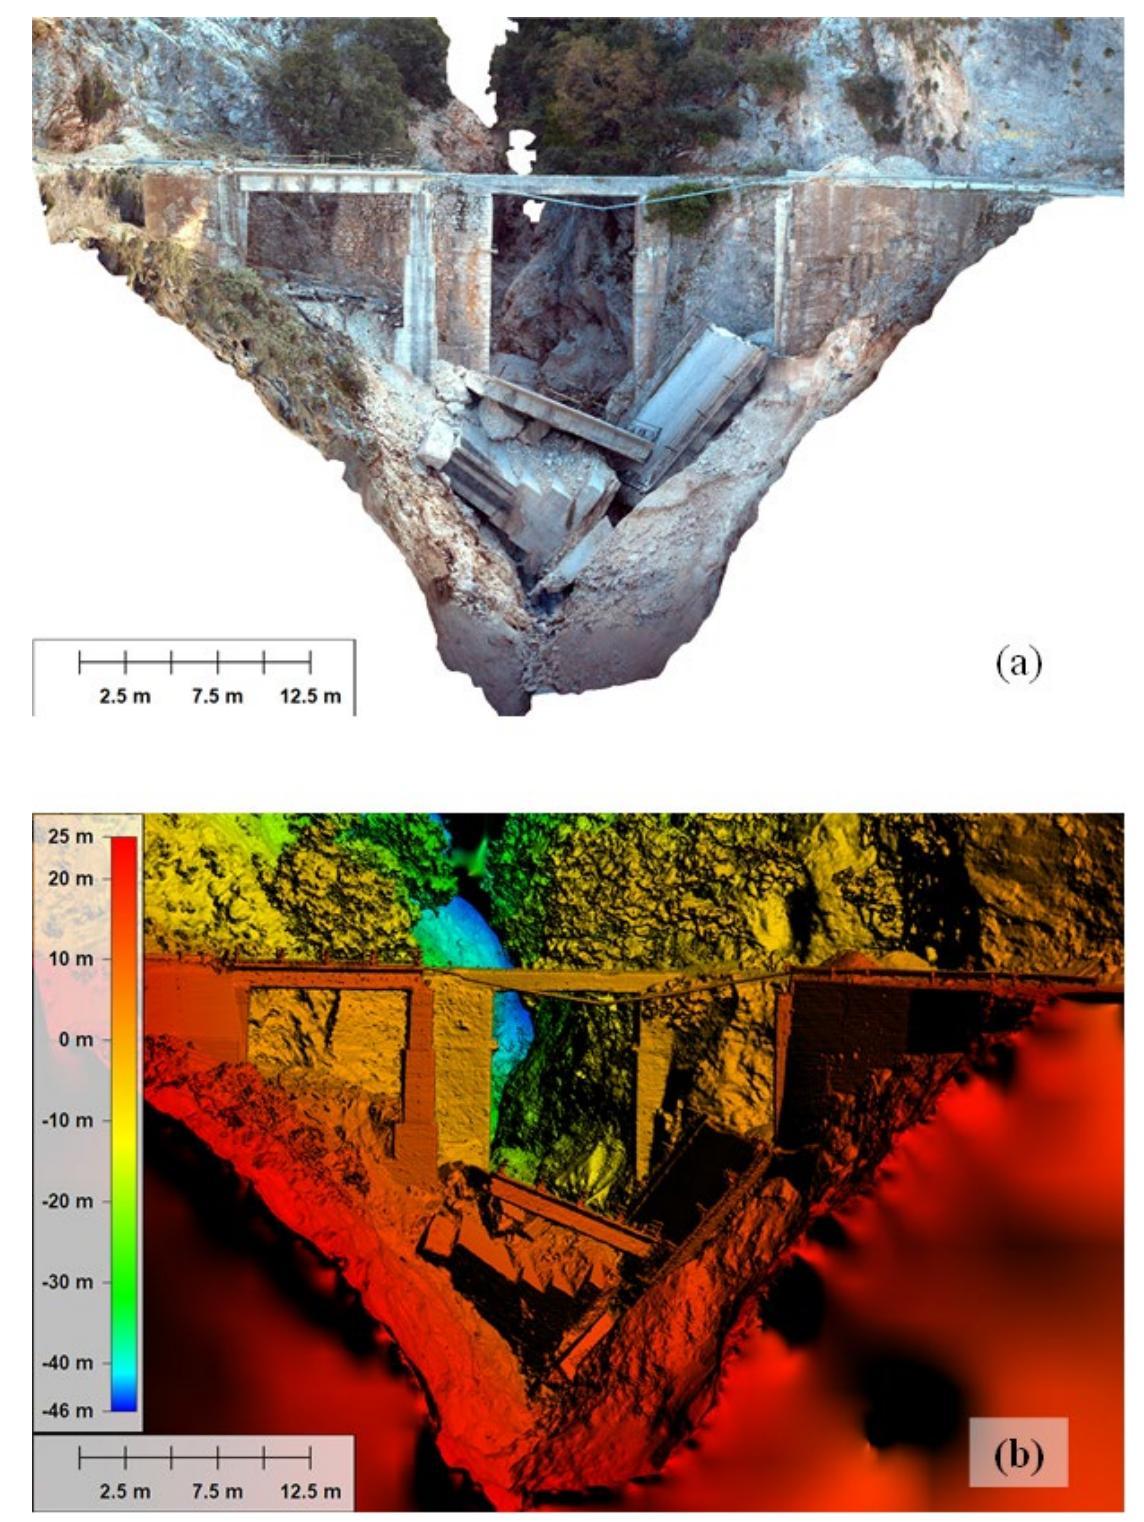
During the post-event reconnaissance, on 10/01/2020, detailed UAV-enabled mapping was conducted to better understand the failure mechanism. Orthophotos and DSM were produced (Figures 5.2 and 5.3), based on which an initial assessment can be made. A visualization of the 3D model of the failed "Chimoniko" bridge can be seen here: <u>https://skfb.ly/6WyYT</u>. The prevalent failure mode appears to be the scour of the west pier foundation from extensive gully flooding and debris. Such mechanism is consistent with the translational downstream movement of the foundation body, the pier, and the deck beams (Figure 5.2). Moreover, the failure mode is also supported by the observation that the older (built in 1943), masonry, single-span bridge just upstream of the collapsed structure, did not show any signs of damage. Contrary to the "Chimoniko" bridge, the older bridge was supported on masonry abutments on both sides of the gully. It can be presumed that the new bridge had a significantly reduced flow capacity, due to the presence of the piers. Particularly the west pier was comparatively more vulnerable since it was located more centrally within the flood/debris flow path. (Figure 5.3).

Figure 5.3. UAV-enabled mapping of collapsed bridge on E.O. Argostoliou-Fiskardou (38.319506°N, 20.508197°E): a) front-view Orthophoto, and b) front-view DSM (view 3D model at: <u>https://skfb.ly/6WyYT</u>)

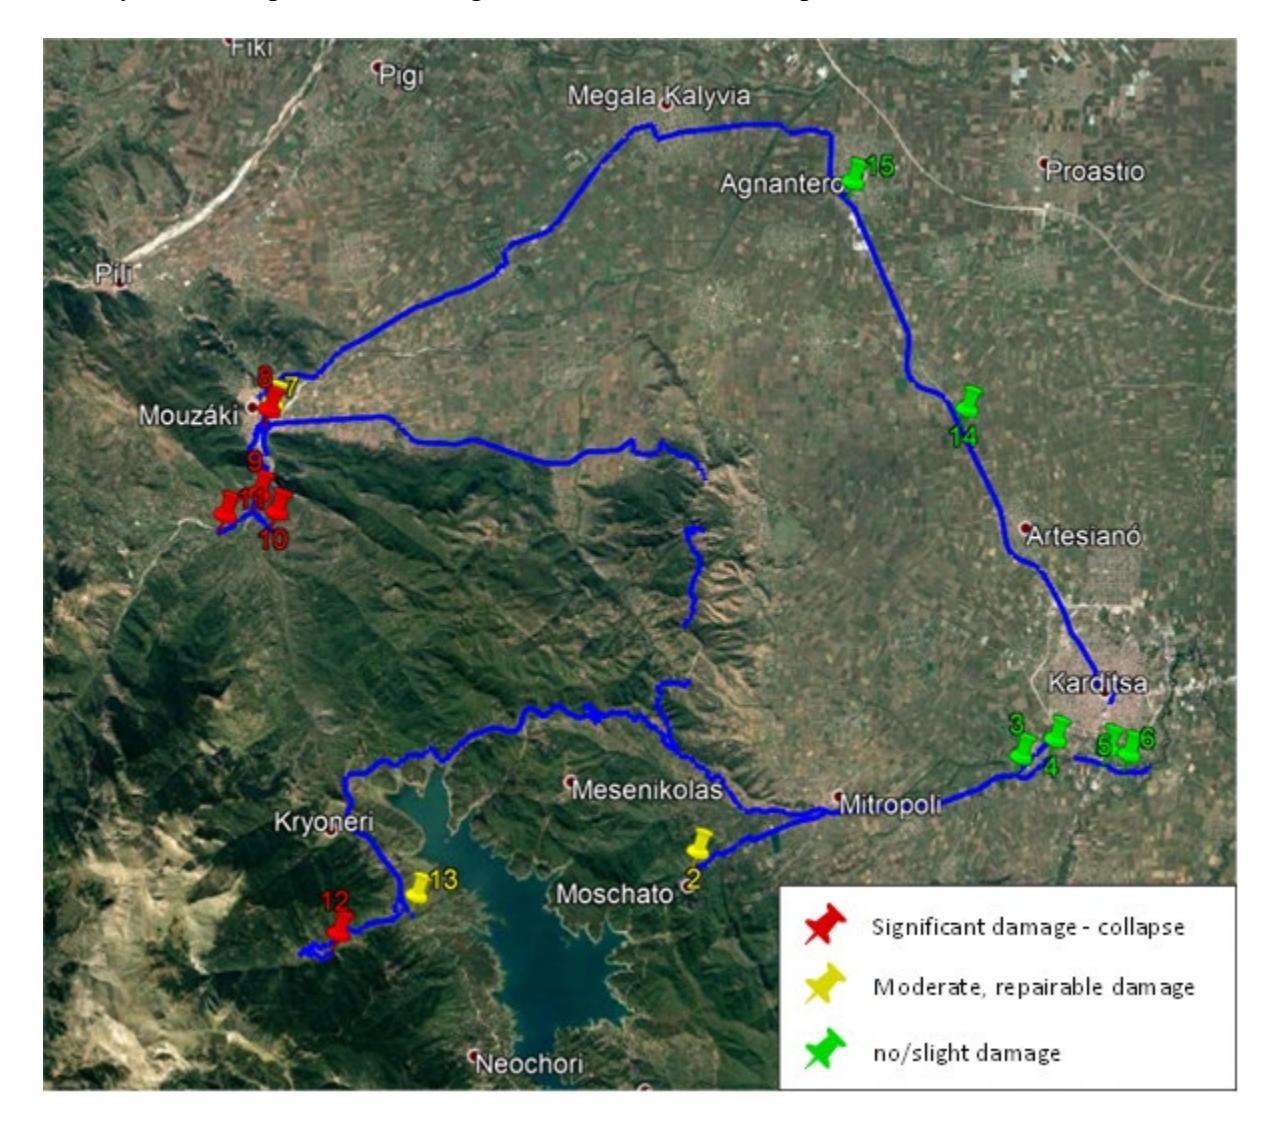
A significant number of bridges were damaged in the mountainous region west of Karditsa, in the perimeter of the Plastiras Lake, and north of it, especially in Mouzaki, causing major traffic disruptions. Figure 5.5 shows a map of a total of 14 bridges inspected during a two-day trip from 2 - 3 October 2020. The color-coded pins indicate the level of structural damage suggesting an evidently milder impact on the bridges of the lowland in comparison to the mountainous areas.

Figure 5.5. Map of bridge inspections carried out during 2 - 3 October 2020 in the area around Karditsa: the route (in blue) and the bridge locations color-coded to indicate the level of damage.

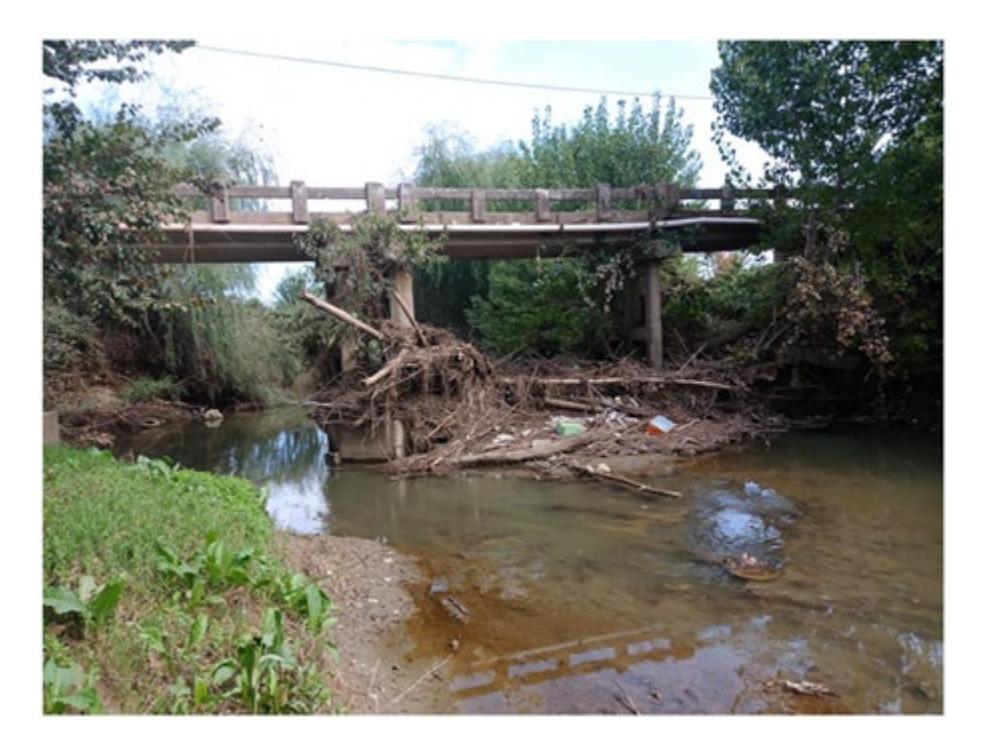
Bridges No. 4 (Figure 5.7), 5 (Figure 5.8), and 6 (Figure 5.9) demonstrated similar response, despite their essentially different structures and their varying ages (as well as maintenance states). All three showed evidence of overflowing and debris built-up, yet without any sign of structural damage or foundation/abutment distress. This was particularly surprising in the case of Bridge No. 6, which is evidently a very old and poorly maintained structure (Figure 5.9b). Although the water level did not allow inspection of its foundation for scour assessment, it would be reasonable to assume that there is no scour otherwise, the structure would have probably collapsed.

Figure 5.7. Photos of Bridge No. 4 of the Gavria Rema (39.348575°N; 21.904591667°E) showing significant debris build-up, but no other damage.

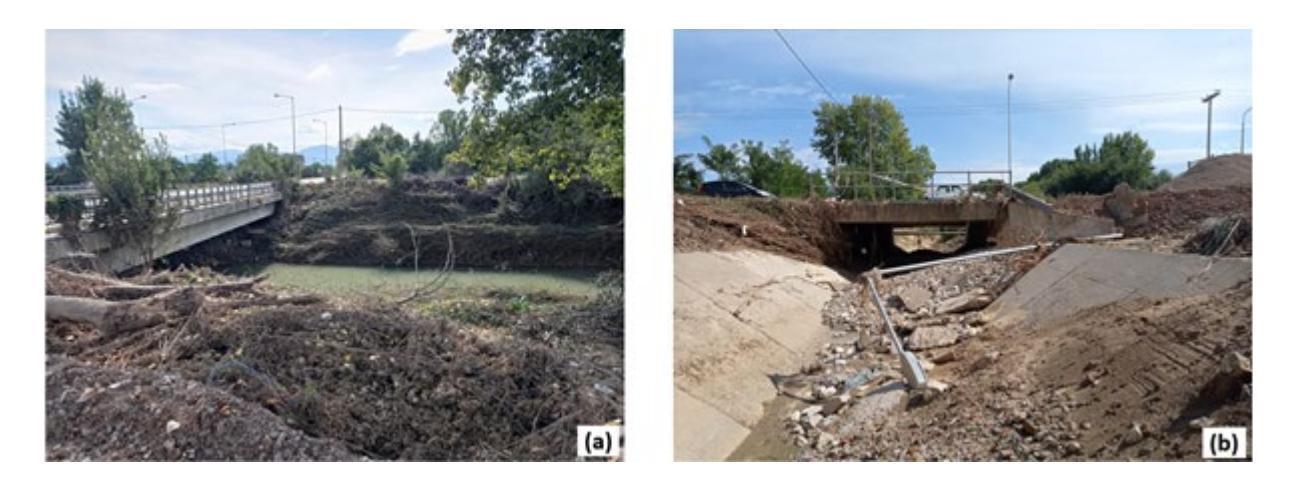
Figure 5.8. Photos of Bridge No. 5 (39.346522222°N; 21.920672222°E): (a) debris has been moved to the side; (b) debris built up in front of the neighboring overpass of the irrigation trench.

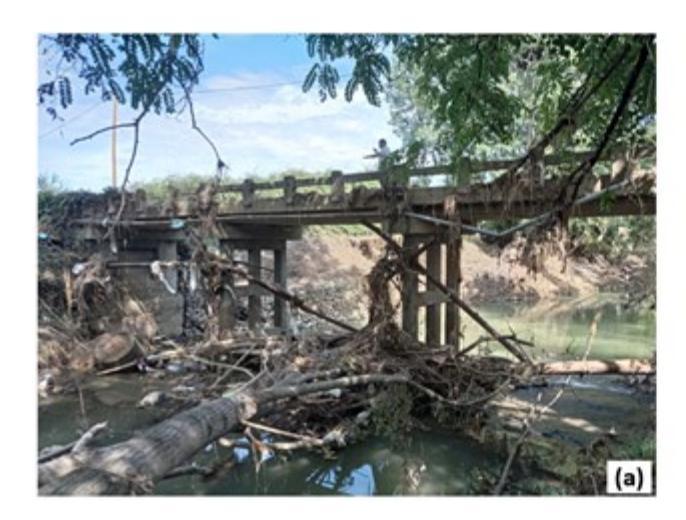
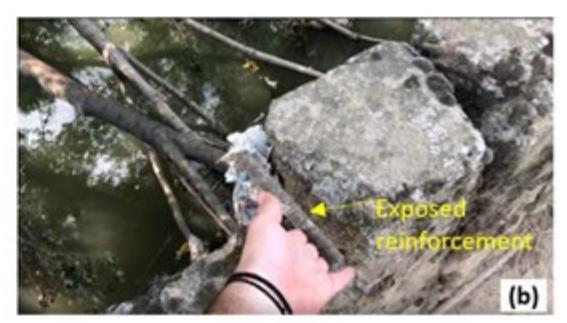
Figure 5.9. Photos of Bridge No.6 (39.344589222°N; 21.894189833°E): (a) debris has been moved to the side; (b) no evidence of flood induced damage despite the bridge being old and poorly maintained with exposed reinforcement.

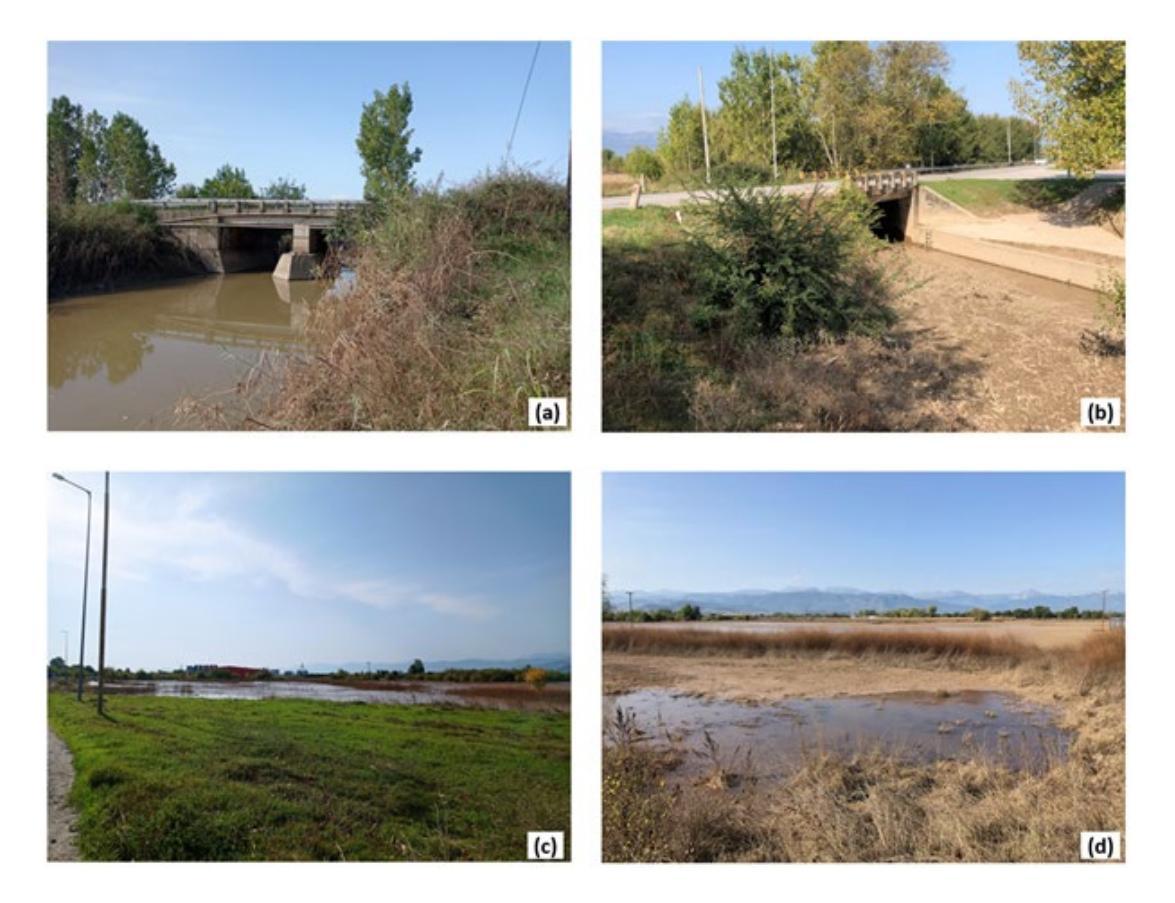
Accordingly, bridges of the northern lowlands of Karditsa, specifically No. 14 (Figure 5.10a) and No 15 (Figure 5.10b) were found structurally unscathed during inspections carried out on October 3, 2020, albeit with evident signs of been overtopped. According to the testimonies of local people, the surrounding fields were flooded (Figure 5.10c and 5.10d) with water height reaching a maximum of 1.5 m (at the parking lot of the Jumbo© store - location 39.475303°N; 21.845064°E).

Figure 5.10. Photos of (a) Bridge No.14 ($39.097792474^{\circ}N$; $21.878223628^{\circ}E$) and (b) Bridge No. 15 ($39.47911111^{\circ}N$; $21.84343611^{\circ}E$) which suffered negligible damage despite being reportedly flooded, with water heights in the (c) – (d) nearby fields exceeding 1.5 m (according to communication with local people).

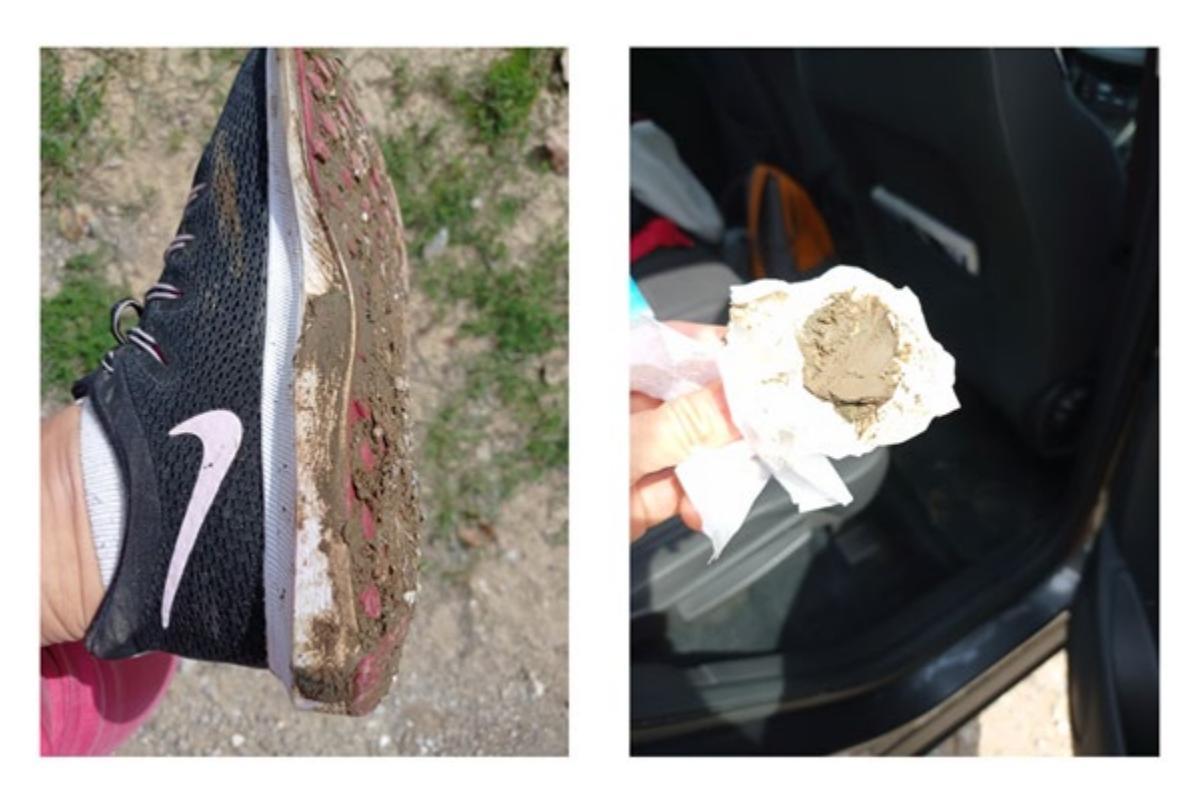
High plasticity clays, the dominant soil type in the lowlands (Figure 5.11), are much less erodible than the cohesionless sediments found in Mouzaki's riverbanks (Govindasamy 2009; Briaud 2008).

Figure 5.11. Examples of the lowland's cohesive soil.
Bridges in the severely impacted mountainous region

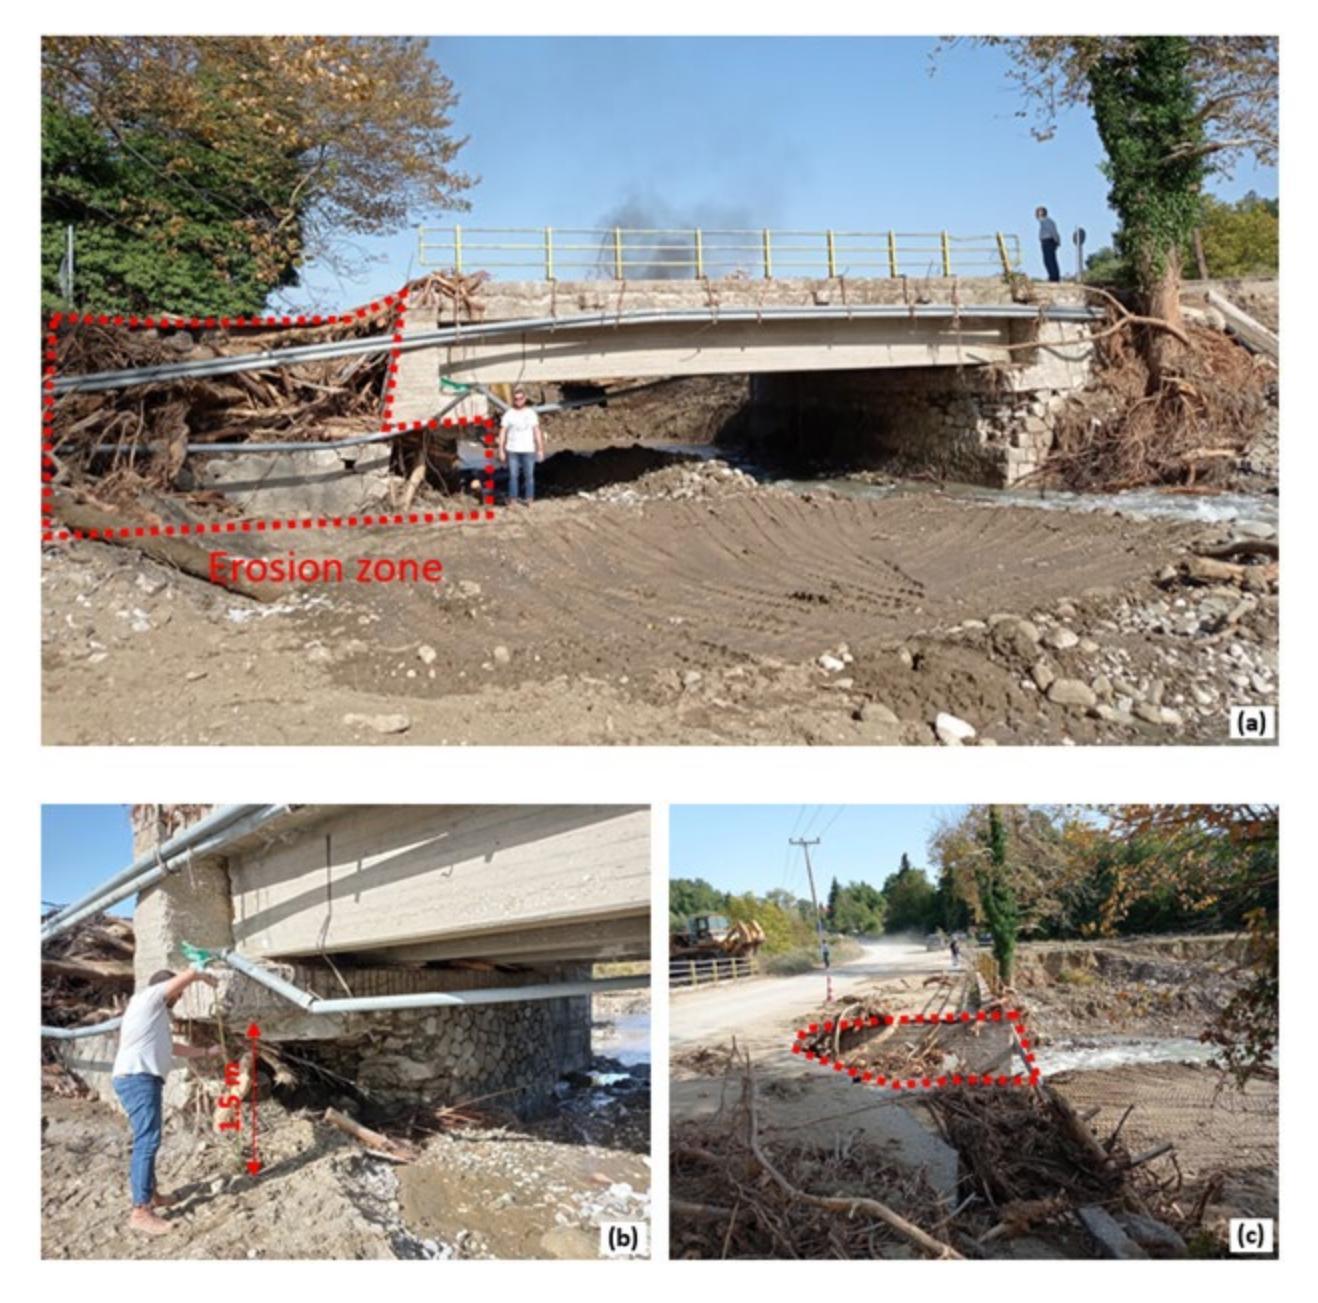
```
-Bridge No. 13 (39.309563356° N; 21.710816055° E) - Figure 5.14:
```

This bridge consists of a RC beam supported on (possibly) older masonry walls that function as abutments. Its southern abutment was partially washed away, leaving a significant part of the deck unsupported (Figure 5.14b) while backfill erosion led to the formation of a 4 m wide gap in the roadway.

Figure 5.14. Photos of Bridge No. 13 located east of the Plastiras lake (39.309563356°N; 21.710816055°E): (a) side view indicating debris built-up and (b) significant abutment scouring and (c) backfill erosion that leads to the partial collapse of the roadway.

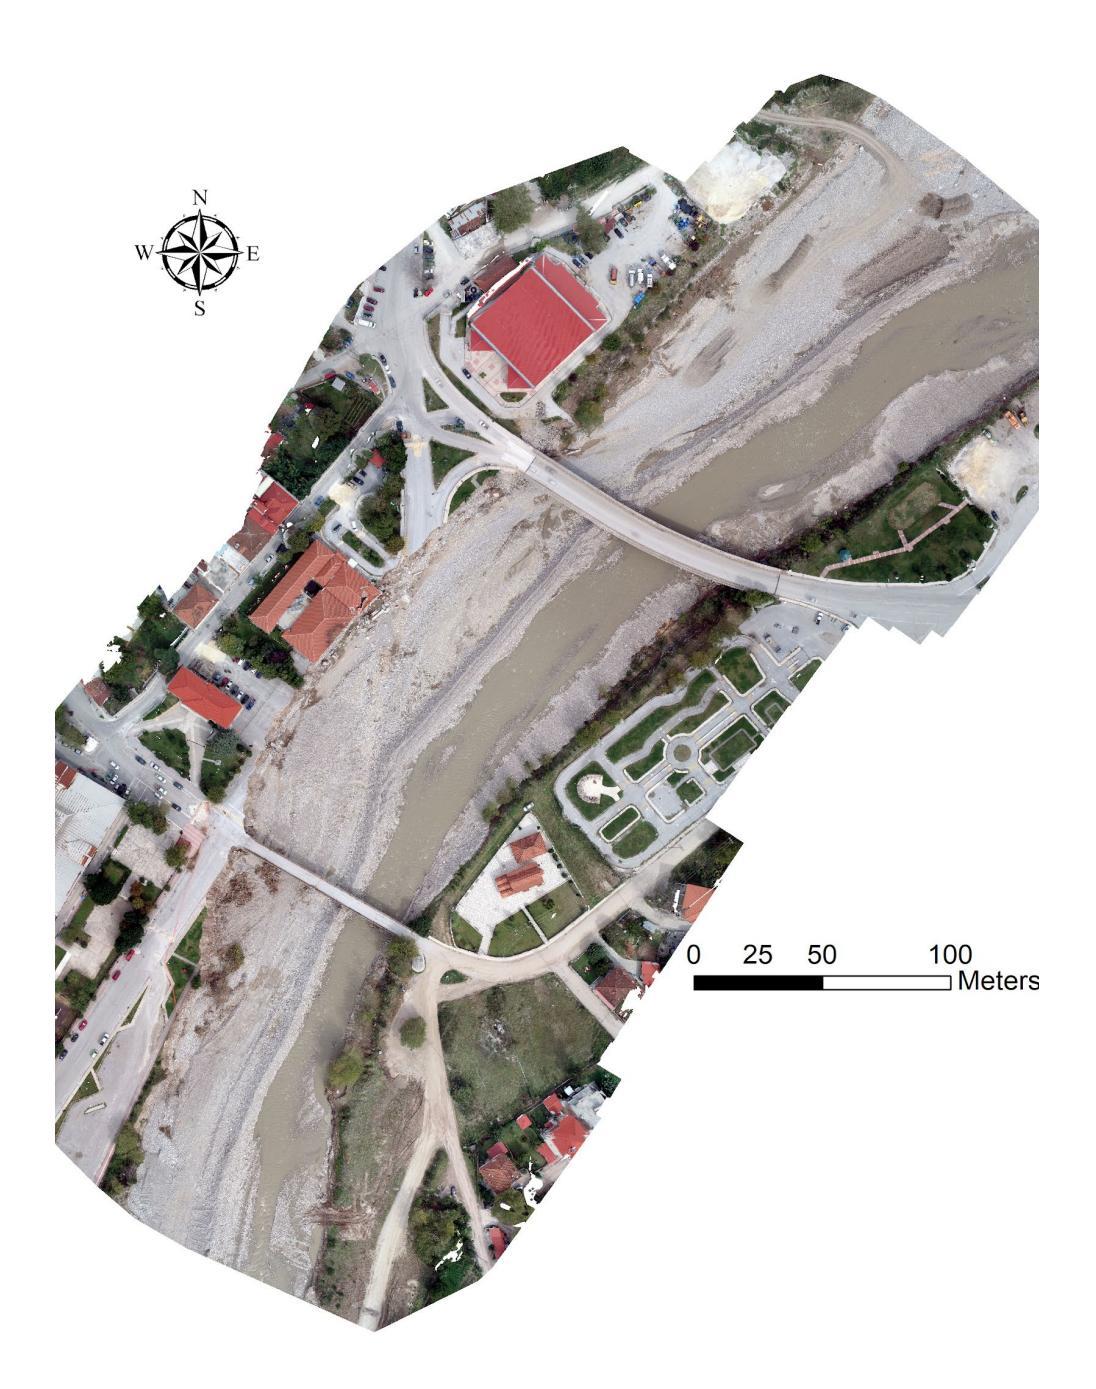
Figure 5.20. Orthophoto of bridges No. 7 and 8 at the village of Mouzaki (2 October 2020).

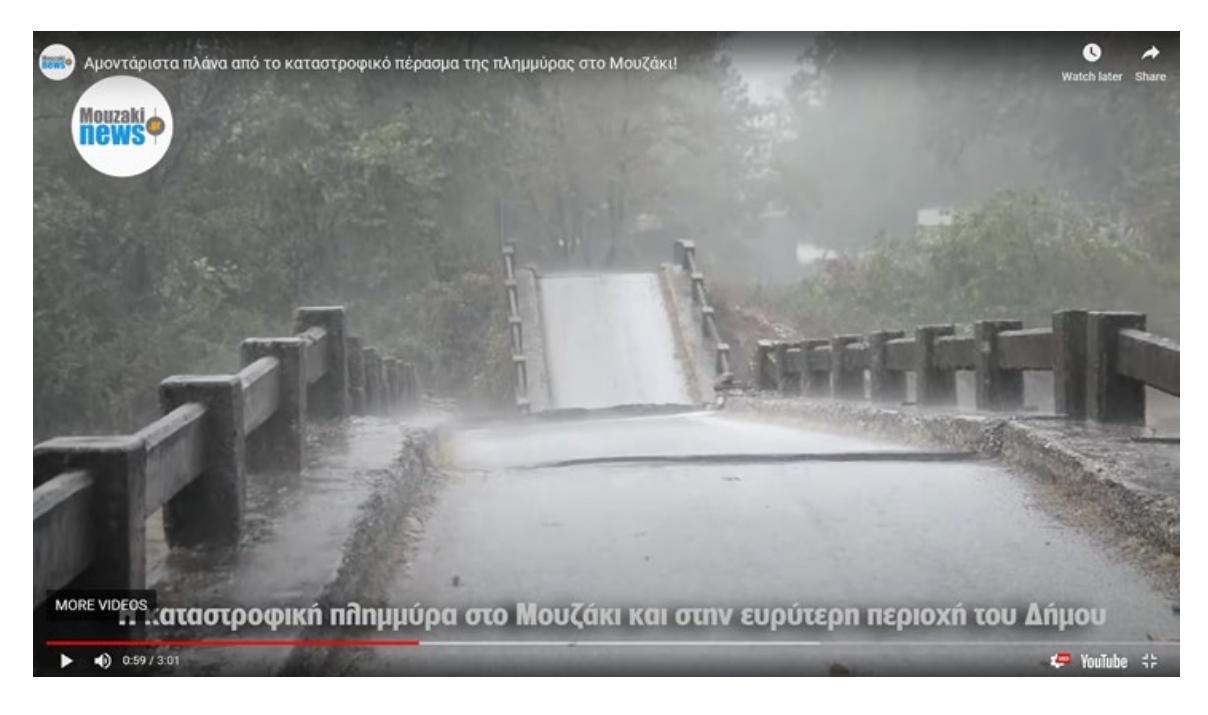
Bridge No. 11 (Figure 5.21) crosses Pamissos at a horizontal distance of 3.2 km from Mouzaki, upstream. The bridge collapsed completely as a result of pier scour and abutment erosion. Based on the deformation of the deck, it is reasonable to deduce that there were two additional piers (i.e. a total of 3 piers) at the locations indicated in Figure 5.21a, which likely suffered significant rotation due to scour, similar to the abutment (Figure 5.21c). Yet, we could not locate these piers when we visited on October 3, 2020. Likewise, we could not locate the middle span of the deck, which is evident in footage that appeared in the local media the day after the event (see screenshot in Figure 5.22).

Figure 5.22. Footage of Bridge No.11 in the local news on September 19, 2020 (source: https://www.youtube.com/watch?v=hLP3NdMF9SI).

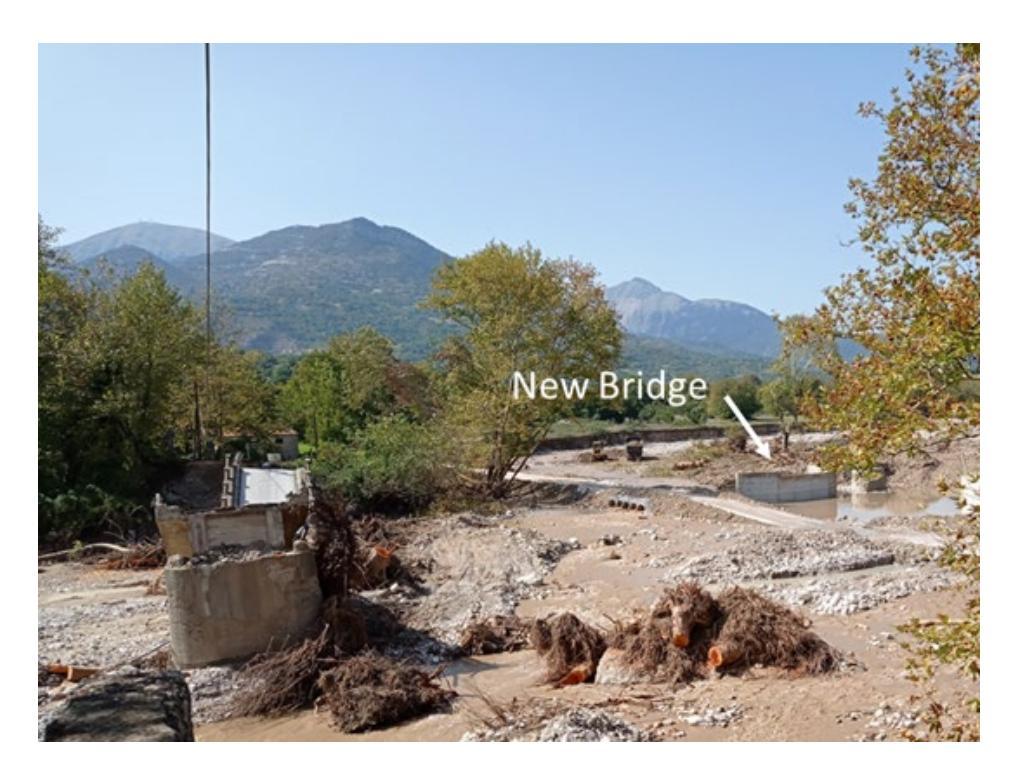
It is important to note that Bridge No. 11 was known to have suffered scour induced deformation prior to this medicane (observed during inspections carried out in August 2020). In August 2020, it was decided to replace it soon with a new bridge, constructed upstream. Construction was ongoing next to Bridge No.11 during our visit on October 3, 2020 (Figure 5.23), which according to workers' testimonies had begun prior to the event.

Figure 5.23. New bridge being constructed next to the collapsed bridge No. 11.

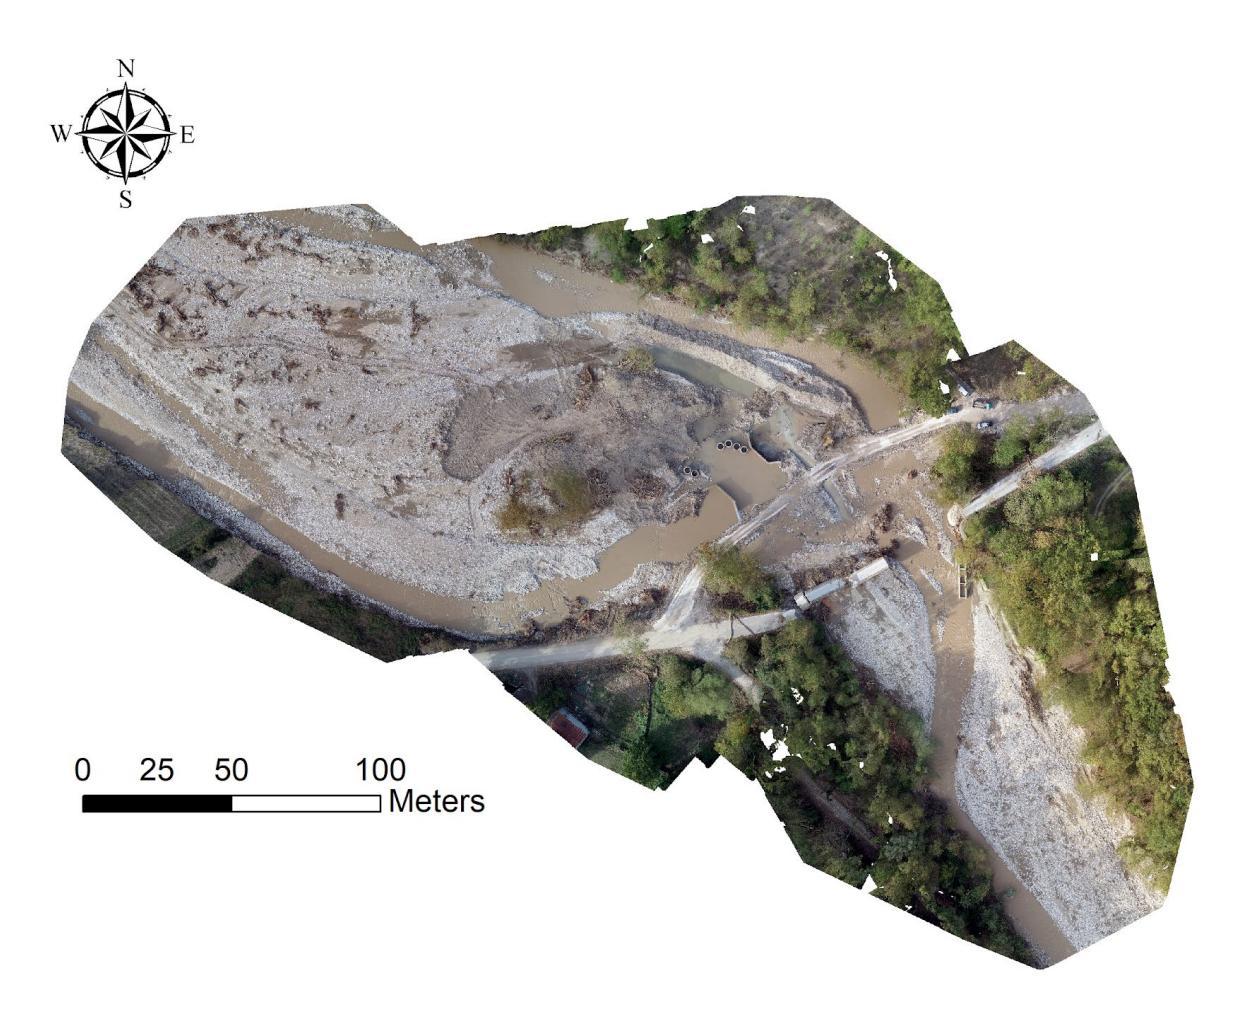
Figure 5.24. Orthophoto of bridge No. 11 near the village of Mouzaki (2 October 2020).

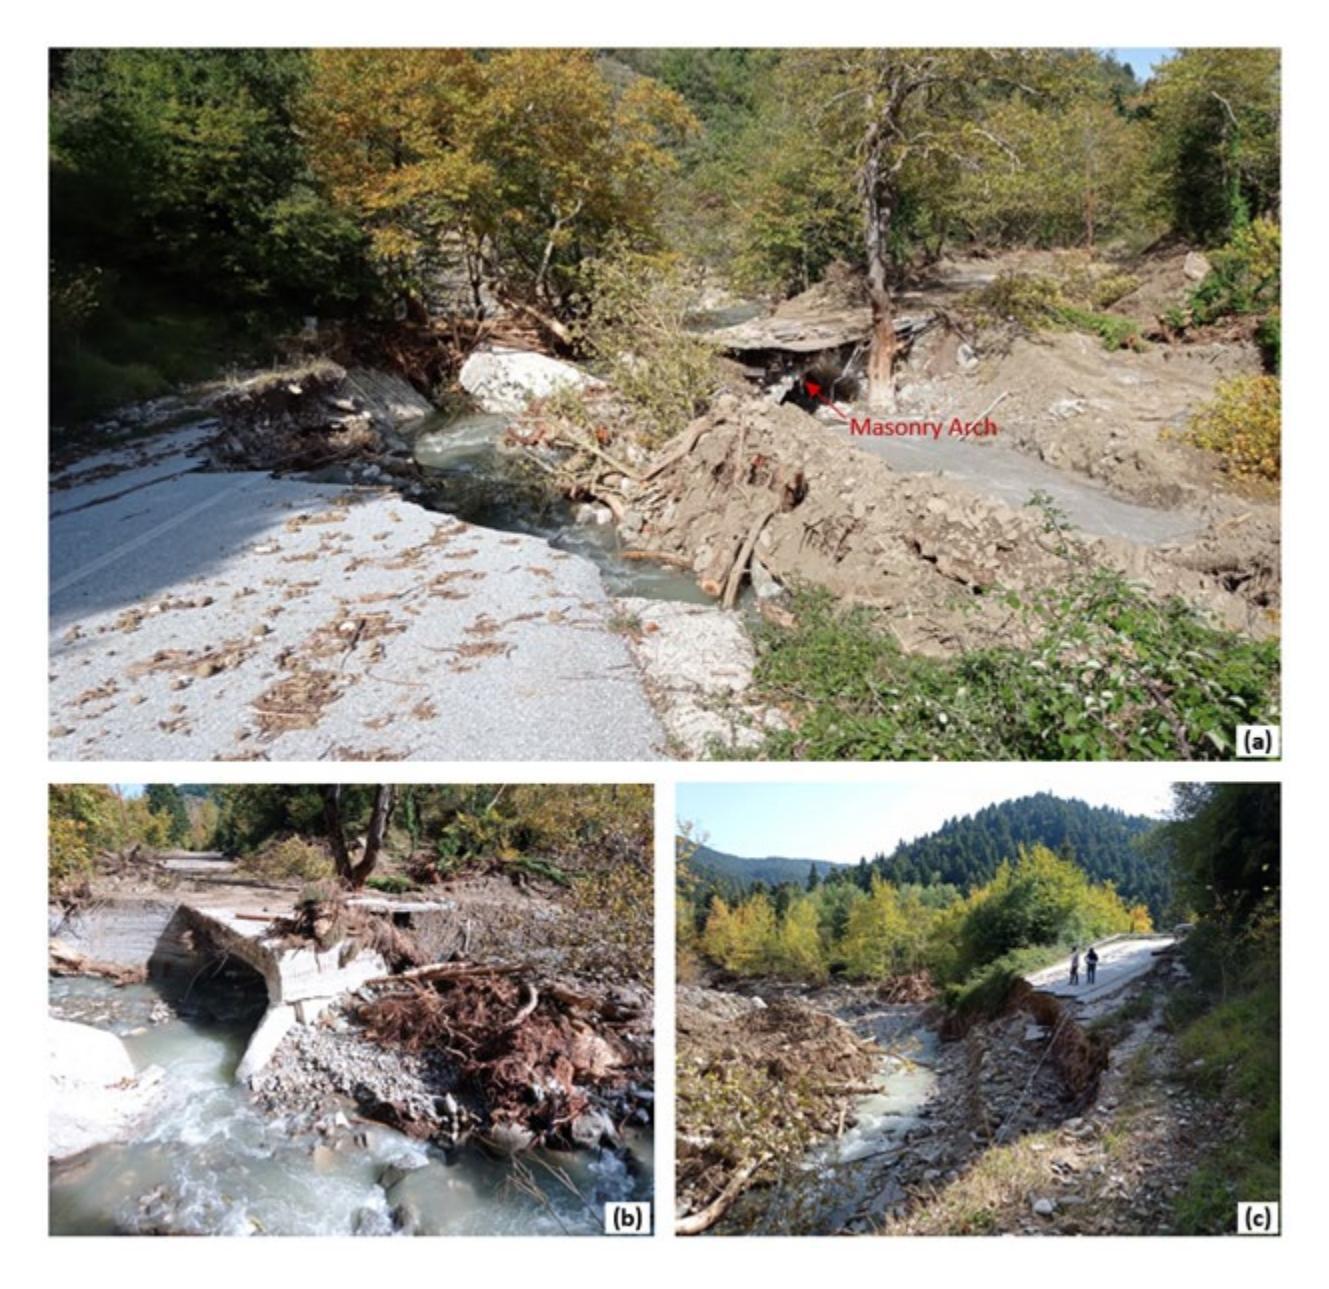
Similar to the previously discussed single-span RC bridges, the response of two old masonry arches found in the area was dominated by abutment erosion (Figures 5.25 and 5.26). Particularly interesting is the case of Bridge No. 2 (Figure 5.25), which is considered a cultural monument with an estimated age of 300 years. Its integrity was certainly undermined by the modern, narrower overpass located at a close distance upstream (Figure 5.25). The latter, presumably, caused contraction of water flow leading to increased flow velocities impacting Bridge No.2.

Figure 5.26. Photos of Bridge No.12, a masonry arch located on the way from Filakti to Pezoula $(39.303508426^{\circ}N; 21.686573208^{\circ}E): (a) - (b)$ suffering extended abutment and riverside erosion that lead to (c) collapse of the roadway.
