The September 18-20 2020 Medicane Ianos Impact on Greece

Phase I Reconnaissance Report

Geotechnical Extreme Events Reconnaissance Association

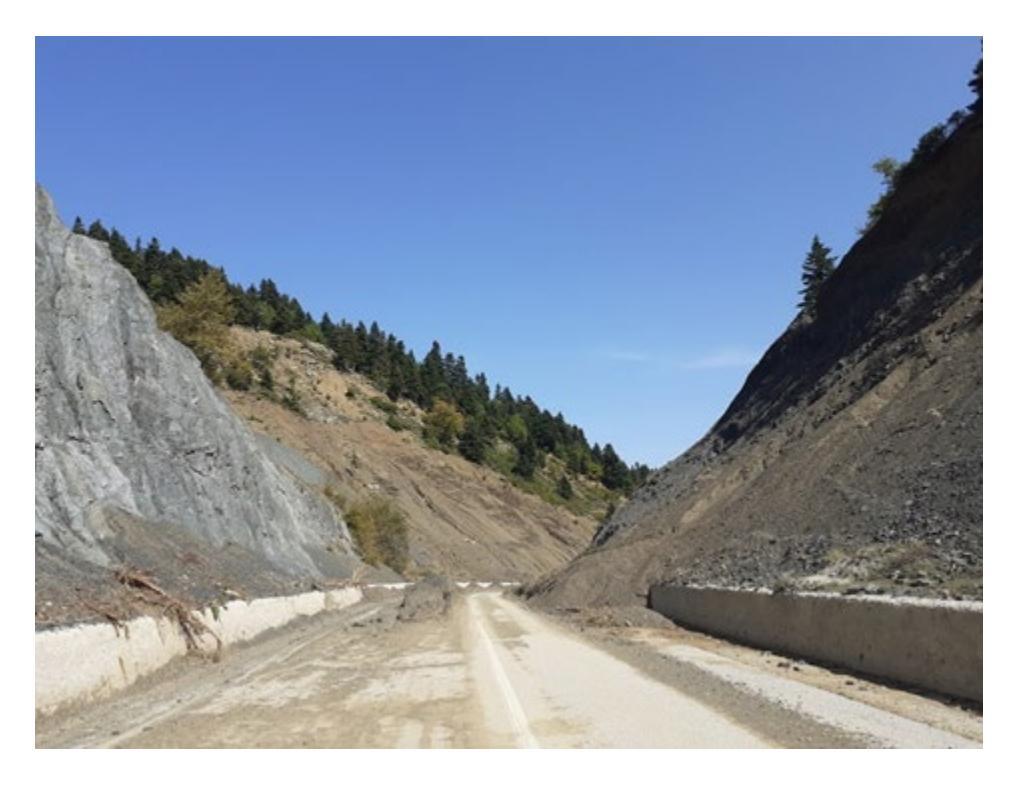
In this area, along the road section between Kastania and Rachoula (total length of about 10 km), extensive sliding occurred. The flysch type consists mainly of shales. During the time of the visit the road was covered with slipped material on either side, but remained accessible (see Figure 5.31).

Figure 5.31. Landslips from side slopes along the Kastania – Rachoula section (39.2314830°N, 21.8016040°E)

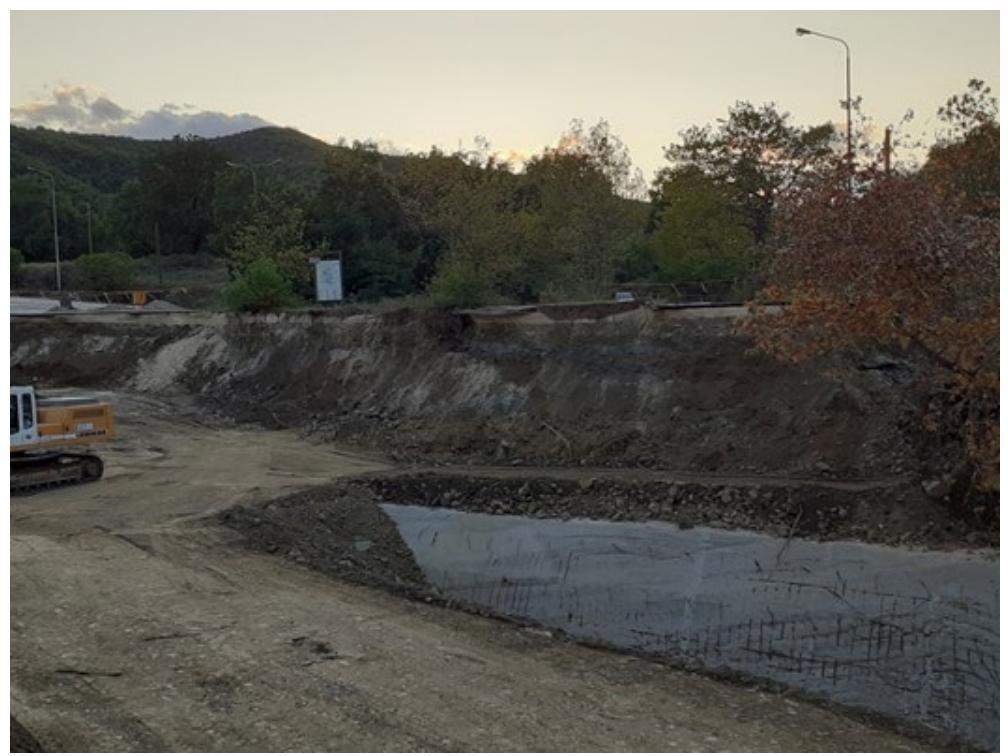
At the location before Rachoula village, the road was completely damaged due to the extensive erosion in the riverbed and the impact of the transported materials on the road (see Figure 5.32). The riverbank erosion was accompanied by a complex rotational-type slope failure in sandstone flysch. The height of the landslide's crown was about 30 m and material travelled at a distance of around 200 m (Figure 5.33).

Figure 5.32. Damaged road near Rachoula due to impact of transported materials (39.2494490°N, 21.8889110°E)

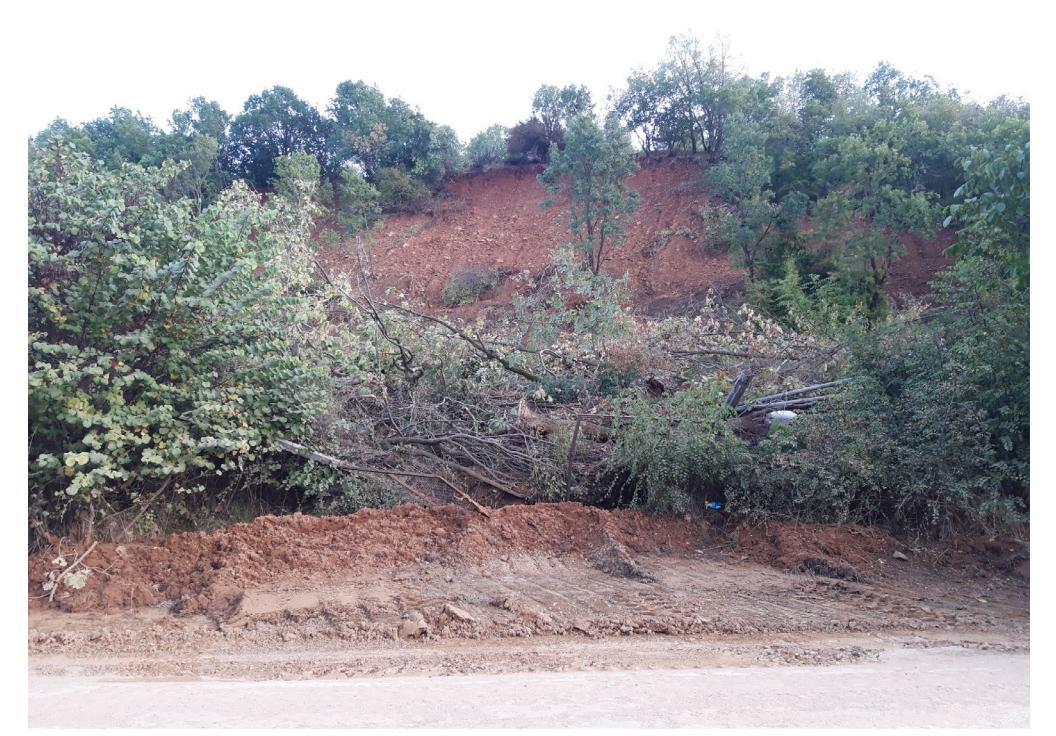
Figure 5.33. Complex rotational-type slope failure near Rachoula (39.2494490°N, 21.8889110°E)

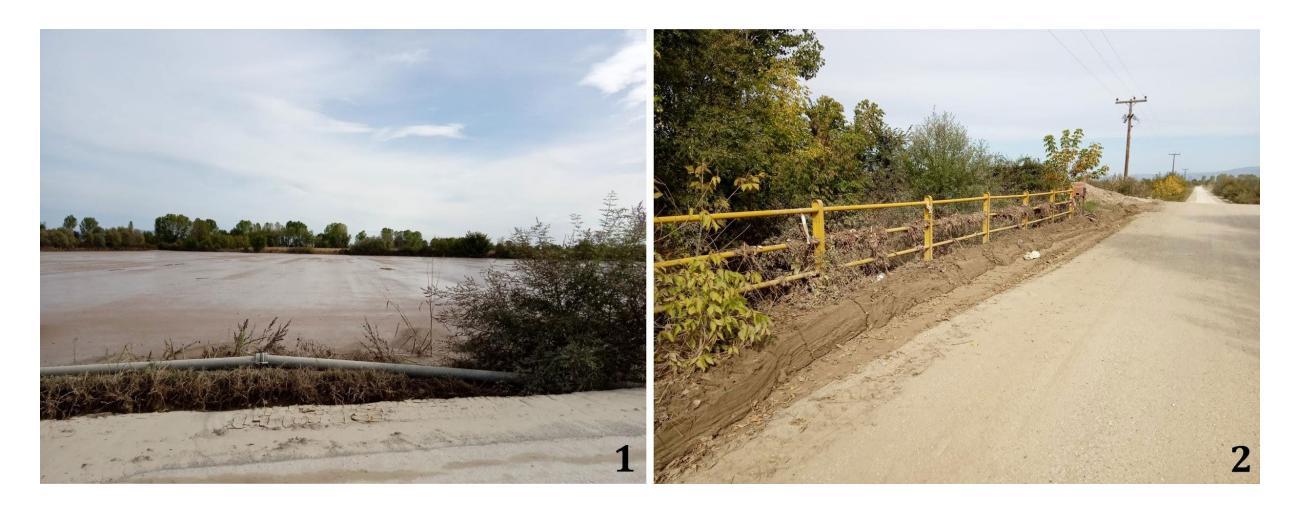
Figure 5.38. 1) Flooded areas south of Megala Kalyvia, Trikala (39.4765°N, 21.7887°E). 2) Road bridge over an irrigation canal (39.4694°N, 21.7907°E). Debris and flood deposits over the deck (upstream view) show that the maximum flood level exceeded the bridge height.

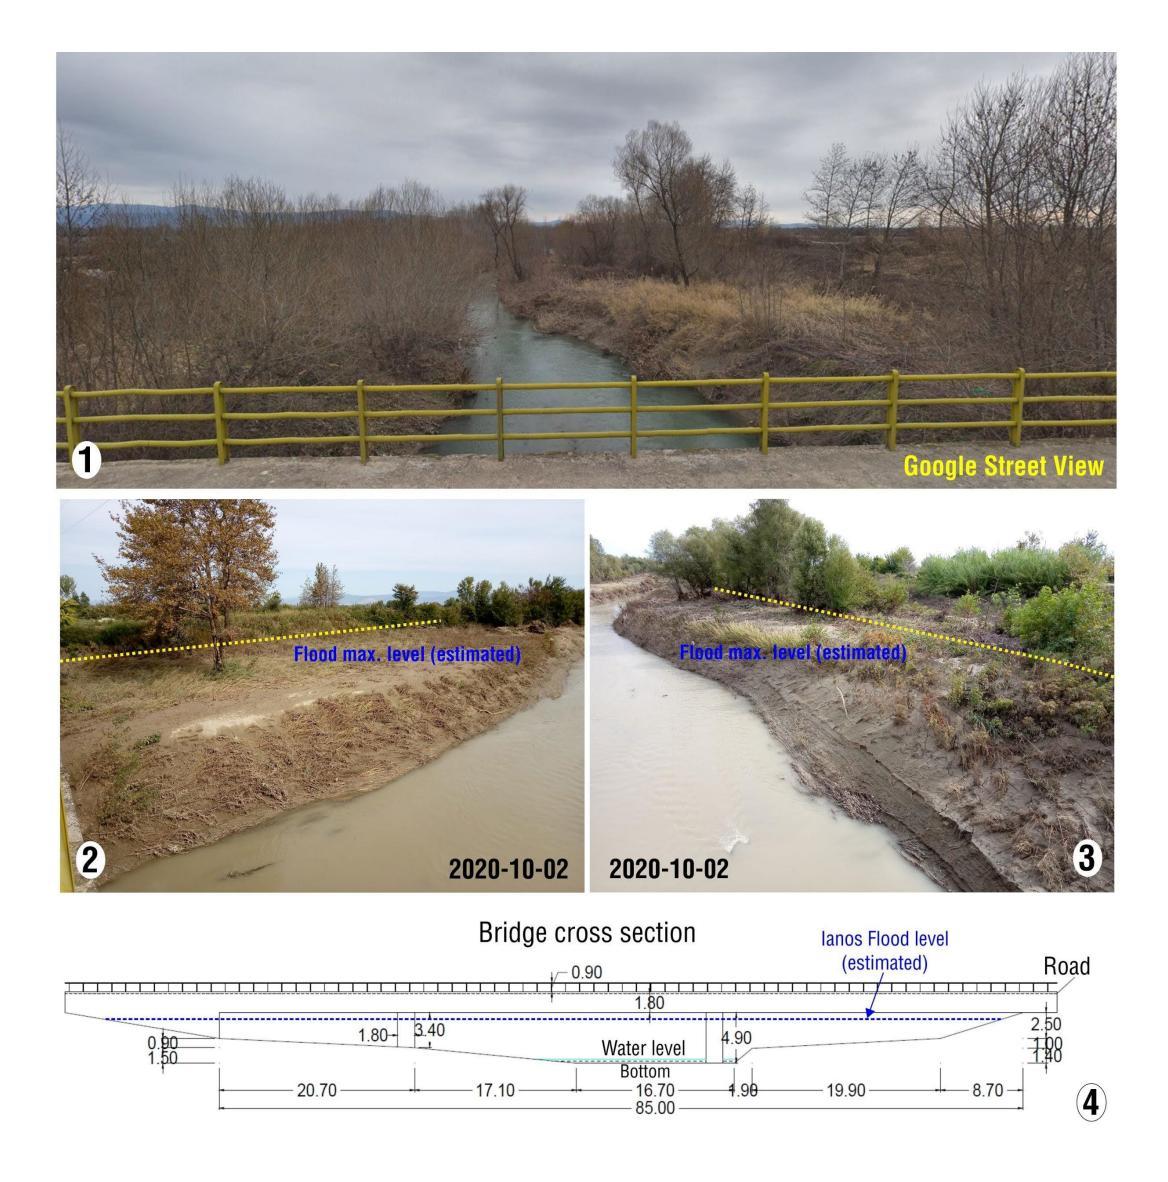
Figure 5.39. Road bridge over Pamisos canal, view to the east - downstream ($39.46341^{\circ}N$, $21.79944^{\circ}E$). Field photos (2,3) compared with pre-event Google Street View image (1) and technical cross section. Maximum flood level did not overtop the bridge, but is estimated close to ~4 meters from the bottom.

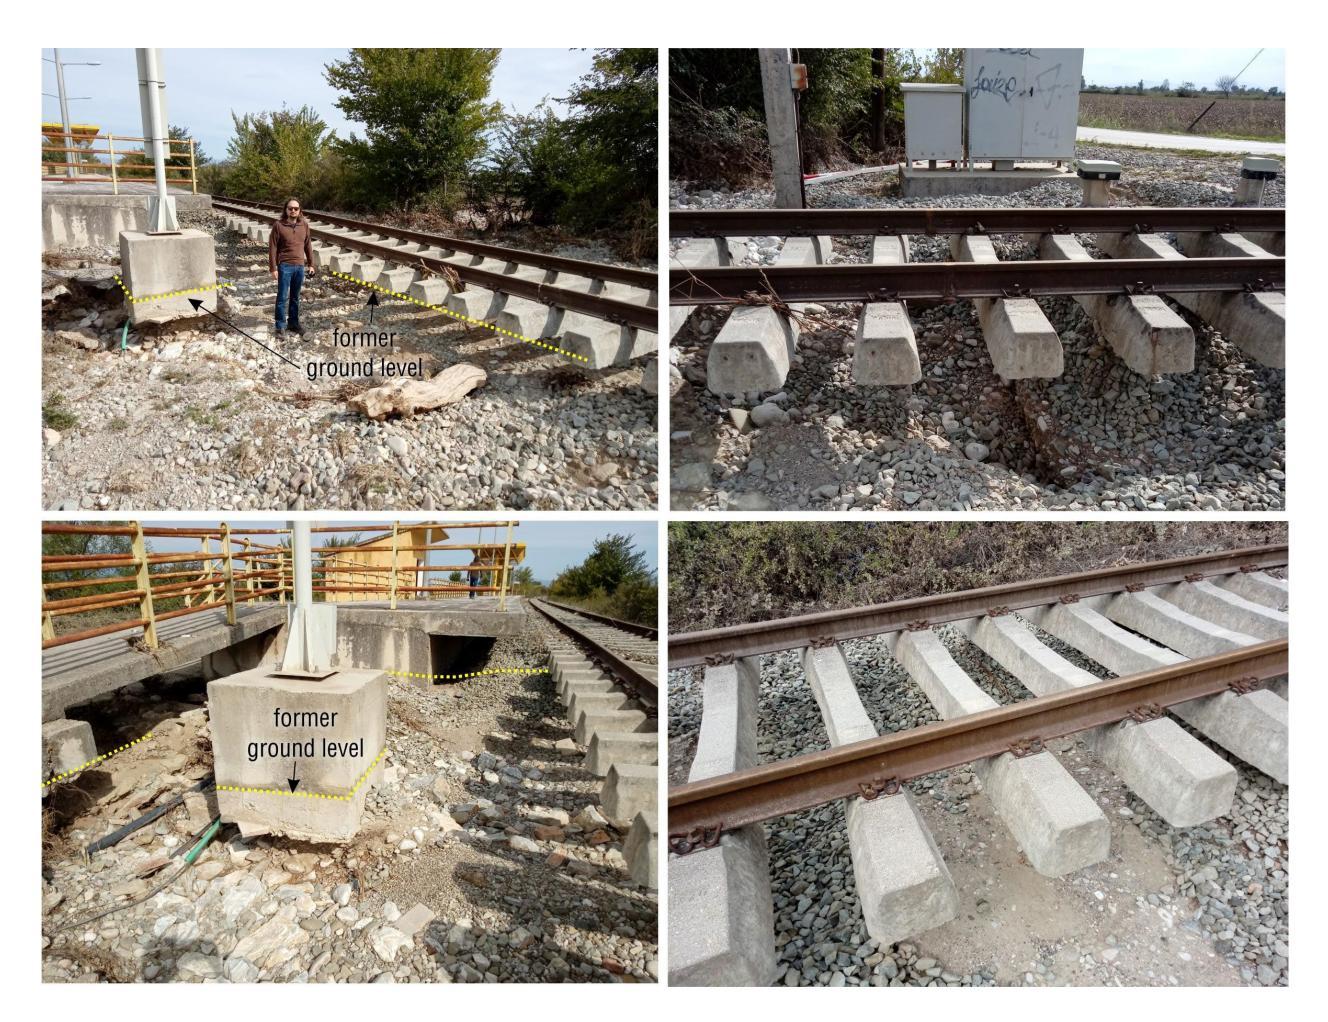
Severe flooding outburst by Pamisos river discharged large amounts of water towards two directions: to the north, flooding the area around Megala Kalyvia, and to the east towards Magoula. Field survey of Magoula train station and rail track showed severe ballast scouring that deformed the rail line along significant parts of the line. The rail track is composed of metal rail lines and cement sleepers, over a ~0.5m thick ballast underbed, over an earth embankment. Flood waters breached and eroded the ballast, deforming the rail line and leaving parts of the rail track hanging. The direction of the flood water flow towards east, is evident by oriented remnant vegetation, and the direction of ballast washout towards the east side of the rail track. Figures 5.37 through 5.47 document in detail the observations made at the Magoula Station Site.

Figure 5.40. Railway embankment & ballast scouring at Magoula train station (39.45127°N, 21.78824°E).

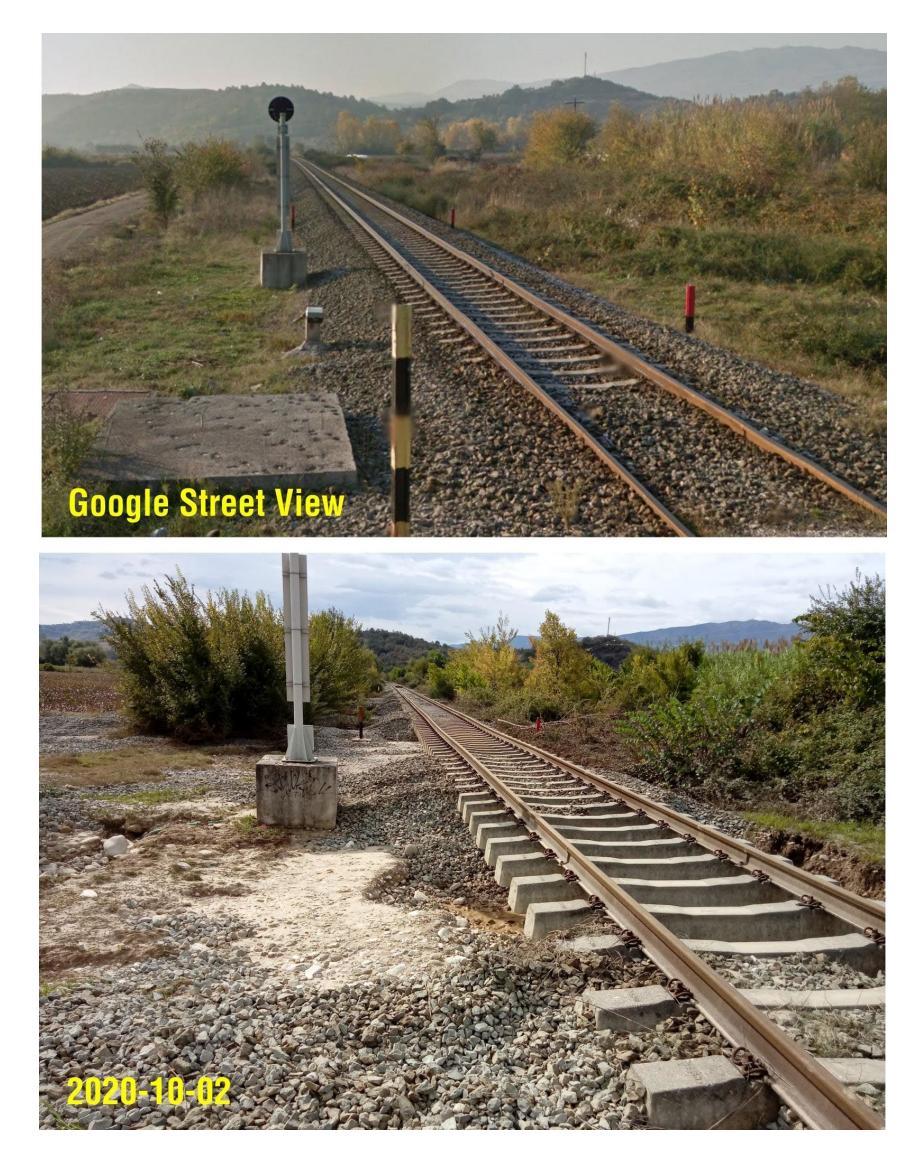
Figure 5.41. Railway embankment & ballast scouring along Paleofarsalos-Kalabaka line, near Magoula (39.45127°N, 21.78824°E). Comparison of field photo (bottom) with pre-event Google Street View image (top).

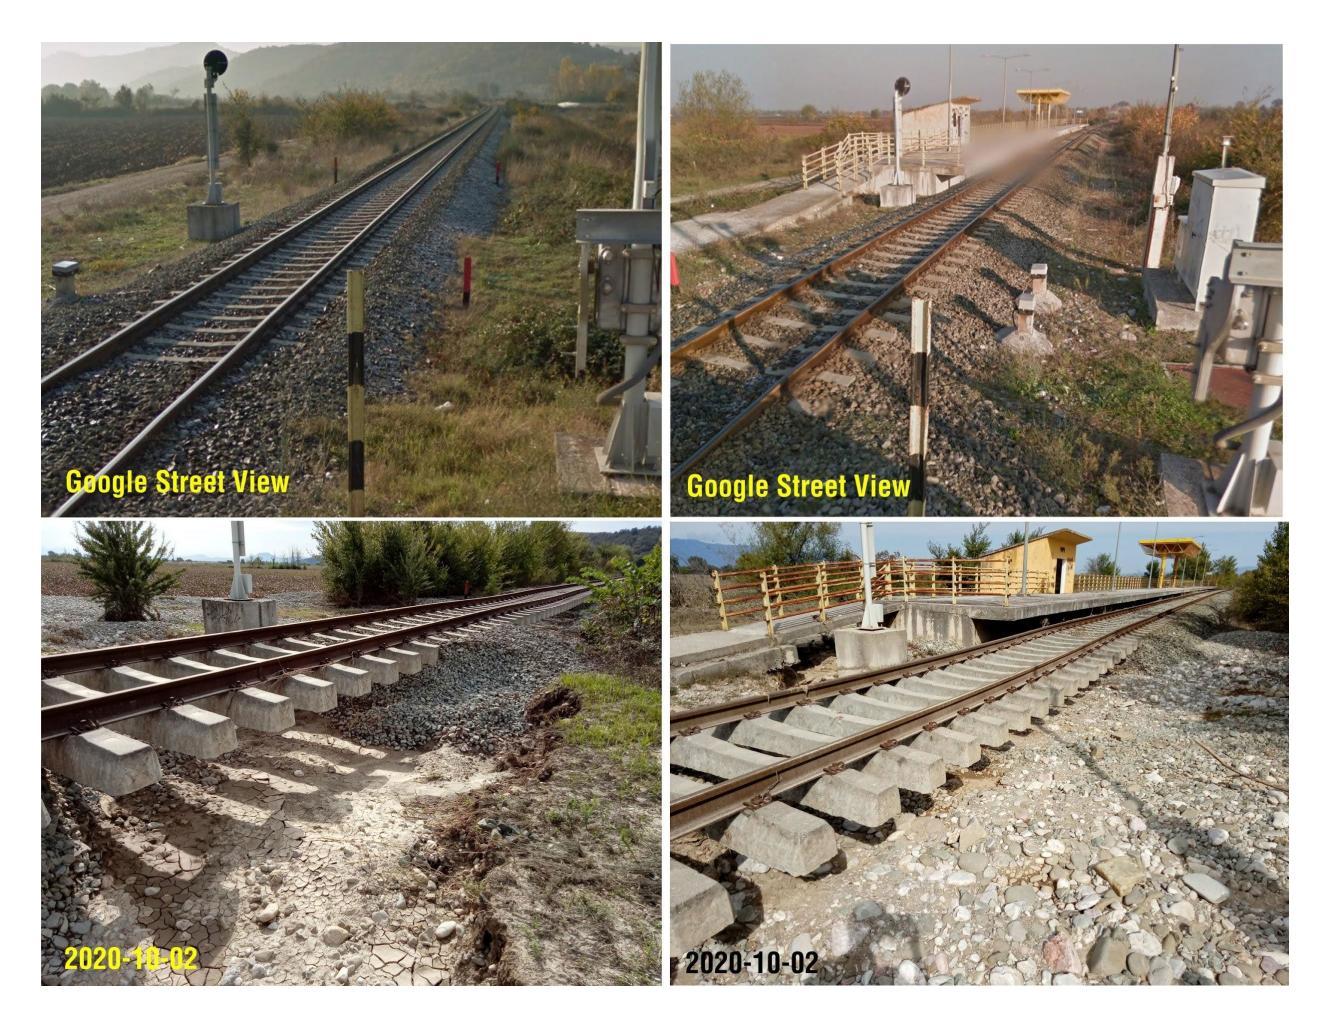
Figure 5.42. Railway embankment & ballast scouring along Paleofarsalos-Kalabaka line, Magoula station (39.45127°N, 21.78824°E). Comparison of field photo (bottom) with pre-event Google Street View image (top).

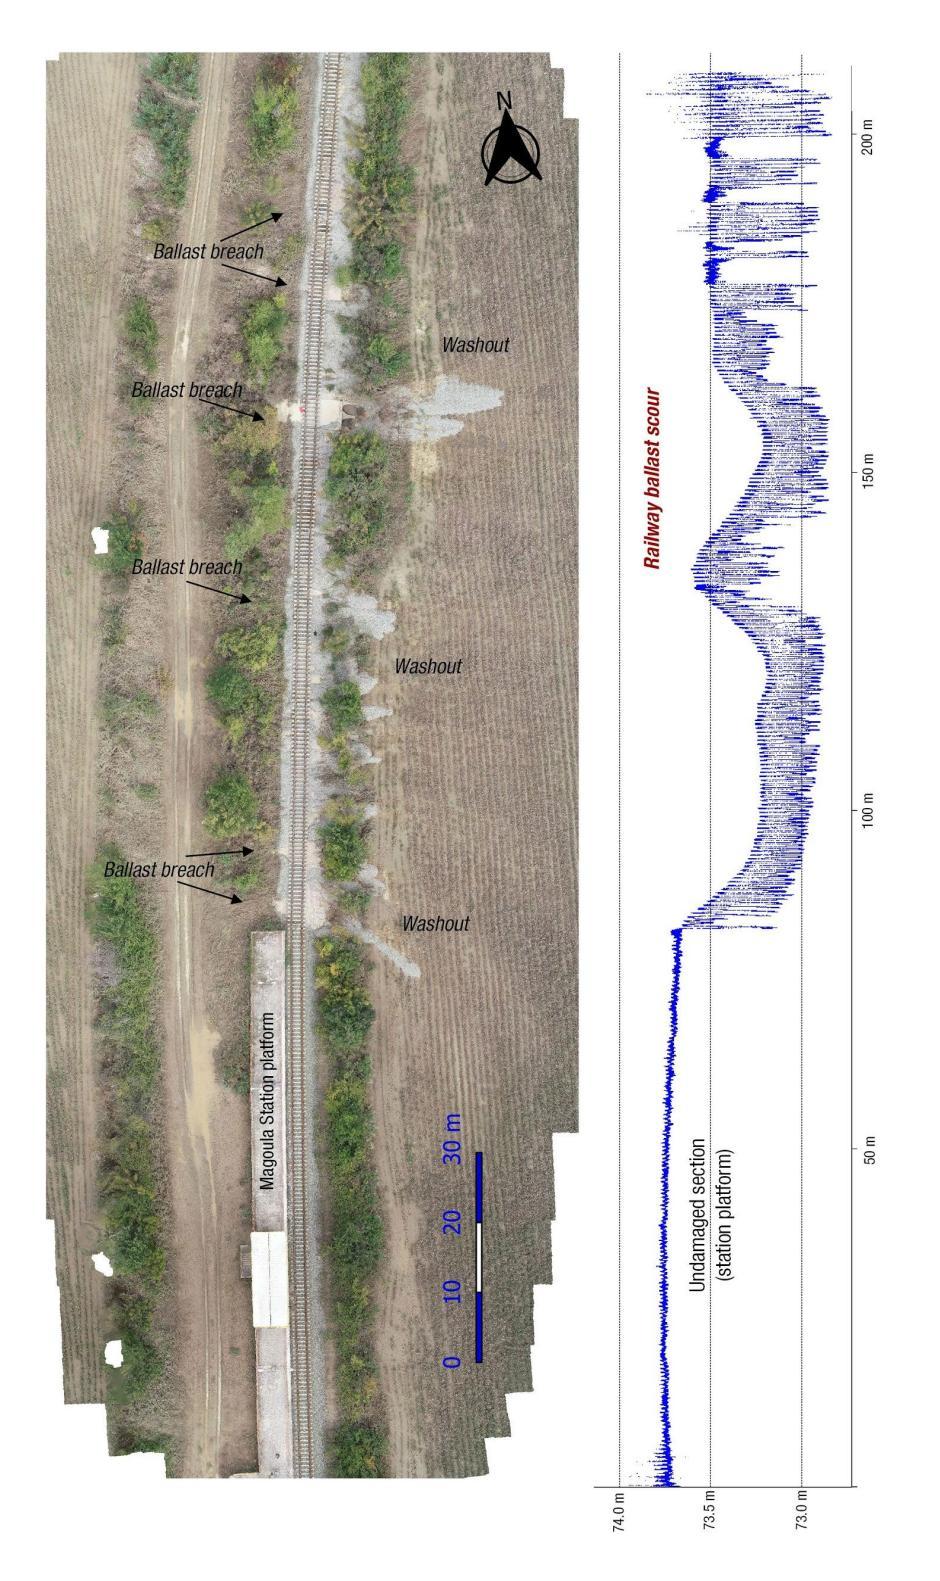
Figure 5.43. Orthophotomap (left) from the UAV survey in Magoula Station site and point cloud profile along the rail track (right) that shows deformation of the rail line due to ballast scouring.

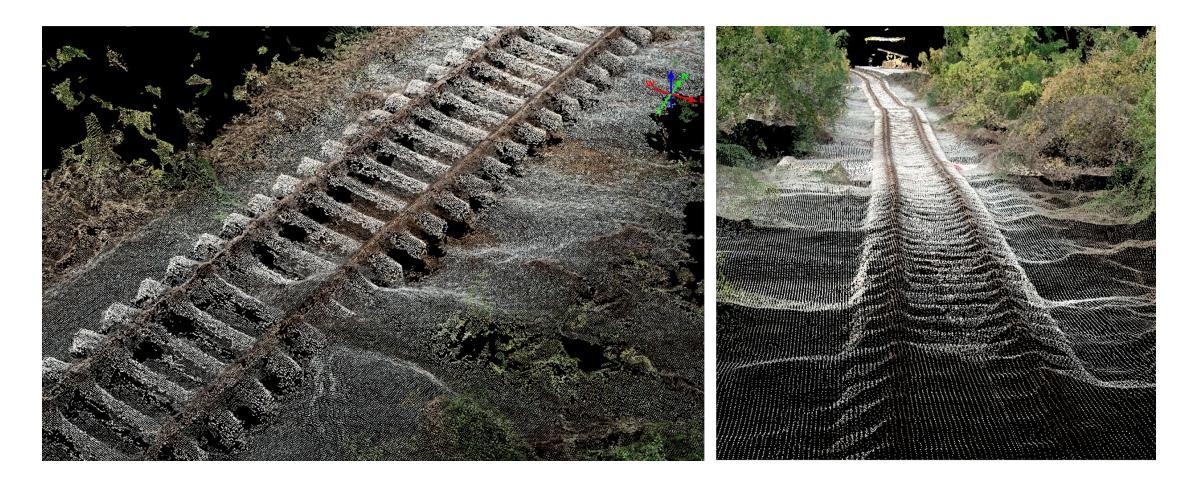
Figure 5.44. 3D Point cloud views of railway ballast breach (left) and rail line deformation (right).

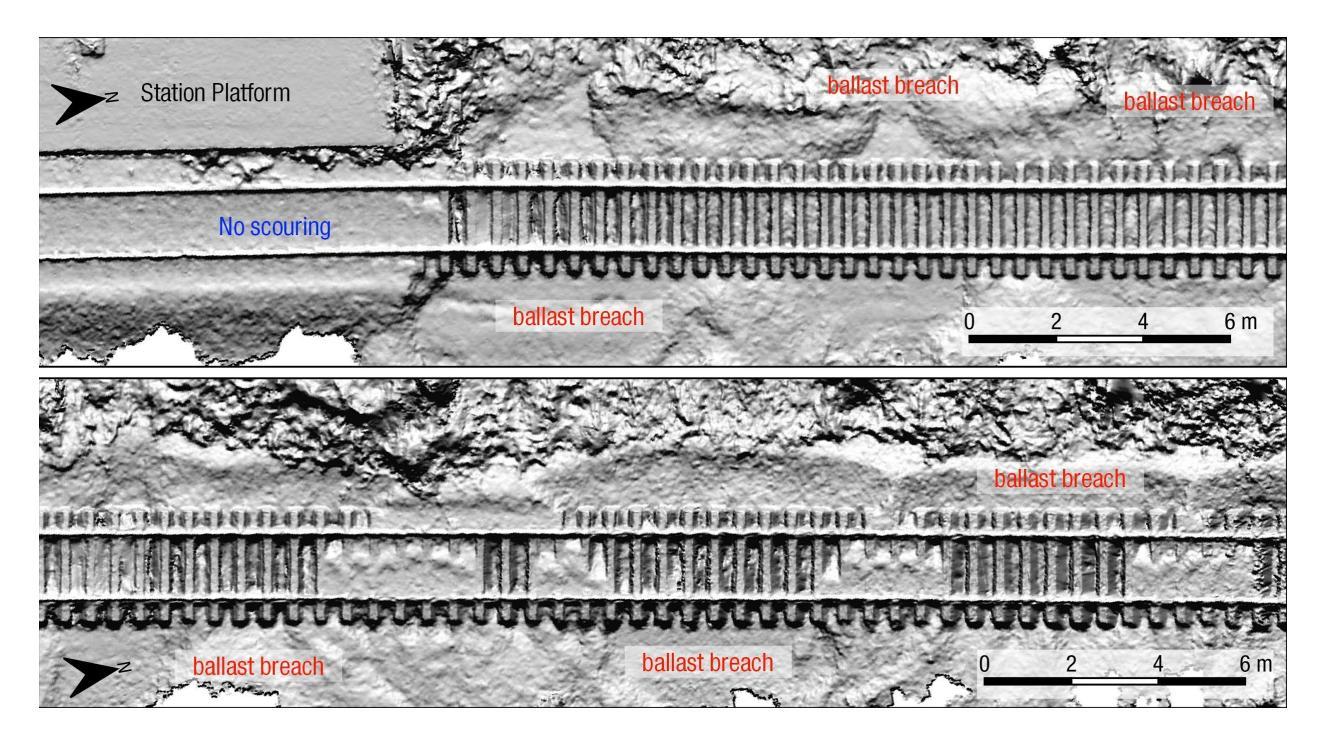
Figure 5.45. Close-ups of digital surface model (from UAV survey) along the rail track bed. Removal of ballast is visible as has created empty space between and below the sleepers. The protection of the track bed from scouring, due to the presence of the (cement) station platform, is visible in the top figure.

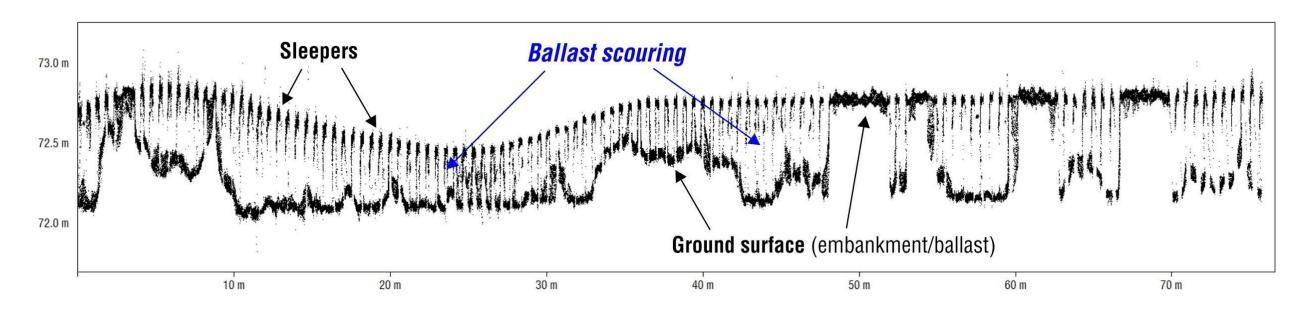
Figure 5.46. Point cloud swath profile, between the rails, along a part of the track near Magoula station. Ballast scouring in various spots is visible, that has left the sleepers and lines hanging.

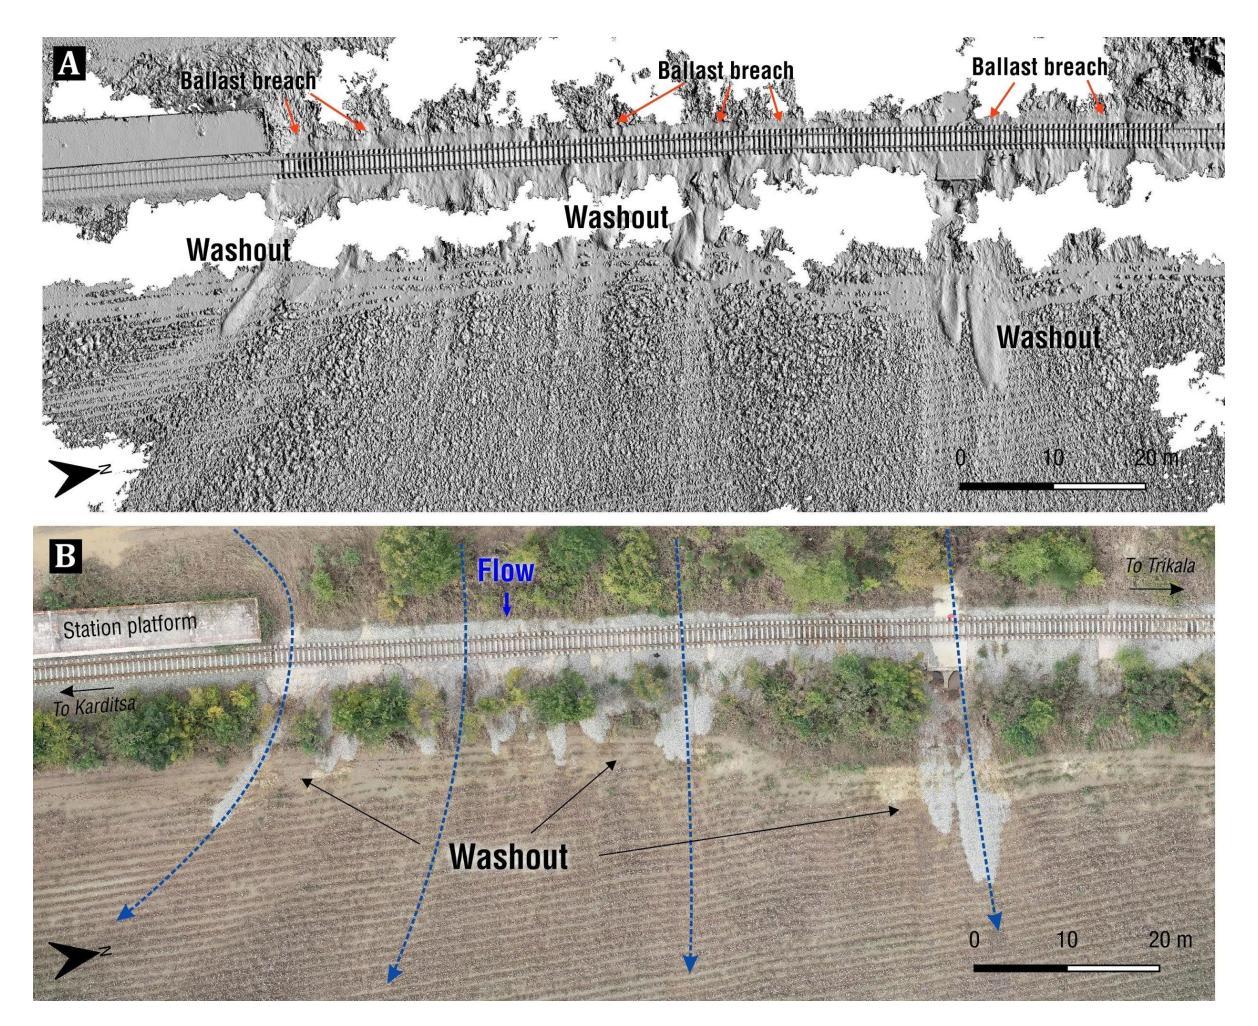
Figure 5.47. Railway ballast scouring effects in Magoula Station site. Flood water flow can be inferred from oriented overrun vegetation and the morphology/distribution of washout ballast in the eastern side of the rail line embankment. Top: digital surface model from UAV survey, bottom: UAV orthophoto.

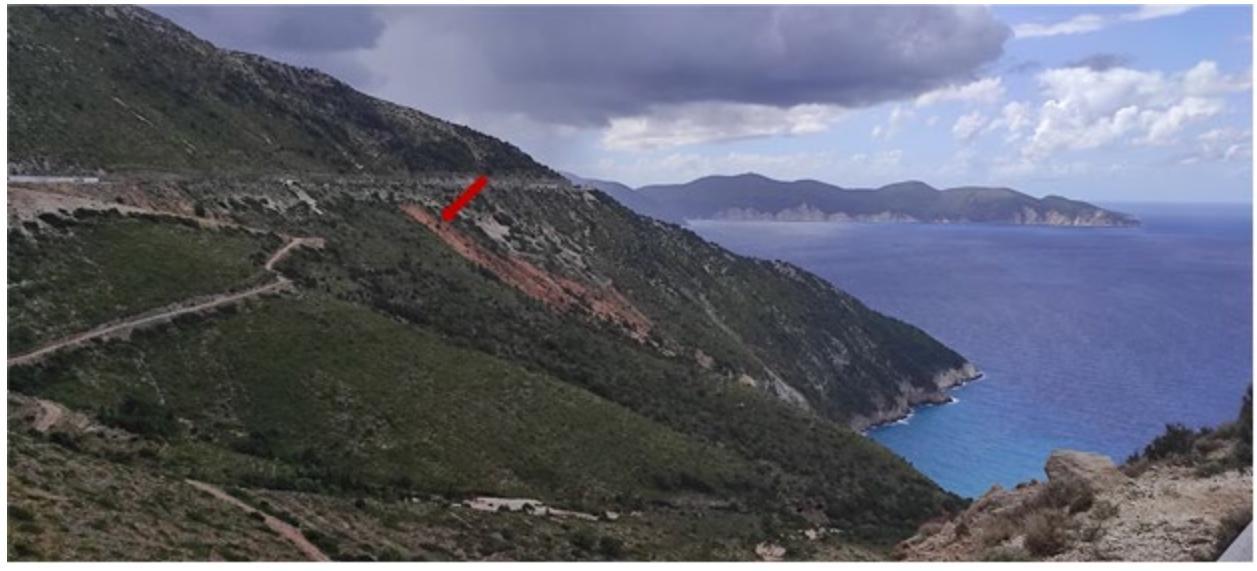
A landslide was identified along the steep western slopes of Cephalonia, near the village of Assos (Figure 6.1) and engaged the soils and weathered limestone/dolomite formations. Due to the steep topography the slipped material traveled a long distance. A few rotational landslides were identified along the road leading to Myrtos beach, through the village of Divarata (Figure 6.2). Access to Myrtos beach was impossible due to landslides and debris covering the roadway. Thus, mapping using UAVs revealed several landslips and related features (ex. debris). Figure 6.3 illustrates a comparison between a pre-event (May 24 2016), UAV-enabled, 3D textured mesh of Myrtos beach and its post-event counterpart. A 3D model of the area is visualized here: https://skfb.ly/6WyR6.

Figure 6.1. Landslide on limestone/dolomite weathered bedrock (38.354888°N, 20.5537649722°E)

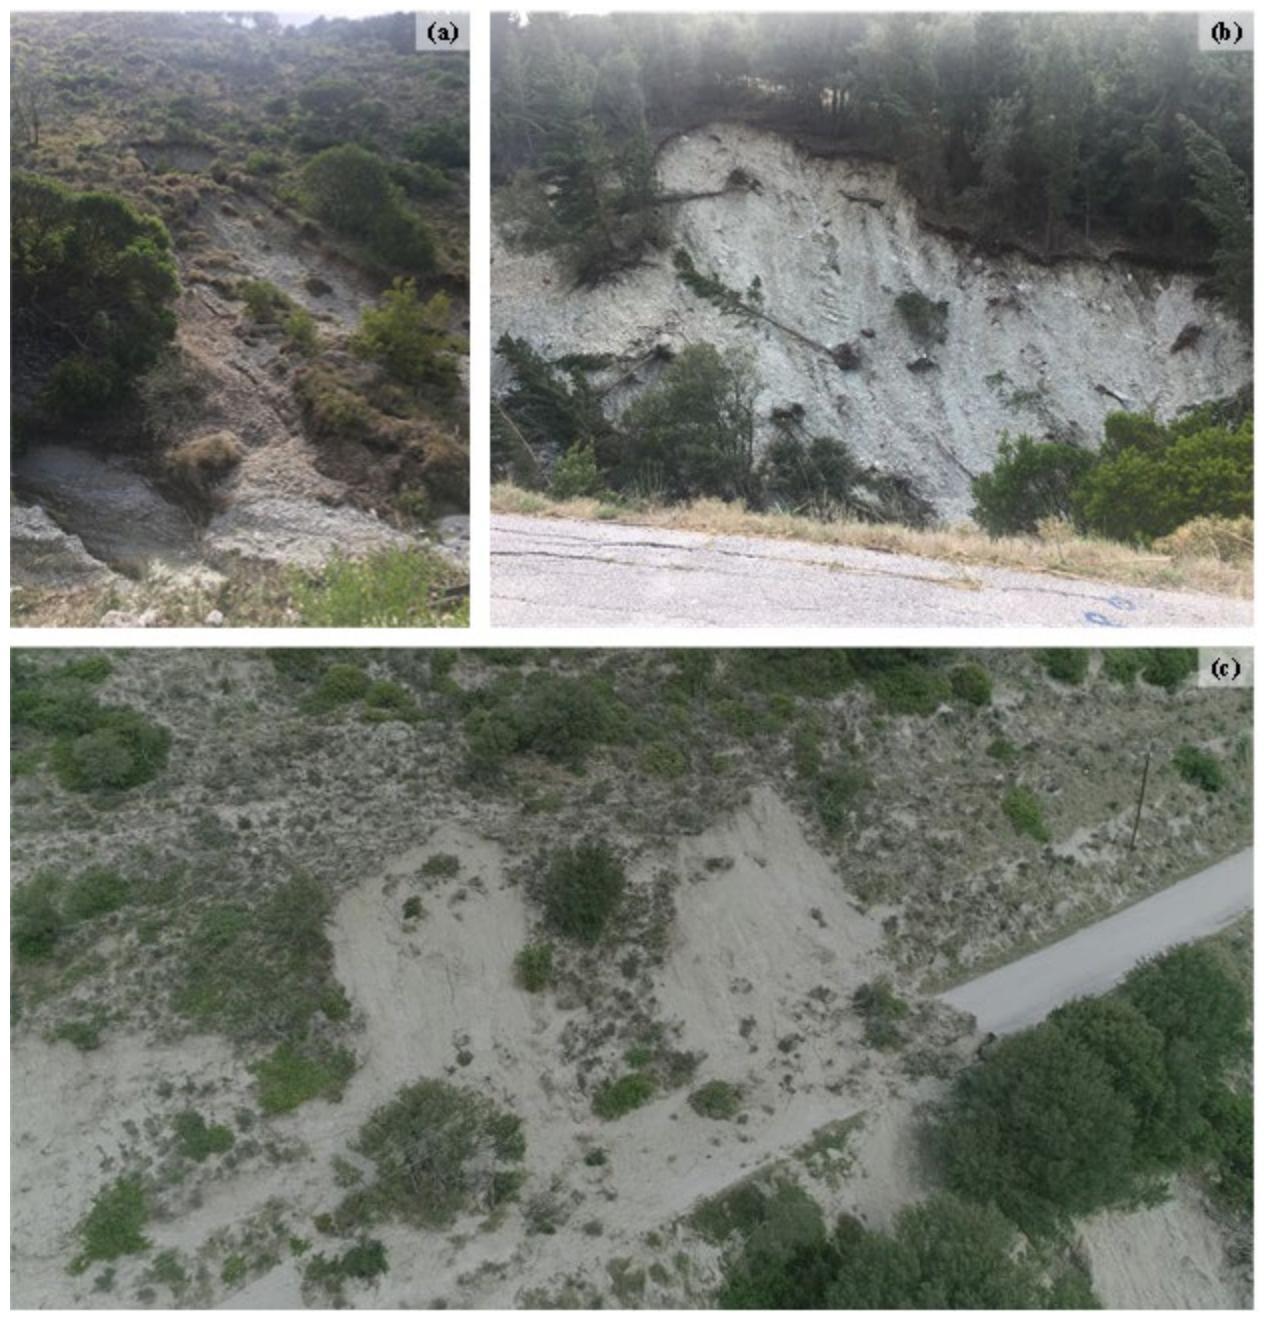
Figure 6.2. Rotational slides along the road to Myrtos beach through Divarata village: a) 38.33571944°N, 20.543633°E; b) 38.3365027°N, 20.5427166°E, c) 38.337106°N, 20.541785°E

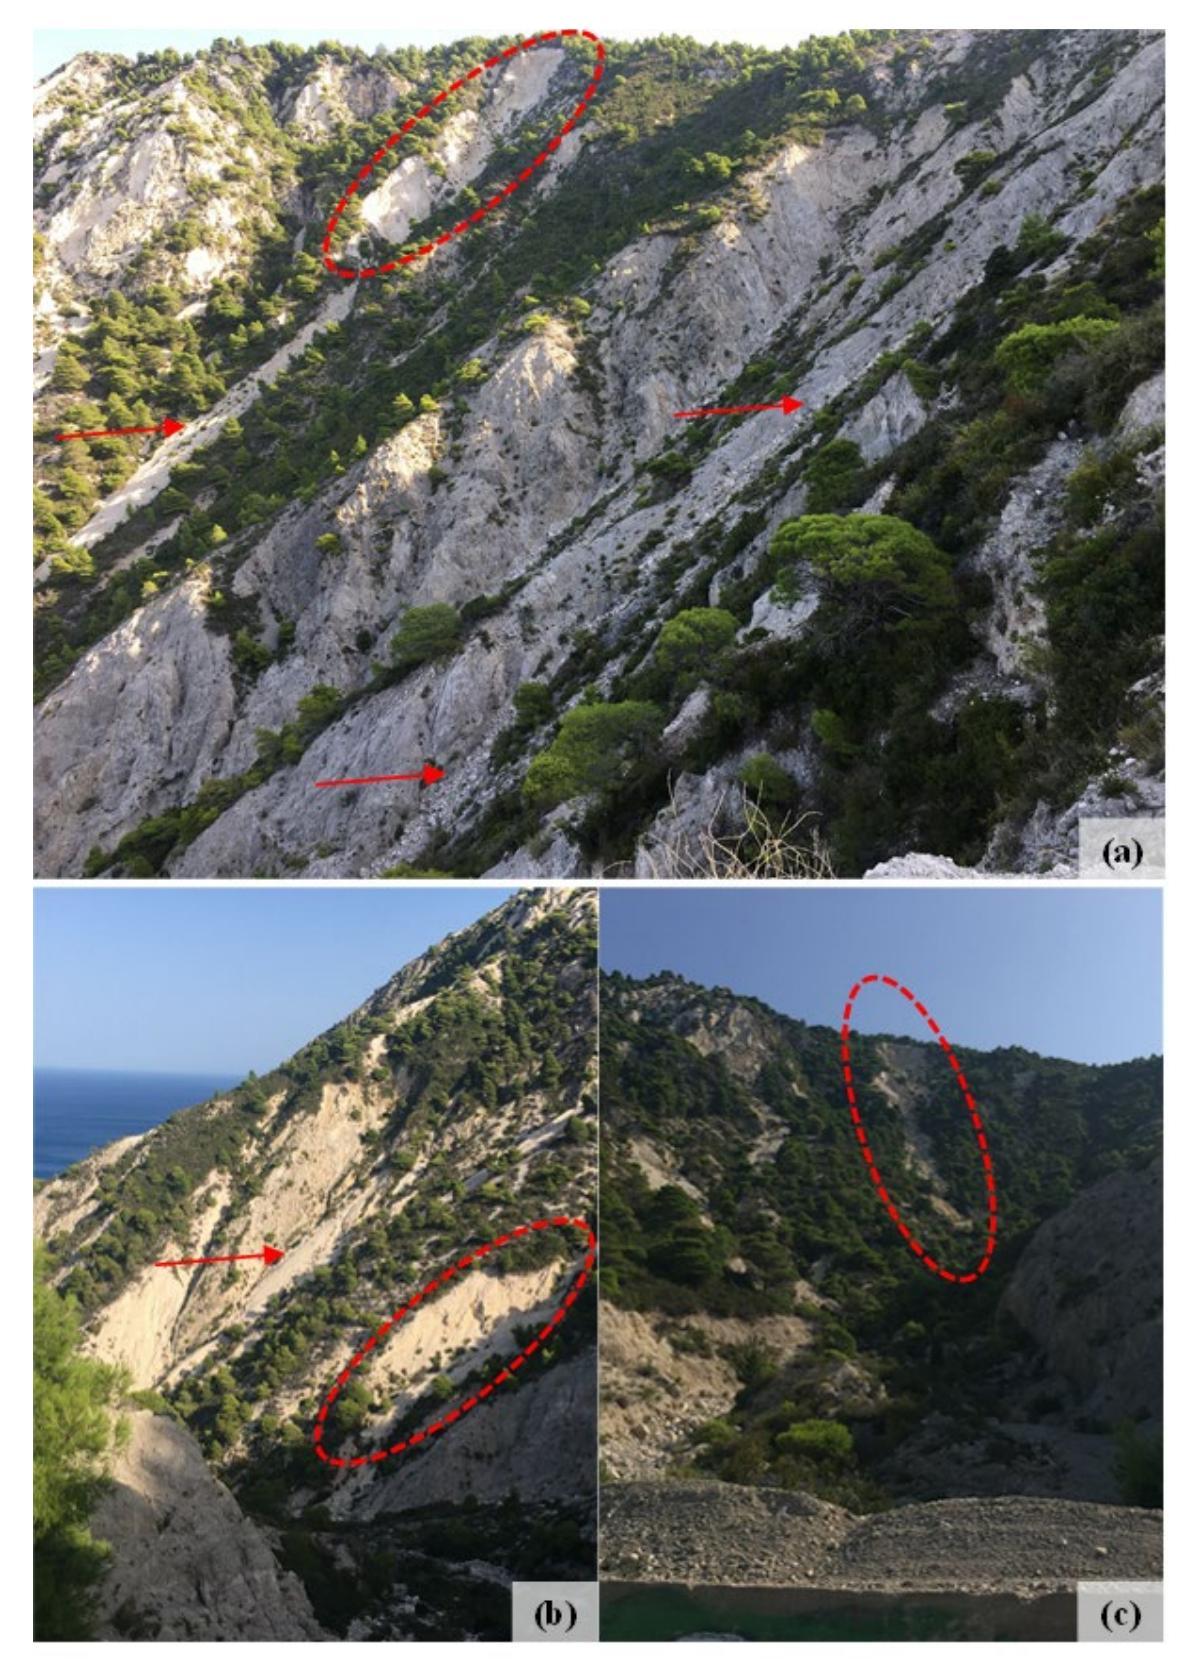
In Lefkada, the unfavorable wind conditions did not allow for UAV deployment for mapping purposes and thus imagery was collected primarily from the ground. Landslides along the coast were identified in several instances (Figure 6.4) and especially along the western coastline of Lefkada that had most recently experienced numerous landslides during the 2015 earthquake. These areas were affected by the precipitation with fresh sediment and debris found on the roads and at the beach (Figure 6.5). Previous mapping in the area last year had shown that the landslides remained active and thus, mapping the coastline to quantify that activity is valuable.

Figure 6.4. Evidence of mass movement along the steep western coastline of Lefkada island: a,b) 38.672194°N, 20.5629639°E, c) 38.67467°N, 20.55967°E

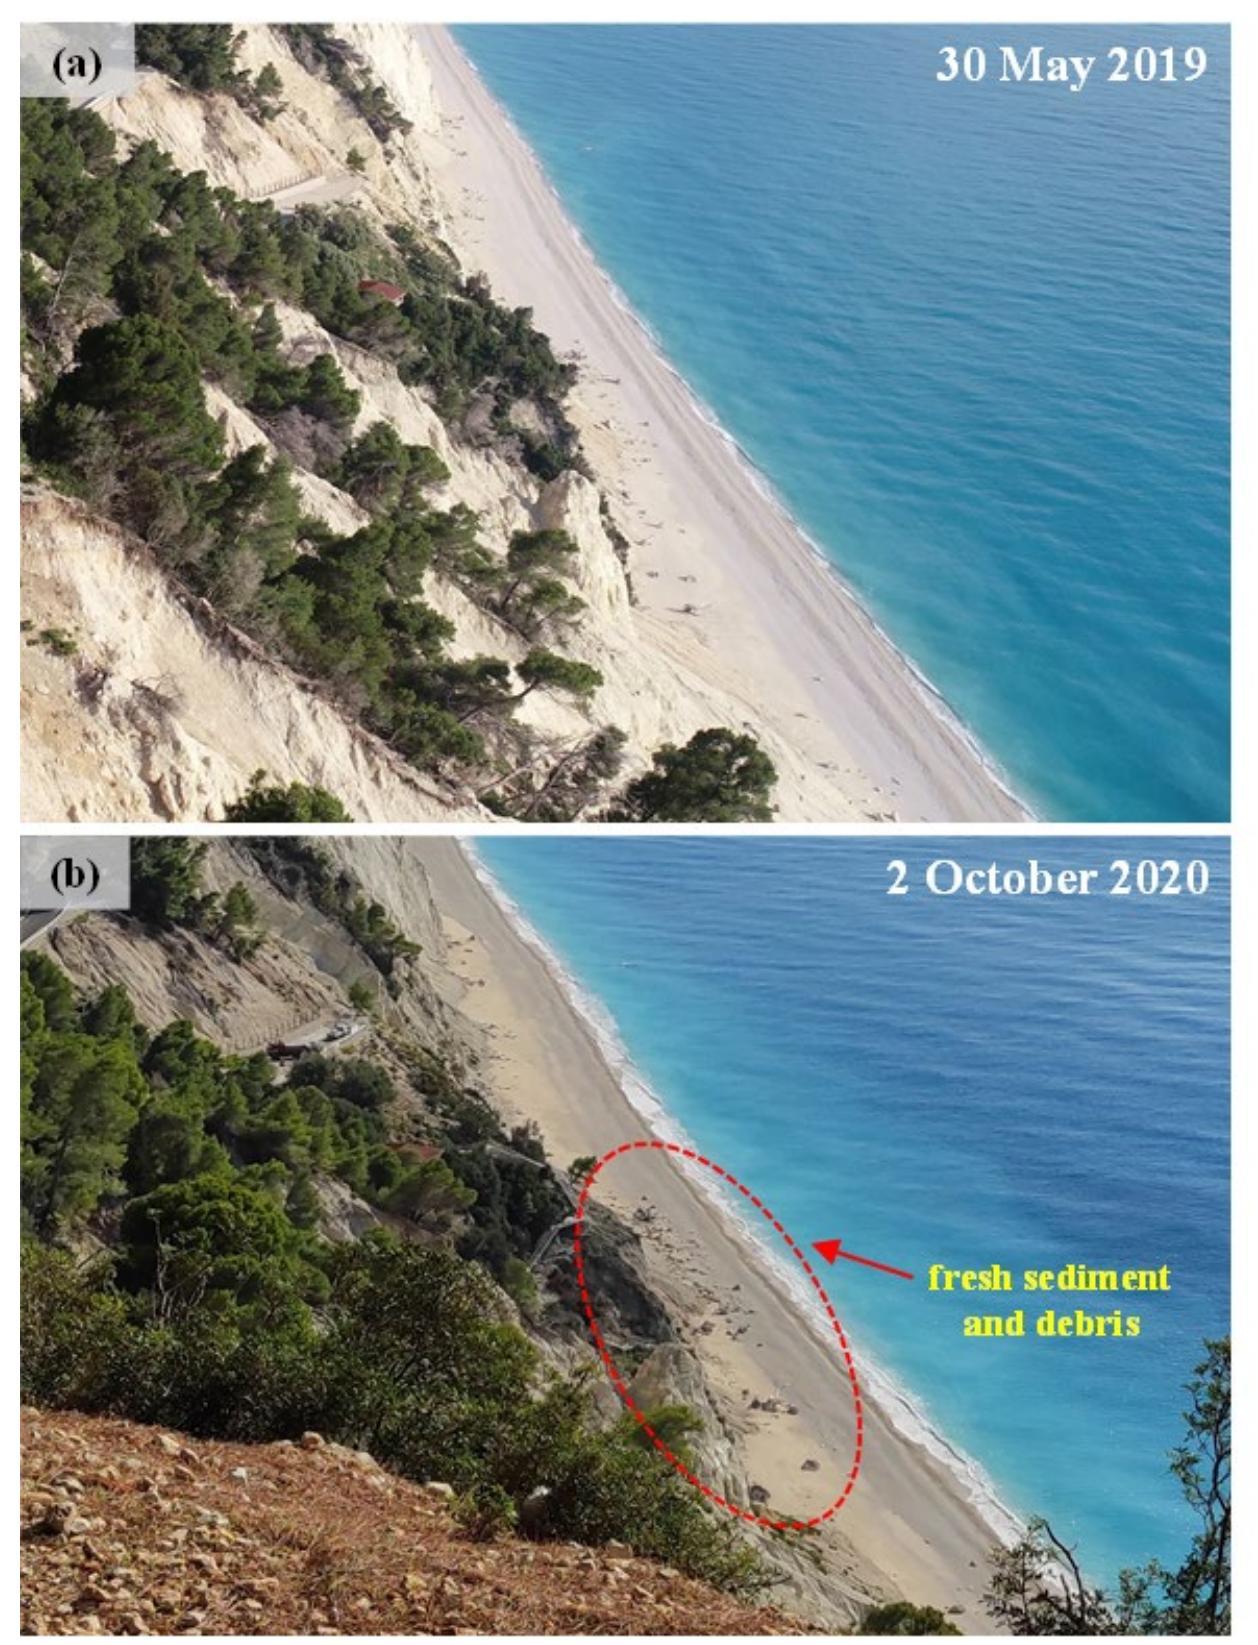
Figure 6.5. Evidence of fresh rockslide sediment and debris along the steep western coastline of Lefkada island (38.637676°N, 20.558488°E): a) pre-event photo, b) post-event photo.

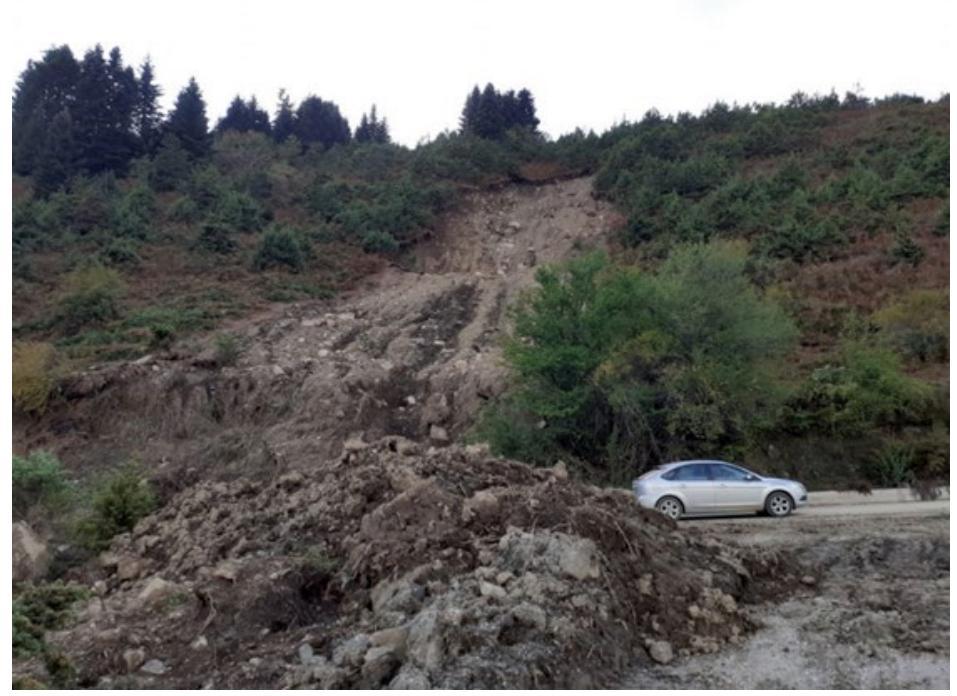
Figures 6.6 to 6.20 are characteristic examples of rotational slumps mainly formed in shale flysch, in conglomerates (flysch) and in weathered flysch. More specifically, the slope failure which occurred in location 41 (Figure 4.22) was formed in the weathered mantle of sandstone flysch (Figure 6.6). The complex sliding mechanism includes a rotational failure followed by an earth flow that has impacted the roadway. The slump is considered deep-seated with an estimated height and length of 30 and 50 m, respectively. Another example is the complex slope failure in location 50 (Figure 6.7) which consisted of one of the most extensive landslides that was detected during this expedition. Its height and length were calculated at 70 and 150 m, respectively. The landslide is relatively shallow (7-10 m deep) and is formed in two parts: 1) a rotational landslide at the upper part and 2) an earth flow at the lower part. This slope failure occurred in shale flysch. In Figure 6.20, another significant rotational slide in the weathered mantle of sandstone flysch was documented. The landslide resulted in the collapse of the road. The length and depth of the slide were 10 meters.

Figure 6.6. Complex slide (slump – earth flow) in mixed type flysch (39.3118220°N, 21.5960140°E)

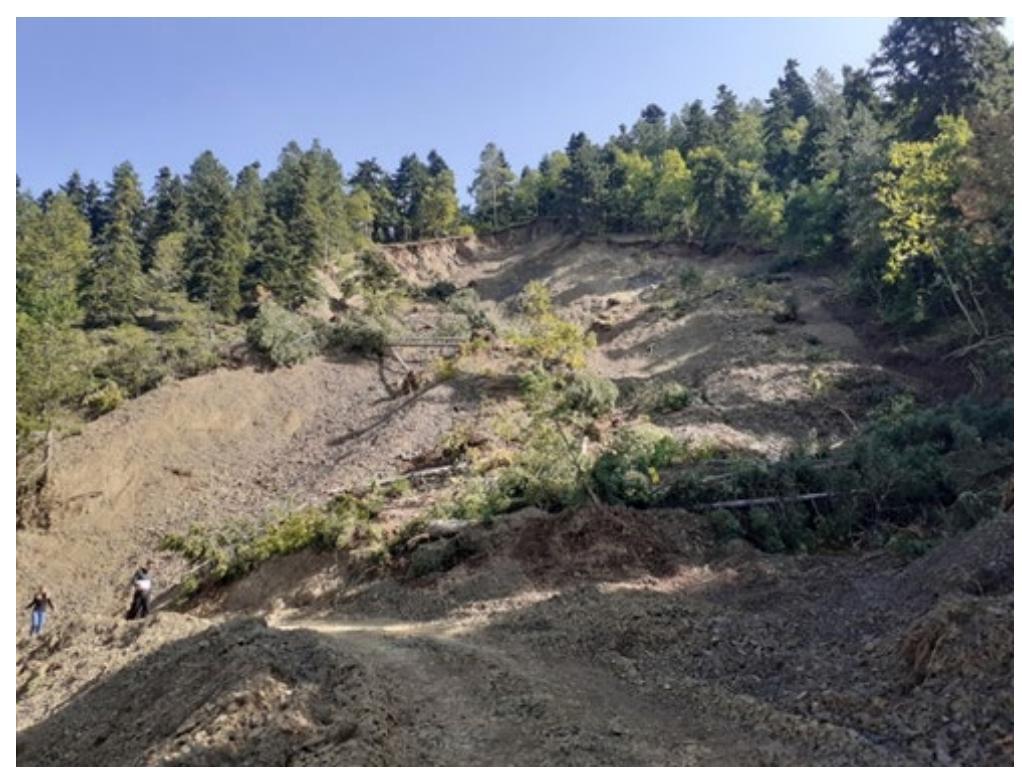
Figure 6.7. Complex slide (rotational and earth slide) in shale dominant flysch. The slipped material has completely covered the road (39.2116910°N, 21.7942940°E)
