The September 18-20 2020 Medicane Ianos Impact on Greece

Phase I Reconnaissance Report

Geotechnical Extreme Events Reconnaissance Association

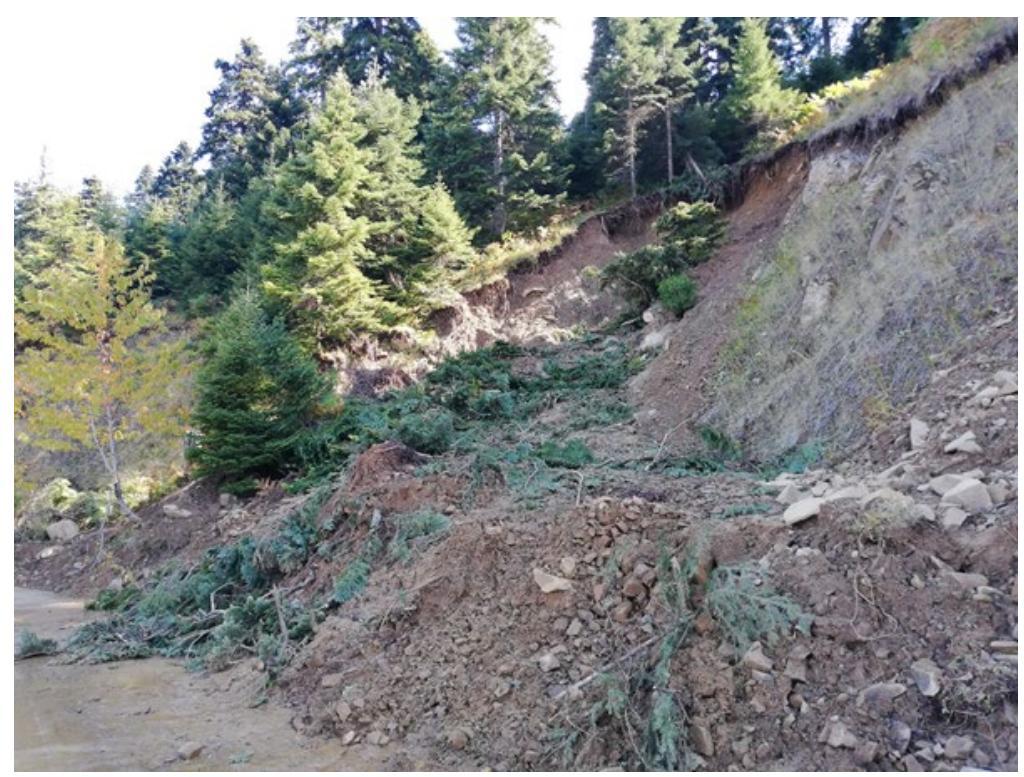
Figure 6.8. Complex slide (slump – earth flow) (39.28353°N, 21.68537°E)

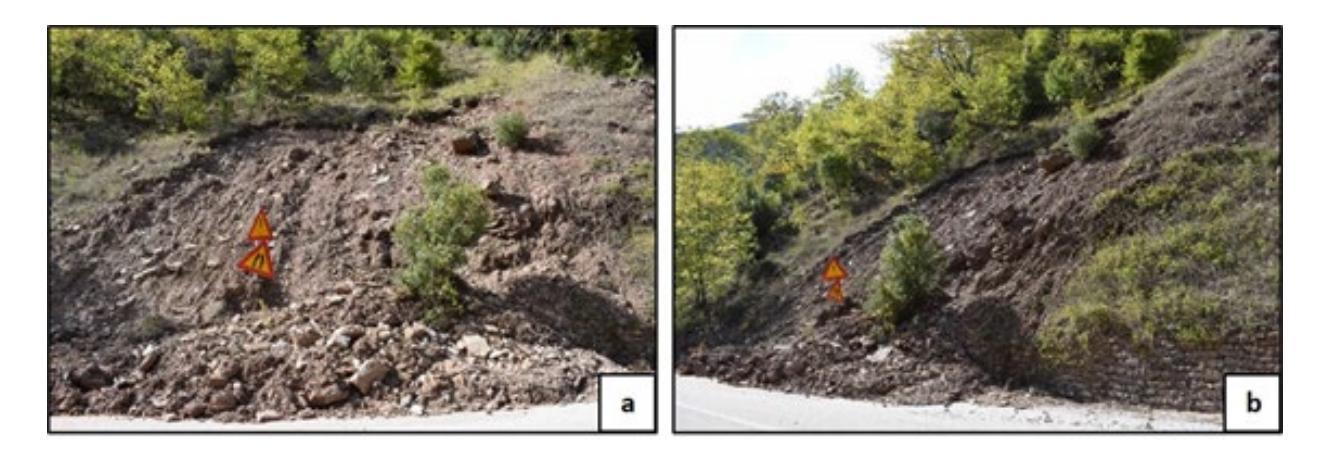
Figure 6.9. Rotational slide along the Argithea to Zervo village road (39.351111°N, 21.521389°)

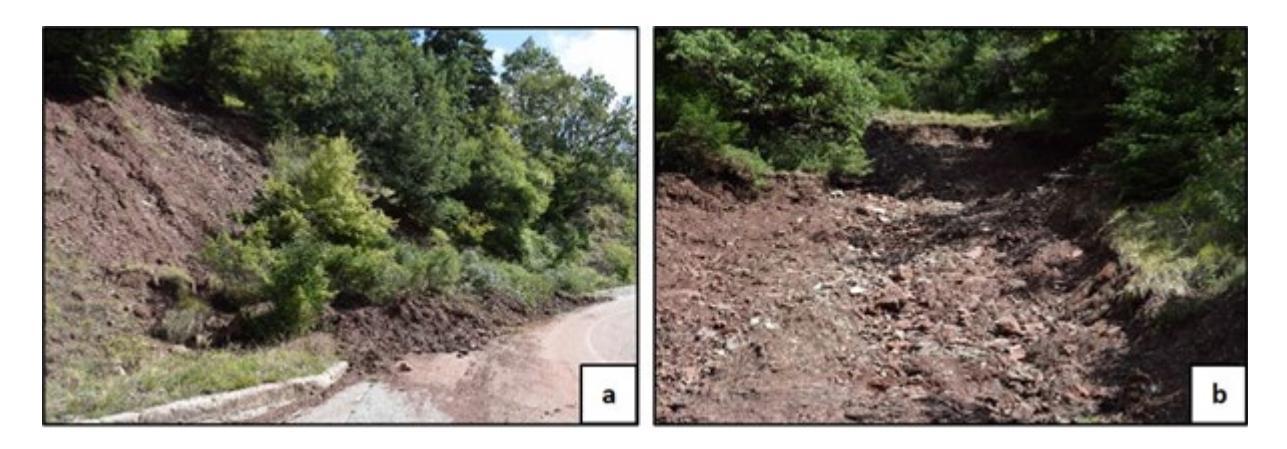
Figure 6.12. Rotational slide in Eastern Argithea area (39.363889°N, 21.538611°E).

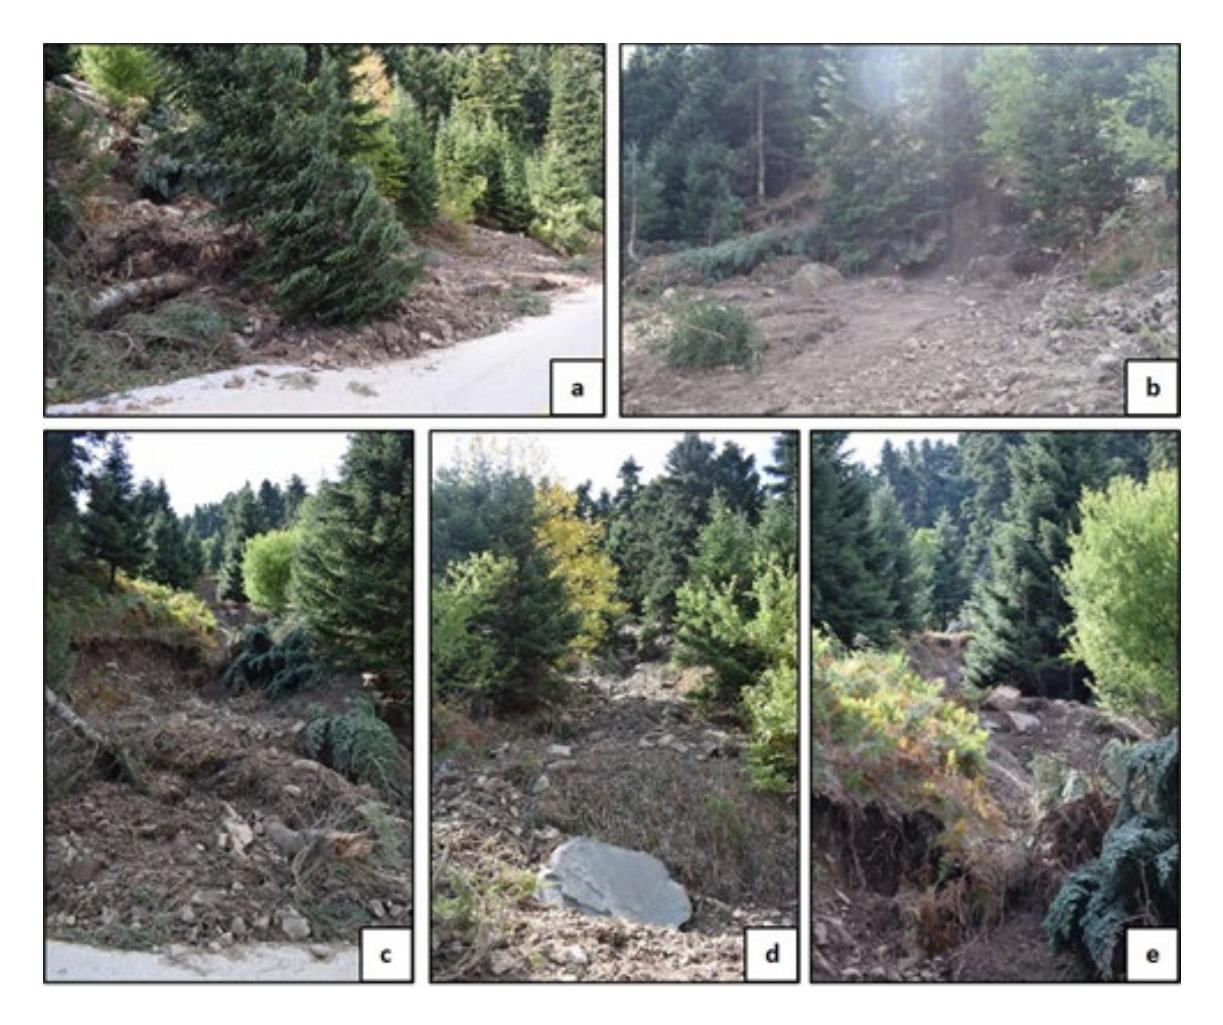
Figure 6.13. Rotational slide on the road to Oxya village (39.366667°N, 21.592222°E)

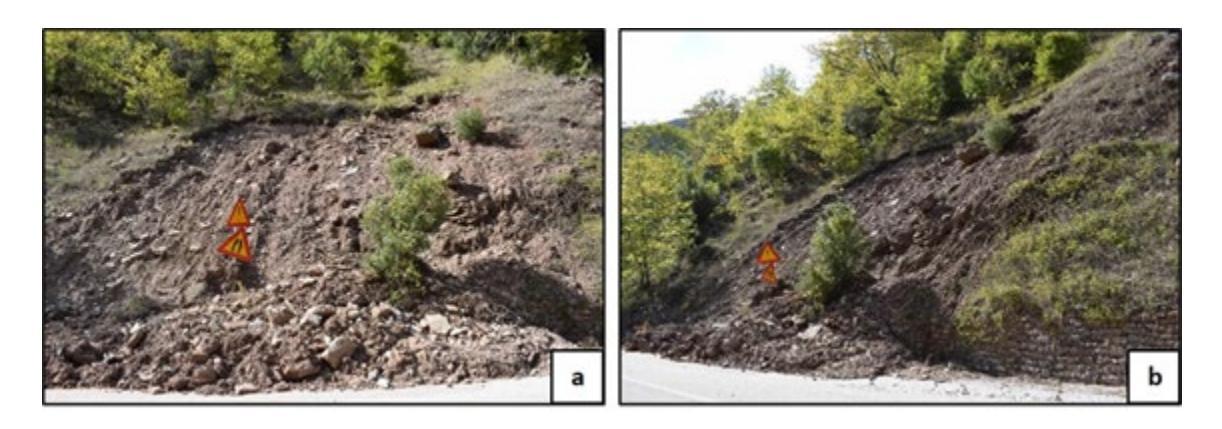
Figure 6.14. Rotational slide at Argithea to Zervo road (39.351111°N, 21.521389°E).

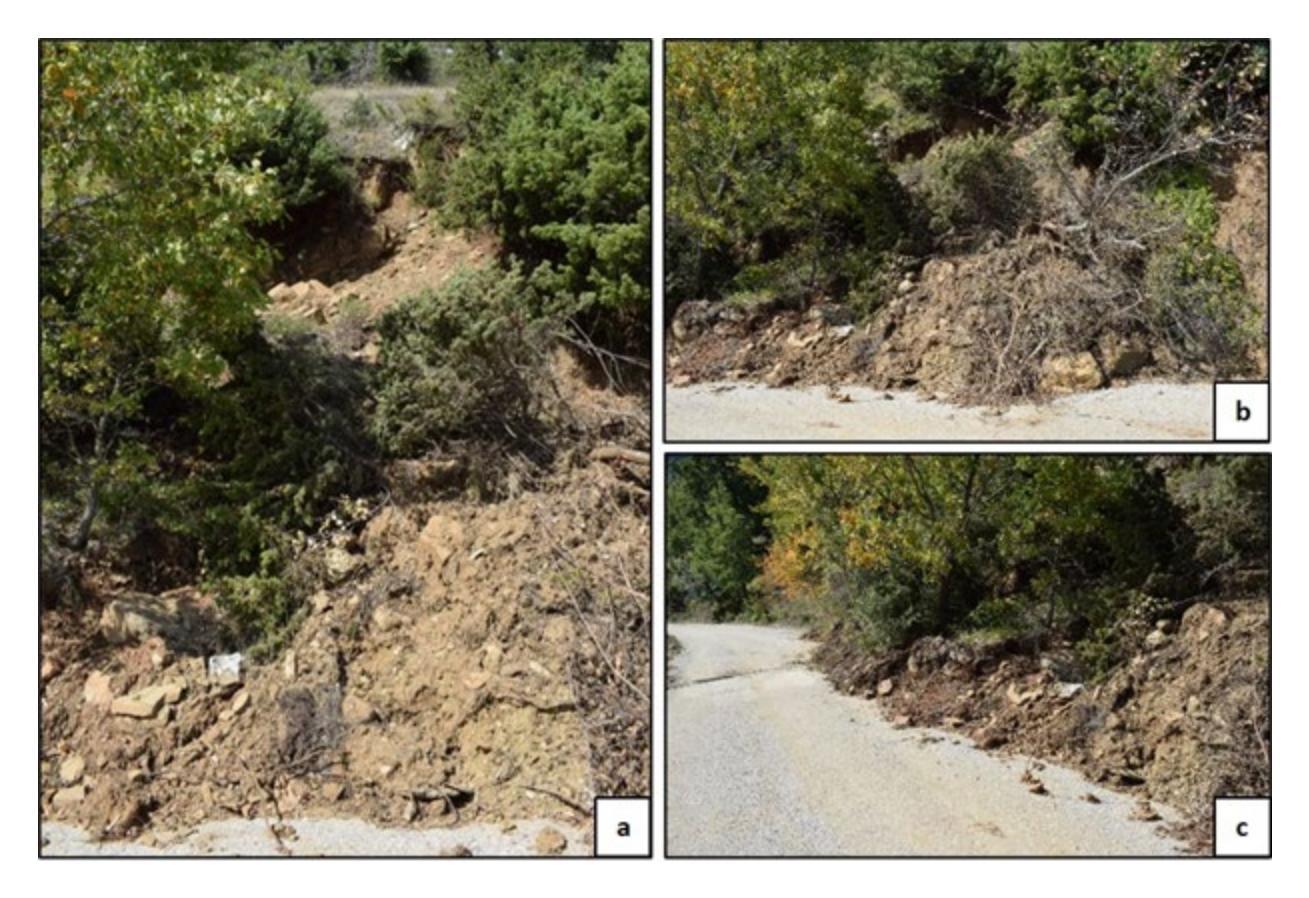
Figure 6.15. Rotational slide on the road to Oxya village (39.36°N, 21.591944°E)

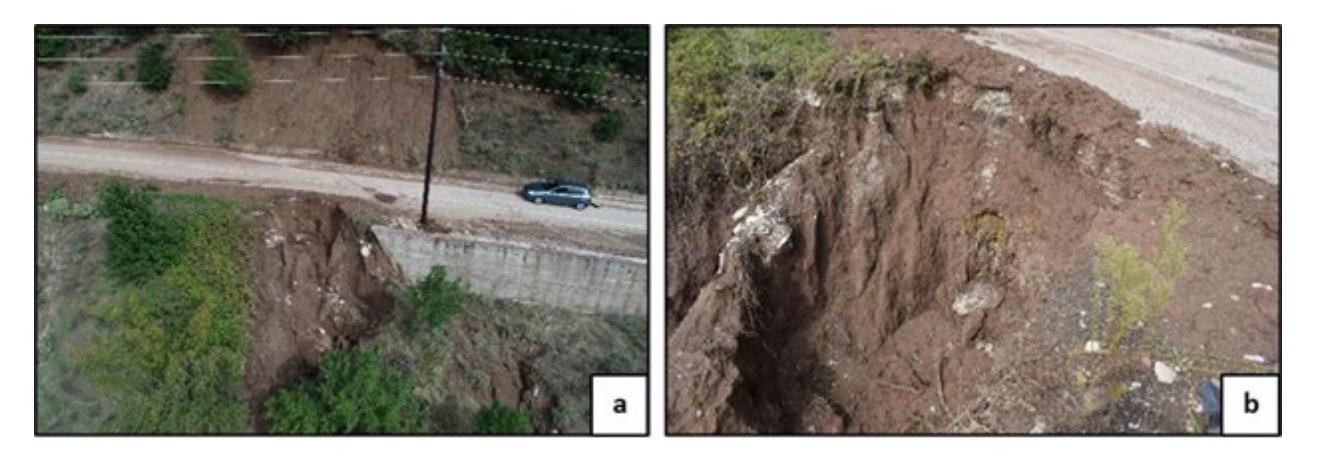
Figure 6.16. Rotational slide towards Porti village (39.425833°N, 21.665556°E)

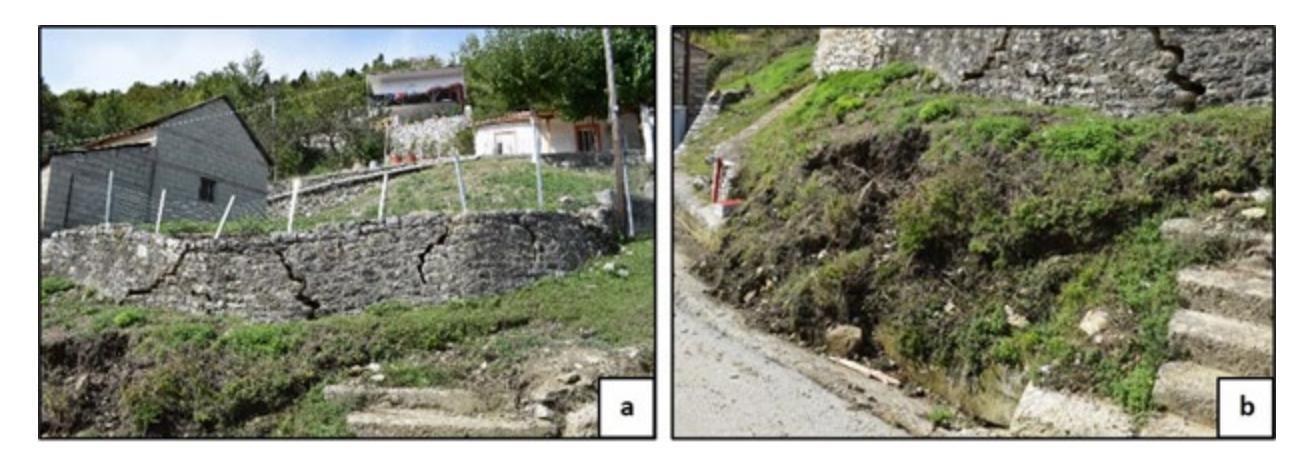
Figure 6.17. Rotational slide on the road to Oxya village that damaged a retaining wall (39.358889°N, 21.596111°E)

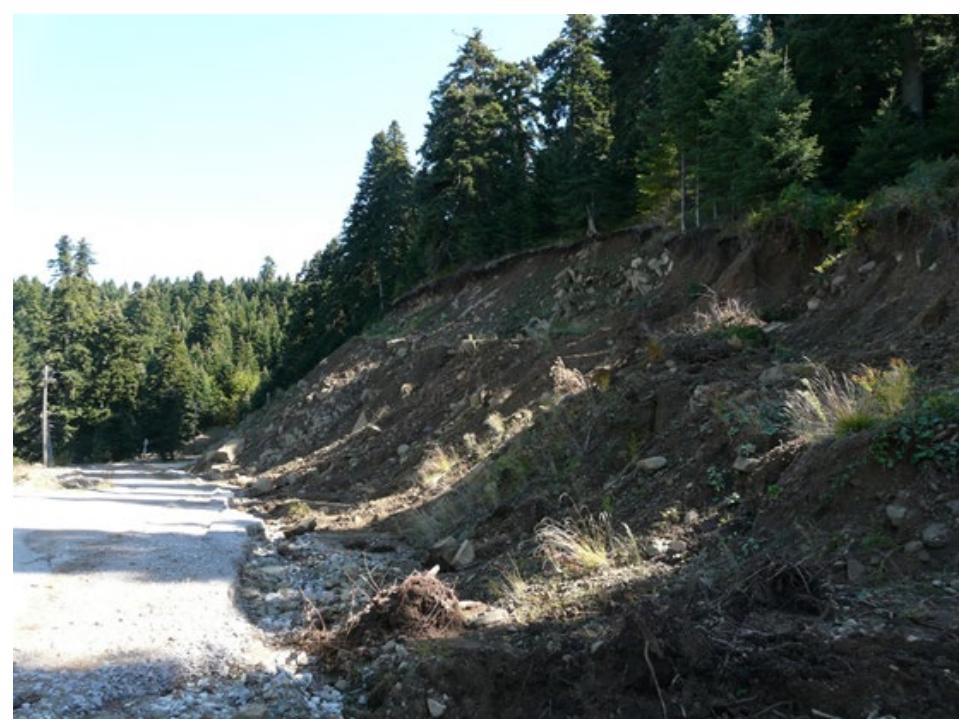
Figure 6.19. Rotational slide inducing damage on the road network (39.28596°N, 21.69099° E)

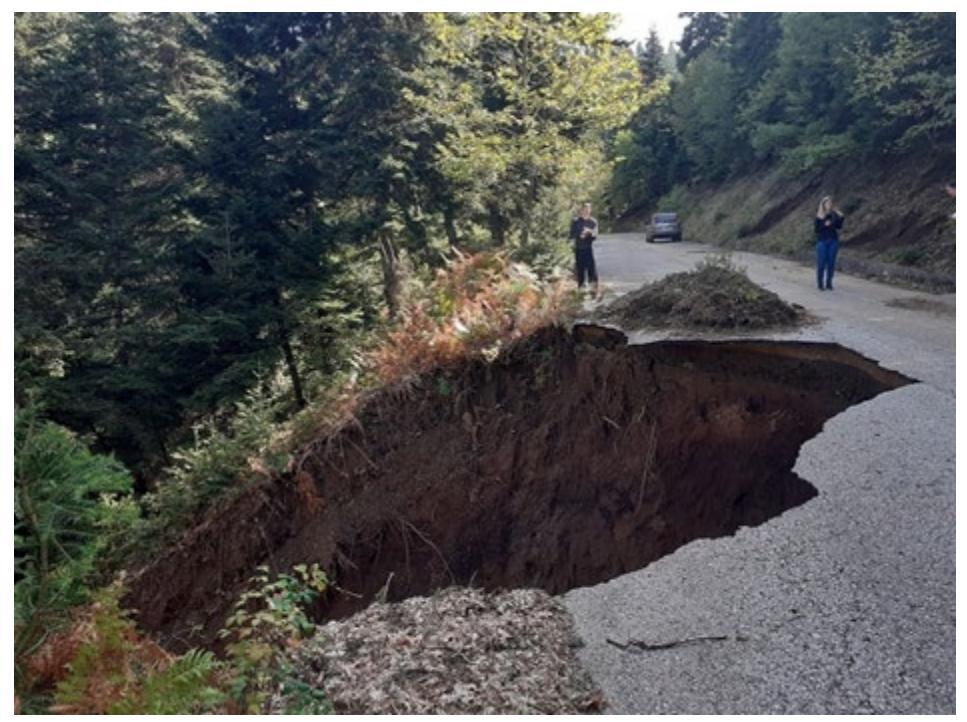
Figure 6.20. Rotational slide in weathered mantle that caused damage to road (39.2174890°N, 21.7949870°E)

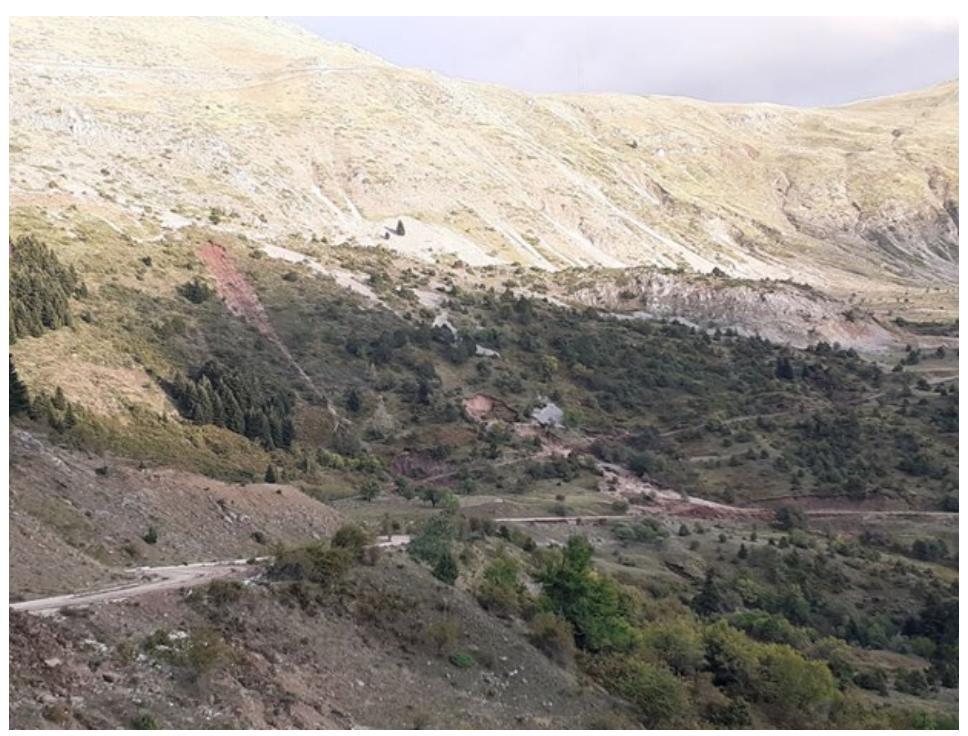
Figure 6.21. Earthflow in weathered mantle of shale flysch (39.3115490°N, 21.6142420°E)

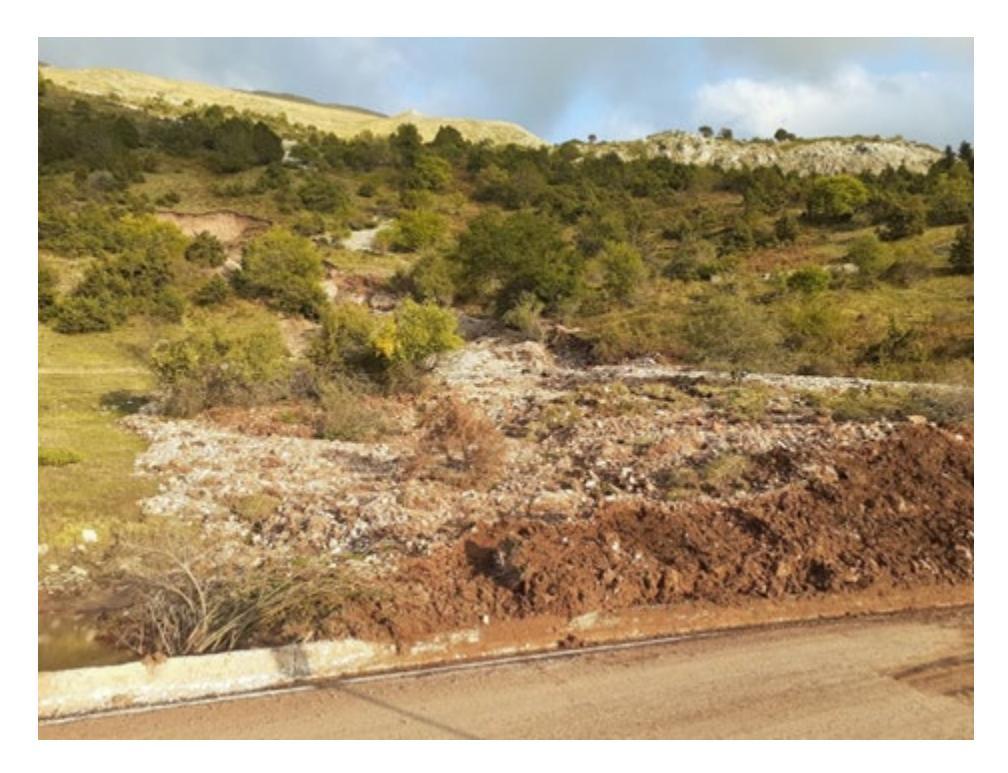
Figure 6.22. Accumulated earth material at the road level (39.3115490°N, 21.6142420°E)

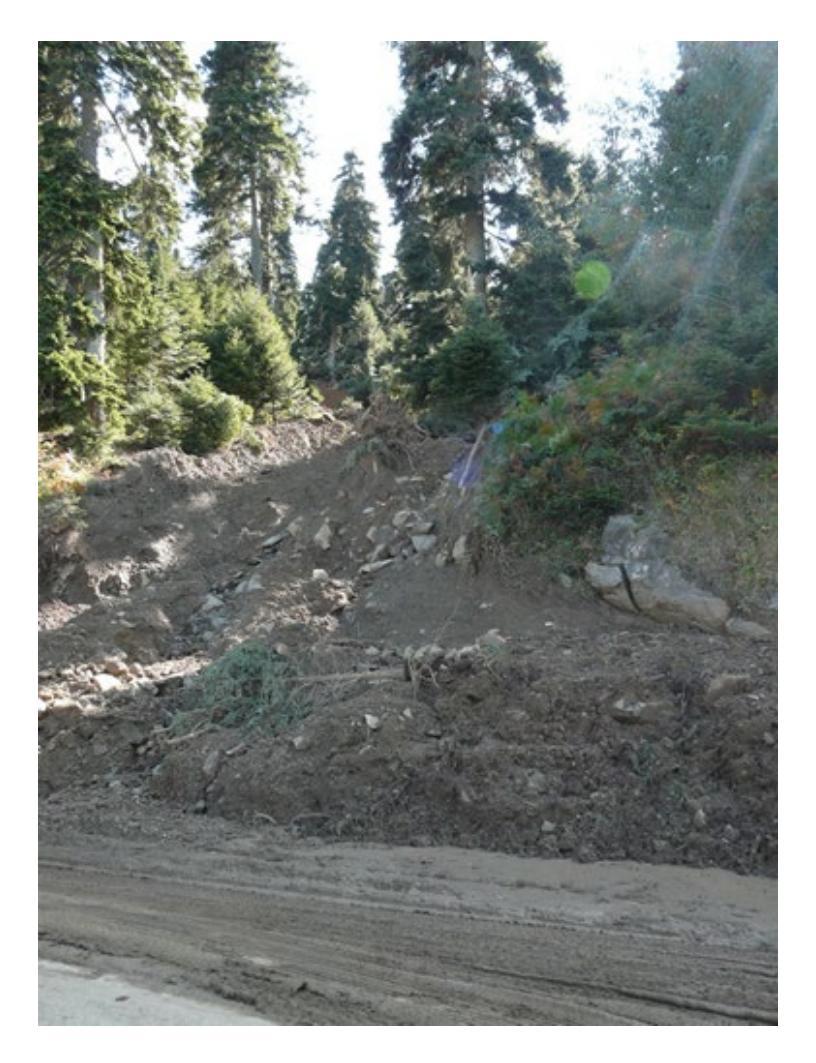
Figure 6.23. Accumulated earth material at the road level (39.28709°N, 21.69355°E)

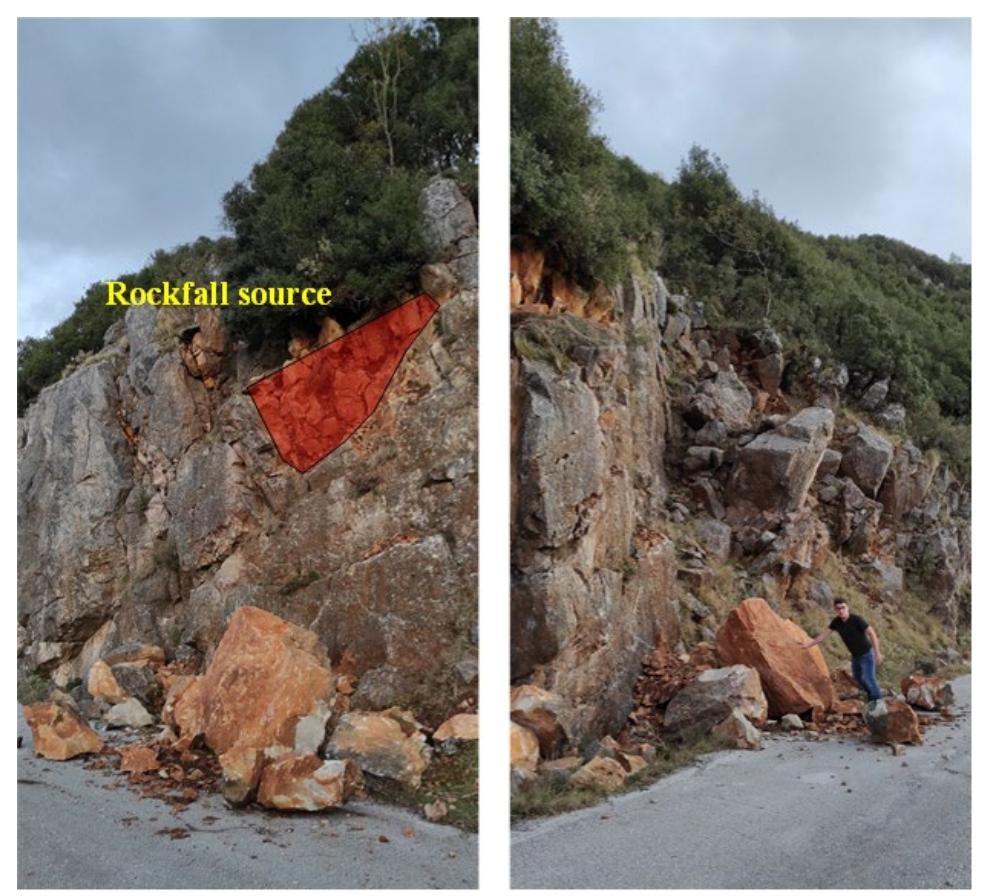
A single rockfall was encountered along the road network, during the reconnaissance deployment to Cephalonia (Figure 6.24). The limestone rock wedge had a size of approximately $2m \times 1.5m \times 1.5m$. Another rockfall example from Lefkada is shown in Figure 6.25. Moreover, the western coastline of Lefkada that had most recently experienced numerous landslides during the 2015 earthquake was affected by the precipitation with fresh rockslide sediment and debris found on the roads and at the beach (Figure 6.26).

Figure 6.24. Rockfall in Cephalonia island (38.36995197°N, 20.5684499722°E)

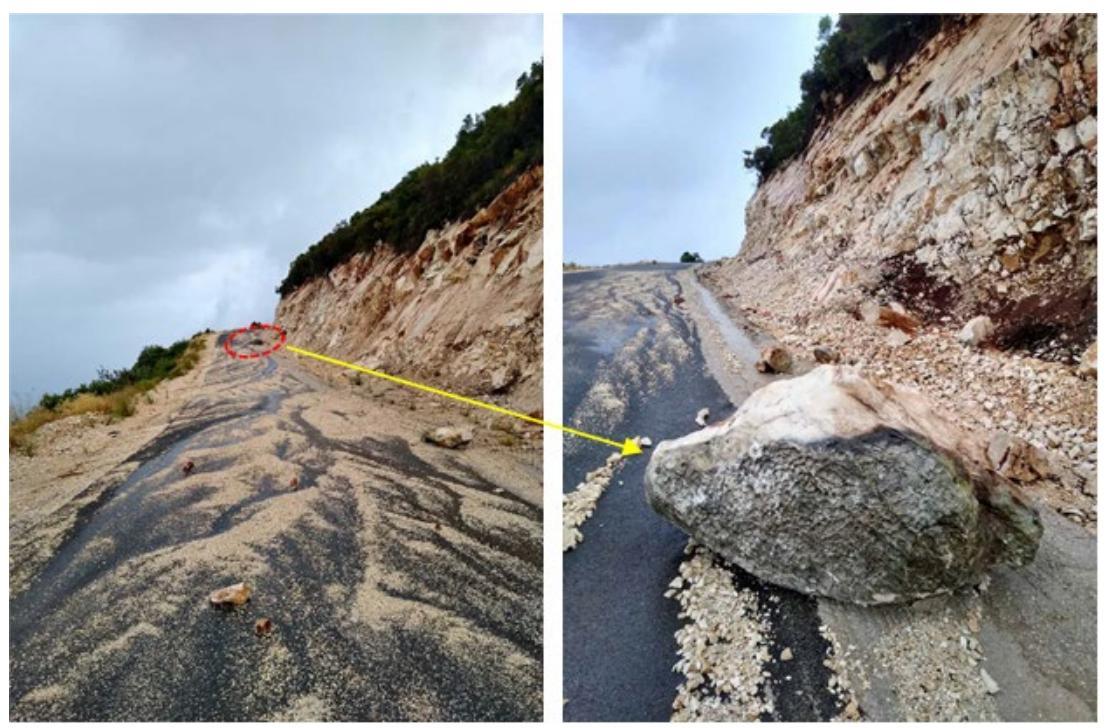
Figure 6.25. Rockfall in Lefkada island (38.616356°N, 20.57904167°E)

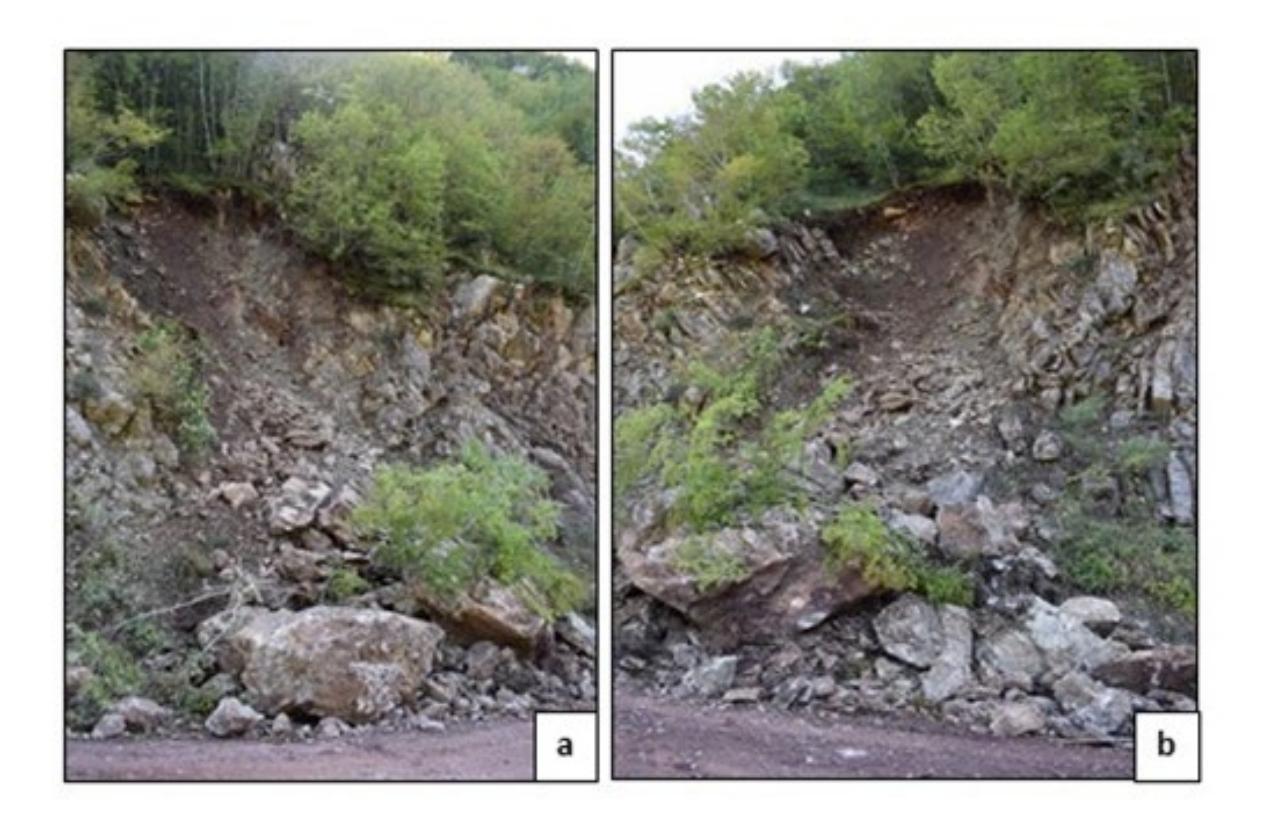
Figure 6.27. Rockslide failure at the area of Karpenisi - Vraggiana

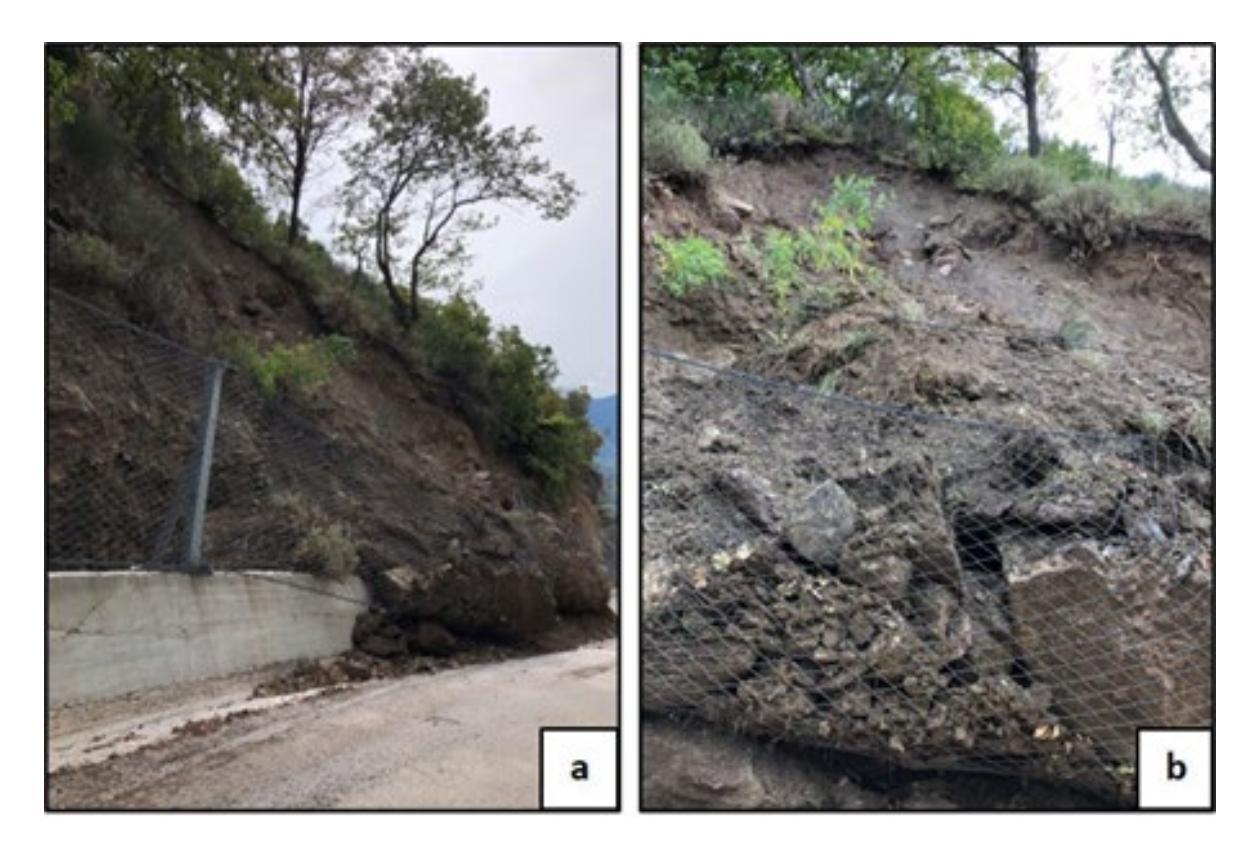
Figure 6.29. Rockslide towards Porti village (39.410556°N, 21.658611°E)

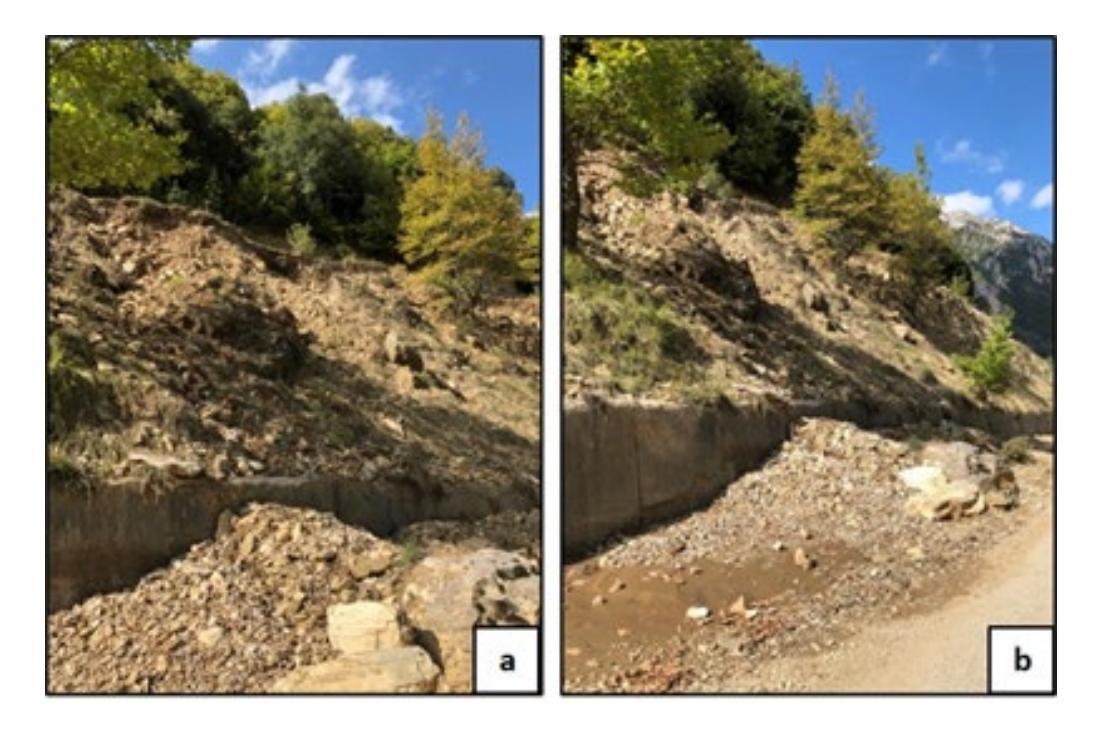
Figure 6.30. Rockslide along the road from Argithea to Zervo village road (39.3425°N, 21.514167°E)

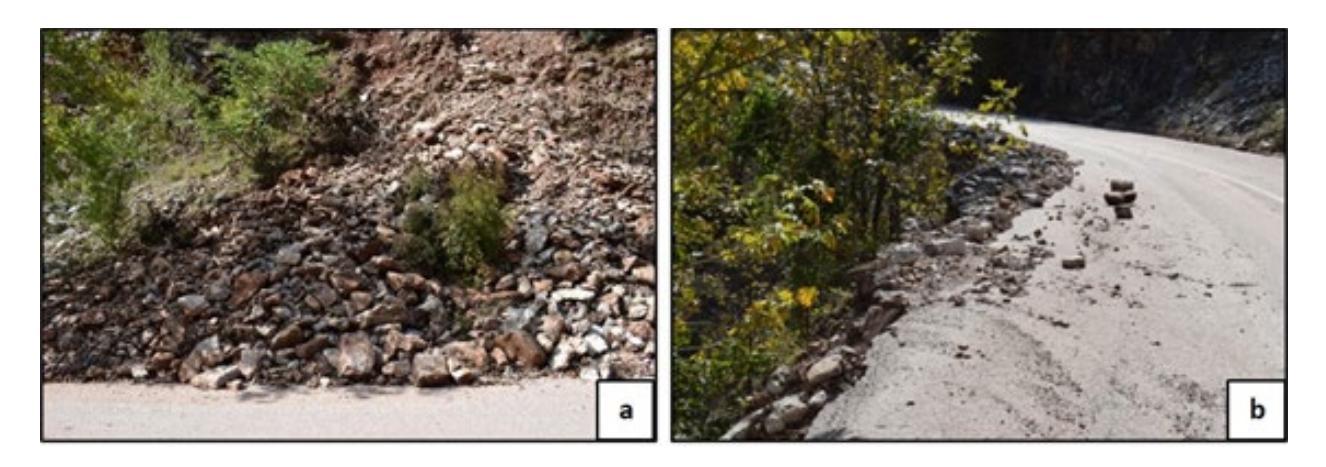
Figure 6.31. Rockslide along the road from Argithea to Zervo village road (39.348333°N, 21.517222°E)

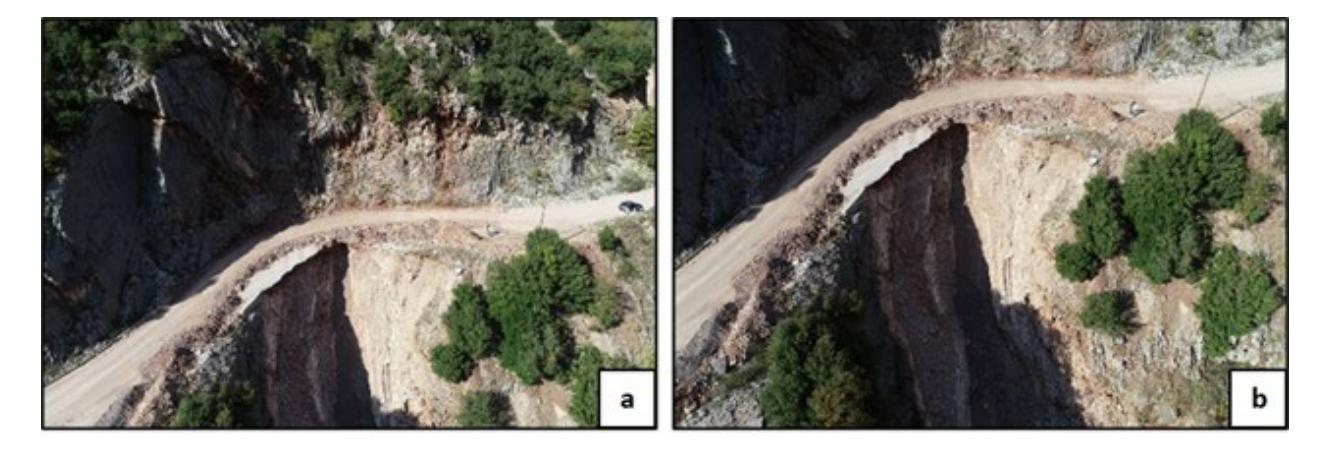
Figure 6.32. Rockslide along the Argithea to Zervo road network (39.354167°N, 21.5175°E).

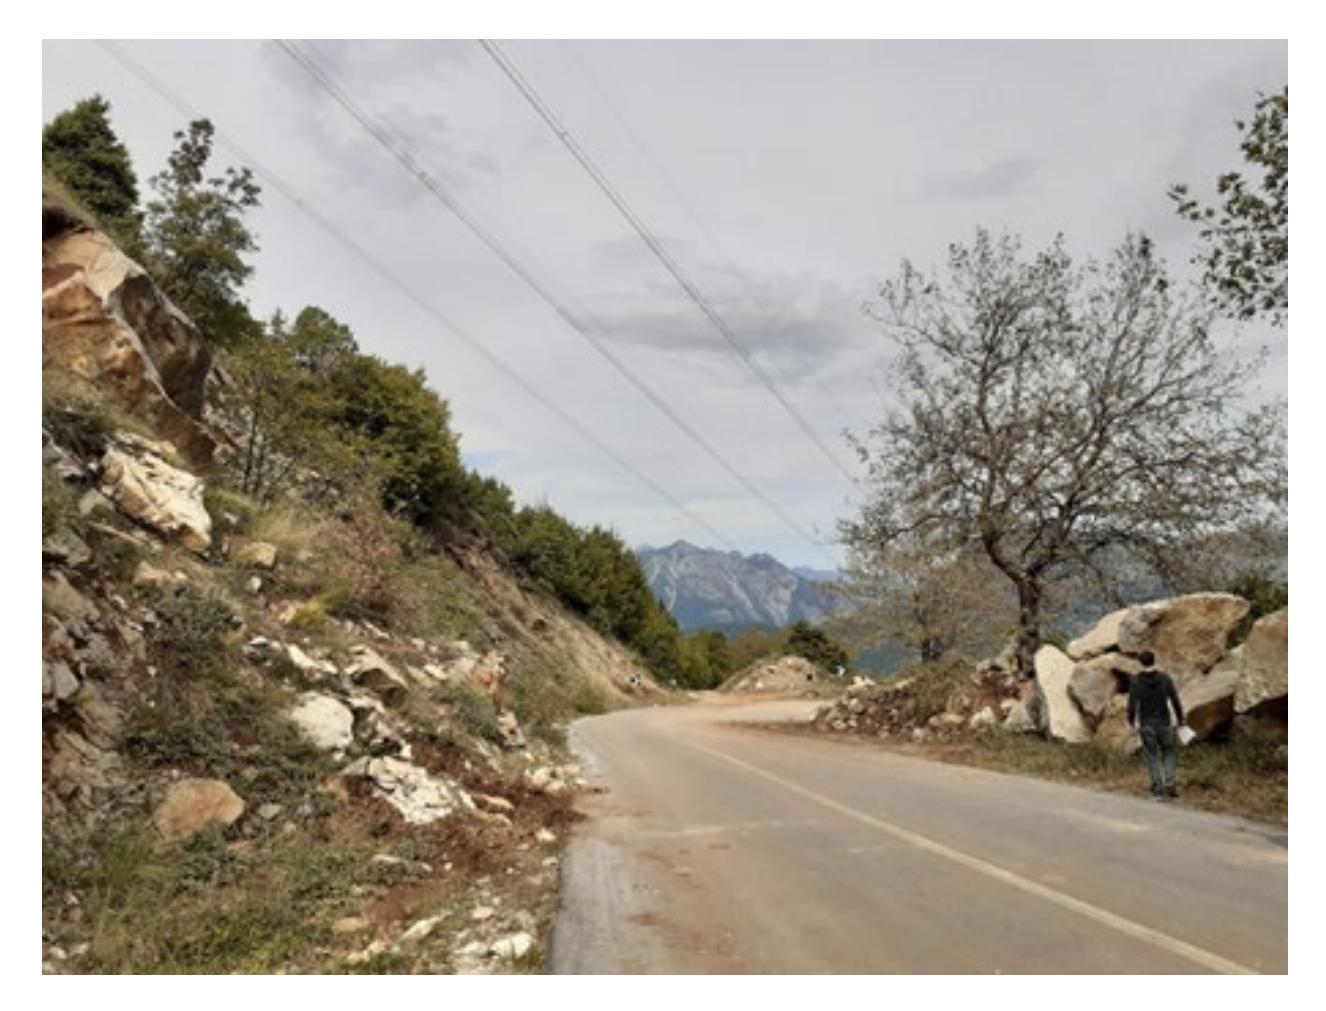
Figure 6.35. Planar sliding and rockfalls in limestone rockmass. Road to Oxia. (39.3895330°N, 21.6145240°E)

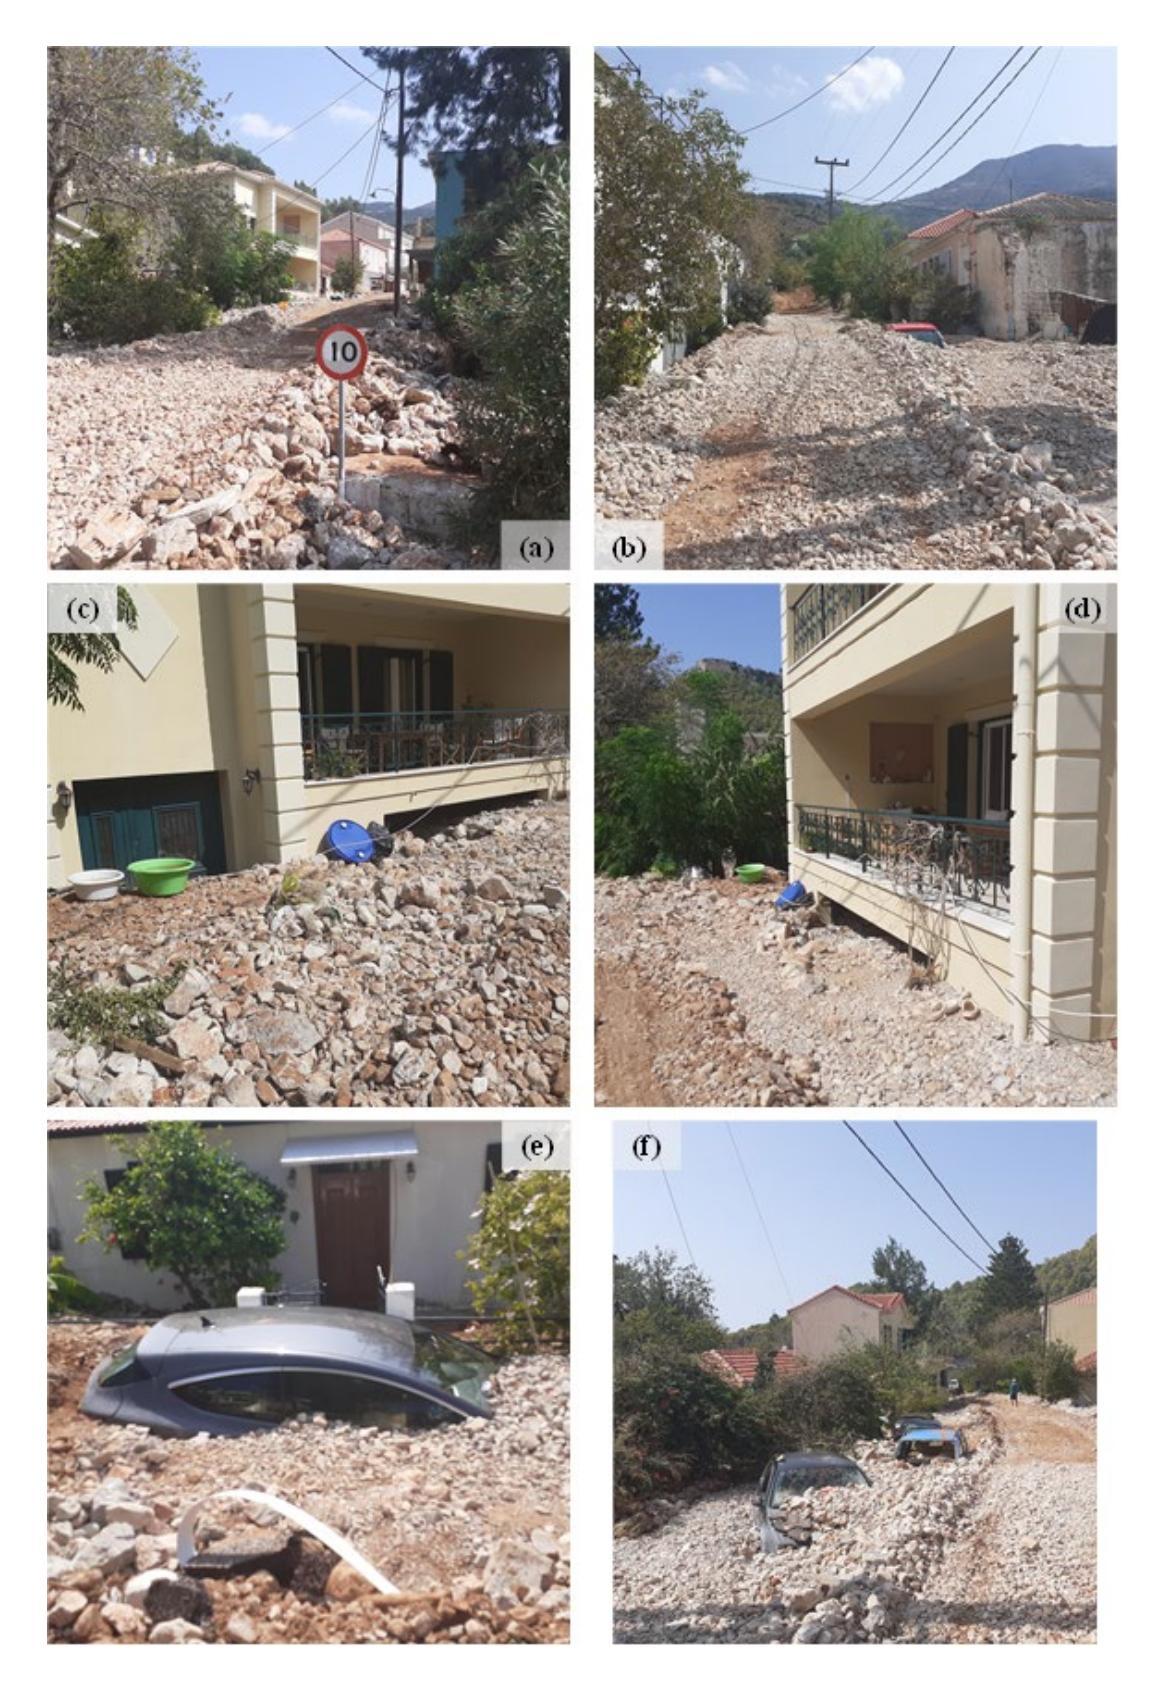
Figure 6.37. Debris flow within the village of Assos ($38.319506^{\circ}N$, $20.508197^{\circ}E$), as of 9/22/2020

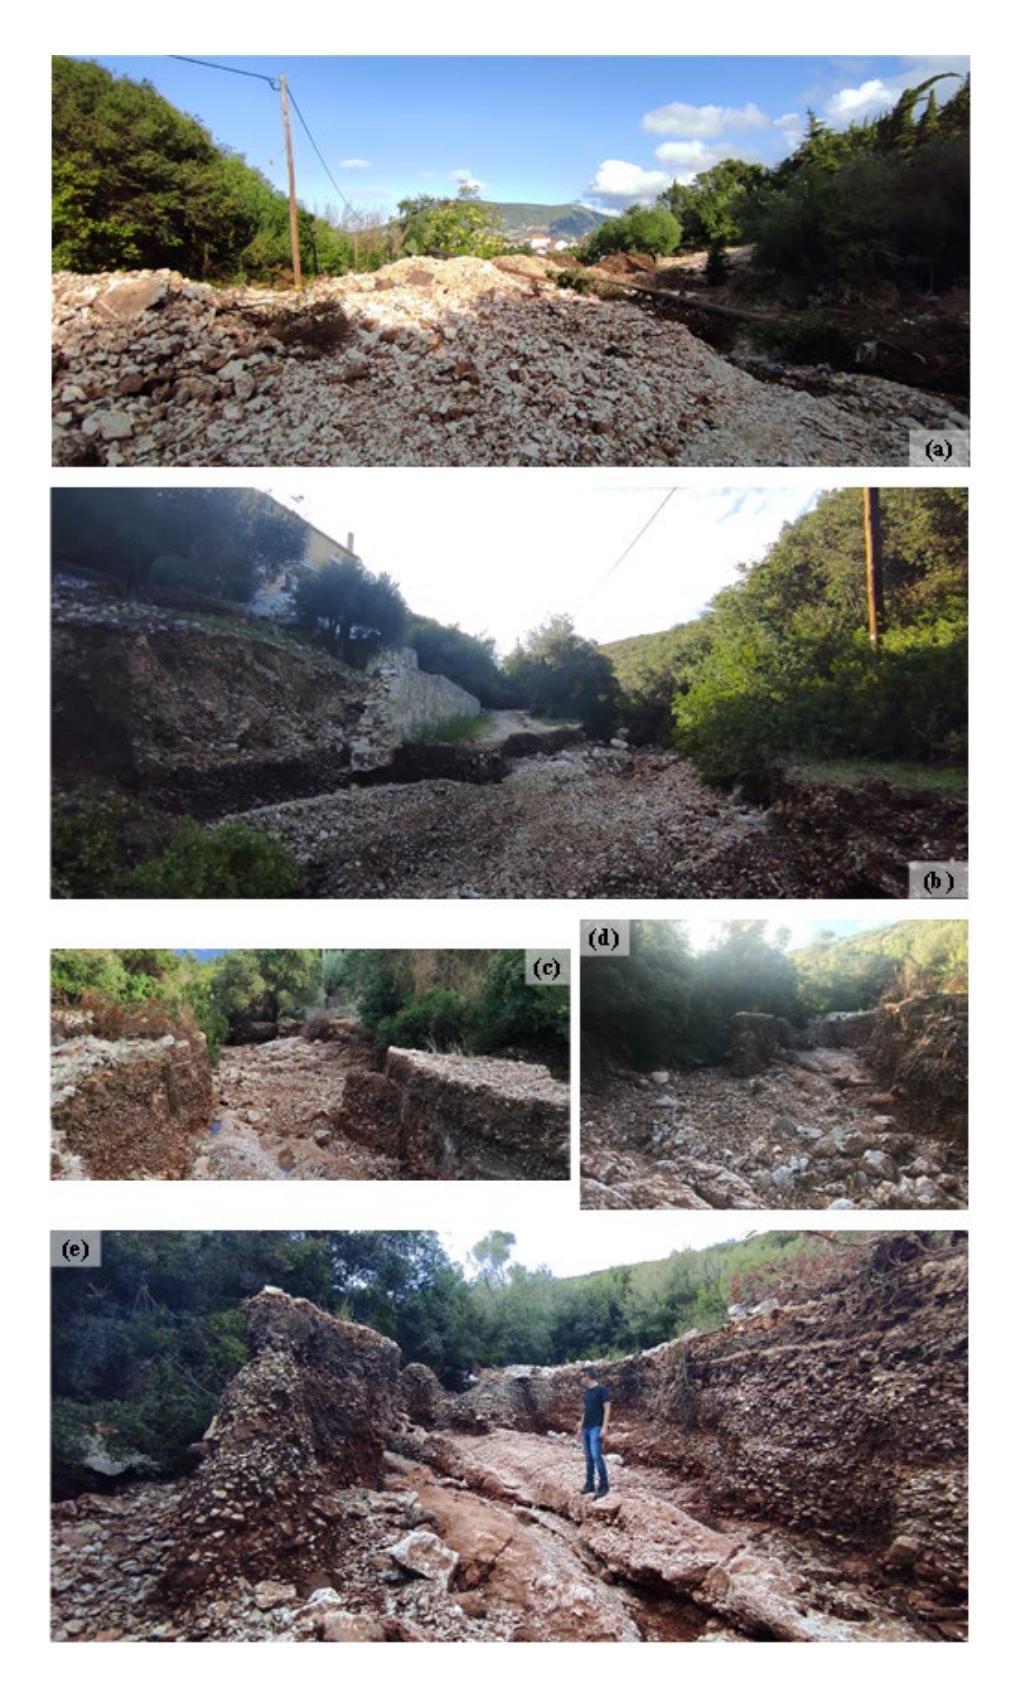
Figure 6.43. Manifestation of debris flow outside of Fiskardo village: a) 38.459158972°N, 20.573128°E; b) 38.459304°N, 20.57232°E; c,d, and e) 38.459501°N, 20.57179499°E

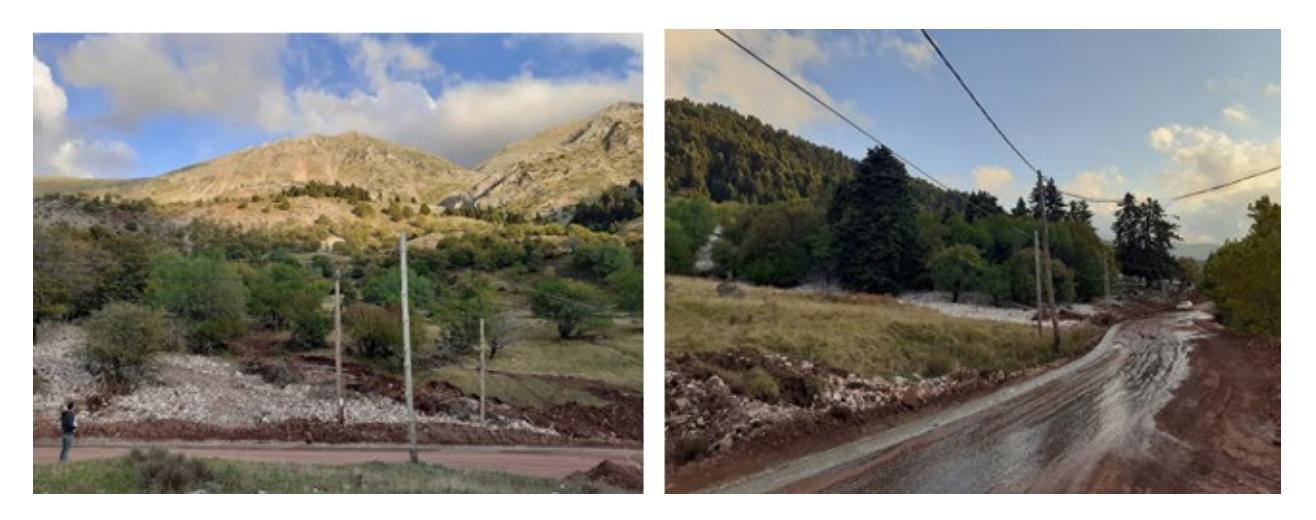
An example from Livadia is shown in Figure 6.49. The thickness of the accumulated debris material at the base of the slope was up to 5 meters while the width of the deposit area was about 300 meters. Additional examples are shown in Figure 6.50 to 6.57.

Figure 6.49. Debris flow at Livadia. (39.3036610°N, 21.6068020°E)

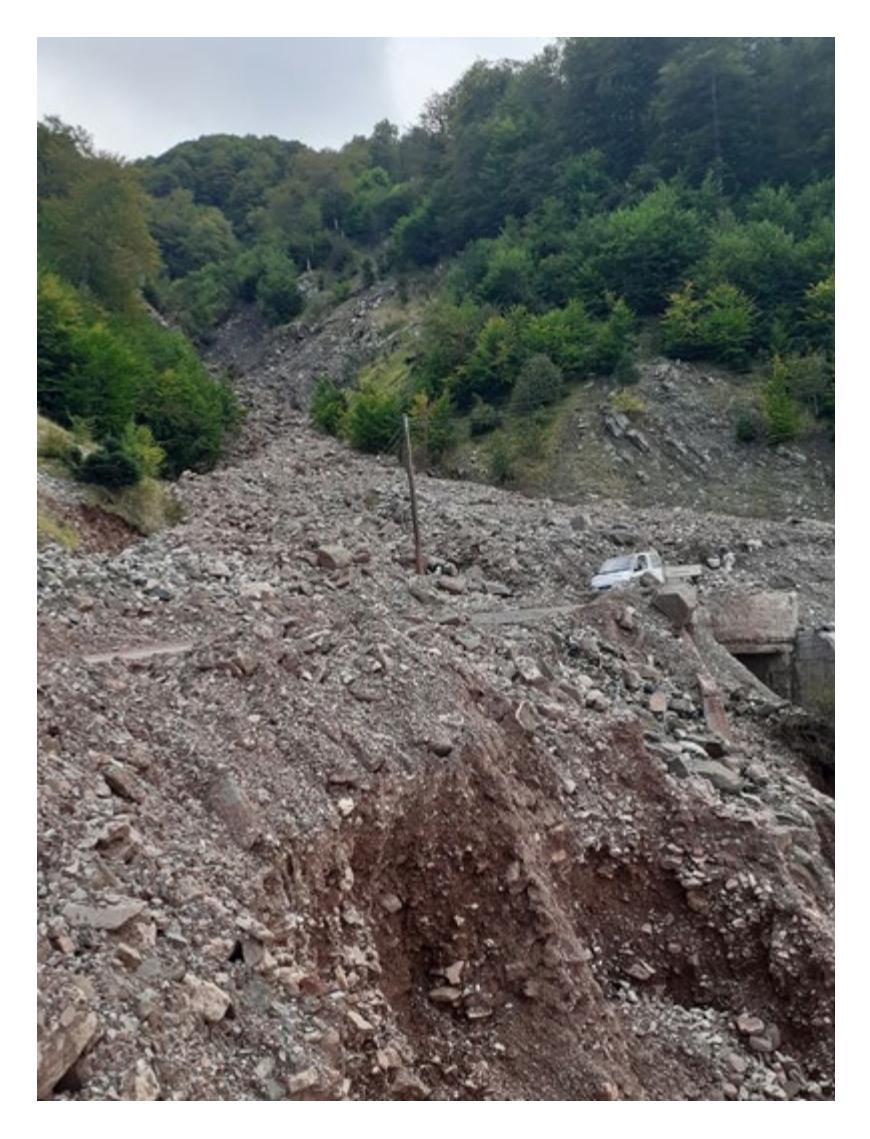
Figure 6.50. Debris flow in gully at Pefkofito area. (39.3296110°N, 21.6094720°E)
