The September 18-20 2020 Medicane Ianos Impact on Greece

Phase I Reconnaissance Report

Geotechnical Extreme Events Reconnaissance Association

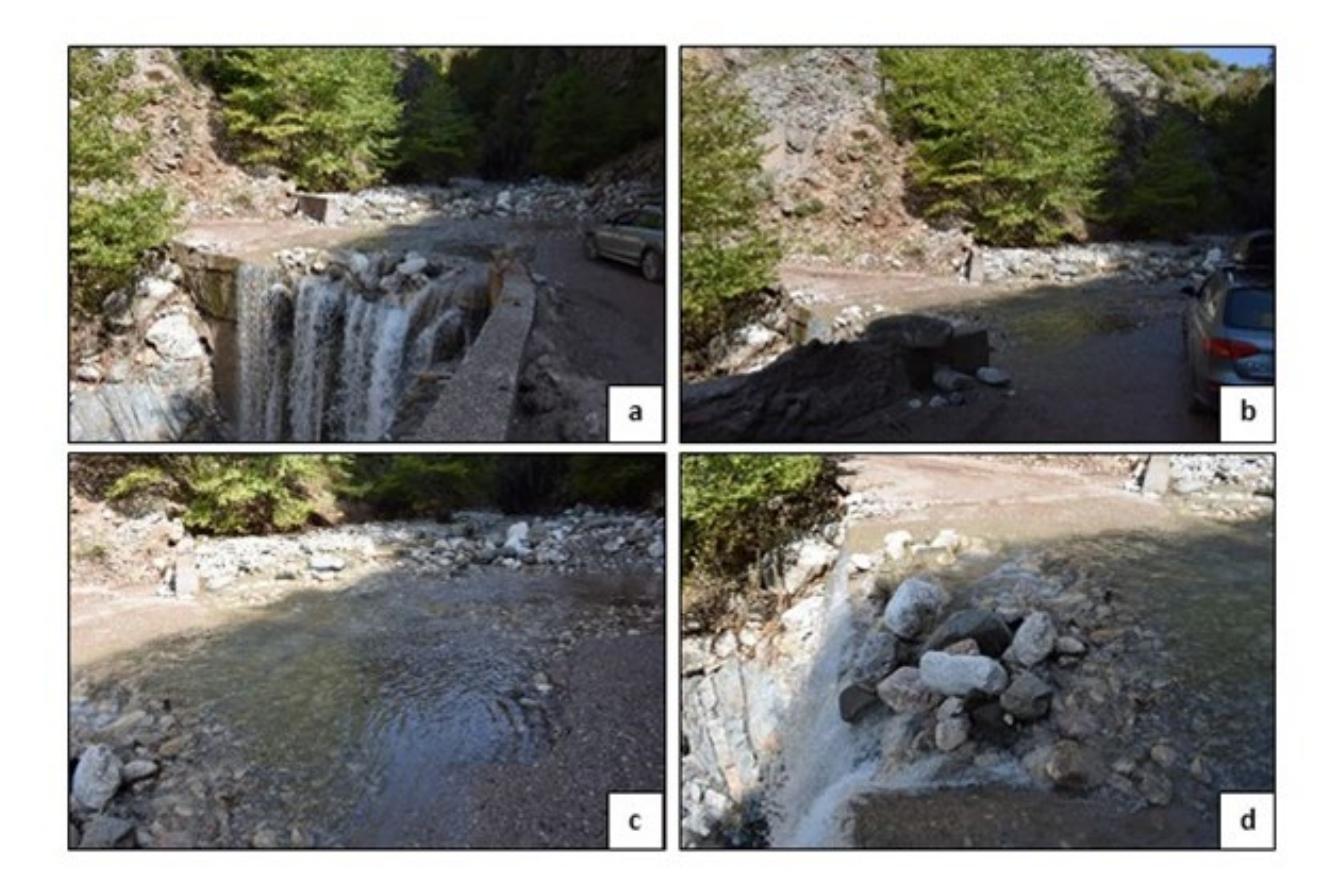
Figure 6.51. Debris flow intercepting a road at the entrance of village Vraggiana

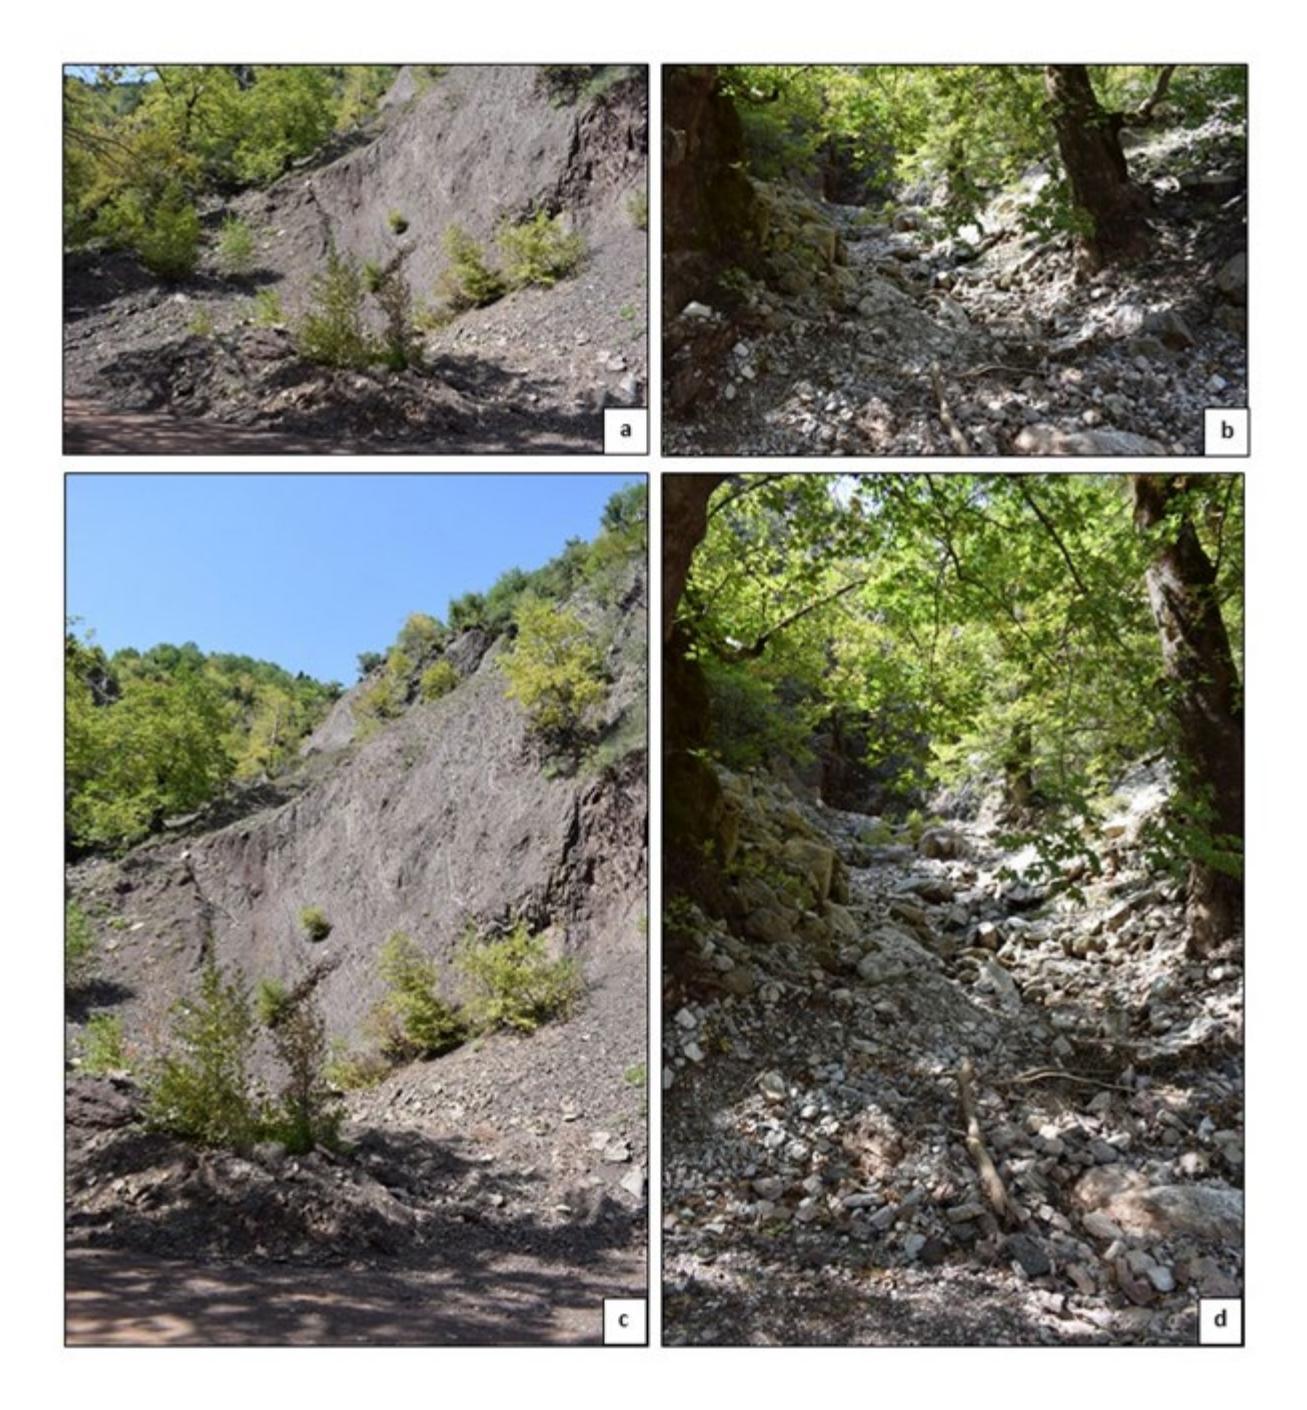
Figure 6.52. Debris flow along the road network of Karpenisi - Agrafa

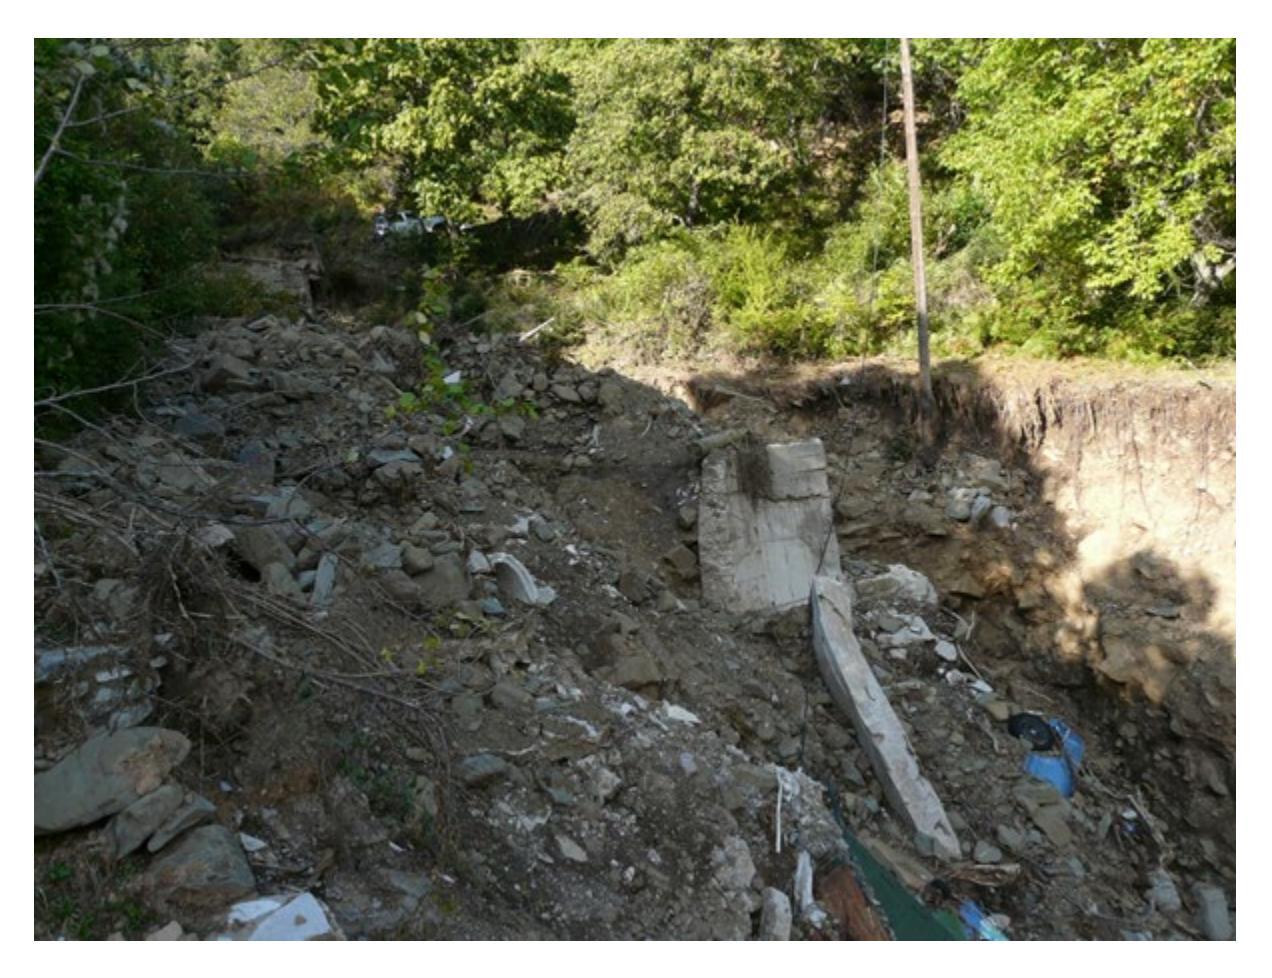
Figure 6.55. Debris flow at the entrance of village Rafina. (39.27220°N, 21.69772°E).

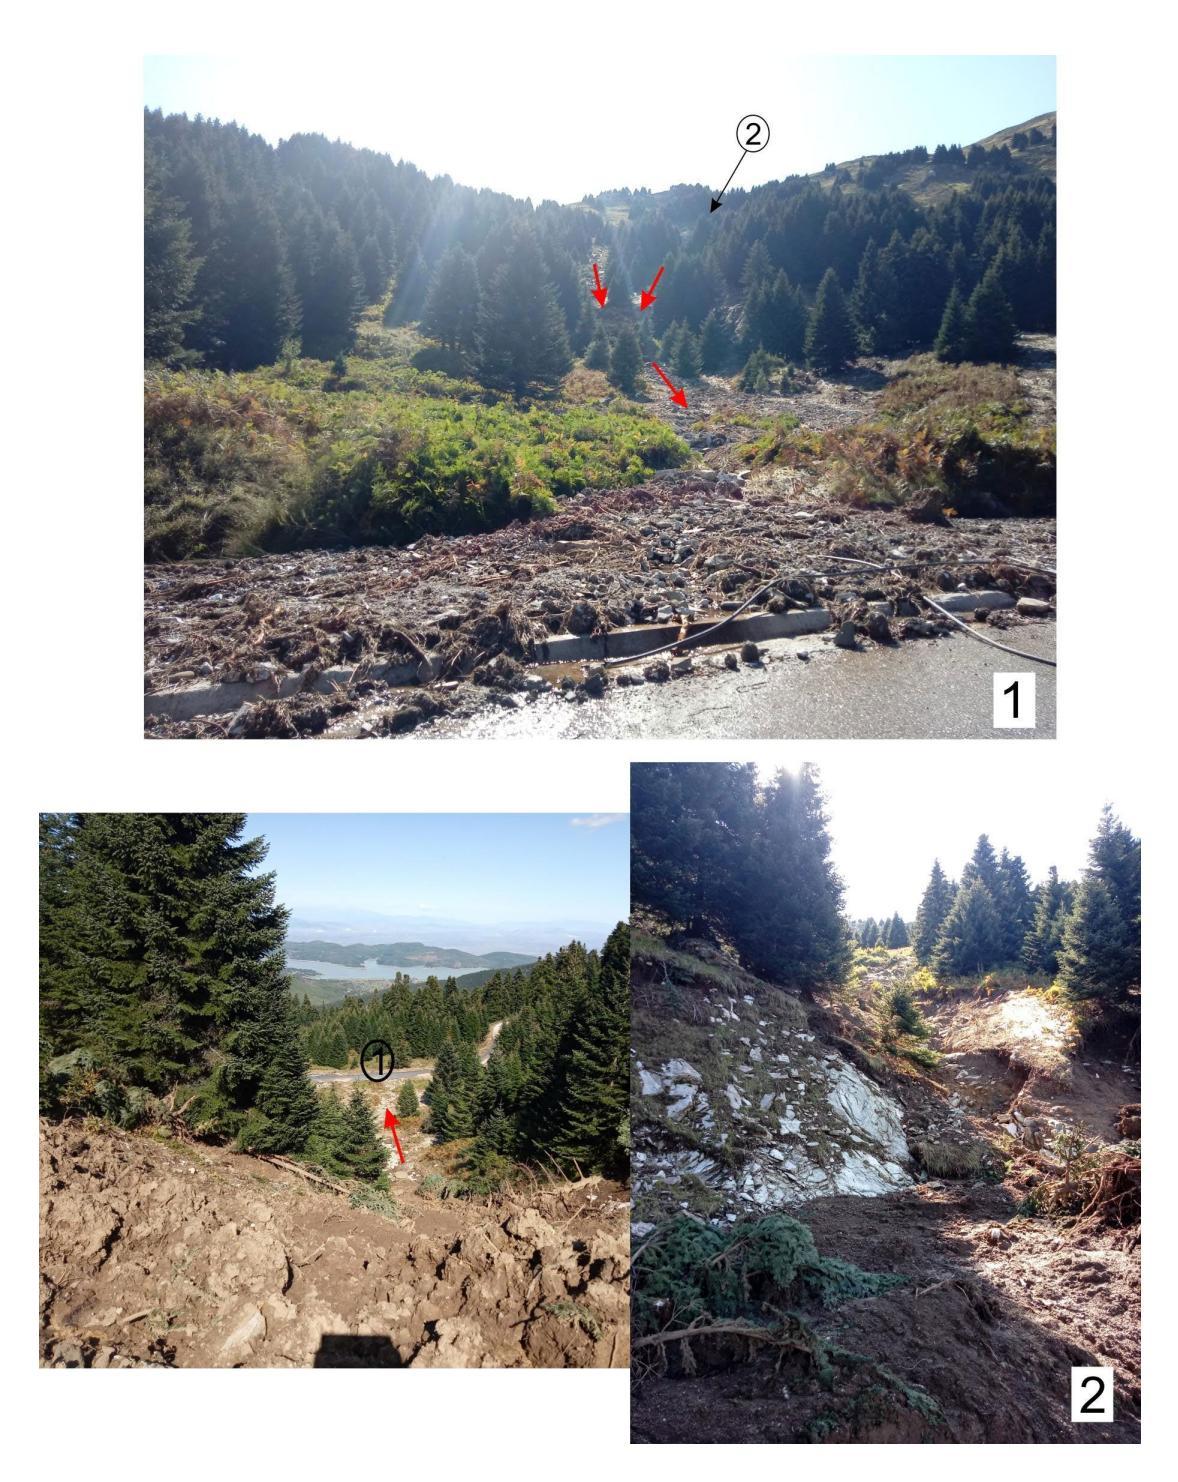
Figure 6.56. Debris flow that intercepted twice the road leading to Agrafa Ski Center, above Plastira Lake: (1) 39.28118°N, 21.67614°E; (2) 39.28013°N, 21.6750°E.

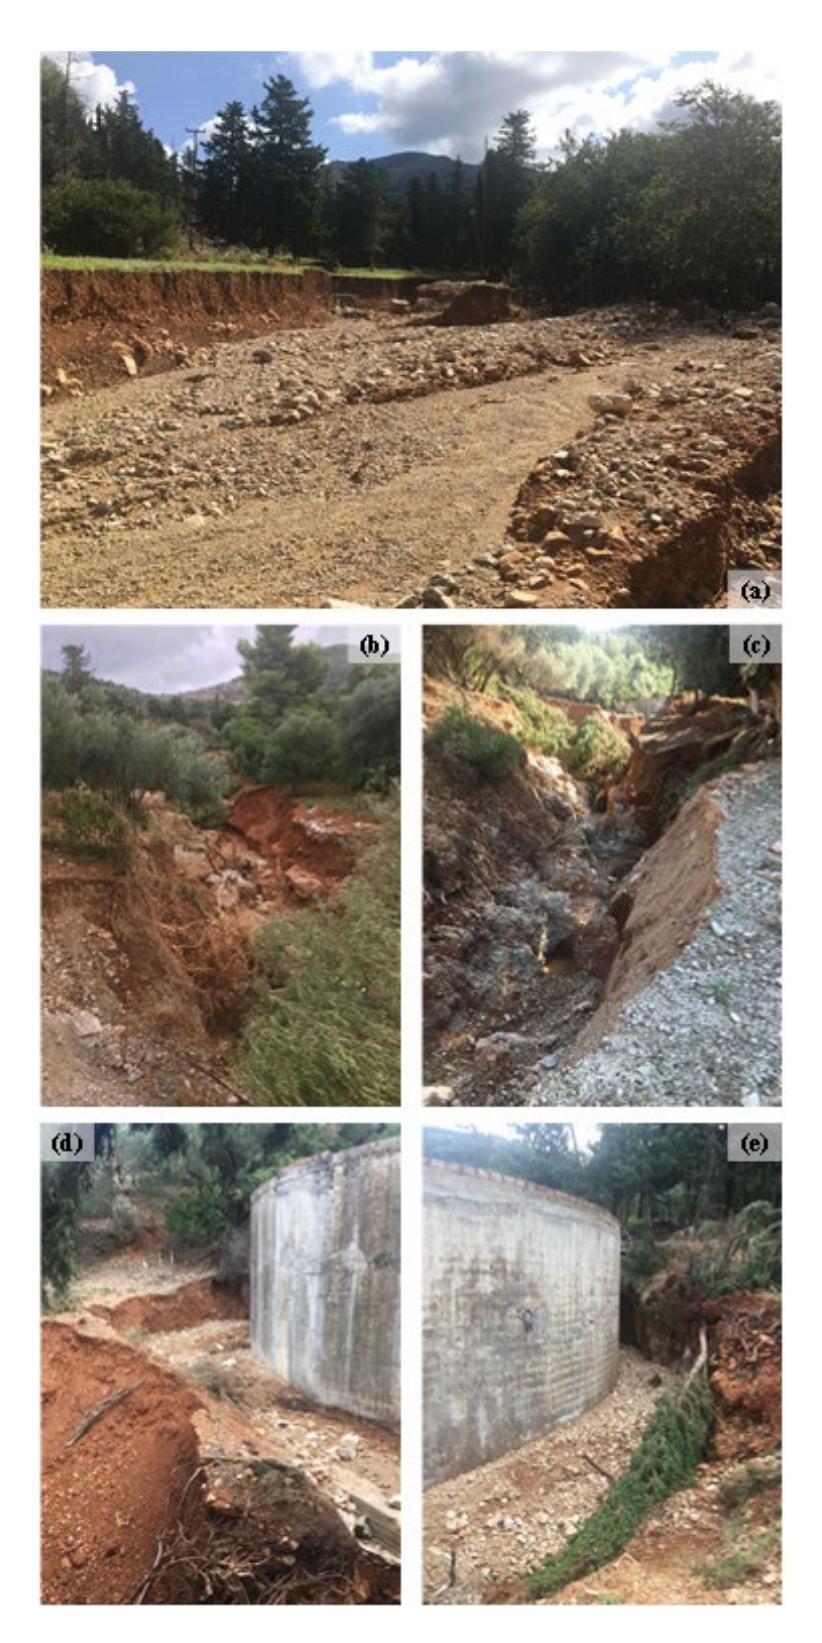
The reconnaissance team found that surface and riverbank erosion and scour was extensive in Cephalonia. The most notable cases were the surface erosion documented outside of the villages of Fiskardo and Assos (Figure 7.1 and 7.2, respectively). In both areas, residual soil and conglomerates were washed away exposing the bedrock formation (Figures 7.1 and 7.2c). The depth of the erosion reached, at places, up to 2 m (Figure 7.1). The eroded material contributed significantly to the debris/earth flows that impacted the nearby communities.

Figure 7.2. Surface erosion outside of Assos village, Cephalonia: a) 38.377188°N, 20.5445722°E; b) 38.3753611°N, 20.5463055°E; c) 38.374833°N, 20.5452722°E, d,e) 38.37619722°N, 20.5511166°E On the island of Lefkada, extensive flooding within the lowlands of Vassiliki valley was reported. Based on photographs taken by eyewitnesses during the flood, the water level within parts of the town of Vassiliki seems to have risen by roughly 0.5 m (Figure 7.3).

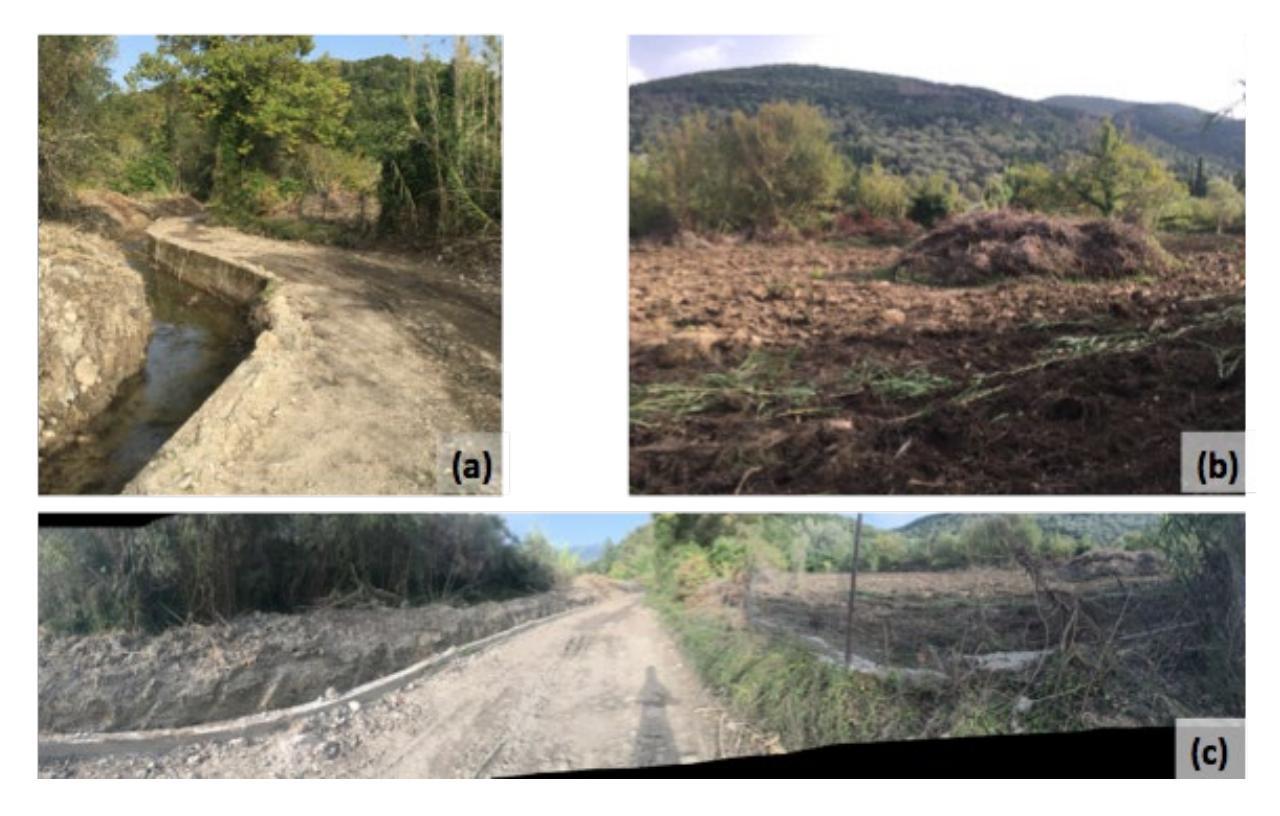
Figure 7.5. Location of severe flooding (1 m from ground level) outside of Vasiliki village, Lefkada (38.637388°N, 20.617512°E).

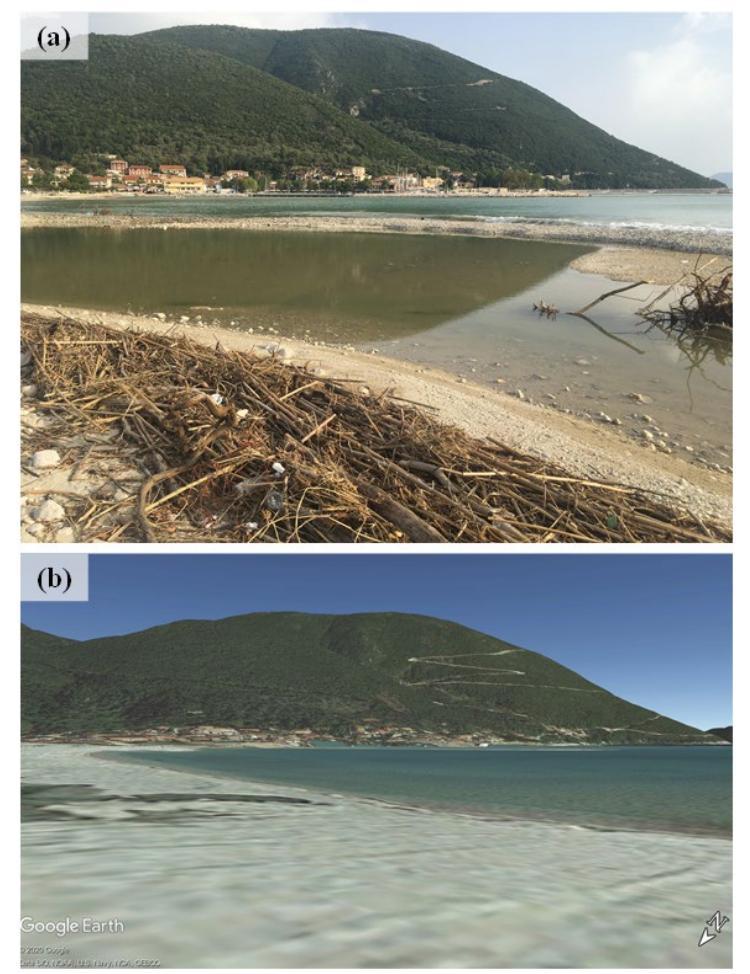
Figure 7.6. a) Photo from Vasiliki beach (38.629816°N, 20.603735°E), showing that the shoreline has receded due to debris deposited by the river. (b) Location the photo was taken from appears to be in shallow water according to Google Earth street view, corroborating this.

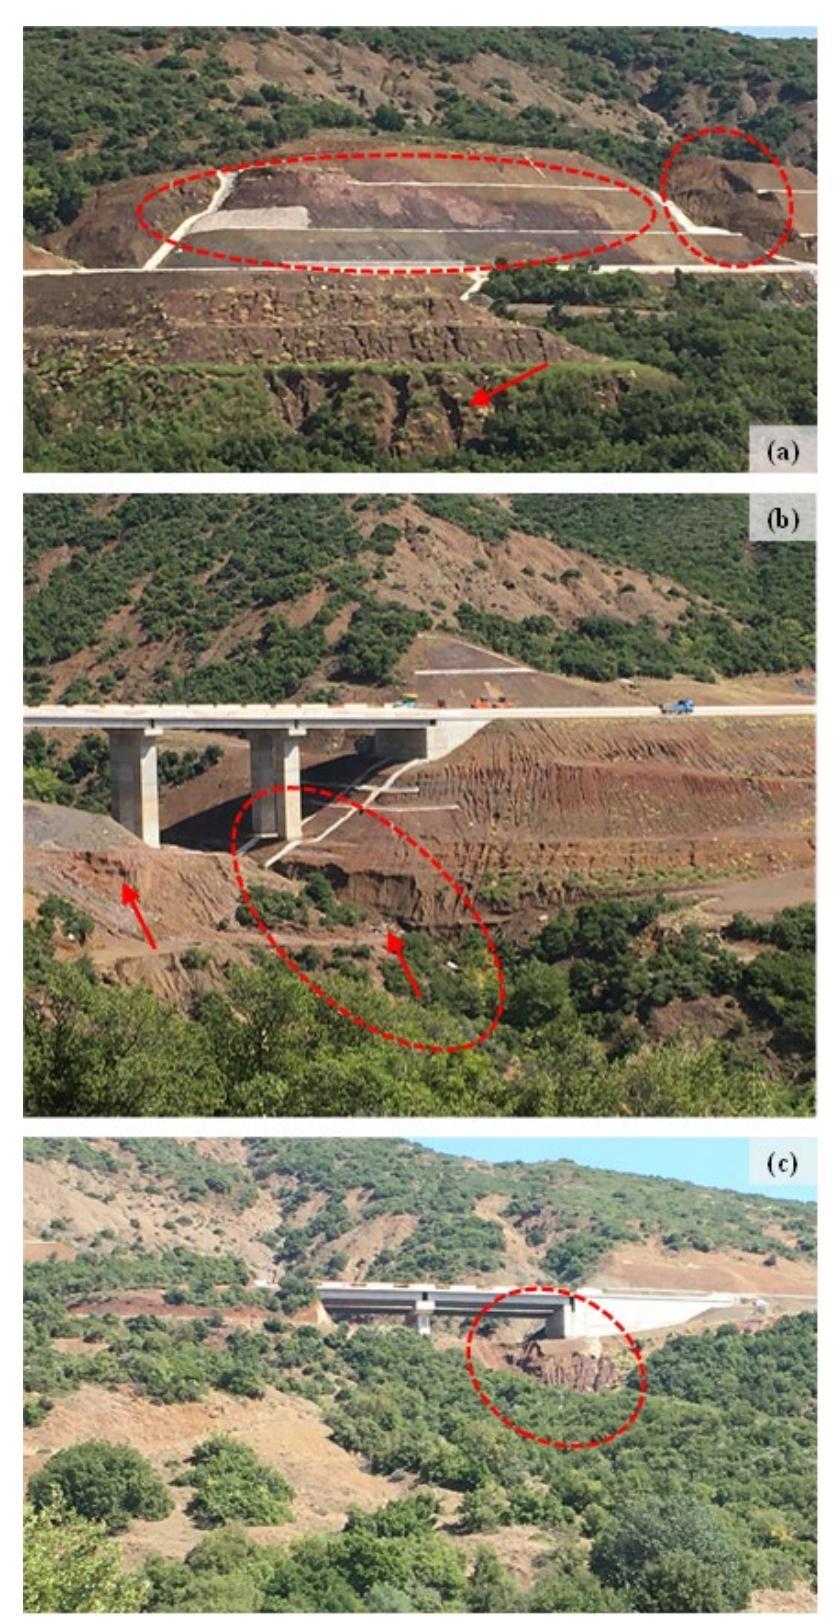
Figure 7.8. Evidence of erosion on embankments and slopes along the construction site of highway E65, north of Stirfaka village. Photos taken from: a) 38.97244167°N, 22.29606945°E; b) 38.97348055°N, 22.2946056°E; c) 38.96774722°N, 22.2956834°E, facing eastwards.

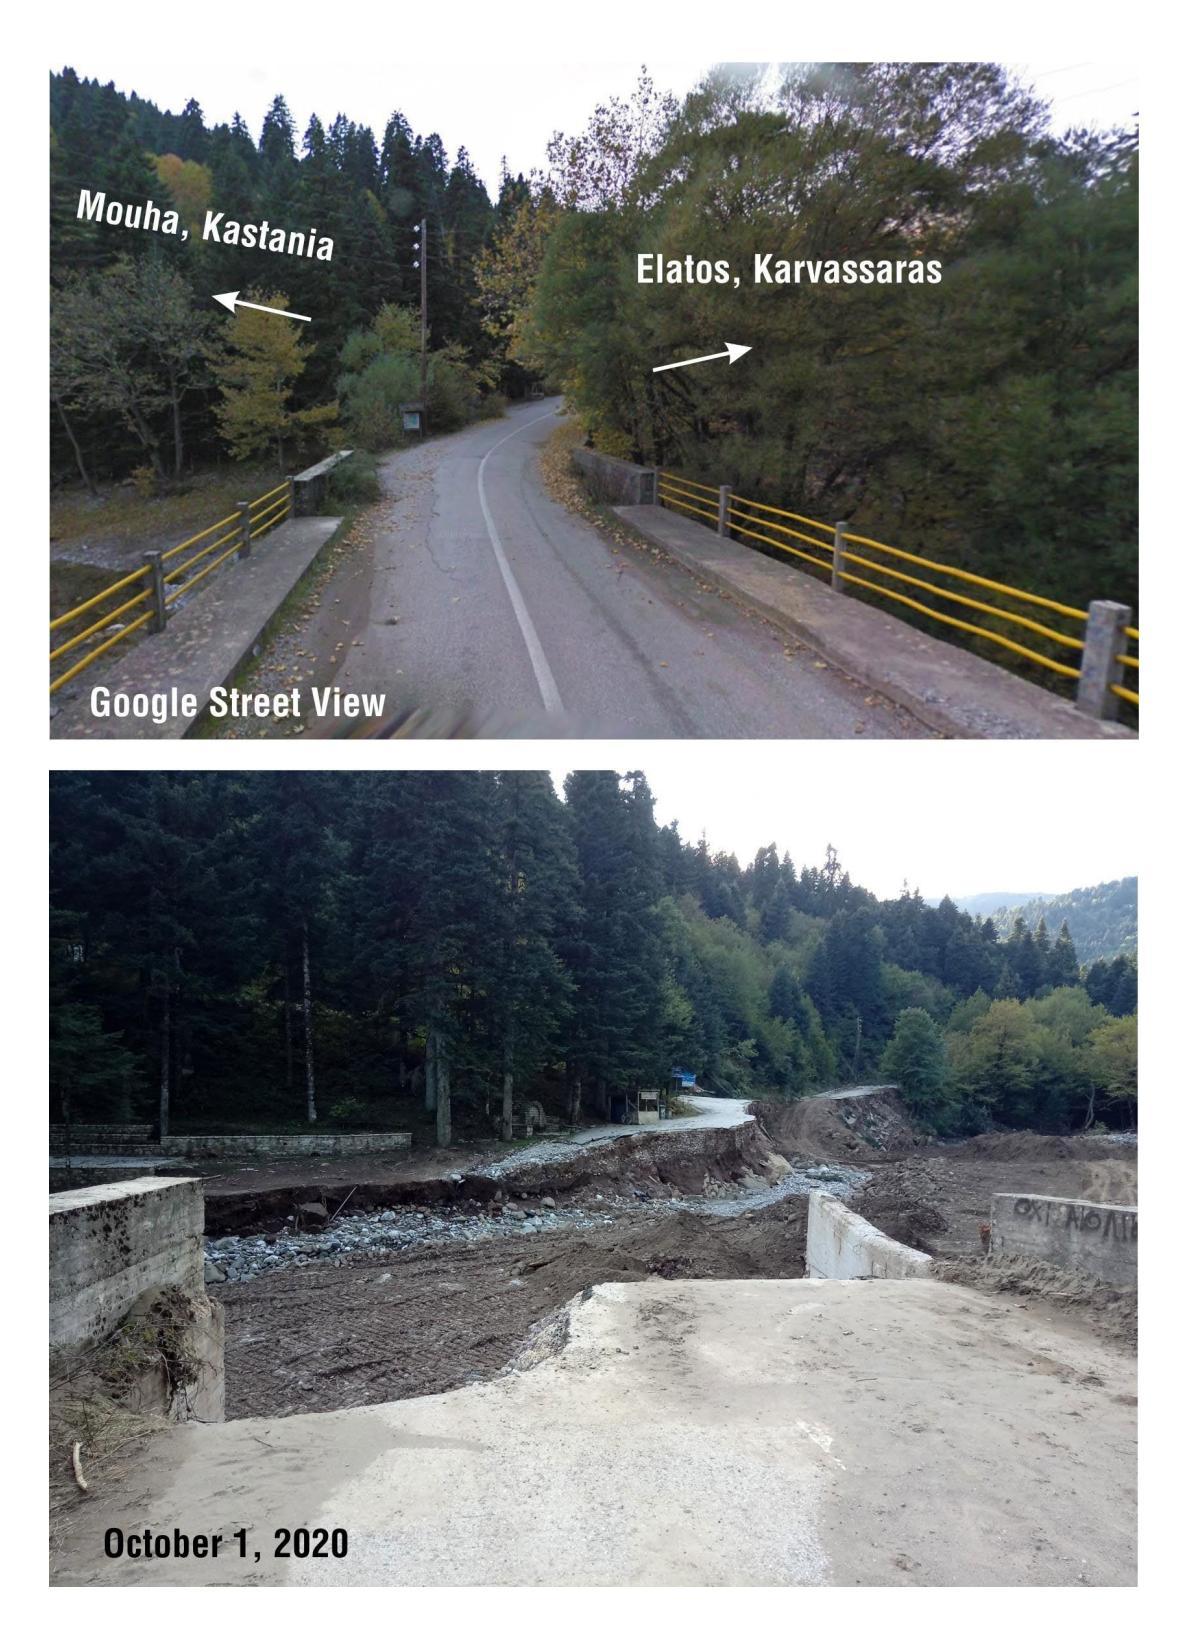
Moreover, erosion and flooding of the Karitsiotis River damaged and blocked the road crossing south of Belokomiti village, Plastira Lake, as shown in Figures 7.15 through 7.18. While the bridge itself did not collapse, road embankments on both sides were partially or completely washed out. The intersection of the roads west of the bridge was the most damaged part, blocking road traffic towards Elatos - Karvassaras and Mouha - Kastania. During the field investigation (October 1, 2020), repair works were underway in order to modify the river bed and restore the road embankments.

Figure 7.17. View towards south-west from the remaining Karitsiotis river bridge, south of Belokomiti, Plastira Lake. Comparison with Street View image. (39.2538°N, 21.7161°E).

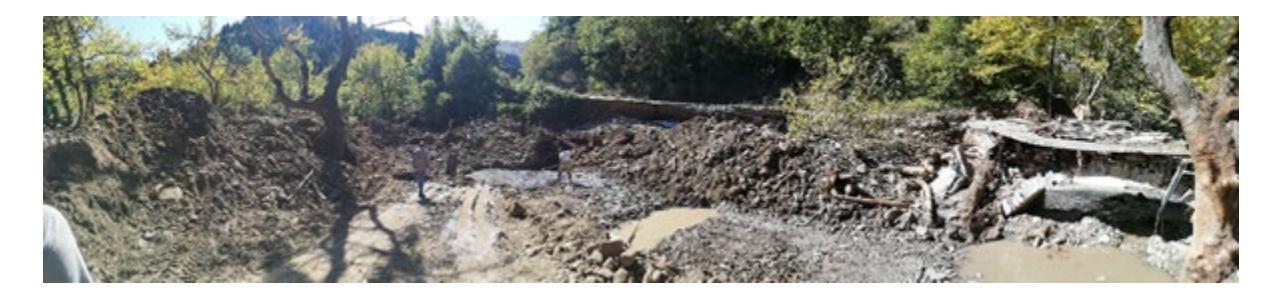
Figure 7.19. Riverbank erosion – slope failure that damaged the road at the village Pezoula. (39.30351°N, 21.6876°E)

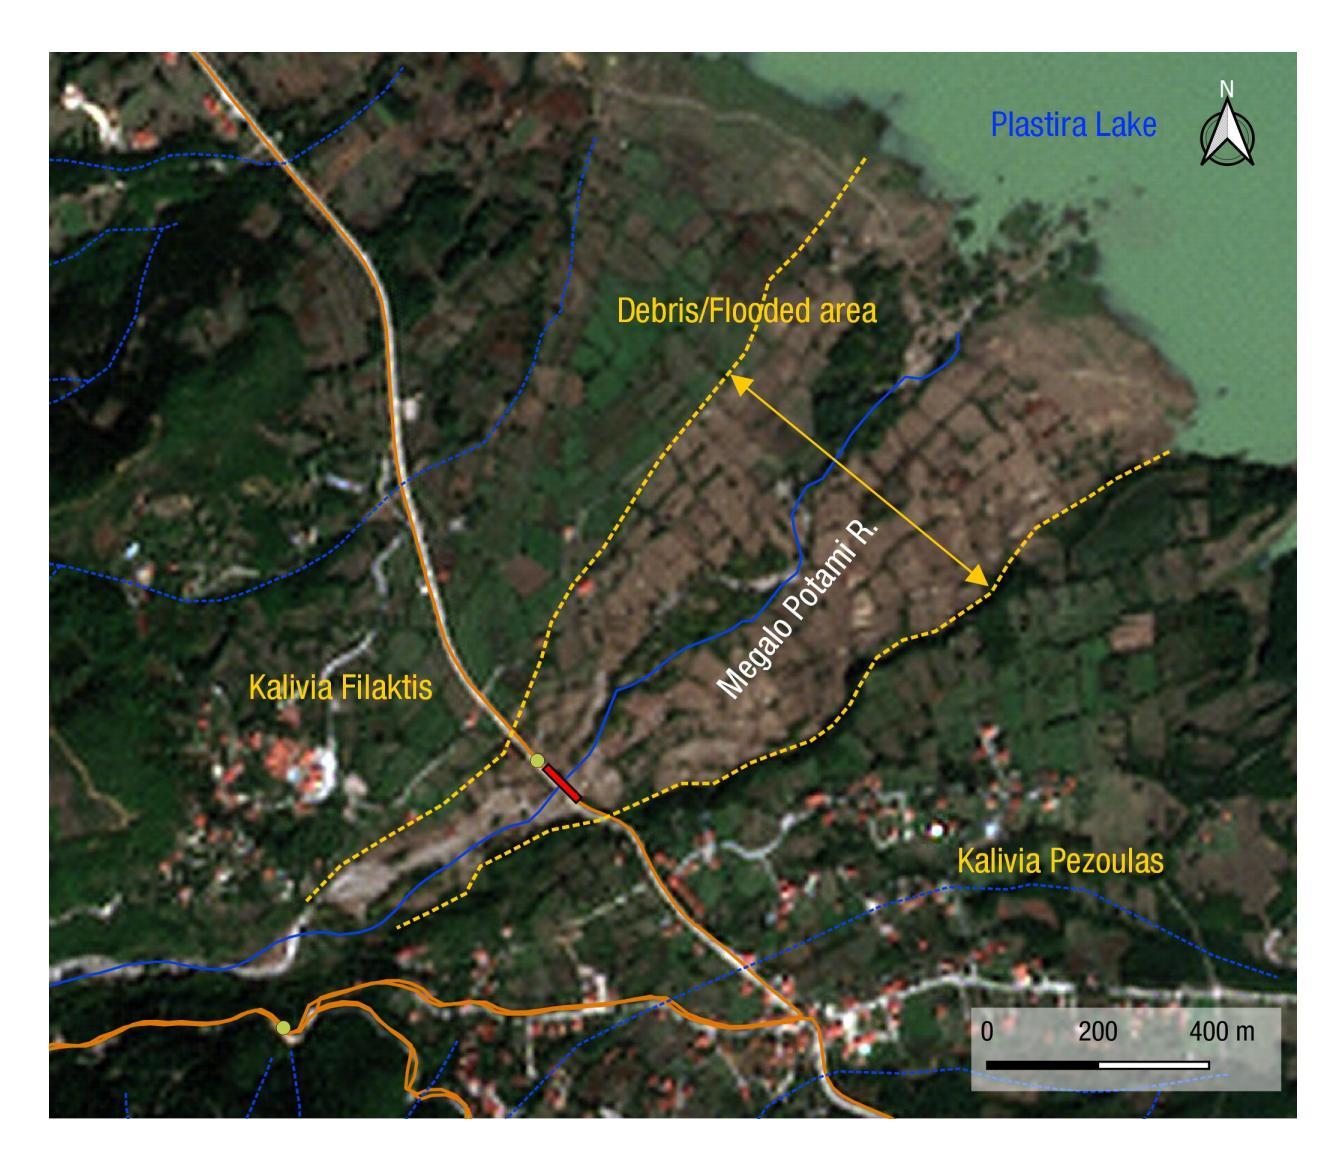
Figure 7.21. Riverbank erosion and debris flow near Pezoula and Filakti, Plastira Lake. Browndiscolored area in Megalo Potami river fan shows the extent of flooding and debris deposition. Red bar marks the location of the damaged road bridge (39.31226°N, 21.7109°E). Sentinel-2 (super-resolution) satellite imagery acquired on September 25.

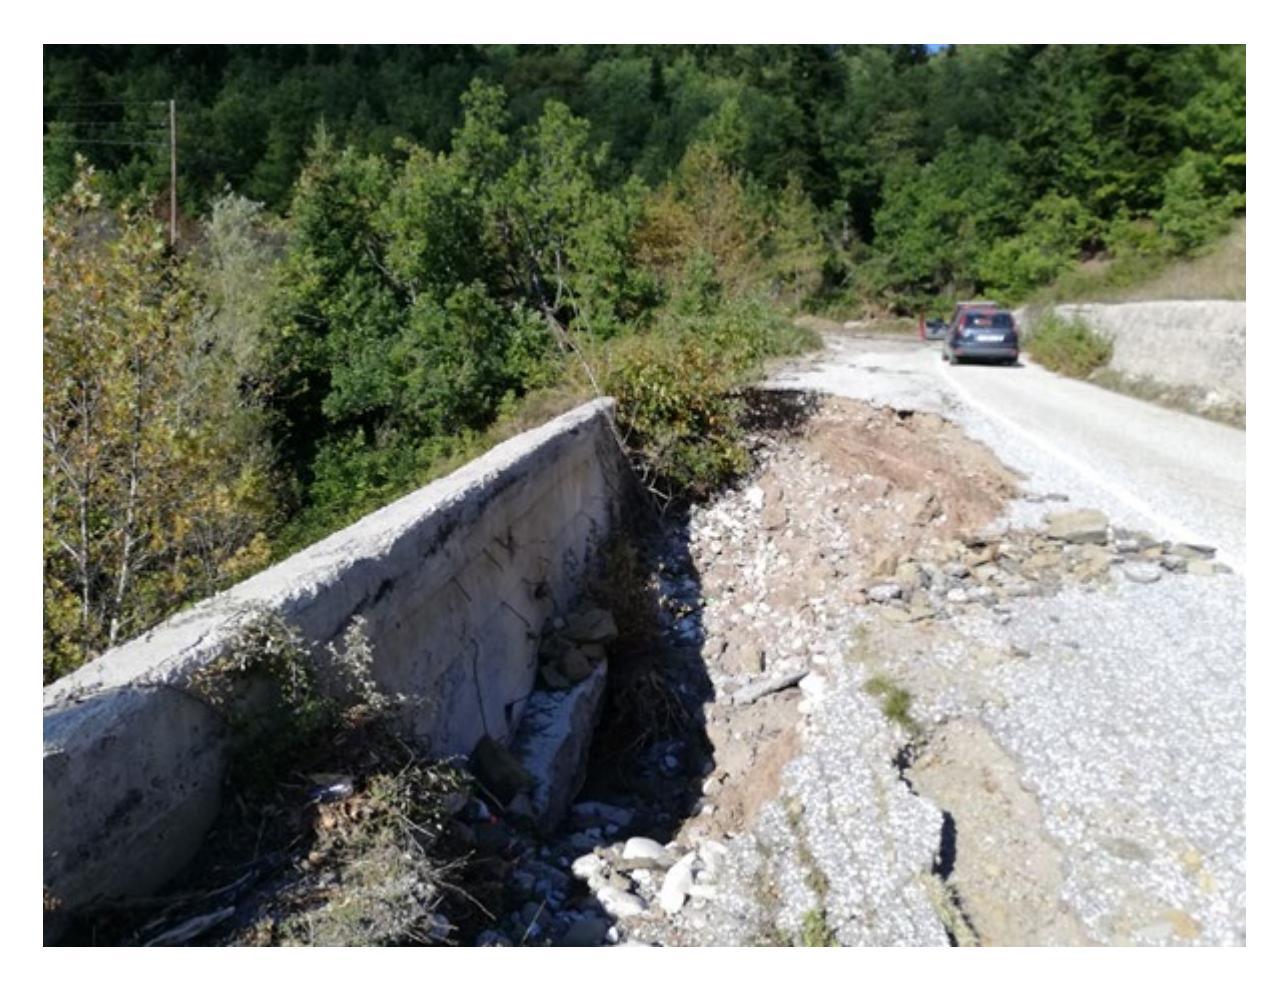
Figure 7.23. Extensive surface erosion on the side of Belokomiti - Karditsa road. (39.26022°N, 21.72556°E).

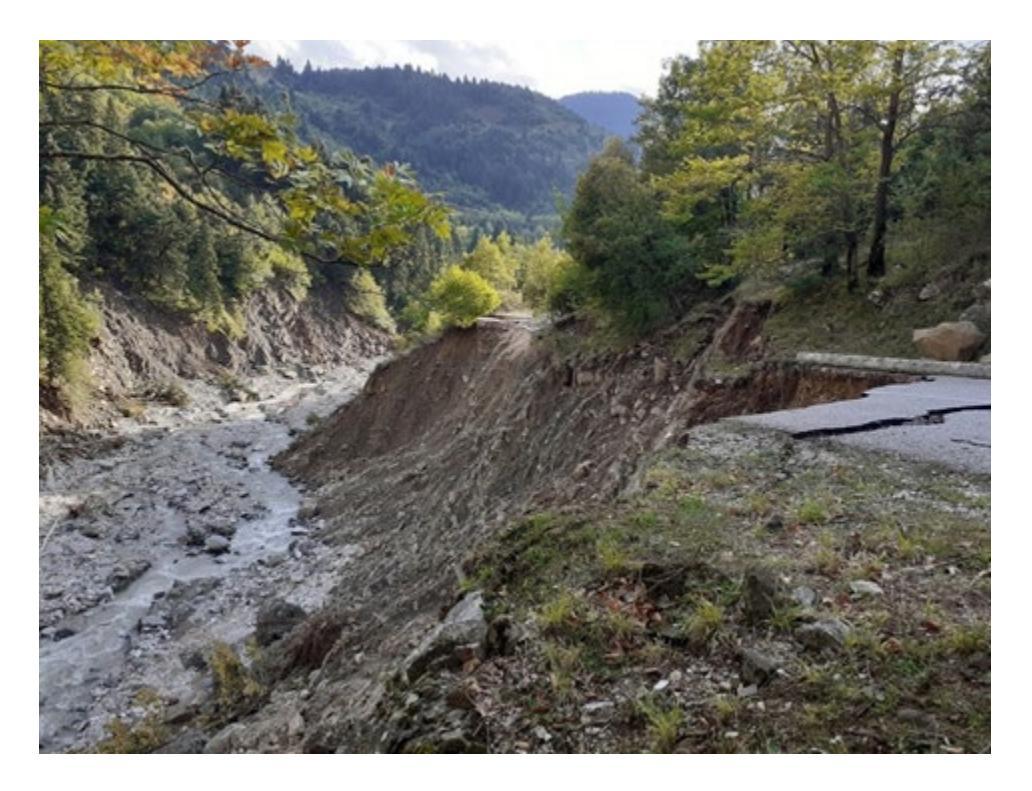
Figure 7.24. Riverbank erosion – slope failure that totally damaged the road at Vlasi village (39.2906260°N, 21.5862230°E).

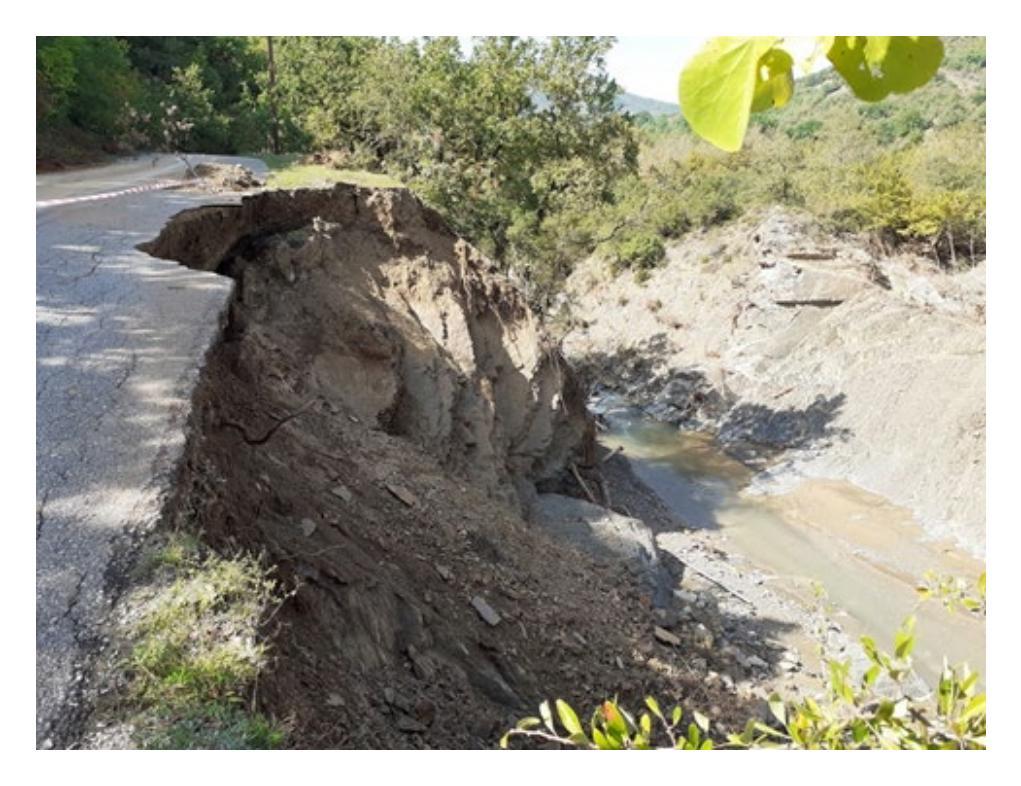
Riverbank erosion also caused several slope failures across the region as shown in Figures 7.19 through 7.26. The flooding of the river caused slope undercutting that resulted in road failures. Example of road embankment failures in weathered mantle of mixed flysch are shown in Figures 7.25 and 7.26. In Figure 7.25, the height and the width of the slope were estimated at 15 and 30 meters respectively, while in Figure 7.26, the surface erosion was extensive reaching a depth of 8-10 meters. A retaining wall that supported the road failed while nearby slopes were intensely eroded.

Figure 7.25. Riverbank erosion – slope failure that partially damaged the road (39.2515460°N, 21.8736180°E).

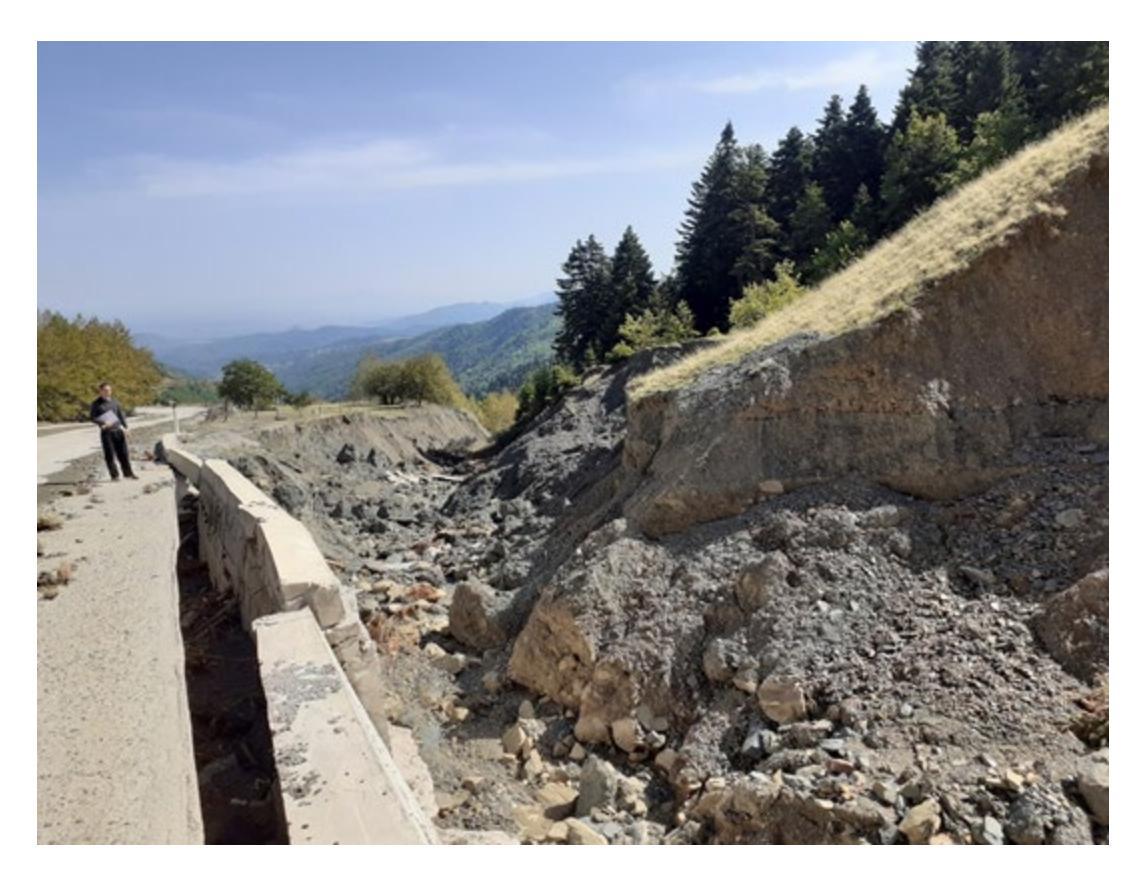
Figure 7.26. Extensive surface erosion on the side of Kastania – Rachoula road. Failure of retaining wall (39.2314830°N, 21.8016040°E).

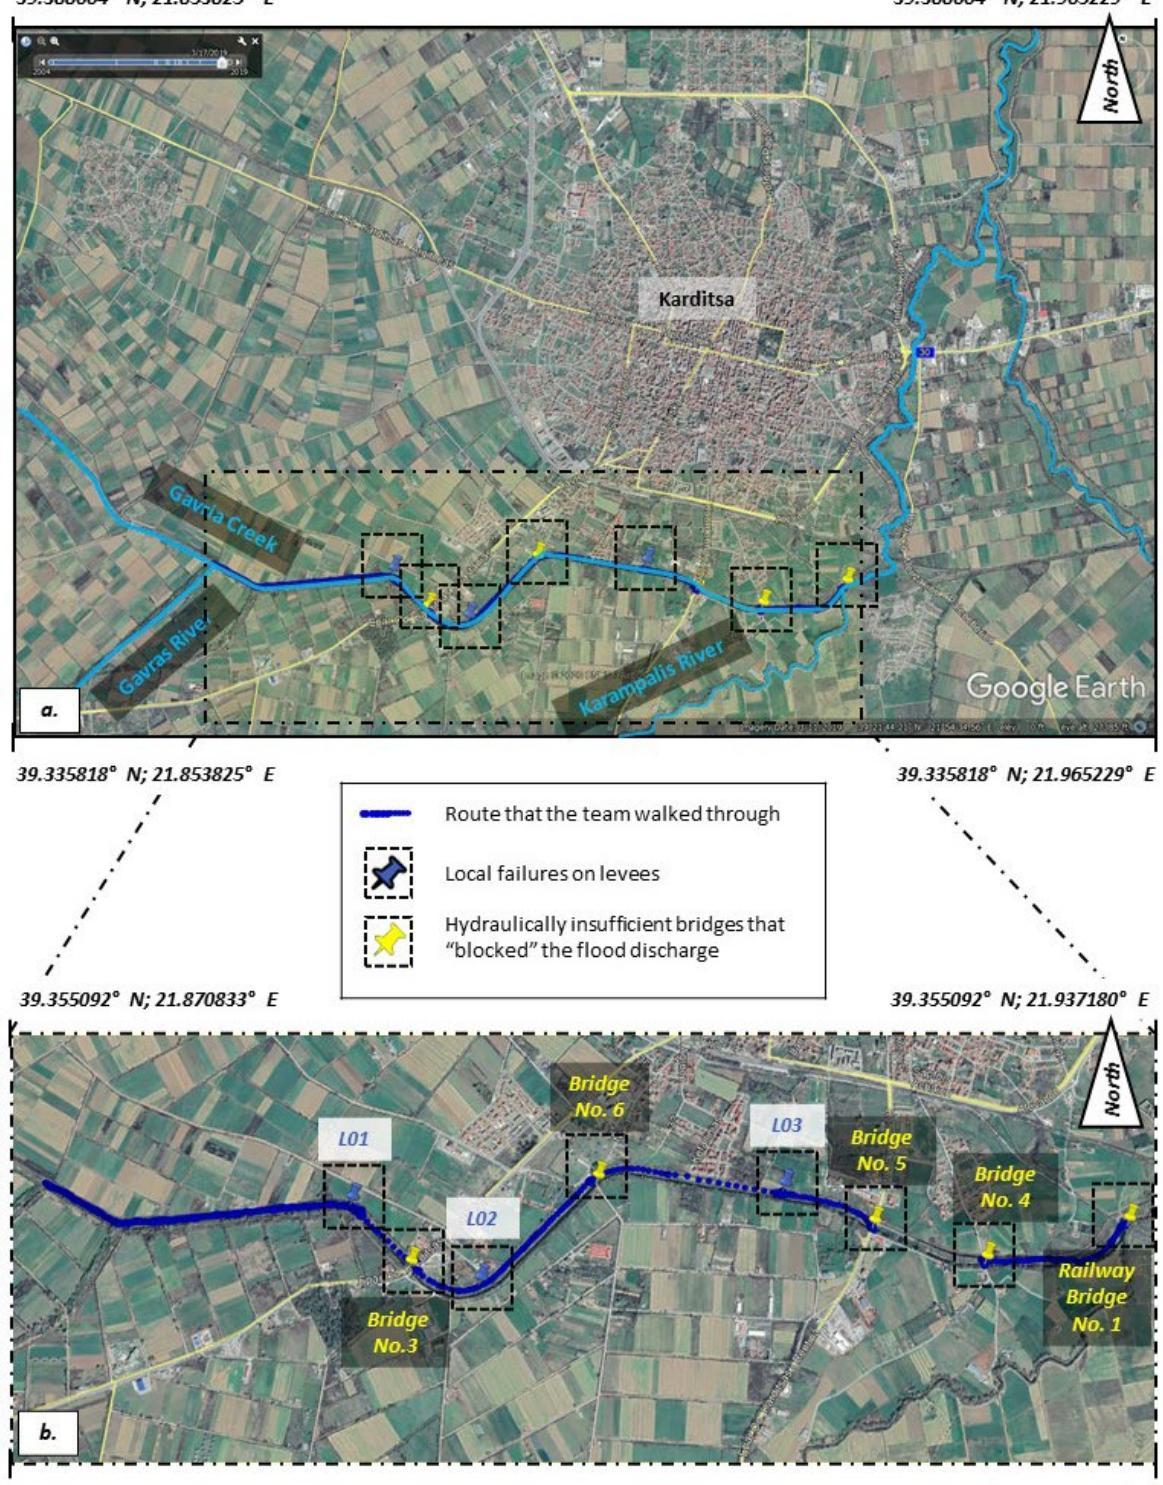
A flood protection system that consists of levees and bridges on the southern part of Karditsa protect the city from a potential flood event of the Gavria Creek, which is intersected by the Gavras River to the west and the Karampalis River to the east, as can be seen in Figure 8.1. The system failed to withhold the flooded waters, during the heavy rainfall (reportedly 214 mm of water in 24 hours, or 54,000,000 tons of water) between September 17-18, 2020, and as a result, the city of Karditsa flooded (reportedly over 80 cm of water). A team of two civil engineers, supported by Mr. Konstantinos Pistrikas, a local hydraulic engineer with over 40 years of experience in the local hydrology of the broader area of Karditsa, inspected the flood protection levees during a two-day trip from 2-3 October 2020 and reported their failures. Table 8.1 summarizes the assets that were inspected, which fall into two categories: levees and bridges (asset coding is consistent with that of Figure 8.1 and with that of Table 5.1). The Gavria Creek flows to the east, and is inhibited from flooding Karditsa from a system of levees on its northern bank, which are intersected by highway bridges (one or two lanes/ direction). Right next to the bank lies an irrigation channel of significantly lower section. On its southern bank, the creek is not contained by any levees, and is hence free to overflow. Figure 8.5a provides a conceptual overview of the arrangement of the flood protection levees of the Gavria Creek.

Figure 8.1. (a) Overview of the rivers and creeks that flooded the city of Karditsa; (b) Levees with local failures (L##) and hydraulically insufficient bridges (*Bridge No.* #) along the Flood Protection Levee of the Gavria Creek and the Karampalis River.
