The September 18-20 2020 Medicane Ianos Impact on Greece

Phase I Reconnaissance Report

Geotechnical Extreme Events Reconnaissance Association

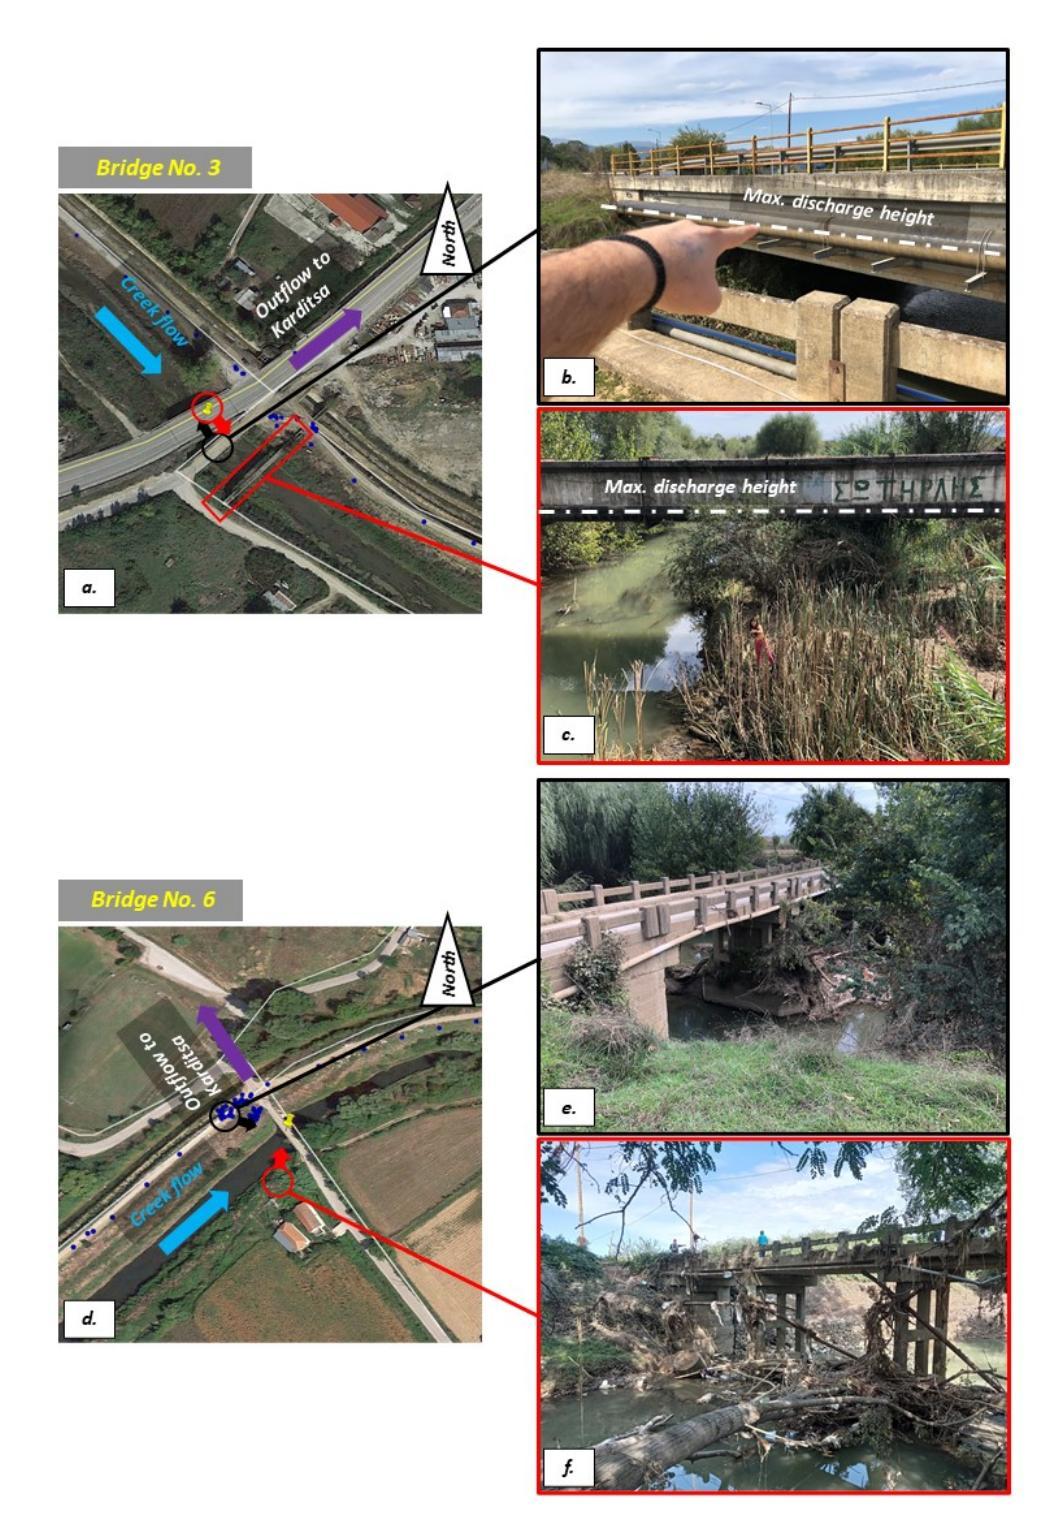
Out of the five bridges inspected, which are both newly constructed, and old with obvious signs of ageing and poor maintenance (e.g. exposed rebar for the case of Bridge No. 6), none had signs of structural damage or abutment distress/ extensive displacement (see also 5.1.3). However, they all had signs of overflowing by the flood discharge of the Gavria Creek, which hints to poor hydraulic design, since their hydraulic sections were proven inadequate for this flood event. More specifically, Bridge No. 3 (Figure 8.2a, 8.2b, and 8.2c) is built next to an old and obsolete bridge, which apparently exacerbated the flood discharge, by reducing further the already insufficient hydraulic section. Bridge No. 3, as well as a utility bridge right across the flow of the creek (Figure 8.2c), have clear marking of the maximum height of the water, leading to the conclusion that the flooded waters overtopped the old bridge, whose deck is on a lower elevation. Bridge No. 6 (Figure 8.2d, 8.2e, and 8.2f), Bridge No. 5 (Figure 8.2a; 8.2b, and 7.27c), and Bridge No. 4 (Figure 8.3d, 8.3e, and 8.3f) also contributed to the flooding of Karditsa by "blocking" the creek flow. Poor maintenance of the riverbed was also an issue, further reducing the effective hydraulic sections beneath the bridges. Tree trunks, mud, debris, even corpses of animals from livestock facilities upstream were found in the riverbed (Figure 8.3f). Figure 8.3e shows the lower elevation of the Bridge No. 4 deck compared to the crest of the flood protection levee. The waters merely overtopped the bridge and flooded the area to the north. Railway Bridge No. 1 (Figure 8.4) is an out-of-use old railway steel bridge, which had a clear mud line, indicative of the maximum discharge height. Notably, a permanent concrete dam with temporary lags is placed slightly upstream this bridge (Figure 8.4c). The lags are used in the summer months, to confine the river flow and create a small-scale reservoir for irrigation purposes. As per local narratives, the lags were not placed in the dam during the flood, thus did not further constrain the flow.

Figure 8.2. (a; b; c) Bridge No. 3 (39.34458922°N; 21.89418983°E): (a) location, (b) evidence of overflow from the horizontal mudline (photo taken from the old bridge on the SE of Bridge No. 3), (c) evidence of overflow on an old utilities bridge (on the SE of Bridge No. 3); (d; e; f) Bridge No. 6 (39.34506944°N; 21.92634722°E): (d) location, (e) section that failed to discharge the flow during the flood event, (f) debris leftovers on the riverbed.

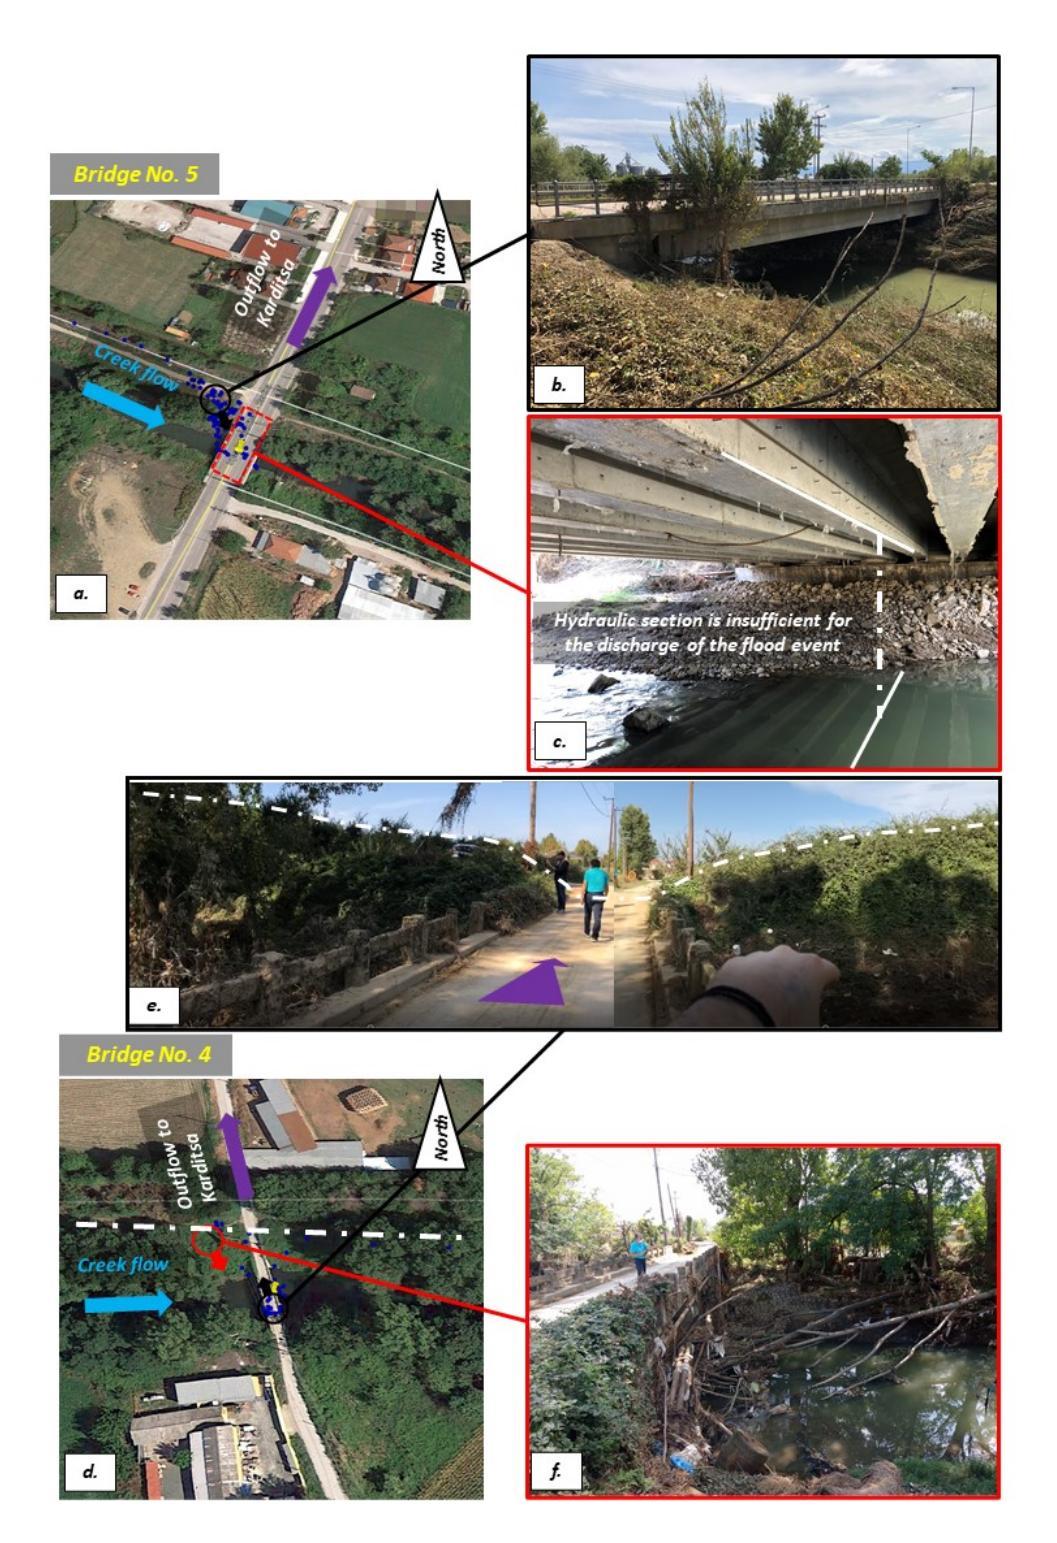
Figure 8.3. (a; b; c) Bridge No. 5 (39.34652222°N; 21.92067222°E): (a) location, (b) section that failed to discharge the flow during the flood event, (c) debris leftovers on the bridge girders (photo taken below the bridge); (d; e; f) Bridge No. 4 (39.348575°N; 21.90459167°E): (d) location, (e) the Flood Protection Levee is lowered at the location of Bridge No. 4, hence leaving a free pass to the flooded water to the north, (f) debris leftovers on the riverbed.

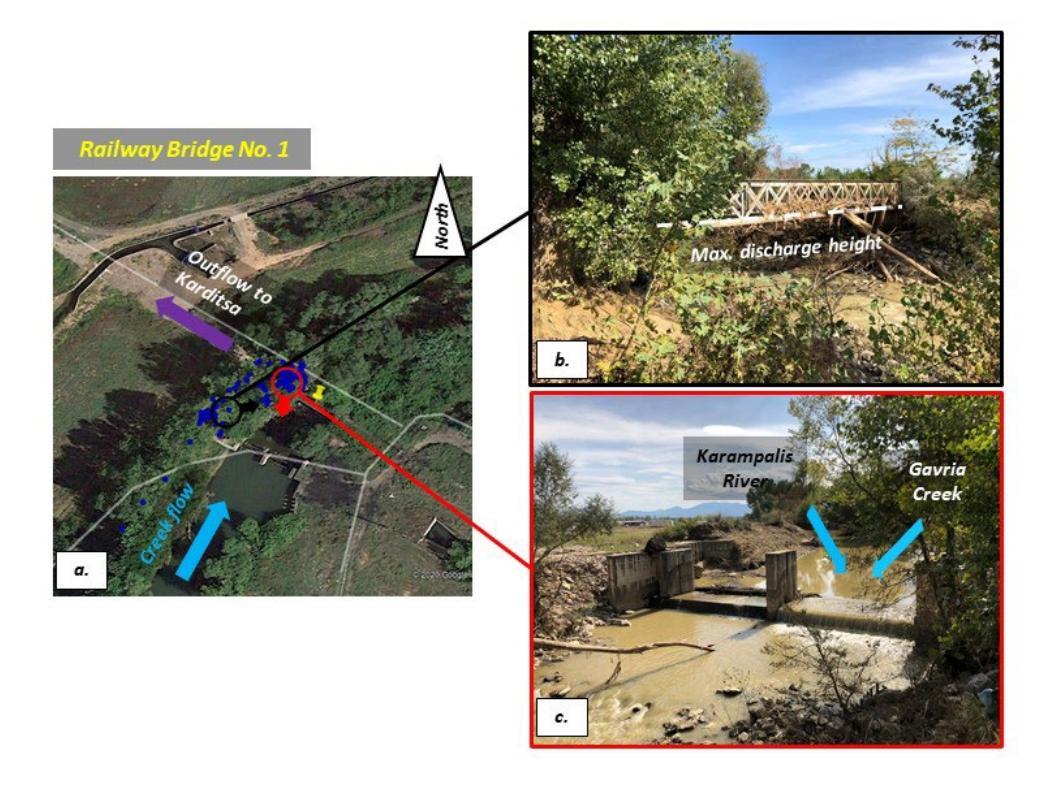
Figure 8.4. Railway Bridge 01 (a) location (39.346627°N; 21.935205°E), (b) photo of the railway Bridge 05 (the max. discharge height is estimated from the horizontal mud line on the bridge); (c) permanent concrete dam with temporary horizontal lags upstream Railway bridge No. 5 – the dam is placed at the intersection of the Gavria Creek with the Karampalis River.

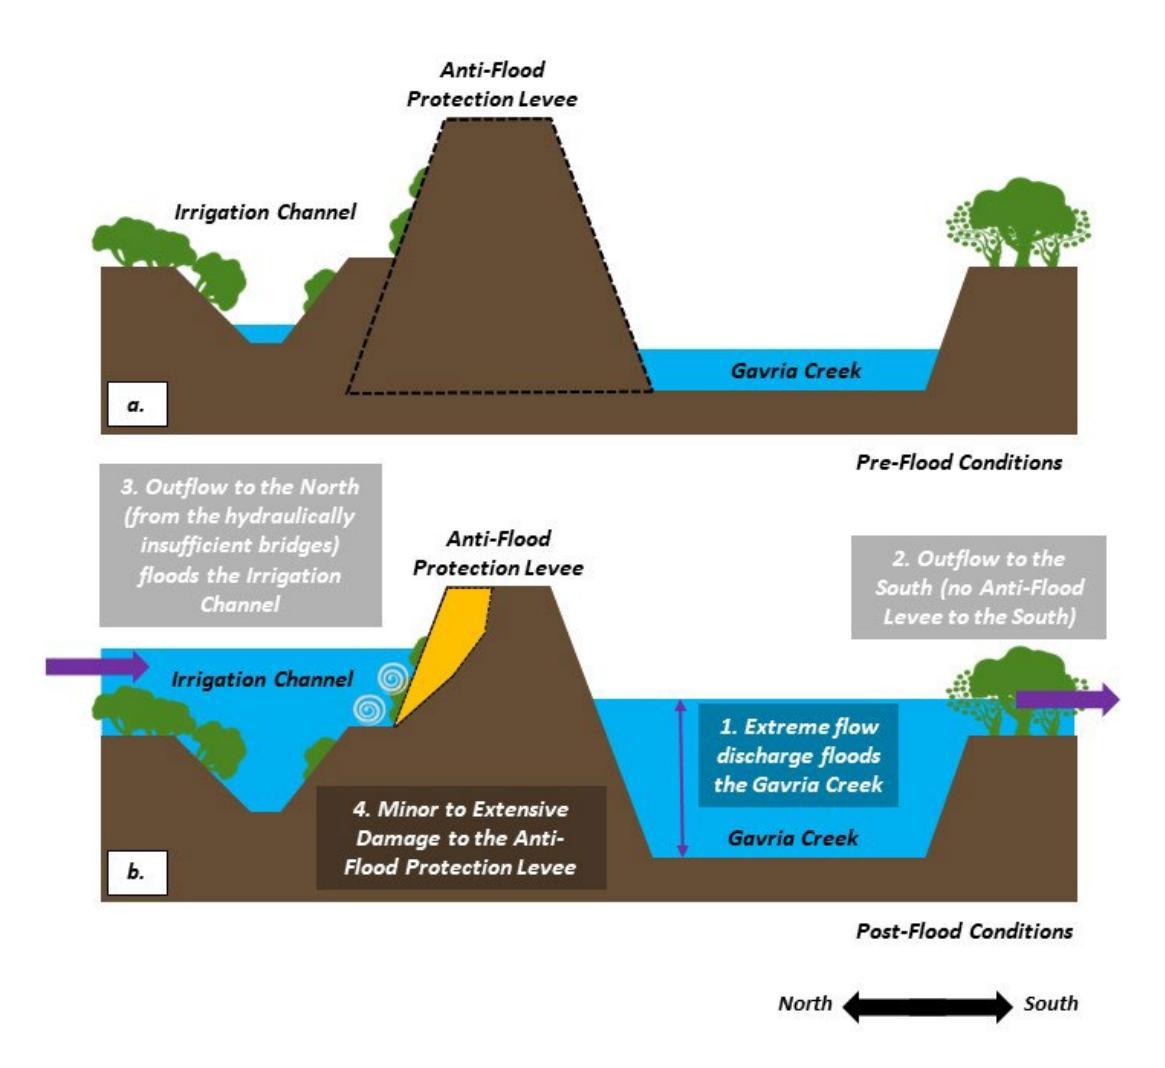
All three inspected levees had evidence slight to extensive erosion to the northern side (to Karditsa). This side has lesser vegetation, hence is more vulnerable against erosion, but at the same time is more accessible. The southern side (the bank of the Gavria Creek) of the levees sustained lower to no damage, but the inspection was not carried out as meticulously there, due to the presence of high vegetation and trees. Presumably, the latter protected this side of the levee more effectively. No levee collapsed, indicating that the water did not reach the crest elevation, but rather overflew to the south, or to the north from the passages created by Bridge No. 3 - No. 6, which is also demonstrated in Figure 8.5 conceptually. The particular location of the erosive patterns (Figure 8.5b) regardless of their extent (slight to extensive) indicates that they were caused by the flooding of the irrigation channel, due to the discharge of the creek flow over the bridges to the north. Presumably, once the waters passed over the bridges, they inundated the channel, and eroded the northern side of the protection levees.

Figure 8.5. Conceptual sketches of the erosion damage on the Flood Protection Levee, on its northern side: (a) pre-flood conditions & (b) post-flood conditions and 4-step explanation of the erosion mechanism.

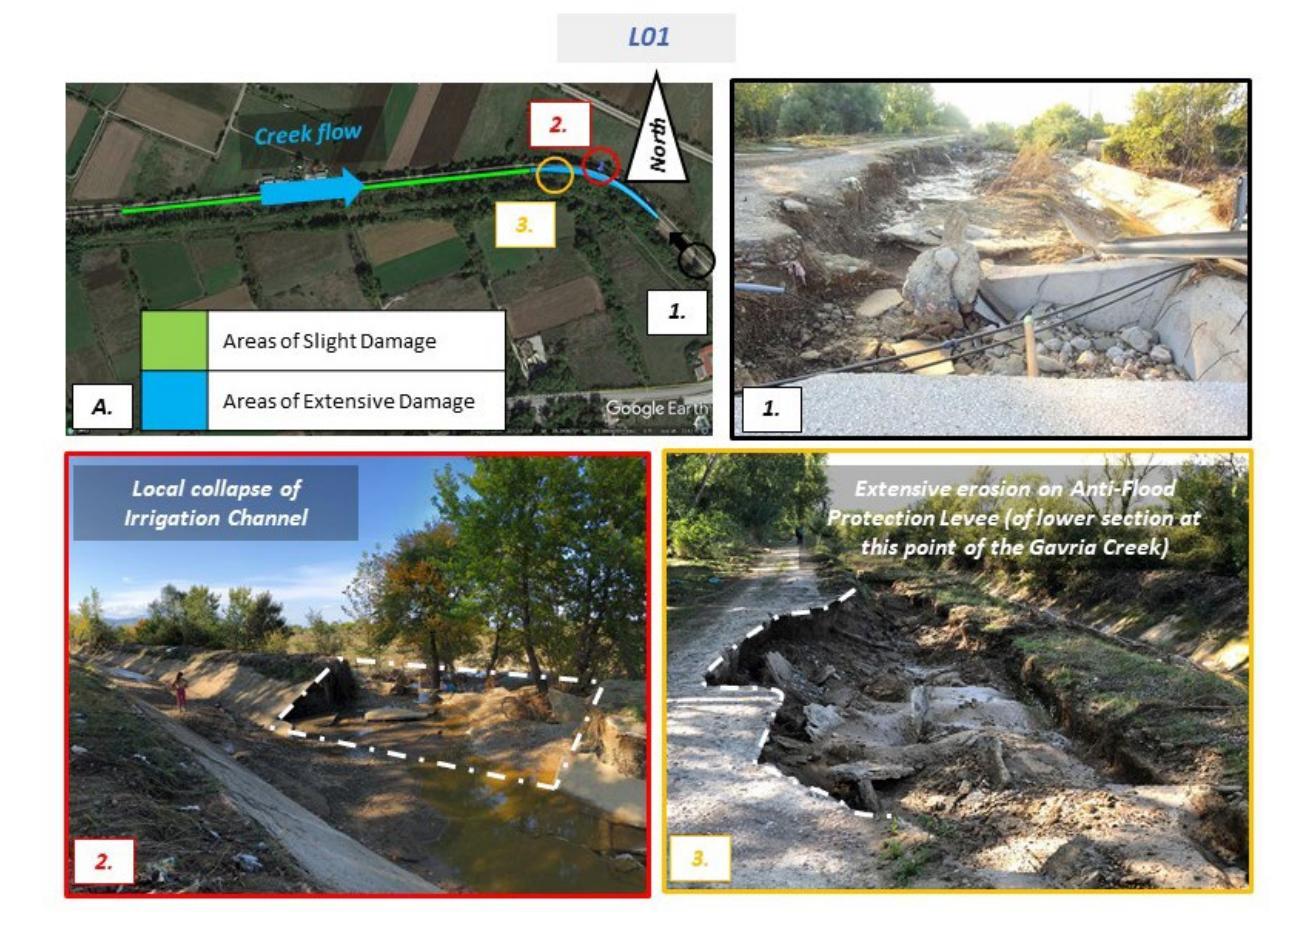
More specifically, Levee 01 had signs of extensive erosion, and the irrigation channel had collapsed locally, allowing the flooded waters to flow to the north uninterruptedly (Figure 8.6). A light green and a light blue zone can be seen in Figure 8.6a, indicative of slight and extensive damage zones, respectively. Increased water velocity due to reduced hydraulic section, circular longitudinal segments of the channel, or the presence of obstacles, such as the water-gate a few

Figure 8.6. (A) location of Flood Protection Levee 01 ($39.347550^{\circ}N$; $21.890664^{\circ}E$) – the Flood Protection Levee sustained extensive damages over an area of ~ 2,500 m2 (light blue) and slight damage over an area of ~ 5,500 m2 (light green); (1) extensive damage with bottom-up erosion of the levee (courtesy of *Mr. Apostolos Vergis*); (2) local collapse of the irrigation channel section, (3) extensive erosion of the levee downstream the irrigation channel failure.

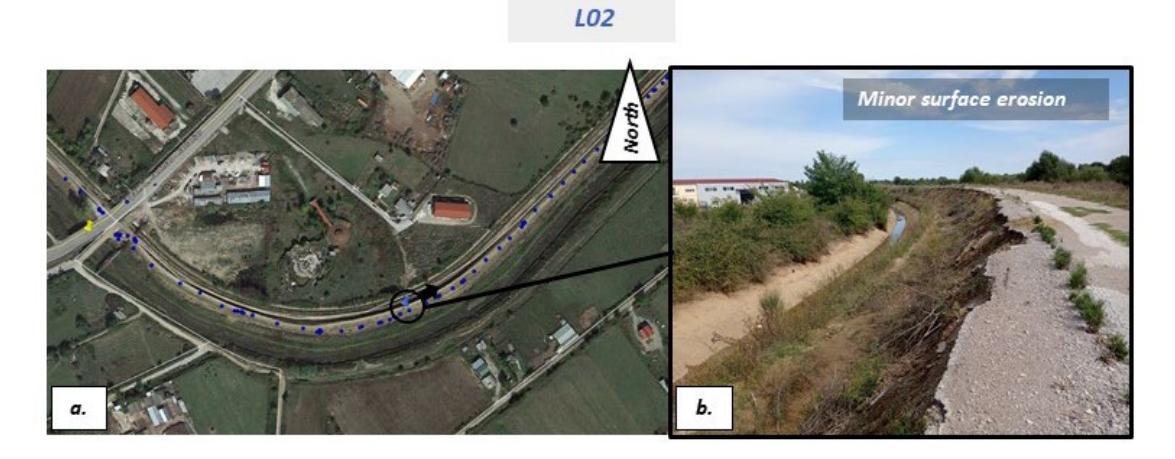
hundred meters downstream the blue zone (close to point 1 of Figure 8.6a) could have led to the extensive erosion and the local failure of the irrigation channel concrete section at this specific location, while the flow upstream caused less severe distortion. Levee 02 (Figure 8.7) had minute damage, and the surface erosion may be irrelevant to the flood event, as no other indications exist suggesting that the irrigation channel was flooded at this point. On the contrary, at the location of Levee 03 (Figure 8.8), the irrigation channel was fraught with mud debris depositions, and extensive erosion was observed. What is more, by the arrival of the reconnaissance team (October 2, 2020), part of the levee had already been restored with layers of compacted soil, suggesting that (1) the traffic on the crest would have been imperiled by the degree of section loss due to erosion, and (2) the local authorities wanted to fix the levee quickly, for preparedness against a new flood event in the near future.

Figure 8.7. (a) location of Flood Protection Levee 02 (39.343994°N; 21.898058 E); (b) minor surface erosion on the crest of the levee.

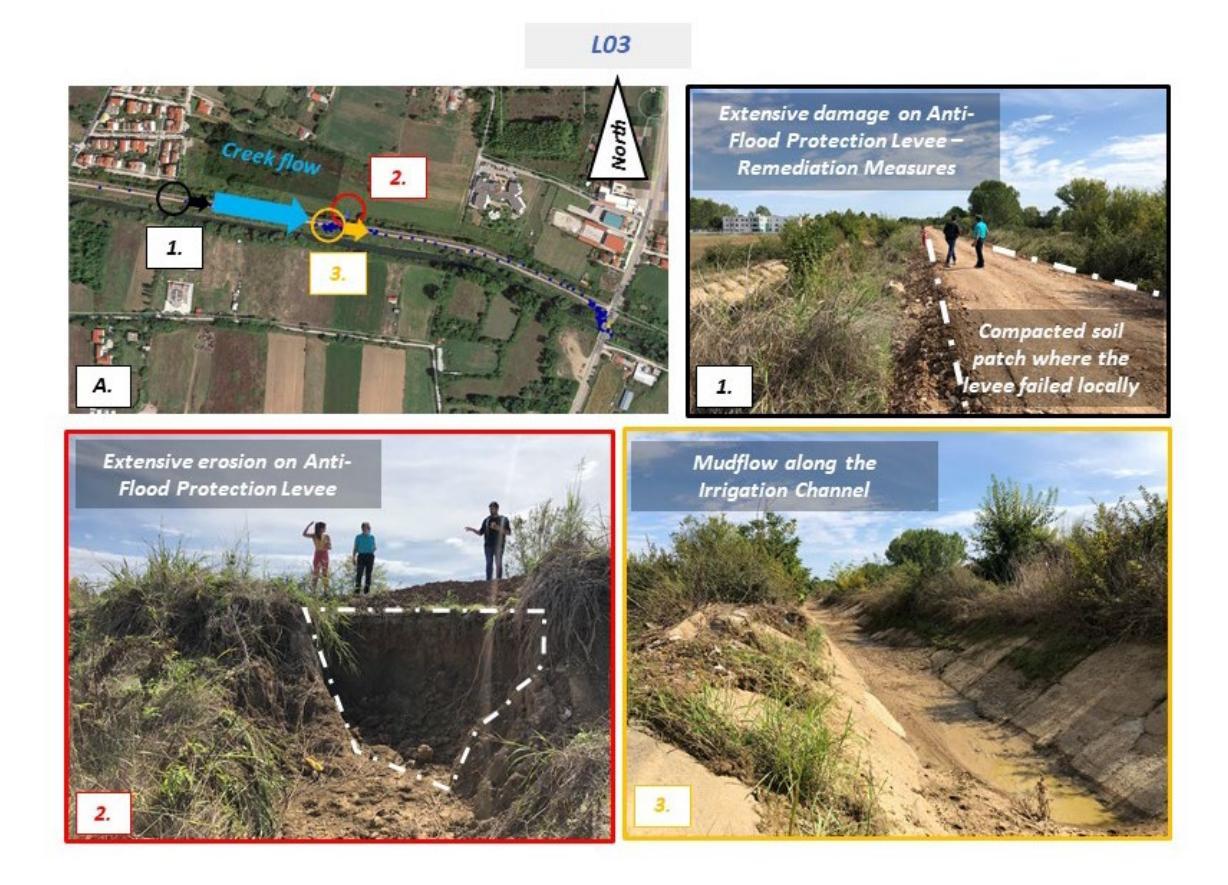
Figure 8.8. (A) location of Flood Protection Levee 03 (39.348173°N; 21.915506°E); (1) extensive damage with loss of a significant part of the levee section (was compacted when we arrived there on October 2, 2020); (2) extensive erosion caused most probably by vortices of the flooded irrigation channel; (3) debris build up on the irrigation channel (photo looking downstream).
