## Preliminary Report on Geotechnical Aspects of the May 15<sup>th</sup> 2020 Magnitude 6.5 Monte Cristo Range Earthquake in Nevada

A report of the NSF-Sponsored Geotechnical Extreme Event Reconnaissance Association

> Report GEER-71: <u>https://doi:10.18118/G67H4F</u> March 10, 2021 (version 1)

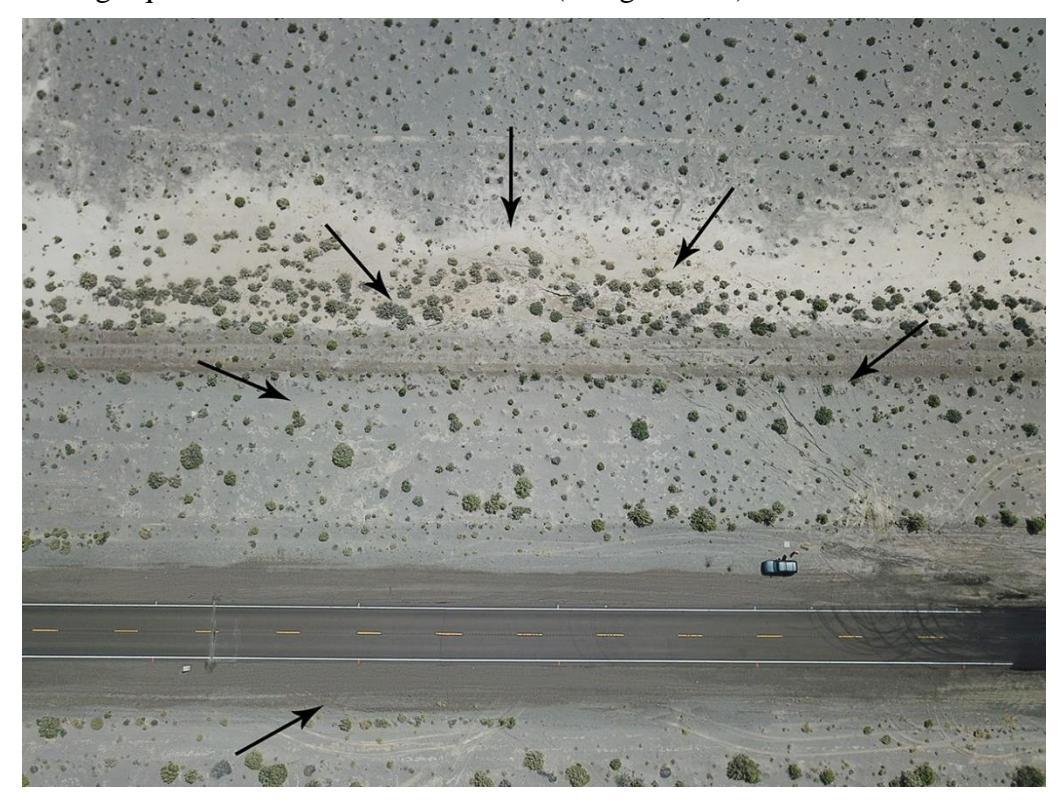
**Figure 4-3:** Drone image A of surface deformation adjacent to Highway 95 (38 6' 41.6077" N, 117 55' 43.4268" W, altitude 1572.76 m; photo courtesy of Conni De Masi Castillo, UNR).

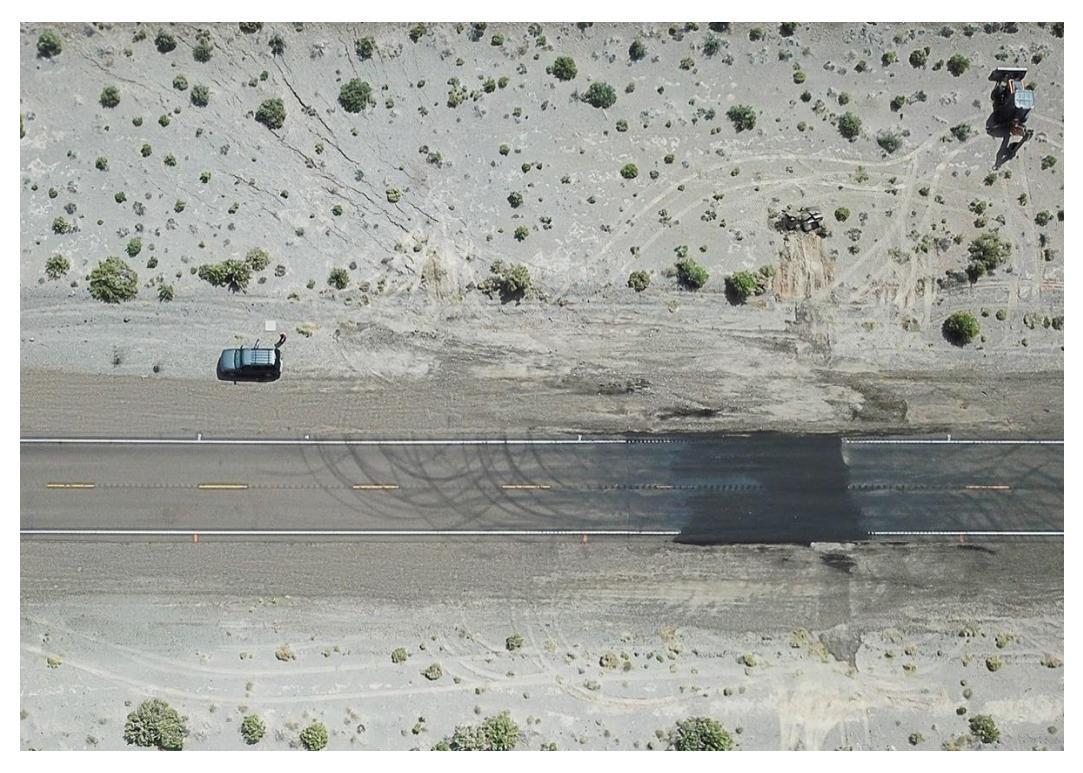
**Figure 4-4:** Drone image B of surface deformation adjacent to Highway 95 (38 6' 41.6077" N, 117 55' 43.4268" W, altitude 1572.76 m; photo courtesy of Conni De Masi Castillo, UNR).

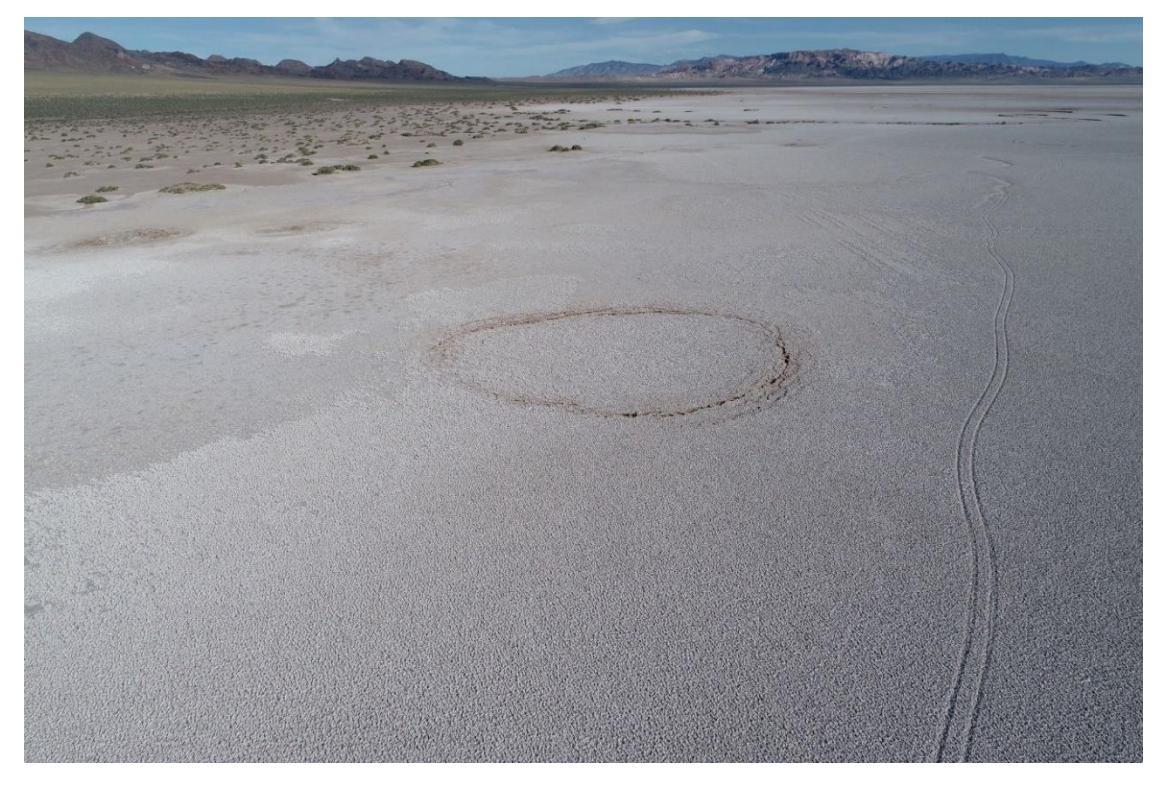
Subsidence feature GSS1 is approximately circular with N-S and E-W widths of approximately 34m. It appears in relatively flat terrain. Table 4-1 lists the observations associated with each waypoint of subsidence feature GSS1, and Figures 4-17 through 4-37 show the accompanying photographs. The blocks described in Table 4-1 are intact soil bounded by cracks, and the gaps described in Table 4-1 are open fissures in the soil in between the blocks. The subsurface conditions of this feature are analyzed using ReMi surveys as discussed in Chapter 10.

**Figure 4-11:** Aerial view of the circular subsidence feature labelled GSS1 (*photo courtesy of Conni De Masi Castillo, UNR*).

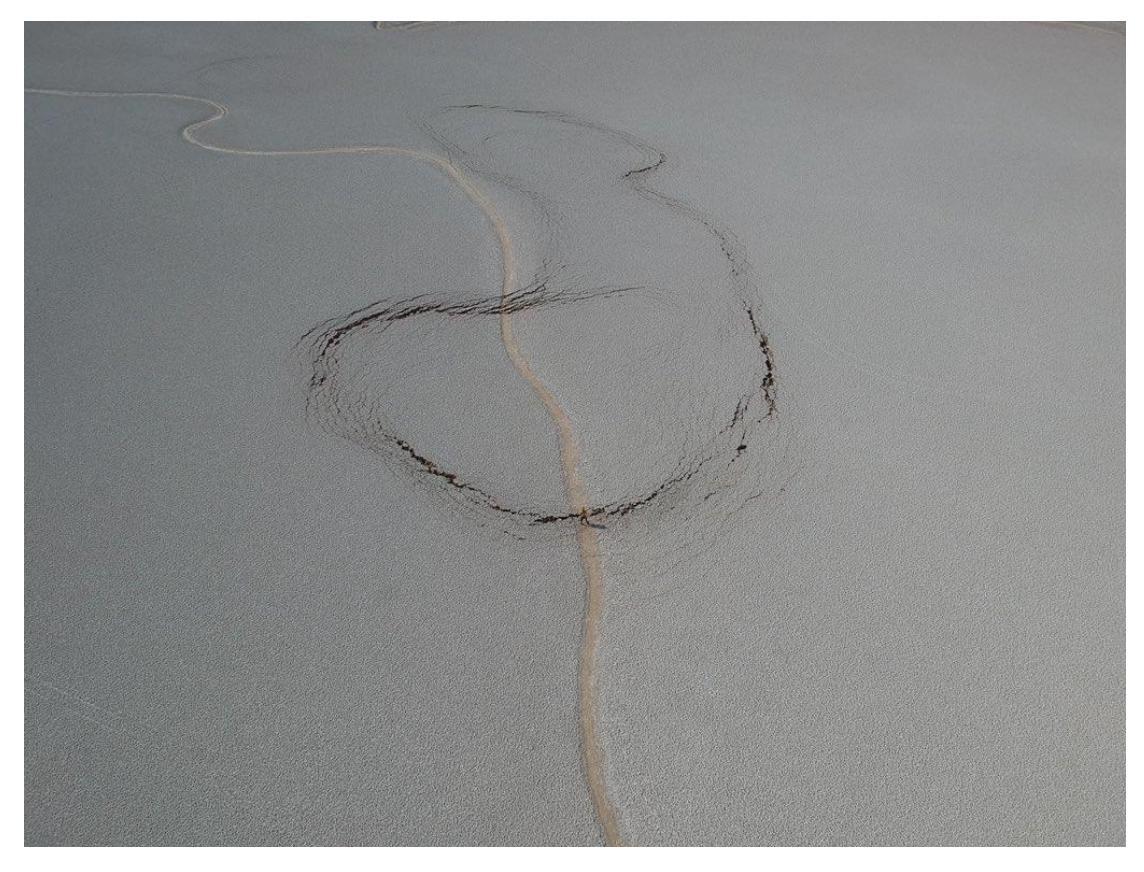
Feature GSS2 is a kidney-bean shaped subsidence feature with a concave portion on each of its E-W sides. The distance between Waypoint 1 and Waypoint 5 of GSS2 is 108.5m. Table 4-2 lists the observations associated with each waypoint, and Figures 4-38 through 4-50 show the associated photographs. As shown in Figure 4-39, the ground surface displacements associated with GSS2 cross an ephemeral stream channel within the Columbus Salt Marsh.

Figure 4-13: Aerial view of the kidney-bean shaped subsidence feature labelled GSS2 (*photo courtesy of @snowhorse420 on Twitter*).

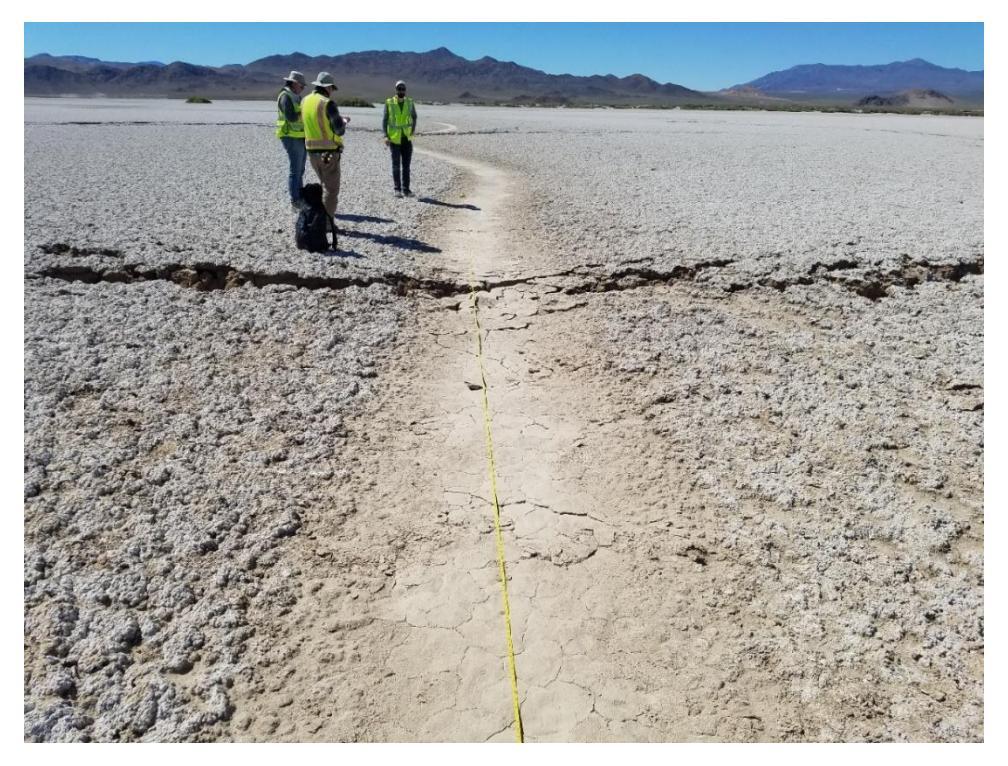
**Figure 4-39:** Ground surface displacements at Waypoint 1 of subsidence feature GSS2 looking northwest (*lat/lon = 38.11355, -117.93671*).

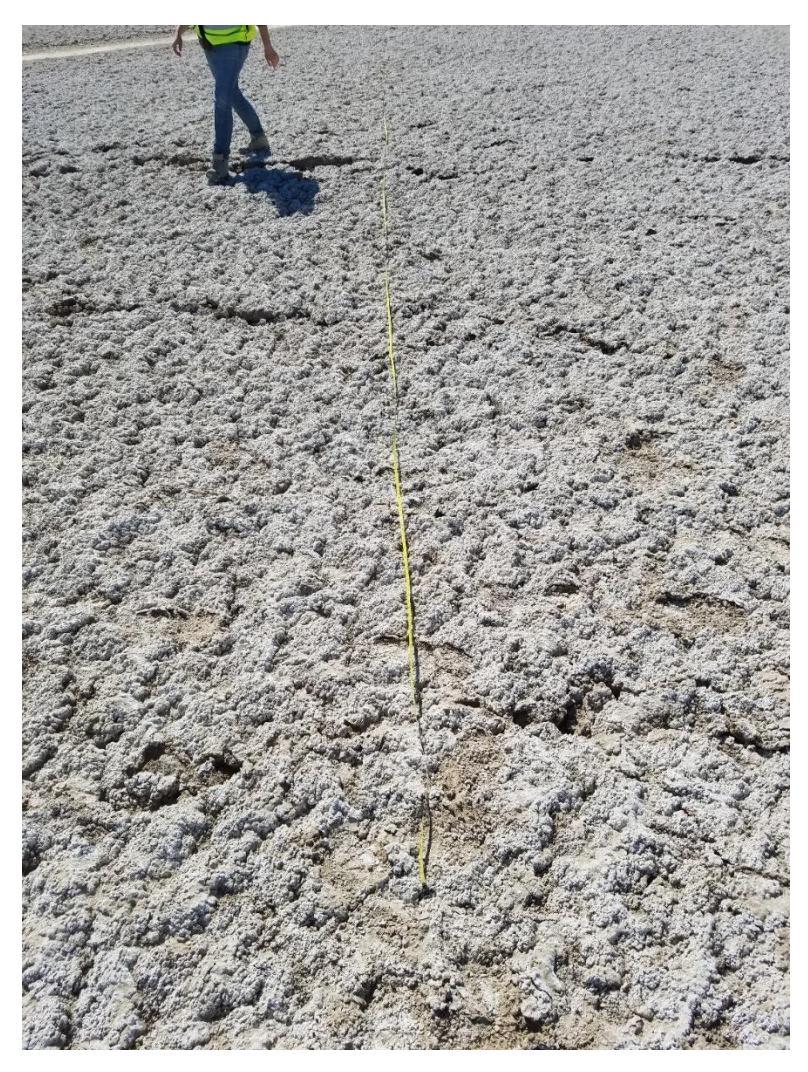
**Figure 4-40:** Ground surface displacements at Waypoint 2 of subsidence feature GSS2 (*lat/lon* = *38.11368, -117.93661*).

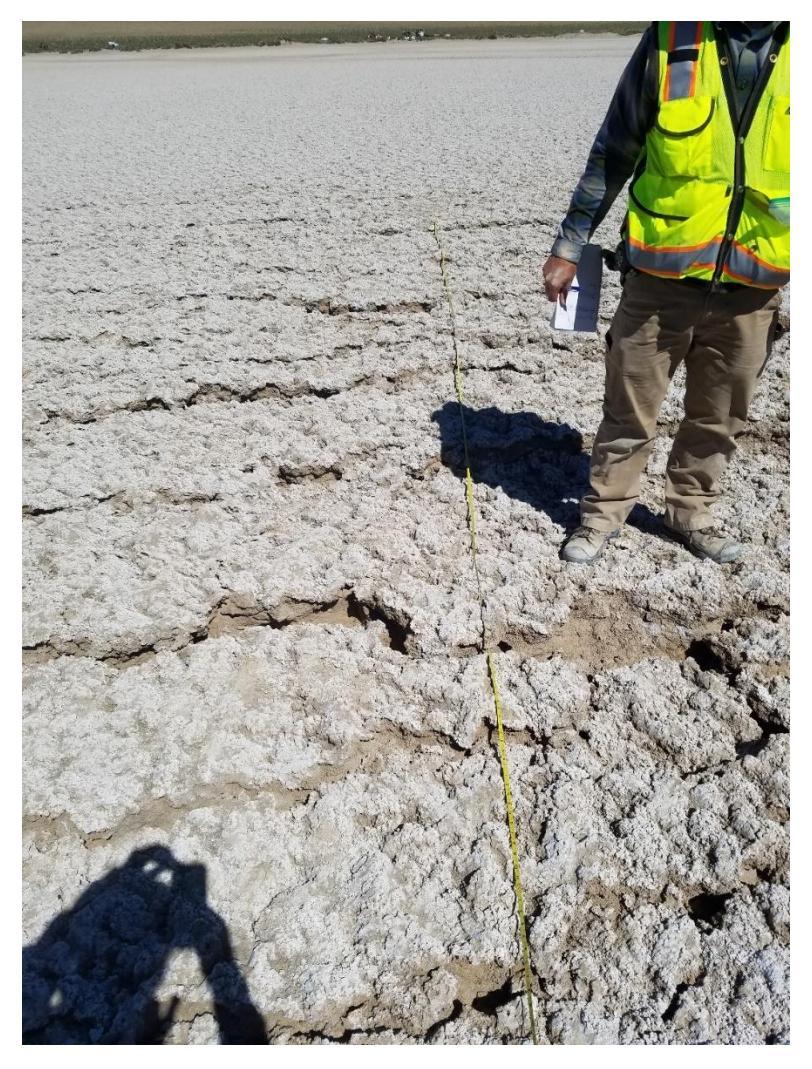
**Figure 4-41:** Ground surface displacements at Waypoint 2 of subsidence feature GSS2 looking southeast (*lat/lon = 38.11368, -117.93661*).

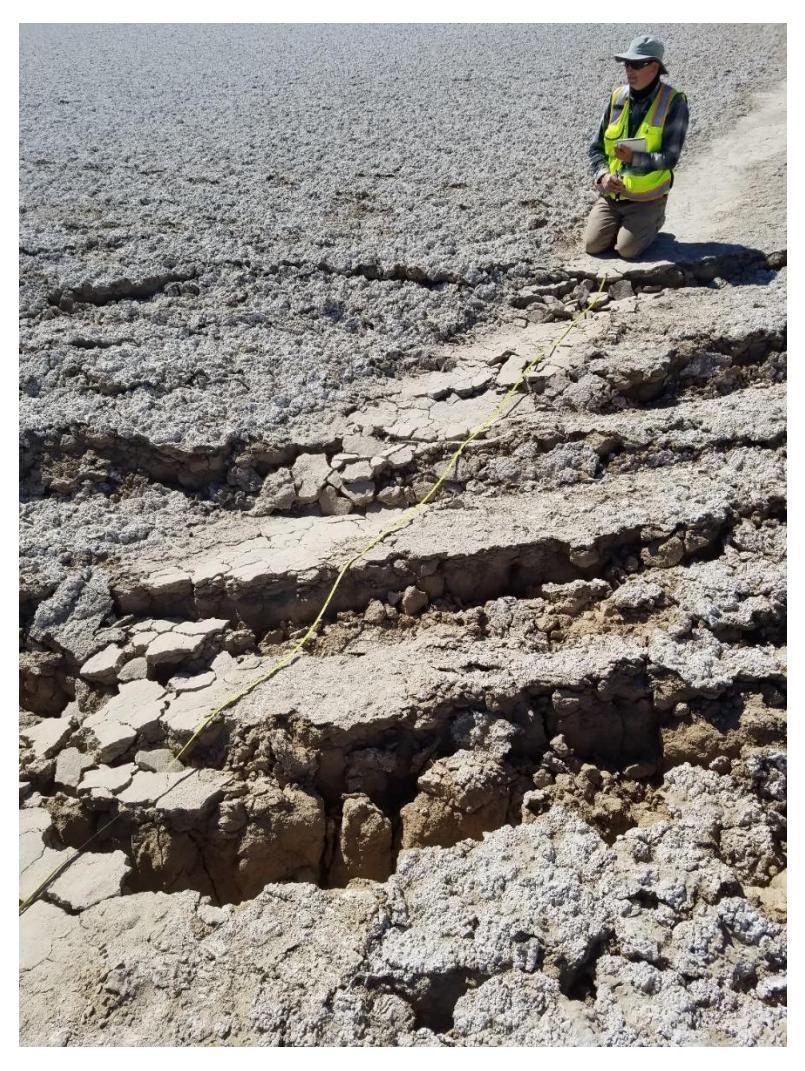
**Figure 4-42:** Ground surface displacements at Waypoint 3 of subsidence feature GSS2 looking northwest (*lat/lon = 38.11385, -117.93703*).

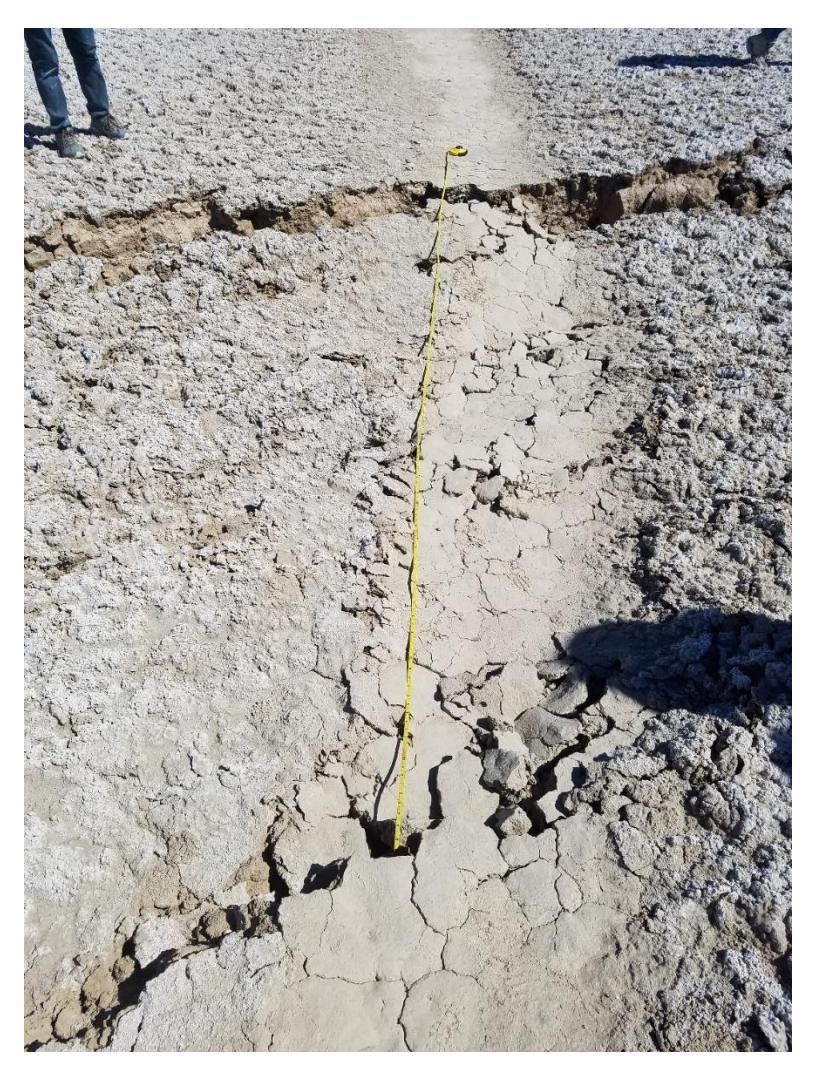
**Figure 4-43:** Ground surface displacements at Waypoint 3 of subsidence feature GSS2 looking southeast (*lat/lon = 38.11385, -117.93703*).

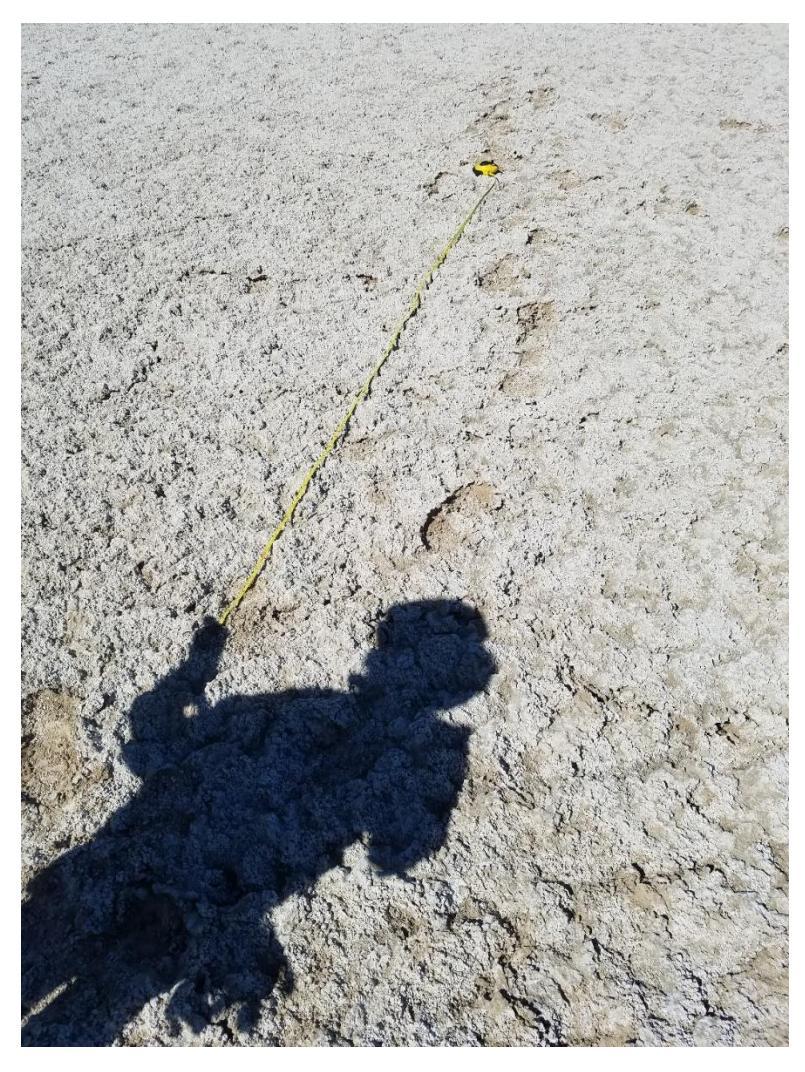
**Figure 4-44:** Ground surface displacements at Waypoint 4 of subsidence feature GSS2 (*lat/lon* = *38.11398*, *-117.93707*).

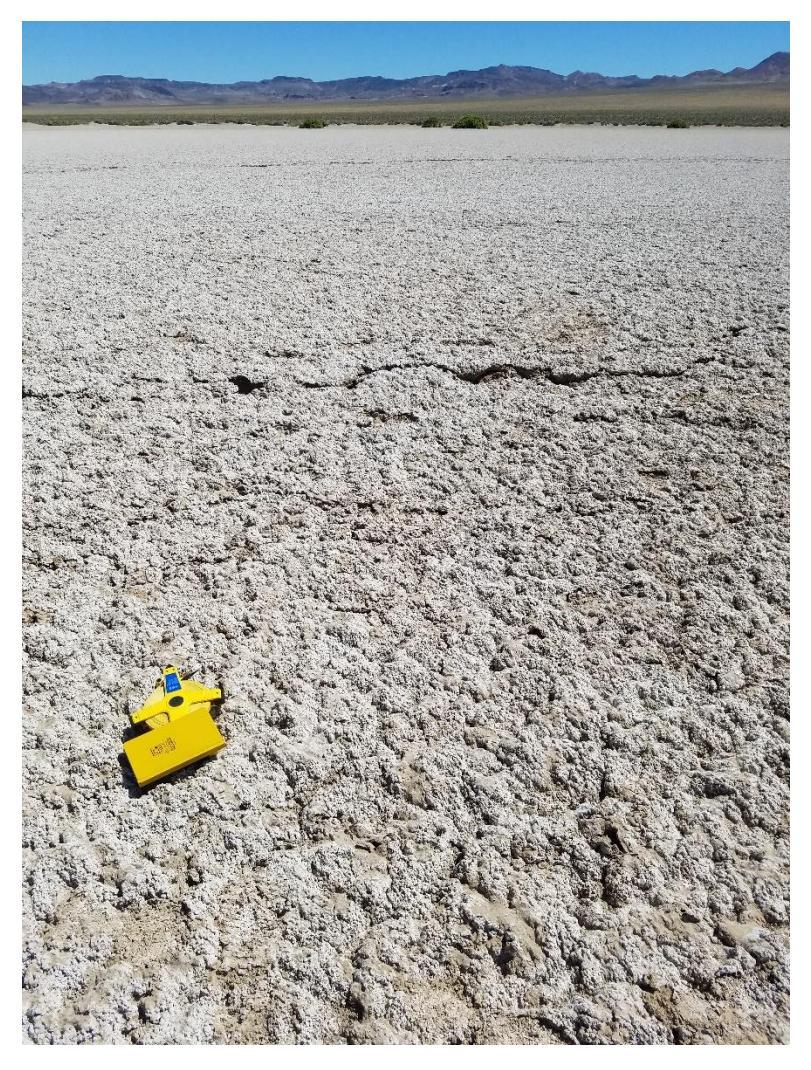
**Figure 4-45:** Ground surface displacements at Waypoint 6 of subsidence feature GSS2 looking northeast (*lat/lon = 38.11405, -117.93736*).

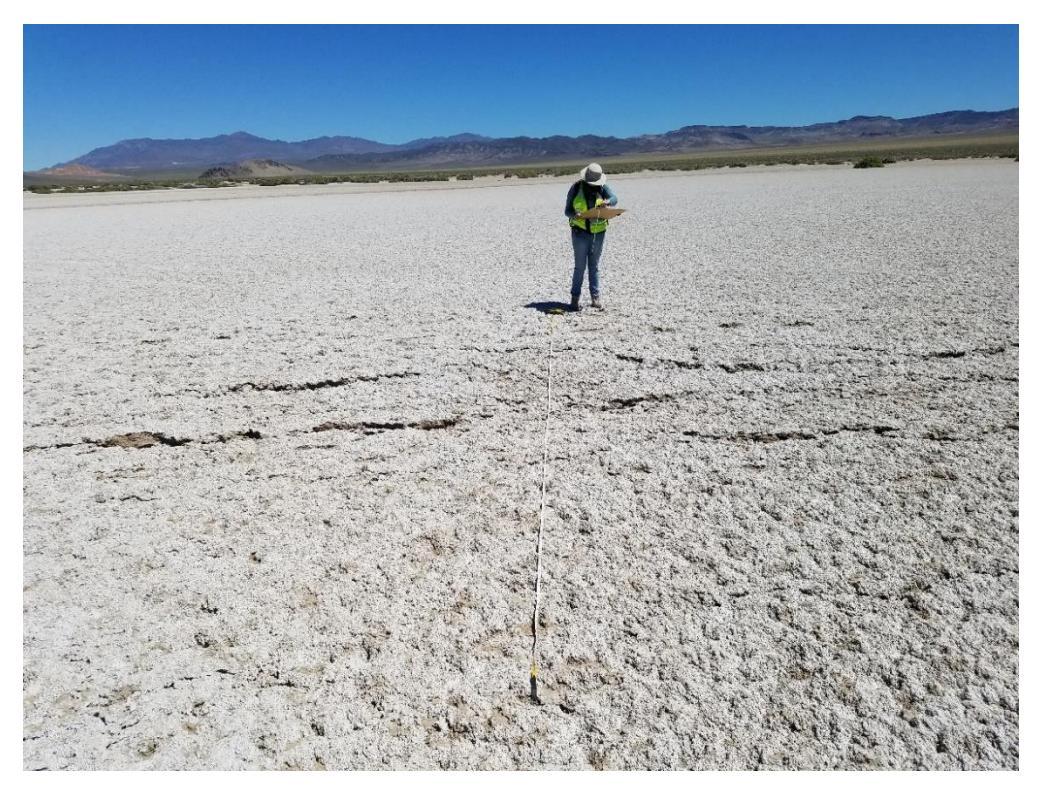
**Figure 4-46:** Ground surface displacements at Waypoint 7 of subsidence feature GSS2 looking northeast (*lat/lon = 38.11433, -117.93716*).

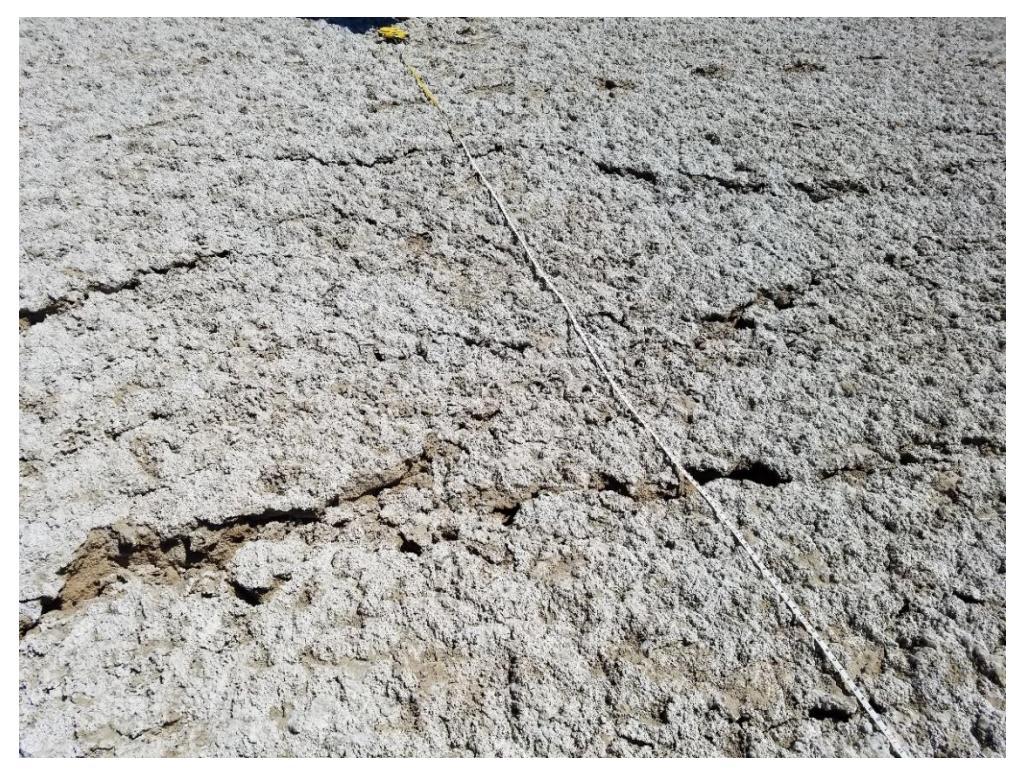
**Figure 4-47:** Ground surface displacements at Waypoint 7 of subsidence feature GSS2 (*lat/lon* = *38.11433, -117.93716*).

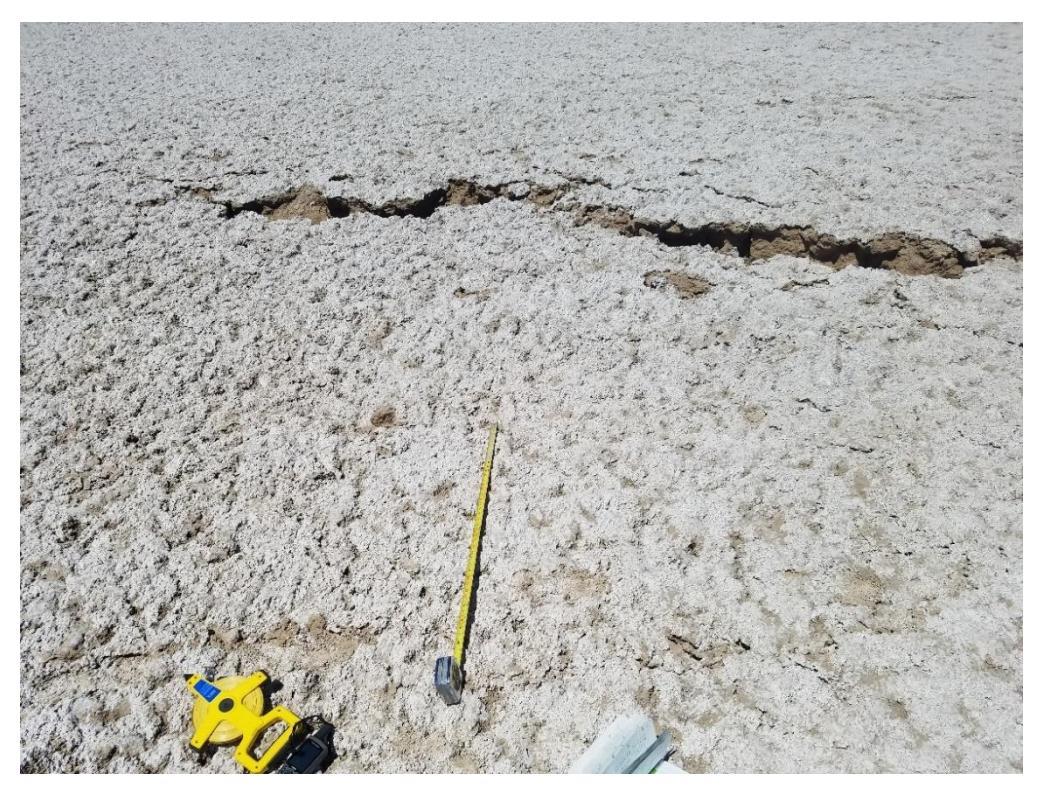
**Figure 4-48:** Ground surface displacements at Waypoint 9 of subsidence feature GSS2 (*lat/lon* = *38.11417, -117.93697*).

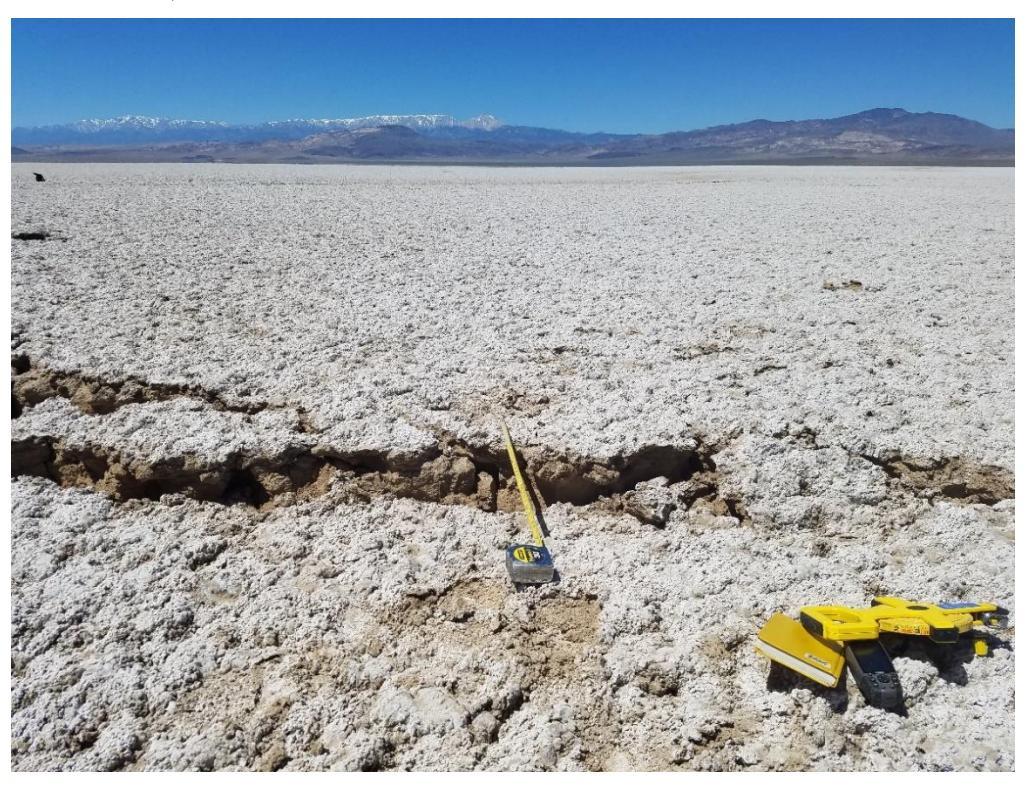
**Figure 4-49:** Ground surface displacements at Waypoint 10 of subsidence feature GSS2 looking southwest (*lat/lon = 38.11422, -117.93699*).

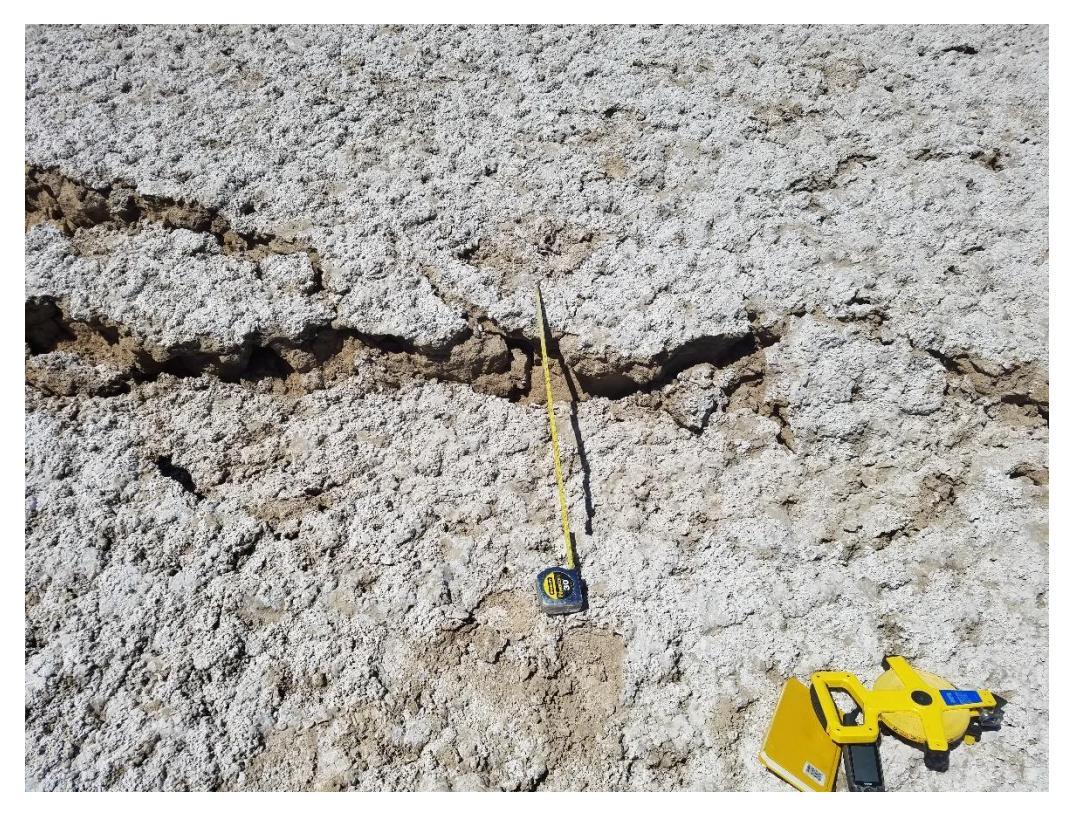
**Figure 4-50:** Ground surface displacements at Waypoint 10 of subsidence feature GSS2 (*lat/lon* = 38.11422, -117.93699).

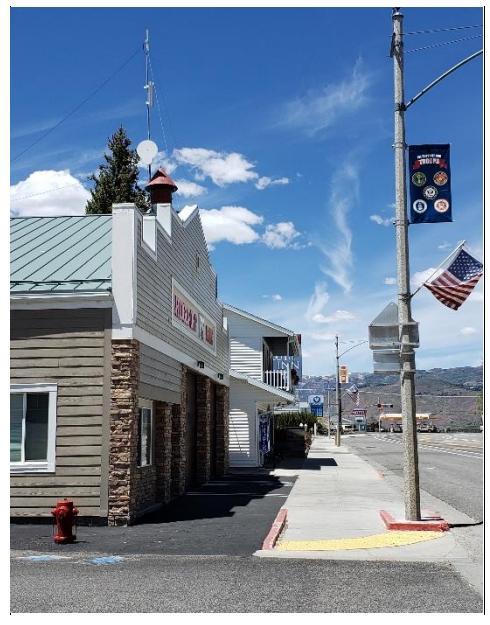
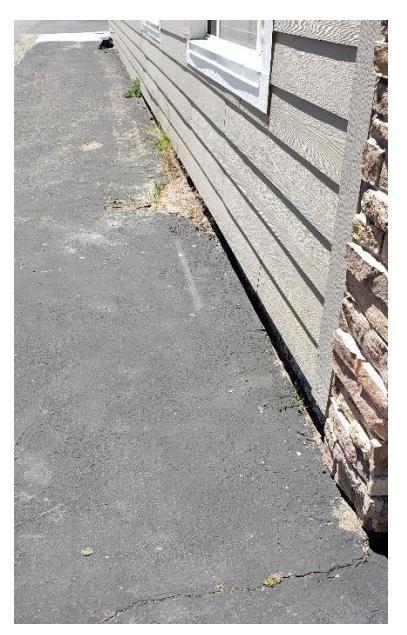
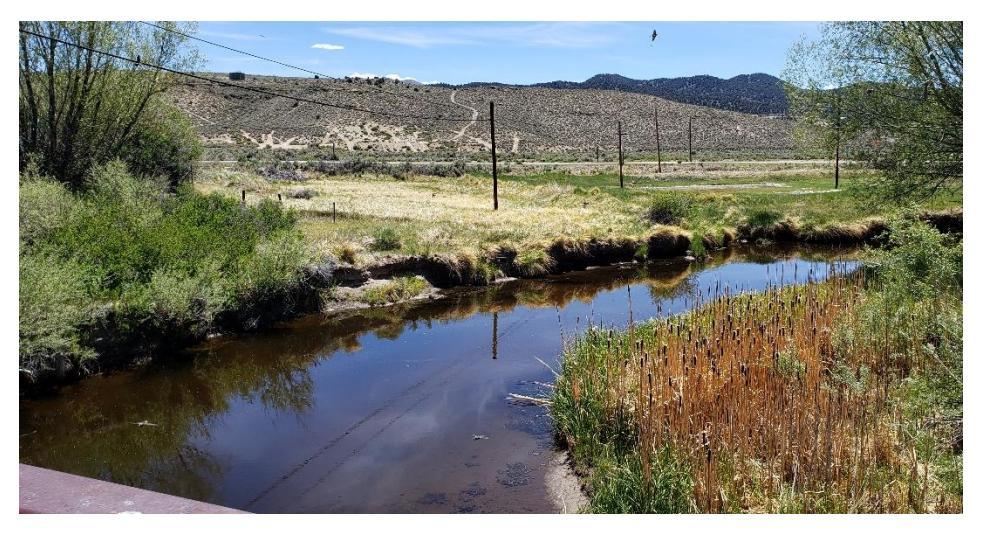
The GEER team visited the location of the "CE-65654 Bridgeport – Main & School Street" recording station on June 10, 2020. This station is located in Bridgeport, California and is housed within the property of the Bridgeport Fire Station building. Several open fields and streams surround the town of Bridgeport. The GEER team examined the area surrounding the Fire Station building, as well a nearby stream channel flowing towards the Bridgeport Reservoir (Figure 5-5). No signs of earthquake damage or ground failure were observed.

**Figure 5-5:** Bridgeport, CA photos near recording station CE-65654 with no signs of earthquake damage; (a) West facing view of Bridgeport Fire Station building front (*lat/long* = 38.2557, - 119.2288), (b) east floor edge of Fire Station building (sand shown likely wind-blown from nearby properties and settled within pre-earthquake asphalt spalls and cracks; *lat/long* = 38.2556, -119.2289), (c) stream channel east of town of Bridgeport, CA with no observable ground failure (*lat/long* = 38.2571, -119.2236).

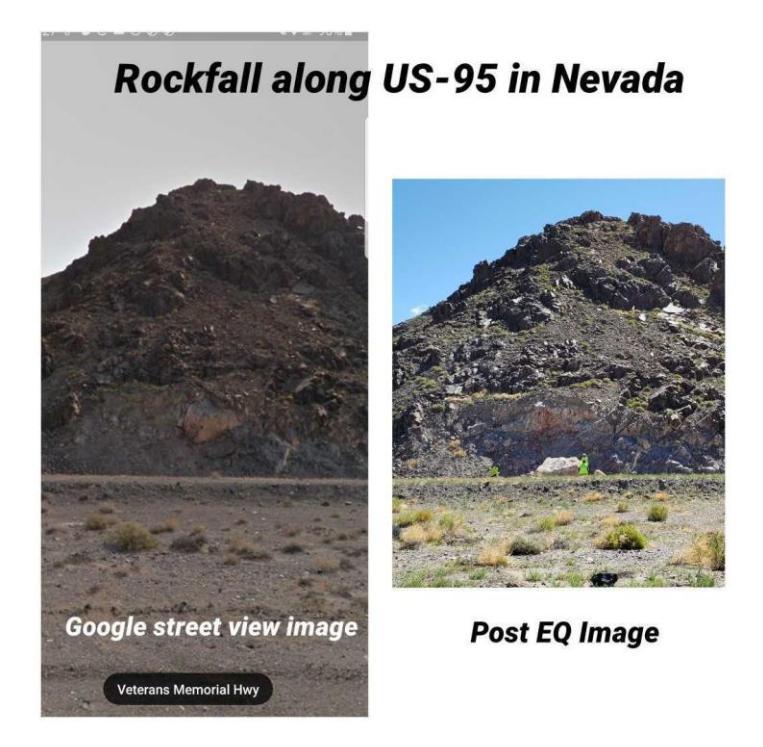
The rockfall debris included one large boulder (shown in Figure 6-3 to 6-4) with a debris cone consisting of smaller, angular cobbles to boulders of widths on the order of 0.5m (shown in Figure 6-5 to 6-6). The boulder was approximately 2.7m at its widest point and had travelled approximately 12m from the cliff face. Figure 6-2 shows the position of the large boulder as it was located on the rockface prior to the Monte Cristo Earthquake and is compared with a similar view as seen from US95 after the rockfall event.

**Figure 6-2:** Before and after images of the rockfall (*lat/lon = 38.145794, -117.94509*). Google street view image is from August 2018.

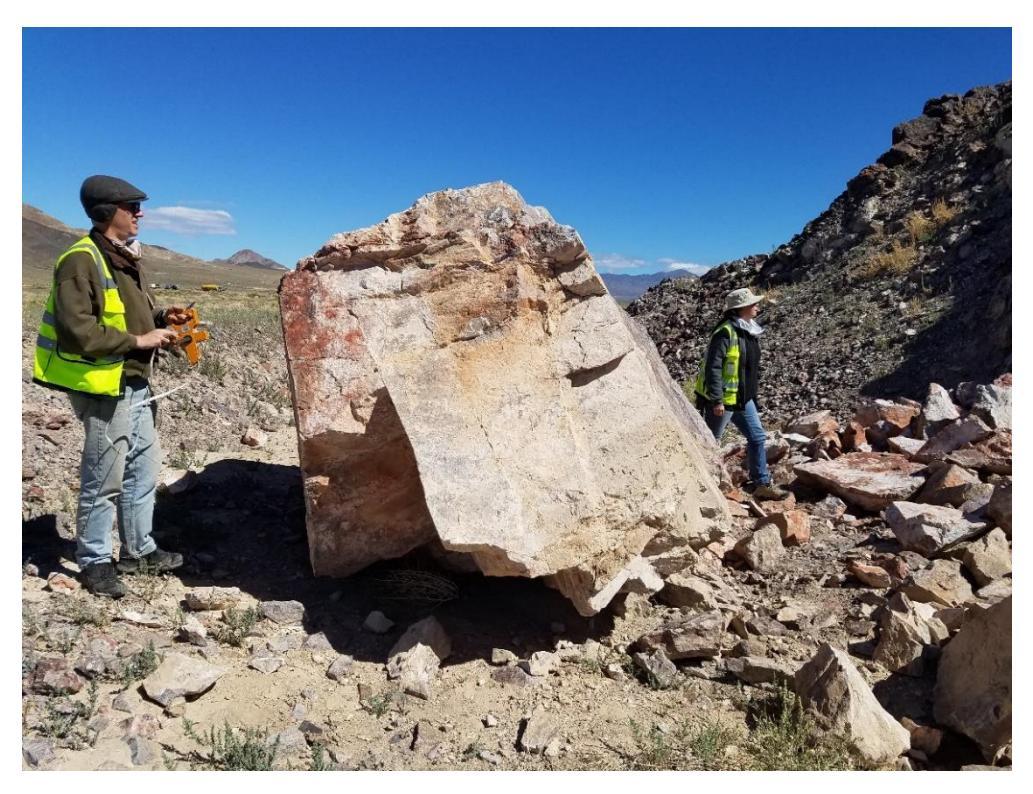
As mapped by Stewart, Kelleher, and Zorich (1994), the western portion of the ridgeline is underlain by the Roberts Mountains Allochthon, consisting of Late Devonian to Late Cambrian siliceous and volcanic rocks. The rockface, including the source area of the rockfall, consisted of several different rock types, including breccia, shale, and a shear zone. The rock mass surrounding the source area of the boulder was moderately fractured, with planar fractures spaced at approximately 0.15m to 0.6m. The intact boulder appeared to be much larger than the spacing of the rock mass surrounding its original position, as well as being lithologically distinct.

**Figure 6-3:** Boulder from the rockfall, looking northwest (*lat/lon* = *38.14613078*, - *117.944488056*).

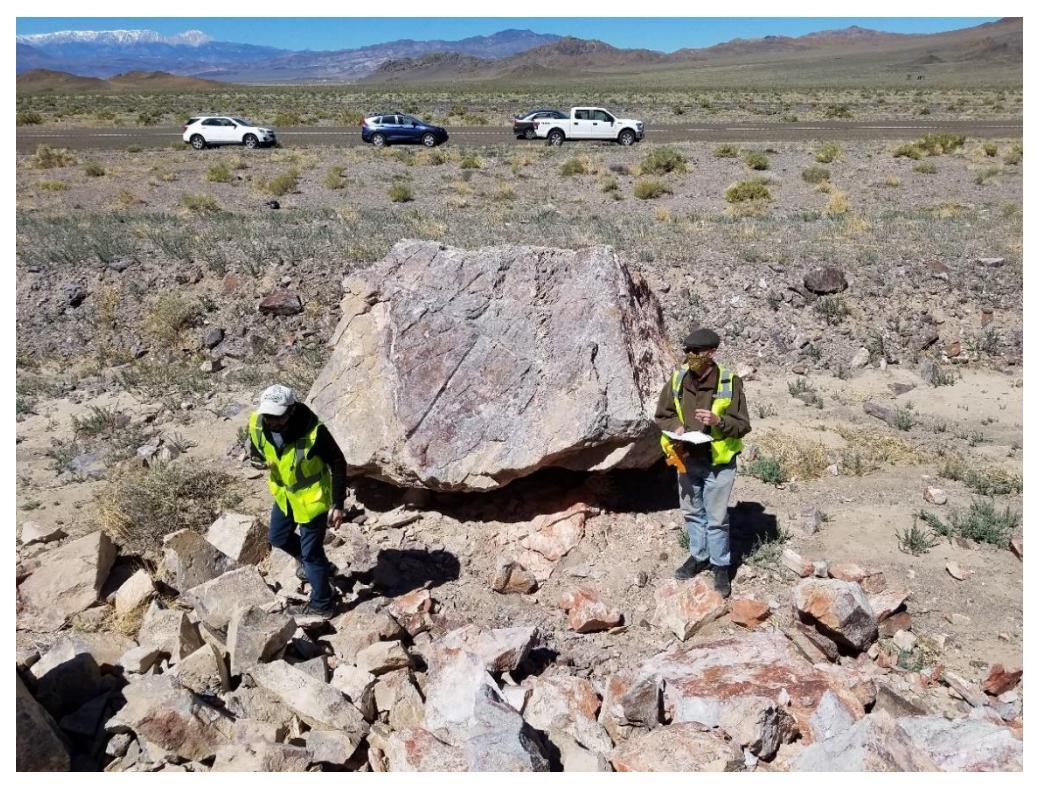
**Figure 6-4:** Boulder from the rockfall, looking west. Smaller debris is visible at the bottom of the picture. (*lat/lon = 38.14613078, -117.944488056*).

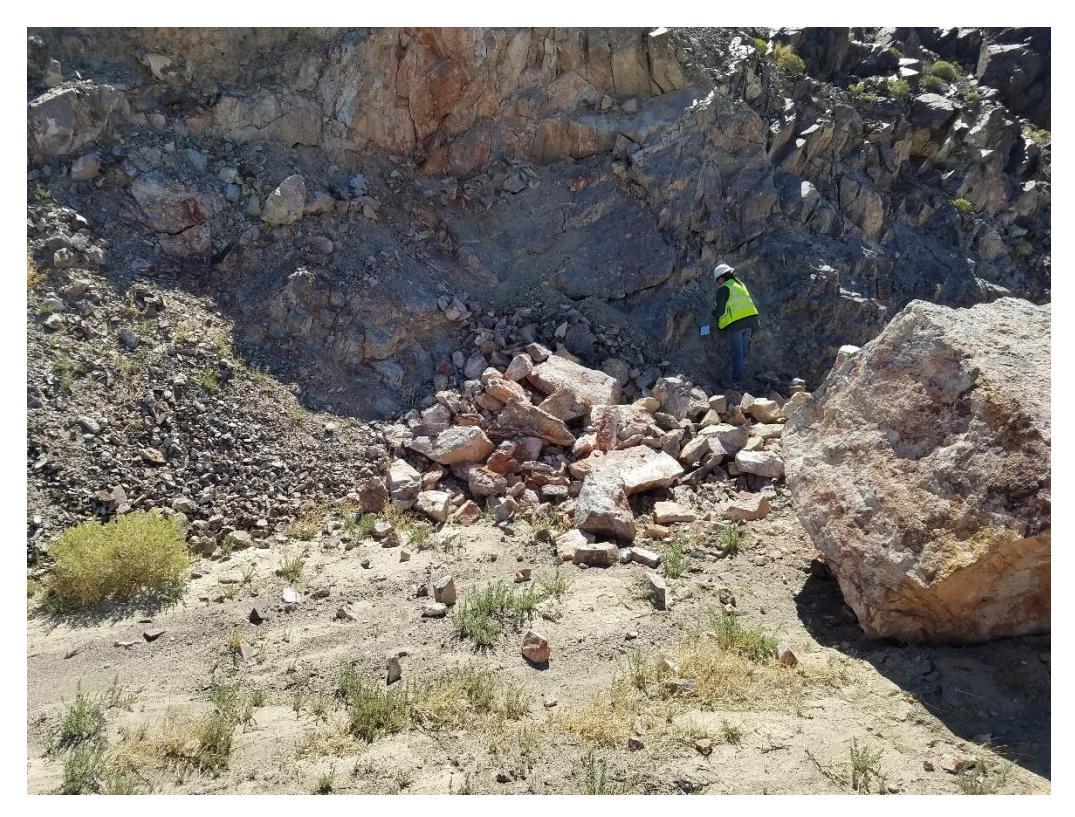
**Figure 6-5:** Rockfall debris located between the boulder and the rockface, looking east. (*lat/lon* = 38.14596278, -117.9445302).

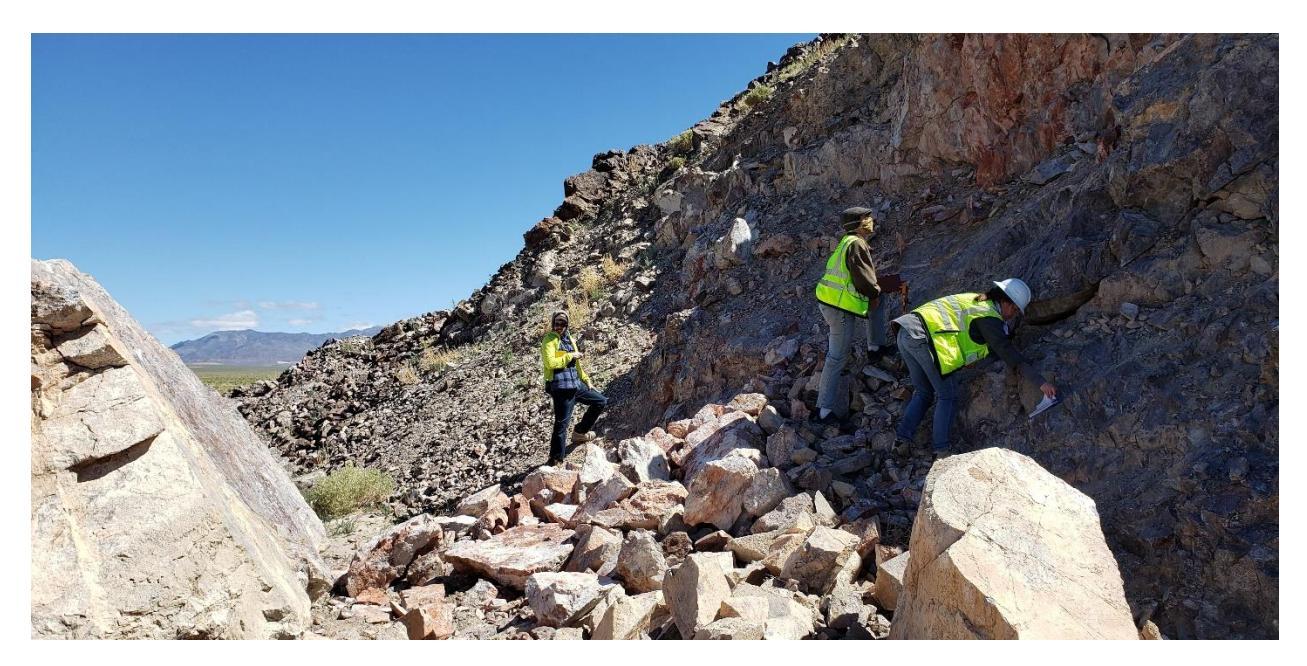
**Figure 6-6:** Rockfall debris located between the boulder and the rockface, looking northwest. (*lat/lon = 38.047707, -117.896156*).

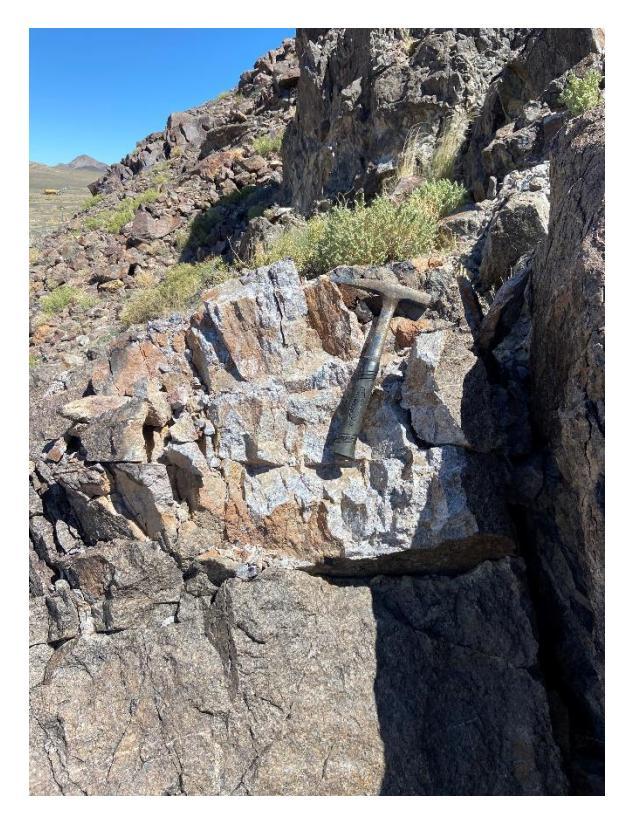
The GEER team traversed the perimeter of the promontory looking for further evidence of rockfall. Several small debris cones and impact scars appeared fresh to slightly weathered, such as in Fig 6-7, but it was not clear that these rock falls were due to the recent earthquake. Several cobble-sized and smaller clasts were observed with fresh to slightly weathered surfaces, generally located within a meter of the toe of the slope. These features were located along the western slope face of the promontory that included the main rockfall. No significant recent rock fall features were observed on the north, east, and south sides of the promontory.

**Figure 6-7:** Fresh to slightly weathered impact scar on rock outcrop, south of main rockfall. (*lat/lon = 38. 1458, -117. 1457*).
