## Preliminary Report on Geotechnical Aspects of the May 15<sup>th</sup> 2020 Magnitude 6.5 Monte Cristo Range Earthquake in Nevada

A report of the NSF-Sponsored Geotechnical Extreme Event Reconnaissance Association

> Report GEER-71: <u>https://doi:10.18118/G67H4F</u> March 10, 2021 (version 1)

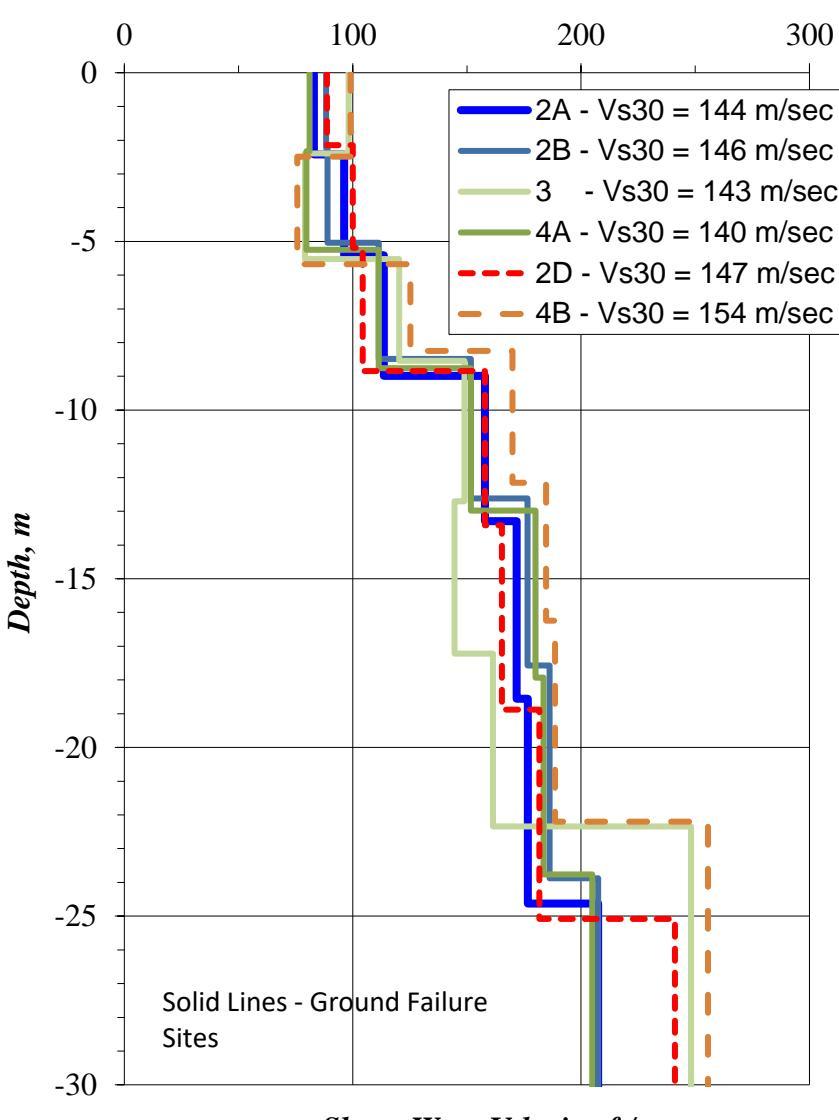
Results of the ReMi surveys are shown on Figure 7-3. There is little difference in shear wave velocity between the playa ground failure sites and sites without ground failure. Each site has a loose zone in the upper 0.45-0.7 m that may be associated with shrinkage cracks, and the shear-wave velocity to 8.5-10 m depth is less than 110 m/s. For sands, a shear-wave velocity of less than about 150 m/s would be interpreted as a loose granular material and below 200 m/s would indicate medium density and potential susceptibility to liquefaction during strong ground shaking (>0.3 g). However, the materials are likely to be intermediate/mixed fine-grained soils (with variable plasticity) for which there is no direct correlation between shear-wave velocity and strength/liquefaction potential. In any case, the soil type (granular versus fine-grained) cannot be determined from shear-wave velocity results. The moderate increase in shear wave velocity in all the seismic surveys at about 8.5 m depth suggests that there is a depositional, density, and/or aging boundary at this depth and (in combination with the expected vertical limits with depth of a 30 m wide failure zone) that ground failures potentially may not extend to greater than 8.5 m depth.

The inverse-weighted average in the upper 30 m (Vs30, used in determining building code site class) is slightly higher for the non-failure ReMi lines (151 m/s) compared to the ground failure zones (143 m/s). Site 3 was included as a ground failure site due to the sand ejecta, although no other failure features were noted. The average Vs30 for all six sites was 146 m/s with a standard deviation of 5 m/s. However, both results are within 2% of the average value at all sites and are unlikely to be statistically different from each other for a small sample size. Interestingly, both sites 2A and 4B without ground failure and the sand boil site have higher shear-wave velocity at greater than 22 m depth – 250 m/s versus ground-failure sites at about 200 m/s. These stronger layers may be primarily what increases the average Vs30 for the three non-liquefied sites. However, shear wave velocities at greater than about 20 m depth are often less reliable.

If the ReMi shear wave velocity differences at greater than 22 m depth are valid, it is possible that the primary mechanism that influenced ground failure was soil amplification/wave propagation through weaker soils immediately under the ground failure sites. The sites with lower shear-wave velocity profiles at depth would potentially have increased amplification of longer-period ground motions, which may have triggered ground failure in these localized areas.
Furthermore, the lateral variations in measurements observed in the vicinity of the ground failures (e.g., the shear wave velocity differences between Lines 4A and 4B below 22 feet depth, and the variation at all depths across Line 4A), may subject the soil profile to spatially incoherent wave propagation and scattering. This incoherency can potentially cause excessive tensile and compressive forces within the soil mass during shaking, which may result in observable ground distortions. However, it is also possible that the observed variations in shear-wave velocity are simply within the accuracy of ReMi interpretation and modeling.

Figure 7-3: 1D ReMi Profiles of Shear-Wave Velocity versus Depth.

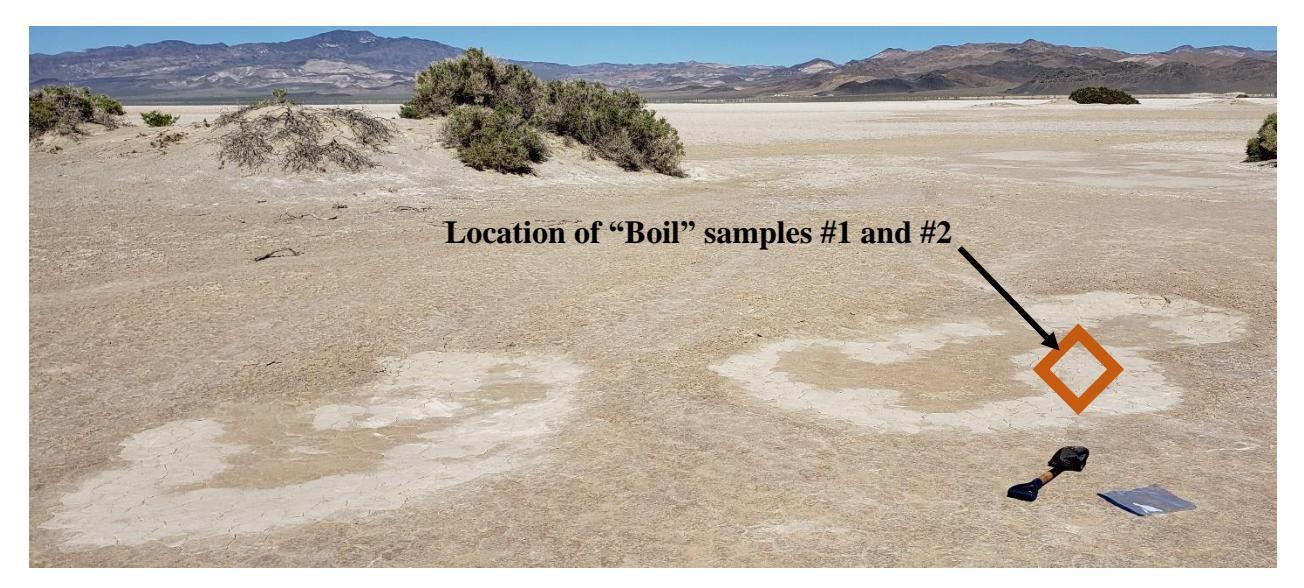
The *Boil* samples were taken at two different locations where the surficial soil compositions were believed to be distinct from one another. Samples *Boil #1 and #2* were taken within one of two slightly depressed (i.e., by ~1 to 2 inches) surface features that were lighter in color than the majority of the surrounding ground (Figure 7-17). A single test hole was used to obtain both samples, to a maximum depth of 2 feet. The surface of the depressed features prior to sampling felt highly compacted, and desiccation cracks were clearly visible. It is unclear whether these features were the result of liquefaction manifestations reaching the surface, or due to some other natural causes prior to the earthquake. Sample *Boil #3* was taken in an area where the ground surface felt "soft" and deformable when walked over. It was also adjacent to what appeared to be dissipation holes and cracks (Figure 7-18), which may have acted as outlets for excess pore pressures, following possible liquefaction of surficial soils under perched water conditions or deeper soils beneath the water table. No groundwater was visible during sampling.

**Figure 7-17:** Locations of samples *Boil* #1 and #2 prior to sampling (*lat/long* = 38.11204, -117.93291).

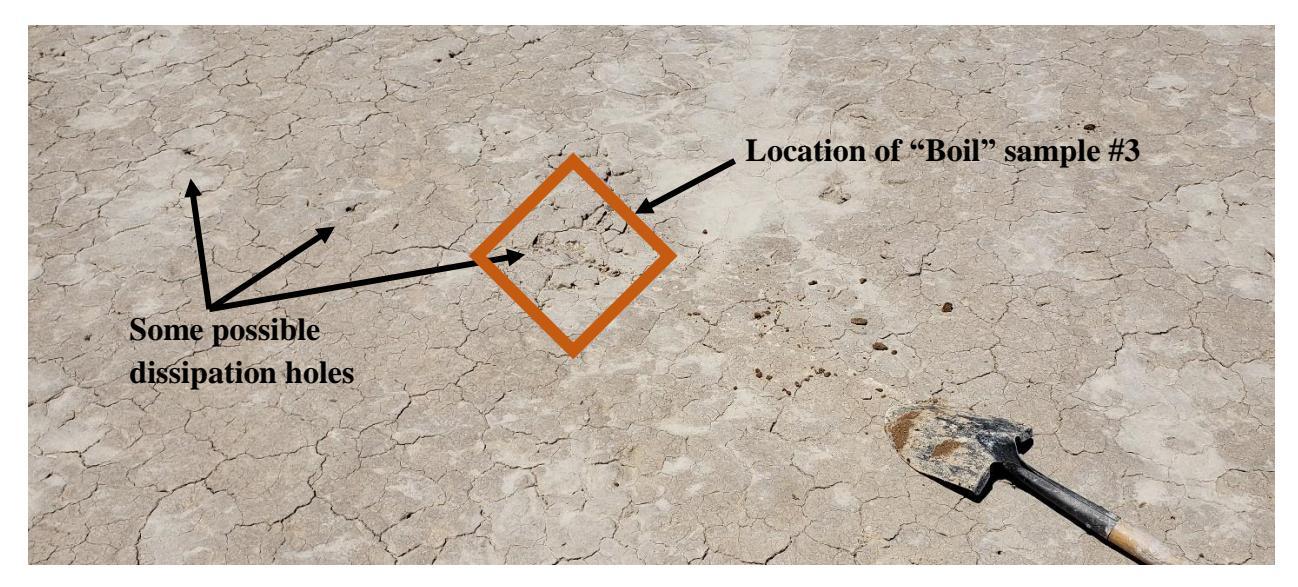
Figure 7-18: Location of sample *Boil #3* prior to sampling (*lat/long = 38.11174, -117.93252*).

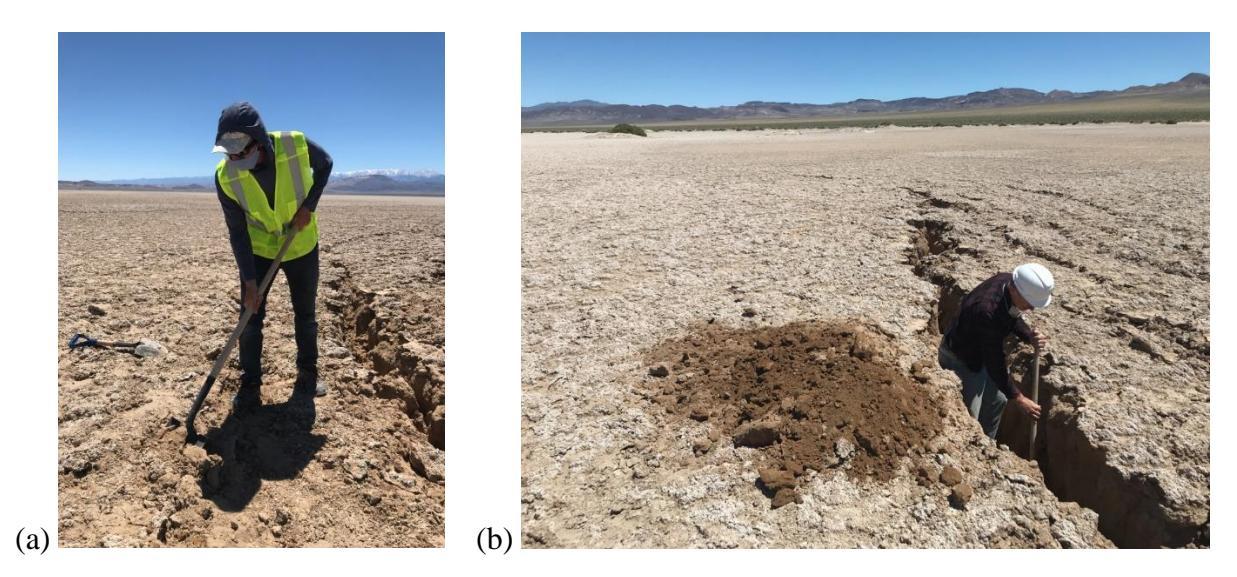
The *GSS1* samples were taken at a single location along the western side of the GSS1 surface feature described in Chapter 4. Sample *GSS1 #1* was taken near the surface, about 3 feet away from the outside edge of the fracture (Figure 7-19a). Samples *GSS1 #2, #3* and *#4*, were taken within the already open fracture, down to a depth of about 5 feet (Figure 7-19b). Samples were only taken from soil that was freshly exposed during the excavation, either from the side walls of the excavation or from beneath the base of the current excavation level. No groundwater was visible during sampling.

**Figure 7-19:** Locations during sampling of (a) Samples GSS1 #1 (lat/long = 38.11159, - 117.93487), and (b) Samples GSS1 #2, #3, and #4 (lat/long = 38.11160, -117.93499).

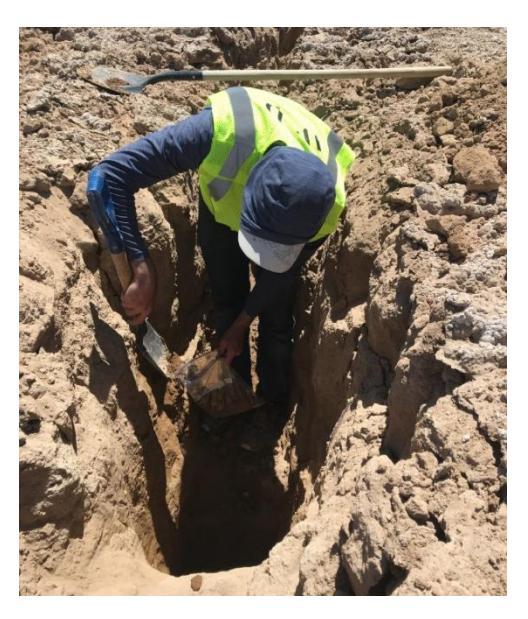
GEER team members used a shovel to excavate down to the sample depths at each test location (Figure 7-20). Plastic "zip-lock" bags were used to store and label the samples immediately after obtaining them (Figure 7-20). These bags remained sealed until tested in the lab, in an attempt to retain the in-situ moisture conditions.

**Figure 7-20:** Obtaining and storing sample *GSS1* #2 in a moisture sealing plastic bag (*lat/long* = 38.11161, -117.93488).

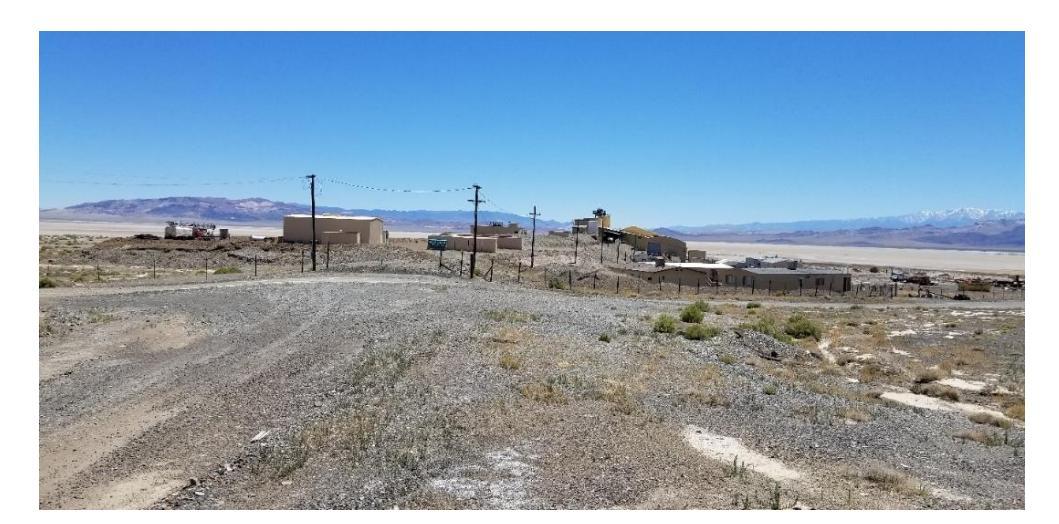
We also observed an old mine processing plant at the north end of the Columbus Salt Marsh (Figure 9-1) where a small laboratory is now set up where we were able to ask the sole employee about the event. The site inlcuded one permananet building (Figure 9-4), approximately 120 feet by 100 feet in plan view. The building was 2-stories tall and constructed with a combination of masonry block walls and metal. The employee reported that several small (less than 1-inch aperture) diagonal cracks were found radiating out from the top corners of the doors in the building. We were able to visually confirm the existence of the cracks, but we were not granted permission to enter the building to take photographs.

Figure 9-4: Buildings at the Mine Processing Plant. Photo looking south. (Photo GL29-1).

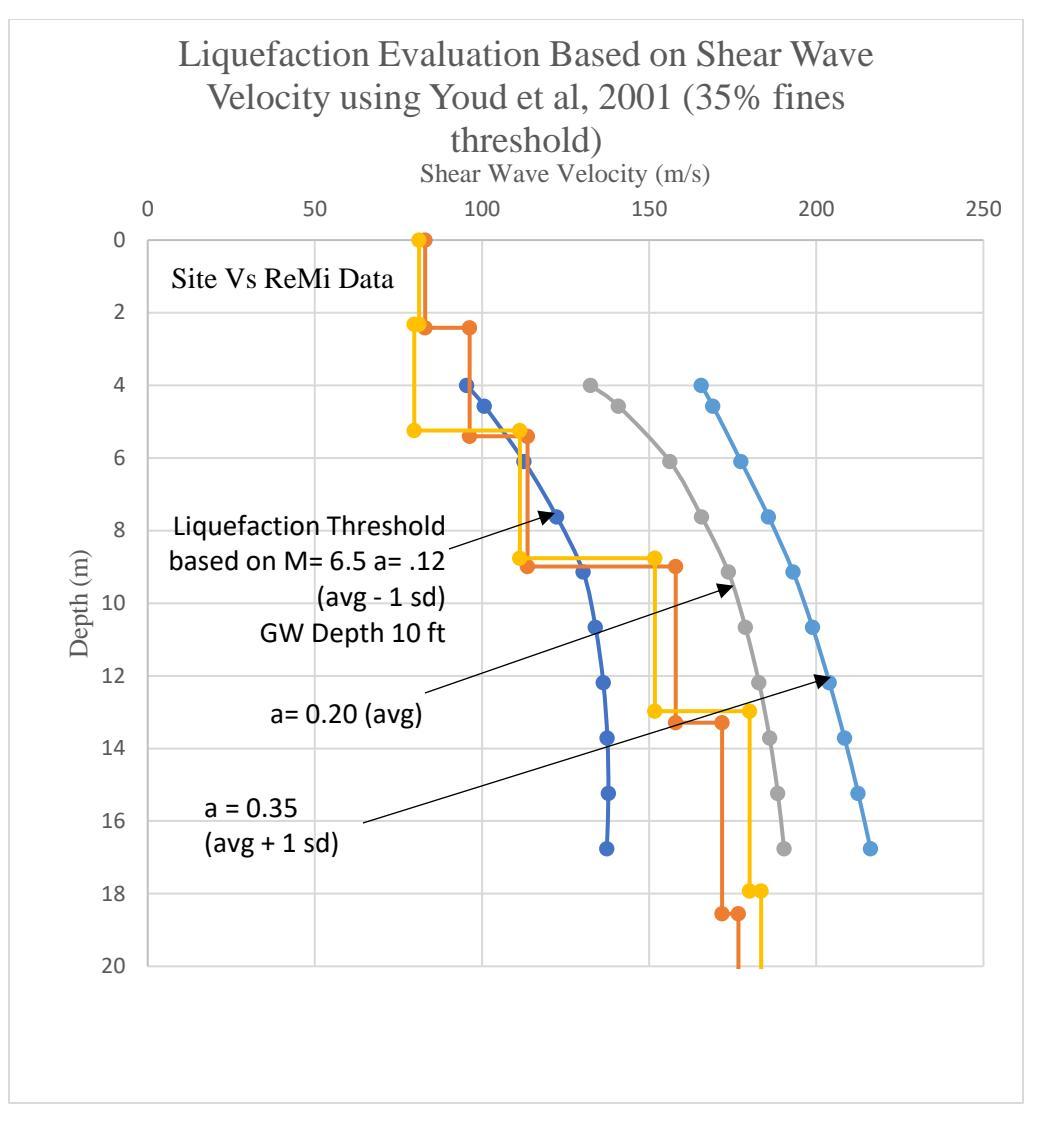
Liquefaction potential can be assessed using shear-wave velocity for saturated granular soils in Youd et al (2001), using the general approach adopted by Andrus & Stokoe (2000). Curves were developed for clean sands, silty sands with 20% fines, and for silty sands with more than 35% fines. The liquefaction threshold for 35% fines or more was evaluated for the earthquake magnitude, potential ground accelerations, and assumed groundwater table at 4 m depth. The liquefaction threshold versus depth on Figure 10-1 can be compared to the shear wave profiles measured at the side to identify which depth intervals are potentially liquefiable.

The results of the liquefaction analysis suggest that at the average-minus-one-standarddeviation ground acceleration of 0.12g, the site soils would potentially have been close to incipient liquefaction between about 4 m and 8.5 m depth. For the predicted average peak ground acceleration, soil could have liquefied to far greater depth, in excess of 20 m. The results of liquefaction prediction above may not be applicable because low-stiffness clays on the site may potentially not be liquefiable based on the criteria below, and the method is not believed to be well-calibrated to materials with significantly greater than 35% fines. The response at the average ground conditions suggest that, with a slightly more powerful earthquake, significantly more ground failure might have been observed at the Columbus Salt Marsh site.

**Figure 10-1:** Liquefaction evaluation based on shear wave velocity using Youd et al. (2001) methodology.

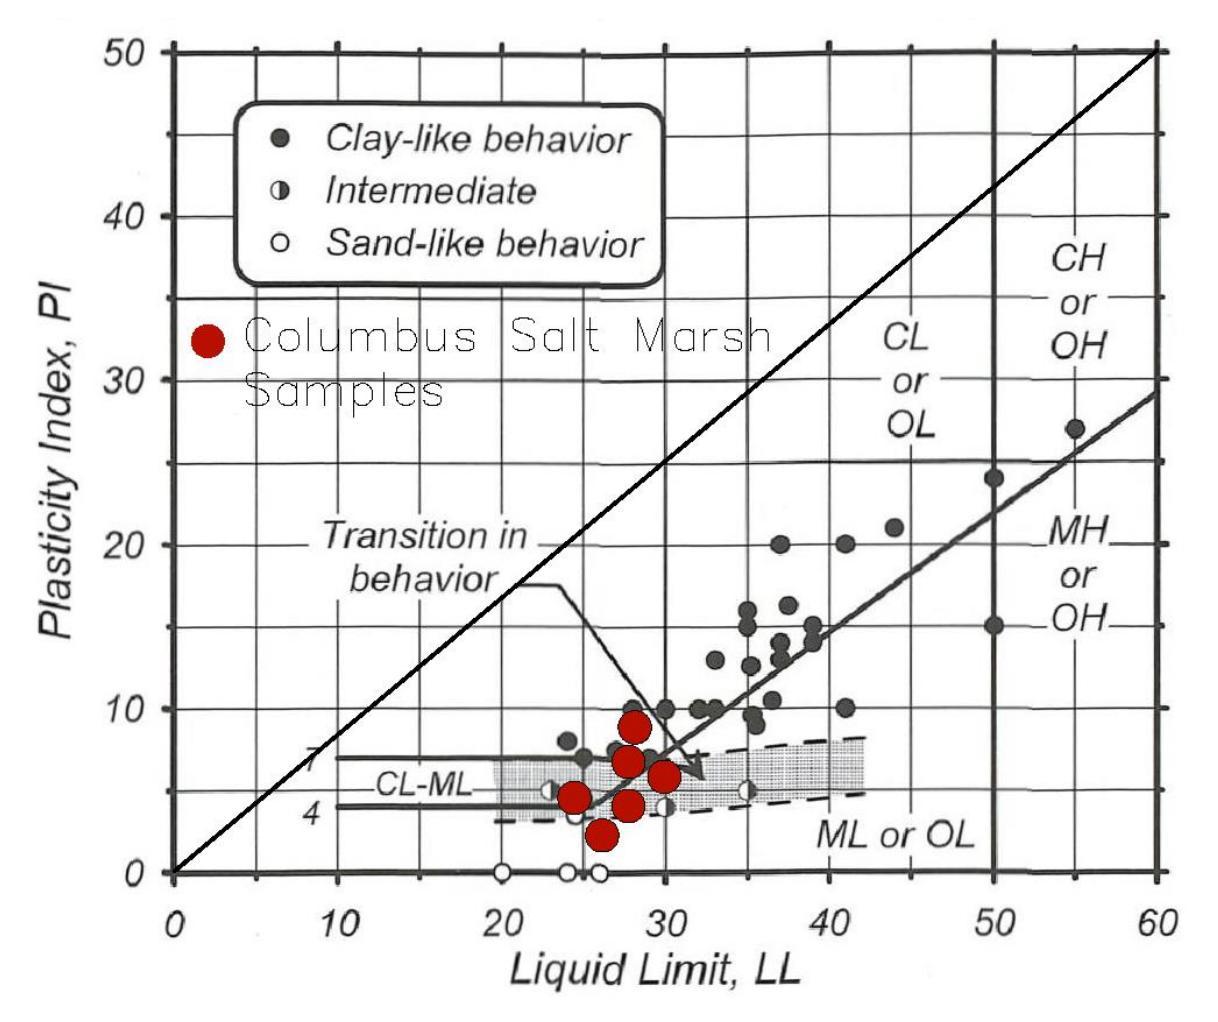
Results of laboratory index testing, which were presented in Section 7 and Appendix B, indicate that most of the near surface materials sampled are potentially liquefiable based on the state-of-the art liquefaction prediction methods based on plasticity. Shallow soils were not sufficiently saturated to liquefy, but the stabilization of water content at 24% to 25% at 1.1 to 1.5 m depth suggests soils were nearly fully-saturated at and below that depth. Furthermore, the liquid limit at 1.5 m depth was 28%. With respect to various classification criteria,

- Soils classified as SC, SM, ML or CL with low plasticity fines (LL< 37 and PI< 12) and WC >0.80 LL will be susceptible to liquefaction per Seed et al 2003. The WC/LL ratio for the 1.5 m depth sample in the ground oscillation crack was 25/28 = 89%. All three criteria are valid for the site soils.

Figure 10-2: Fine-grained liquefaction criteria recommended by Idriss and Boulanger (2008).
