PRELIMINARY REPORT ON

THE PRINCIPAL GEOTECHNICAL ASPECTS OF

THE JANUARY 17, 1994 NORTHRIDGE EARTHQUAKE

Report No. UCB/EERC-94/08

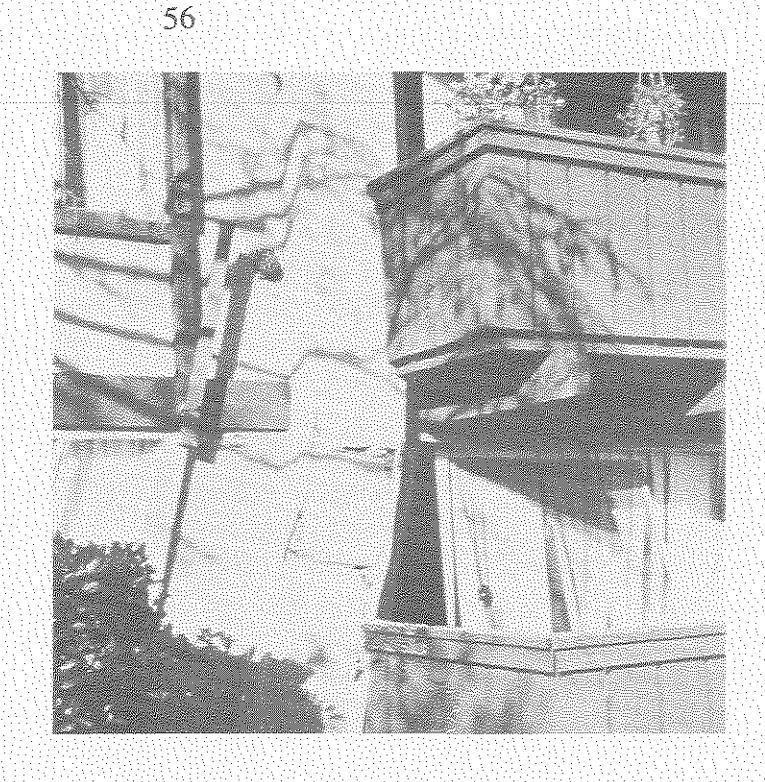
- Fig. 3.28: Damaged structures in the Northridge epicentral area
- (a) Soft story collapse of a three-story wood frame apartment building in Northridge
- (b) Partially collapsed 5-story Kaiser Permanete office building in Granada Hills
- Heavily damaged 5-story building at Sherman Way and Lindley Ave. in Reseda

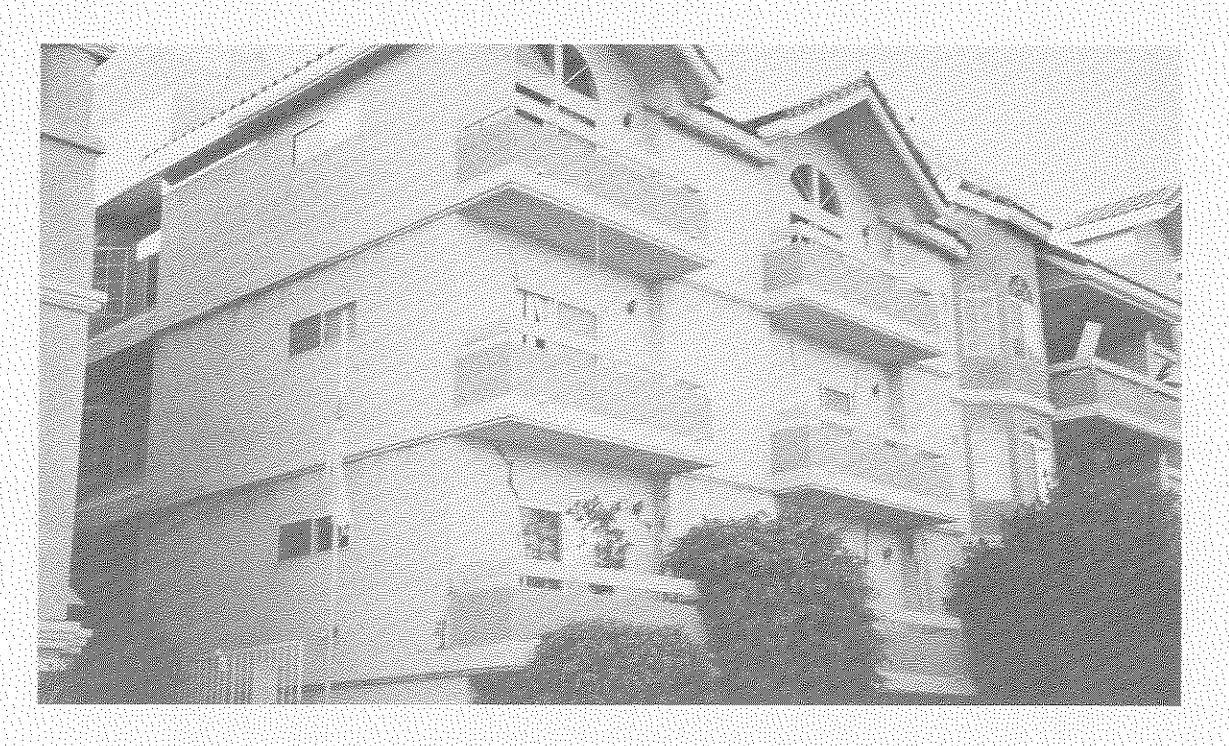
(b): Yellow-tagged 4-story apartment building on Fulton Way, near the banks of the Los Angeles River

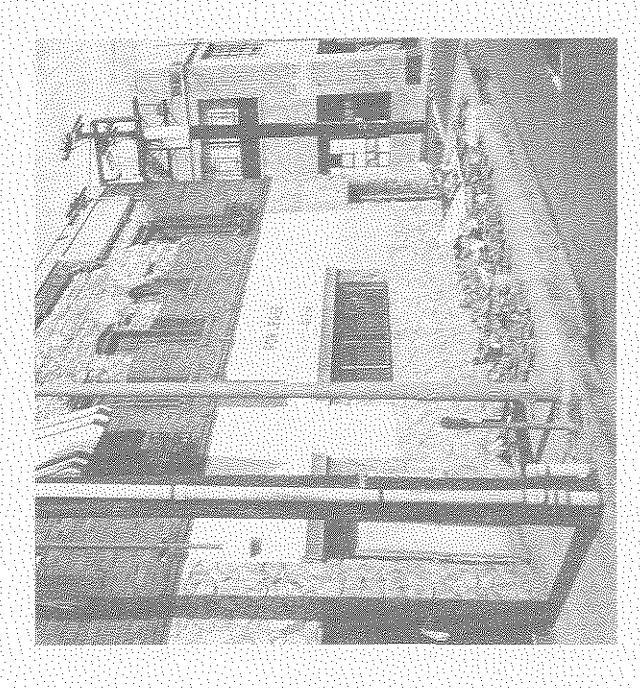
In the Hollywood area, shear cracking and chimney damage to single-story residences, as well as damage to soft story apartments and buildings of up to 12 stories in height, were observed. Typical damage to a URM building is shown in Figure 3.31.

Fig. 3.31. Damage to an URM building in Hollywood

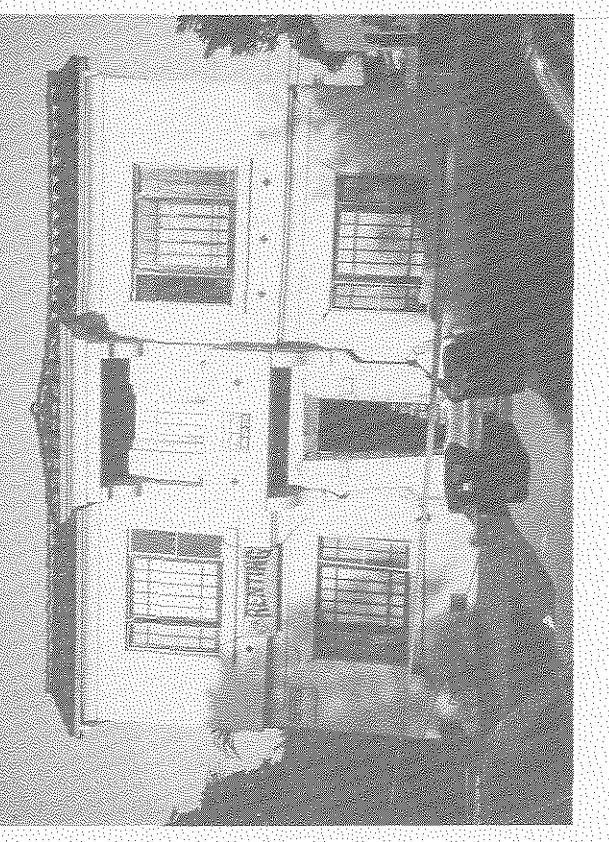
Structures in the central Los Angeles area typically appeared to be small residences, oneto three-story warehouses and commercial buildings, and low-rise apartments. Again, damage to URM buildings and apartments with soft stories was observed. Much of the damage appeared to be to residential structures; cracks in walls, collapsed chimneys, and shifting off of foundations was observed. A typical damaged home is shown in Figure 3.33.

Fig. 3.33: Typical damage to a two-story residence in Central Los Angeles

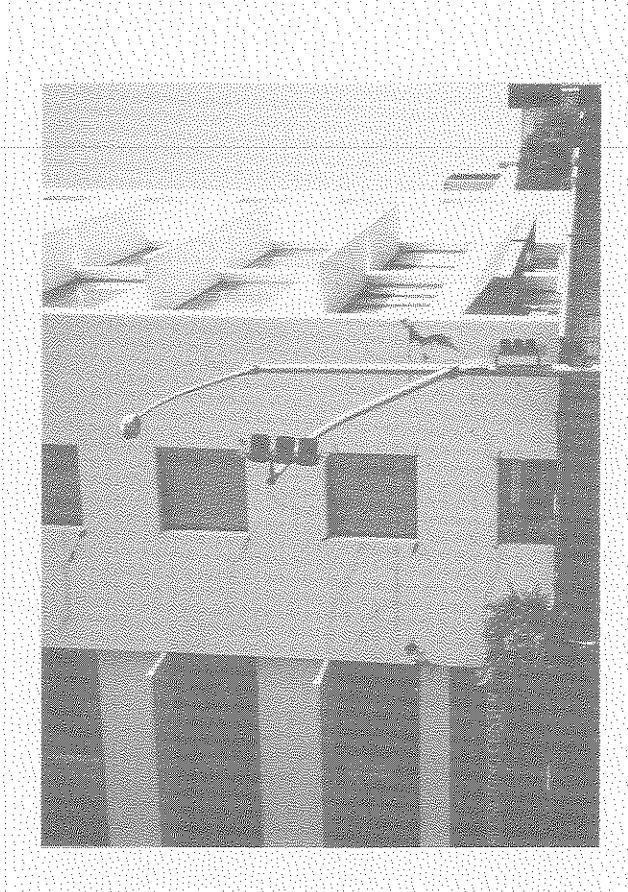
(b) Cracks in the shear walls of a 6-story commercial building

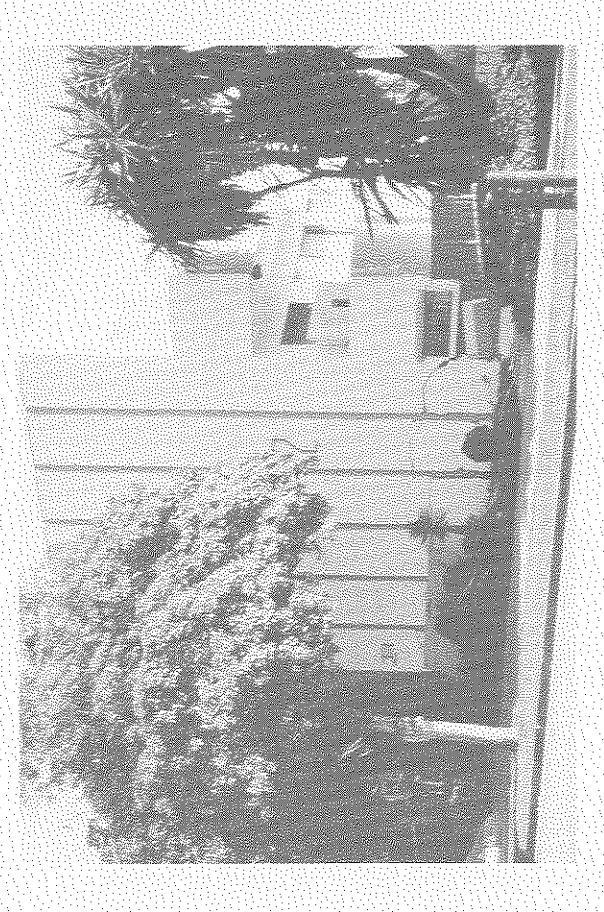
(a) Typical damage to a soft story apartment building

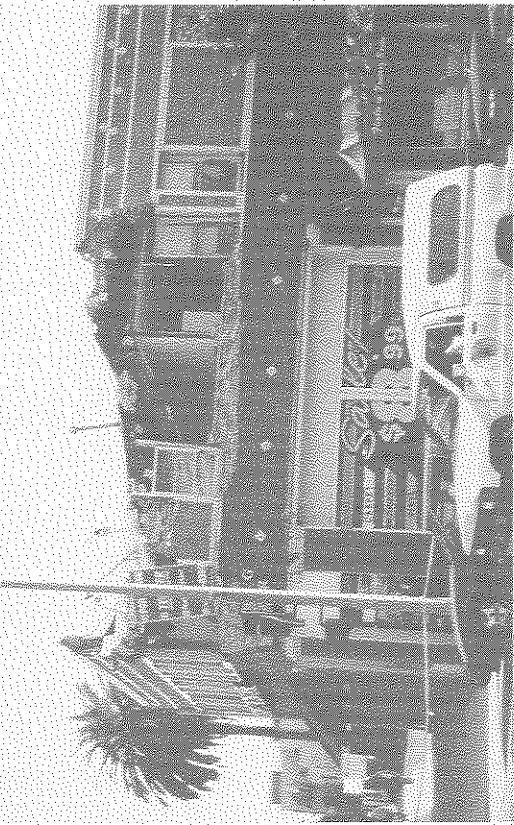
(d) Typical damage along Chataqua Boulevard

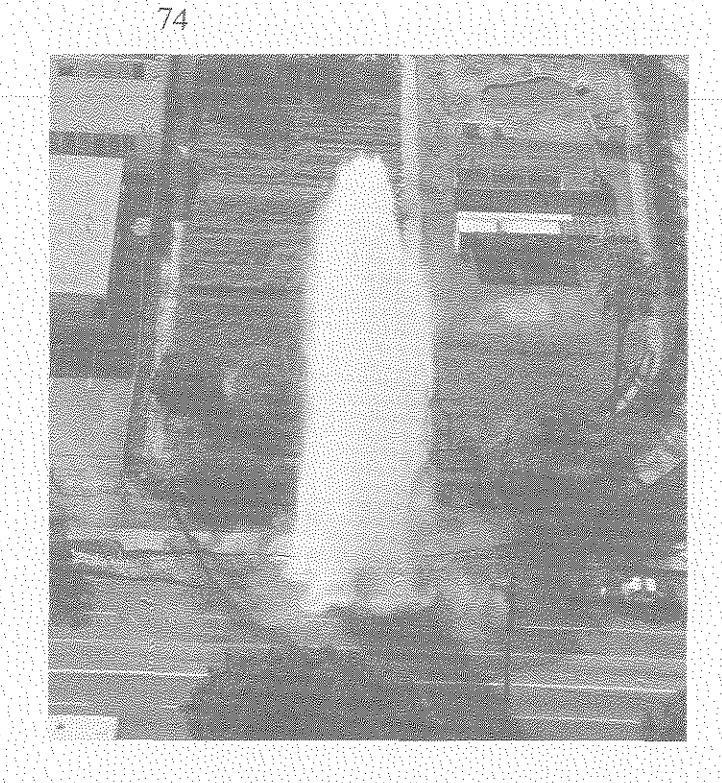
Fig. 4.2: Geyser from broken water pipe in Sherman Oaks

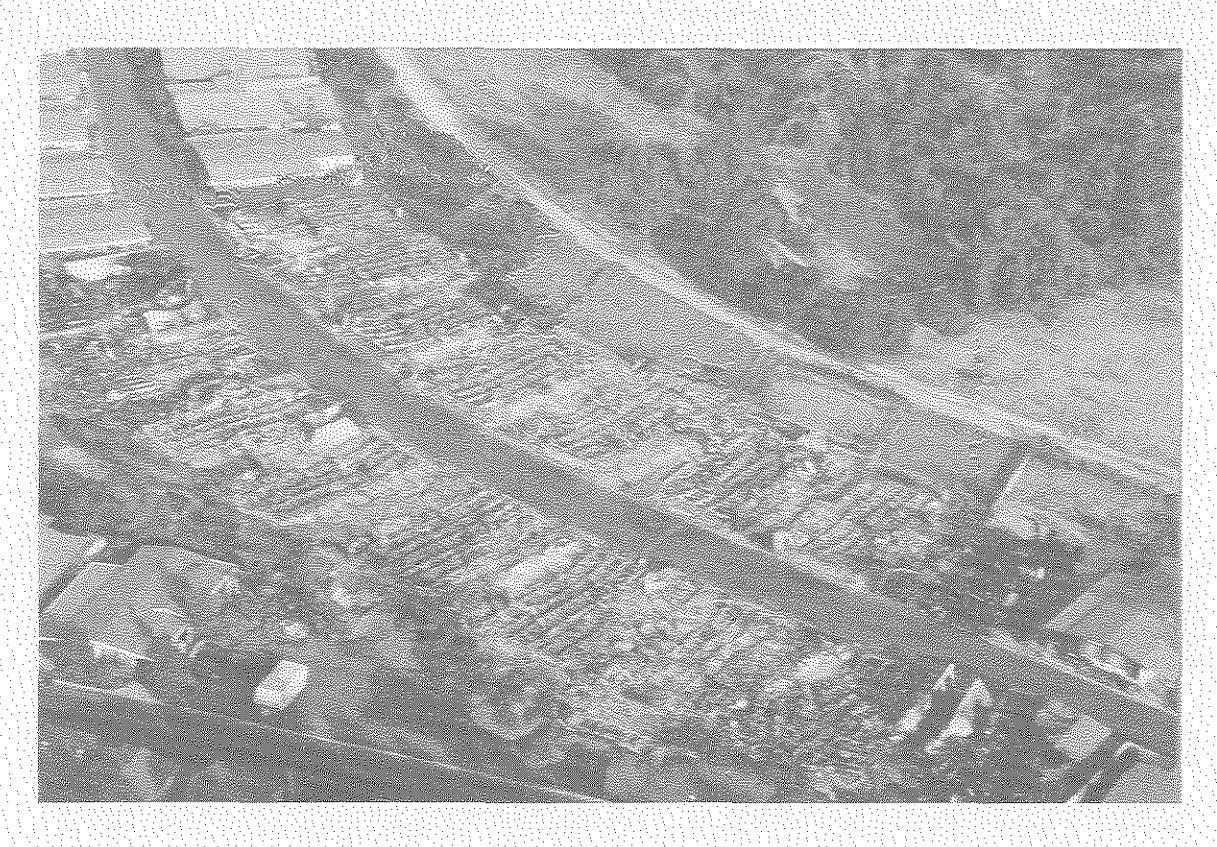
Fig. 4.4: Homes destroyed by fires in Pacoima

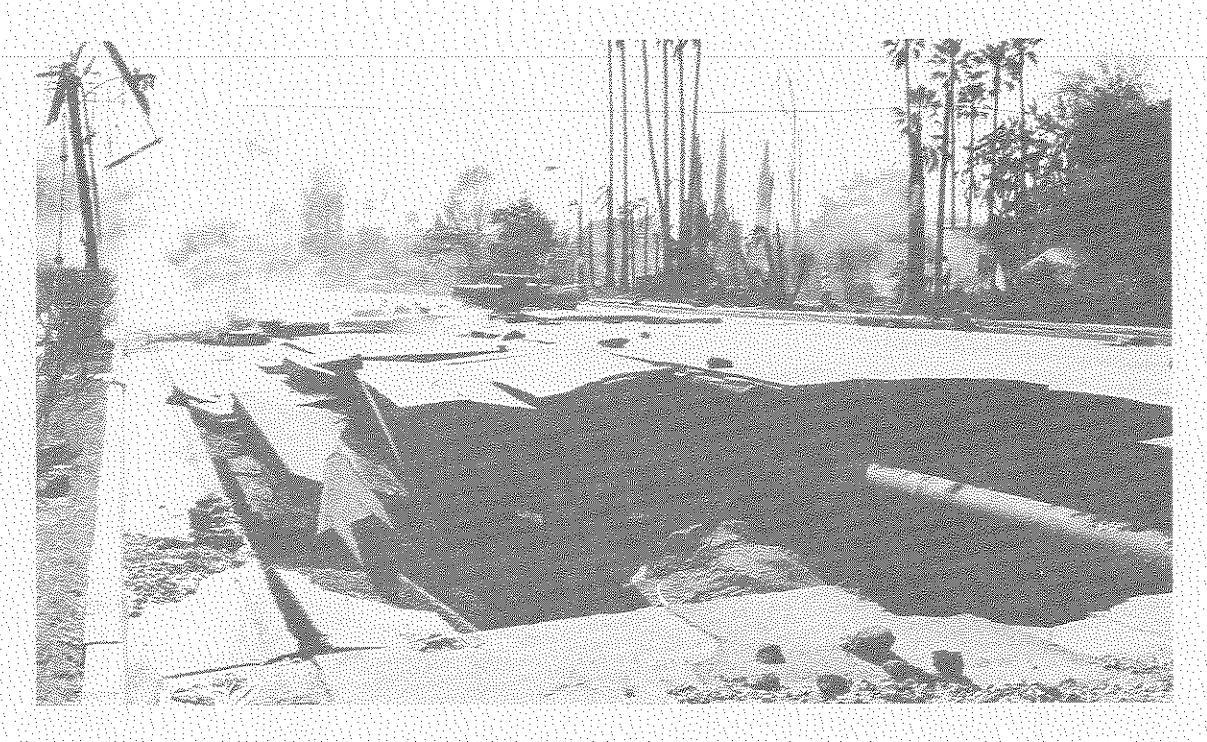
Fig. 4.7: Ground crater and fire resulting from pipe breakage, Balboa Boulevard, Granada Hills. Photo by Los Angeles Times.

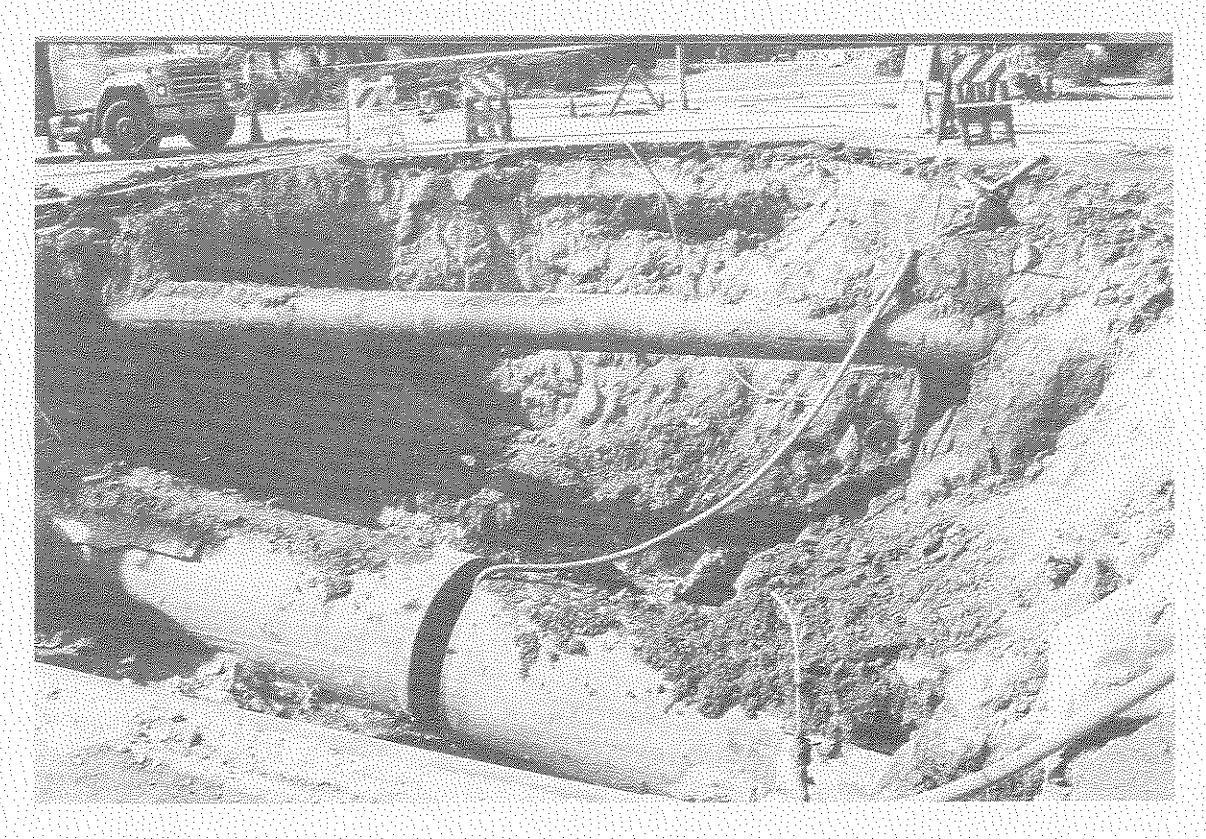
Fig. 4.8: Water pipe broken by extensional ground movement, Balboa Boulevard, Granada Hills

separation in extension. Figure 4.8 shows a typical extensional water pipe break in this area.

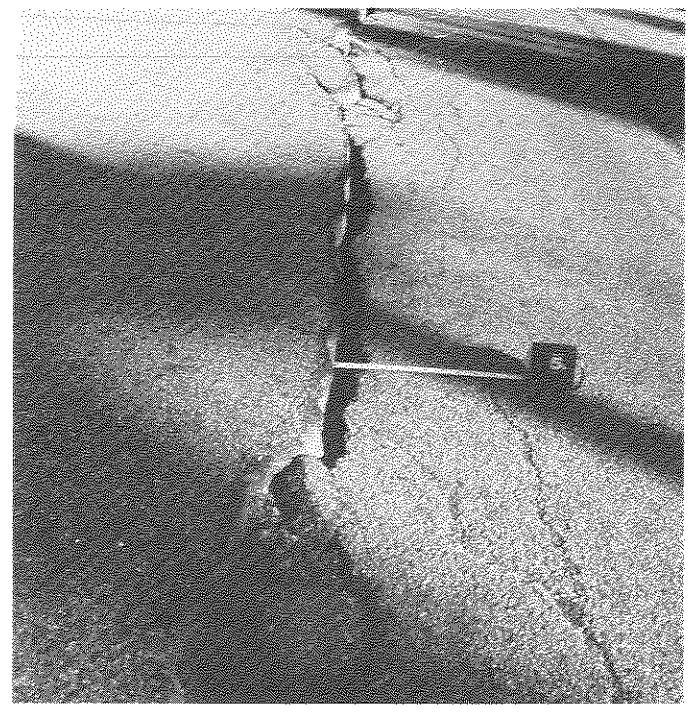
In addition to pipe breakage, the area also experienced widespread ground cracking, primarily in lateral extension and settlement, although some lateral compression was also observed. Figures 4.9 to 4.11 show examples of pavement breakage in neighborhoods just north of Rinaldi Street due to localized differential settlement, lateral extension, and lateral compression, respectively. Figure 4.12 shows evidence of extensional ground movements adjacent to a house. Surficial lateral and vertical differential offsets in pavements were generally on the order of 2 to 6 inches, but in isolated instances, differential lateral extension and compression of up to one foot and more were observed. The ground cracking in these areas was not accompanied by sand boils or sand fissures, and the distress often formed a distinct linear pattern oriented in an east-west direction, generally sub-parallel to the slope contours.

Fig. 4.9: Pavement crack from settlement and extension on Rinaldi Street near Balboa Boulevard, Granada Hills

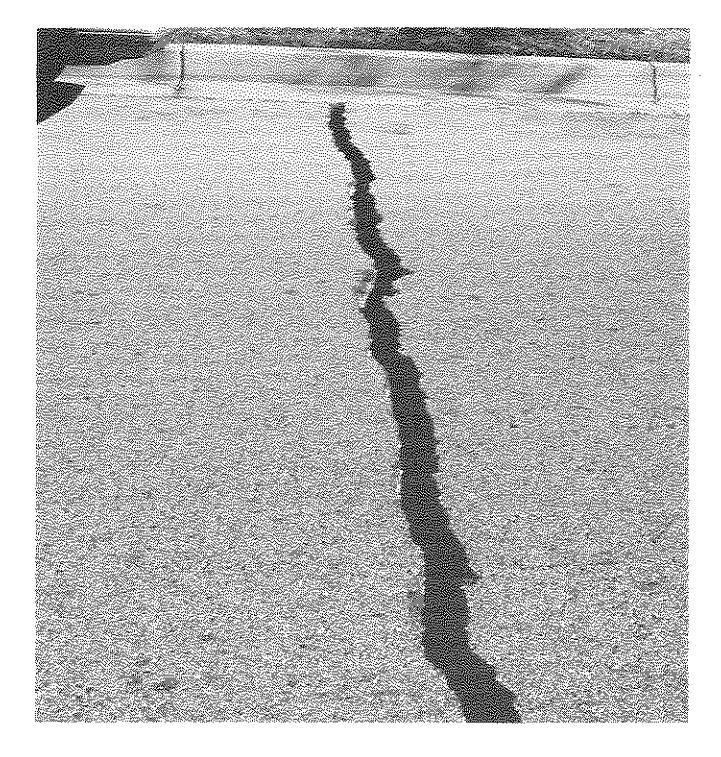
Fig. 4.10: Pavement crack from extensional ground movements, Granada Hills

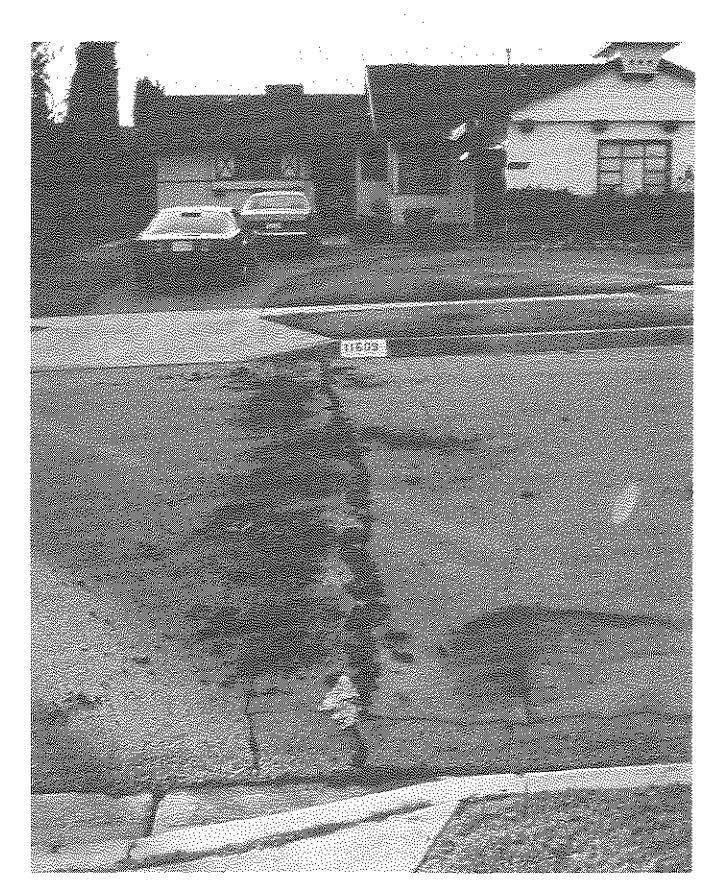
Fig. 4.11: Pavement buckling in compression, Granada Hills

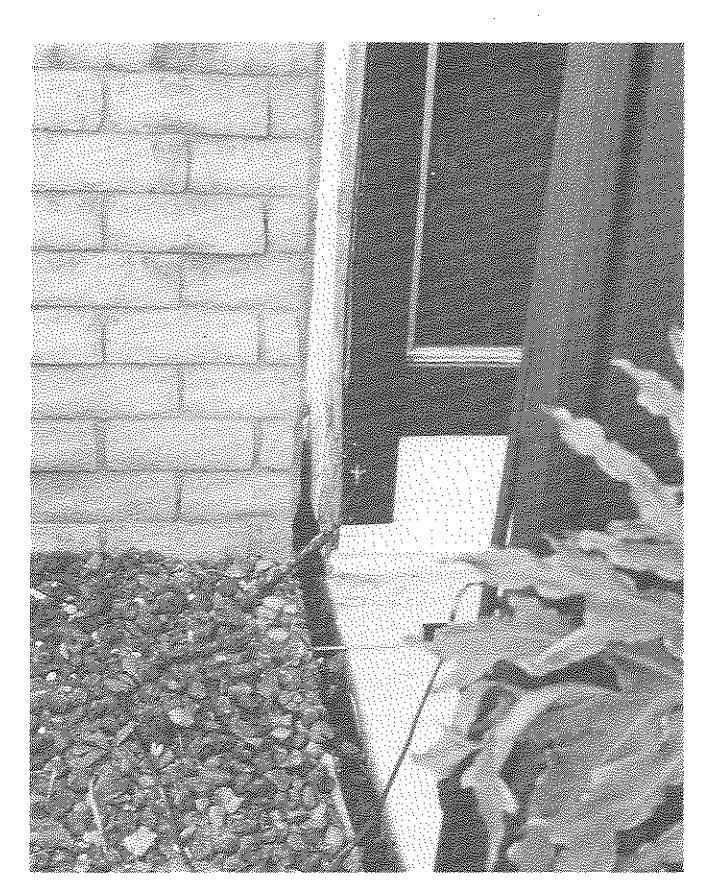
Fig. 4.12: Evidence of extensional ground movement near a house. Small masonry wall and adjacent ground separated from house.

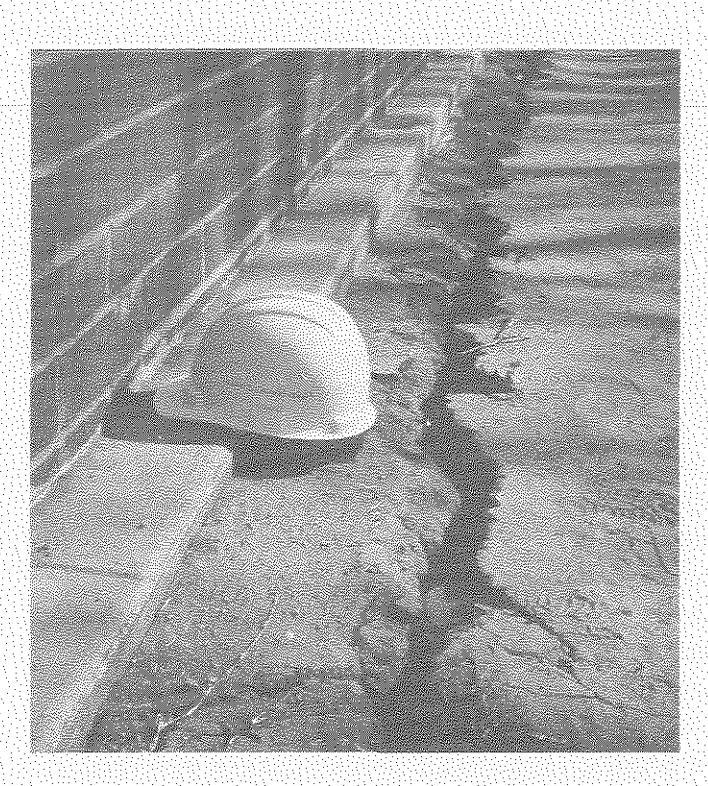
Near the top of the apparent slide feature, extensional ground movements were observed at several locations within the Juvenile Hall complex. The buttress fill underlying the southern structures at the site appeared to perform reasonably well, although some ground fissures developed outside of, and parallel to, the footings of some buildings, as shown in Figure 4.22. In addition, some structural distress to the southern Juvenile Hall buildings was observed (Figure 4.23), though this distress has not generally been attributed to ground failure (Leighton and Associates, 1994). Outside of the buttress fill, typical extensional features in the parking area included fissures up to 4 inches wide and several feet deep, as shown in Figure 4.24. According to maintenance personnel, many of these fissures in the parking area developed parallel to a large sewer line.

Fig. 4.22: Ground fissure with extensional movement near edge of building, Juvenile Hall facility

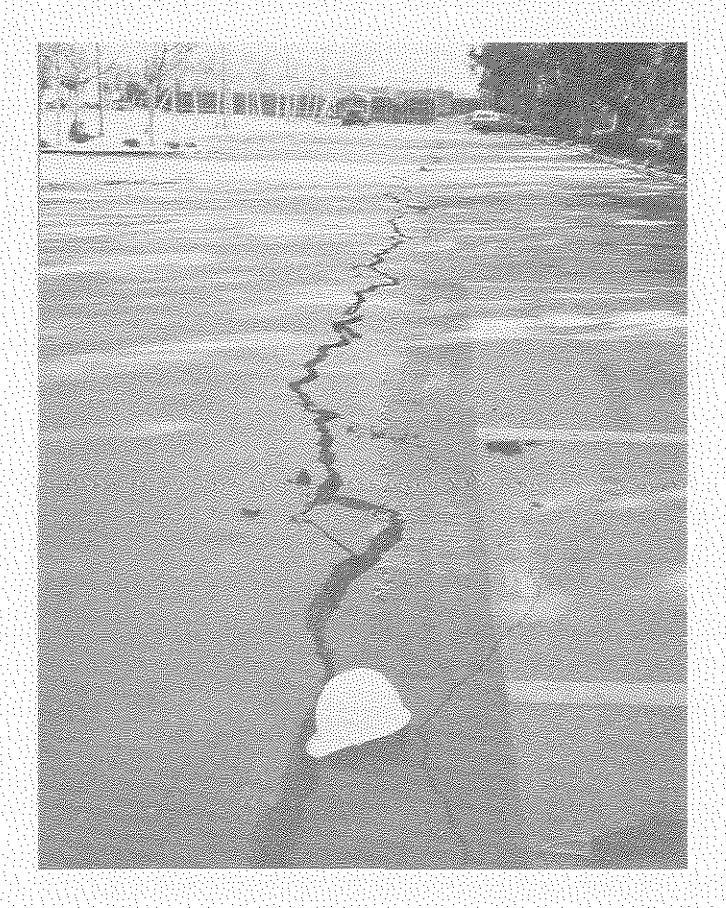
Fig. 4.24: Ground fissure from extensional movement, parking lot at Juvenile Hall facility

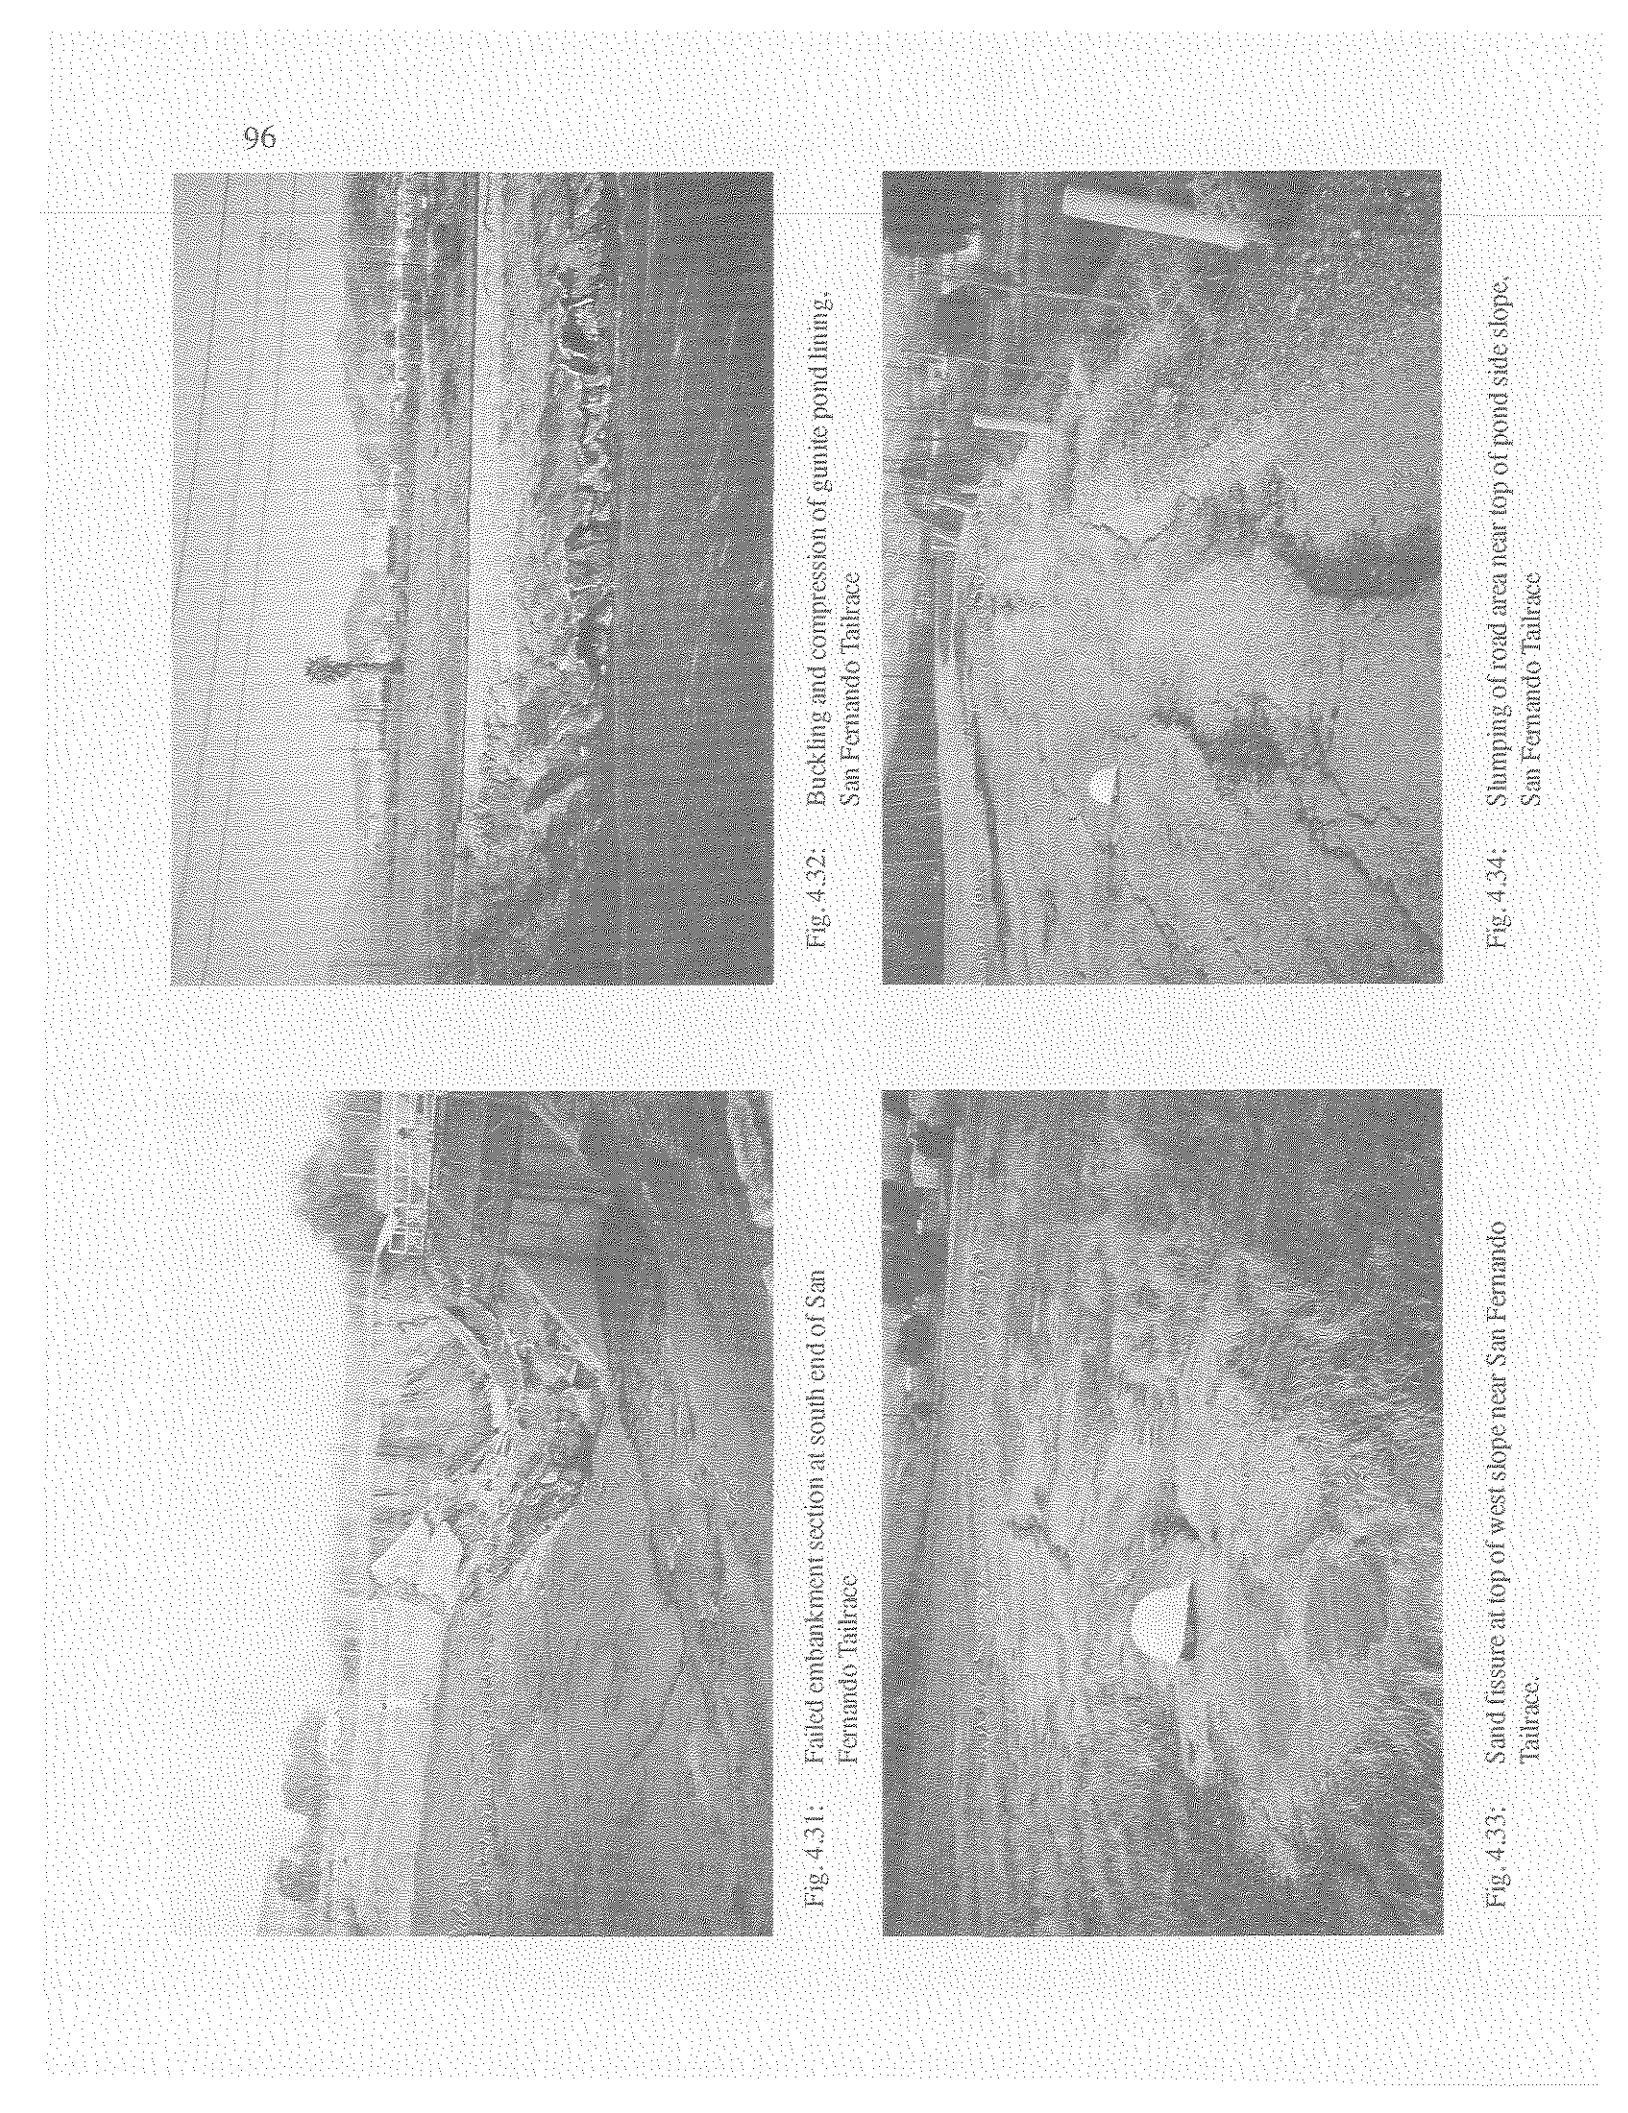
Extensive liquefaction occurred in the vicinity of the tailrace, as evidenced by lateral spreading and sand fissures at numerous locations around the perimeter of the tailrace pond. The cracking pattern around the pond is shown in Figure 4.30 along with the location of the breach, which is also shown in Figure 4.31. On both the east and west sides of the tailrace, the lateral spreading occurred in the downslope direction towards the pond. Figure 4.32 shows buckling and compression of the gunite lining of the pond resulting from lateral spreading of the adjacent ground. Figures 4.33 and 4.34 show a typical sand fissure adjacent to the pond, and typical slumping at the top of the pond side slopes from the lateral spreading and settlement in the area, respectively. Many ground fissures adjacent to the tailrace had vertical and horizontal offsets on the order of 6 inches.

As a result of the significant lateral spreading observed in the abutment areas adjacent to the breach, it is likely that the retention embankment experienced cracking as it deformed under the imposed lateral deformations. The breach then may have ensued as water flowed through these cracks and eroded away the embankment. Although the consequences of the tailrace embankment breach were minor in this instance, the failure serves as a reminder of the potential hazards posed to earth structures by liquefiable foundation soils.

Map of San Fernando Power Plant Tailrace facility showing locations of embankment breach and cracks induced by lateral spreading during the Northridge Earthquake. (data courtesy of Los Angeles Department of Water and Power)

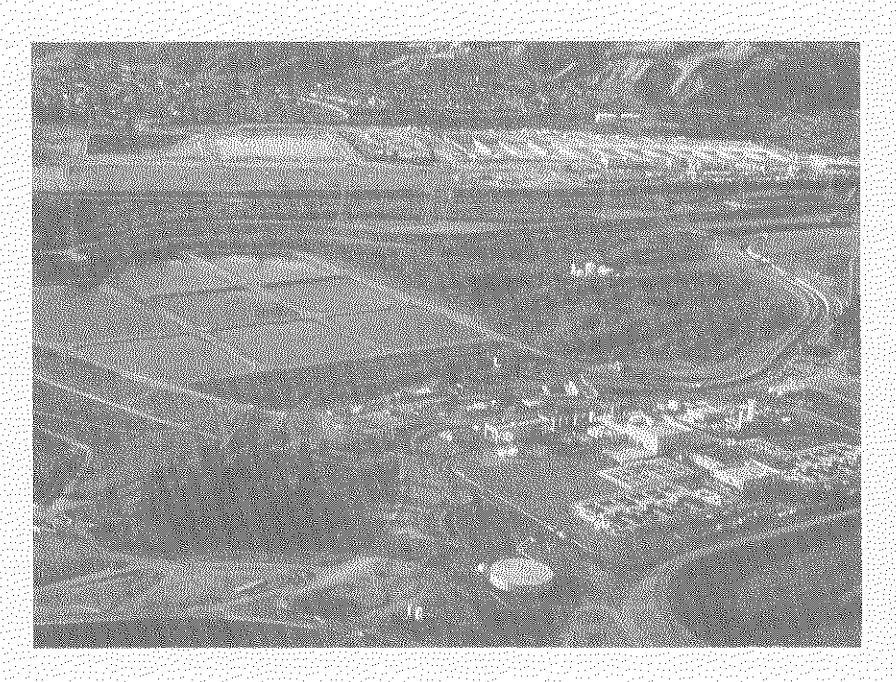
In the vicinity of the former Upper Van Norman Lake (shown in Figure 4.35), liquefaction affected an embankment leading to an observatory from the northern end of the lake and several small embankments impounding shallow ponds immediately upstream of the former. The locations of the observatory and the small ponds are shown in Figures 4.21 and 4.35. Figure 4.36 shows slope displacements on the order of 3 feet within the long, narrow embankment north of the observatory. This embankment suffered somewhat larger displacements on the order of 6½ feet during the 1971 San Fernando Earthquake under high water conditions for Upper Van Norman Lake, which at that time surrounded the embankment peninsula. Figure 4.37 shows a large fissure across a road immediately north of the ponds upstream of the dam. Cracks with offsets on the order of several inches to several feet were observed in the embankment fills around these ponds.

Fig. 4.35: Overview of former Upper Van Norman Lake Area, Jensen Filtration Plant visible in background

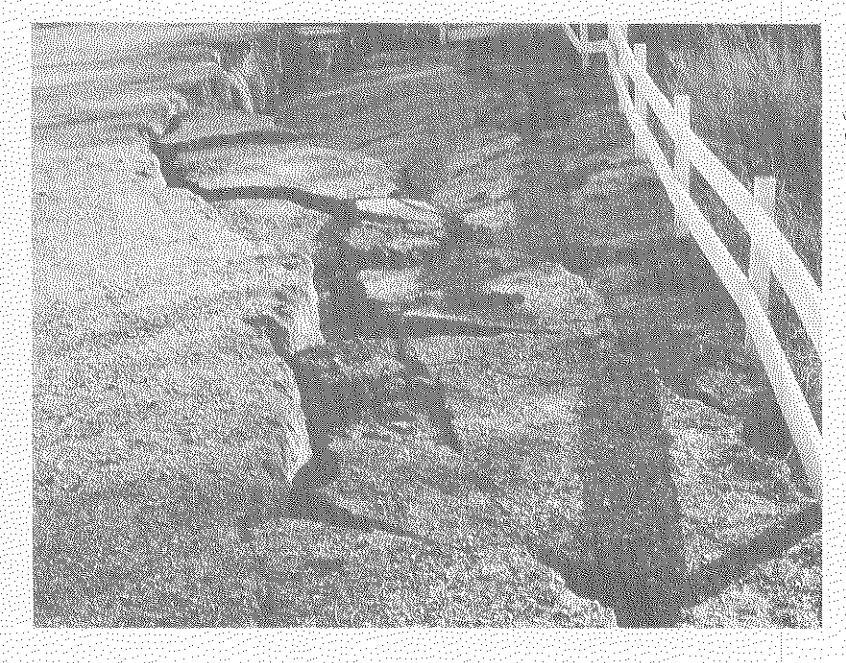
Fig. 4.36: Slope failure in embankment near north end of Upper Van Norman Lake (photo courtesy of Les Harder)

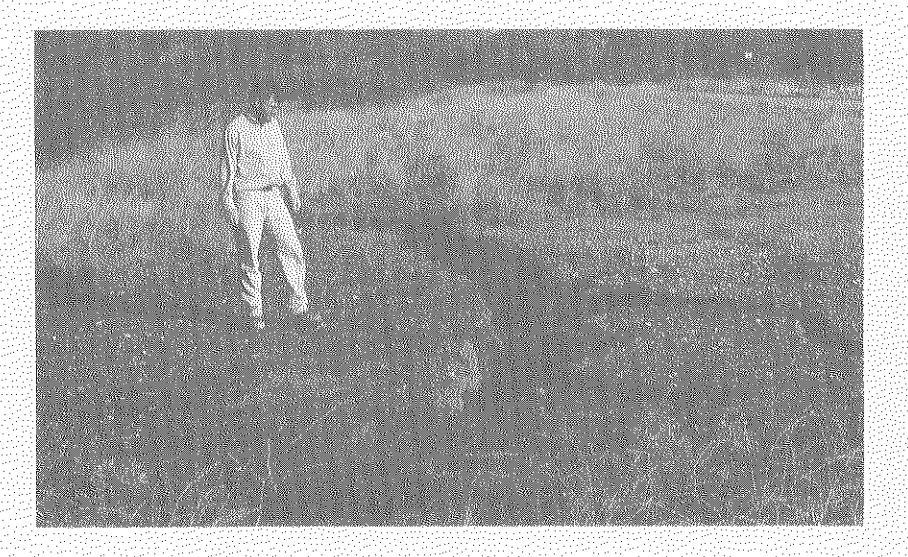
Fig. 4.37: Ground fissure across road embankment north of pond within bed of former Upper Van Norman lake

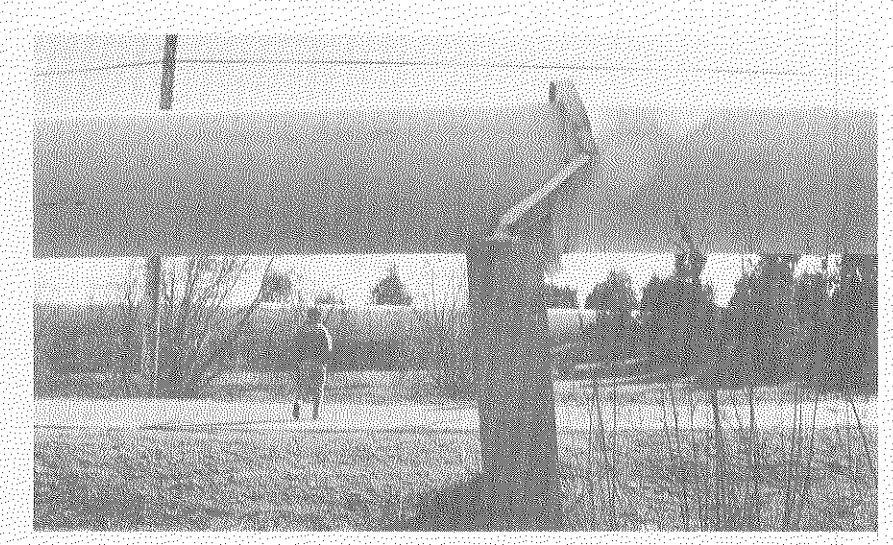
Immediately downstream of Upper San Fernando Dam, soil liquefaction appears to have been the cause of foundation pier movements for an above-ground water conduit. These movements failed several pipeline-foundation connector elements, as shown in Figure 4.38.

Fig. 4.38: Failure of pipe support due to liquefaction-induced foundation movements (photo courtesy of Ross Boulanger)

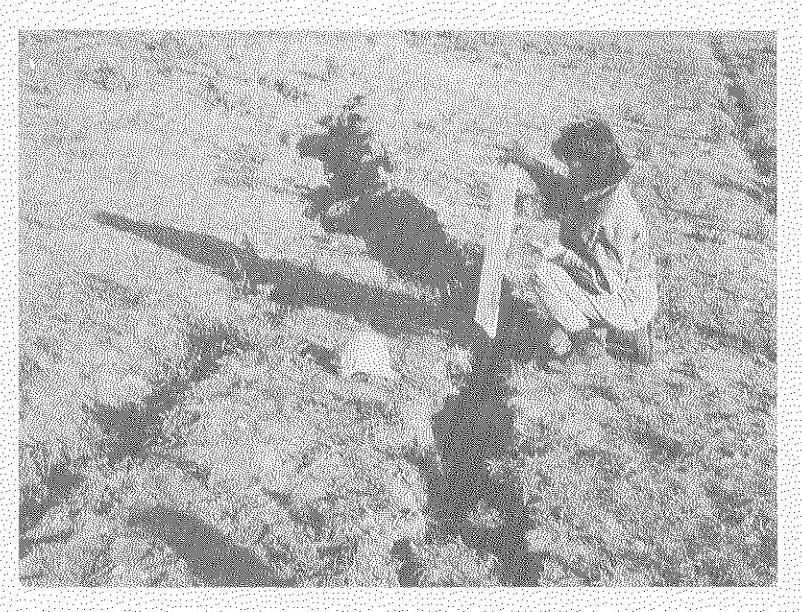
Figures 4.45 and 4.46 show lateral spreading and settlement at Rory Lane, located near the Simi Arroyo Channel within an area in the eastern portion of Simi Valley which experienced significant ground failure. Extensive ground cracking with up to 8-inch lateral and vertical offsets developed in this area, as well as several large sand boils near the channel. This ground cracking and settlement appears to have resulted from lateral ground displacements towards the channel due to liquefaction-induced strength loss of the underlying alluvial soils. At another location near the channel, pronounced ground failure disrupted pavement and pipes at the intersection of Christine Avenue and Hope Street, just east of Rory Lane. Figure 4.47 shows warping of Christine Avenue and damage to a masonry wall at this location due to lateral spreading and settlement. Ground cracking and pavement distress in the eastern portions of Simi Valley not immediately adjacent to the Simi Arroyo Channel was generally relatively modest. A typical example of pavement buckling in these areas from lateral ground compression is shown in Figure 4.48, taken at Kuehner Drive near Katherine Road. In the central portion of Simi Valley below Tapo Canyon, very little pavement distress or ground cracking was observed.

Fig. 4.45: Ground fissures from settlement and lateral spreading near Rory Lane, Simi Valley

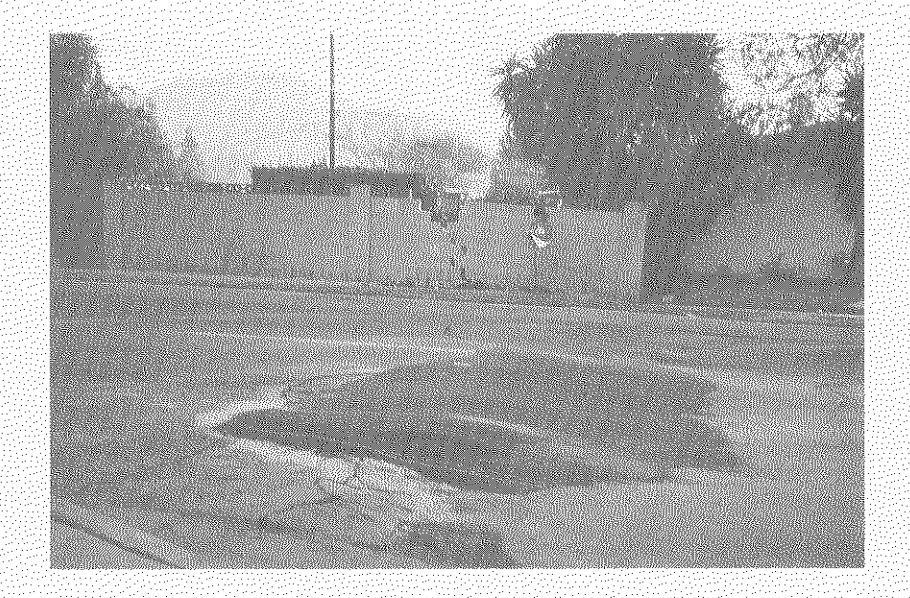
Fig. 4.47: Damage to pavement and masonry wall from settlement and lateral spreading, Hope Street at Christine Avenue, Simi Valley

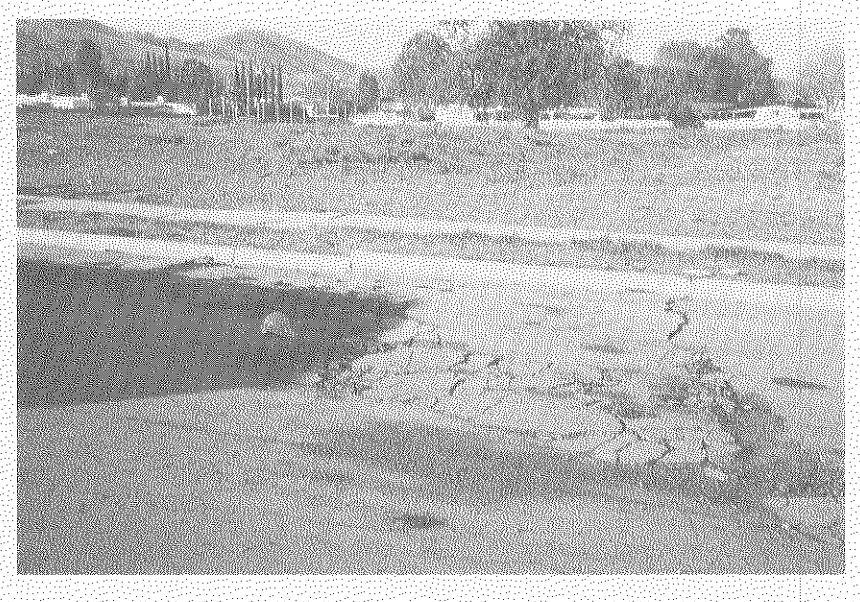
Fig. 4.46: Ground fissure from settlement and lateral spreading near Rory Lane, Simi Valley

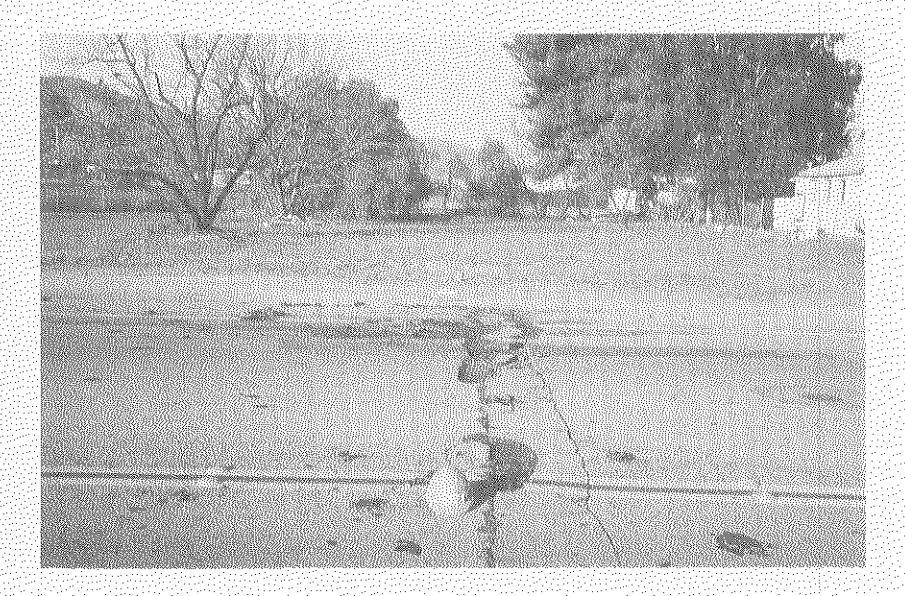
Fig. 4.48: Pavement buckling from lateral compression on Kuchner Drive near Katherine Road, Simi Valley

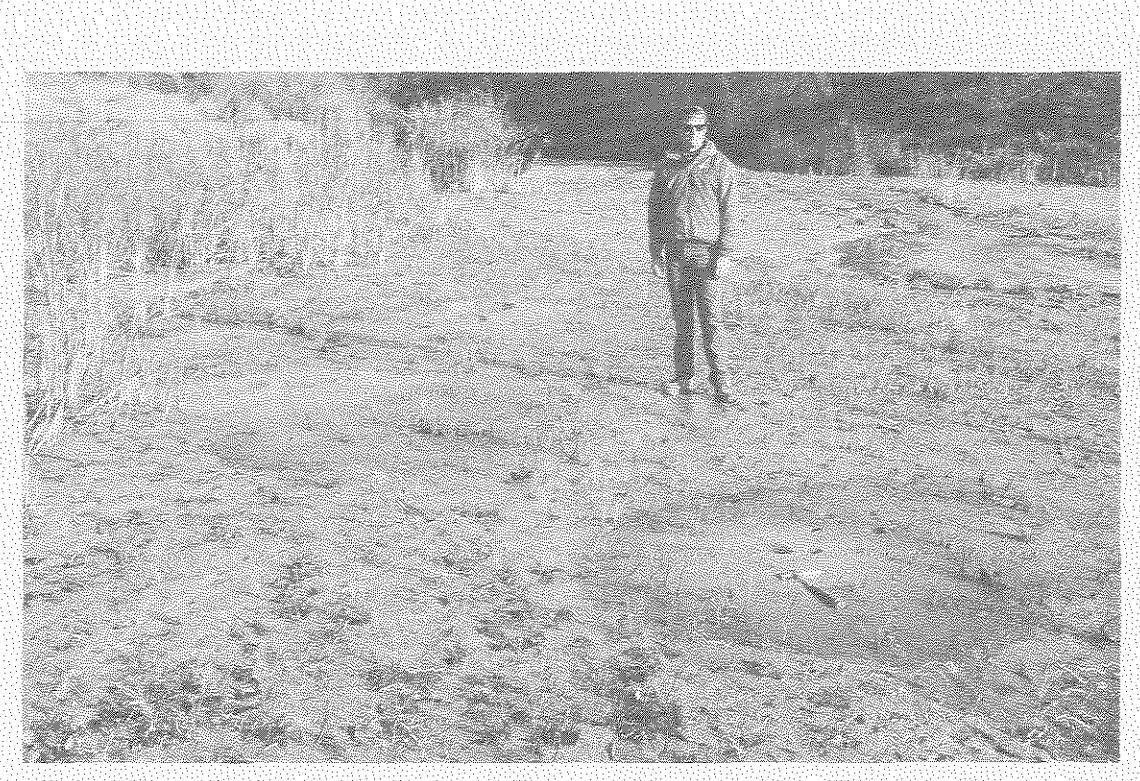
It should be noted the northern-most area found to have experienced liquefaction during the Northridge Earthquake was along the banks of Gorman Creek. This area is located approximately 40 miles north of the epicenter (about 32 miles north of the northern-most extension of the fault plane), and is beyond the limits of the map in Figure 1.3. Peak horizontal ground accelerations in the area are estimated to have been less than 0.1g. Liquefaction caused numerous sand boils to form along the creek at this location as shown in Figures 4.50 and 4.51, but caused no damage as the area is undeveloped.

Fig. 4.50: Evidence of liquefaction in the form of sand boils along Gorman Creek, approximately 40 miles north of the epicenter (photo courtesy of Les Harder)
