PRELIMINARY REPORT ON

THE PRINCIPAL GEOTECHNICAL ASPECTS OF

THE JANUARY 17, 1994 NORTHRIDGE EARTHQUAKE

Report No. UCB/EERC-94/08

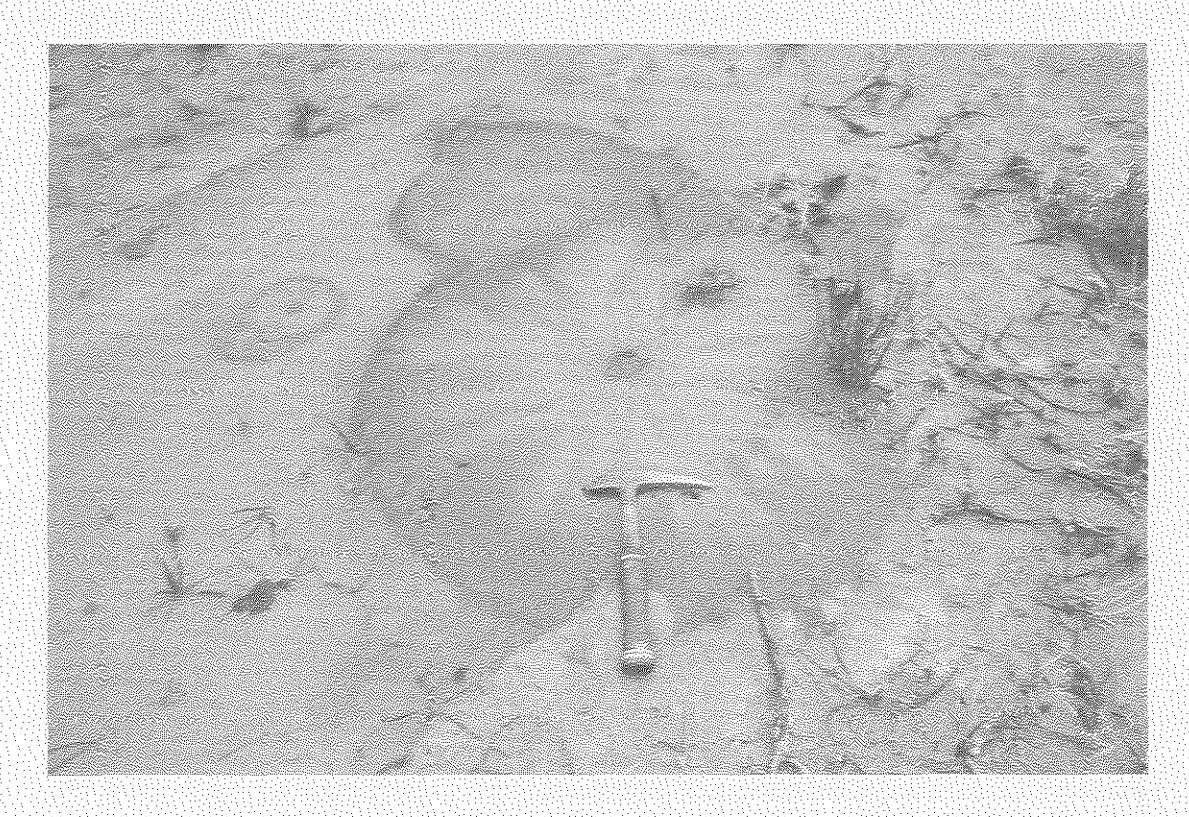
Fig. 4.51: Sand boils along Gorman Creek (photo courtesy of Les Harder)

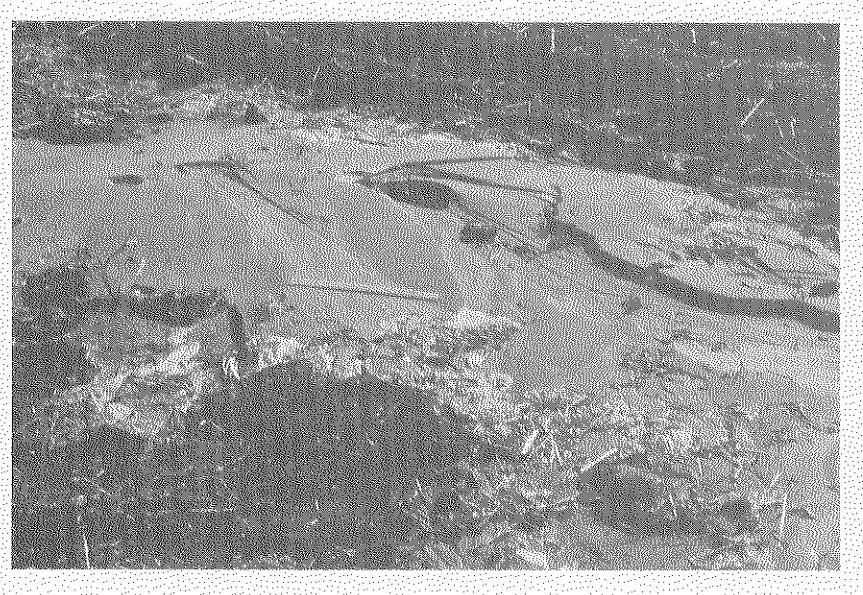
Linear ground breakage features, which are parallel to the axis of the canyon, were observed along the northern and southern margins. Sand boils were noted in several locations throughout the canyon, generally in close proximity to the stream channels (Figure 4.53). The locations of observed ground failures are plotted on the topographic map shown in Figure 4.52. In most locations, movements are distributed over wide zones of ground cracking. An aerial view of typical deformations along the base of a hill within the canyon is shown in Figure 4.54. Deformations appeared to be more pronounced at the base of small hills along the margins of the main canyon walls, and in many locations the cracks follow the contours around the toe of the hill. However, the dense grasses and other vegetation inhibited mapping of cracks in several small swale areas between hills. Where ground deformation features could be mapped through these swales, the cracks cut across the alluvial deposits at the toe of the swale linearly, remaining approximately parallel to the overall trend of the canyon.

Fig. 4.53 Sand boil within Potrero Canyon

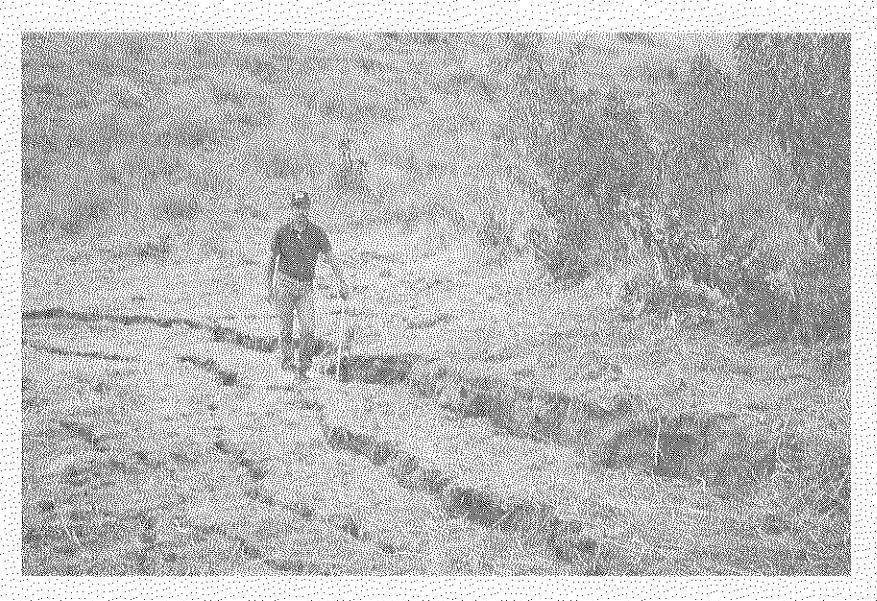
Along the northern margin of the canyon, fractures are primarily extensional, with substantial differential vertical offsets and minor right lateral offsets. Multiple ground fractures within zones 5- to 50-feet wide accommodate as much as two feet of vertical movement. A zone of parallel extension cracks with almost two feet of relative vertical displacement is shown in Figure 4.55. Typical right-lateral ground deformation is shown in Figure 4.56.

Fig. 4.55: Wide zone of extension cracks at the soil to bedrock contact in Potrero Canyon

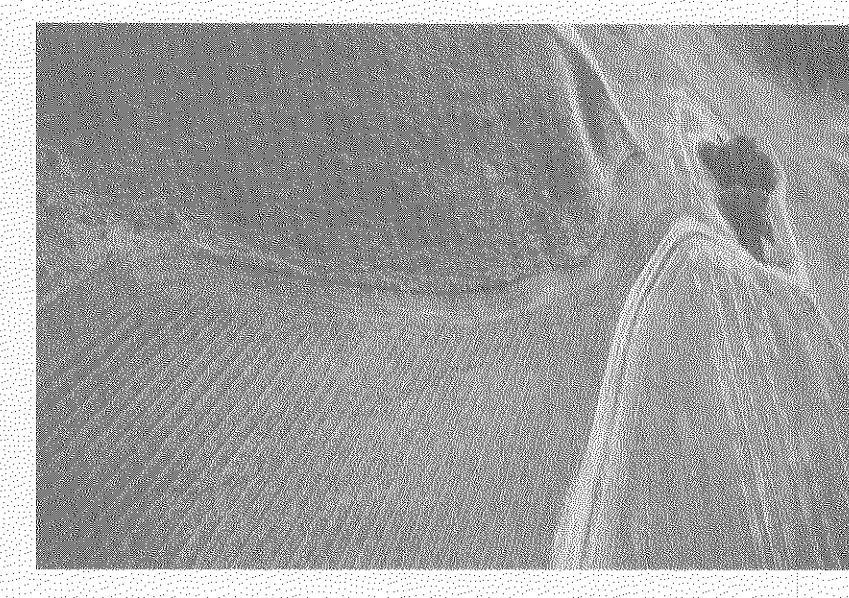
Fig. 4.54: Aerial view of cracking along the southern margin of Potrero Canyon

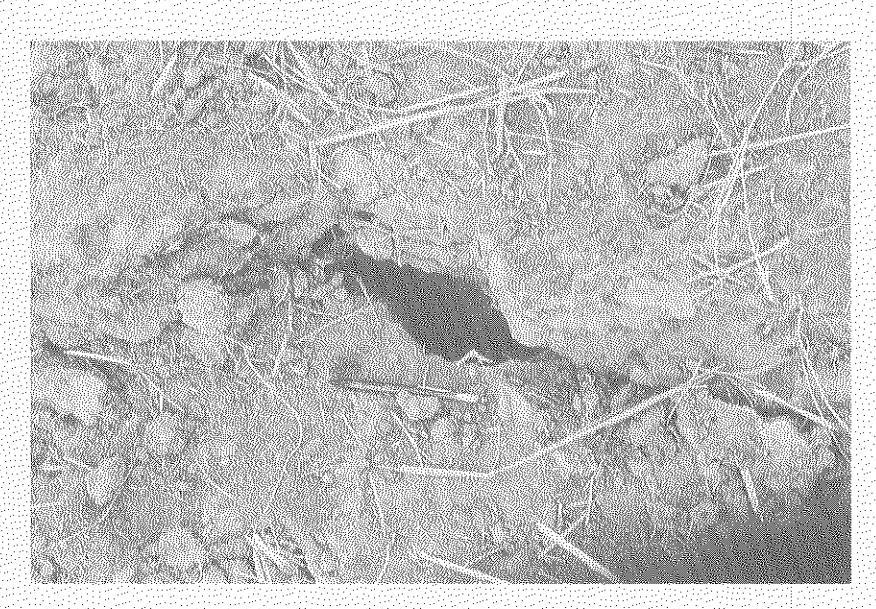
Fig. 4.56: Example of right lateral displacement along the northern margin of Potrero Canyon

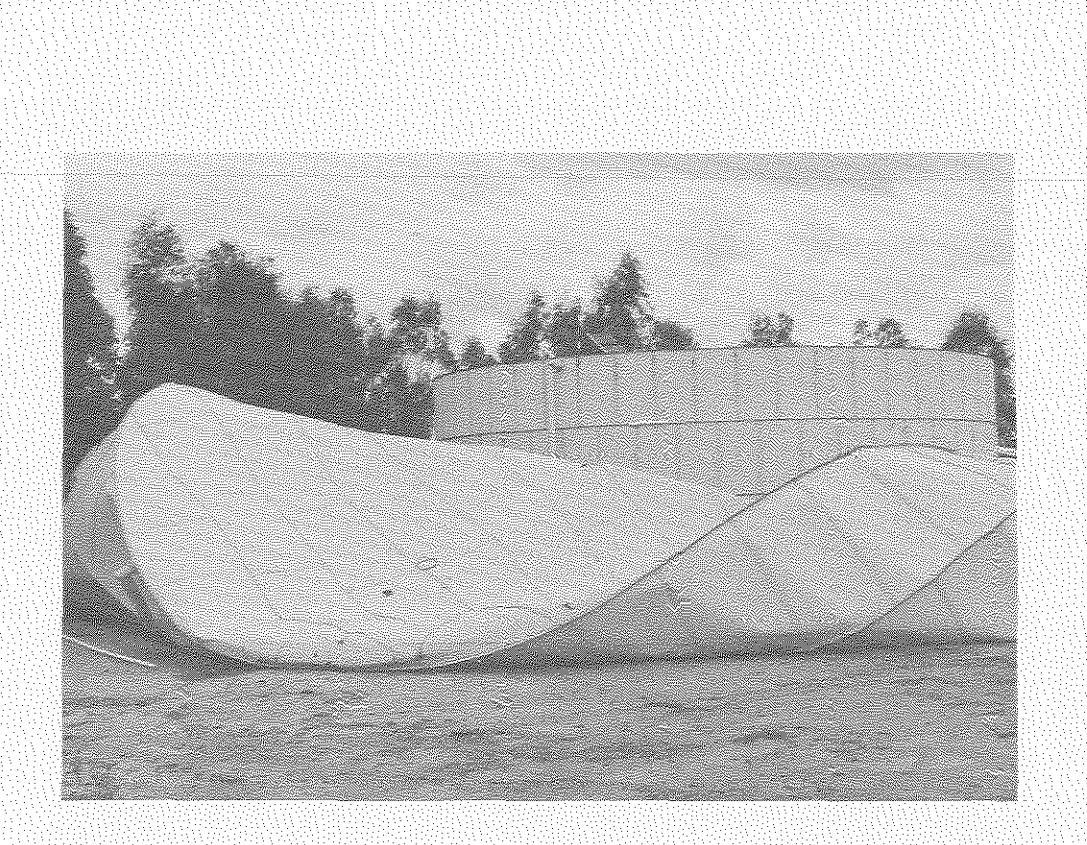
Fig. 4.66: Failed water storage tank, Santa Clarita (photo courtesy of Valencia Water Company)

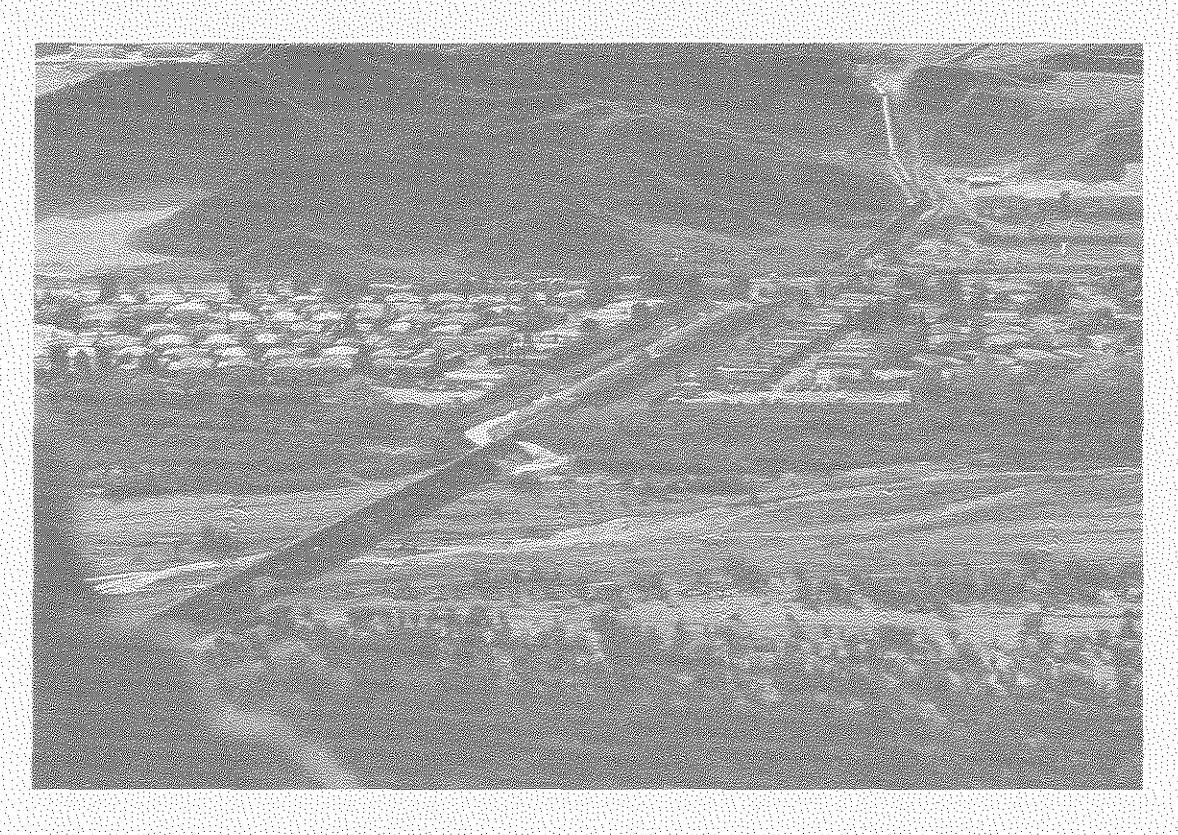
Fig. 4.67: Bleeding of water from the Los Angeles Aqueduct just west of Saugus

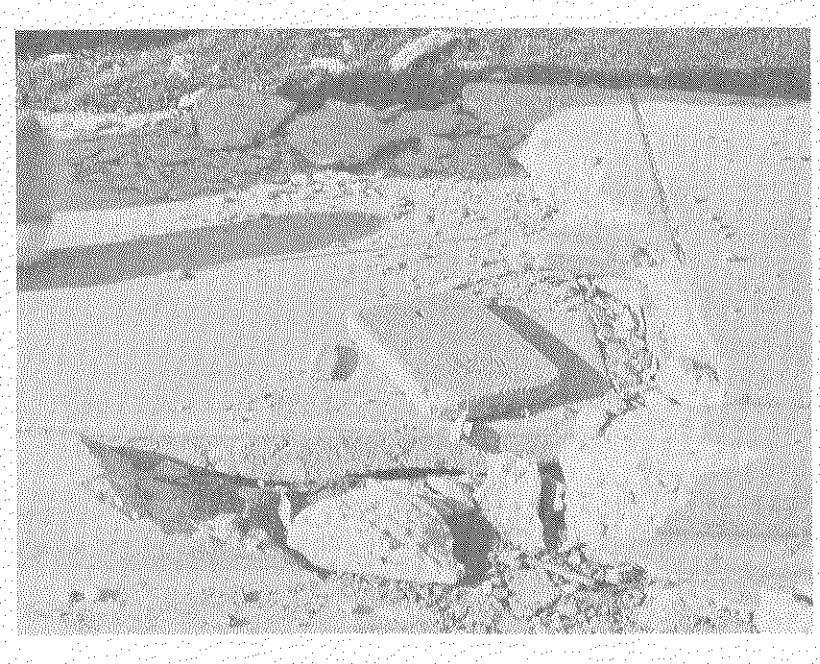
Fig. 4.68: Crushed water meter and sidewalk from lateral ground compression. Wintergreen Court, Santa Clarita (photo courtesy of Valencia Water Company)

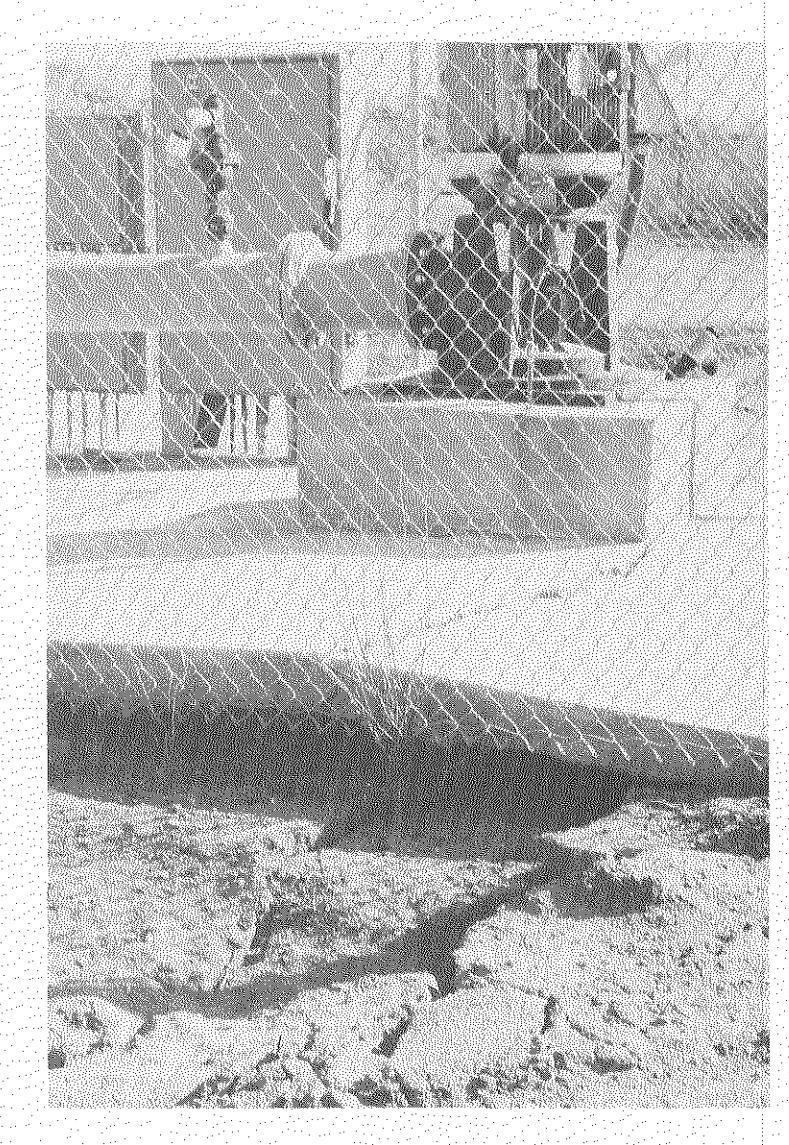
Near the Santa Clara River, settlement and lateral spreading caused numerous pipe breaks, including the rupture of an oil pipeline which led to contamination of the adjacent river area. Figure 4.70 shows a typical example of lateral spreading near the river banks, where a concrete slab at a water well was buckled by lateral compression. Due to the shallow groundwater and recent soils near the river bank, the ground failure in this area likely resulted from soil liquefaction.

Fig. 4.70: Slab at water well buckled by lateral spreading near the Santa Clara River, Santa Clarita (photo courtesy of Valencia Water Company)

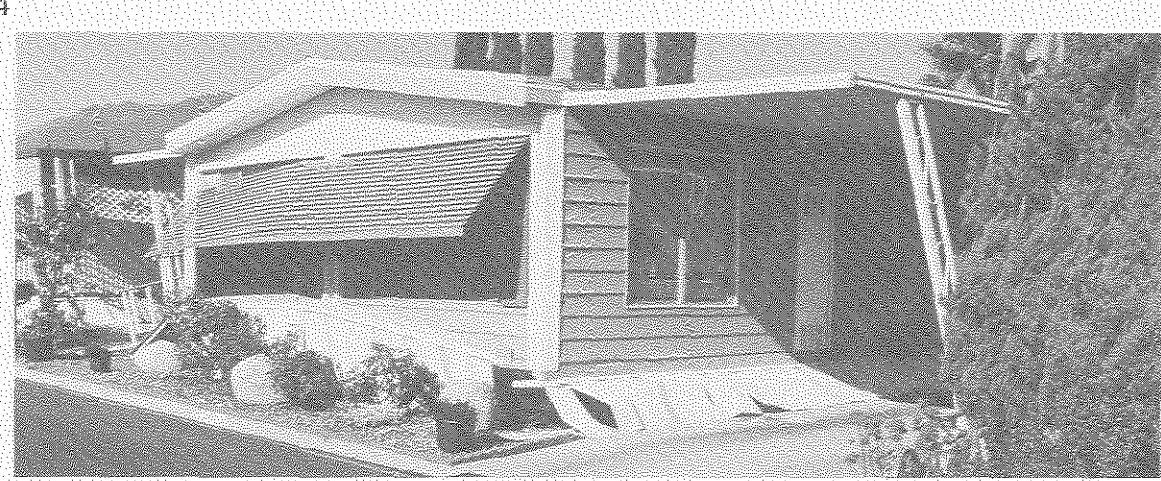
Fillmore was heavily impacted by structural distress during the Northridge Earthquake, as shown by the concentration of red-tagged structures in Figure 3.23. However, no significant evidence of ground failure in the form of ground cracking or major pipe breakage was observed in field reconnaissance of the area. It is likely that much of the severe structural damage in the area resulted from strong shaking overwhelming a number of inadequately designed structures, as shown in Figure 4.71.

Fig. 4.71: Damaged mobile home in Fillmore. Numerous structures were severely damaged in Fillmore in the absence of any apparant large-scale ground failure.

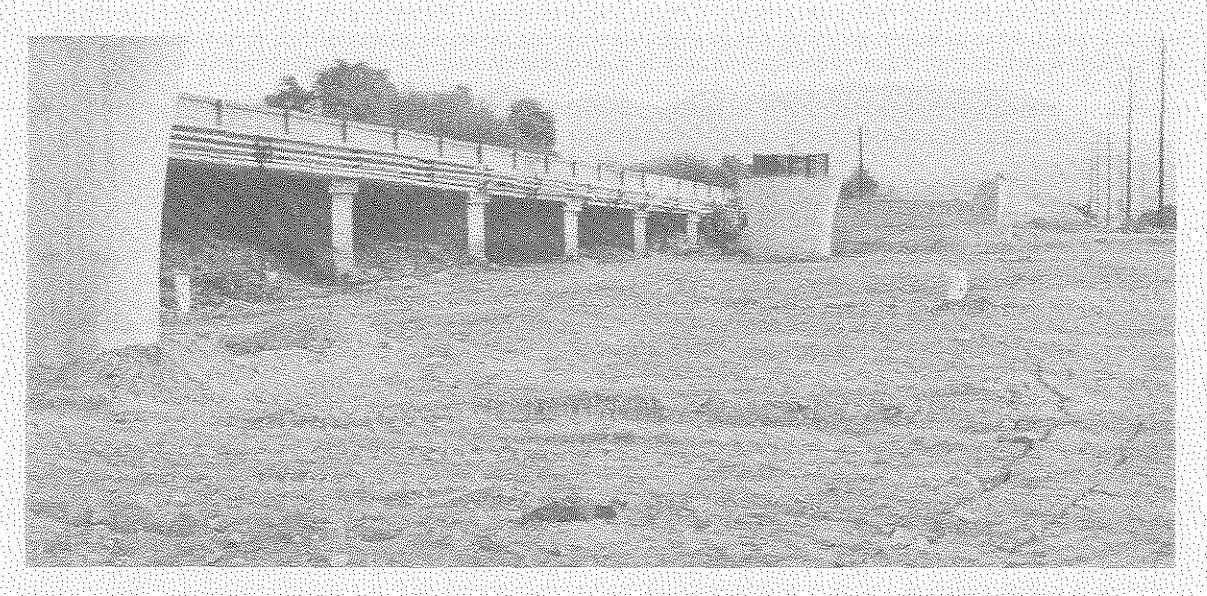
Near the Highway 23 crossing over the Santa Clara River, sand boils were observed near a bridge pier for an overcrossing under construction, and cracks induced by lateral spreading were found approximately 15 feet away from the pier. The ground cracking and sand boils observed at this location are shown in Figures 4.72 and 4.73. This liquefaction in the river bank area caused no apparent damage to the bridge structure.

Fig. 4.72: Ground cracking from lateral spreading in river bed area near Highway 23 crossing over Santa Clara River

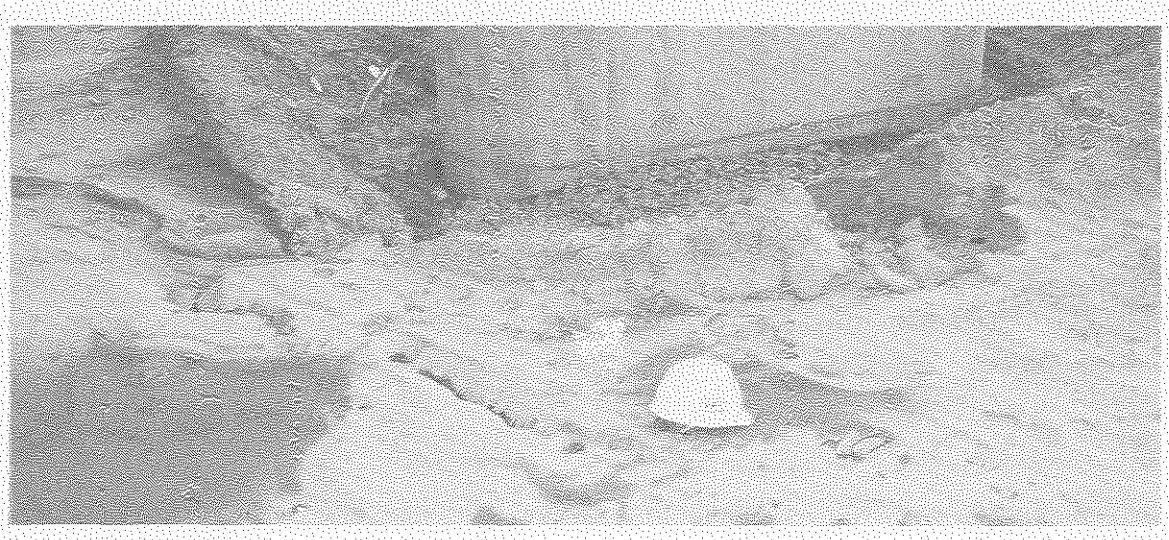
Fig. 4.73: Sand boil near bridge pier, Highway 23 crossing over Santa Clara River

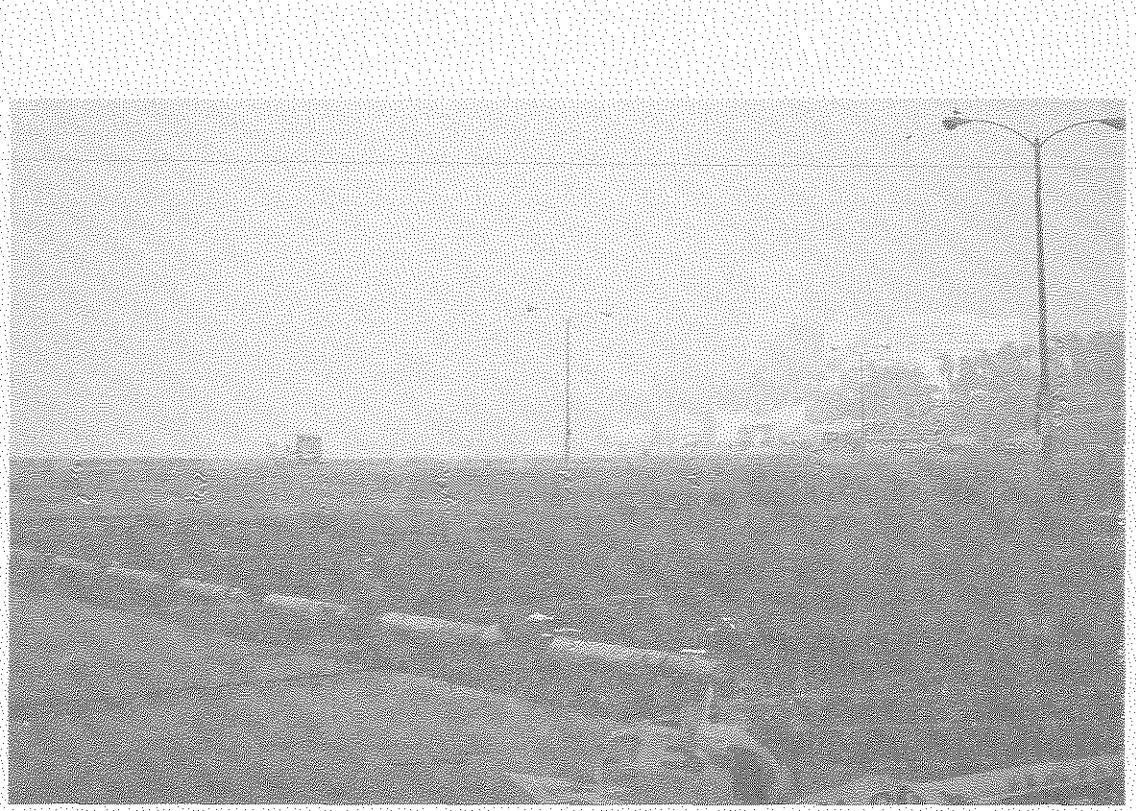
Fig. 4.76: Overview of parking lot with numerous sand fissures near Santa Monica Municipal Pier

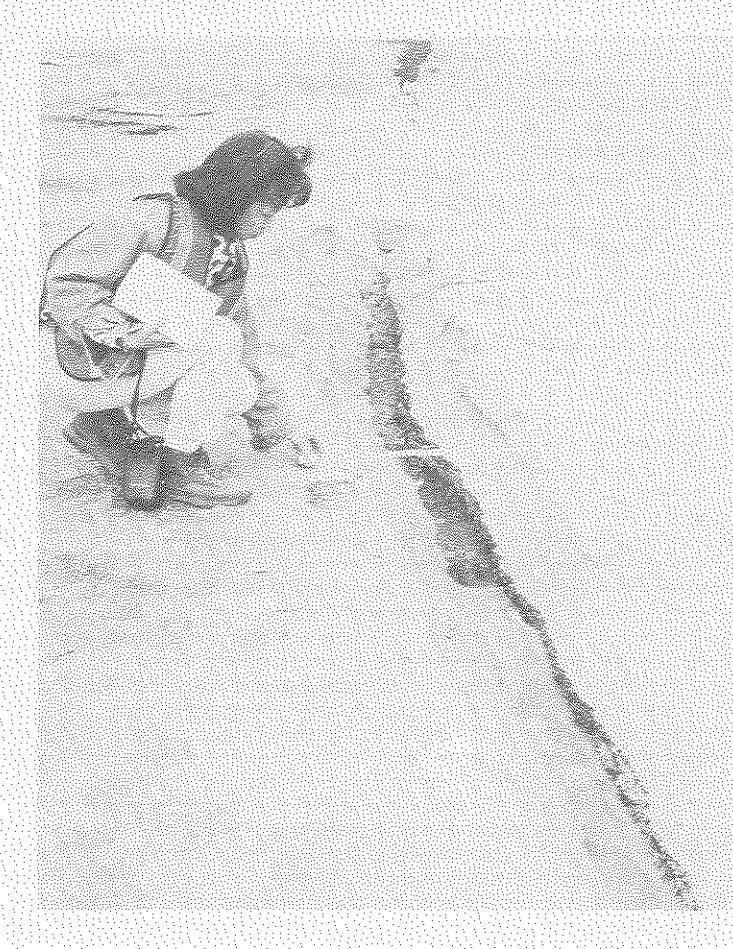
Fig. 4.77: Sand fissure in parking lot near Santa Monica Municipal Pier

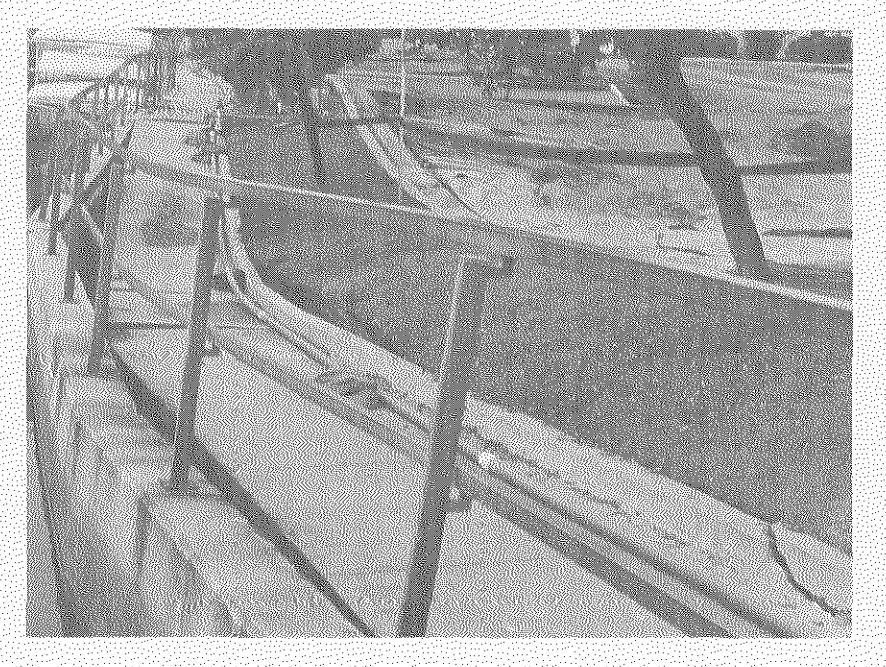
The Northridge Earthquake caused liquefaction of the sandy fill materials at Mole B, and possibly of the underlying beach and lagoonal deposits as well. Liquefaction-induced strength loss in the fill materials resulted in significant lateral spreading and settlement which caused up to 17 feet of displacement of the south wall of Mole B into the marina, as well as several feet of settlement of the mole surface, as shown in Figure 4.79. In addition, numerous utility pipes in the mole were broken, pavements were disrupted, and several small buildings on the mole were damaged. Figures 4.80 and 4.81 show an overview of the Mole B area including the damaged bulkhead wall and parking area. Figure 4.82 shows damage in a parking area behind the displaced wall section near the location of a ruptured utility pipe. Virtually every utility pipe located behind the failed wall section was reported to have been broken by the lateral spreading and settlement in the area (City of Redondo Beach, 1994). The liquefaction-induced strength loss of soils underlying the parking lot caused "bearing capacity" failures to occur beneath several cars as shown in Figure 4.83. Figure 4.84 shows a close-up view of the wall near the maximum displacement section.

Fig. 4.84: View of failed retaining wall near maximum displacement section at Mole B

Re-construction of the Mole B area is planned in conjunction with remedial efforts to reduce the liquefaction susceptibility of the sandy soils underlying the mole. Currently, proposed remediation techniques include the installation of stone columns through the fill materials and underlying beach and lagoonal deposits, and vibrocompaction of the remaining fill soils underlying the mole (M & T Agra, Inc., 1994).

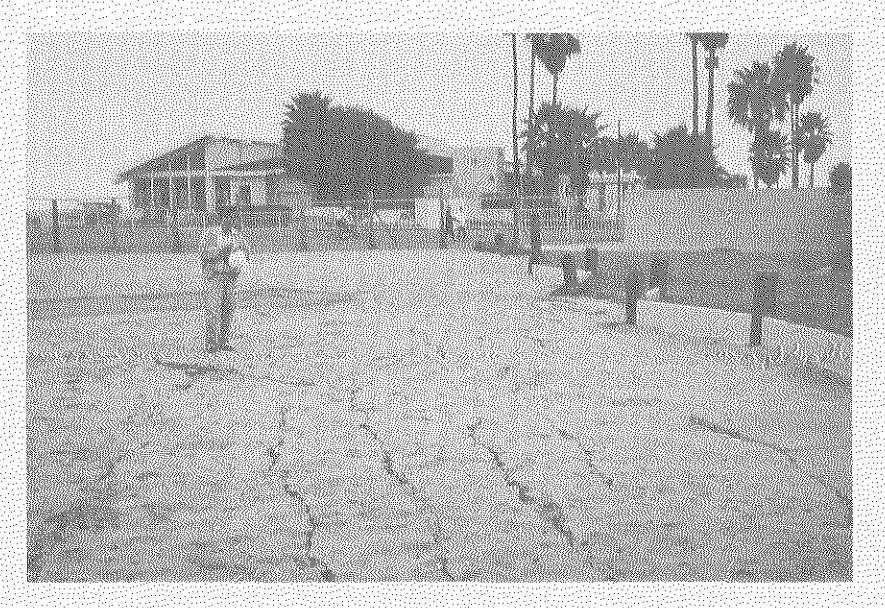
Fig. 4.86: Ground cracking from lateral spreading adjacent to Seaside Lagoon

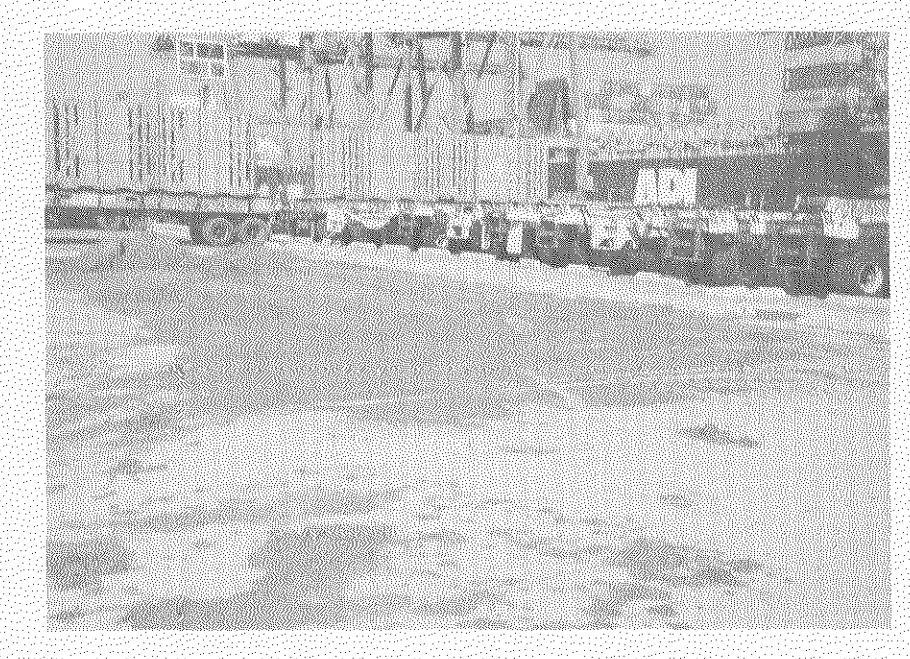
The most significant occurrences of liquefaction at the port were near Berths 121 to 126 and at Pier 300. At Berths 121-126, a paved area 200 feet in diameter behind a dike and wharf experienced lateral spreading and settlement from liquefaction of the underlying loose, silty and sandy fill soils. Cone penetration testing performed after the earthquake indicated the fill soils in this area had relative densities on the order of 20 to 50 percent, based on penetration resistance correlations with relative density. Some of the damage and clean-up operations in this area are shown in Figures 4.88 to 4.90. Lateral spreading in the area caused 2 to 3 inch movements of the wharf structure, and several 1 to 2-inch wide cracks 500 to 600 feet in length behind the wharf. Settlements of 6 to 8 inches occurred to pavements, and approximately 10 cubic yards of sand emerged from large boils which penetrated the 7-inch thick asphalt in the area (Hayden, 1994).

Fig. 4.88: Sand ejecta in parking area adjacent to Berths 121 to 126, Port of Los Angeles (photo courtesy of Doug Thiessen, Port of Los Angeles)

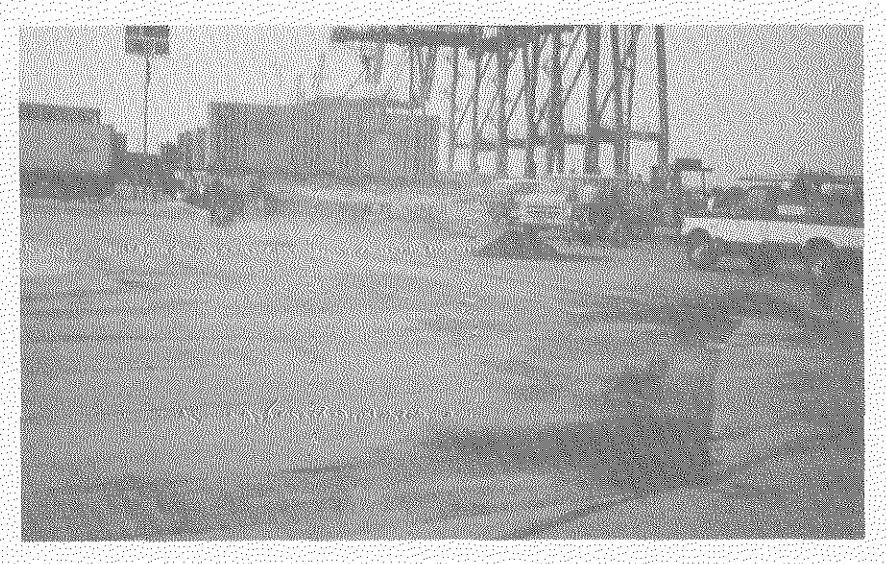
Fig. 4.90: Clean up of sand ejecta at Port of Los Angeles (photo courtesy of Doug Thiessen, Port of Los Angeles)

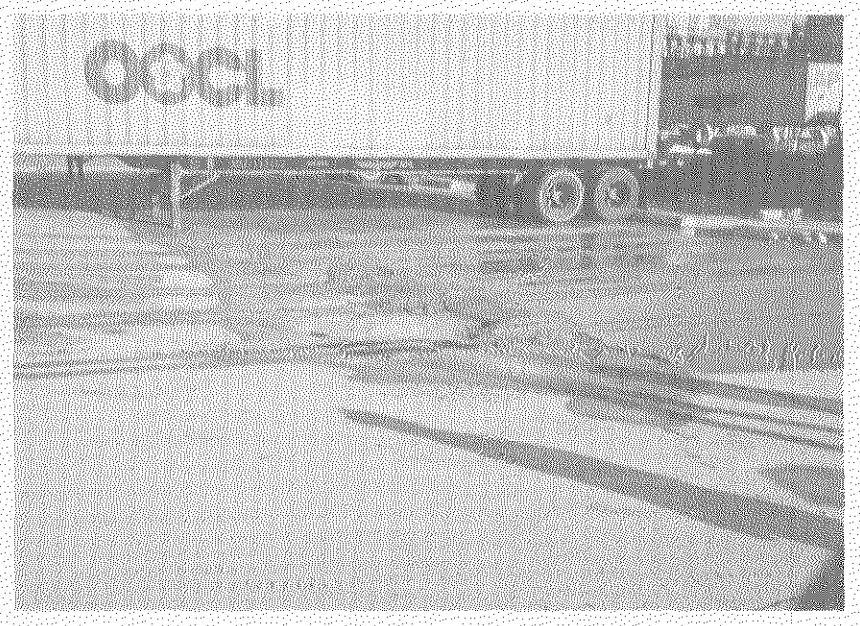
Fig. 4.89: Sand ejecta in parking area adjacent to Berths 121 to 126, Port of Los Angeles (photo courtesy of Doug Thiessen, Port of Los Angeles)

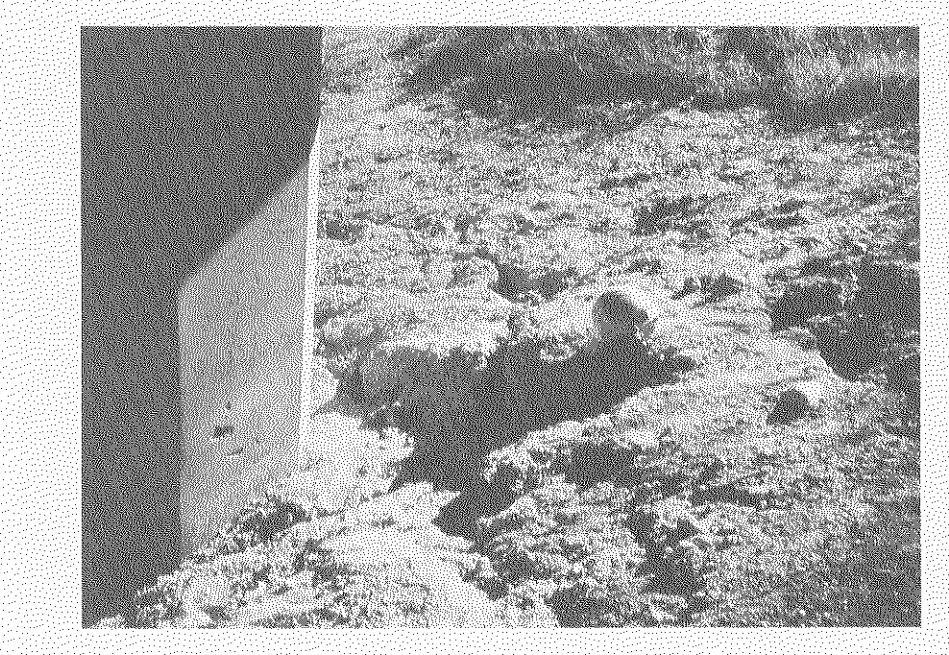
To date, no cases have been reported of ground failure resulting from the Northridge Earthquake causing severe distress to deep foundations such as piles or piers, although it should be noted that such distress would be intrinsically difficult to observe. At several locations, however, structural inertial forces were found to have induced permanent displacements of pile/pier caps. One such case was at the Highway 14-Interstate Highway 5 interchange, where several collapses of bridge structures occurred. This interchange is located in steep terrain with shallow bedrock. Several columns for the bridge structures were observed to have suffered residual lateral displacements in the downslope direction, as shown in Figure 4.95. These displacements are believed to have resulted from permanent distortion of the foundation elements under seismically-induced inertial forces from the bridge superstructure, and do not appear to be associated with ground failure or landsliding. It is not known to what extent these movements of the pile/pier cap may have influenced the structural collapse.

Fig. 4.95: Ground cracking and graben formation behind bridge column due to downslope movement of pile/pier cap, Highway 14 - Interstate Highway 5 interchange

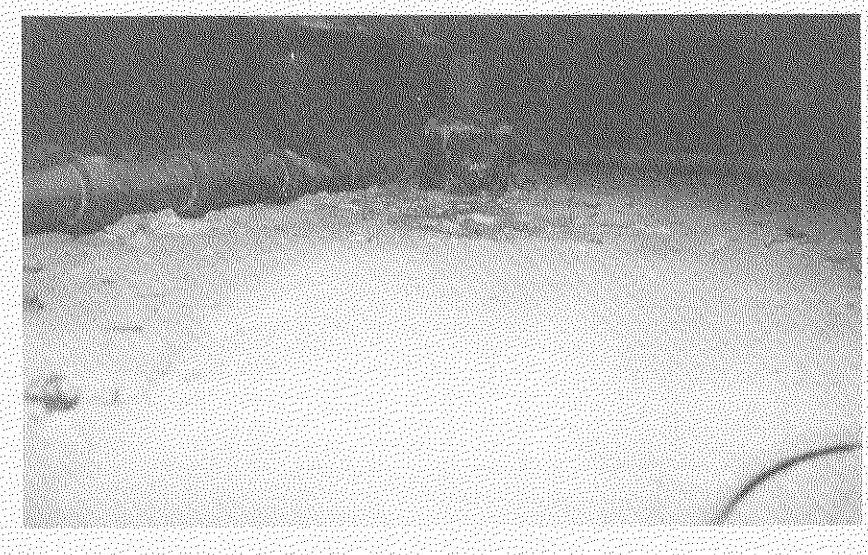
Fig. 4.97: Ejecta from sand fissure beneath residence in Woodland Hills. The ejecta at this location consisted almost exclusively of salts

The second site where liquefaction of evaporite salts was found is in Woodland Hills and is founded on a ridge of commonly gypsiferous, diatomaceous sandstone/siltstone/claystone within the Modelo Formation. Shallow groundwater occurs in the area, likely due to a perched aquifer on relatively impermeable claystones. Liquefaction at the site was observed in the form of boils which contained a significant salt content. In one location, the ejecta was comprised almost exclusively of salts, as shown in Figure 4.97. The salt particles were generally of coarse sand-size, although a finer-grained "plaster-like" material was observed to have segregated from the coarser particles. This "plaster-like" material (shown in Figure 4.98) exhibited flow features on its surface and appeared to have dried as a result of its proximity to a hot water pipe beneath the house. In this case, liquefaction is believed to have resulted from the collapse of crystalline gypsum veins, commonly found along bedding and joints in the Modelo Formation.

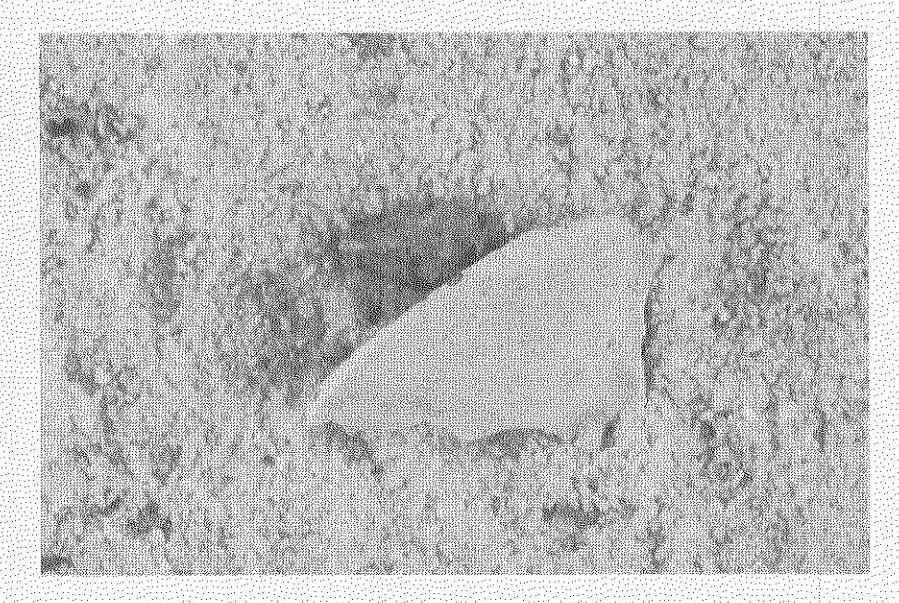
Fig. 4.98: Close-up view of salt ejecta from Figure 4.97 showing coarse sand-sized particles and fine 2-inch "plaster" block. The plaster was originally found beneath the coarse material.

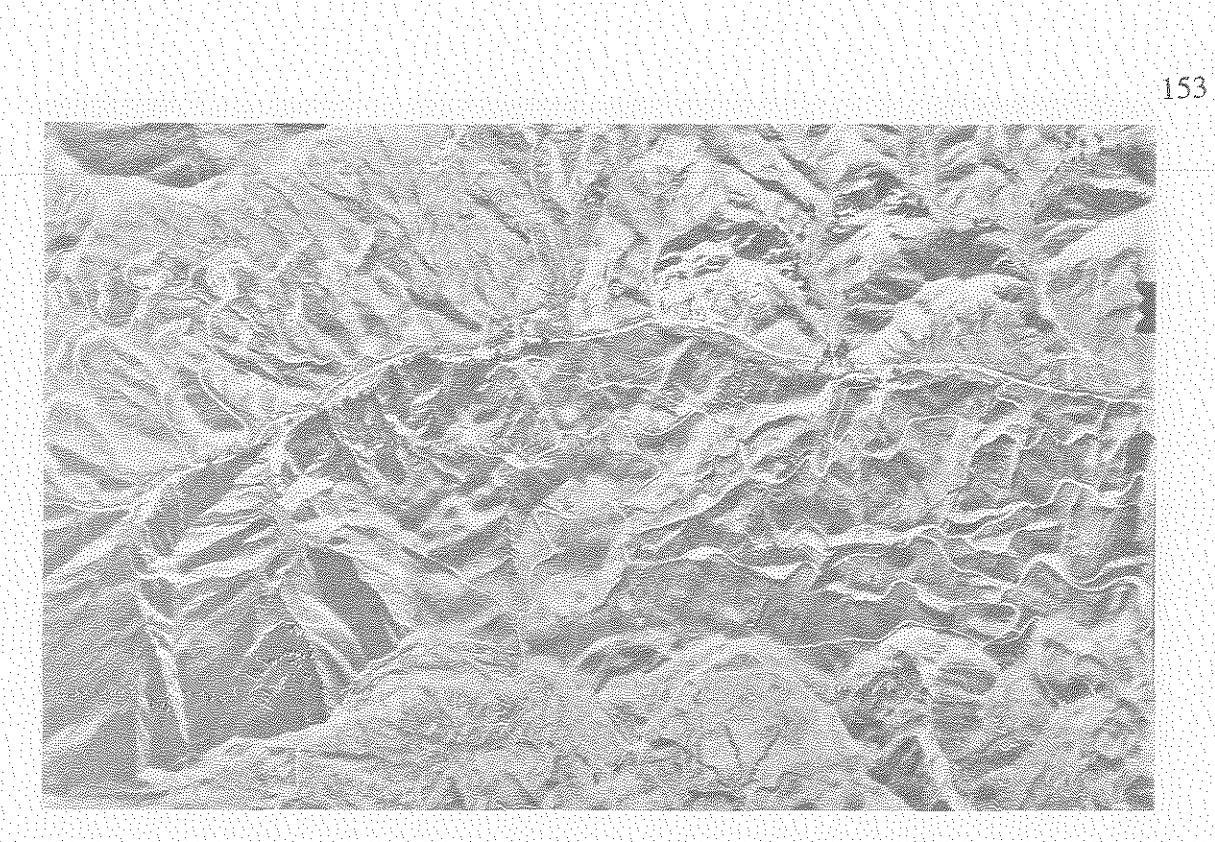
Fig. 5.7: Vertical aerial view of San Martinez Grande Canyon showing landslide at Del Valle. (photo courtesy of NASA-Ames Research Center, C-130 Program)

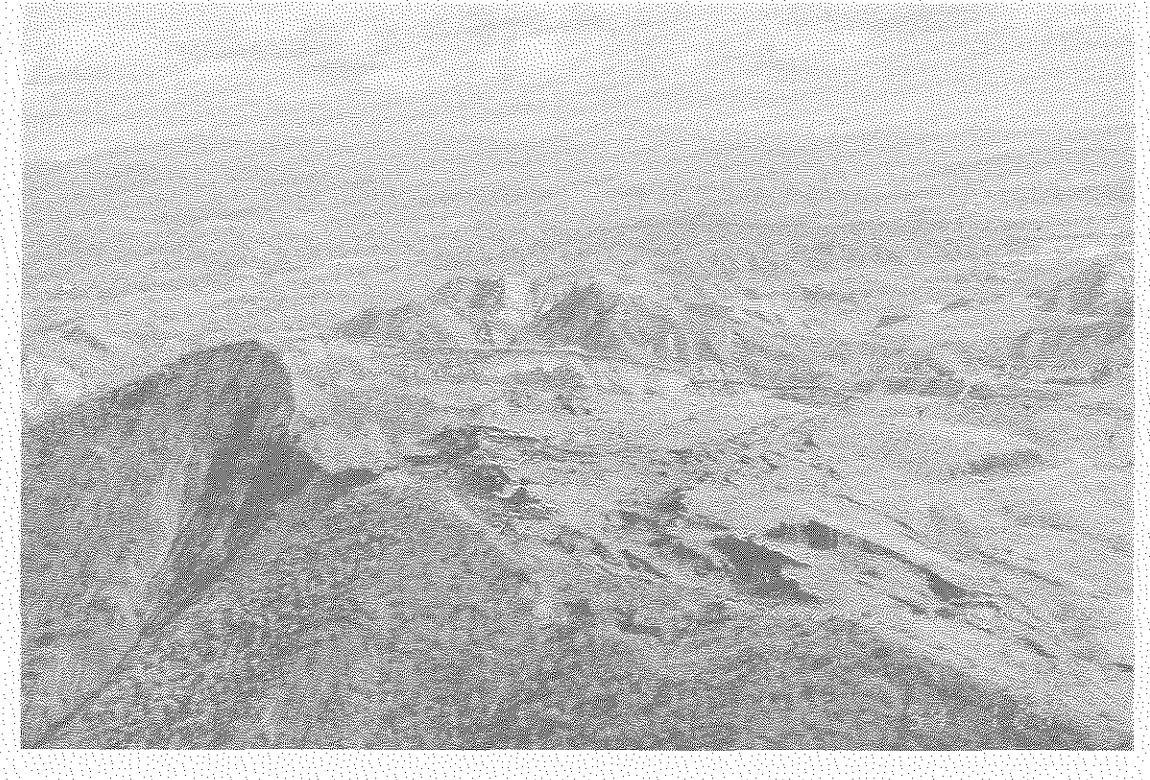
Fig. 5.8: View of Del Valle landslide headscarp, looking east. (Photo courtesy of T. McCrink, California Division of Mines and Geology)

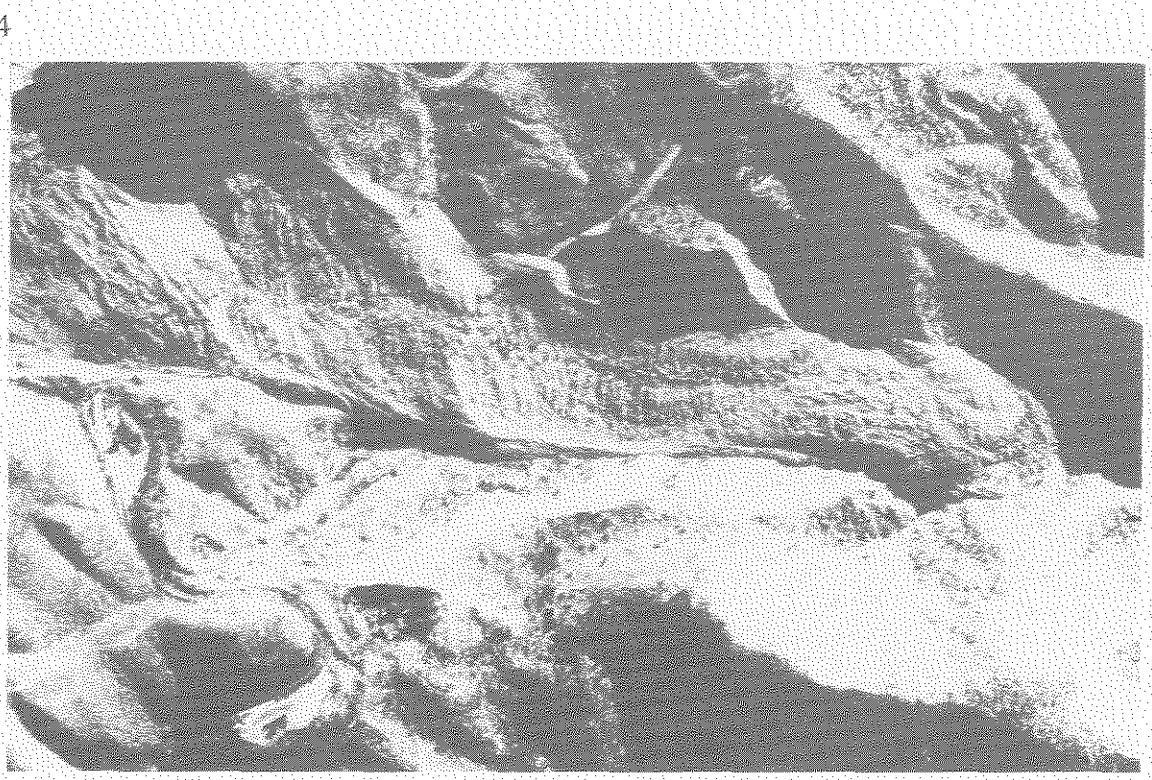
Fig. 5.9: Aerial view of landslide at Ramona Oil Field. (Photo courtesy of USAF - Beale AFB, 9th ISS)

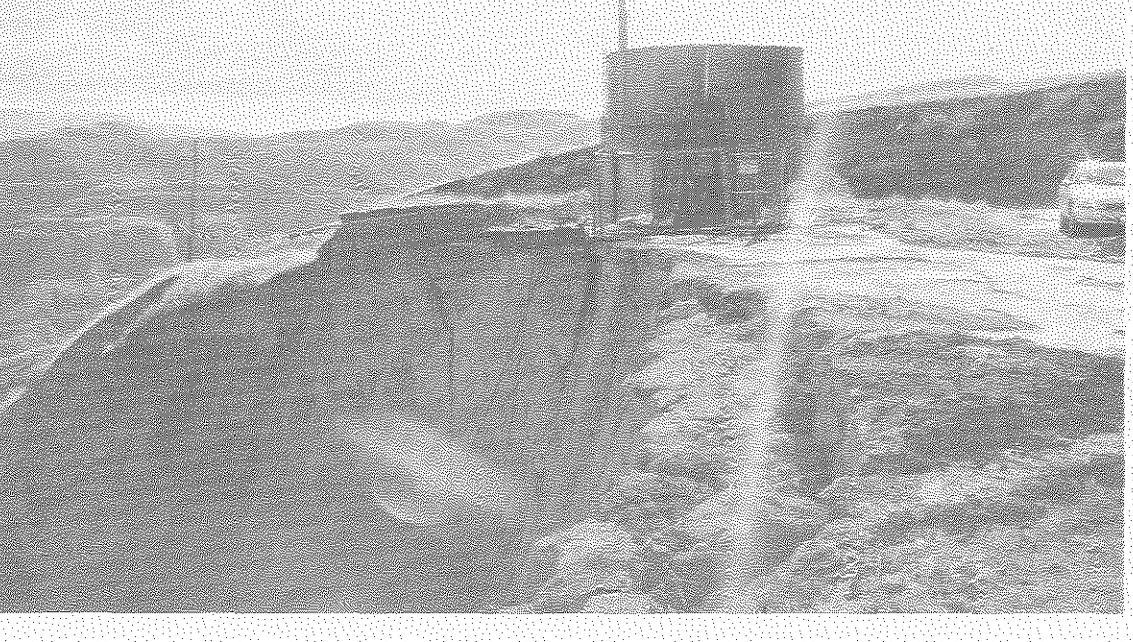
Fig. 5.10: Oil well at headscarp of landslide at Ramona oil field. (Photo courtesy of T. McCrink, California Division of Mines and Geology)

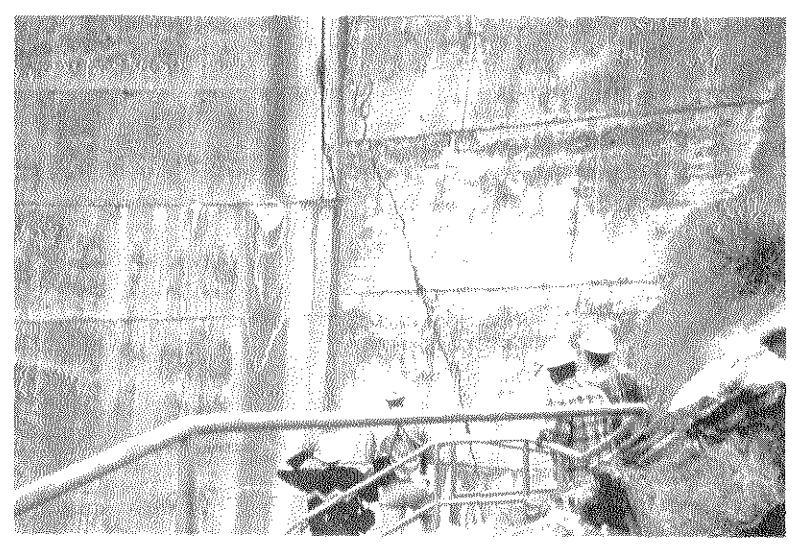
The most significant damage appeared to be related to movements of the left abutment relative to the dam (see Figure 6.7). A ¼ to ½ inch wide crack in the thrust block ran diagonally up the block to merge with the vertical joint between the block and the concrete arch (see Figures 6.8 through 6.10). In addition, there were also diagonal hairline cracks extending several feet into the concrete arch from the joint near the thrust block crack. The vertical joint also opened up and widened towards the crest of the dam. At the dam crest, the joint had opened to a width of about 2 inches (see Figure 6.11). The thrust block side of the joint was also offset about ½ inch downstream and ¾ of an inch down relative to the concrete arch. Thus, apparently the left abutment had moved away and downstream relative to the arch. This distress and behavior was similar to what had happened following the 1971 San Fernando Earthquake, but was more severe following the 1994 event.

Fig. 6.8: Photograph of cracking in Pacoima Dam thrust block (photo courtesy Division of Safety of Dams)

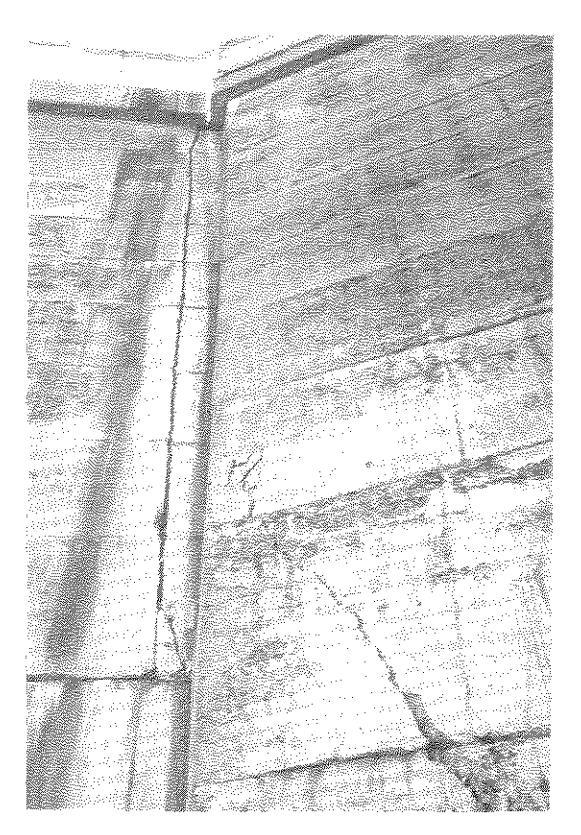
Fig. 6.9: Photograph of vertical joint between Pacoima Dam arch and left abutment thrust block

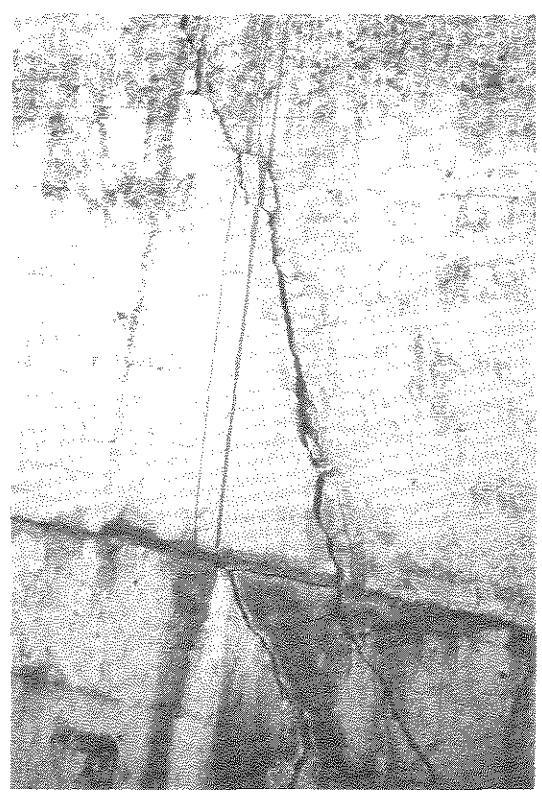
Fig. 6.10: Close-up photograph of cracking in Pacoima Dam thrust block
