PRELIMINARY REPORT ON

THE PRINCIPAL GEOTECHNICAL ASPECTS OF

THE JANUARY 17, 1994 NORTHRIDGE EARTHQUAKE

Report No. UCB/EERC-94/08

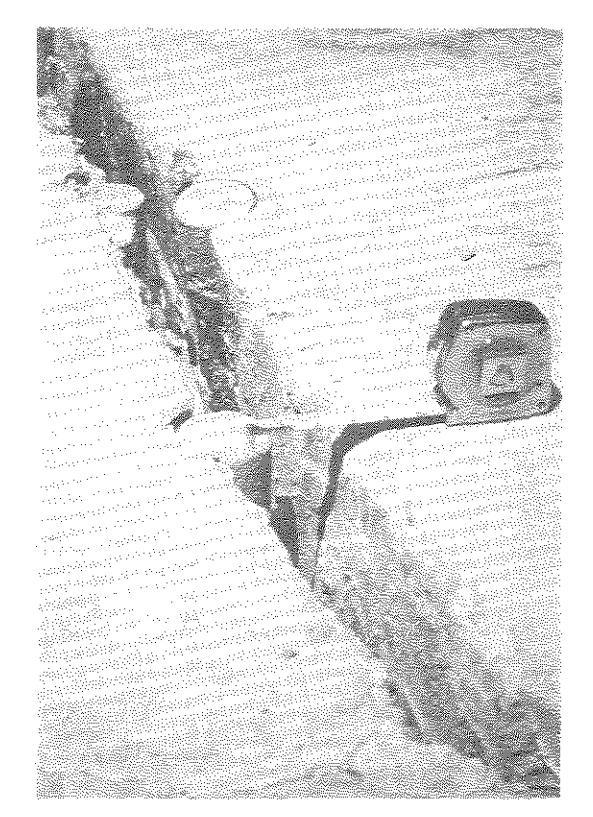
Fig. 6.11: Close-up photograph of opened thrust block vertical joint on Pacoima Dam crest

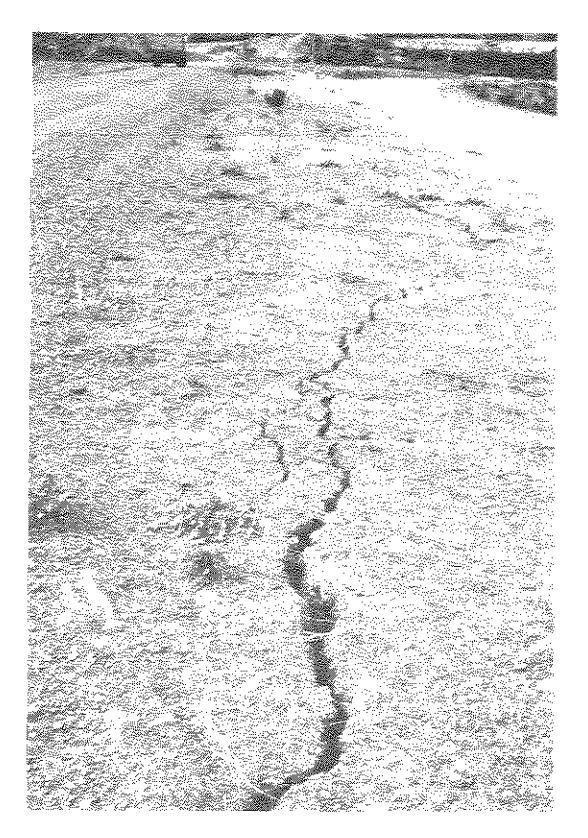
which resulted in lateral spreading upstream towards the small pond. The lateral spreading resulted in widespread longitudinal cracking running hundreds of feet. On the dam crest, cracks were generally less than about 2 inches in width (see Figure 6.14). Upstream of the recompacted portion, longitudinal cracks had widths as much as 6 inches, together with vertical offsets of several inches (see Figure 6.15). Additional cracking further upstream towards the lower access road and pond was accompanied by numerous sediment boils (see Figures 6.16 and 6.17). These sediment boils were generally composed of silty sands. The locations of significant cracks and sediment boils were mapped by staff of the City of Los Angeles Department of Water and Power and are shown in Figure 6.18.

Fig. 6.14: Photograph of 2-inch wide longitudinal crack on crest of Lower San Fernando Dam

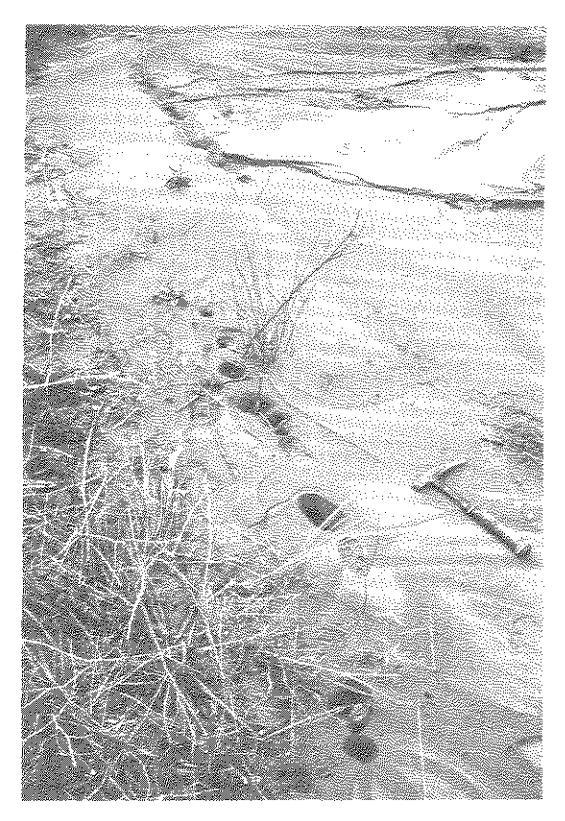
Fig. 6.16: Photograph of sediment boil at Lower San Fernando Darn located on old slide downstream of lower access road

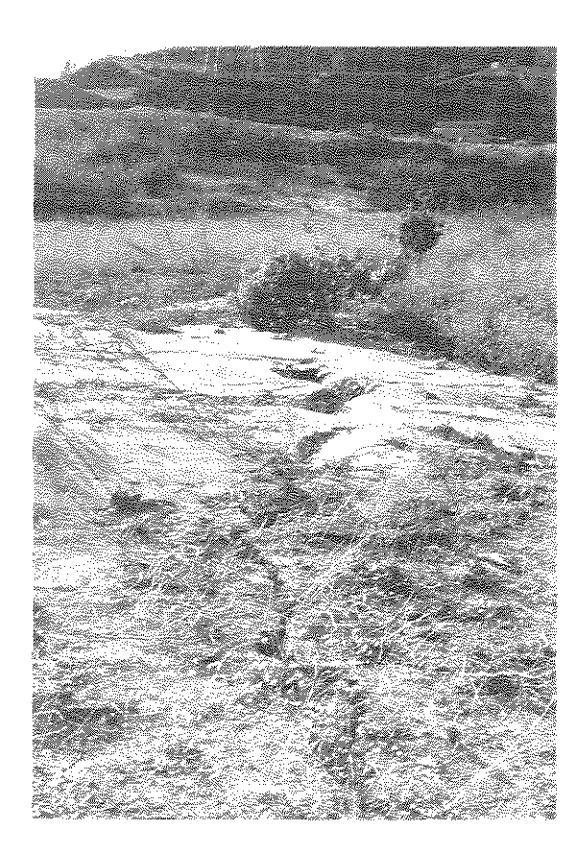
Fig. 6.17: Photograph of sediment boil at Lower San Fernando Dam on old slide upstream of lower access road

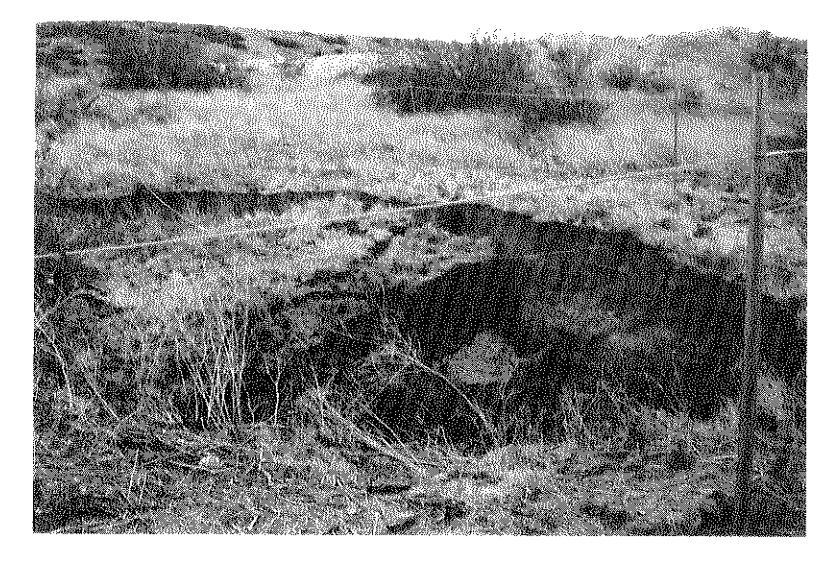
The most serious distress sustained by the rebuilt Lower San Fernando Dam consisted of a sinkhole which developed near the right edge of the upstream cracking (see Figures 6.18 and 6.19). This sinkhole had a width (parallel to the dam axis) of 26 feet, a length (normal to the dam axis) of about 42 feet, and a maximum depth of about 13 feet. The sinkhole was later found to be centered on the corrugated metal pipe connecting the old outlet pipe to the upstream pond. The corrugated metal pipe was excavated in May 1994 and found to have sustained near complete lateral collapse, presumably due to increased lateral pressures caused by the earthquake (see Figures 6.20 and 6.21). During the excavation, additional sinkholes were discovered. Apparently, erosion caused by the water flowing through the partially collapsed pipe removed soil which entered through tears in the pipe, thus causing the sinkholes. Following the replacement of the outlet pipe and perhaps regrading of some of the cracks, the dam is expected to resume its function of providing limited flood control.

Fig. 6.19: Photograph of sinkhole at Lower San Fernando Dam

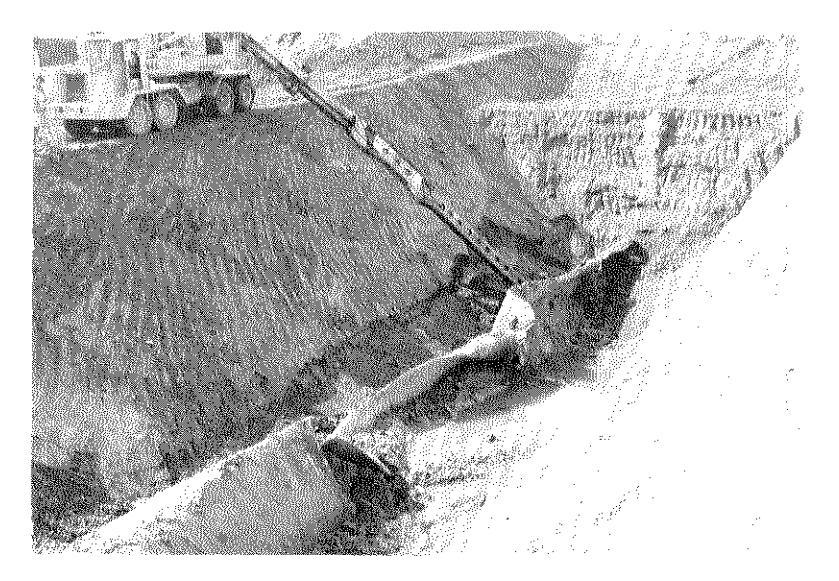
Fig. 6.20: Photograph of collapsed CMP outlet pipe at Lower San Fernando Dam

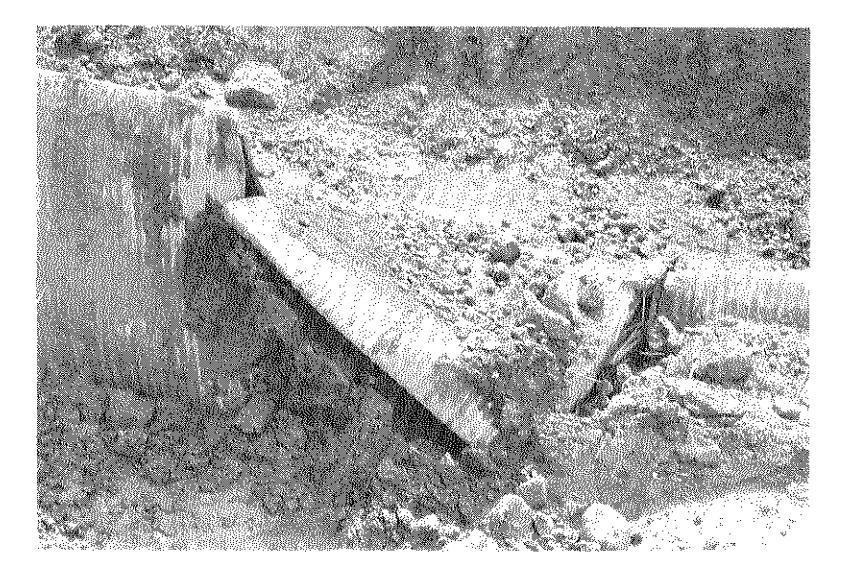
Fig. 6.21: Photograph of portion of collapsed CMP directly beneath sinkhole at Lower San Fernando Dam

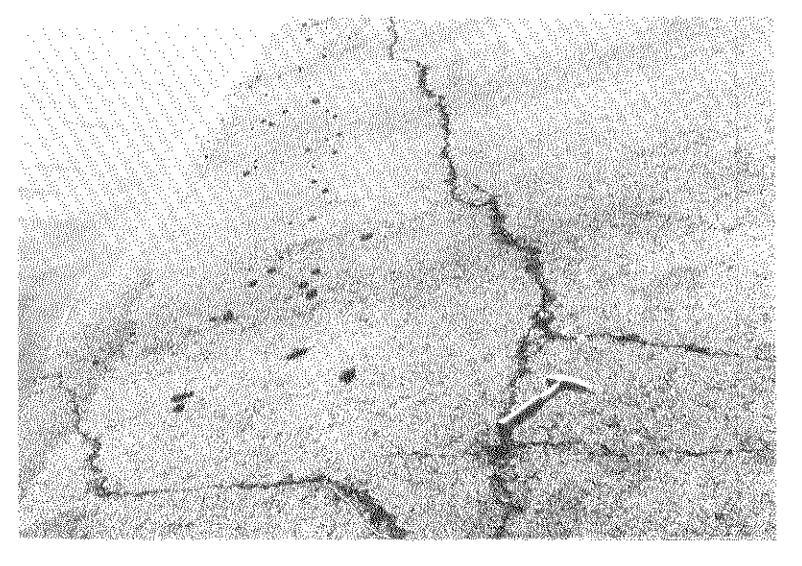
Fig. 6.27: Cracking of upstream asphalt concrete slope protection on Los Angeles Reservoir North Dike

The 1994 Northridge Earthquake induced settlements of about 3.5 inches at the Main Dam and about 1 inch at the North Dike, along with fairly extensive cracking of the upstream asphalt concrete slope protection (see Figure 6.27). The largest of these cracks was about 1-inch wide. There was also a ¹/₄-inch wide transverse crack across the crest of the North Dike near its left abutment (see Figure 6.28). This crack extended across a 30-inch deep pre-existing utility trench and was only about a hairline in width at the bottom of the trench.

In light of the relatively high levels of shaking, the Los Angeles Dam can be considered to have performed reasonably well. The cracking appears to be of minor significance. The staff of the Los Angeles Department of Water and Power plan to patch some of the cracks, remedy the displaced walkway of the outlet tower, and to closely monitor the seepage at the North Dike.

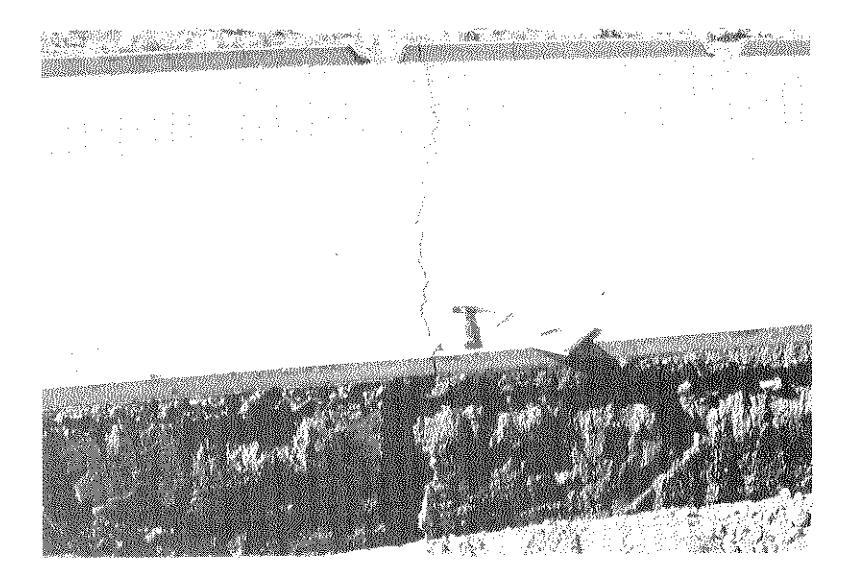
Fig. 6.28: Photograph of transverse crack on crest of Los Angeles Reservoir North Dike near its left abutment

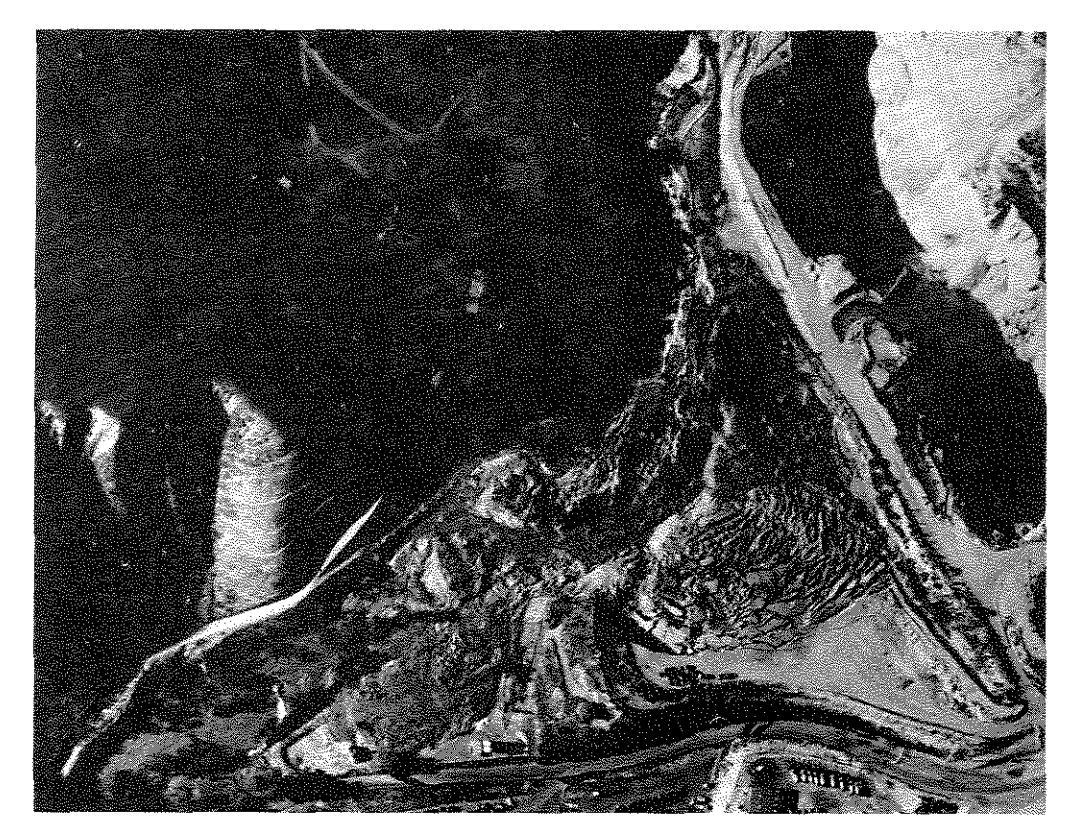
Fig. 6.38: Aerial photograph of Tapo Canyon Tailings Dam on day of Northridge Earthquake. (photo courtesy of U.S. Air Force)

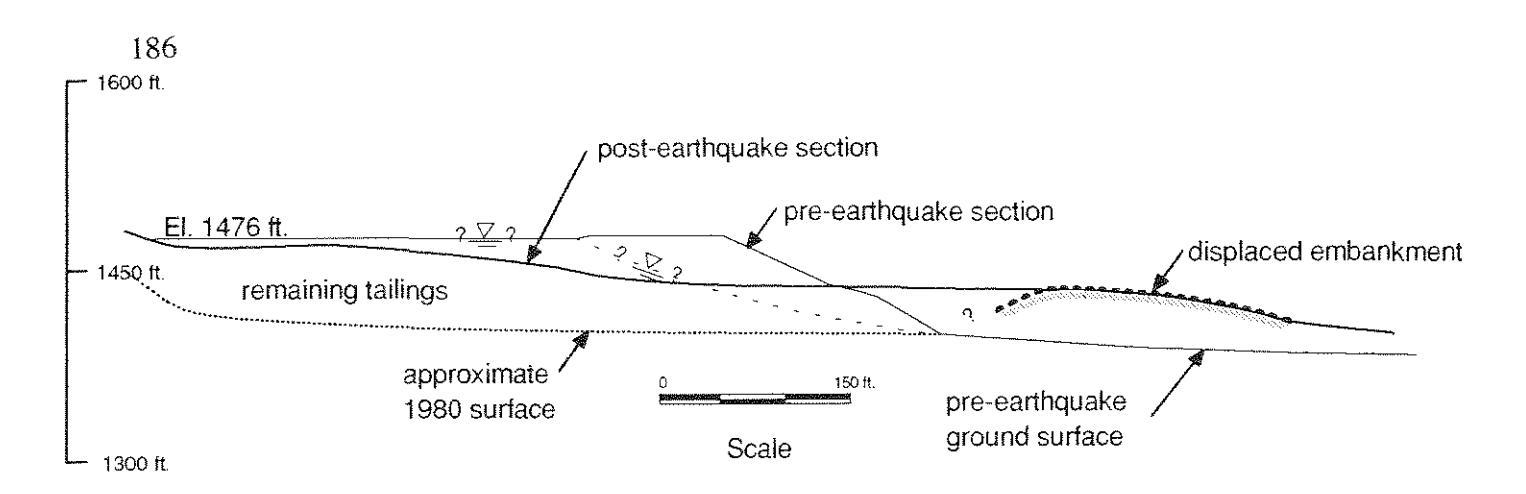
Fig. 6.41: Section A-A from Figure 6.39, showing failed tailings dam and resulting flow slide.

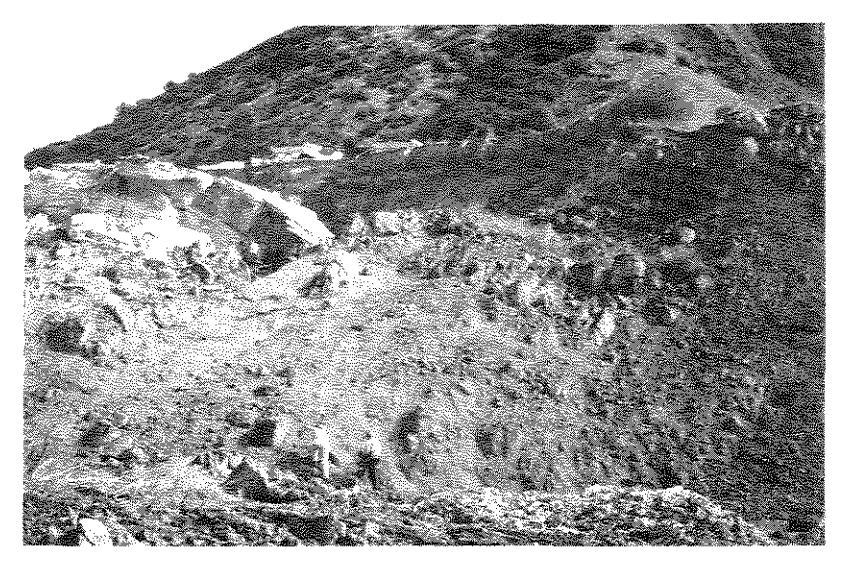
Fig. 6.42: View looking east across flow slide within breach towards southeast embankment

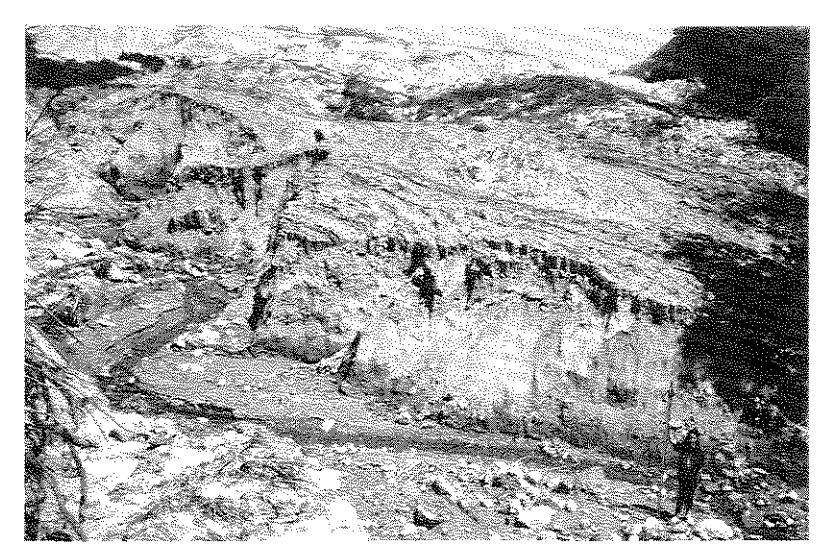
Fig. 6.43: Edge of lobe of viscous tailings flow near creek, photograph taken 600 feet downstream of the failed pond, looking north.

Downstream of the principal, relatively viscous flow slide, more "fluid" tailings were found to have splashed up across the creek and against the adjacent hillside. The splashed material appears to be composed predominantly of clayey soils. Further downstream, tailings entered the creek channel, filling much of the channel to unknown depths, and flowed thousands of feet downstream. Trees were found in the channel surrounded by tailings with "splashes" running several feet up the upstream side of their trunks.

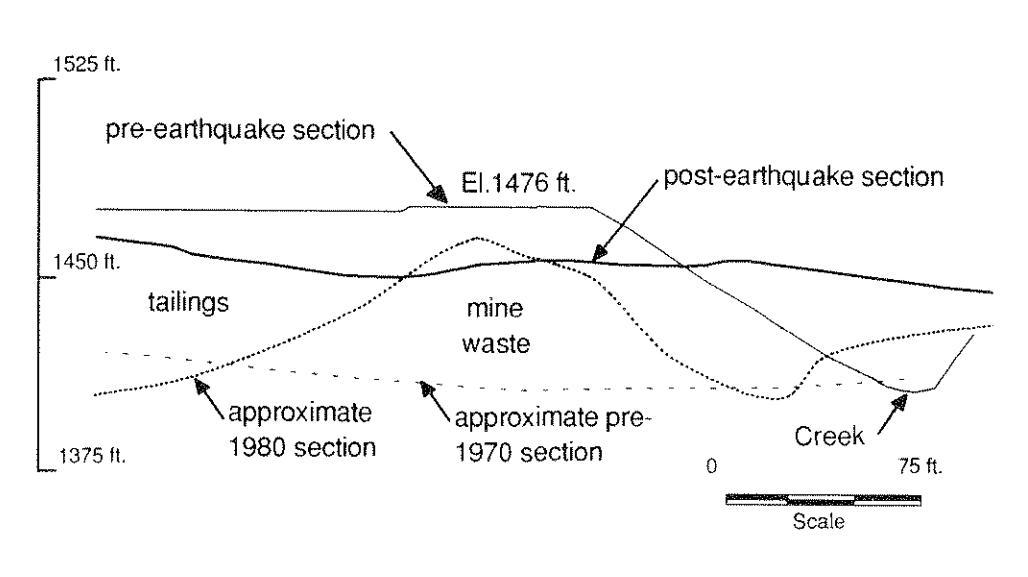
Fig. 6.44: Section B-B from Figure 6.39, failed embankment section northwest of breach

in extensive cracking with crack dimensions exceeding several feet in both vertical and horizontal directions. Portions of the buttress and riprap added in 1987 ended up on the opposite (western) side of the creek from where they had been constructed (see Figures 6.44 through 6.46). For a while, the creek was partially dammed up in this area by the displaced dam and tailings (see Figure 6.47). The fact that this portion of the dam did not experience a complete flow failure, and the nature of the observed lateral spreading, are probably due to the presence of the mine waste piles and possible rock ridges underlying the retaining dam in this area (see Figure 6.44). Some of the displacements of the southwestern dam may also have been limited by the presence of the opposite, or western, creek bank.

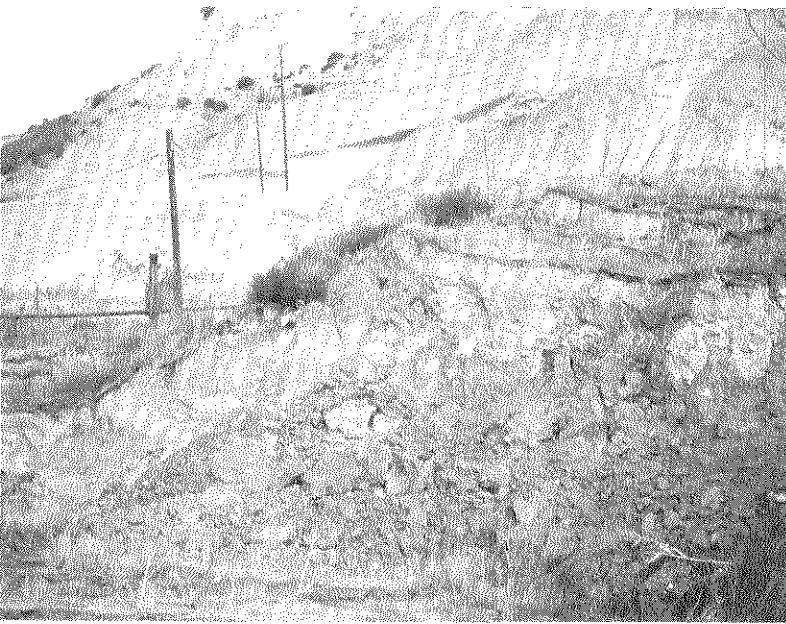
Fig. 6.45: Offset in roadway on north portion of southwest embankment

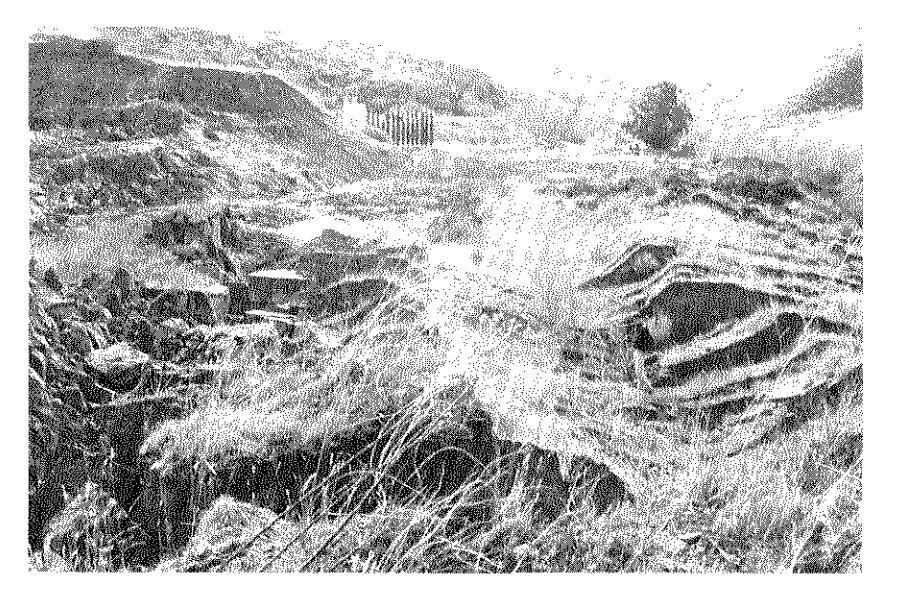
Fig. 6.46: "Split" crest area of failed southwest embankment

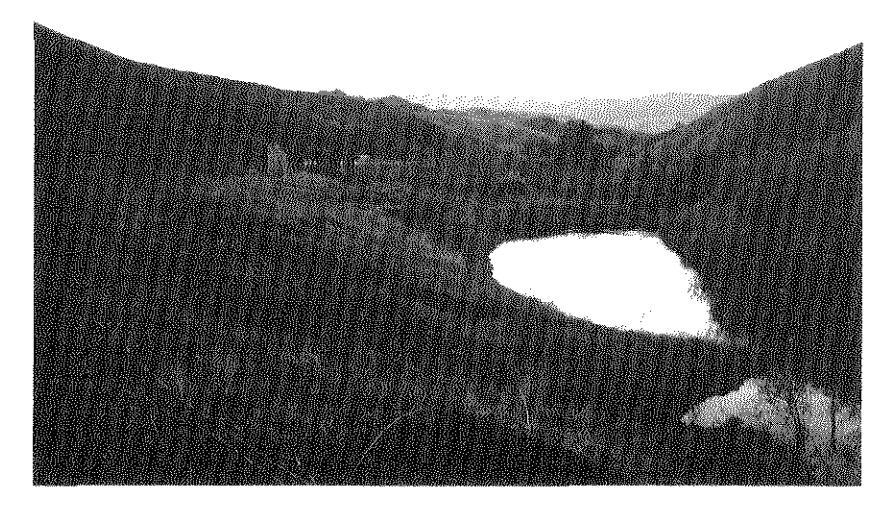
Fig. 6.47: Portion of failed southwest embankment blocking creek, forming small lake.

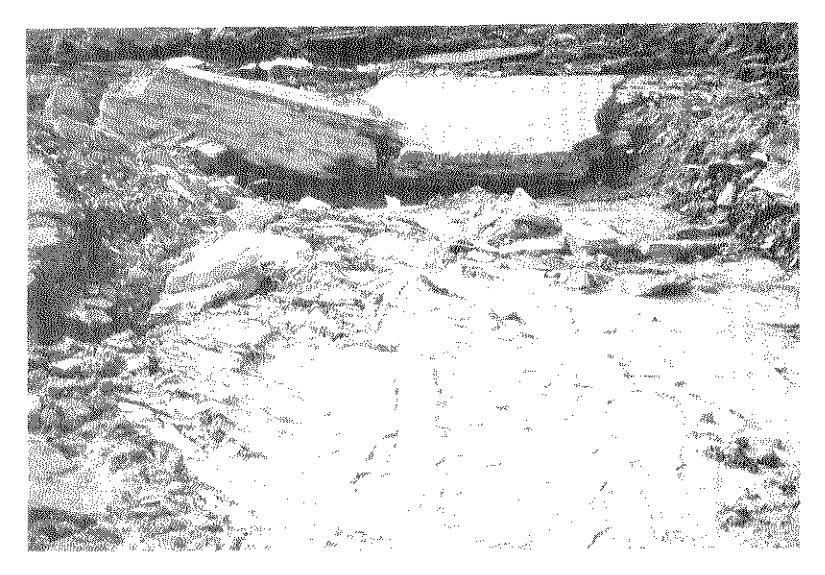
Fig. 6.50: Photograph of pair of concrete blocks which traveled 84 feet across pond surface

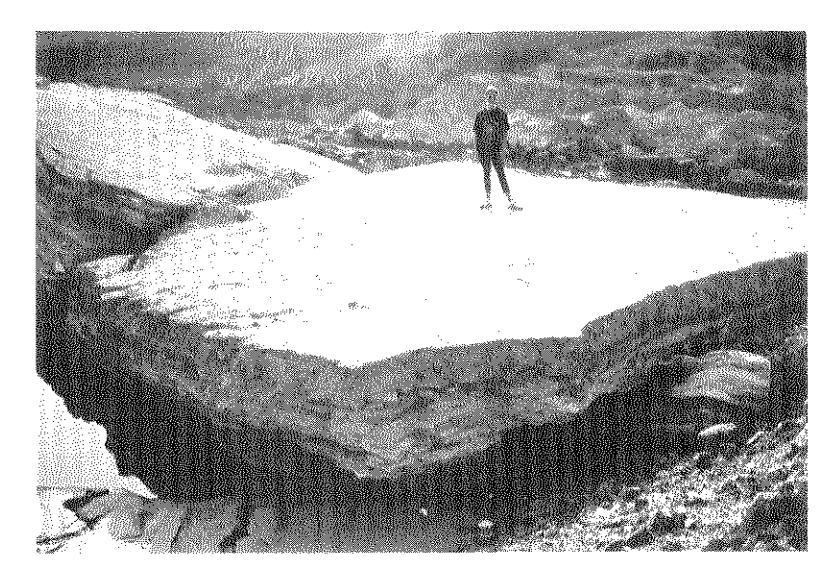
Fig. 6.51: Close-up photograph of 200-ton concrete block

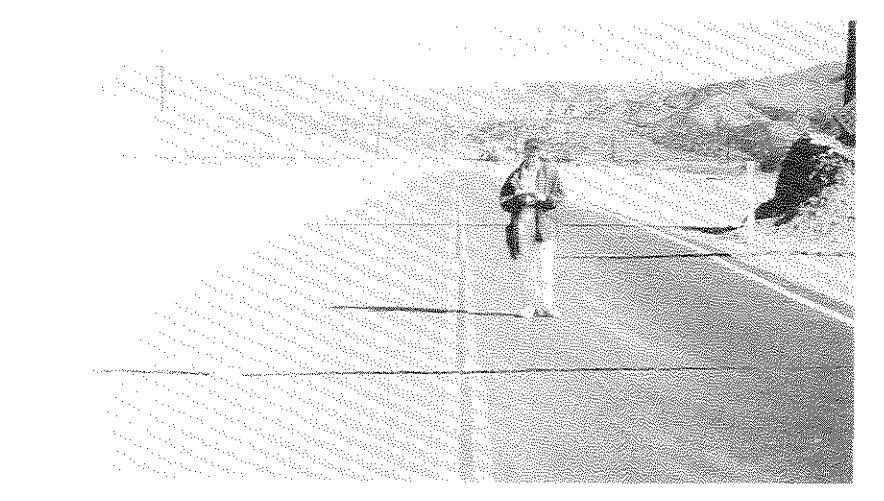
One particularly recent fill damaged by the Northridge Earthquake is located along Highway 126 just west Interstate Highway 5. A new post office which was not yet occupied is located in the vicinity of this fill and was severely damaged by the earthquake. It is not known whether the post office was underlain by the fill soils or a natural rock ridge. However, the fill does underlie an access road to the post office which experienced several inches of lateral and vertical ground movements, as shown in Figures 6.53 and 6.54.

Fig. 6.53: Pavement cracking due to movements of underlying fill, access road for Newhall post office.

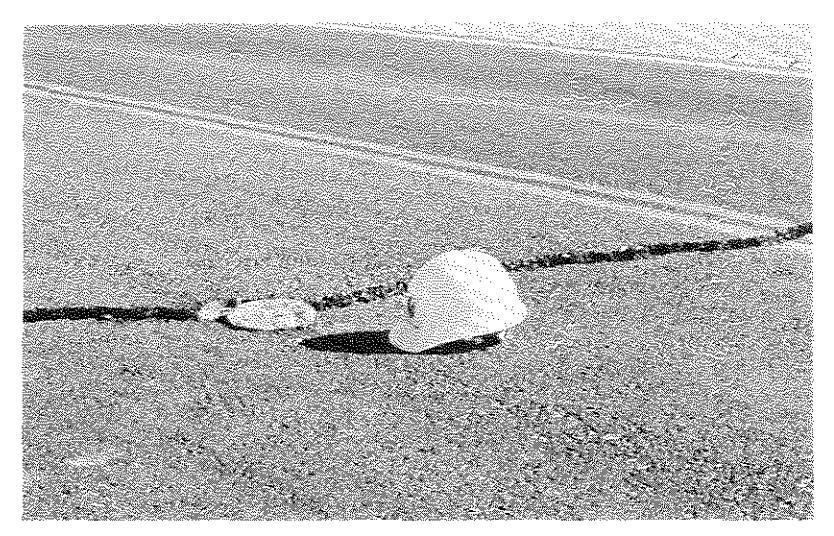
Fig. 6.54: Pavement cracking from fill movements below Newhall Post Office

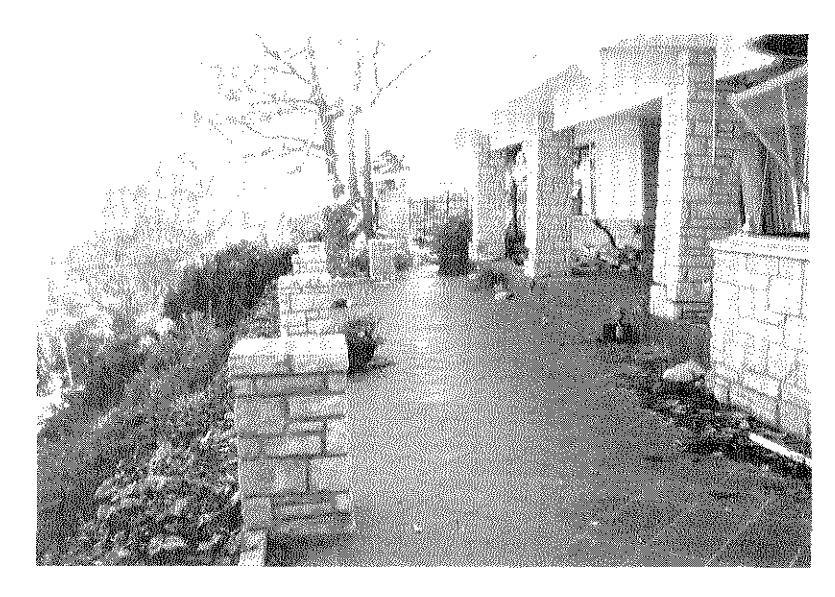
Many of the damaged hillside homes were constructed on "wedge" fills having geometry similar to that shown in Figure 6.55. Typical damage to hillside homes on these fills are shown in Figures 6.56 to 6.59. Localized vertical and horizontal soil displacements of several inches were observed in many instances within the fill portions of the building pads. Significant structural distress occurred when these movements developed within the building envelope. In addition, cracks resulting from these movements could collect surface runoff and thereby contribute to future static slope instability. In many cases, the areas closest to the tops of slopes were most severely damaged, possibly due in part to topographic/geometric amplification effects which may have locally increased the severity of ground shaking and resultant inertial forces in these locations.

Fig. 6.56: Structure damaged by movements in "wedge" fill, view is along top of fill slope

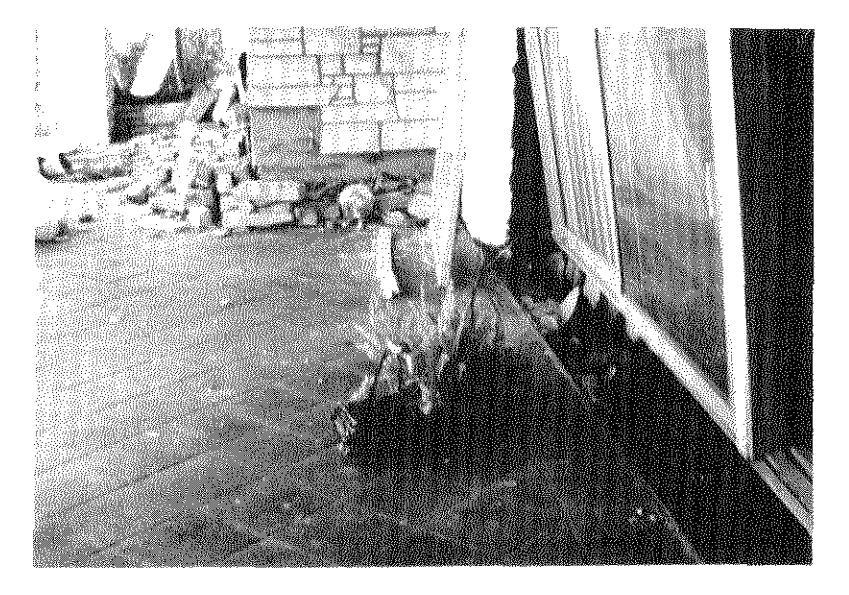
Fig. 6.57: Evidence of extensional ground movements near back of structure shown on Figure 6.56

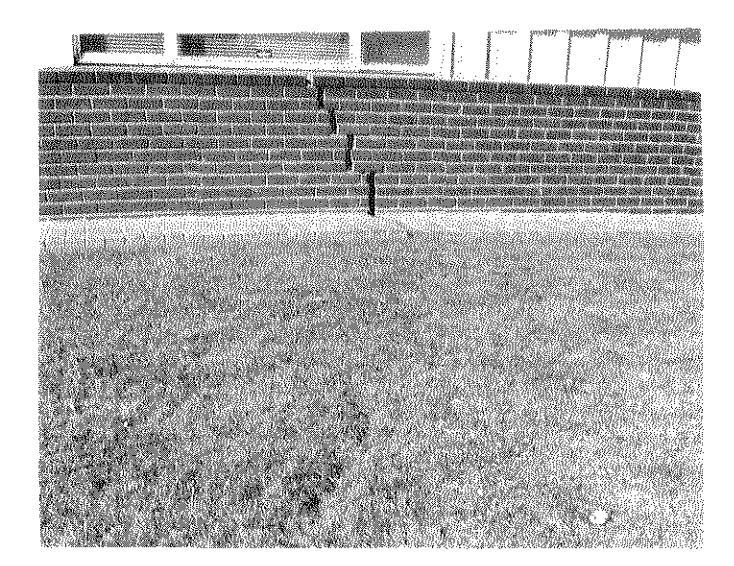
Fig. 6.59: Extensional ground cracking near cut-fill interface of "wedge" fill. Note extension of crack into structure and resulting damage.

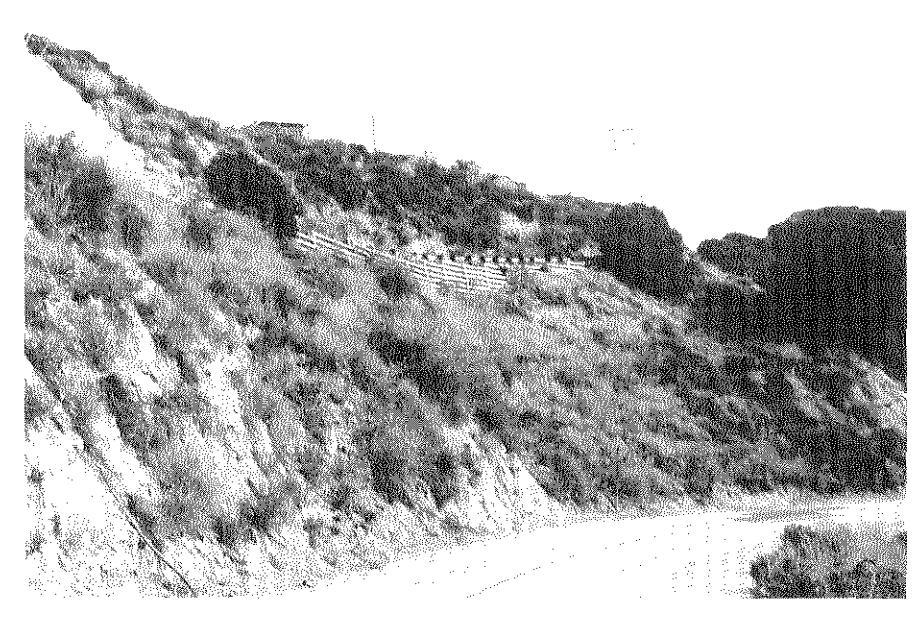
Fig. 6.61: Typical reinforced concrete crib wall in the Angeles National Forest. The scarp on the top left side of the picture is from a landslide induced by the earthquake.

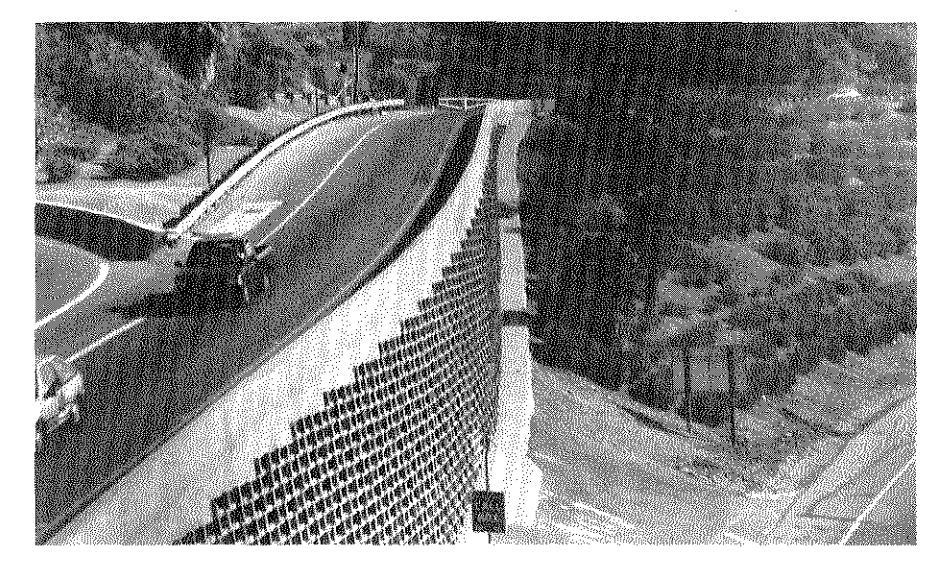
Signs of earthquake-induced distress were found on structures located in Universal City along Highway 101 at the Universal Center Drive Overcrossing. Three large, up to 12 m (40 ft) high crib walls with segmental concrete facing units have been privately built at this location. The walls are located approximately 19 km (12 miles) from the epicenter of the earthquake. Based on data from nearby stations, the estimated peak horizontal ground acceleration at the site appears to have been approximately 0.35g. The southern-most wall at this location showed evidence of distress and movements during the earthquake, as shown in Figure 6.62. Continuous cracks more than 25 mm (1 inch) in width were observed on the paved surface, parallel and approximately 1.5 m behind the wall facings. Settlements of the backfill of up to 50 mm in relation to the retaining structure occurred along the cracks (Figure 6.63). A second set of cracks, also parallel to the facing, were located approximately 6 m

Fig. 6.62: Southern-most crib wall at University Center Drive Overcrossing. Note pavement cracking parallel to wall.

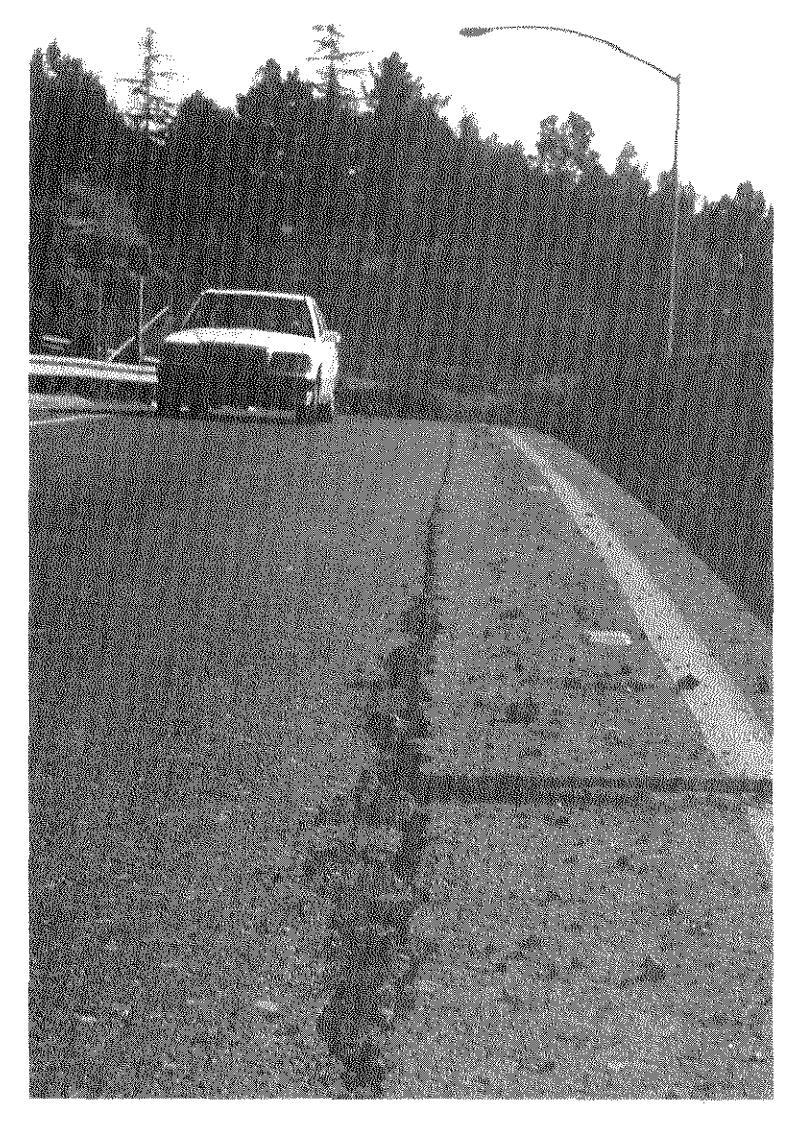
Fig. 6.63: Close-up of crack behind the southern-most crib wall at Universal Center Drive Overcrossing

behind the wall. These cracks occurred at a location where the wall foundation transitions from natural ground to an engineered fill slope. This foundation transition occurs at the highest section of the structure, and it is not clear whether the localization of cracking was influenced by the fill height, the foundation transition, or both. Analysis of the cross section of the reinforced concrete crib wall shows that the location of the continuous line of cracking near the wall corresponds to the inboard end of the concrete crib. The vertical differential settlements likely resulted from either earthquake-induced compaction of the retained fill or, most probably, lateral deflection of the crib wall which resulted in settlement of the retained backfill.

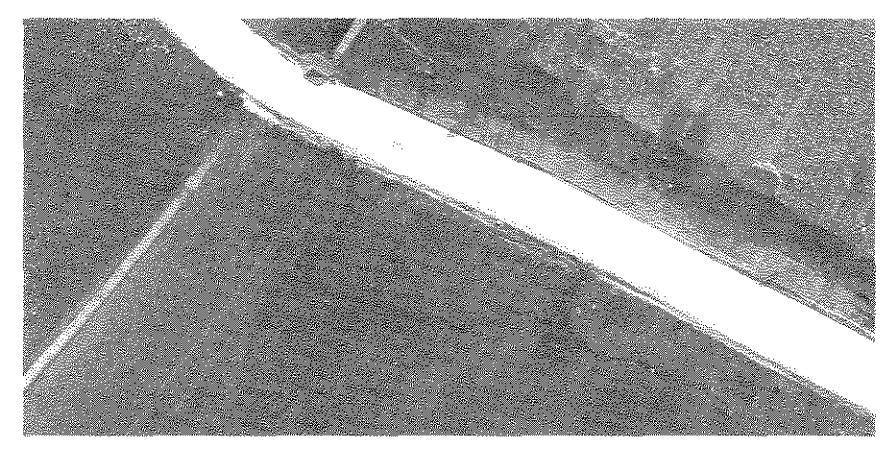
Minor cracking occurred at a number of locations on the faces of the slopes of the OII landfill, mainly but not exclusively at or near to the berm roads. Figure 6.67 is an air photo showing some of the cracks observed along the slope of the north face at the OII landfill three days after the earthquake. Figure 6.68 and 6.69 show typical cracks along the berm roads on the north face of the landfill. The cracks were generally on the order of 5 to 15 cm or less at their widest point, and post-earthquake trenching indicated that surficial cracks did not appear to extend fully through the soil cover system into the underlying waste at this landfill. The cracking of the stiffer compacted soil veneers overlying the more ductile waste fill and did not appear to represent any threat of incipient instability. However, cracking of the cover veneers can provide pathways for the

Fig. 6.67: Crack along north side slope near to a berm road at the OII Landfill

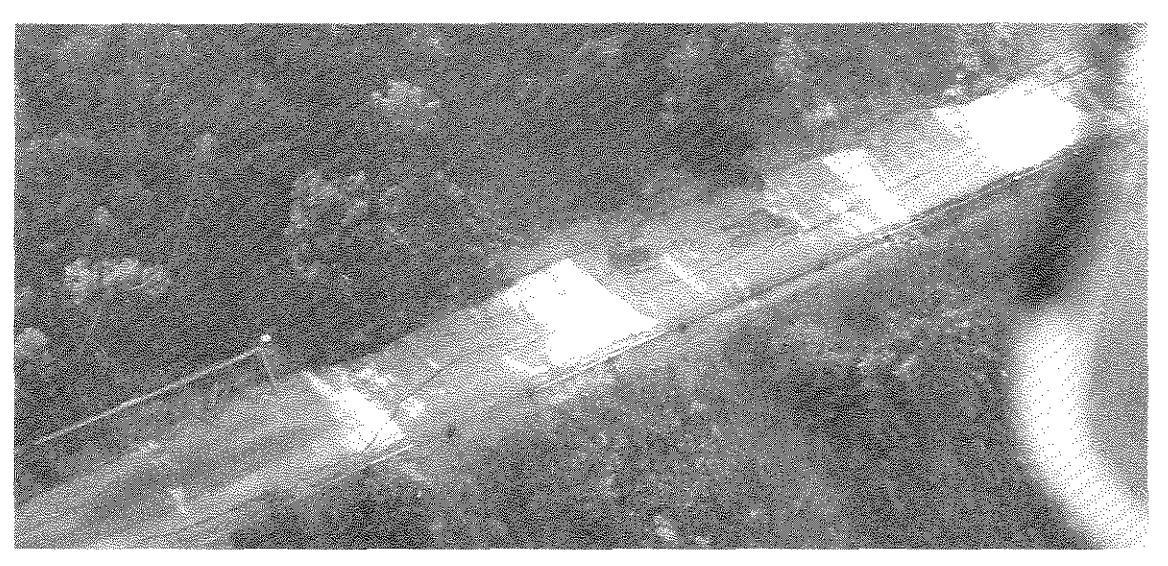
Fig. 6.68: Crack along berm road north side of the OII Landfill

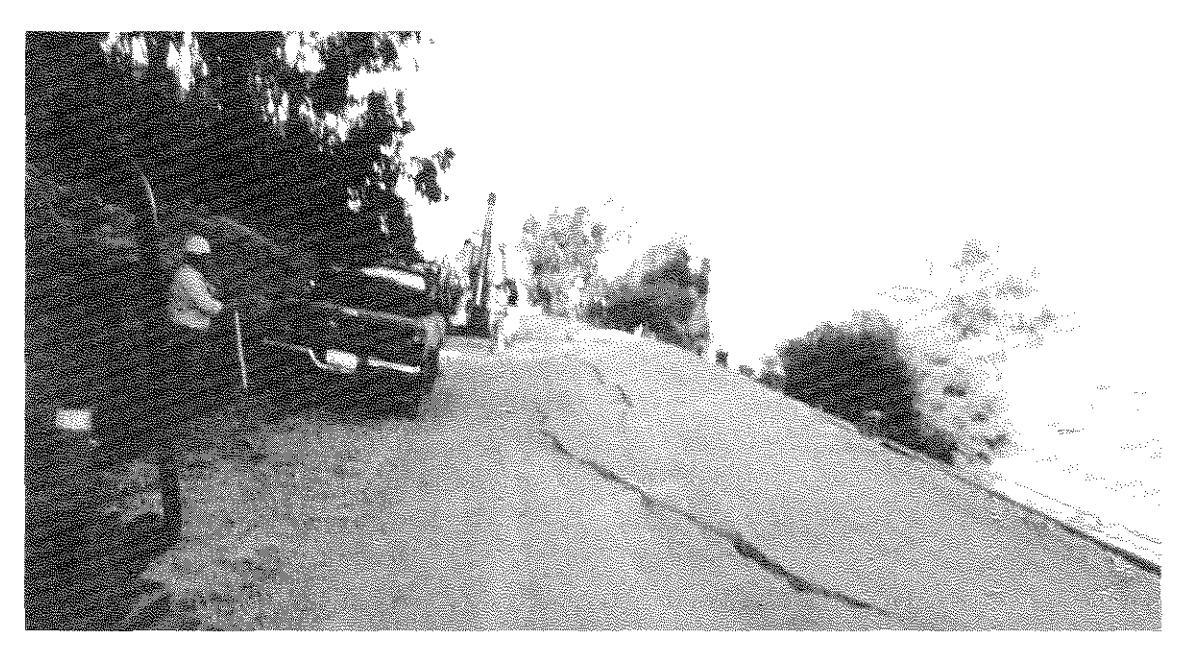
Fig. 6.69: Crack along berm road, north side of the OII landfill

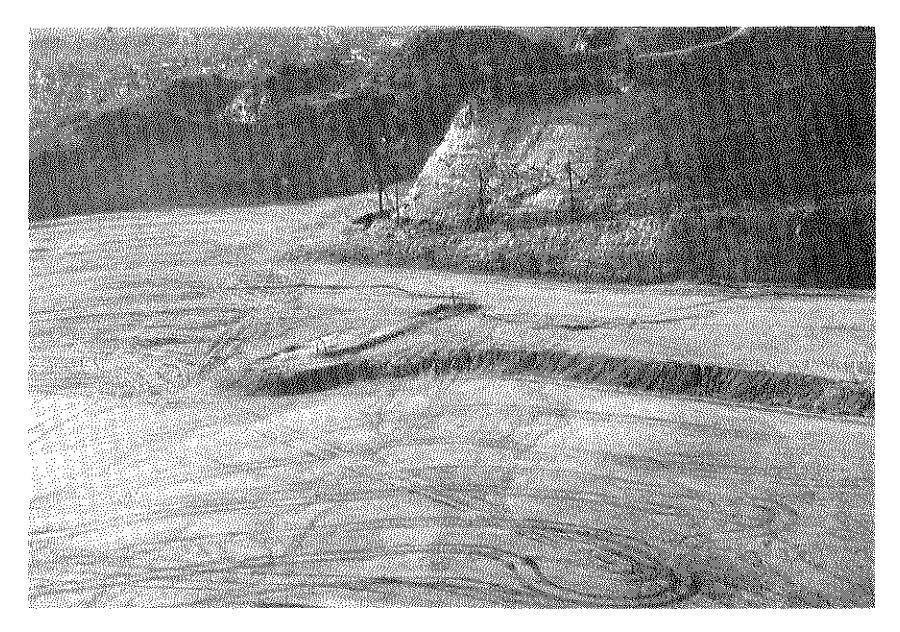
At the Sunshine Canyon site, longitudinal cracks were observed along the top of the waste fill along the interface with the natural canyon walls. The cracks varied from less than 2 cm to as much 30 cm wide, showing in some areas 15 to 30 cm of differential vertical offset. Figures 6.83, 6.84 and 6.85 show the cracking observed in the soil cover of the top deck at the western end of the Sunshine Canyon landfill after the earthquake. Figure 6.86 shows the crack in the soil cover in the center of the landfill near the water tank which was built on natural ground. This cracking did not appear to represent any threat of overall instability. It appeared instead to have been caused by settlement of the waste fill which occurred as a result of the earthquake shaking. However, it is difficult to differentiate cracking associated with ground shaking induced settlements from cracking at the back of the waste fill potentially resulting from limited downslope movement of waste along a failure plane. The landfill gas extraction system was temporarily shutdown due to a loss of power, and was restarted several days later.

Fig. 6.83: Air photo of crack along the top deck at the western end of the Sunshine Canyon Landfill

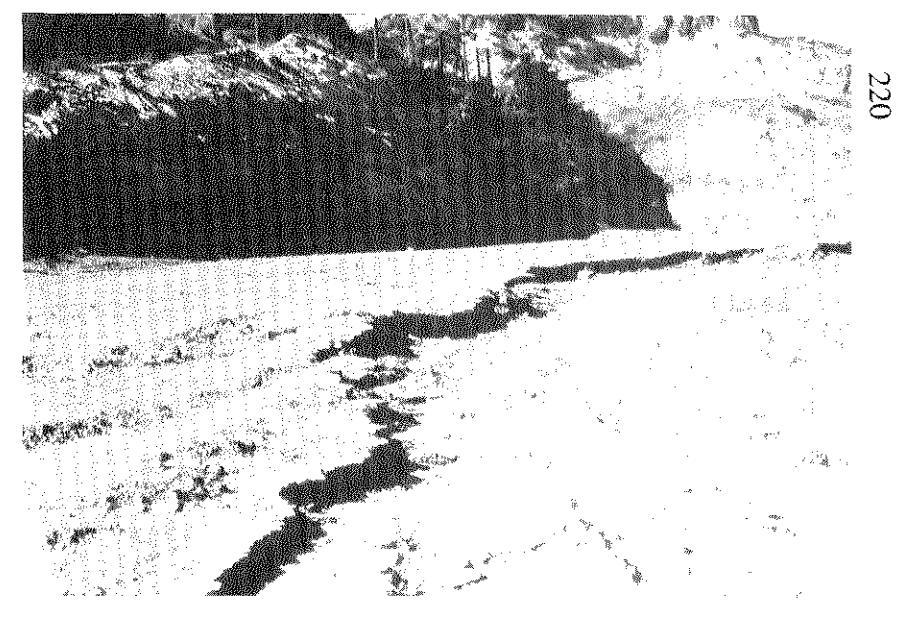
Fig. 6.84: Crack along the top deck at the western end of the Sunshine Canyon Landfill (photo courtesy of Calif. EPA, Integrated Waste Management Board)

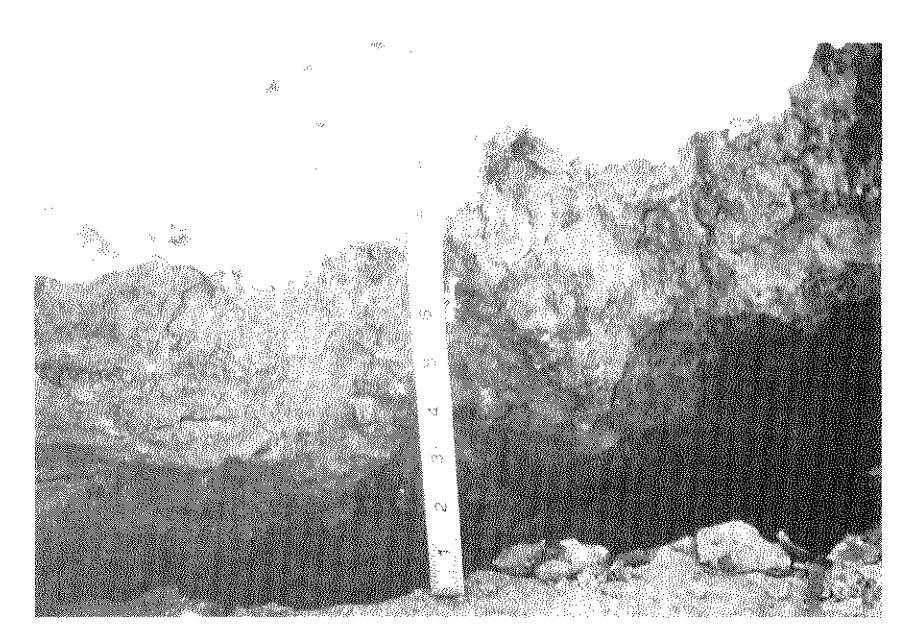
Fig. 6.85: Close-up of crack along the top deck at the western end of the Sunshine Canyon Landfill (photo courtesy of Calif, EPA, Integrated Waste Management Board)

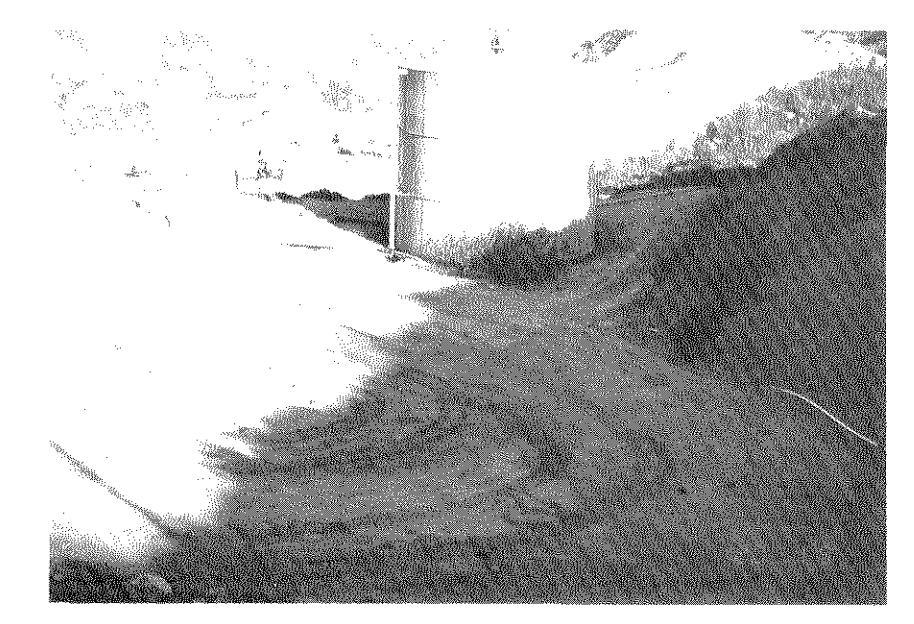
Fig. 6.86: Crack in the soil cover along the interface between the natural soil and the waste fill at the center of the Sunshine Canyon Landfill near the water tank

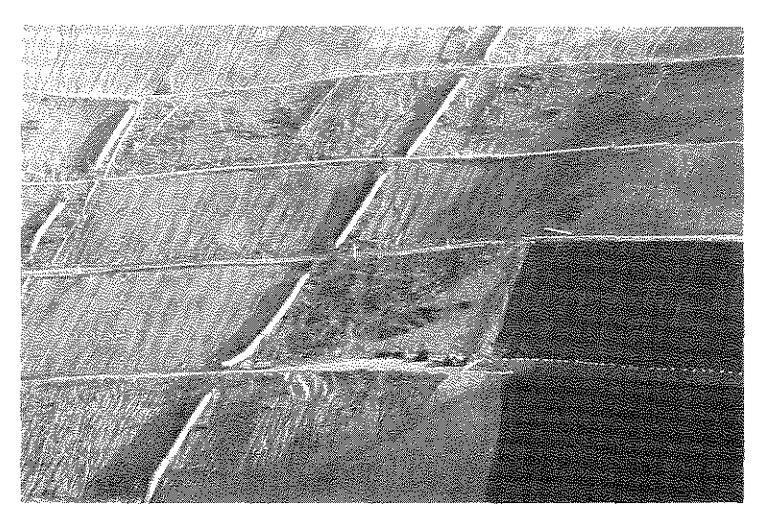
At Lopez Canyon, minor cracking was observed in the interim soil cover at the interface between the older unlined waste fills and the natural canyon slopes. Landfill slopes in the unlined landfill cells are approximately 90 m high with an average slope angle of 2H:1V and locally as steep as 1.75H:1V. Figure 6.90 shows the interface between the southeastern end of Area AB and the natural canyon wall where cracks were observed. The cracks in this area were minor, typically being on the order of 2-3 cm wide (Figure 6.91). The cracking in the interim cover soils appeared to be brittle cracking caused by the difference in the relative stiffnesses of the older waste fill areas and the canyon walls. There was no sign of permanent relative displacement between the waste fill and the subgrade in the newer geosynthetically lined areas. The 1 million gallon water tank visible in Figure 6.89 ruptured during the earthquake. However, the water, which probably drained slowly since the rupture could not be located, was removed by the surface water runoff collection system shown in Figures 6.89 and 6.90 without erosion of the interim cover system. The landfill also suffered minor damage to the surface gas extraction system which was quickly repaired.

Fig. 6.90: Photo of the interface between the waste fill of Disposal Area AB+ and the natural canyon walls where cracking was typically observed
