PRELIMINARY REPORT ON

THE PRINCIPAL GEOTECHNICAL ASPECTS OF

THE JANUARY 17, 1994 NORTHRIDGE EARTHQUAKE

Report No. UCB/EERC-94/08

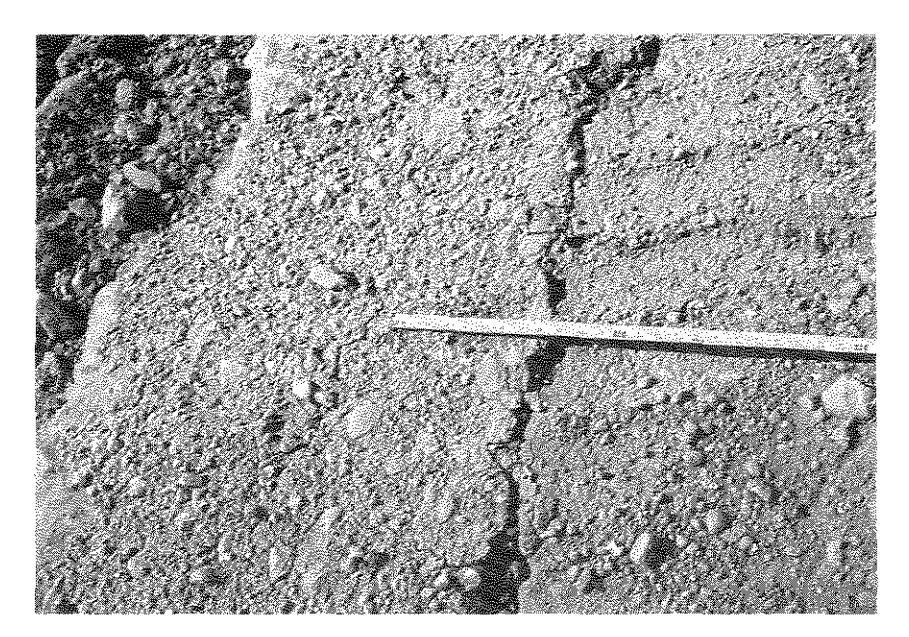
Fig. 6.91: Close-up of crack observed at the interface between the waste fill and the natural canyon walls
