# February 6, 2023 Türkiye Earthquakes: GEER Phase 3 Team Report on Selected Geotechnical Engineering Effects

GEER Association Report 082-S1

June 30, 2023

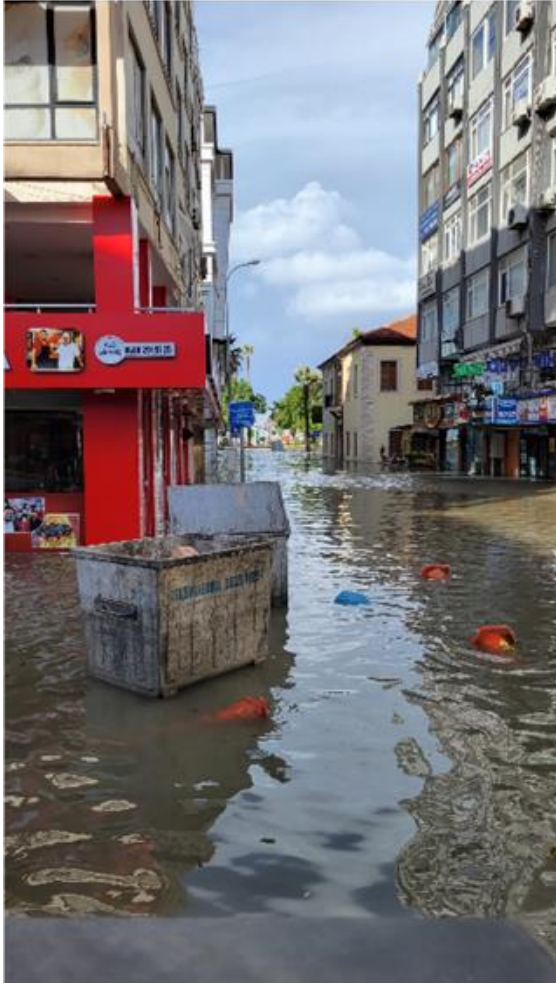
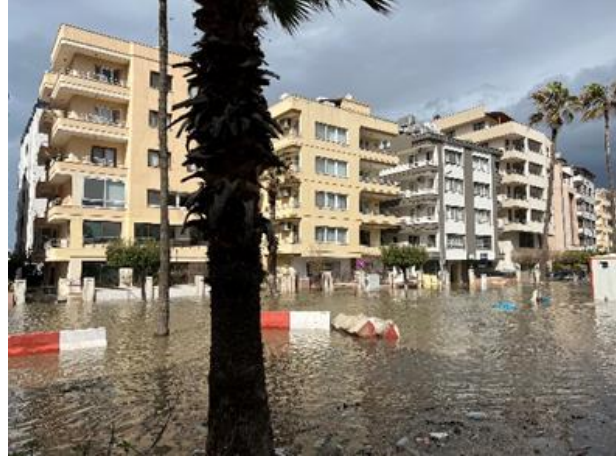
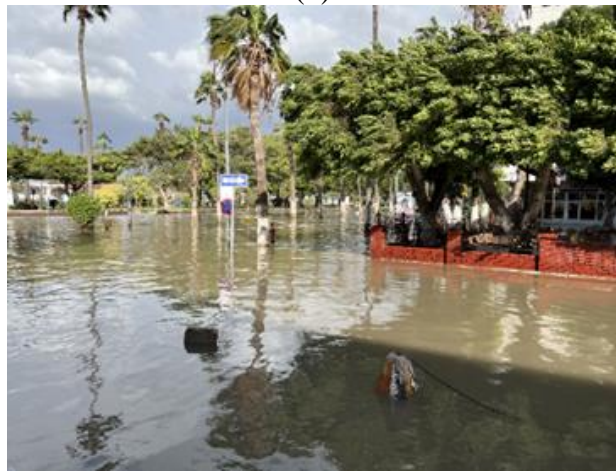
The GEER Phase 3 team observed notable flooding that took place on March 29, 2023 (Figure 2.4). On this day there was heavy rainfall and strong onshore winds in the İskenderun area. The flooding was observed from the Çay district and southeast along Atatürk Boulevard and the shoreline to past Mithatpaşa Street. The photos show that flooding advanced at least two roads in from the shoreline, including past Mareşal Fevzi Çakmak Street (Figure 2.4a), and past Bahçeli Sahil Evler Street (Figure 2.4b) in the Çay district. The team returned to İskenderun and Çay on April 1, 2023 when flooding had largely subsided, however, significant standing water remained. Drone footage taken on April 1 with observations of standing water in the Çay district is shown in Figure 2.5.

**Figure 2.4.** Flooding in İskenderun, Hatay: (a) (36.5912N, 36.1698E; 29MAR2023) flooding in a commercial district (b) (36.59102N, 36.1792E; 29MAR2023) flooding in the Çay district, (c) (36.5922N, 36.1687E; 29MAR2023) flooding of Atatürk Boulevard, near a commercial district.

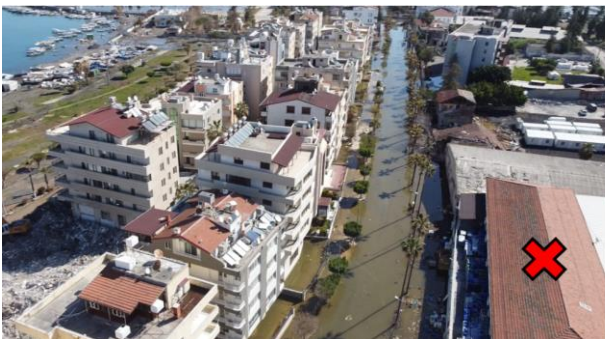
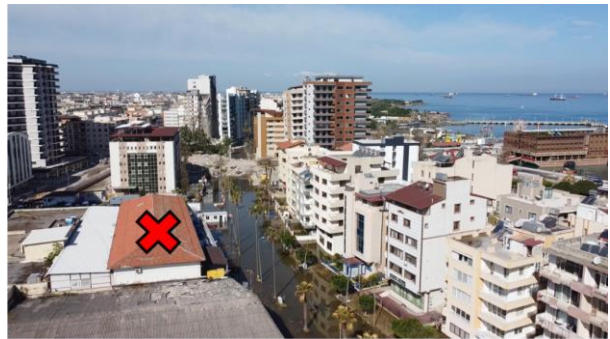
**Figure 2.5.** Remnant flooding in İskenderun, Hatay captured from drone footage on April 1, 2023. Red-roofed building marked with a red “X” for reference. (a) (approx. 36.5900N, 36.1773E) (b) (36.5901N, 36.1783E).

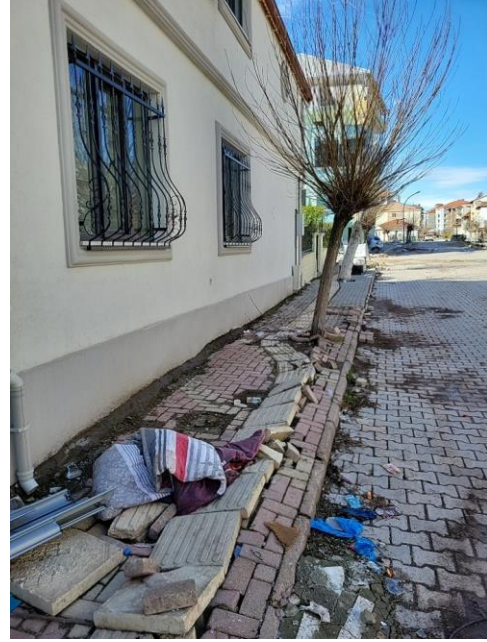
**Figure 2.6.** Reconnaissance photos in Gölbaşı, Adıyaman (a) (37.7874N, 37.6430E; 30MAR2023) building tilting and settlement, and road cracking, (b) ground and sidewalk disturbance (37.7979N, 37.6430E; 30MAR2023), and (c) ejecta (37.7877N, 37.6430E; 30MAR2023).

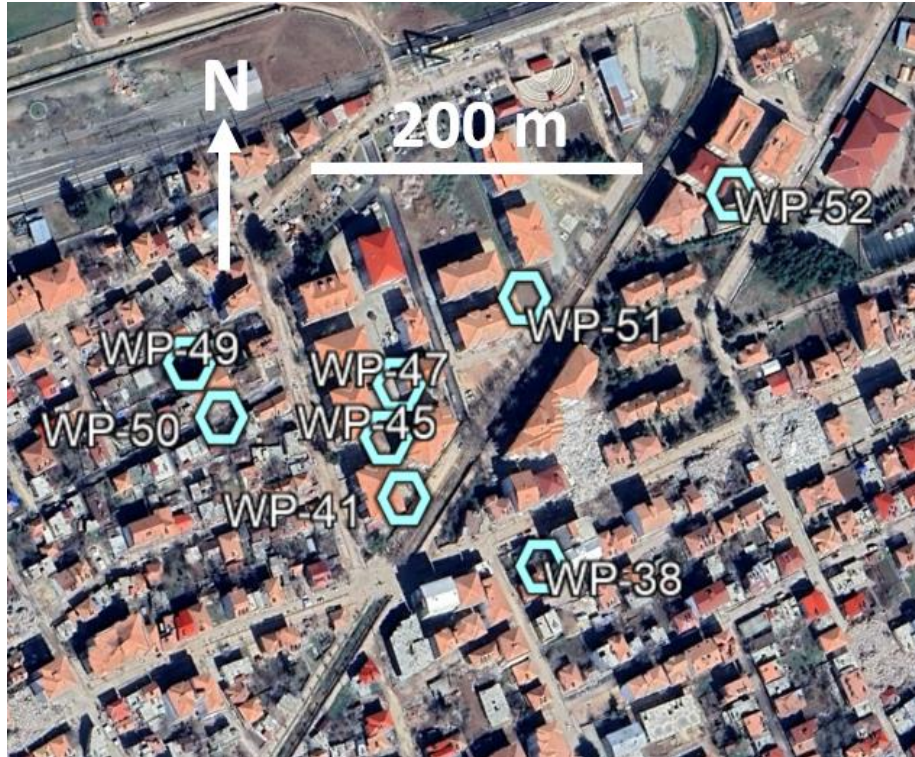
Eight samples of liquefaction ejecta were collected by the GEER Phase 3 team on March 30, 2023. The sample locations and sample numbers are indicated in Figure 2.7. The ejecta samples were characterized in the ZETAŞ geotechnical laboratory. The measured Atterberg Limits, fines content (percentage of sample by mass  $< 0.075$  mm), proportion of sand ( $\geq 0.075$  mm, and  $< 4.75$  mm), and gravel content ( $\geq 4.75$  mm) are summarized in Table 2.1. The measured plasticity index (PI) is between 9 and 14, with fines content between 18% and 52%. The METU team also collected samples of liquefaction ejecta in Gölbaşı during March 30, 2023 at similar locations. Their testing indicated PI values varying the range of 16 to 23, as shown in the parentheses in Table 2.1. Additional testing of ejecta samples will be performed to investigate the discrepancies in index values further. Moreover, as part of the follow up studies, intact samples are to be retrieved which will help more accurately identify the critical layers and sources of ejecta.

**Figure 2.7.** Locations and sample numbers of ejecta sampled in Golbaşı on 30MAR2023. Base image from Google Earth<sup>®</sup> dated 6MAR2023. Approximate center of the image is (37.7884N, 37.6428E).

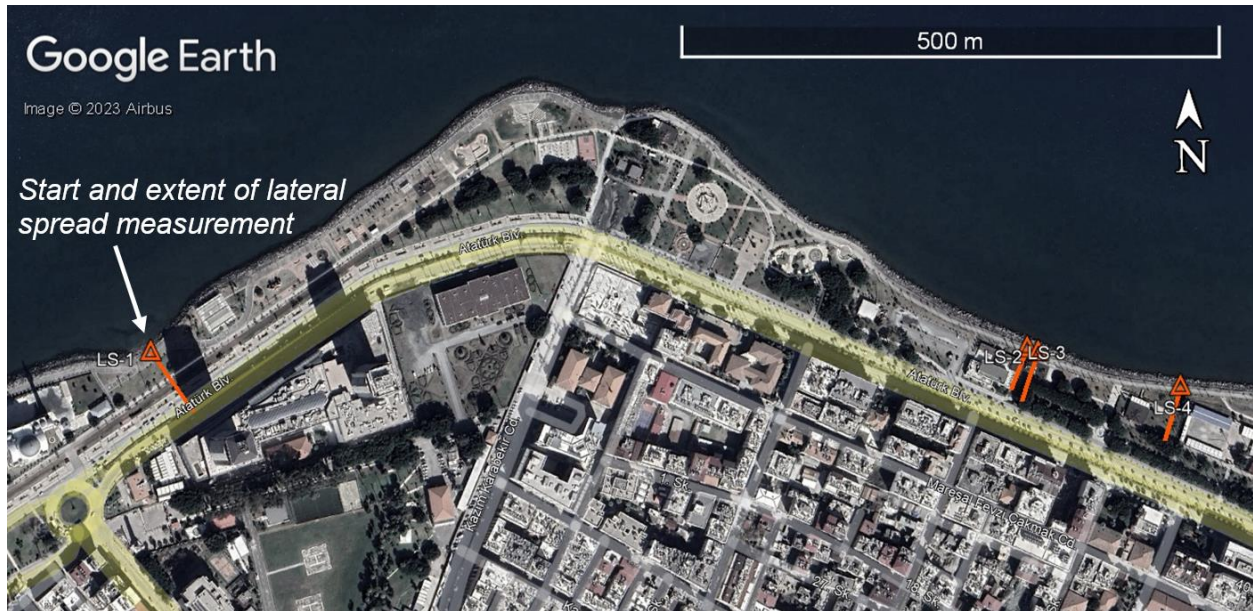
The GEER Phase 3 team obtained detailed measurements of lateral ground displacements at lateral spread sites along seven transects perpendicular to the İskenderun shoreline. Four of the transects labeled as LS-1 to LS-4 were taken directly from the waterfront and are documented herein. A map depicting the transect locations of LS-1 to LS-4 is presented in Figure 2.10 below. Three other transects labeled as LS-5 to LS-7 were taken in the Çay District near buildings with noticeable settlement and are presented in Section 2.2.2 of this report.

**Figure 2.10.** Map of measured lateral spread locations (LS-1 to -4) extending from the seawall in İskenderun, Hatay Province, Türkiye (Google Earth® image dated February 16, 2023, centered near 36.5928N, 36.1632E).

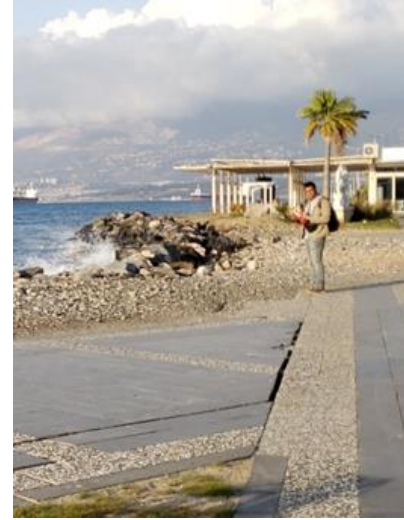
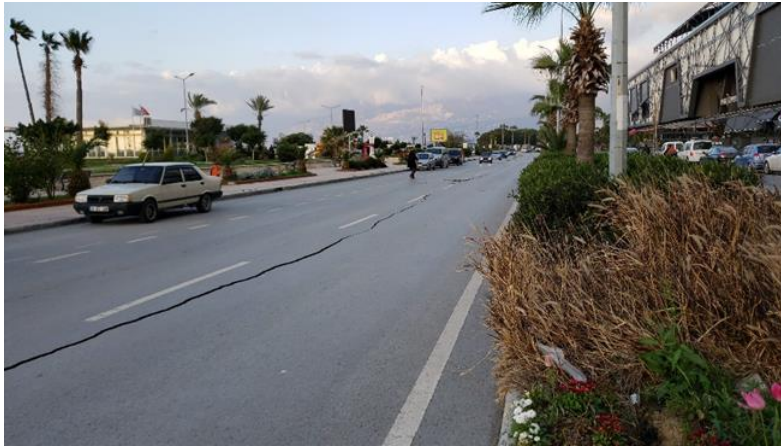
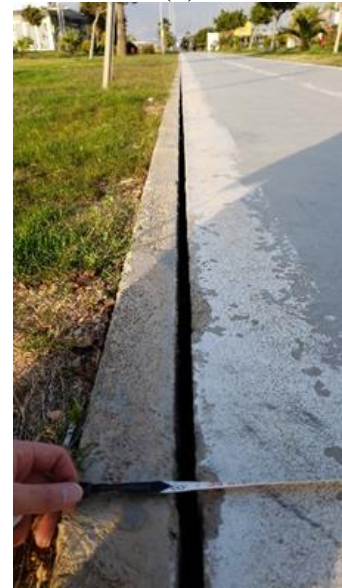
Figures 2.11 to 2.14 depict photos of each lateral spreading transect. LS-1 (start point: 36.59360N, 36.15846E) was taken about 100 m to the east of the Nihal Atakaş Camii mosque as depicted in Figures 2.11a-d. As observed from a series of past Google earth satellite images, the mosque appears to be built over recently infilled land, and construction was likely completed in 2018. However, the transect extends through previously existing ground along the shoreline. The transect starting point was taken at a rubble mound seawall that was observed to have a reduced height of 0.5 to 0.8 m relative to the seawall directly in front of the mosque (Figure 2.11a). The transect extended to the south end of Atatürk Blvd. Significant extensional cracks along the shoreside pedestrian path, grass field, and Atatürk Blvd were documented (Figure 2.11b-c), suggesting a total horizontal ground movement of about 54 cm. The overall extent of this spread to the south may have been constrained by the İskenderun Park Forbes AVM shopping mall.

**Figure 2.11.** Photos of lateral spread LS-1: (a) observed 0.5 to 0.8 m reduction in height of rubble mound seawall at start of LS-1 relative to infilled area of Nihal Atakaş Camii mosque (36.5936N, 36.1583E; 28MAR2023), (b) pavement tile separation near shorefront (36.5933N 36.1581E; 28MAR2023), (c) pavement crack extending along southwest bound portion of Atatürk Blvd (36.5930N, 36.1588E; 28MAR2023), and (d) separation between curb and bike lane (36.5934N, 36.1587E; 28MAR2023).

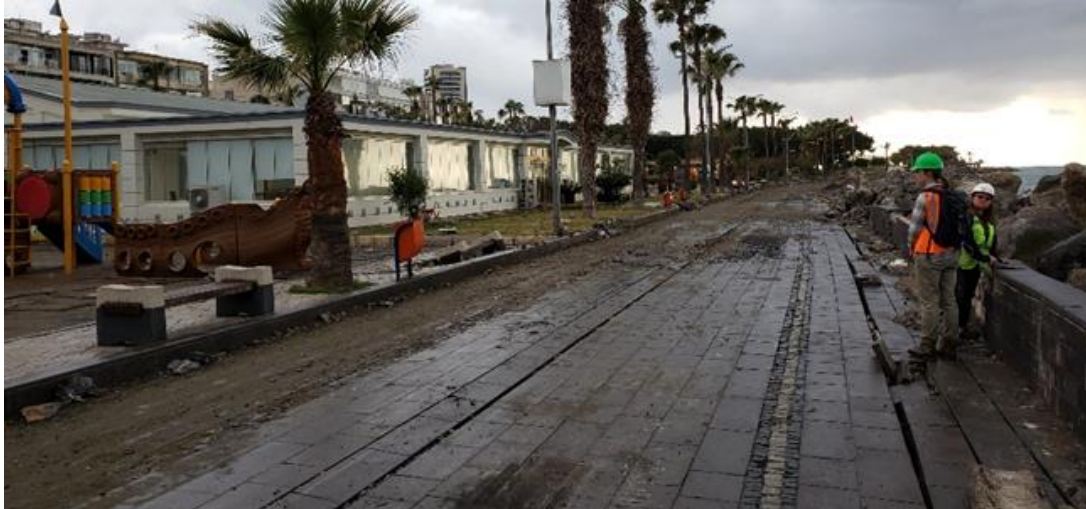
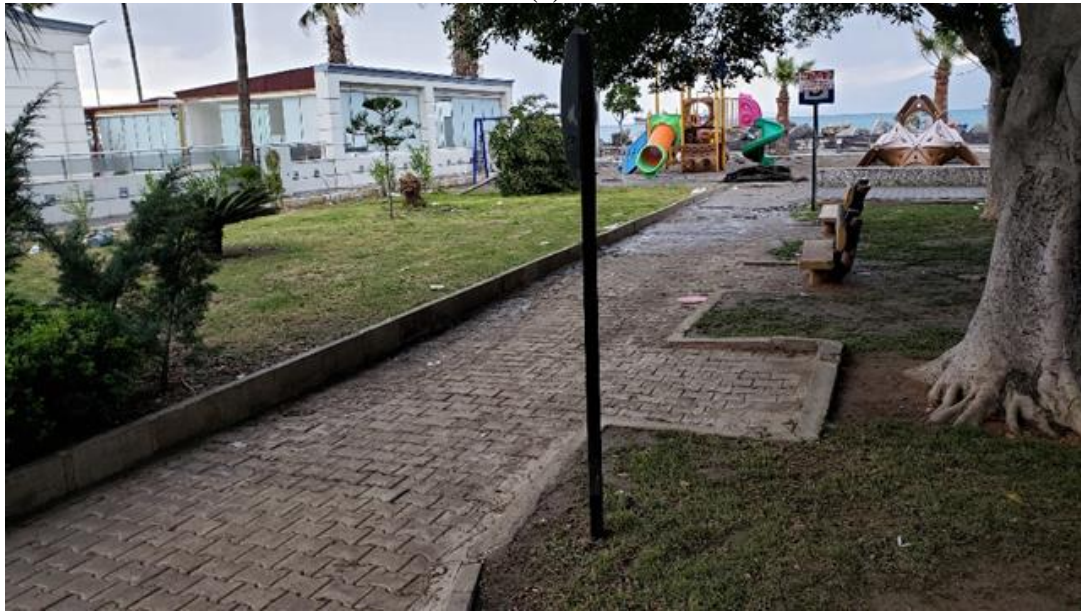
LS-3 (start point: 36.59355N, 36.16742E) was taken about 10 m to the east of LS-2, over a similar north to south extent, as depicted in Figures 2.13a-b. The purpose of this transect was to understand whether LS-2 was influenced by the structural performance of the patio foundation. The accumulated lateral spreading measured over LS-3 was about 72 cm and followed a consistent spreading trend with distance from the seawall as LS-2.

**Figure 2.13.** Photos of lateral spread LS-3 (10 m east of LS-2): (a) seawall at start of LS-3 (36.5934N, 36.1668E; 01APR2023), and (b) walkway at end of LS-3 (36.5931N, 36.1673E; 01APR2023).

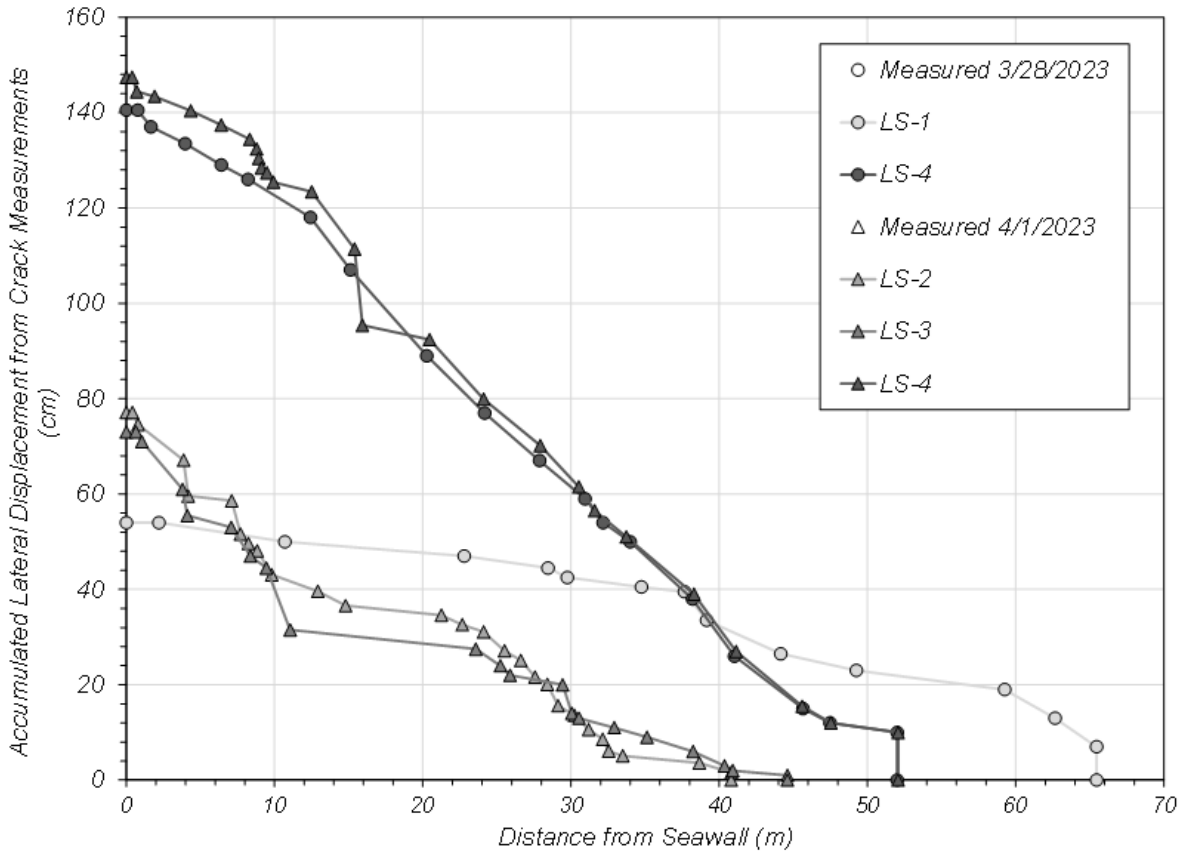
Figure 2.15 depicts the accumulated measured lateral displacement along each transect from the shoreline. The maximum lateral ground movements at the shoreline for these four transects varied from 50 to 150 cm. Lateral ground displacements could be observed up to distances of 40 to 65 m from the shoreline. It is of interest to note that the distribution of lateral ground movement with distance from the shoreline is generally constant over the length of each measured transect (i.e., the change in the accumulated lateral displacement over equal increments of distance from the seawall is relatively constant). However, the rate of change of the accumulated lateral displacement over equal increments of distance from the seawall of each of the transects varies.

**Figure 2.15.** Accumulated lateral displacements as measured from crack opening widths along LS-1 to LS-4 relative to distance from the seawall in İskenderun.

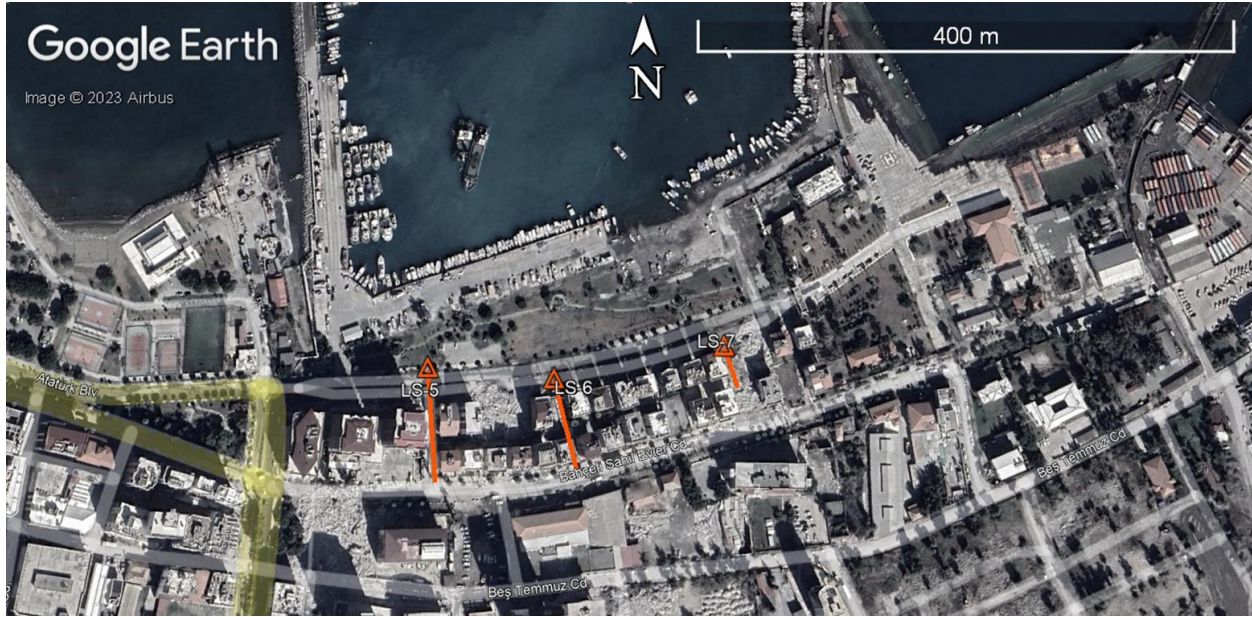
**Figure 2.16.** Map of measured lateral spread locations (LS-5 to LS-7) extending from Atatürk Boulevard in the Çay district of İskenderun, Hatay Province, Türkiye (Google Earth® image dated February 16, 2023, centered near 36.5906N, 36.1784E).

As depicted in Figure 2.16, transects LS-5 to LS-7 did not extend to the shoreline. This was due to the GEER team’s inability to access the boat dock, and the difficulty of detecting cracks within the adjacent grassy park that may have been obscured following recent floods. However, significant spreading likely occurred shoreward of the measured transects, as evidenced by ground cracks and preserved sand boils observed in the grassy park and extensional cracking observed along the perimeter of the boat dock as shown in Figure 2.17. The documented cracks were visible along the paved ground in the vicinity of the buildings of interest.

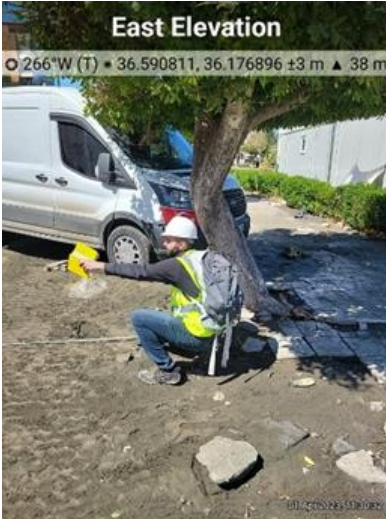
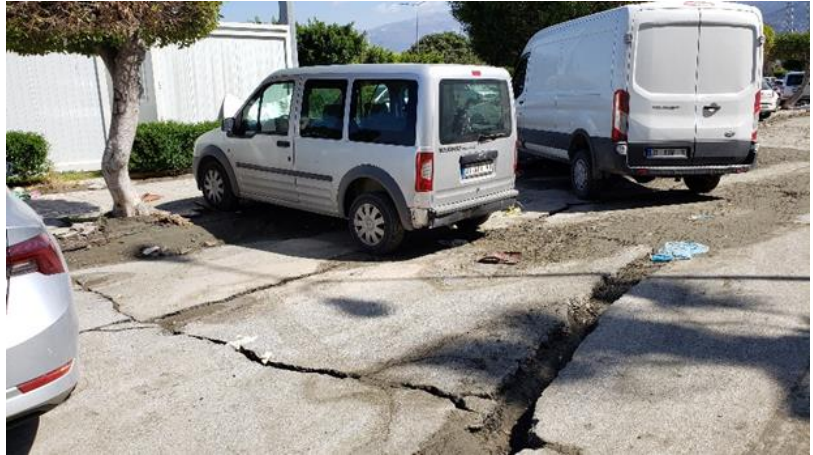
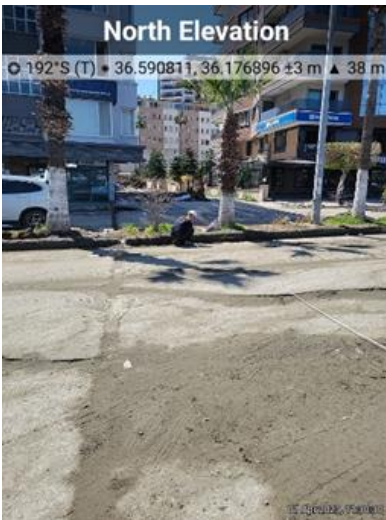
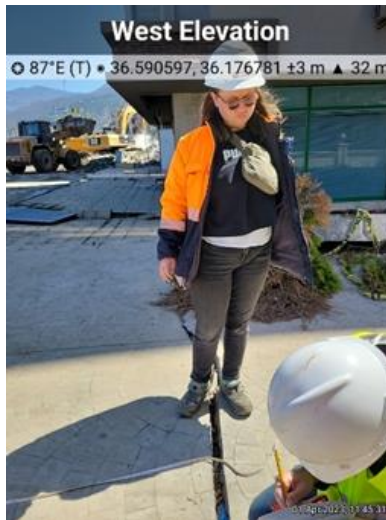
Figures 2.18 to 2.20 depict photos along each lateral spreading transect. LS-5 (start point: 36.59081N, 36.17679E) extended from the north side of Atatürk Blvd to Bahçeli Sahil Evler Street just south of the inspected block of 5-story buildings. Ground cracks observed along Atatürk Blvd were primarily oriented parallel to the shoreline, however, transverse cracking and the formation of separated blocks were also observed across the roadway (e.g., Figure 2.18a). South of Atatürk Boulevard, transect LS-5 extended along a paved path between a relatively stable 7-story building to the west, and the 5-story block of buildings that settled to the east. LS-6 (start point: 36.59073N, 36.17781E) extended from the south side of Atatürk Blvd to Bahçeli Sahil Evler Street. A majority of the transect was taken within the alley between the Pallet Hookah building and three 5-story buildings that had settled (Section 3.3.1f). LS-7 (start point: 36.59093N, 36.17918E) extended from the south side of Atatürk Blvd to the north edge of building No. 14 Bahçeli Sahil Evler Street and runs along the east side of the group of four buildings (Section 3.1.1g).

**Figure 2.18.** Photos of lateral spread LS-5 taken April 1, 2023: (a) start of LS-5 at north sidewalk curb along Atatürk Blvd (36.5908N, 36.1769E; 01APR2023), (b) separated pavement block with 3 to 6 cm of vertical displacement bounded by horizontal cracks of 10 to 20 cm along Atatürk Blvd (36.5908N, 36.1767E; 01APR2023), (c) cracks along Atatürk Blvd (36.5908N, 36.1769E; 01APR2023), (d) 5 cm crack aligned with front edge of building foundations along Atatürk Blvd (36.5906N, 36.1768E; 01APR2023), and (e) minor cracking along end of LS-5 (36.5903N, 36.1767E; 01APR2023).

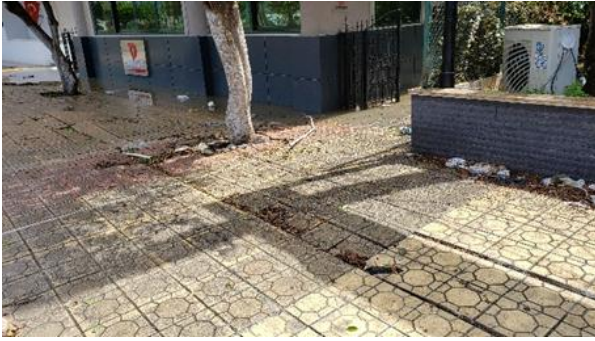
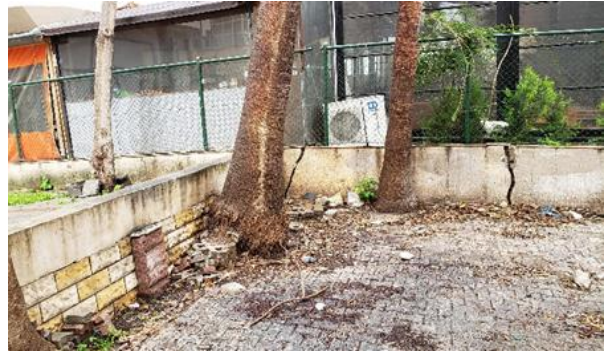
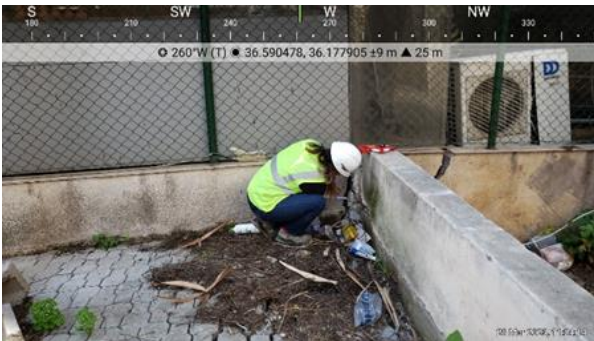
**Figure 2.19.** Photos of lateral spread LS-6: (a) start of LS-6 at south sidewalk along Atatürk Blvd in front of building Belli Apartment #18 (36.5907N, E36.1778E; 29MAR2023), (b) cracking along wall behind buildings (36.5904N, 36.1778E; 29MAR2023), (c) cracking along wall behind buildings (36.5905N, 36.1779E; 28MAR2023), and (d) end of LS-6 along the side of building Kaan Ela #24 (36.5905N, 36.1779E; 29MAR2023).

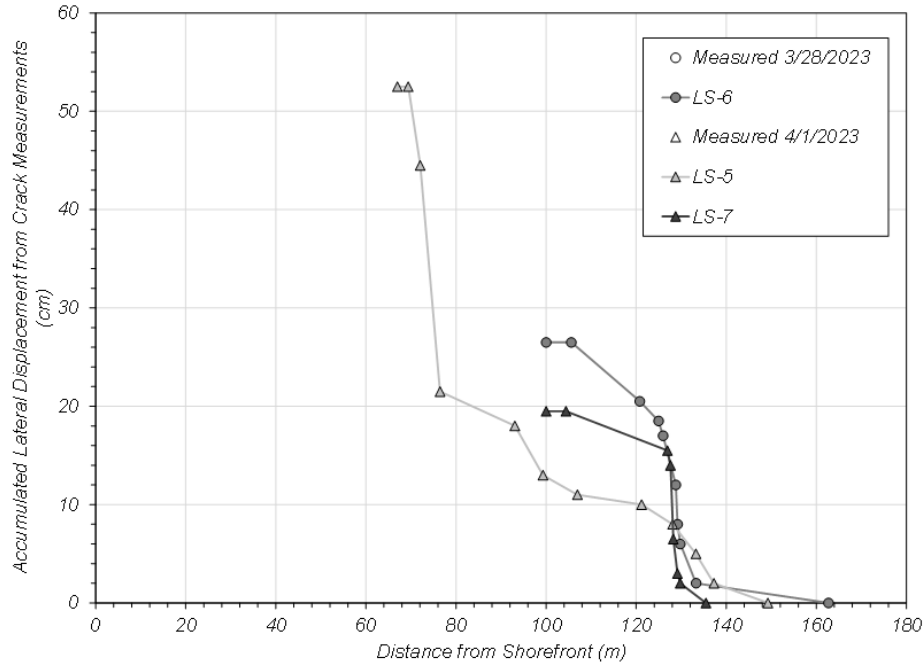
Figure 2.21 depicts the accumulated measured lateral displacement along each transect (i.e., y-axis) relative to their distance from the shoreline (i.e., x-axis). While the full extent of spreading between the shoreline and the buildings (i.e., between about  $x = 0$  and 100 m) could not be measured, it is believed to have been greater than 50 cm at all transects. Ground cracks were highly concentrated within the alley behind the two rows of 5-story buildings (i.e., between about  $x = 120$  and 140 m), suggesting over 20 cm of lateral extension in this area for LS-6 and LS-7. LS-5 depicted more gradual cracking along the building alley, which could potentially be attributed to the stable 7-story building redistributing the crack patterns in this area. With the current information, it remains difficult to speculate whether the cracks between buildings resulted from building settlement, overall seaward lateral spreading, or a combination of both mechanisms. Additional insights from remote sensing change detections, subsurface data, computational analyses, and other evaluations may help clarify the global picture of damage in this area.

**Figure 2.21.** Accumulated lateral displacements as measured from crack widths along LS-5 to LS-7 relative to distance from the approximate shorefront of the Çay district in İskenderun.

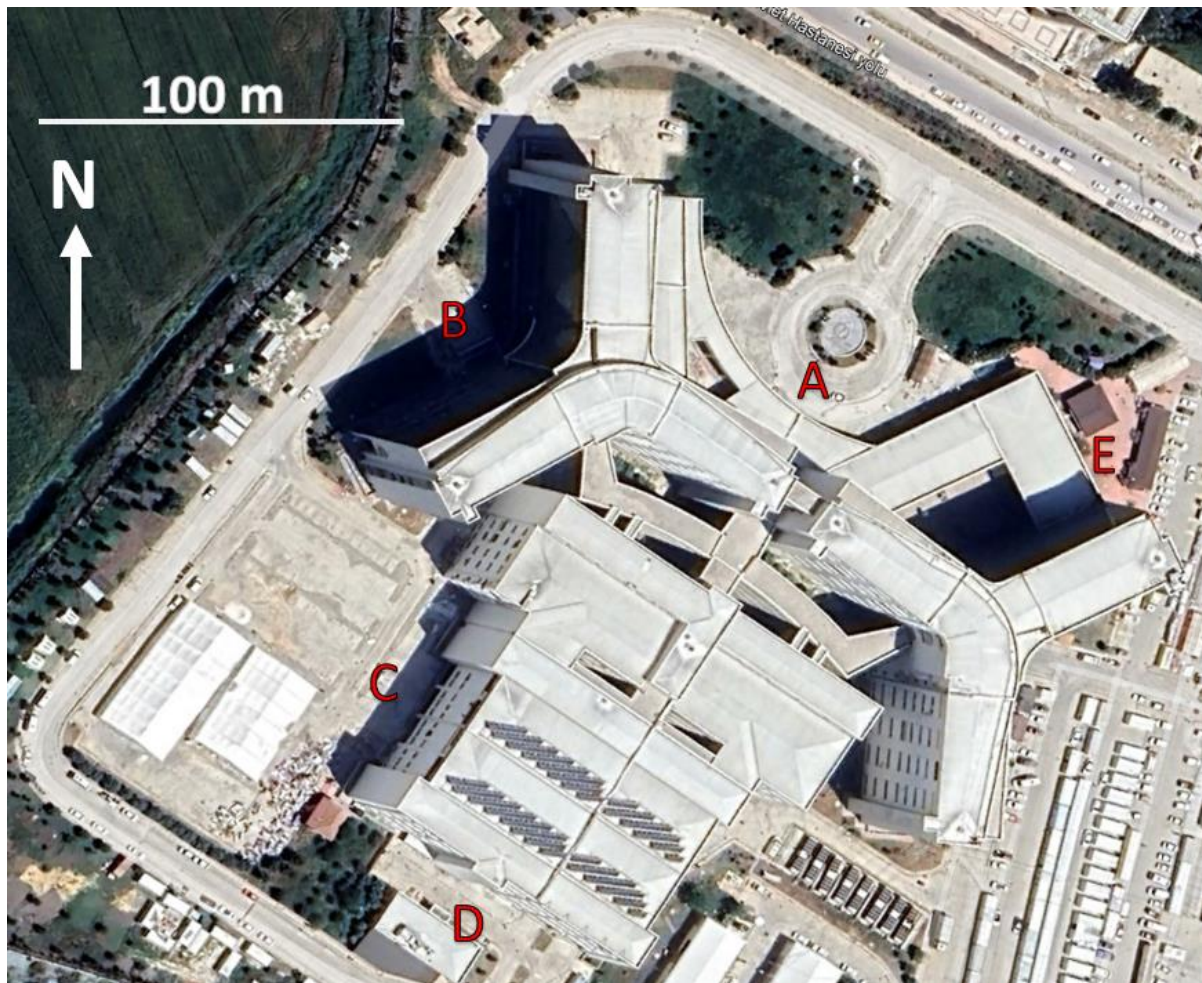
The hospital appears to be composed of several structures connected by walkways. Google earth images indicate that hospital construction started between 2013 and 2014. Reconnaissance included walking the perimeters of the hospital buildings and taking measurements and pictures to document fill settlement and other damage. The team did not enter the buildings. An aerial image of the hospital area is shown in Figure 2.22 with “A”, “B”, “C”, and “D” put on the photo to indicate areas being referenced in the reconnaissance description. The compacted earth fill settled relative to the hospital building throughout its perimeter, exceeding 48 cm in some areas. Some of the pipelines and utilities connected to the building were damaged due to this difference in settlement. Several of the entrances into the hospital structures were damaged due to the ground settlement, which limited access to and from the hospital. The hospital and surrounding parking lot and facilities appear to be built over compacted earth fill, due to their higher elevation than the

surrounding valley. It is believed that the hospital's foundation system extended to stronger material beneath the surrounding earth fill that settled, presumably due to earthquake shaking.

**Figure 2.22.** Aerial photo of the hospital perimeter surveyed for geotechnical damage. The approximate center of the image is (36.2700N, 36.2240E). Image dated 8MAY2023 and obtained from Google Earth<sup>®</sup>.

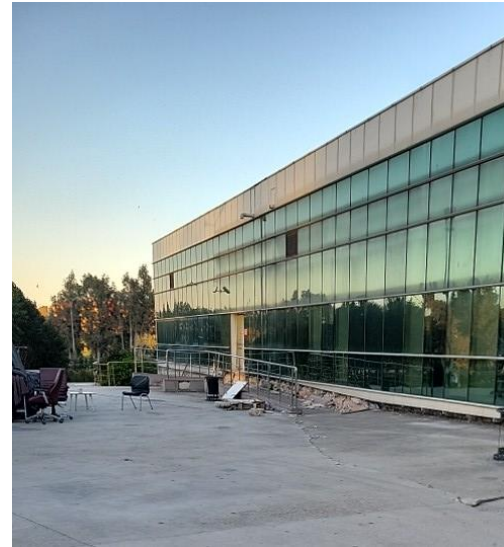
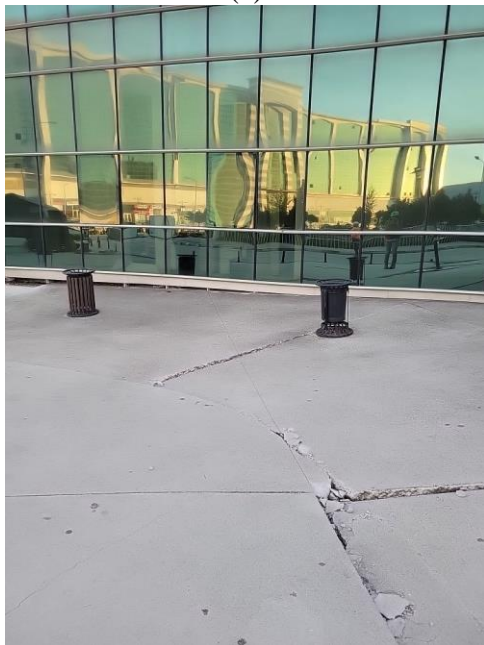
Area "A" is the north side of the north building and appeared to be the main hospital entrance. An overview of this area is shown in Figure 2.23a, including some pavement damage. Closer inspection of the ground close to the structure resulted in measurements of fill settlement from 0 cm to 48 cm. Figure 2.23b pictures an entrance ramp where 48 cm of fill settlement was measured between the entrance and the top of the ramp. Figure 2.23c pictures the ground near the base of the ramp where 0 cm to 18 cm of fill settlement was measured. Figure 2.23d shows another entrance where there was damage to the pavement and stairs.

**Figure 2.23.** Fill settlement on the north side of the main hospital building (area “A” in Figure 2.22): (a) overview of north-facing front of hospital showing some pavement damage (36.2709N, 36.2241E; 31MAR2023), (b) settlement of an entrance ramp about 48 cm relative to the structure and entrance (36.2705N, 36.2244E 31MAR2023), (c) 0 cm to 18 cm of fill settlement relative to the structure (36.2704N, 36.2245E, 31MAR2023), and (d) damage to pavement and stairs at an entrance (36.2709N, 36.2239E, 31MAR2023).

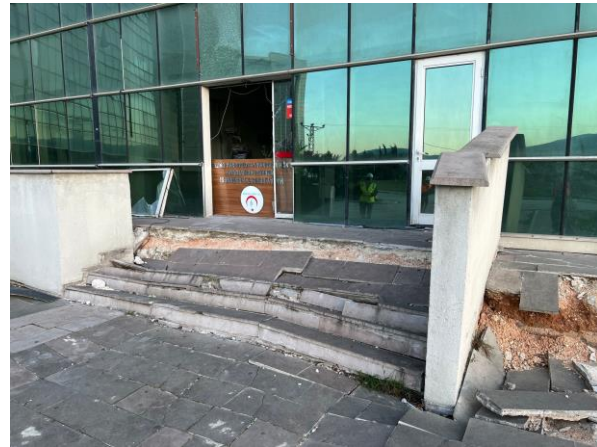
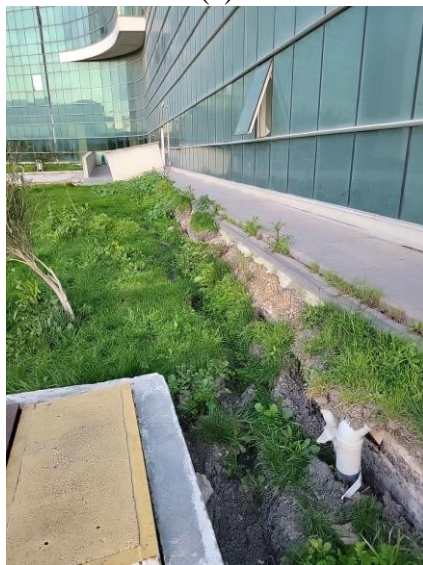
Area “B” is the west side of the north hospital building. Damage to utility connections, likely due to differential fill settlement, was also documented in this area. Figure 2.24a shows an overview of this area including an entrance and a landscaped area. Notable settlements and damage to stairs at the entrance was documented by the picture in Figure 2.24b. There were notable differences in settlement measured between the concrete and grass areas. These deformations also opened up a

gap between the concrete and grass areas, and exposed damaged utility connections (Figures 2.24c,d). The differences in settlement were measured to be 30 to 40 cm, and the opening between the concrete and grass was measured to be up to about 10 cm.

**Figure 2.24.** Fill settlement on the east side of the main hospital building (area “B” in Figure 2.22): (a) view of the east side (36.2711N, 36.2234E, 31MAR2023), (b) damage to entrance stairs (36.2707N, 36.2233E; 31MAR2023), (c) different settlements between the concrete and grass area exposing damaged utility connections (36.2704N, 36.2230E, 31MAR2023), and (d) different settlements between the concrete and grass area exposing utility connections (36.2704N, 36.2231E, 31MAR2023).

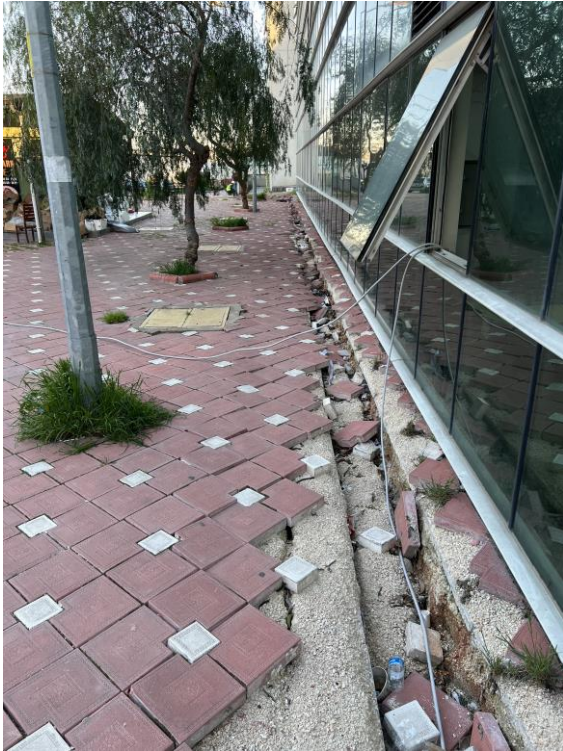
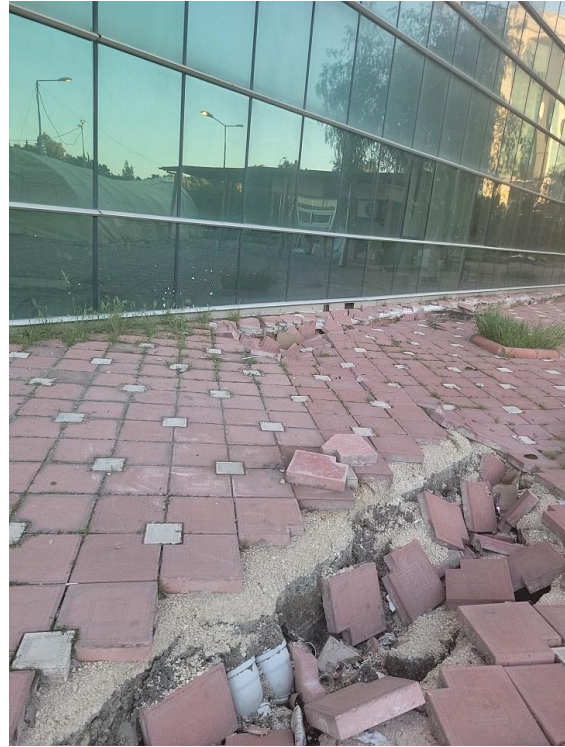
Area “E” is the west side of the northside hospital structures. The ground in this area is finished with paver tiles. Ground openings were measured in this area, with the opening at one point measured to be 32 cm wide, 47 cm deep and having 8 cm of settlement.

**Figure 2.27.** West side of the northside hospital structure (area “E” in Figure 2.22): (a) fill settlement along the structure (36.2706N, 36.2250E, 31MAR2023), (b) fill settlement and ground opening (36.2703N, 36.2252E, 31MAR2023).

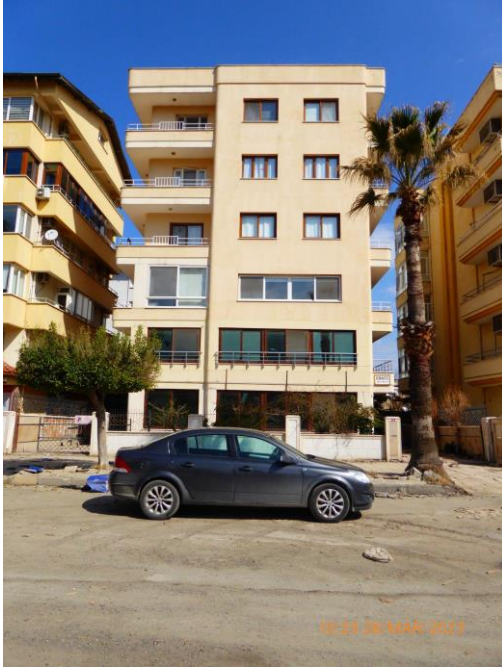
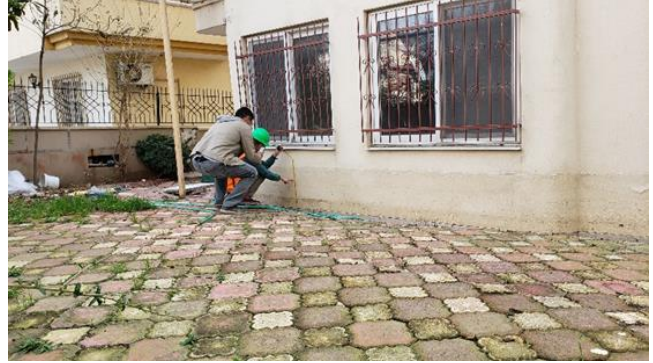
The residential apartment building No. 34 Ersoz located on Bahçeli Sahil Evler Street (36.5902N, 36.1772E) was surveyed on March 27, 2023. This building and the nearby Building No. 36 were surveyed previously by the GEER Phase 2 team. The street-view of Building No. 34 is shown in Figure 3.2a; a view of the rear of the building is shown in Figure 3.2b. There was minimal damage to the structure observed from the exterior. There was no apparent basement for the building. On the east side of the building, there is access to a sub-ground level electrical panel. An elevator is also present on the east side of the building. The estimated distance from ground level to the slab was 0.94 m based on access to the electrical panel room.

**Figure 3.2** İskenderun, Hatay. (a) (36.5900N, 36.1772E; 28MAR2023) building surveyed at Apt. No. 34 Ersoz on Bahçeli Sahil Evler Street, and (b) (36.59031N, 36.1771E; 27MAR2023) measurement performed on northeast building corner and showing ground deformation.

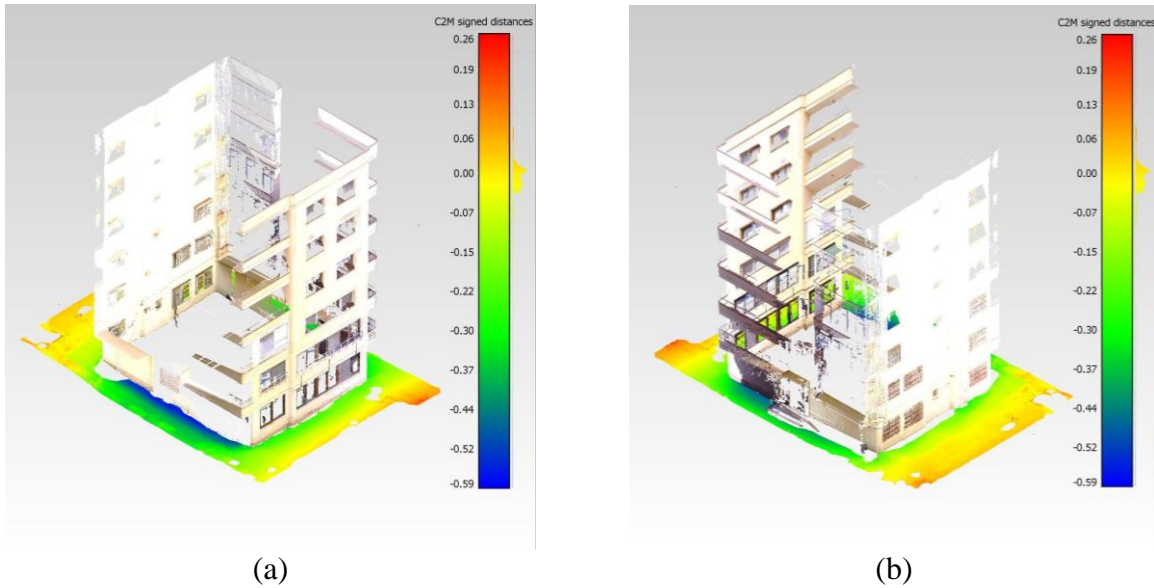
Lidar scans were performed at the four corners of the building. The scan numbers for this building are 284, 286, 288, 291, 294. An initial ground reference plane was fit to the site with a 1° slope from the rear (north) to front (south) of the building. Vertical ground displacements relative to this reference plane are shown in Figure 3.3 with a view from the SW corner (Figure 3.3a) and the NE corner (Figure 3.3b) of the building. The lidar scans were also used to estimate building settlements, which are summarized in Figure 3.4. Figure 3.4 also shows the hand-survey laser-level-measured settlements, which are relative to a single datum; however, there were challenges in tying the settlement measurements at the four corners of the building into a single datum. Thus, the lidar-scan measurements are judged to be more reliable. The average building settlement is 40 cm as estimated by the lidar data.

**Figure 3.3.** Lidar data from scans no. 284, 286, 288, 291, and 294 of Apt. No. 34 Ersoz showing ground settlement relative to a reference plane that dips  $1^\circ$  from the rear to the front of the building. The color scale on the pictures represents the ground settlement in meters relative to the site reference plane. (a) view of the southwest corner, and (b) view of the northeast corner.

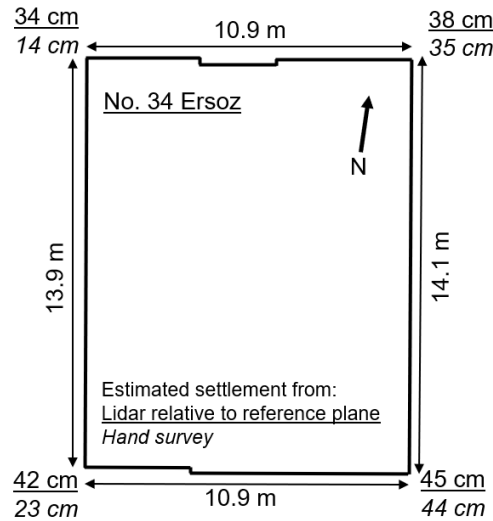
**Figure 3.4.** Dimensions of the footprint of Apt. No. 34 Ersoz in the Çay district, and the estimated building settlements at each building corner. Settlements were estimated from lidar scans (top #) and hand surveys with laser level (bottom #).

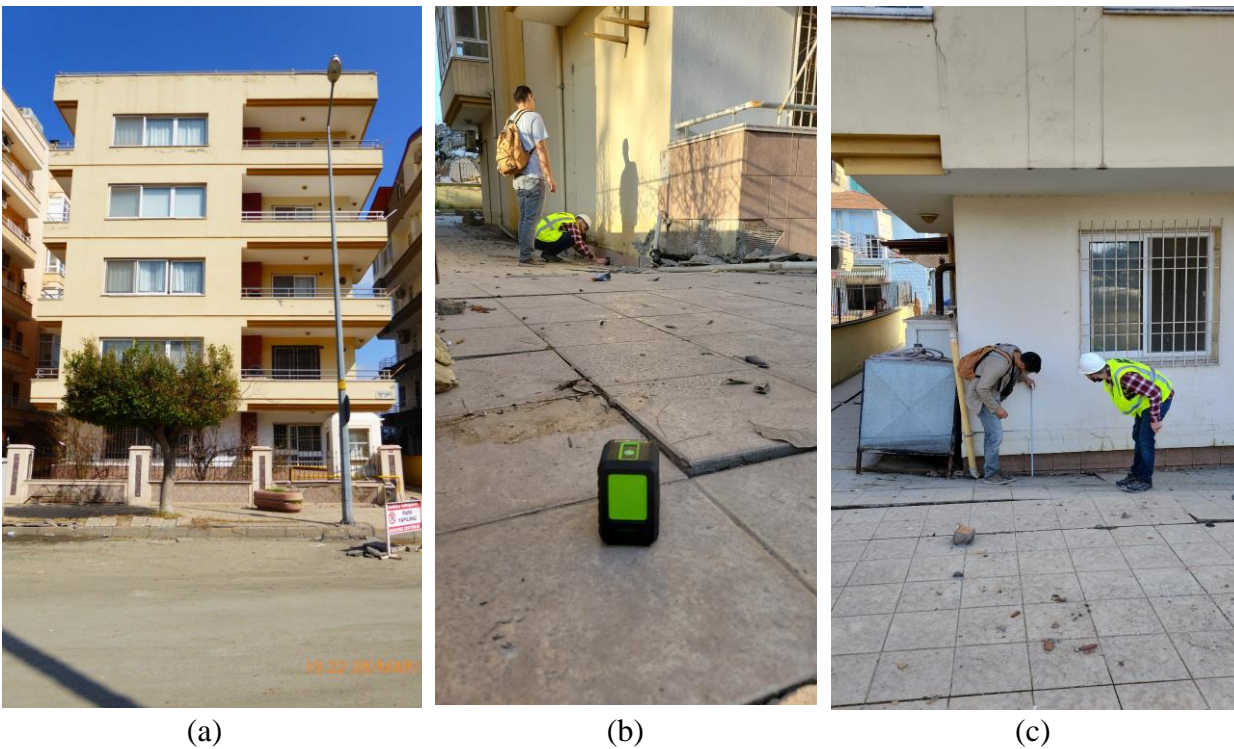
**Figure 3.5.** (a) (36.5898N, 36.1769E; 28MAR2023) Apt No. 32 Yenerer in Çay district, İskenderun, (b) (36.5901N, 36.1772E; 27MAR2023) view from the southwest corner showing laser level device used to make hand-survey measurements, (c) (36.5903N 36.1774E; 27MAR2023) hand survey at the northeast building corner.

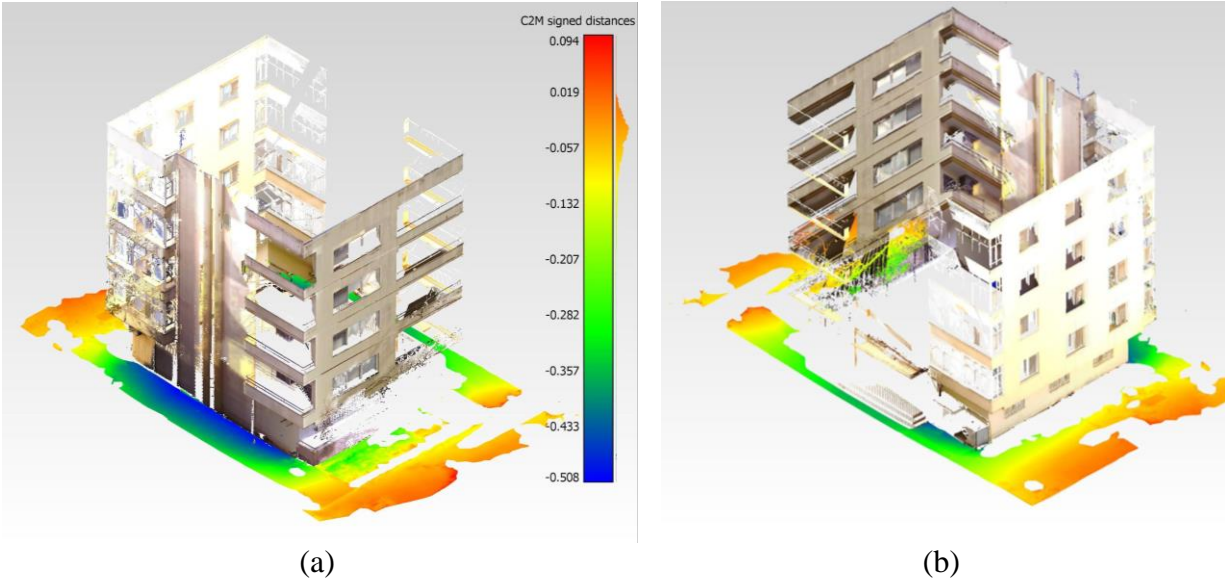
Three lidar scans were performed at the building (no. 295, 296, and 298). In addition, scan numbers 286, 288, and 291 from No. 34 captured the ground or structure at No. 32 and were also used. Building settlements were estimated with lidar data relative to an estimated initial reference plane that dips  $0.40^\circ$  from the rear of the lot (north side) to the front of the lot (south side); this reference plane was fit to ground elevations at the site. The ground contours relative to the reference plane and building scan are shown in Figure 3.6. Figure 3.7 shows the building dimensions and estimated settlements from lidar scans and hand surveys. Note that hand-survey laser-level measurements of building settlement were difficult to implement at this building due to uneven settlement of the surrounding ground, and therefore are only provided for one building corner. Based on lidar data, the average building settlement is 50 cm.

**Figure 3.6.** Lidar scan data (from scans no. 295, 296, 298, 286, 288, and 291) showing ground deformations relative to an estimated pre-earthquake reference plane from lidar scans at Apt. No. 32 Yenerer. The color scale on the pictures represents the ground settlement in meters relative to the site reference plane. (a) view of the southwest corner, (b) view of the northeast corner.

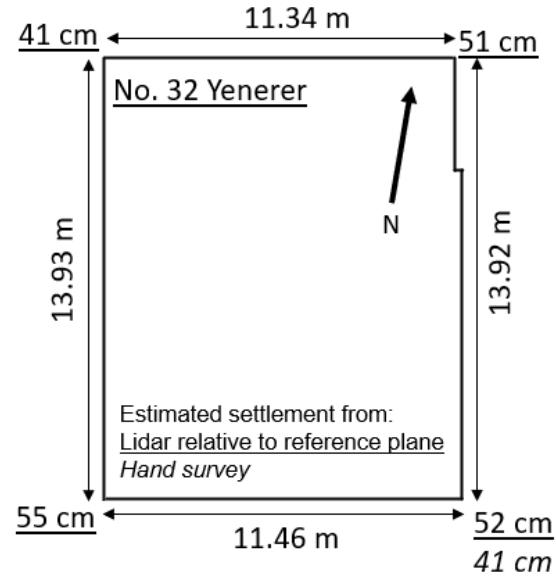
**Figure 3.7.** Dimensions and building settlement, estimated from LiDAR scans at Apt. No. 32 Yenerer.

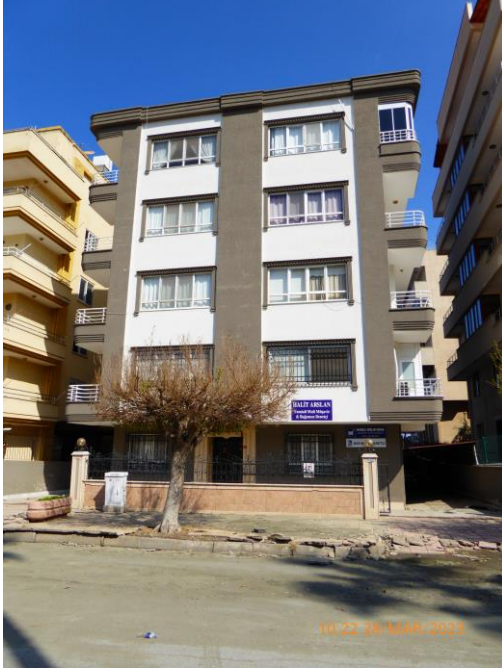
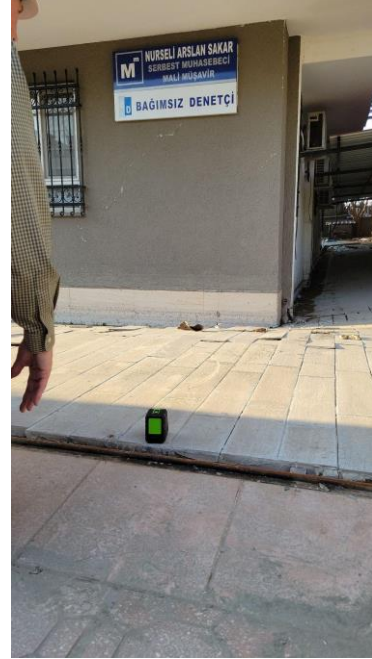
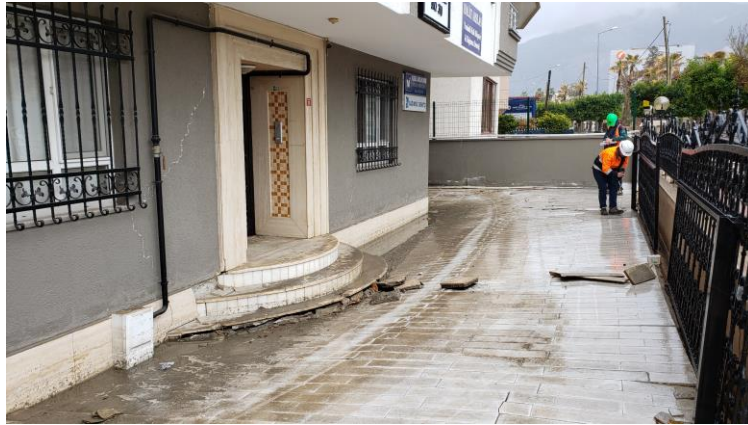
The owner of the adjacent building (Apt. No. 28), named Ahmet Palalıođlu, reported that the building has a 3 m deep half-basement. A basement full of water was observed on the west side of the building on March 29, 2023. No basement windows were observed on the east side of the building. Mr. Palalıođlu also noted that soil sloughing occurred during excavation for the building, which was mitigated with a sheet pile retaining wall. Some cracking on the building exterior was observed to the south side of the building, as shown in Figures 3.8b,c.

**Figure 3.8.** Surveyed building in the Çay district, Apt. No. 30 UYGAR A.P. (a) (36.5900N, 36.1776E; 28MAR2023), (b) (36.5901N, 36.1776E; 27MAR2023) view of the southeast corner of the building, and (c) southside of the building (36.5901N, 36.1774E; 29MAR2023).
