# February 6, 2023 Türkiye Earthquakes: GEER Phase 3 Team Report on Selected Geotechnical Engineering Effects

GEER Association Report 082-S1

June 30, 2023

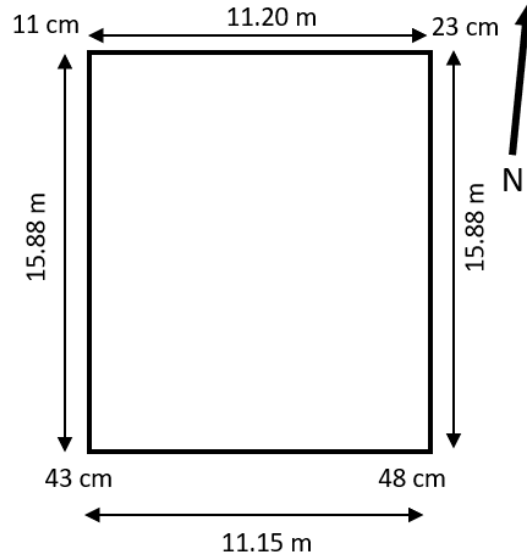
Building settlement at the building corners and the building dimensions were obtained from hand surveys with a laser level; these estimates are summarized in Figure 3.9. The building settlement is estimated to be 11 cm, 23 cm, 48 cm, and 43 cm at the northwest, northeast, southeast, and southwest corners, respectively. These settlements are relative to a reference point at the southeast corner of the property, shown in Figure 3.8b. The settlement of 11 cm at the northwest corner of the building is judged to be less reliable because it was difficult to tie-in the laser-level vertical measurement at the northwest corner of the building with the reference point at the southwest corner of the property. Note that these measurements are not corrected for any initial grade of the ground.

**Figure 3.9.** Schematic of hand survey measurements of building settlement using a laser level device at Apt. No. 30. Northwest building settlement estimate is less reliable than other measurements.

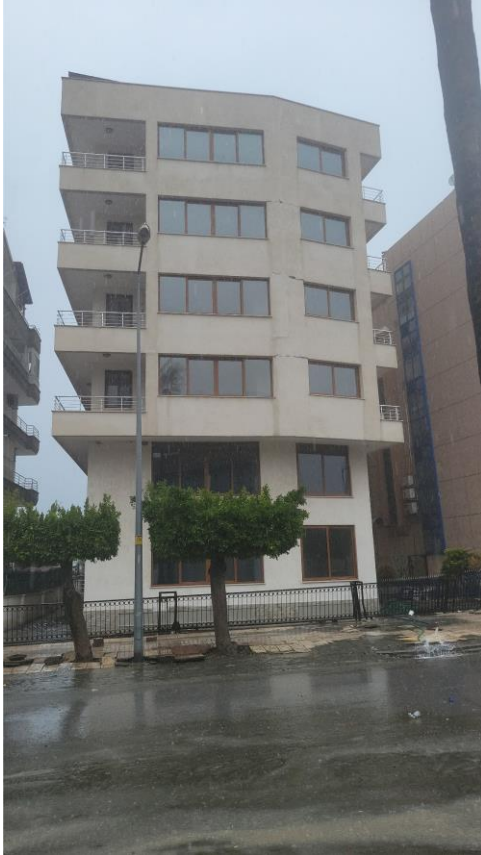
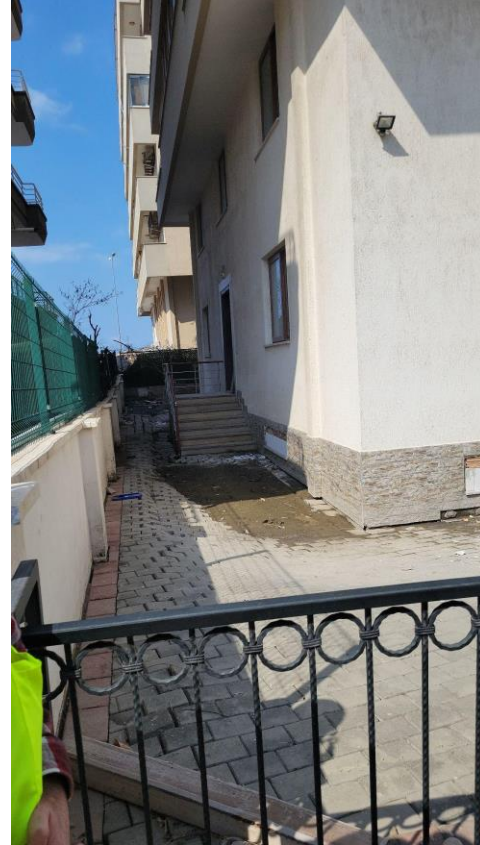
The No. 28 apartment building on Bahçeli Sahil Evler Street (36.5902N, 36.1777E) is a 6-story residential building, approximately 19.9 m high. The street view of the building is shown in Figure 3.10a. The building owner, Ahmet Palalıoğlu, reported that the building has a full, 2.8 m deep basement with a 40 cm thick reinforced concrete foundation and the foundation laterally extended 1.5 m around the footprint of the building. Mr. Palalıoğlu also reported that building construction was completed in 2016. Mr. Palalıoğlu reported that regular flooding was occurring in the neighborhood after the 2023 earthquakes. Consequently, he was pumping water from the basement and sealing off the windows to the basement while the GEER Phase 3 team was surveying the building on March 29, 2023. Notable building settlement occurred at this site; the ground deformation pattern is visually evident from the ground pavers in Figure 3.10b.

**Figure 3.10.** Apt. No. 28 on Bahçeli Sahil Evler Street in Çay district, İskenderun, and (b) (36.5900N, 36.1777E) showing ground settlement from the south-west corner of the building.

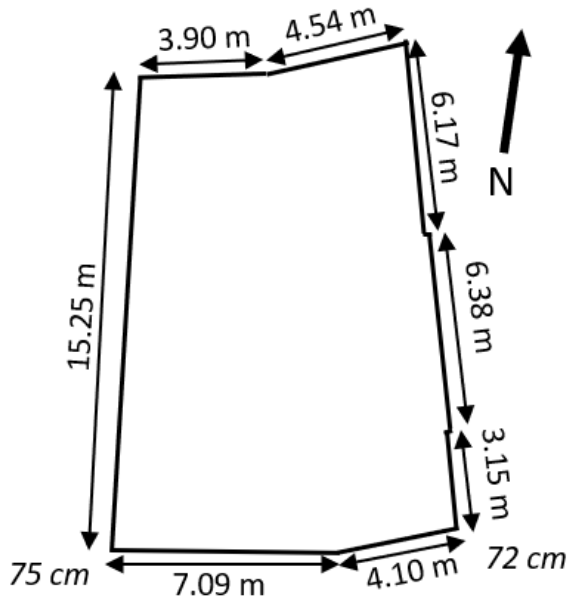
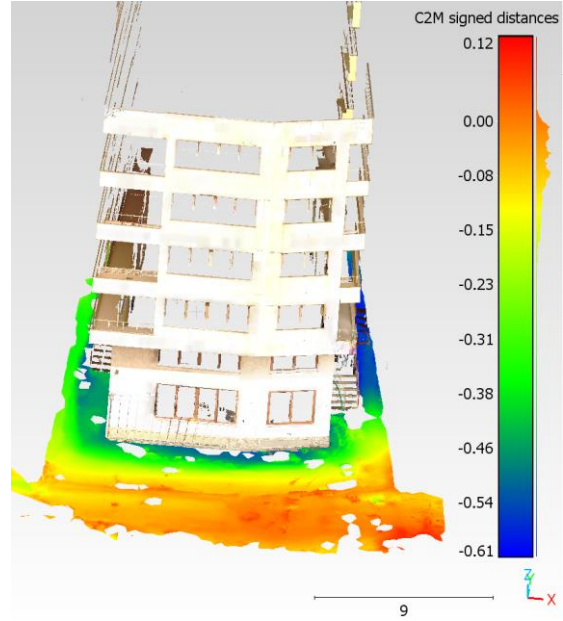
The building settlements were estimated from lidar scans. One lidar scan was performed at the southwest corner of the building (no. 300) and two scans were performed at the southeast corner (no. 302 and no. 304). An additional scan (no. 303) was performed at the northeast corner, however, it requires additional processing and is not included in the presented survey. The building dimensions and lidar scan data are summarized in Figure 3.11. Building settlements were estimated at the two south corners of the building to be 75 cm and 72 cm for the southwest and southeast corners, respectively. Note that these settlements are relative to a reference point on the ground near the property fence, and are not corrected for any initial grade, although Mr. Palalıoğlu confirmed that the ground did originally slope away from the building. The pattern of ground deformation around the building is shown by the lidar ground contours in Figure 3.11b; these

ground contours summarize the ground settlement below the assumed initial ground level. The ground deformation pattern appears to be consistent with the foundation extending around the building footprint.

**Figure 3.11.** Apt. No. 28 on Bahçeli Sahil Evler Street. (a) settlements and dimensions estimated from lidar scans, and (b) ground deformations from lidar scan data (scans 302, 303, and 304); the color scale on the picture represents the ground settlement in meters relative to the assumed site reference level.

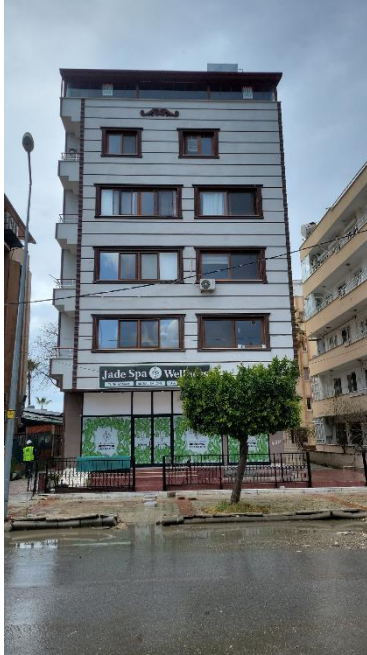
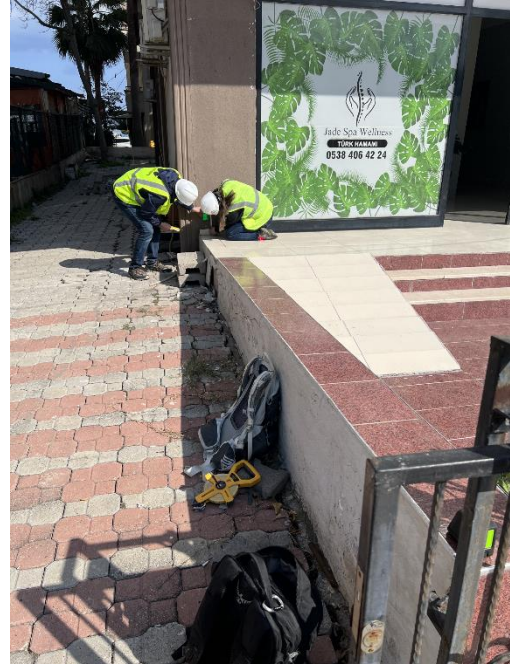
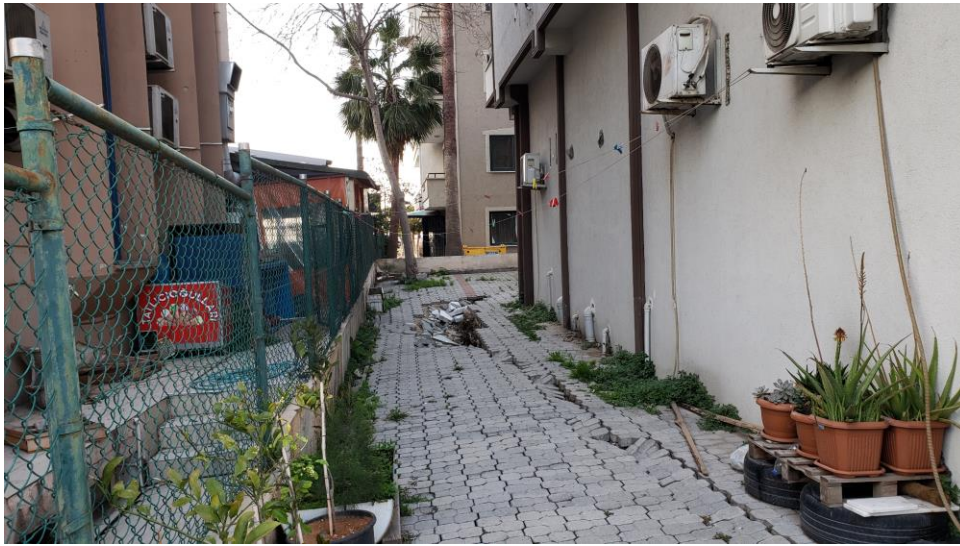
The No. 24 building (36.5903N, 36.1781E) of Bahçeli Sahil Evler Street is a 5-story building approximately 16.5 m high. A street view of the building is shown in Figure 3.12a, note that this picture also shows rolled curbs in front of the building indicating liquefaction in the area. The building owner reported that the foundation has concrete piles beneath a 1-story basement. There was no discernable damage to the structure observed from the outside.

**Figure 3.12.** (a) (36.5900N, 36.1782E; 29MAR2023) street view of Apt. No 24 Kaan Ela, (b) (36.5900N, 36.1777E; 28MAR2023) surveying building settlement at the southwest corner of the building, and (c) (36.5902N, 36.1778E; 29MAR2023) view of the west side of the building and ground.

are not corrected for an initial ground slope. Figure 3.13b shows the building's lidar scan data with a mesh of the ground settlements relative to the assumed reference plane. There was a depression in the ground on the west side of the building (Figure 3.12c) where the ground pavers had fallen into the opening, however it was not apparent what caused this depression. It could potentially be attributed to poor fill compaction near the basement walls leading to excessive settlements and erosion during flooding. The depression was removed from the lidar data in Figure 3.13b since it distorted the scale of the ground settlement adjacent to the building.

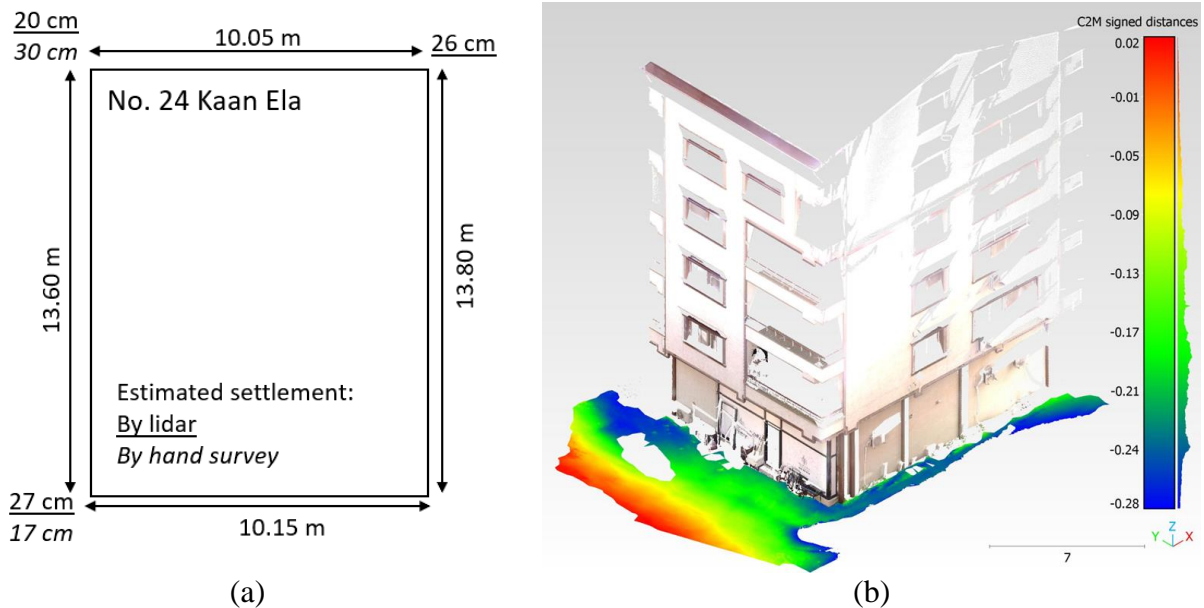
The average building settlement was estimated as 24 cm based on one lidar scan (no. 306) from the northwest corner of the courtyard. The measured settlements from lidar are estimated from an assumed reference plane that slopes at  $0.75^\circ$  from the rear (north side) of the property to the front. Settlements were also estimated with hand-surveys using a laser-level from the front of the building (Figure 3.12b). The settlements estimated by laser-level survey and lidar scans are summarized in Figure 3.13a; however, it should be noted that the laser-level survey measurements

**Figure 3.13.** (a) measured dimensions and estimated settlement at Apt. No. 24, (b) lidar scan data (scan no. 306) showing ground settlement relative to an assumed initial slope (reference plane) of the property; the color scale on the figure represents the ground settlement in meters relative to the site reference plane.

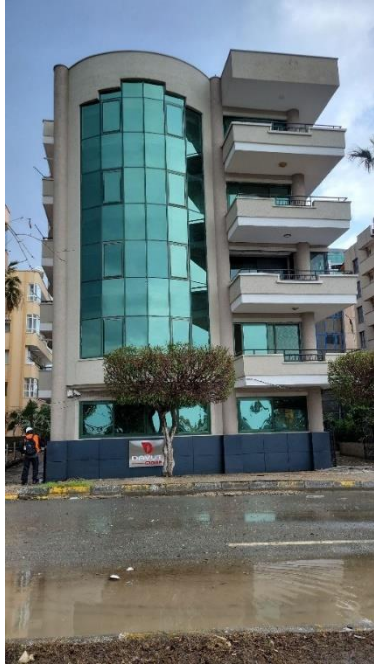
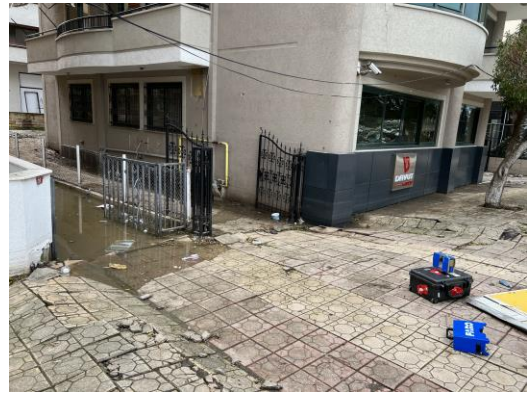
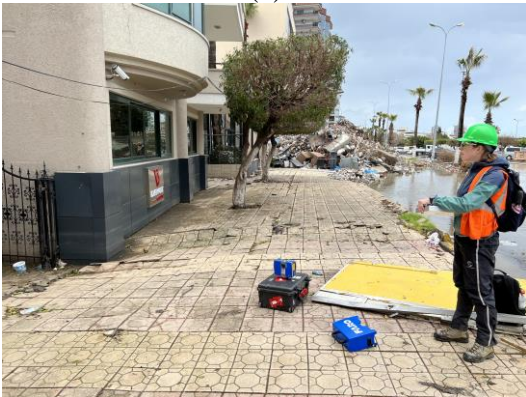
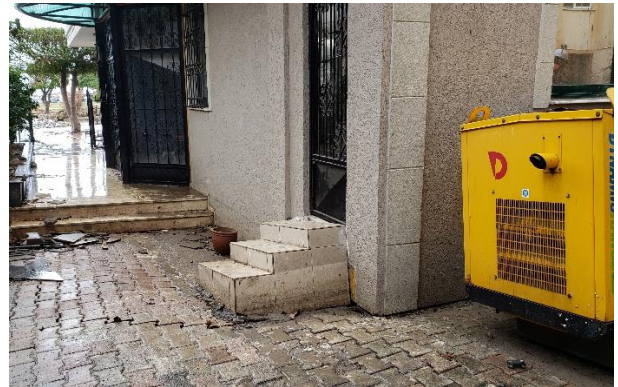
The building to the east of Pallet Hookah, called No. 18 Belli, is a 5-story building approximately 16 m high. A street-view of the building is shown in Figure 3.15a, along with pictures of the ground at the front of the building (Figure 3.15b,c). The measured dimensions of the building are

illustrated in Figure 3.16; note that there is a cantilevered section of the building that extends beyond the south side of the foundation by about 1.5 m. This cantilever section is also shown in Figure 3.15d. The building appears to have a small (partial) basement at its west-side associated with an elevator. The GEER Phase 3 team observed that the basement was full of water on March 29, 2023. The extent of the basement is not known since basement windows were not observed around the entire building.

**Figure 3.15.** Building No. 18 Belli: (a) (36.5908N, 36.1779E; 29MAR2023) street view of Building No. 18 Belli (b) (36.5907N, 36.1780E; 29MAR2023) view of the ground from the northwest corner including a view of the cantilever south section, and (c) (36.5907N, 36.1780E; 29MAR2023) view of the ground at the front (north) of the building showing ground deformations that extend around the structure.

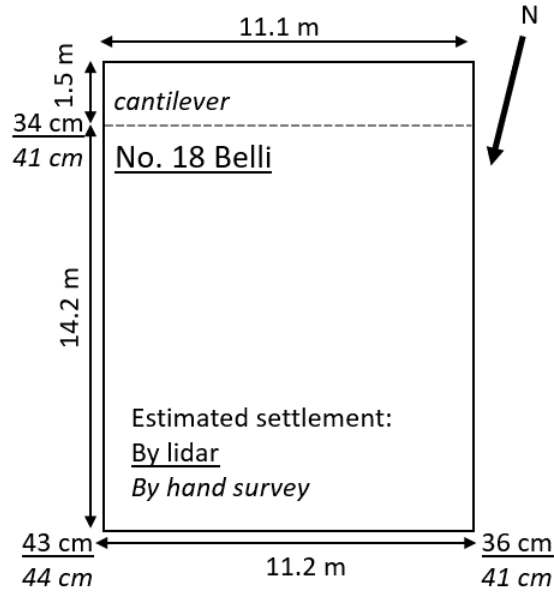
The building settlement of No. 18 Belli was estimated from hand-surveys using a laser-level and one lidar scan from the northeast corner (scan no. 307). These building settlements are apparent in the ground deformations around the building. Additionally, Figure 3.15c shows the ground slope at the front of the building, indicating that the post-earthquake grade slopes towards the building, whereas it is typical for the ground to be graded to slope away from the structure for drainage. The average building settlement, based on the lidar scans, for settlements at the northwest, northeast, and southeast corners is 38 cm.

**Figure 3.16.** Schematic of measured dimensions and settlements at the No. 18 Belli building.

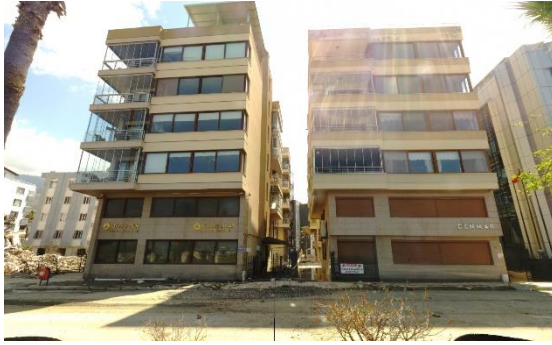
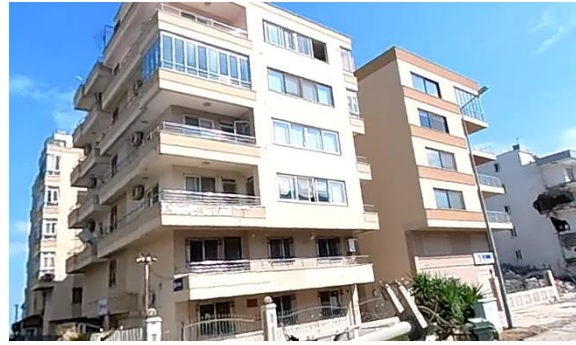
**Figure 3.17.** (a) (36.5910N, 36.1789E; 1APR2023) Street view of No. 26 and No. 28 in the group of 4 buildings. (b) (36.5903N, 36.1789E; 28MAR2023) Street view of No. 14 and No. 16 in the group of 4 buildings.

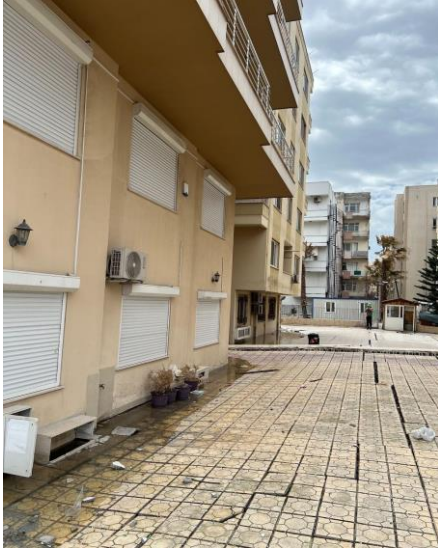
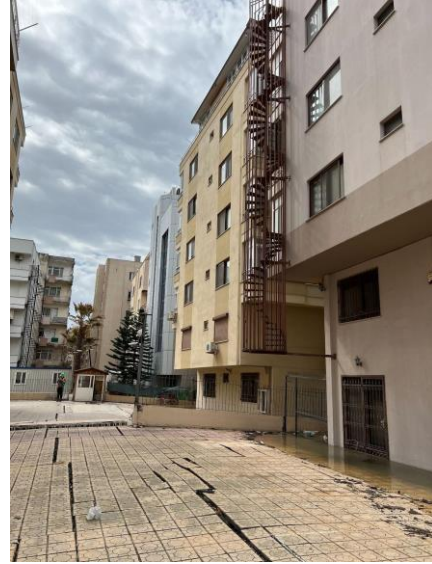
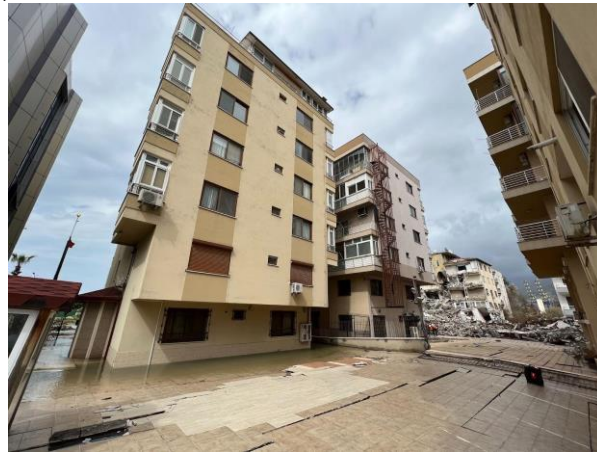
**Figure 3.18** A group of four mid-rise buildings in the Çay district. The photos show hogging ground deformations in the rear courtyard between the four buildings. (a) (36.5907N, 36.1793E; 29MAR2023) rear of south buildings, (b) (36.5907N, 36.1793E; 29MAR2023) rear of north buildings, and (c) (36.5906N, 36.1788E; 29MAR2023) all buildings.

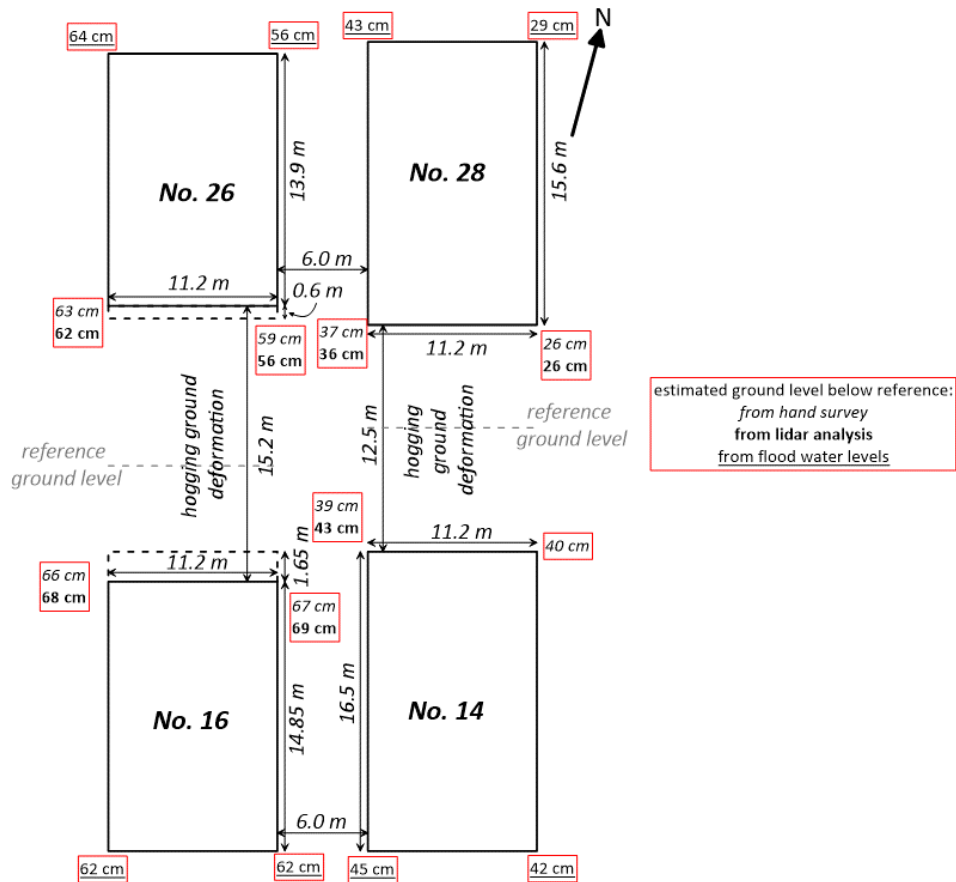
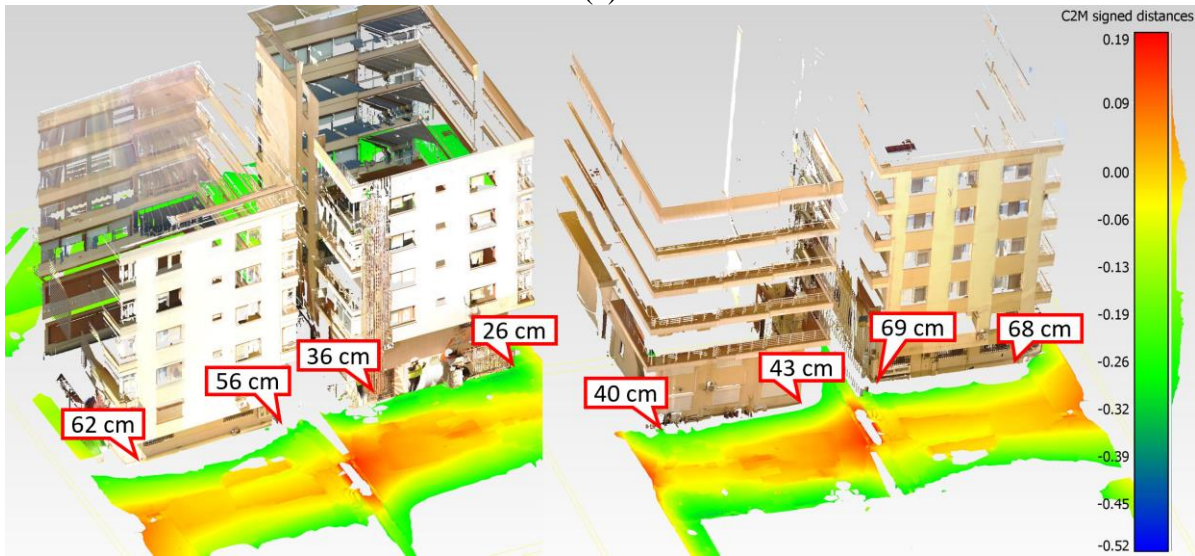
The settlements for each building were estimated from (i) lidar scans on March 29 and April 1, 2023 (scan no. 308, 316, 317, 318, and 319), (ii) a laser-level hand-survey survey on April 1, 2023, and (iii) flood water depths on March 29, 2023. The difference of ground levels relative to the reference ground level in the middle of the hogging deformation is shown in Figure 3.19a, along with measured dimensions for the building group. If neither laser-level nor lidar scan estimates were available, the settlement was estimated from measured floodwater depths relative to a lidar scan-based value for the building. Figure 3.19b shows the ground deformations from lidar scan data with the estimated building settlements included as annotation. The lidar data of the ground between the buildings shows the hogging pattern. Building settlements were largest at Building No. 16 (average 65 cm) and Building No. 26 (average 60 cm), and smallest at Building No. 14 (43 cm) and Building No. 28 (34 cm). These estimated settlements do not account for initial surface grades.

**Figure 3.19** Group of four buildings. (a) summary of measurements and dimensions estimated from lidar scans and hand-survey measurements, and (b) lidar data (from scans 308, 316, 317, 318, and 319) including the pattern of ground deformation for Buildings No. 26 and No. 28 (left) and Buildings No. 16 and No. 14 (right).

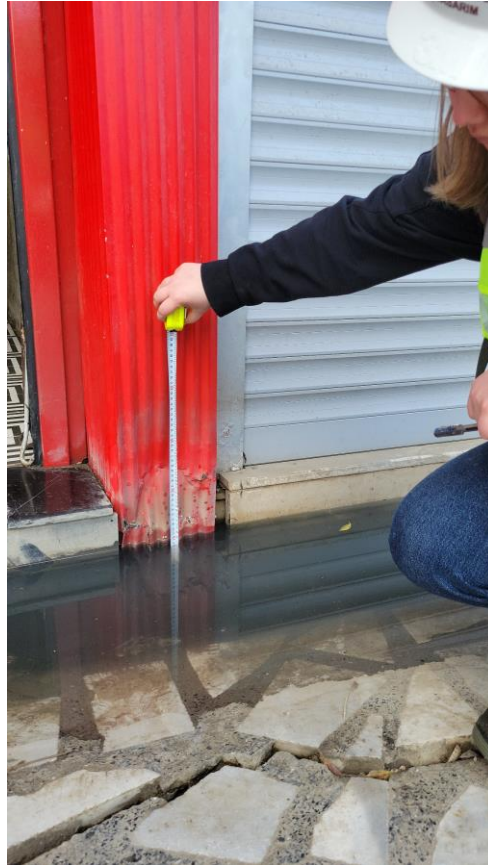
Rapid building settlement surveys were performed at three row buildings in the same block on Atatürk Boulevard: No. 41, No. 47, and No. 49. Building No. 49 is the civil registry building (Figure 2.3) that was originally built along the pre-1916 shoreline. Settlement at all these buildings was estimated at a point in the middle of the building front and relative to a point on the sidewalk that was considered to have not settled. The survey at Buildings No. 49 and 47 shared a reference point. Building No. 41 is a 6-story building with apparent mixed commercial and residential use. Approximately 16 cm of settlement was measured at Building No. 41. There

was some standing floodwater present at Building No. 41 as shown in Figure 3.21.

**Figure 3.21.** (36.5914N, 36.1710E; 28MAR2023) Building settlement survey and standing floodwater at No. 41 Atatürk Boulevard.

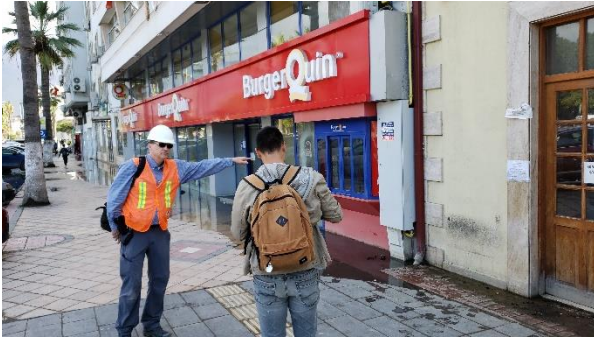
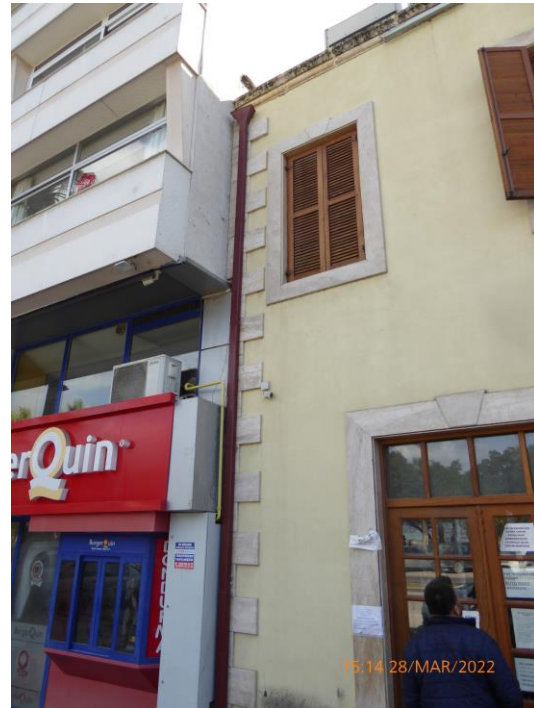
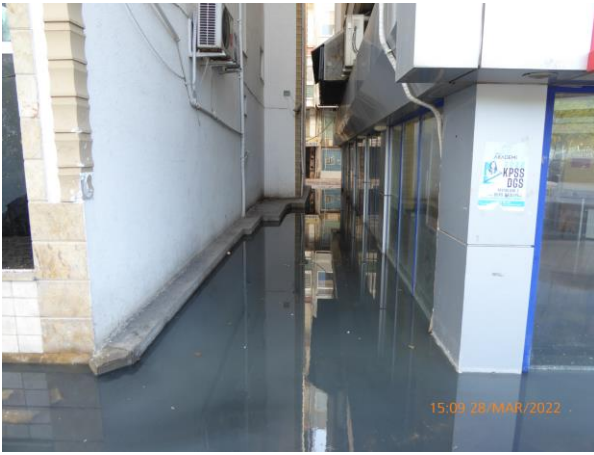
The measured building settlement at No. 47 and No. 49 was 13 cm and 7 cm, respectively. Consequently, there was approximately 6 cm of settlement difference between the two buildings. The two buildings are pictured in Figure 3.22a where No. 47 is in the background and No. 49 is in the foreground. Standing floodwater was present when the buildings were surveyed on March 28, 2023; however, there was notably less water in front of Building No. 49 as shown in Figure 3.22a. Figure 3.22b shows the shared sides of the buildings; there were no apparent interactions between the two structures. Figure 3.22c shows the standing floodwater in the alley on the east side of Building No. 47. The presence of floodwater is notable at these structures and suggests that there may have been widespread ground settlement in addition to the surveyed settlement at individual buildings.

**Figure 3.22.** Surveys at Buildings No. 47 and No. 49 Atatürk Boulevard. (a) (36.5918N, 36.1703E; 28MAR2023) both buildings with standing floodwater in front of No. 47, (b) (36.5918N, 36.1703E; 28MAR2023) side-by-side view, and (c) (36.5915N, 36.1705E; 28MAR2023) standing floodwater in the alleyway east of Building No. 47.

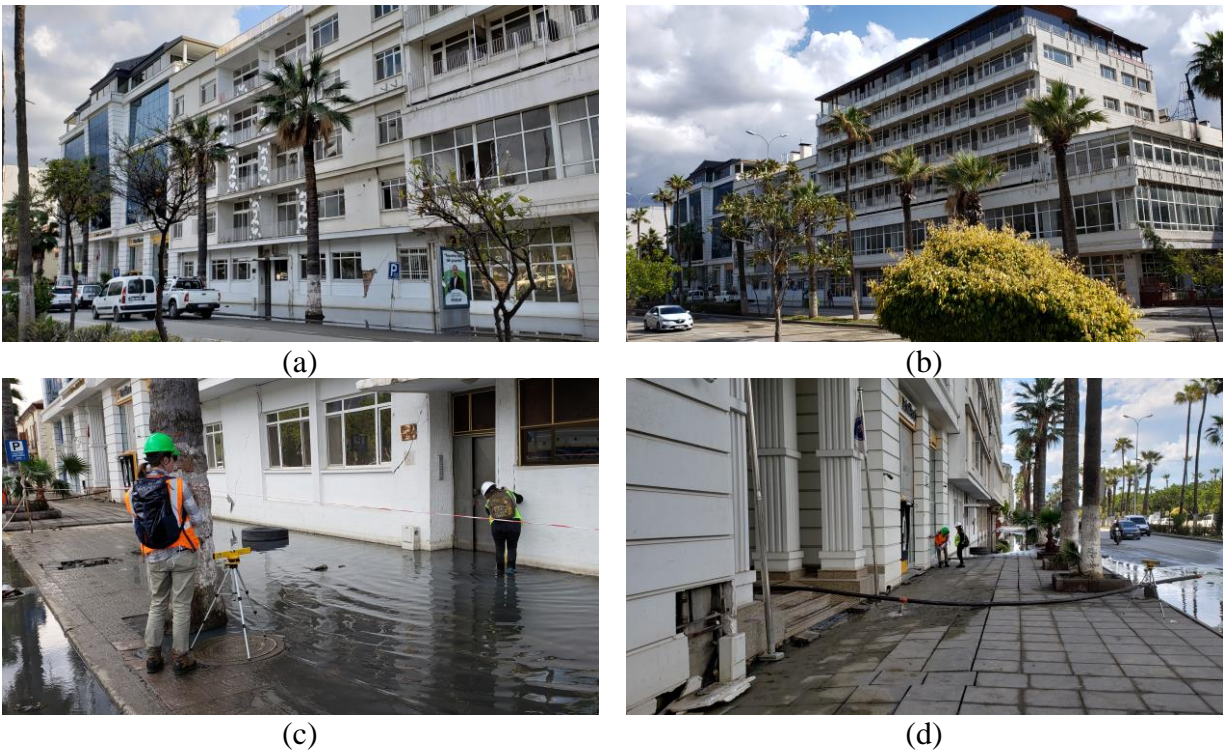
A row of three commercial buildings along Atatürk Boulevard was characterized by hand survey. The addresses are No. 51, No. 53, and No. 55 Atatürk Boulevard (36.5918N, 36.1690E). Photos of the buildings are shown in Figure 3.23, and a schematic of dimensions and settlement in Figure 3.24. The east building is a bank building and approximately 16.2 m high; it appeared to have very little building settlement, and some fill settlement was observed around the east side of the building as shown in Figure 3.23d. The settlements at this building ranged from 0 cm at the east side to 21 cm at the west side. The middle building is approximately 15.2 m high. The measured building settlements ranged from 21 cm at the east edge to 38 cm at the west edge. The west building is approximately 21.6 m high; its settlements ranged from approximately 41 cm at the east edge to 32 cm at the west edge. The settlements of these three buildings indicates a “sagging” ground deformation pattern along this building row. This sagging interpretation was additionally

supported by the presence of standing water on April 1, 2023 (when the buildings were surveyed) that was primarily located around the middle building (see Figure 3.23c).

**Figure 3.23.** Hand surveys of buildings No. 51, No. 53, and No. 55 Atatürk Boulevard: (a) (36.5920N, 36.1694E; 1APR2023), (b) (36.5924N, 36.1689E; 1APR2023), (c) (36.5924N, 36.1689E; 1APR2023), and (d) (36.5916N, 36.1670E; 1APR2023)

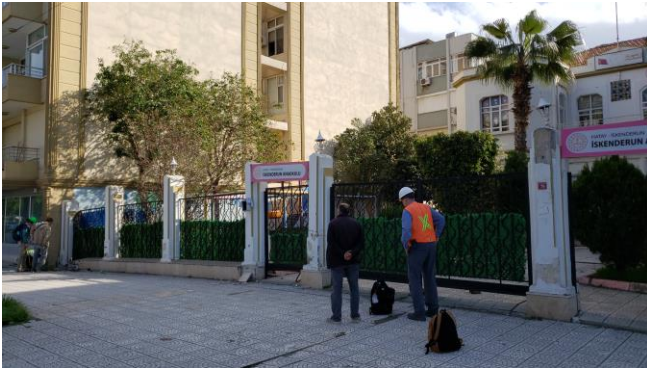
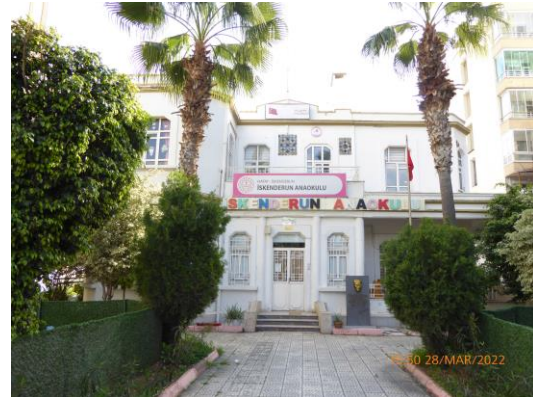
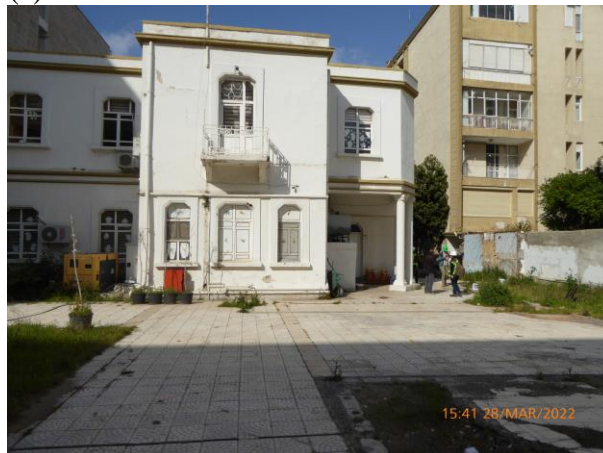
81) located on Atatürk Boulevard, and a kindergarten (No. 79 İskenderun Anakoulu) set back approximately 21 m from Atatürk Boulevard (36.5930N, 36.1676E). A street view photo of the kindergarten is shown in Figure 3.25, which also shows the hogging ground deformation on the sidewalk in front of the kindergarten. The manager of the kindergarten reported that the building settled a small amount, however, no discernible settlement was observed by the GEER Phase 3 team. The GEER team measured a length of about 9 m on the sidewalk in front of the kindergarten that was not impacted by settlement of the adjacent commercial buildings. This suggests the hogging pattern may have leveled out near the center of the kindergarten.

**Figure 3.25** The kindergarten (İskenderun Anakoulu) showing hogging ground deformations from the adjacent buildings. (a) (36.5933N, 36.1659E; 28MAR2023) sidewalk in front of the kindergarten with hogging deformation, (b) (36.5933N, 36.1658E; 28MAR2023) front view of the kindergarten, and (c) (36.5931N, 36.1656E; 28MAR2023) rear view of the kindergarten.

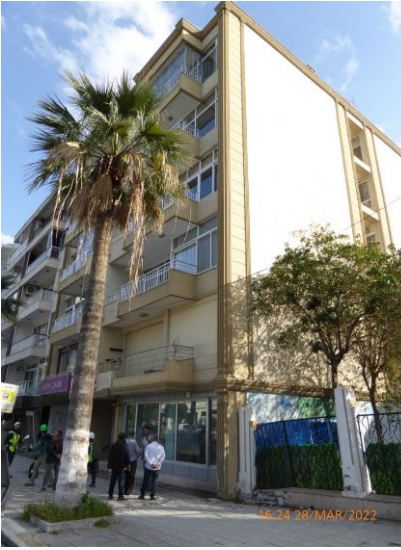
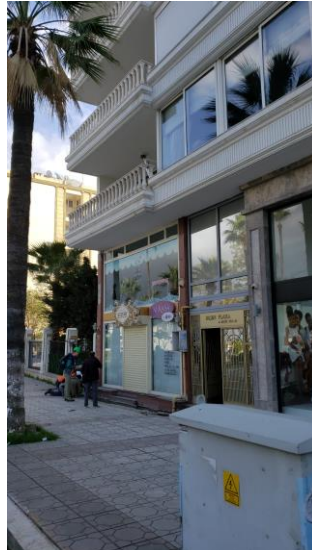
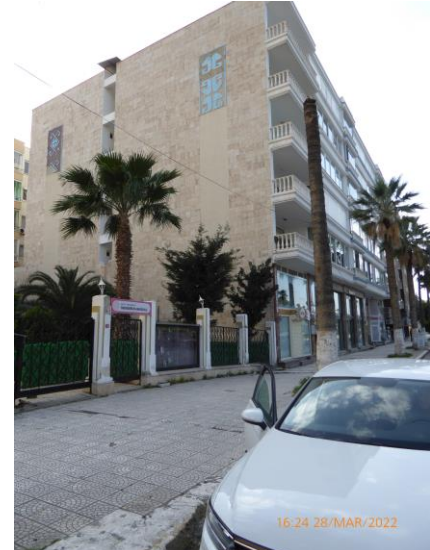
**Figure 3.26** Buildings adjacent to the kindergarten. (a) (36.5928N, 36.1661E; 28MAR2023) building to the east of the kindergarten (No. 77), (b) (36.5934N, 36.1657E; 28MAR2023) building to the west of the kindergarten (No. 81), and (c) (36.5934N, 36.1657E; 28MAR2023) building to the west of the kindergarten.

The hogging ground deformation is attributed to settlement of the two relatively tall commercial buildings on either side of the kindergarten, shown in Figure 3.26. The settlement of the two buildings was measured by laser-level from a point on the sidewalk in front of the kindergarten gate that did not appear to settle. The measured settlements are summarized with a schematic drawing in Figure 3.27. The building to the east (No. 77) is a 6-story building; the manager of the kindergarten reported that this building does not have a basement. The measured settlement at the front of No. 77 was 42 and 47 cm for the northeast and northwest corners, respectively. The building to the west of the kindergarten (No. 81) is a 6-story building; the manager of the kindergarten reported that this building has a basement. The measured settlement was 45 and 55 cm for the northeast and northwest corners, respectively.

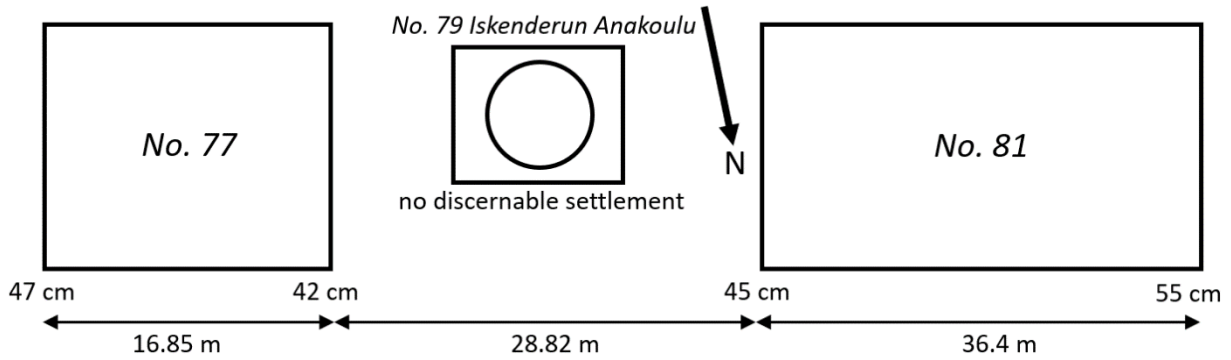
**Figure 3.27.** Schematic of measured building settlements and dimensions of the buildings adjacent to the İskenderun Anakoulu.

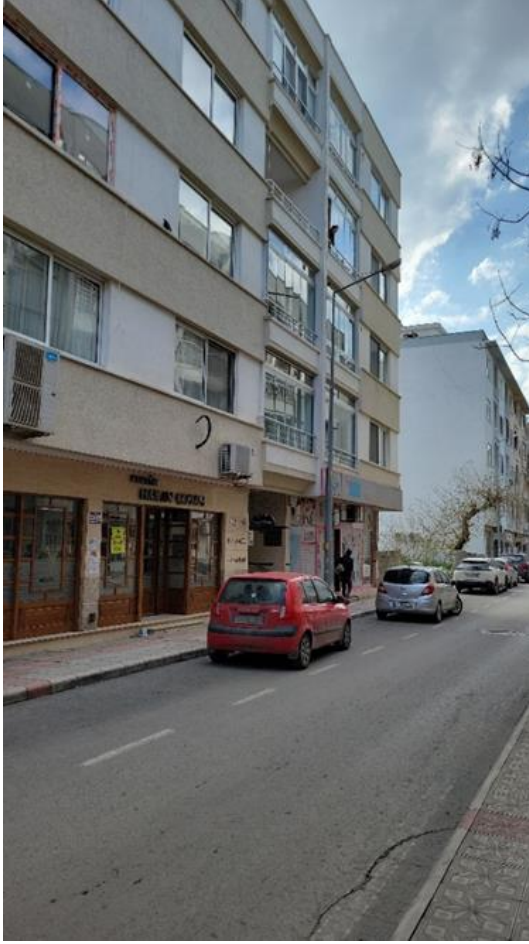
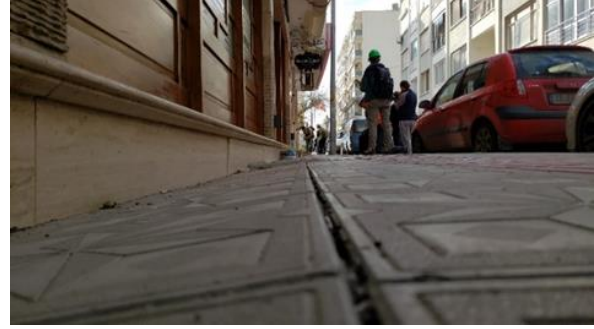
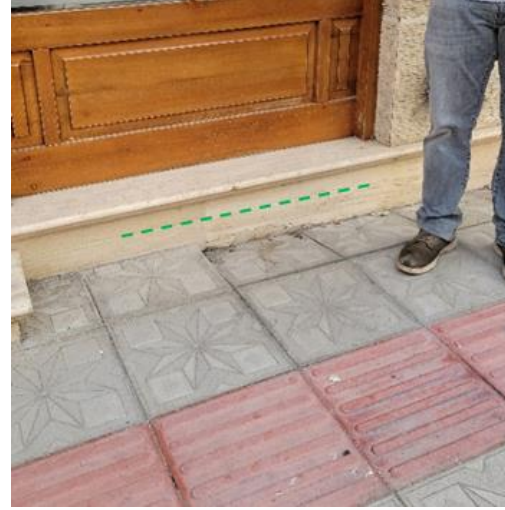
The team surveyed Building No. 33 Mareşal Fevzi Çakmak Street on March 28, 2023. This building underwent less than 10 cm of settlement in an area where larger settlements were observed. The 5-story residential row building has first floor commercial use and faces northeast (Figure 3.28). The adjacent lot northwest of the building is empty; a building to the southeast is in contact with the surveyed building. Deformation of the sidewalk adjacent to Building No. 33 indicates that building settlement took place (Figure 3.28b). Surveys of settlement from the sidewalk to the northwest edge, center, and northeast edge of the building measured settlements of 5 cm, 7 cm, and 6 cm, respectively, indicating a slight sag in the center of the building. Figure 3.28c shows the laser-level survey at the center of the building. The front of the building (northeast edge) was measured as 26.55 m in width. The length of the building is approximately 19 m (estimated on Google Earth from the northwest edge). The building is approximately 16.1 m in height. The building owner reported that there is no basement. No exterior damage was observed.

**Figure 3.28.** Çay district in İskenderun, Hatay building with small settlement: (a) view of building facing west (36.5926N, 36.1662E, 28MAR2023), (b) (36.5926N, 36.1661E, 28MAR2023) deformed sidewalk, and (c) (36.5927N, 36.1661E, 28MAR2023) laser-level survey to the center of the building relative to “stable” sidewalk (dashed green line indicates assumed original ground level).

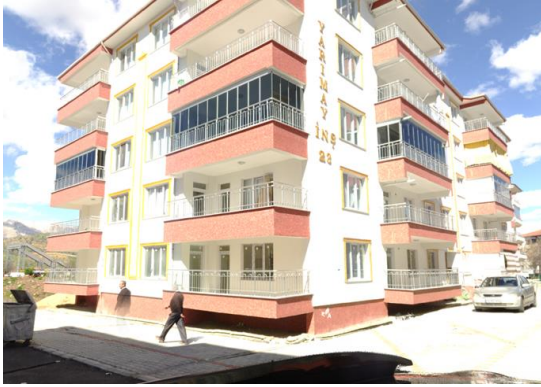
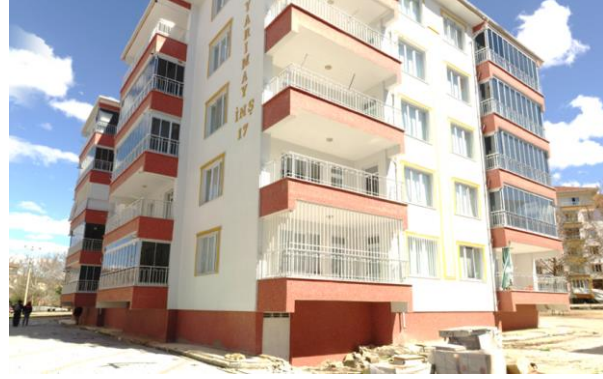
Two adjacent five-story apartment buildings on 511 street in Gölbaşı were observed to document their differences in performance. The apartments were constructed by “Yarımay İnş”. The apartment building No. 23 is the north building (Figure 3.30a) and No. 17 is the south building (Figure 3.30b). Both apartment buildings are nearly identical in appearance, with the exception that Building No. 17 has a one-story basement and Building No. 23 has no basement. The structures are composed of a reinforced concrete frame with masonry infilled walls. From Google Earth images, construction at No. 23 was completed after June 2021 and construction at No. 17 was completed after August 2019. They are located within 700 m of the Gölbaşı Lake to the north, and they are adjacent to a channelized creek just across 511 street at the south.

**Figure 3.30.** Apartments constructed by Yarımaya İnş. (a) (37.7890N, 37.6422E; 30MAR2023) No. 23, the north building, image obtained from lidar scan, (b) (37.7890N, 37.6422E; 30MAR2023) No. 17, the south building, image obtained from lidar scan.

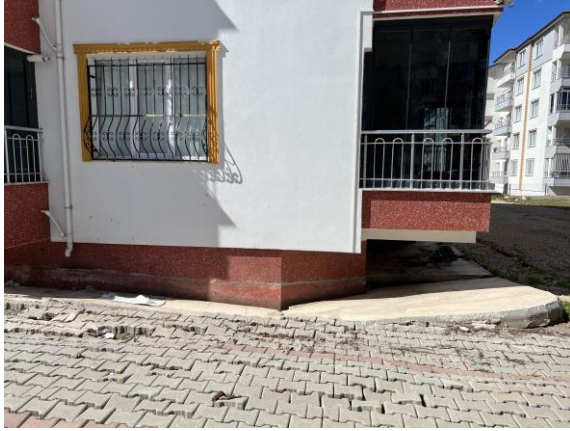
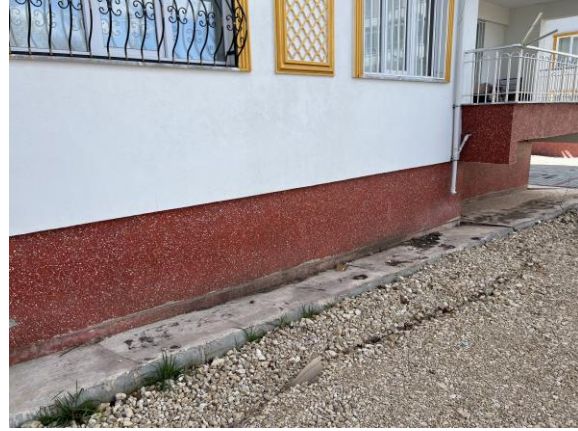
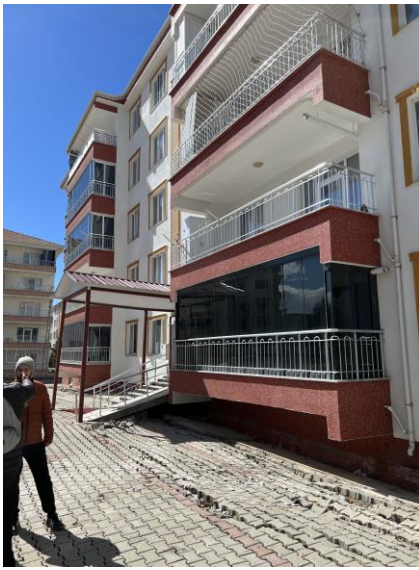
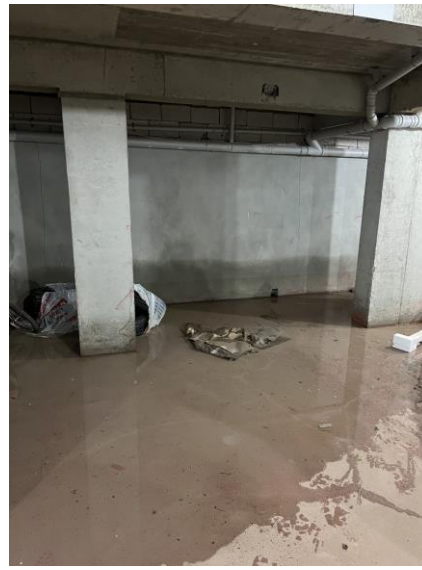
Both buildings did not appear to have structural damage; however, they showed obvious signs of building settlement around their perimeter. Building settlement and ground cracks were observed around No. 17 (the south building) as shown in Figures 3.31a,b,c. The owners allowed access into the building's basement, which was observed to have some ponded water along its southern wall (Figure 3.31d). Although the owners mentioned that water often puddles in the basement due to the lack of a sump pump, the water may also indicate some tilt towards the south. Traces of soil (i.e., possible ejecta) and minor cracking of the concrete floor were also observed near structural columns within the basement.

**Figure 3.31.** Yarımay İnşaat Apartments No. 17 (south building). (a) (37.7890N, 37.6428E; 30MAR2023) southeast corner of No. 17 showing ground deformation, (b) (37.7891N, 37.6429E; 30MAR2023) northeast corner showing ground settlement, (c) (37.7889N, 37.6428E; 30MAR2023) south view showing ground settlement, and (d) (37.7890N, 37.6427E; 30MAR2023) standing water in the basement of the south building.

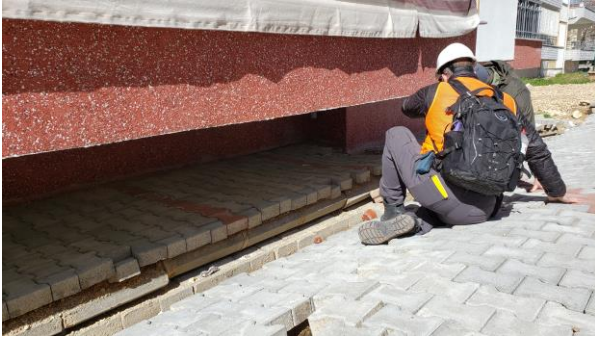
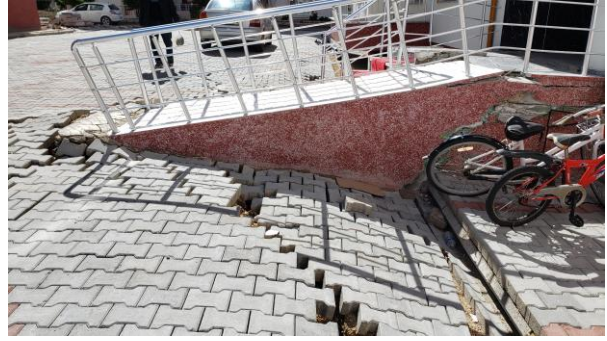
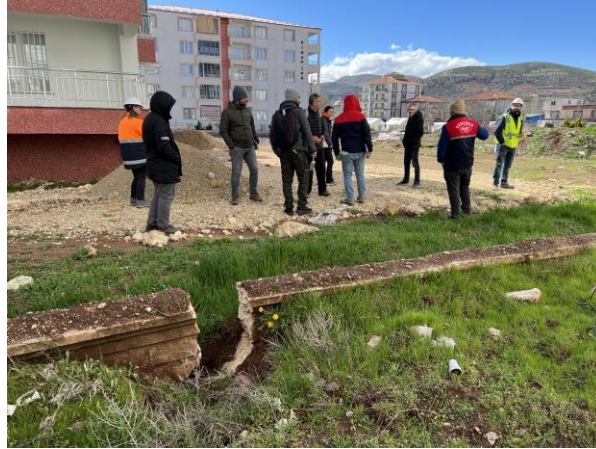
No. 23 (the north building) showed significant settlement and separation from the adjacent ground at its southeast corner (Figure 3.32a). Extensional cracking observed along the north and south wall of the building (parallel to the lakeshore) totaled about 45 cm, which approximately matched the accumulated cracking along a nearby concrete wall (perpendicular to the lakeshore) (Figures 3.32b,c).

**Figure 3.32.** Yarımay İnşaat Apartments No. 23: (a) (37.7892N, 37.6462E; 30MAR2023) ground settlements near the southeast corner, (b) (37.7892N, 37.6426E; 30MAR2023) ground deformation around the south entrance, and (c) (37.7895N, 37.6426E; 30MAR2023) cracking in a concrete wall that runs approximately north-to-south; the northeast corner of No. 23 is in the background.

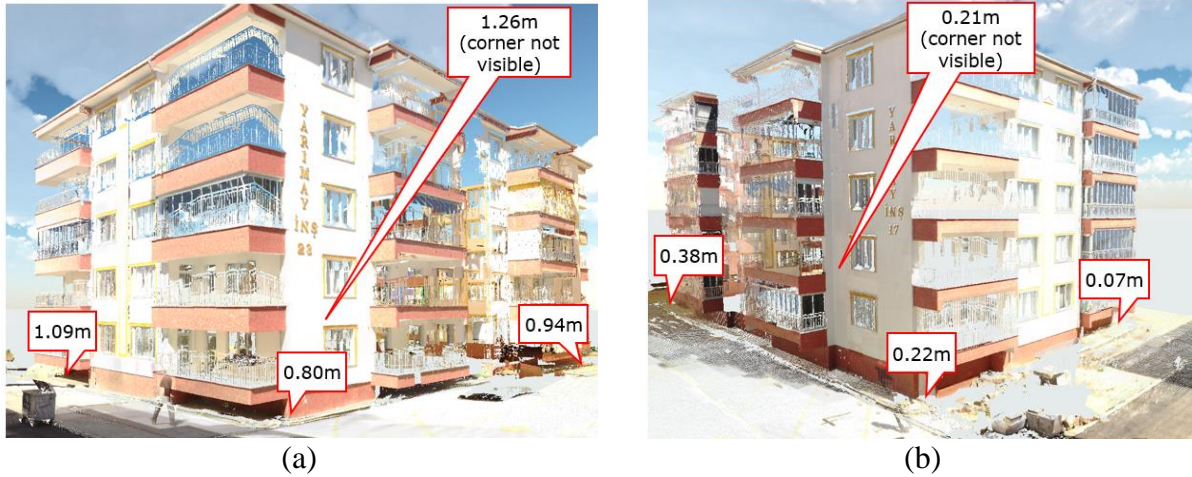
Lidar scans were performed for these apartment complexes (i.e., scan numbers 309, 310, 311, and 313) with approximate locations as shown in Figure 3.29. The initial estimates of the building settlements and building dimensions from the lidar scans are shown in Figure 3.33 and Figure 3.34. No. 23 (the north building) is settled considerably more than No. 17 (the south building). The average building settlement at No. 23 is 1.02 m and the average building settlement at No. 17 is 0.22 m.

**Figure 3.33.** Lidar scan results data with estimated settlements for Yarımay İnşaat Apartments: (a) No. 23, and (b) No. 17.

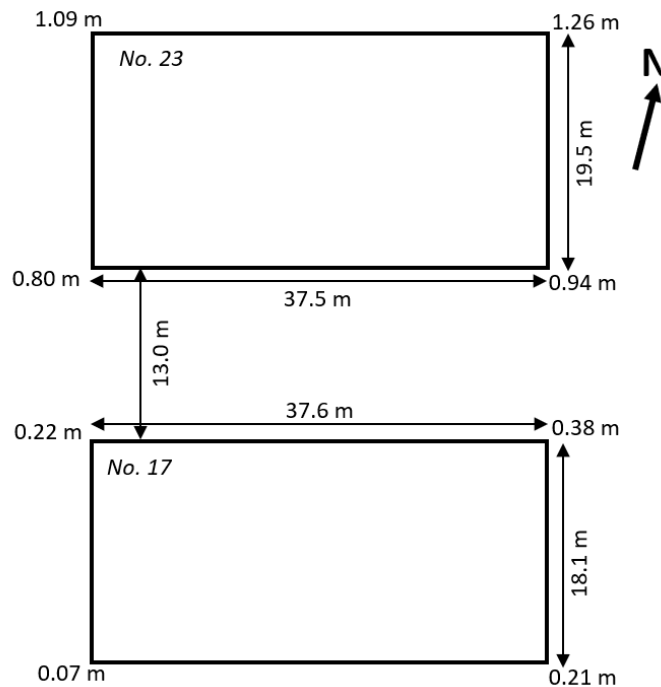
**Figure 3.34.** Schematic of estimated dimensions and settlements from lidar scans of the two Yarımay İnşaat apartment buildings.
