# February 6, 2023 Türkiye Earthquakes: GEER Phase 3 Team Report on Selected Geotechnical Engineering Effects

GEER Association Report 082-S1

June 30, 2023

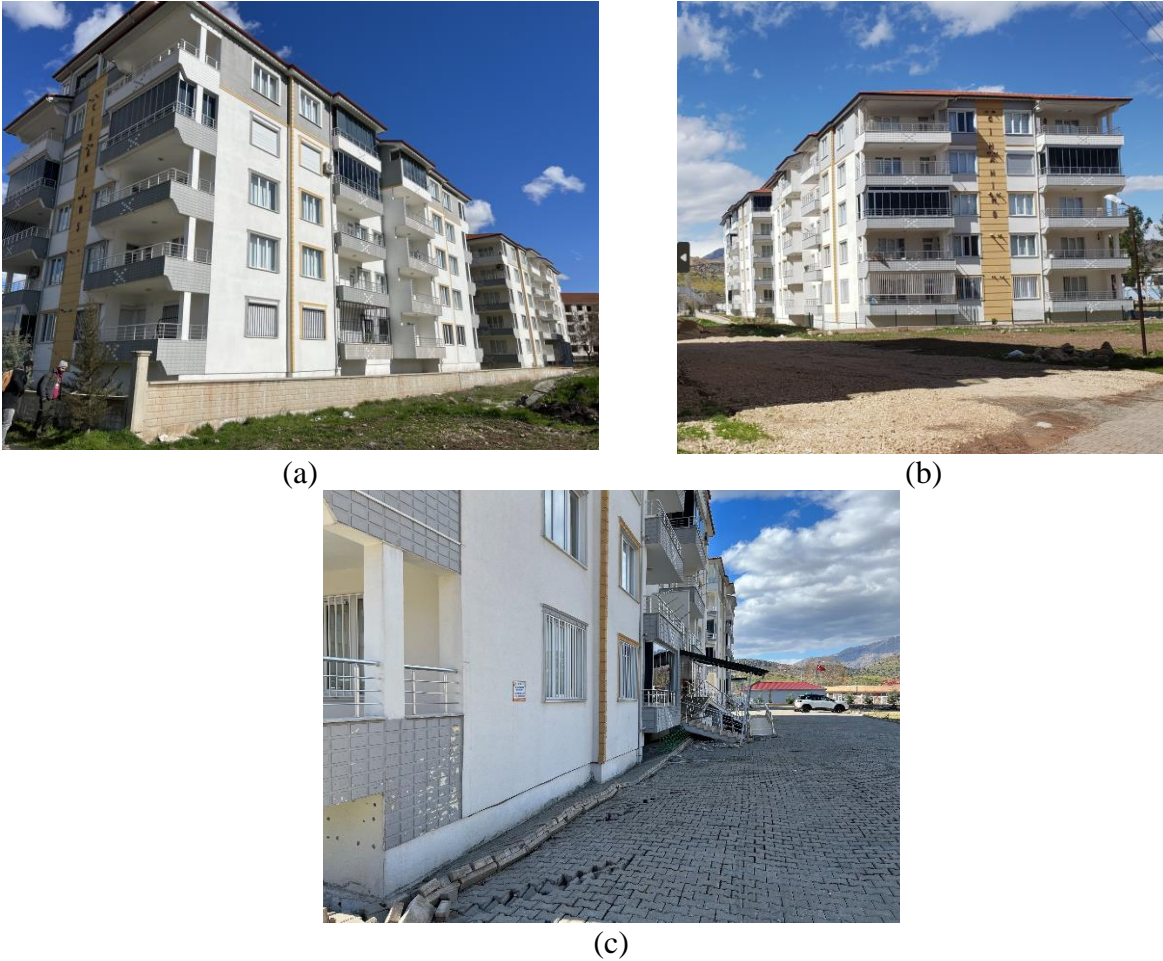
appear to have similar design and construction. Images from Google Earth indicate that the buildings were constructed at a similar time with construction starting after June 2017 and appearing to be mostly complete by August 2019. The buildings are similar in appearance and design; however, the north building has a basement, which was 2.9 m high from the top of slab to the bottom of the ceiling. There was no obvious damage to the structures observed from their exterior.

**Figure 3.35.** Cihan İnşaat apartment complex: (a) the north building (37.7902N, 37.6423E; 30MAR2023), (b) the south building (37.7889N, 37.6427E; 30MAR2023), and (c) north building settlement at along south east side of building (37.7894N, 37.6431E; 30MAR2023),

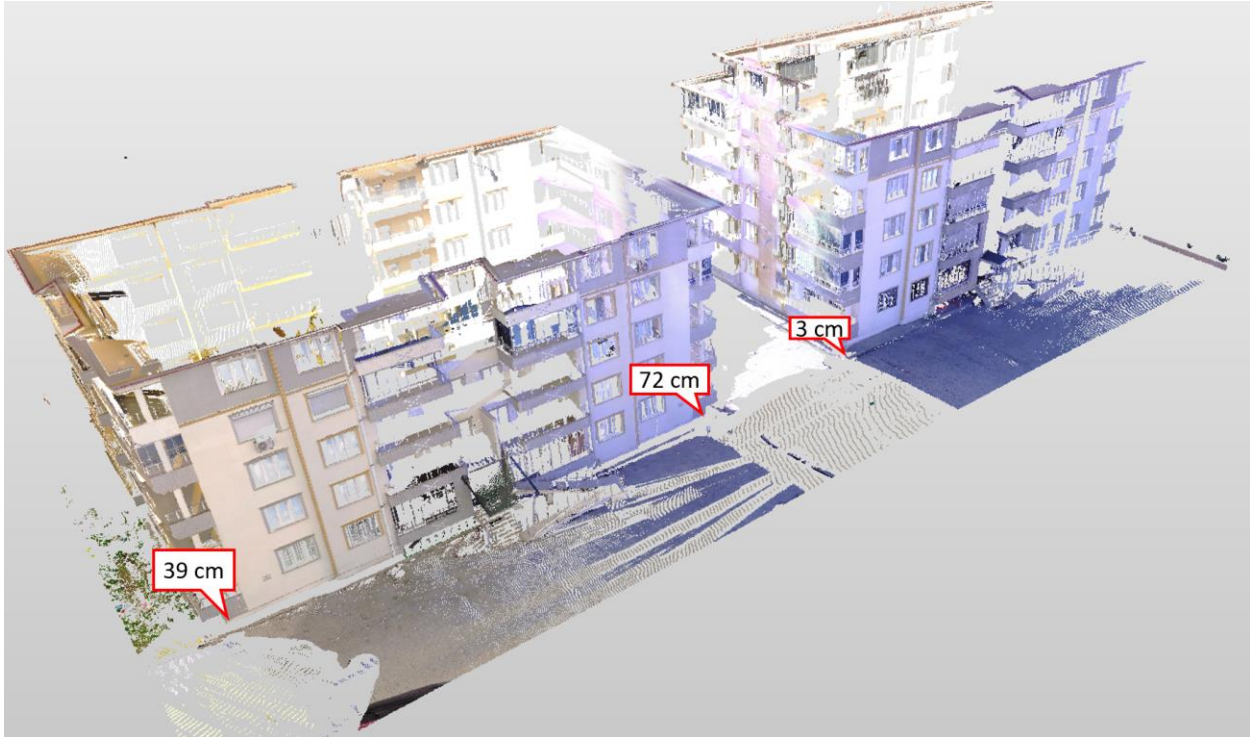
Two lidar scans on the east side were performed for the buildings (scan no. 314 and 315). These lidar scans allow estimation of settlement at the two east corners of the south building, and settlement at the southeast corner of the north building. The lidar scan data and measured settlements are shown in Figure 3.36. The building settlement and ground damage are shown in Fig. 3.35c. The estimated settlement at the south building is 36 cm and 72 cm for the southeast and northeast corners, respectively. The estimated settlement at the southeast corner of the north building is 3 cm. These settlements are estimated relative to a reference point on the road in front of the south building, which did not appear to have settled.

**Figure 3.36.** Lidar scan data from Cihan İnşaat and estimated settlements from lidar analysis. The north building with a basement is shown at the upper right part of the scan, whereas the south building without a basement is shown in the lower left part of the scan.

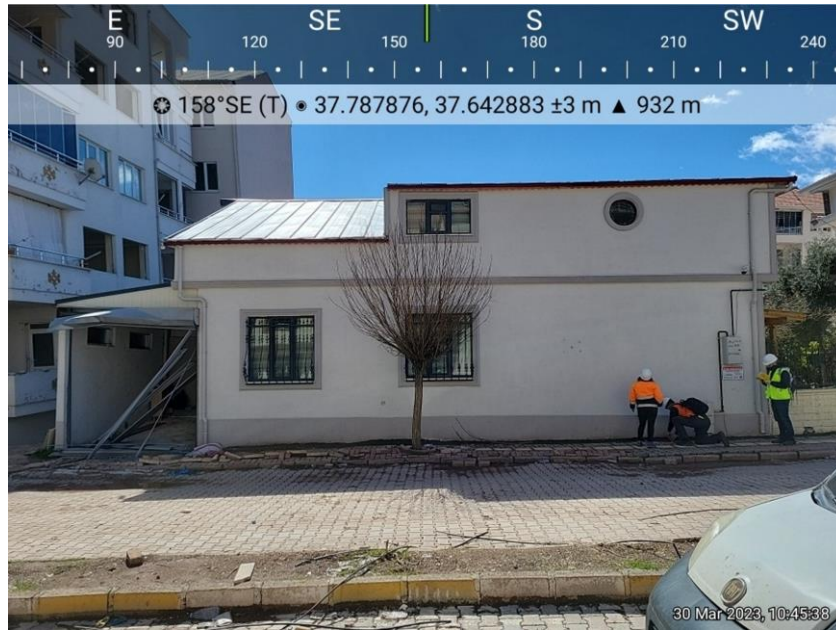
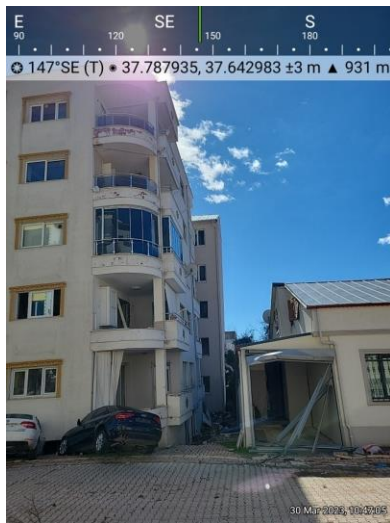
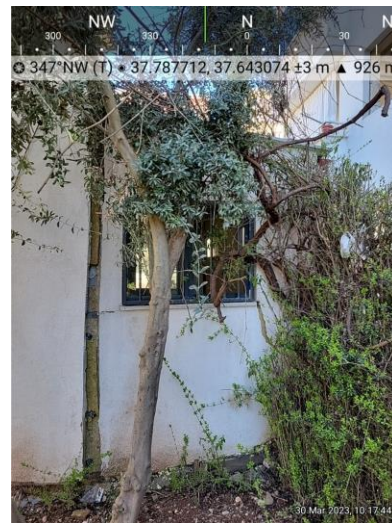
Negligible settlement was observed at the two-story single-residential building (37.7877N, 37.6429E). The building is 10.32 m long north-to-south and 13.4 m wide east-to-west with an additional -m wide garage on the east side (Figure 3.37a). The building is approximately 5.6 m high. From examining Google Earth images, the structure was built after 2019. The structure appears to be cinder block and plaster construction with no apparent basement. Although there was negligible settlement documented, there was damage to the structure that appeared to be due to ground deformation at the structure to the east. Figure 3.37b shows the notable settlement at the east-adjacent structure. An approximately 10 cm crack was observed on the south side of the building near the connection between the house and the garage (Figure 3.37c); additionally, a 1° tilt towards the house was measured on the east wall of the garage.

**Figure 3.37.** 2-story cinder block and plaster construction residential building in Gölbaşı with no discernable settlement: (a) (37.7879N, 37.6429E; 30MAR2023) street view of the building with attached garage showing disturbance in the adjacent sidewalk and road, (b) (37.7879N, 37.6430E; 30MAR2023) settlement at adjacent 5-story building and its effect on the attached garage, and (c) (37.7877N, 37.6431E; 30MAR2023) crack that opened on the south side of the house due to displacement of the garage.

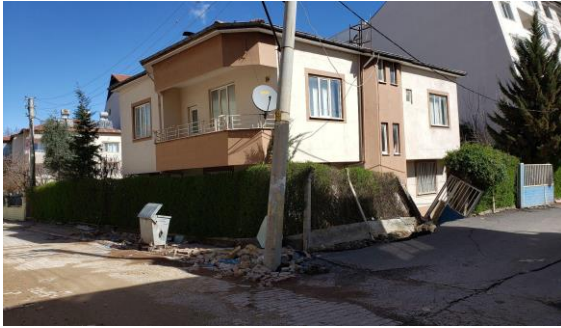
Significant building settlement was observed at the two-story building (37.7876N, 37.6430E) as shown in Figures 3.38a-c. The building was measured to be 9.9 m wide north-to-south and 12.2 m long east-to-west with an approximate height of 7 m. From examining Google Earth images, the structure was constructed prior to 2008. Settlement at the front door building entrance at the

southwest corner was measured to be over 1.1 m. Ponded water was present along the south side of the building. The east perimeter of the building settled about 20 cm more than the west perimeter of the building, inducing some tilt. The building owner told our team that the building was originally constructed without the partial shallow storage area, which was later built under the backyard cantilevered patio.

**Figure 3.38.** Settled two-story residential building with a partial basement in Gölbaşı: (a) view of building from southwest corner (37.7874N, 37.6429E; 30MAR2023), (b) collapsed deck over partial shallow storage area along north wall (37.7878N, 37.6429E; 30MAR2023), and (c) front door entrance at southwest corner with over 1.1 m of measured settlement (37.7875N, 37.6430E; 30MAR2023).

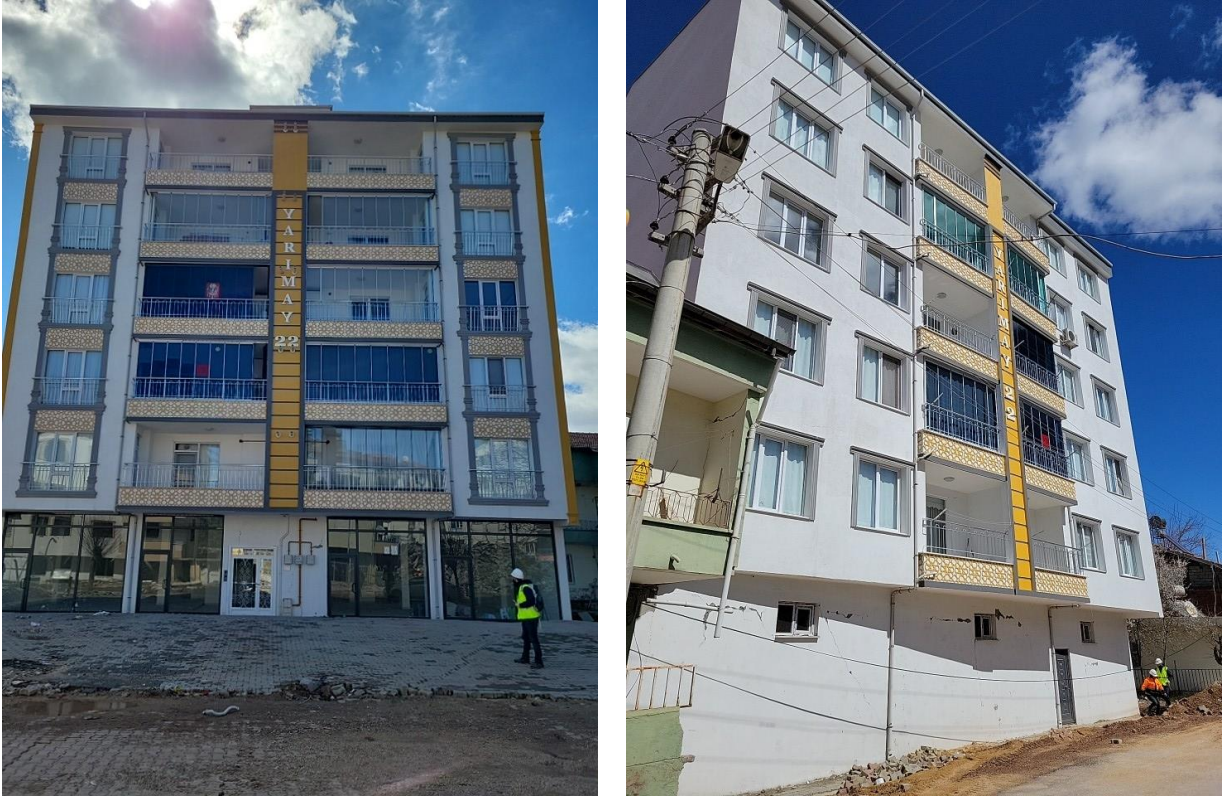
Settlements at No. 91 Gazi Street (37.7880N, 37.6438E) were surveyed at the north side of the building with hand measurements using a laser-level. The building is a 6-story residential apartment building. Some cracking was observed in the first floor exterior of the building at the front and rear (Figure 3.39). The dimensions were measured as 20.0 m by 16.6 m with an approximate height of 19.4 m. Settlements were measured across the front (north side) of the

**Figure 3.39.** Survey at No. 91 Gazi Street. (a) (37.7882N, 37.6437E; 30MAR2023) street view, and (b) (37.7878N, 37.6437E ; 30MAR2023) rear view of the building including cracks in the exterior of the first floor.

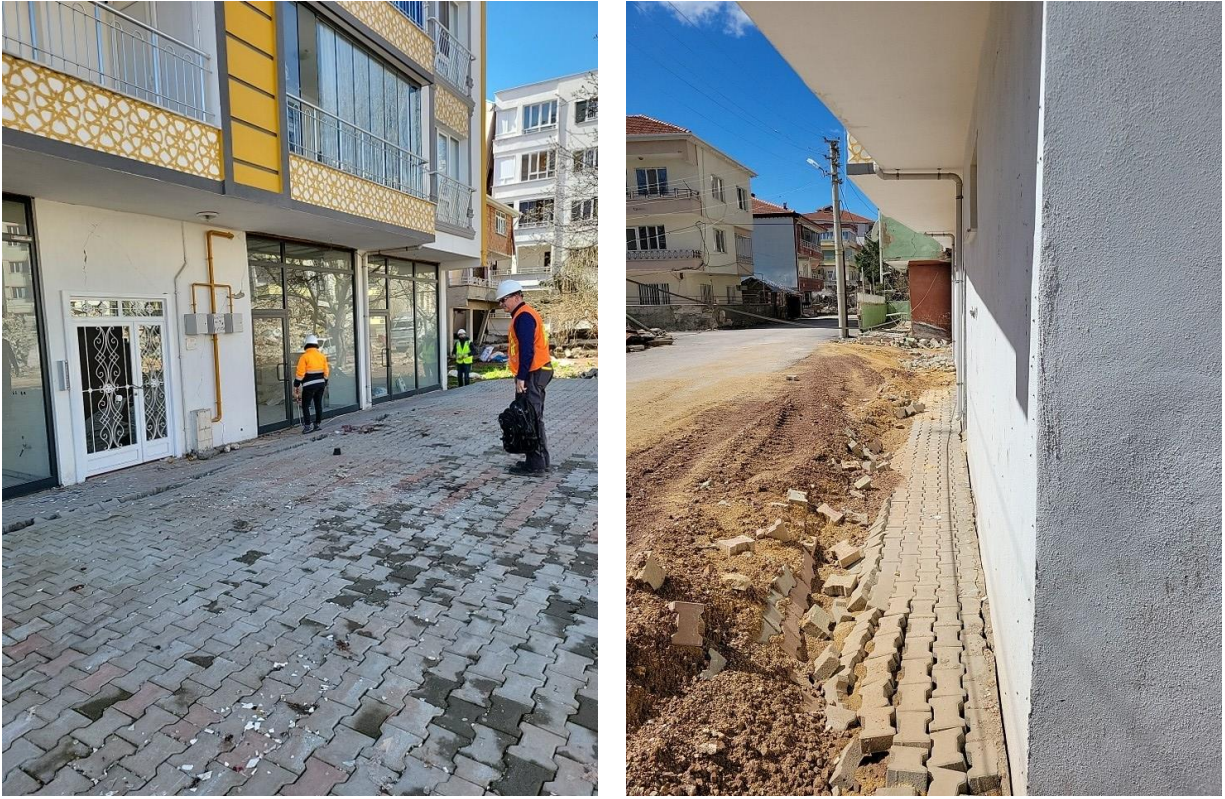
building where ground deformations were observed. Ground settlement is captured at the front and rear of the building in Figure 3.40. The settlements and dimensions are summarized in Figure 3.41. At the front of the building, 18 cm was measured at the northeast corner and 22 cm was measured at the northwest corner. There was no measurable tilt on the west side of the building.

**Figure 3.40.** Ground deformations around No. 91 Gazi Street. (a) (37.7882N, 37.6438E; 30MAR2023) ground deformations at front of the building, and (b) (37.7880N, 37.6439E; 30MAR2023) ground deformations at the rear of the building.

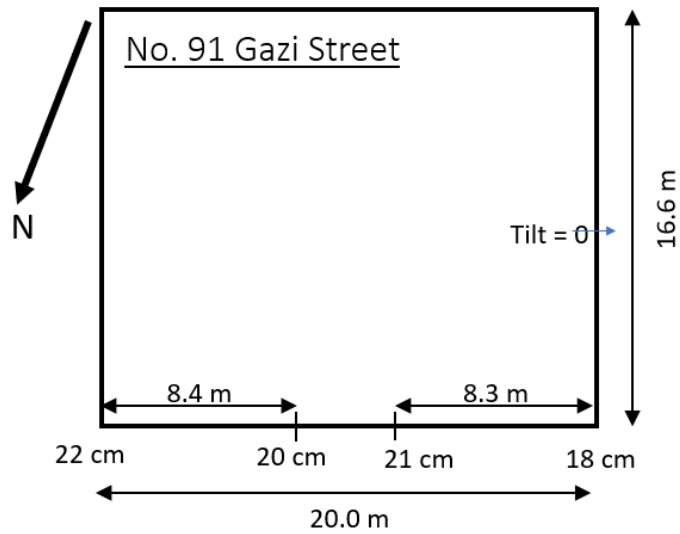
**Figure 3.41.** Schematic of surveyed settlements and dimensions of No. 91 Gazi Street, including distance between measured settlement points.

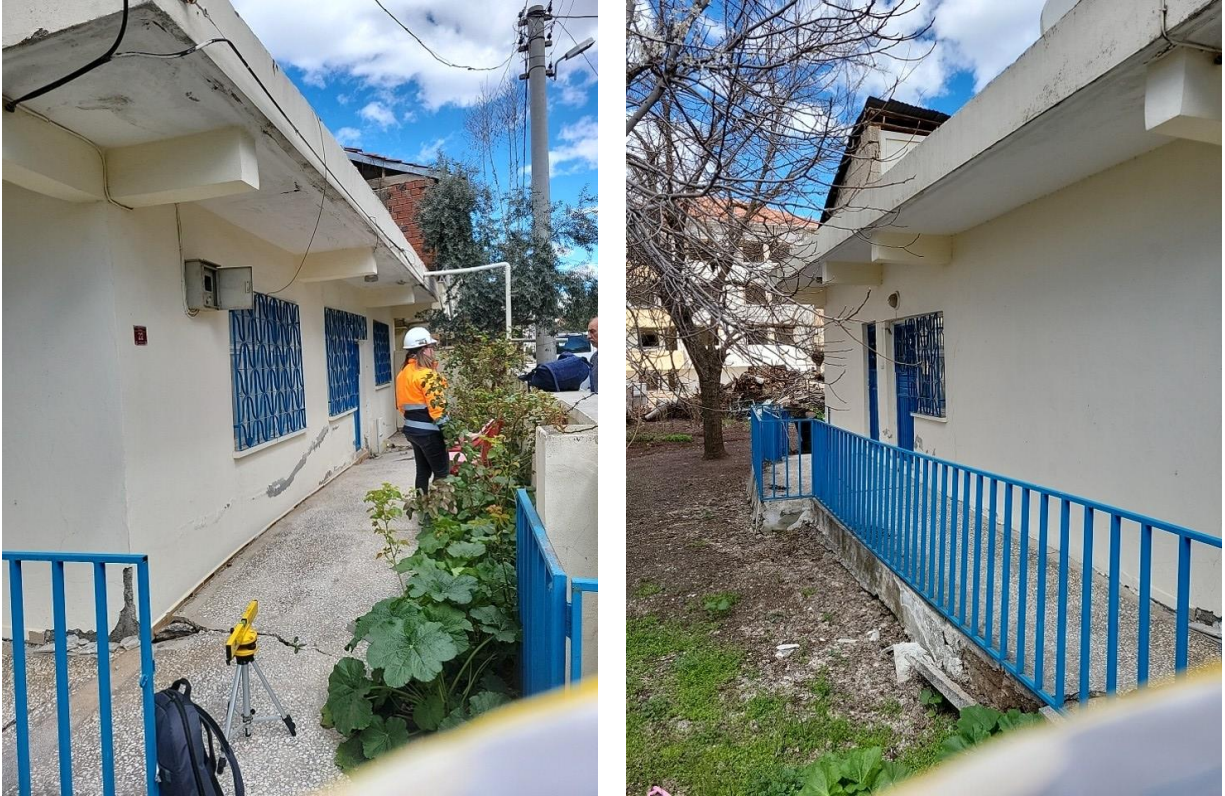
Building No. 13 52 Sk. (37.7880N, 37.6440E) is a 1-story house. Pictures of the house are shown in Figure 3.42. Based on a hand-survey of measurements on the south and west sides of the structure, there was an average 13 cm of building settlement. A neighbor reported that the foundation is a 50 cm thick mat.

**Figure 3.42.** No. 13 52 Sk. (a) (37.7879N, 37.6440E; 30MAR2023) view of the south side, and (b) (37.7879N, 37.6440E; 30MAR2023) view of the westside.

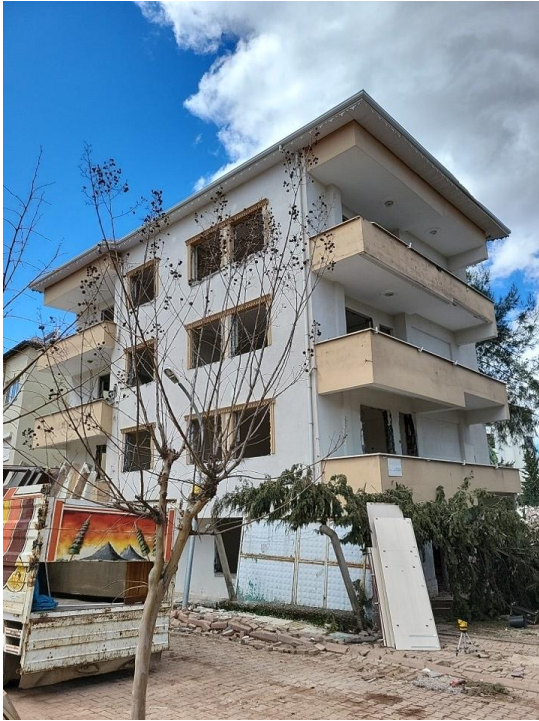
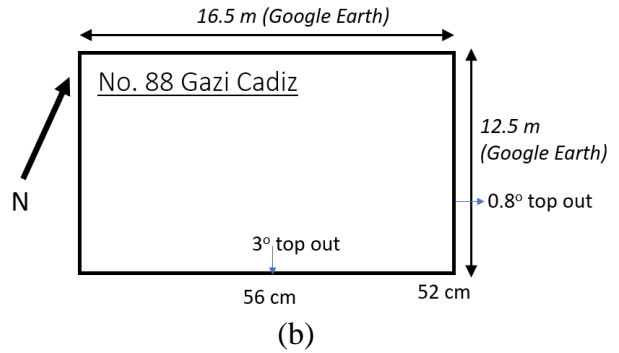
Building No. 88 Gazi Street (37.7883N, 37.6438E) is a 4-story residential building. A summary of the estimated settlements, at two points on the south face of the building, the building tilt, and dimensions (measured on Google Earth) are summarized in Figure 3.43. The average building settlement was 54 cm. Tilts of  $1^\circ$  towards the east and  $3^\circ$  towards the south were measured for this building. A building resident reported that the building does not have a basement and has a 1 m-thick mat foundation.

**Figure 3.43.** No. 88 Gazi Street: (a) (37.7883N, 37.6440E; 30MAR2023) street view, and (b) schematic illustration of hand-surveyed settlements, tilts, and estimated dimensions.

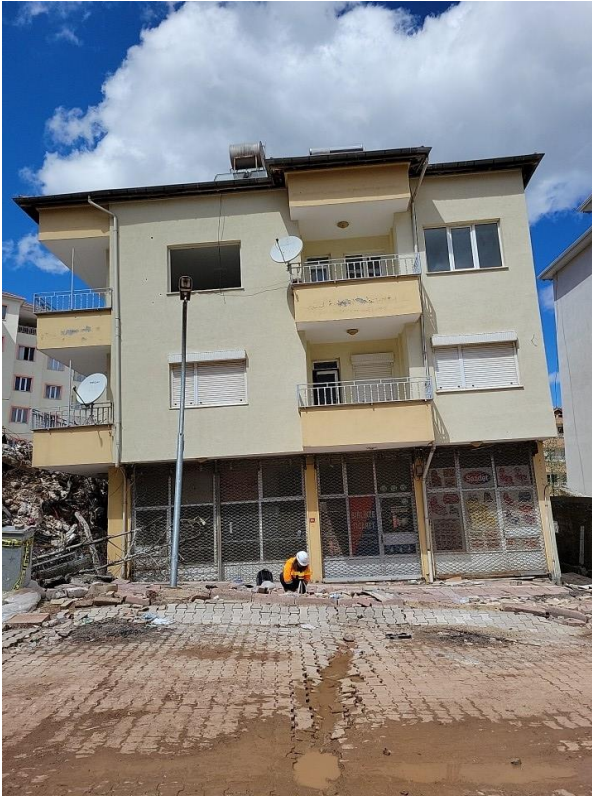
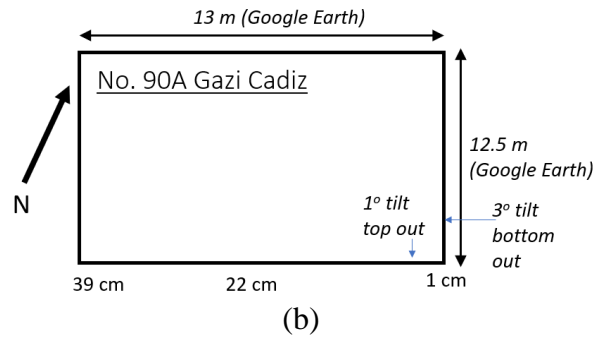
No. 90A Gazi Street (37.7883N, 37.6436E) is a 3-story building with a convenience store on the first level and what appear to be residential units on the second and third floors. A summary of the estimated settlements, at two points on the south face of the building, the building tilt, and dimensions (measured on Google Earth) are summarized in Figure 3.44. The building settlement at the southeast corner was estimated as 1 cm and the building settlement at the southwest corner was estimated as 39 cm, indicating a differential settlement of 38 cm over the length of the building (i.e., a length of 13 m as measured from Google Earth). The measured tilt at the east side of the building was 3° towards the west. The measured tilt at the south side (front) of the building was 1° towards the south. There was no apparent basement.

**Figure 3.44.** No. 90A Gazi Street (a) (37.7882N, 37.6437E; 30MAR2023) street view, and (b) schematic illustration of hand-surveyed settlements, tilts, and estimated dimensions.

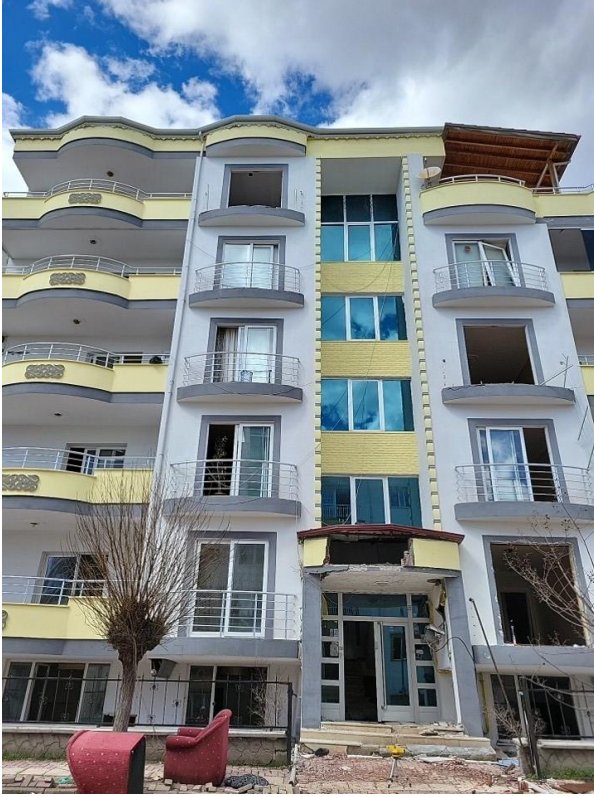
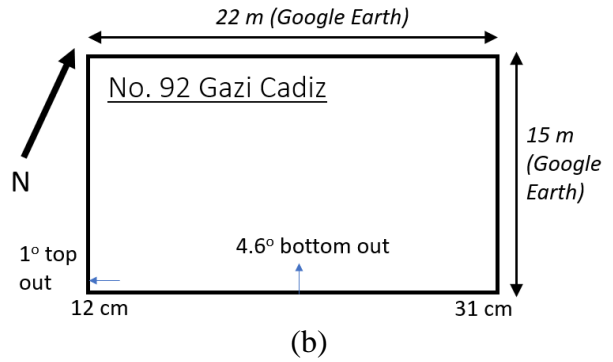
No. 92 Gazi Street (37.7881N, 37.6431E) is a 6-story residential apartment. These 6-stories include a sub-grade first level apartment. The estimated settlement at the southeast and southwest corners, the measured tilts, and estimated dimensions (measured from Google Earth) are summarized in Figure 3.45. The building settlement at the southeast corner was estimated as 31 cm and the building settlement at the southwest corner was estimated as 12 cm, indicating a differential settlement of about 19 cm. The measured tilt on the west side of the building was  $1^\circ$  towards the west. The measured tilt at the front (south side) of the building was  $4.6^\circ$  towards the north.

**Figure 3.45.** No. 92 Gazi Street (a) (37.7880N, 37.6432E; 30MAR2023) street view, and (b) schematic illustration of hand-surveyed settlements, tilts, and estimated dimensions.

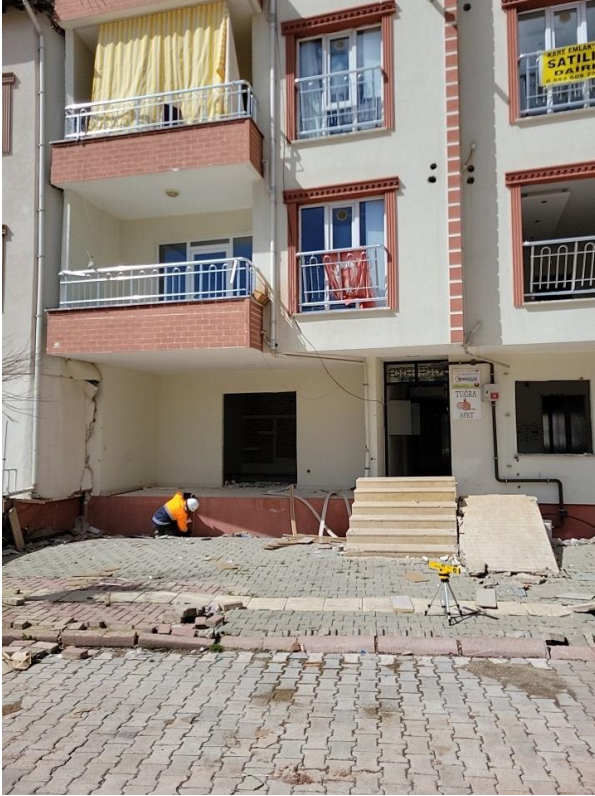
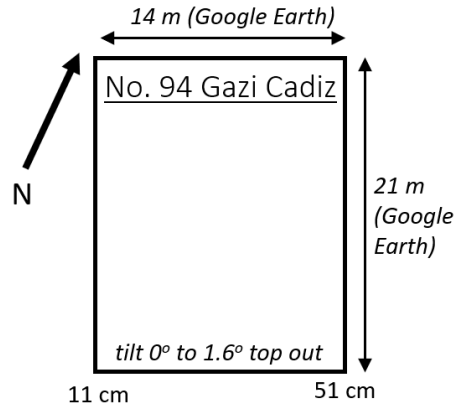
No. 94 Gazi Street (37.7880N, 37.6429E) is a 5-story building with no apparent basement (Figure 3.46a). The building appears to be residential. The estimated building settlement at the southwest corner was 11 cm and 51 cm at the southeast corner. The building tilt at the front (south) face was measured between 0 and 1.6° towards the south (top out). The estimated settlements, tilts, and dimensions are summarized in Figure 3.46b.

**Figure 3.46.** No. 94 Gazi Street (a) (37.7879N, 37.6429E; 30MAR2023) street view, and (b) schematic illustration of hand-surveyed settlements, tilts, and estimated dimensions.

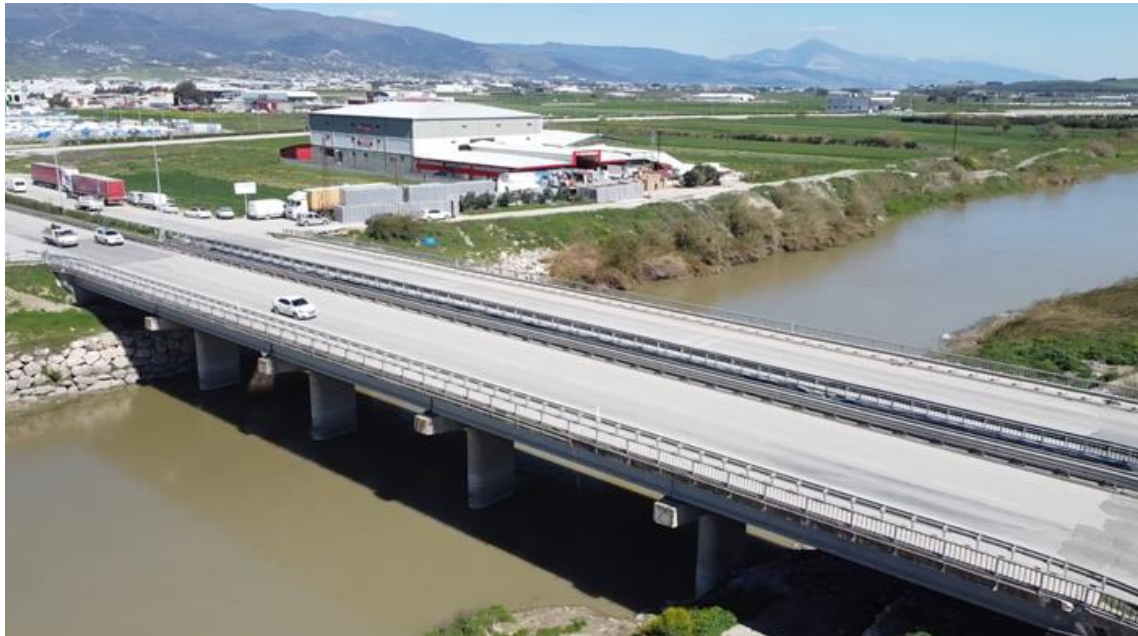
**Figure 4.2.** Drone image of D817 Bridge crossing the Orontes River viewed from the east bank (36.2482N, 36.1999E; 31MAR2023).

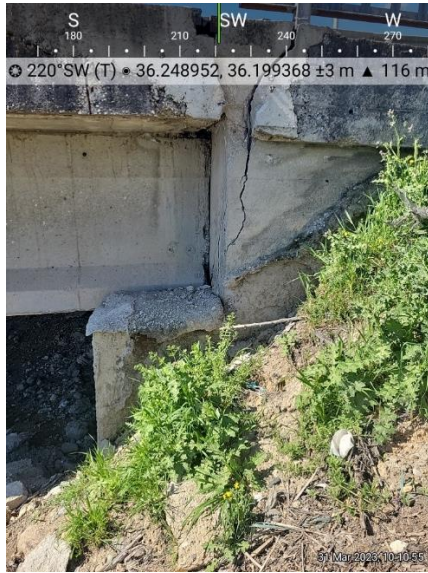
The north and south bridge structure abutments along the west bank were also visually inspected. The north side of the north bridge structure abutment shown in Figure 4.5a, depicts a detached guardrail, a separated concrete deck block, and a 3 cm extensional opening at the top of the deck. The opening on the south side of the same bridge and abutment was observed to be more closed, although no measurements were recorded (Figure 4.5b). The conditions below the deck for the north bridge abutment are shown in Figure 4.5c. As seen at the left edge of this photo, the portion of the abutment beneath the bridge deck had a vertical hairline crack near its south edge, extending through the top half of its face. The abutment face was also measured beneath the bridge deck to have a bottom-out tilt of about 3°. A 3° dip of the deck surface was also measured above this area relative to the approach. The upper ~50 cm of three of the four underlying drilled shafts were exposed, showing visible concrete spalling and 0.5 to 1 cm thick horizontal tension cracks. Concrete spalling was similarly observed along the top of all four shafts for the south bridge abutment (e.g., Figure 4.5d). However, insignificant tilting (< 1°) was observed for this south bridge abutment.

**Figure 4.5.** D817 Bridge damage at west bank abutments: (a) extensional cracks and deck tilt at north side of abutment interface with north bridge (36.2490N, 36.1994E; 31MAR2023), (b) slight separation at south side of abutment interface with north bridge (36.2490N, 36.1994E; 31MAR2023) (c) abutment face crack and spalling of drilled shafts at north bridge (36.2490N, 36.1995E; 31MAR2023), (d) spalling of drilled shaft at south bridge (36.2489N, 36.1993E; 31MAR2023).

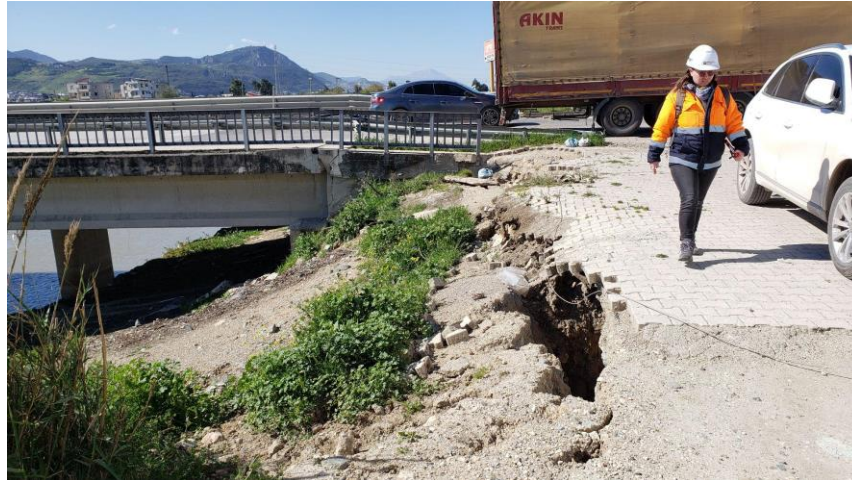
Soil slumping failures and potentially rotational earth slides were observed along both the east and west banks near the D817 bridge. Movements were most significant near the crest of the banks located north of the bridges and appeared to extend 200 m north of the bridge. The movements were measured to spatially vary along the northwest bank with distance from the bridge deck. Within 20 m north of the bridges, a ground crack along the west bank had about 10 to 30 cm of vertical offset (Figure 4.6a), with horizontal offsets of a similar magnitude. About 70 m north of the bridge, in front of a warehouse facility, horizontal cracks of up to at least 80 cm wide were measured (Figure 4.6b). Movement was also observed along the west bank, south of the bridges,

**Figure 4.6.** Local slope failures along west bank near the D817 Bridge: (a) head scarp near north bridge with 10 to 30 cm vertical offset (36.2492N, 36.1995E; 31MAR2023) (b) head scarp north of bridges with up to 80 cm lateral offset and 10 to 30 cm vertical offset (36.2496N, 36.2000E; 31MAR2023), (c) head scarp south of bridges with 30 to 50 cm lateral offset and 50 to 60 cm vertical offset (36.2487N, 36.1990E; 31MAR2023).

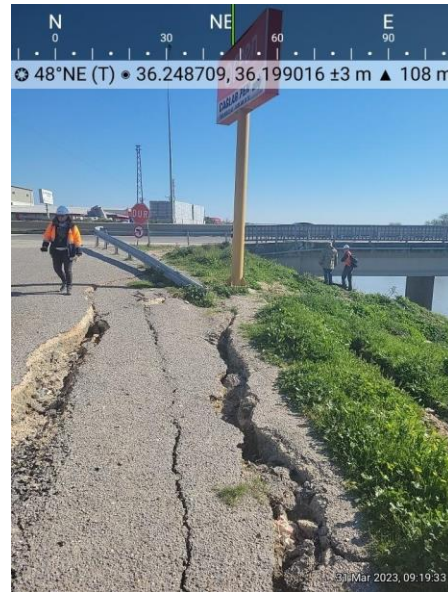
(c)

as shown in Figure 4.6c. Lateral offsets of about 30 to 50 cm, and vertical offsets of about 50 to 60 cm were measured in this area. The slope movements along the river banks displayed ground movements that were consistent with the observed bottom-out tilt of the abutments which induced cracking in some of the piles.

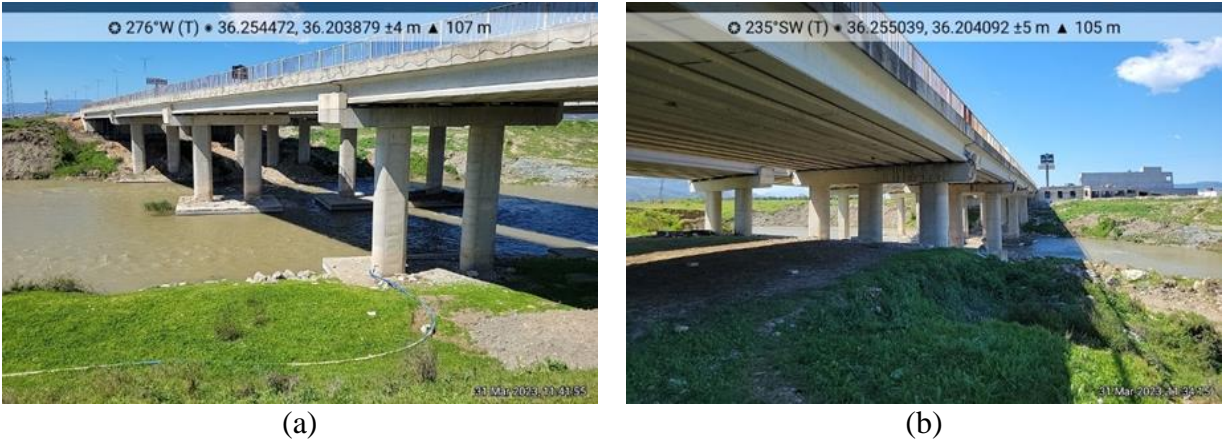
south bridge structure (Figure 4.7a) and a 16 m wide north bridge structure (Figure 4.7b). The south bridge is supported on four bents with two piers each and the north bridge is supported over four bents with three piers each, with large concrete abutments supporting the end spans of both bridges. A post-earthquake satellite image of the bridge decks is shown in Figure 4.8 with some of the observations by the GEER team labeled.

**Figure 4.7.** ‘Hatay Stadium’ Bridge viewed from the east bank of the Karasu River: (a) south bridge structure (36.2547N, 36.2039E; 31MAR2023), and (b) north bridge structure (36.2550N, 36.2041E; 31MAR2023).

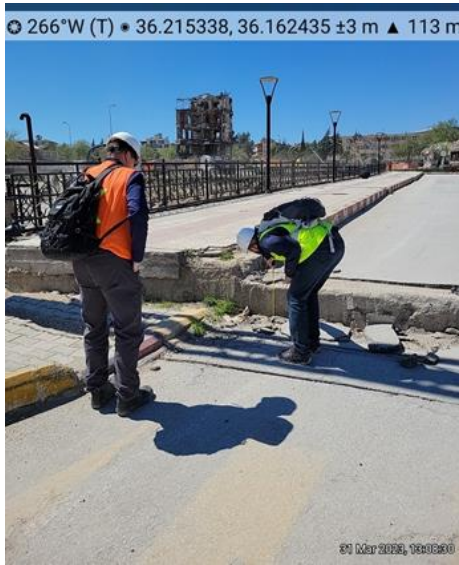
Significant displacements and damage were observed along the deck of the south bridge structure. At the east end of the bridge, the deck was uplifted by 37 cm relative to the adjacent approach (Figure 4.15a). At the west end of the bridge, significant compressive deformations were apparent from amid broken up and compressed pavement slabs. Measurements of the displaced pavement slabs atop the bridge decks slabs suggest that the deck had compressed towards the approach with a displacement of about 50 cm at the south end and 20 cm at the north end of the south span (Figure 4.15b). A thin mound of soil was also observed across the deformations in this area, likely to allow easier access for construction traffic. Above and parallel to the wall piers, the bridge deck

**Figure 4.15.** Deformations along south bridge deck: (a) east edge of deck is 37 cm higher than adjacent approach (36.2153N, 36.1624E; 31MAR2023), (b) pavement buckling with up to 50 cm of compression (36.2156N, 36.1619E; 31MAR2023), (c) extensional cracks above wall piers (36.2154N, 36.1620E; 31MAR2023), (d) observed compression along pipeline (36.2153N, 36.1624E; 31MAR2023).

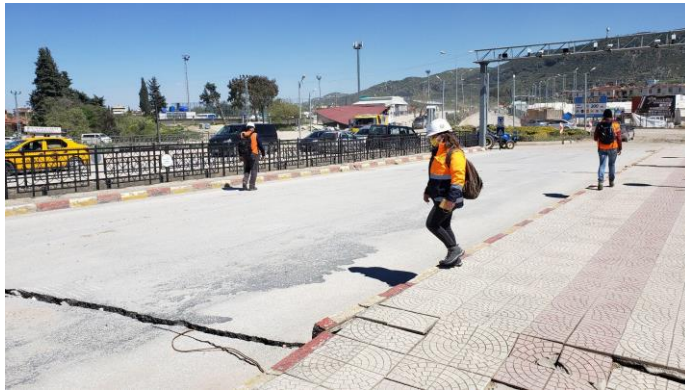
(c)

sustained extensional cracks as depicted in Figure 4.15c. A pipeline along the south span deck appeared to have generally compressed (Figure 4.15d).

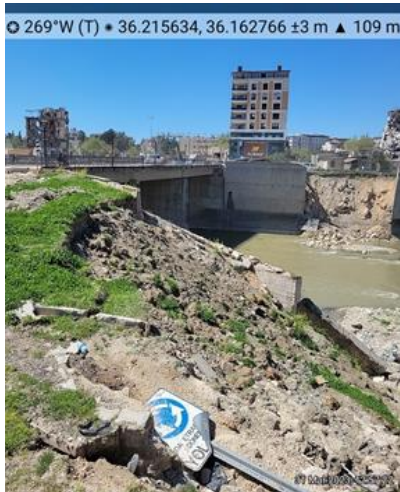
Retaining wall failures were observed at the wingwalls of all four corners of the Bekir Karabacak twin bridge. The failures at the northwest and northeast corners of the bridges are depicted in Figure 4.16a, and failures at the southwest and southeast corners are depicted in Figure 4.16b. The overall wall height above the water is over 6 m based on a rough estimate. The failures along the west bank revealed the retained fill as containing a significant volume of large cobbles and boulders. The east bank fills contained smaller cobbles and rock fragments, and was primarily composed of finer soils. It appeared that the bridge decks helped to restrain partially the movement of the abutment walls.

**Figure 4.16.** Retaining wall failures: (a) northeast failure in foreground and northwest failure in background (36.2156N, 36.1628E; 31MAR2023), and (b) southwest failure in background and partial view of southeast failure in foreground (36.2150N, 36.1624E; 31MAR2023).

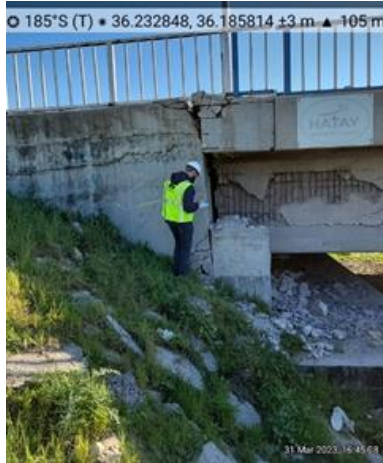
The east abutment was inspected in greatest detail, due to ease of accessibility and more obvious damage. The portion of the abutment supporting the north and south bridge deck approaches was damaged with compressive fractures and spalling near the base of the deck girders. The bridge approach sections were tilted down away from the river at an angle of 1 to 2°. This resulted in a gap of 10-12 cm at the north bridge (Figure 4.19a), and 12-16 cm at the south bridge, as measured along the approach-to-deck interface at the road surface. The north bridge structure deck shifted right laterally (northward) by 17 cm (Figure 4.19b), whereas such transverse movements were not apparent for the south bridge structure deck and supporting pipeline. Below the deck, the girders were cracked, and shear key damage between the girders was observed. The girders had clearly shifted relative to the bearing pads beneath them.

**Figure 4.19.** Damage at east abutment of Utku Acun Street Bridge: (a) north side of abutment is tilted  $1^{\circ}$  to  $2^{\circ}$  back (deck approach shifted away from river), with a separation gap of over 12 cm near the deck (36.2329N, 36.1858E; 31MAR2023), (b) north bridge deck shifted about 17 cm to the north (36.2329N, 36.1858E; 31MAR2023), and (c) girder and shear key damage (36.2327N, 36.1856E; 31MAR2023).

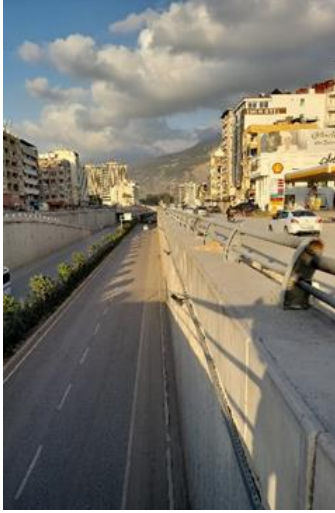
**Figure 4.24.** U-box underpass in İskenderun, Hatay: (a) (36.5829N, 36.1691E; 28MAR2023) negligible damage observed along retaining wall, (b) (36.5828N, 36.1679E; 28MAR2023) sidewalk damage from the street level above the underpass, and (c) (36.5825N, 36.1678E; 28MAR2023) drainage from storm drains.
