3. EPICENTRAL REGION

This chapter summarizes the observations made by GEER Team members on the geotechnical/geological aspects of the M_w 5.8 Mineral, Virginia earthquake of 23 August 2011 in the epicentral region. Within hours of the event, members of the team arrived in the epicentral region (i.e., Louisa County, Virginia) to document perishable data that potentially could be used to advance the geo-engineering profession's understanding of the geotechnical/geological aspects of earthquakes in general, and of intra-plate earthquakes more specifically. The team focused on documenting tectonically/seismically-induced ground deformations, evidence of liquefaction and lateral spreading, land/rock slides, ground subsidence, performance of earthen dams, damage to building foundations, and damage to public infrastructure and lifelines, among other effects of the earthquake. The team began collecting data on the night of the main shock (i.e., 23 August 2011) and continued for several months thereafter, with the majority of effort being concentrated in the few days immediately following the main shock. The documentation of the data following the event was time critical because of the hea

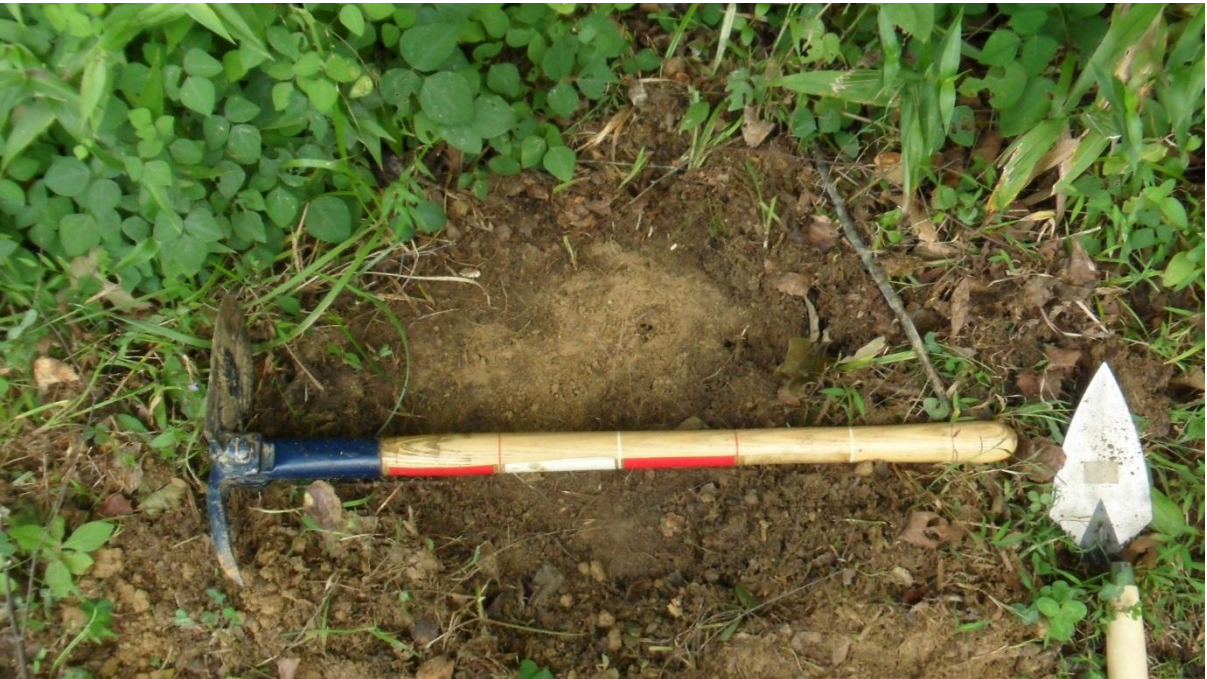
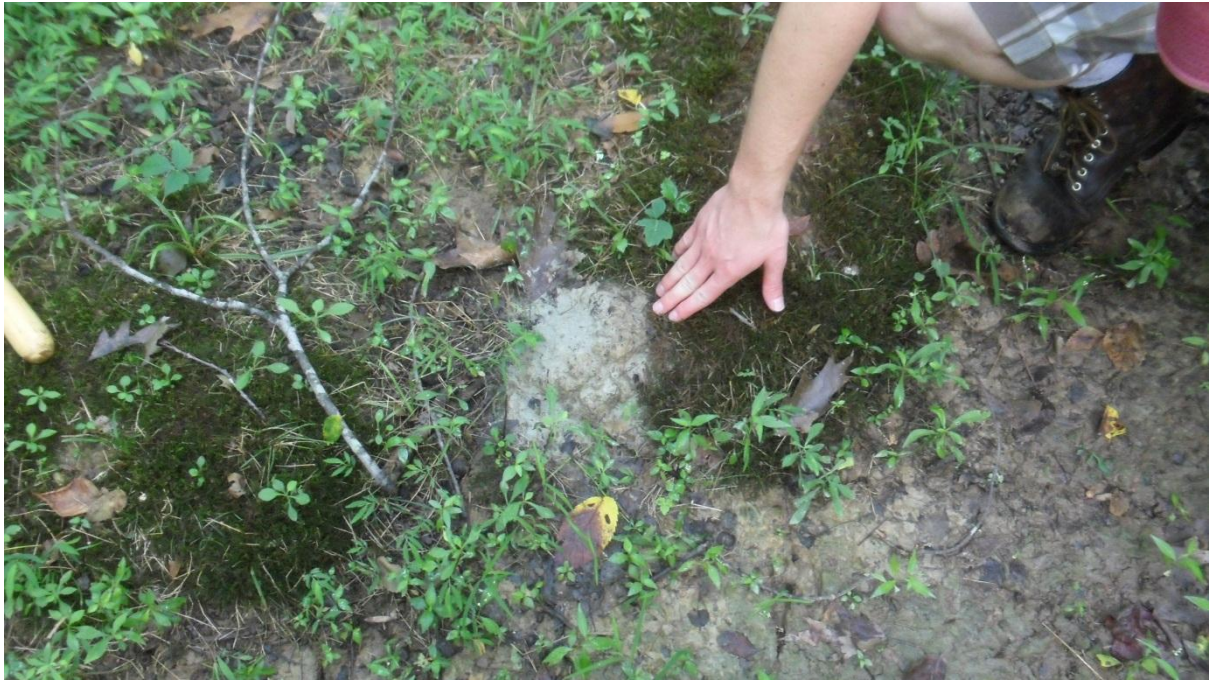
The liquefied soil was coarse sand, with the feature in the drainage channel containing some plasticity. No feeder dikes could be found for the features in the S. Anna River riverbed (Figure 2b), but the riverbed was very gravelly and the water table was only an inch or two below the ground surface. As a result, a clean cut could not be made vertically through the feature and the cut quickly filled with water. The features on the roadside (Figures 2c,d) and the feature in the drainage channel in the woods (Figures 2e,f) both appeared to have vented through existing animal holes or burrows.

Figure 2. Liquefaction sand boils found in the epicentral region: (a) two sand boils in the S. Anna River riverbed near Yancy Mill (features found by Jeff Munsey, TVA) (37.93839, 77.98269); (b) cross-sectional cut through one of the sand boils in the S. Anna River riverbed. The trowel points to a layer of leaves, indicating that the blow material was recently placed; (c) sand boil found across the road from the features in the riverbed (feature found by Ed Harp, USGS) (37.93807, -77.98238); (d) horizontal cut through the roadside feature showing a plan view of the feeder dike; (e) sand boil found in a drainage channel in the woods of Bend

of River Rd (37.95668, -78.00502); (f) horizontal and vertical cut through the drainage channel feature.

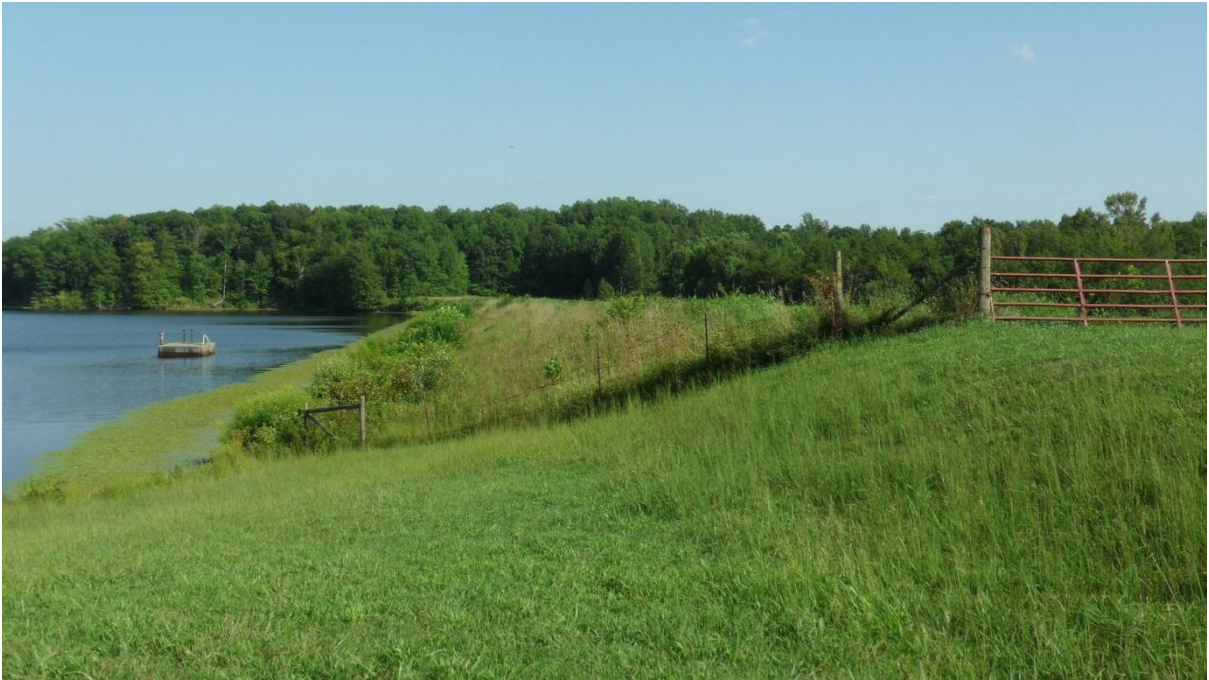
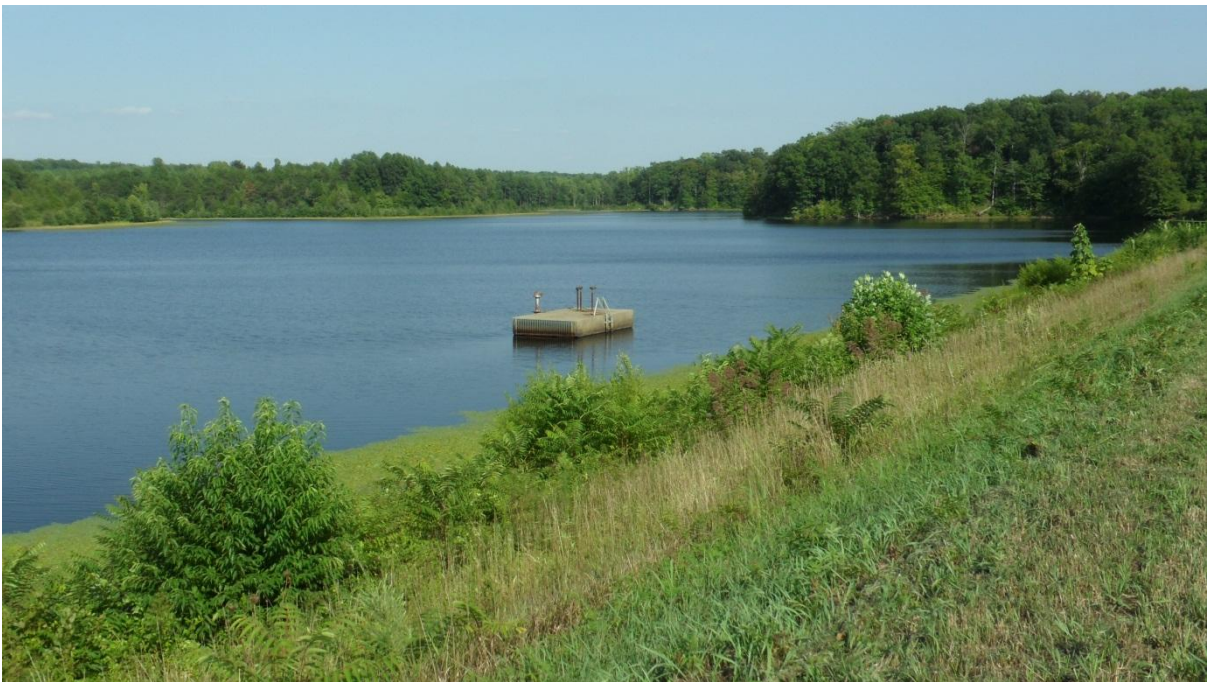
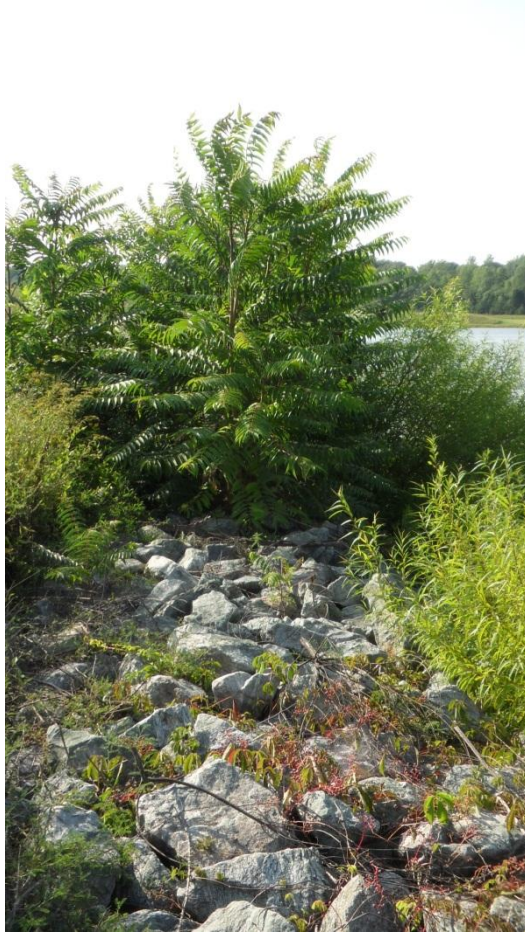
Figure 28. Northeast Creek Reservoir Dam (37.98087, -77.93952).

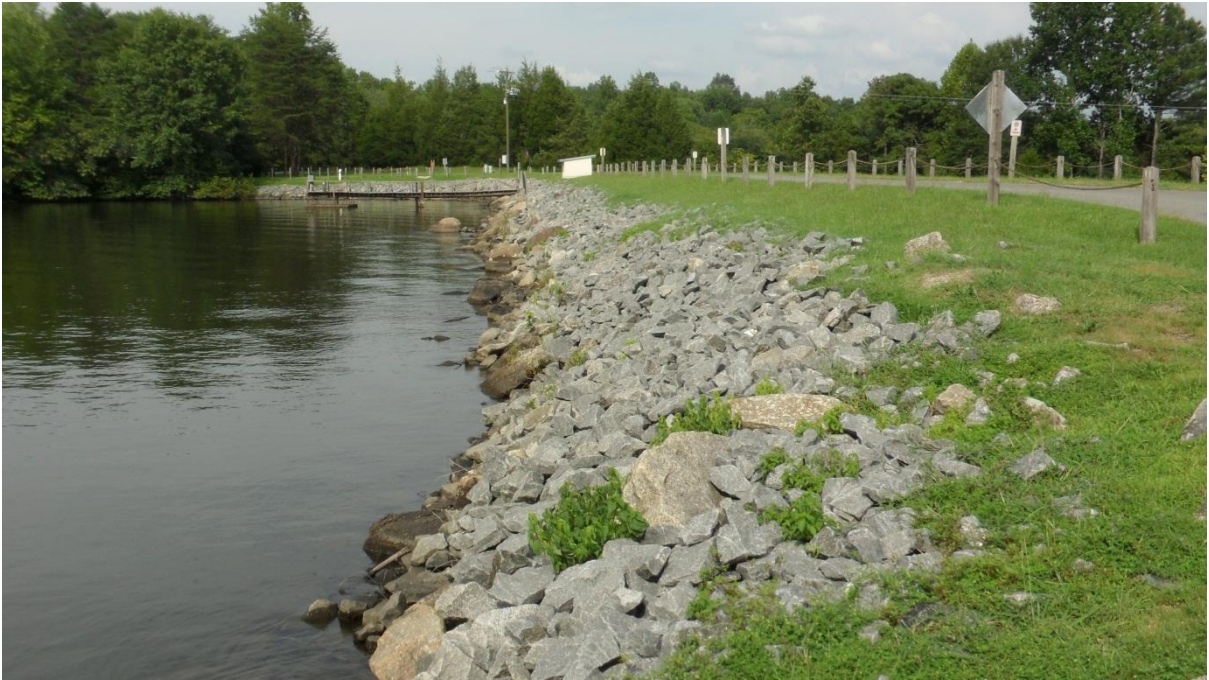
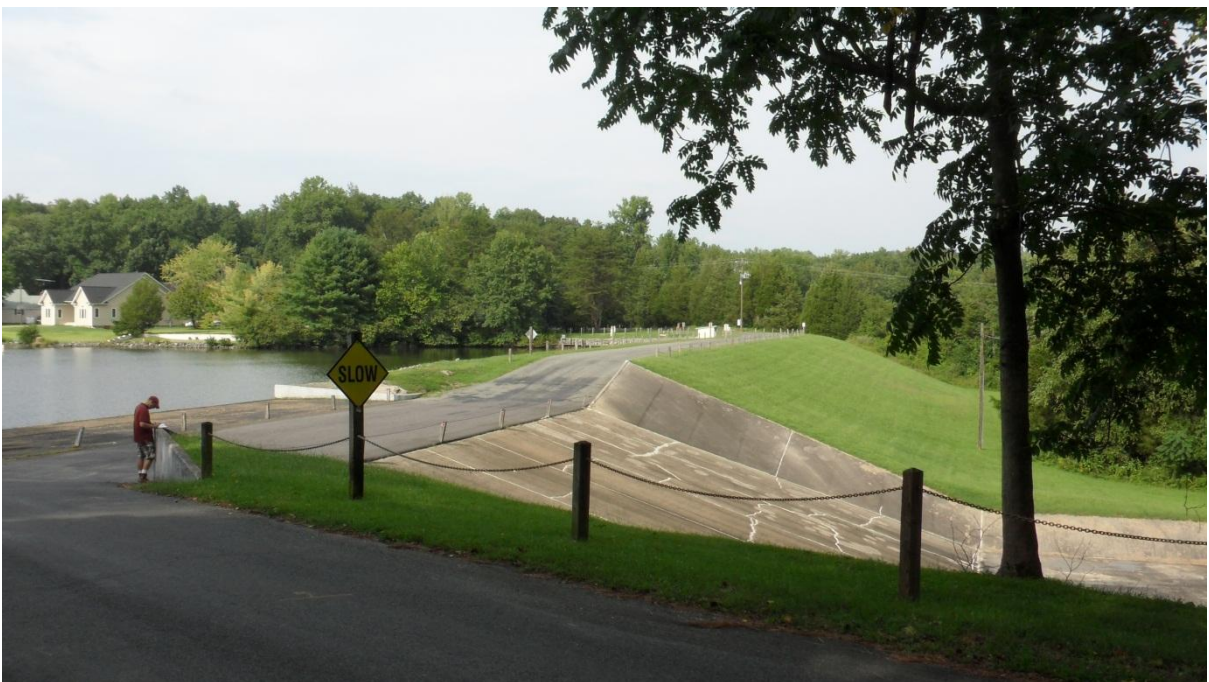
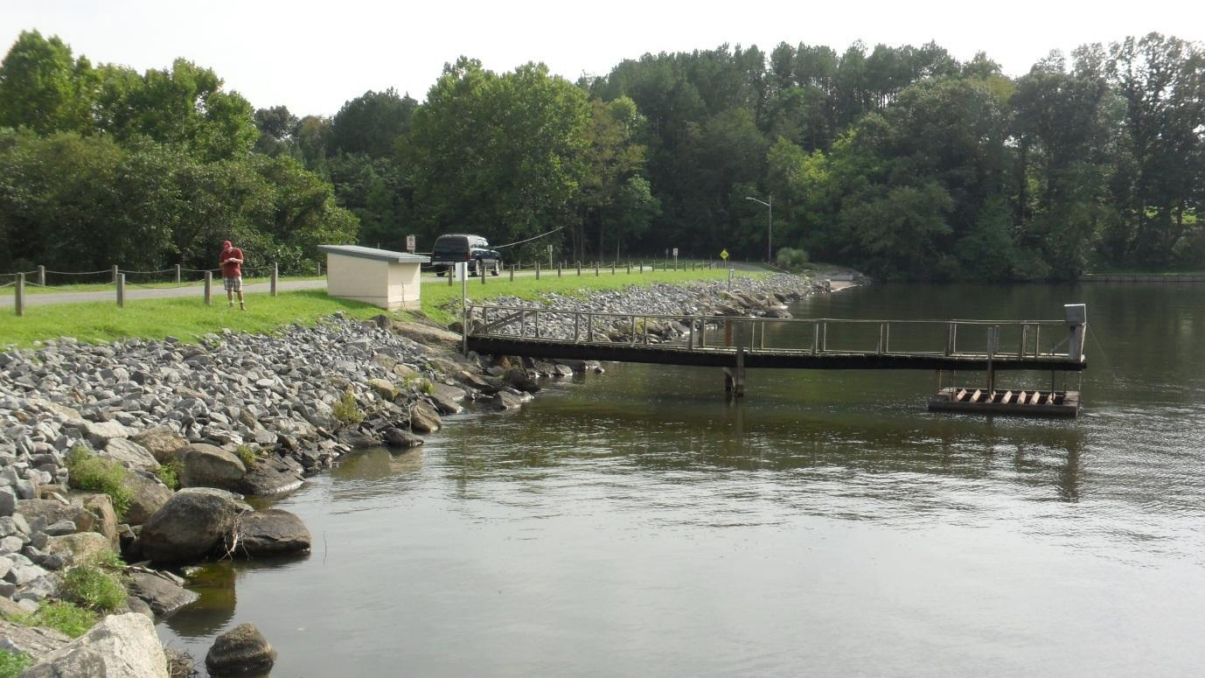
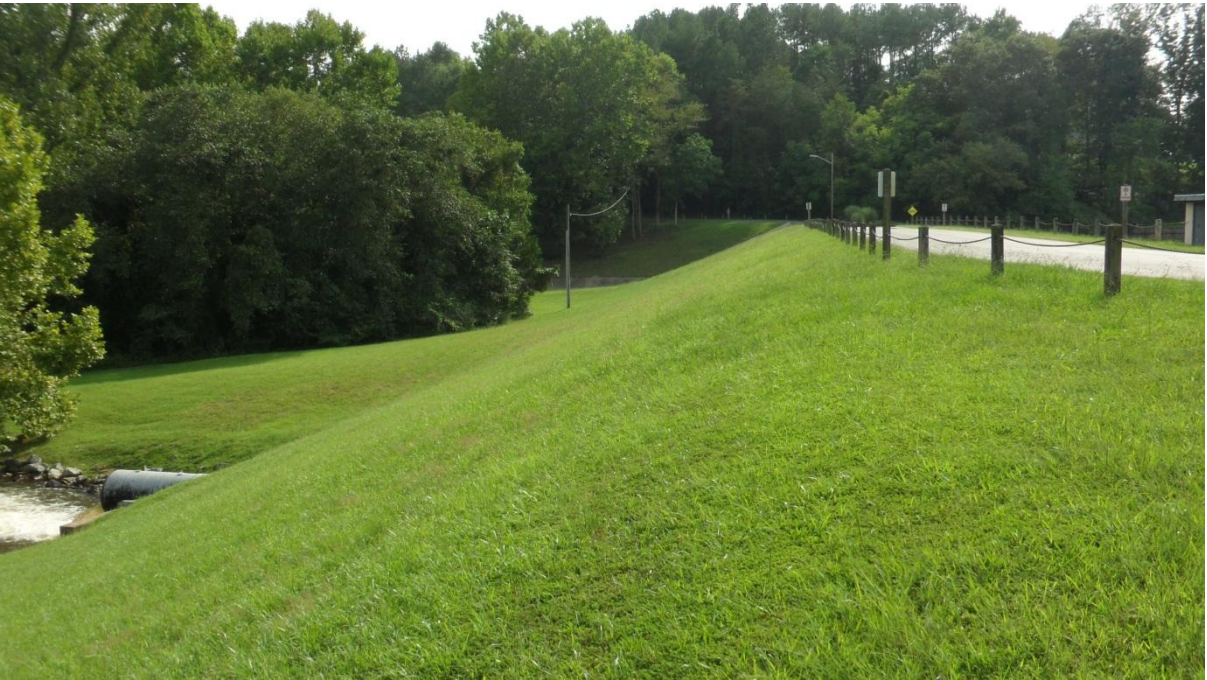
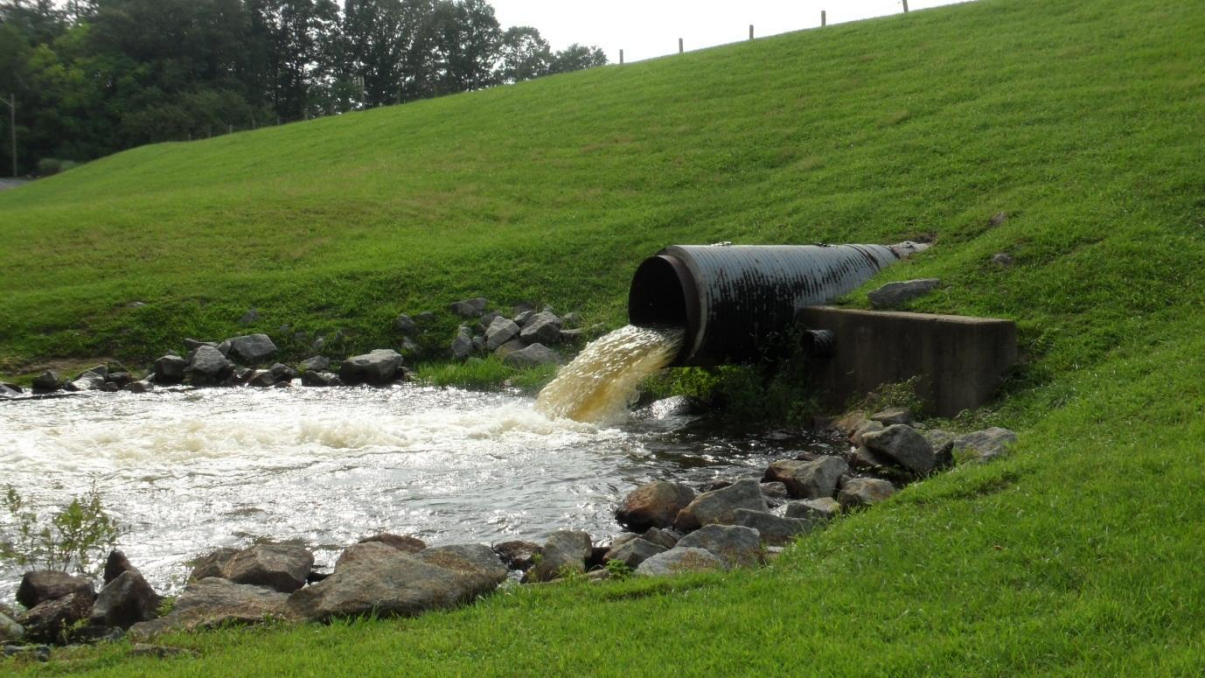
Figure 29. Lake Louisa dam and outflow (38.11439, -78.01041).

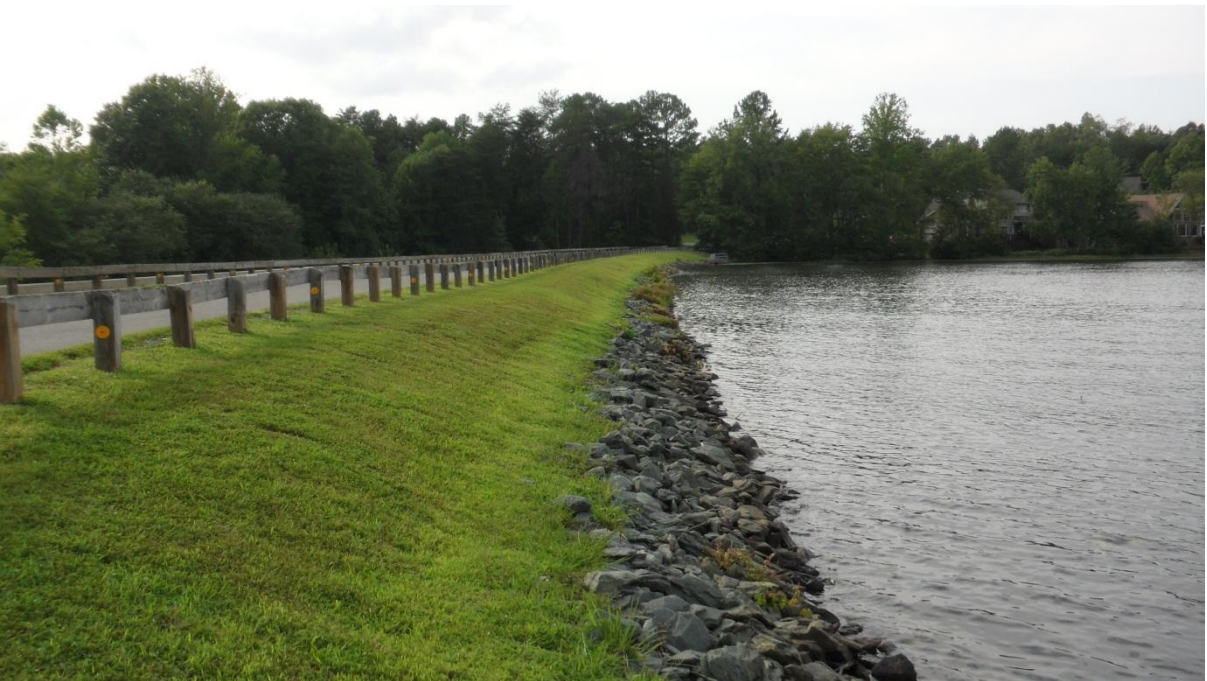
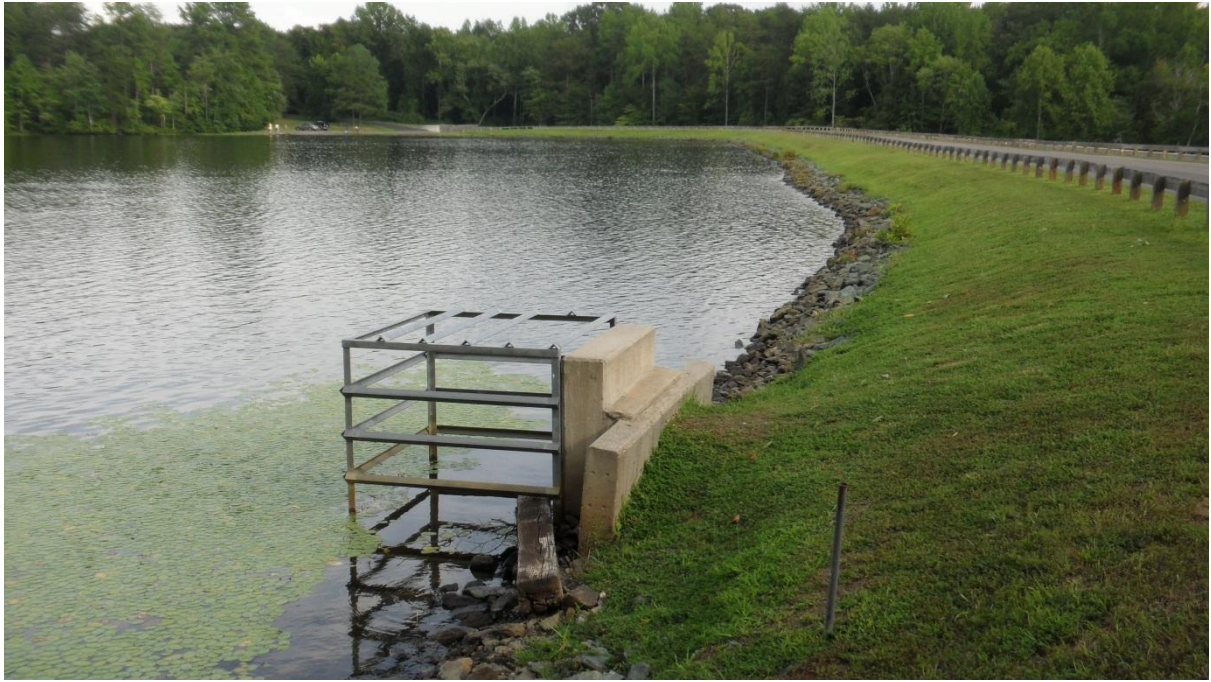
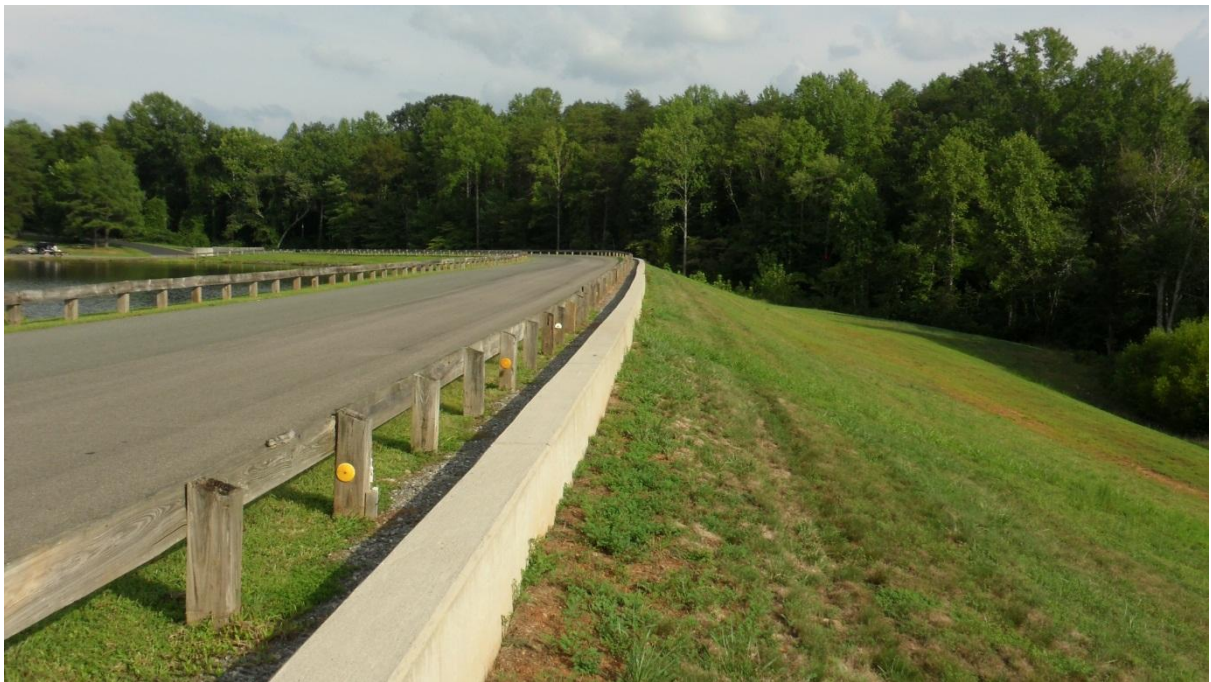
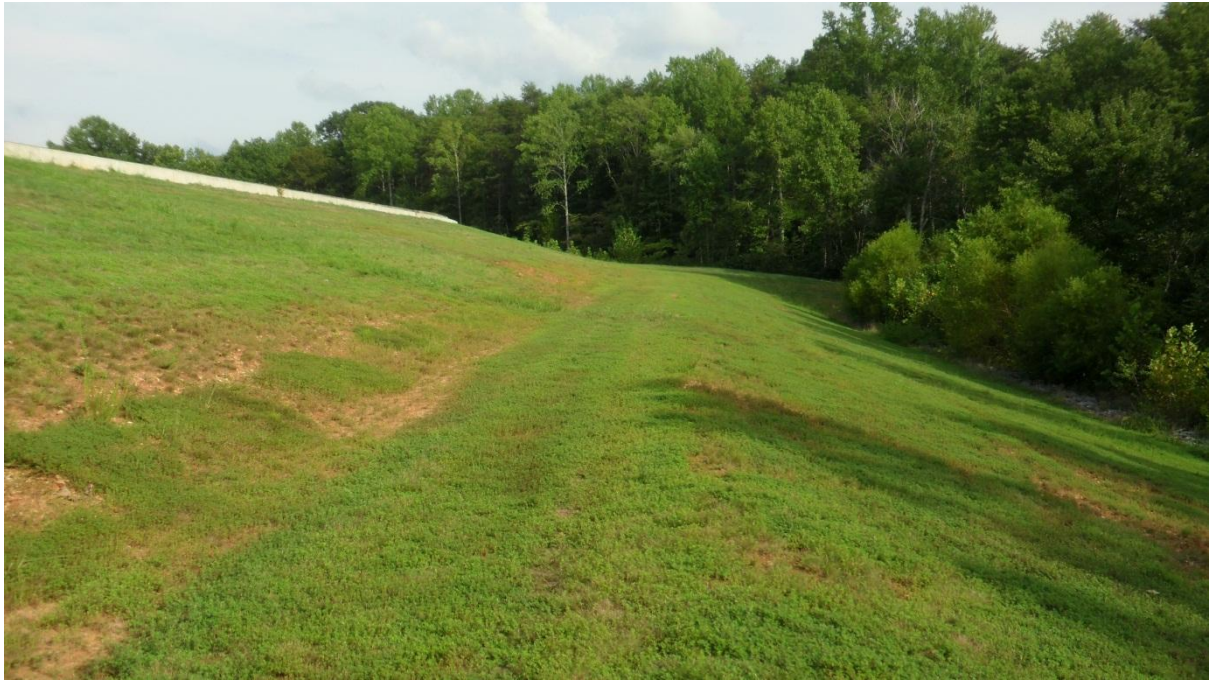
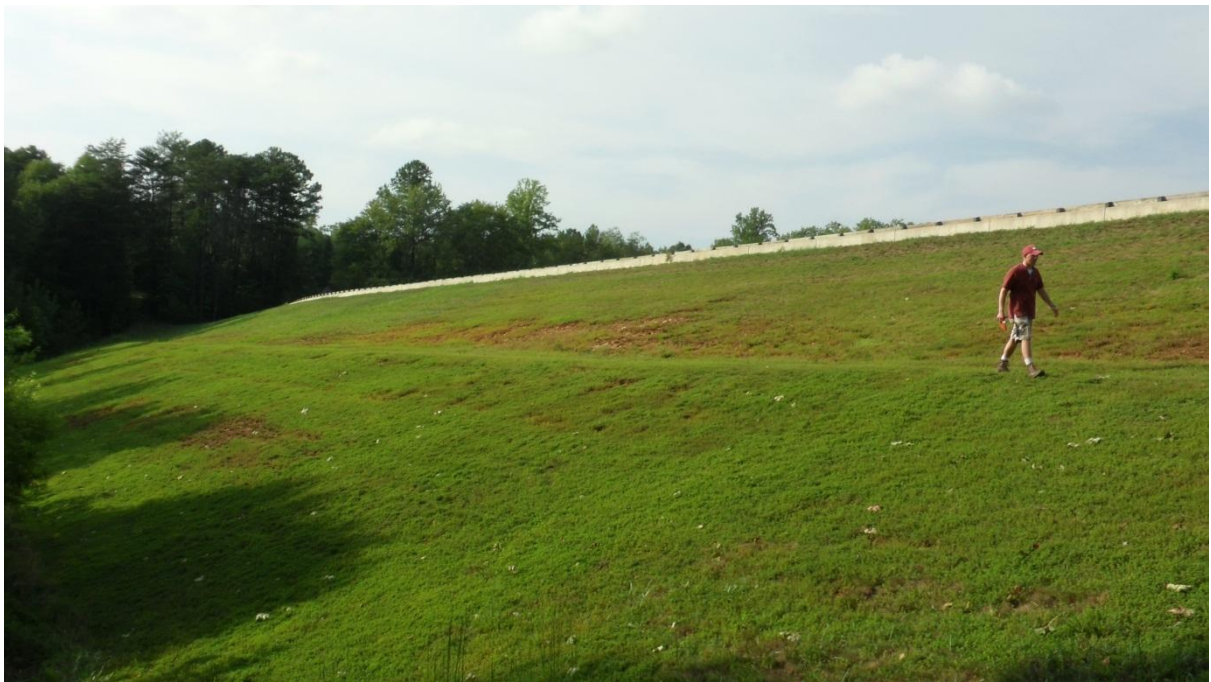
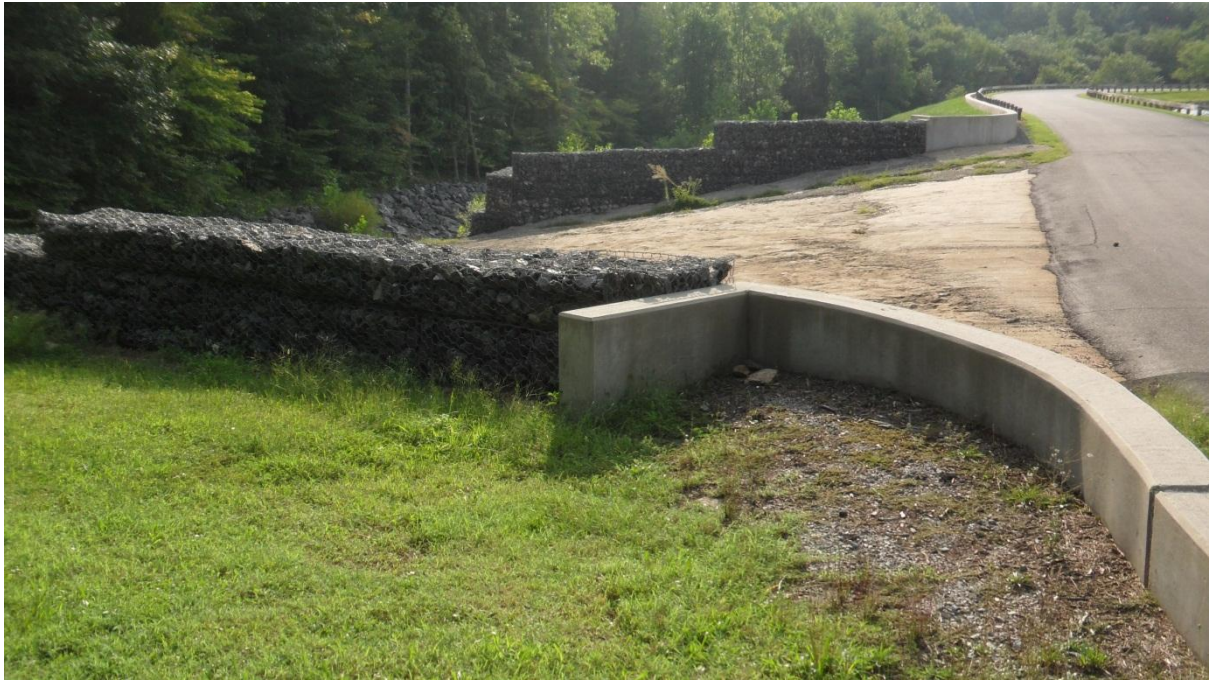
Figure 30. Izac Lake dam (38.07649, -78.14759).

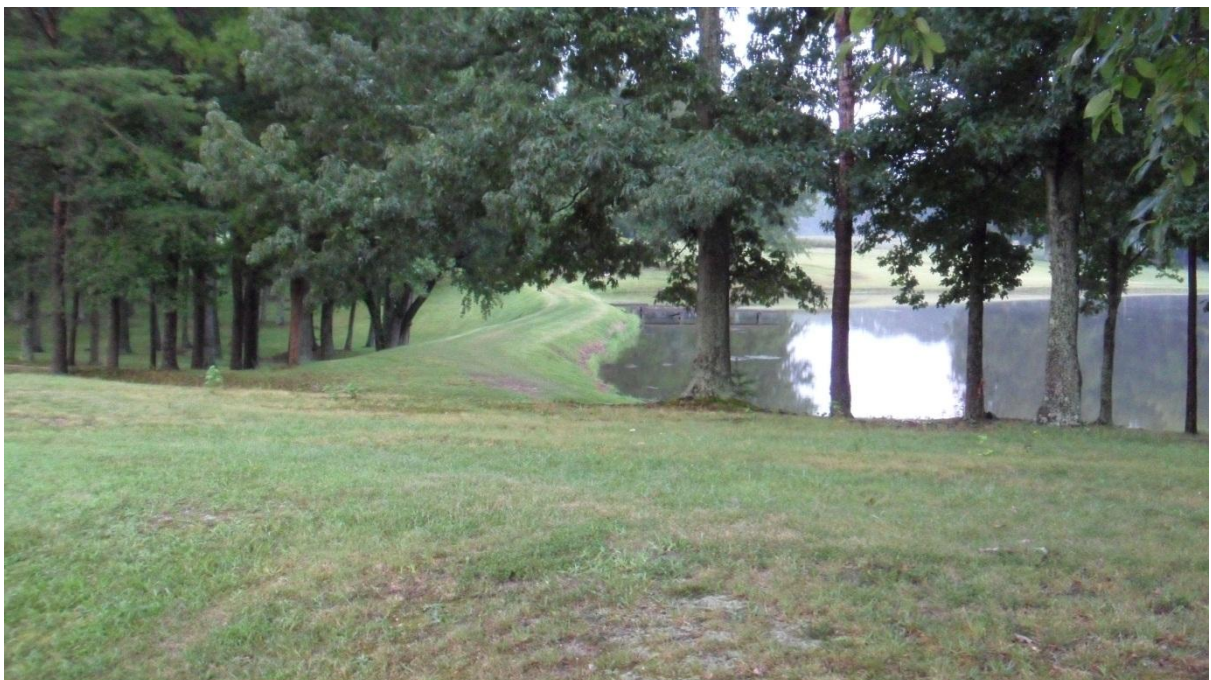
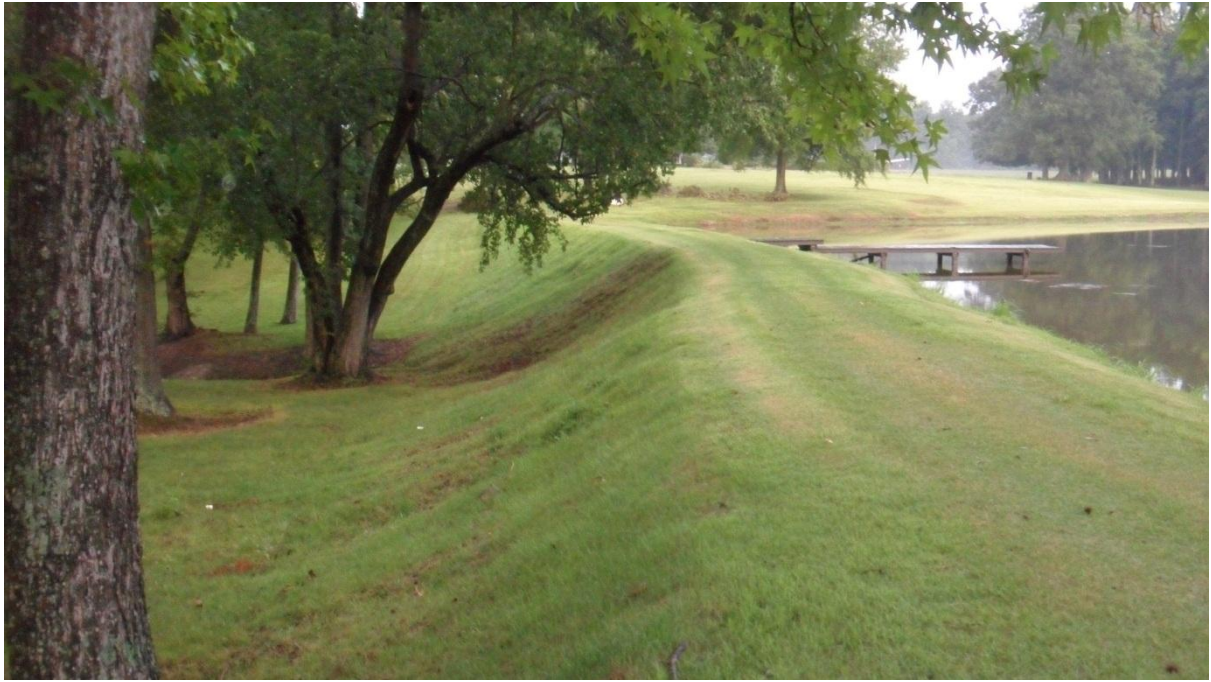
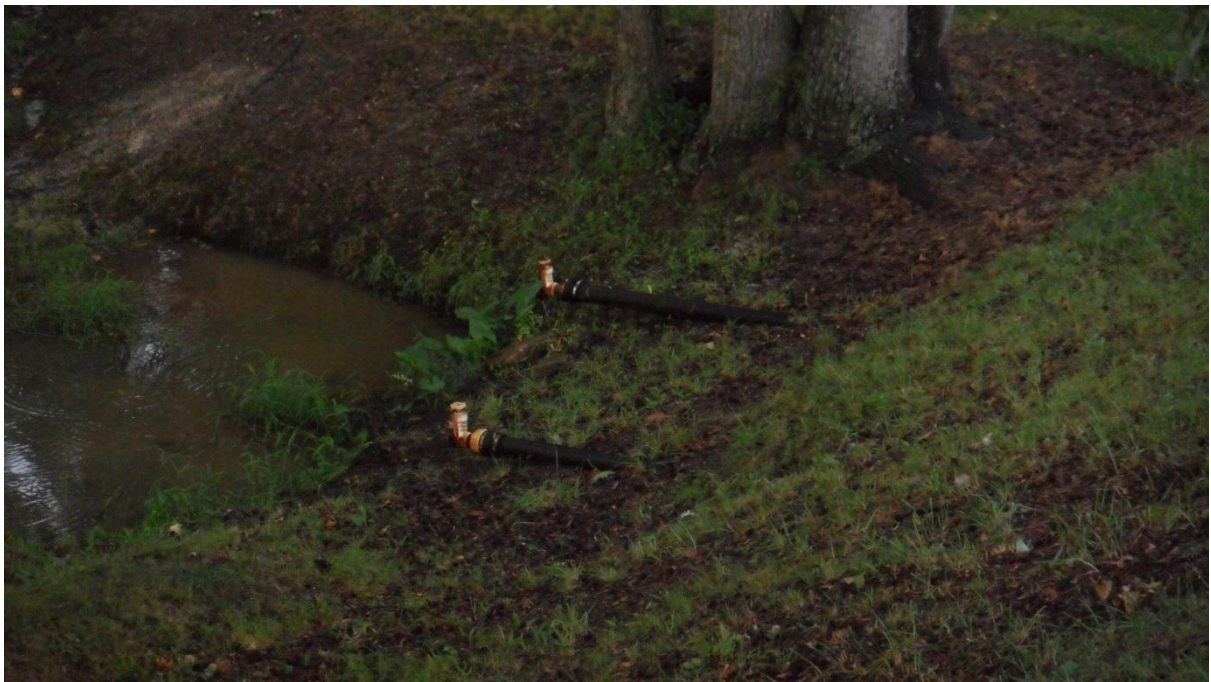
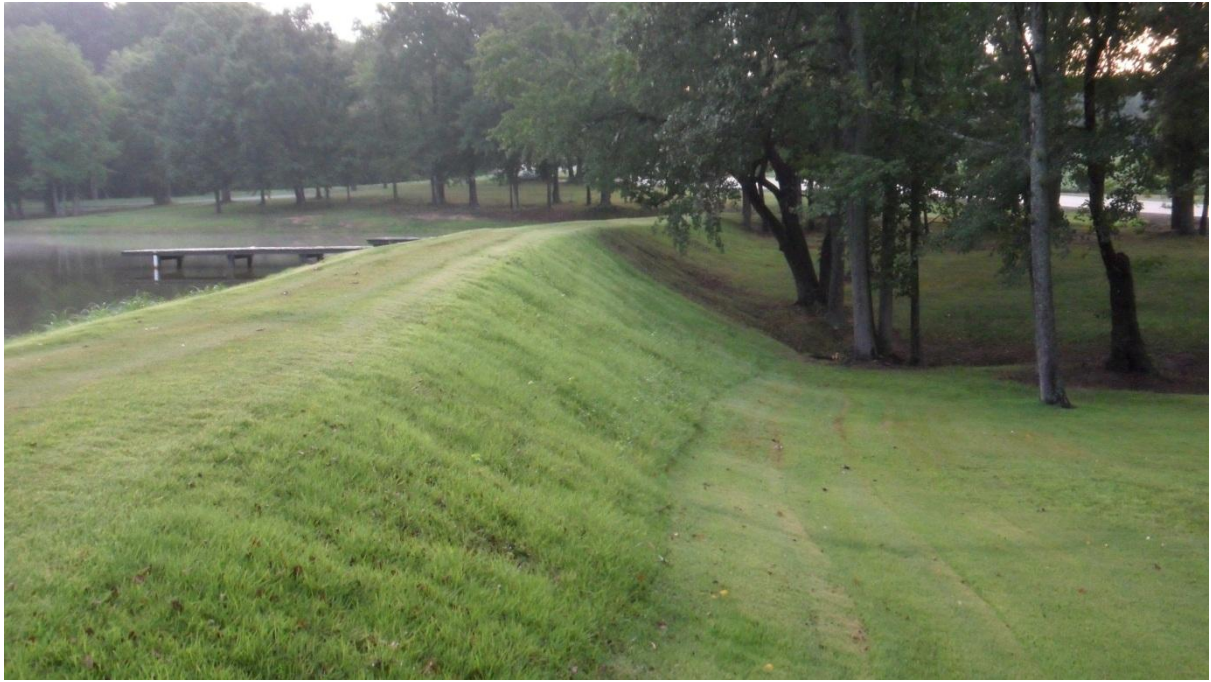
Figure 31. Greenes Corner Road Dam (38.00511, -77.70724).

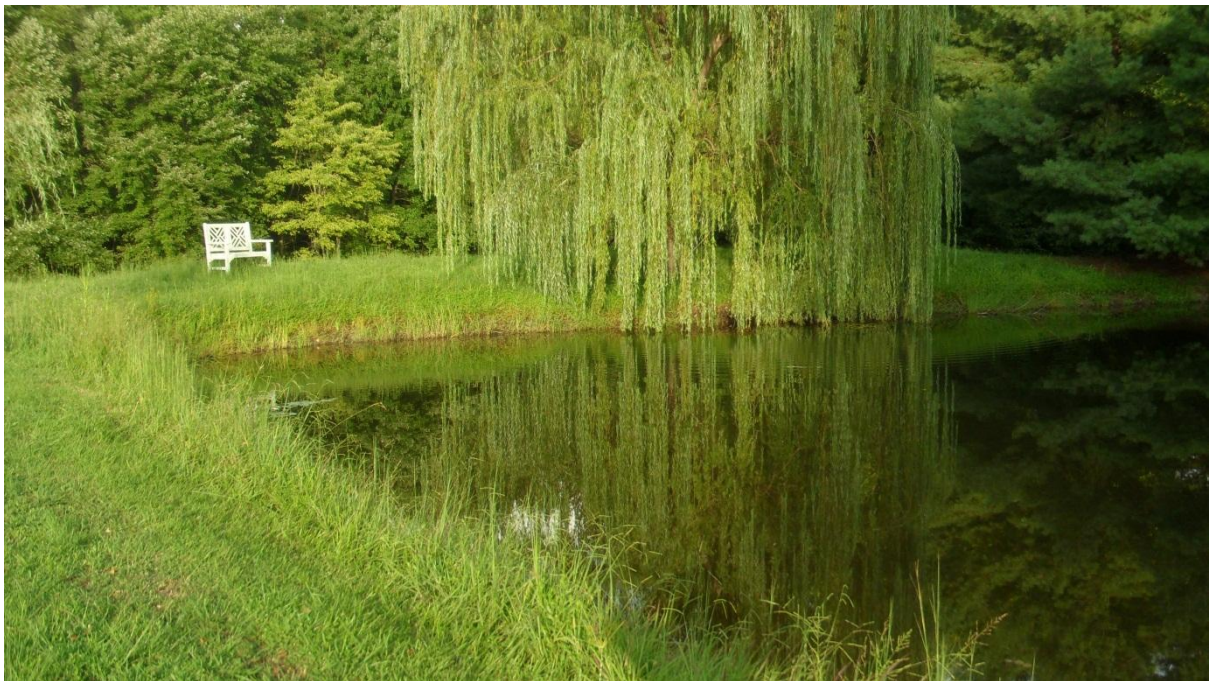
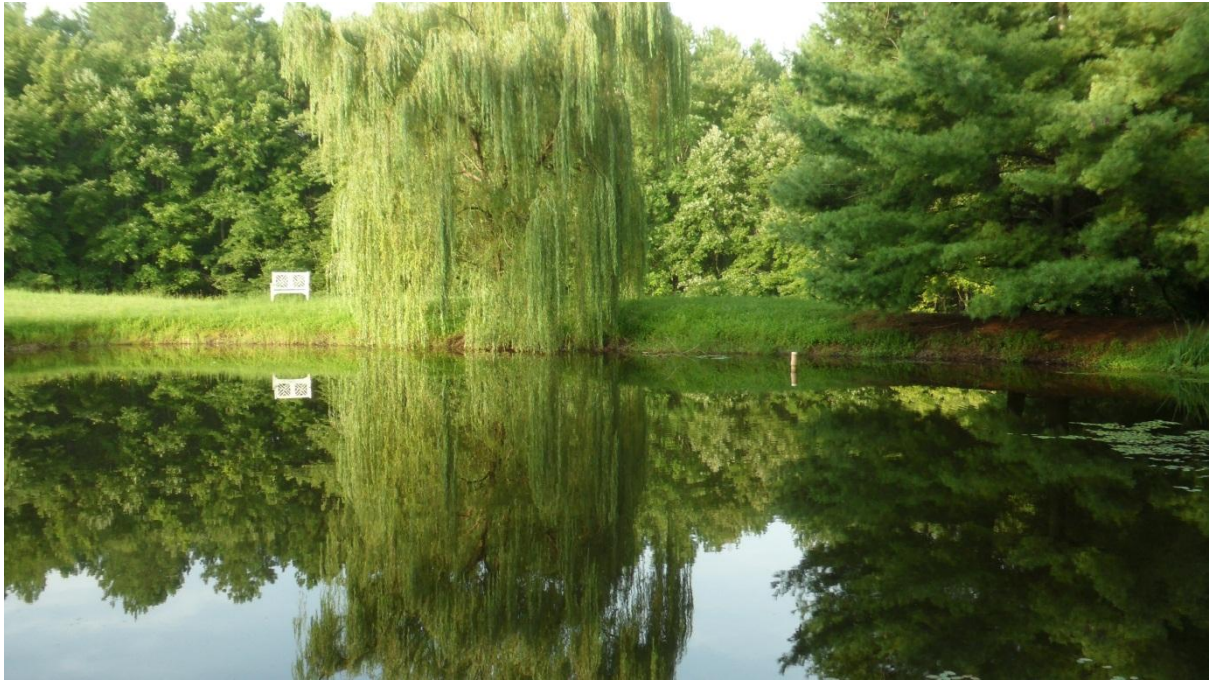
Figure 32. Pendleton House Dam (37.95283, -77.89812).

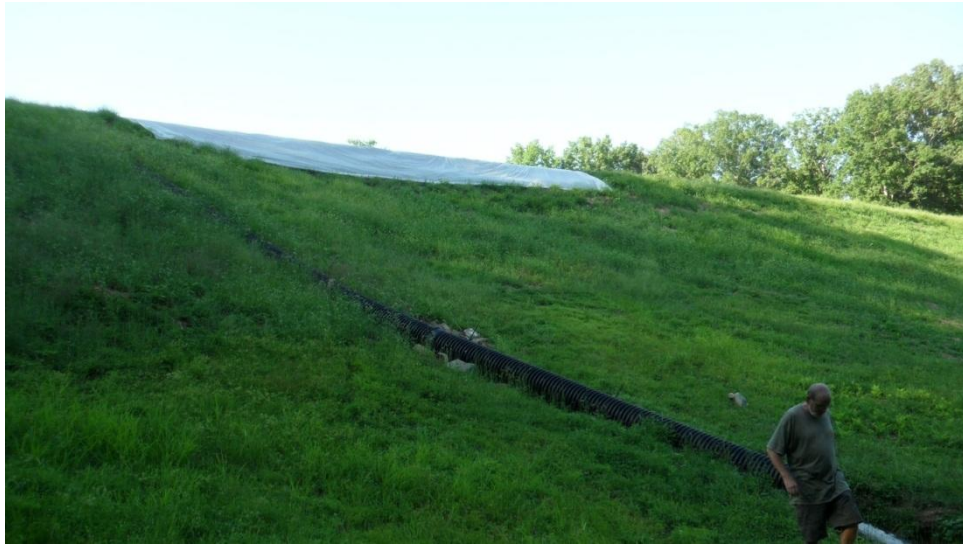
A team member met with W. Gray, the president of the homeowners association that owns the dam, on 9 September and inspected the dam. W. Gray said that 3 days before the earthquake they had 17.8 cm of rain in 12 hours. The saturated ground conditions likely triggered the initiation of the slide that occurred while the homeowner was weed eating, with the earthquake shaking making the slide worse. W. Gray said they covered the slide shortly after the earthquake with a plastic sheet to prevent water from flowing into the scarp. Photos of the slide taken both before and after it was covered with the plastic sheet are shown in Figure 34.

Figure 34. Shallow slide in the Elk Garden Lake Dam (37.4223, -79.5009): (a) photo of the shallow slide on the downstream face of the dam; (b) closer view of the shallow slide on the downstream face of the dam; (c) photo of head scarp of slide; (d) photo of slide taken from downstream toe of the dam; (e) photo showing head scarp covered with plastic sheet; (f) closer view of plastic sheet covering the head scarp; and (g) photo of plastic sheet taken from downstream toe of dam.

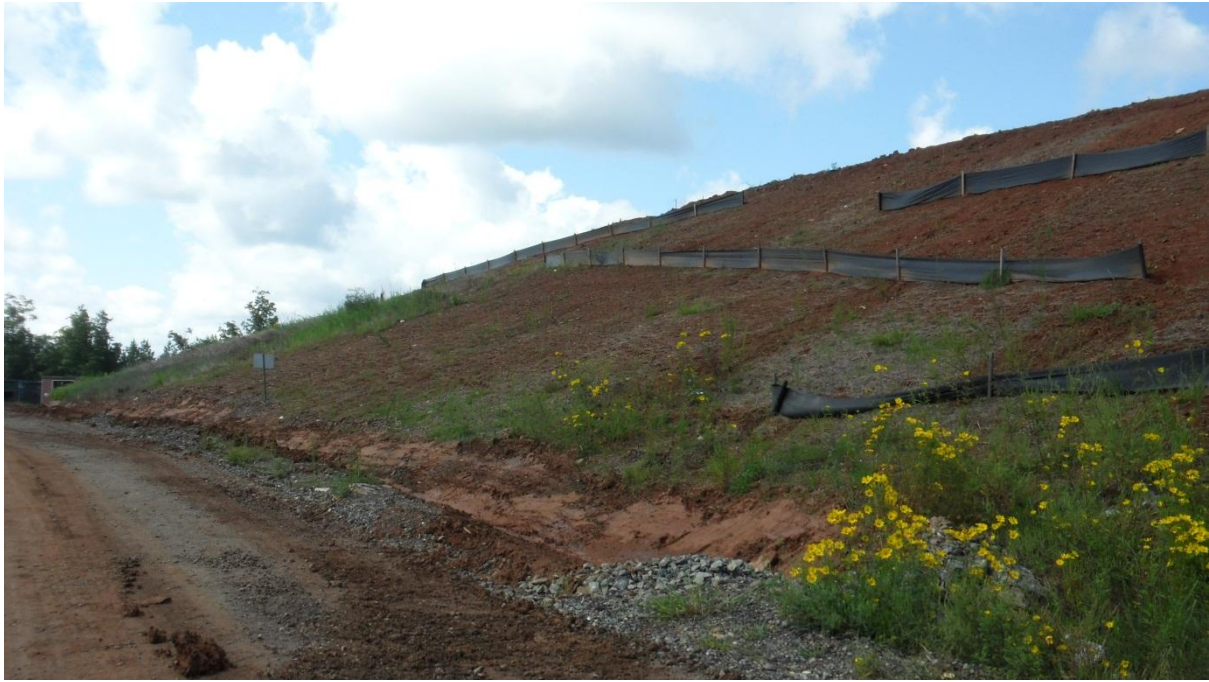
Figure 36. Photos of the front slope of the Louisa County landfill (37.98670, -77.88474).

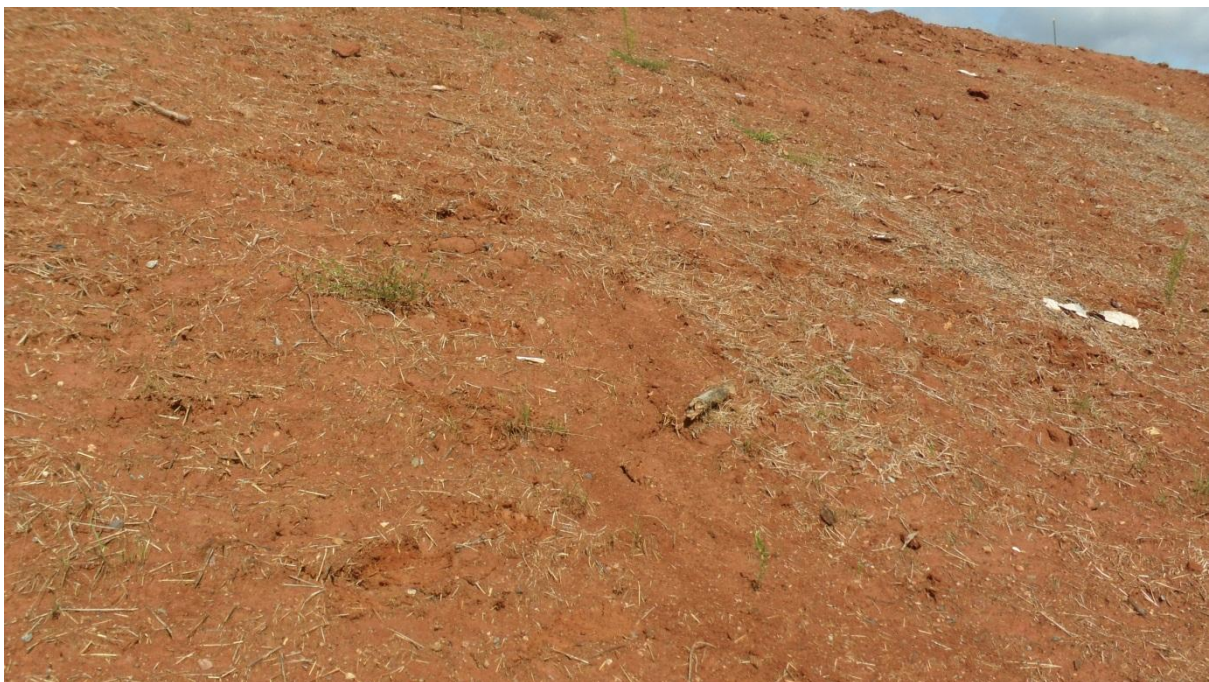
(a)

The Louisa County landfill was inspected on 9 September. It is located ~10 km from the epicenter of the main shock as shown in Figure 35. A team member talked with R. Petty, who is the operations manager for the landfill and who was present at the landfill during the earthquake. R. Petty said he noticed a small crack on the front slope of the landfill immediately after the earthquake. The crack was ~2.5 cm wide, but R. Petty was uncertain whether it was there prior to the earthquake. Photos of the front slope of the landfill are shown in Figure 36. By the time R. Green visited the landfill, the crack had largely filled in as a result of the heavy rains from hurricane Irene. However, the crack looked like it was the scarp of a shallow slide in the temporary clay cover; remnants of the crack are shown in Figure 37.

Figure 37. Photos showing the remnants of a crack in the front slope of the landfill that might have formed as a result of the earthquake shaking.

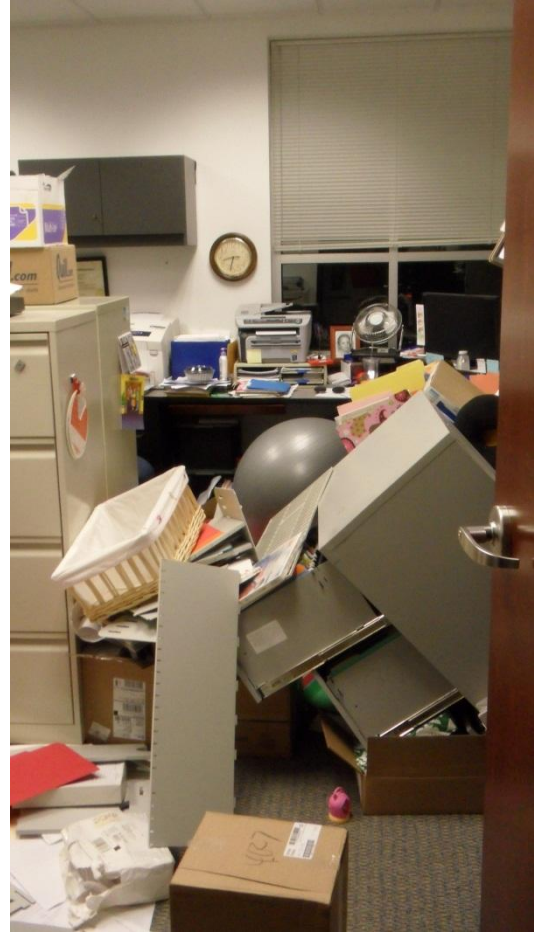
(b)

Team members inspected the Louisa County Public School Administration Building and the Louisa County High School on 23 August, about 6 hrs after the main shock and about a half hour after a $M_w 4.2$ aftershock. The two buildings are located in the same complex, ~0.5 km apart. The Administration building only had minor cracking in the walls, but the internal contents of the building were in complete disarray. Photos of some offices in the Administration building are shown in Figure 40. The major axis of the building is in the NW-SE direction and the majority of the items that were tipped over were those along the NW and SE walls.

Figure 40. Typical damage to internal contents of offices in the Louisa County Public School Administration Building (38.02066, -77.92373).
