3. EPICENTRAL REGION

This chapter summarizes the observations made by GEER Team members on the geotechnical/geological aspects of the M_w 5.8 Mineral, Virginia earthquake of 23 August 2011 in the epicentral region. Within hours of the event, members of the team arrived in the epicentral region (i.e., Louisa County, Virginia) to document perishable data that potentially could be used to advance the geo-engineering profession's understanding of the geotechnical/geological aspects of earthquakes in general, and of intra-plate earthquakes more specifically. The team focused on documenting tectonically/seismically-induced ground deformations, evidence of liquefaction and lateral spreading, land/rock slides, ground subsidence, performance of earthen dams, damage to building foundations, and damage to public infrastructure and lifelines, among other effects of the earthquake. The team began collecting data on the night of the main shock (i.e., 23 August 2011) and continued for several months thereafter, with the majority of effort being concentrated in the few days immediately following the main shock. The documentation of the data following the event was time critical because of the hea

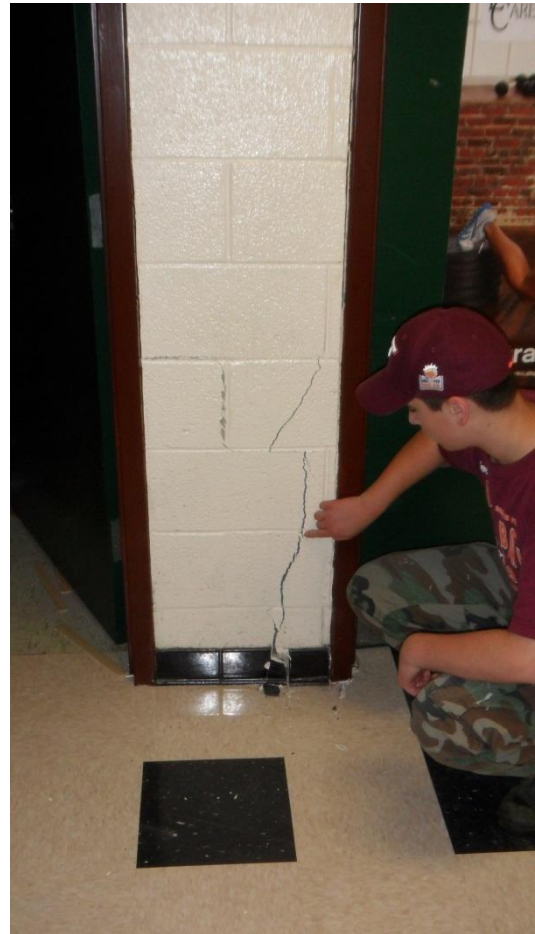
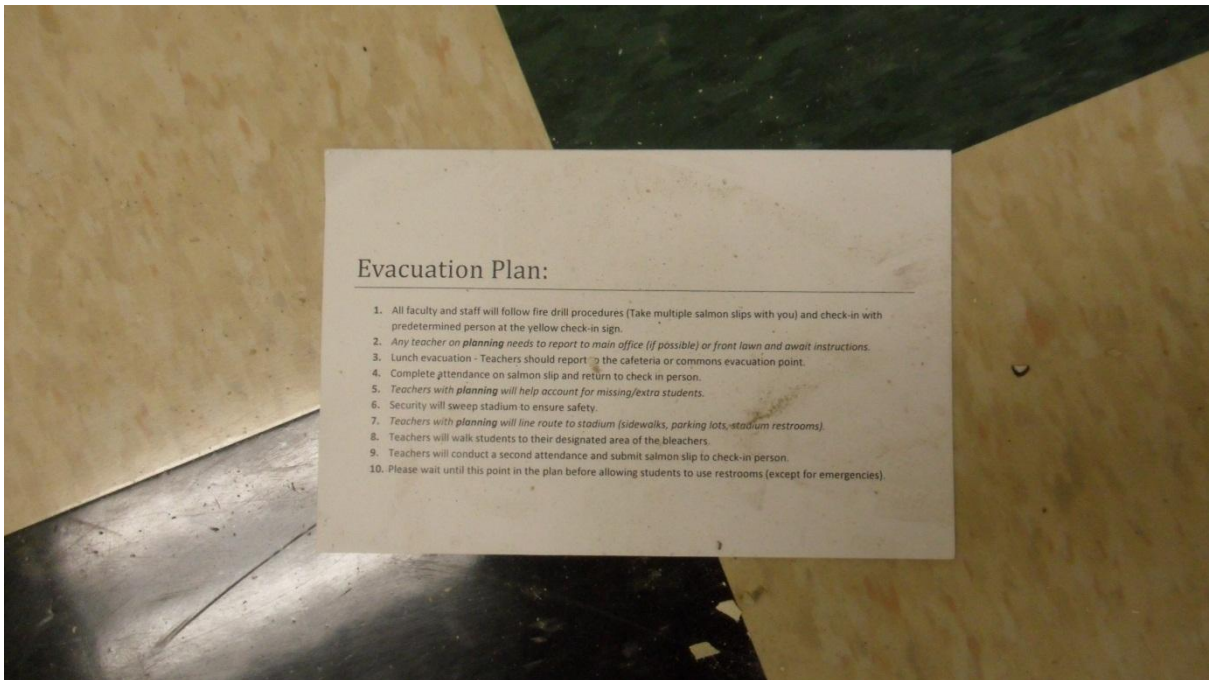
The Louisa County High School building was built in sections over a period of several decades. The most severe damage to the building was in a portion that had a steel frame with concrete block infill walls and a brick façade; it is uncertain whether this same type of structural system was used in all sections of the building. The observed damage included cracks in the infill block walls, with blocks from the top of the walls falling through the dropped ceiling in places. Additionally, in many rooms ceiling tiles along opposite walls fell, indicating a pronounced direction of shaking; unfortunately, the orientations of the walls were not determined. As with the Administration building, the internal contents in many rooms were in disarray. Photos showing some of the damage in the High School building are shown in Figure 41.

Figure 41. Typical damage to the Louisa County High School Building (38.01764, -77.92107).

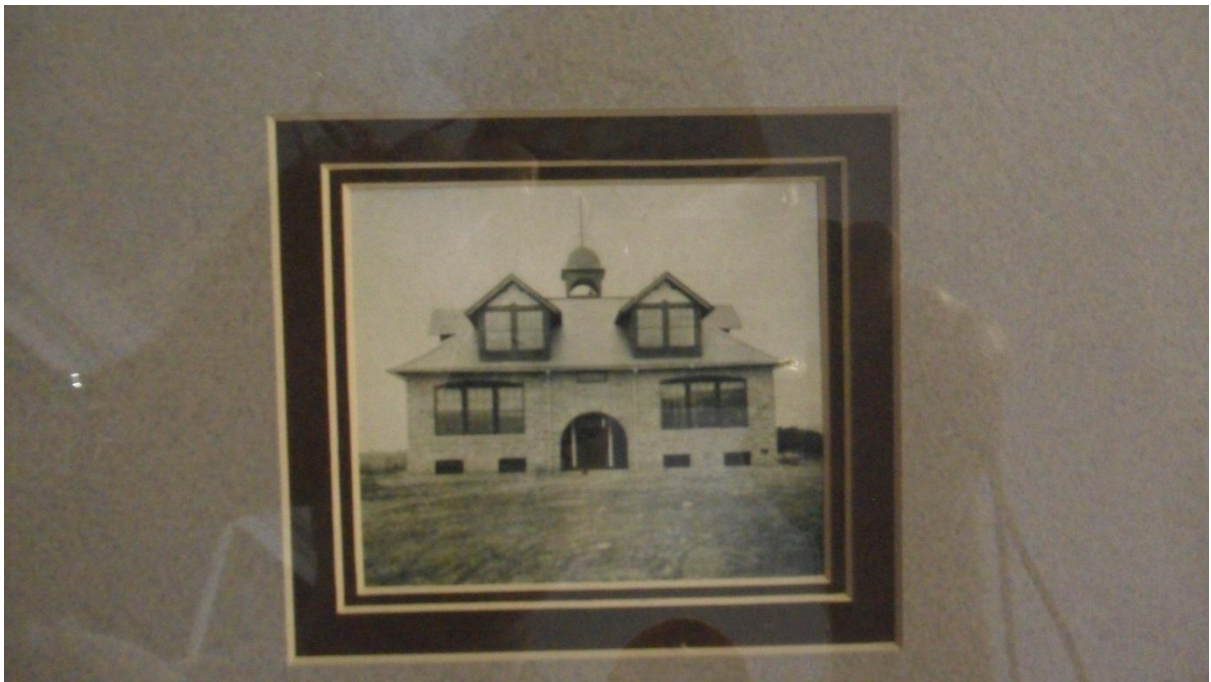
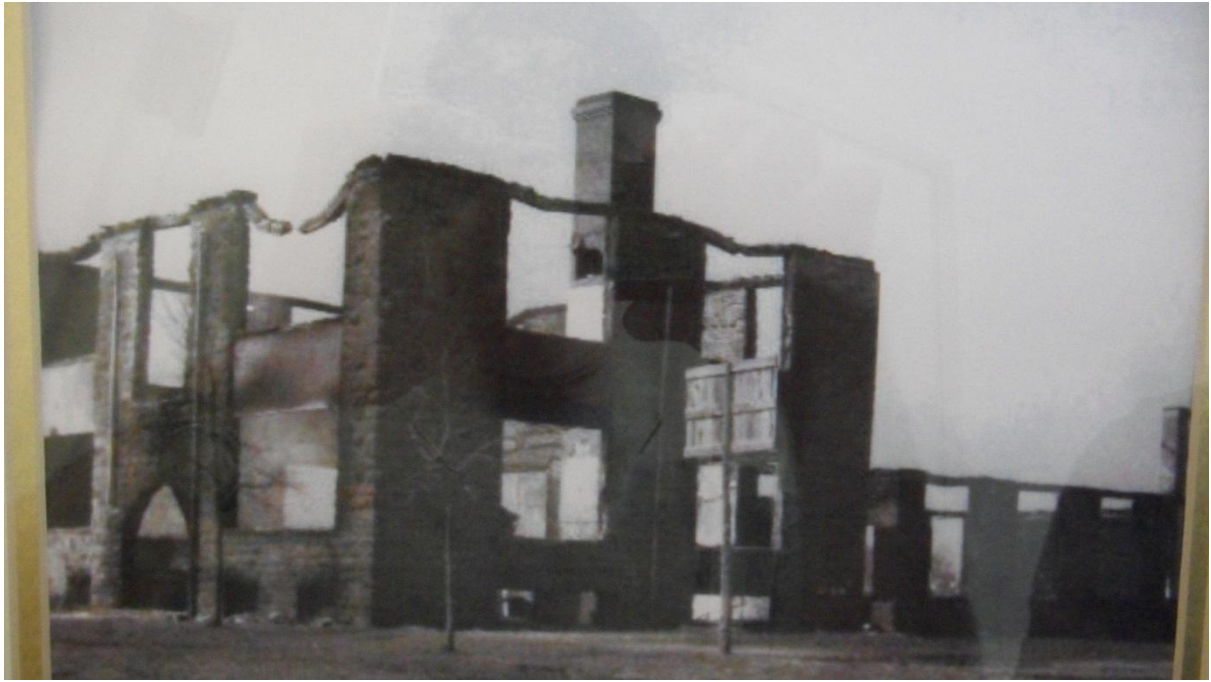
Figure 44. Old photos of the town hall: (a) photo circa 1907 taken shortly after the building was constructed; and (b) photo circa 1924 taken after a fire gutted the structure.

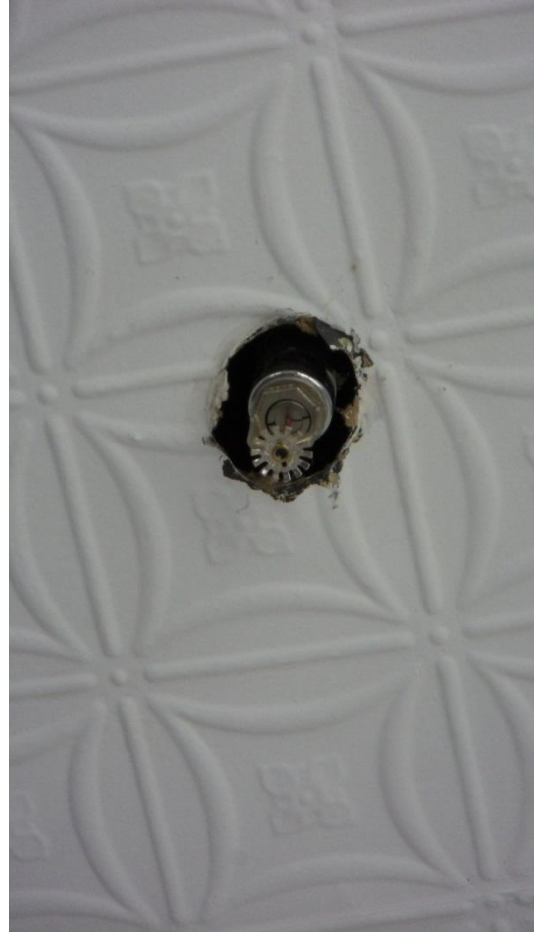
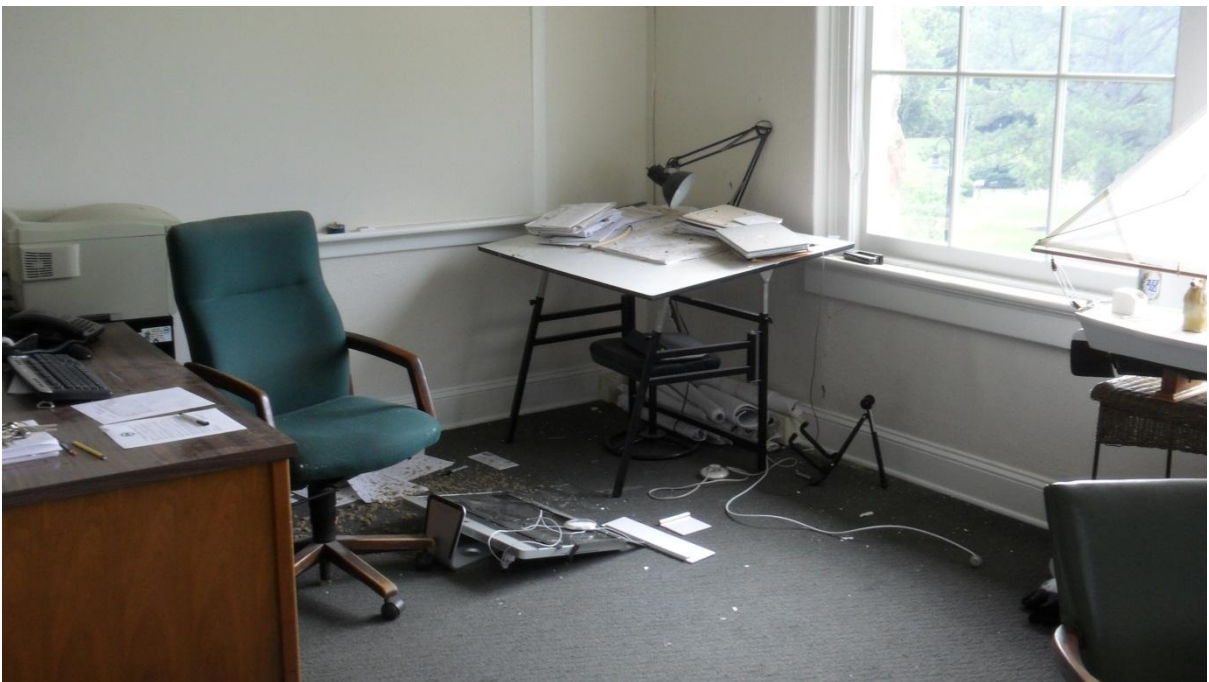
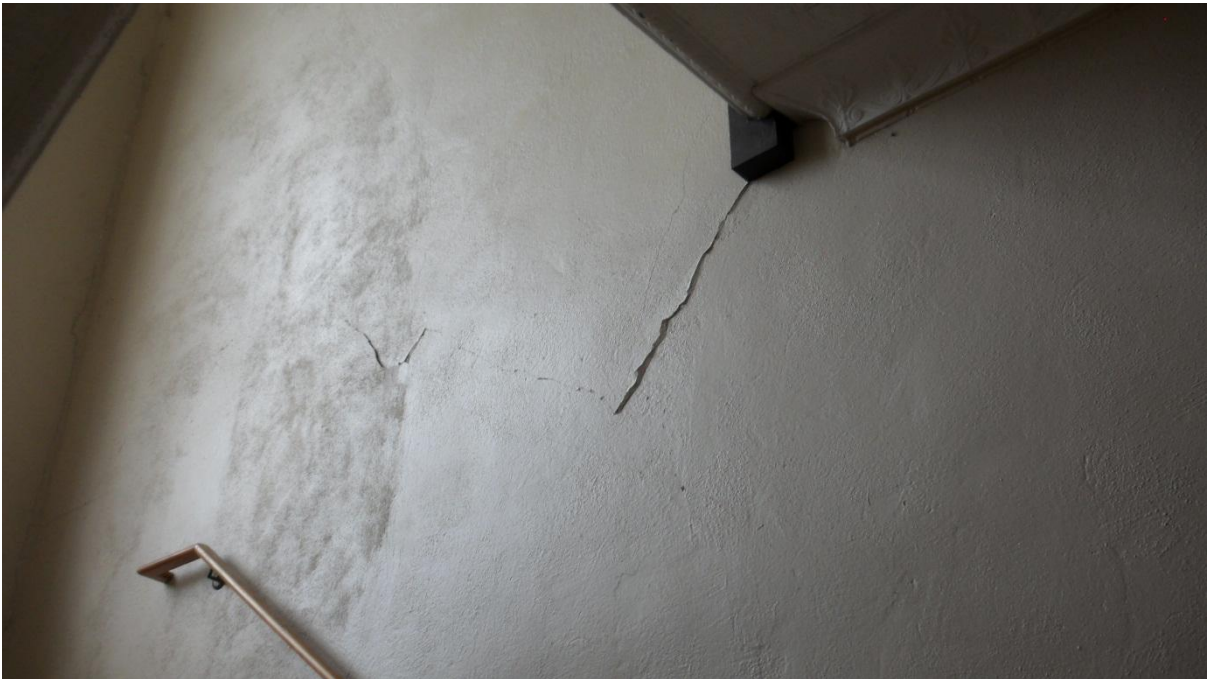
We had received reports on the night of the earthquake that the Louisa Town Hall (Figure 43) had a partial roof collapse. This prompted an inspection of the building on 24 August, the morning after the main shock. The building was constructed in 1907 (Figure 44a) and was damaged by fire in 1924 (Figure 44b); sometime between 1907 and 1924 a second story was added. The reports of damage were grossly exaggerated and most of the damage was cosmetic (e.g., fallen ceiling tiles, cracked plaster); photos of some of the damage are shown in Figure 45. The only structural damage was that the front wall of the building was slightly bowed outward as a result of the earthquake shaking.

Figure 45. Photos showing examples of damage to the Louisa Town Hall.

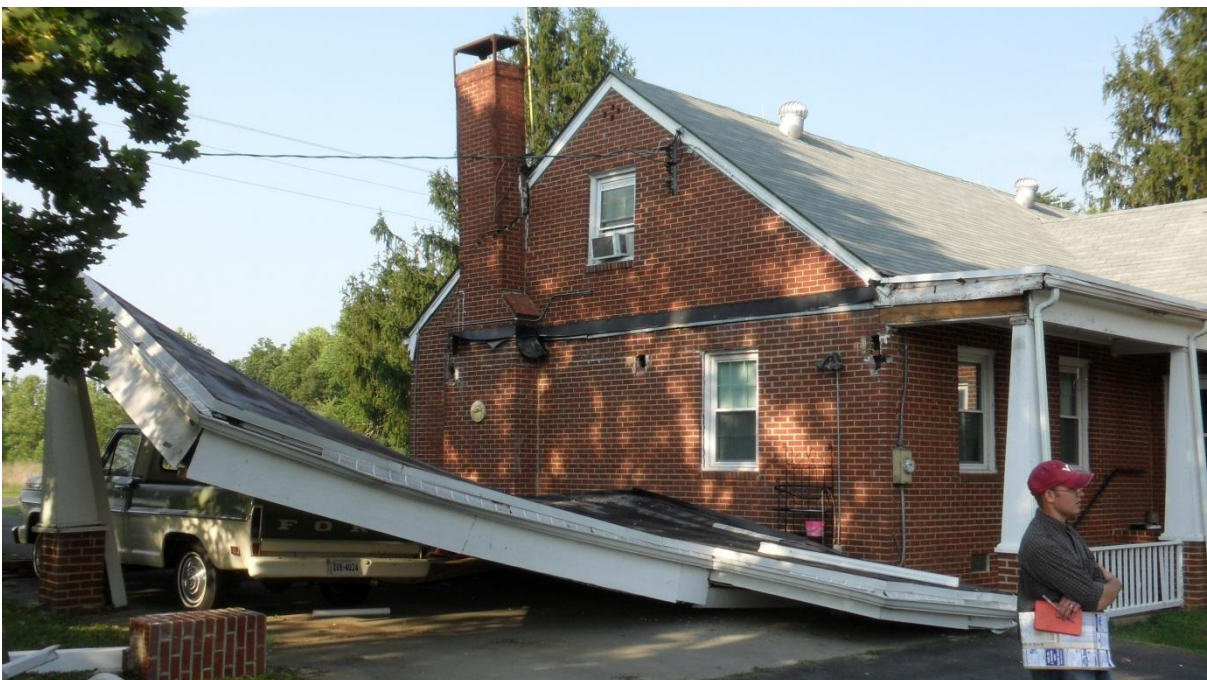
Figure 54. Representative severe damage to brick façade (37.9229, -78.0033).

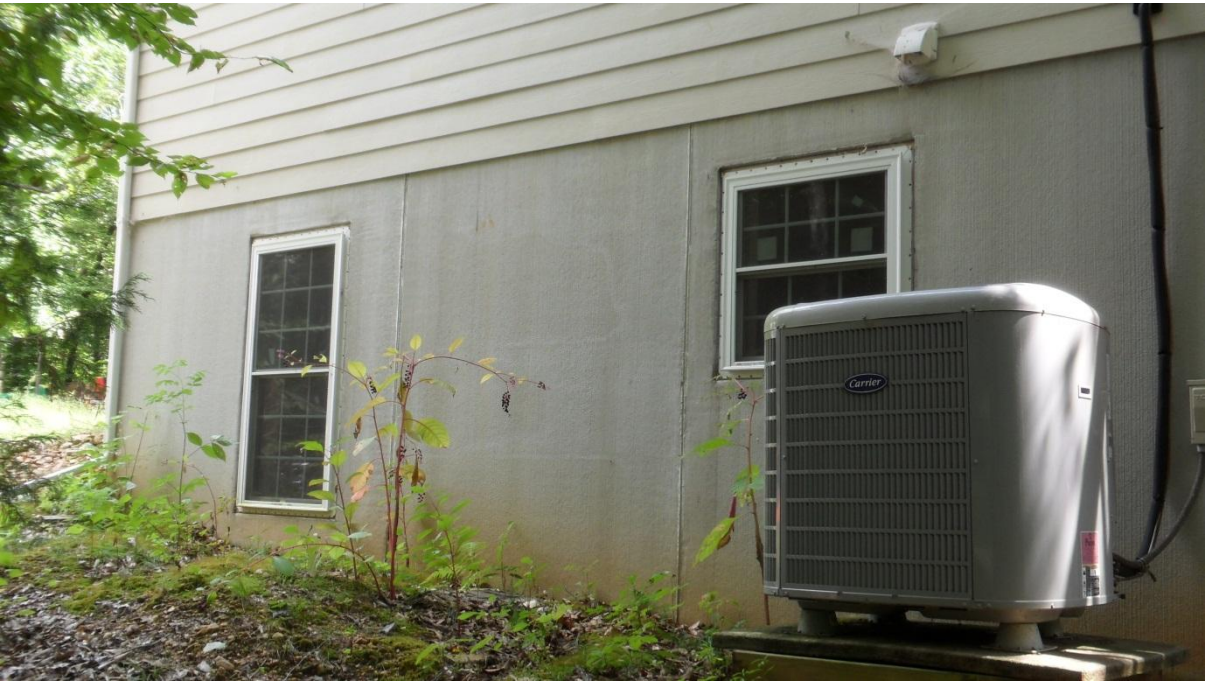
(b)

Team members inspected several houses on Bend of River Rd. The house shown in Figure 59 had a Superior Walls foundation system. The system consists of precast panels that are bolted together onsite. The owners of the house were home at the time of the earthquake and described the level of shaking as very intense. However, we could not find any damage to the foundation system.

Figure 59. Small house with a Superior Walls foundation system. We found no damage to the foundation system despite intense shaking. (37.95806, -78.00606)
