Geotechnical Extreme Events Reconnaissance (GEER)

## **Preliminary Observations of Levee Performance and Damage following the March 11, 2011 Tohoku Offshore Earthquake, Japan**

May 2, 2011

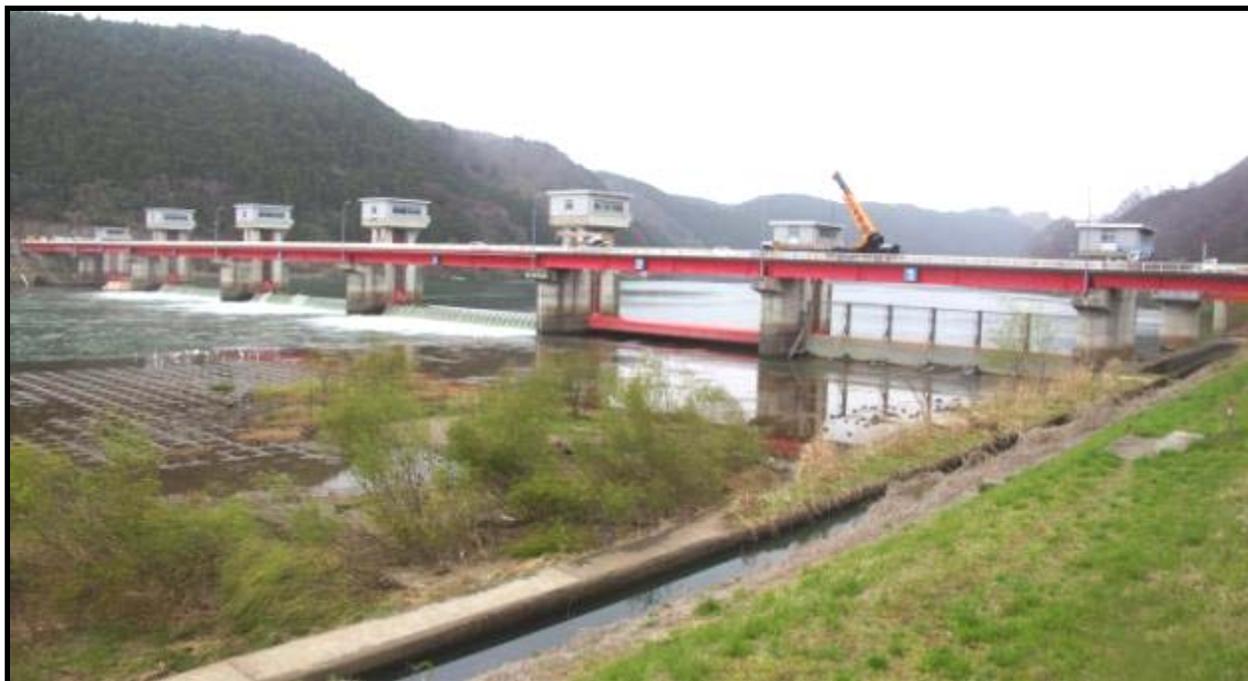
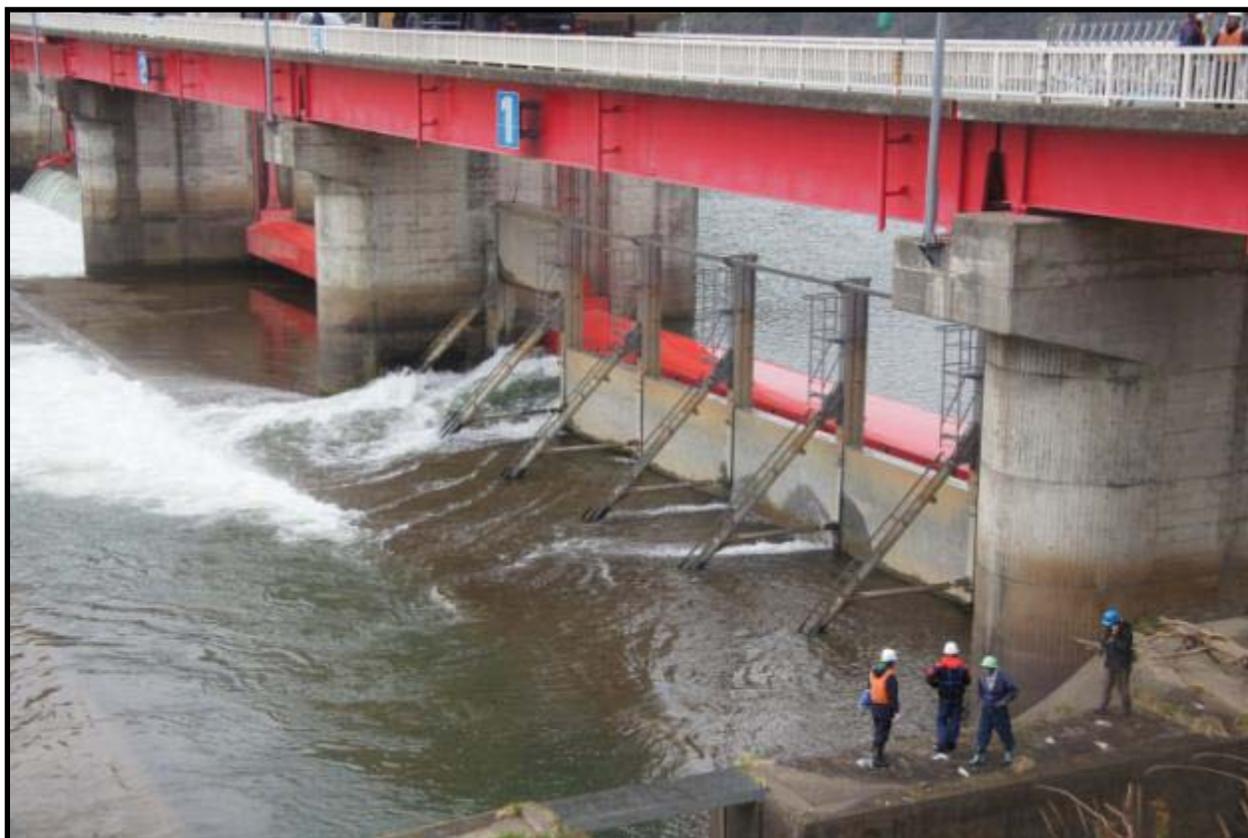
Figure 14: Views of Surge Barrier on Kitakami River at River Kilometer 17  
(N38.5294, E141.3097, April 22, 2011)

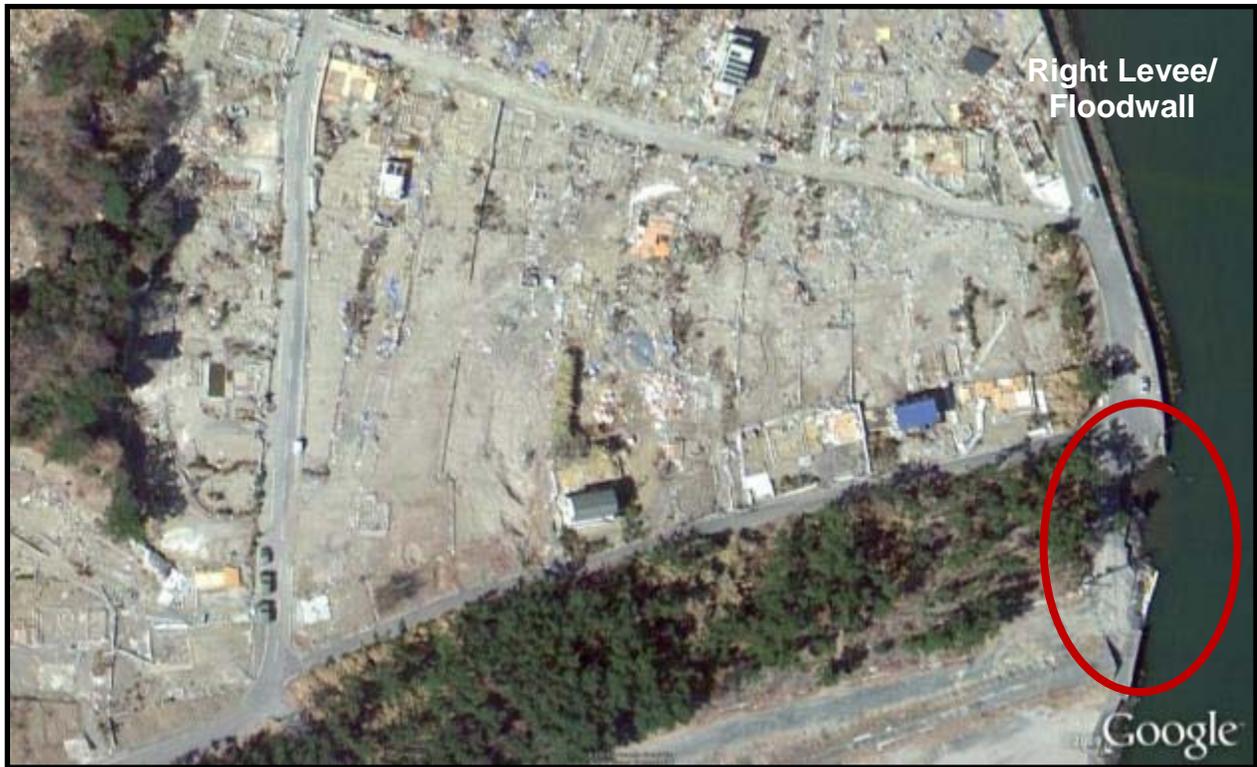
The riverine floodwalls on top of the levees near the mouths of the river sometimes seemed smaller and lower than those placed along the adjacent coast (see Figures 16 and 23). The riverine floodwall along the right levee of the Naruse River was found to be approximately 2 meters lower than the coastal floodwall to which it was connected (see Figure 16). The coastal floodwall at this location appeared to have only minor damage associated with perhaps limited overtopping. However, the much lower riverine levee was extensively damaged and breached by overtopping flows. If all of the riverine levees/floodwalls had the same heights as the coastal floodwalls they were connected to, the tsunami damage might have been smaller.

Figure 16: (a) View of Collapsed Levee/Floodwall Along Right Bank of Naruse River at River Mouth and Connection with Coastal Floodwall and (b) View Illustrating 2-meter Higher Crown Elevation of Coastal Floodwall Above Riverine Floodwall (N38.3756, E141.1727, April 20, 2011)

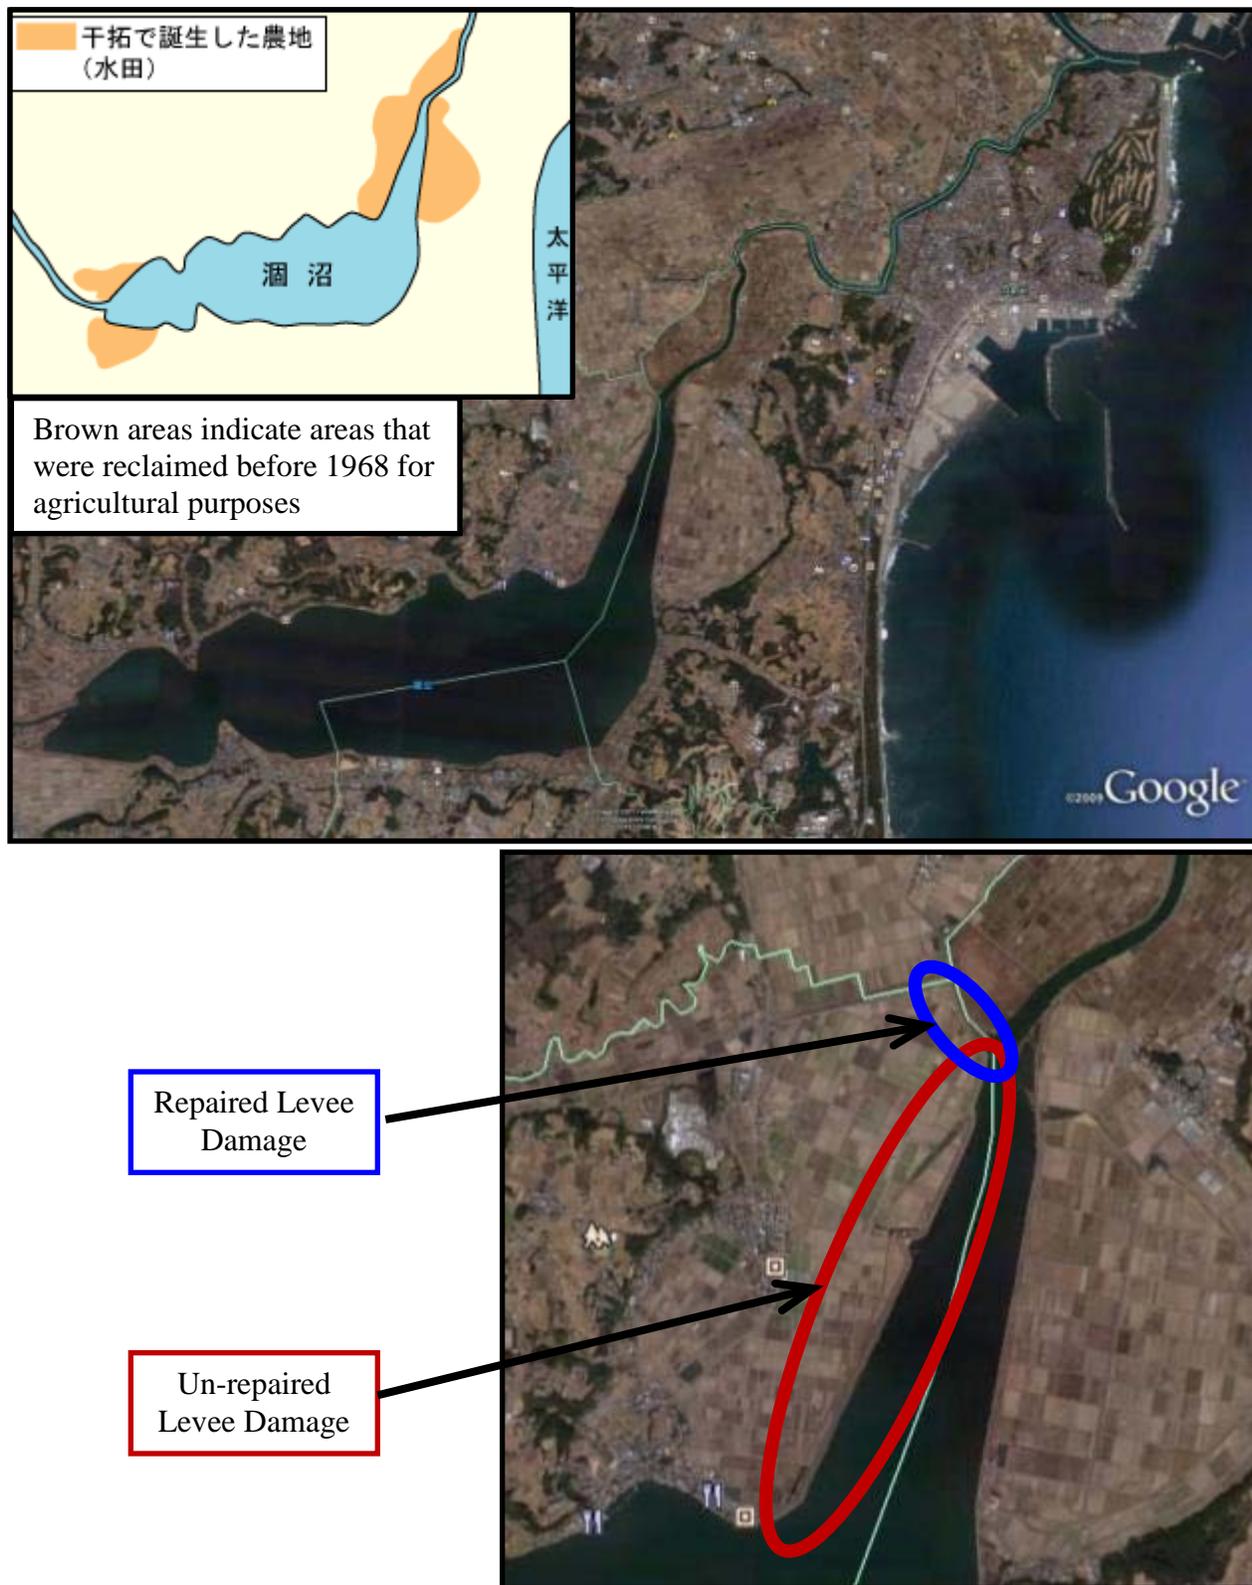
The Hinuma River flows from Lake Hinuma to the ocean near the town of Mito (see Figure 26), and is bordered on the west by levees that experienced relatively extensive damage from foundation liquefaction (see Figures 27 through 31). This levee, apparently founded on dredged fill/reclaimed land, was observed to have extensive cracking and slumping for over 2½ kilometers along the western margin of Lake Hinuma, a shallow, near-coastal lake. In some areas, new fill had been placed into limited reaches where it appeared that the river/lake might breach the slumped levee. The difference in the length of damage along this levee, as opposed to the more limited (but multiple) damaged reaches in the Miyagi Prefecture, and other locations in the Ibaraki Prefecture, appears to reflect the presence of man-made foundation materials and/or the presence of lake water that was high enough to saturate both the foundation and the lower portions of the embankment. In some lengths along the left levee, the Hinuma Lake/River water level was about a meter higher than the landside ground surface. Exposed embankment material in the numerous large cracks indicated that at least the upper fill was composed of clayey sands and gravels. However, the numerous sand boils found in the cracks were generally clean, fine to medium-grained sands – the latter material consistent with dredged or hydraulic fill. The long length of liquefaction damage has significant implications for saturated levees constructed of or on dredged material, such as those in the Sacramento-San Joaquin Delta in California’s Central Valley.

Figure 26: Aerial View of Lake Hinuma and Hinuma River near Mito, Ibaraki Prefecture (adapted from Google Earth, 2011)

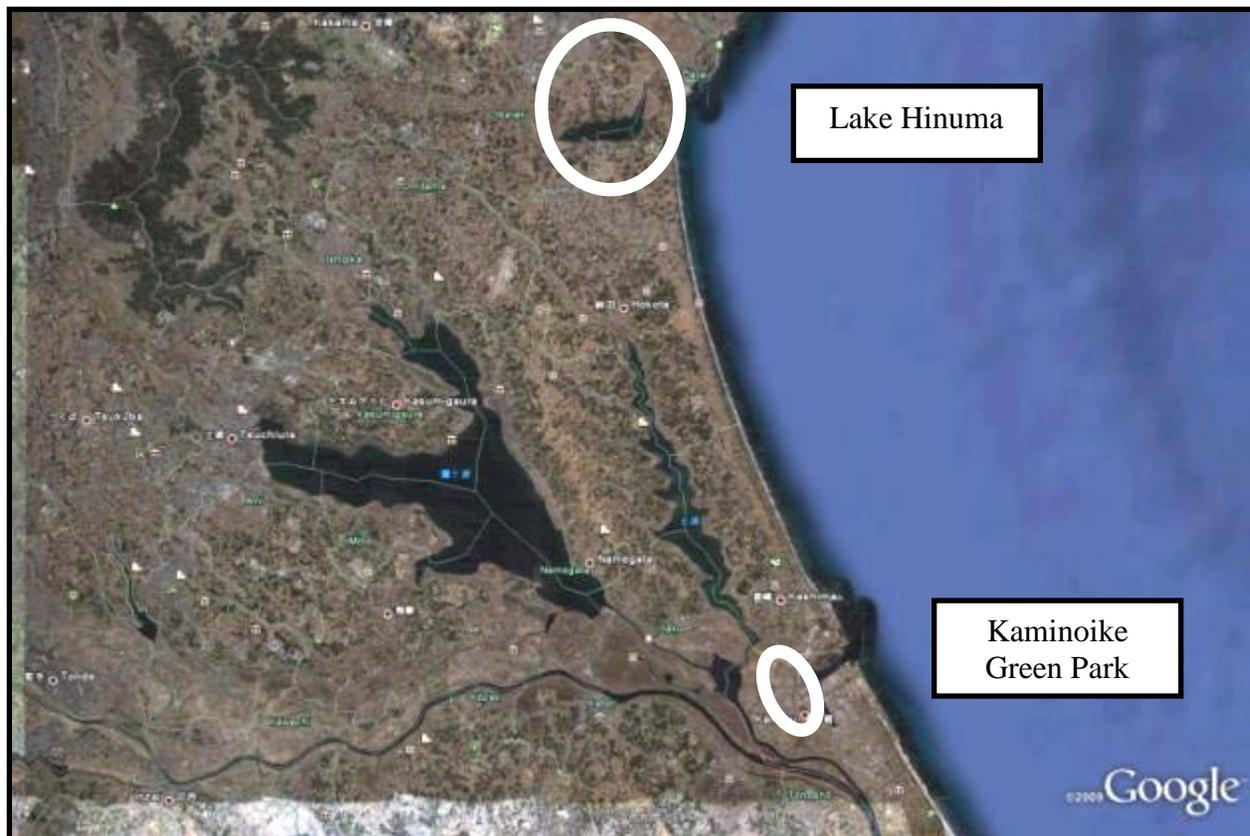
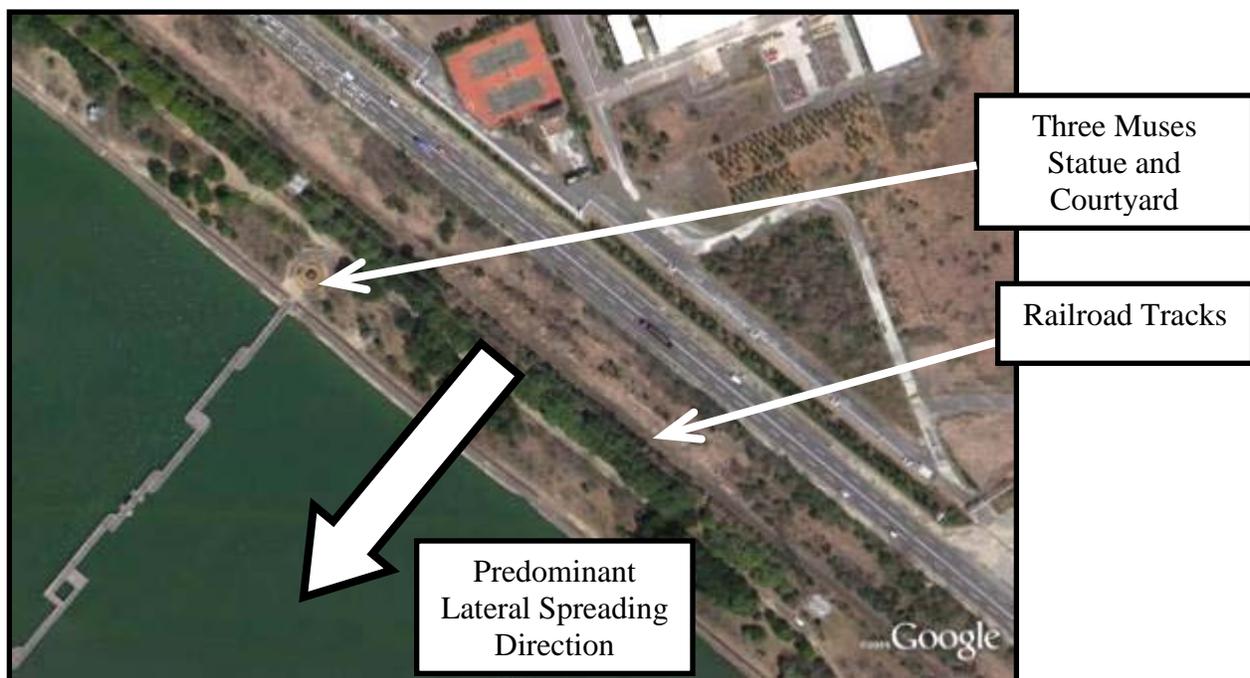
The Kaminoike Green Park is located near the coast near the town of Kamisu City (see Figure 32). The general topography and layout of the park suggests that much of the area is reclaimed land. Within the park along a linear lake, a significant lateral spread of almost flat ground occurred towards the lake. In some locations, the lateral spread appeared to have moved laterally towards the lake by at least as much as 3 meters. In the park area, numerous longitudinal cracks, some as much as a meter wide, paralleled the lake front. Numerous sand boils were also observed in the park area and along railroad tracks immediately behind the park. Compression and buckling of the rails indicated that the surface crust of the foundation had broken up into blocks and experienced ground oscillation and spreading not only towards the lake, but also parallel to the lake. Behind and parallel to the railroad tracks, relative settlement and minor damage was also apparent in a major roadway. Figures 33 and 34 illustrate some of the liquefaction-related damage in the park.

Figure 32: Aerial Views of Kaminoike Green Park near Kamisu, Ibaraki Prefecture (adapted from Google Earth, 2011)
