Geotechnical Extreme Events Reconnaissance (GEER)

# Preliminary Observations of Surface Fault Rupture from the April 11, 2011 Mw6.6 Hamadoori Earthquake, Japan (an aftershock of the March 11, 2011 Tohoku Offshore Earthquake, Japan)

Keith I. Kelson<sup>1</sup>, Leslie F. Harder, Jr.<sup>2</sup>, Tadahiro Kishida<sup>3</sup>, and Isabelle Ryder<sup>4</sup> June 5, 2011

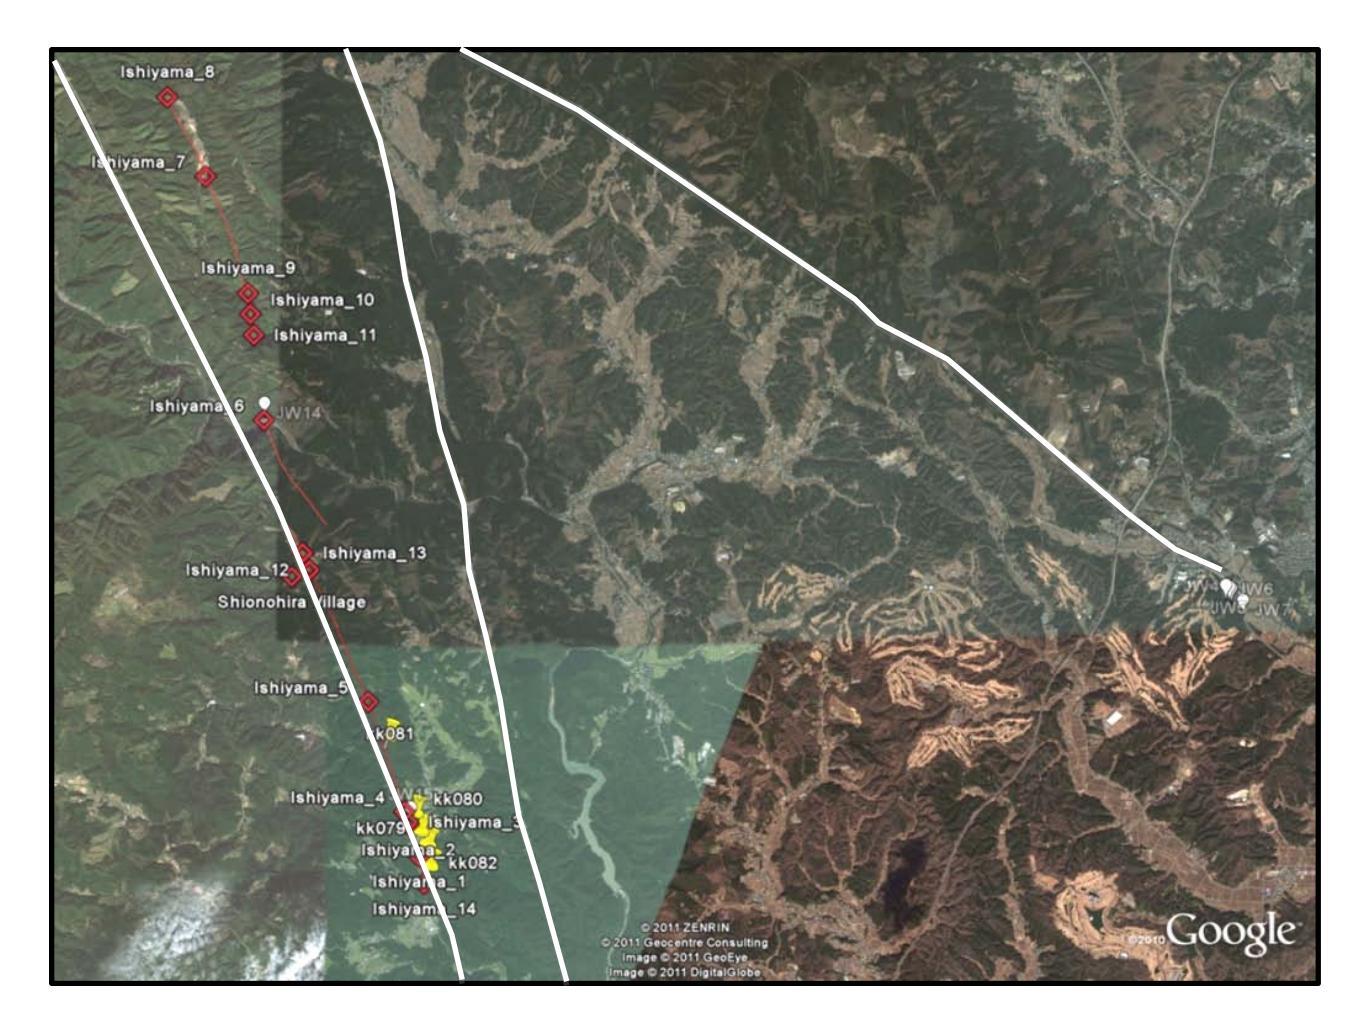
Figure 4: Summary of locations visited by the GEER Team (waypoints kk078 to kk082), Ishiyama and others (2011b), and the ASCE Team (waypoints jw3 to jw7 and jw14 to jw17; J. Wartman, personal communication). GSJ (2009) faults shown in thin white.

trace (as mapped by the Geological Survey of Japan, 2009) extends an additional 11 km southward. The total length of the trace mapped by the GSJ (2009) and termed the Shionohira fault by Ishiyama et al. (2011b) is 22 km. In addition, there is a parallel fault trace located about 1 km east of the Shionohira fault (GSJ, 2009; Figure 4). This latter fault has a total length of about 23 km, strikes north-northwest (N10°W), and appears to displace the same suite of rock units as does the Shionohira fault. For simplicity, this fault is referred to herein as the "Idosawa East fault." Lastly, GSJ (2009) identified a fault that strikes about N45°W and is located northeast of the both the Shionohira and Idosawa East faults (Figure 2). This fault has a total length of about 24 km and may be associated with local surface rupture (J. Wartman, Personal Communication, 2011); it is referred to herein as the "Idosawa North fault" (Figure 4).

- (3) Other possible surface-rupture locations should be checked and documented, including:
  - Possible surface rupture along the Idosawa North fault, especially near its southeastern end where J. Wartman observed a surface scarp across Highway 14 (site jw7; Figure 4);

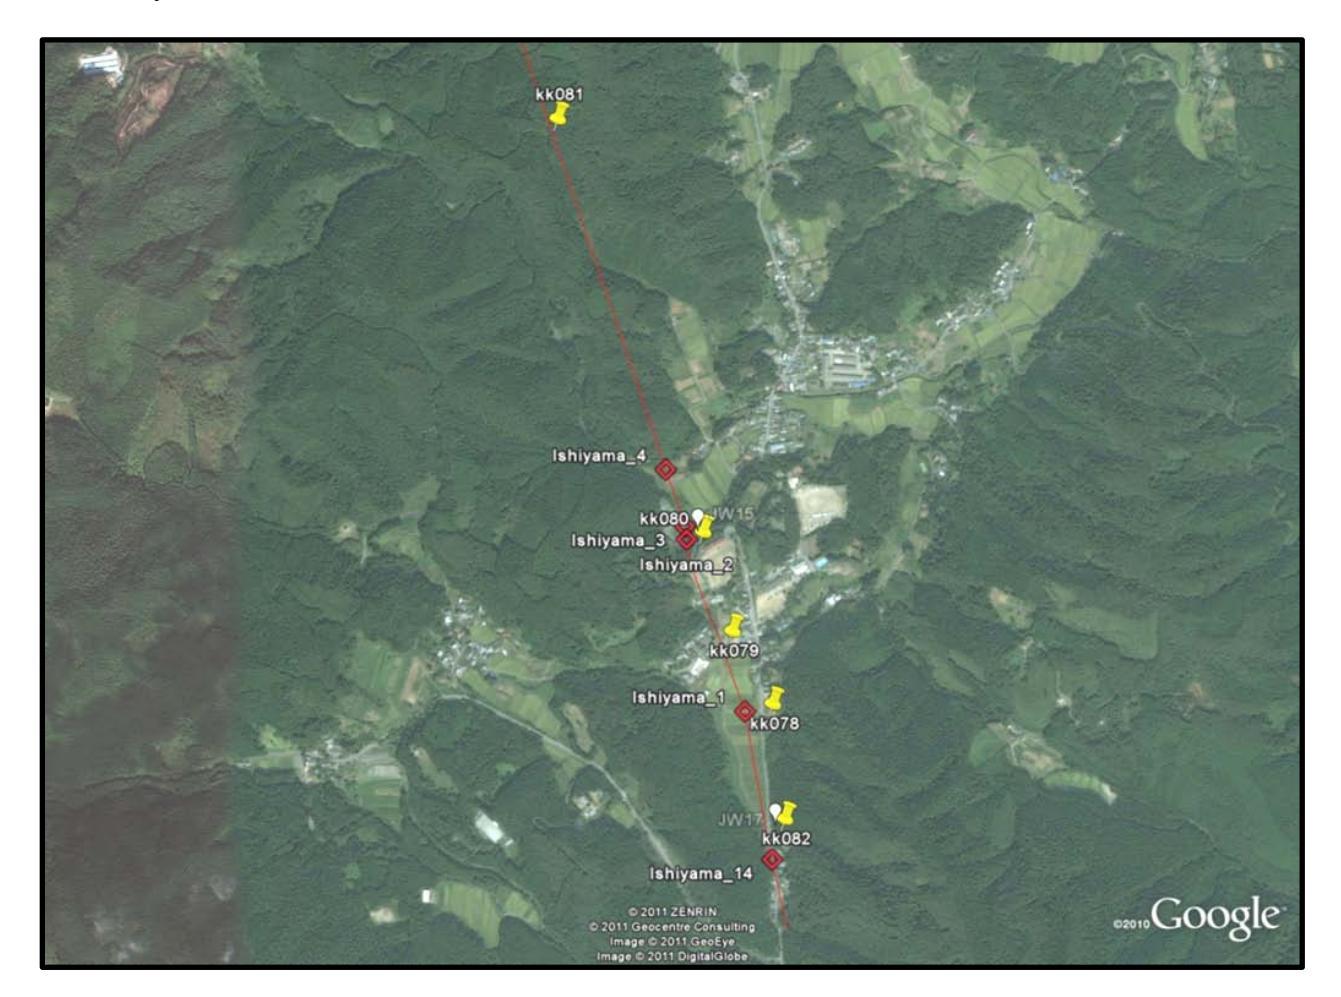
Figure 5: Generalized fault map of surface rupture along the Shionohira fault in the village of Tabito, Fukushima Prefecture, Japan, showing waypoints noted by Ishiyama et al., (2011a; Ishiyama\_1 to \_4), the GEER team (kk078 to kk081), and the ASCE Team (jw15 and jw17).

Approximately 0.8 km to the south of locality kk081 (Figure 5), the fault extends across the floodplain of Bettougawa Creek (Figures 9 and 10, Ishiyama et al., 2011a, b). West-down displacement on the western side of the scarp resulted in an uphill-facing scarp, ponding of the creek west of the fault, and flooding of the low floodplain (Figure 11). Deformation of the alluvium and agricultural fields in the valley suggests west-down net vertical displacement of about 1.2 m and a minor component of right-lateral offset. The fault strand is distinct here, lacks substantial off-fault folding, and appears to be continuous with the scarp at locality kk081 to the north.

The fault rupture extends from these roadway scarps south to the Tabito Middle School (locality kk080 in Figure 5), which is located on a saddle in the crest of an east-plunging ridge underlain by bedrock (Figure 5). The presence of the scarp transverse across the ridge supports a tectonic origin rather than liquefaction or slope instability. School buildings and facilities located across the fault trace are deformed (Figures 15 through 17). The gymnasium straddles a

Locality kk079 (Figure 5) approximates the northern end of a linear valley currently occupied by several rice fields, within which Ishiyama et al. (2011a, b) identified the fault

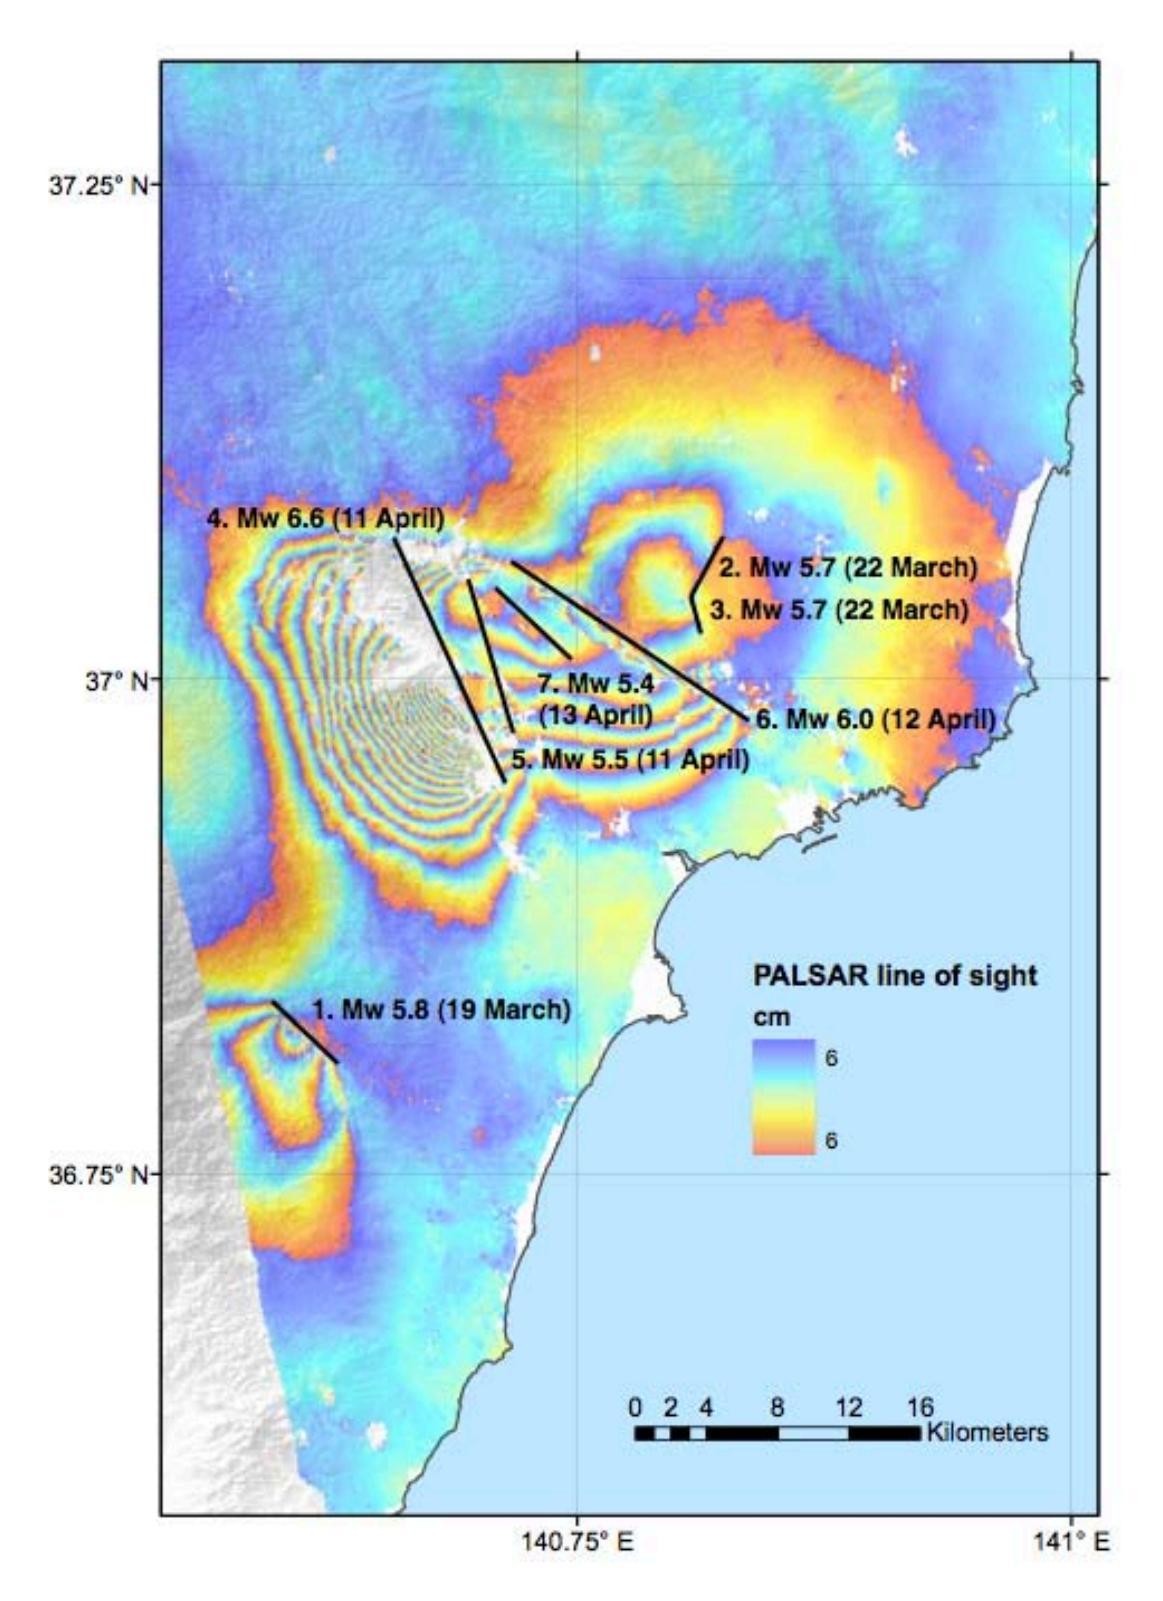
The wrapped interferogram in Figure 22 shows several distinct, and in some cases overlapping, sets of phase fringes, which can be associated with several of the post-March 11 quakes centered in the onshore area of southeastern Fukushima Prefecture. On Figure 22, aftershocks greater than Mw5.4 are numbered in temporal sequence from 1 to 7, with the Mw6.6 Hamadoori shown as event number 4. The most distinct phase shift is spatially associated with this largest aftershock, and suggests deformation on a northwest-striking fault. Other fringe discontinuities suggest possible surface deformation (although to a lesser degree) associated with the Mw6.0 earthquake on April 12 (number 6 on Figure 22) as well as all the other moderate-magnitude aftershocks shown on the figure. These data support the interpretation that the upper crustal area in southeastern Fukushima Prefecture experienced normal faulting, block tilting, and discrete surface rupture in the shallow crust for several weeks following the March 11 mainshock. In

Figure 22: Interferogram generated from ALOS PALSAR (InSAR) data by University of Liverpool, showing pattern of surface deformation between mid-March and mid-April, 2011. Numbered events 1 through 7 show interpretation of deformation associated with noted aftershocks.

particular, the area first experienced small amounts of deformation in the southwest on March 19 and in the northeast soon after (from two aftershocks on March 22), followed by a cluster of moderate earthquakes (and documented surface rupture) in the intervening area from April 11 to 13 (Figure 22). Speculation could be made that the mid-April cluster of earthquakes (and surface rupture) represent the response of the upper crust to changes in local stress fields resulting from the mid-March mainshock and subsequent moderate-magnitude aftershocks.

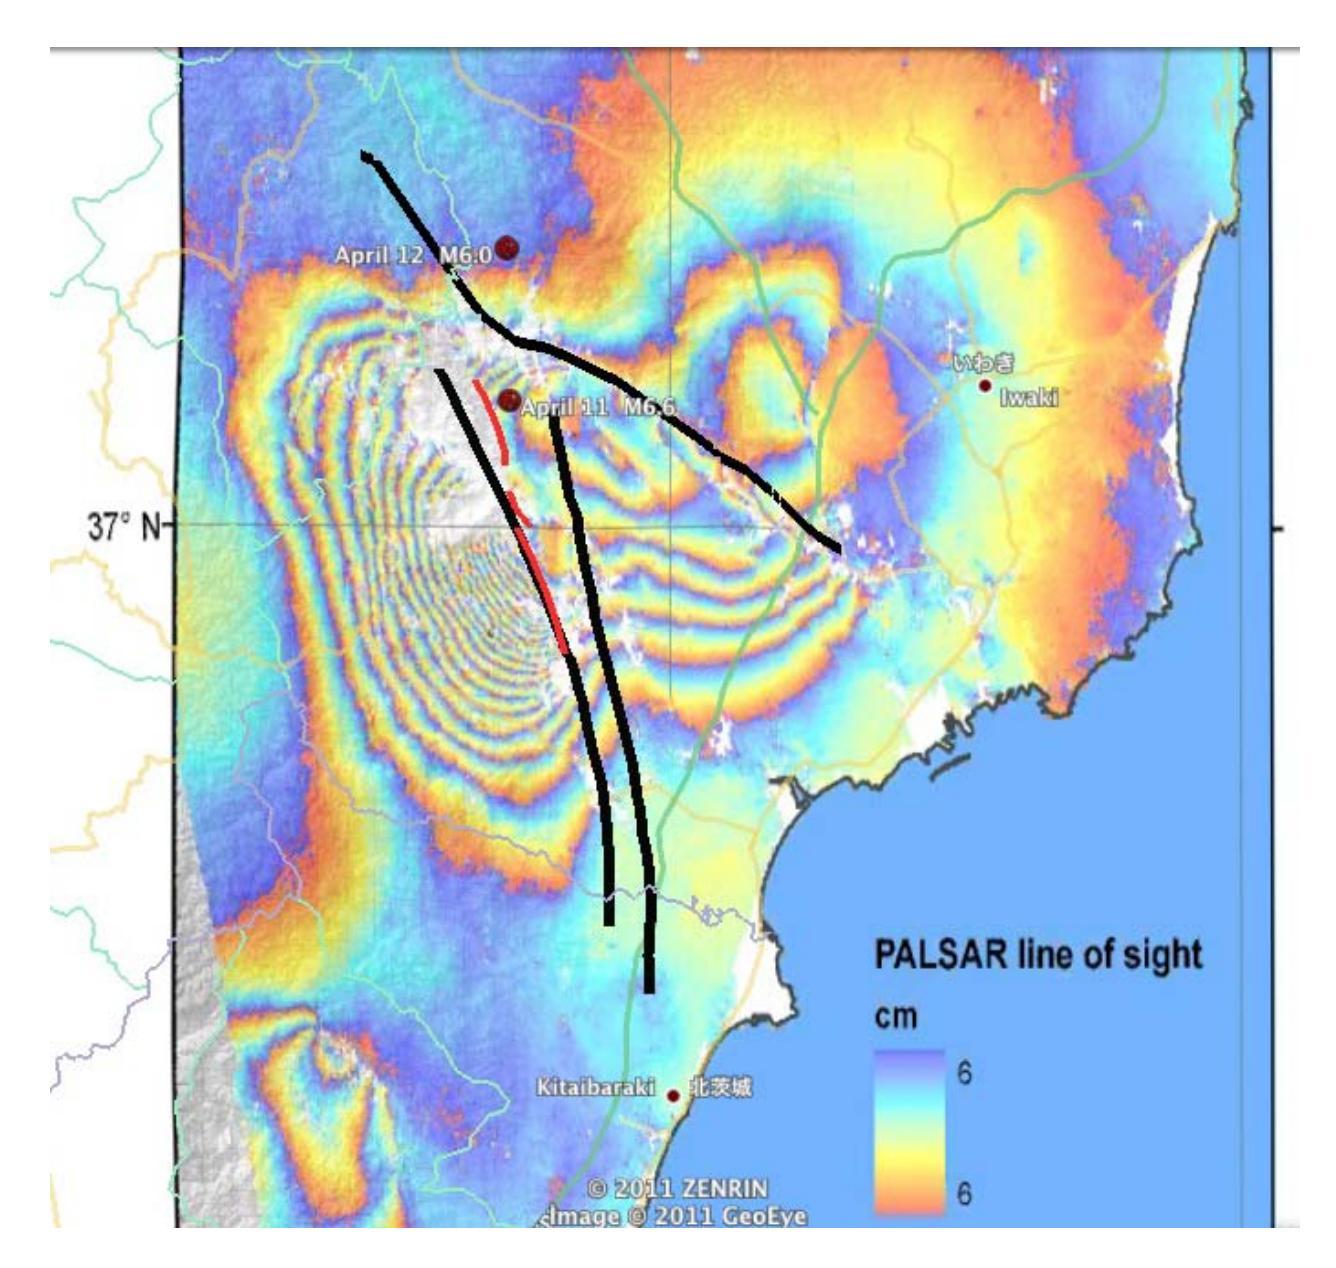
Figure 23: Interferogram generated from ALOS PALSAR (InSAR) data by University of Liverpool, showing pattern of surface deformation between mid-March and mid-April, 2011. Epicenters of the Mw6.6 April 11 and Mw6.0 April 12 aftershocks from GCMT (2011); fault traces mapped by GSJ (2009) shown in black. Documented surface rupture shown in red, with southern part of rupture coincident with Shionohira fault (this report, Ishiyama et al., 2011a, b).

Figure 23 shows the same interferogram focused on the area containing the Shionohira fault identified by Ishiyama et al. (2011a, b) and the "Idosawa East" and "Idosawa North" faults identified herein; these mapped faults are shown as black lines. On this figure, red lines indicate the locations of documented surface rupture along the Shionohira fault, based on observations by our team and Ishiyama et al. (2011a, b). This interferogram clearly shows coincidence of the surface rupture along the Shionohira fault with deformation defined by the InSAR data. In addition, Figure 23 suggests possible surface deformation in the vicinity of the Idosawa East fault, although the degree of phase shift is less than that along the Shionohira fault, and thus may not be perceptible at the ground surface via field reconnaissance. Lastly, the interferogram in Figure 23 strongly suggests the occurrence of surface deformation along or near the Idosawa North fault, which likely occurred during the Mw6.0 April 12 aftershock (Figure 22). The possibility of surface fault rupture along this structure is not known at this time, although observations by J. Wartman (University of Washington, personal communication, May 19, 2011) suggest that the fault may have displaced Highway 14 with down-on-the-northeast relative movement (site jw7, Figure 4). Based on the InSAR data, the amount of surface deformation, if any, would appear to be less than that documented along the Shionohira fault as noted above.
