#### Geotechnical Extreme Events Reconnaissance (GEER)

# LiDAR and Field Investigation Of the March 11, 2011 M9.0 Great Tohoku Offshore Earthquake, and April 7, 2011 M7.4 Aftershock.

## July 20, 2011

#### Tohoku Earthquake Reconnaissance

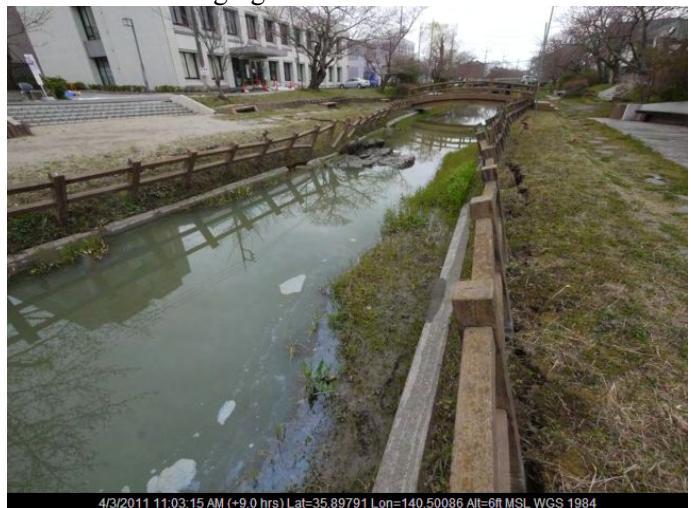
The river channel running through central Katori city suffered liquefaction, lateral spreading and river shortening (narrowing). The river channel filled with liquefied sand, and the perimeter of the canal had differential settlements in the sub meter range. Several bridges crossing the canal suffered compression and minor buckling but could still convey traffic. At the time of the reconnaissance some dredging of the canal had occurred.

Figure QR6-2: Central canal in Katori City with river shortening and lateral spreading.

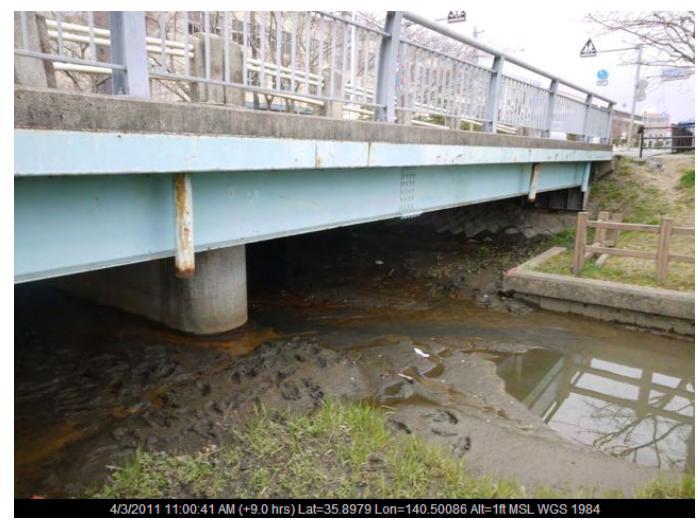
Figure QR6-3: Liquefied sand filling the canal near a small bridge pier.

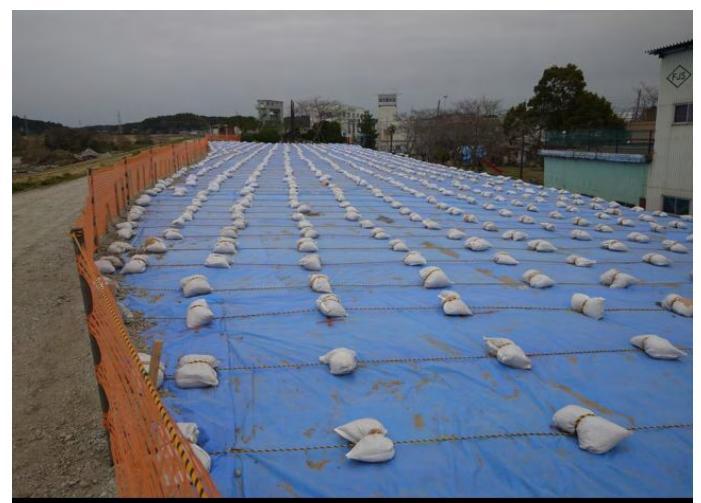
Liquefaction of river soil and rotational failure of wide section of the outboard levee slope. This wide section of Levee had a rotational failure with a headscarf near the crest of Levy and the toe in the playground adjacent to the base of the slope. At the time of the reconnaissance this portion of the levy was covered in blue tarps. Along the inboard side of the levee, the Park perimeter of the Tone River border had spatially extensive soil liquefaction on baseball fields, tennis, soccer fields and other nonstructural park facilities along the river's edge.

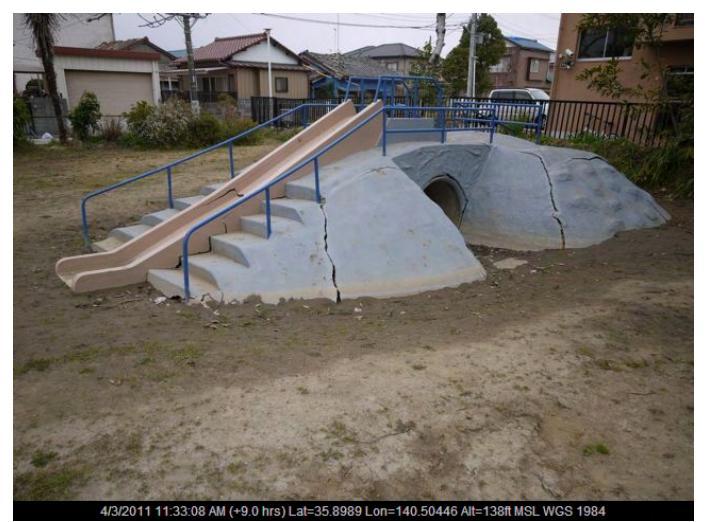
Figure QR6-6: Toe of slump and damage to structures at Tone river levee failure.

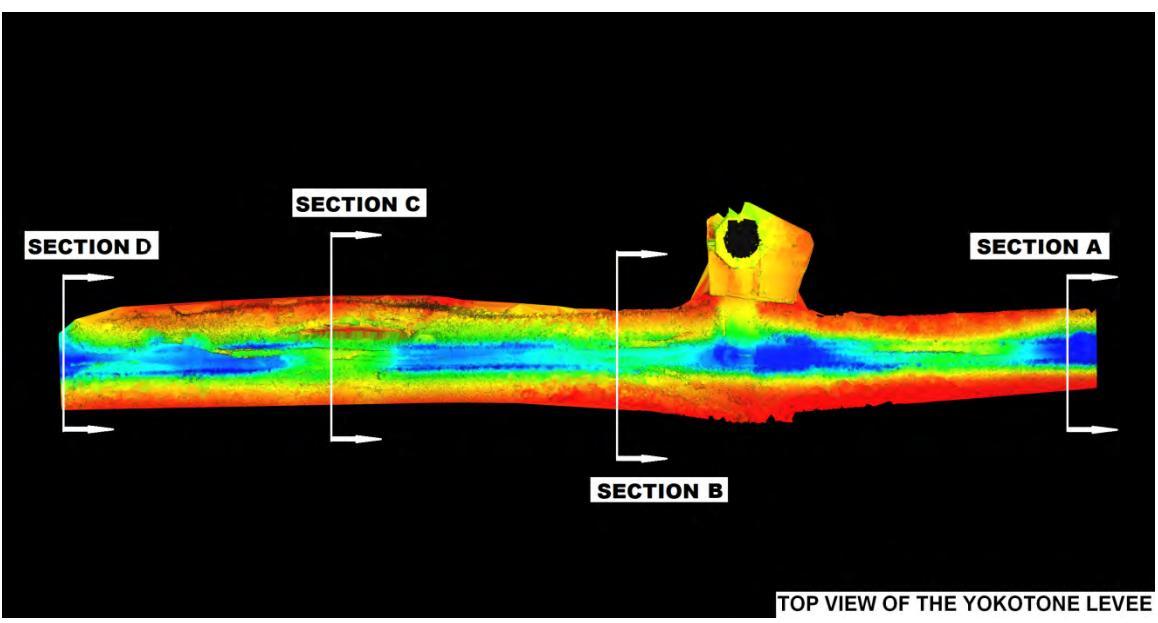
Figure QR6-12: Plan view map of the cross sections through the levee embankment near the Yoko-Tone River. Section A is the unfailed zone.

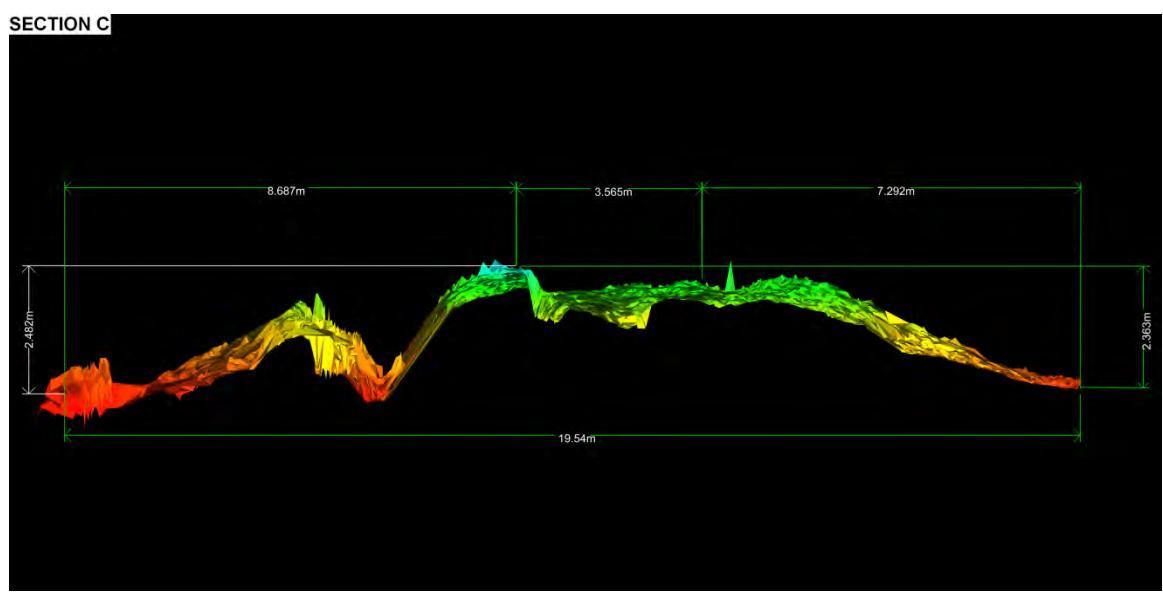
Figure QR6-15: Cross section C, lateral spread is towards the pond.

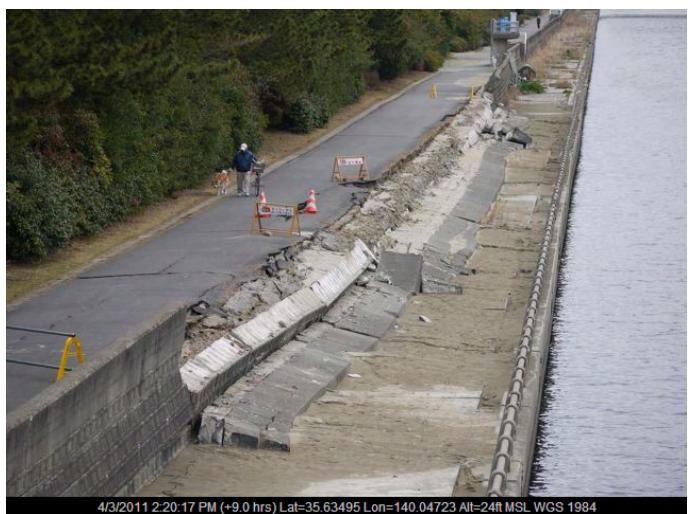
This is a lateral spread ground failure along the river wall at Isobe, Chiba Prefecture, near the mouth of the Isobe river at Tokyo Bay. The lateral spread is described by Stewart et al Quick Report 1. Quick Report. We took our LiDAR measurements from one position on the bridge looking diagonally down at the lateral spread from an excellent vantage point. We took one panorama scan at 0.12 deg. resolution and then a high-resolution scan from the same position at 0.03 deg. Resolution.

Figure QR6-20: Lateral spread and wall failure at the Isobe

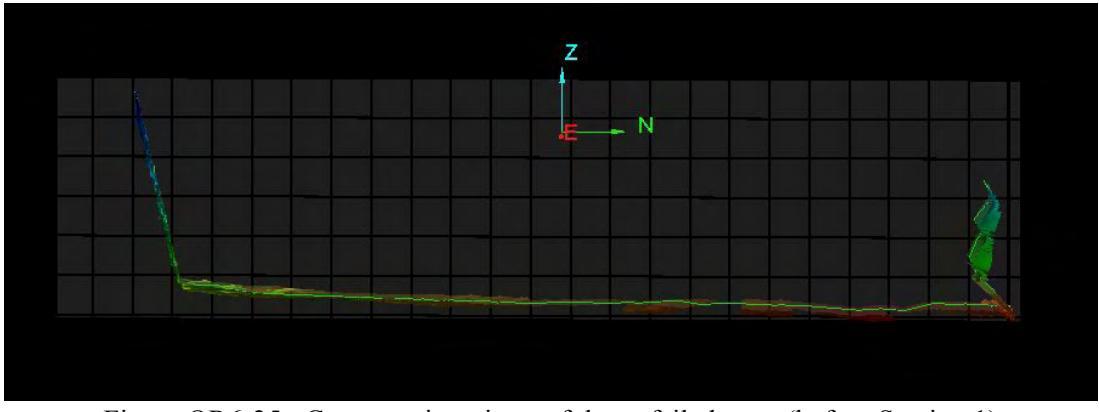
Figure QR6-25: Cross section views of the unfailed zone (before Section 1)

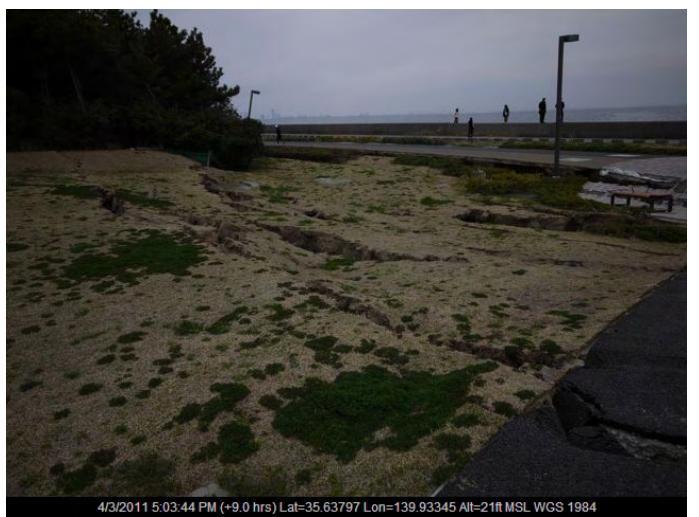
Site RK6 (Also Site JS27): Urayasu, Chiba Prefecture Lateral Spread [LiDAR Site] A large area in this field development suffered liquefaction foundation failures, structural tilting, and lateral spreads. At the southeast end of the filled peninsula is a cemetery adjacent to the bayfront park and Tokyo Bay. We collected LiDAR data along the area of maximum deformation at the boundary of the cemetery and the waterfront park.

Figure QR6-32: Lateral spread at Urayasu, Chiba

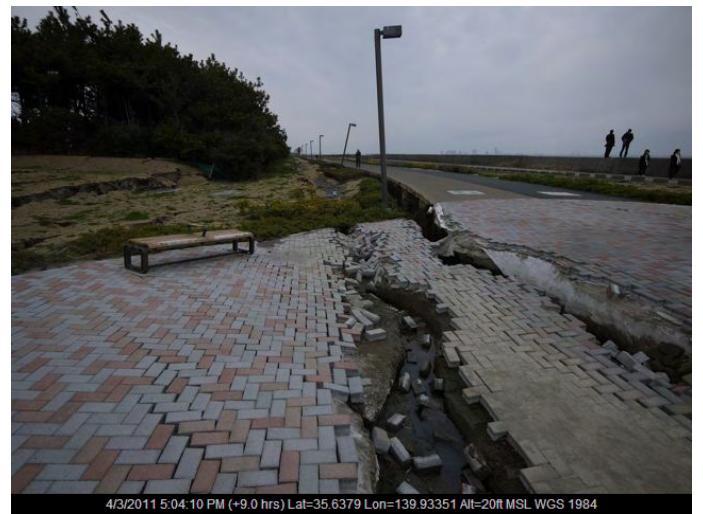
Figure QR6-32: Lateral spread at Urayasu, Chiba

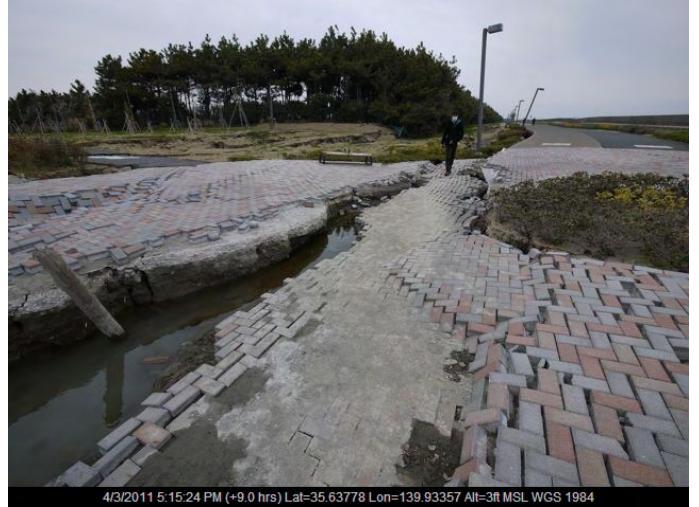
Figure QR6-33: Lateral spread at Urayasu, Chiba

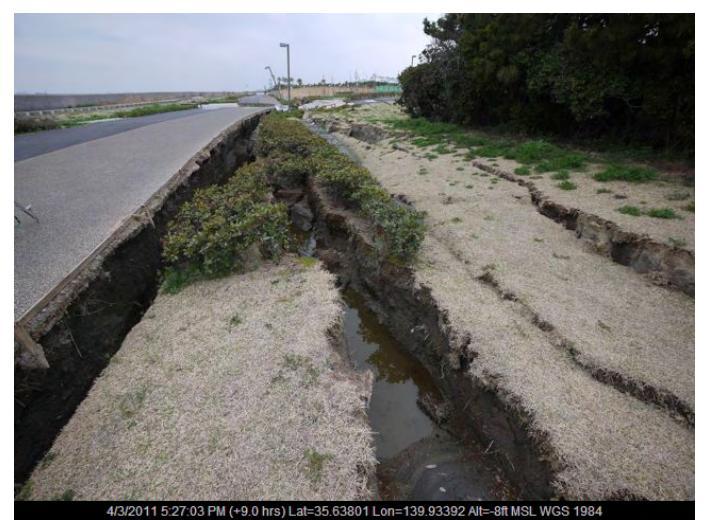
Figure QR6-34: Lateral spread at Urayasu, Chiba

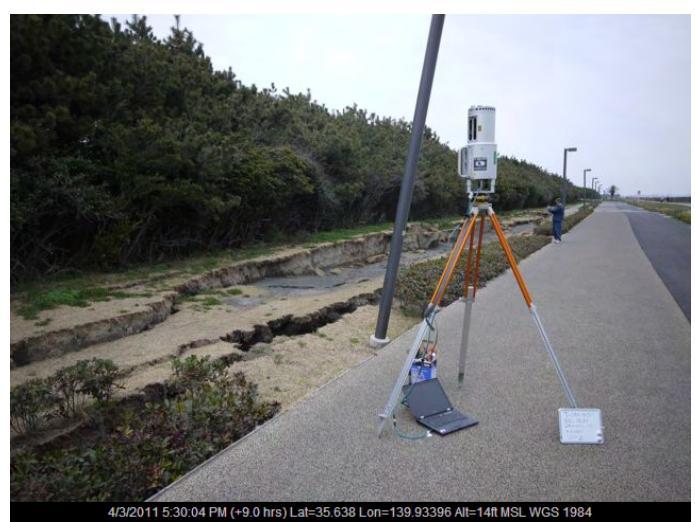
Figure QR6-35: Lateral spread at Urayasu, Chiba

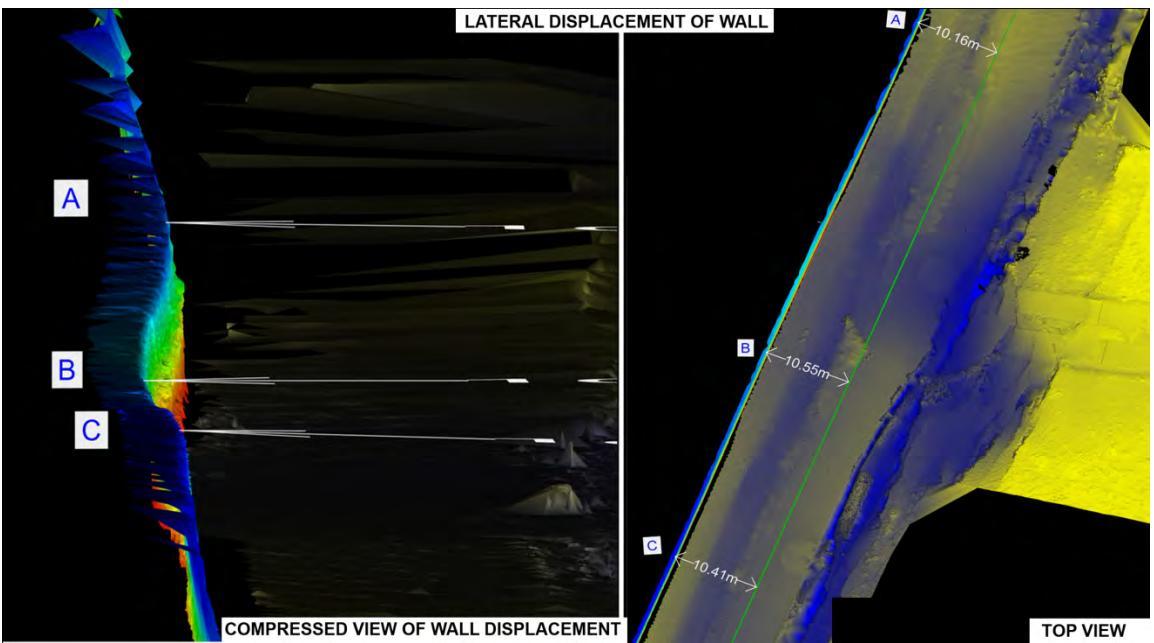
Figure QR6-38: Zone of maximum lateral displacement of the seawall (0.35 m)

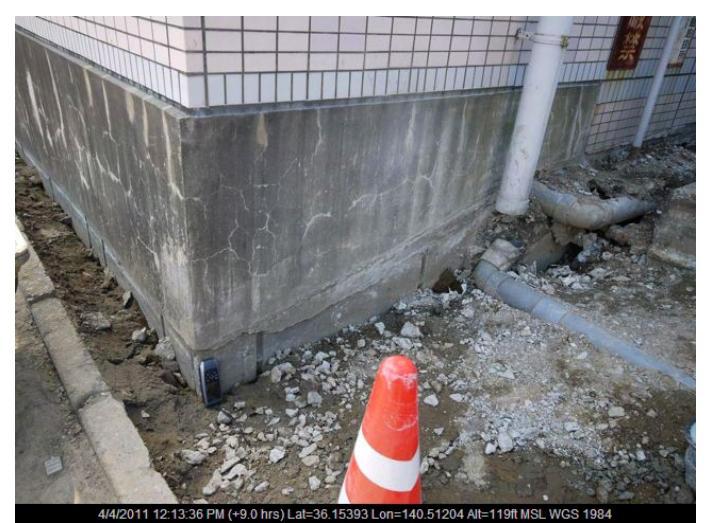
This site experienced liquefaction along the banks of the canal, running through the center of the town. Lateral spreading was typically 0.1-0.5m, resulting in canal shortening. Settlement in the residential/commercial district has affected structural foundations. Empty lots have sand boils, minor lateral spreading, and ground cracking. This is a worthwhile SASW site for additional study.

Figure QR6-39: Liquefaction and settlement at Hokota

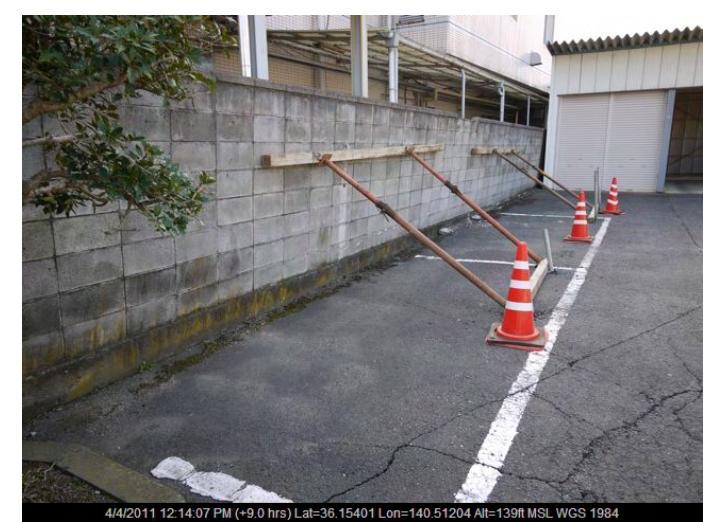
44/2011 12:14:07 PM (+9.0 hrs)Lat=36:15401 Lon=140:51204 Att=139R MSL WGS 1984 Figure QR6-40: Liquefaction and wall deformation at Hokota

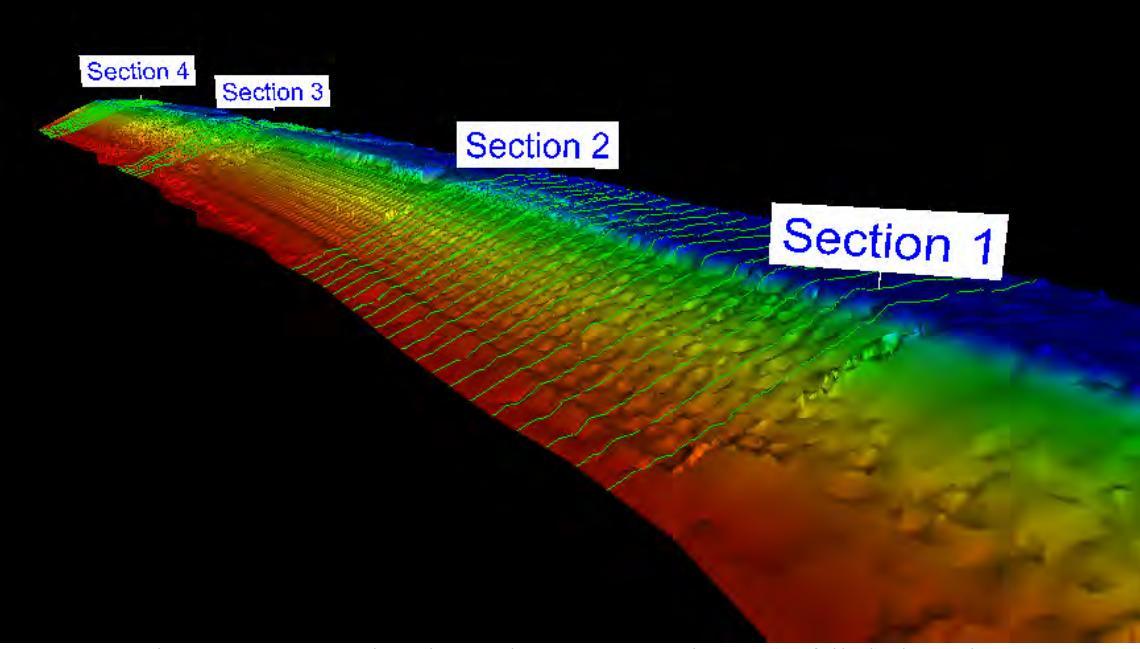
The site is an embankment failure with base widening and settlement of crest. We scanned the site from two positions at the location with the greatest amount of deformation. The crest crack extends for 800 meters.

Figure QR6-45: Lake Hinuma levee cross sections 1 (unfailed) through 4

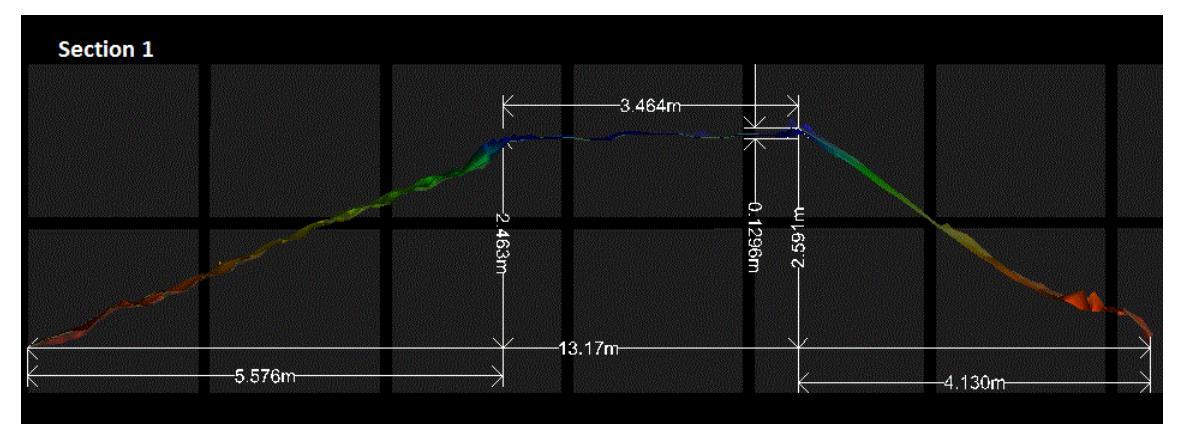
Figure QR6-46:Unfailed section 1 area of levee along Hinuma Lake, Has a crest width of 3.64m and a base width of 11.1m. [Wrong Figure]

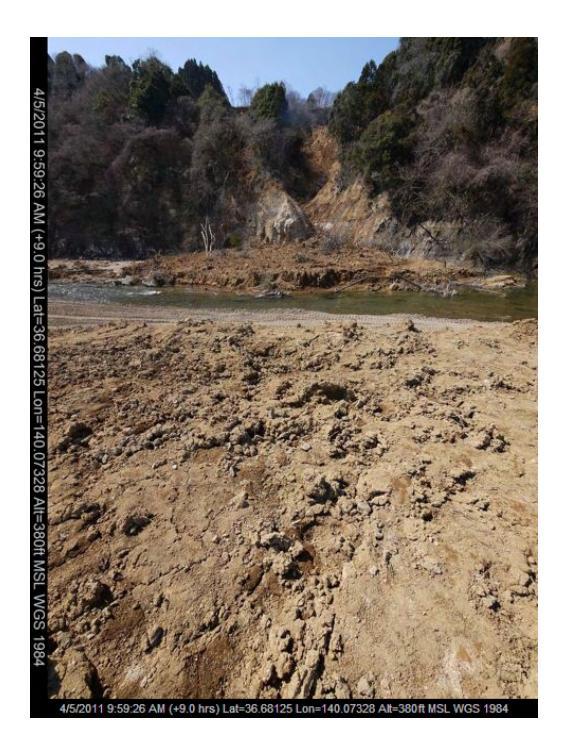
Originating from a terrace above a cut bank of a river valley. Terrace areas slope was forested native landscape. The top of the terrace is the tree farm crest scarp is approximately 250m wide by 150m long and perhaps with an average depth of 2m of material: total volume estimated at  $\sim$ 70,000 m<sup>3</sup>. (W15)

Figure QR6-67: Landslide debris crossing a local stream at Nasukarasuyama Landslide. No LiDAR data was captured at the site.

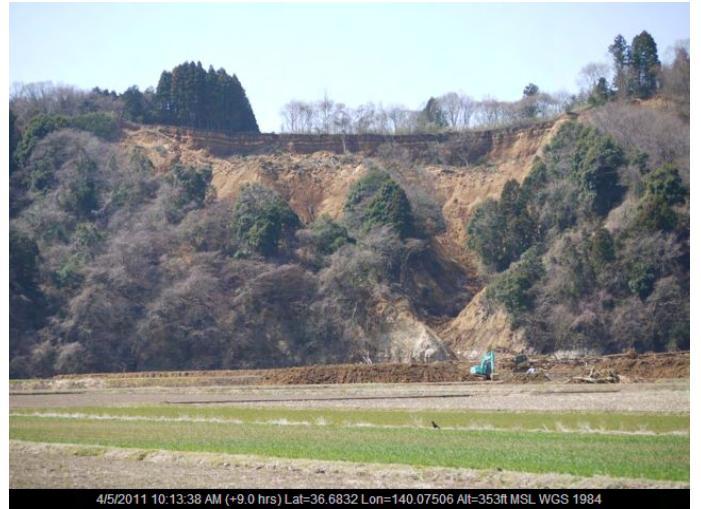
Figure QR6-68: Distant view of landslide debris and headscarp. At the time of the visit some movement of the debris had begun to prevent a landslide dam from flooding rice fields.

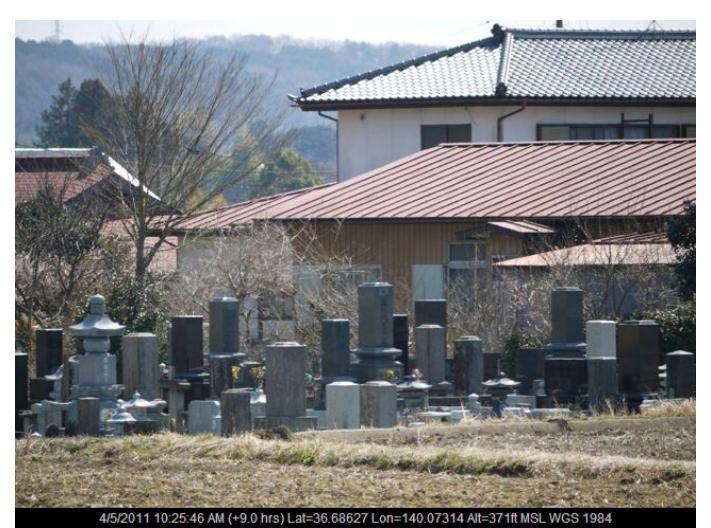
Figure QR6-69: No observable tombstone collapses, Nasukarasuyama Village, Tochigi Prefecture

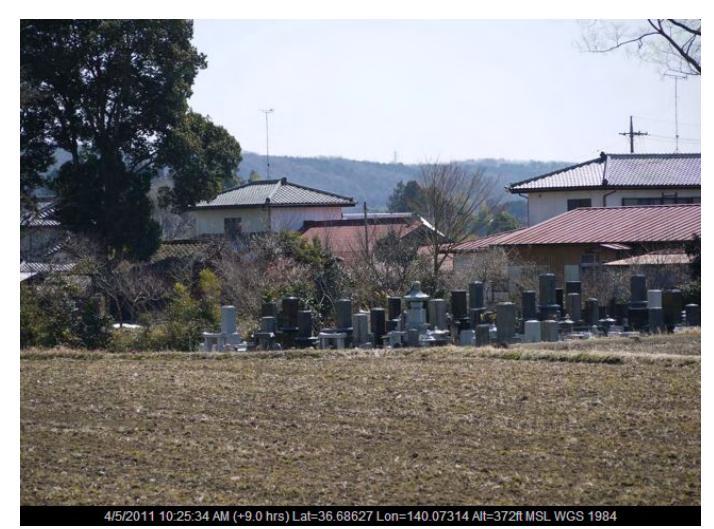
Figure QR6-70: No observable tombstone collapses, Nasukarasuyama Village, Tochigi Prefecture

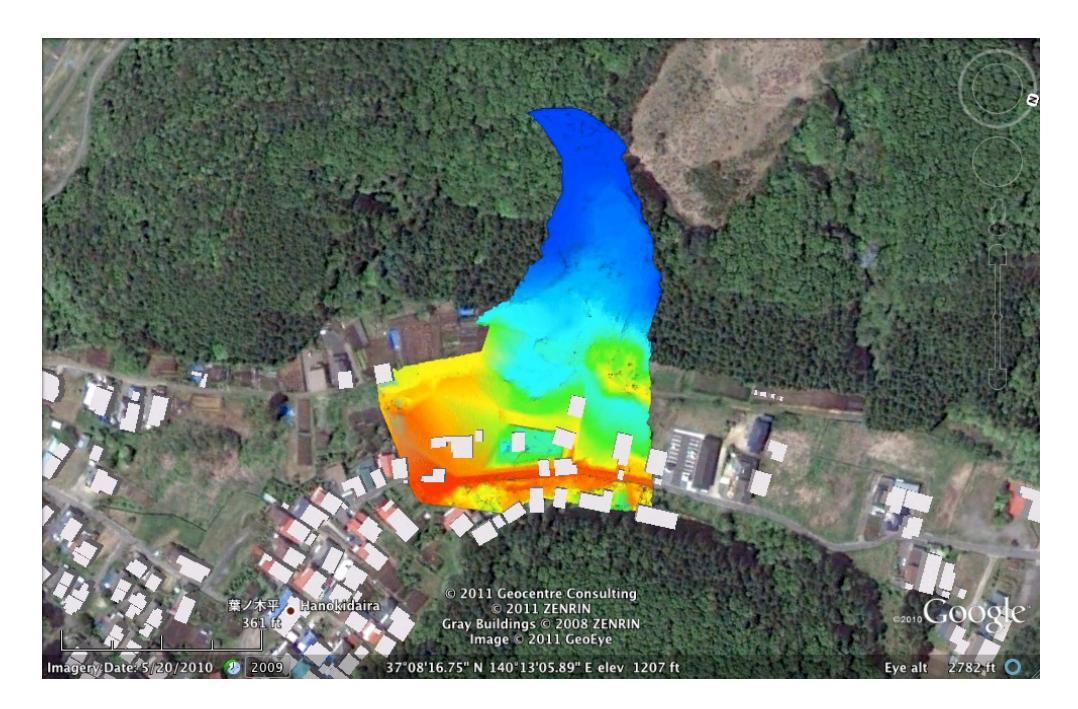
This large landslide impacted a village in the southwestern Fukushima Prefecture. We collected three LiDAR scans on April 5. This landslide appears to emanate from a slope of an accumulation of volcanic ash or pumice(?). Samples are lightweight, white in color or oxidized brown. The landslide initiated on a forest slope and came down onto an agricultural village impacting several houses and resulting in fatalities. The landslide covered the valley floor and crossed to the far side. Estimates from the LiDAR scans indicate that approximately 25,000 cubic meters of material slid from the slope. Approximately half of that material (11,000 cubic meters) are accounted for on the valley floor. The disparity is due to incomplete LiDAR coverage of the valley floor, and re-creating efforts that remove soil from the main debris area.

Figure QR6-71: Google Earth image of the Shirakawa landslide area with the LiDAR data overlay. Low lying structures in the south end were not impacted by the landslide. Approximately 10 residential and out-structures structures (garages, sheds, etc.) were impacted directly.

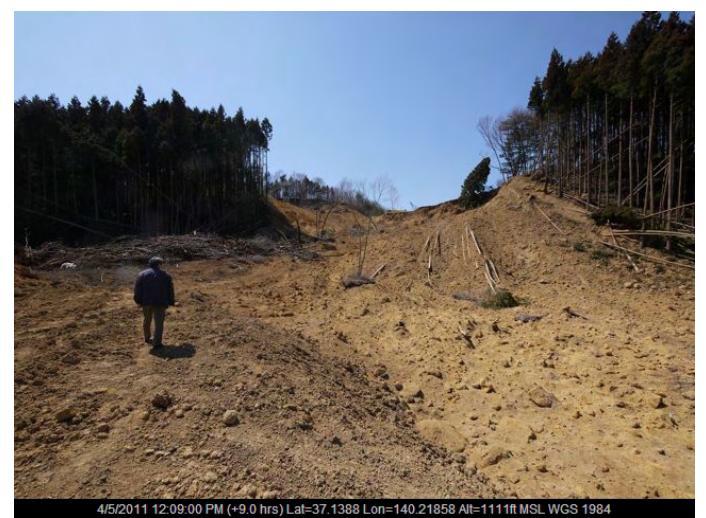
4/5/2011 12 09:00 PM (+9:0 hrs) Lat=37.1388 Lon=140 21858 Att=1111R MSL WGS 1984 Figure QR6-72: Professor Tanaka (Kobe University) walking on debris from Shirakawa landslide

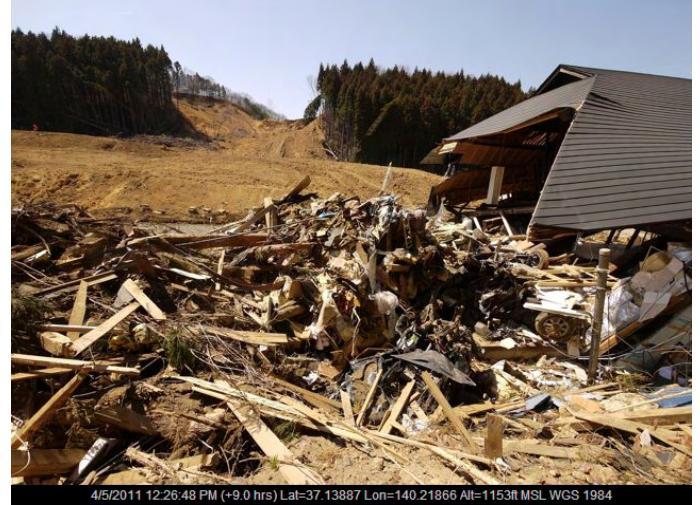
Figure QR6-74: A destroyed home at the north perimeter of the toe of a landslide.

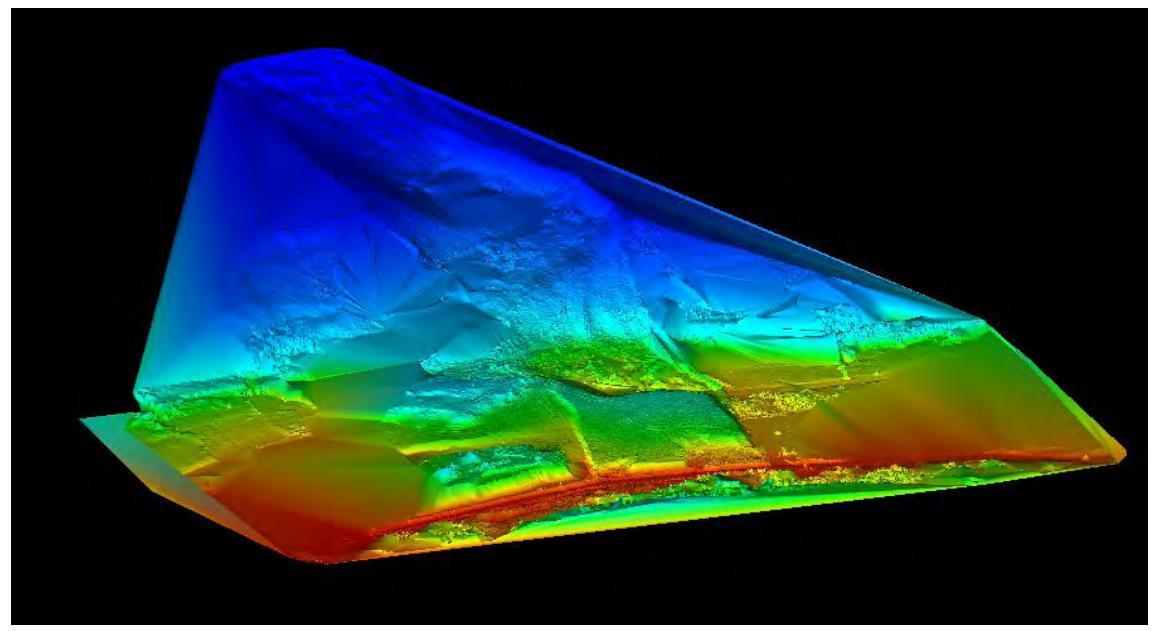
Figure QR6-78: Oblique LiDAR scan from the southeast of the landslide area. The rainbow shade indicates high elevation areas in blue and low elevation areas in red. The landslide scour is clearly evident in the slope. Some regarding of the landslide debris is evident in the valley floor along with the emergency access road cut.

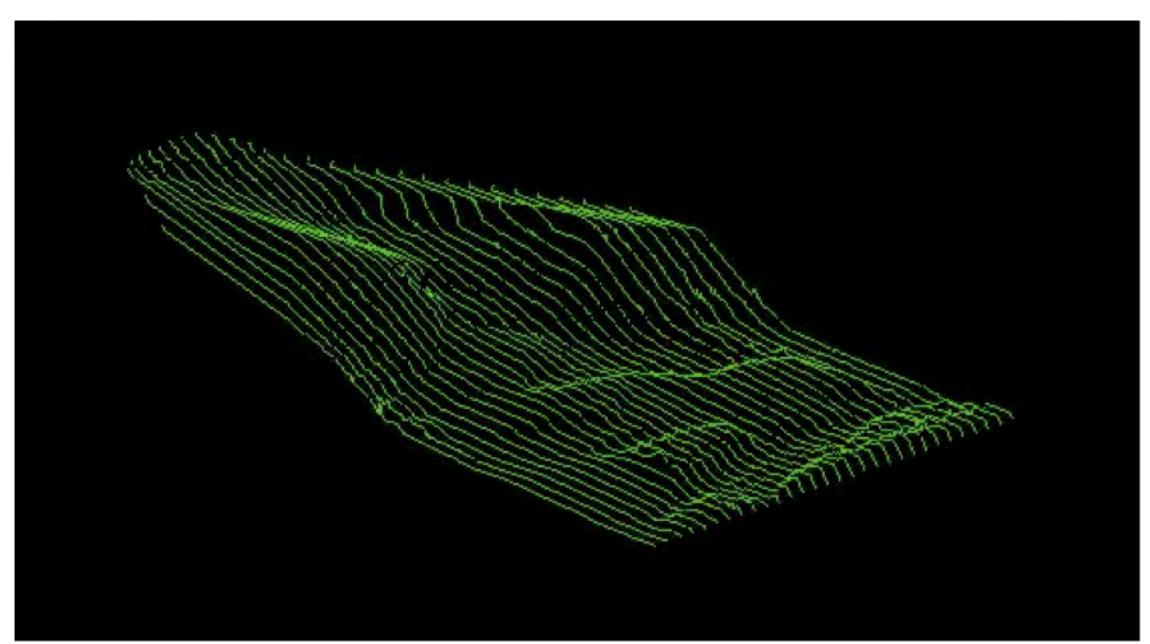
Figure QR6-79: Cross sections through the landslide and adjacent slopes

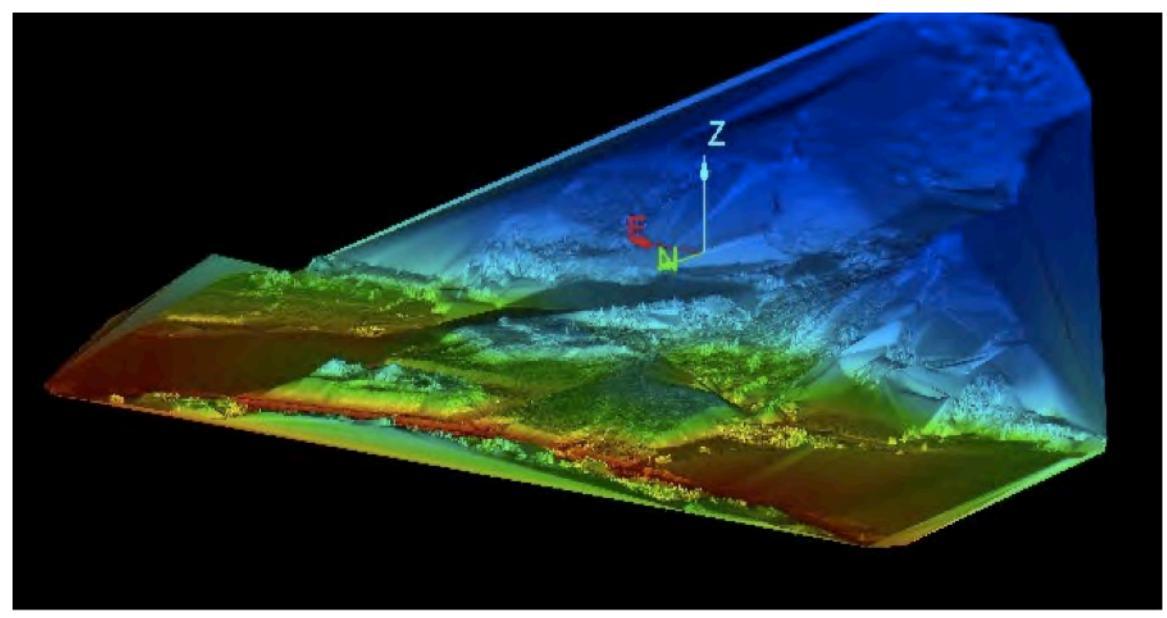
Figure QR6-80: Oblique LiDAR scan from the northeast of the landslide area. The rainbow shade indicates high elevation areas in blue and low elevation areas in red. The landslide scour is clearly evident in the slope. Some regarding of the landslide debris is evident in the valley floor along with the emergency access road cut.

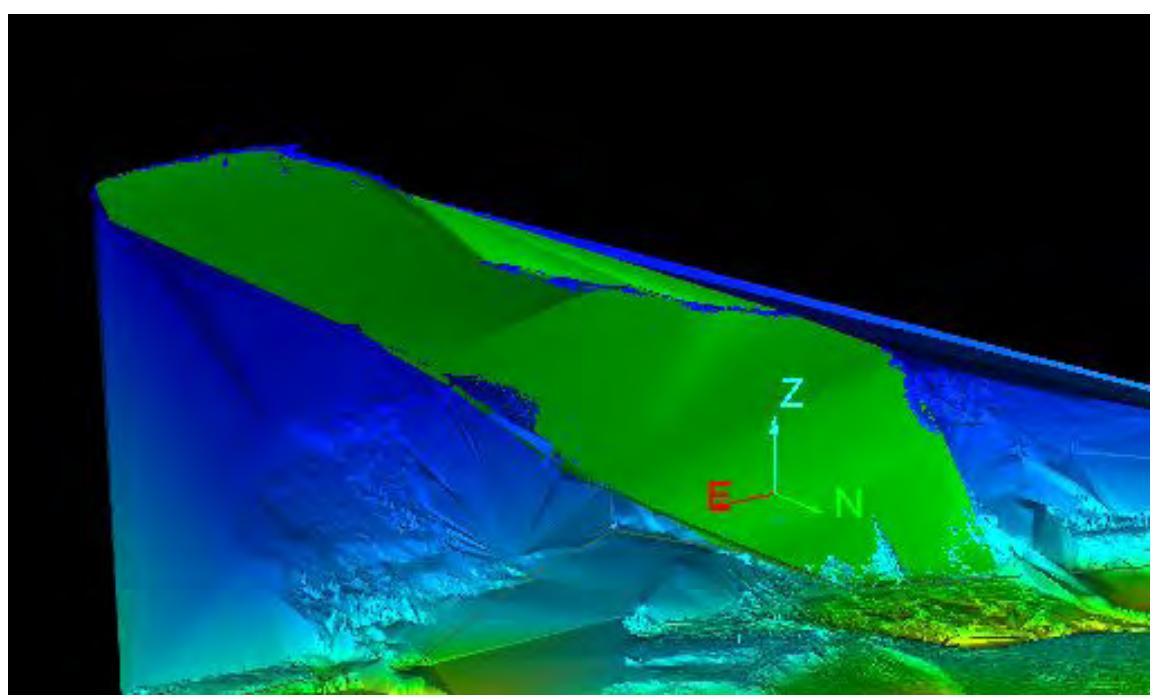
Figure QR6-83: Pre-earthquake model surface across the slope used to estimate the volume of material moved. Approximately 25,000 cubic meters of material were involved in the landslide.

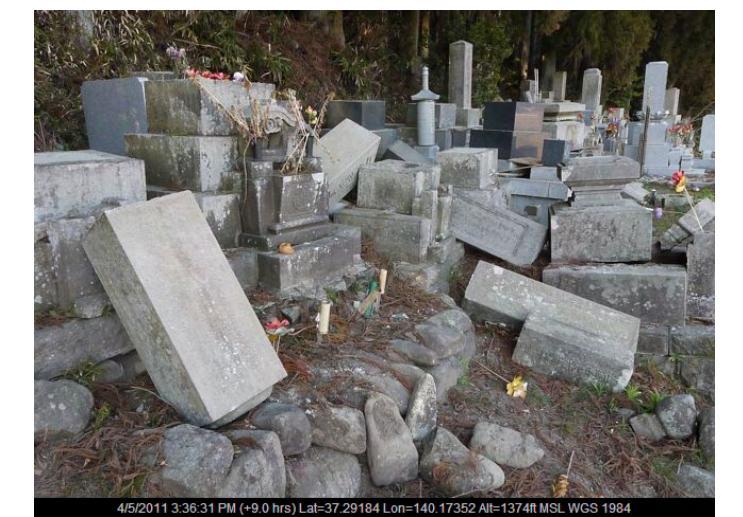
Site RK14: Naganuma Town Cemetery with collapse ratio of approximately 70%.

Figure QR6-85. : Tombstones of a village outside Naganuma. . The collapse ratio is approximately 70%.

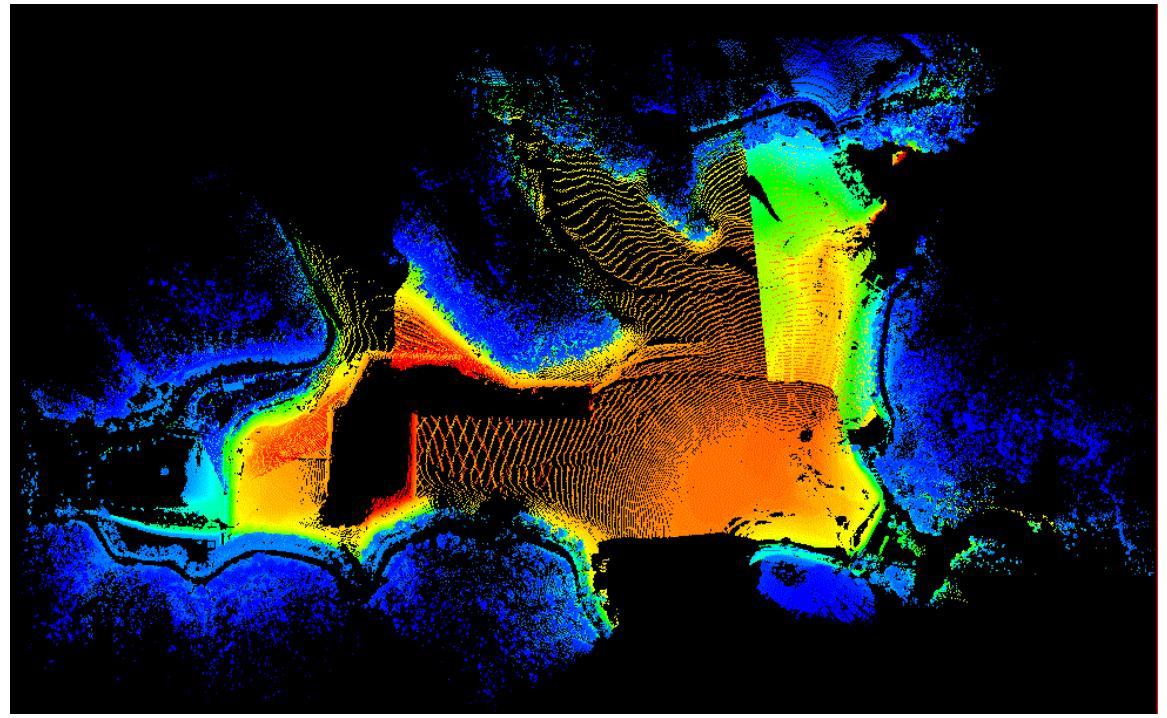
Figure QR6-86: Three areas of LiDAR coverage are the main dam in the upper right of the image above, the auxiliary damn in the lower right, and the embankment slopes along the park frontage on the left side.

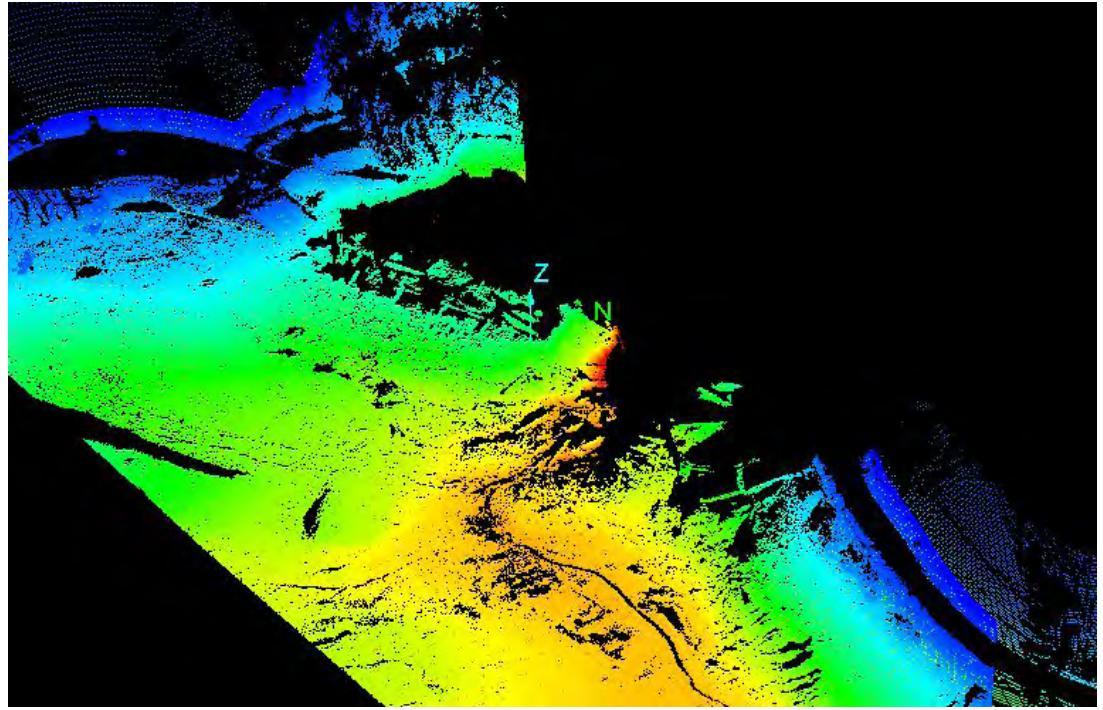
Figure QR6-87: LiDAR data coverage of the main dam includes the upstream slope and remaining crest, but is missing from sections of the downslope face where they still remain.

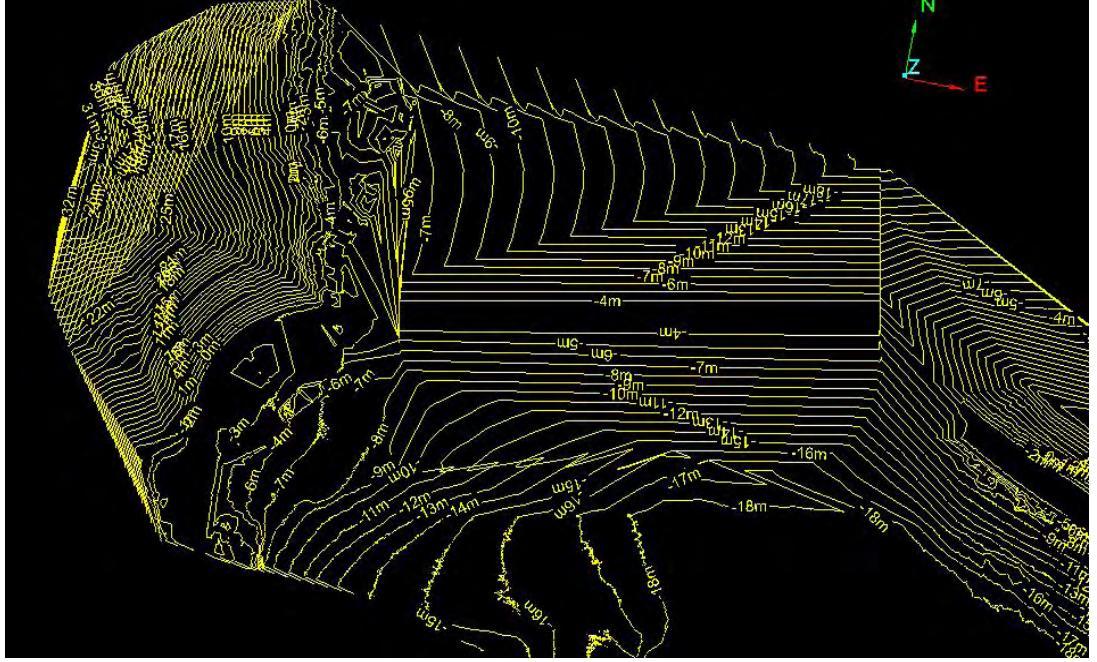
Figure QR6-90: Estimated contour map of the pre-failed dam and surrounding reservoir slopes

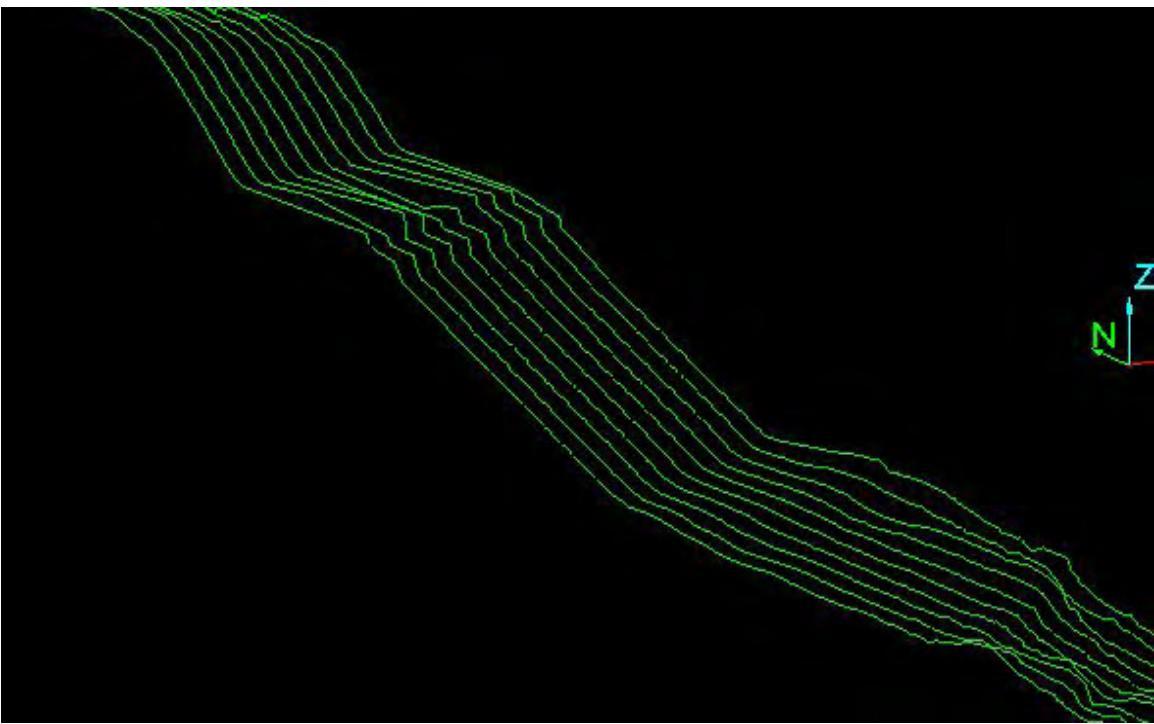
Figure QR6-96: Oblique view of cross-sections of the intact left slope adjacent to the auxiliary dam.

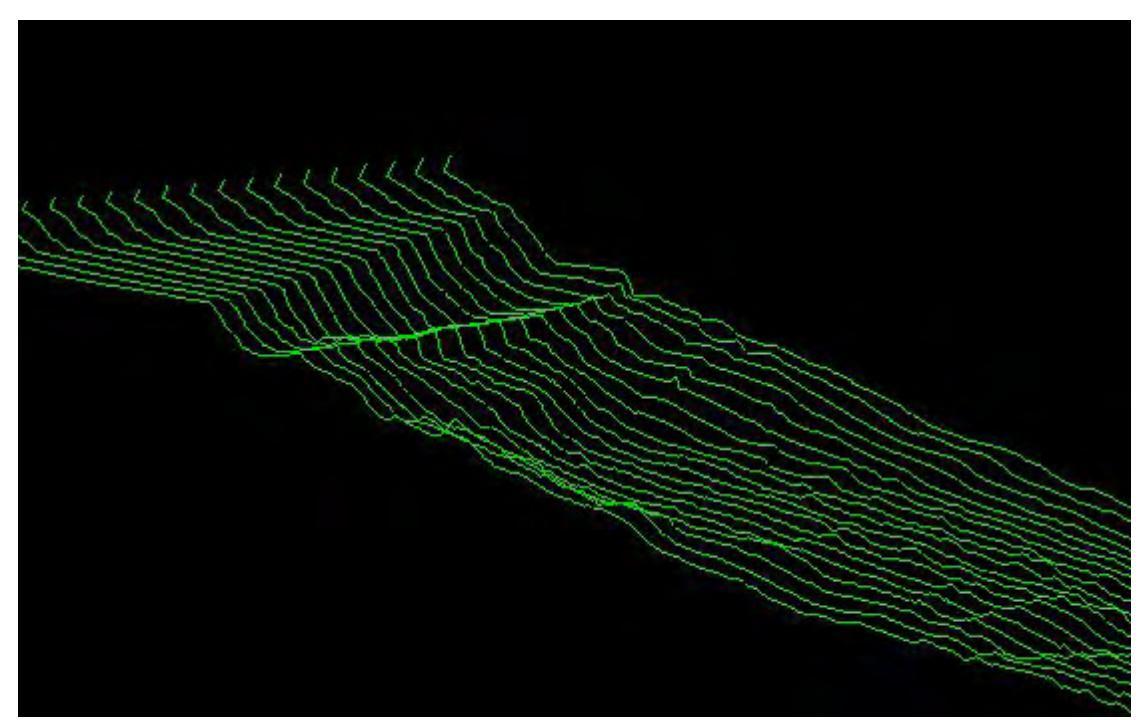
Figure QR6-98: Oblique view of cross-sections through the failed portion of the auxiliary dam.

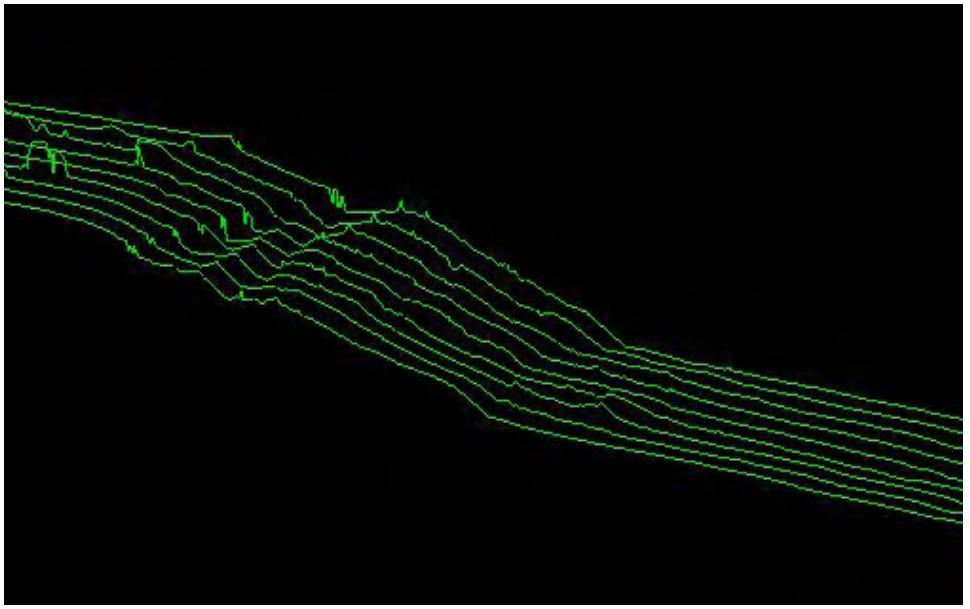
Figure QR6-104. Oblique cross-sections of the failure zone in section 2.

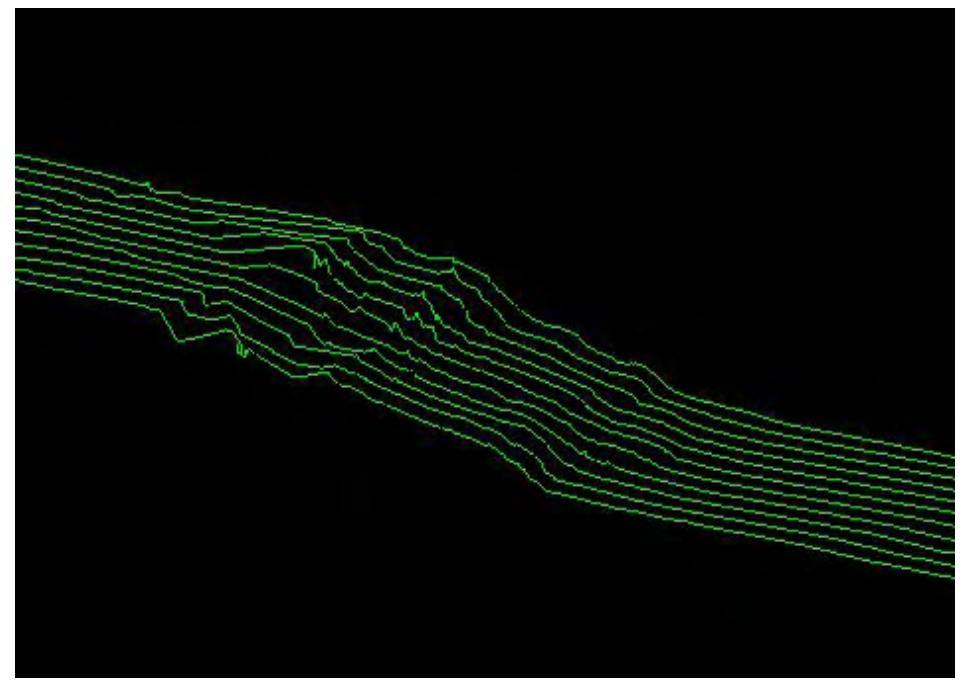
Figure QR6-106: Oblique view of cross sections from failed section 3.

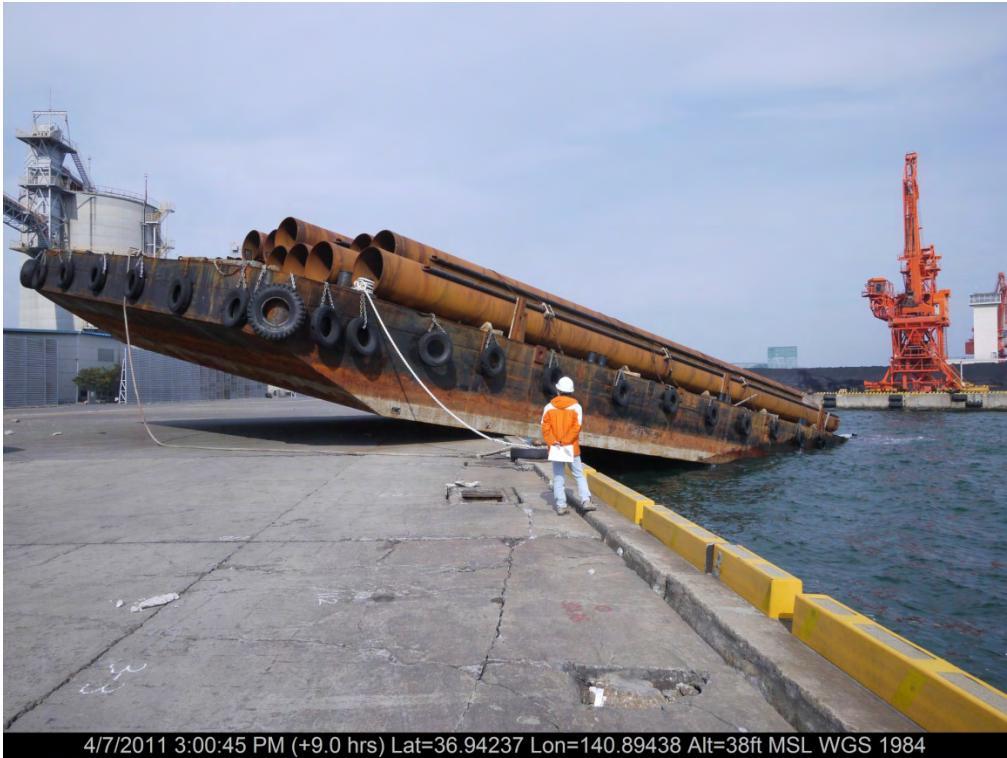
Figure QR6-113: Intact wharf with barge floated onto the deck.
