#### Geotechnical Extreme Events Reconnaissance (GEER)

# LiDAR and Field Investigation Of the March 11, 2011 M9.0 Great Tohoku Offshore Earthquake, and April 7, 2011 M7.4 Aftershock.

## July 20, 2011

#### Tohoku Earthquake Reconnaissance

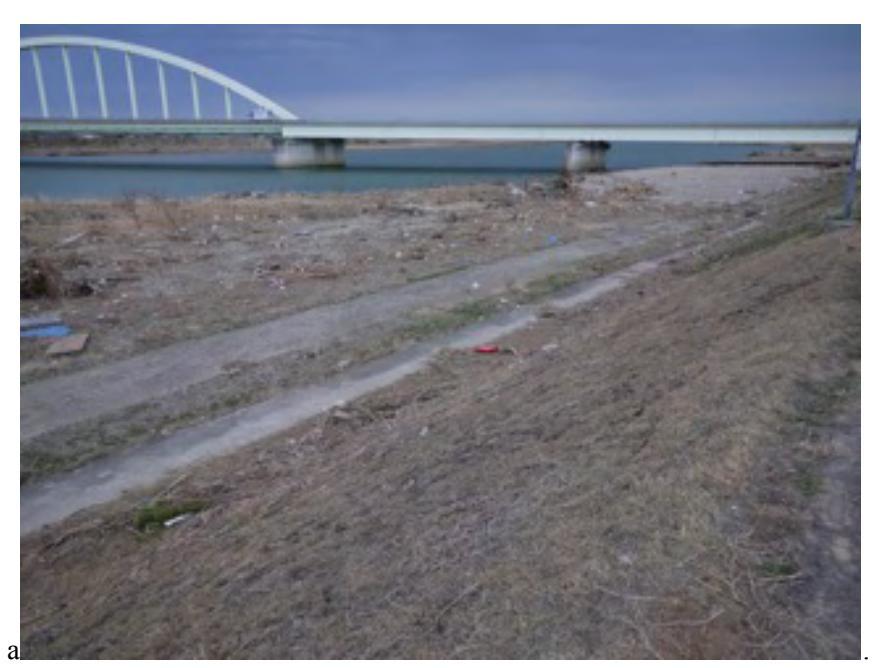
This site liquefied on the night of April 7. On the surface of the riverbank are sand boils of reduced gray sand. This site is located in the tsunami inundation zone and direct evidence of liquefaction from the main event of March 11, 2001 is masked by debris, hydraulic re-working, and tsunami soil deposits. On September 4, 2001, this site was tested by the SASW method.

Figure QR6-122. Liquefaction evidence on the south bank of the Natori River west of the western Yuriage Bridge at RK23 and previous SASW test site 75YUR. In this perspective is similar to photo A

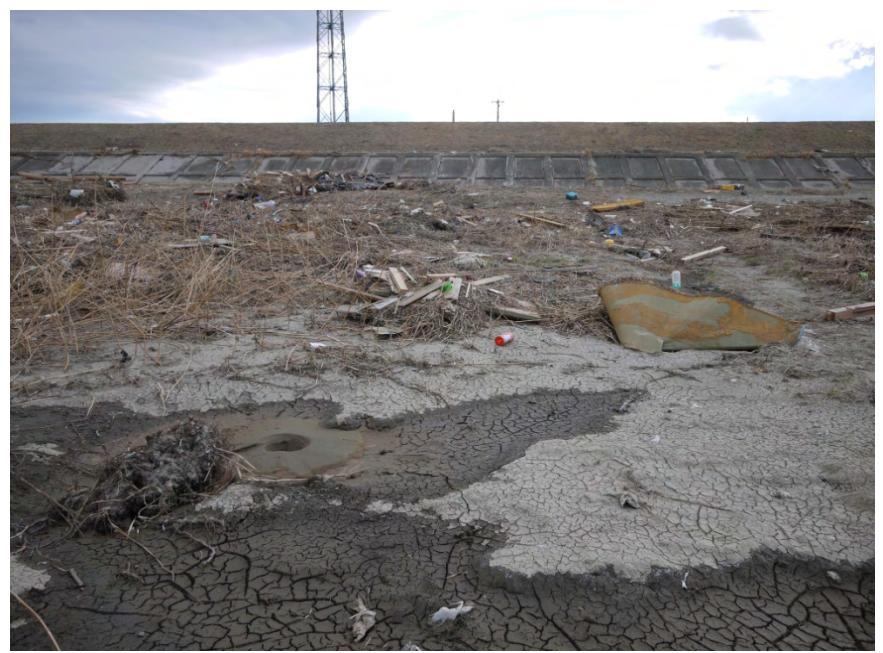
Figure QR6-123: Liquefaction evidence on the south bank of the Natori River west of the western Yuriage bridge at RK23 and previous SASW test site 75YUR. In this perspective is similar to photo A

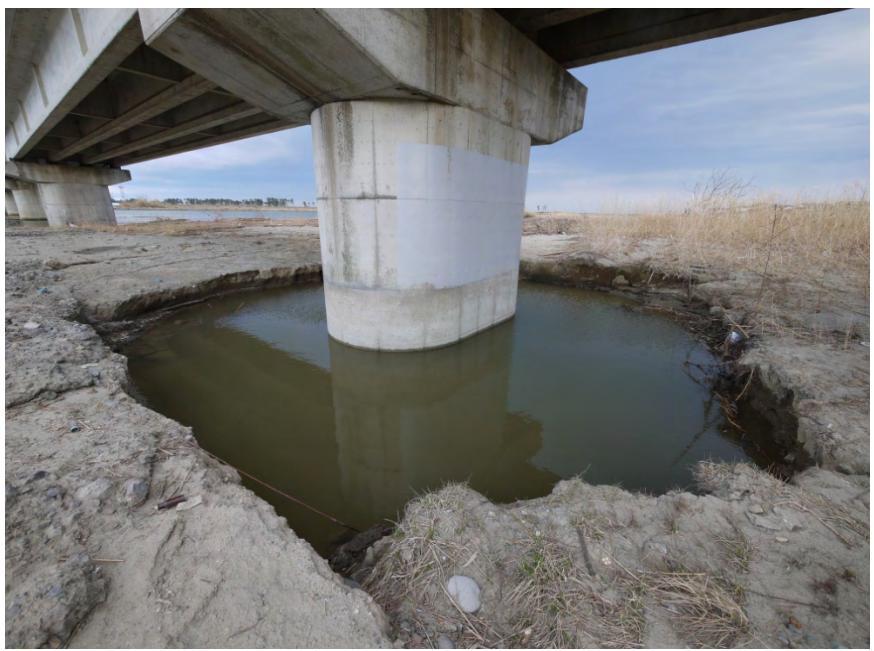
Figure QR6-127: Site RK24 detail of liquefaction features from the April 7, 2011 aftershock on the south bank of the Natori River at the eastern Yuriage Bridge.

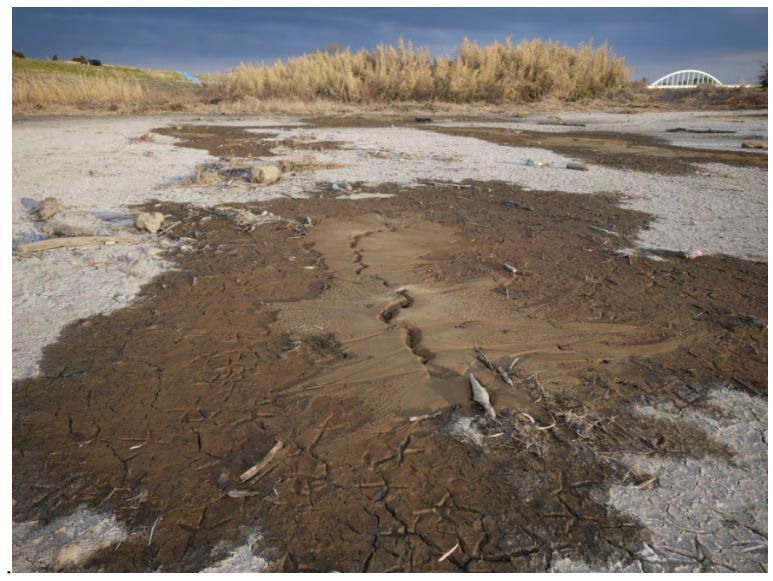
This site liquefied during the 1973 Miyagi Ken Oki earthquake and was originally reported by Iwasaki. The site is on the north bank of the Natori River, on the Sendai side at a location called Nakamura Dike. The site reliquefied the night of 4/7. The soil sand boils were up and oxidized can brown sand.

Figure QR6-129: This site is also SASW test site77SEN (SENDAI), tested on September 4, 2001. This site liquefied during the 1973 Miyagi Ken Oki earthquake and was originally reported by Iwasaki. The site is on the north bank of the Natori River, on the Sendai side at a location called Nakamura Dike. The site re-liquefied the night of April 7. The sand boils were oxidized brown sand. The bridge at site RK 23 is visible in the distance at the top right of the photograph.

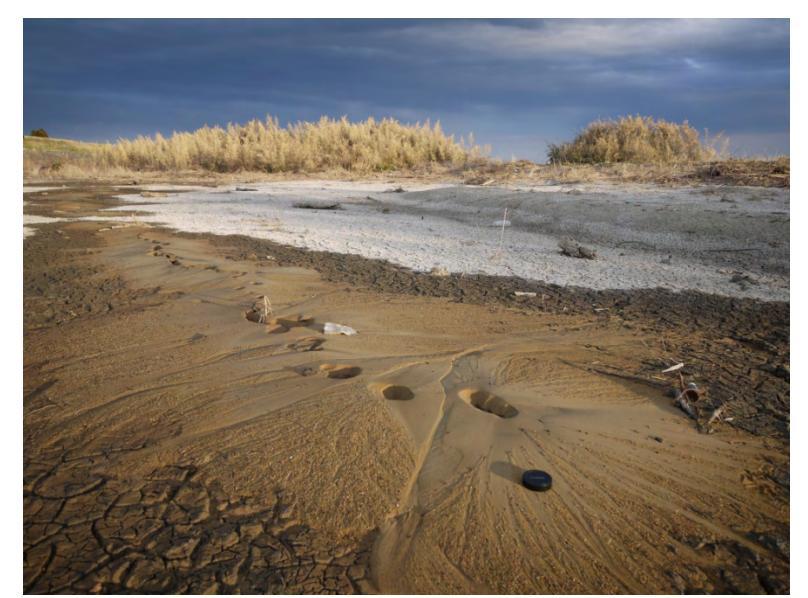
Figure QR6-130: This site is also SASW test site77SEN (SENDAI), tested on September 4, 2001. This site liquefied during the 1973 Miyagi Ken Oki earthquake and was originally reported by Iwasaki. The site is on the north bank of the Natori River, on the Sendai side at a location called Nakamura Dike. The site reliquefied the night of 4/7. The sand boils were up and oxidized sand.

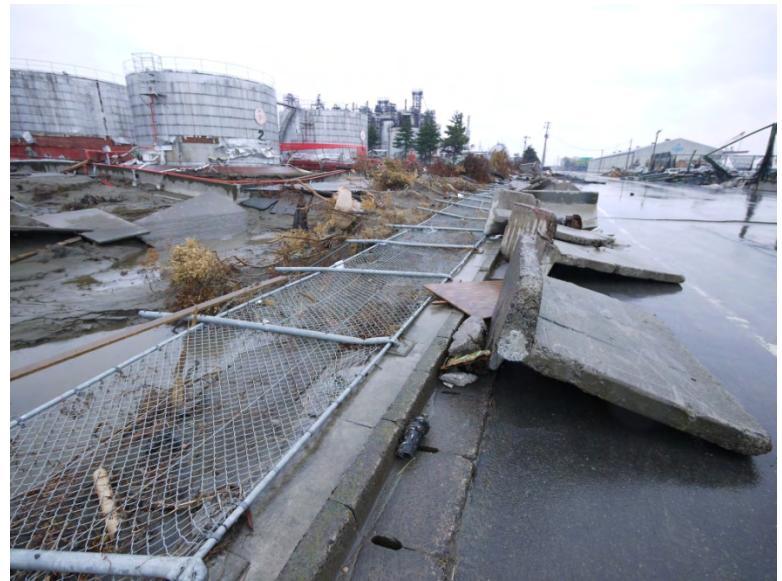
This site is adjacent to a large refinery and oil storage facility. The site liquefied during the aftershock of April 7. Site RK27 was hit by the tsunami and evidence of liquefaction from the main event are completely obscured by the tsunami damage. We also walked through the Ishinomaki of oil refinery and tank storage facility adjacent to SASW site 79ISHI. The site had interesting geotechnical damage of scoured soil beneath the pile supported foundation base of tanks exposing the piles. A buoyant tank floated off one base pad and out of the storage yard. At this site, there is evidence of significant scour of soil from piers supporting the port structures.

Figure QR6-132: Site RK27, also liquefaction test site 79ISHI. This site is called Nakajima Wharf and is adjacent to the Ishinomaki oil refinery and oil storage facility. This photograph has the same perspective as photo A.

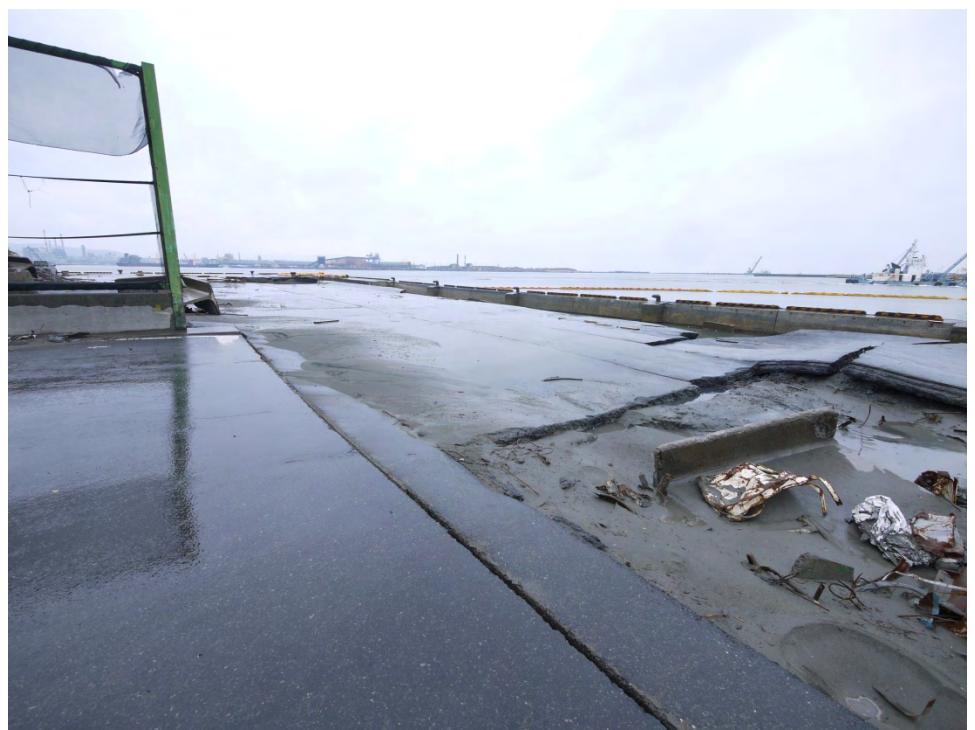
Figure QR6-133: Site RK27, also liquefaction test site 79ISHI. This site is called Nakajima Wharf and is adjacent to the Ishinomaki oil refinery and oil storage facility. This photograph has the same perspective as photo B and D.

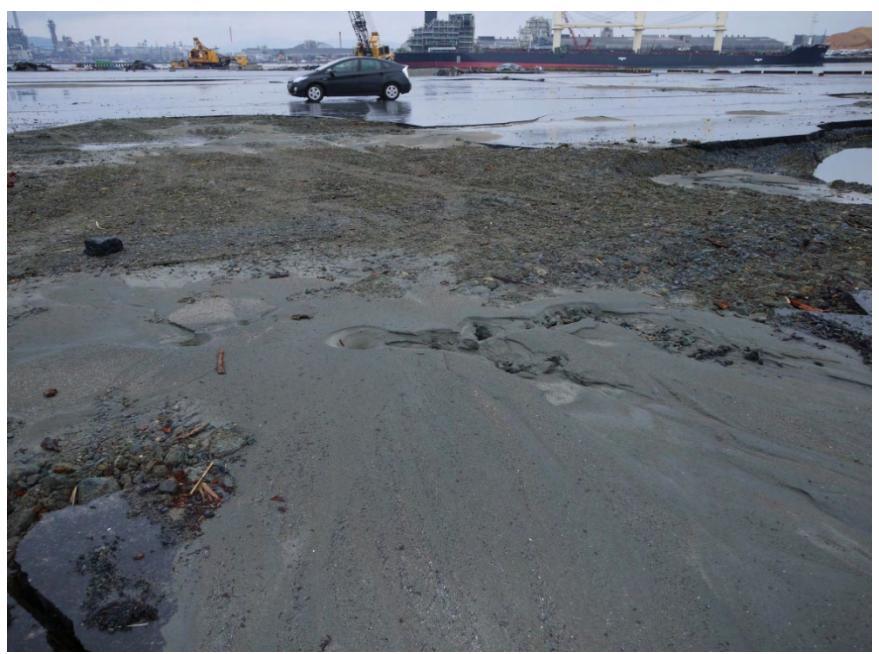
Figure QR6-136: Site RK28 Liquefaction SASW test site 84HIYO on the Hiyori wharf, Port of Ishinomaki .

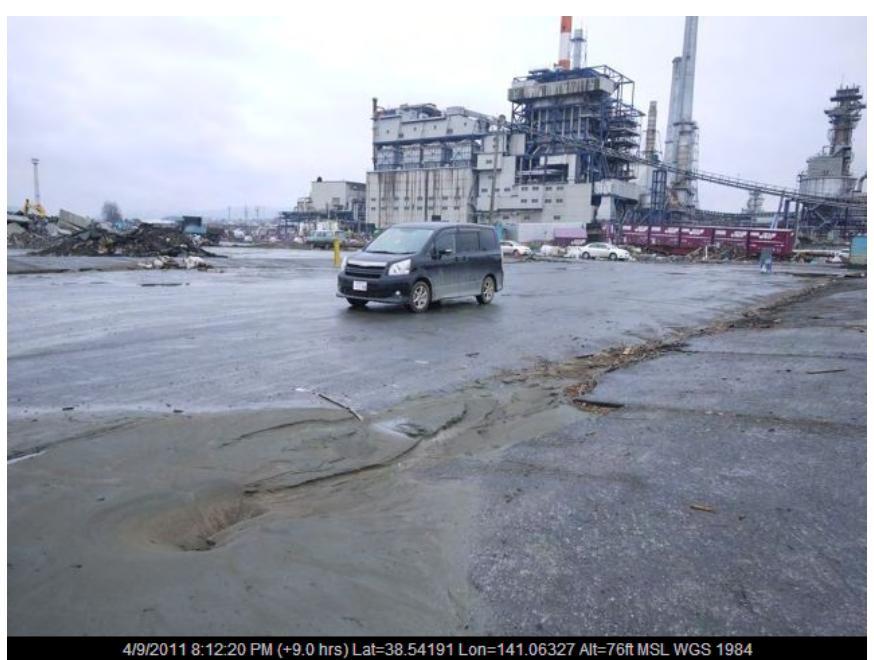
Figure QR6-137: Site RK29 liquefaction at Shiomi wharf. This site is also SASW test site 78ISHS tested on September 5, 2001. Liquefaction occurred during the aftershock of April 7, 2011.

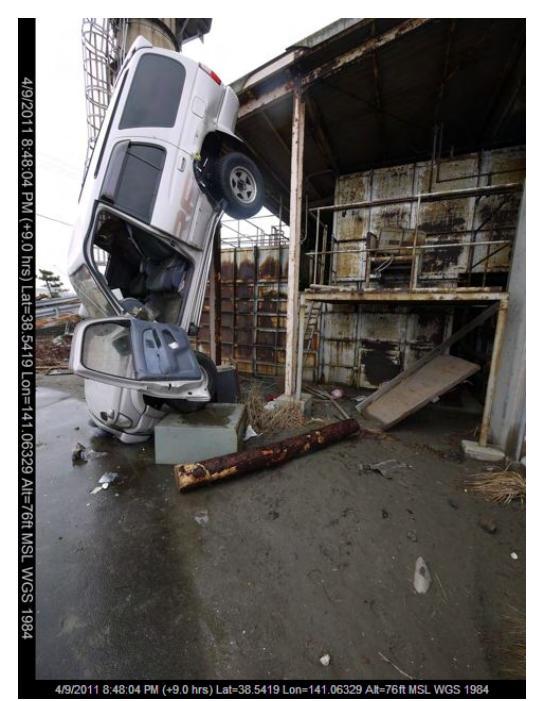
Figure QR6-138: Site RK30 Non-liquefaction site 83SHIOMI. No evidence of liquefaction from the aftershock of April 7, 2001.

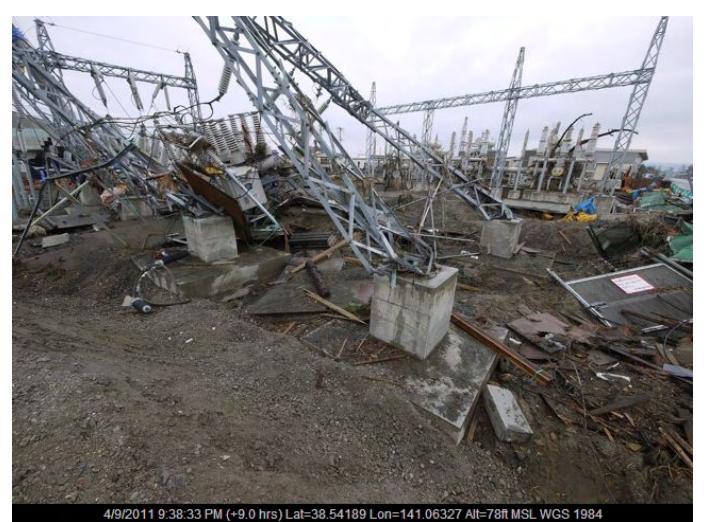
Figure QR6-139: Site RK31 is a Tohoku electric company electrical substation along the frontage road of the port. Flow direction and intensity indicate direct impact of the wave on the structural support frames. Structures are bent towards the land and residential community behind substation. Much of the substation equipment has been removed by the wave from the foundation blocks. Significant scour is evident around the foundations of the substation.

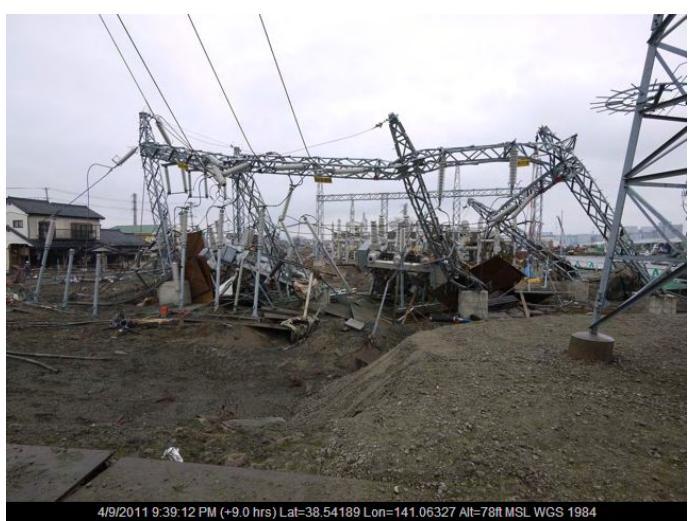
Figure QR6-140: Site RK31 is a Tohoku electric company electrical substation along the frontage road of the port. Flow direction and intensity indicate direct impact of the wave on the structural support frames. Structures are bent towards the land and residential community behind substation. Much of the substation equipment has been removed by the wave from the foundation blocks. Significant scour is evident around the foundations of the substation.

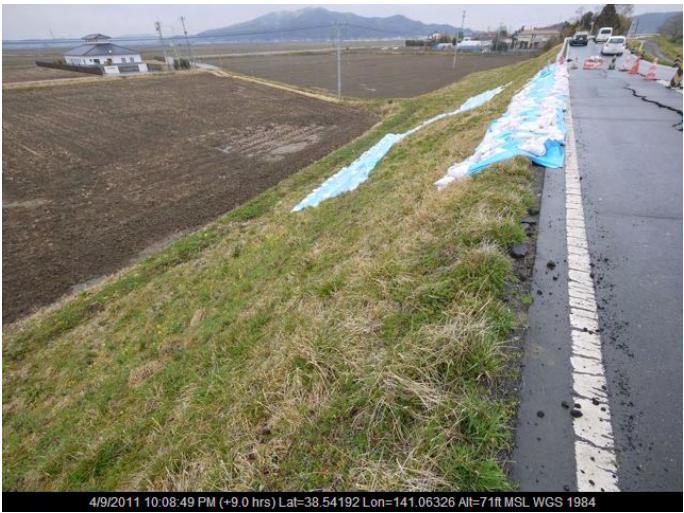
Figure QR6-142: Blue tarp draped over fissures on the west side of embankment highway 257 at Koguchi, Miyagi Prefecture looking north

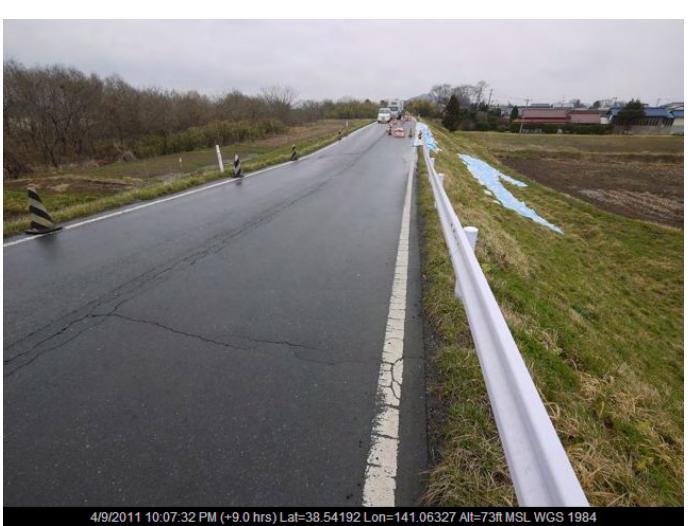
Figure QR6-144: Blue tarp draped over fissures on the west side of embankment highway 257 at Koguchi, Miyagi Prefecture looking south.

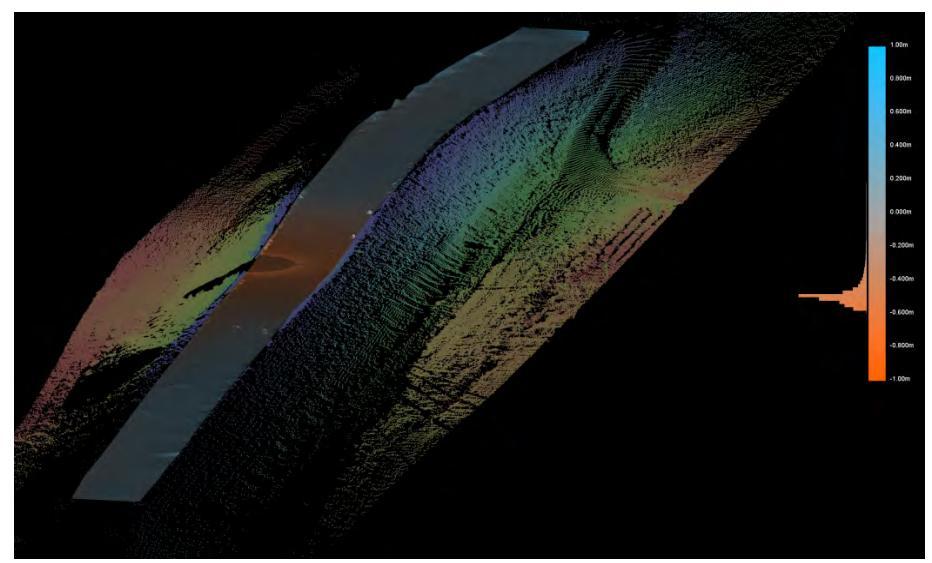
Figure QR6-146: Oblique LiDAR imagery and histogram of settlement along the road crest based on a model of the pre-earthquake geometry of the road.

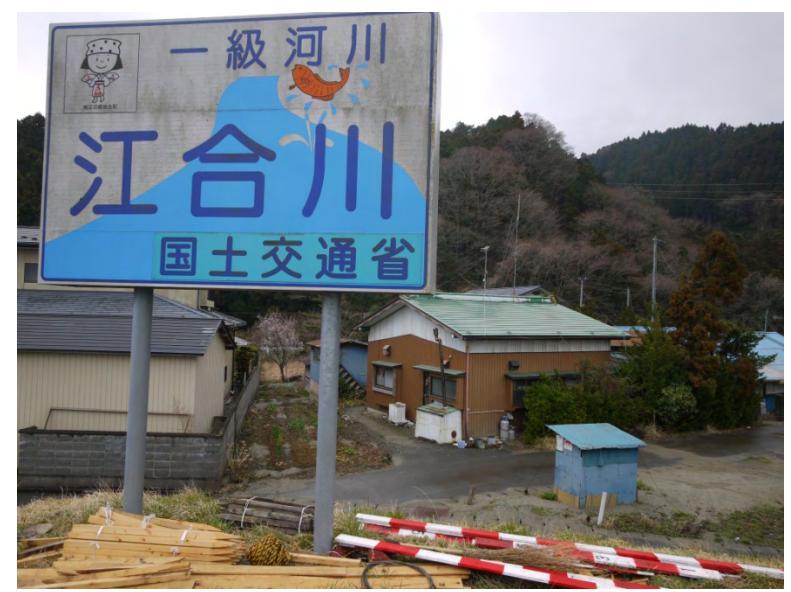
Figure QR6-148:. Signed post of the EAI River, and evidence of liquefaction at RK 33.

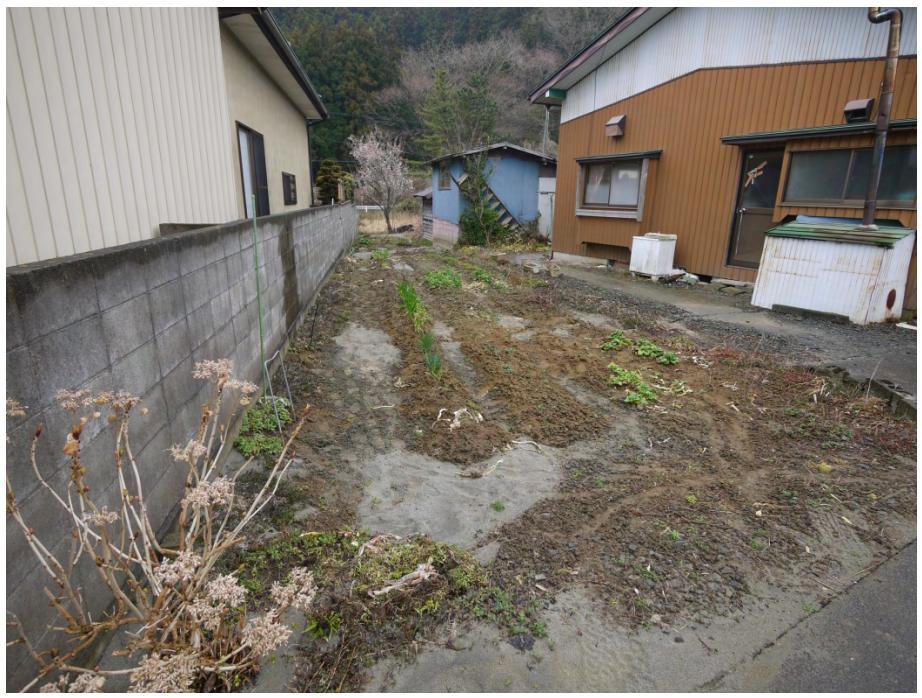
Figure QR6-149: Site RK33 correspond with 82KITA. At the siteRK33, there is overlapping evidence of liquefaction from aftershock of April 7 and the main shock of March 11, 2011. Here, sand boils surround residential and out structures.

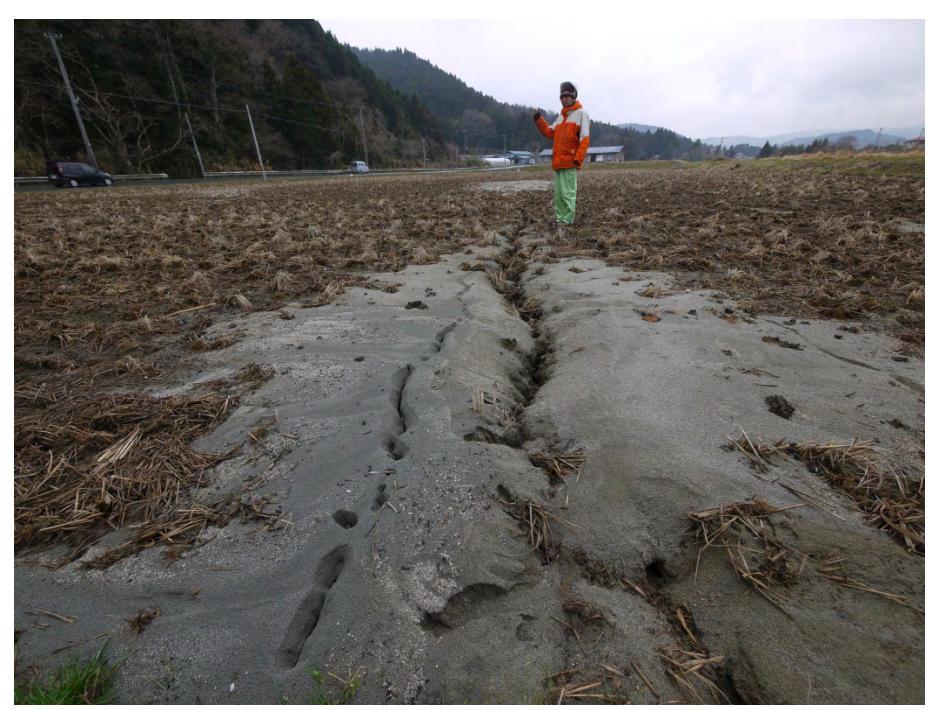
Figure QR6-150: Site RK33 correspond with 82KITA. At the siteRK33, there is overlapping evidence of liquefaction from aftershock of April 7 and the main shock of March 11, 2011.

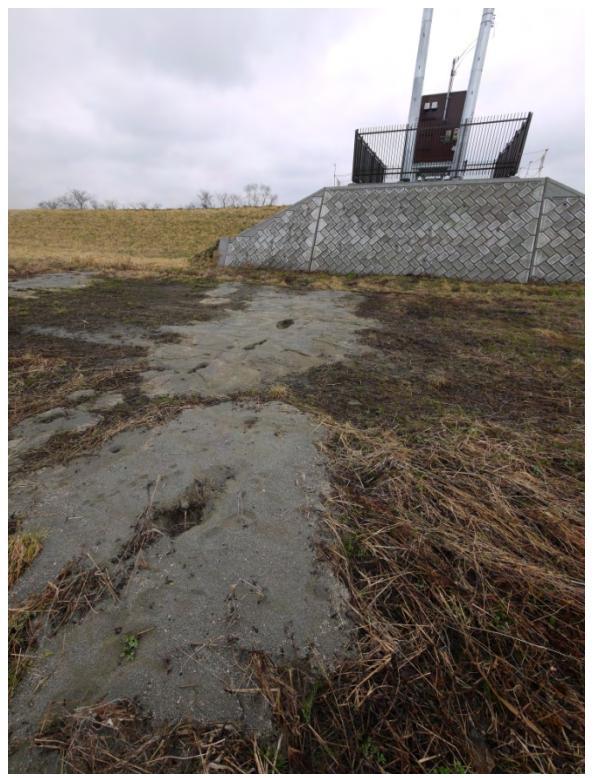
Figure QR6-151: Site RK34, SASW site from 2001 81KITA. This site liquefied during the April 7, 2011 aftershock but it is unclear if the site liquefied during the Main shock.

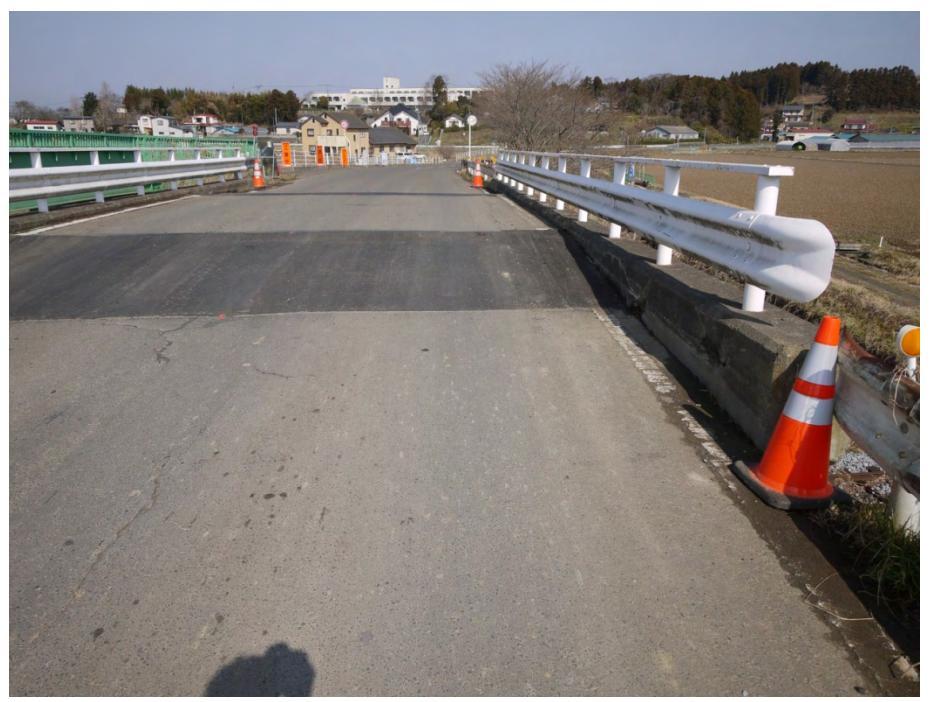
Figure QR6-155: (RK 39) Bridge and settlement of soil approach fill along the country highway at Kubota, Miyagi.

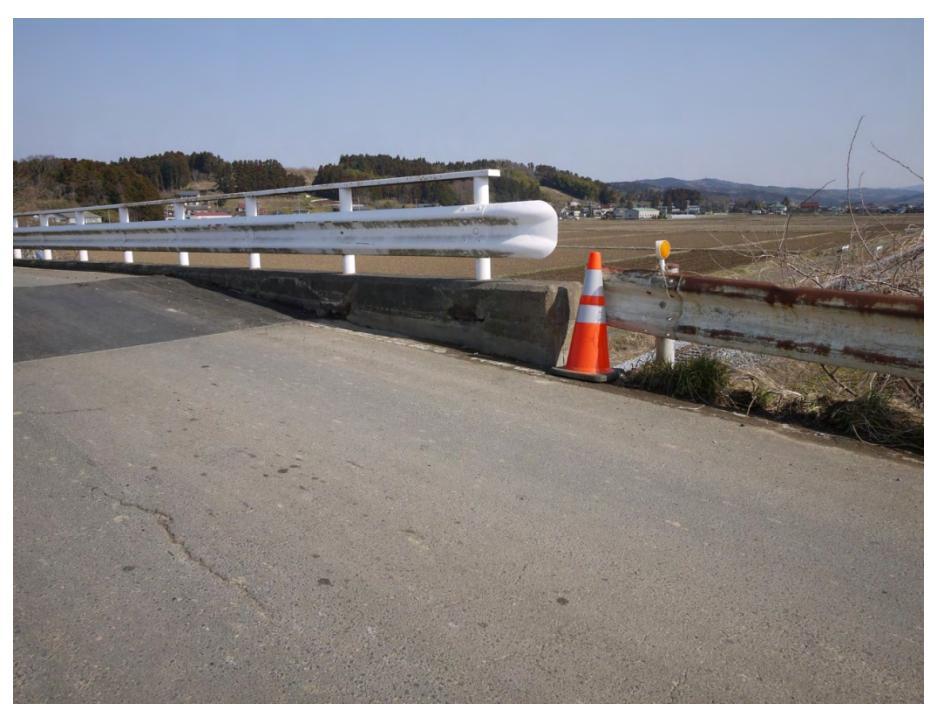
Figure QR6-156: (RK 39) Bridge and settlement of soil approach fill along the country highway at Kubota, Miyagi.

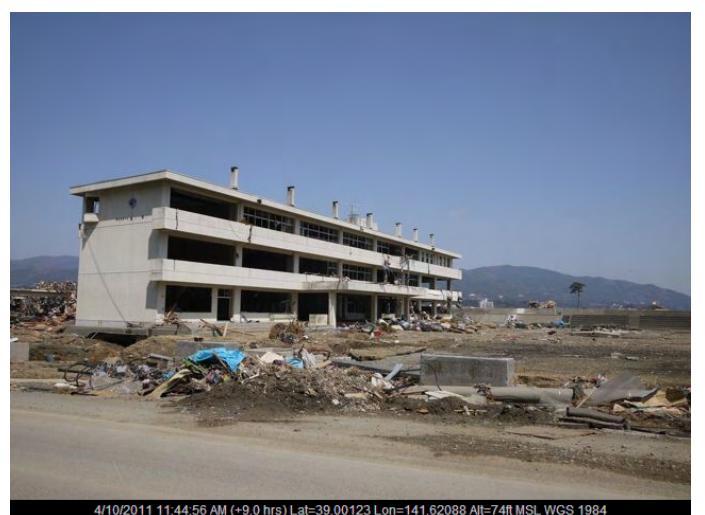
Figure QR6-158: (Site RK43) Three story tsunami damage (~10+m) on structure in Rikuzentakada, Iwate.

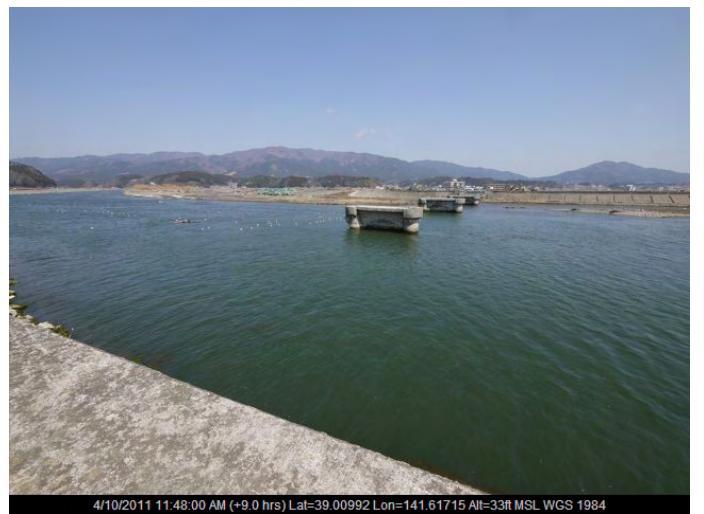
Figure QR6-159: (Site RK43) Rikuzentakada bridge-deck closest to harbor was swept off the piers and scattered several hundred of meters inland. Soil supporting piers are scoured but in place. The bridge was built in 1932. No landslides or other geotechnical aspects other than tsunami damage. The railroad bridge on the north end of Rikuzentakada was also swept off piers with significant scour at the pier base. The bridge through-truss was thrown inland from the bridge piers, and several piers are overturned.

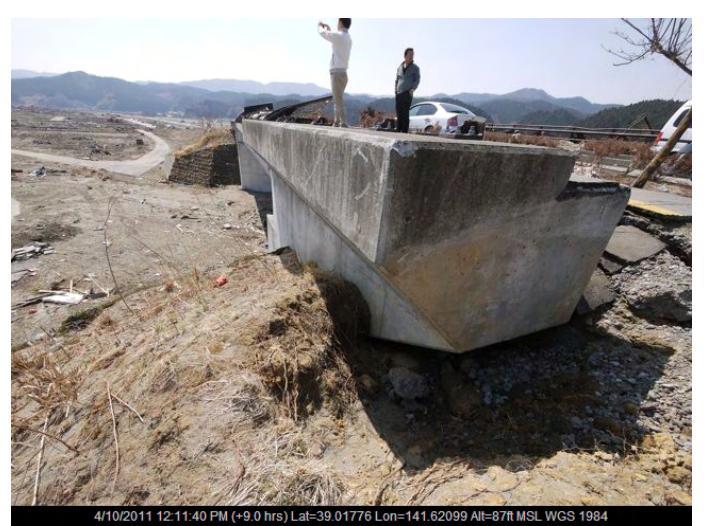
Figure QR6-160: (Site RK44) Rikuzentakada railroad yard overpass northeastern part of town. Wave heights exceeded the overpass height and folded the guard rail over onto the road deck  $(\sim 10m)$ .

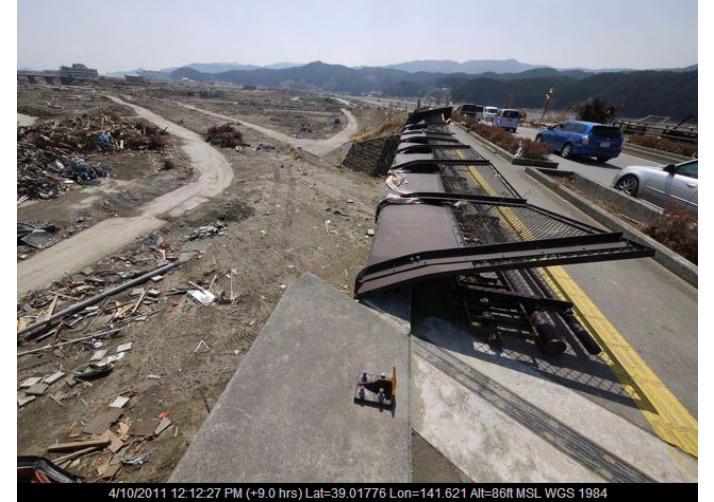
Figure QR6-161: (Site RK44) Rikuzentakada railroad yard overpass northeastern part of town. Wave heights exceeded the overpass height and folded the guard-rail over onto the road deck  $(\sim 10m+$  wave height).

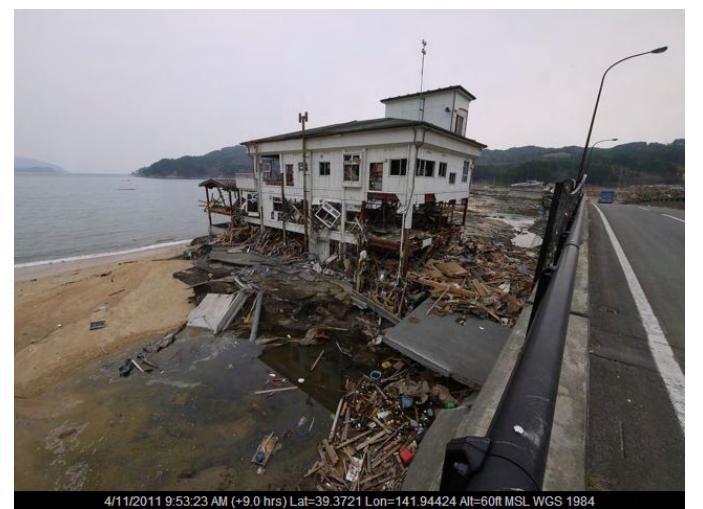
Figure QR6-162: Harbor damage from tsunami damage at Otsuchi (~15m wave height).

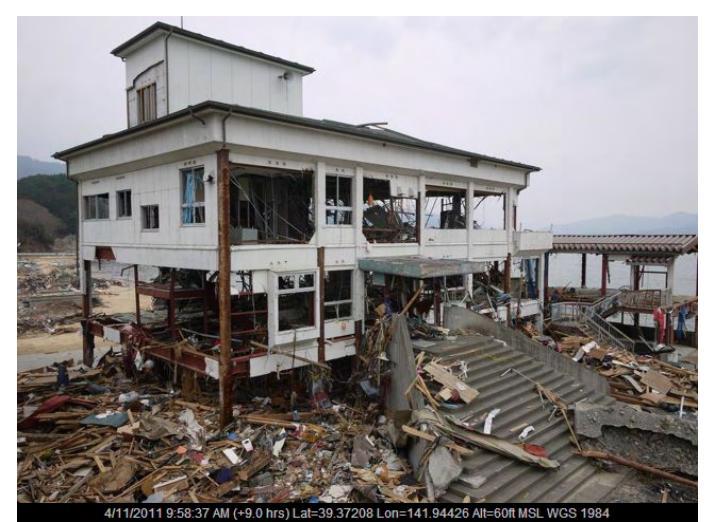
Figure QR6-163: (Site RK46) Otsuchi town very badly impacted by the tsunami waves but no landslides or other factors or shaking-related structural damage.

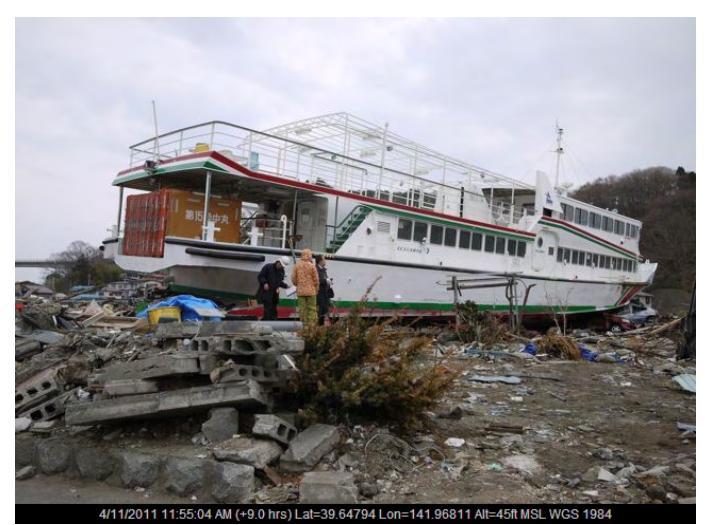
Figure QR6-166: (RK48) - Ferry boat floated far into Miyako town, Iwate.

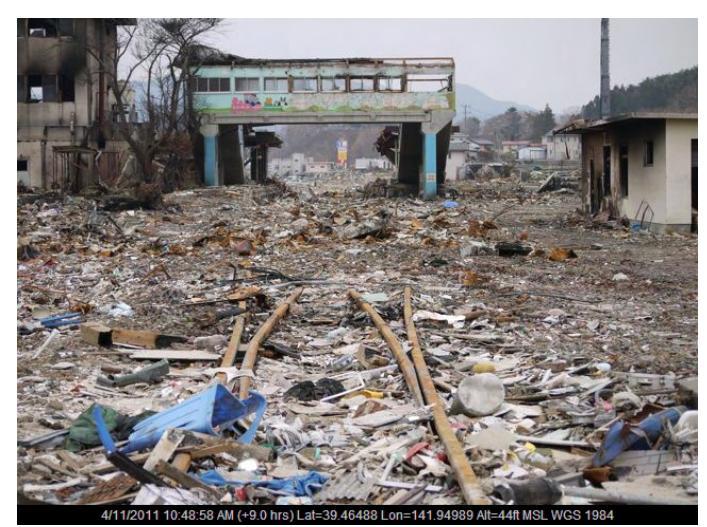
Figure QR6-168: (RK48) Tsunami damage and fire of structures in central Miyako.

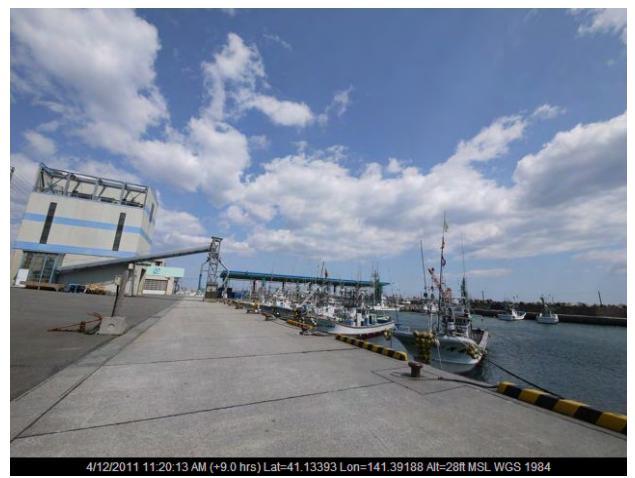
Figure QR6-173: (Site RK52) Mukainagare on the Oma Peninsula no evidence of tsunami damage at the port or any other geotechnical or structural problems. It is the first port without any damage in 670km

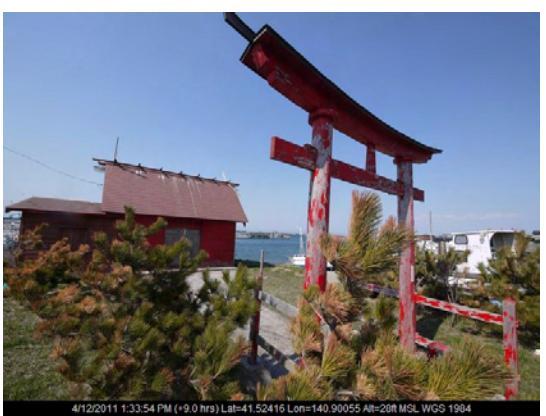
Figure QR6-174: (Site RK53) Oma Point on the Oma Peninsula had no evidence of tsunami damage or any other geotechnical or structural problems.

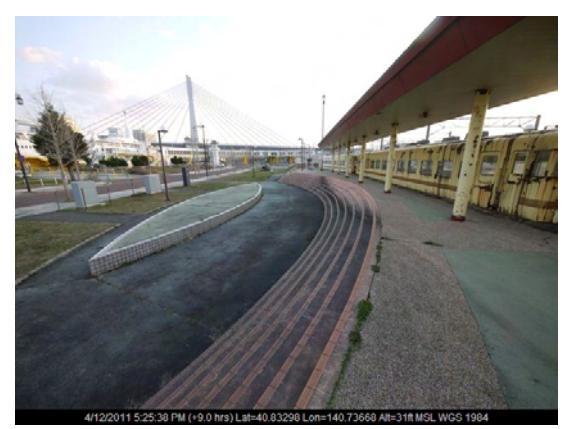
Figure QR6-175: (Site RK54) Old Aomori Train station, Aomori City. No liquefaction. This site liquefied numerous times in the past and is an old-fill at the north end of the Aomori train station. There is no evidence of liquefaction at the site.
