GEOTECHNICAL ENGINEERING RECONNAISSANCE OF THE 30 NOVEMBER 2018 M7.0 ANCHORAGE, ALASKA EARTHQUAKE

Geotechnical Extreme Events Association GEER Report GEER-059 January 2, 2019

GEER Team Co-Leaders: Kevin W. Franke (BYU) and Richard Koehler (UNR)

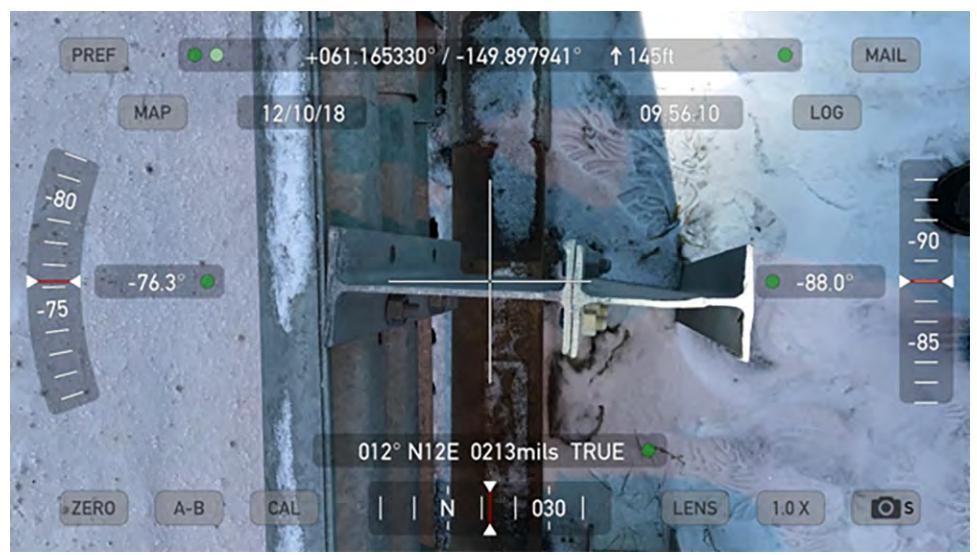
Figure 5-12. West Dowling Road Bridge – View of out-of-plane deformation of light I-Sections supporting guardrails along the bridge deck.

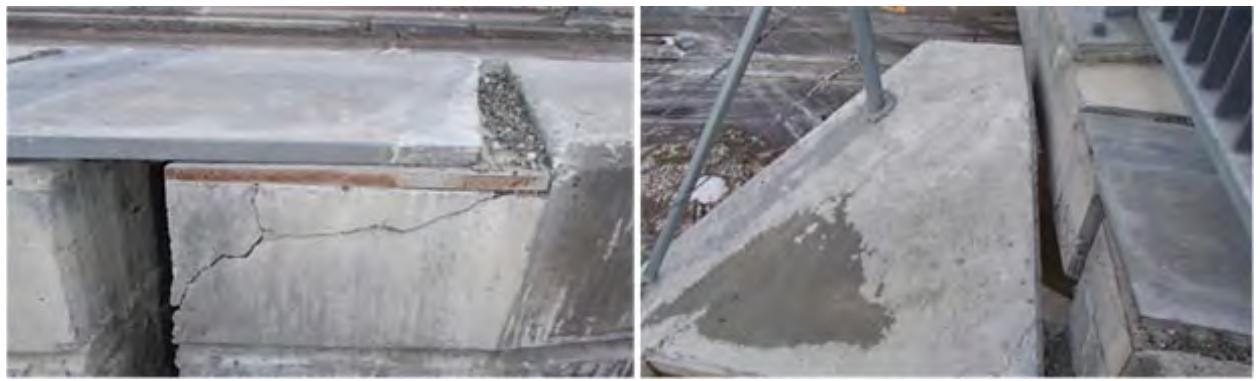
Figure 5-13. West Dowling Road Bridge – View of (left) shear-cracking at the northeast transition from bridge span to approach fill, indicating possible evidence of pounding, and (right) permanent transverse movements at same location (courtesy of Dave Hemstreet, AKDOT).

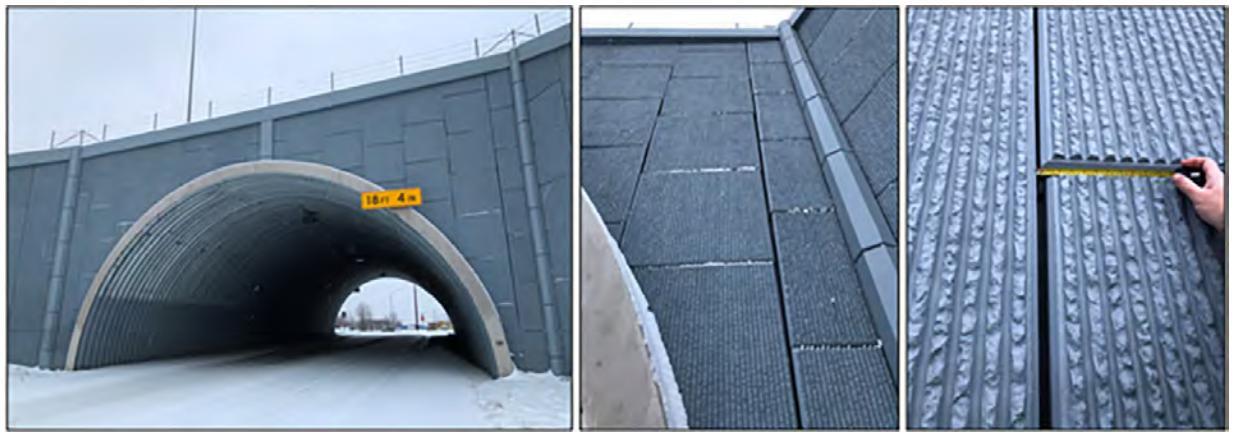
Figure 5-15. West Dowling Road Bridge – overview and close-ups of wall panel movements (Lat/Long: 61.1651, -149.8991).

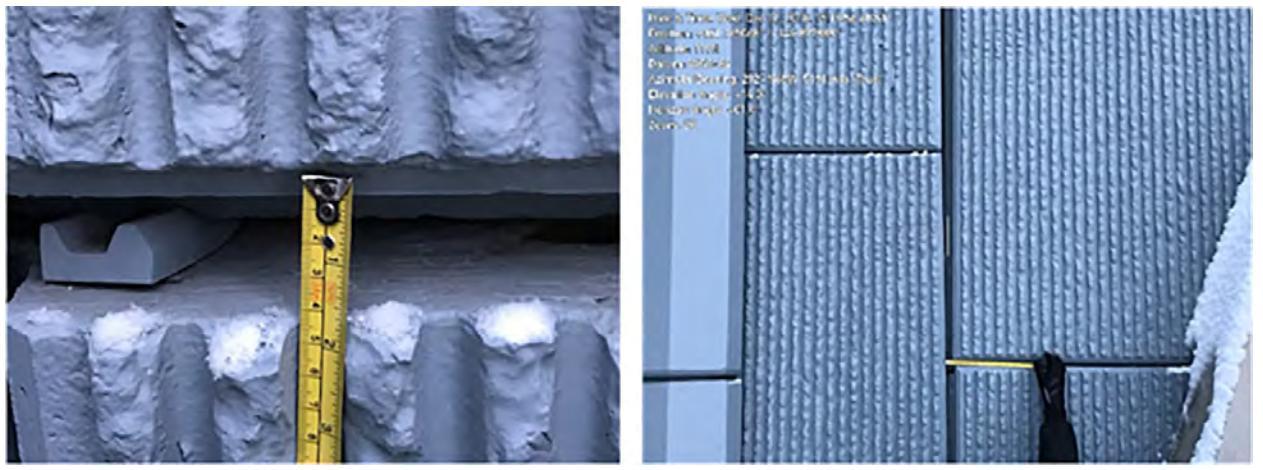
Figure 5-16. West Dowling Road Bridge – unloading of bearing pad (left) and tilt of panel towards culvert opening (right).

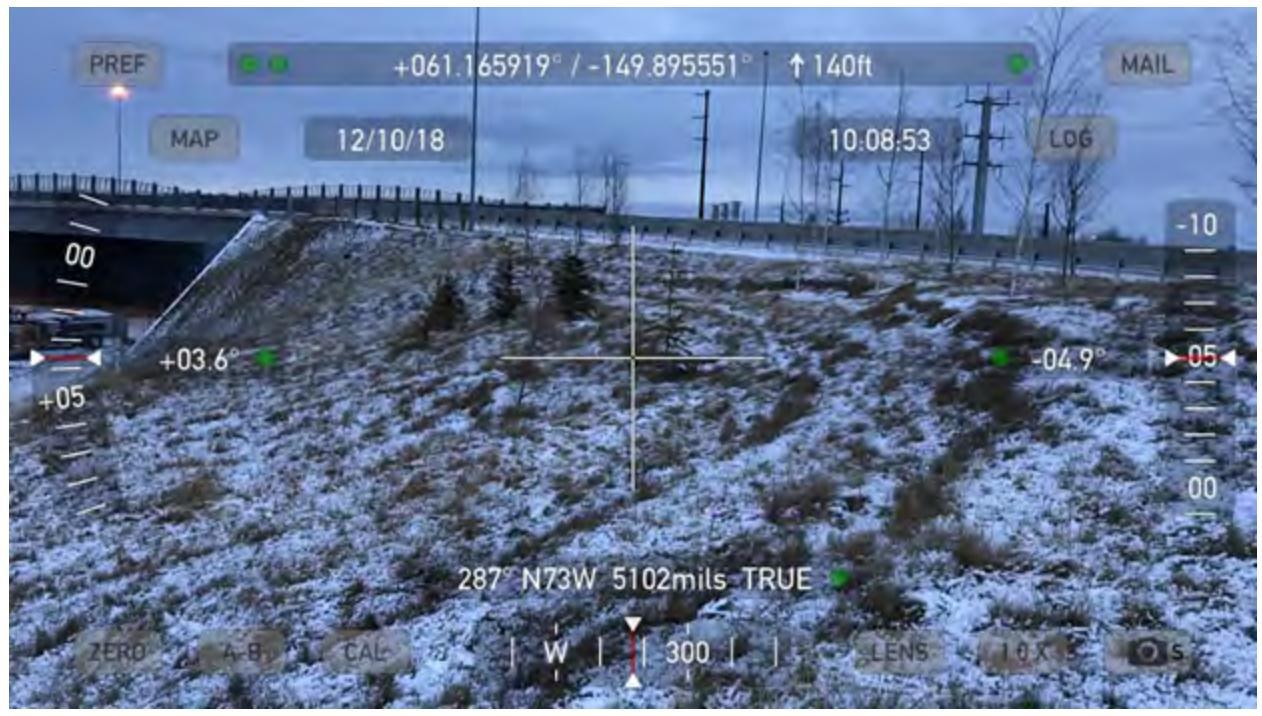
Figure 5-17. West Dowling Road Bridge - slope movement along East approach fill

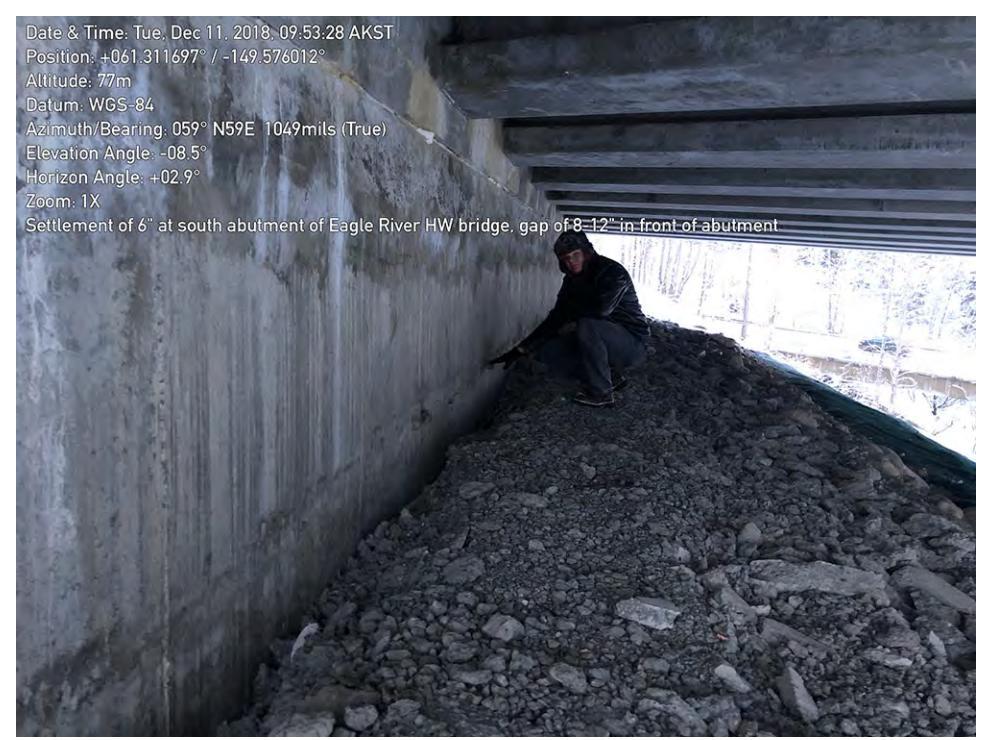
Figure 5-18. Settlements and lateral deformations in the spill slope at the south abutment of the northbound Glenn Highway Bridge over Eagle River (Lat/Long: 61.3117°, -149.5760°)

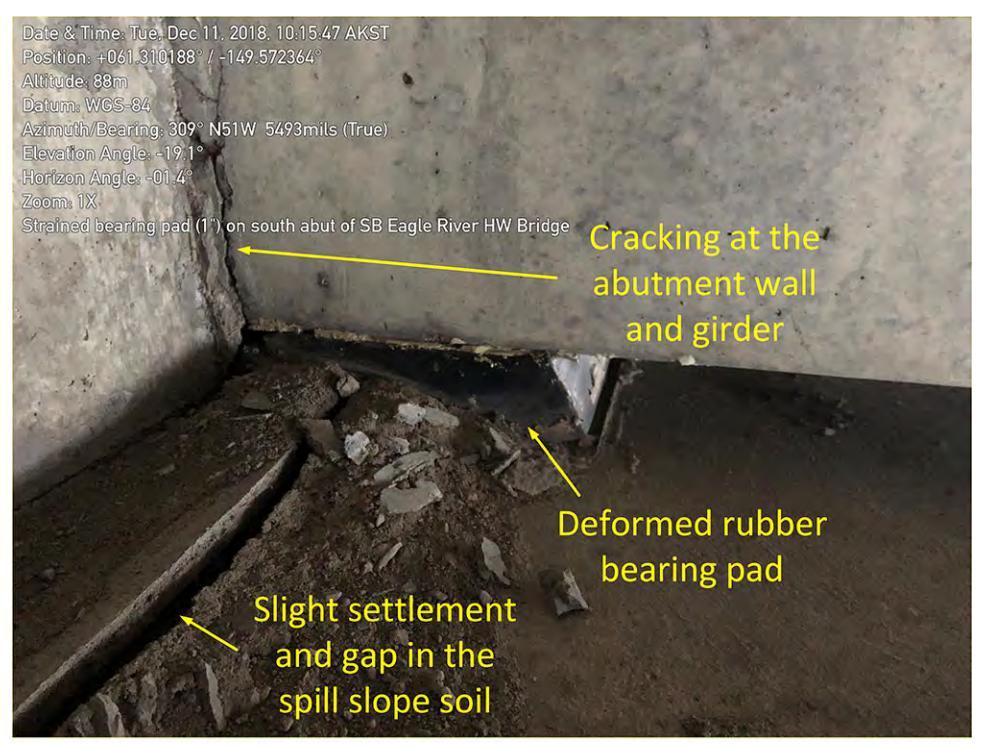
Figure 5-19. Observed girders and abutment seat at the southern abutment of the southbound Glenn Highway Bridge over Eagle River (Lat/Long: 61.1310°, -149.5724°).

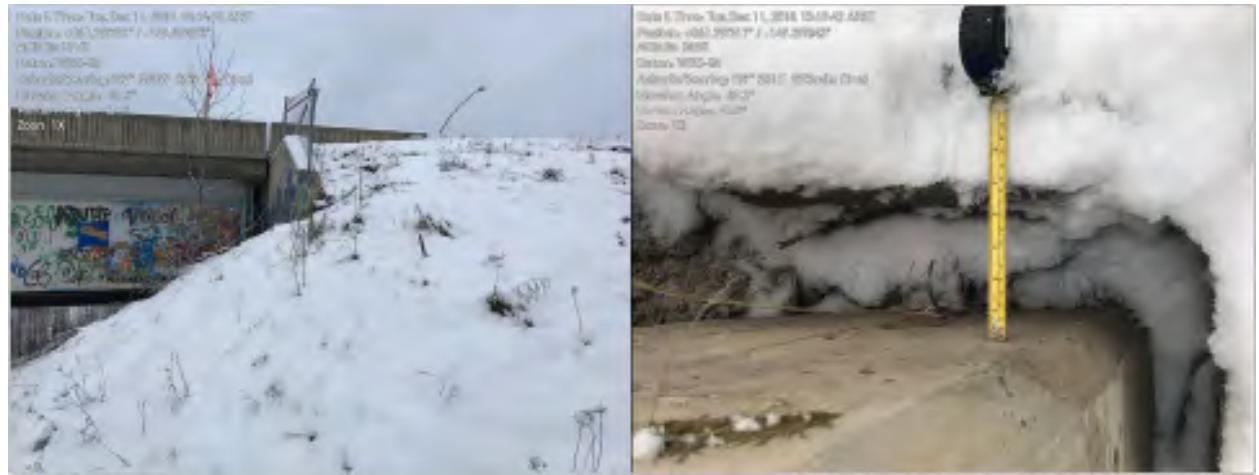
Figure 5-24. View of eastern portion of the north abutment exhibiting vertical and lateral movements downslope.

investigation, however, no additional movement was observed in spring 2019. See figures 5-23 and 5-24 in the main body of the report.

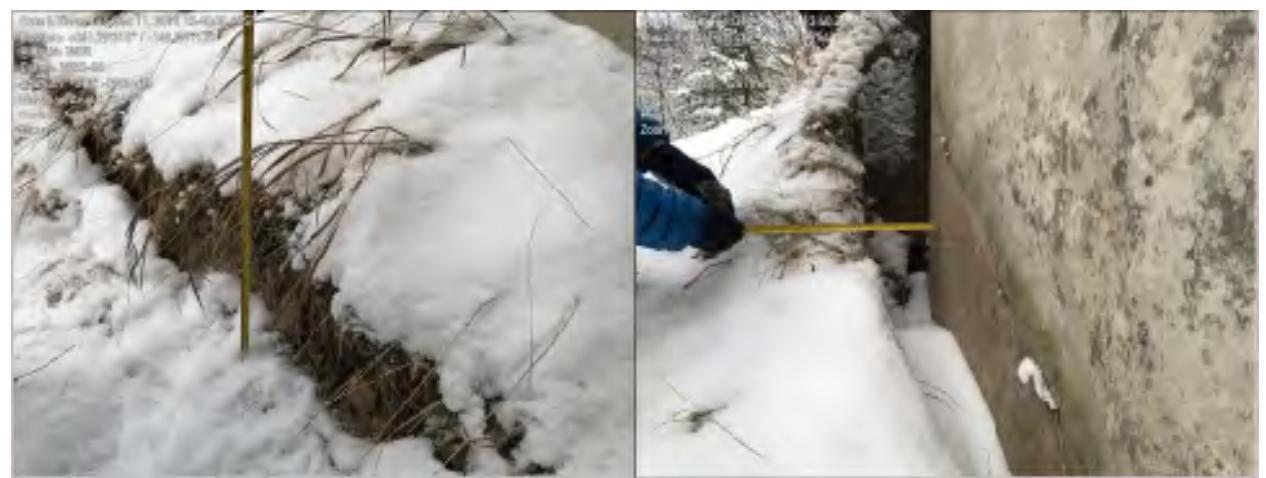
Figure 5-25. View of western portion of the north abutment exhibiting vertical and lateral movements downslope.

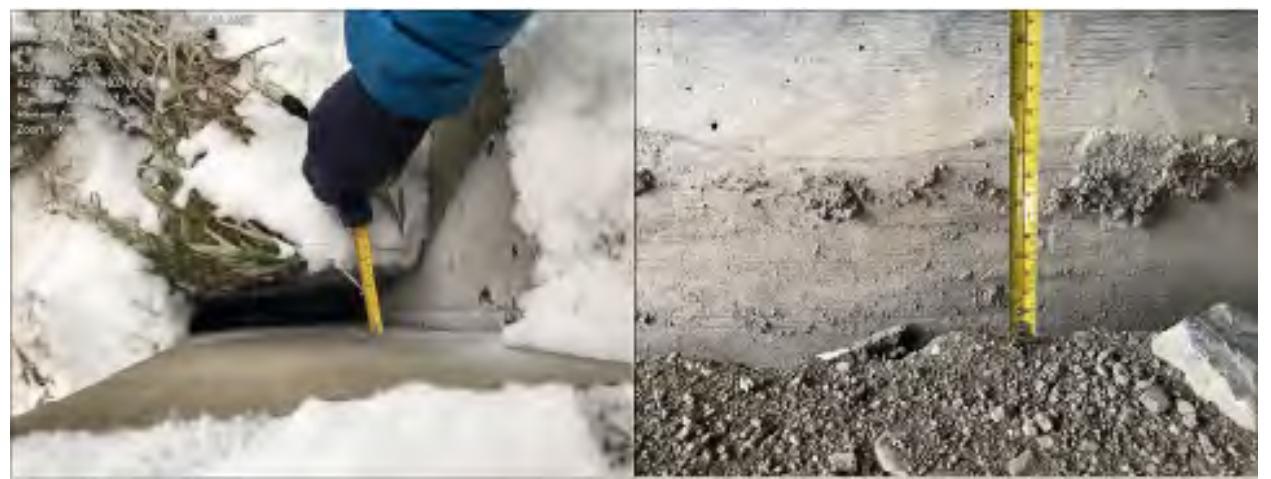
Figure 5-26. View of western portion of the north abutment exhibiting vertical and lateral movements downslope.

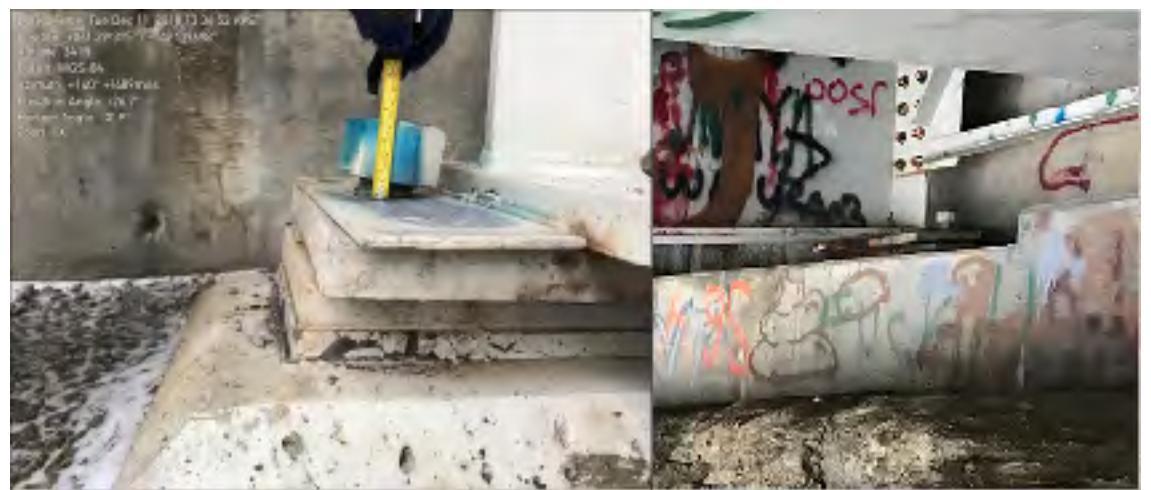
Figure 5-27. Translation and settlement of abutments as indicated by lifted hex nuts attaching girders to bearing pads.

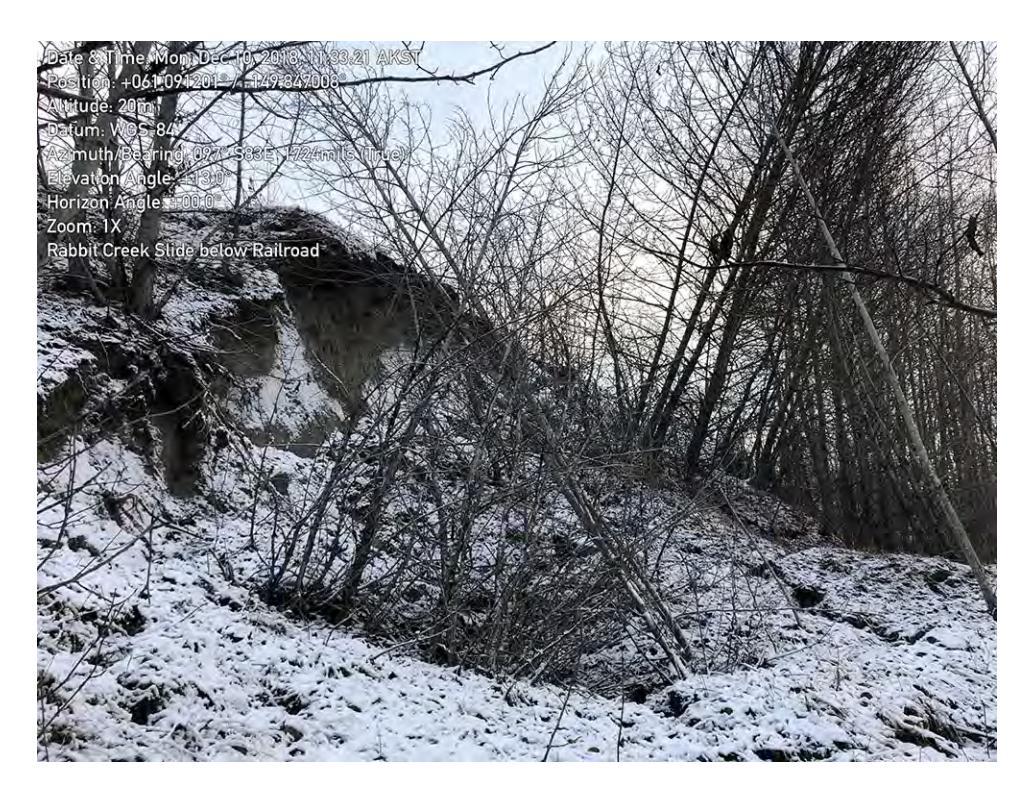
Figure 5-28. Head scarp of the Rabbit Creek Landslide Complex (Lat/Long: 61.0912°, - 149.8470°).

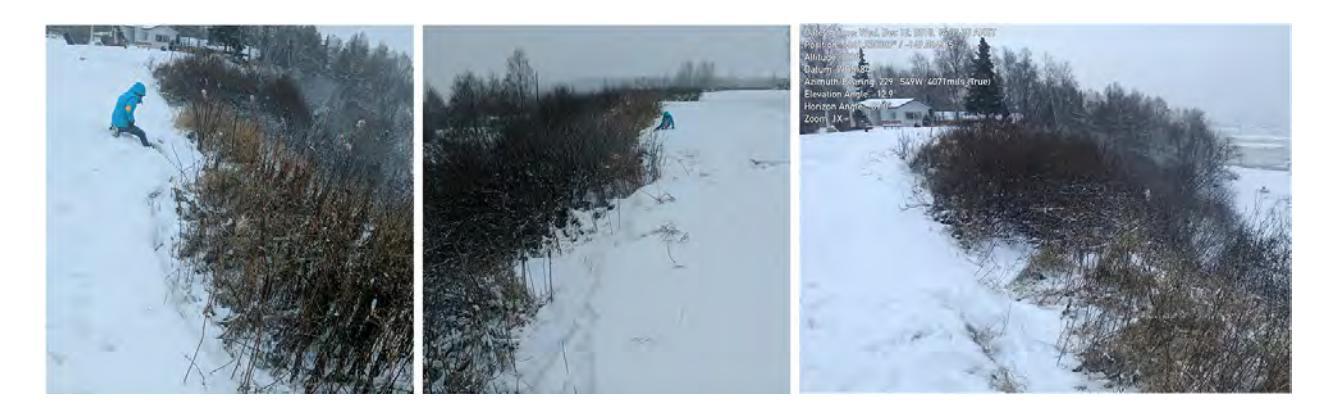
Figure 5-29. Bluff landslide located above the Port of Alaska (Lat/Long: 61.2303°, -149.8849°).

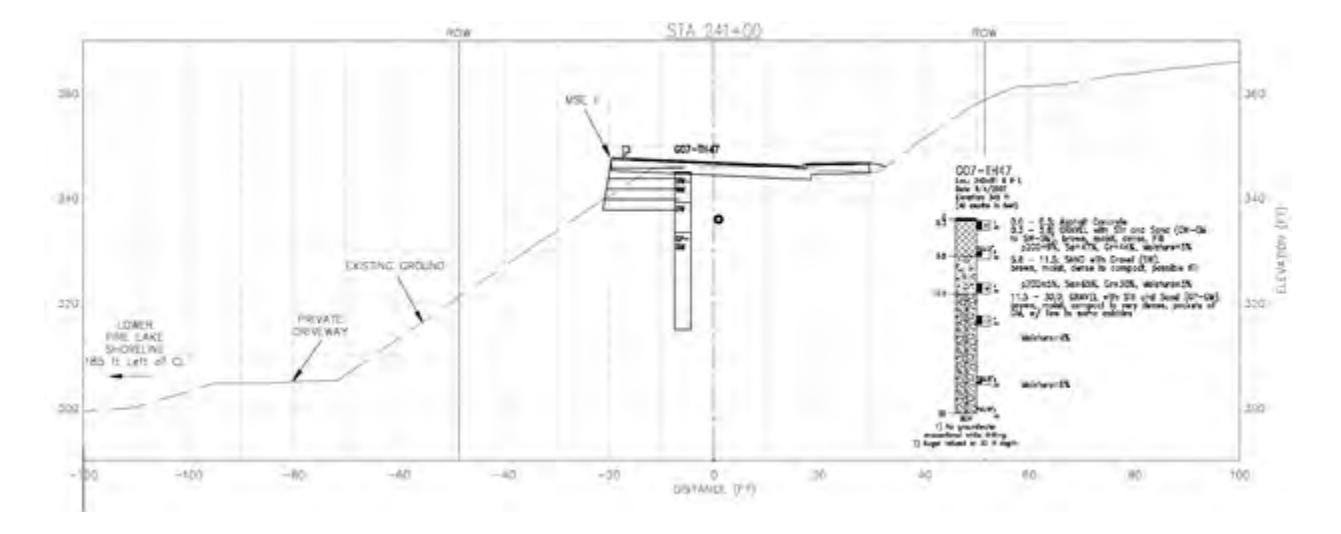
Figure 5-33. Generalized cross-section of MSE wall (proposed, not as-built) along Old Glenn Highway and subsurface conditions (after Golder 2009).

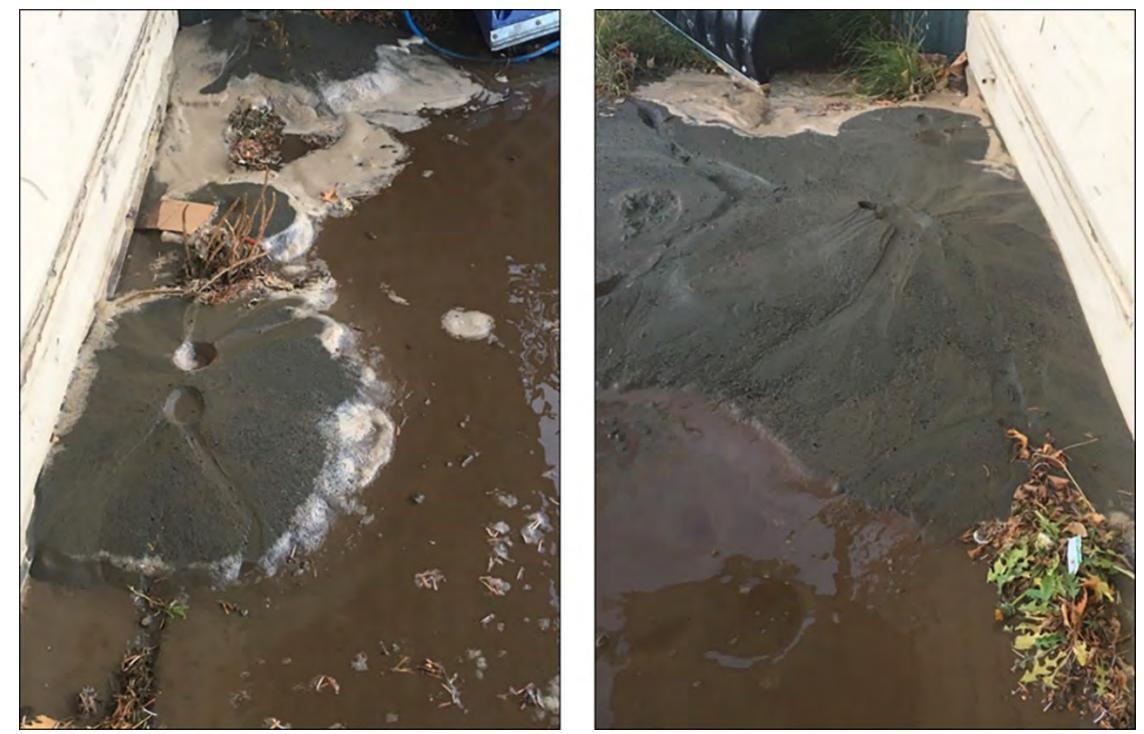
Figure 5-45. Photos of sand boils and ejecta at a residential property, received after Phase 1 field reconnaissance completed (Lat/Long: 61.1481°, -149.9033°).

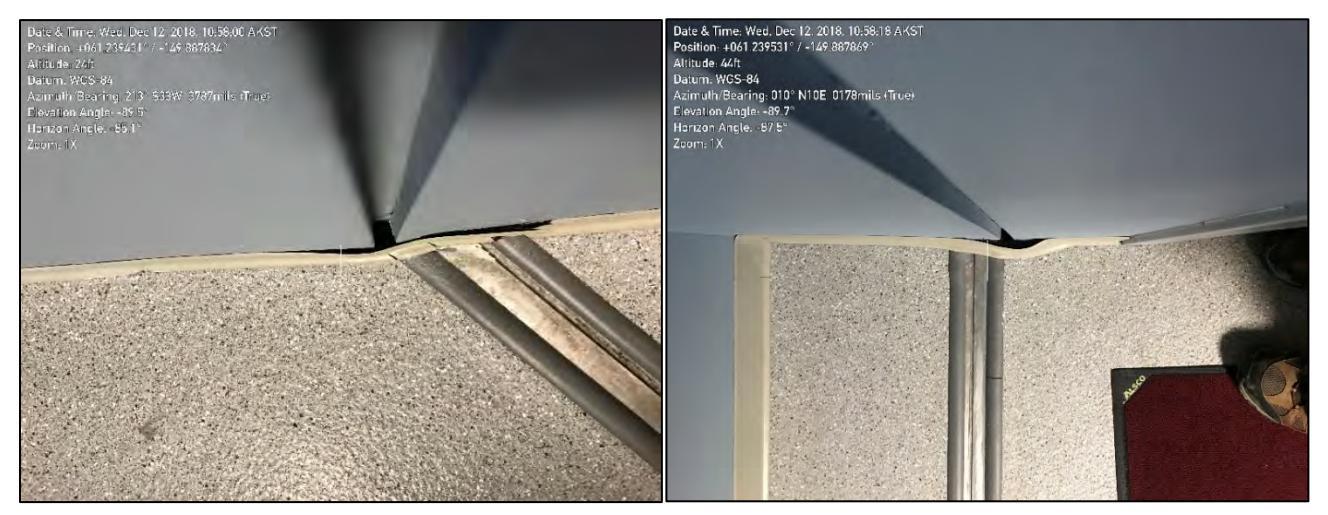
The administration building suffered permanent relative movements, damage to the elevator, and dislocation of non-structural components. Figure 6-12 presents relative movements within the building at the location of expansion joints, ranging in magnitude from one-quarter to one-half inch. Figure 6-13 indicates the relative severity of inertial loading experienced by office staff, with overturned filing cabinets and tables, among other office items.

Figure 6-12. Port of Alaska – View of permanent movement of approximately one-quarter inch (left) and one-half inch (right) on the second floor of the Administration Building

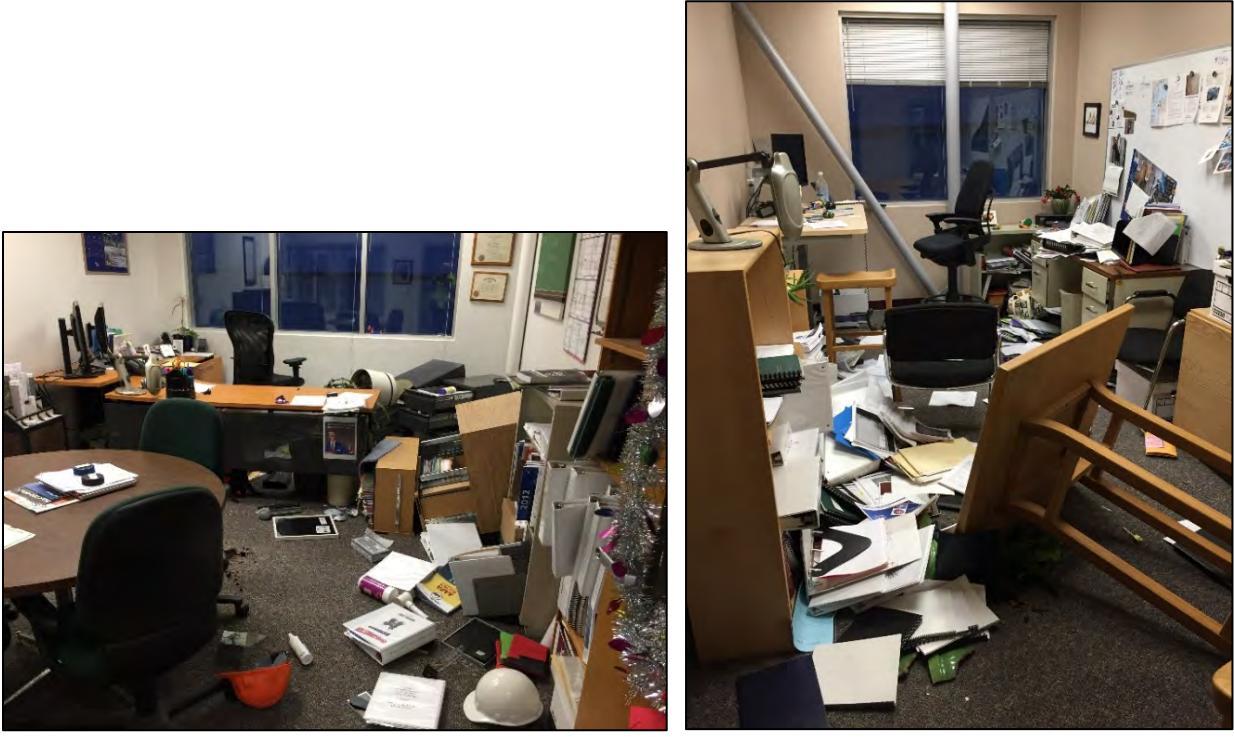
Figure 6-13. Port of Alaska – Post-earthquake view of offices at the Administration Building on 30 November 2018 (photographs courtesy of Jim Jager, PoA)

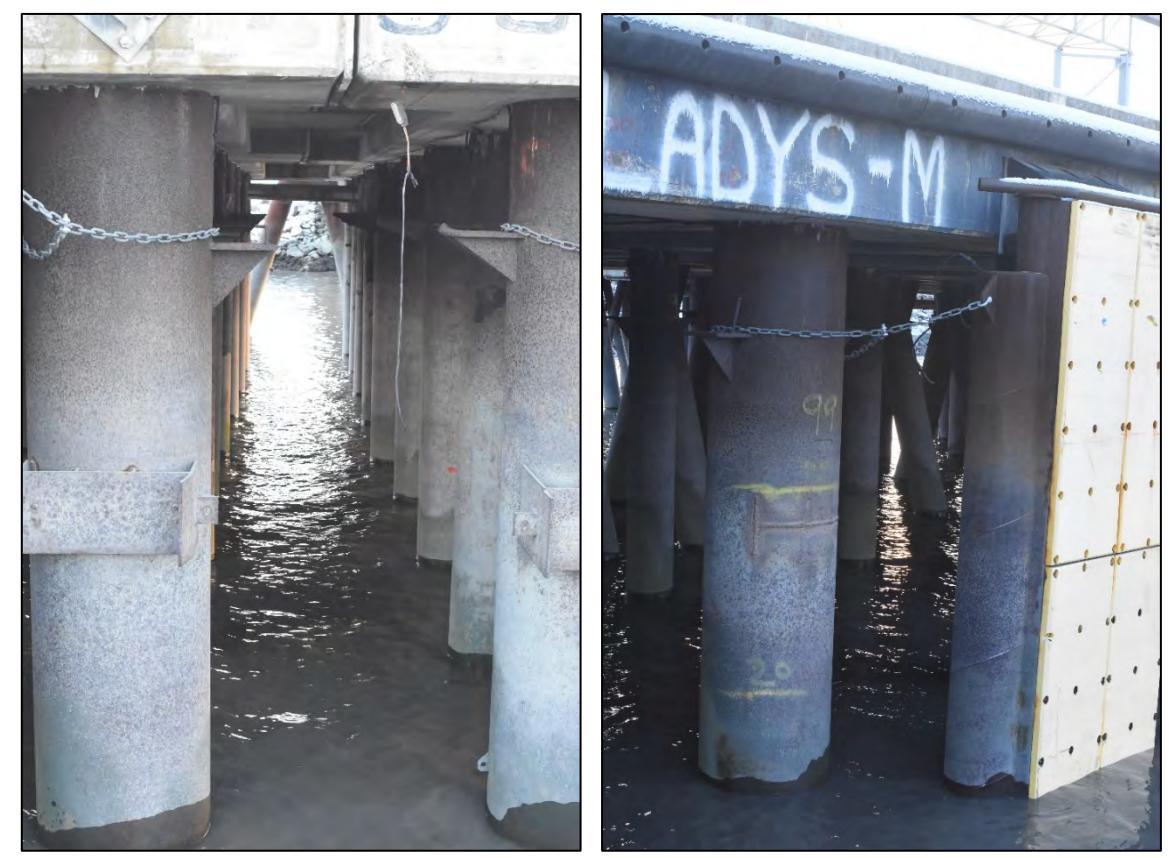
Figure 6-15. Port of Alaska – View of pile-to-apron connections and chained fenders on 30 November 2018 (photographs courtesy of Jim Jager, PoA)

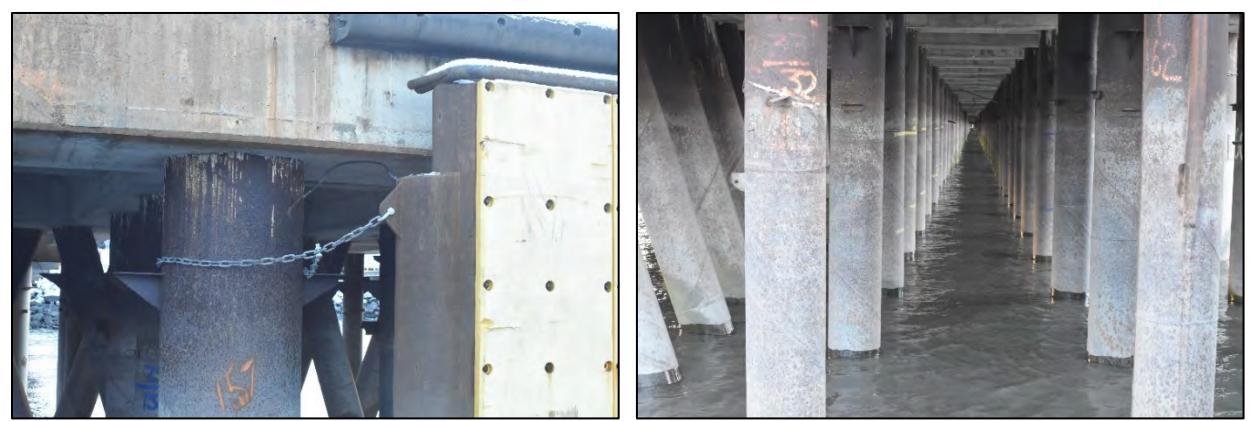
The degradation of the steel piles has affected port operations; for example, in recent years, a fender decoupled from the wharf due to the loss of structural integrity and came to rest along the mudline, presenting challenges to visiting ships and yearly dredging operations. As a result, the Port had chained the remaining fenders to the dock, and this likely contributed to the zero-loss of fenders during the earthquake (Figure 6-15). An immediate, although partial, water-born inspection did not reveal above-water damage to piles or pile-dock connections following the earthquake (Figure 6-16). The pile jacketing program to shore up the corroded piles appears to have largely prevented damage during the earthquake, along with estimated low levels of inertial and kinematic loading as inferred by the relatively small slope movements east of the terminals.

Figure 6-16. Port of Alaska – View of piles below wharf, pile-to-apron connections, and chained fender on 30 November 2018 (photographs courtesy of Jim Jager, PoA)

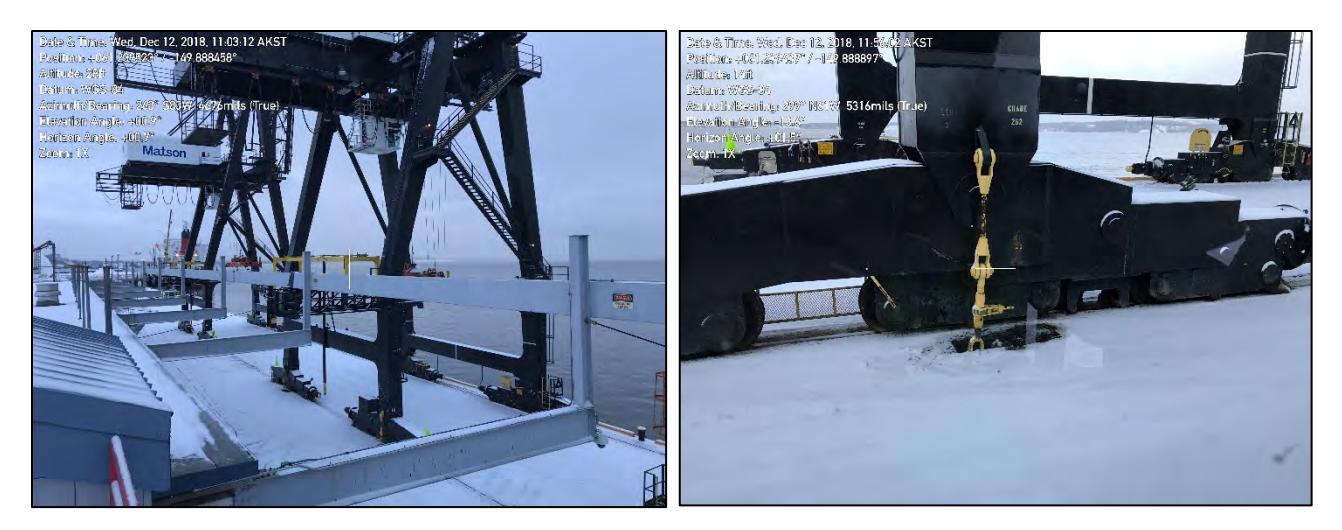
The three gantry cranes were not in use during the earthquake and were tied to the crane rails following typical good port practices (Figure 6-17), which may have contributed to reduced damage levels to the wharfs. No damage to the cranes were noted by Port personnel.

Figure 6-17. Port of Alaska – View of gantry cranes along Terminal 1, chained to crane rails while not in use

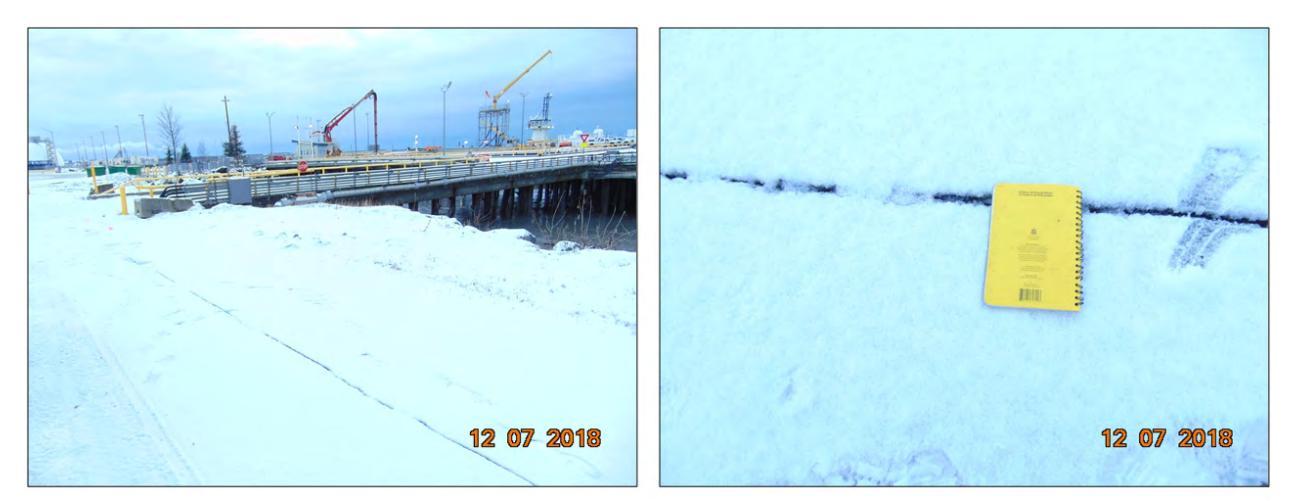
Figure 6-20. Port of Alaska – Transit Yard A: Across from Administration Building (Viewing South)

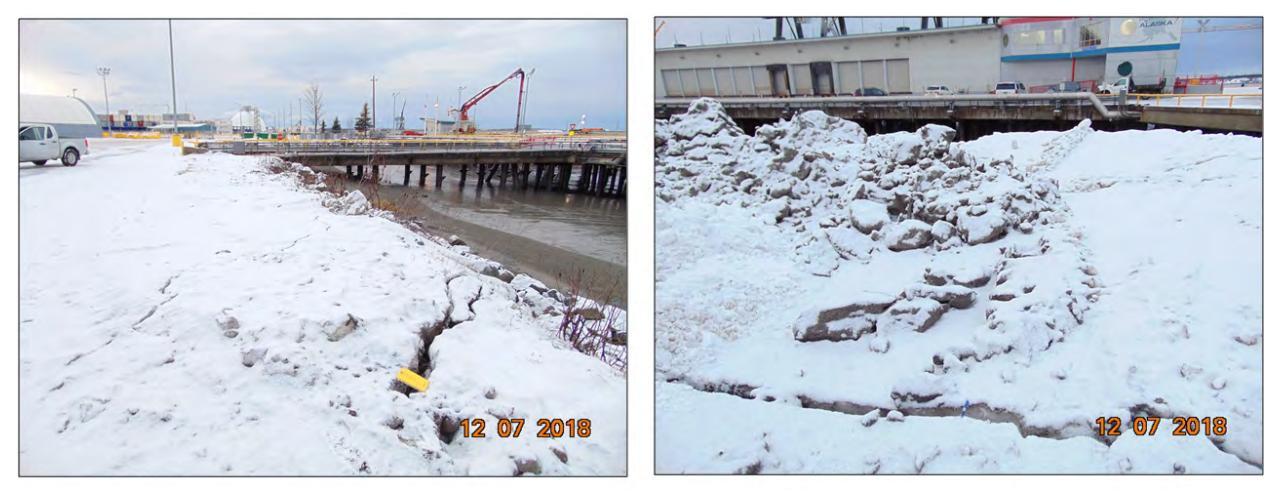
Figure 6-21. Port of Alaska – Transit Yard A: Across from Administration Building (Viewing South)

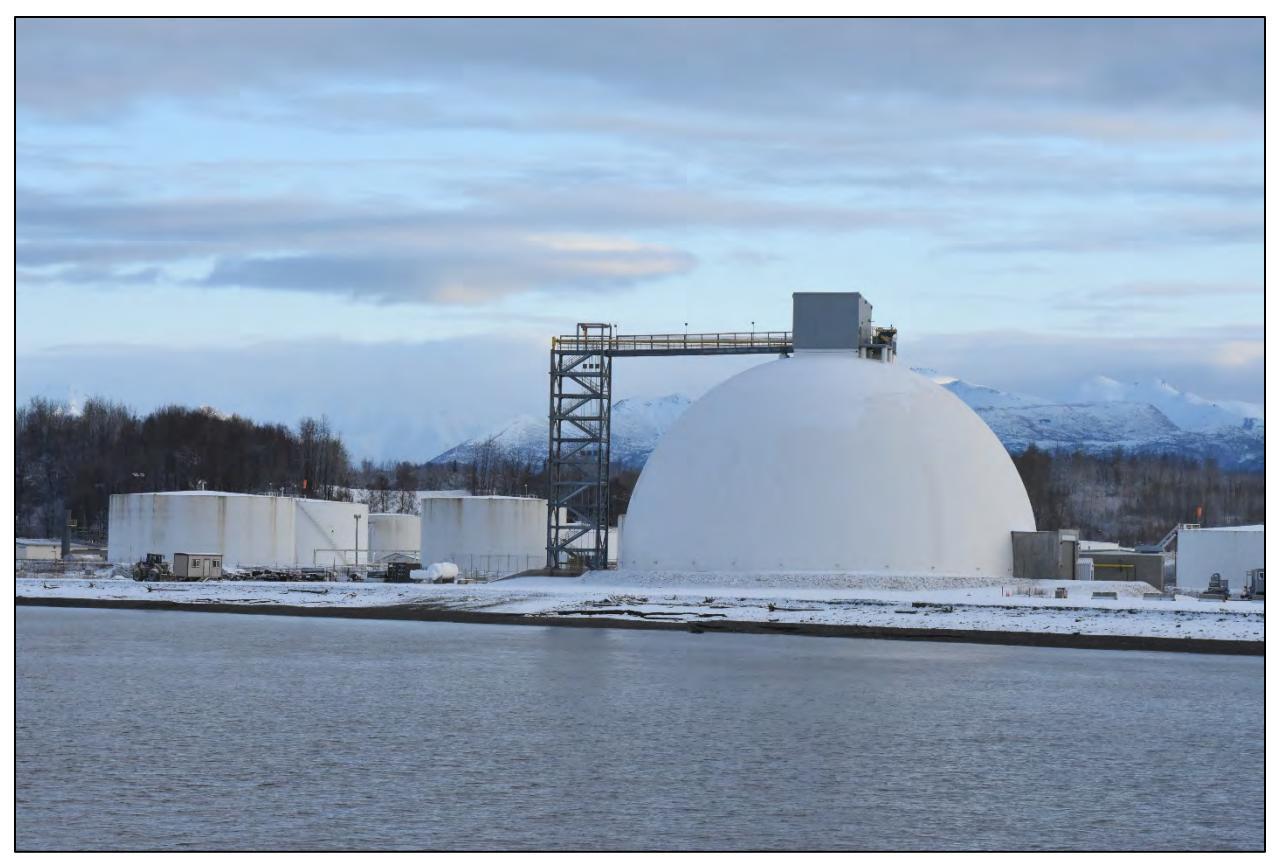
Figure 6-23. Port of Alaska –View of cement storage dome and earthquake-induced movements along shore on 30 November 2018 (Photographs courtesy of Jim Jager, PoA)

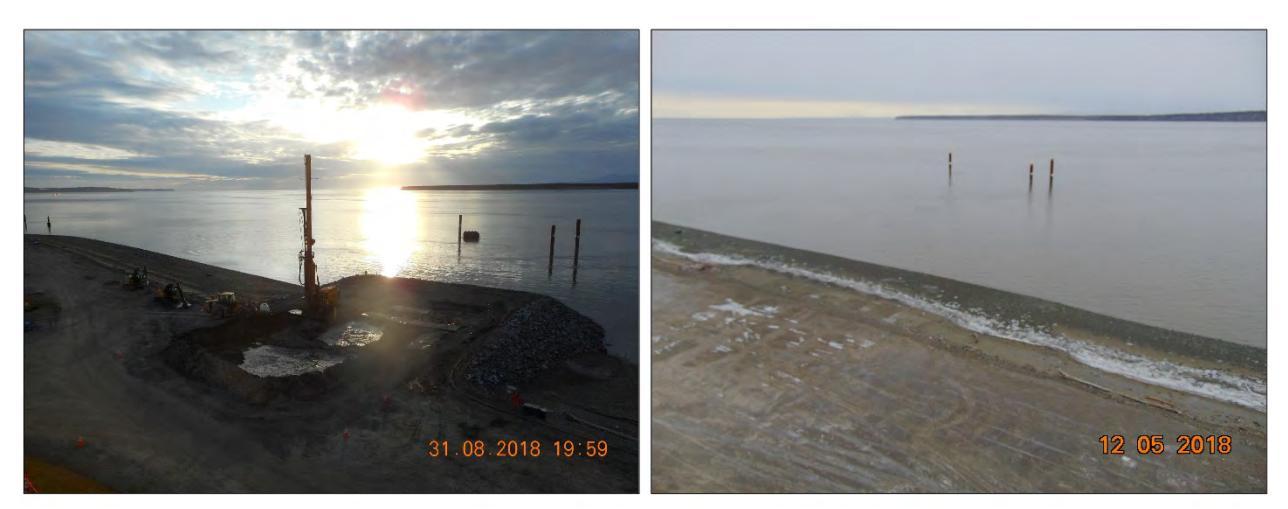
Figure 6-24. Port of Alaska – Pre- and post-earthquake view of shoreline at the PCT

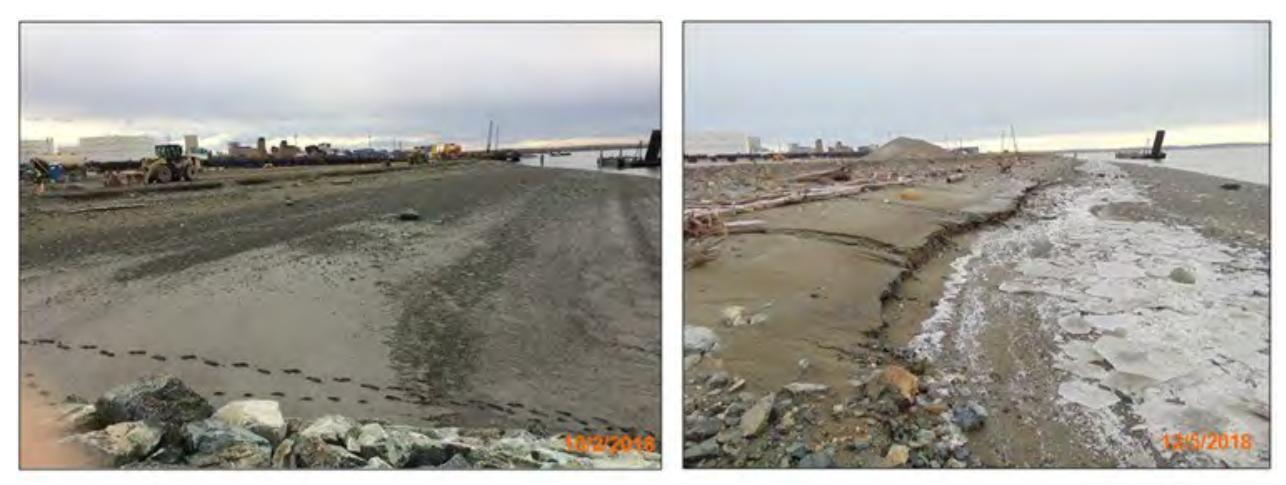
Figure 6-26. Port of Alaska – Pre- and post-earthquake view of shoreline at the PCT (Viewing South of DSM)

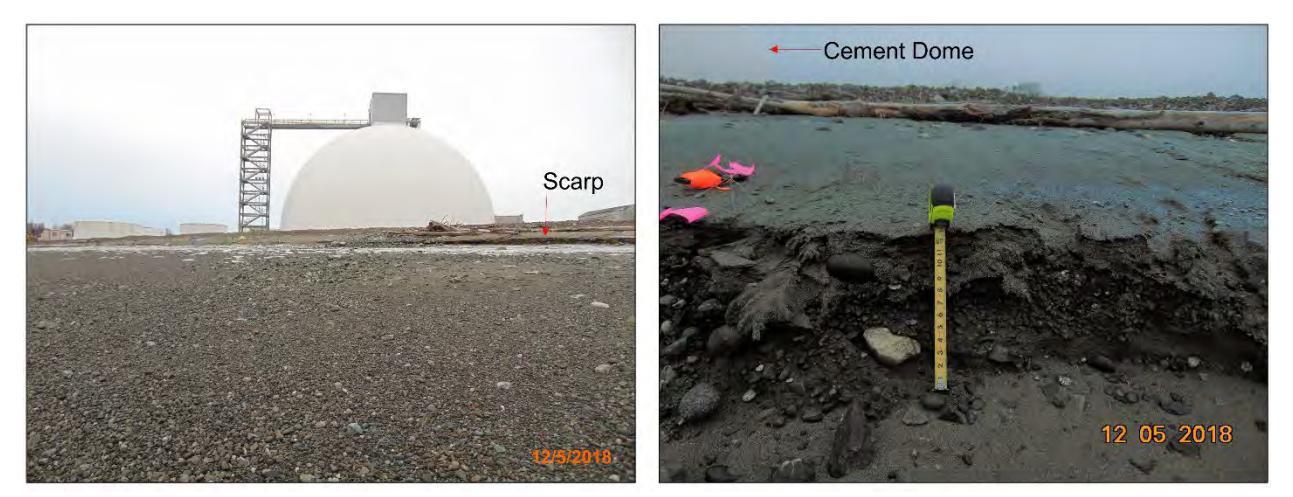
Prior to the November 30th earthquake, the shoreline in the vicinity of the new PCT sloped at approximately 1V:5H and did not exhibit vertical scarps or tension cracks. A side-by-side comparison of the shoreline at the PCT during coring of the DSM taken on October 2nd, 2018 and a post-seismic view of the same slope on December 5th, 2018 (Figure 6-26) shows a pronounced settlement scarp which measured from 150 mm to 300 mm (Figure 6-27). In addition to settlement, tension cracks ranging from 50 mm to 75 mm inches wide were observed both north and south of the DSM ground treatment (Figure 6-28 and Figure 6-29).

Figure 6-27. Port of Alaska – PCT Shoreline Scarp (Viewing Landward)

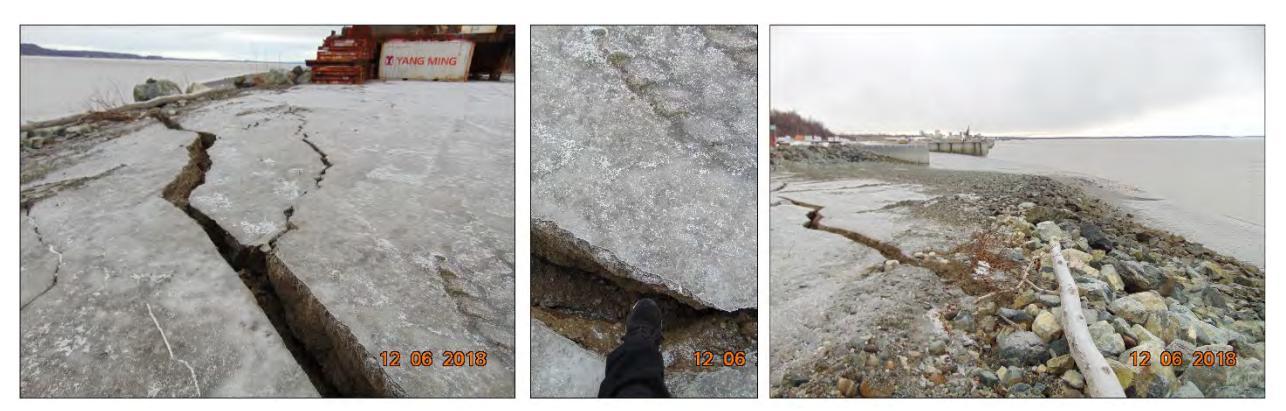
Figure 6-36. Port of Alaska - Northern Rock Slope Tension Cracks

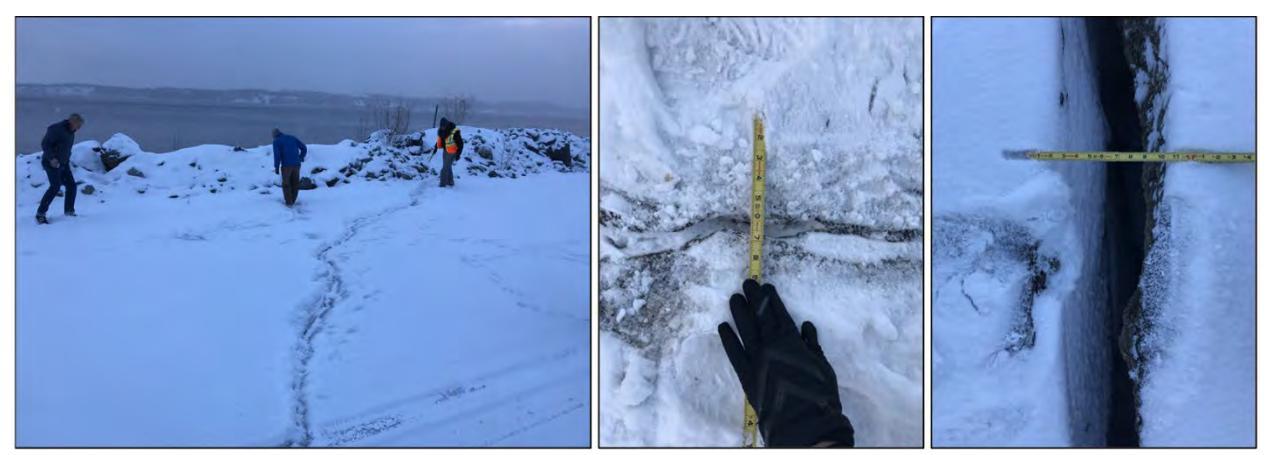
Figure 6-39. Port of Alaska – segments of lateral crack system

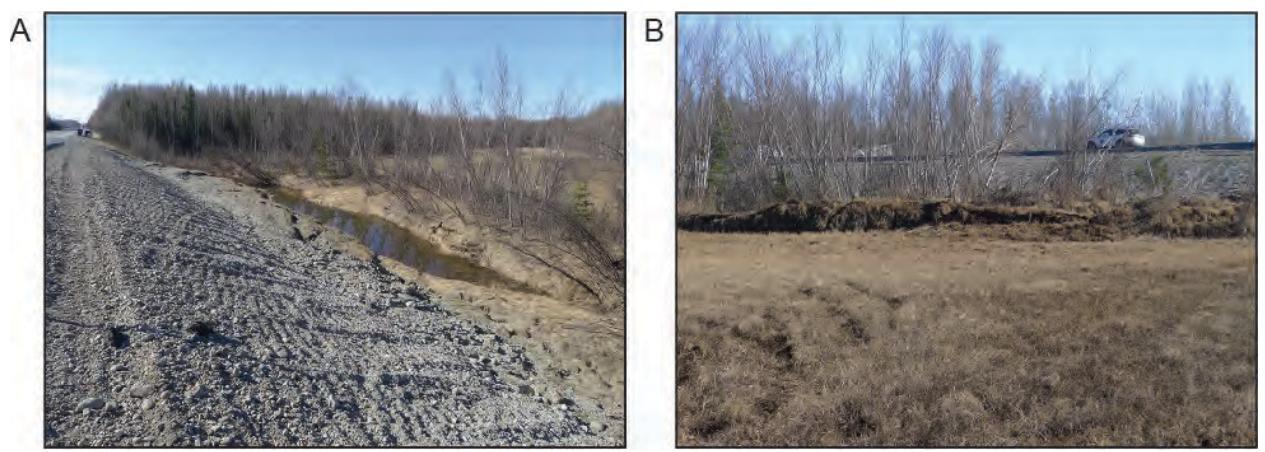
Figure B2. (A) View southwest of the road repair along the western side of the Vine Road failure showing lateral spread mounds adjacent to the roadway. (B) View east towards vine road showing soil mounds. (Lat/Long: 61.56863, -149.60215). See figure 5-38 in the body of the report.

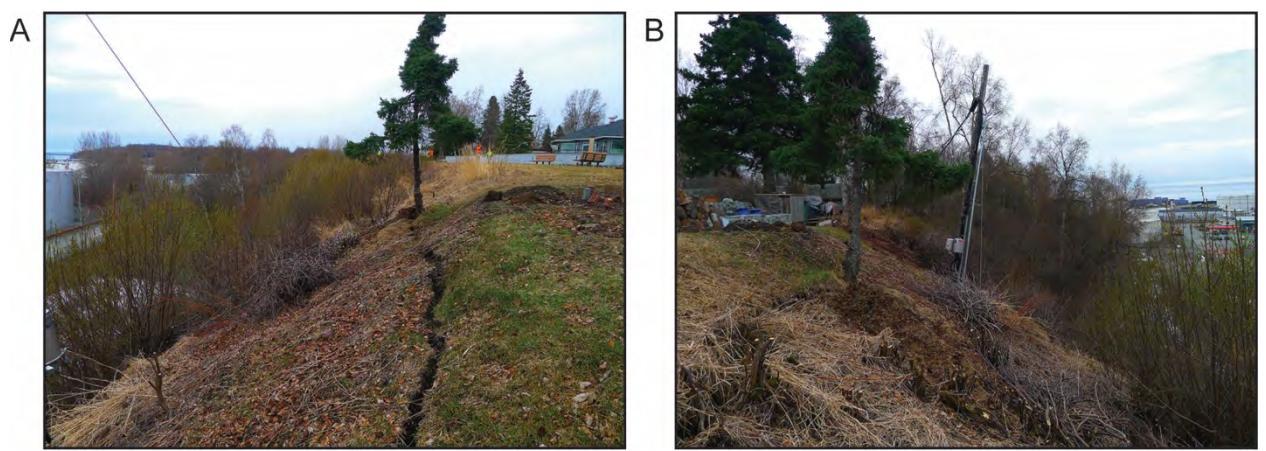
Figure B4. Photographs of a landslide along the steep bluff bordering the southeastern side of the Port of Alaska (Lat/Long: 61.2303°, -149.8849°). Movement of the slide did not affect storage tanks and other infrastructure along the base of the slide. (A) crack along the headscarp. (B) Tilted power pole on the slide surface. See figure 5-29 in the body of the report.

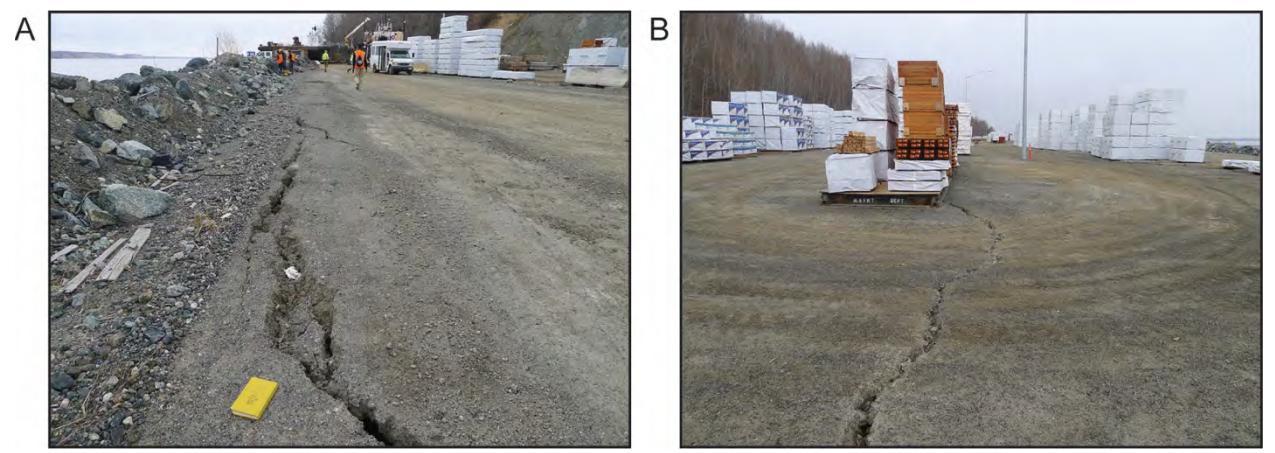
Figure B5. Tension cracks in fill at the North Expansion area of the Port of Alaska (Lat/Long: 61.253183, -149.880492). The cracks were observed during the Phase I investigation, however, no additional movement was observed in spring 2019. See figures 6-33 to 6-39 in the main body of the report.
