GEOTECHNICAL ENGINEERING RECONNAISSANCE OF THE 30 NOVEMBER 2018 M7.0 ANCHORAGE, ALASKA EARTHQUAKE

Geotechnical Extreme Events Association GEER Report GEER-059 January 2, 2019

GEER Team Co-Leaders: Kevin W. Franke (BYU) and Richard Koehler (UNR)

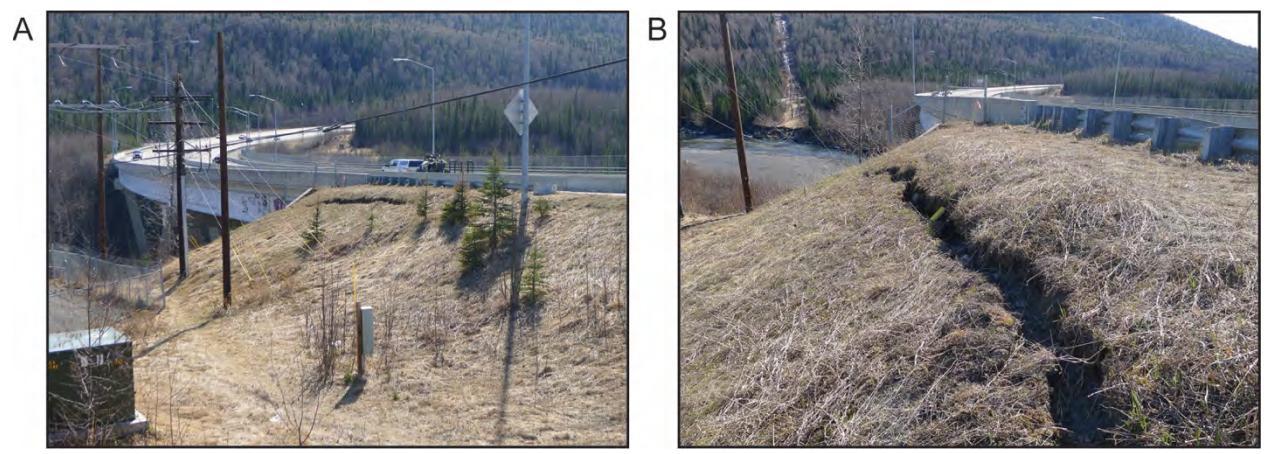
The reconnaissance team made several observations regarding the seismic performance of the Brigg's bridge and approaches. The side slopes along the eastern edge of the north abutment approach fill exhibited an approximately 0.3 to 0.45 m vertical scarp, running north-south parallel to the highway, and accompanying downhill movement (Figure 5-23). The sloped fill against the southeastern edge of the abutment stem/pile cap moved outward 75 to 100 mm, increasing towards the east and the wrap-around side slope (Figure 5-24). Numerous tension cracks were noted along the bare soil slope mantling the southern portion of the north abutment under the bridge girders. Slope movements of 100 to 150 mm south (Figure 5-25), and 65 mm west (Figure 5-26), were observed adjacent to the western edge of the north abutment, with settlement of the soil slope relative to the piled abutment on the order of 100 mm at the southern edge and 200 mm along the western edge above the stem wall. The abutment itself appeared to have translated slightly to the east and settled on the order of 12 to 75 mm, as demonstrated by several tilted bolts and hex nuts hung well above the girder bearing plates (Figure 5-27). Numerous existing vertical cracks within the abutment stem wall appear indicated signs of recent movement, likely associated with the strong ground motion of the 30 November earthquake. Tilt of the northern abutment was observed equal to 1.2 and 1.8 degrees backwards (towards the approach fill) on the western and eastern sides, respectively.

Figure B7. Settlement of fill along the north abutment of the Briggs Bridge in Eagle River (Lat/Long: 61.298906, -149.539131). Settlement cracks were observed during the Phase I

investigation, however, no additional movement was observed in spring 2019. See figures 5-23 and 5-24 in the main body of the report.

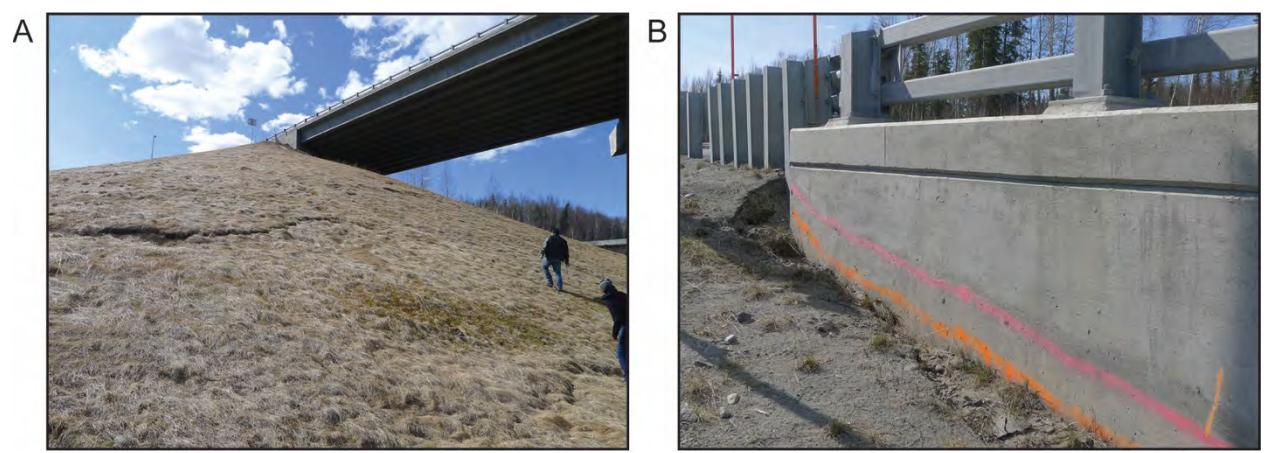
Figure B8. Photographs of ground cracks and settlement in the south abutment of the northbound Glen Highway bridge in Eagle River (Lat/Long: 61.310222°, -149.577127°). Cracks in the abutment fill were observed during the Phase I investigation, however, no additional movement was observed in spring 2019. See Figure 5-18 in the main body of the report.

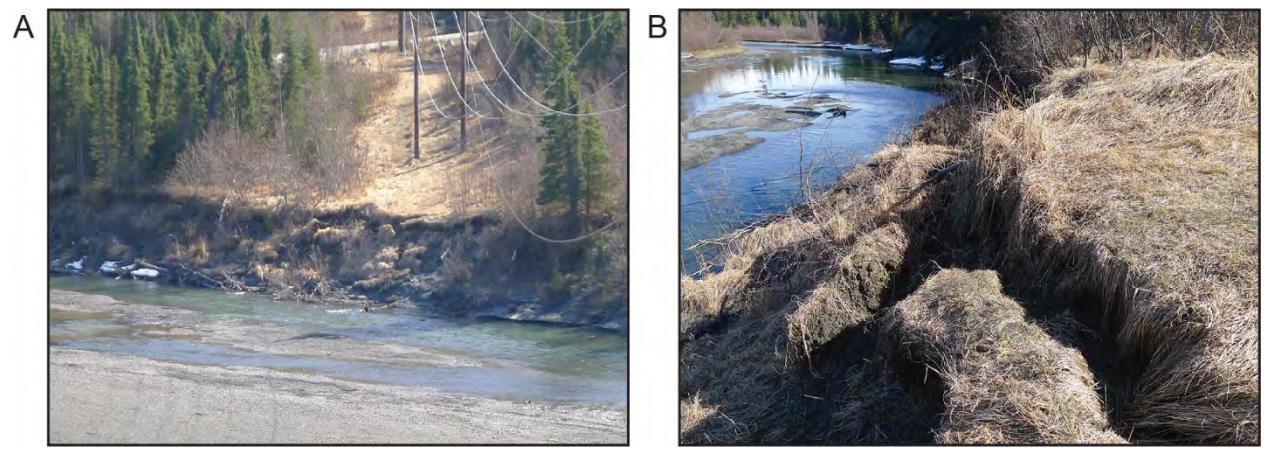
Figure B10. Photographs of a bank slump along Eagle River ~60 m east of the south abutment of Briggs Bridge (Lat/Long: 61.297339, -149.539022). Slump may have been caused by strong ground shaking during the November 30, 2018 earthquake but did not affect the adjacent power poles.

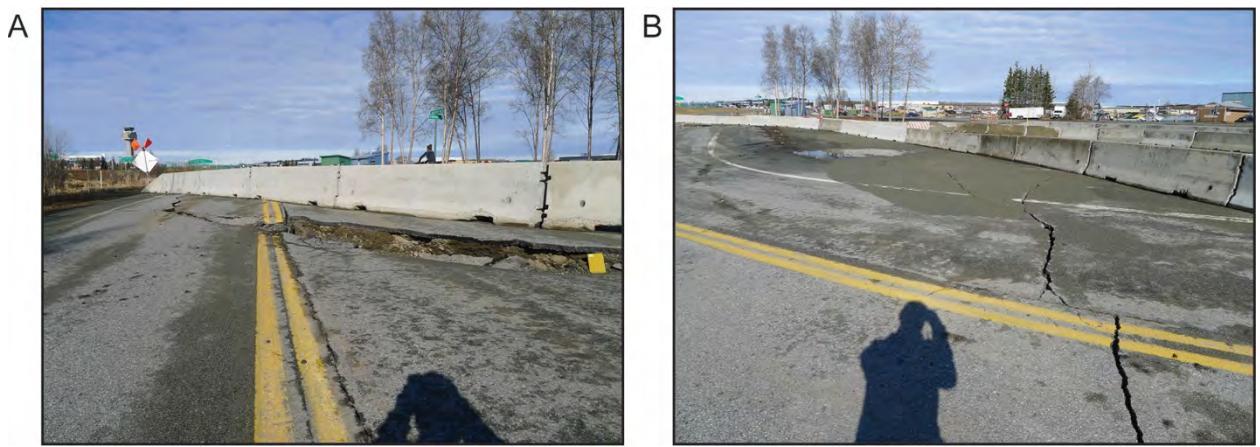
Figure B11. Photographs of ground settlement (A) and liquefaction (B) on Aircraft Drive near the Ted Stevens International airport adjacent to Rusts Flying Service (Lat/Long: 61.178331, -149.97205). Road repairs were still in progress during the GEER Phase II investigation.

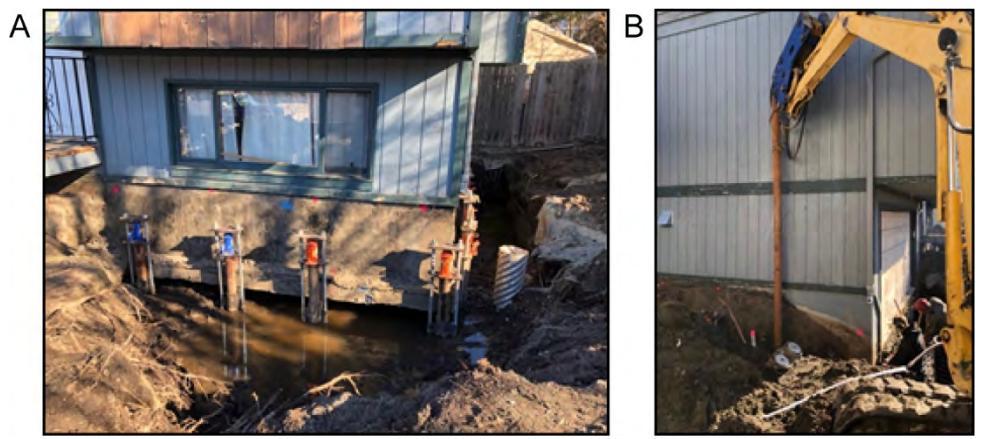
The structure at this site is a single-family residential building. This building partially subsided due to foundation failure and/or liquefaction. When the UMKC team visited this site, a local contractor was working to lift the house at the foundation level using push piers (Figure B15A and B15B). Figure B16A shows the front view of the residential building from Google street view. DJI Inspire was used to fly around the house. When flying this single-family house, the goal was to create a 3D model (not a map) product for the structure, including the ditch and the

Figure B15. Foundation lifting work at the residence. (A) push piers installed in place pending to lift the foundation, and (B) hydraulic driving.

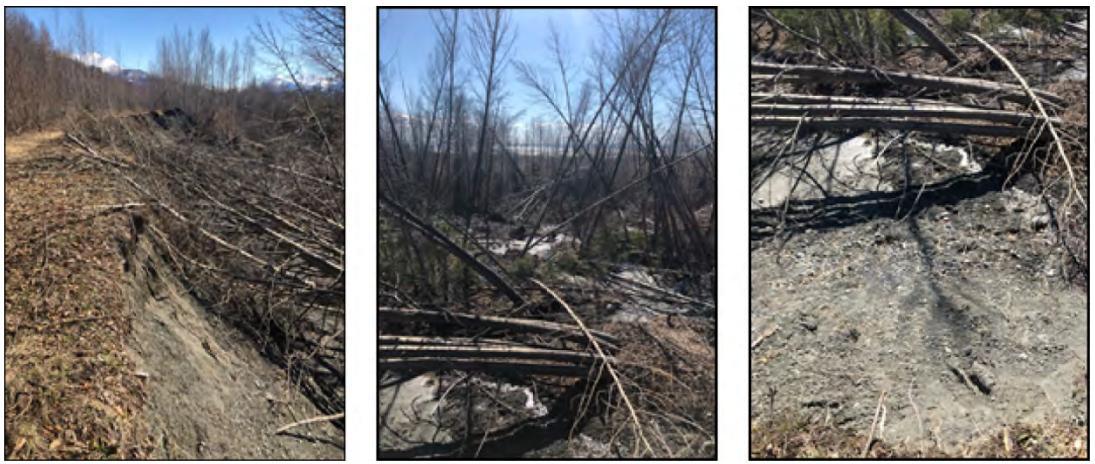
The Rabbit Reek Bluff was visited on 04/27/2019. Slope sliding was observed at this location. Field images in Figure B19 show that slope collapse, ground sink, and falling trees occurred during the earthquake. The UMKC team worked with others and flew along the bluff. A large number of images (1061 high-resolution 3000 x 4000 images) were collected and used in the reconstruction. The resulting Geotiff image is more than 800 MB. To view this Geotiff, an opensource GIS software (QGIS) was used to read the tile images, which can create a hierarchical structure for fast zoom-in and zoom-out (Figure B20).

Figure B19. Observed scenes at the Rabbit Creek Bluff showing collapsed slope, sunk holes (probably due to liquefaction), and falling trees.

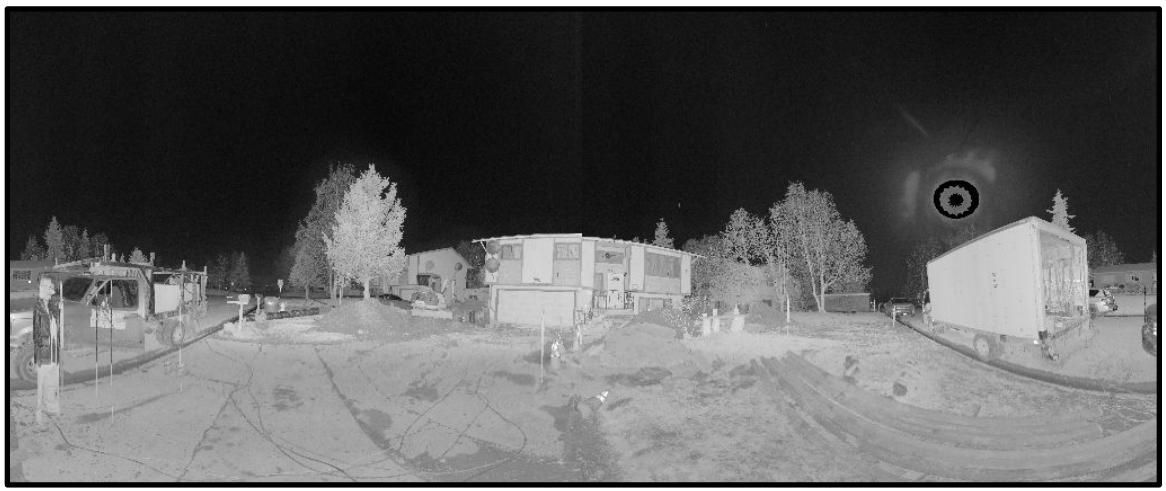
<u>Site description</u>: This site represents a two-story single-family house. This structure was severely tilted due to ground settlement and/or liquefaction. The building foundation was exposed (with surrounding soil excavated) at the time of the survey.

Figure B26. LiDAR preview – 1271 W 82nd Street Single Family House (single scan).

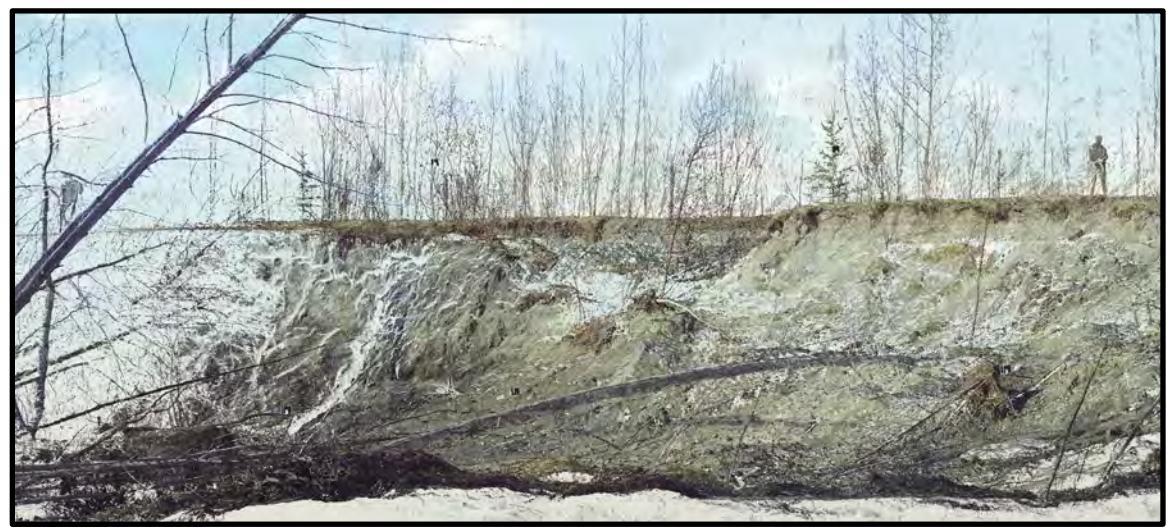
<u>Site description</u>: This site consists of bluff landslide extending several kilometers along the coast line.

Figure B28. LiDAR preview – Rabbit Creek Bluff Landslide.

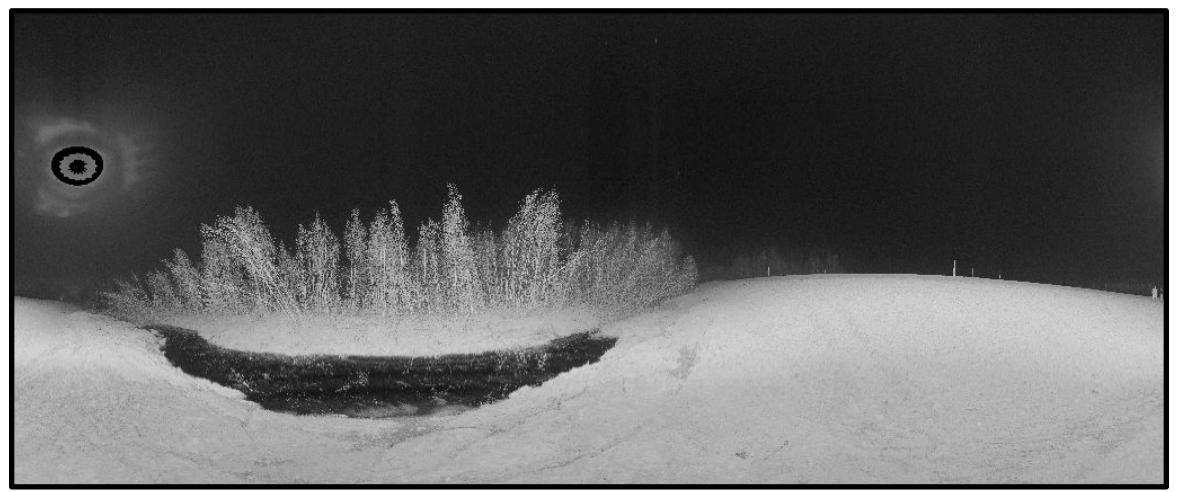
<u>Site description</u>: This site consists of road surface and embankment fill failure (~ 100 meter long). The road pavement was repaired and open to traffic and the time of the survey.

Figure B29. LiDAR preview – Vine Rd east embankment (single scan).

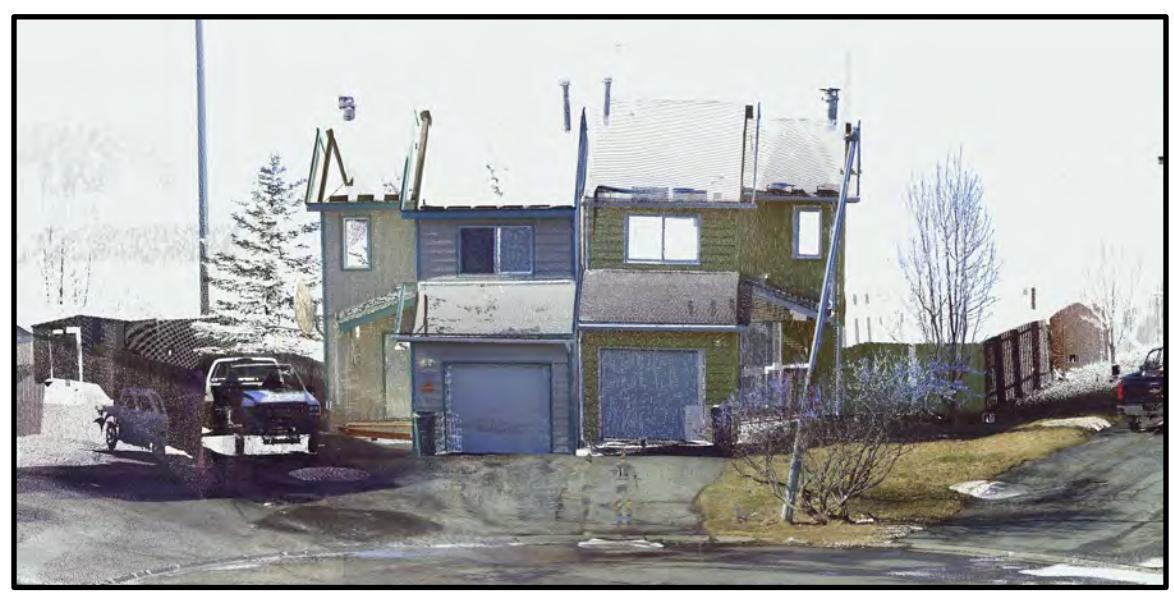
<u>Site description</u>: This site consists of a two-story duplex. This structure was severely tilted as a result of ground liquefaction. The garage doors were severely distorted. This building was unoccupied the time of the survey (according to feedback from nearby residents).

Figure B30. LiDAR preview – 9180 Ticia Cir Duplex.

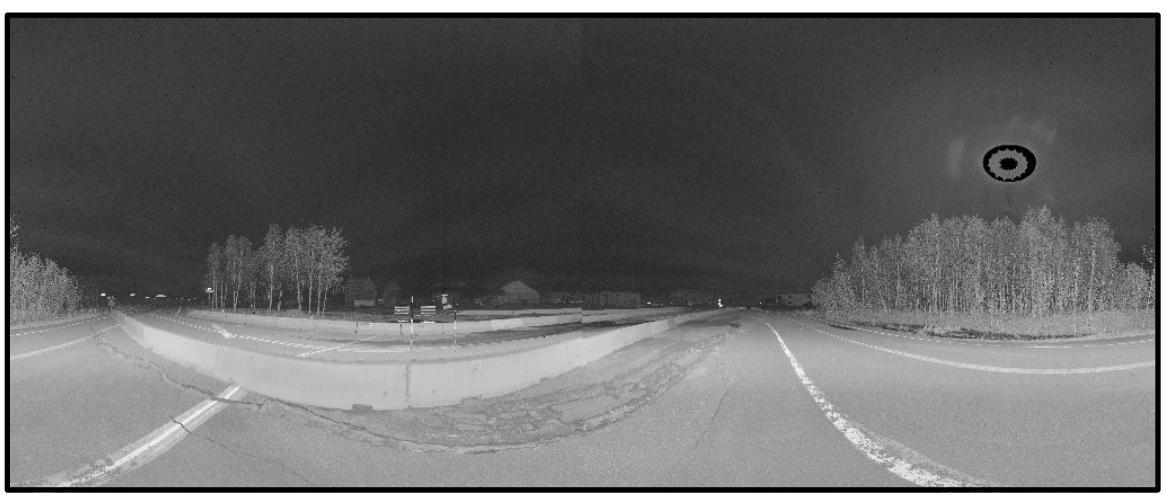
<u>Site description</u>: This site represents a segment of damaged road (~100m meter long). The observed damage involved uneven ground settlement and surface cracks. The damaged road was closed to traffic at the time of survey.

Figure B31. LiDAR preview – Aircraft Drive (single scan).

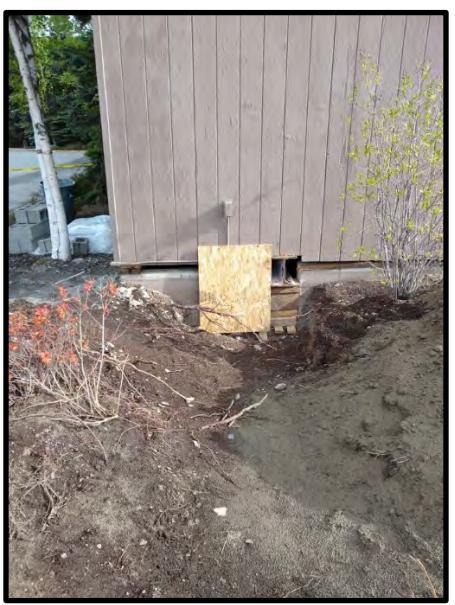
Figure B33. Foundation repairs on the southwestern corner of the southern building wall.

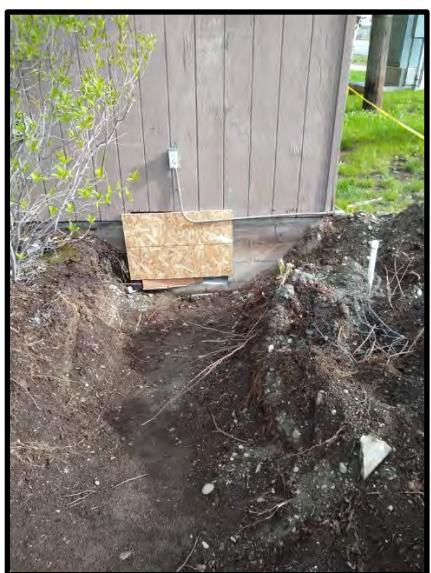
Figure B34. Foundation repairs on the southeastern corner of the southern building wall.

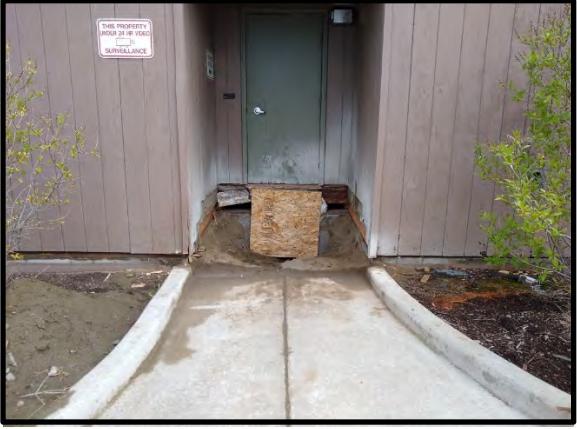
Figure B35. Foundation repairs near the middle of the southern exterior building wall.

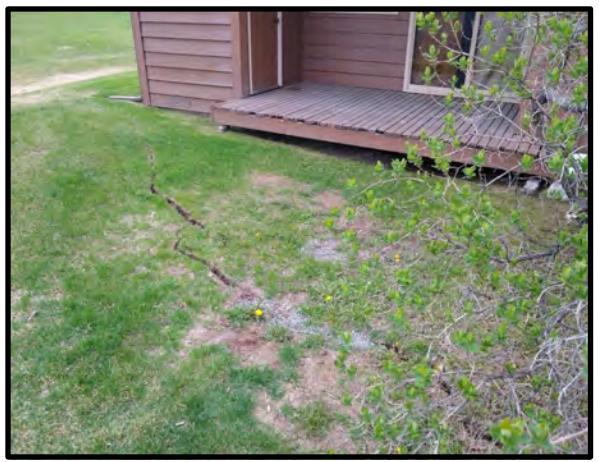
Figure B36. Ground cracking on the east side of apartment building at 2100 Minerva Way.
