April 6 2009 L'Aquila (Abruzzo) Earthquake in Central Italy

Jonathan P. Stewart GEER Team Leader

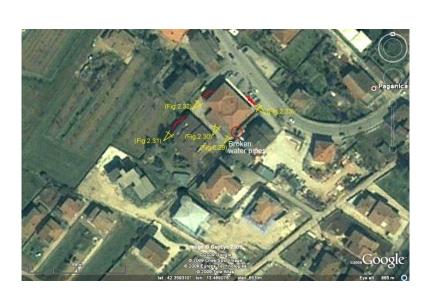
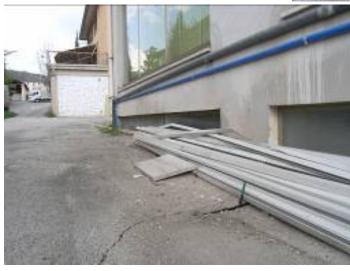
Surface Rupture

- Some deformation reported:
 - Paganica
 - Poggio
 - Aterno
- Consensus: No SR from primary fault
- Controversial: Co-seismic origin of displacements near mapped faults

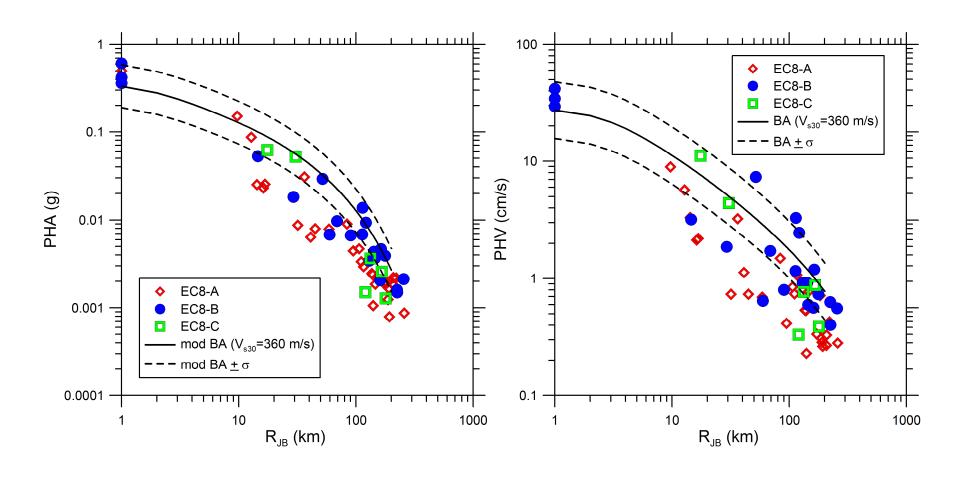
- 56 digital recordings
- Permanent displacement evident in L'Aquila –
 AQ* recordings on hanging wall.
- Analogue recordings?
- Preliminary site classifications in report
- Few sites with velocity profiles

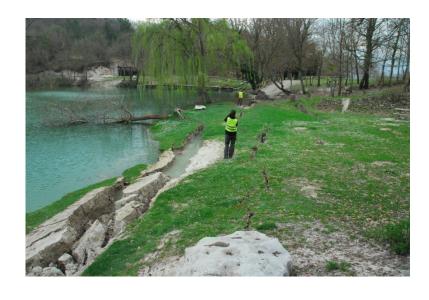
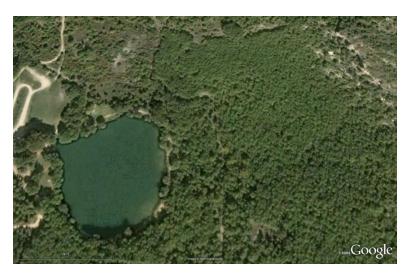
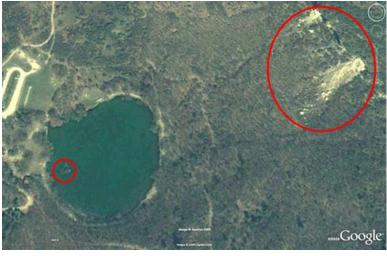
- Damage Patterns
- Landslides/Rockfalls
- Levees/embankments
- Lake Sinizzio
