Natural Hazards and the Built Environment: a State of Practice Perspective

*The 18th Annual
George F. Sowers Symposium*

Scott A. Anderson Ph.D., P.E.
Federal Highway Administration
Geotechnical Services Team Manager

Probability and Volume of Potential Postwildfire Debris Flows in the 2012 Waldo Canyon Burn Area near Colorado Springs, Colorado

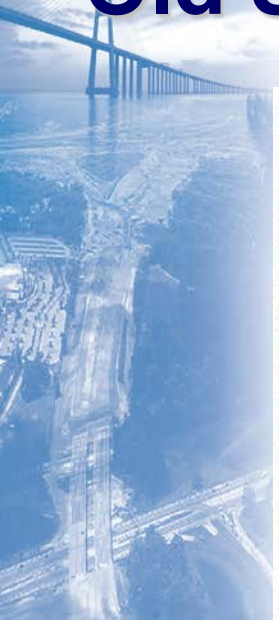
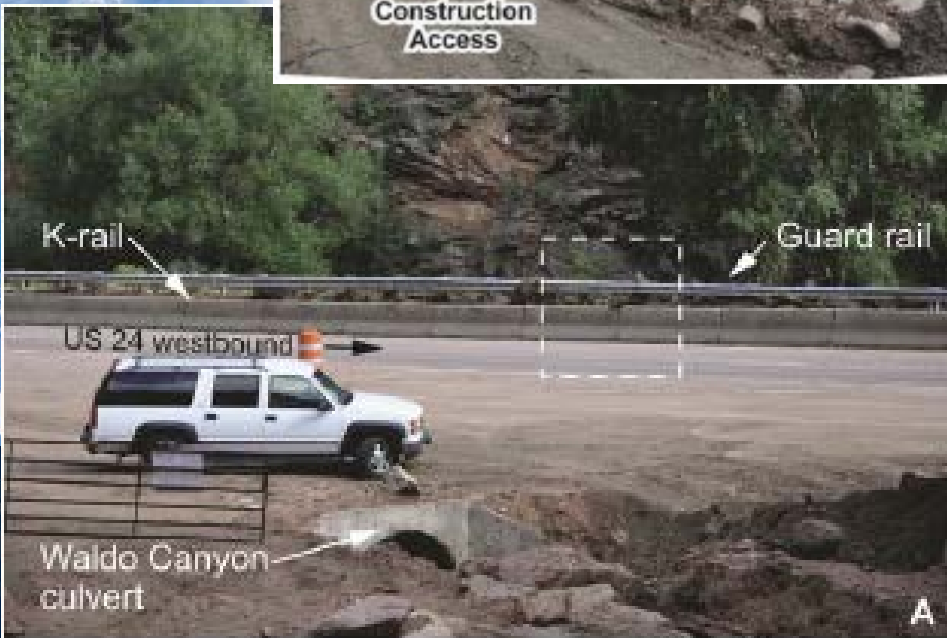
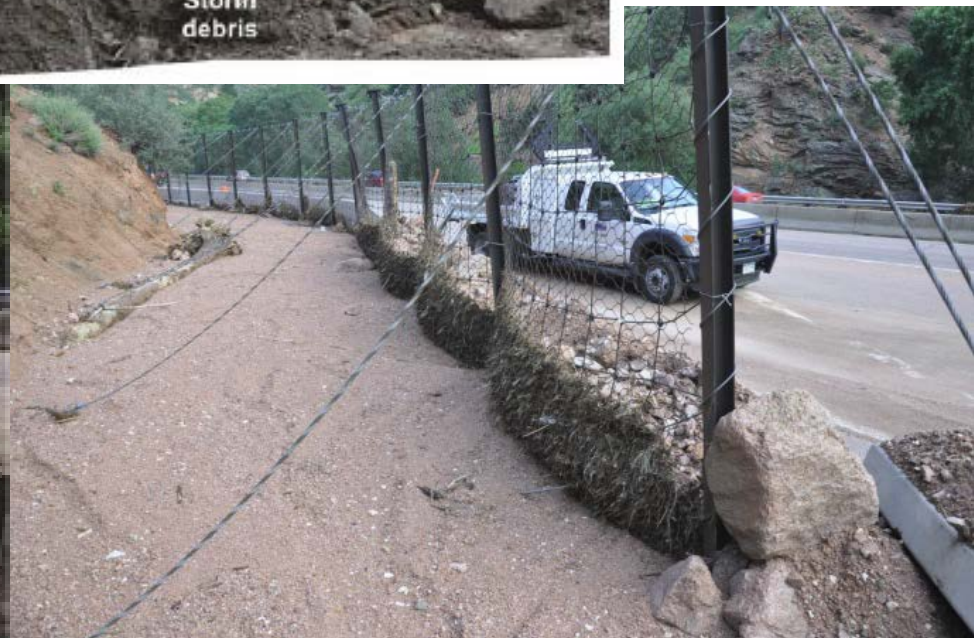
Old School Reconnaissance

West of Manitou Springs, CO, August 2013

Super-elevated highway curve

K-rail barrier

Rock fall fence

Lower Waldo Canyon
Precipitation Gage

Tributary canyon
flow direction

Fountain Creek
flow direction

Steel guard
rail barrier

Culvert inlet

Narrow area

Wide area

Waldo Canyon
flow direction

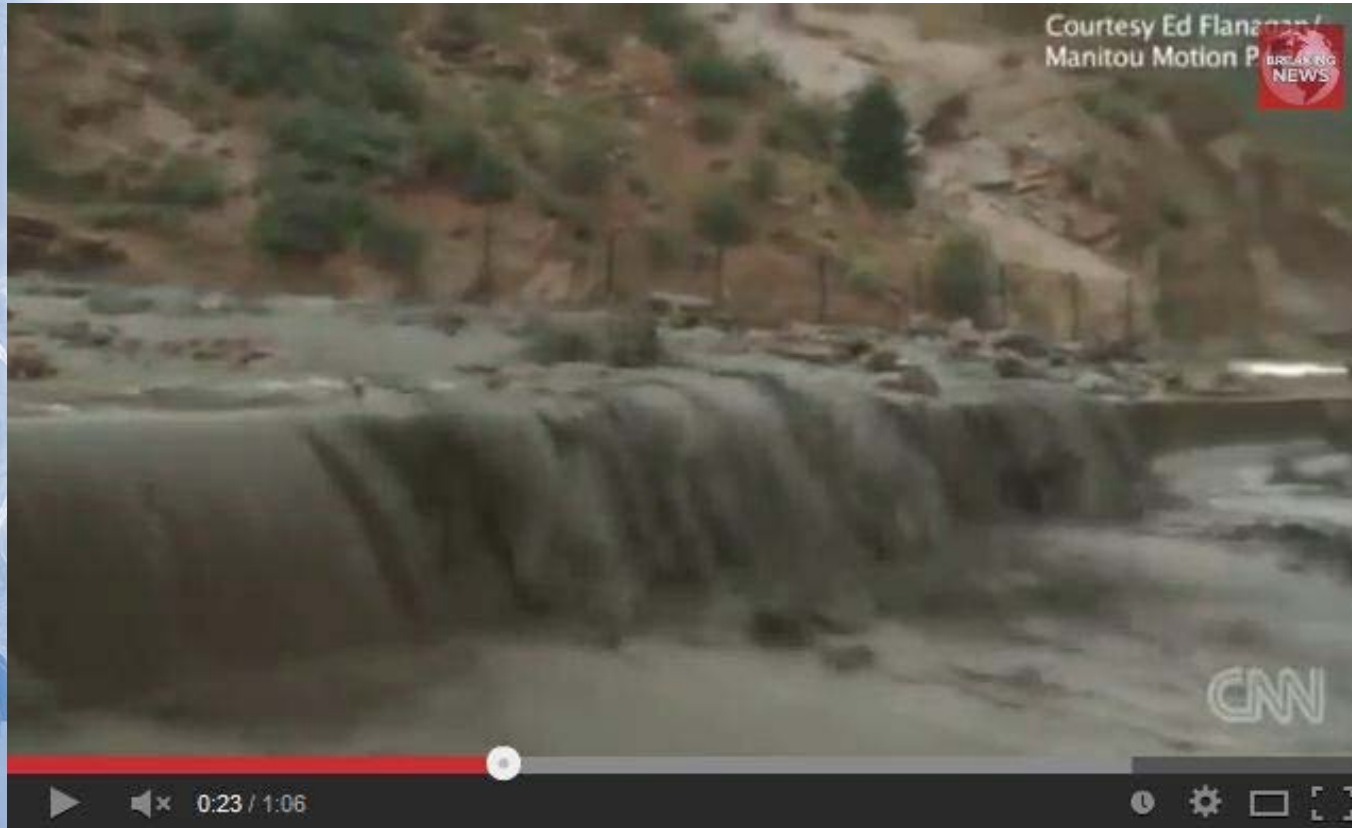
New School: YouTube

- Note the Rockfall Fence

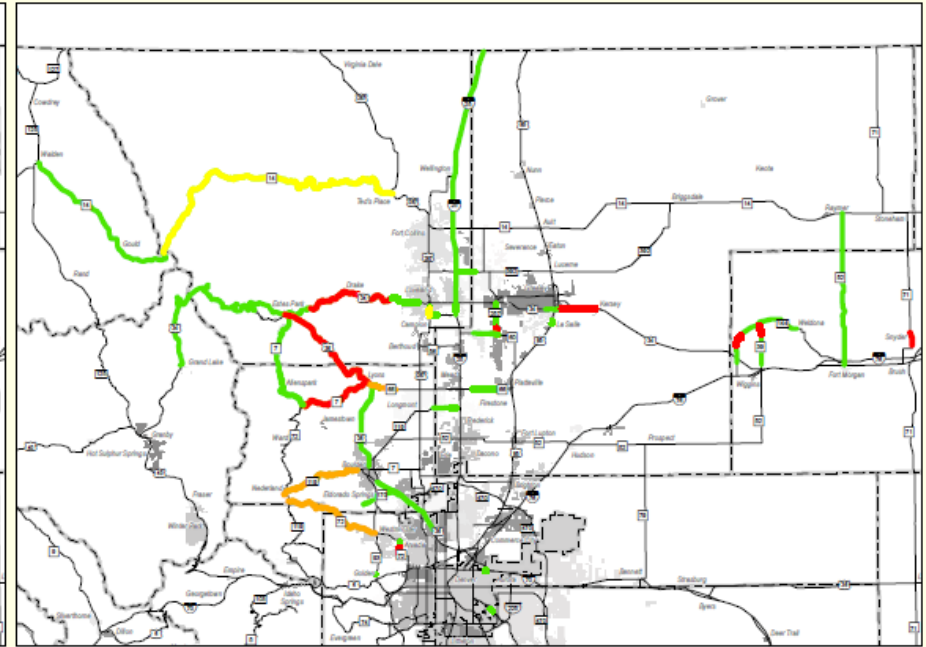
Highway Status
as of
September 24, 2013

STATE HIGHWAY CLOSURES

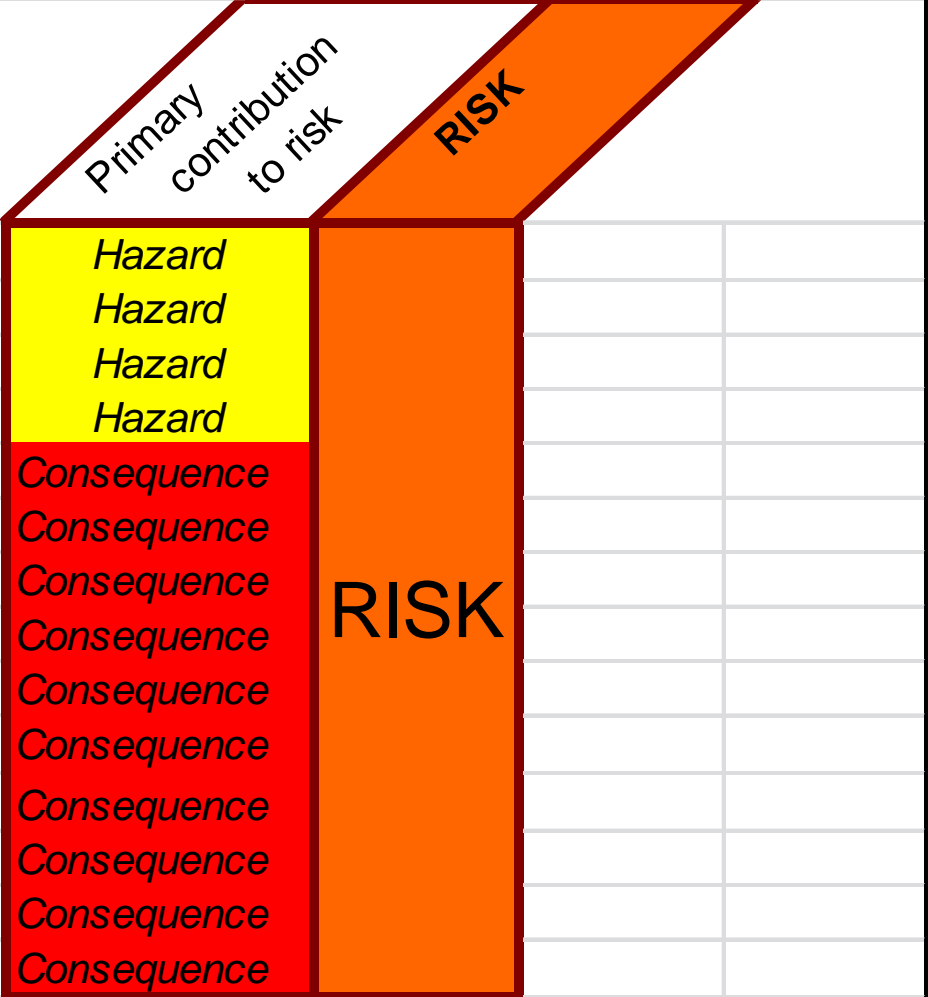
RHRS FACTORS

- 1 Structural Condition
- 2 Strength/Stability
- 3 Water/Climate
- 4 Rockfall History
- 5 Ditch Effectiveness
- 6 Vehicle Risk (Exposure)
- 7 Sight Distance
- 8 Roadway Width
- 9 Size/Volume
- 10 Slope Height

- A Education/Warning
- B Maintenance Frequency
- C
- D

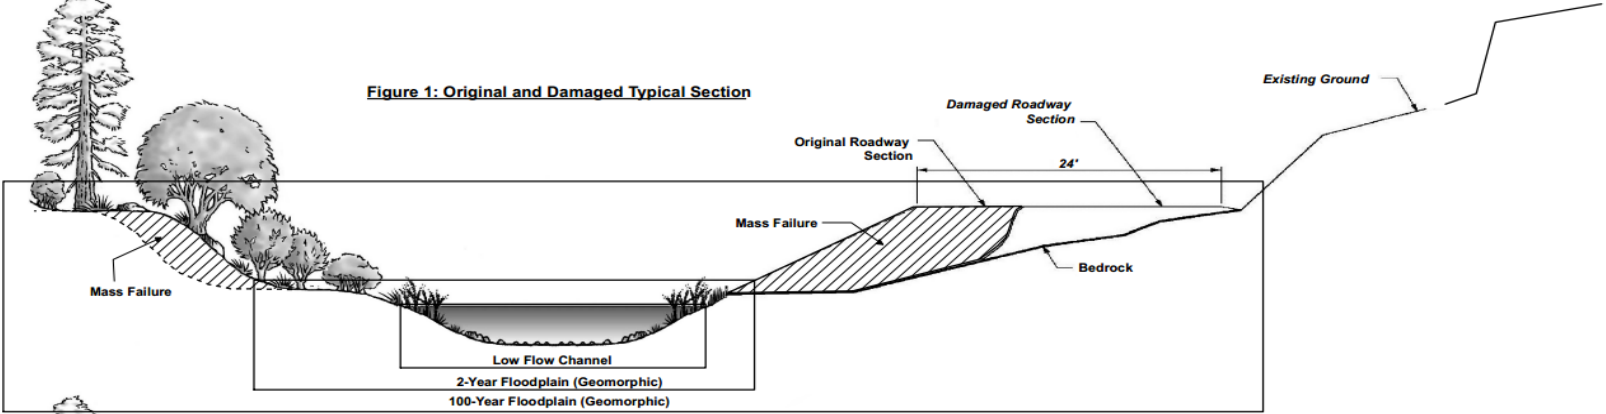
Figure 1: Original and Damaged Typical Section

Design Template

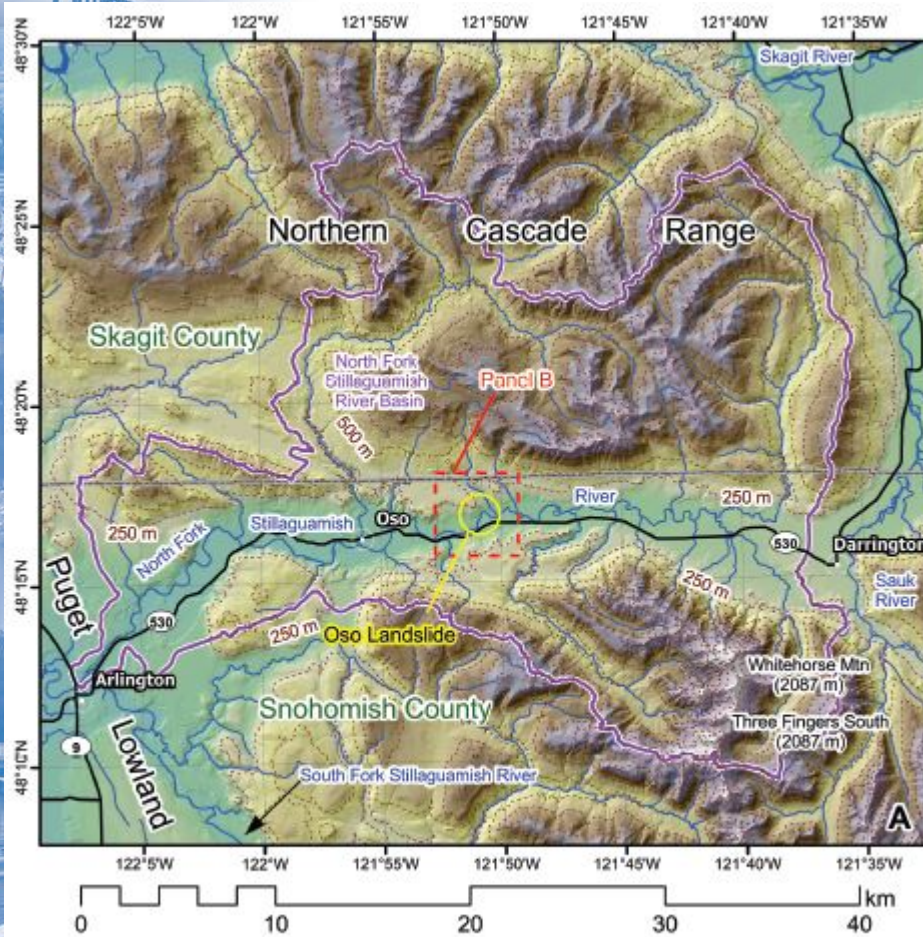
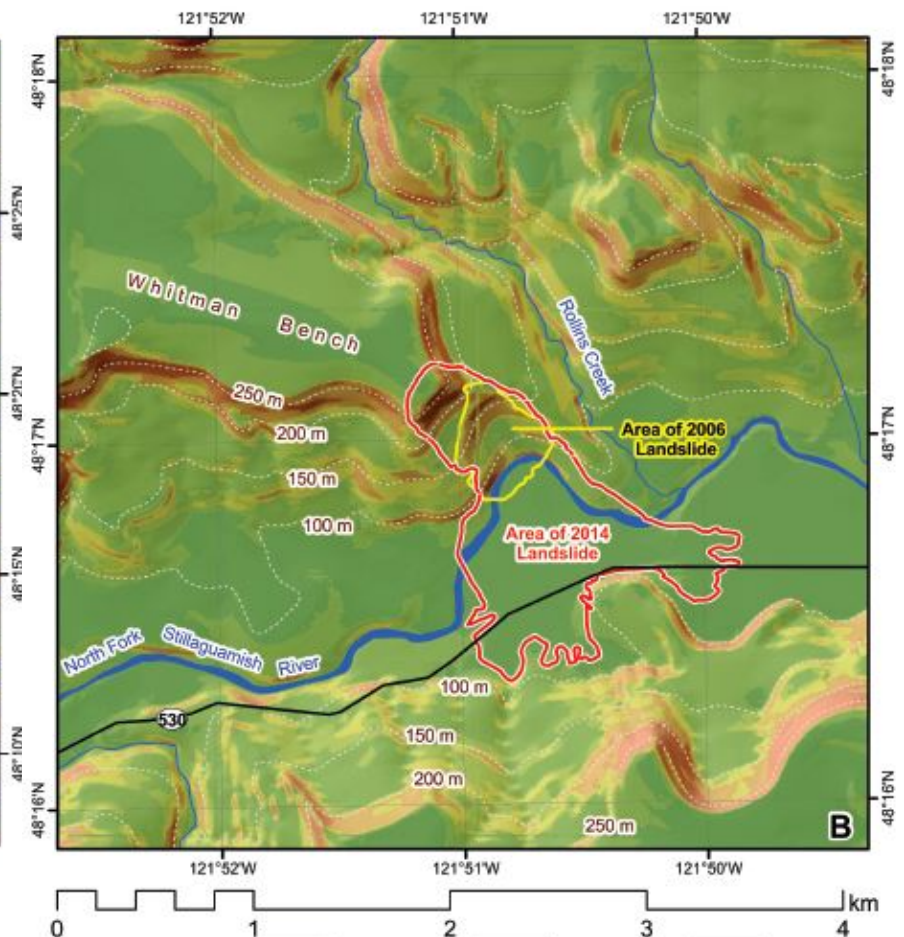
Location and General Slope

Projection: NAD_1983_UTM_Zone_10N_m
 Panel A: Contour interval = 250 m
 Panel B: Contour interval = 50 m

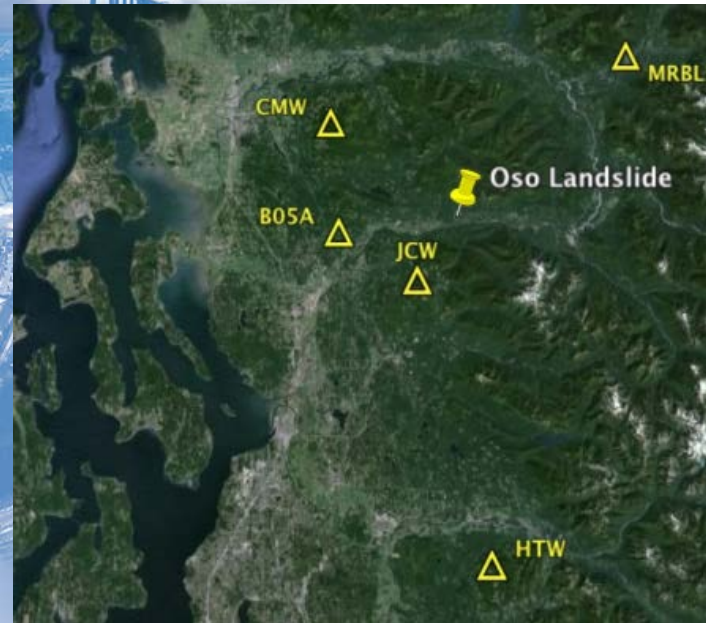
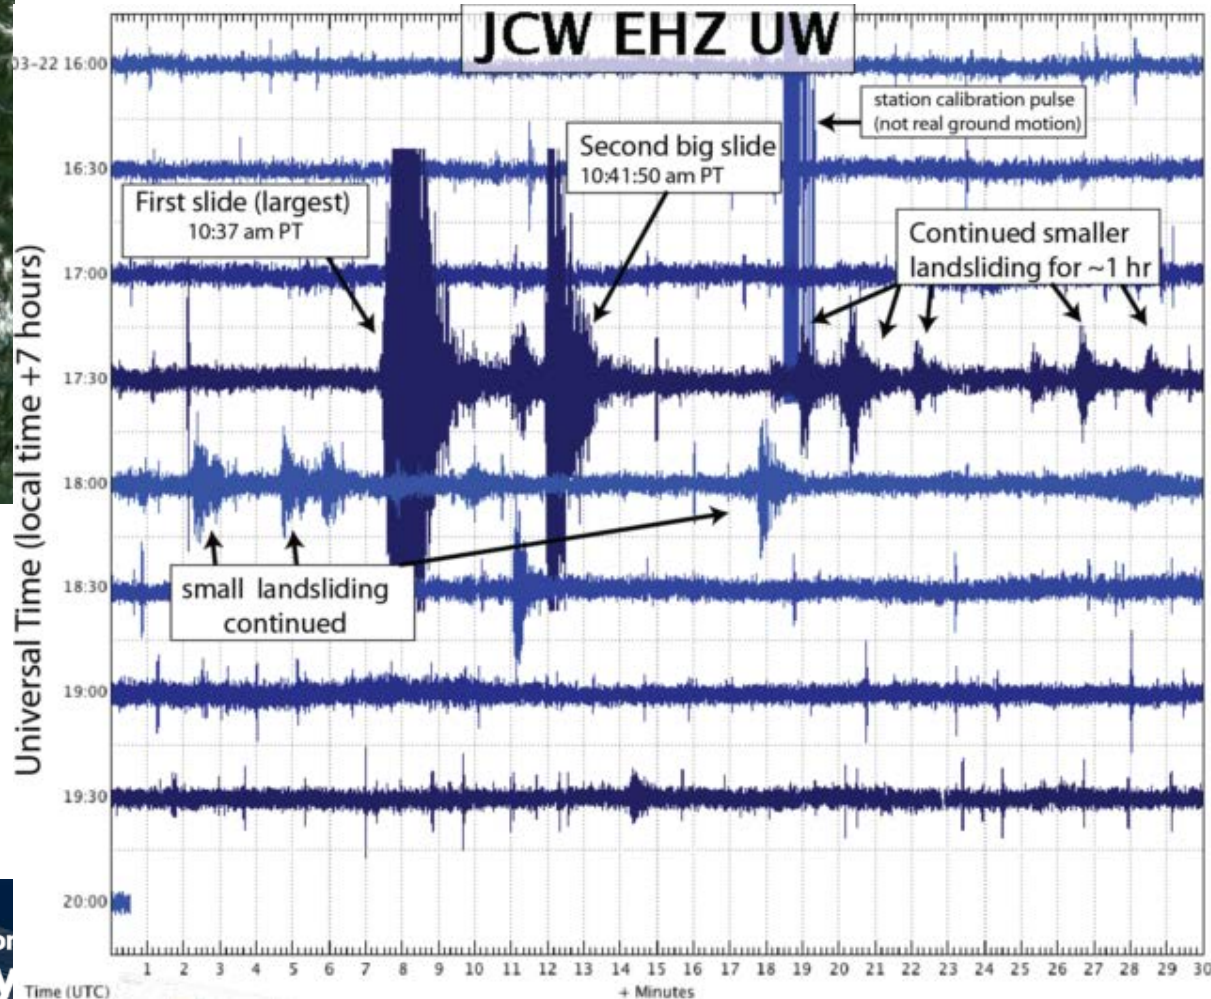
Jim Creek Wilderness Station – 11 km Away

Seismic Signals

Pacific Northwest
Seismograph Network

03/22/2014 10:37

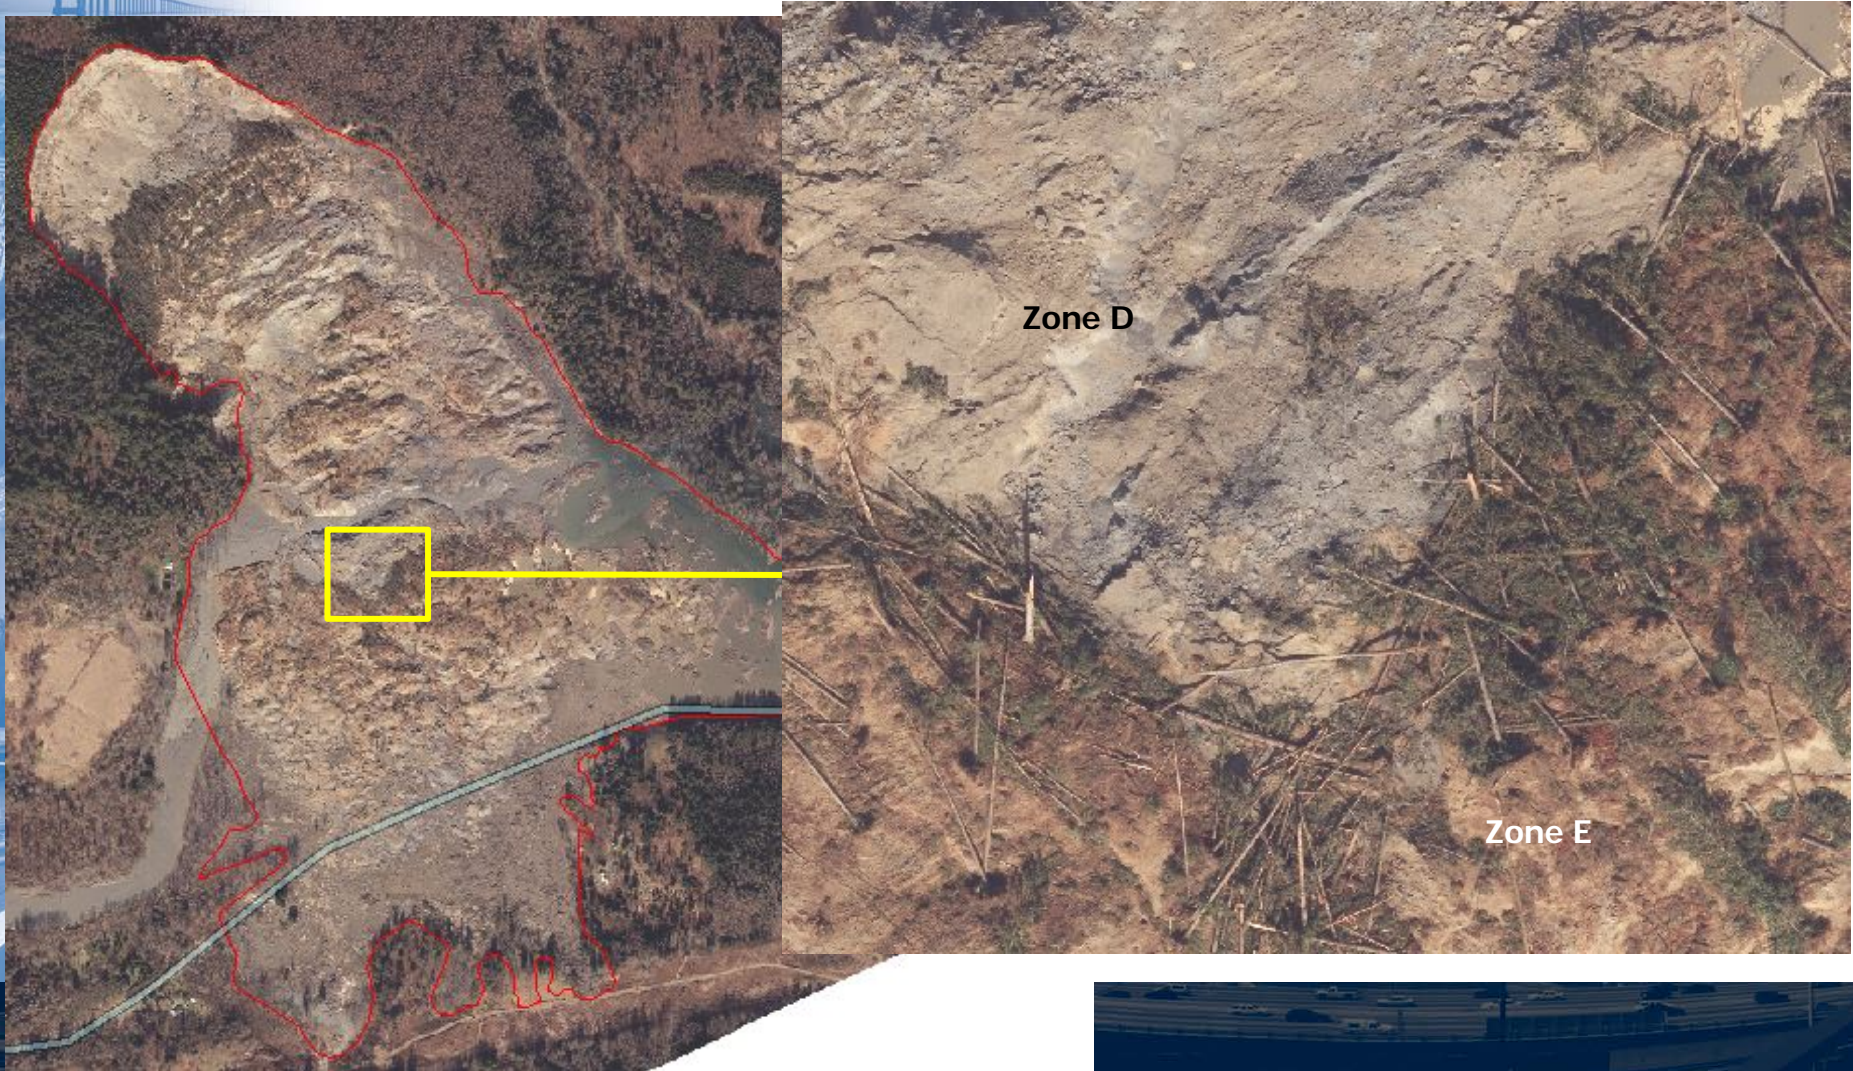
WSDOT High-Resolution Mosaic

24 March 2014

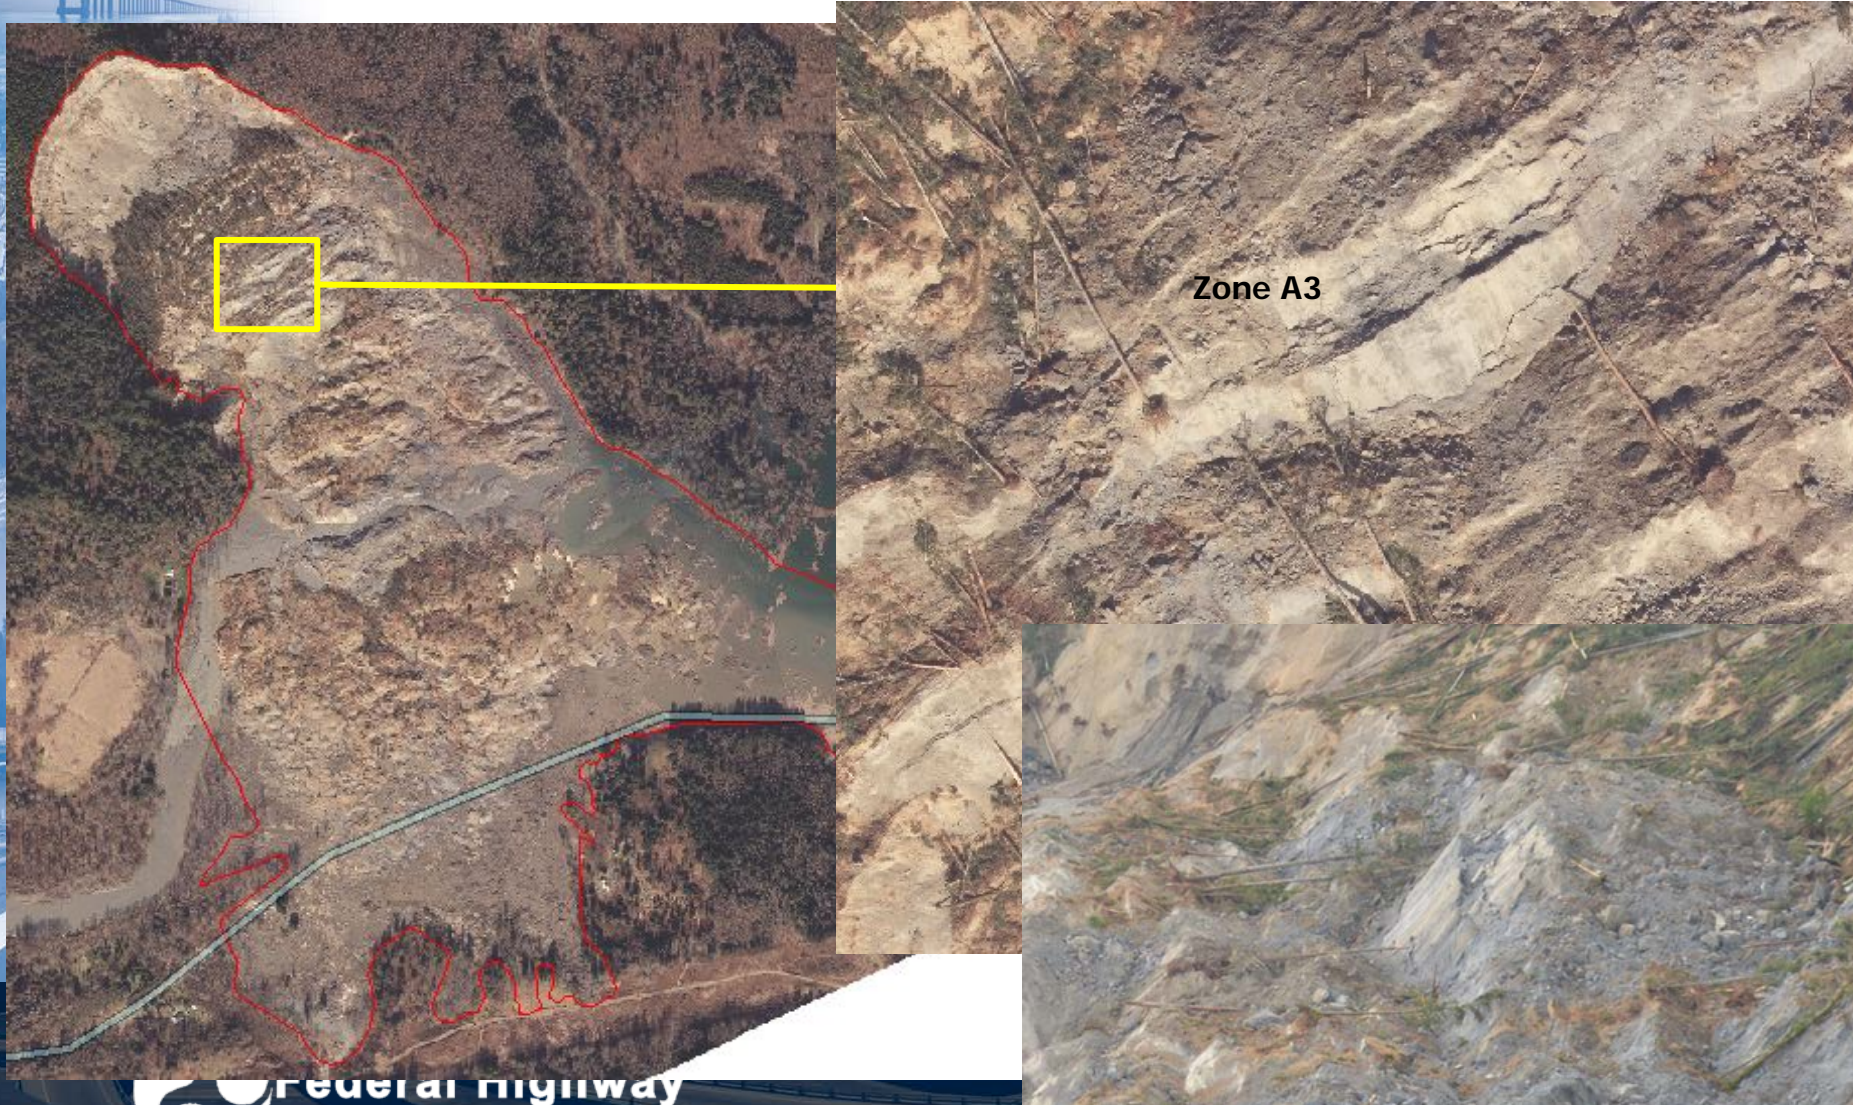
Record of Extension

WSDOT High-Resolution Mosaic 24 March 2014

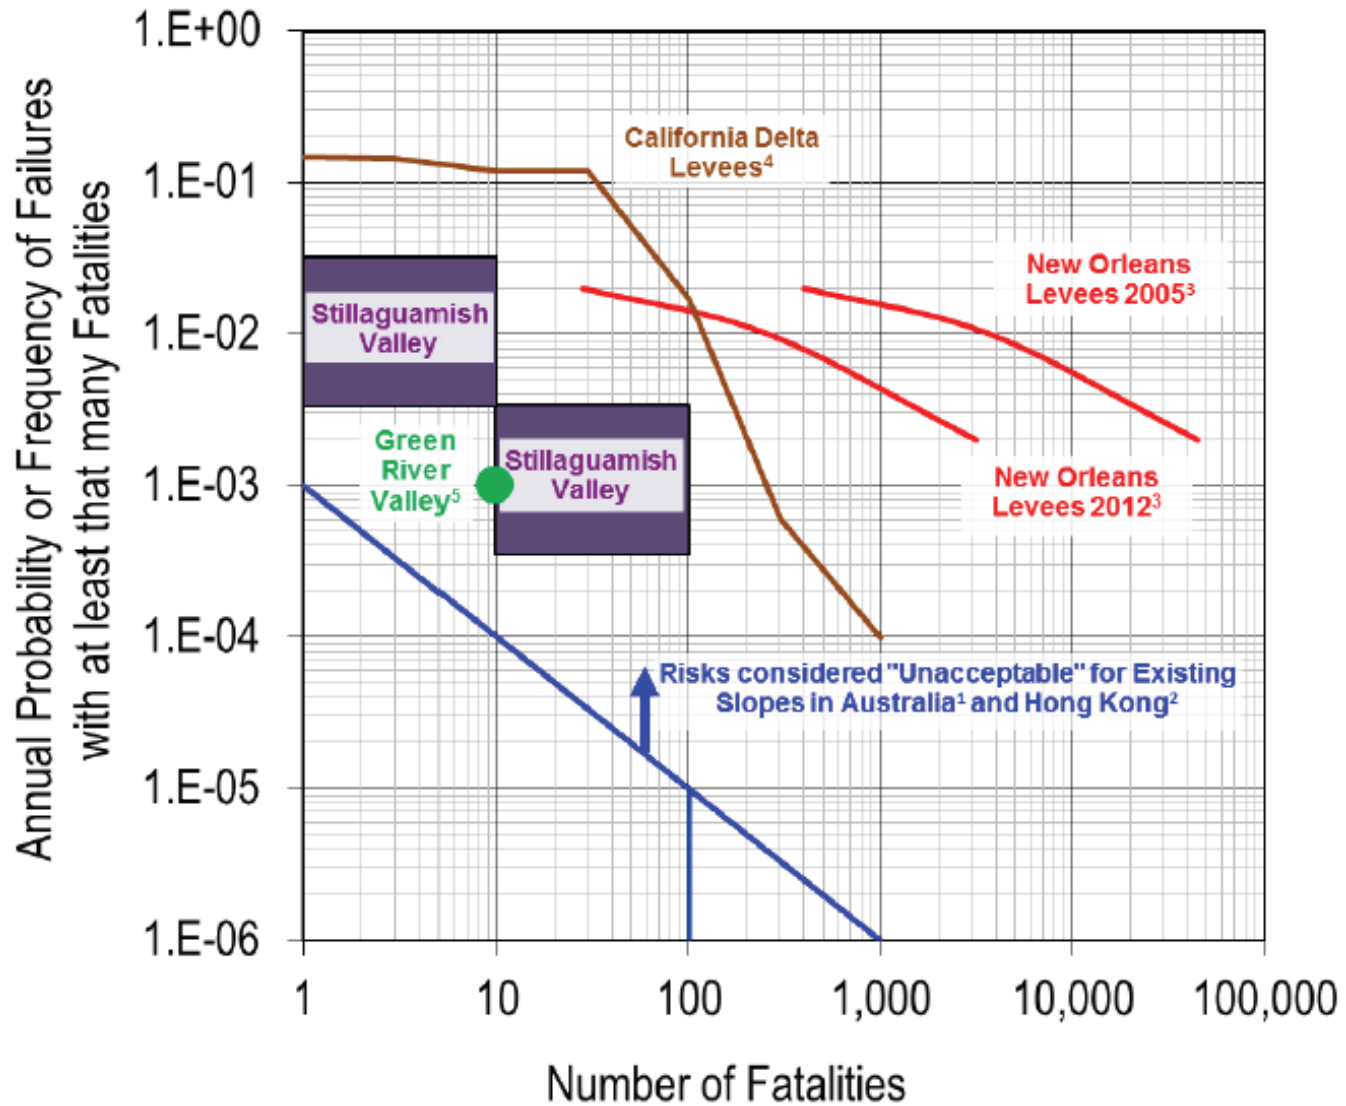
Risk (as understood now)

Approximate risk within 5 km of Oso

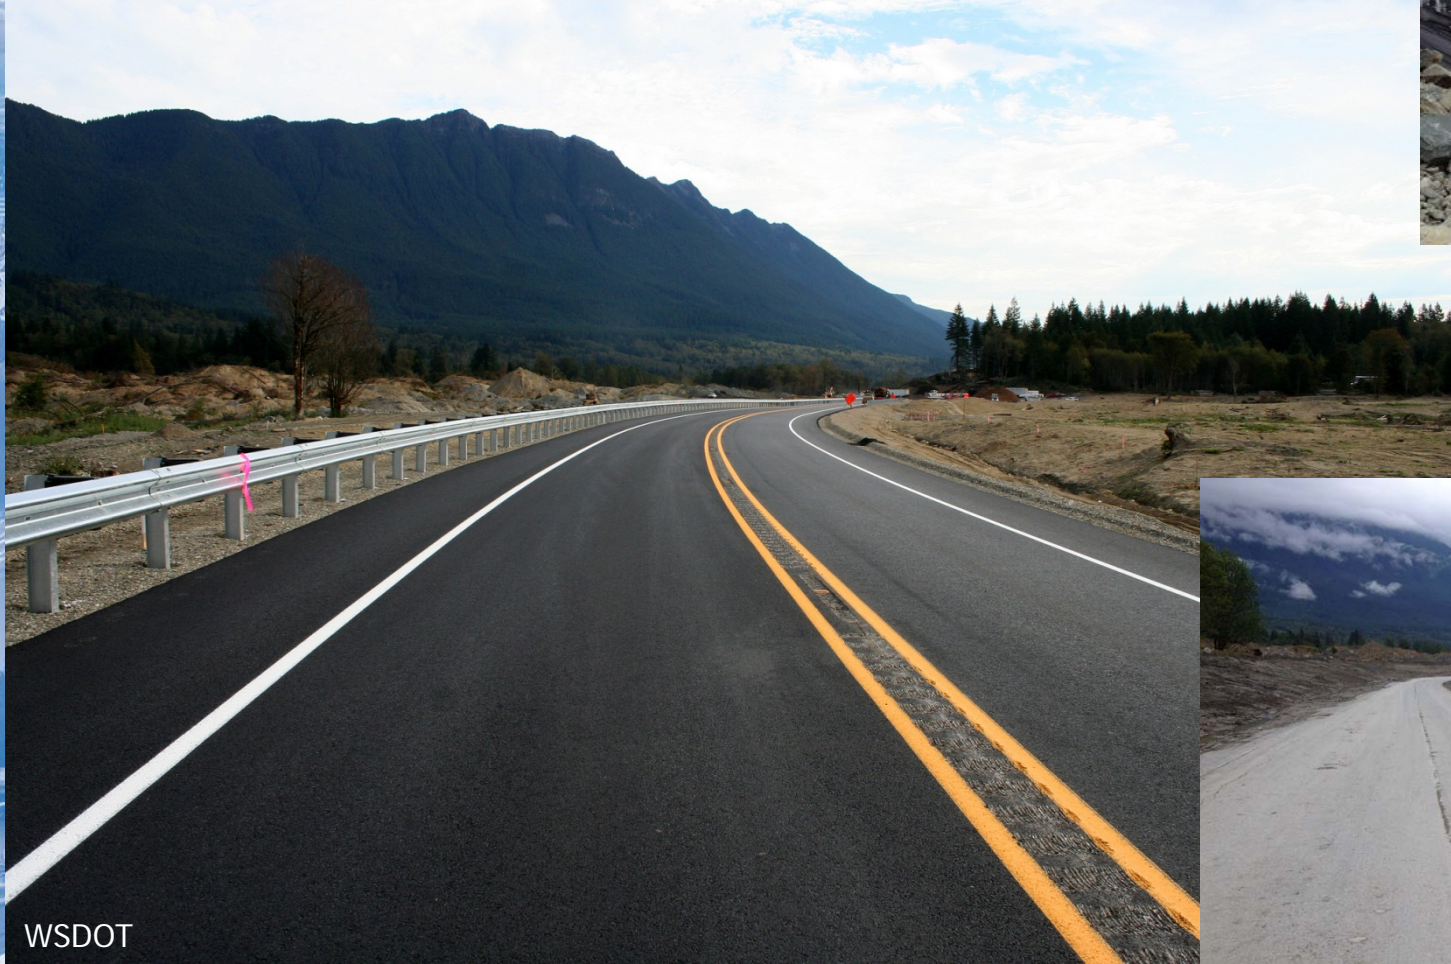
Design Solution

WSDOT

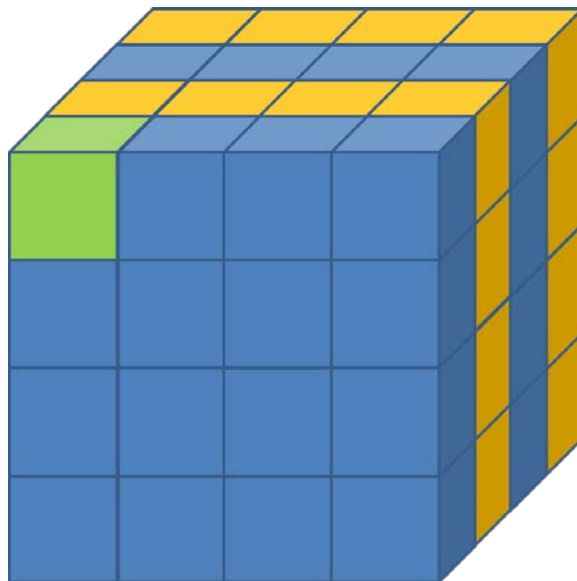
Consider a “Risk Cube”

Highway departments (and others) are using risk based plans to manage their assets and to achieve performance goals.

The SR 530 embankment on the Oso landslide is now an asset subjected to risks.

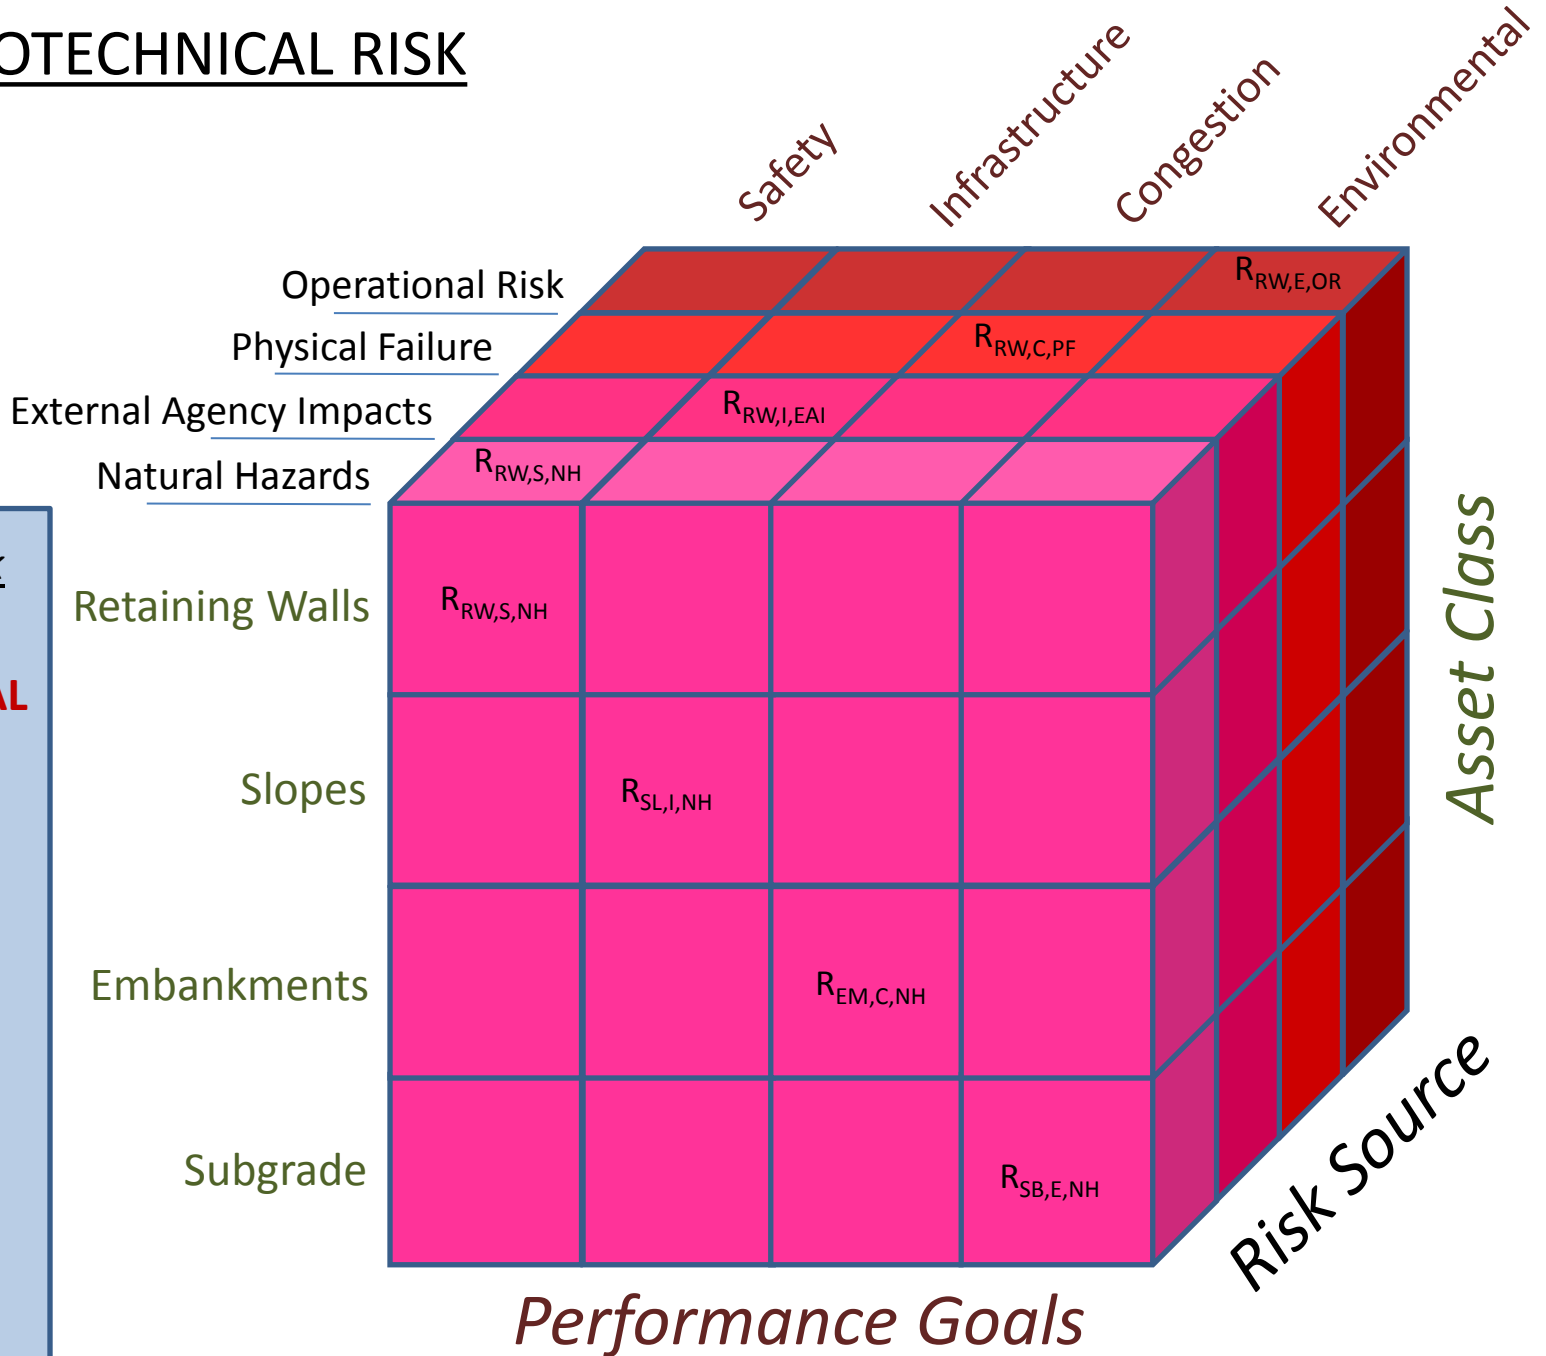
ALL GEOTECHNICAL RISK

Σ of **ALL Risk**
Sources on
GEOTECHNICAL
Assets with
 respect to **ALL**
Performance
Goals

Can be done
 for GAM
 Section,
 Corridor or
 entire
 inventory

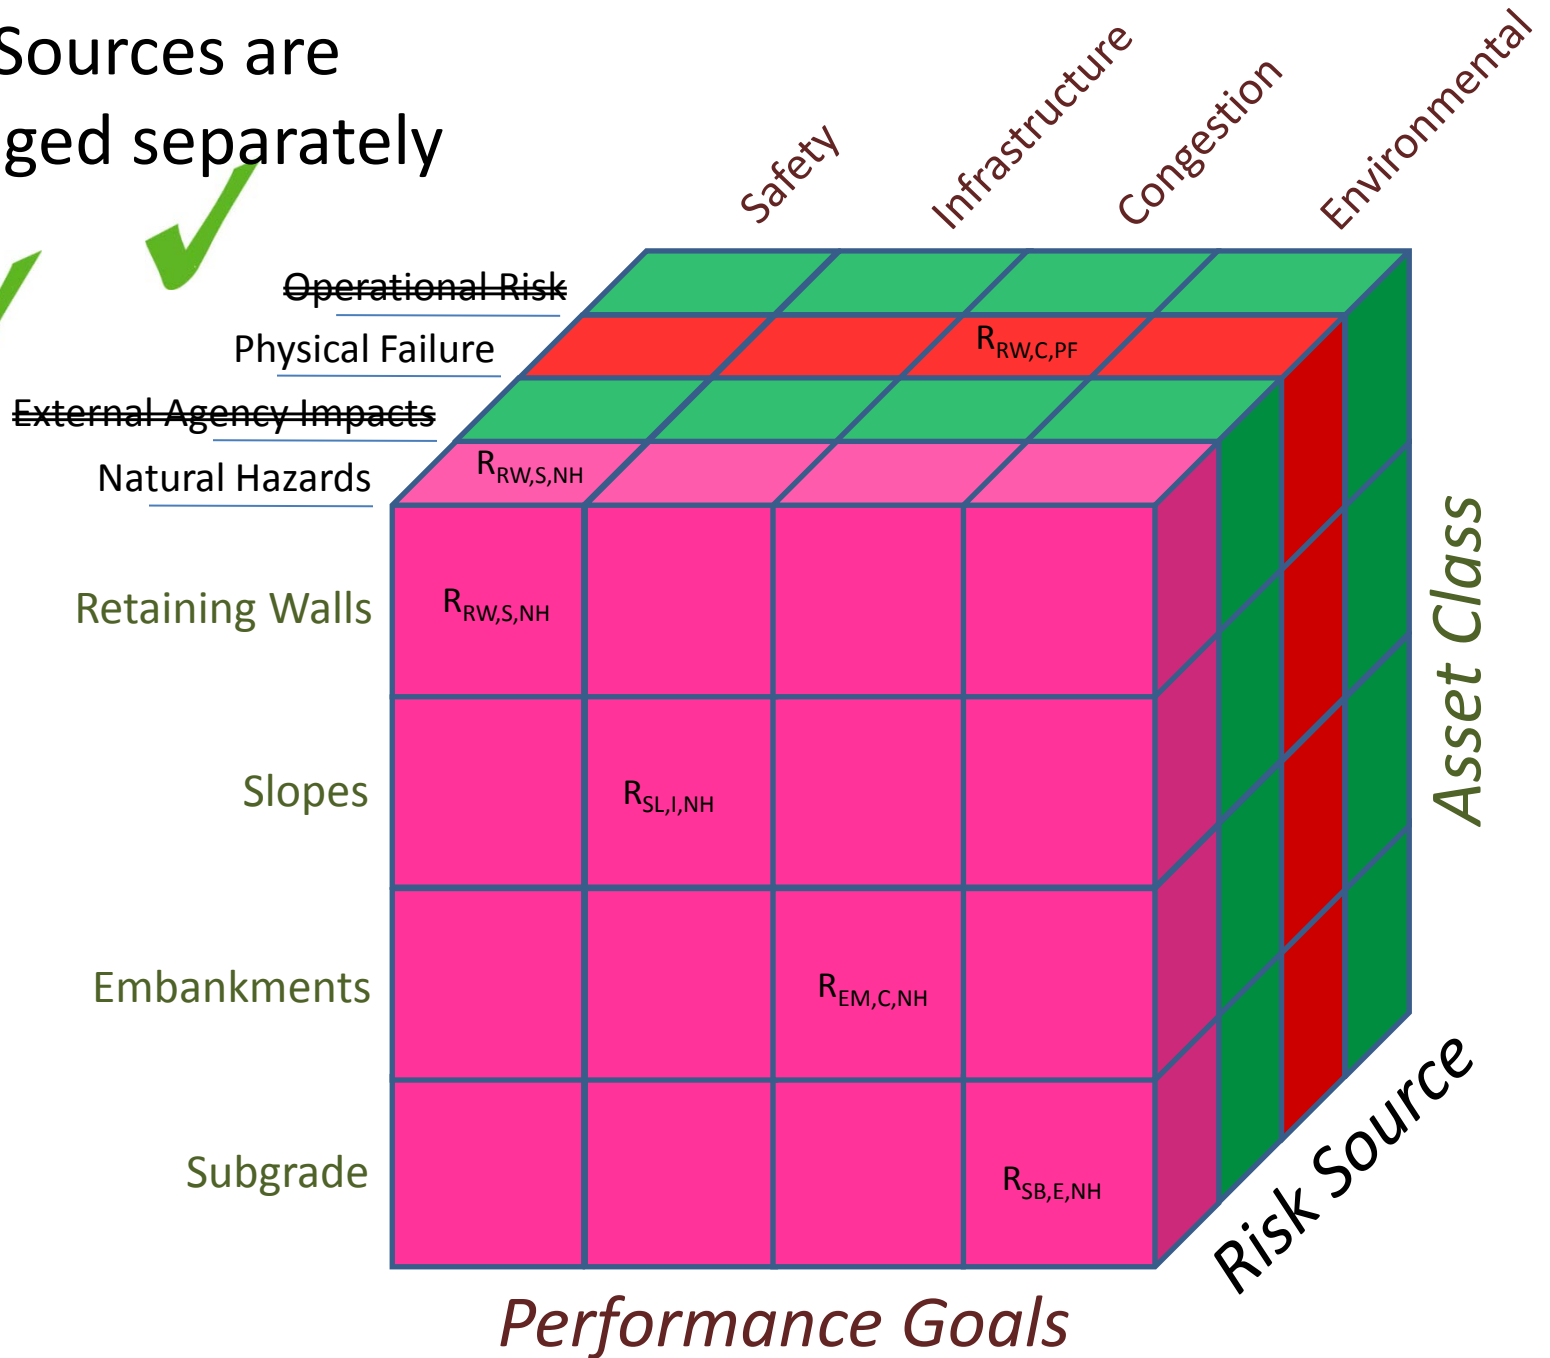
2 Sources are managed separately

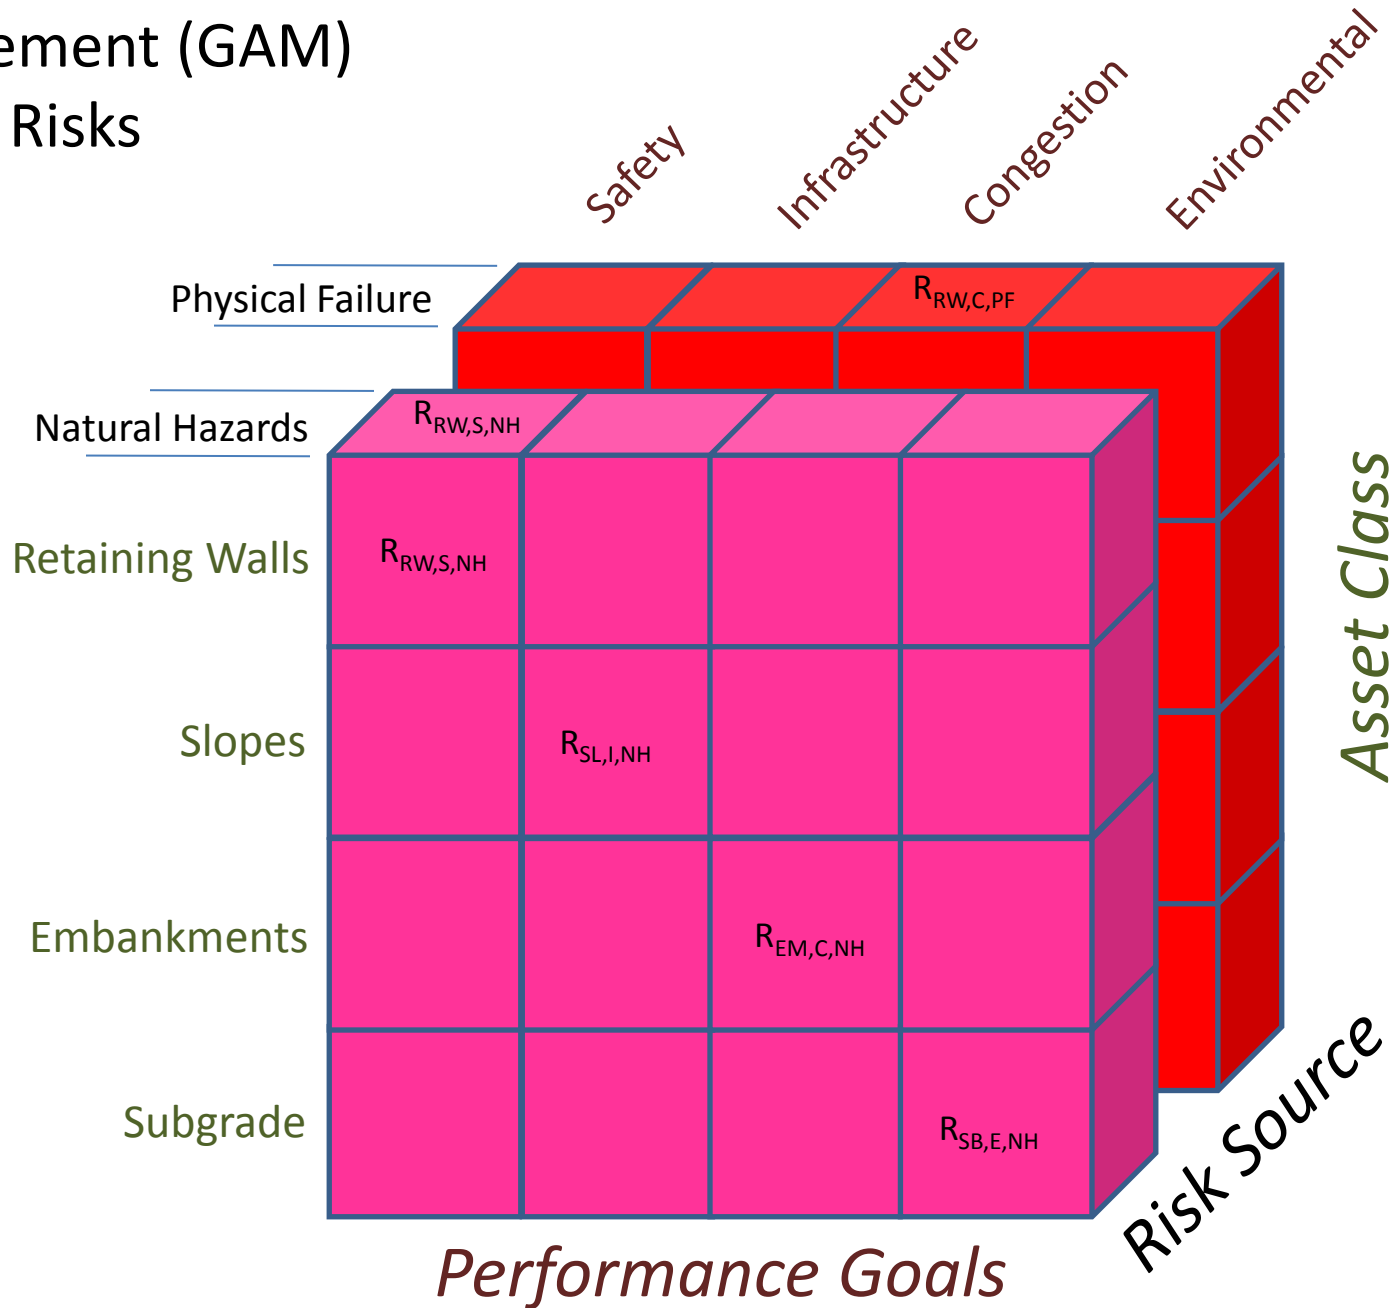
Geotechnical Asset Management (GAM) Risks
