Natural Hazards and the Built Environment: a State of Practice Perspective

*The 18th Annual
George F. Sowers Symposium*

Scott A. Anderson Ph.D., P.E.
Federal Highway Administration
Geotechnical Services Team Manager

Probability and Volume of Potential Postwildfire Debris Flows in the 2012 Waldo Canyon Burn Area near Colorado Springs, Colorado

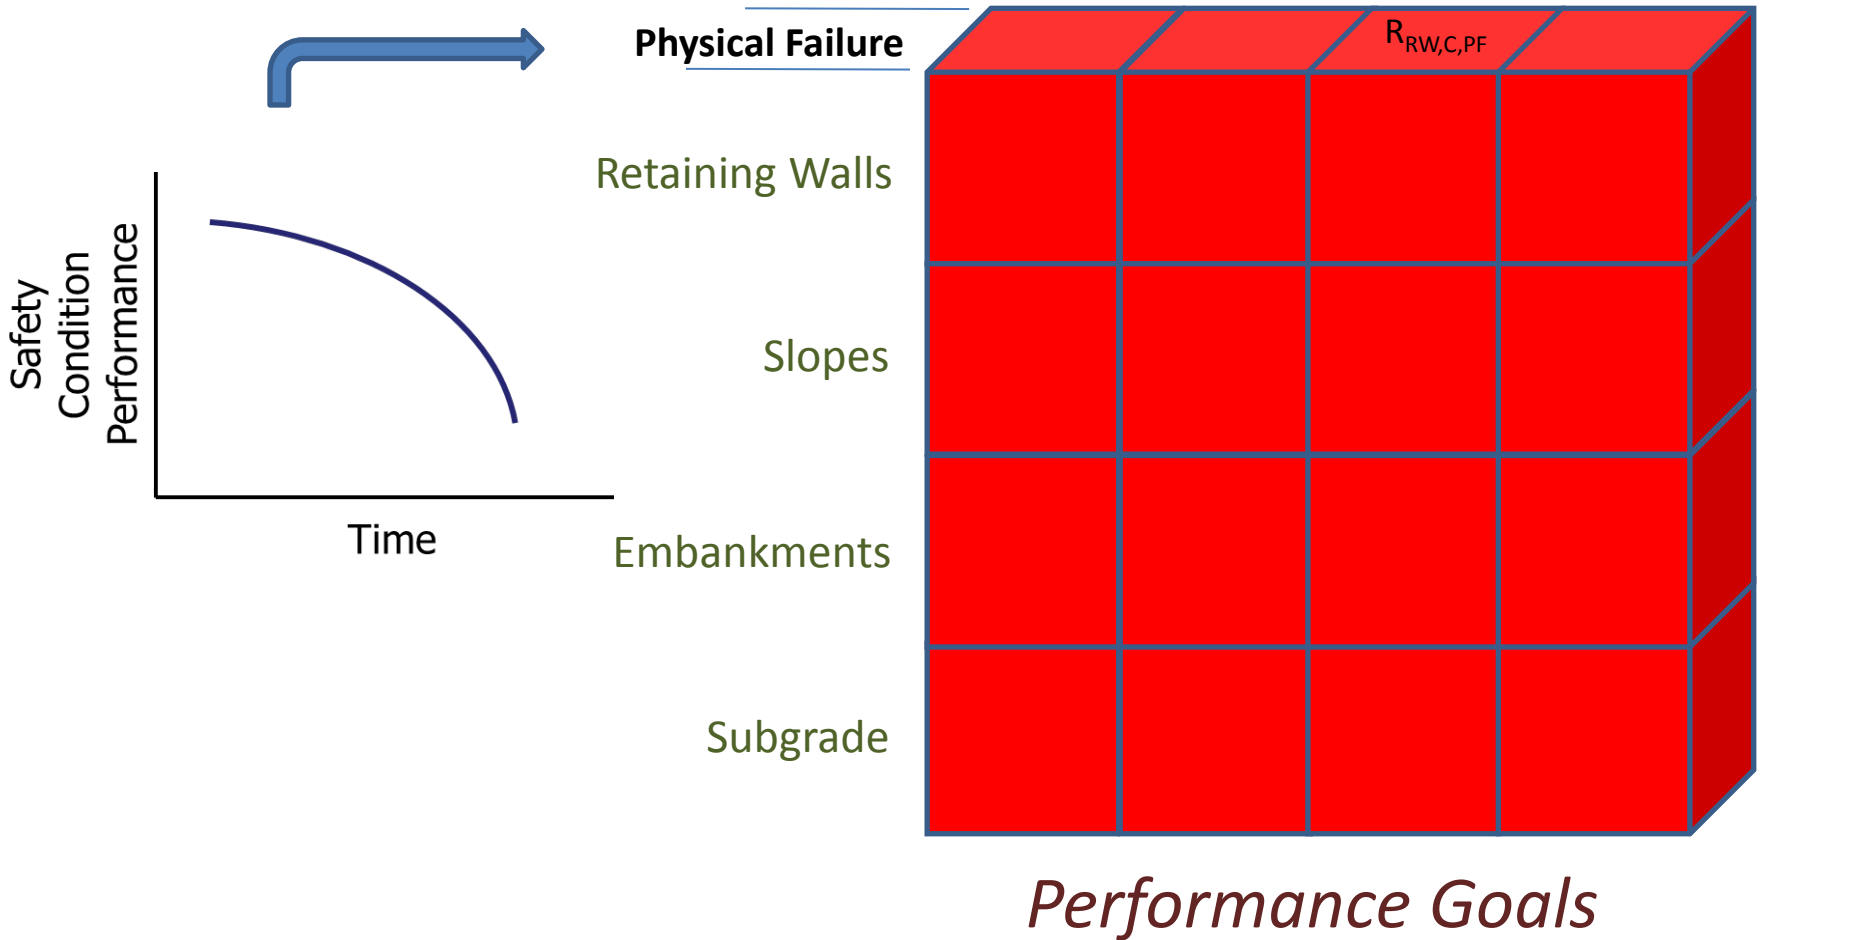
Physical Failure Risk Source

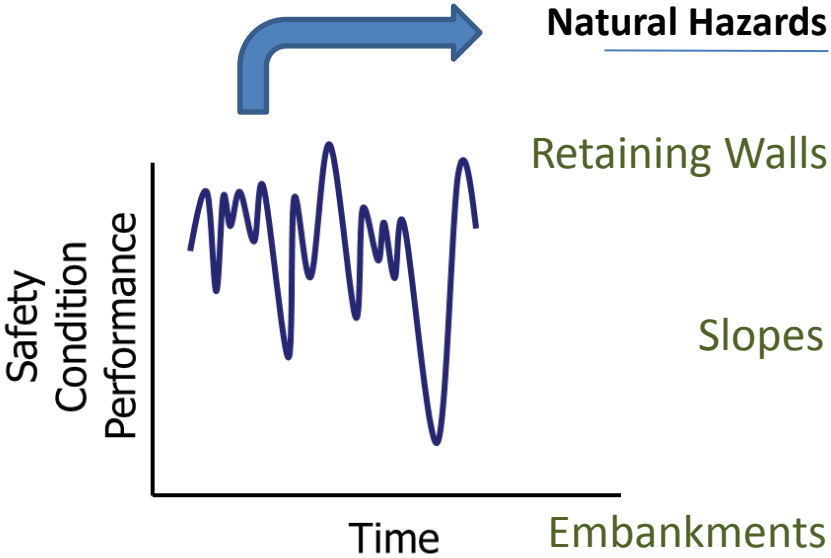
Natural Hazard Risk Source

Natural Hazards

Retaining Walls

Slopes

Embankments

Subgrade

Safety

Infrastructure

Congestion

Environmental

$R_{RW,S,NH}$			
$R_{RW,S,NH}$				
	$R_{SL,I,NH}$			
		$R_{EM,C,NH}$		
			$R_{SB,E,NH}$

Performance Goals
