GEOTECHNICAL IMPACTS OF AUGUST 2018 FLOODS OF KERALA, INDIA

Event: August 2018

Geotechnical Extreme Events Reconnaissance
Turning Disaster into Knowledge
Sponsored by the National Science Foundation
GEER Association Report NO - 058

Date: 10-17-2018

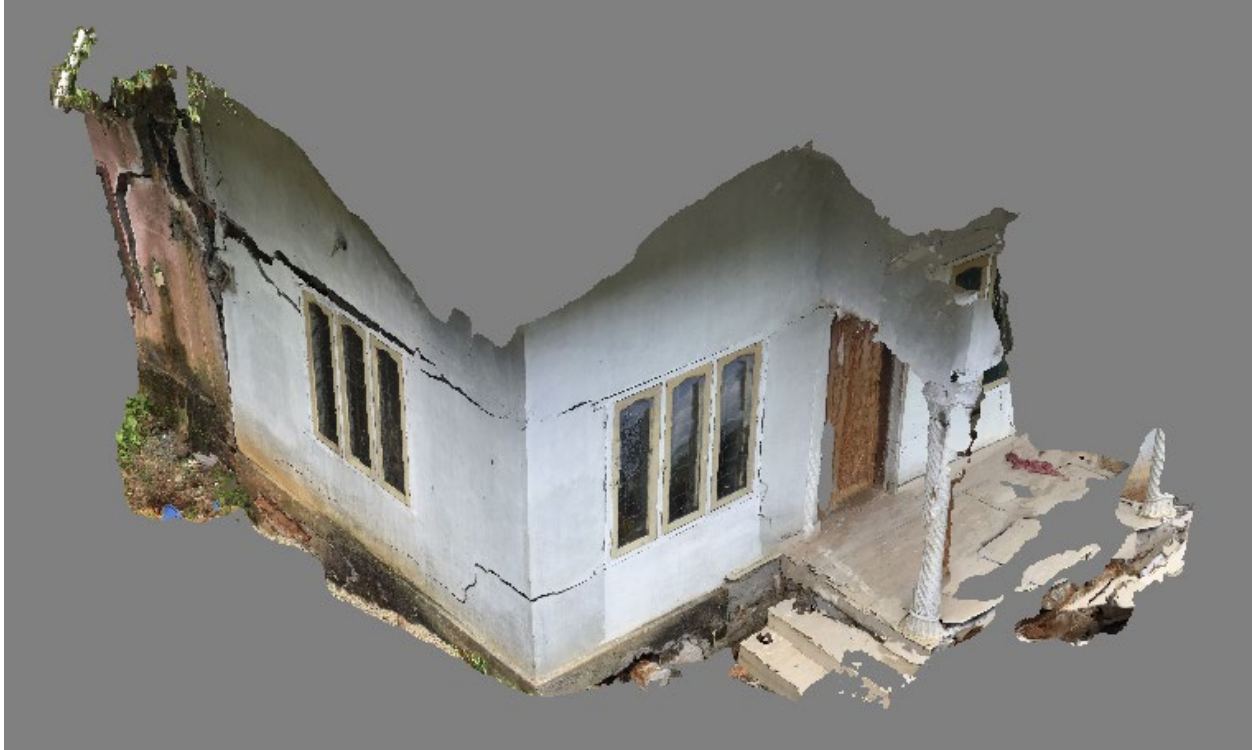
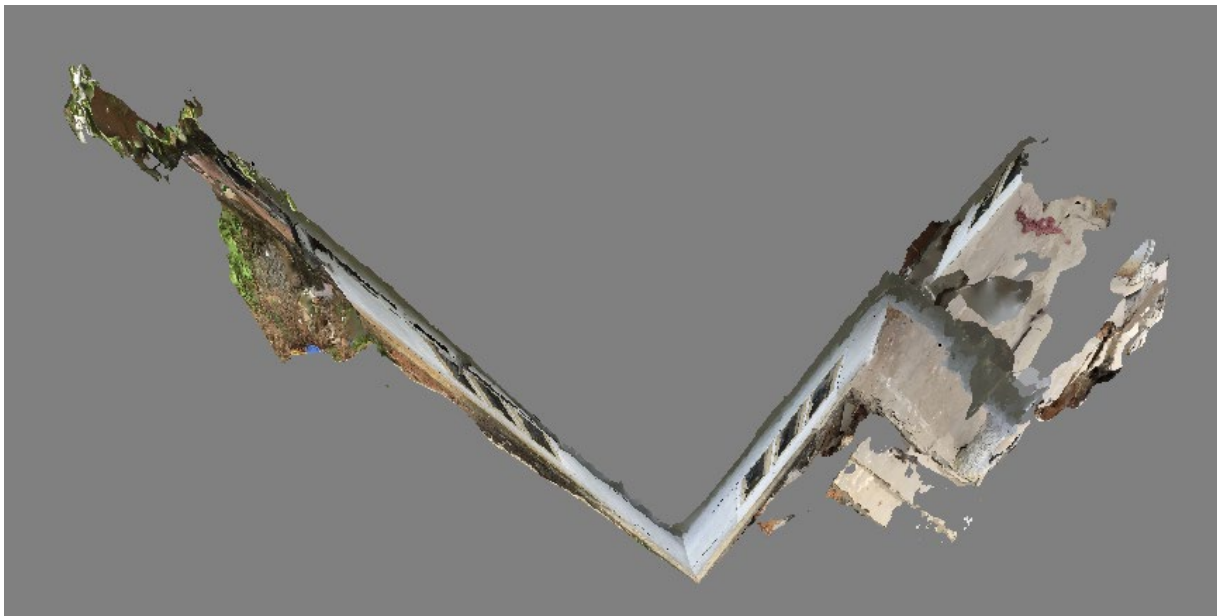
located within the large landslide was also reconstructed using PhotoScan (Figures 2.15, 2.16, 2.17, & 2.18). This house was selected because of 1) the extensive damage to the structure and 2) for the possibility of doing forensic damage investigations by means of the cracking pattern. As shown in Figure 2.14, it appears that the structure was built in multiple stages and most of the damage occurred at the connection between the original structure and the addition to the original structure. The addition/original structure damage pattern did not appear to start or progress from a location of head scarp movement or block-wedge movement. Therefore, it is believed that the damage location was a function of different modulus and rigidity values for the different portions of the structure.

Figure 2.16: Three-dimensional reconstruction of one of the houses within the Idukki Landslide by means of Photoscan. (a) Front left isometric projection, (b) top left isometric projection (9.7962622°N; 77.0681814°E).

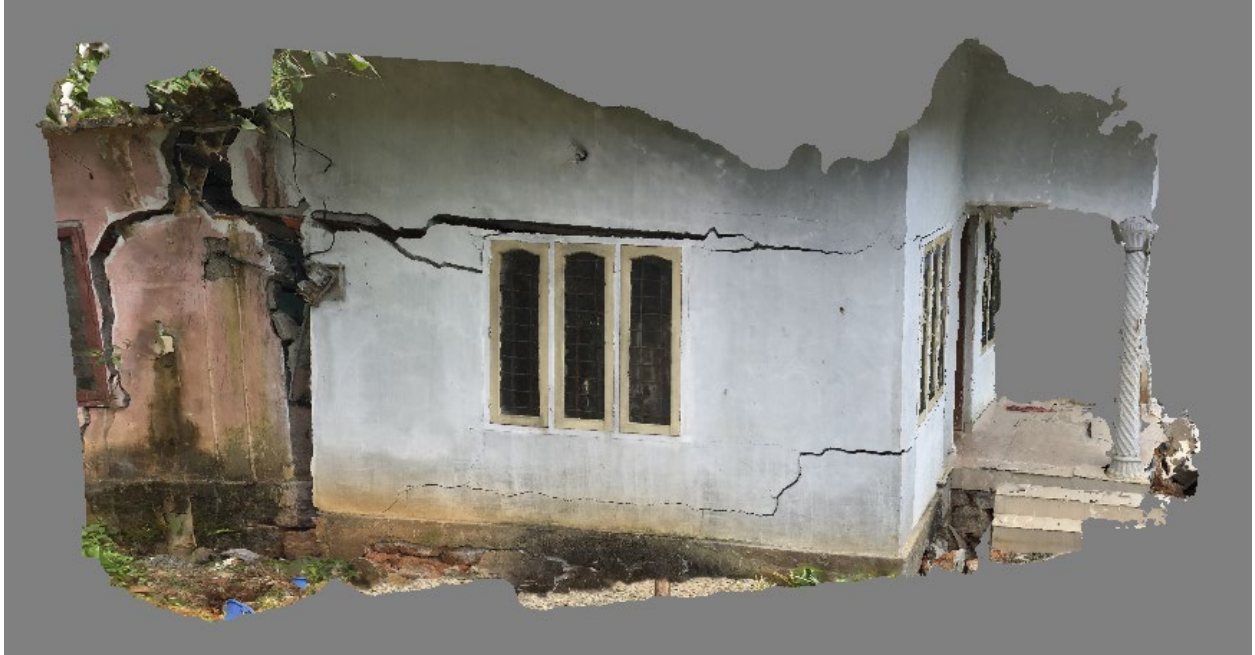
Figure 2.17: Left side isometric projection of the three-dimensional reconstruction of one of the houses within the Idukki Landslide by means of Photoscan (9.7962622°N; 77.0681814°E).

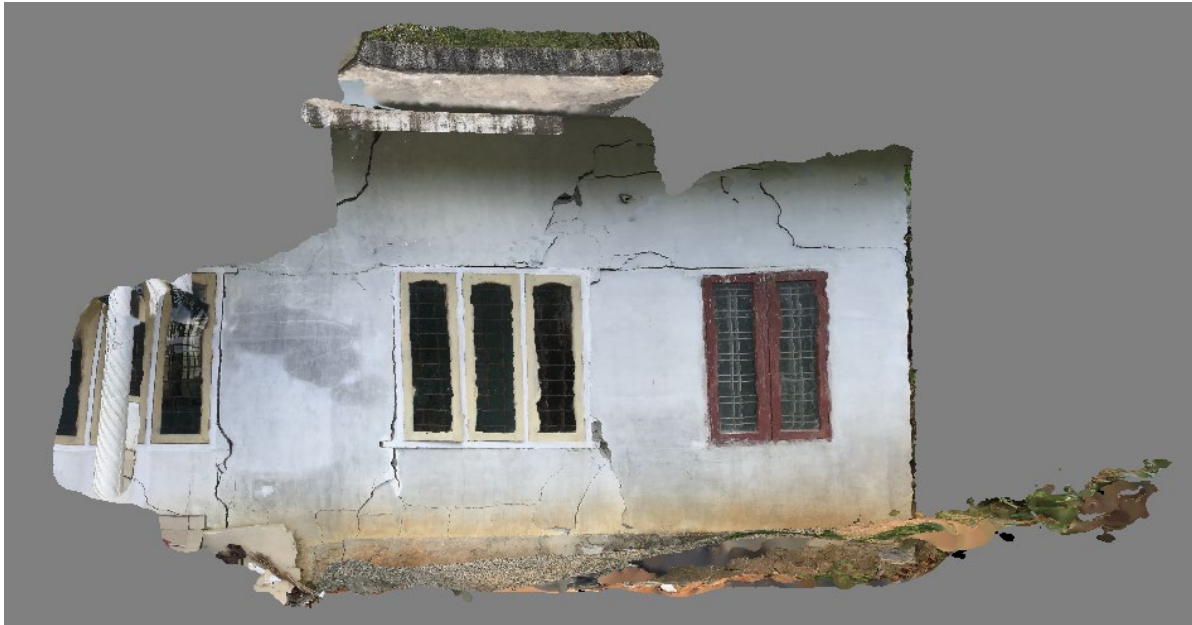
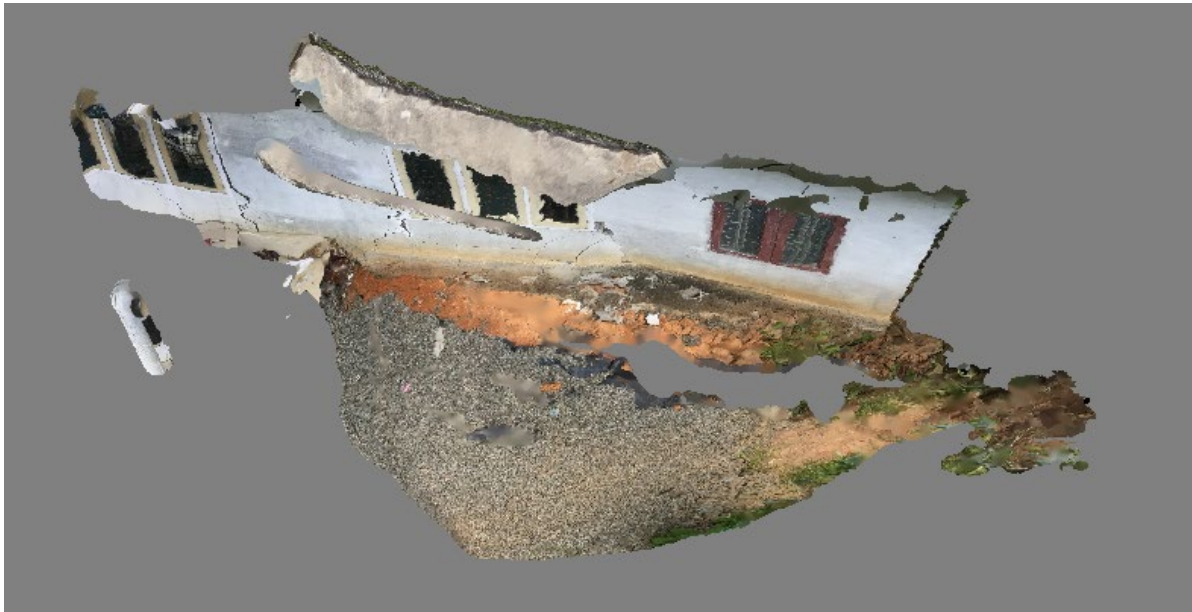
Figure 2.18: Three-dimensional reconstruction of one of the houses within the Idukki Landslide by means of Photoscan. (a) Front right side isometric projection, (b) top right side isometric projection (9.7962622°N; 77.0681814°E).

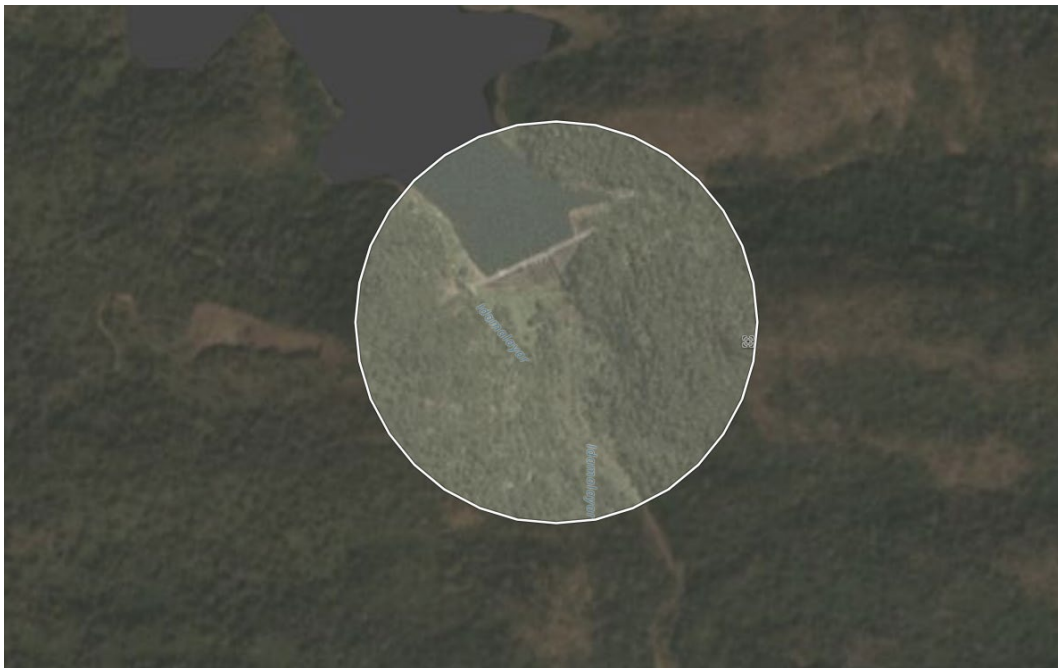
However, looking at the available high-resolution satellite images from Planet lab indicates that these landslides were formed after the opening of the shutters. Figure 3.4 is a planet lab imagery of Idamalayar dam from July 1, 2018. It is evident from the image that the dam shutter is closed and the downstream channel is vegetated. Figure 3.5 is a planet lab imagery of Idamalayar dam on September 3rd, 2018 and it documents the landslides that are occurring in the downstream channel at close vicinity of the dam. The initial estimates indicate that the landslide is occurring less than 150m downstream of the dam. The width of the slide is roughly 100m.

Figure 3.4: Planet lab imagery of Idamalayar dam from July 1, 2018.

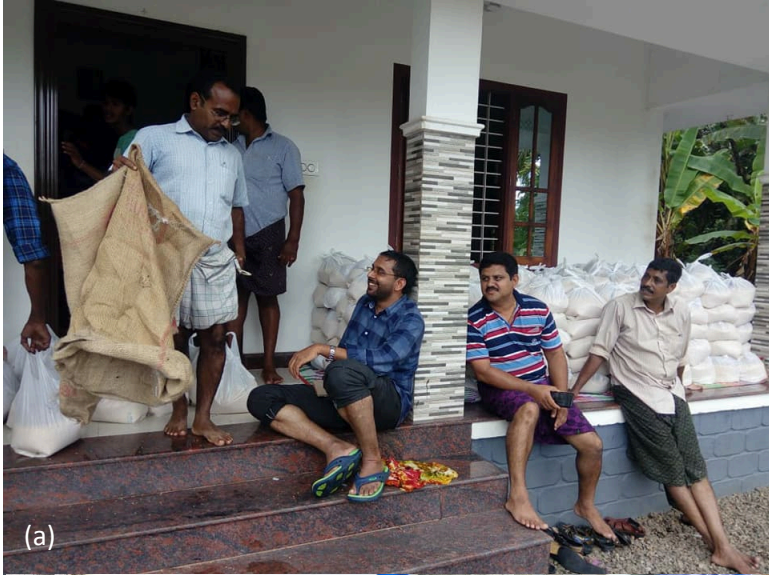
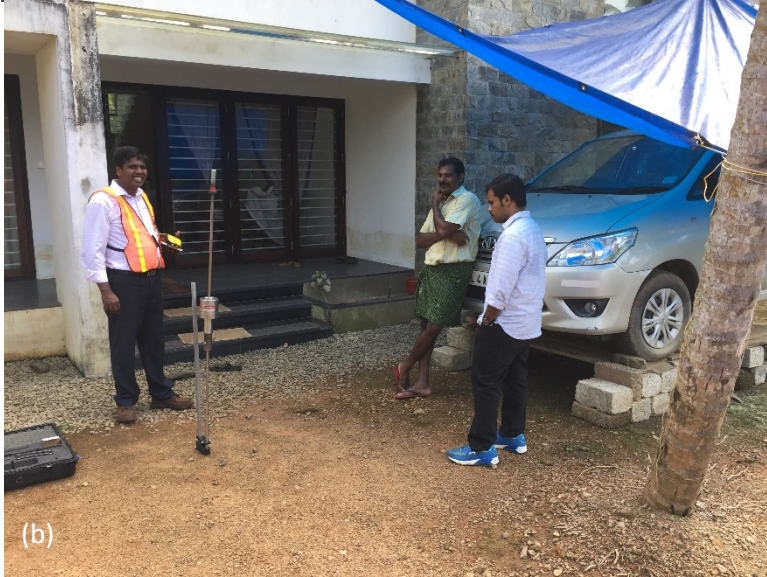
Photographs of the two-story houses (identified as the white and gray houses) are shown in Figure 4.9. Based on conversations with the residents of the homes, the second story of the white house was constructed from lightweight concrete and the gray house was constructed on a mat foundation. For completeness, photographs of the blue prints for this house, which were provided by the owner of the house, are included as Figure 4.10. The residents also stated that the original building of the Mar Sleeveva Church (Figure 4.11), located across SH11 from the houses, was constructed on 30-foot long concrete piles and the ancillary building was constructed on six- to eight-foot long sections of coconut trees placed in nine-pile groups. The location of the DCP soundings around the white and tan two story homes are provided in Figure 4.12. The DCP sounding data from the four soundings that were performed at this site are provided in Figure 4.13.

Figure 4.9: Photographs of the a) white and b) gray houses located across from the Mar Sleeva Church. Photograph of white house provided by Thomas Mampra.

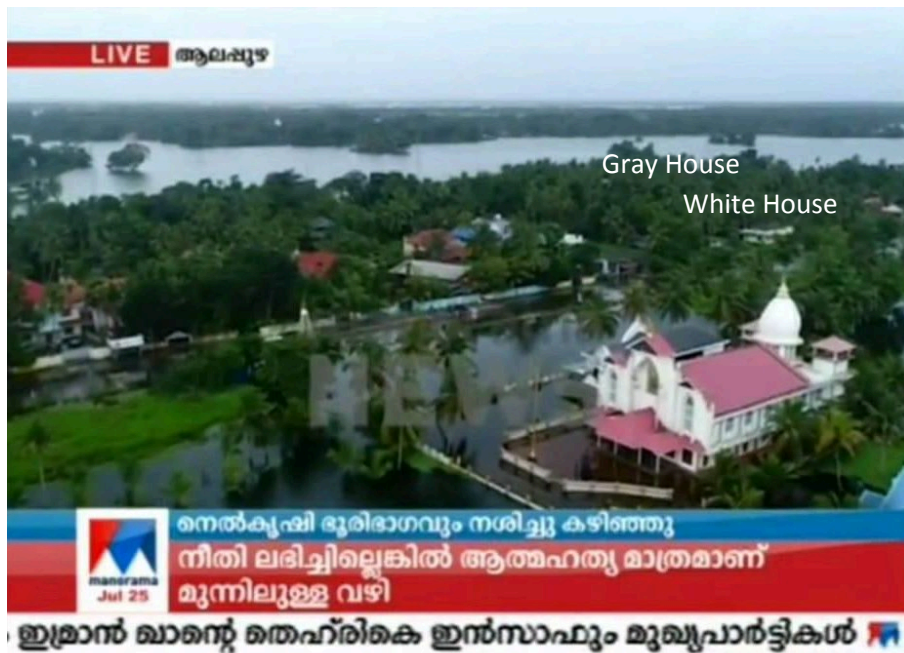
Figure 4.16: Photograph of the Mar Sleeva Church Ponga when subjected to flooding. Gray house and white house identified in background. Photograph provided by Mar Sleeva Church Ponga.

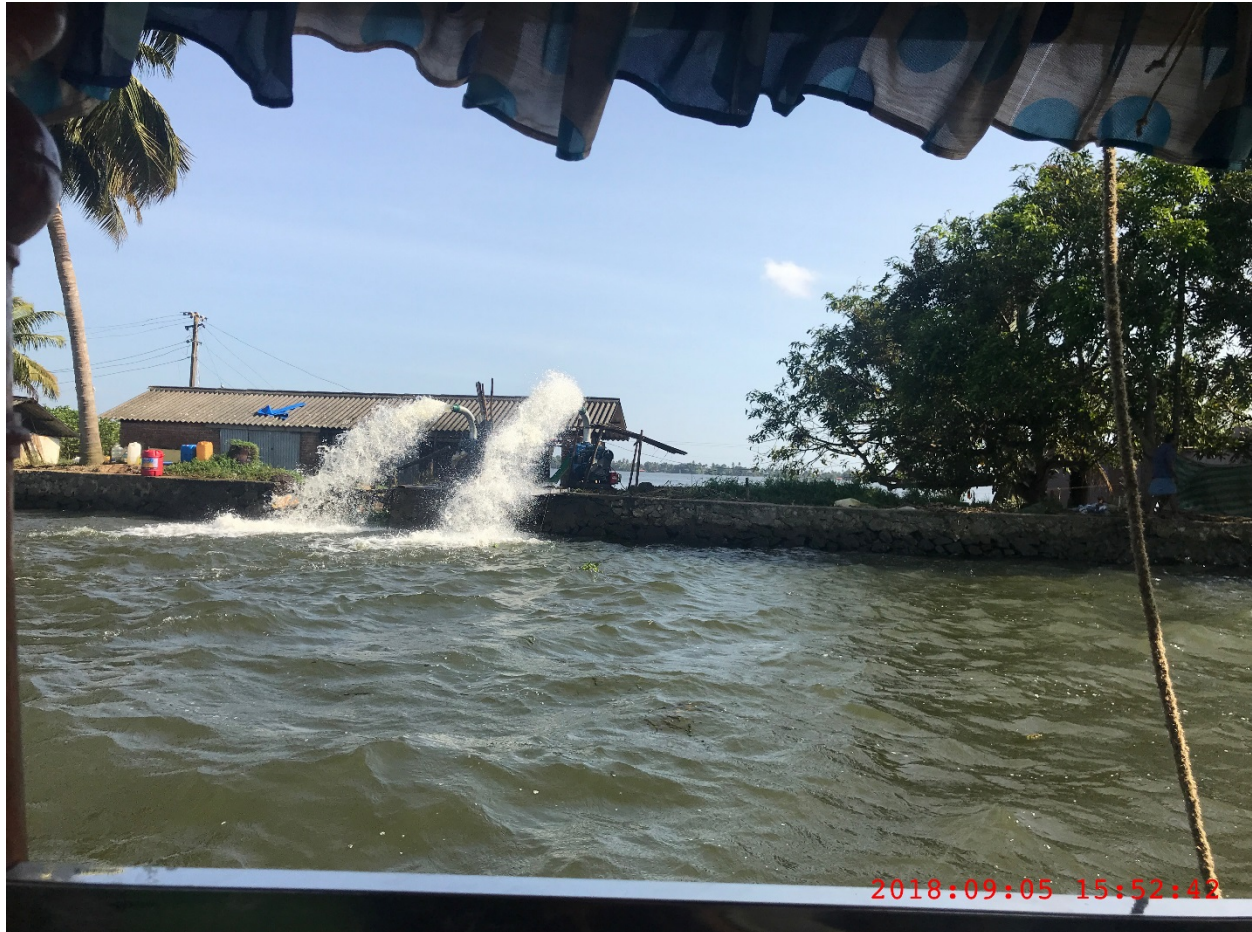
Figure 5.10: Water being pumped from the fields to the lake @ 9.5166260°N 76.3810643°E

The GEER team witnessed the reconstruction of the major bund failure. The reconstruction was labor intensive and was done using locally available construction material (Figure 5.5). The government had taken measures to pump the water from the flooded fields as the bund was being reconstructed as shown in Figure 5.10.

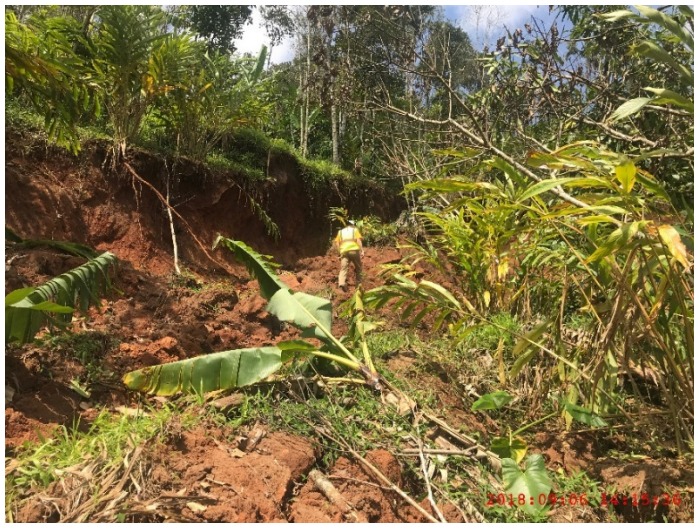
Figure A-10: Landslide scarp @ 9.7970015° N 77.0683650° E

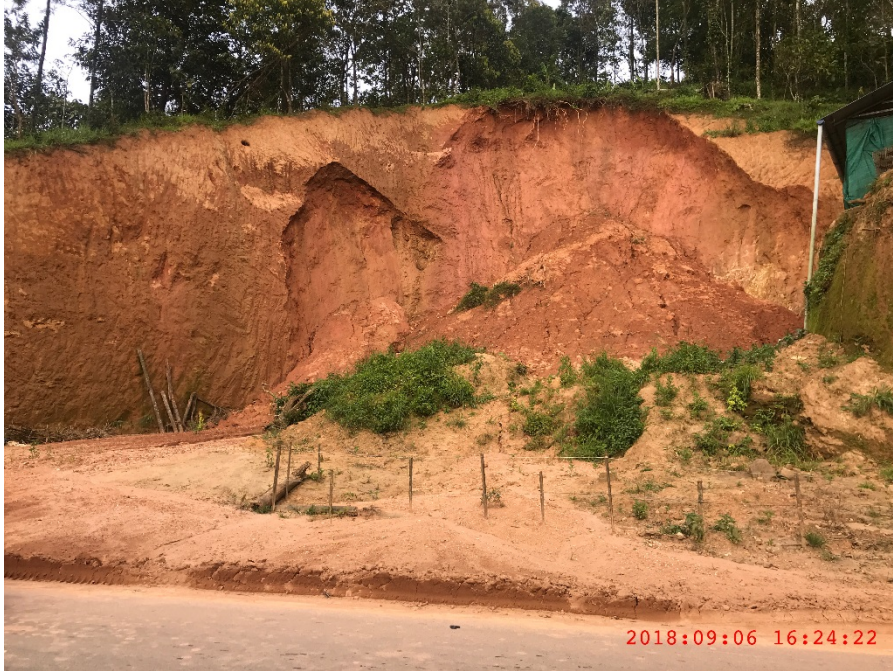
Figure A-13: Minor landslide @ 9.7694732^o N 77.0890198^o E

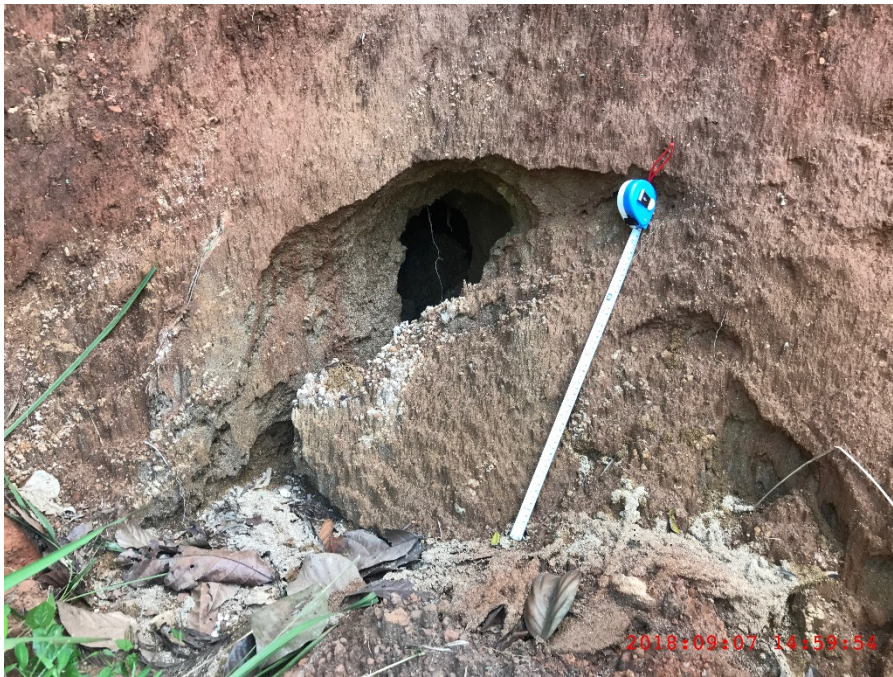
Figure A-21: Another view of the pipping @ 10.0088132° N 77.0257597° E

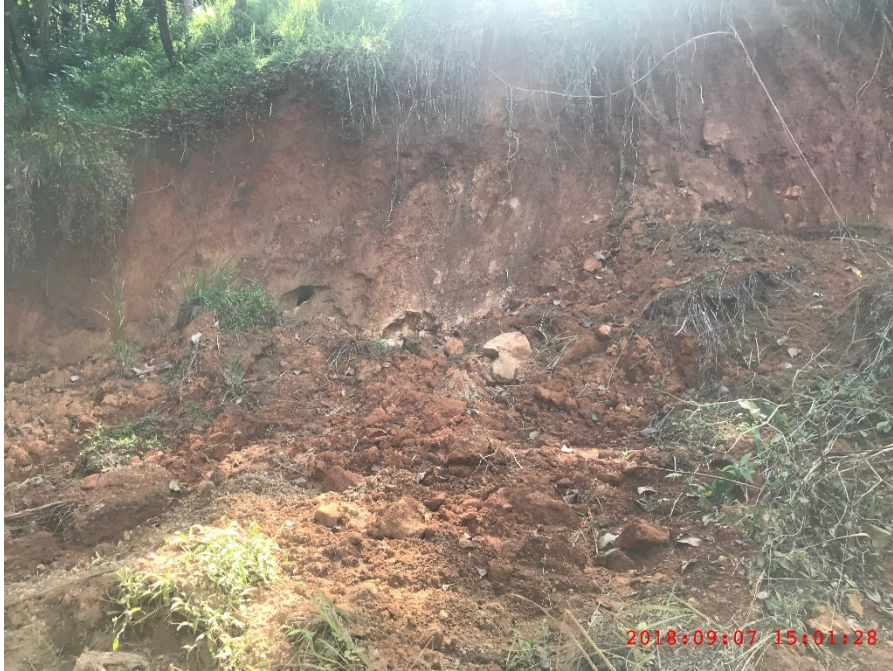
Figure A-22: Another case showing soil pipping @ 10.0088800° N 77.0258132° E

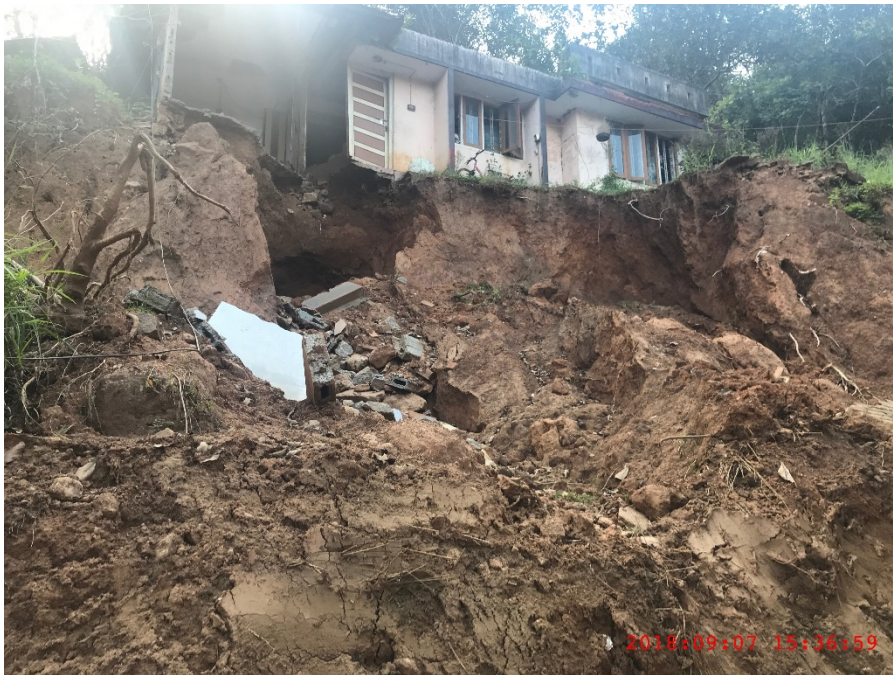
Figure A-23: A landslide case with large pipping channel @ 9.9756943° N 77.0216695° E

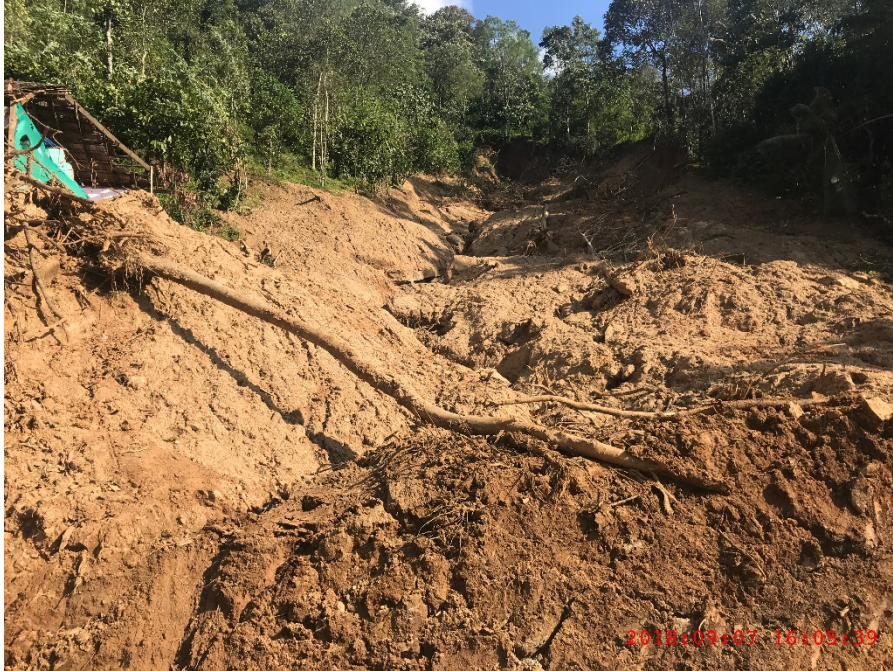
Figure A-27: Origin of the Panniyarkutty landslide @ 9.9748956° N 77.0427662° E
