# A RECONNAISSANCE REPORT ON TYPHOON MORAKOT

September 21, 2009

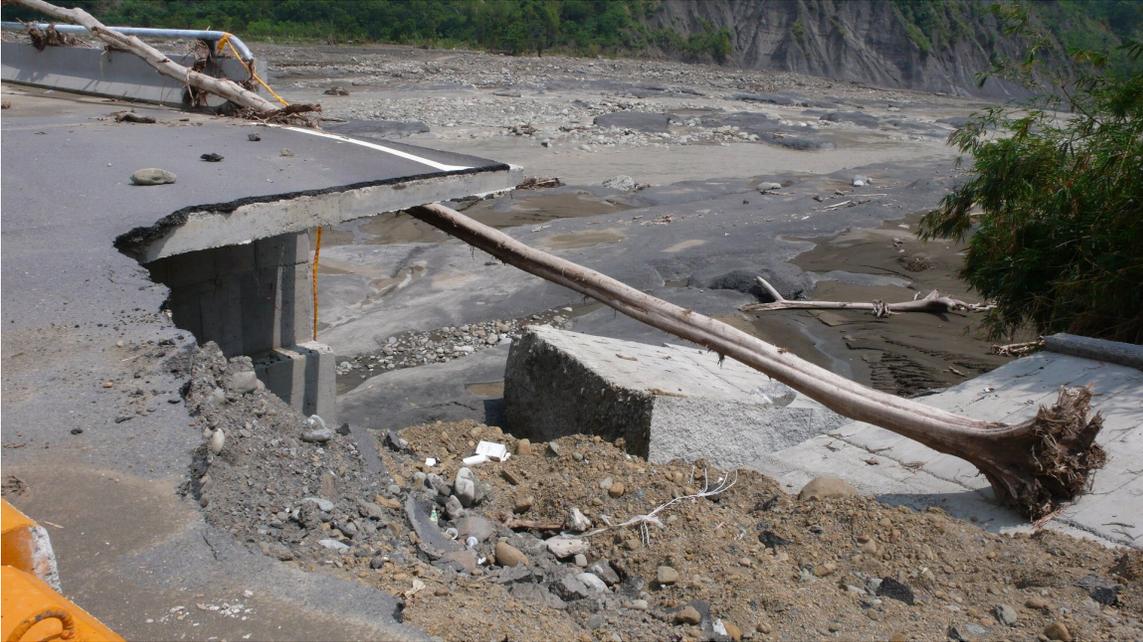
The Jia Xian Bridge was severely damaged by flooding (Photo 2-1-1) and a temporary access was built, as shown in Photo 2-1-2. Part of the bridge deck and piers (with steel pipe) disappeared. The retaining walls near the bridge abutment collapsed due to scouring (Photo 2-1-3).

Photo 2-1-3. Collapse of retaining walls at the abutment of Jia Xian Bridge.

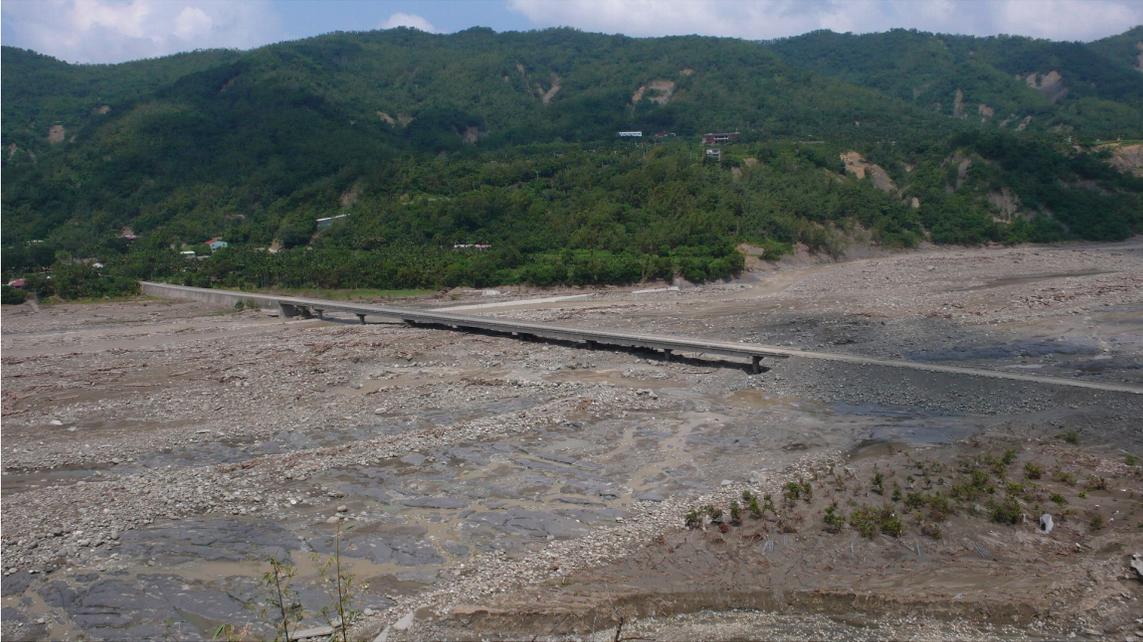
Another bridge nearby the site (marked as 3 in the map;  $23^{\circ}05'44''\text{N}$   $120^{\circ}35'39''\text{E}$  elev. 262 m) remained intact, but significant amounts of gravel and timber debris were deposited under the deck and on the road (Photo 2-1-7). Many landslides occurred in the mountains near the site (Photo 2-1-8).

Photo 2-1-7. A bridge nearby Jia Xian Bridge remained intact. The river was filled with debris.

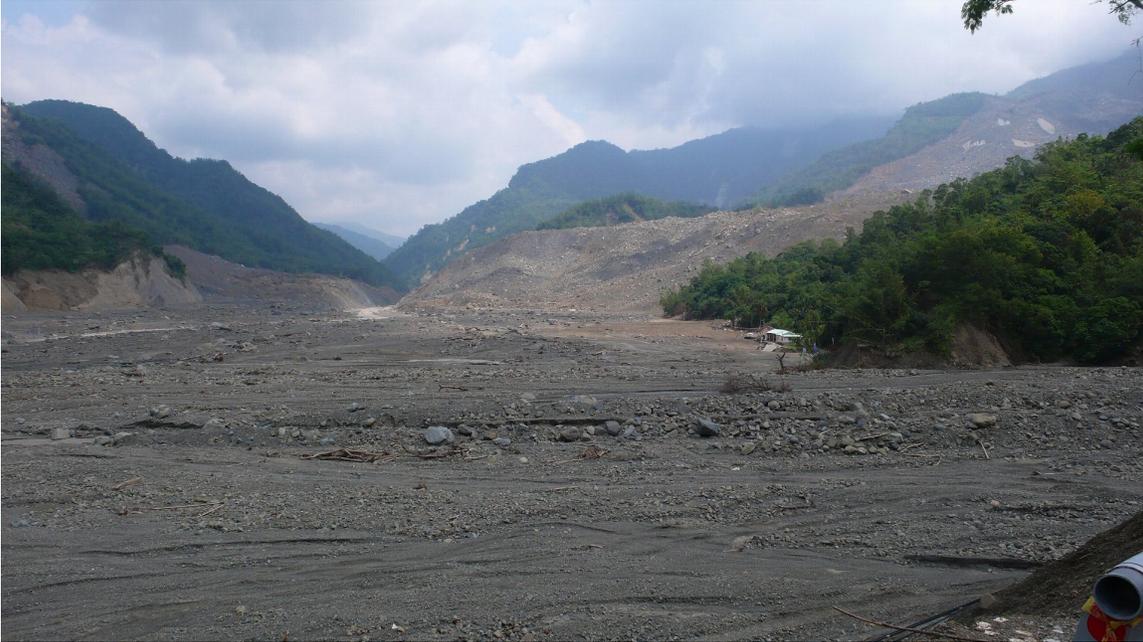
The reconnaissance along Route 21 ended at Hsiao Lin Village, where a bridge was damaged. More than 400 people were buried alive by debris flow. One debris flow originated from mountains to the left of the photo, while another debris flow occurred from the mountains on the opposite side of the river. The debris is estimated to be several meters deep, thus recovery of bodies has been abandoned.

Photo 3-3-2. Hsiao Lin Village was devastated by debris flow. Only two houses were left, as can be seen on the right side of the photo. More than 400 people were buried by the debris.

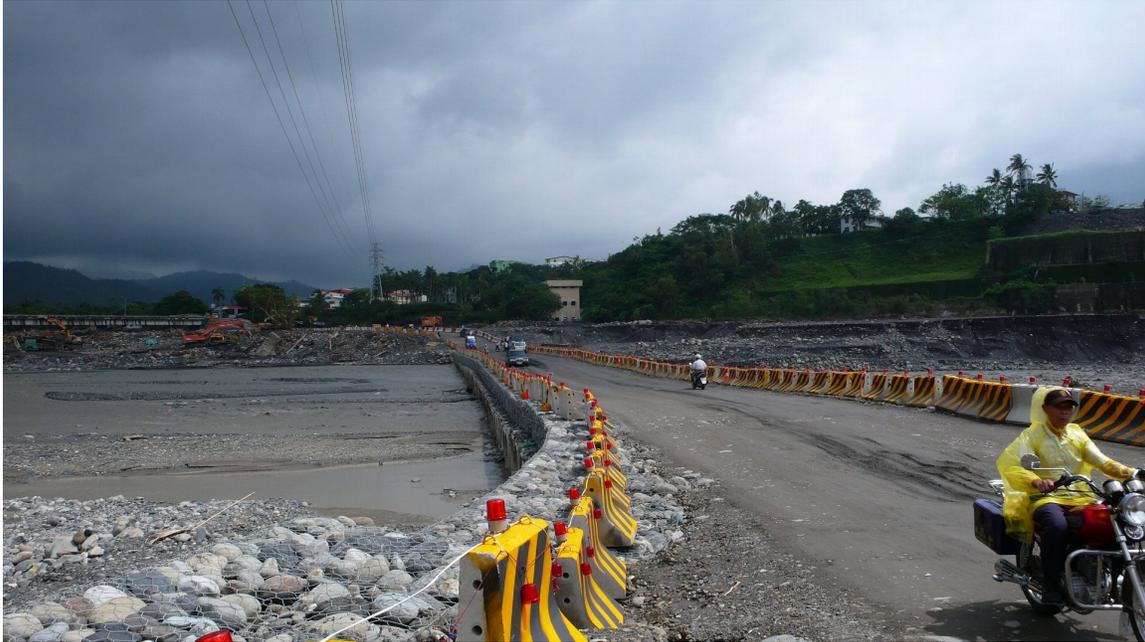
Photo 4-1-5. A temporary access road that crossed the river.

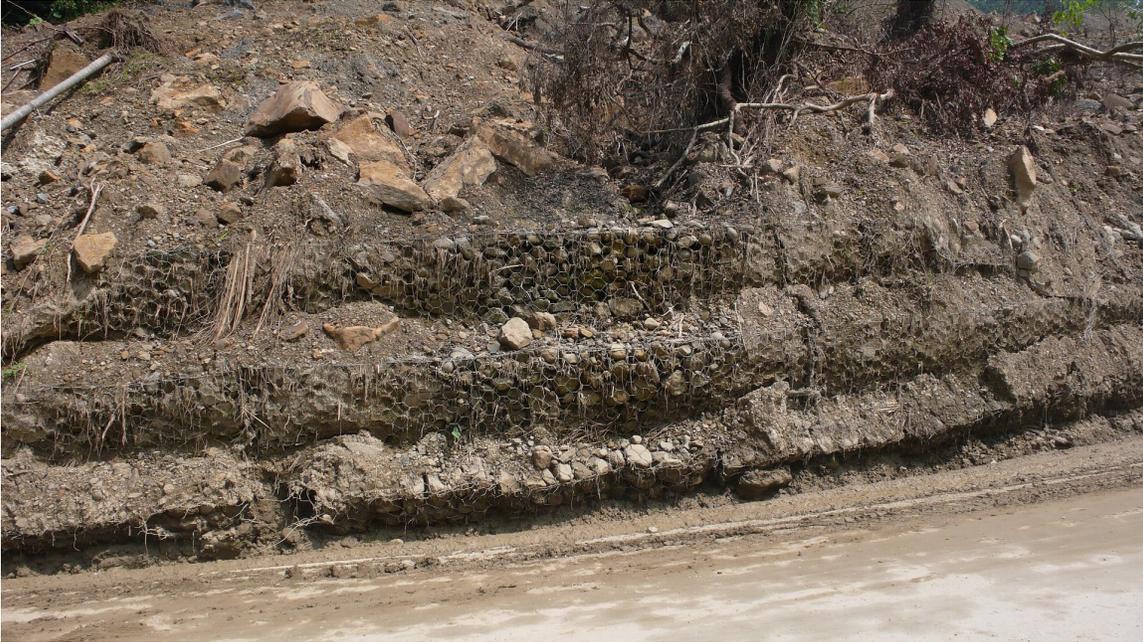
Photo 5-2-4. Gabions were used in the lower part of the slope.

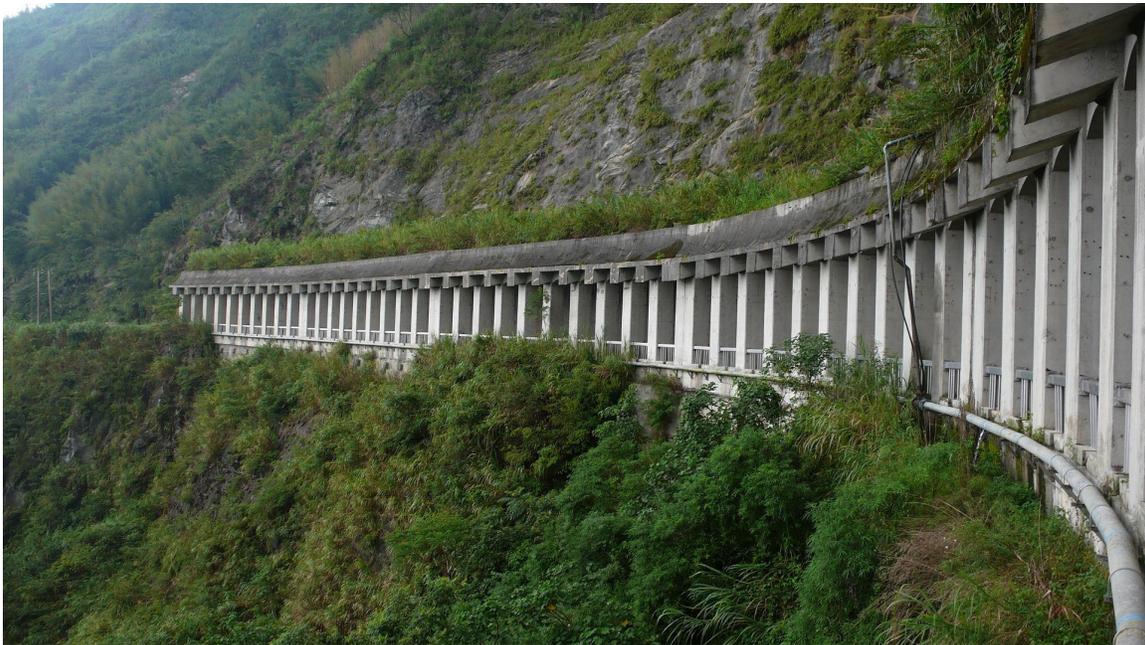
Photo 5-5-1. Another site with the shed.

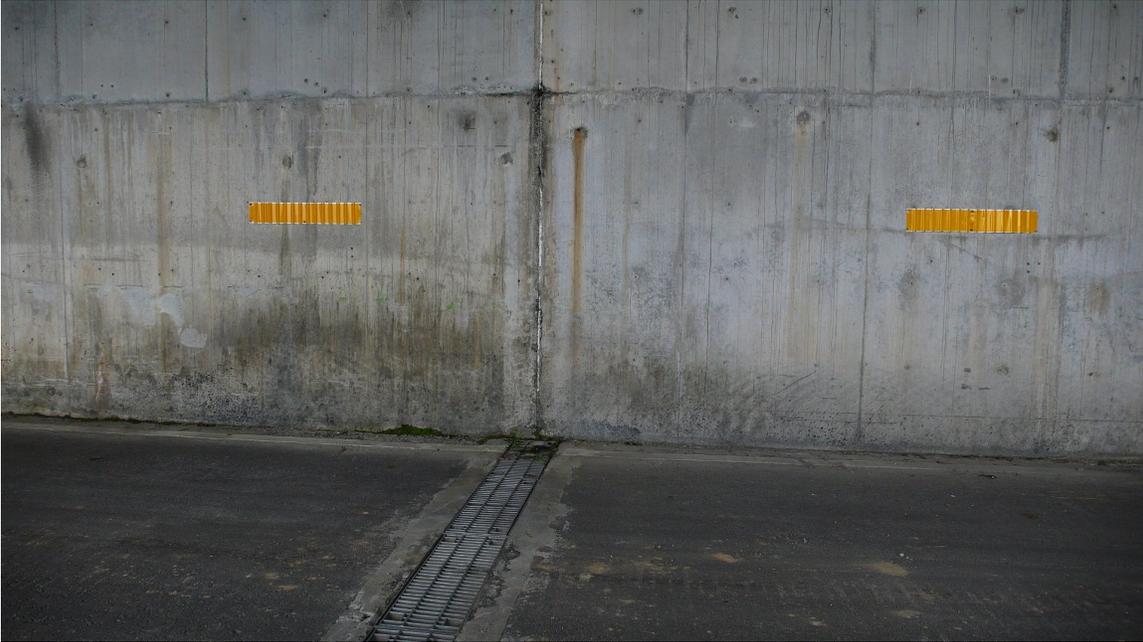
Photo 5-5-2. Construction joints remained intact; these did not show evidence of relative displacement.

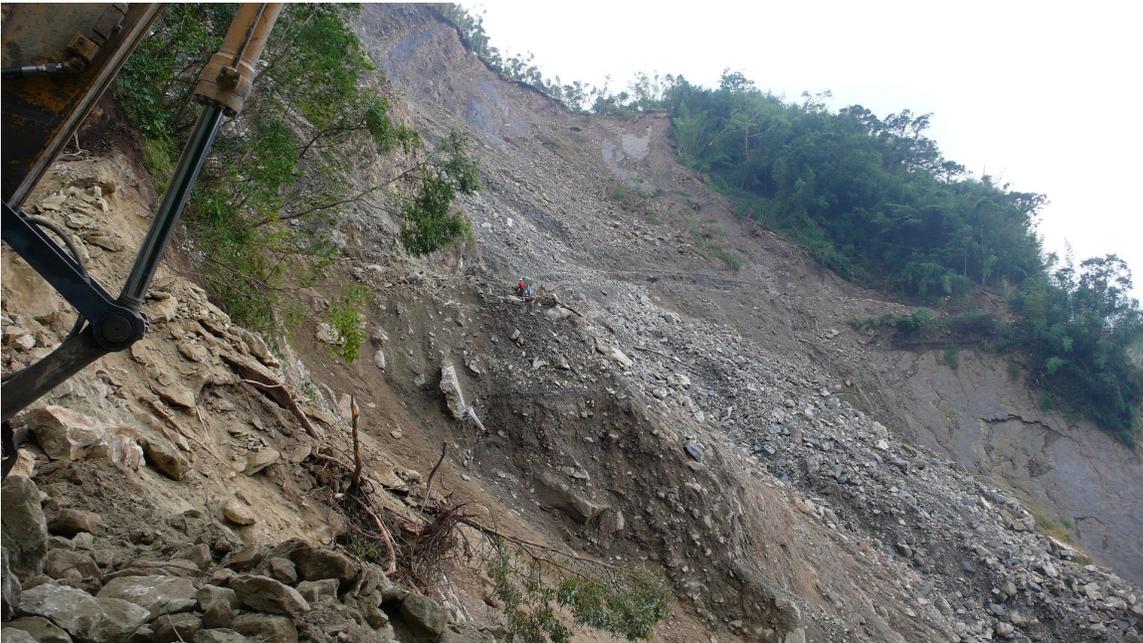
Photo 5-5-3. Several hundred meters of the highway were lost due to a landslide.

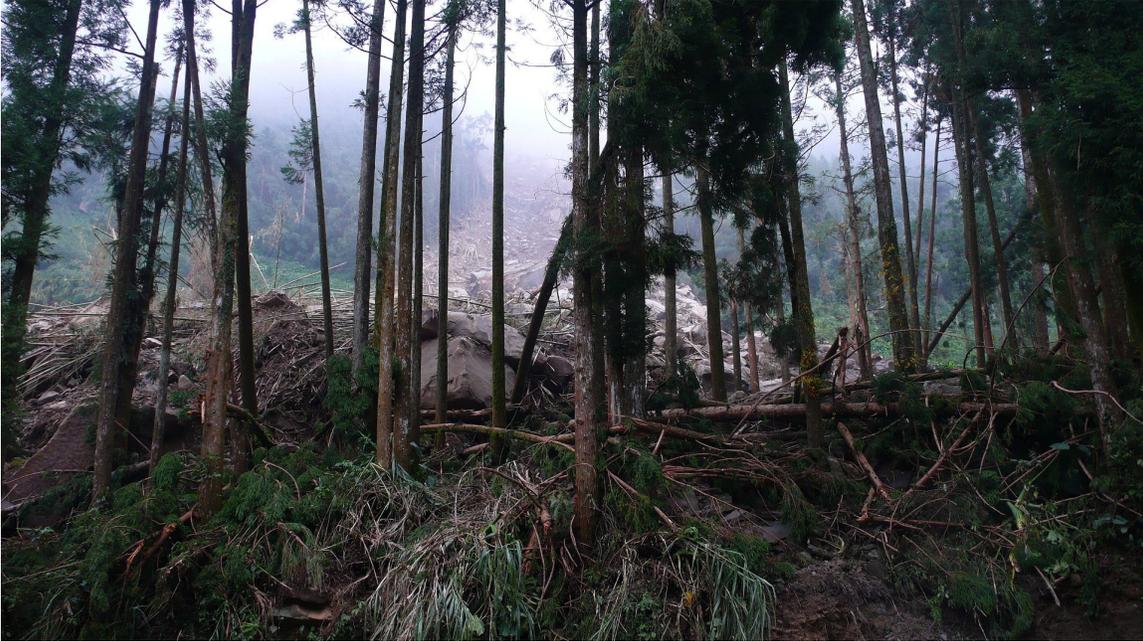
Photo 5-6-1. Source of debris flow can be seen in the distance, up the mountain.

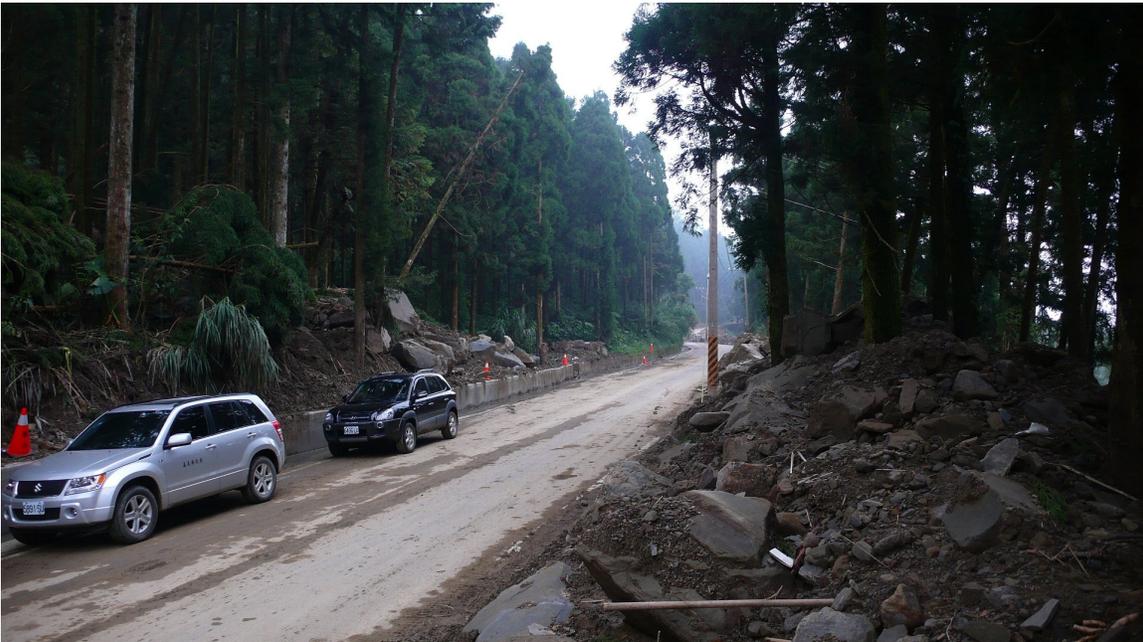
Photo 5-6-2. Debris flow with boulders and gravel of various sizes. The road has been cleared for traffic.

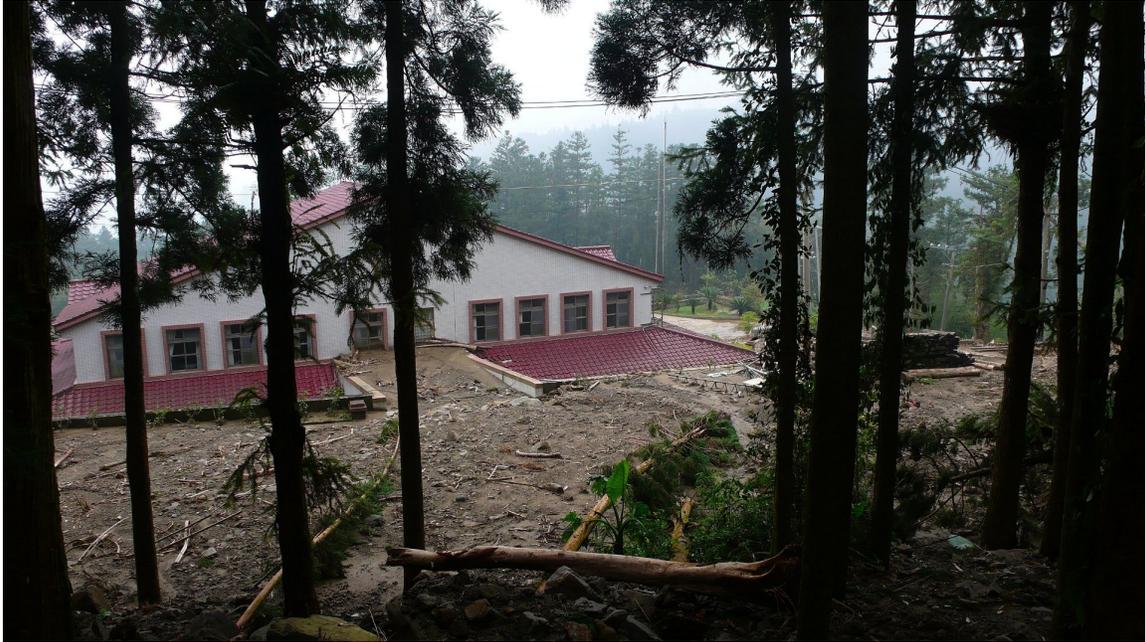
Photo 5-6-3. A building partially buried by debris flow

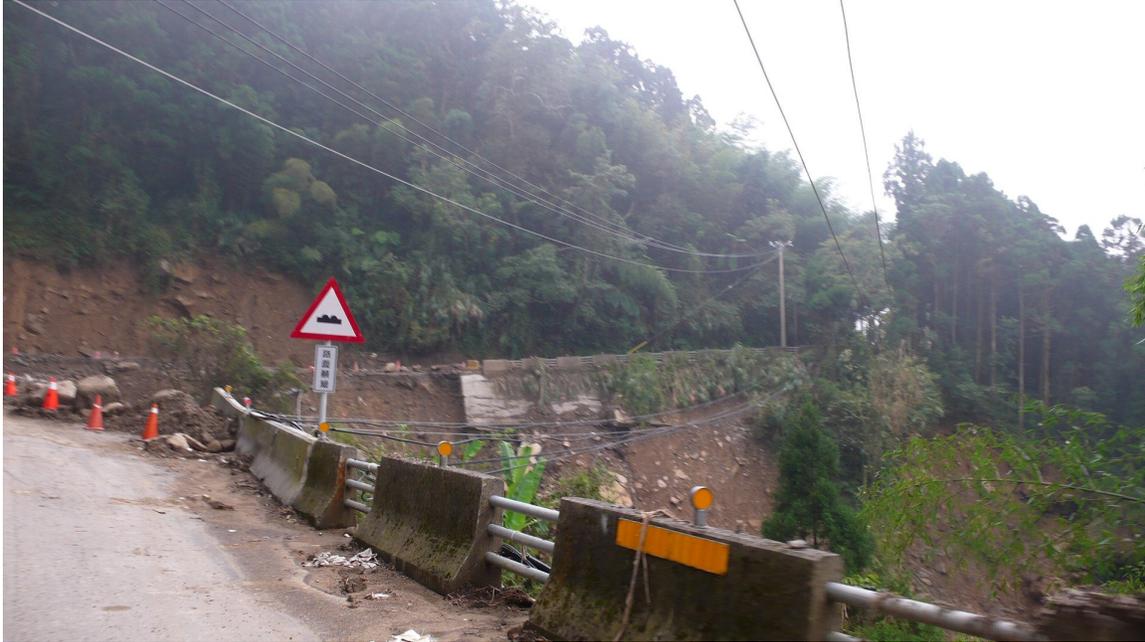
Photo 5-6-5. A different form of barrier which allowed free drainage of rainwater.

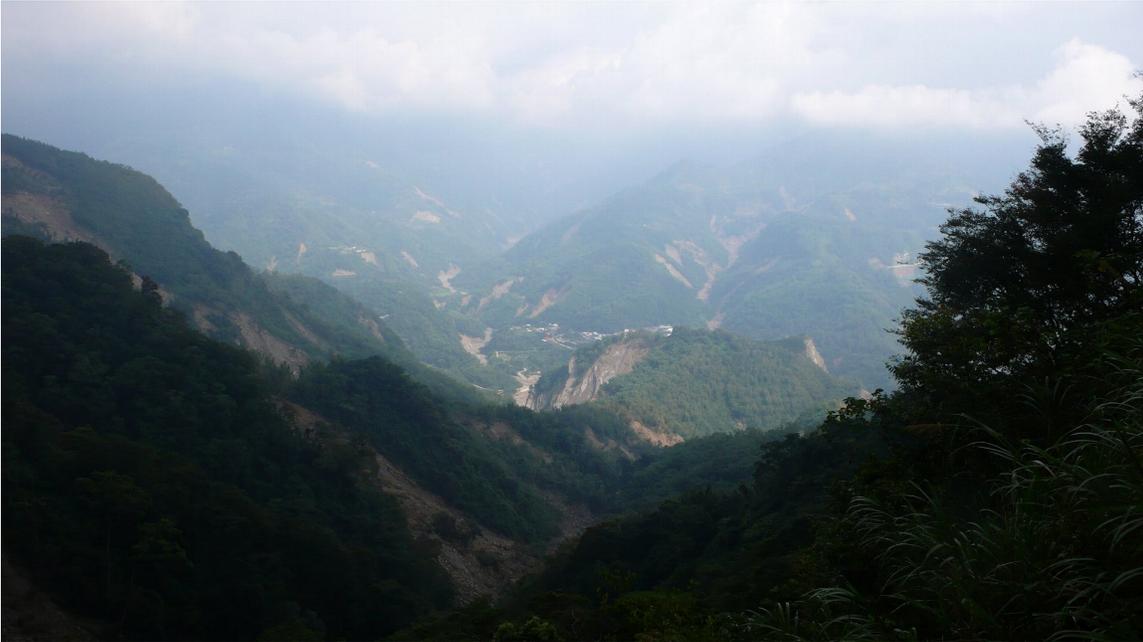
Photo 5-7-1. Landslides

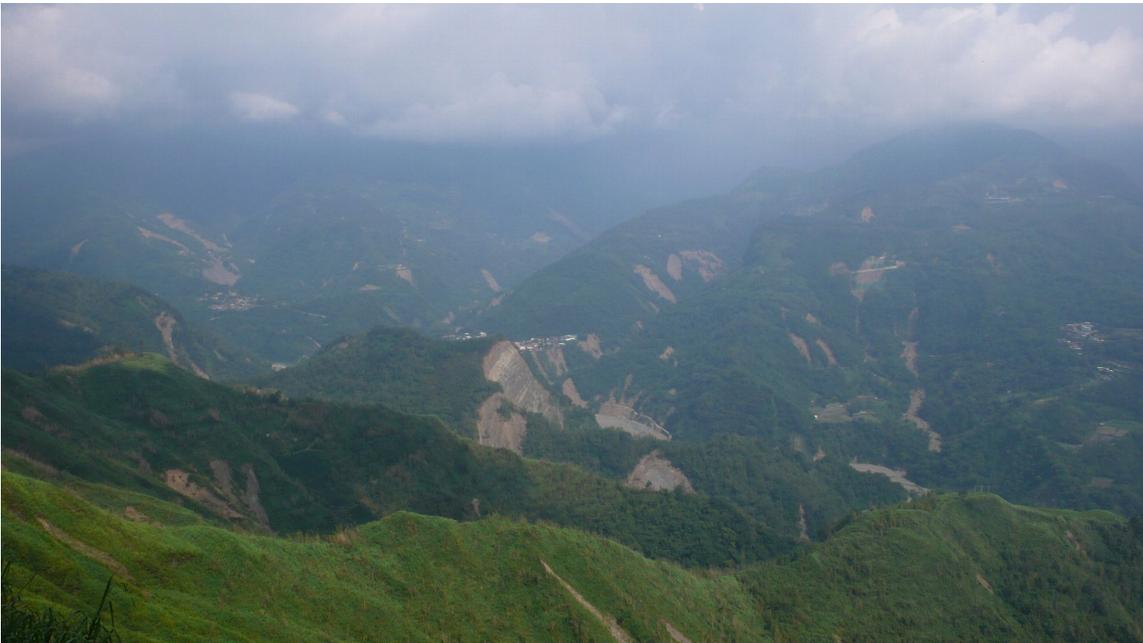
Photo 5-7-2. Landslides

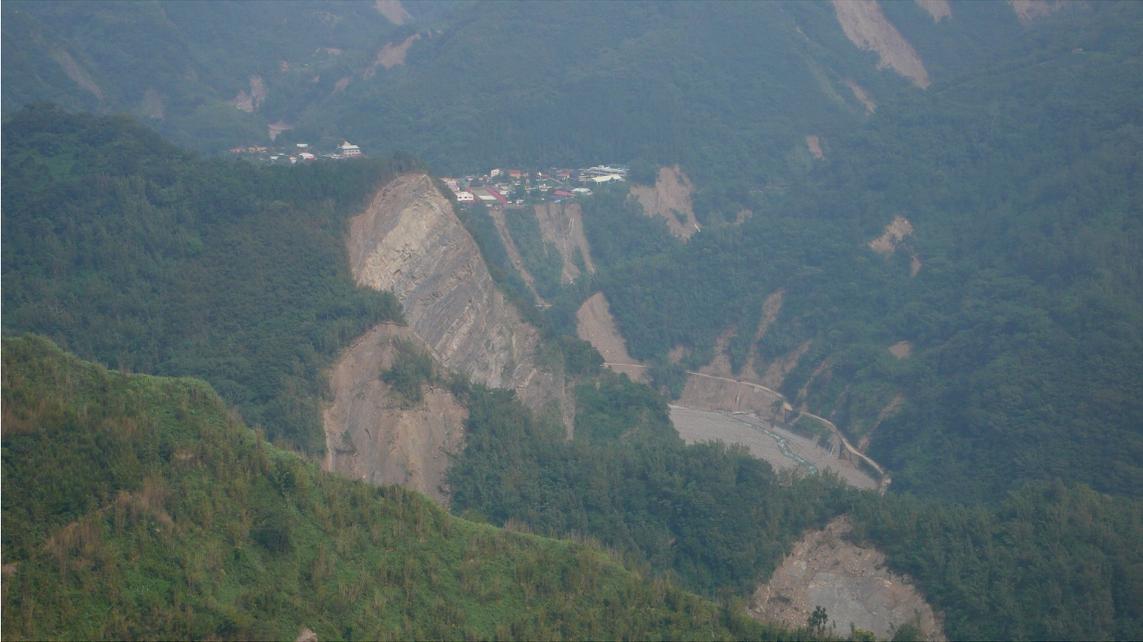
Photo 5-7-3. A closer view of huge landslides of Photo 5-7-2
